U.S. Army Corps of Engineers – St. Louis District

# Geomorphology Study of the Middle Mississippi River

Supplemental report to Brauer, E.J., Busse, D.R., Strauser, C., Davinroy, R.D., Gordon, D.C., Brown, J.L., Myers, J.E., Rhoads, A.M., and Lamm, D. (2005) Geomorphology Study of the Middle Mississippi River. U.S. Army Corps of Engineers, Prepared for Mississippi River Stakeholders, 43 p.

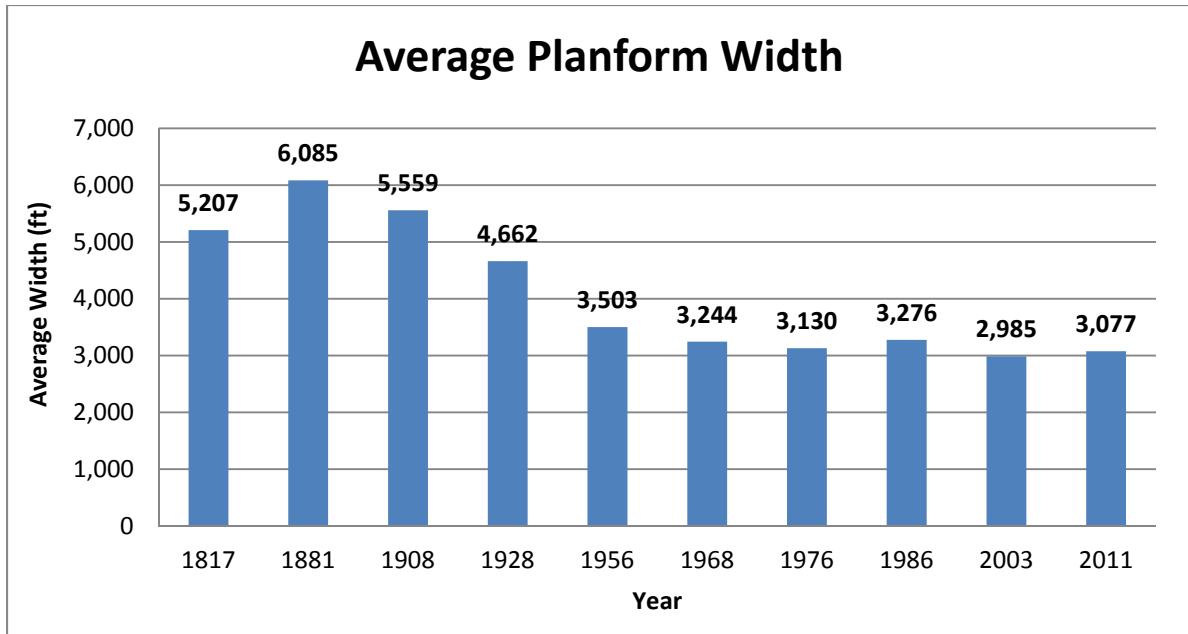
Figure 1: Average Planform Width

Average planform width is shown in Figure 1. The planform width represents the width of the planform from tree line to tree line. This width incorporates all channels, side channels, sandbars and islands. Each cross section was used to measure the average planform width taken perpendicular to the banklines. The average width for 1866 is only incorporated into the reach specific graphs since the survey did not cover River Miles 40-0.

From 1817 to 1881 an increase in planform width of 877 feet occurred. With a few exceptions, there were no river stabilization measures or training structures on the Middle Mississippi River prior to 1879. The increase in planform was due to the river’s response to changes along the bankline and in the river basin. These changes include clearing of bankline vegetation, changes in land use and changes in runoff (Brauer et al 2005, Heitmeyer 2008). The 1881 planform shows that the Middle Mississippi River became wider, shallower and more braided when compared to 1817.

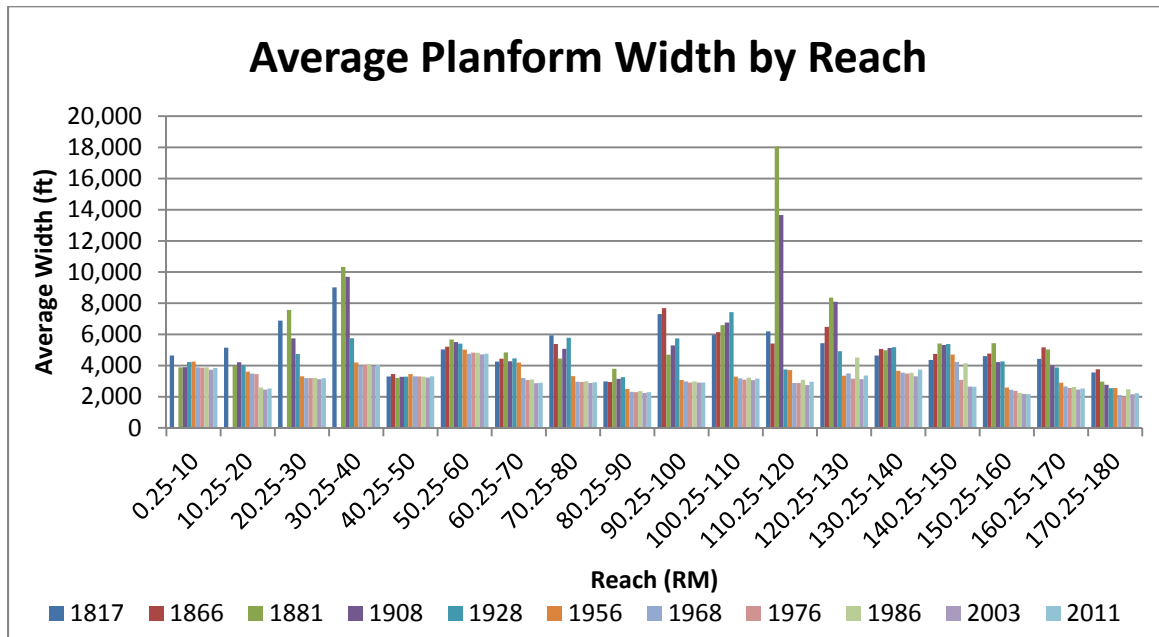
Figure 2: Average Planform Width by River Reach

Figure 2 shows average planform widths broken down by river reach. A few locations decreased in planform width between 1817 and 1881. The St. Louis Harbor reach, between River Miles 180.0-170.25, saw a decrease in average width of 591 feet. Wilkinson Island, between River Miles 100.0 and 90.25, disappeared between 1866 and 1881 reducing the average planform width by 2,989 feet. Grand Tower Island also became part of the floodplain reducing the average planform width between River Miles 80-70.25 by 1,497 feet. The reaches between River Miles 20-10.25 and 10-2.5 saw reductions in average planform width of 1,156 and 759 feet respectively.

The reach with the most dramatic change in planform width was between River Miles 110.25-120.0 which increased in planform width by 11,859 feet. During the flood of April

1881, a major planform change occurred when the Mississippi River and Kaskaskia River meandered together. The Mississippi River captured the Kaskaskia River channel upstream of the confluence leaving the “old” Mississippi River channel to serve as a side channel. The land between the two rivers became a large island. This change decreased the length of the Mississippi River by 5 miles.

The reach between River Miles 120.25 and 130 also experienced a notable increase in average planform width of 2,930 feet between 1817 and 1881. In this reach there was a steady increase both between 1817 and 1866 and 1866 and 1881 of 1,042 feet and 1,887 feet respectively.

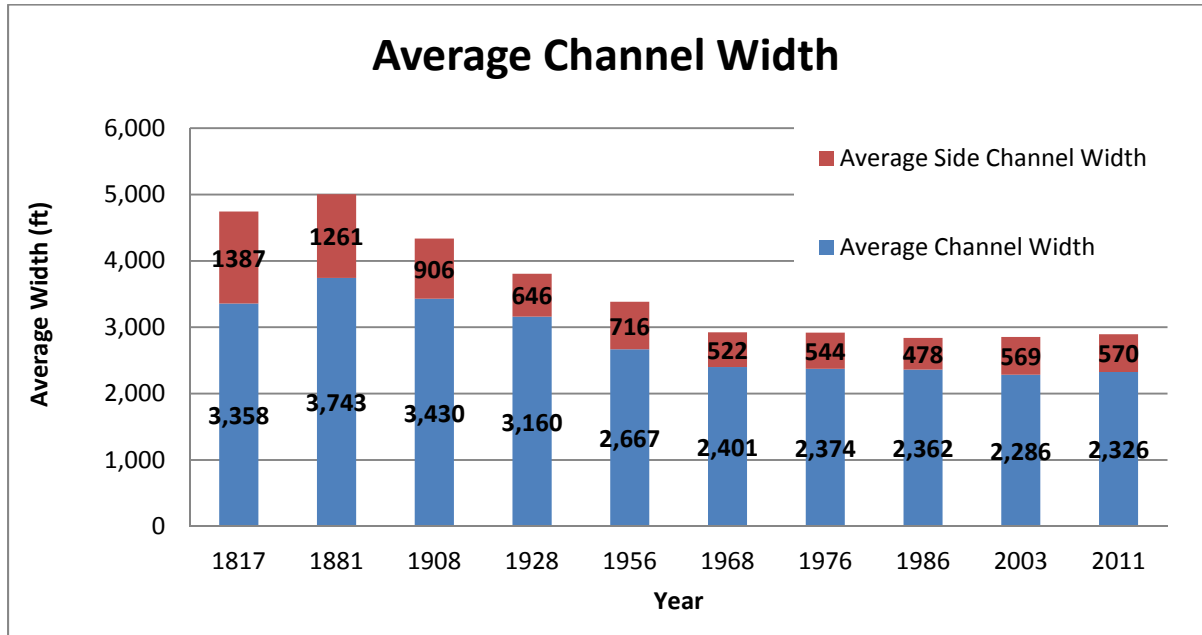
Figure 3: Average Channel Width

From 1817 to 2011 the average main channel width decreased 1,032 feet from 3,358 feet to 2,326 feet. Between 1817 and 1881 the average main channel width increased by 385 feet. The increase in main channel width was relatively uniform throughout the entire Middle Mississippi River. However, some locations observed a decrease in average channel width. The largest decrease was between River Miles 170.25 – 180.0. The construction of dikes and revetment had already begun in this reach and are shown in the 1881 survey.

The construction of river training structures coincided with a constant decrease in average main channel width between 1881 and 1968. After 1968 the main channel width remained

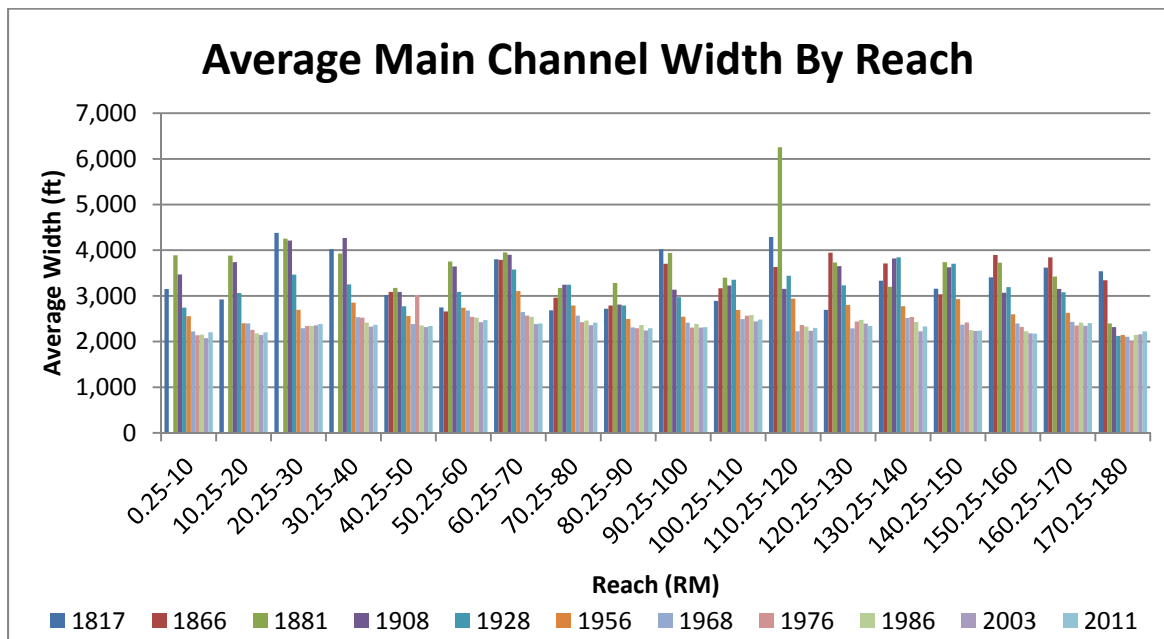
Figure 4: Average Main Channel Width by Reach

Another observation from Figure 4 is that the average main channel width has become more uniform on the Middle Mississippi River. The standard deviation between the reaches in 1817 was 577 feet, in 1881 it was 752 feet. In 2011 it was 96 feet.

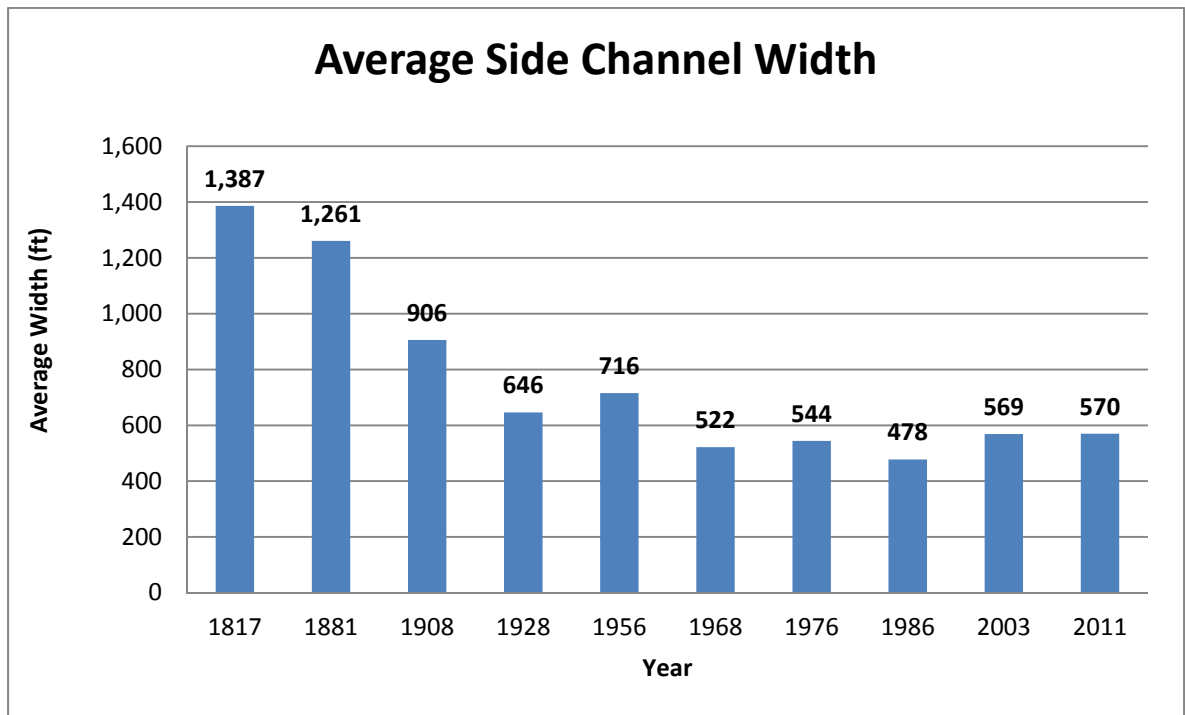
Figure 5: Average Side Channel Width

The average side channel width is shown in Figure 5. The average side channel width is difficult to interpret independently since it averages the widths of all of the existing side channels and does not directly account for the gain or loss of side channels over time. A more detailed analysis of side channels on the Middle Mississippi River by Tom Keevin and Erin Guntren is ongoing and will be available in the future.

The average side channel width decreased steadily between 1817 and 1928. After a slight increase in 1956, it remained relatively constant until 2011. To help understand these trends it is necessary to understand the changes in cumulative side channel length. The larger average side channel width in 1817 was primarily due to the presence of split flows. The decrease in side channel width between 1817 and 1881 was due mostly to the increase in the number of smaller islands and the presence of a more braided channel. The braided channel had shorter, narrower side channels than what was present in 1817. Between 1968 and 2011 the average side channel width and cumulative side channel length remained relatively constant.

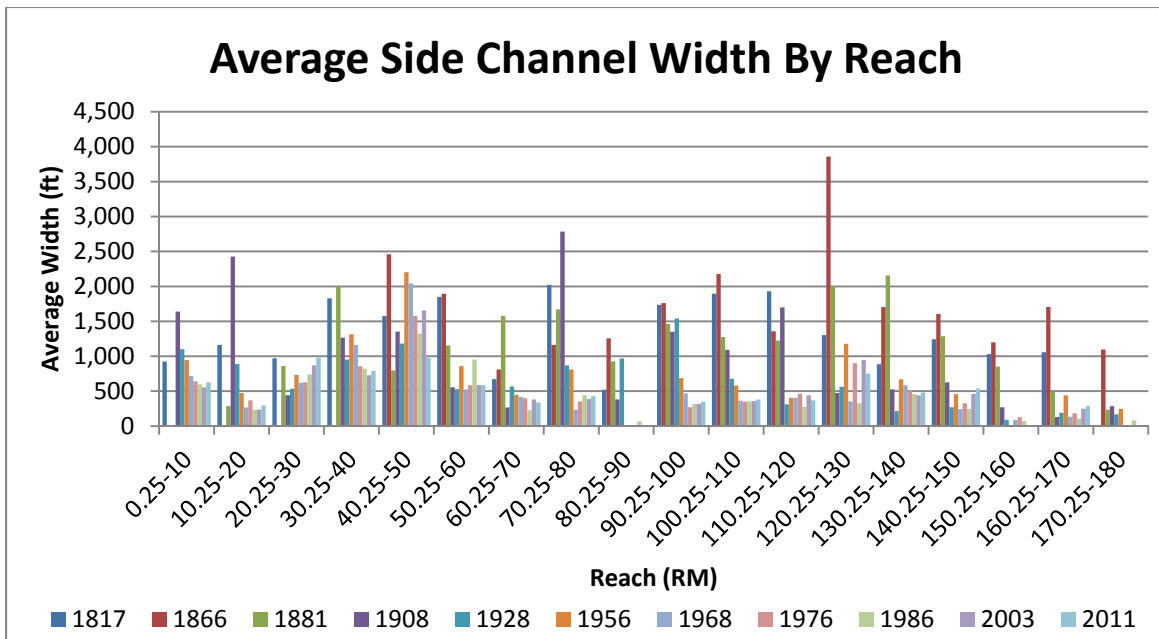
Figure 7: Average Side Channel Width by River Reach

The average side channel width was broken down into 10 mile river reaches in Figure 7. This figure helps identify changes in specific side channels.

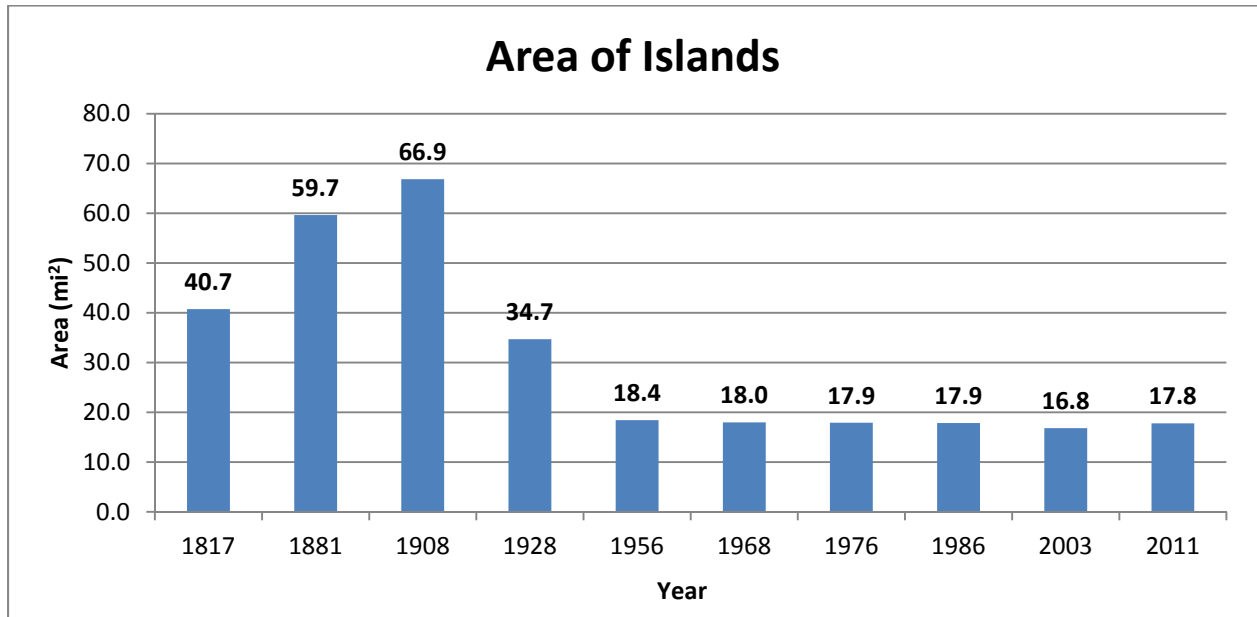
Figure 8: Area of Islands

The Island number and area were analyzed in this study (shown in Figures 8 and 9). Between 1817 and 1881 Kaskaskia Island was formed by the capture of the Kaskaskia River by the Mississippi River. This added approximately 25 square miles of island area to the Middle Mississippi River. The “old” Mississippi River channel was cut off from the main channel between 1908 and 1928, reducing the area of islands by 25 square miles. Since 1956 the island area has remained relatively constant.

There is some variability in the number of islands due to the definition of an island. An island was defined as a body of land surrounded by water that contained vegetation. Depending on the vegetation patterns, an island in one survey could be categorized by more than one island in another over the same area. Many early islands were dynamic in nature and evolved between a single land mass and a series of separate land masses.

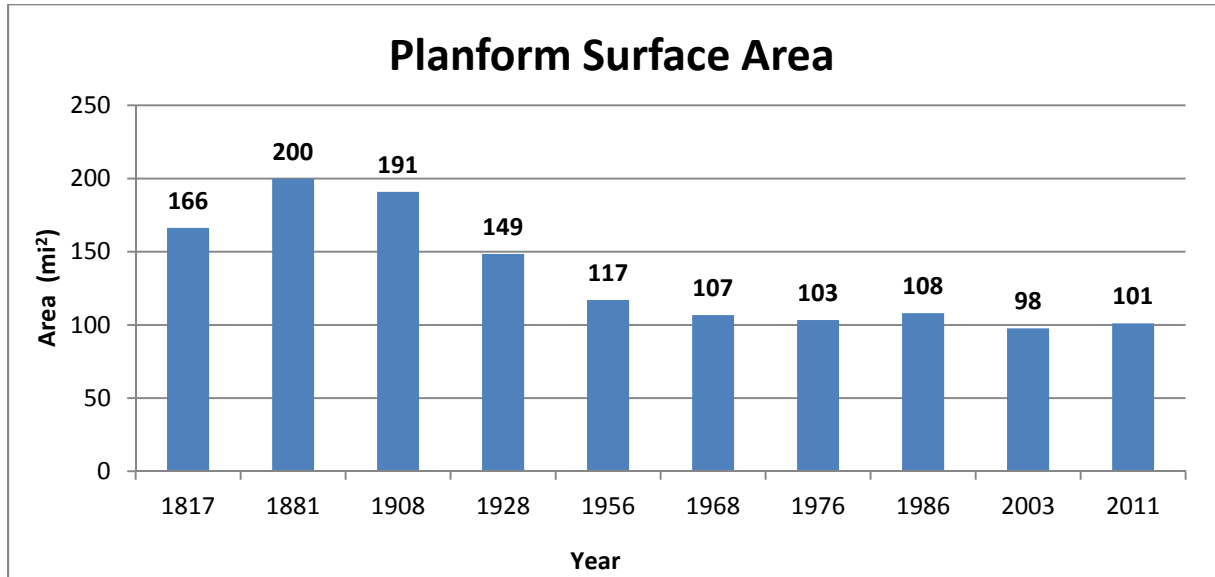
Figure 9: Planform Surface Area

The planform surface area is shown in Figure 10. This value was calculated by using the area calculation in ArcGIS on the planform polygon. The Kaskaskia Island Reach has the same effect on the planform surface area as it did on island area. The increase between 1817 and 1881 and the decrease between 1908 and 1928, are partially attributed to the addition and later subtraction of approximately 25 square miles of island. Another factor influencing the planform surface area was the loss of side channels and conversion of former side channels and deposition between dikes into vegetated floodplain. The planform surface area remained

relatively constant after 1968. This is mainly due to the different structures used as described in previous sections.

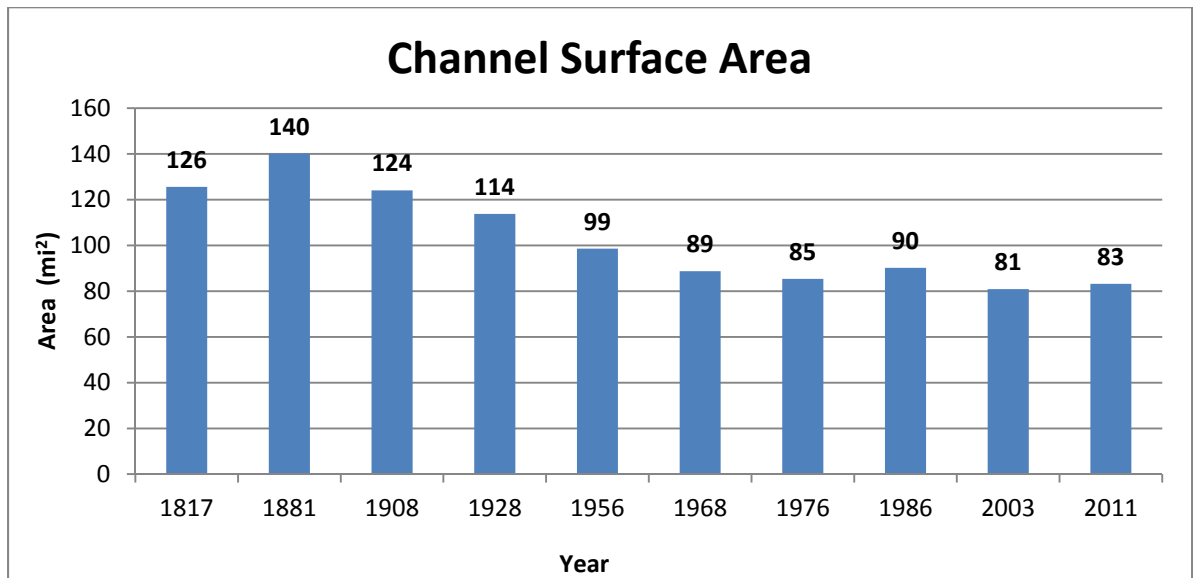
Figure 10: Channel Surface Area

Total channel surface area was calculated by subtracting the island area from the planform surface area. The surface area graph shows the same trends as the ones discussed in the average width section. Similar to the planform surface area the channel surface area has remained relatively constant since 1968.
