STONE DIKE ALTERATIONS PROJECT REPORT
MIDDLE MISSISSIPPI RIVER, MILES 201 – 0
(UMRS – EMP) ENVIRONMENTAL MANAGEMENT PROGRAM

REPORT UPDATE

10/4/12

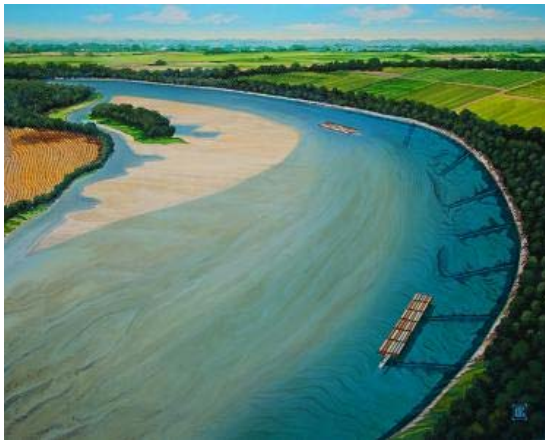
Bendway Weirs - The Bendway Weir is a low level, totally submerged rock structure that is positioned from the outside bankline of the riverbend and angled upstream toward the flow. These underwater structures extend directly into the navigation channel underneath passing tows. Their unique position and alignment alter the river's spiraling, secondary currents in a manner which shifts the currents away from the outside bankline. This controls excessive channel deepening and reduces adjacent riverbank erosion on the outside bendway. Because excessive river depths are controlled, the opposite side of

the riverbank is widened naturally. This results in a wider and safer navigation channel through the bend without the need for periodic maintenance dredging. The Bendway Weir also eliminates the need for dikes to be constructed on the inside of the bendway, protecting bend interior sandbar habitat. There had been concern that bendway weir construction was leading to increased bend-interior slopes; analysis of pre- to post-construction data found that slope changes were largely within the expected natural deviation¹.

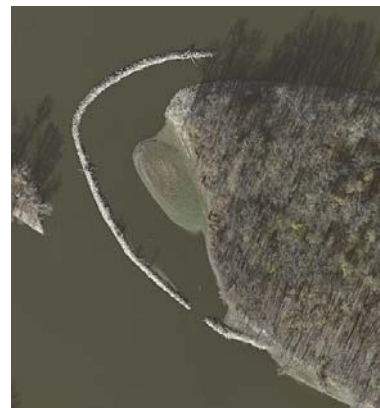
Bullnoses – Bullnoses redirect flows around islands protecting the islands from erosion. Without the rounded upstream rock structures, island heads can be exposed to high-velocity flows that hit head-on and mobilize sediment, eroding an island away. The bullnose locks

in the island's upstream geometry, rendering the island, and the aquatic and terrestrial habitat it forms, largely permanent.

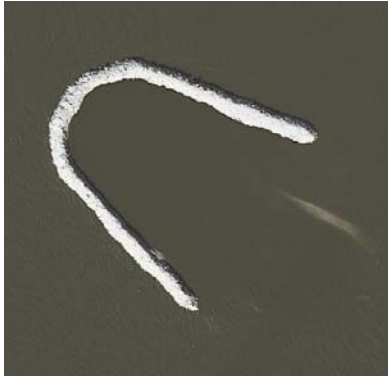
Chevrons – Chevrons are “U”- or “V”-shaped rock structures with their apexes oriented upstream that divide flow smoothly so that a portion of the flow can be redirected without a significant undesired scour area forming. Dividing the flow in this manner can increase energy and decrease sedimentation in both side channels and the main channel. Besides redirecting flow along the front of the chevron, chevrons are designed with intent of periodic overtopping of the apex occurring. This overtopping results in the formation of a plunge pool within the chevron. The lower-velocity flow exiting the plunge pool can no longer maintain its sediment load and deposits sediment

downstream of the chevron. This deposition can lead to the development of ephemeral or permanent islands downstream of chevrons. The bathymetric diversity presented by a plunge pool and downstream depositional area have been found to be favorable habitat for a variety of fish species. In the case of two or more chevrons, deposition behind the chevrons and side channel depth both increased with the number of chevrons. Use of multiple chevrons in a field can be used to either maintain a split flow situation or direct a split flow to a particular location (such as an area prone to a lower energy level). The disadvantage to the construction of chevrons is that they obstruct far less flow than a typical dike of equivalent length. Chevrons can be constructed with rootless trails extending the effective length of the chevron legs with regards to splitting flow while allowing for some flow behind the chevron. They can also be constructed with notches, with the intent of decreasing the depth of the plunge pool; these effects are still being studied. A third option for chevron construction is the shortening of one leg and the extension of the other. This J-shape can be used to further maintain a split flow.

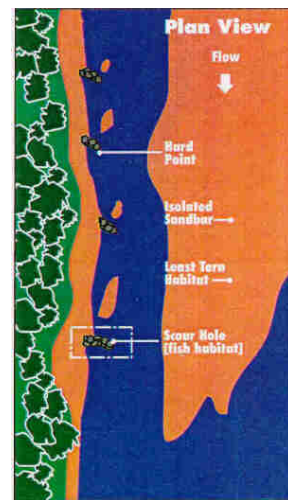
Hard Points - Hard points are very short rock dikes that are used to stabilize side channel river banks. The structures extend from the bank into the side channel and do not cause a significant buildup of sediment. Their

contribution to habitat improvement is the creation of scour holes behind the hard points. These plunge holes attract fish that flourish in this environment. Effective hardpoint placement requires a relatively active side channel with little ongoing sedimentation.

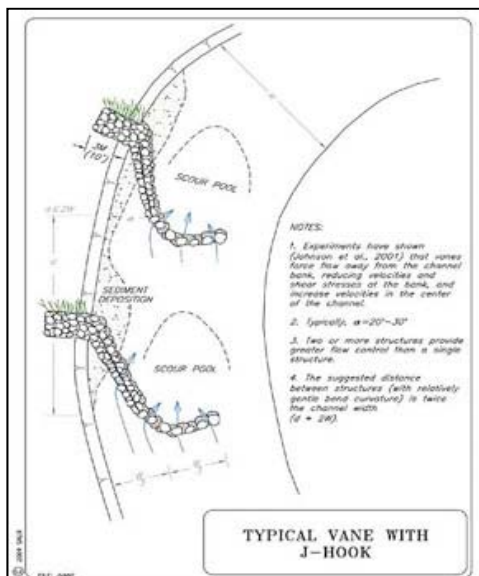
J-Hooks – J-Hook Rock Vanes are structures designed to redirect velocity distribution and high velocity gradient in the near-bank region, stabilize stream-banks, dissipate energy in deep, wide, and long pools created below the structure, and create holding cover for fish and spawning habitat in the tail-out

of the structure. The basic function of the structure utilizes the principle that water will flow over immovable objects at right angles (90° angles). The device is constructed of large stone that is tied into the streambank. The stone is trenched into two rows at an upstream angle of 20° to 30° at a distance of 1/3 stream width. The stone is then formed into a hook shape to cover a distance of 1/3 stream width. The downstream row of rock is trenched into the stream bottom so that the top of the rock is approximately level with the stream bottom. The second row of rock is then placed just upstream of that row of rock slightly overlapping it so that as the water flows over the top of the upstream line of rock it will flow onto the downstream line of rock. This creates a stable surface on which the energy of the stream can be dissipated without completely scouring the stream bottom. As the stream dissipates its energy, it will scour the stream bottom slightly, creating a small scour pool immediately downstream of the device that serves as a source of aquatic habitat.

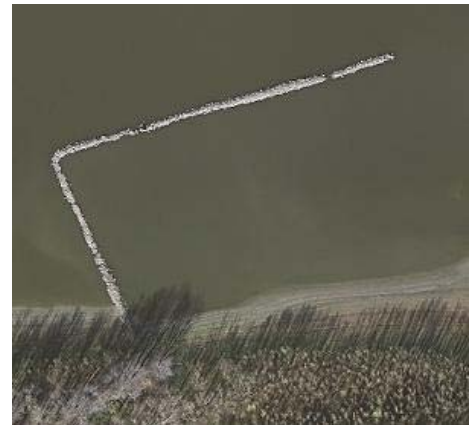
L-Dike – L-Dikes consist of a normal dike that has a trail dike constructed parallel to the flow from the tip. The constructed trail dike continues the constriction of the channel further along the main channel to increase main channel energy and decrease deposition. The area behind the L-Dike becomes a slack water area with beneficial habitat characteristics. This area can be prone to deposition due to the low energy level within the dikes, but such deposition can be reduced by notching the trail dike so that periodic sediment flushing occurs. Some disadvantages of L-Dikes are that they isolate the bankline from the river channel and that they don't promote new bathymetric diversity.

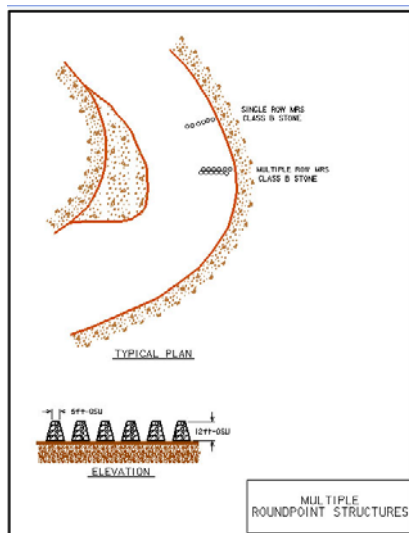
Multiple Roundpoint Structures (MRS) – Multiple Roundpoint Structures induce scouring off the tips of the structures and create depositional areas with the increased roughness generated by the structures. The MRS can also act as a primitive bank stabilization technique by creating depositional zones near the banks of the structures. The structures are generally built to 2/3 bankfull and the grade of stone needed is channel dependent. The spacing of the MRS is dependent of the height of the structure and natural angle of repose of the rock used. A rule of thumb with the spacing between the structures is to space them no less than 2/3 of the height. MRSs can be designed as a single row or in multiple rows. Preliminary data shows that incorporating more rows generates increased bathymetric changes. MRSs are not recommended as a bank stabilization technique but can be incorporated with other forms of bank stabilization such as revetment. The data collected suggest that

MRS are providing useful and valuable habitat for a variety of riverine fishes. Collection of blue suckers may indicate these structures are providing a unique habitat type, once more common in the river.

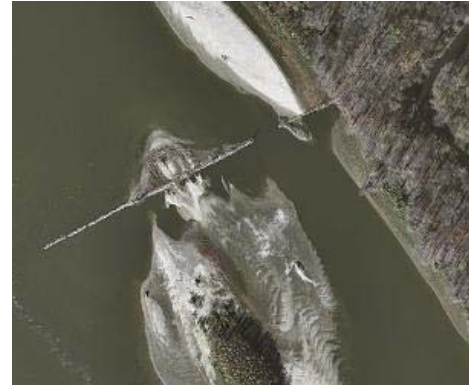
Notched Dikes – Many rock dikes with notches in them can continue to have the same effect on navigation dimensions as un-notched dikes while also promoting increased bathymetric variation. Notches in the center or bank side of dikes achieve this variation by promoting scour downstream of the notch leading to a diversity of habitat. Varying notch depth is one factor that can be used to alter the depth of scour and thus the diversity. Low energy areas behind the un-notched portions of dikes can lead to deposition, supporting the creation of islands

or side channels when used in a series. Notching is not always recommended; notching does remove a portion of the dike that may be necessary for the dike to have its intended effect, and a notch may have little effect without the proper flow depth and frequency through the notch.

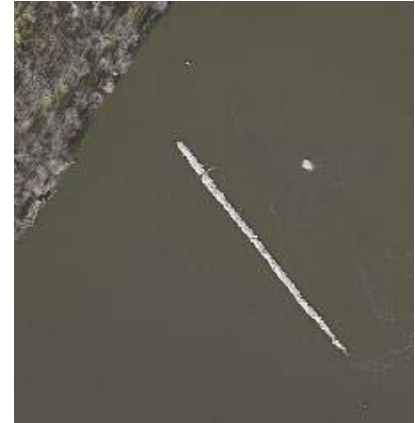
Rootless Dikes – Rootless dikes function much like notched dikes; they can have the intended effect of redirecting flow in beneficial directions while promoting bathymetric and habitat diversity in the space between the dike and the bank.

Rootless dikes are also like notched dikes in that they need to obstruct enough of the flow to have their desired effect, they need to cause a constriction of the flow, and they need the gap between the dike and the bankline to experience the proper flow depth and frequency to have an effect.

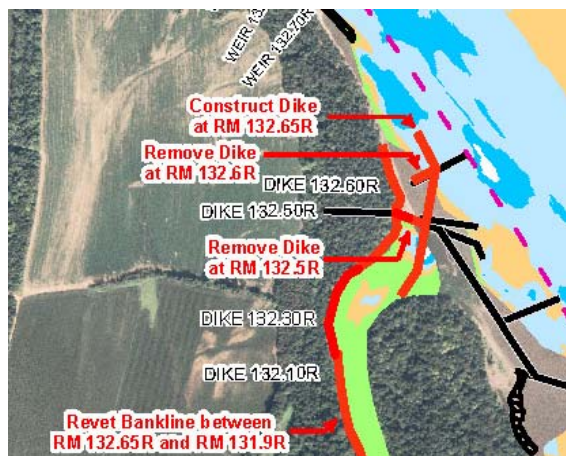
Side Channel Enhancement Dike – Side Channel Enhancement Dikes (SCEDs) are a special class of L-Dikes with the trail oriented upstream from a spur dike constructed on the island side of a side channel entrance. With the upstream-oriented trail, the SCED captures flow from the main channel and redirects it down a side channel, increasing the energy in the side channel, scouring out deposited sediment, and preventing further sedimentation in the side channel. Under the right conditions, the installation of a SCED can reopen closed

side channels, once again providing aquatic habitat in areas it had previously existed. The construction of a SCED does require certain conditions to be met for a higher likelihood of success: 1) a SCED works best when it can be constructed on the channel-dominant bank, and 2) SCED design requires a careful balance of flow capture between the side channel and main channel to avoid sedimentation in either channel.

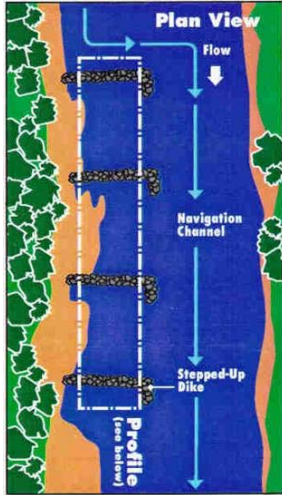
Stepped-Up Dikes - Stepped-Up dike fields of various elevations were developed to provide an additional element of diversity. They counteract sediment deposition, thereby preventing the conversion of aquatic environment into terrestrial. In the stepped-up dike configuration, each dike in sequence rises two feet higher than the previous one. This approach utilizes the river's energy to change the sediment deposits as the water level rises and falls. When the river's current hits the first dike it is propelled toward the main channel. As the river level rises, it moves over the first dike and hits the second dike, once again moving back into the main channel. This process repeats itself as the river rises and falls. The river's current, moving over each submerged dike, allows the sediment buildup to be redistributed back into the main channel and carried downstream.

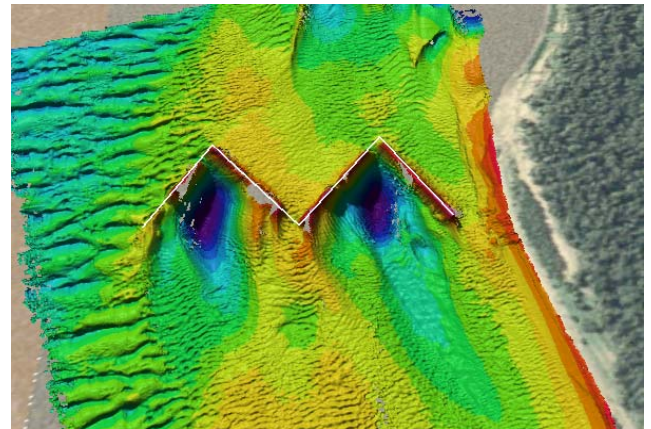
W-Dikes – W-Dikes function in a manner very similar to chevrons, but are constructed to act over a

larger width of the channel. By using a W-Dike instead of a chevron, two plunge pools are created between the inside and outside legs of the W, with deposition typically occurring downstream of the center of the W. Disadvantages of W-Dike construction include the cost of construction (as they require 2-3 times the stone), the difficulty in construction, and the channel width and depth needed.

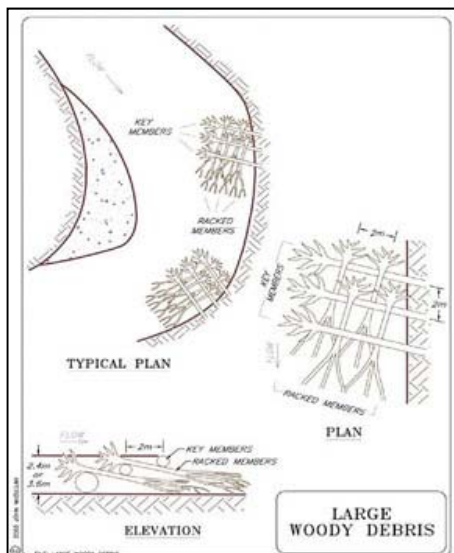
Woody Debris - Naturally occurring large woody debris (LWD) (i.e., >10 cm diameter and 2 m in length) is an important component of many lotic systems. It provides roughness, reducing velocities and providing overhead cover for fishes, substrate for aquatic invertebrates, and can be an important source of particulate organic matter adding to primary productivity of a river. Large woody debris dissipates flow energy, resulting in channel stability and improved fish migration. It also provides basking and perching sites for reptiles and birds. Placing LWD into streams is an increasingly popular technique to improve fish and wildlife habitat. Large woody debris projects can be divided into two categories: improving the habitat by increasing the amount of LWD in the

stream, and using LWD to alter flow in some way to improve aquatic habitat. Some specific objectives that can be accomplished by using LWD are the following: create pool habitat, generate scour, increase depths through shallow reaches, divert flows away from the bank to reduce erosion, armor stream banks to reduce erosion, promote bar formation through induced sediment deposition, and increase instream cover and refugia. Large woody debris commonly placed into the streams can be categorized as three types: whole trees, logs, and root wads. The use of woody bundles is more common in side channel rehabilitation and streambank stabilization, but can be implemented in dike structures in river environments. A primary concern with the installation of woody debris is that it can have a short life in the field.

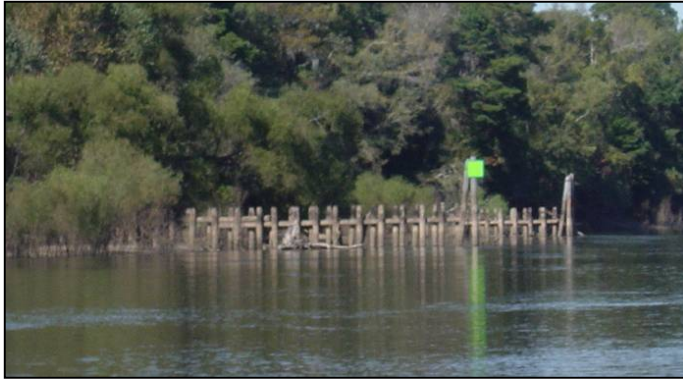
Wood Pile Structures - Prior to the 1960's almost all of the structures placed in the Middle Mississippi River were of the woody pile type. Logs were driven into the river bed to create roughness and formed into a river training structure. Due to the higher maintenance of these woody structures, river training structures began to be constructed from stone during the 1960s. There is currently a push to start bringing back the

woody pile structures because of their benefit to the micro- and macro-invertebrate species. While wood pile structures promote bathymetric diversity, they are not as effective as stone dike structures for maintaining the navigation channel.

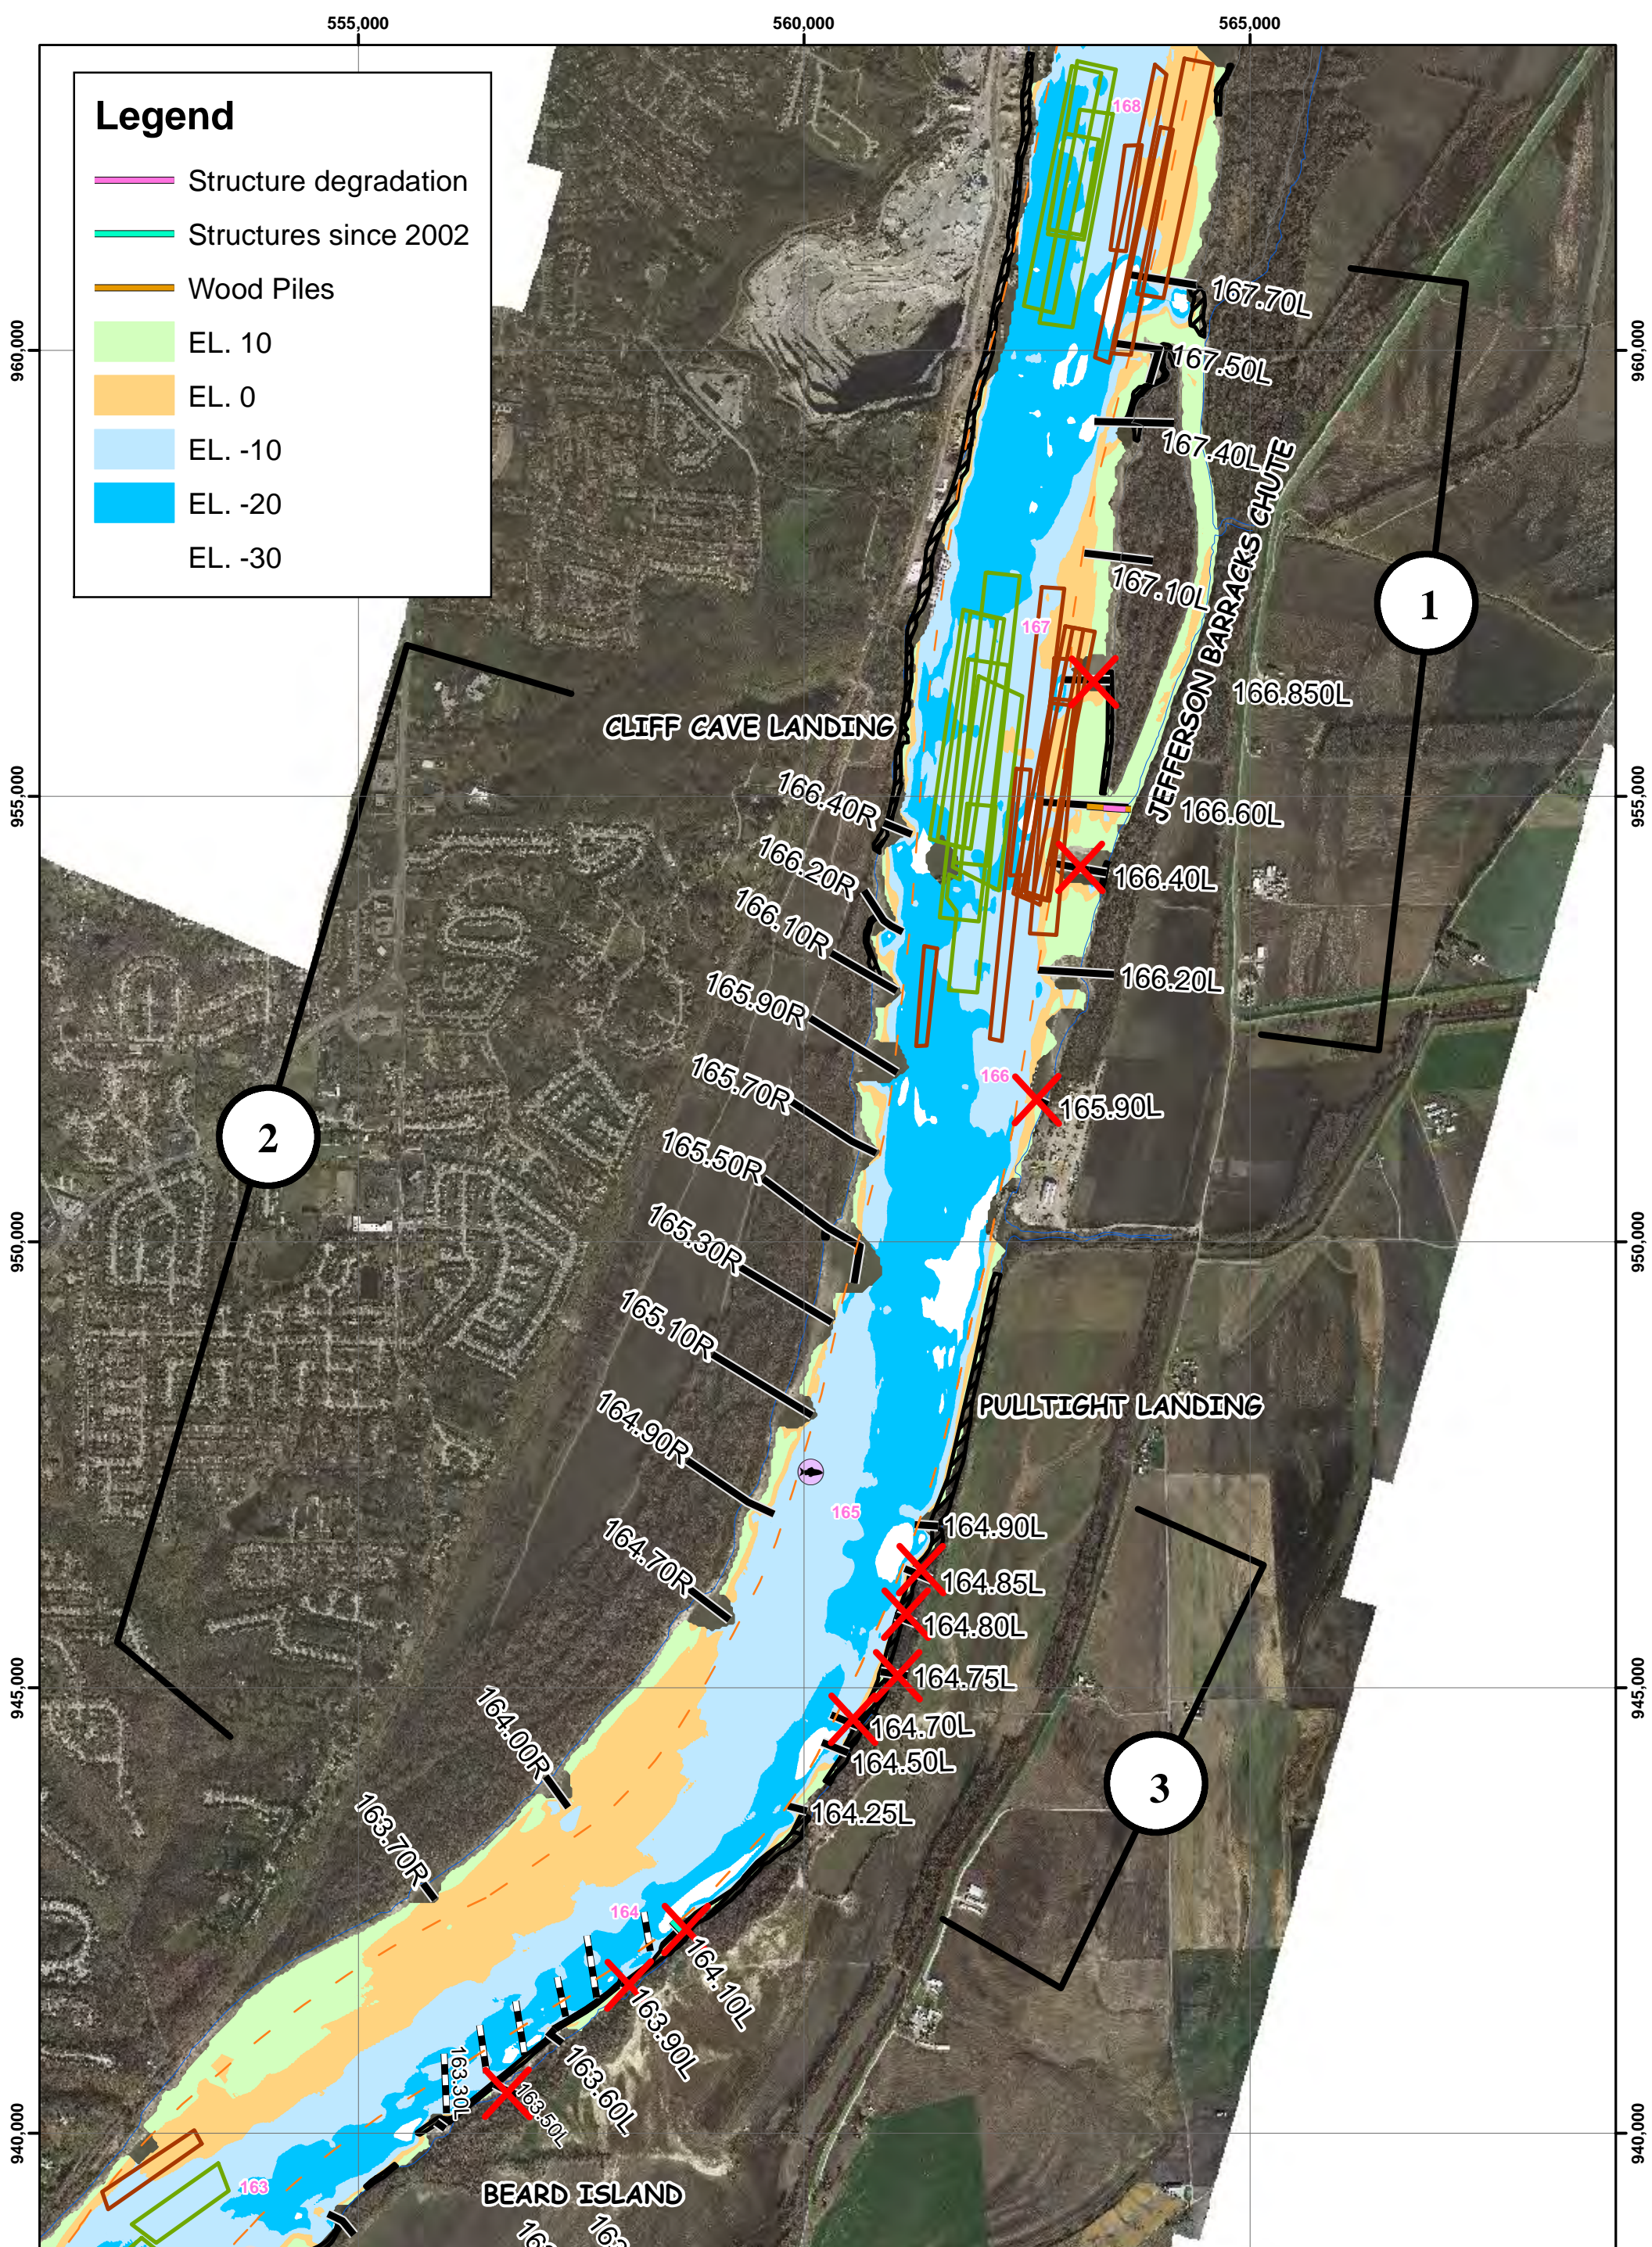
0 350 700 1,400 2,100 2,800 Feet
THE INFORMATION DEPICTED ON THIS MAP REPRESENTS THE RESULTS OF SURVEYS MADE ON THE DATES INDICATED AND CAN ONLY BE CONSIDERED AS INDICATING THE GENERAL CONDITIONS EXISTING AT THAT TIME
**REACH 4
CLIFF CAVE**

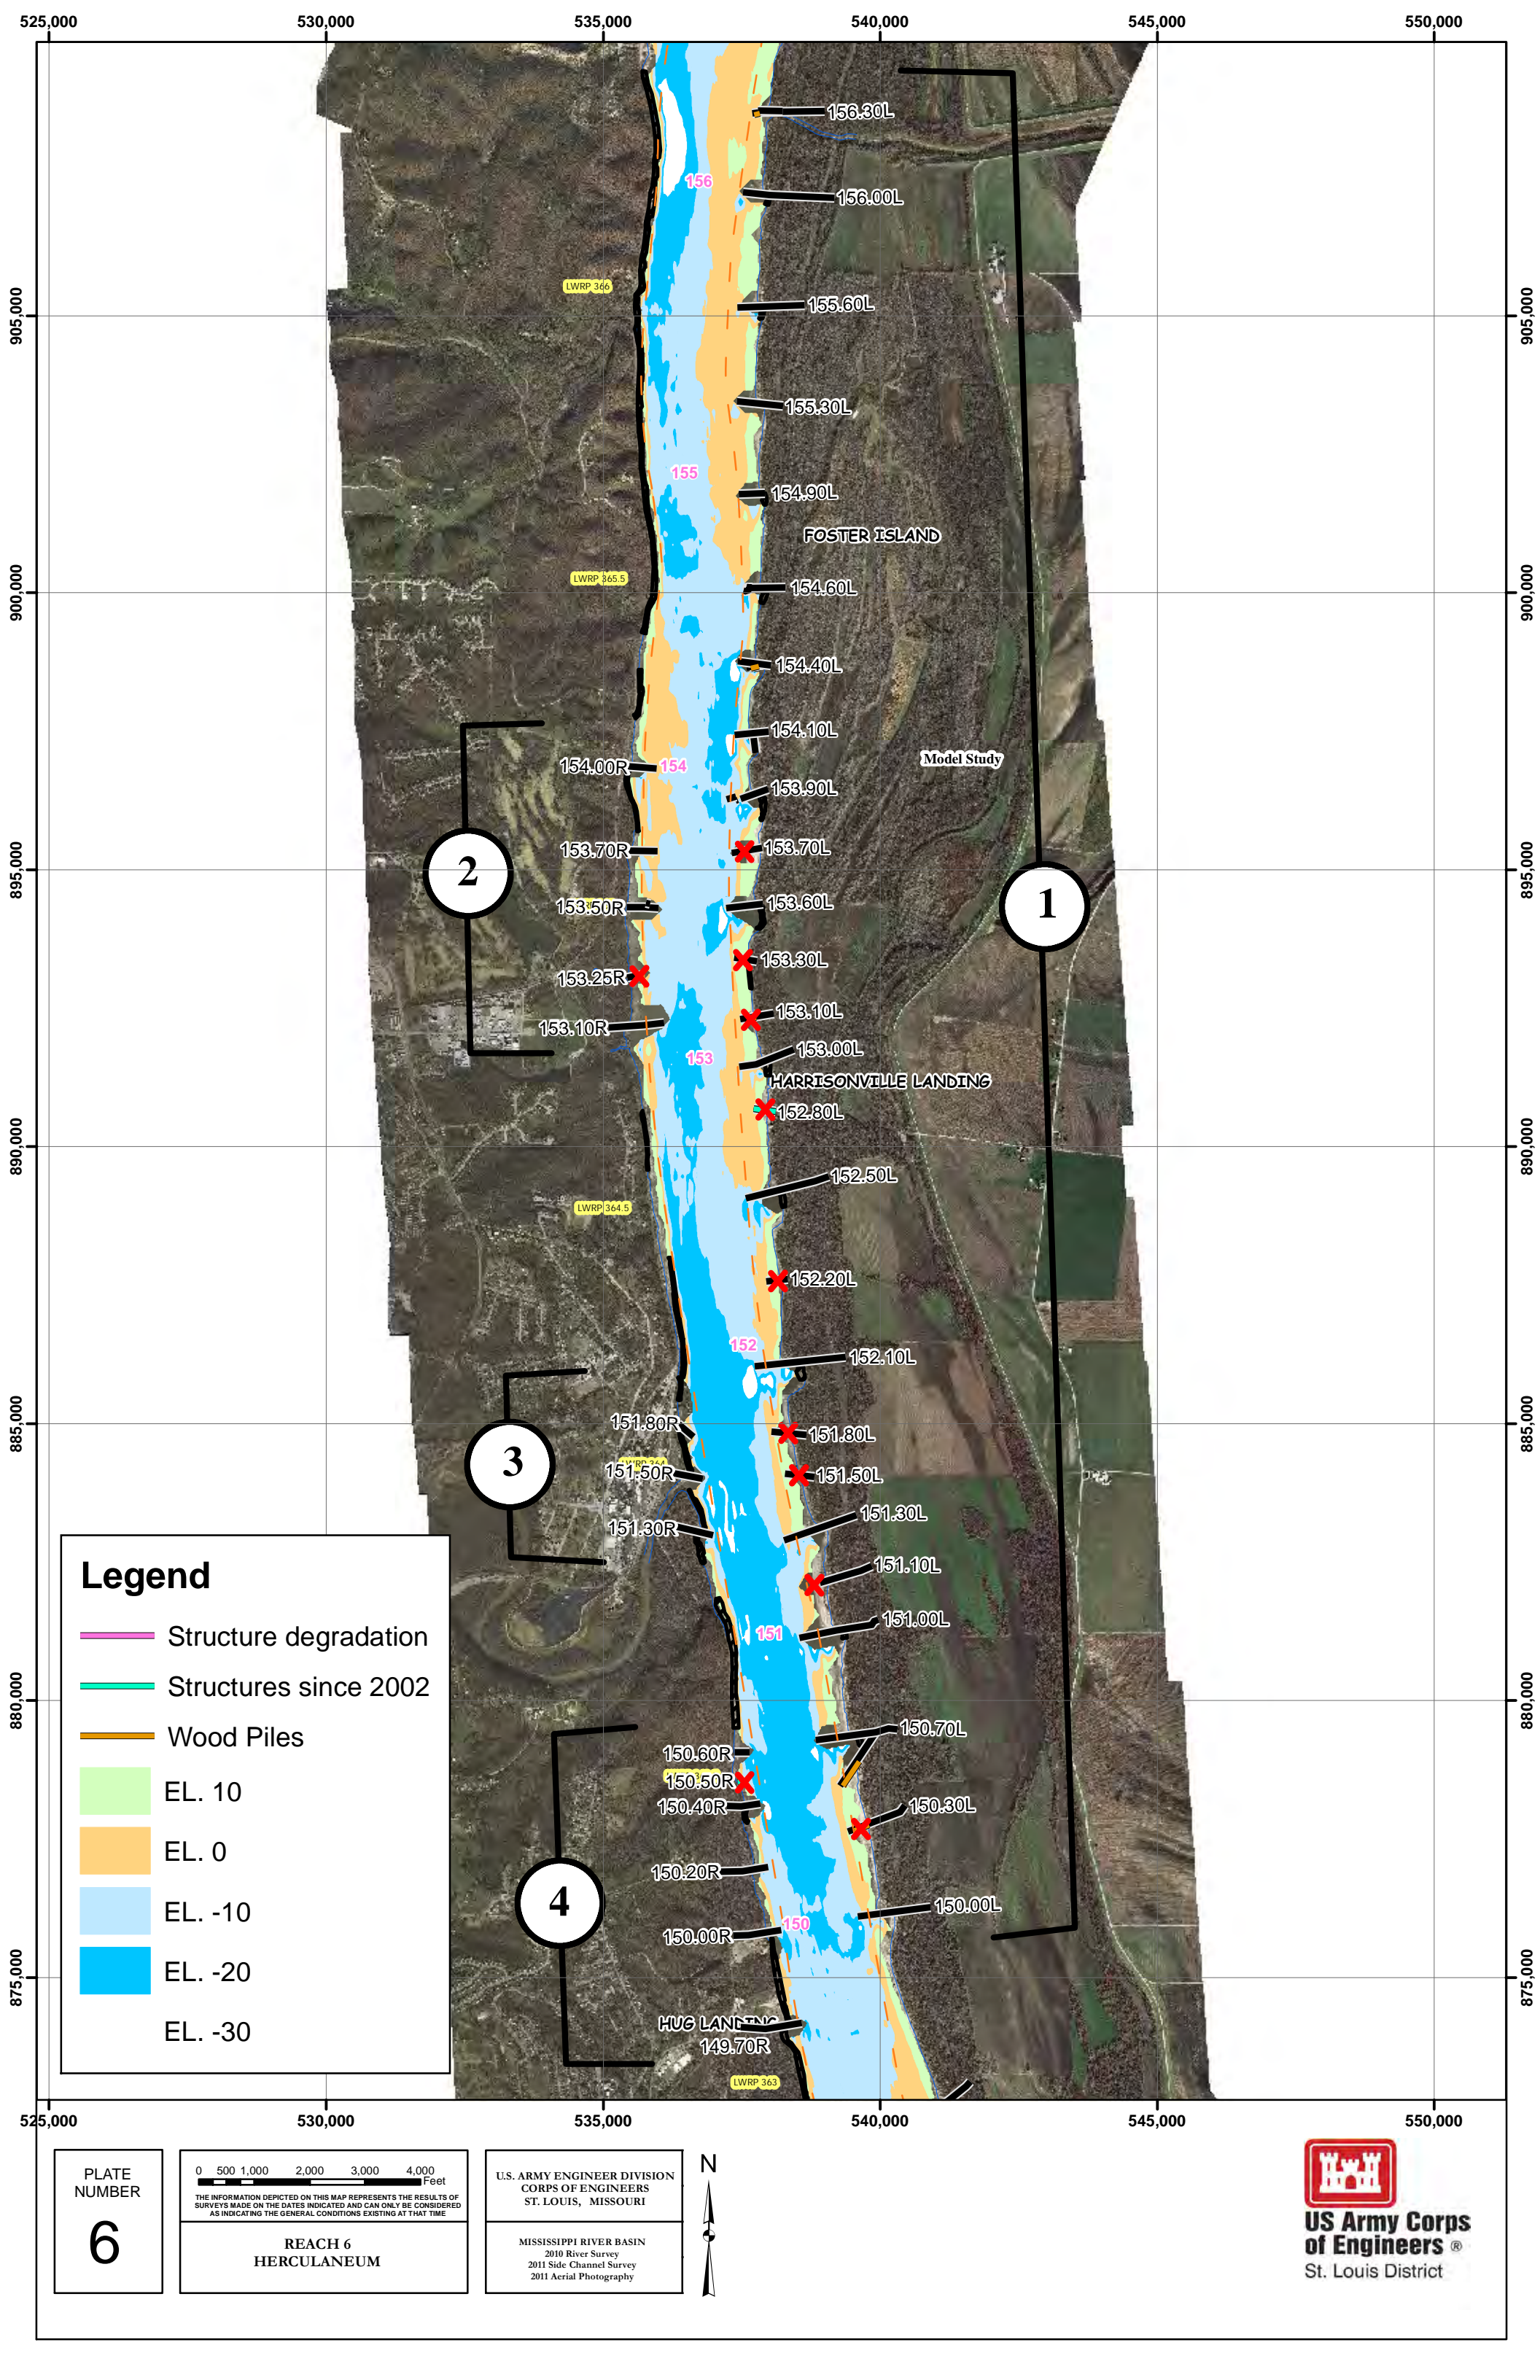
0 500 1,000 2,000 3,000 4,000
Feet
THE INFORMATION DEPICTED ON THIS MAP REPRESENTS THE RESULTS OF SURVEYS MADE ON THE DATES INDICATED AND CAN ONLY BE CONSIDERED AS INDICATING THE GENERAL CONDITIONS EXISTING AT THAT TIME
**REACH 6
HERCULANEUM**
