# **Summary Report**

## **Lock and Dam 24 Physical Model, Upstream Scour**

By: Timothy J. Lauth  
Hydraulic Design Section  
US Army Corps of Engineers St. Louis District  
1222 Spruce St.  
St. Louis, MO 63103-2833

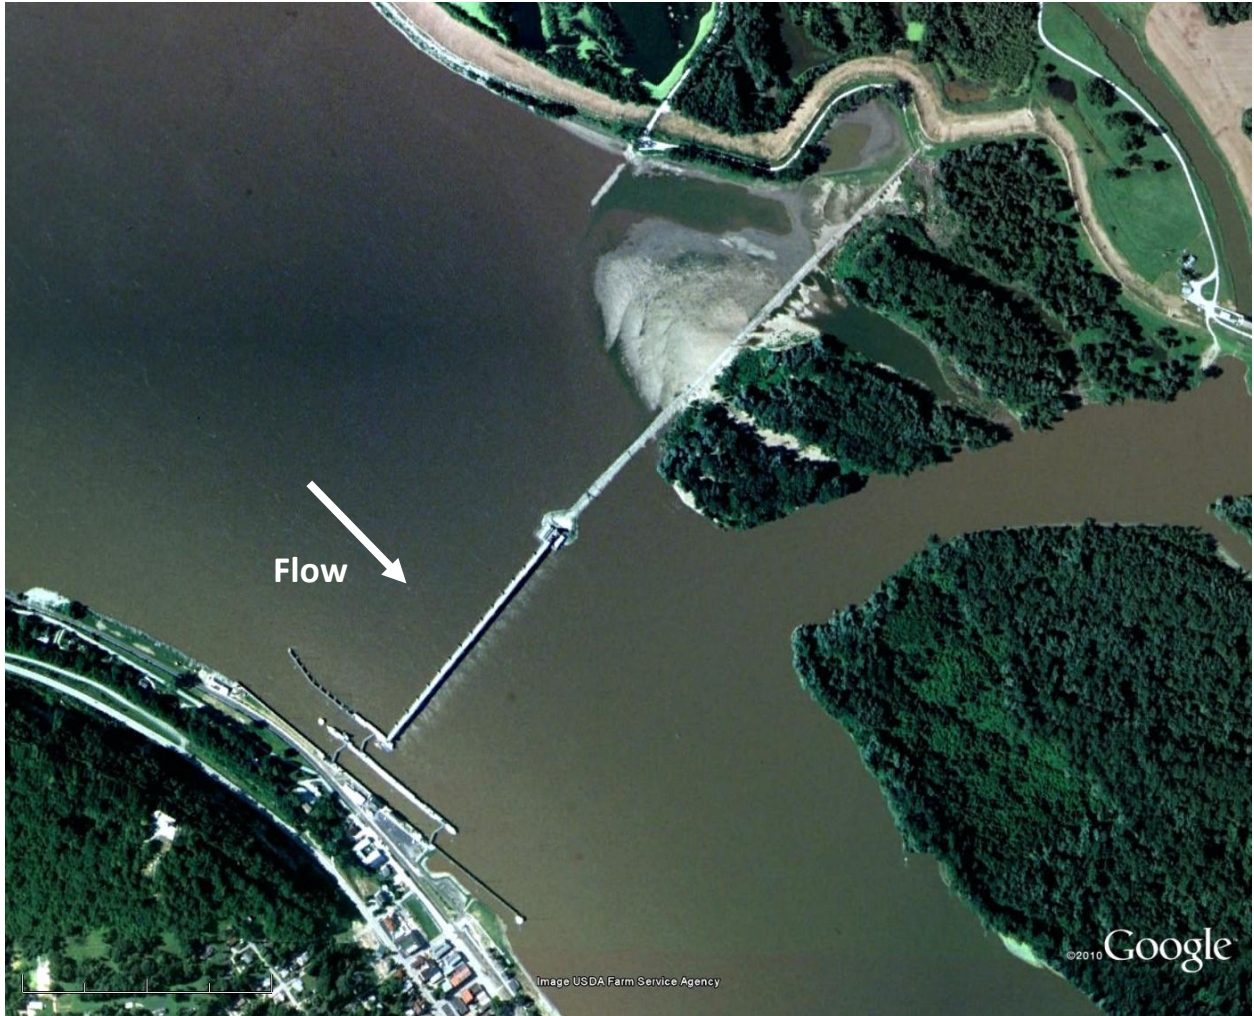
**Figure 2 - Aerial photograph of Lock and Dam 24**

Lock and Dam 24 is located on the Mississippi River at River Mile 273.4 near Clarksville, MO. It is approximately 64 miles northwest of St. Louis, MO (**Figure 1**). Construction began in July 1936 and was finished in March 1940. A major rehabilitation project was completed in 2005. Lock and Dam 24 has one 600 ft long lock chamber controlled with two miter gates (**Figure 2**). The dam is 1,340 feet long and water level is controlled by the manipulation of fifteen 80-ft-wide tainter gates. There is a 2,720 ft auxiliary spillway adjacent to the dam on the Illinois side. Over 24 million tons of cargo was locked through in 2010 when over 3,800 lockages were completed. The structure maintains a pool that is 27.8 miles long covering 13,000 acres. The pool elevation in the vicinity upstream of the dam is typically 448.58 ft. The dam has a stone bed armor layer of 5 ton stone that extends approximately 24 ft from the dam sill.

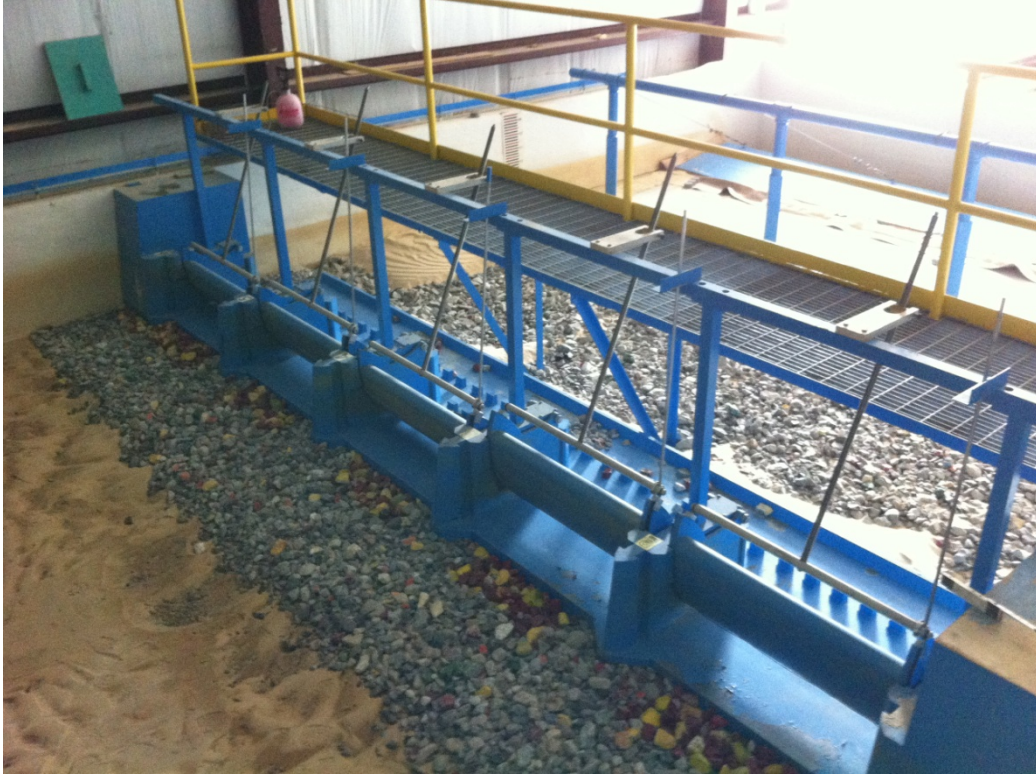
**Figure 3 - The model gate structure and walkway viewed from upstream**

The Lock and Dam 24 physical model was built at the Engineer Research and Development Center (ERDC) Coastal and Hydraulics Laboratory in Vicksburg, MS. A 1 ft to 25 ft scale model of five tainter gates was constructed inside a 69 ft long, 21.1 ft wide flume. The five tainter gates were used instead of the full upriver dam face (**Figure 3**) due to size and cost limitations and to better isolate the flow occurring in front of individual piers.

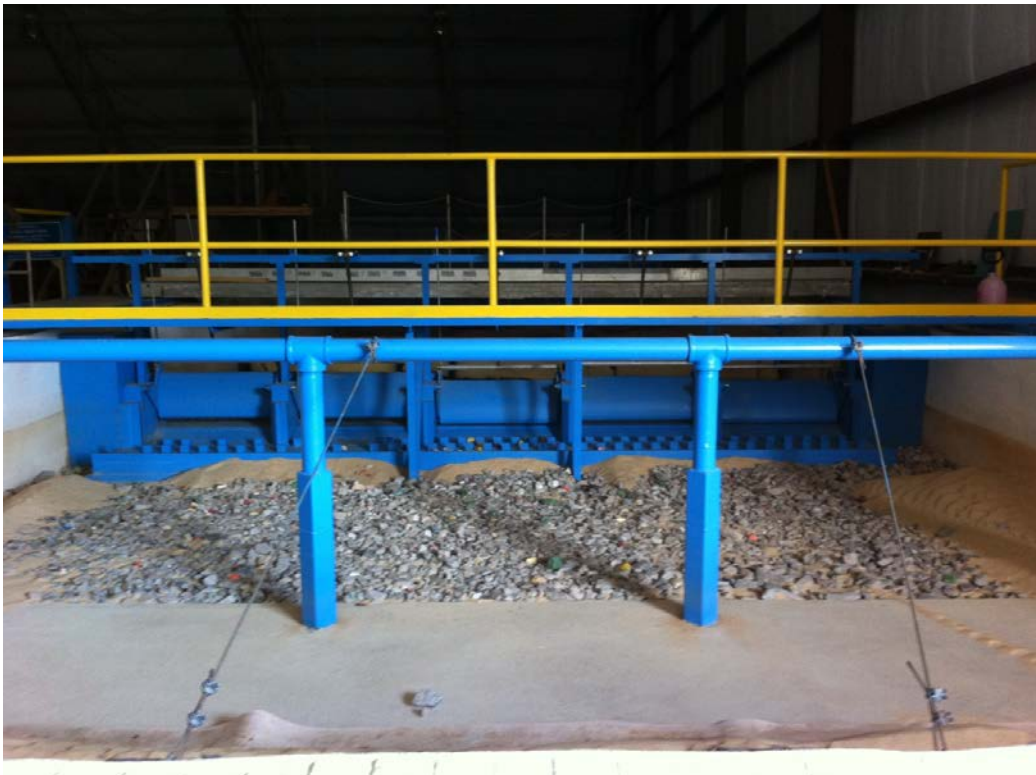
**Figure 4 - The model gate structure and walkway viewed from downstream**

Stone cobbles were used below the spillway to dissipate the velocity of the flow through the gates (**Figure 4**). The tailwater and upriver pool elevations were measured with rulers set to scale in both portions of the model. The flow into the flume is supplied by 12-inch and 20-inch diameter pipes from a constant head tank fed by multiple pumps. The maximum flow possible into the flume is 40 cfs. A gate was used at the end of the flume to maintain the tailwater pool elevation.

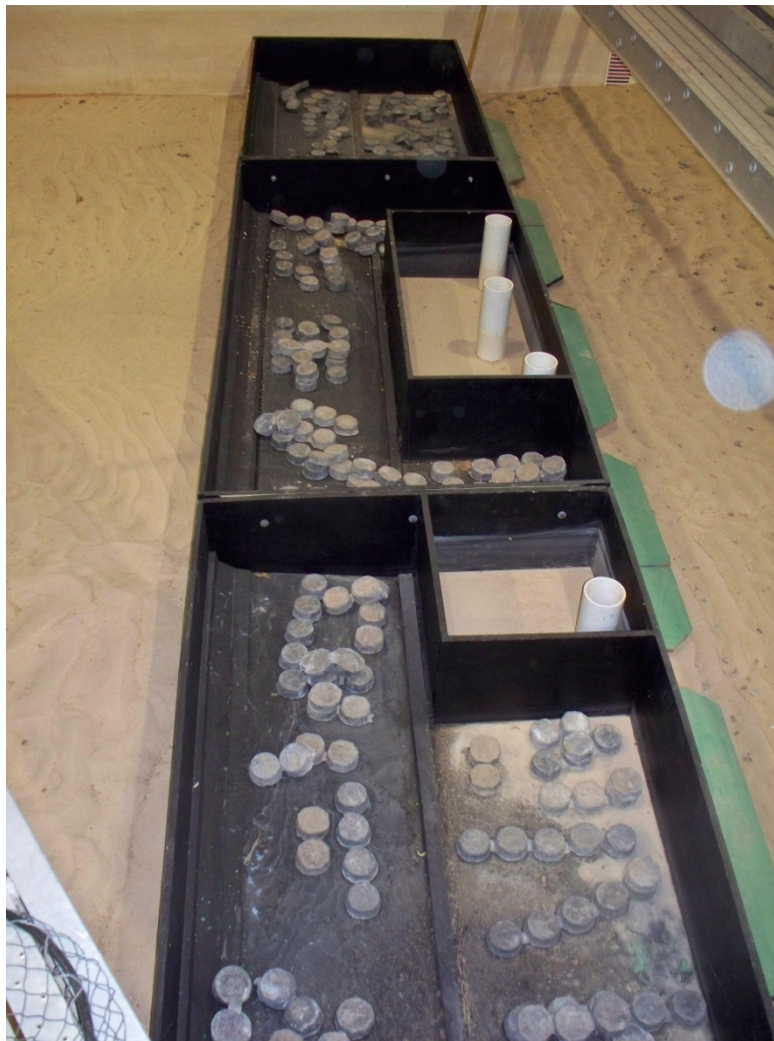
Ice development was simulated using a 21ft x 4ft x 1.2 ft wooden raft built in three sections to facilitate installation and removal (**Figure 5**). The bottom of a raft was sloped and lined with chicken wire to simulate the natural friction of the ice. The draft was controlled by adding or removing lead weights. Initially, walled cutouts were made in three of the sections to allow use of an underwater camera, lighting, and a 2D acoustic Doppler velocimeter (ADV) used to take velocity measurements underneath the ice raft. After later tests suggested that the panels were exaggerating the scour, the cutouts were covered and PVC shafts were installed in the raft to allow for the continued use of the ADV.

**Figure 5 - Wooden raft used to simulate upstream ice**

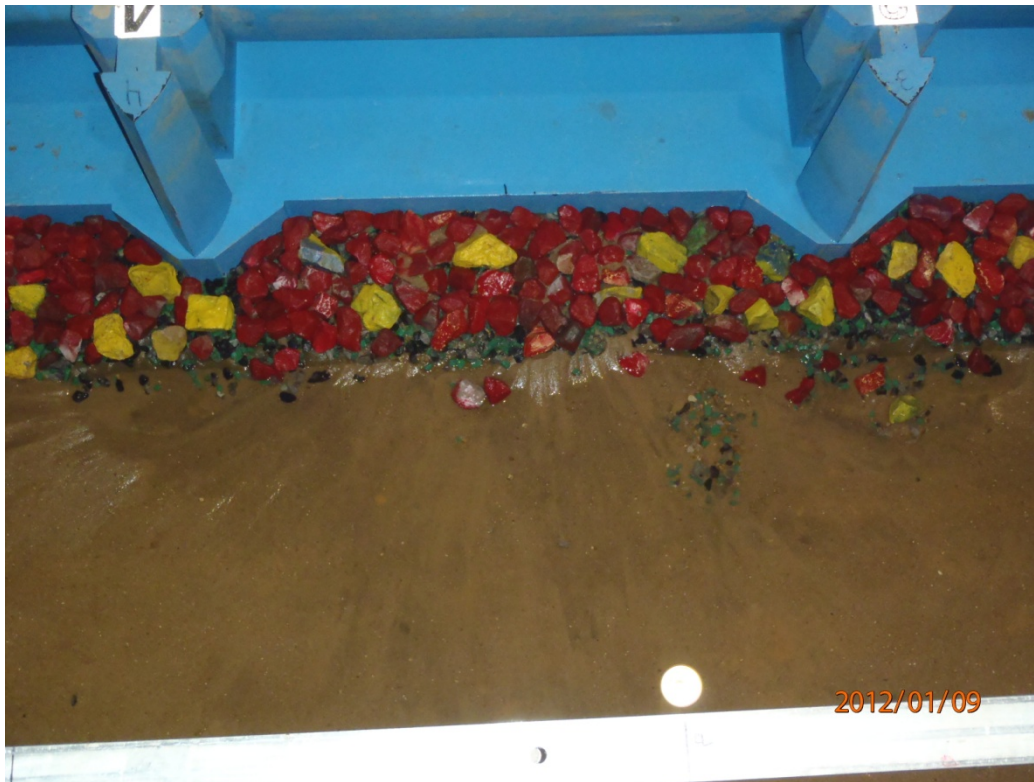
The testing proceeded with the modeling of the build-up of ice using the ice raft as done in the Mel Price Scour modeling. Testing was conducted with the ice raft drafting 10 ft and gates 1, 2, and 3 open at multiple heights starting at 5 ft and increasing in 2 ft increments. The filter cloth was buried 6 inches below the sand elevation. This test format, with a slightly increased draft, successfully replicated the scour occurring at Mel Price Lock and Dam during the Mel Price model testing. These tests for the Lock and Dam 24 model led to little scour, and the scour that did occur was not indicative of the scour adjacent to the piers at the prototype (**Figure 7**).

**Figure 7 - Variable 3 center gates, 10 ft ice raft draft**

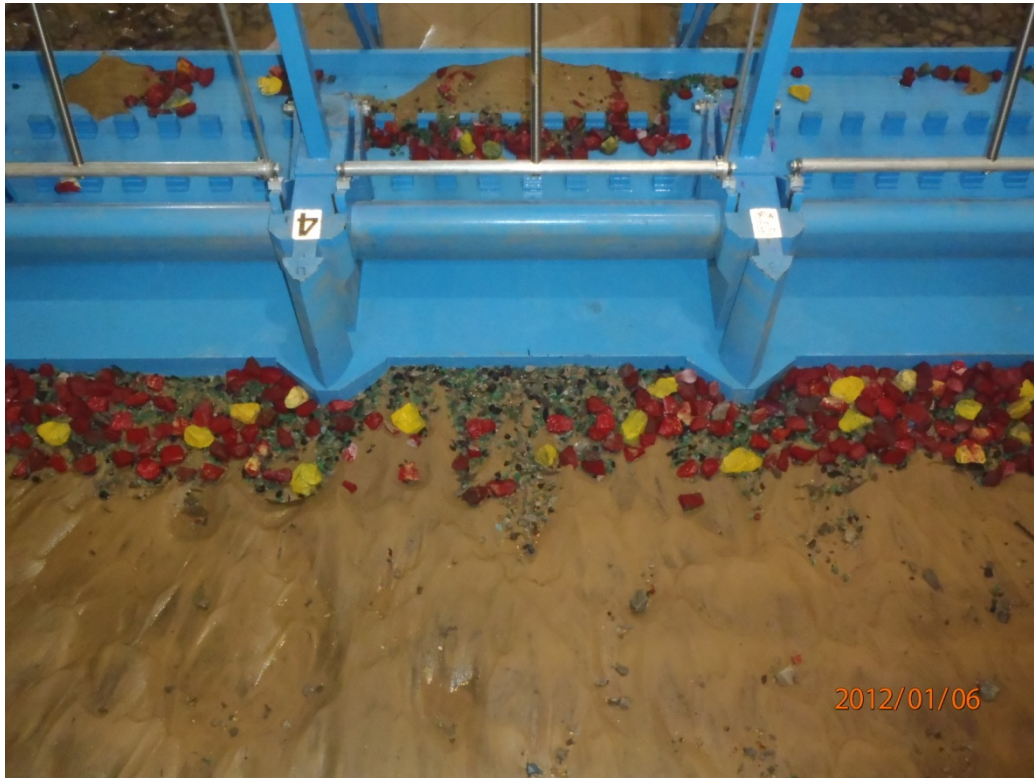
The tests were repeated with the draft of the ice raft increased to 15 ft. Additional scour occurred, but the scour was once again not representative of the scour occurring in the prototype, where the scour was focused in front of the gates instead of the piers. This test with three gates open scoured away nearly all of the protection in front of Gate 3 with the little rock remaining in front of the adjacent piers (**Figure 8**).

**Figure 8 - Variable 3 center gates, 15 ft ice raft draft**

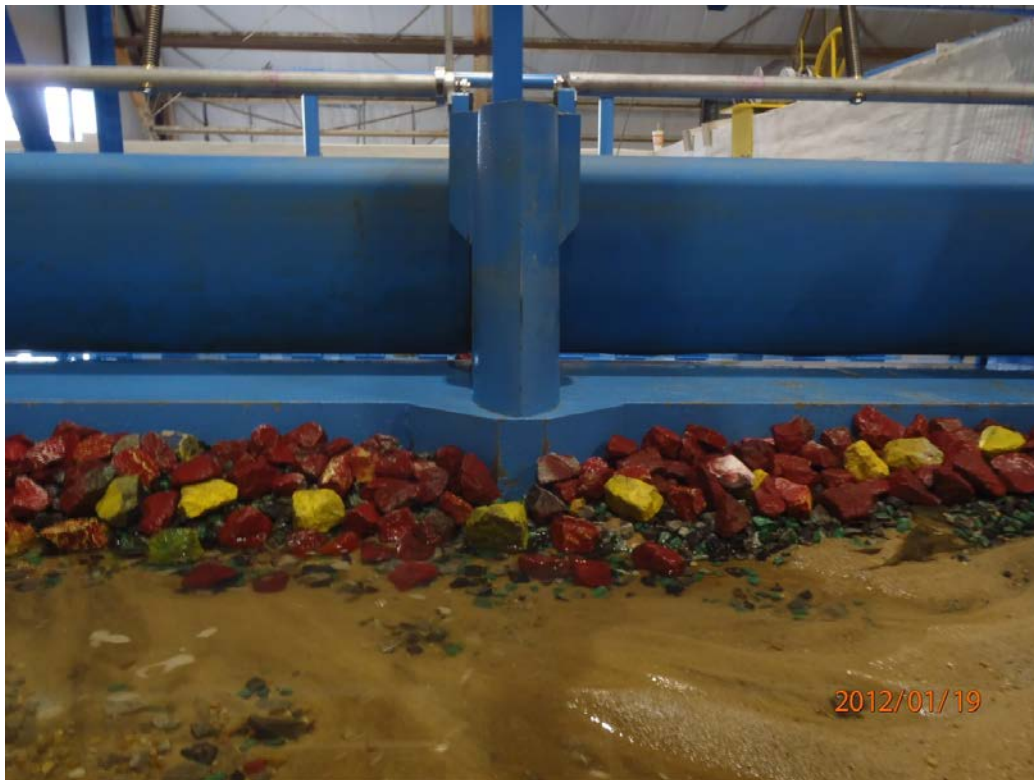
These tests did lead to representative scour along the leading edge of the scour protection and immediately adjacent to the pier. Comparing the results, a greater ice draft led to increased scour both upstream of the stone bed protection and at the dam piers.

**Figure 10 - 7 ft center gates, 20 ft ice raft draft**

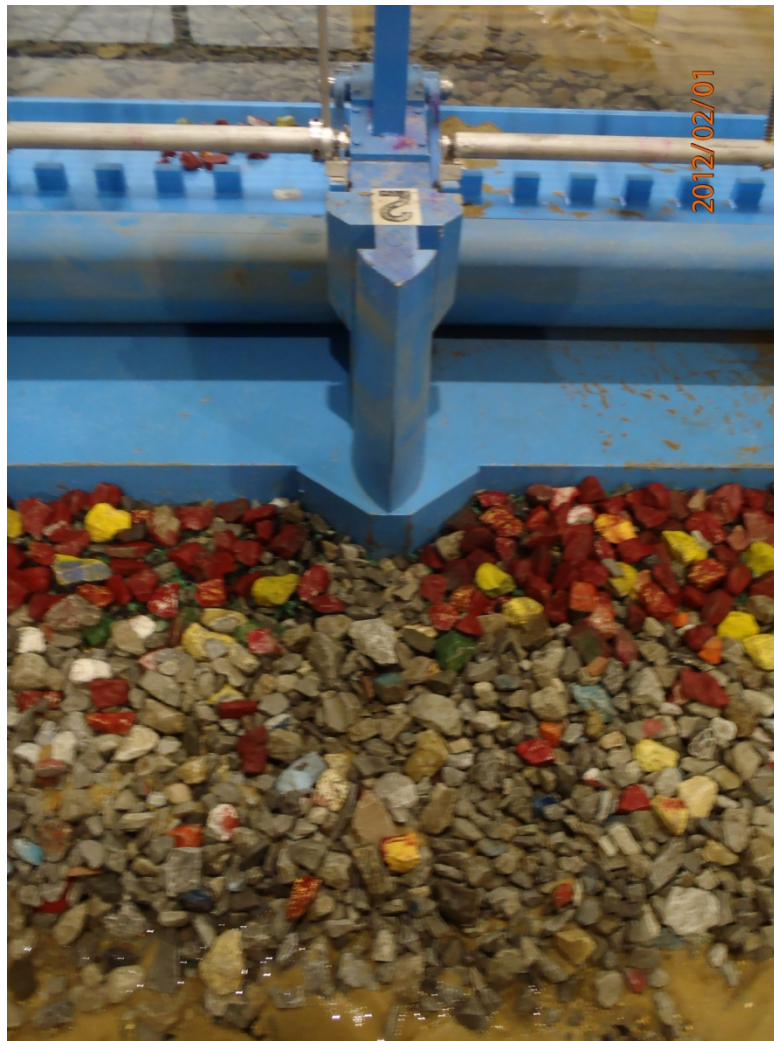
The pier scour was tested using different stone placements in the immediate vicinity of the piers. The first placement was based on the Lock and Dam 25 repair. This placement tested two conditions; 1) a pier location where 8 ft of scour had occurred, allowing for placement of both the “A” and “C” stone, and 2) a pier location where 4 ft of scour had occurred, allowing for placement of only “A” stone. For all tests with two placement conditions, a successful possible solution was determined to be a solution where a maximum of 4 ft of scour occurred at the pier on either placement condition. With the ice draft set to 15 ft, the maximum scour depth observed in the first condition was approximately 6 ft (**Figure 12**); the maximum observed in the second condition was approximately 8 ft. Both conditions were more than enough to potentially reach the pier base.

**Figure 12 - 9 ft center gates, modified “A” stone over modified “C” stone**

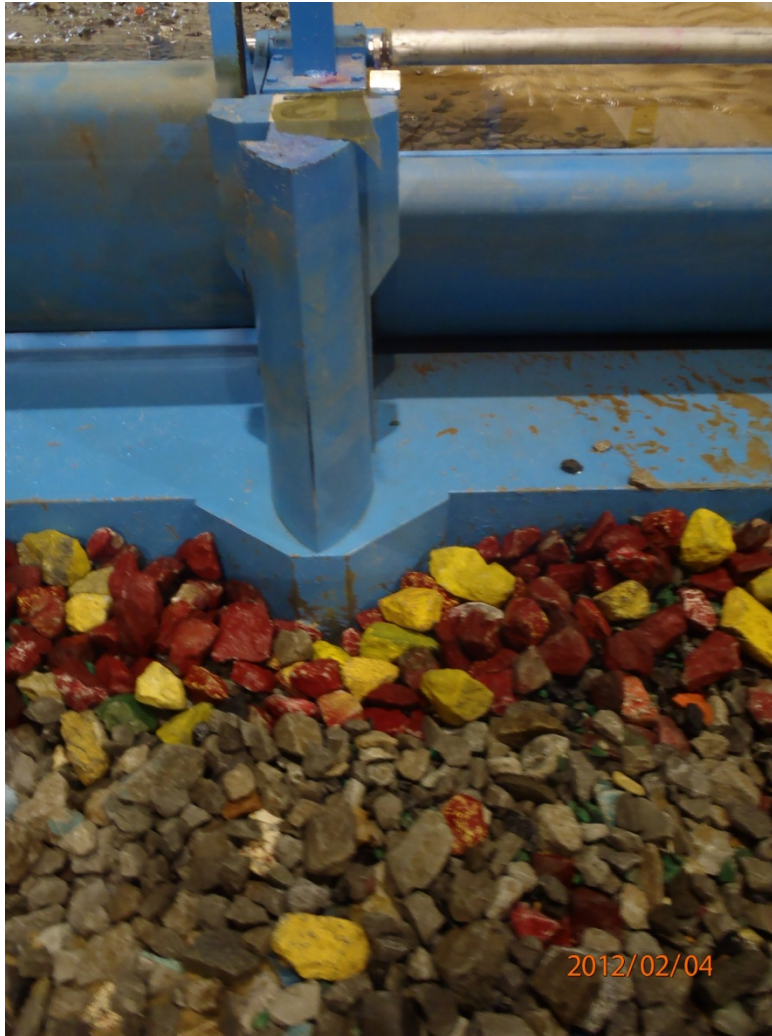
The second placement tested was based on using derrick stone as the top layer of stone protection. Two conditions were again tested: 1) a pier location a pier location where 8 ft of scour had occurred, allowing for placement of both the derrick stone and modified “C” stone, and 2) a pier location where 4 ft of scour had occurred, allowing for placement of only derrick stone. The tests for these two conditions both yielded a maximum scour depth of 5-6 ft at the piers (**Figure 13**).

**Figure 13 – 9 ft center gates, derrick stone over modified “C” stone**

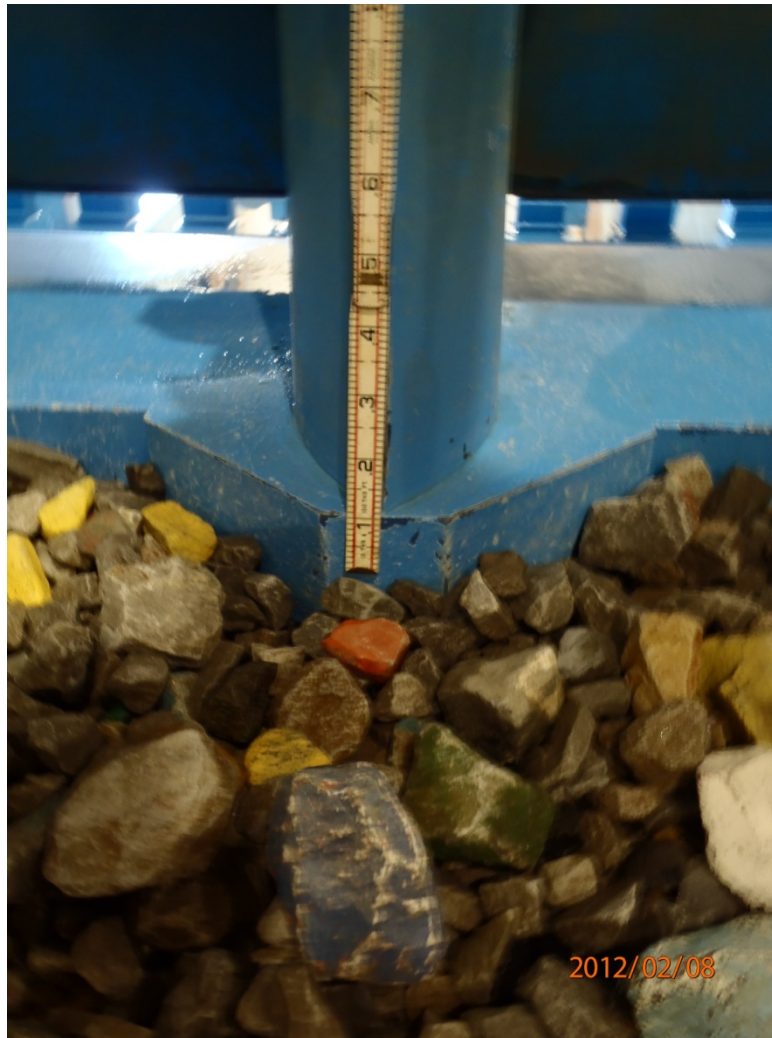
After the stone placements were tested, the model was run with the gates adjacent to the main ice passage gates open. For these tests, the three center gates of the model were held open 9 ft with the two outer gates opened 1, 3 and 5 feet. These openings were tested for two stone placements: 1) an 8 ft scour hole filled with the L&D 25 repair and 2) a 4 ft scour hole filled with modified "A" stone. The side gates open 1ft produced a maximum of 9 ft scour in the immediate vicinity of the pier and the 3 ft open tests produced a maximum of 8 ft scour. The 5 ft side gate open tests, however, produced a maximum scour depth of 3-4 ft at one gate with the other gates experiencing less than 3 ft of scour (**Figure 14**).

**Figure 14 - 9 ft center gates, 5 ft side gates, modified "A" stone over modified "C" stone**

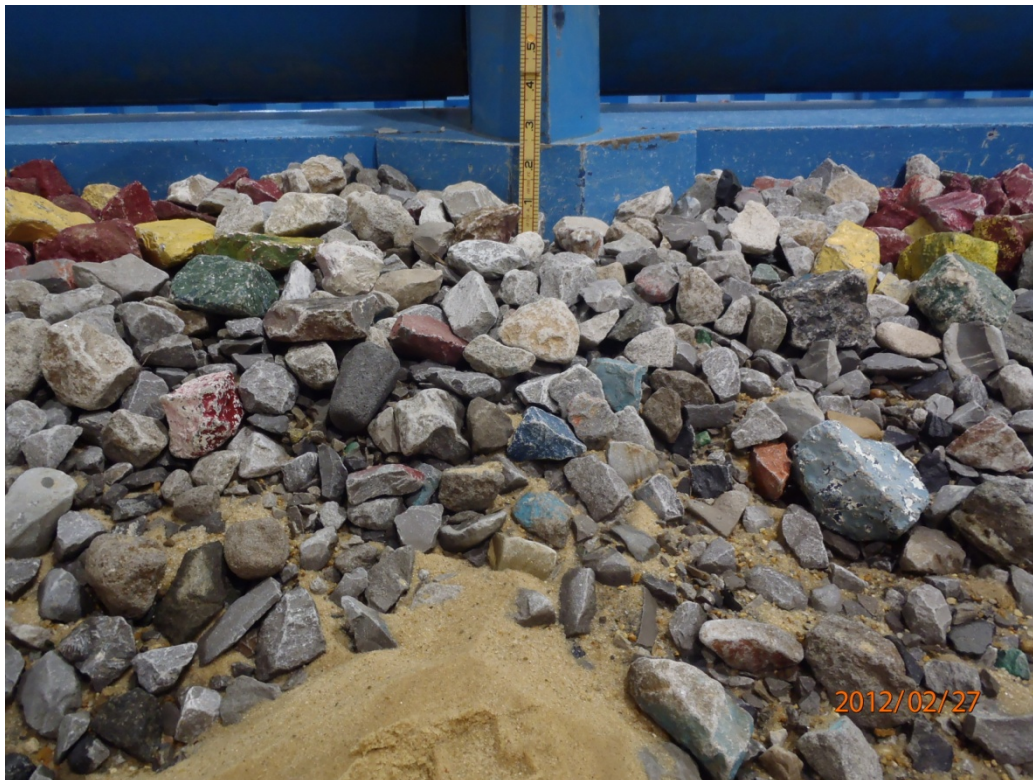
A test with a 15 ft extension of the stone bed protection produced 5 ft of pier scour and, although the upstream protection edge again unraveled, the stone protection in front of the gates was more stable than in previous tests (**Figure 15**). A re-testing of the 30 ft extension produced a scour depth of approximately 3-4 ft with little unraveling of the upstream edge of protection.

**Figure 15 - 9 ft center gates, 5 ft side gates, 15 ft protection extension**
