Regional Coastal Photograph Archive of the Beach Erosion Board

Andrew Morang, Ph.D.

*U.S. Army Engineer Research and Development Center
Coastal and Hydraulics Laboratory
3909 Halls Ferry Road
Vicksburg, MS 39180-5002
Andrew.Morang@erdc.usace.army.mil*

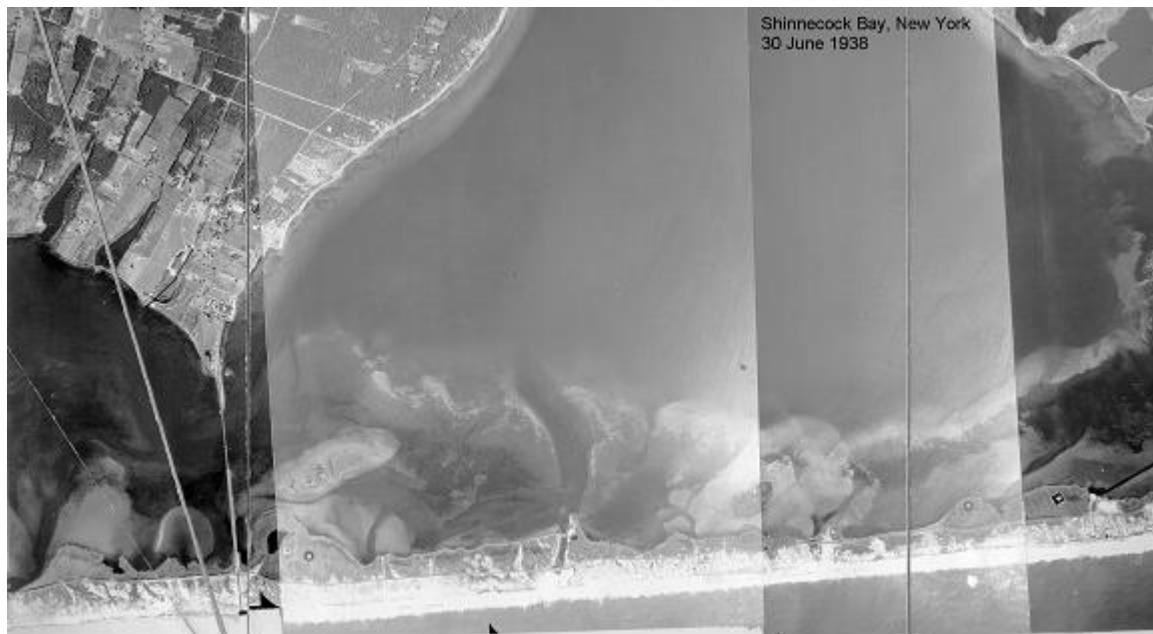
Figure 1. Shinnecock Bay, Long Island, New York, June 30, 1938. Photograph taken before the Great New England Hurricane of September 21, cut the barrier island in several locations. The present Shinnecock Inlet was cut where a channel crosses from the bay to the road. The channel may be a remnant of an artificial cut dug by the Shinnecock and Peconic Canal Company in 1896. Shoal areas in the bay near the barrier attest to former inlets that had been open long enough to form flood shoals. North is to the top, the water body in the center of the image is Shinnecock Bay, and the Atlantic Ocean is on the bottom (Mosaic prepared by the Beach Erosion Board).

June 1938, and September 24, 1938, only 3 days after the Great New England hurricane crossed Long Island and caused catastrophic damage throughout New England (Figures 1 and 2). The post-storm flights show hundreds of channels and overwash fans on the south shore beaches. Many Long Island images are labeled, “U.S. Army Air Corps, 97th Obs. Sq., Mitchel Field, NY,” demonstrating a fruitful cooperation between the Army Air Corps and the BEB. The barrier island near Ocean City, Maryland, was breached by a hurricane on August 25, 1933. In the 70 years since then, Assateague Island has receded more than 1,000 m, which can be confirmed from the 1933 photograph, where the shores on both side of the new inlet are aligned (Figure 3). The hurricane of record on the New Jersey shore was the September 14, 1944, Category 3 storm that caused over 390 deaths in the Northeast. One day later, the U.S. Navy took a series of high-quality photographs from a blimp to document property damage (Figure 4).

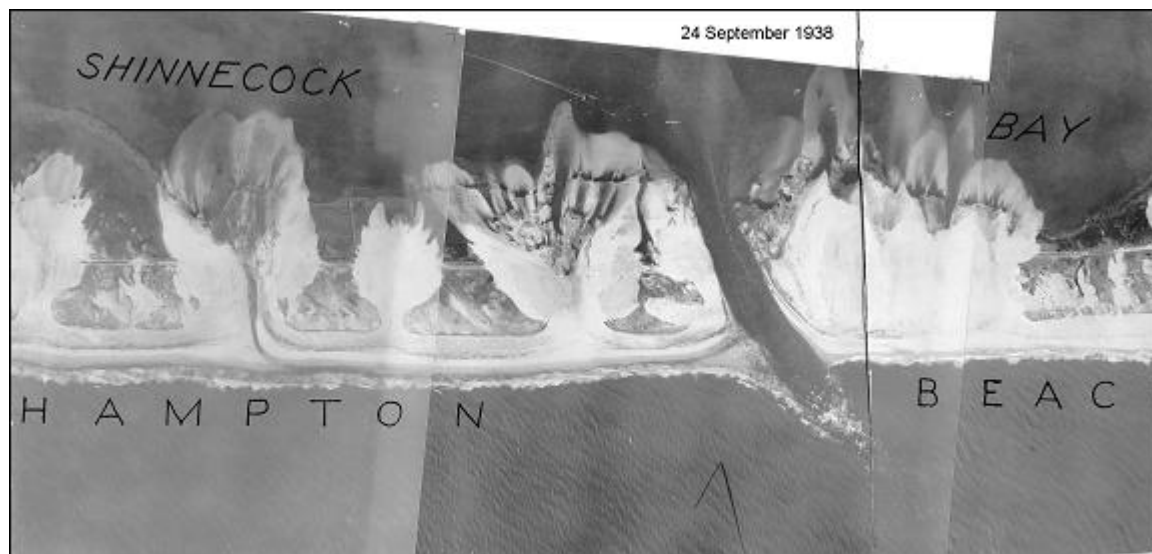
Figure 2. Shinnecock Inlet, Long Island, New York, September 24, 1938. Taken 3 days after Great New England Hurricane breached the barrier, this image shows the new Shinnecock Inlet and many overwash fans along the adjacent shore. Immediately after the storm, all the breaches along this stretch of the coast trended left of shore-perpendicular (Mosaic made at the Beach Erosion Board, original photographs from U.S. Army Air Corps, Mitchel Field).

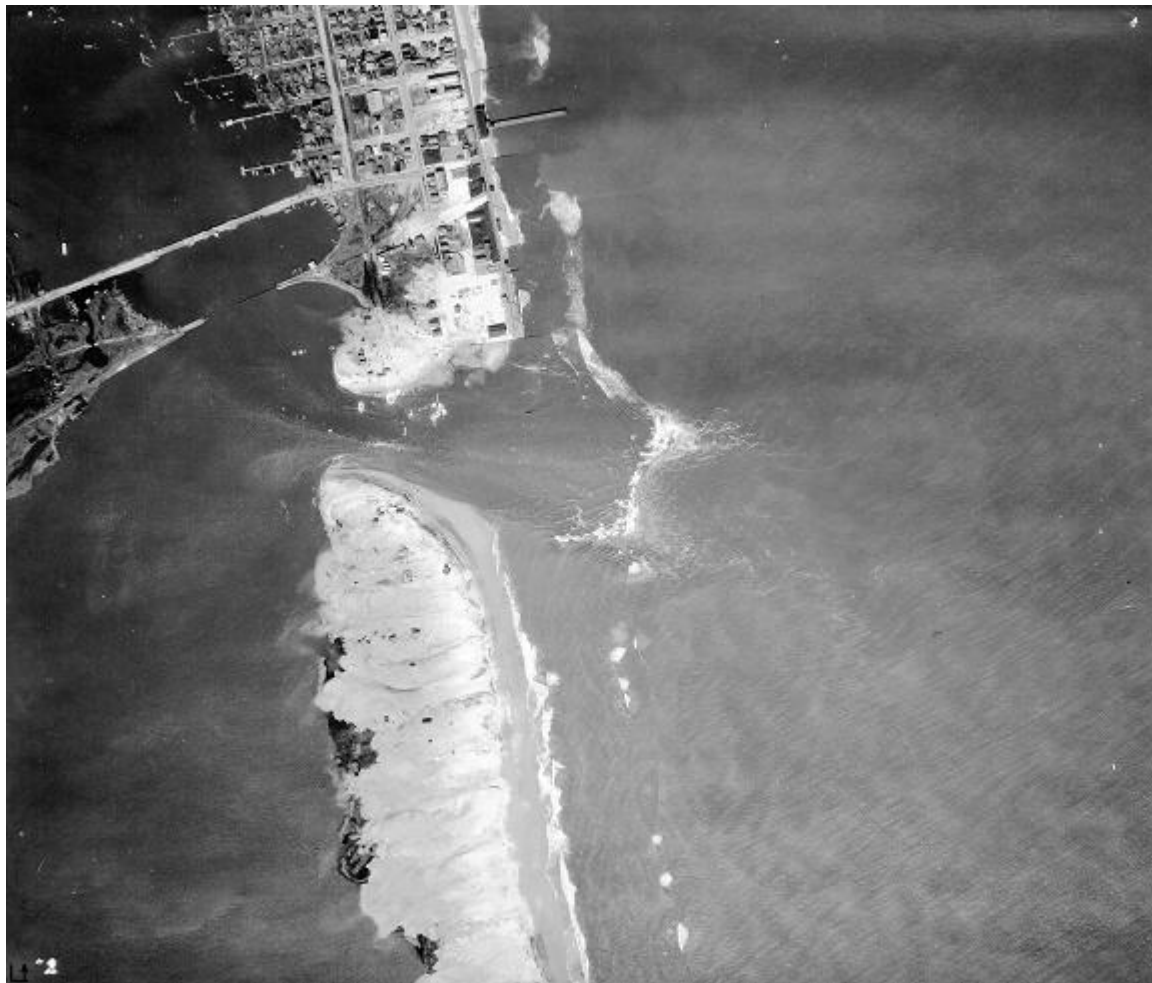
Figure 3. Ocean City Inlet, Maryland, September 1933. Ocean City is on Fenwick Island in the top center of the image, the Atlantic Ocean is to the right, and Assateague Island is on the bottom. This photograph was taken only 1 month after a hurricane breached the barrier island. Note waves breaking at the edge of a small ebb shoal.

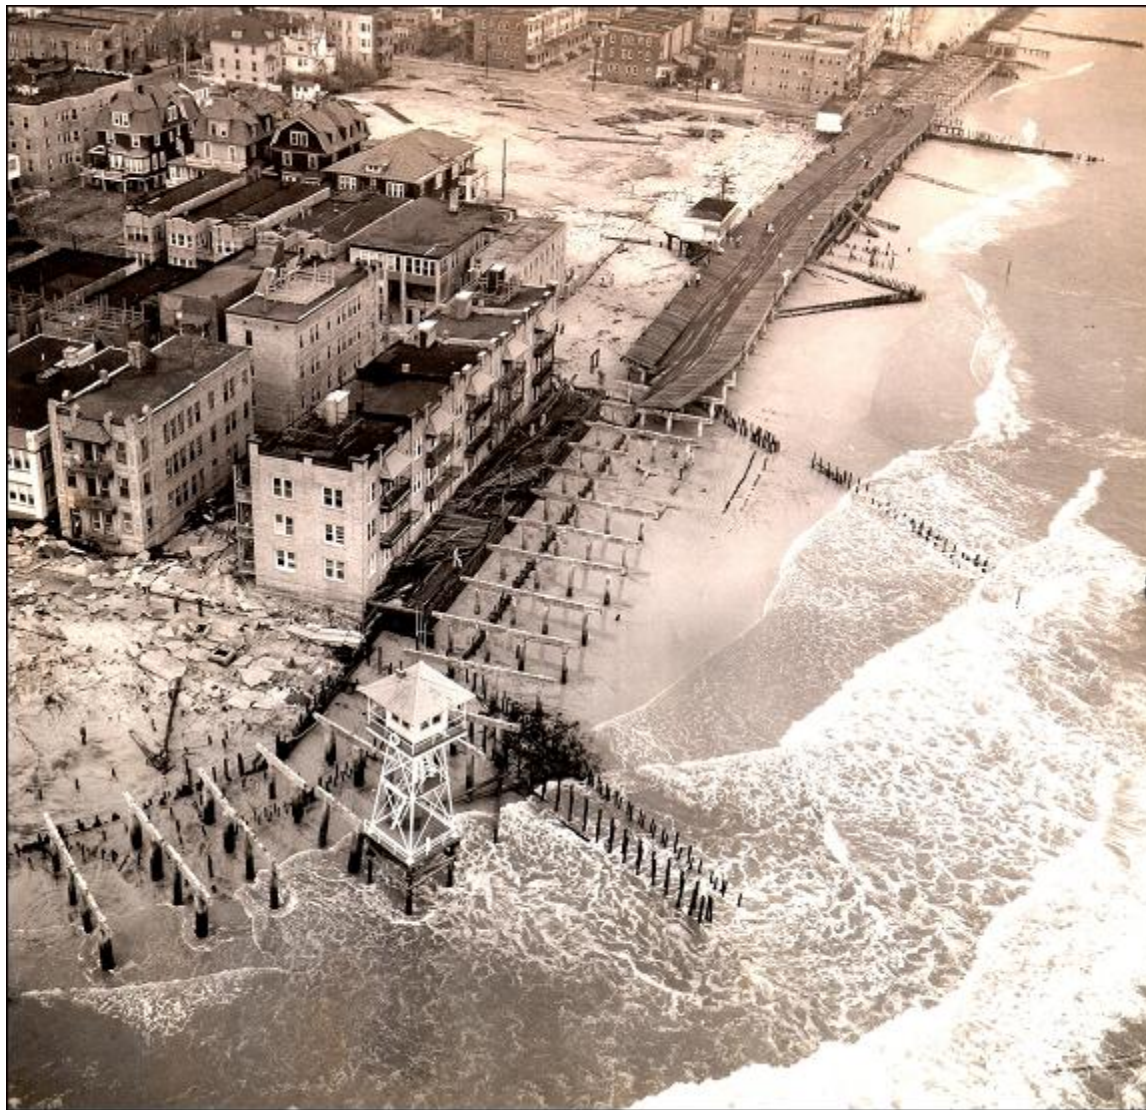
Figure 4. Atlantic City, New Jersey, at the mouth of Absecon Inlet, September 15, 1944. This is one of a series of images taken after the hurricane of September 14, a Category 3 storm that caused 390 deaths in the northeast U.S. This photograph illustrates the degree of urban development along this coast. Photograph taken from a blimp from the U.S. Naval Air Station, Lakehurst, New Jersey (Official U.S. Navy Photograph).

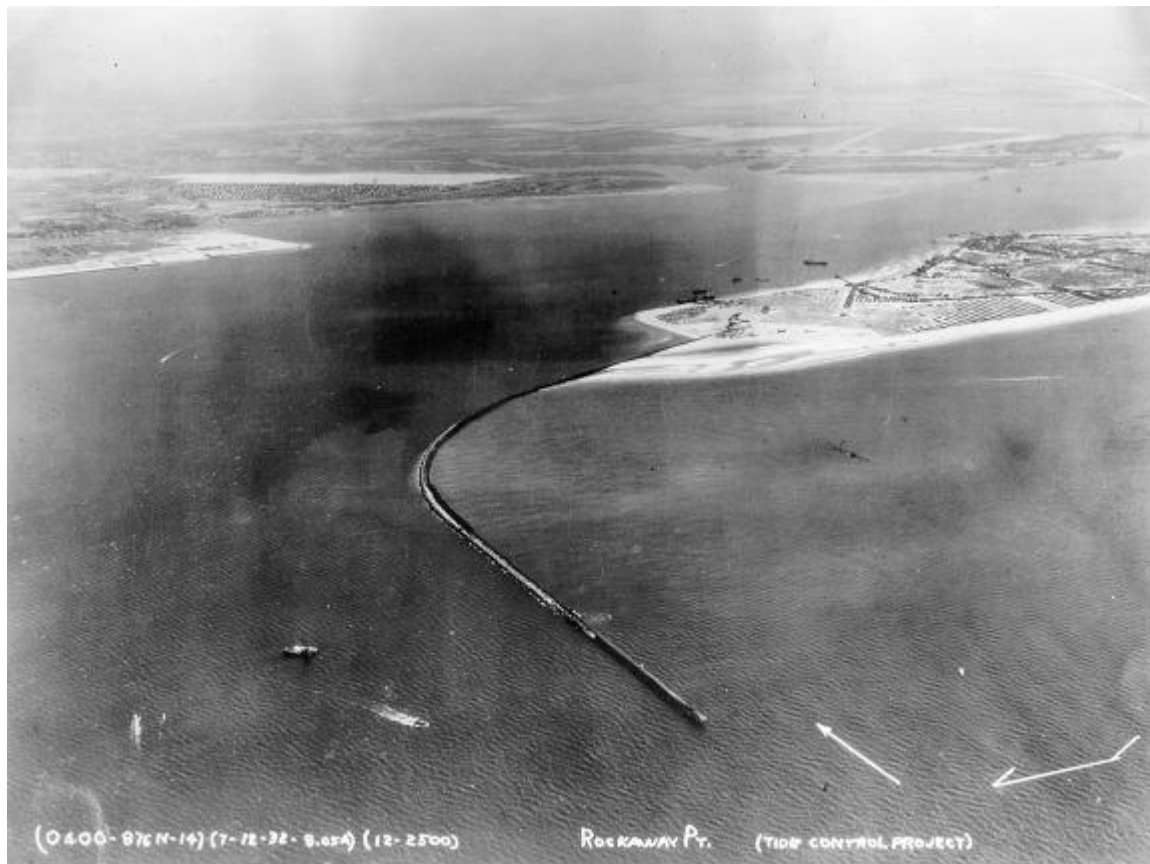
Figure 5. Construction of the jetty on the east side of Rockaway Inlet, Long Island, New York, July 12, 1932. The urban area on the opposite side of the inlet is the east end of Coney Island, and Jamaica Bay is in the distance. In 7 decades, the fillet has filled with sand to approximately the end of the jetty seen in this image.

In addition to notable storms, the BEB also documented major coastal infrastructure projects. For example, Figure 5 shows the terminal groin at Rockaway Point on Long Island under construction in 1932. Many federal jetties constructed during the late 1800s and early 1900’s were built using a railroad trestle that was erected out into the water. Rail cars brought in the stone, which was placed by crane (Figure 6). Although many inlets were first cut by hurricanes, others, like Manasquan, on the New Jersey shore, were artificially cut in 1930 (Figure 7). Other artificially-cut openings that are now Federal navigation projects include Panama City Inlet, Florida, East Pass, Florida, Duluth Cut, Minnesota, and Aransas Pass, Texas. Only 3 years after the opening of Manasquan, the south fillet was almost full, clear proof of northward longshore littoral transport (Figure 8).

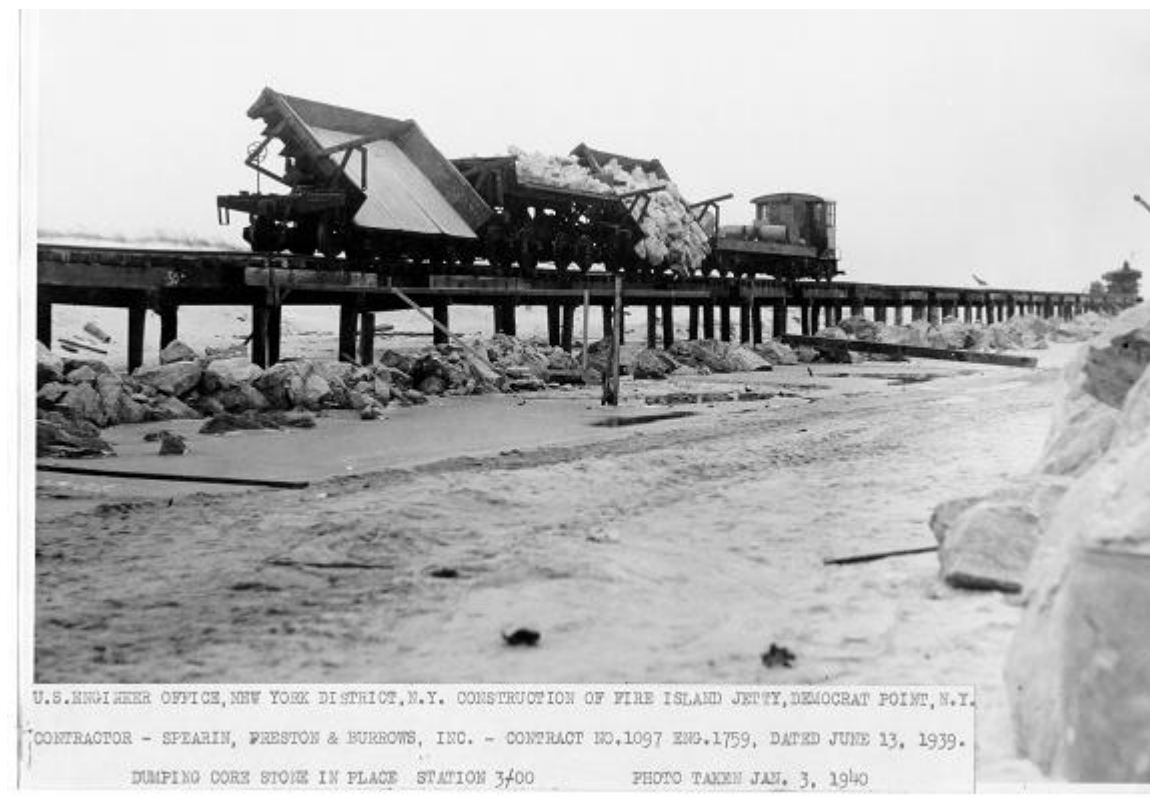
Figure 6. Construction of the Fire Island jetty on Democrat Point, at the west end of Fire Island, Long Island, New York, January 3, 1940. Many early USACE jetties were built from the land moving seaward using materials brought in by train.

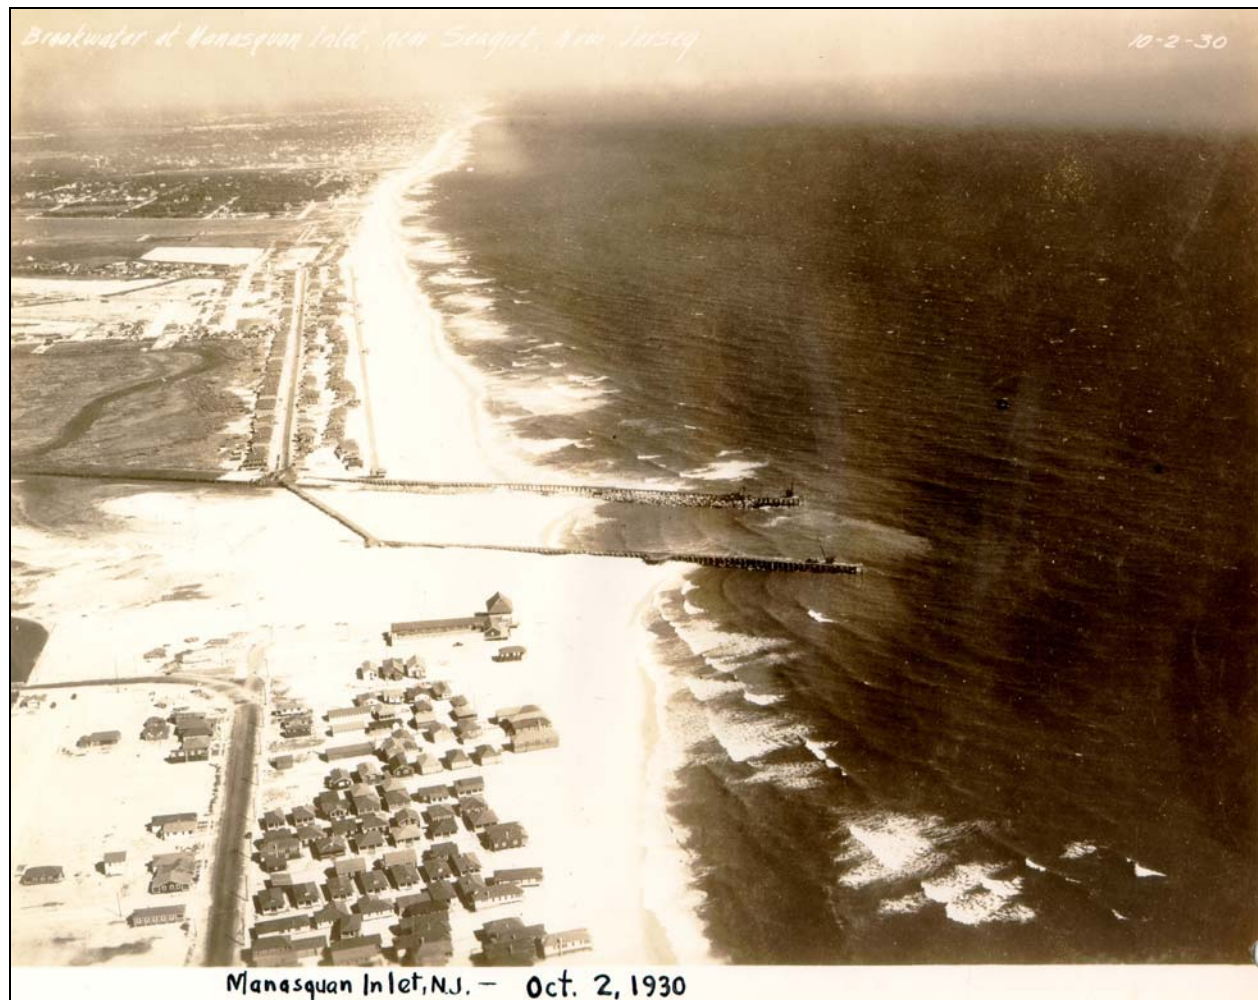
Figure 7. Construction of Manasquan Inlet jetties, New Jersey, October 2, 1930, view looking north. Material for the jetties was supplied via an elevated roadway that extended out to sea from the land. Note that sand is already accumulating on the south (lower) side of the south jetty. The shoreline is continuous, and at this site the inlet was dredged after the jetties were completed.

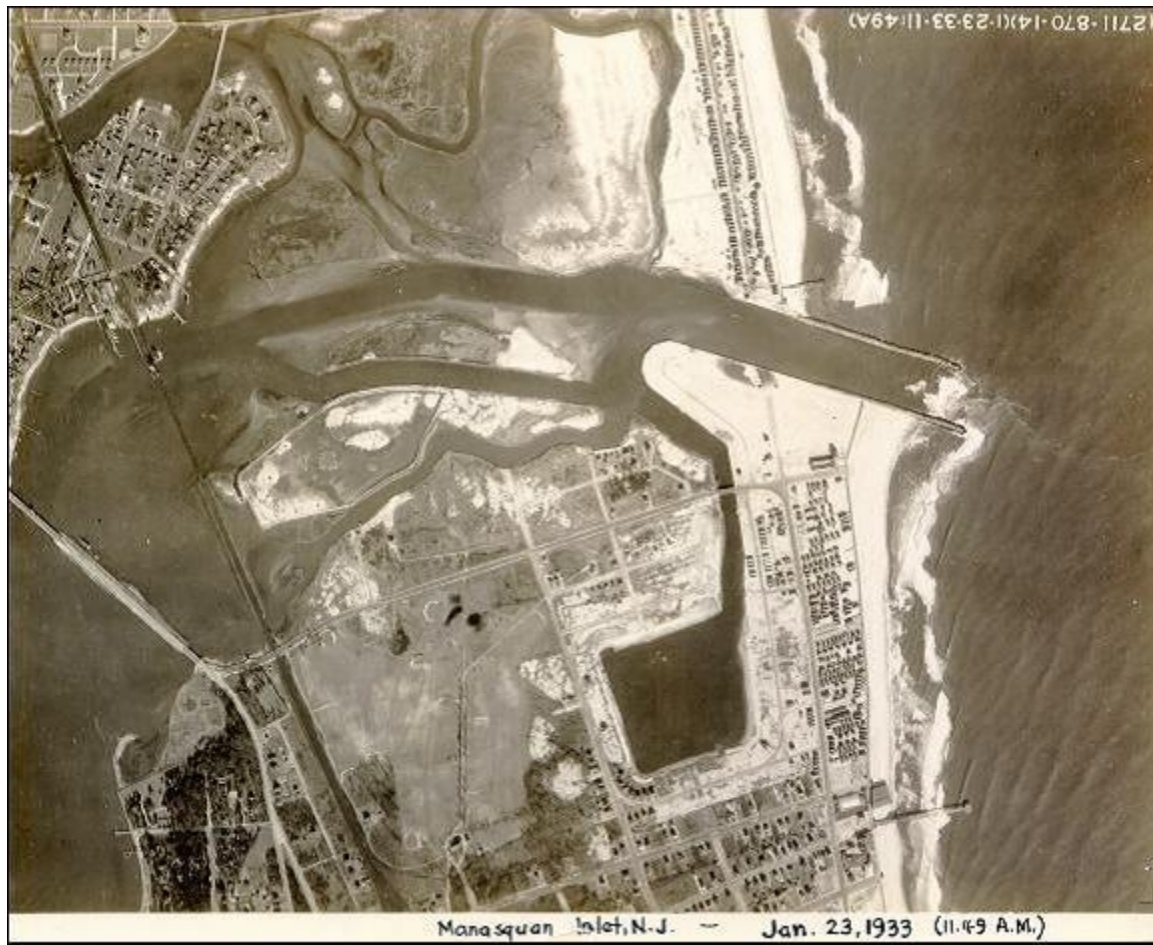
Figure 8. The recently opened Manasquan inlet, January 23, 1933. The south fillet has almost filled with sand, and developers have built a road seaward of the seaward-most row of cottages in Figure 7.

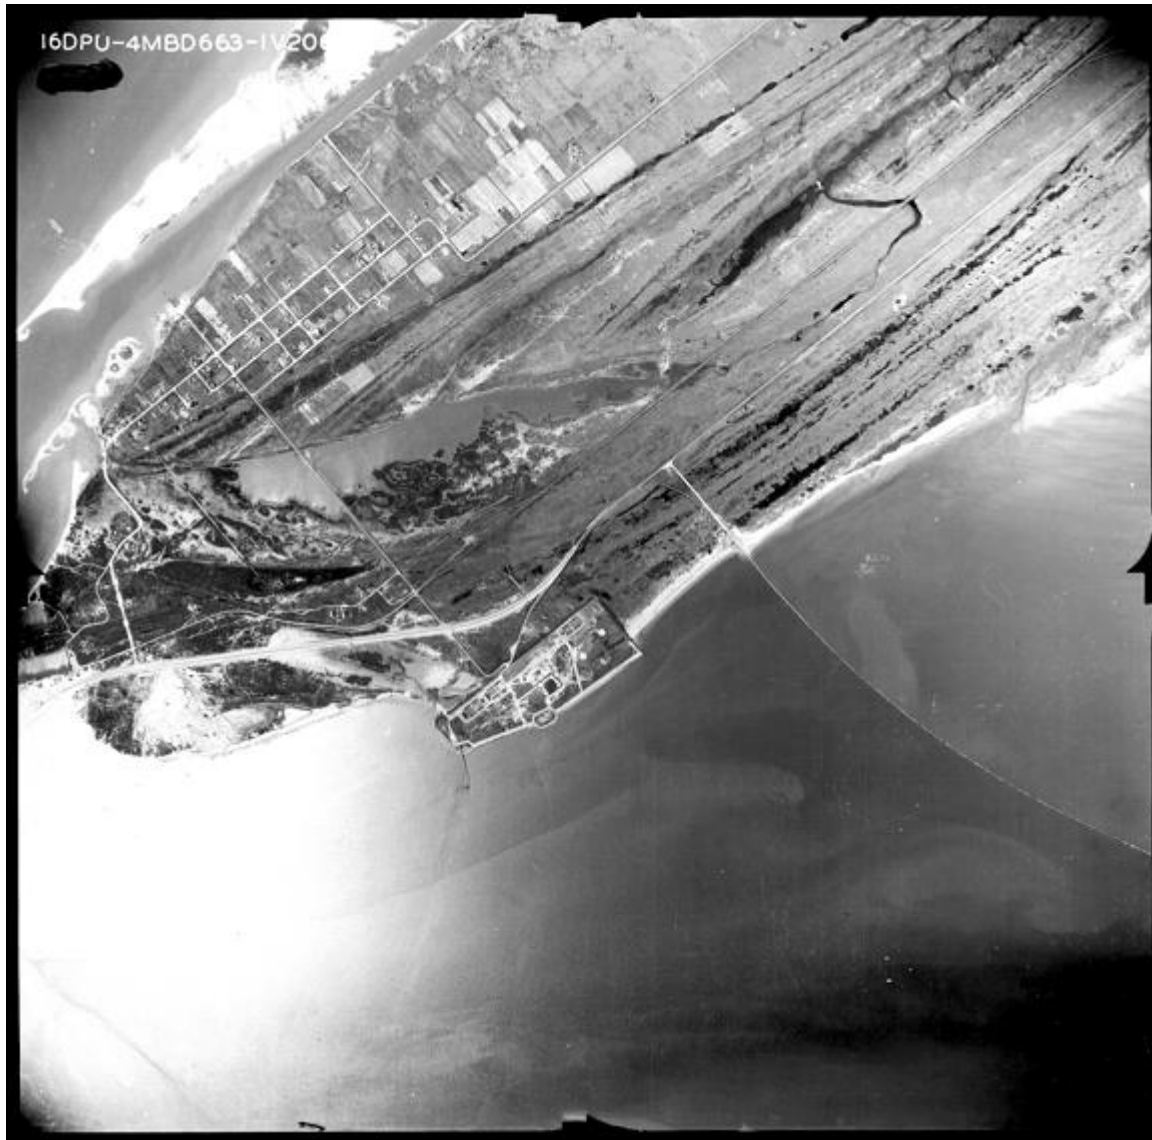
Figure 9. Bolivar Peninsula, near the mouth of Galveston Bay, Texas, January 1952. The line extending to the lower right is the Galveston north jetty. A fillet has not built up against the jetty, but shoals have accumulated further to the northeast.

Historical photographs can also reveal unusual sediment conditions. Along the north Texas coast of the Gulf of Mexico, the littoral transport is from northeast to southwest. But, a 1952 photograph of the Bolivar Peninsula, at the mouth of Galveston Bay, Texas, shows that a fillet had not built up on the northeast side of the north jetty (Figure 9). The reason appears to be that the north jetty was so long (7.6 km), it sheltered the Bolivar shore from wave energy, and sediment accumulated further to the northeast. Light color bands in the image indicate some of these shoals. Even now, 5 decades later, a low, marshy zone still separates the fillet from the jetty proper.

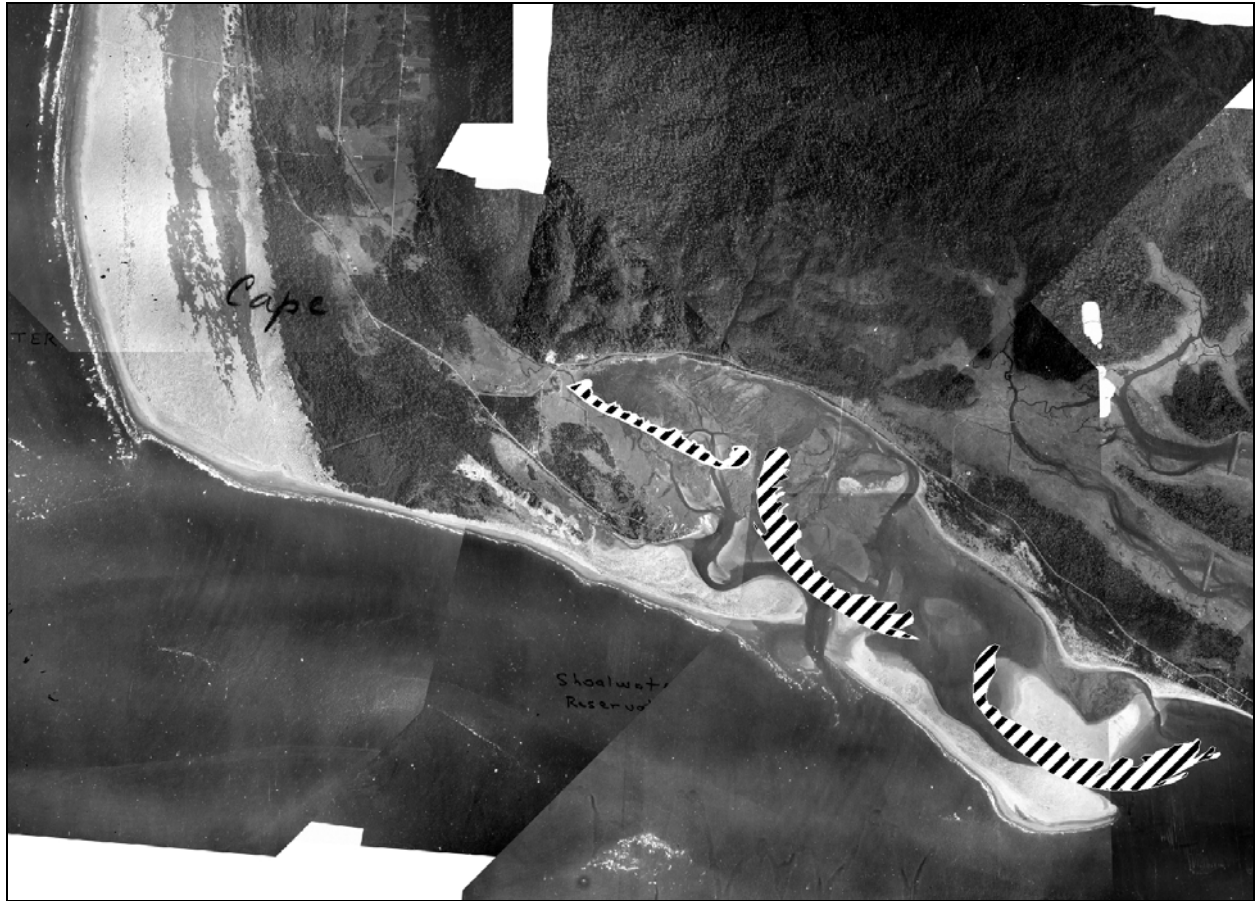
Figure 10. North Willapa Bay, Washington State. This mosaic consists of six frames flown on September 19, 1945. These have been photogrammetrically rectified to create a map projection. The three islands (hatched polygons) were traced from an October 12, 2000, orthophoto. The shoreline retreat at the spit in the center of the map was 1,100 m, or 20 m/year. (Original photographs, BEB archives, mosaic courtesy of Washington State Department of Ecology).

One of the most valuable uses of historical vertical air photographs is for shoreline change measurements. Before measurements can be made, images have to be photogrammetrically rectified to remove distortions and create map projections with real coordinates (e.g., latitude-longitude, state plane, etc.). Once the photographs have been transformed, they can be superimposed in mapping or geographic information system (GIS) software, and features can be outlined and measured. Figure 10 is an example of a 1945 photo mosaic from the north shore of Willapa Bay, Washington. This area is said to have some of the most extreme sustained erosion in the United States. Outlines of Graveyard Spit and two islands, traced from a 2000 orthophoto, have been superimposed on the mosaic to show how the shore has retreated. At the spit on the west (left), the shore retreated northward over 1.1 km in 55 years, or about 20 m/year.
