# Accelerating Roundabout Implementation in the United States - Volume I of VII

## Evaluation of Rectangular Rapid-Flashing Beacons (RRFB) at Multilane Roundabouts

PUBLICATION NO. FHWA-SA-15-069

SEPTEMBER 2015

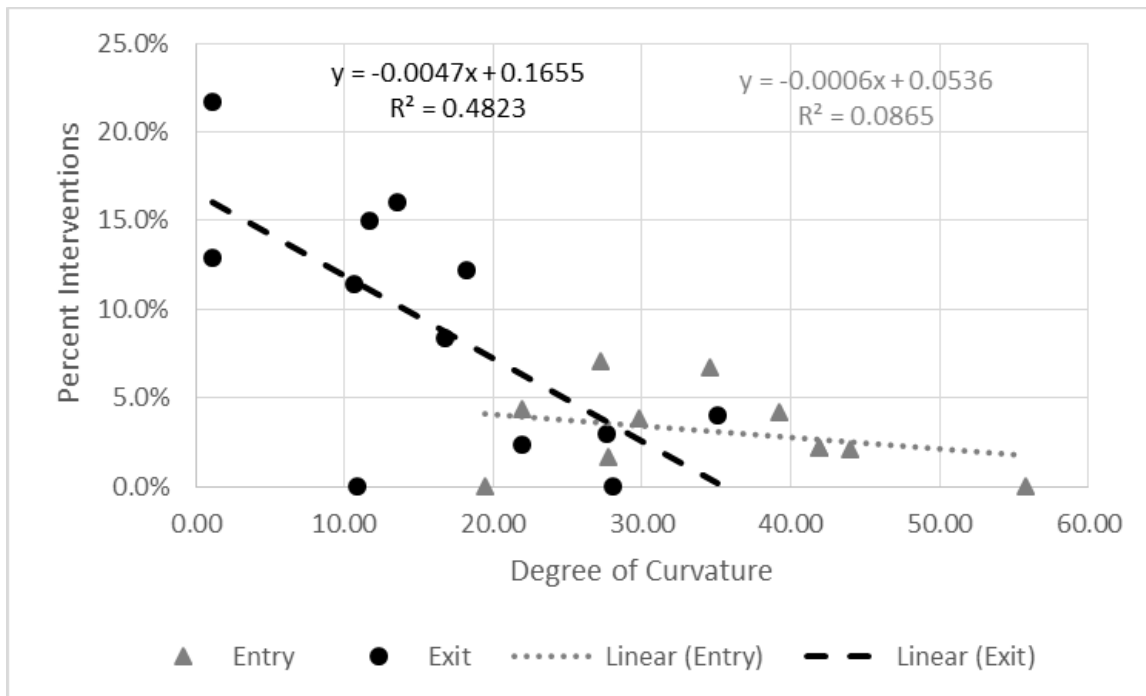
The same data are shown in figure 4 as a scatterplot, showing percent interventions as a function of the degree of curvature for entry (gray triangles) and exit (black circles). For the entry leg data, the channelized turn lane site has been removed from the plot, as it represents a generally different geometric configuration than the other entry legs.

**Figure 4. Graph. Percent intervention as a function of degree of curvature (all sites).**

The scatterplot presented in figure 4 shows correlation between interventions and the radius of curve for the exit with an R-squared value of 0.4823. The Davidson, North Carolina, site is an outlier in this relationship as discussed above. As shown in figure 5, if the outlier is excluded, the R-squared of the relationship increases to 0.7119. Without the Davidson site, there was also a relationship for the entry leg between degree of curvature and interventions, but at a somewhat lower R-squared (0.4260). With inclusion of the Davidson site as shown in figure 4, this relationship is weaker, with an R-squared value of 0.0865.

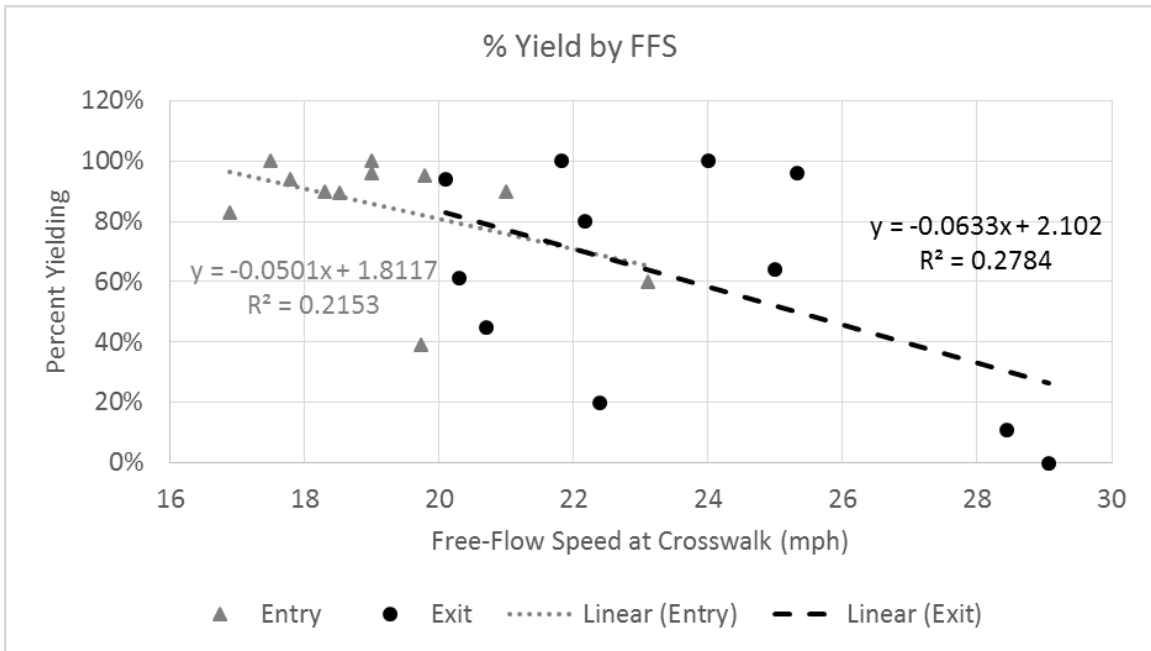
Figure 7 shows the percentage of drivers yielding as a function of free-flow speed measured at crosswalks. The yield percentage was determined through the naturalistic yielding study; the speed measurements were obtained with a radar device during free-flow conditions in the absence of any pedestrians. The chart shows entry legs in gray triangles and exit legs in black circles. The two exceptional cases—the channelized turn lane at entry and the single-lane exit—were excluded from this analysis as to not bias the trend line results.

**Figure 7. Graph. Percent yielding as a function of free-flow speed at crosswalk (mph).**

Figure 7 shows an inverse correlation between percent yielding and speed for entry and exit. Exit speeds are generally higher than entry speeds. Figure 7 shows that the speed effect (slope of the line) is strikingly similar for both entry and exit legs. The corresponding R-squared values for entry and exit are 0.2153 and 0.2784, respectively, suggesting that while speed is a factor impacting yielding, it is clearly not the only explanatory factor. In other words, the dispersion in the data makes it difficult to identify clear relationships, although general trends are observable.

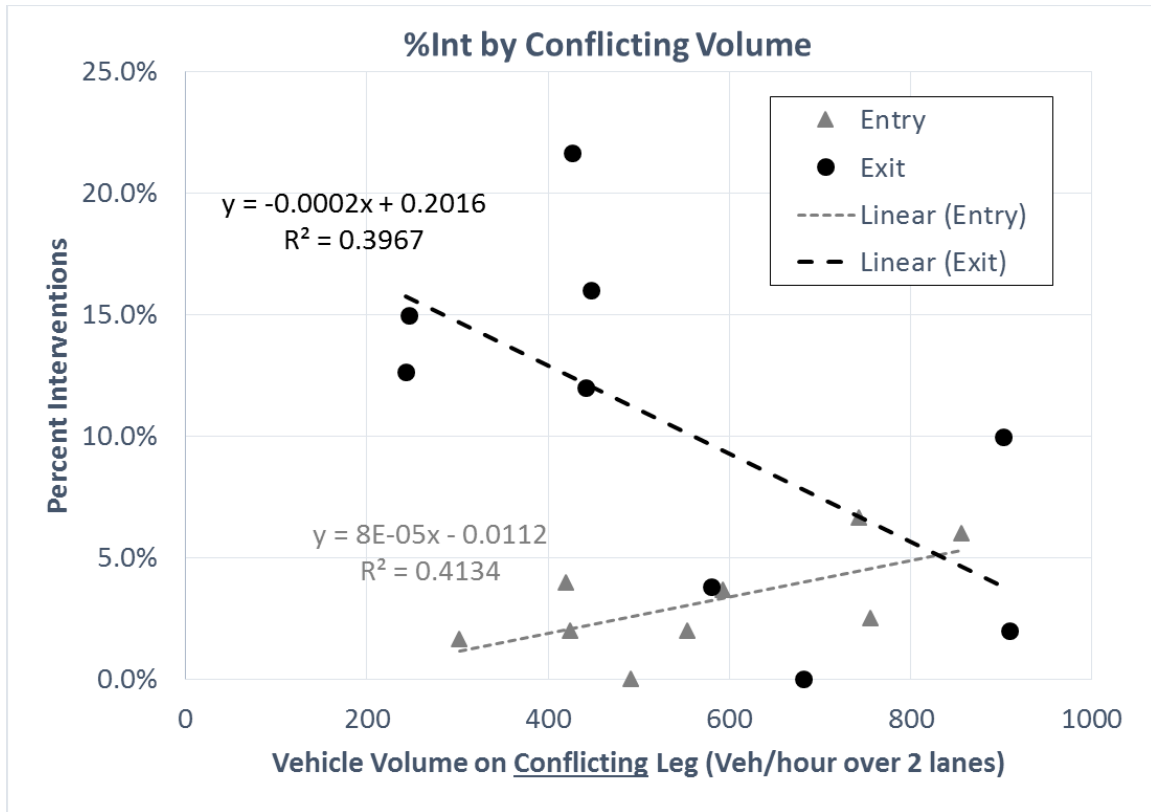
This section evaluates percent interventions as a function of traffic volume on the conflicting leg (lanes closest to the participant), as shown in figure 12. The graphs distinguish entry legs (gray triangles) and exit legs (black circles), and include a linear trend line fit to the data. The single-lane exit and channelized turn lane are excluded from this analysis. The Davidson site is also excluded, as no traffic volume data were available.

**Figure 12. Graph. Percent intervention as a function of vehicle volume on conflicting leg.**

One possible explanation here is that pedestrians faced with more traffic at exits had to wait for a gap or yield, and therefore made safer decisions. When exiting traffic is high, there could be a lot of auditory information conveyed to pedestrians that a crossing is NOT safe. However, when traffic is lighter, pedestrians may have perceived more gaps and attempted to cross during a quiet period with lighter volume, but missed an oncoming vehicle. At several sites, the team noted interventions because pedestrians did not perceive fast-moving cars exiting the circulating lane until very late.

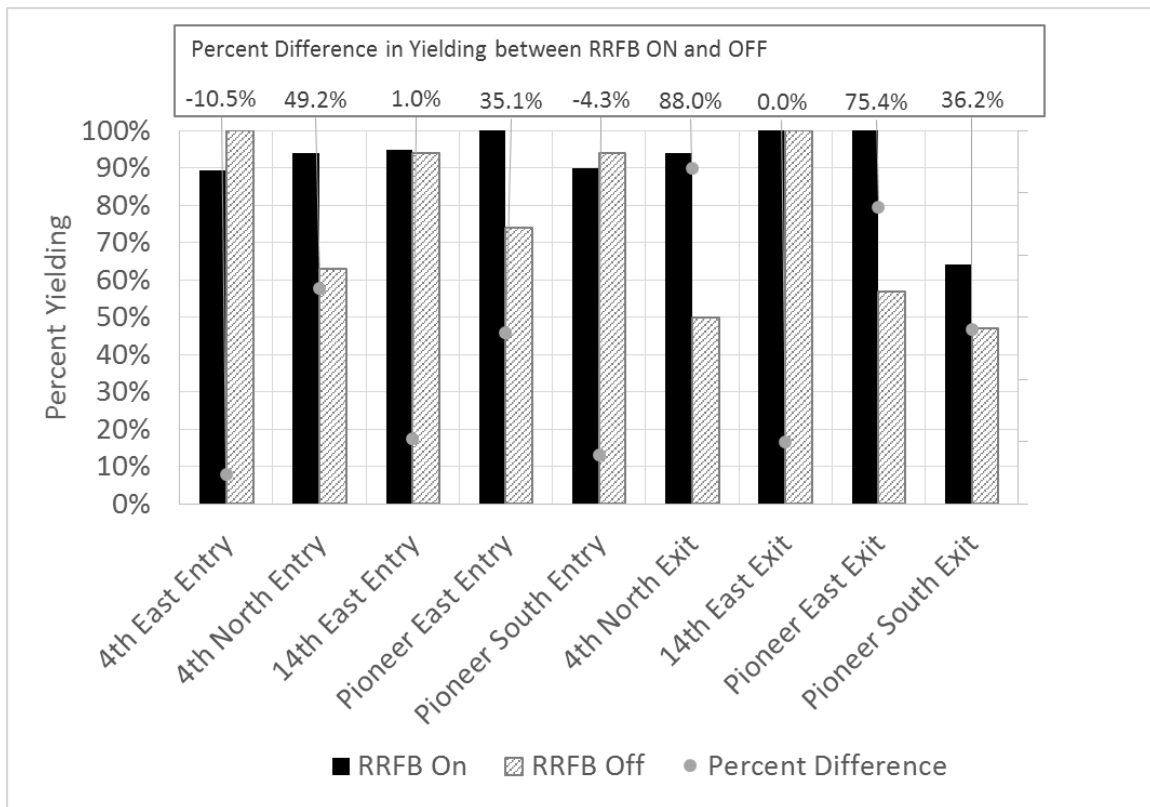
The RRFB was always activated in trials measuring percent intervention. However, at nine approaches, the team performed the naturalistic yielding study both with and without the RRFB devices activated to compare yielding behavior between those conditions. The results are shown in figure 13.

**Figure 13. Chart. Effect of RRFB activation on yielding.**

where yield rates were compared between RRFB conditions had yielding rates below 45 percent, so these results should not be extrapolated to sites with lower non-RRFB yielding rates.

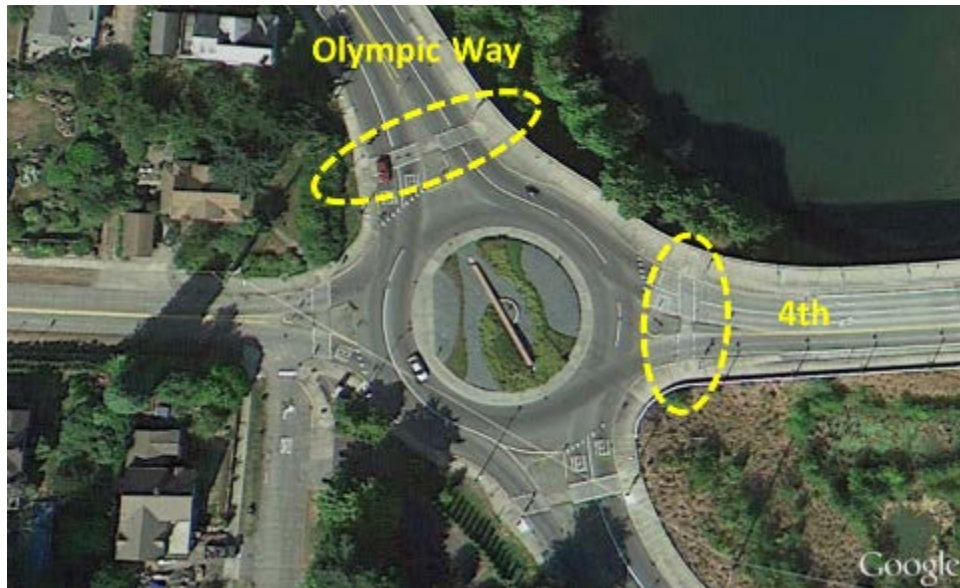
Figure 15 shows the Google aerial view of the roundabout located at the intersection of Olympic St. W and 4<sup>th</sup> Ave. W in the city of Olympia, WA. The audit was applied to the east leg on 4<sup>th</sup> Ave. W and north leg on Olympic St. W, both entry and exit. Figure 16 and figure 17 show the ground level view of the studied approaches. All the approaches have two lanes, except for the 4<sup>th</sup> Ave. exit, which is a single lane.

**Figure 15. Photo. Aerial view of Olympic St. W at 4th Ave. W, Olympia WA.**

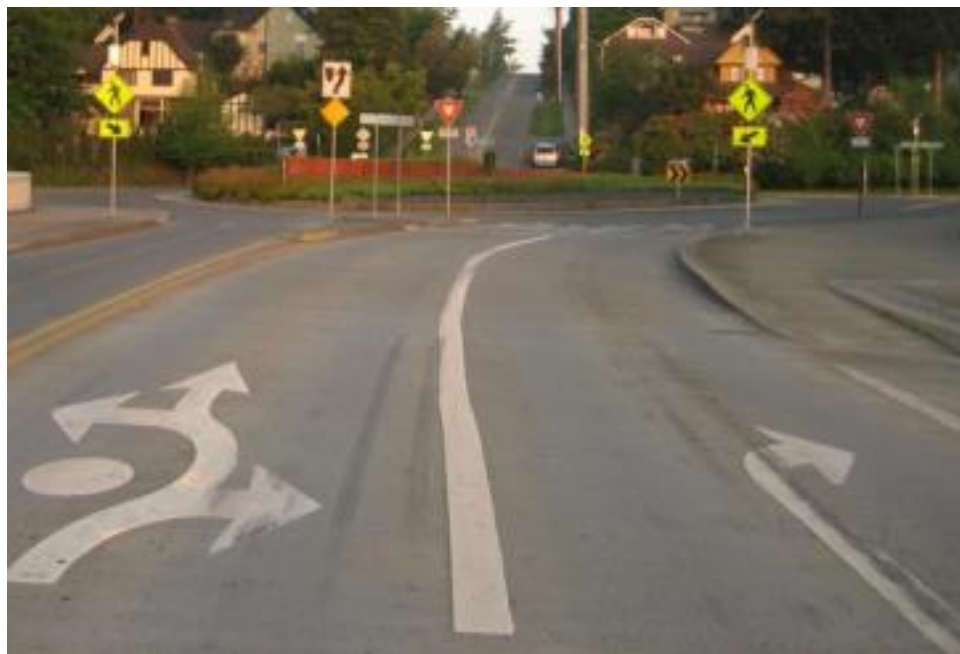
**Figure 16. Photo. 4th Ave. W, east leg two-lane entry, one-lane exit, Olympia WA.**

This site exhibited high pedestrian and bicycle activity, and thus high driver expectation of pedestrians. Olympia, WA, generally had a very compliant driver culture with drivers expecting to yield and expecting pedestrians to activate the RRFB. At this roundabout, a steep approach grade at Olympic St. (northern approach) resulted in higher entering speeds (downhill) and lower exiting speeds, which were reflected in the safety performance at these two legs. The east exit on 4<sup>th</sup> was a single-lane exit, and showed lower interventions and delay than most two-lane exits studied in this research.

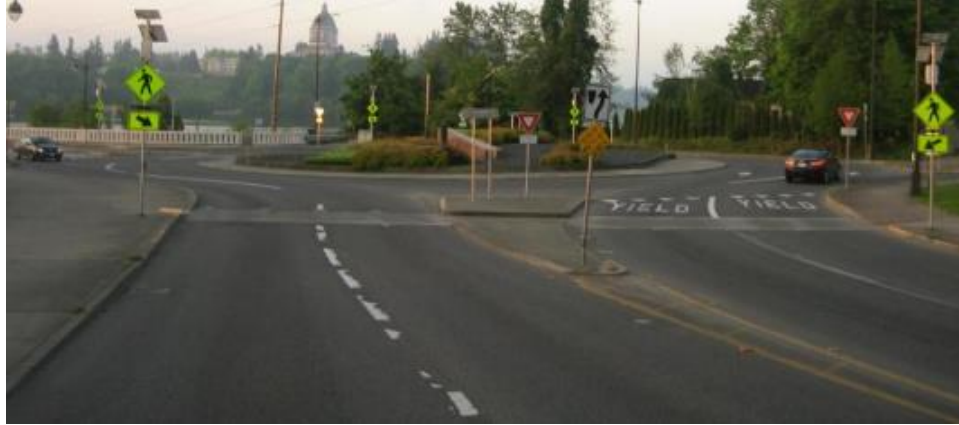
**Figure 17. Photo. Olympic St. W, north leg two-lane Entry, two-lane exit, Olympia WA.**

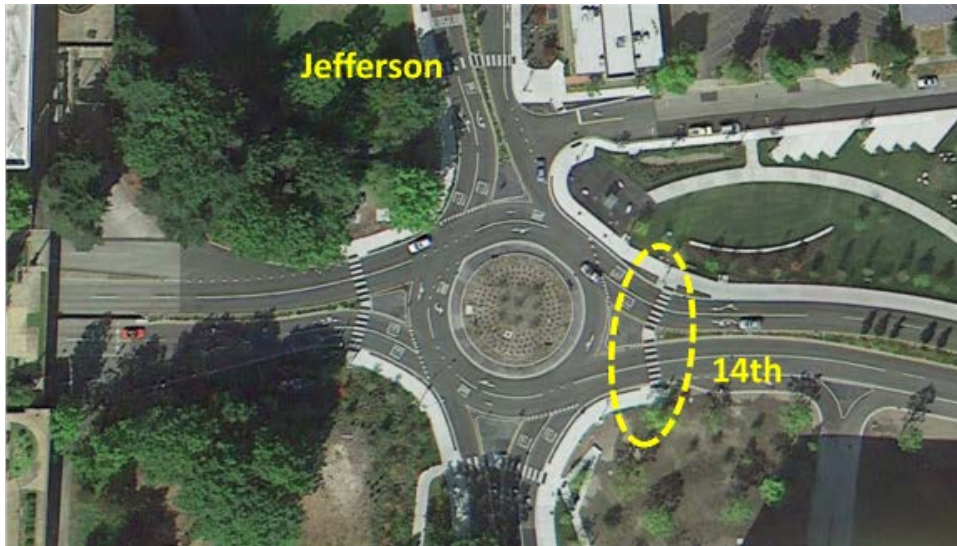
Figure 18 shows a view of the second studied roundabout in Olympia, WA. This roundabout is located at the intersection of Jefferson St. SE and 14<sup>th</sup> Ave. SE. Only one approach was evaluated for the indicator study, which is shown in a street-level view in figure 19. The exit leg of 14<sup>th</sup> Ave. SE, westbound was also studied in the naturalistic yielding study (front crosswalk in figure 19). The studied east leg of 14<sup>th</sup> Ave. SE has two entering and two exiting lanes, and experiences heavy inbound a.m. peak volumes from I-5 as shown by a long queue in the right approach lane in figure 19. A close-up view of the studied entry leg is shown in figure 20.

**Figure 18. Photo. Aerial view of 14th and Jefferson roundabout in Olympia, WA.**

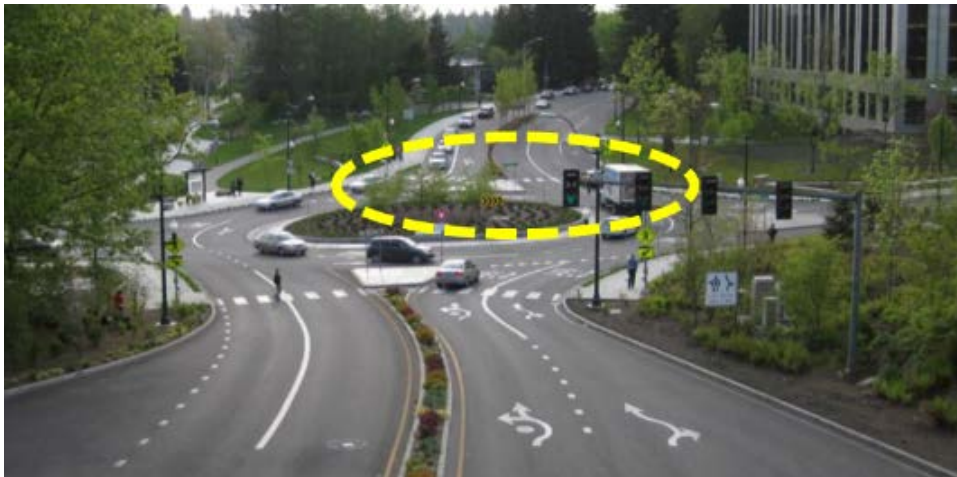
**Figure 19: Photo. Phase I data collection site, Jefferson St. at 14th Ave. SE, Olympia WA.**

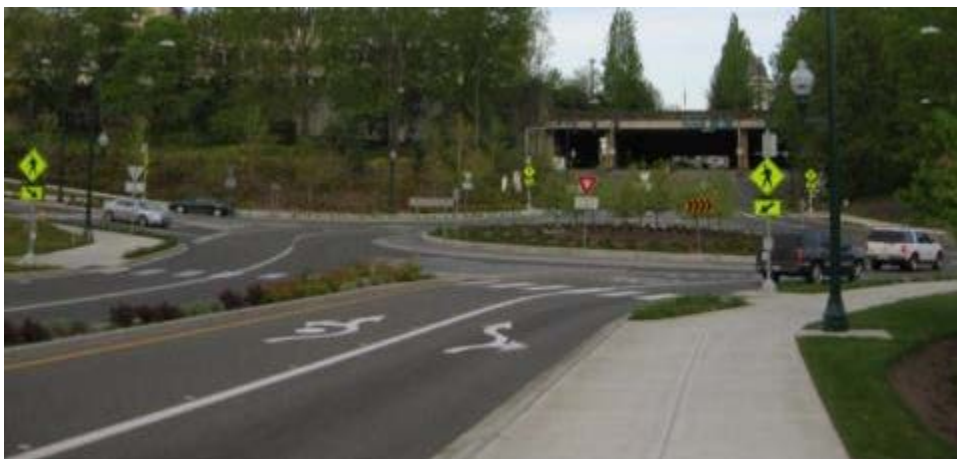
**Figure 20. Photo. 14th Ave SE, east leg two-lane entry, two-lane exit, Olympia WA.**

This site generally exhibited high pedestrian and bicycle activity, and thus high driver expectation of pedestrians. Similar to the other Olympia, WA, site, this location showed a very compliant driver culture with drivers expecting to yield and expecting pedestrians to activate the RRFB. There was further high police presence adjacent to state government complex.

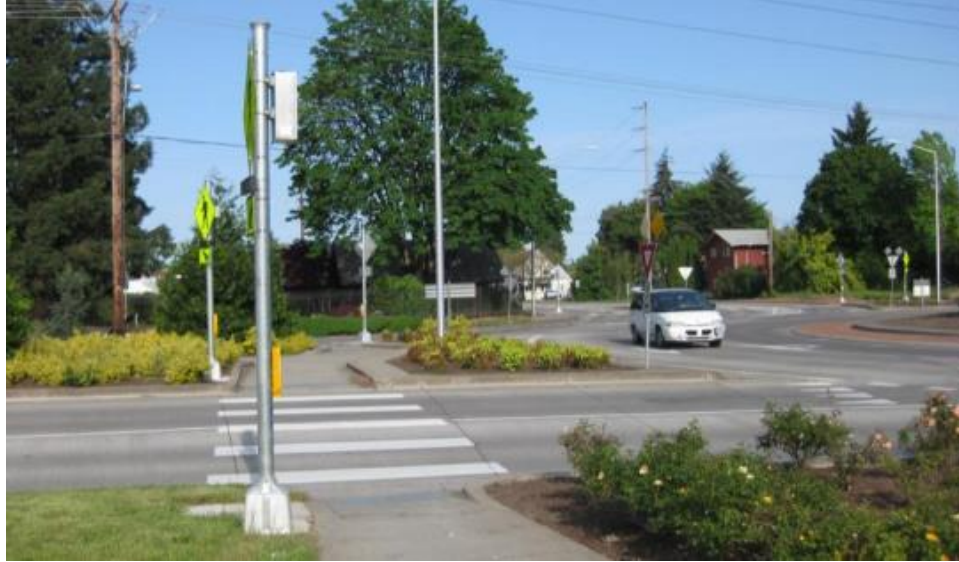
**Figure 22. Photo. Pioneer Pkwy. south leg two-lane entry, two-lane exit, Springfield, OR.**

The site had a high rate of exit-leg interventions at the south exit, which featured an upstream channelized right-turn lane to accommodate the eastbound to southbound right-turning movement. The team noted that a fairly large portion of interventions seemed to have been associated with right-turning vehicles from the west approach. Being faced with heavy conflicting flows, it appears that those upstream right-turn drivers would accelerate rapidly into the few available gaps in the circulating lane, with drivers' heads rotated to the left towards the conflicting traffic stream. The Pioneer Pkwy. exit-leg crosswalk is located relatively close to the

circulating lane, and driver reaction time at that exit leg is very short because they accelerate rapidly and are facing away from the crosswalk. This may at least partially explain the low yielding rate observed at the south exit. In addition, the rapid acceleration from a stopped position within a short distance also appeared to make it very difficult for blind participants to react to these vehicles. The roundabout geometry and landscaping appeared to contribute to some sight obstruction between the right-turning driver and the waiting pedestrian.

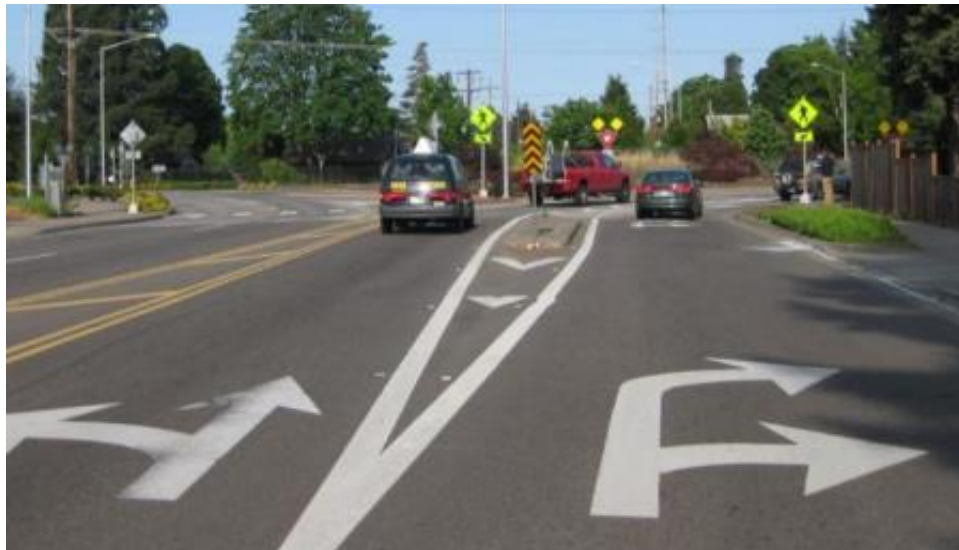
Figure 21 shows the Google aerial view of the roundabout located at the intersection of Pioneer Pkwy. and Hayden Bridge Rd. in the city of Springfield, OR. The team studied the south leg on Pioneer Pkwy. and east leg on Hayden Bridge Rd. for this phase of data collection. Both approaches featured two-lane entries and exits. Ground-level pictures of the studied approaches are shown in figure 22 and figure 23.

**Figure 23. Photo. Hayden Bridge Rd. east leg two-lane entry, two-lane exit, Springfield, OR.**

This roundabout design has a larger roundabout diameter and entry/exit radii than the previously described sites in Olympia, WA. A bus rapid transit station on the south approach results in high pedestrian volume and driver expectation of pedestrians. The roundabout was very busy during certain times of day with both vehicles and pedestrians.

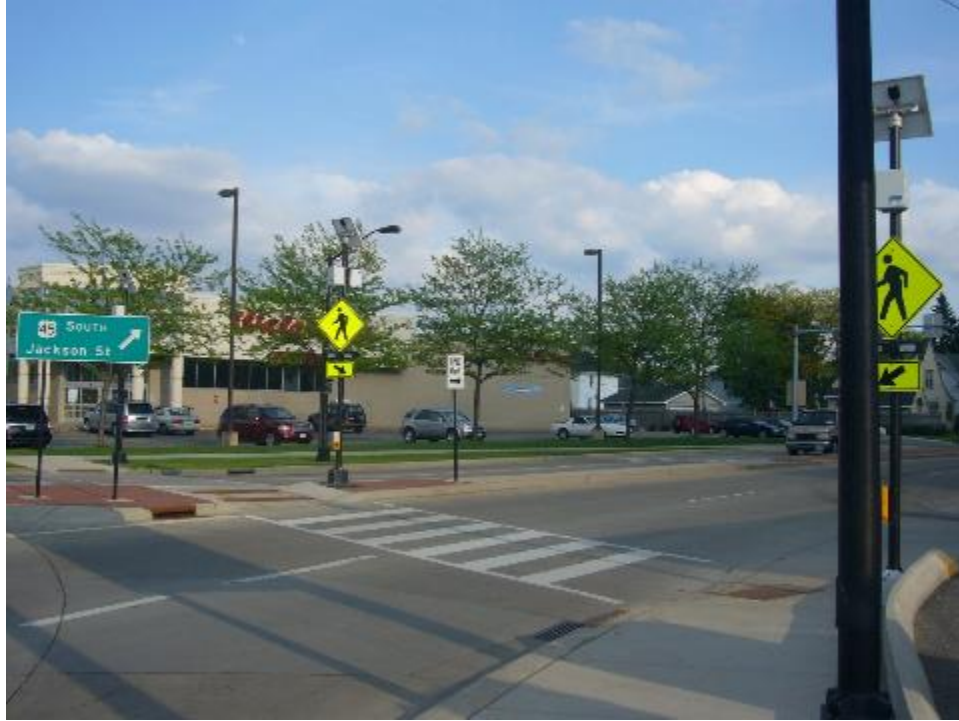
Figure 24 shows the Google aerial view of the roundabout located at the intersection of Jackson St. and Murdock Ave. in the city of Oshkosh, WI. The audit was applied to the east leg Murdock Ave. and south leg on Jackson St., both entry and exit. Figure 25 shows a street-level view of the southern approach on Jackson St.

**Figure 25. Photo. Street-level view of Southern Approach on Jackson Street., Oshkosh, WI.**

This site was busy with traffic from all approaches with varying patterns throughout the day. The roundabout featured moderate to heavy pedestrian activity throughout the day, including children, elderly pedestrians, and some wheelchair users. The roundabout design is offset left with relatively low deflection at exit. Observations by the team suggested that drivers seemed impatient, with horn-blowing at pedestrians or other drivers yielding to pedestrians. One exit crosswalk (south exit) was very close to the circulating roadway due to a gas station exit driveway, resulting in poor visibility of the crosswalk for circulating drivers. However, both exit crosswalks were problematic for blind pedestrians.

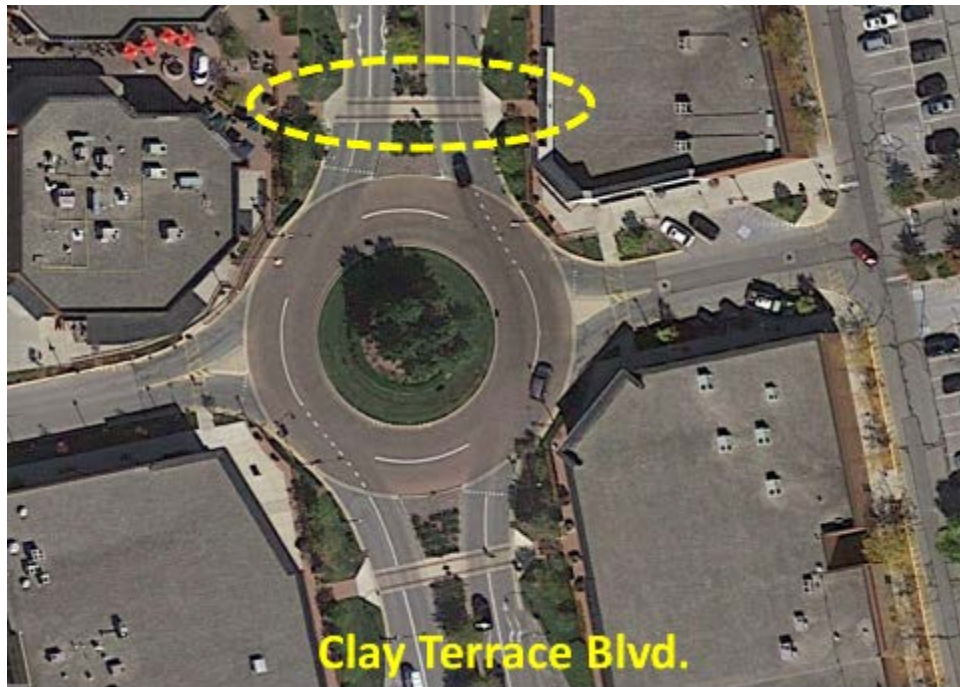
Figure 26 shows an aerial photo of the data collection site located in Carmel, IN, in the Clay Terrace shopping center. Only the north east approach of the roundabout was equipped with RRFB and therefore that approach was the only one studied. Figure 27 and figure 28 show street-level views of the studied crosswalk and approach to the roundabout.

**Figure 26. Photo. Phase II data collection site, Clay Terrace Blvd., Carmel, IN.**

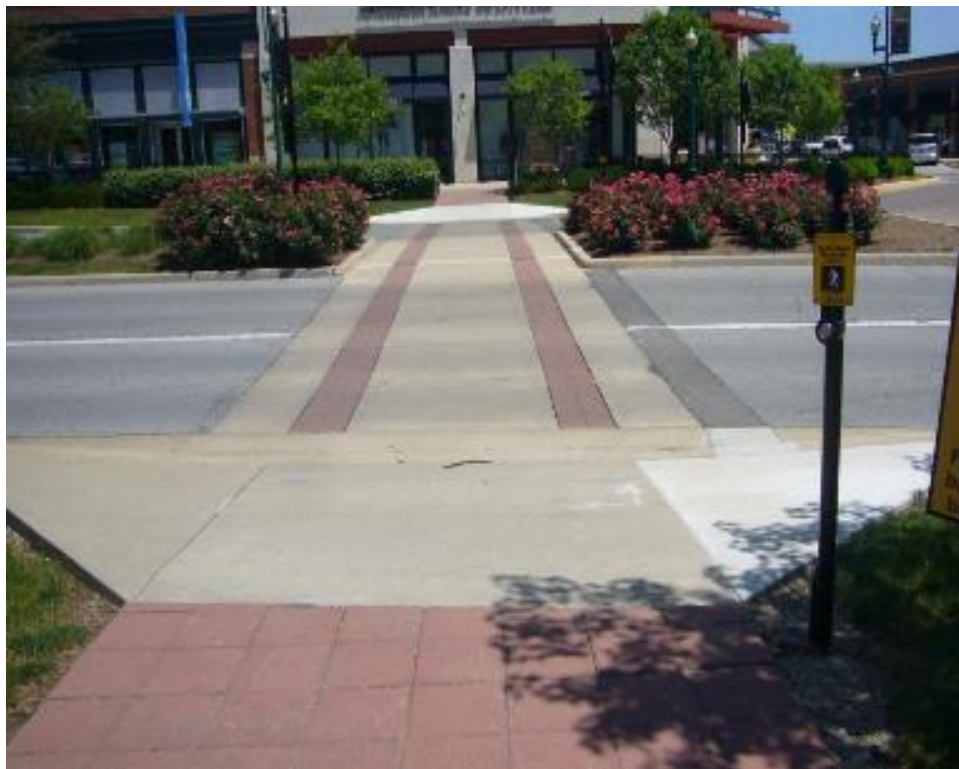
**Figure 27. Photo. Street-level view of the studied crosswalk on Clay Terrace Blvd., Carmel, IN.**

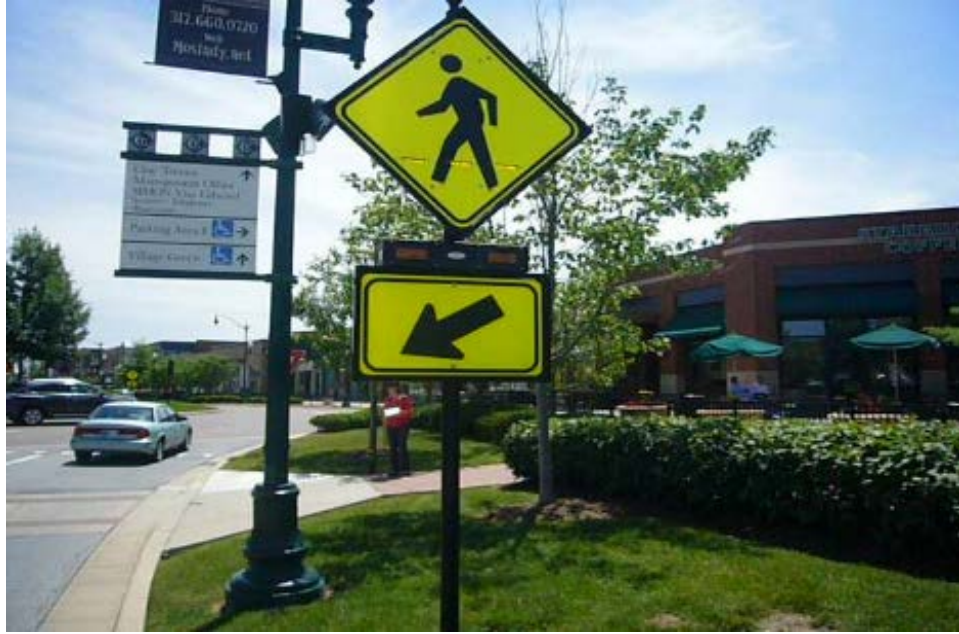
**Figure 28. Photo. Street-level view of approach on Clay Terrace Blvd., Carmel, IN.**

This roundabout was located on a public street in a shopping center environment with high pedestrian expectation, including a significant amount of parents with children and strollers. There are two roundabouts on Clay Terrace Blvd., and the study focused on one crosswalk at the northern site, the only location where RRFBs were installed. The roundabout had signs on the splitter islands (which are not accessible to blind pedestrians) informing pedestrians to yield to vehicles. The roundabout featured relatively low speeds. Upstream signals seemed to result in platoons of traffic at the roundabout entries and exits.

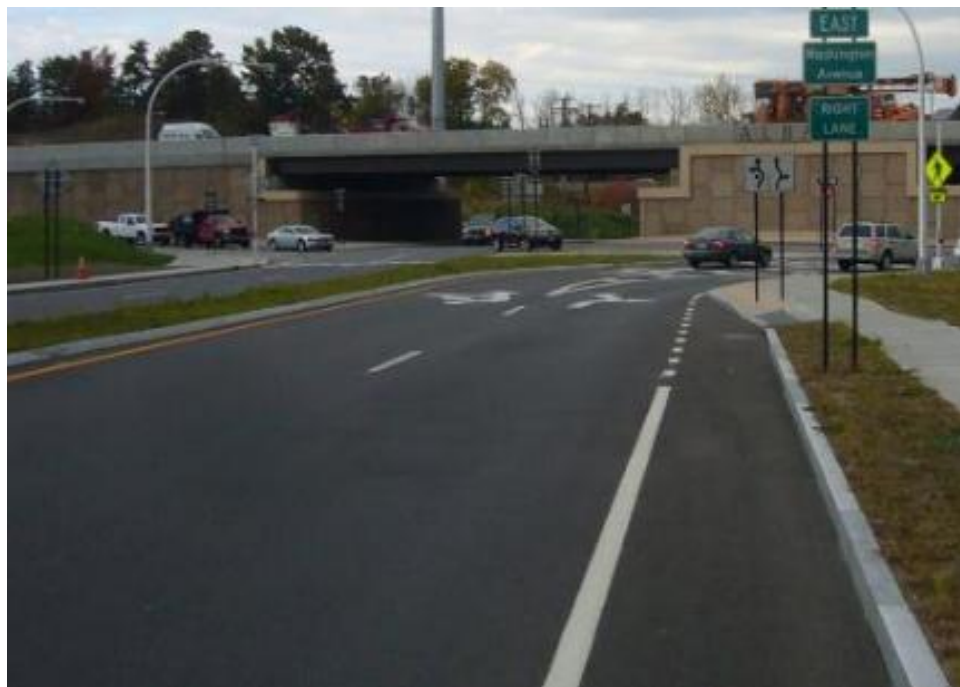
Figure 29 shows an aerial photo of the data collection site in Albany, NY, at the intersection of Fuller Rd. and Washington Ave. Figure 30 and figure 31 show street-level views of the studied crosswalks on the southern and northern approaches to the roundabout, respectively. The picture of the northern approach shows the channelized turn lane that was evaluated at the entry leg.

**Figure 30. Photo. Street-level view of southern approach on Fuller Rd., Albany, NY.**

This roundabout was an underpass at an expressway, resulting in unique sound patterns with bridge abutments masking audible information and causing echoes. As such, it was very difficult to see or hear vehicles coming around the circle towards the exit, with drivers traveling very fast when there was low traffic volume. The roundabout design featured a very strong offset left design with very little deflection at exit.

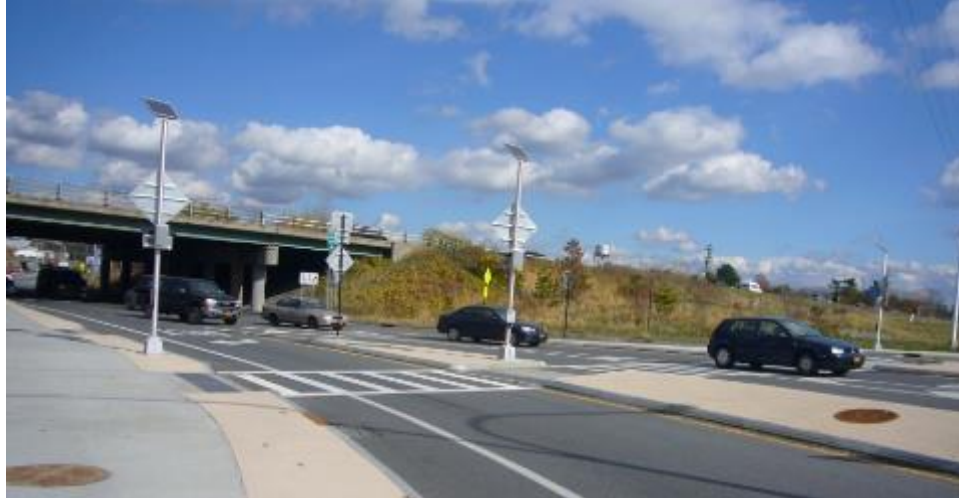
**Figure 31. Photo. Street-level view of channelized turn lane on northern approach on Fuller Rd., Albany, NY.**

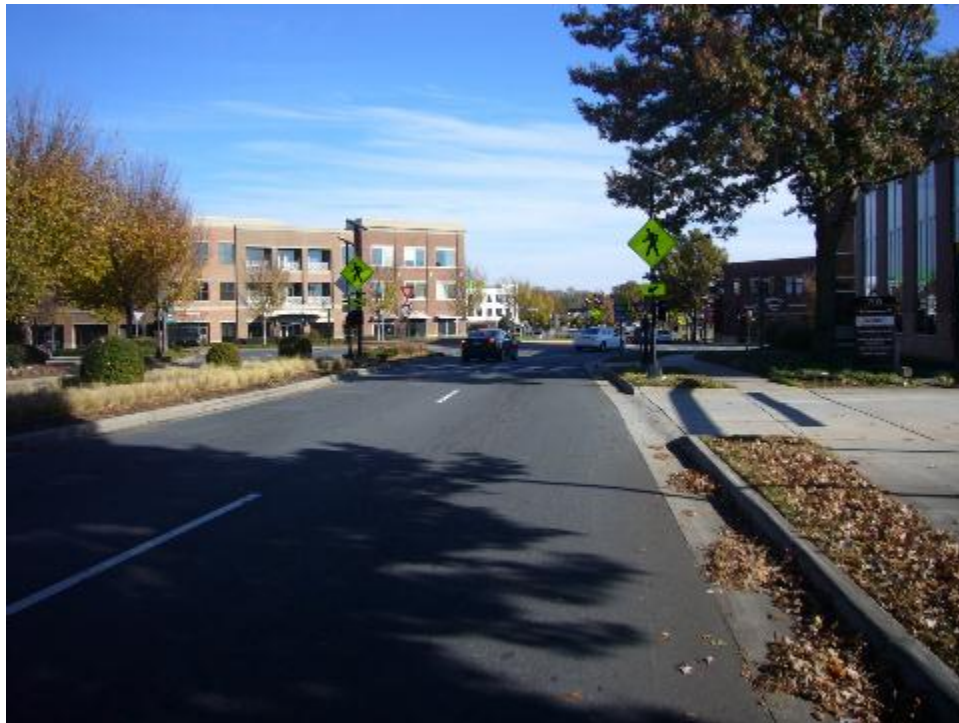
Figure 32 shows an aerial photo of the data collection site in Davidson, NC, at the intersection of Griffith St. and Harbour Place Dr. Figure 33 and figure 34 show street-level views of the studied crosswalk on the west approach to the roundabout. Figure 35 shows the studied east approach to the roundabout.

**Figure 33. Photo. Street-level view of west approach entry in Davidson, NC.**

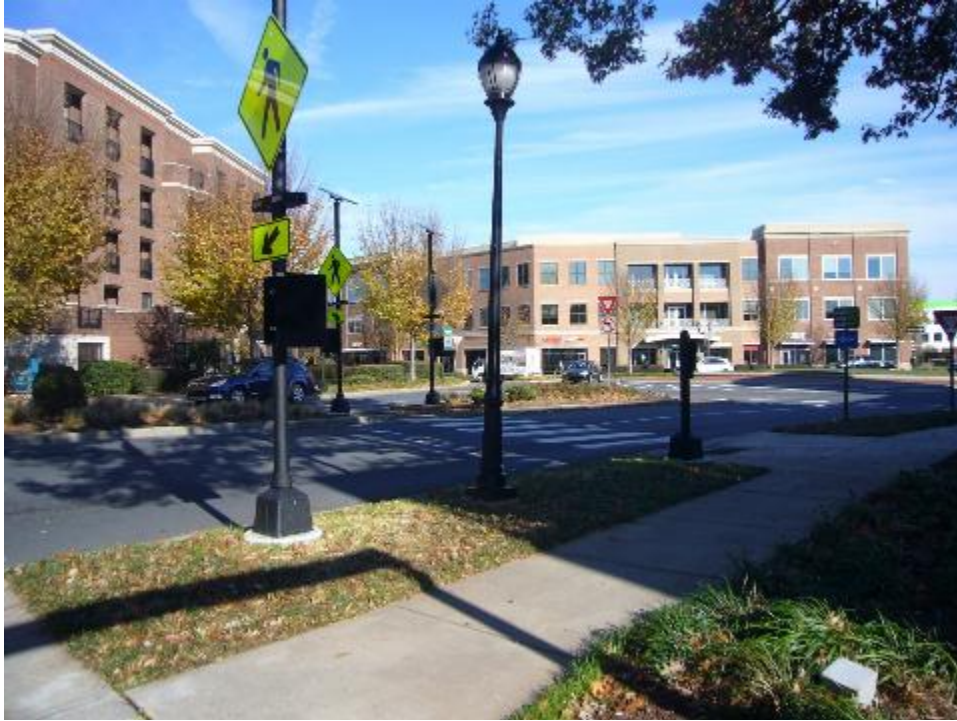
**Figure 34. Photo. Crosswalk view at west approach in Davidson, NC.**

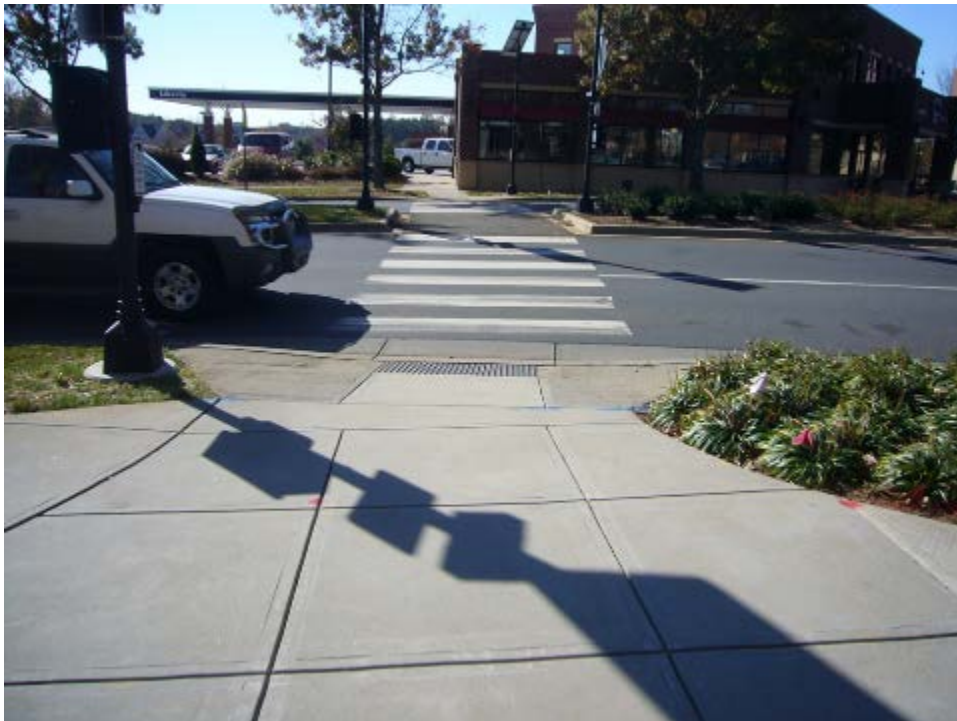
**Figure 35. Photo. Crosswalk view of east approach in Davidson, NC.**

This site was located on the main arterial connecting Interstate I-77 to the town of Davidson, NC. The roundabout at Griffith St. and Harbour Place Dr. had steady flow in the east-west direction and through the studied crosswalks, but little traffic on the north and south legs with more

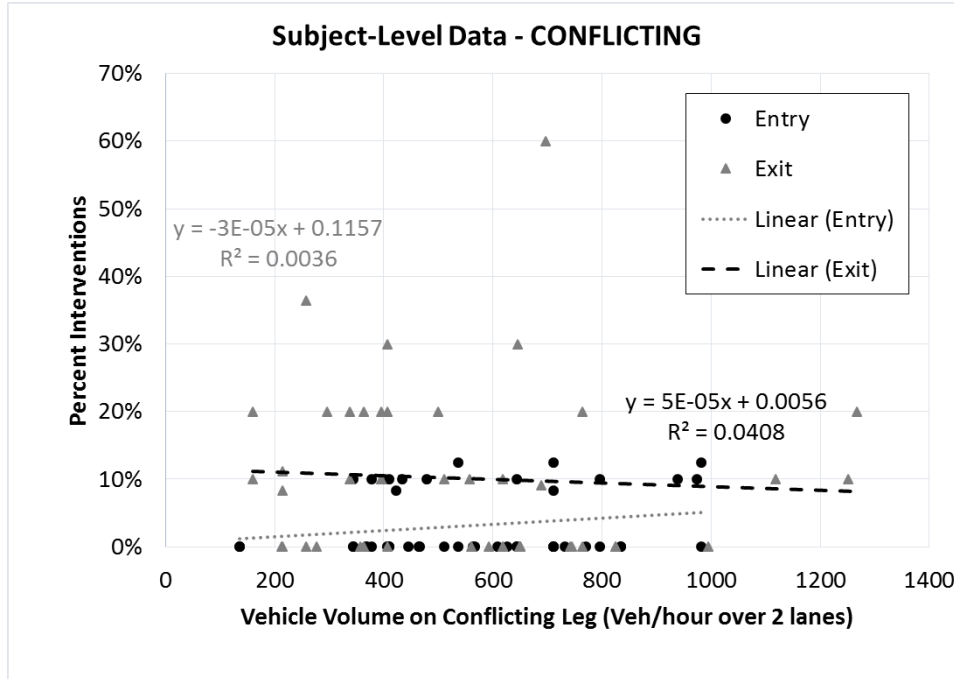
To further evaluate the effects of traffic volume, the volume vs. intervention analysis in the previous section was repeated using the individual subject-level data. This section evaluates percent interventions as a function of traffic volume on the conflicting lane, the lane closest to the participant attempting to cross. While volume on that lane is an important variable, other traffic in the roundabout could potentially mask the sound of traffic approaching in that lane. The graph in figure 36 distinguishes entry (gray triangles) and exit (black circles), and further show a linear trend line fit to the data. The single-lane exit and channelized turn lane trials were excluded from this analysis.

**Figure 36. Graph. Percent intervention as a function of vehicle volume on conflicting leg at subject level.**

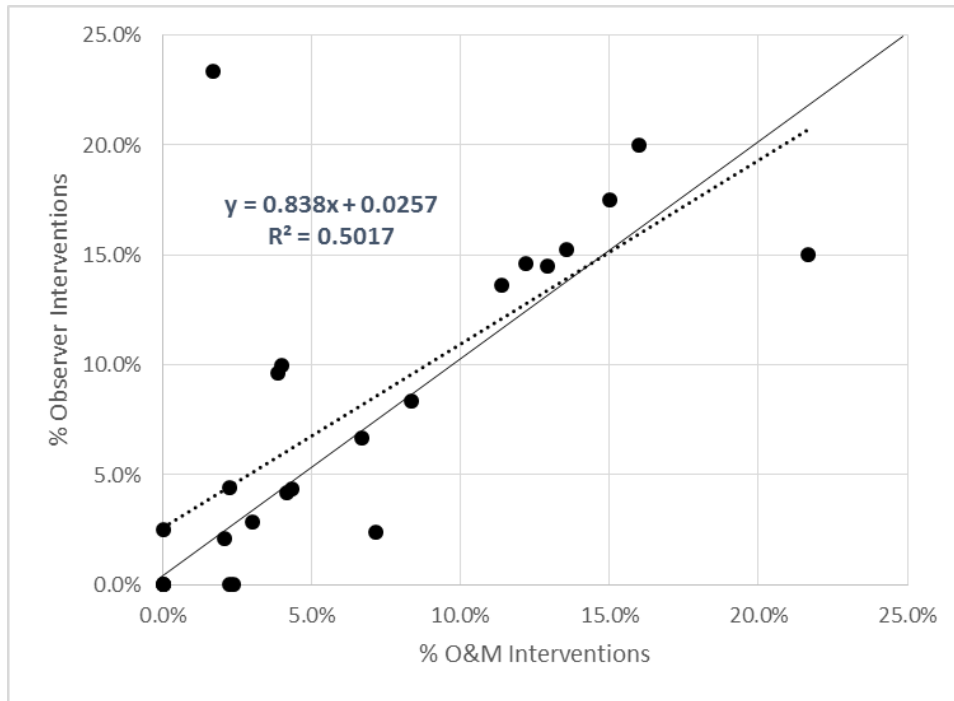
line is shown in the graph. This trend is influenced greatly by the Albany, NY, outlier site. Without those outliers, the two ratings have a level of agreement above 80 percent.

**Figure 42. Graph. Comparison of observer and COMS percent interventions.**
