Accelerating Roundabout Implementation in the United States - Volume VII of VII

Human Factor Assessment of Traffic Control Device Effectiveness

PUBLICATION NO. FHWA-SA-15-075

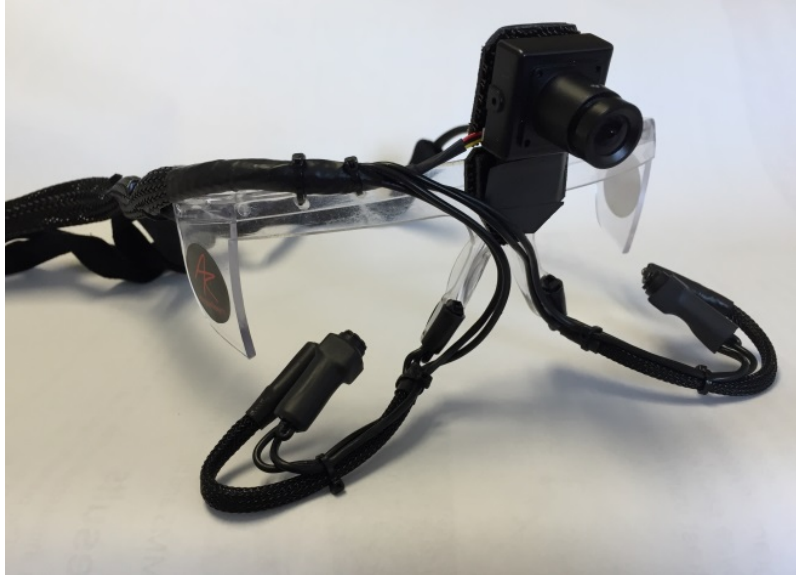
The study used a ViewPoint eye tracker, a head-mounted system that uses infrared lights and cameras mounted on a plastic frame to track the movement of the wearer's eyes (Figure 1). The eye tracker also includes a forward-facing color camera to record the scene in front of the wearer. After calibration, the eye tracker provides a video recording of the scene with the wearer's gaze point overlaid on the photo, as well as the XY coordinates of the gaze point and fixation times, among other variables. A screenshot is shown in Figure 2.

Figure 1. Photo. ViewPoint eye tracker goggles.

The frames are connected to a laptop with a cable that runs behind the wearer's right ear. This cable is clipped to the wearer's shirt to prevent pulling on the frames, and allows unrestricted movement of the wearer's head. The system calculates eye movement with an accuracy of between 0.25 and 1 degrees of visual arc, and a spatial resolution of approximately 0.15 degrees of visual arc.

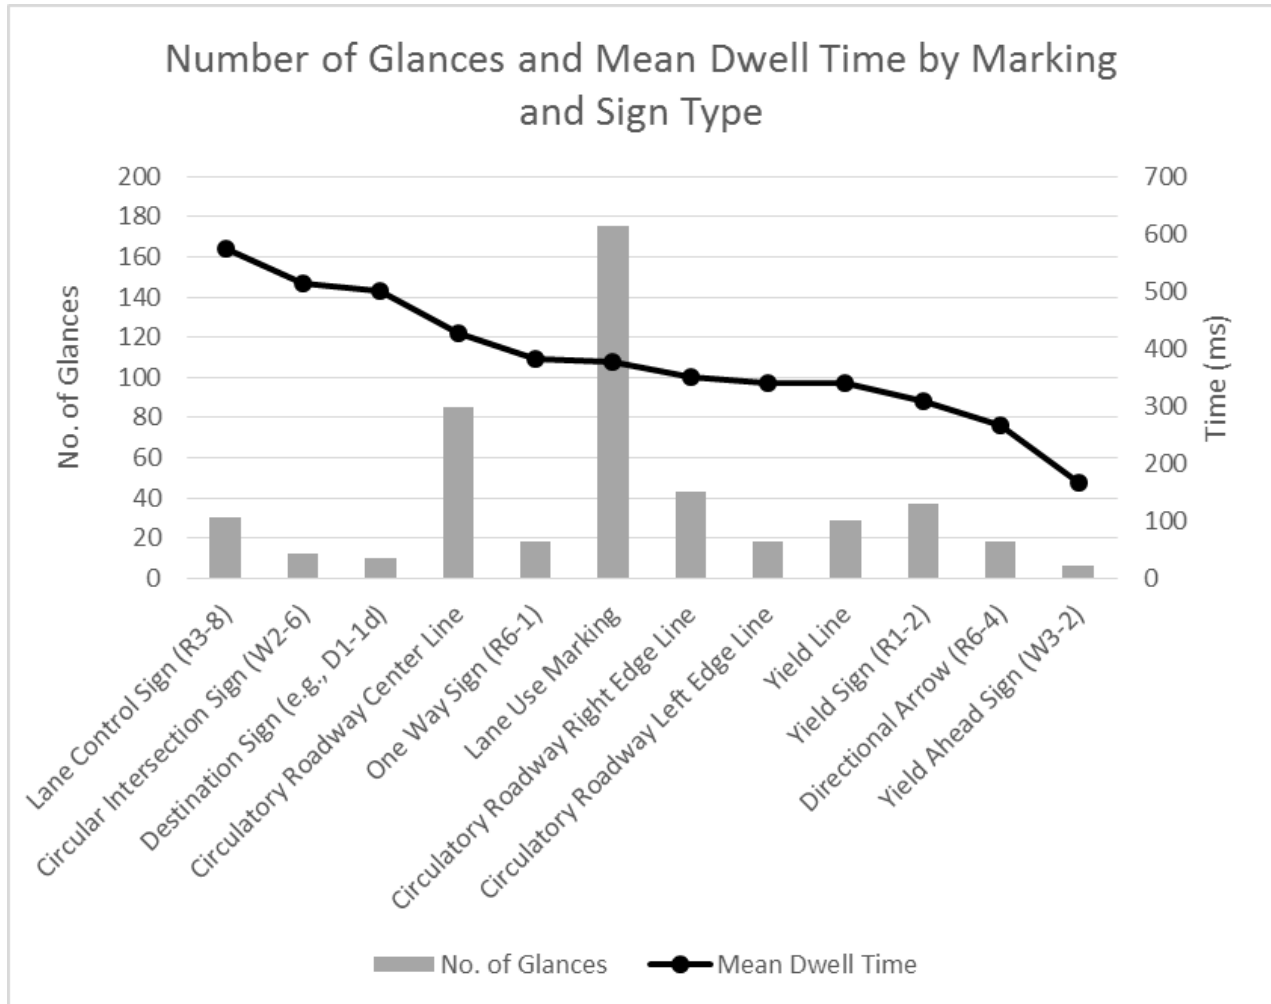
This left a total of 493 glances. Figure 12 shows the total number of glances and the mean dwell time for each of the markings and sign types. The majority of glances were toward lane use markings in the circulatory roadway, and center lane striping in the circulatory roadway. Together, these two markings accounted for nearly 54% of glances to signs and markings. These two markings also appear directly in front of the participant’s vehicle, which may help explain the large number of glances toward them.

Figure 12. Chart. Total glances and mean dwell time by marking and sign type.

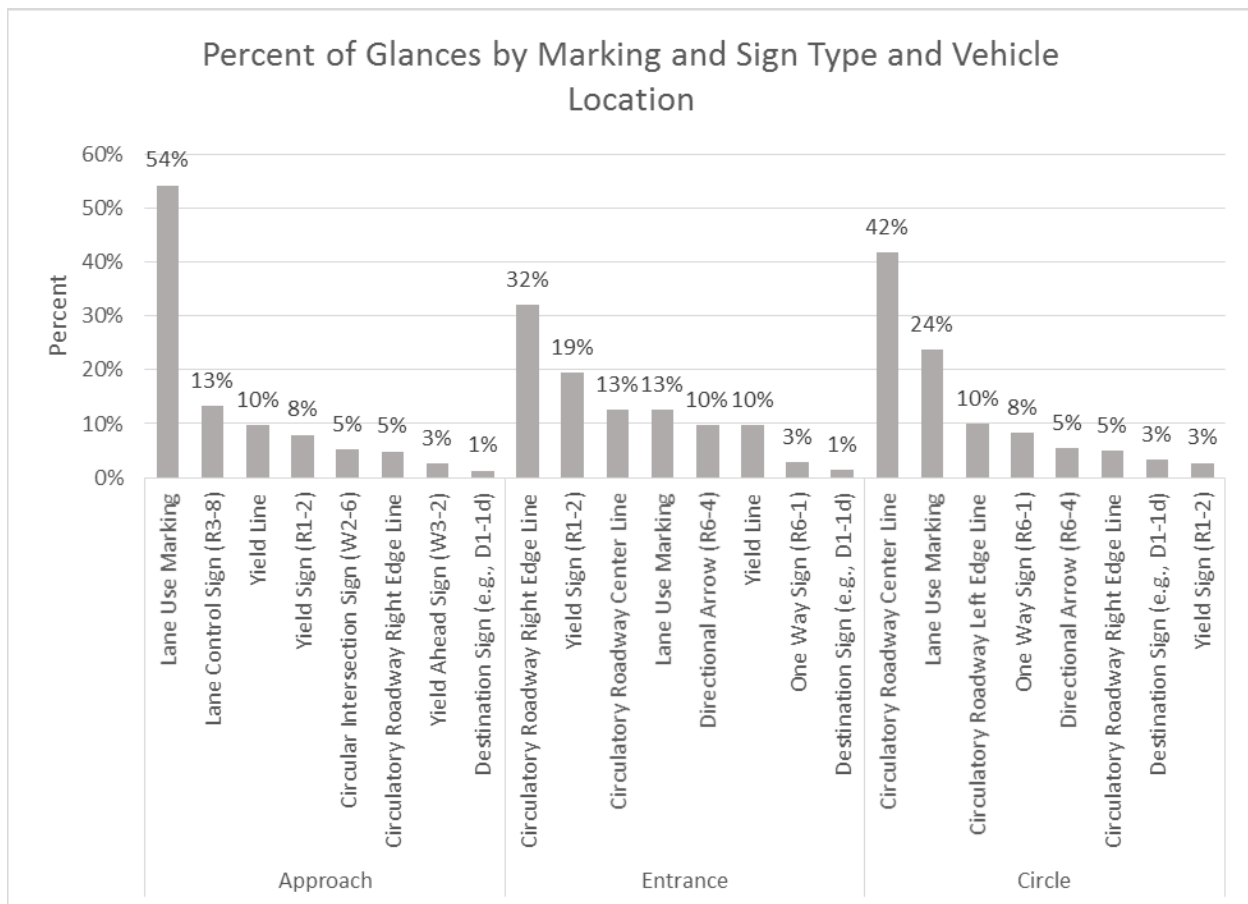
Figure 13 shows the percentage of total glances toward the different marking and sign types by the vehicle's location: the approach, entrance, or circle. Signs and markings, which accounted for less than 1% of glances are not shown. The entrance was defined as the area between the crosswalk and the circle, where drivers yield before entering the circle (section A2 in figure 4). During the approach, participants glanced toward the lane use markings in the circulatory roadway far more than any other sign or marking. While in the entrance, participants made many fewer glances at signs and markings in general compared to when they were in the approach or the circle. This is likely due to the fact that they were only in the entrance for a short time, and needed to spend that time looking for traffic. Of the glances that were made in the entrance, most were toward the lane striping in the circulatory roadway. While in the circle, participants glanced at the lane striping most often, followed next by the lane use markings.

Figure 13. Chart. Percent of total glances by marking and sign type and vehicle location.

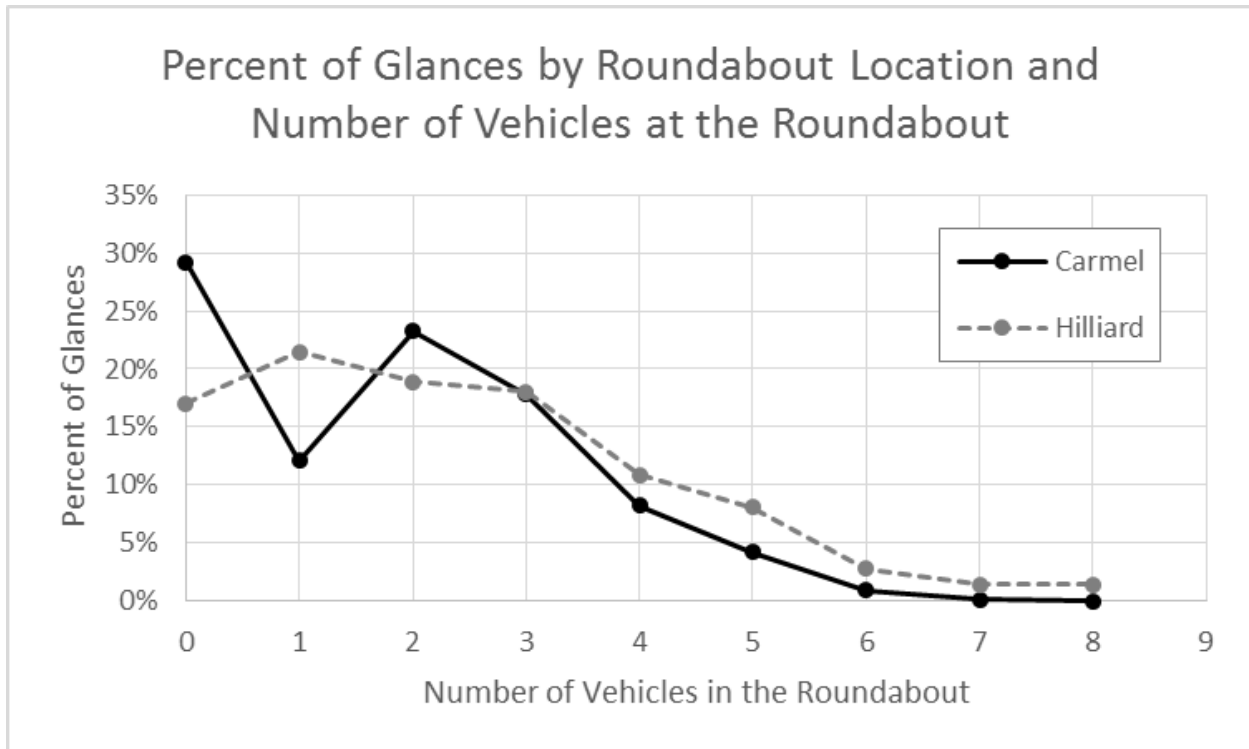
Figure 17 shows the percent of all glances for each roundabout location versus the number of vehicles in the roundabout at the time the glance occurred. Most glances that occurred in Carmel, IN, (about 30%) occurred when there were no other vehicles within the roundabout. Only about 17% of glances that occurred in Hilliard, OH, occurred when there were no other vehicles in the roundabout. Glances that occurred when there were four or more other vehicles in the roundabout made up a larger percentage of glances that occurred in Hilliard, OH, than in Carmel, IN. These results suggest that traffic volume is not the only factor affecting number of glances towards traffic.

Figure 17. Graph. Percent of glances by roundabout location and number of vehicles in the roundabout.
