U.S. Department
of Transportation
**National Highway
Traffic Safety
Administration**

DOT HS 811 832

Cumulative Fuel System Life Cycle and Durability Testing of Hydrogen Containers

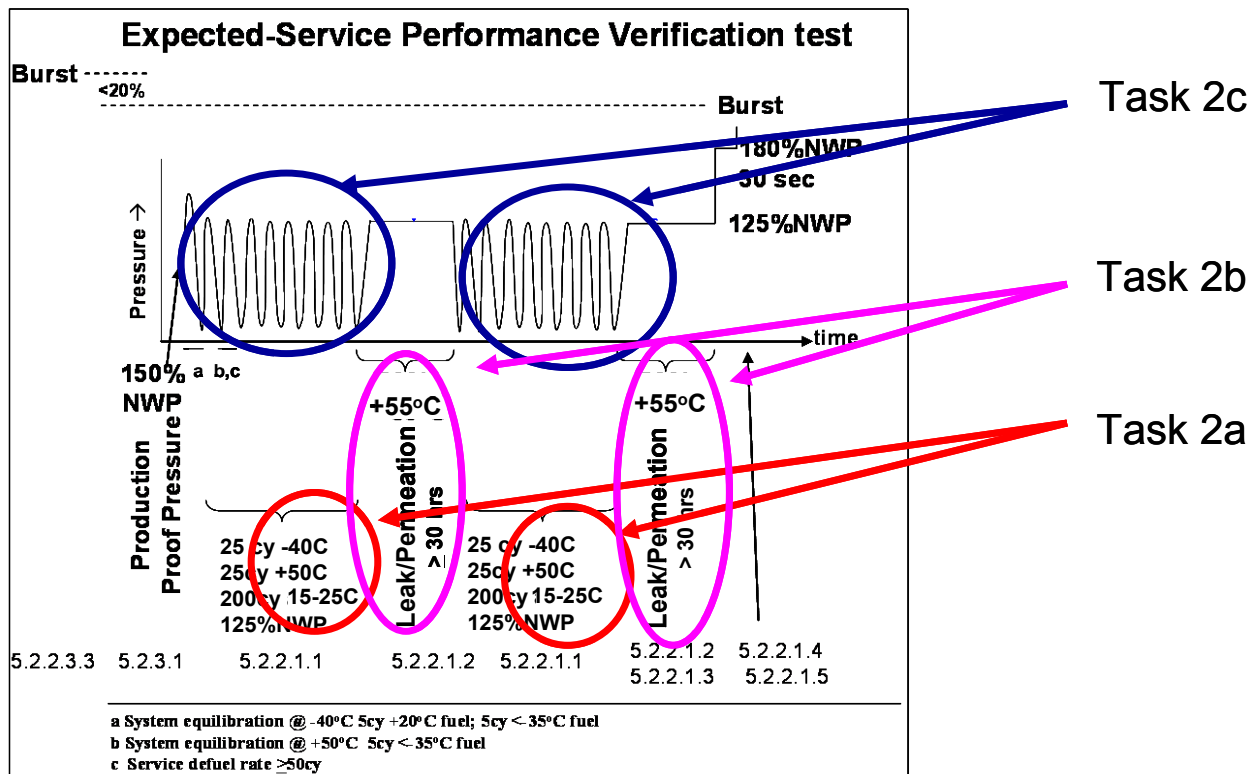
Figure 3. Illustration of the test conditions examined in Subtasks 2a, 2b and 2c.

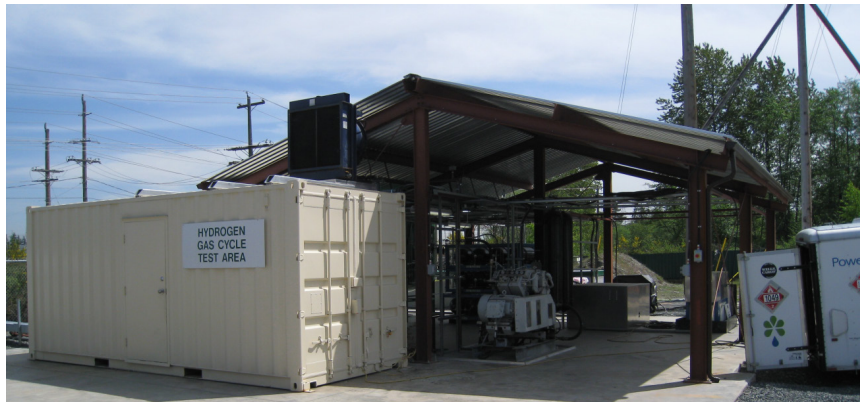
Figure 6. Powertech Labs SAE J2579 Pneumatic Test Facility.

Figure 6 and Figure 7 are photographs of the test equipment.

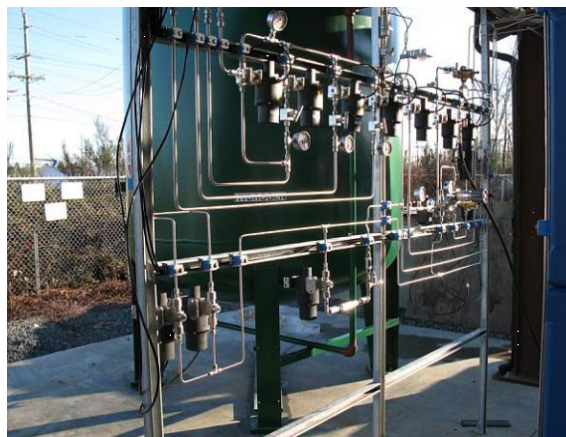
Figure 7. Powertech Labs SAE J2579 Pneumatic Test Facility Inlet Flow Control Panel.

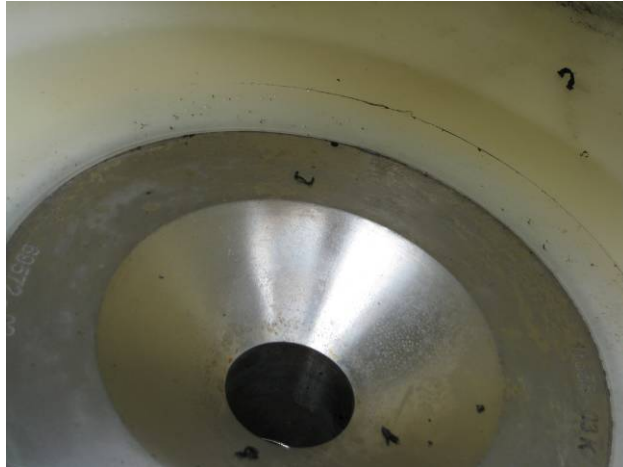
Figure 9. Normal interface between a liner end and the boss.

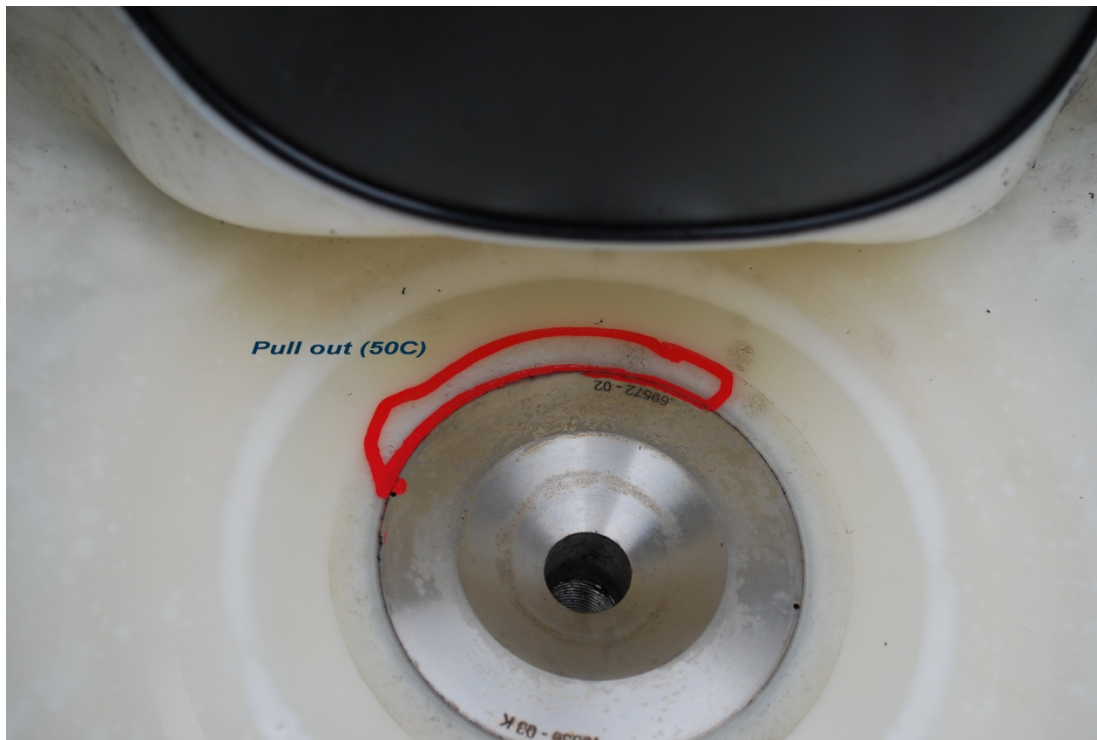
Figure 10. Interface between the liner and the boss of the container that was cycled at +50°C.
The red shows where the liner pulled away from the boss.

No damage was visible in high-temperature test containers when their liners were inspected using a borescope. The containers were then sectioned and the liners were visually inspected. This inspection showed that there was minor separation of the liner-boss interface on both high temperature test containers at the rear dome (opposite the gas inlet/outlet), with significantly more separation on the +65°C container. These gaps may be one of the causes of the observed increases in permeation. Liner bubbling was present in both containers, with more bubbling occurring on the rear dome section. Prior investigation experience suggests that the bubbling likely did not contribute to the observed increases in permeation. A normal liner end boss interface is shown in Figure 9, and the interiors of the cycled containers are shown in Figure 10, Figure 11, and Figure 12.

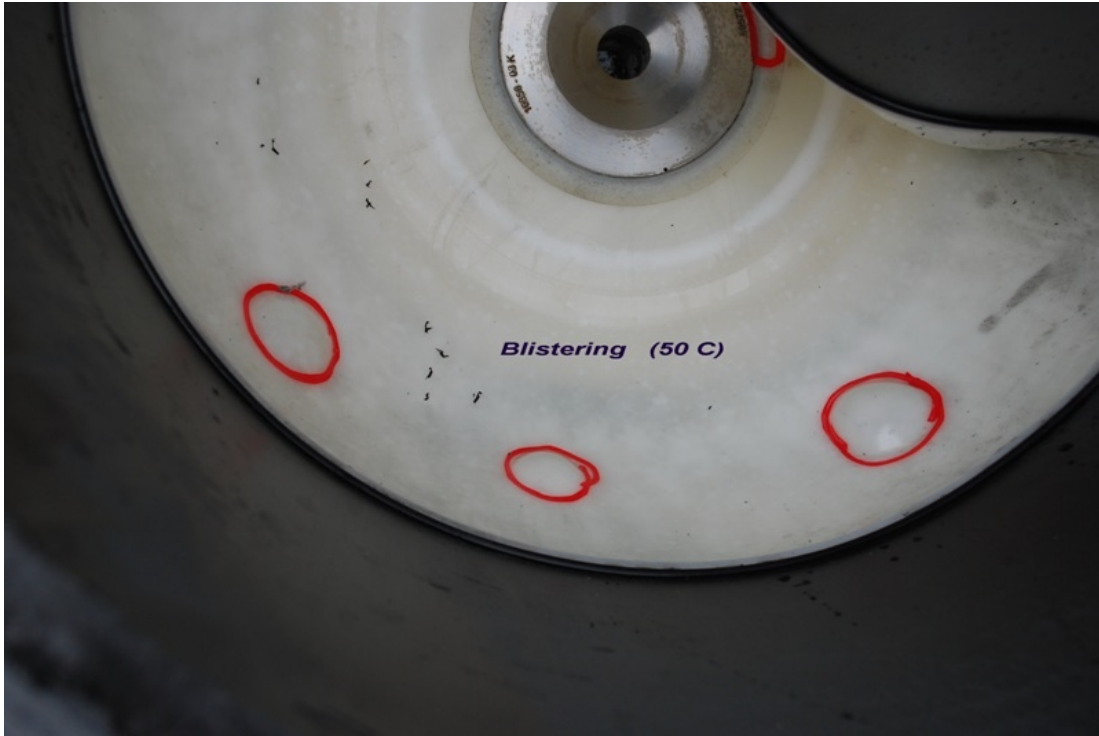
Figure 11. Red circles show blisters in the liner of the container that was cycled at +50°C.

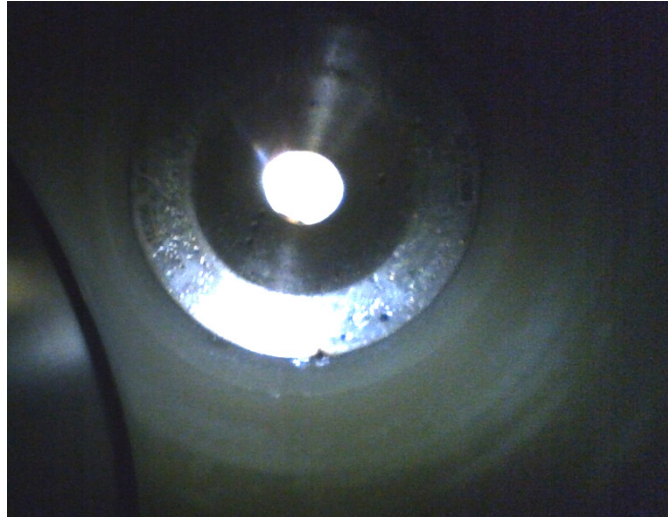
Figure 13. Container 1 (>30hr Hold Time) Following 500 Cycles and Two Time-at-Pressure Exposures.

The liners of both containers were inspected after testing and no damage was visible. Both had evidence of liner buckling, likely caused during final depressurization for inspection. Images of both containers are shown in Figure 13 and Figure 14. No liner-boss separation was visible.
