U.S. Department
of Transportation
**National Highway
Traffic Safety
Administration**

DOT HS 811 780

NHTSA Tire Aging Test Development Project Phase 4: Oven Aging of Tires Followed By Testing to Failure on a Roadwheel

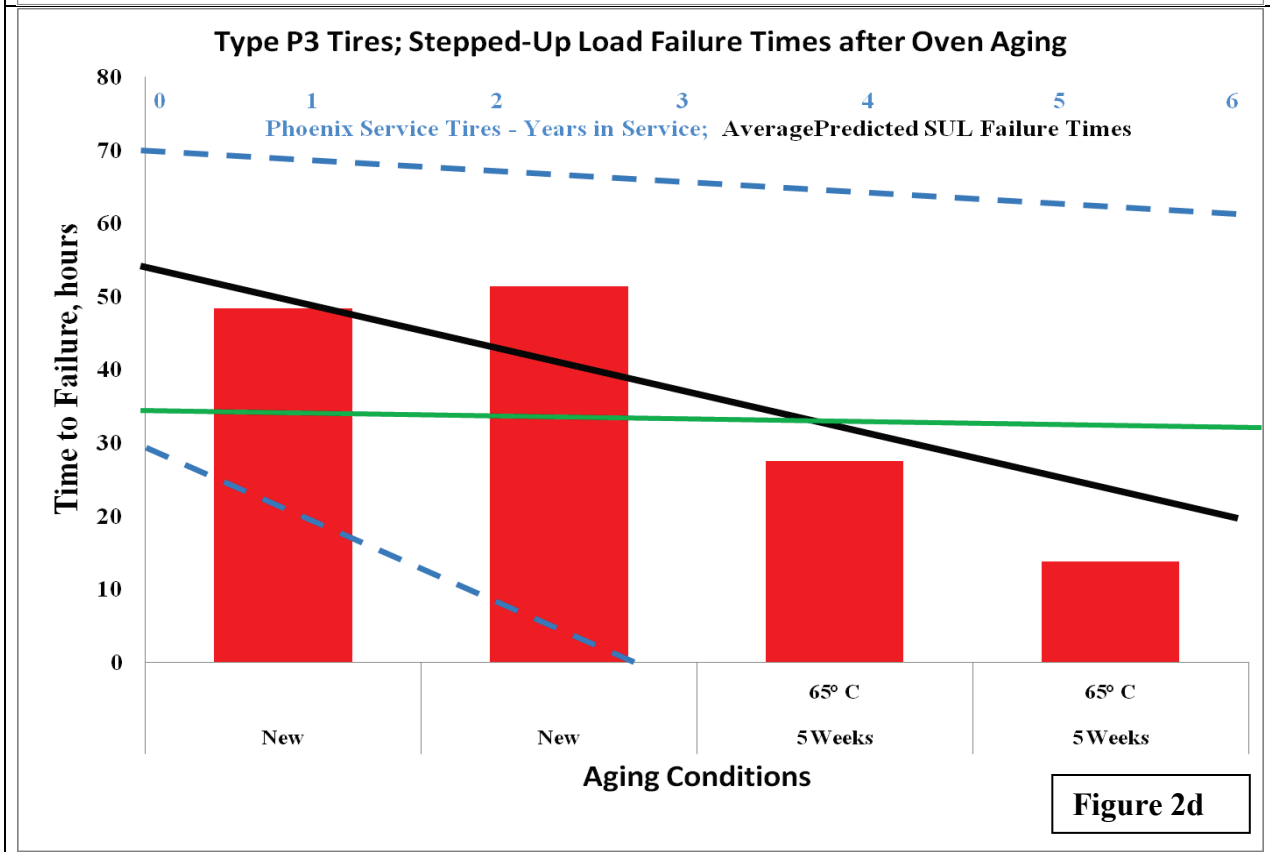
Figure 2. Tire Failure Times for Stepped-Up-Load to Failure (SUL) Test

The results of the stepped-up-load test failures for the tires tested by the SUL procedure (shown graphically in Figure 2a to Figure 2j) are compared to the predicted values from linear regression of the tires of varying ages taken from Phoenix service. The mean predicted time to failure for the Phoenix tires is indicated by the solid black line. The average failure times of the tire models showing the least change in time to failure, and those showing the greatest reduction in time to failure are indicated by the dashed light blue lines. The green line at 34 hours represents the maximum time tested at 100 percent or less of the tire's rated load. Testing at loads above this level causes stress on parts of the tire, such as the sidewall and bead, beyond what is expected during normal operation, often causing failures in these components.

At failure times of less than 34 hours, the load on the tire was equal to or less than the rated load of the tire, therefore the stresses on individual components could have been experienced in normal service conditions. The 5 of 14 aged passenger tires (36%) exhibiting visible failures in less than 34 hours of roadwheel testing are summarized in Figure 3. Approximately two-thirds of these failures occurred in the belt area, with another 22 percent of failures taking place in the shoulder area. As discussed previously, over 90 percent of failures that consumers reported to NHTSA happened in the belt and shoulder area. Failures by tread cracking accounted for 6 percent of the visible failures in the oven-aged tires, with a small number of carcass and sidewall failures.

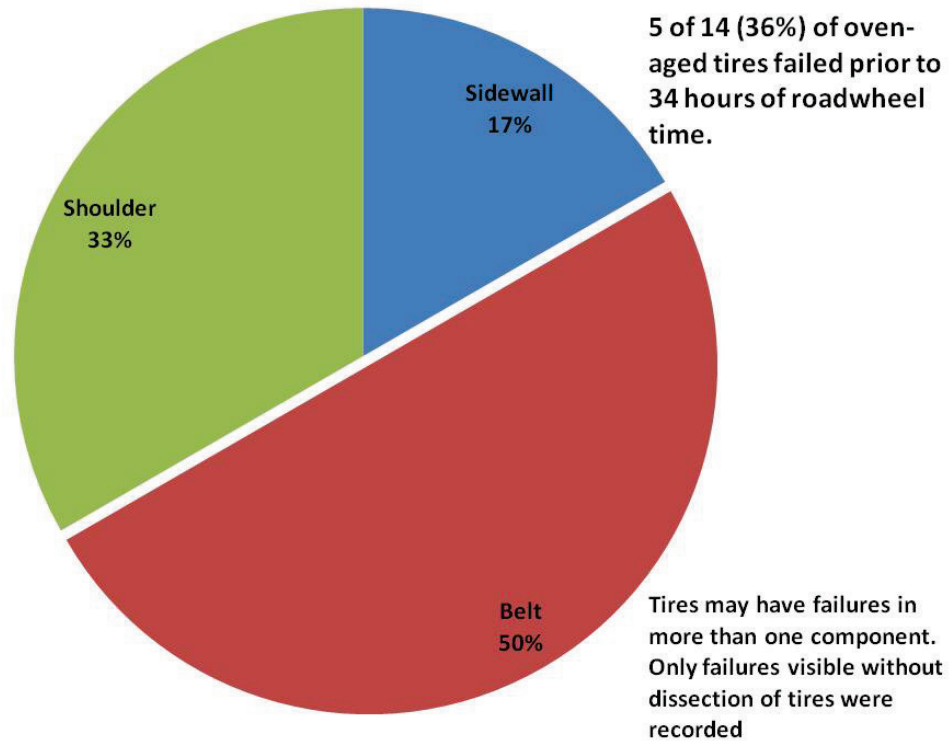
Figure 3. Failure for Passenger Tires, if Failure Time Was Less Than 34 Hours

Visible Failure Site for Passenger Tires, if Failed Prior to 34 Hours

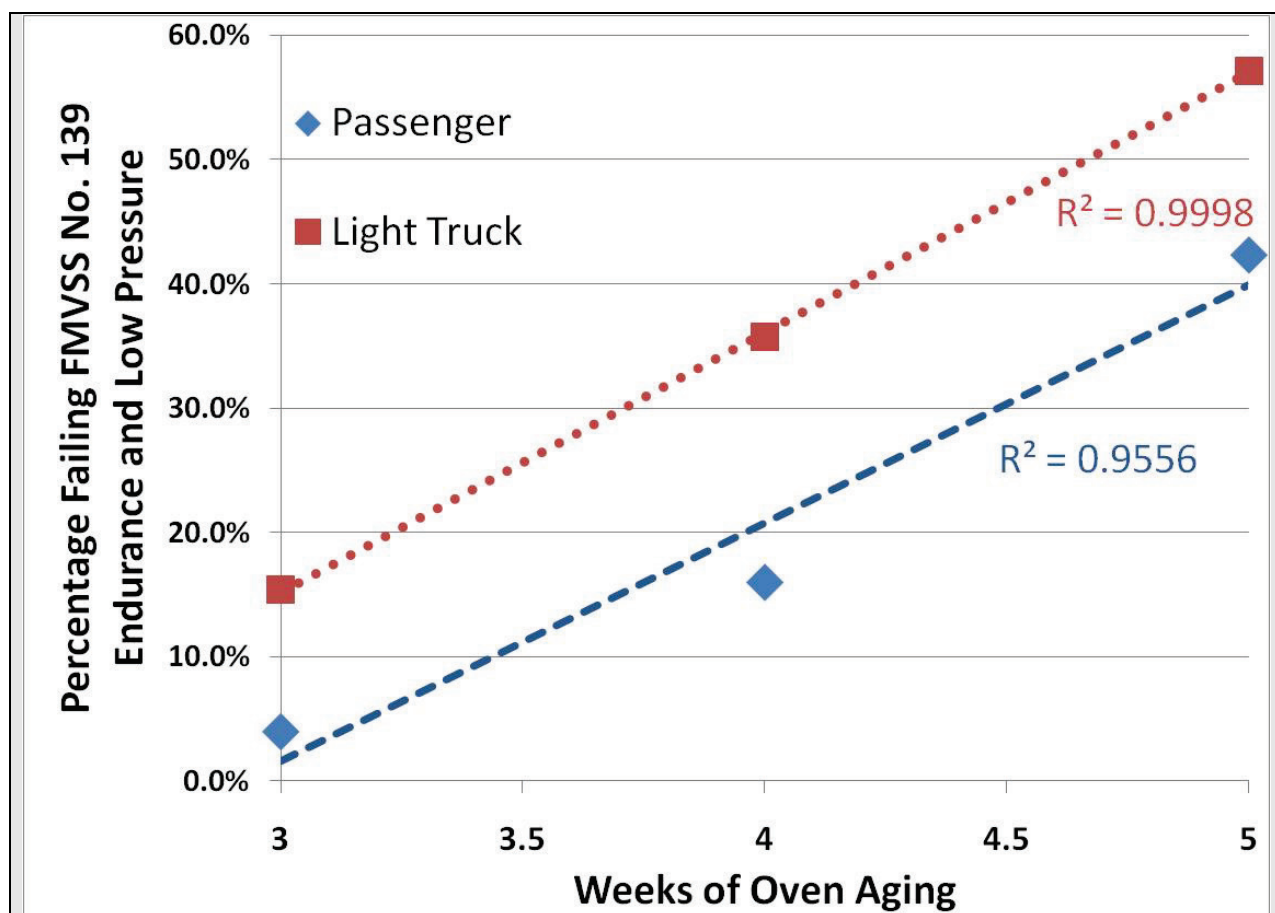
Figure 5. Percentage of Tires That Failed Before the Completion of the FMVSS 139 Endurance and Low Pressure Test Versus Weeks of Oven Aging at 65°C

All new tires completed the endurance and low pressure tests. Forty-six percent (6/13) of passenger tire models and 43 percent (3/7) of light-truck tire models exhibited no failures after oven aging up to 5 weeks at 65°C. The percentage of individual oven-aged tires failing prior to completion of the test is shown in Figure 5. Over 40 percent of passenger tires (11/26) and nearly 60 percent (8/14) of light-truck tires failed before the end of the test.

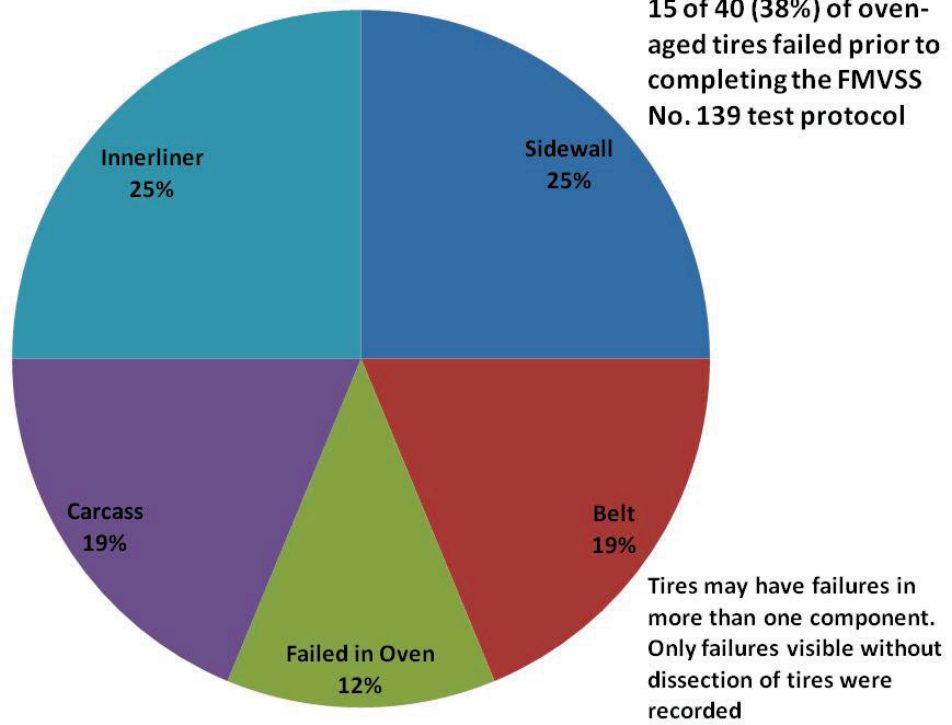
Figure 7. Failure Site for Light Truck Tires That Did Not Complete the FMVSS 139 Endurance and Low Pressure Test Protocol

Visible Failure Site for Light Truck Tires Failed during Testing

Figure 6 shows the failure sites for passenger tires. Approximately 70 percent of the failures occurred in the critical belt edge and shoulder region of the tire. Figure 7 shows the failure sites for the light-truck tires. Failures in light-truck tires consisted predominantly of separations between components in the innerliner and sidewall region of the tire, including two tires that separated in the oven during aging. Inspection of the failures indicated that the separations were likely initiated by a buildup of air pressure between the components. Figure 8 shows a failure that took place at the ply end of the sidewall, and Figure 9 shows a separation between the innerliner and the ply coat that took place during oven aging of the tires.

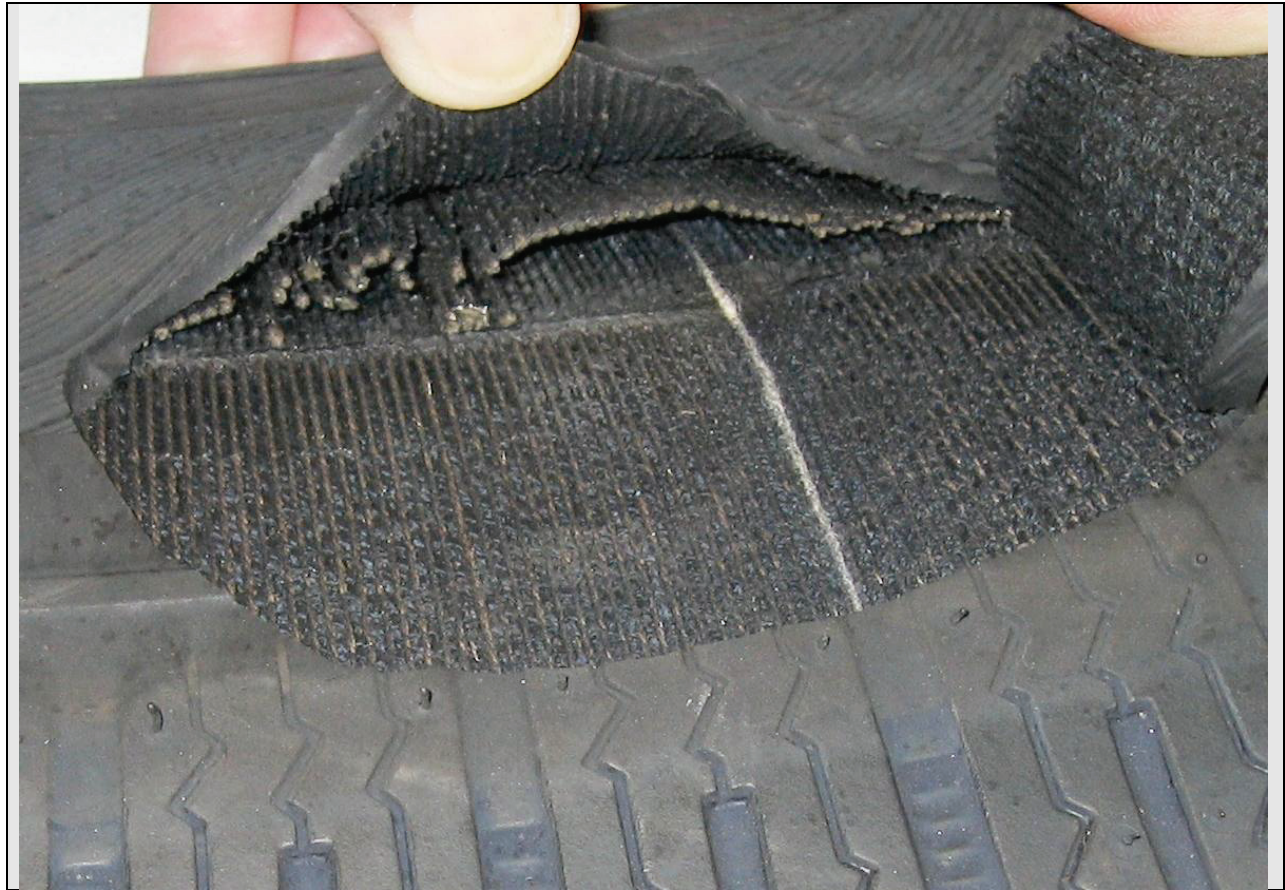
Figure 8. Failure at Ply End of Sidewall During Oven Aging

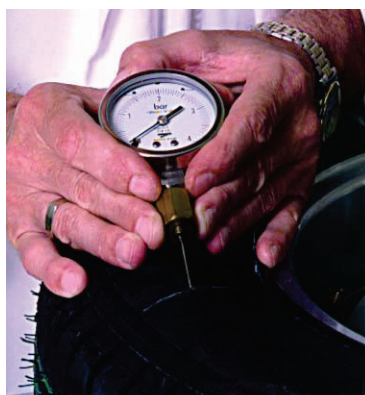
- Measure tire intracarcass pressure at 21°C ±3°C (69.8°F ±5°F) with the following method:
 - Equilibrate tires at 21°C
 - Inflate tires to 2.2 bar and maintain pressure with a pressure manifold system
 - Fill hypodermic needle / pressure gauge with water
 - Insert 4 needles into tire sidewall until carcass cords are touched
 - Rest gauge on inclined support tray
 - Monitor ICP
 - Equilibrium is usually reached within 20 days

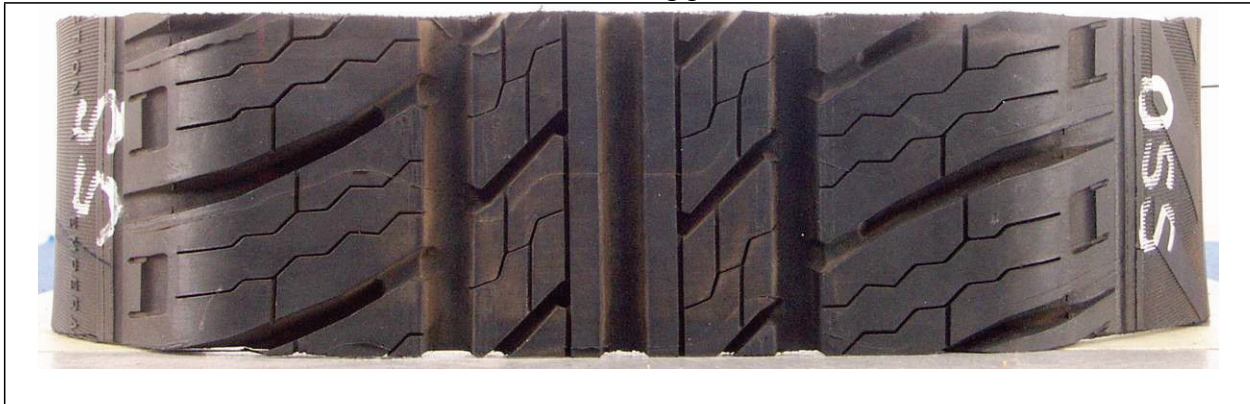
- For each of the two chosen tire regions, cut one 63.5 mm (2½") wide radial section bead to bead. The section should resemble the following photo:

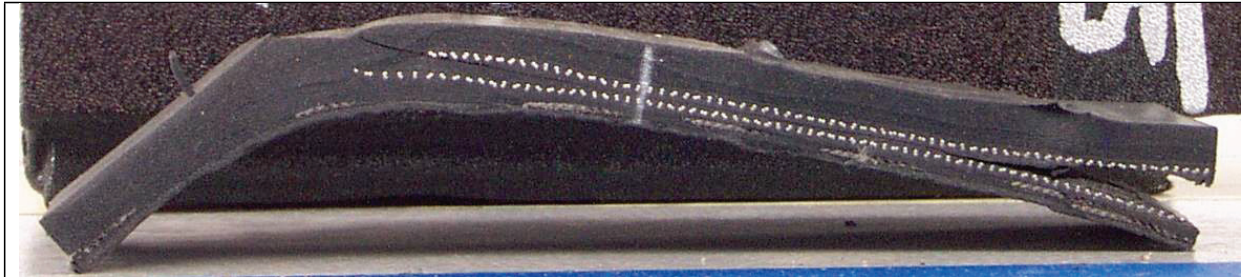
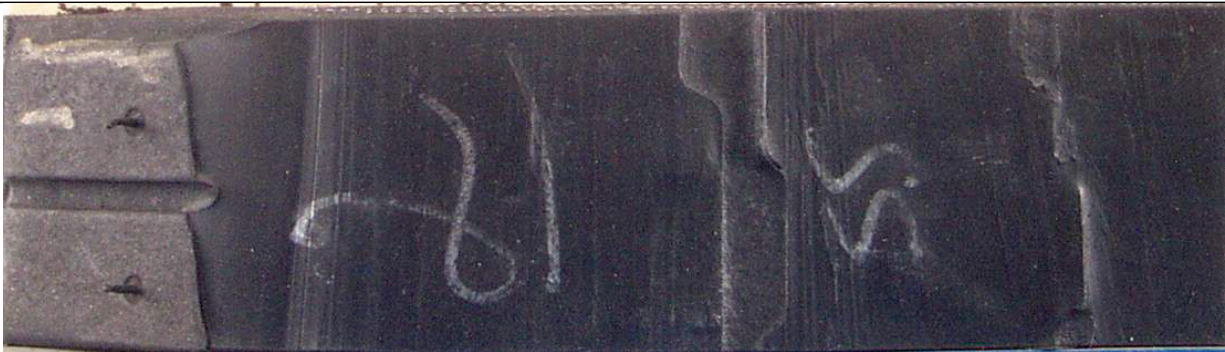
- Score the sides of each specimen at a point midway between the belts to a depth of 3.175 mm (1/8"). The scoring will extend from the end of the gripping surface to the end of belt #2 in the shoulder area, providing a final 25.4 mm (1") wide peel section. The final section should look like this:

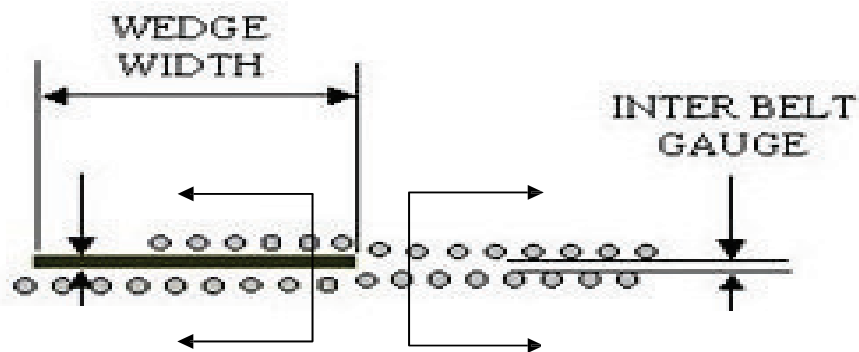
- Skim rubber sample: Locate the region between the 2 steel belts, inboard of the end of the 2nd (top) belt. Come inboard to the 2nd cable of the top belt beyond the wedge ending (beyond the flare) and excise the rubber sample.
- Wedge rubber sample: Samples shall be taken from the belt wedge rubber outboard of the flare in the inter-belt rubber to a thicker gauge (under the edge of the 2nd (top) belt). Care should be taken to excise only the belt wedge compound, as tires occasionally have a belt wedge compound that differs from the skim coat.

Wedge Sample

Skim Sample*

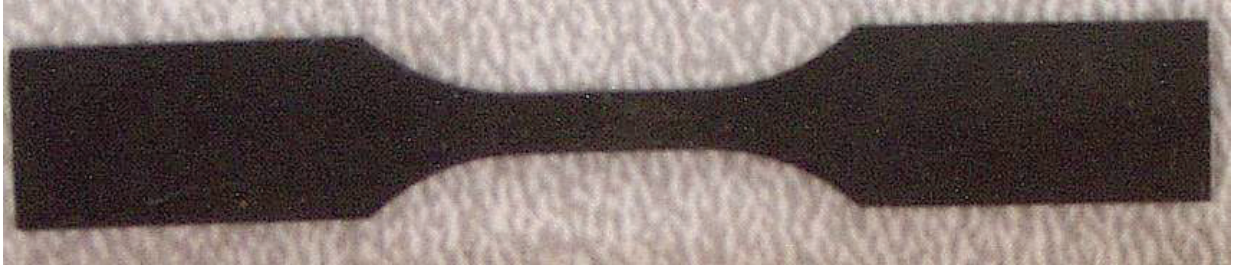
- Samples of at least 100 mm (4 in) in length and 25 mm (1 in) in width shall be removed from the skim and wedge rubber (see Item 23 for sample region details) for each test. Samples shall be buffed to uniform thickness of 0.5 to 1.0 mm (0.02 to 0.04"). Care must be taken to minimize heat generation during buffing.
- Since the test specimen sizes available in D 412 are too large for tire sample purposes, specimens shall be die-cut using an ASTM D 638-02a Type V dumbbell die (see following photo):

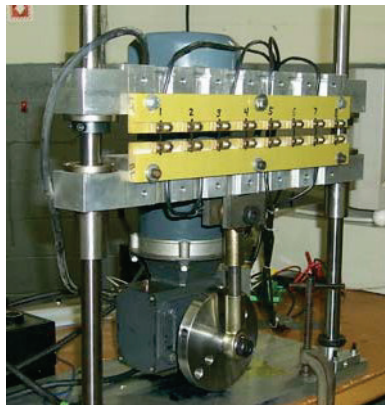
Specifications: Prepare the necessary test samples to conduct Demattia rate of crack growth testing. Use a test machine scaled down from the ASTM specifications D813-95(2000) *Standard Test Method for Rubber Deterioration-Crack Growth* and ASTM D430-95(2000) *Standard Test Methods for Rubber Deterioration-Dynamic Fatigue* to give less variation in testing. This is otherwise referred to as “Micro Demattia” testing.
