U.S. Department  
of Transportation  
**Federal Highway  
Administration**

Subject: **INFORMATION:** Crash Tested Work Zone Traffic  
Control Devices

Date: August 28, 1998

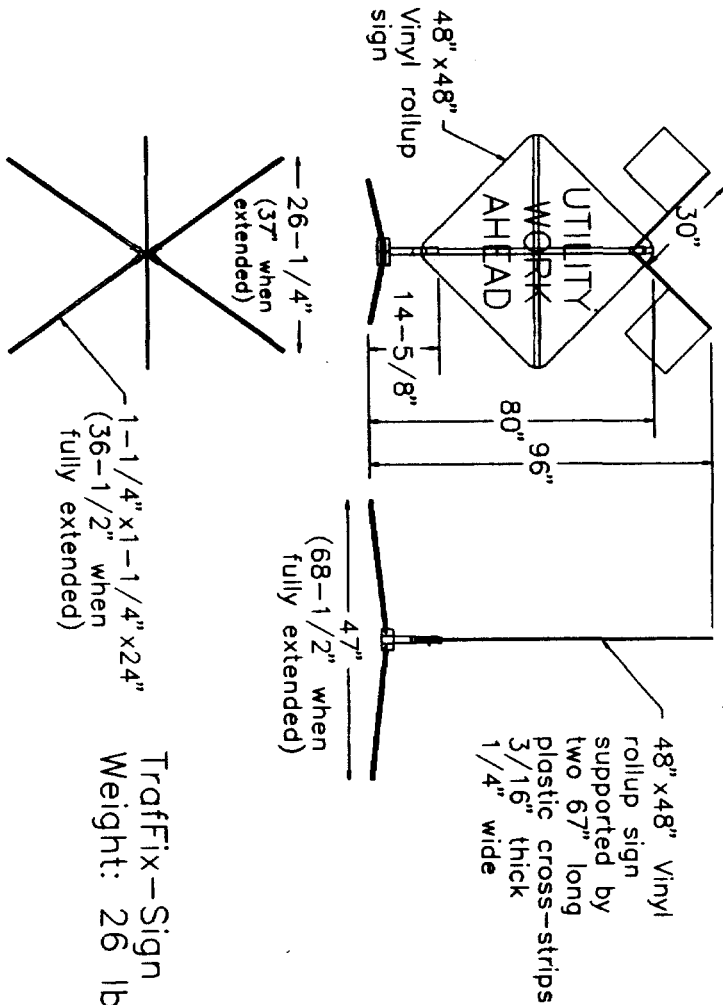
Figure 29. Schematic of Portable Sign Support with Plastic/Fabric Sign (Test No. 453790-1)

A schematic of the portable sign support with a 1219 mm x 1219 mm (48 in x 48 in) plastic/fabric sign mounted at a height of 305 mm (1 ft) is shown in Figure 29. The test vehicle was a 1988 Chevrolet Sprint, as shown in Figure 30. Dimensions and information on the vehicle are given in Appendix Figure 94. The test vehicle impacted the sign support head-on with the centerline of the vehicle aligned with the centerline of the sign support, traveling at a speed of 97.9 km/h (60.9 mi/h).

The portable sign support separated upon impact, as can be seen in Figure 30. Fragments of the sign were strewn along the path of the vehicle in an area 5.5 m (18.0 ft) wide by 19.3 m (63.3 ft) long. Damage to the vehicle is also shown in Figure 30. There was no measurable crush to the exterior of the vehicle, only scratches on the hood and on the roof where the flags made contact.

A brief summary of the results of this test is presented in Figure 32. The portable sign support shattered upon impact. Fragments of the plastic/fabric sign panel and the sign support made contact with the roof, but there was no penetration or intrusion into the occupant compartment. Debris from the sign was thrown along an area 5.5 m (18.0 ft) wide by 19.3 m (63.3 ft) long. The fragments were not large enough to pose potential hazard to oncoming traffic in adjacent lanes or to workers in the area. The vehicle sustained minor scratches to the hood and roof. There was no measurable crush to the exterior of the vehicle. There was no longitudinal or lateral occupant impact. The 50-msec average accelerations were -0.6 g in the longitudinal direction and -0.4 g in the lateral direction. The vehicle exited the immediate test site in a relatively smooth, stable manner and showed no potential for intrusion into adjacent traffic lanes.

In summary, the portable sign support with plastic/fabric sign panel was judged to have met all evaluation criteria set forth in NCHRP Report 350.

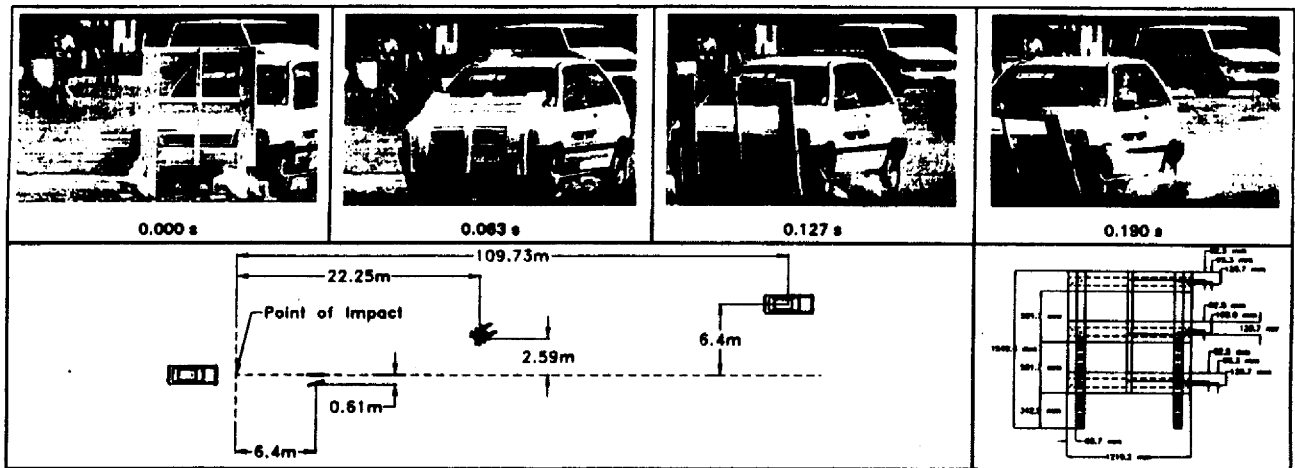
Figure 41. Summary of Results for Test 439107-12.

General Information	Test Agency	Texas Transportation Institute	Impact Conditions	Speed (km/h)	100.60	Debris Pattern Spread (m)	Longitudinal	22.3	
	Test No.	439107-12	Angle (deg)	0		Lateral	2.6		
Test Article	Date	06/03/97	Exit Conditions	Speed (km/h)	88.48	Vehicle Damage	Exterior	VDS	12FD1
	Type	Traffic Control Device	Angle (deg)	0		CDC	Maximum Exterior	Vehicle Crush (mm)	nil
Test Vehicle	Name	Type III Barricade	Occupant Risk Values	Impact Velocity (m/s)	N/A	Interior	OCDI	FS0000000	
	Installation Length (m)	1.22	x-direction	N/A		Max. Occ. Comp.	Deformation (mm)	0	
Soil Type and Condition	Size and/or dimension and material of key elements	Recycled plastic U-channel with fiberglass panels	Ridedown Accelerations (g's)	x-direction	N/A	Post-Impact Behavior	(during 1.0 s after impact)		
	Standard soil, dry		y-direction	N/A		Max. Roll Angle (deg)	N/A		
Test Vehicle	Type	Production	Max. 0.050-s Average (g's)	x-direction	N/A	Max. Pitch Angle (deg)	N/A

Designation	820C		y-direction	N/A	Max. Yaw Angle (deg)	N/A		
Test Vehicle	Model	1990 Ford Festiva		z-direction	N/A				
	Mass (kg) Curb	828							
Test Vehicle	Test Inertial	820							
	Dummy	76							
Test Vehicle	Gross Static	896
