U.S. Department
of Transportation
**National Highway
Traffic Safety
Administration**

DOT HS 811 795

Evaluation of CIB System Susceptibility to Non-Threatening Driving Scenarios on the Test Track

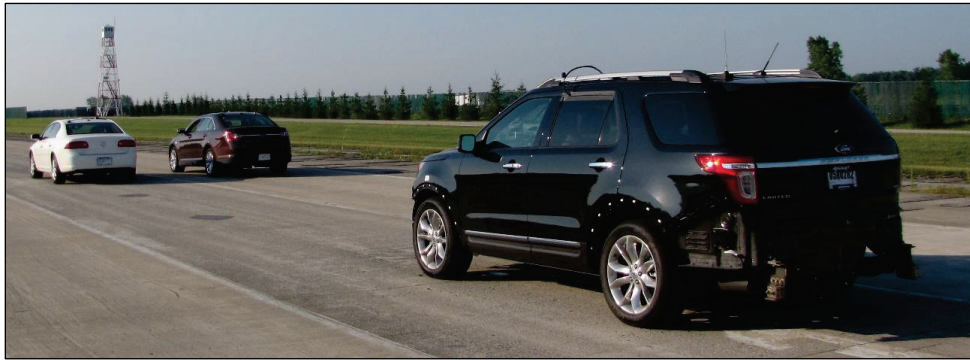
Figure 2.2. Ford Explorer Test Vehicle With the MLV and DLV on the TRC Skid Pad (Facing South)

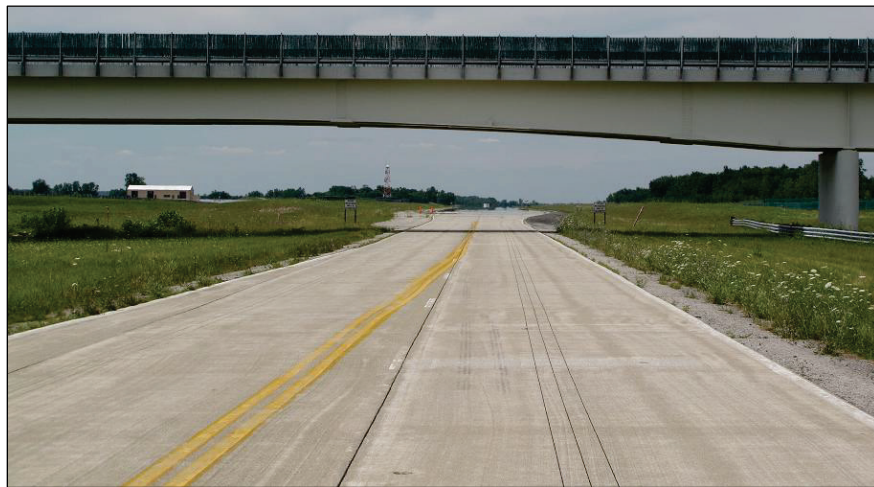
Figure 2.6. A Driver’s View of the Overhead Bridge.

Figure 2.6 shows how the test scenario appeared from the driver’s perspective. The bridge was located at the south end of the TRC Skid Pad. All tests were performed with the SV being driven north under the bridge.

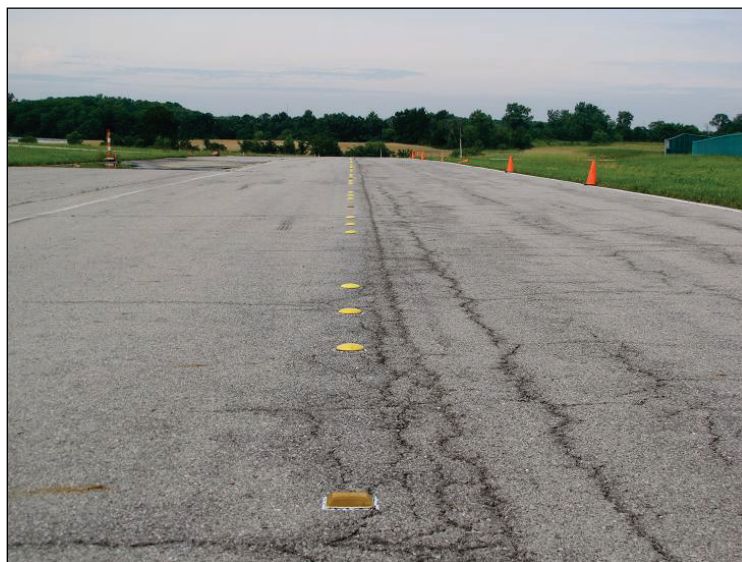
Figure 2.9. A Southwest Facing View of the Botts' Dots Course on the Front Stretch of the WRC

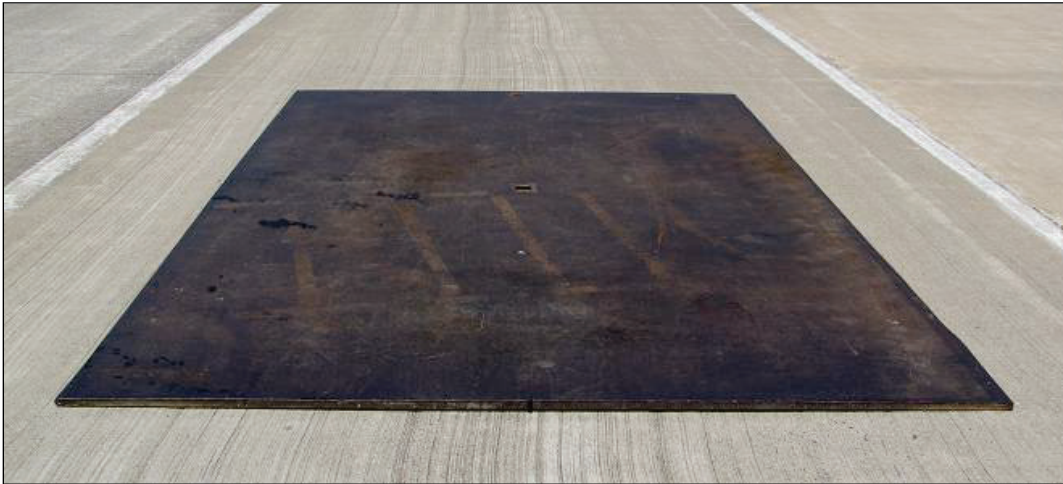
Figure 2.10. Steel Trench Plate Positioned on the TRC Skid Pad

In this scenario, the SV was driven toward, and over, a large ASTM A36 steel trench plate centered in a 12 ft wide lane. The lane was located on the TRC Skid Pad and delineated by two solid white lane lines, as shown in Figure 2.10. The plate, which was leased from a road-construction equipment supplier, had dimensions of approximately 8 ft × 12 ft x 1 in. Trench plates like that used in this study are often used in construction to temporarily cover sections of pavement unsafe to drive over directly (typically during repair).

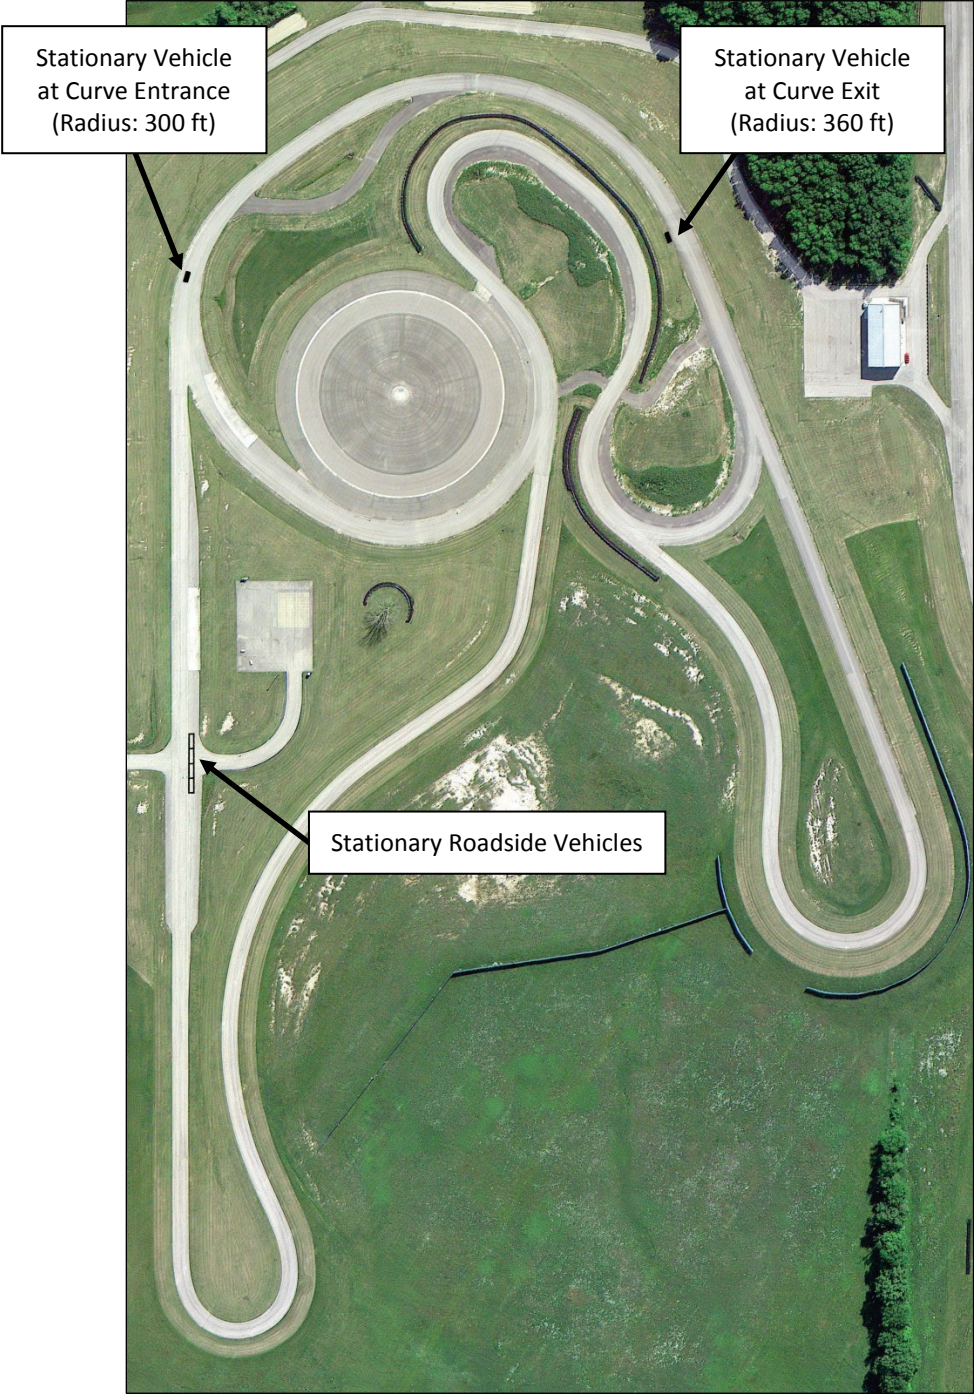
Figure 2.13. Relative Locations of the Two Stationary Vehicle-in-Curve Maneuvers (WRC)

Before exiting the curve, the Curve-Exit evaluations were performed. Figure 2.13 shows the relative location of the two test maneuvers on the TRC Winding Road Course (WRC). For both test series, the SV was driven at a constant forward velocity of either 25 or 45 mph. Note: the stationary roadside vehicles indicated on Figure 2.13 were used during the maneuver described in S2.4.4.1, which was performed separately from the combined Curved-Lane test series.

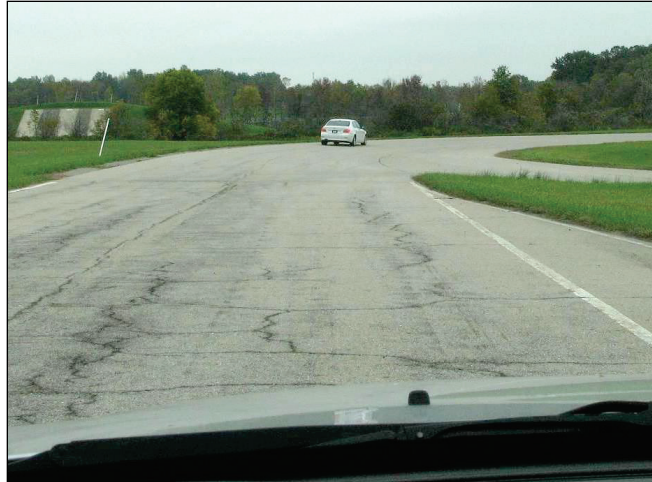
Figure 2.15. The Stationary Vehicle at Curve Entrance Maneuver was performed on the WRC

Figure 2.15 shows the SLV position in the curved road from the perspective of the SV driver. The SLV's right front and right rear wheels were approximately 12 inches from the leftmost side of the SV's lane of travel, allowing 0.4 to 3.9 ft⁷ between the two vehicles as the SV was driven by the SLV. The SLV used for this maneuver was a 2008 BMW 528i.

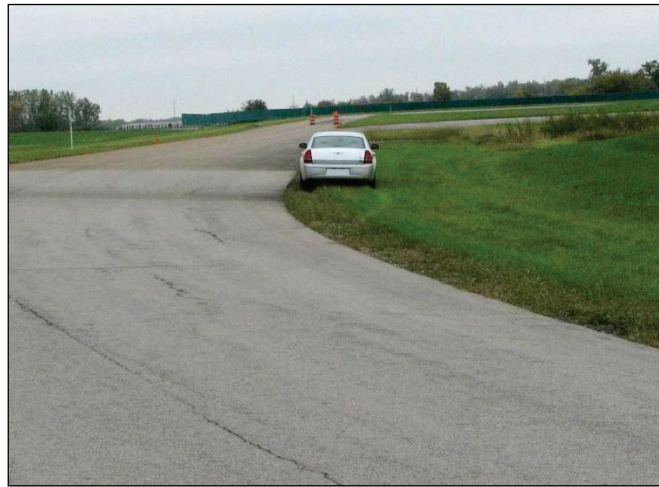
Figure 2.17. The Stationary Vehicle at Curve Exit Maneuver was performed on the WRC

rightmost side of the roadway, approximately 2.6 to 9.9 ft⁸ from the SV as it was driven by to the left of the SLV. The SLV used for this maneuver was a 2005 Chrysler 300C.

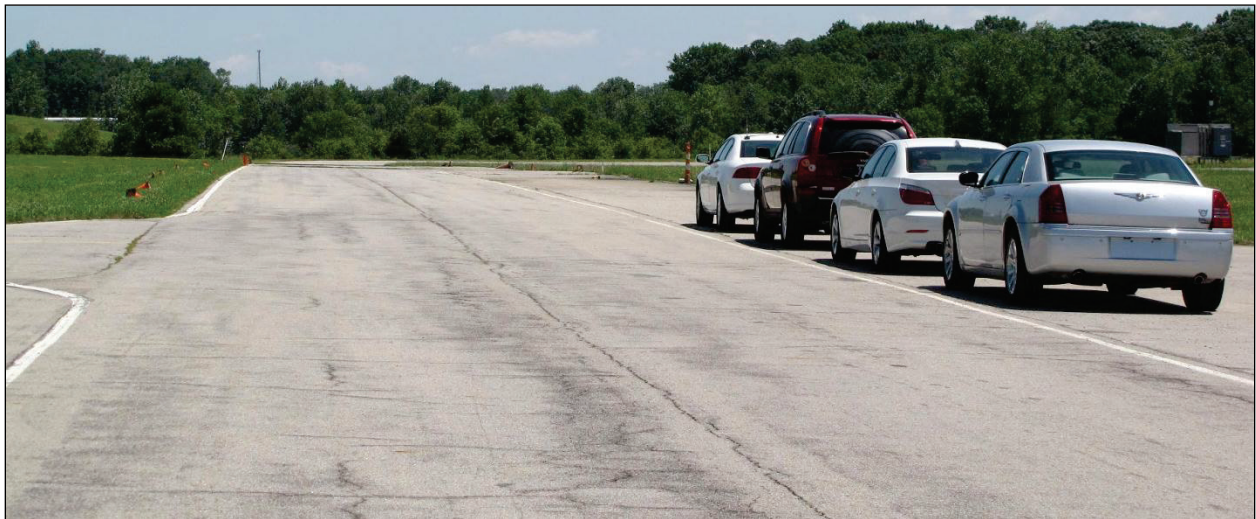
Figure 2.19. Four Roadside Vehicles Parked Beside Two 12-ft Lanes

Figure 2.18 shows the four roadside vehicles from the perspective of the SV driver. From nearest to farthest, the parked vehicles were a 2005 Chrysler 300C, a 2008 BMW 528i, a 2004 Volvo XC90, and a 2008 Buick Lucerne. Each parked car was centered within a 24 ft long parking space, and positioned with its inboard¹⁰ tires 18 in from the lane boundary.

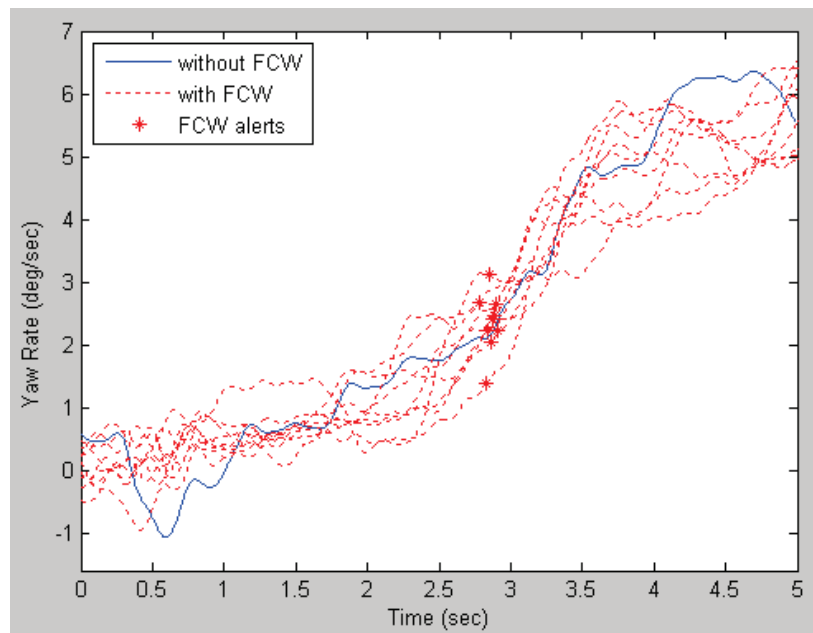
Figure 3.1. Volvo S80 Yaw Rate – Stationary Vehicle at Curve Entrance (25 mph)

In addition to range at steering onset, yaw rates and path data from the 25 mph tests were compared to identify any obvious differences in curve entry. Plots of the yaw rate data in Figure 3.1 present the 5-second time interval used to calculate the 25 mph test data in Table 3.6. The yaw rate trace for Test 135 is shown in blue and follows the general trend of the other nine tests.

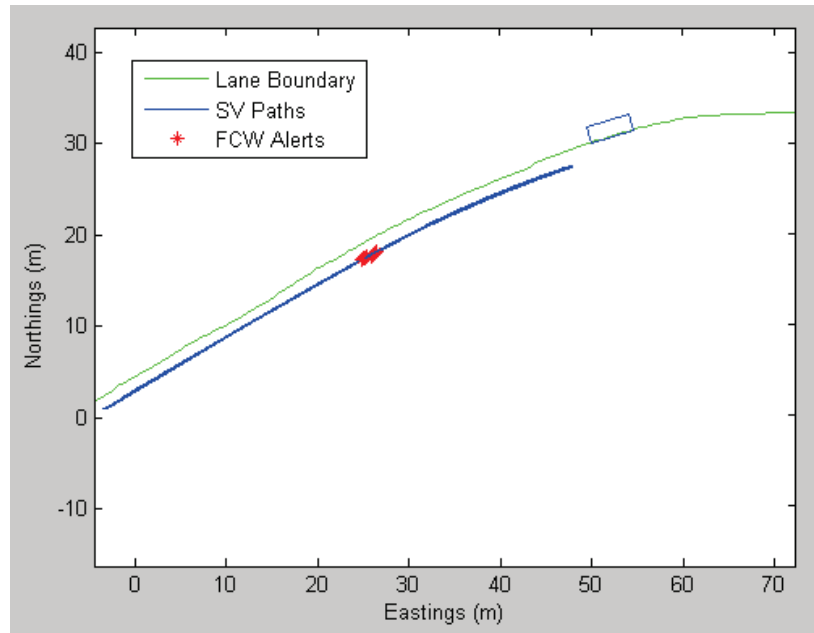
Figure 3.2. Volvo S80 Paths and FCW Alert Locations – Stationary Vehicle at Curve Entrance (25 mph)

Figure 3.2 plots the path the S80 took during the ten tests performed at 25 mph. The tight cluster of red dots visually indicates the consistency of the FCW alerts when issued. The x- and y-axes have been labeled in “Northings” and “Eastings” but in reality have been modified for plotting purposes¹³. In Figure 3.2, the right-rear bumper of the POV has been fixed at 30 m on the north axis and 50 m on the east axis.

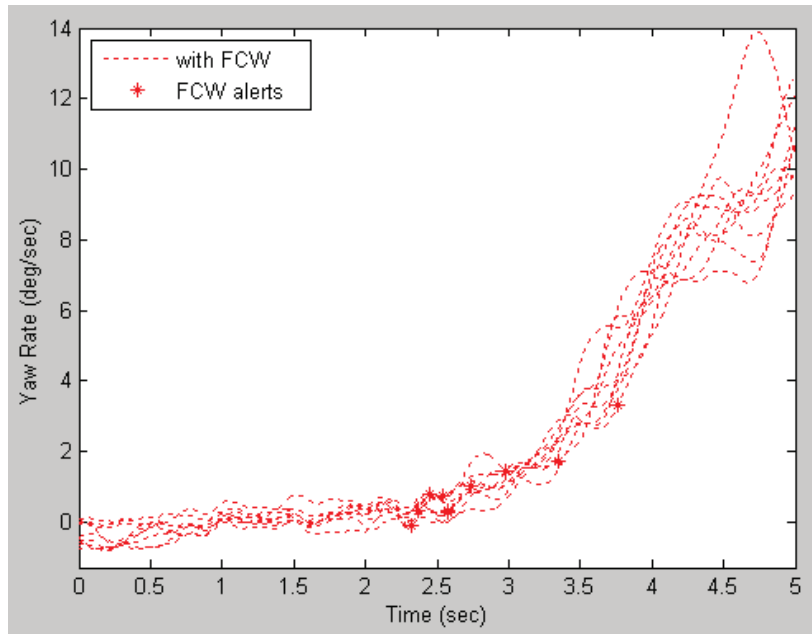
Figure 3.3. Volvo S80 Yaw Rate – Stationary Vehicle at Curve Entrance (45 mph)

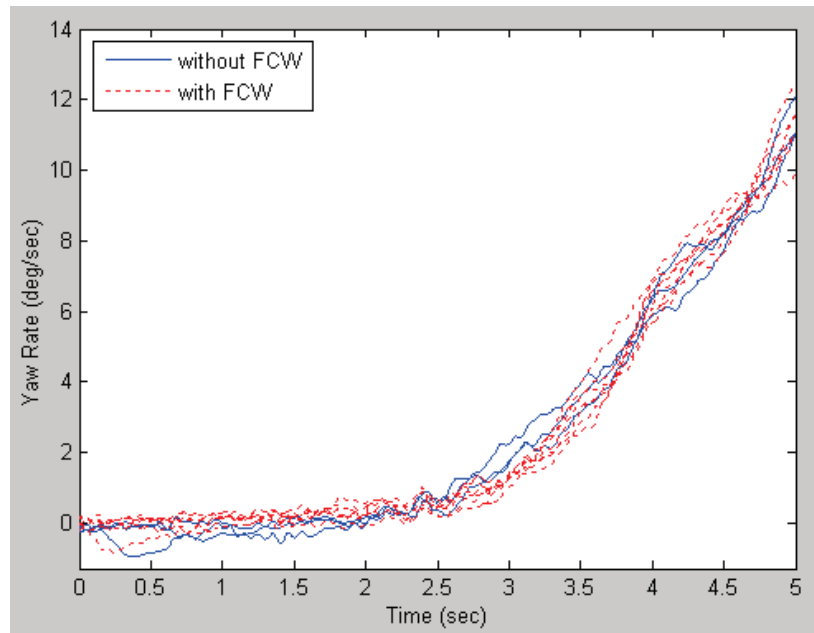
Figure 3.5. Mercedes E350 Yaw Rate – Stationary Vehicle at Curve Entrance (45 mph)

Curve Entrance tests performed at 45 mph with the Mercedes E350. Figures 3.5 and 3.6 plot the yaw rates and vehicle paths for these tests, respectively.

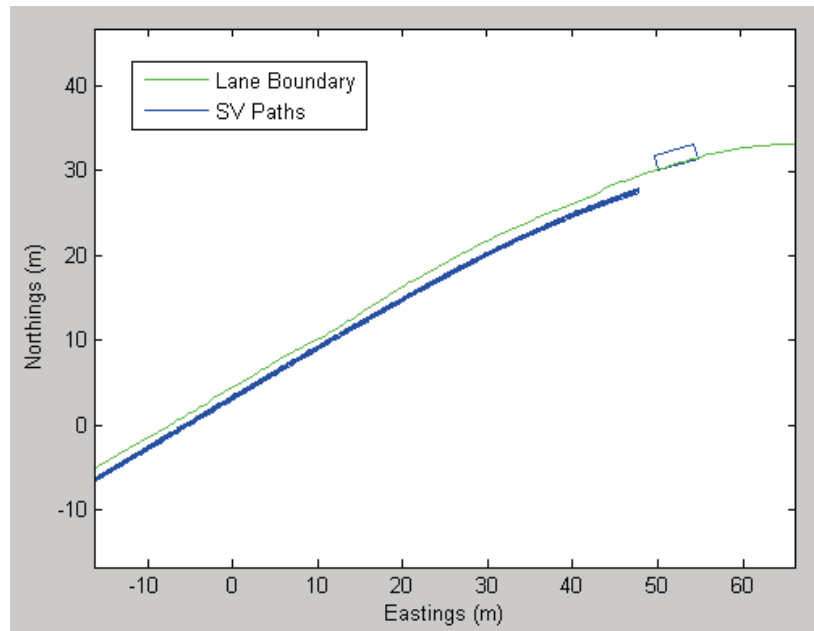
Figure 3.6. Mercedes E350 Paths – Stationary Vehicle at Curve Entrance (45 mph). FCW alert status was not available for these tests due to an instrumentation malfunction.

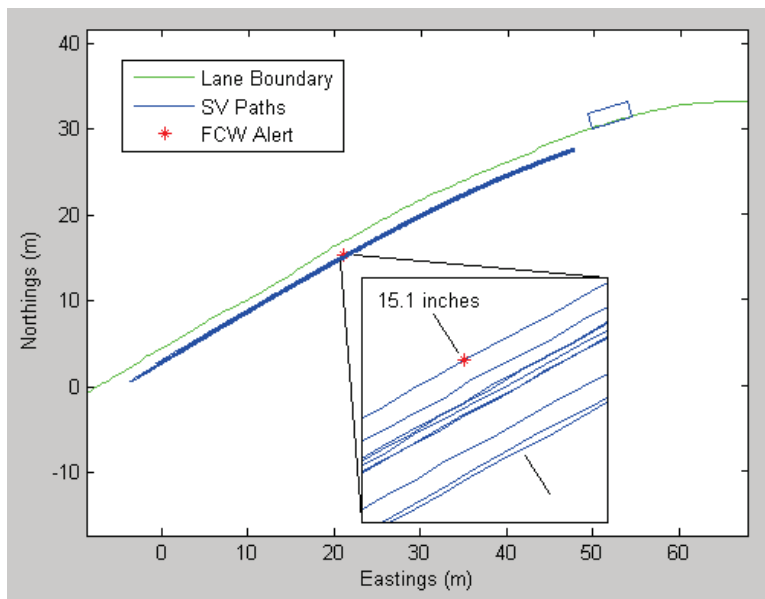
Figure 3.8. Subaru Outback Paths and FCW Alert Location – Stationary Vehicle at Curve Entrance (25 mph)

The 25 mph Stationary Vehicle at Curve Entrance was the only test condition to produce an FCW alert with the Subaru Outback. For this test series, the inputs that produced the FCW alert were not markedly different from those used when it did not (i.e., while the test generating an alert was at the extreme of the observed trajectories, it only differed from tests that did not generate alerts by a few inches.) Table 3.8 presents a summary of the Stationary Vehicle at Curve Entrance tests performed at 25 mph with the Subaru Outback. Figures 3.7 and 3.8 plot the yaw rates and vehicle paths for these tests, respectively.

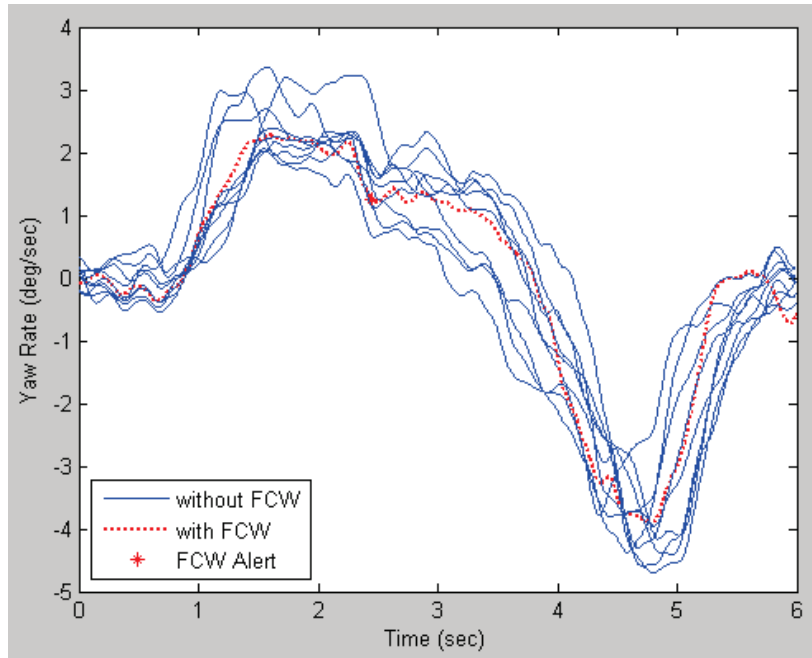
Figure 3.9. Volvo S80 Yaw Rate – Stationary Roadside Vehicles on the Right (45 mph)

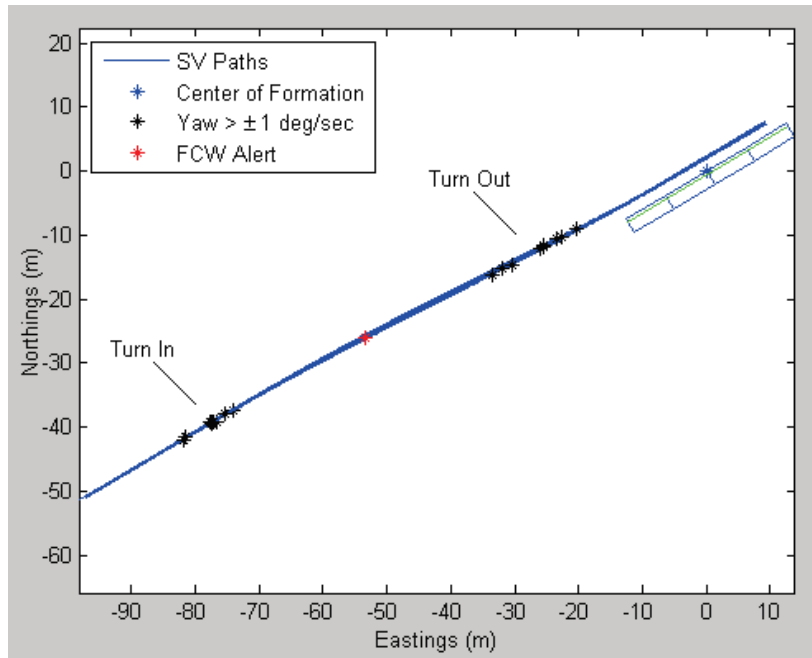
Figure 3.11. Volvo S80 Paths and FCW Alert Location – Stationary Roadside Vehicles on the Right (45 mph)

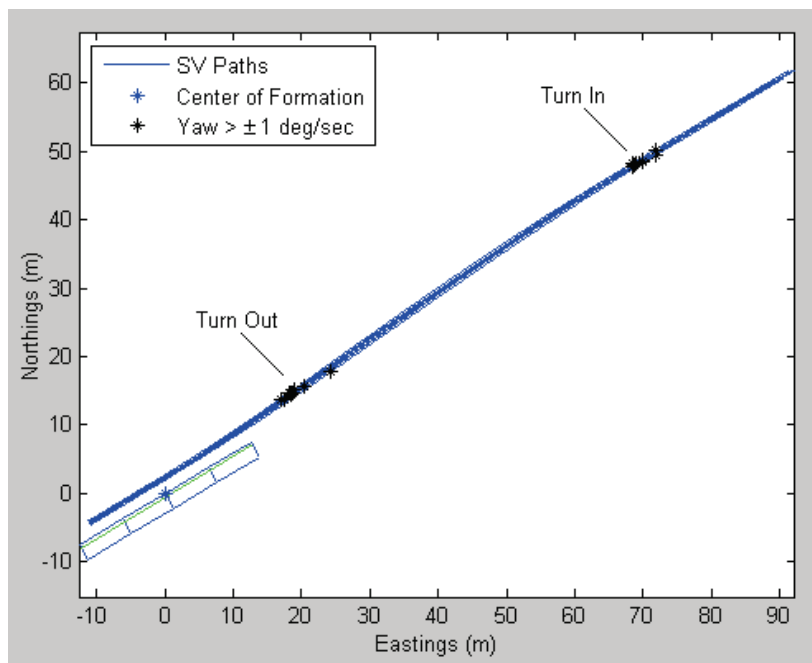
Figure 3.12. Volvo S80 Paths – Stationary Roadside Vehicles on the Left (45 mph)

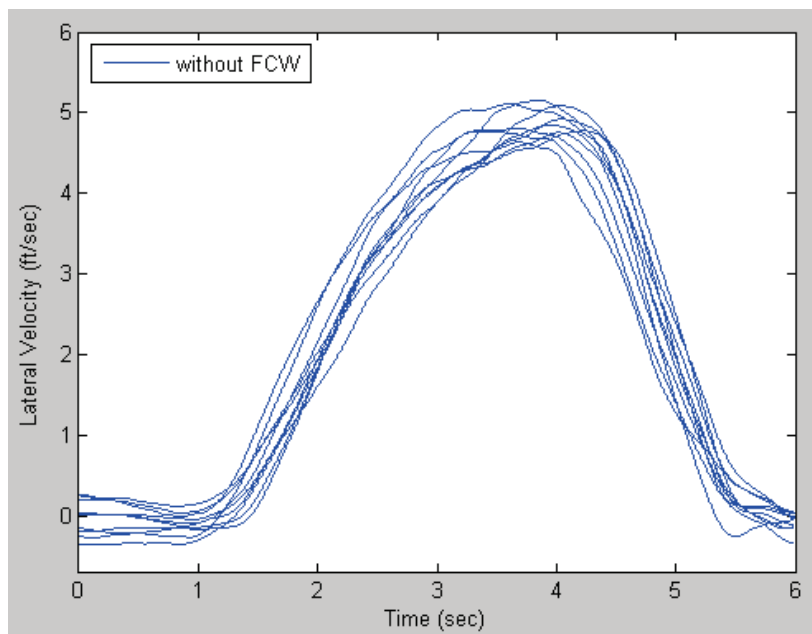
Figure 3.14. Volvo S80 Lateral Velocity Toward Formation – Stationary Roadside Vehicles on the Left (45 mph)

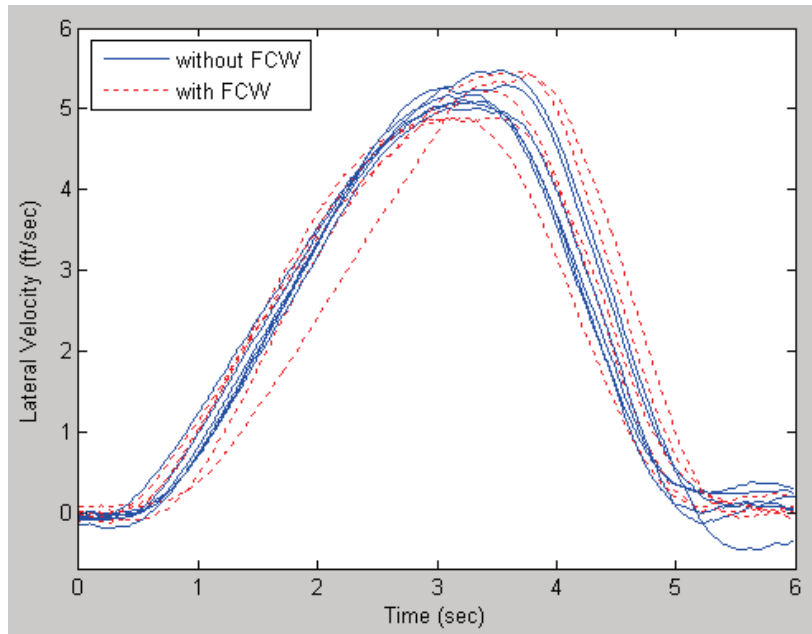
Figure 3.19. Mercedes E350 Lateral Velocity Toward Formation – Stationary Roadside Vehicles on the Right (25 mph)

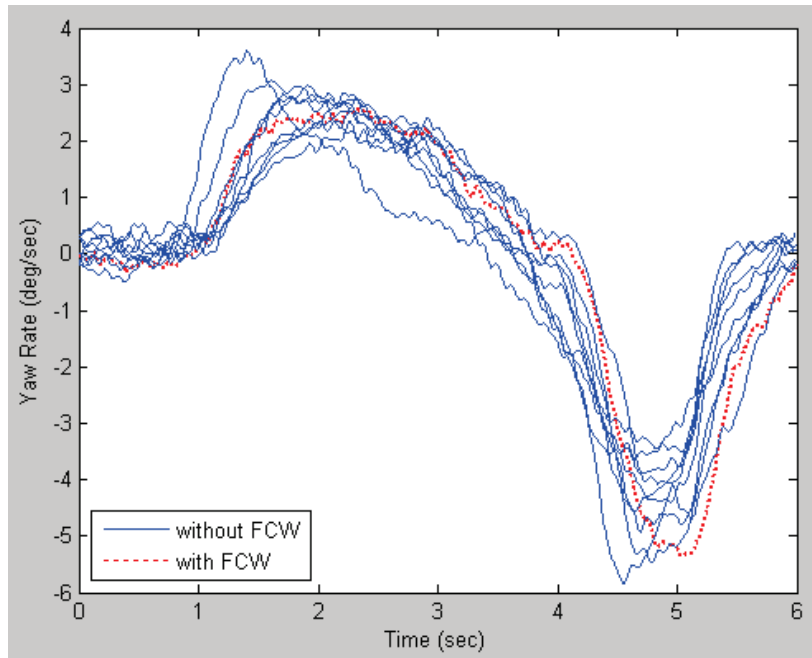
Figure 3.21. Mercedes E350 Yaw Rate – Stationary Roadside Vehicles on the Right (45 mph)

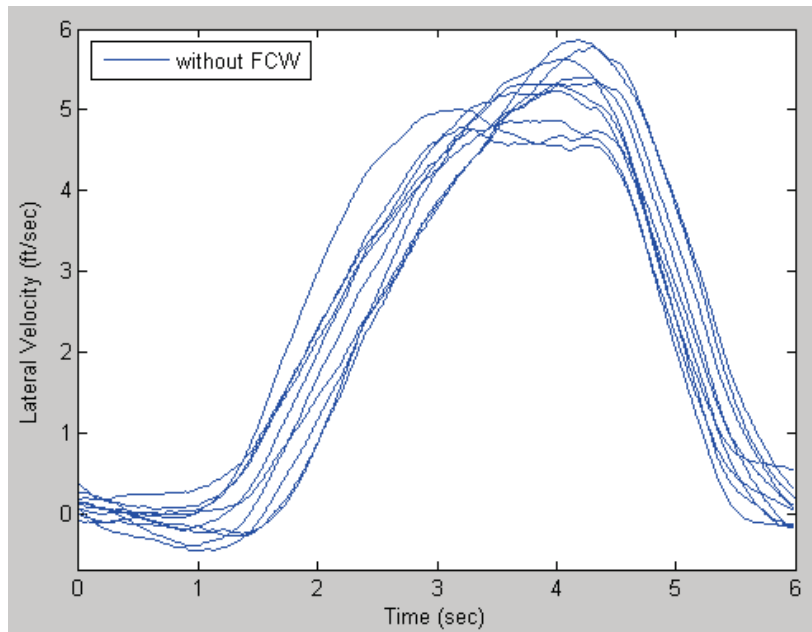
Figure 3.26. Mercedes E350 Lateral Velocity Toward Formation – Stationary Roadside Vehicles on the Left (45 mph)

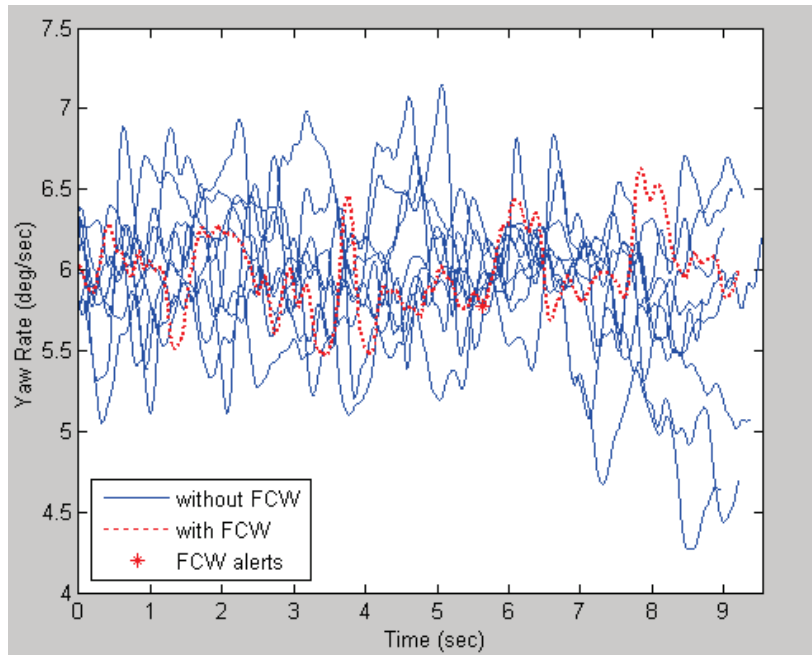
Figure 3.27. Volvo S80 Yaw Rate – Decelerating Vehicle in Left Lane (Curved Road) (45 mph)

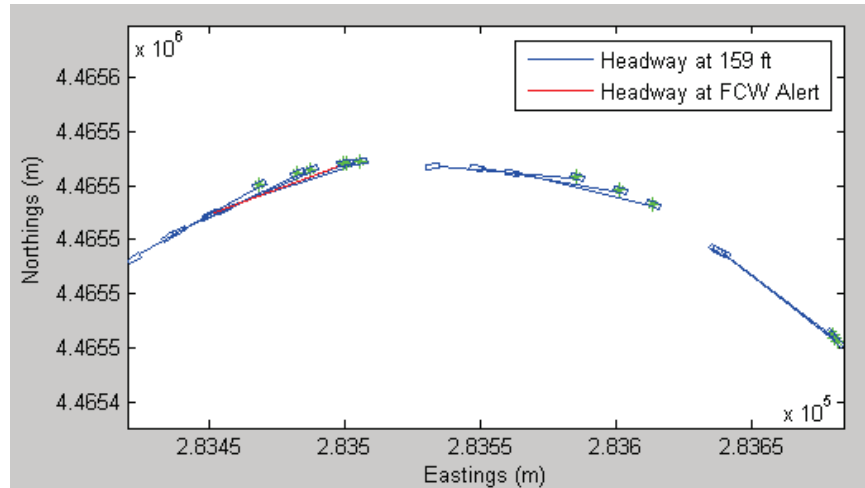
Figure 3.32. Vehicle Positions – Decelerating Vehicle in Left Lane (Curved Road) (45 mph)

yaw angle, lateral position, and longitudinal position of the decelerating vehicle relative to the subject vehicle to be directly compared. As was the case for the other comparisons made in this section, the comparison made in Figure 3.33 offers no explanation as to why one test had an FCW alert and the others did not.
