NAPSR Perspectives on Pipeline Safety-Related Research & Development Projects

Ralph Graeser
National Association of Pipeline Safety Representatives

Presented at the PHMSA R&D Forum
August 6, 2014

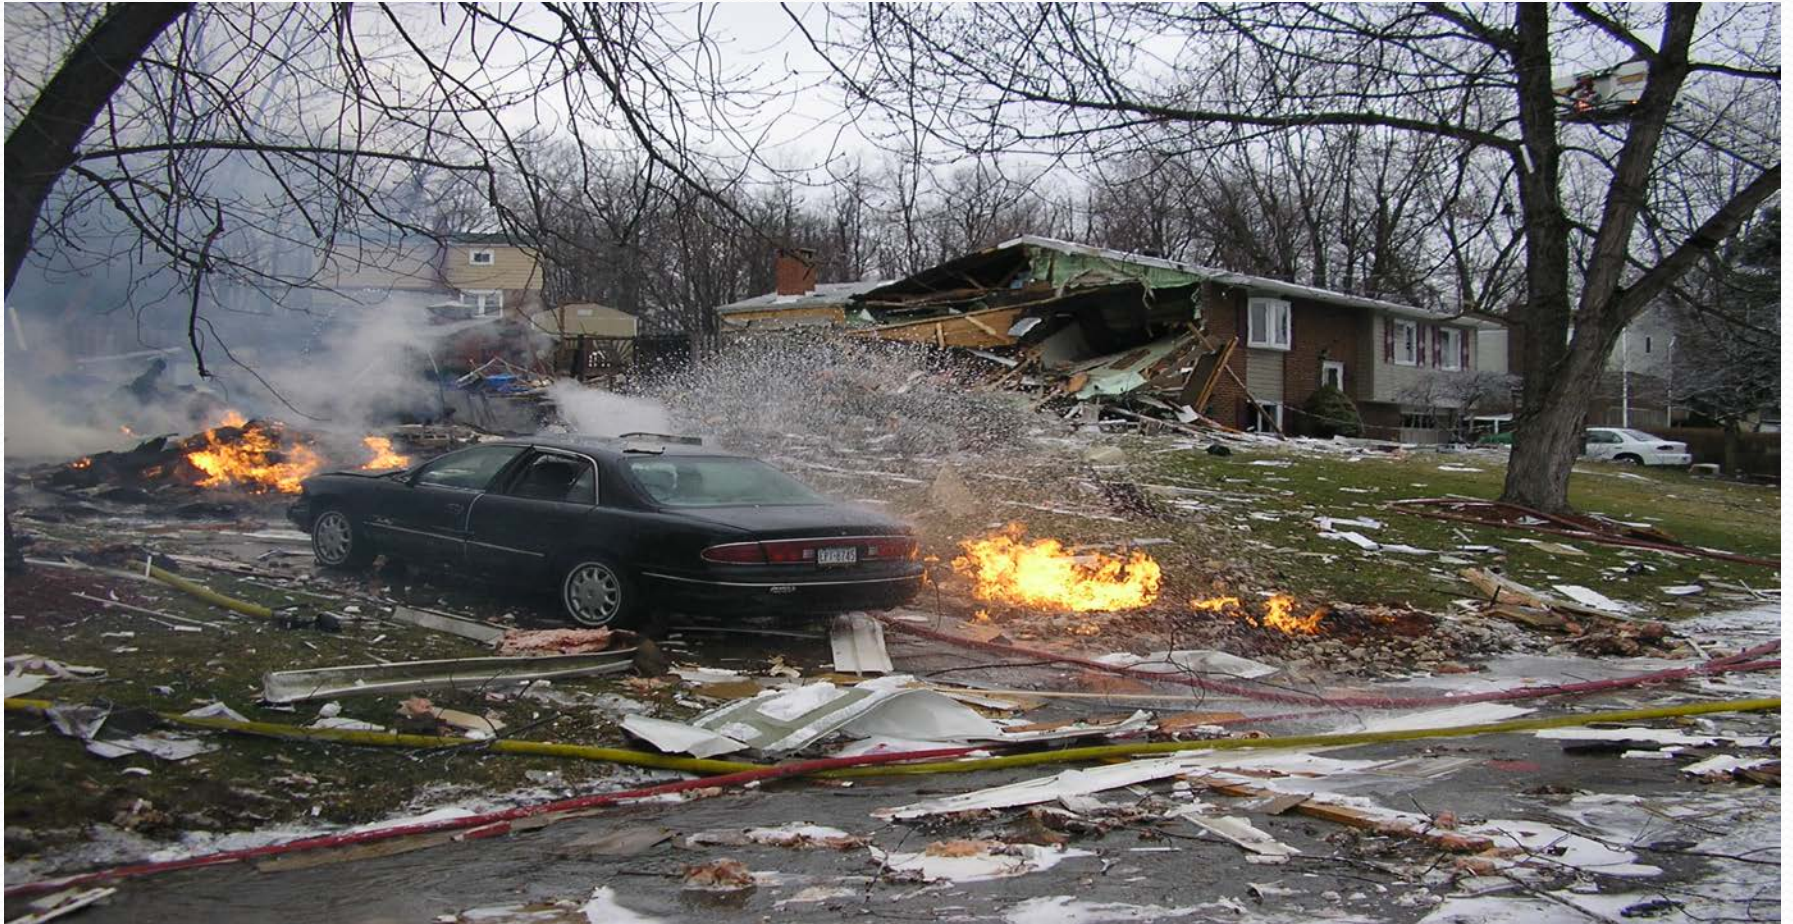
1238K00177000000

171 Mardi Gras Drive on March 5, 2008

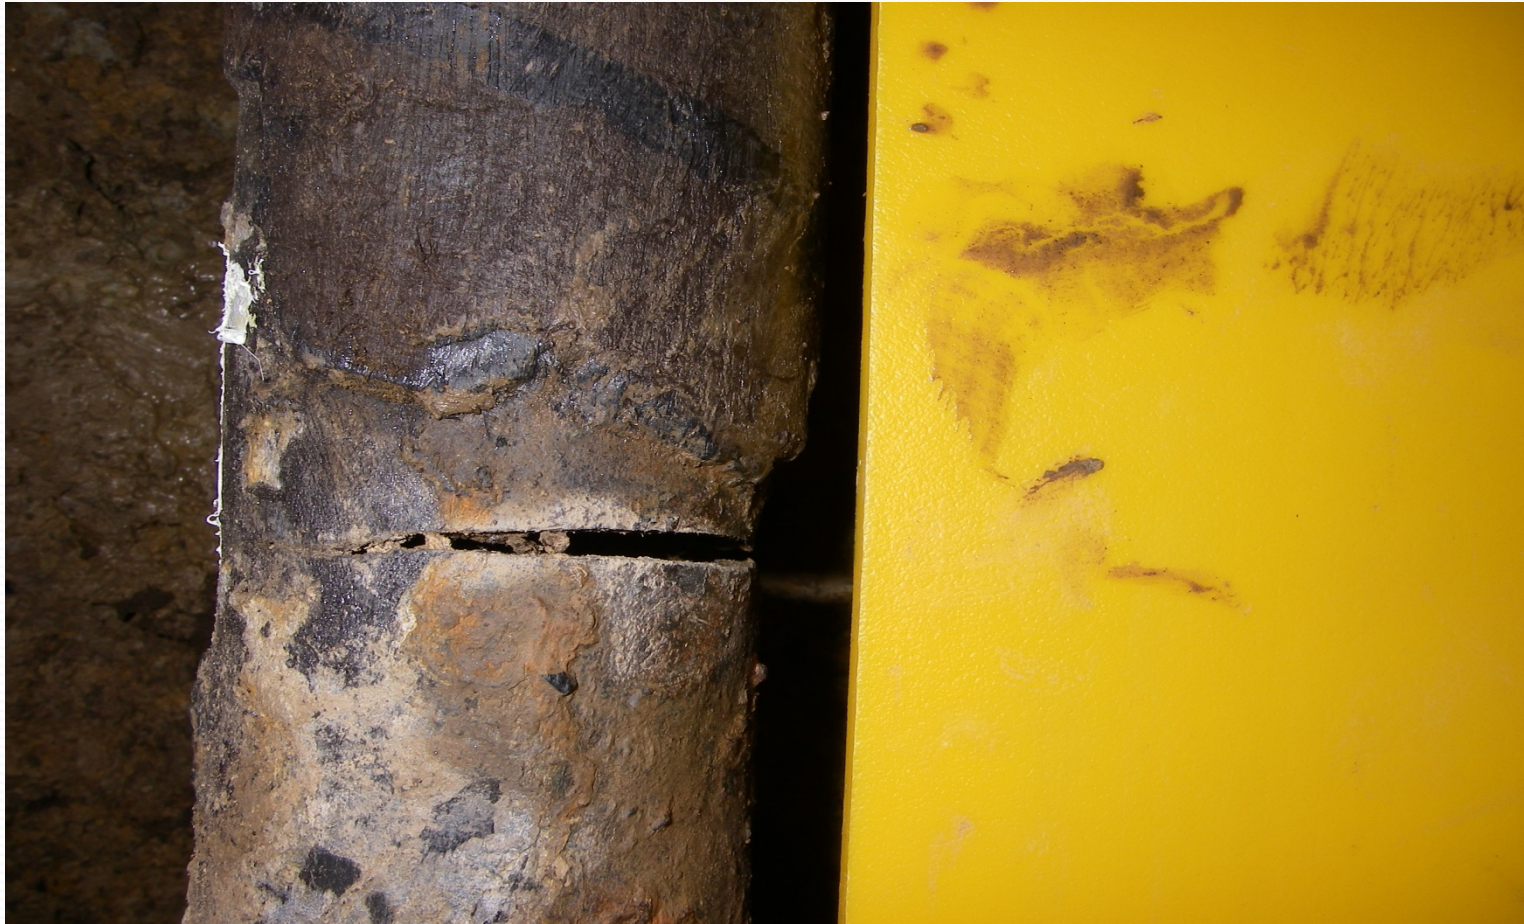
Cracked Distribution Pipe

- Transmission line cracks occur from SCC, seam corrosion, and weld defects
- Distribution line cracks occur from graphitization of cast materials, dents, dents with corrosion and weld defects
- The ability for a pipeline operator to identify the location of the pipeline defects that contribute to the propagation of cracks is a tool needed by pipeline operators

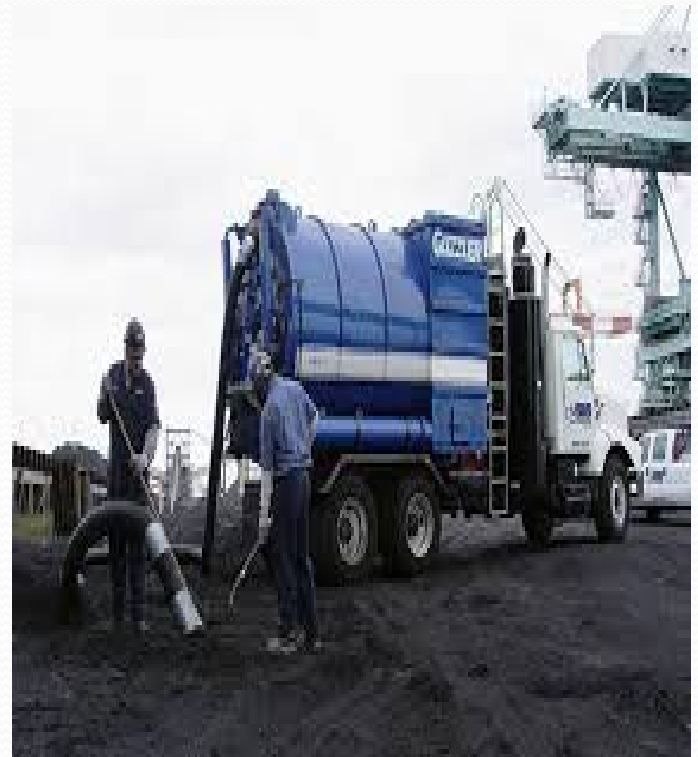
Continued Development of Keyhole Tool Technology

- This technology is in use now and has proven to lessen impact to streets and to save time
- Need more projects to enhance keyhole technology and to expand applications

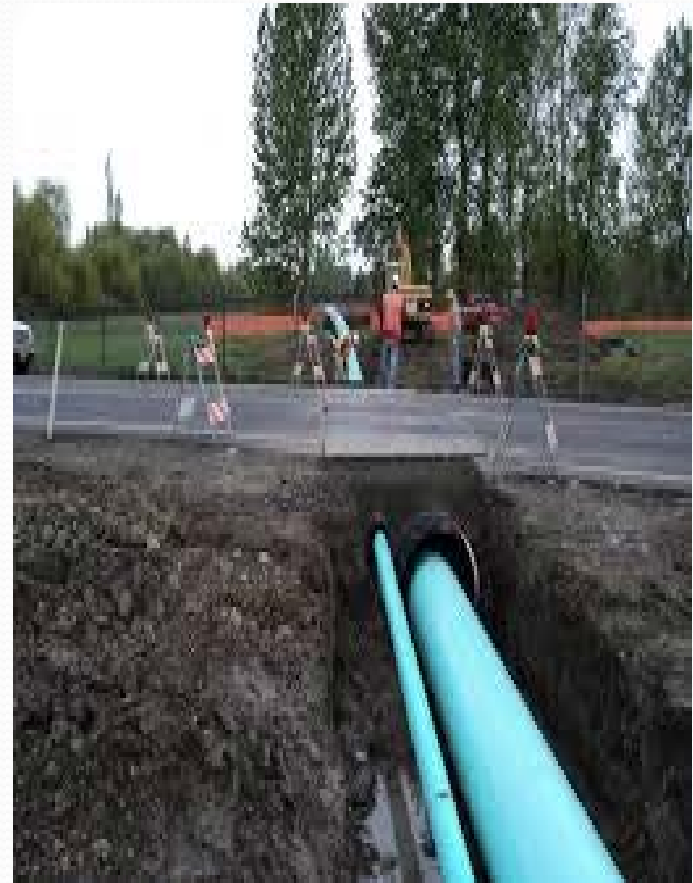
Improved Technology for Assessment of Casings

- Casings that are “shorted” can result in accelerated corrosion and other issues
- Established methods of detection of electrical isolation are often inadequate
- Casings with anodes can cause additional challenges to determination of electrical isolation

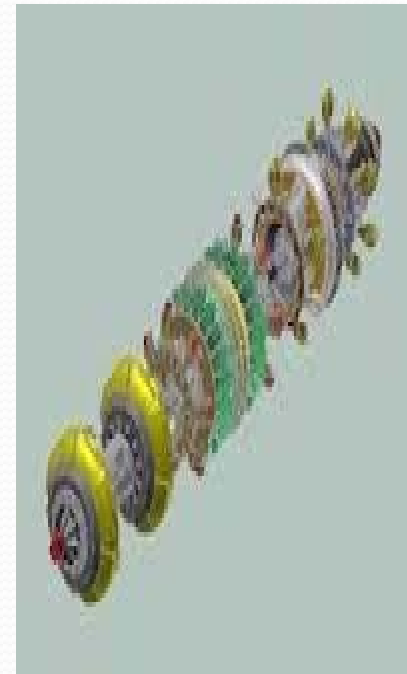
Development of In Line Inspection Tools for Small Diameter Pipelines

- Current Explorer II technology can inspect pipelines down to 6" in diameter
- Need micro technology to enable internal inspection of even smaller diameter steel pipelines that may be operating at transmission SMYS or at higher distribution pressures

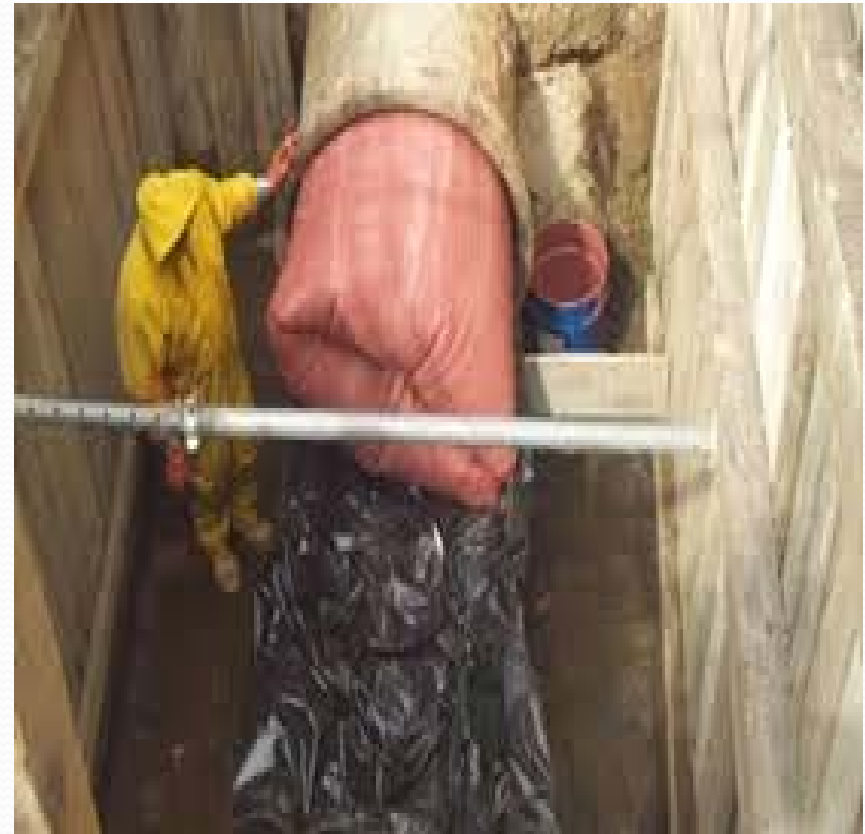
Cured in Place Liners for Pipelines

- NAPSR generally disagrees with use of cured in place liners
- Not enough data to form a conclusion
- Issues with sharp edges as cast iron deteriorates
- Issues with tapping and potential for leakage at lateral joints
- Issues with MAOP unclear and relationship from a regulatory perspective on what the pipe MAOP becomes if cast iron completely goes away
- NAPSR agreeable with research of liner performance
