ENHANCING THE SAFETY AND RELIABILITY OF PLASTIC GAS DISTRIBUTION PIPELINES: DEFECT REMEDICATION, REPAIR AND MITIGATION

**> Presented at
Government/Industry Pipeline R&D Forum
New Orleans, LA
February 7, 2007**

**Presented by
Michael M. Mamoun
Senior Institute Scientist
Gas Technology Institute (GTI)**

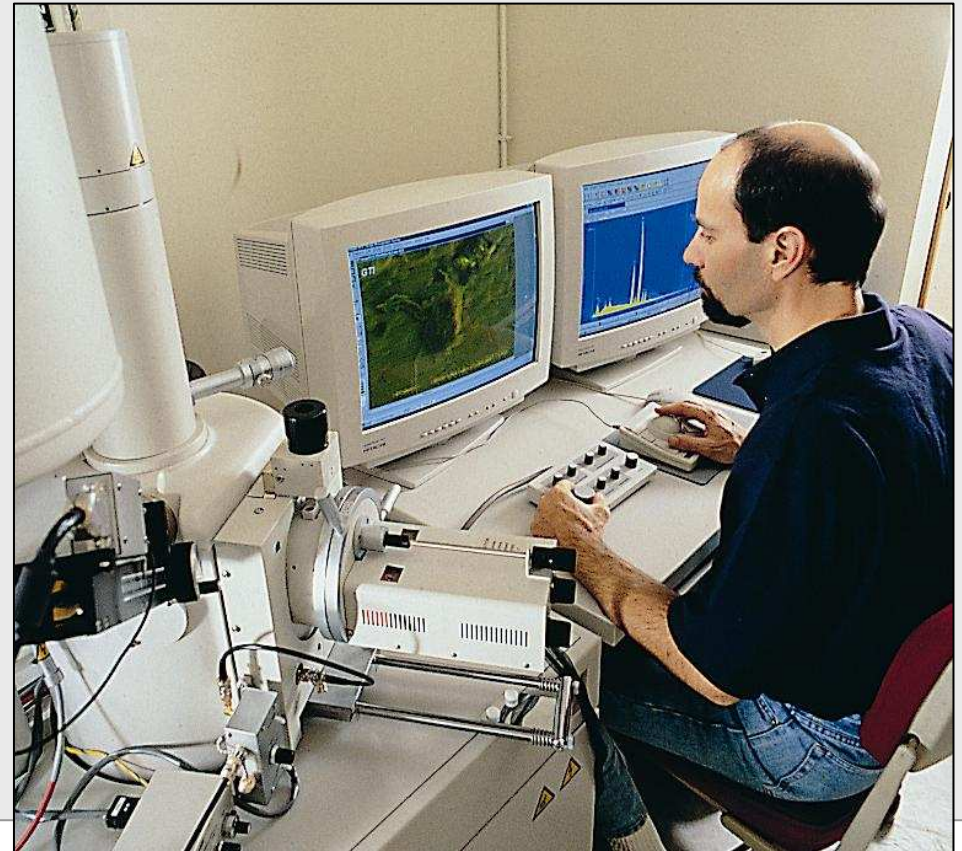
GTI State-of-the Art Laboratory for Plastic and Metal failure analysis

» Optical and Microscopic Examinations

**Scanning Electron
Microscopy (SEM) for
material examinations up to
200,000X**

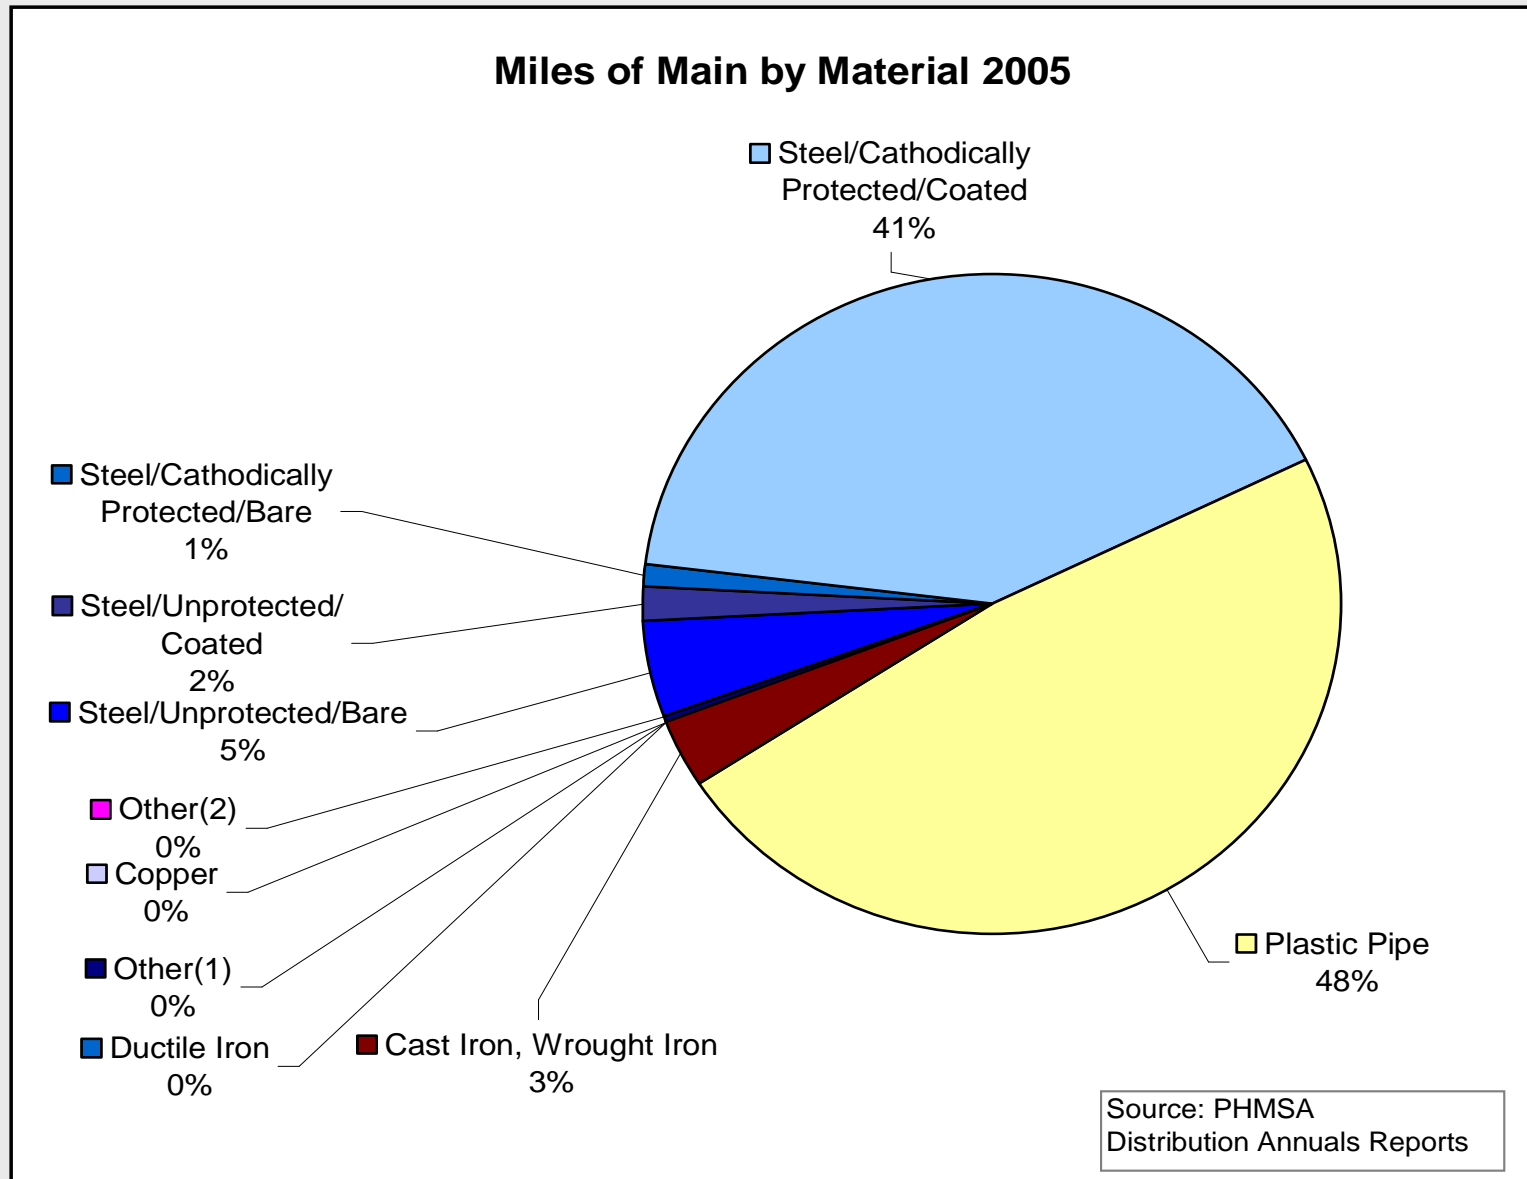
Distribution Miles of Main by Material

- **In 2006, the U.S. Gas Distribution Pipeline Network Consisted of About**
 - **1,450,000 Miles of Mains**
 - **900,000 miles of steel, CI, etc. mains**
 - **550,000 miles of plastic mains**
 - **750,000 Miles of Services (About 60,000,000 Services)**
 - **40,000,000 plastic services**
 - **20,000,000 services other materials**

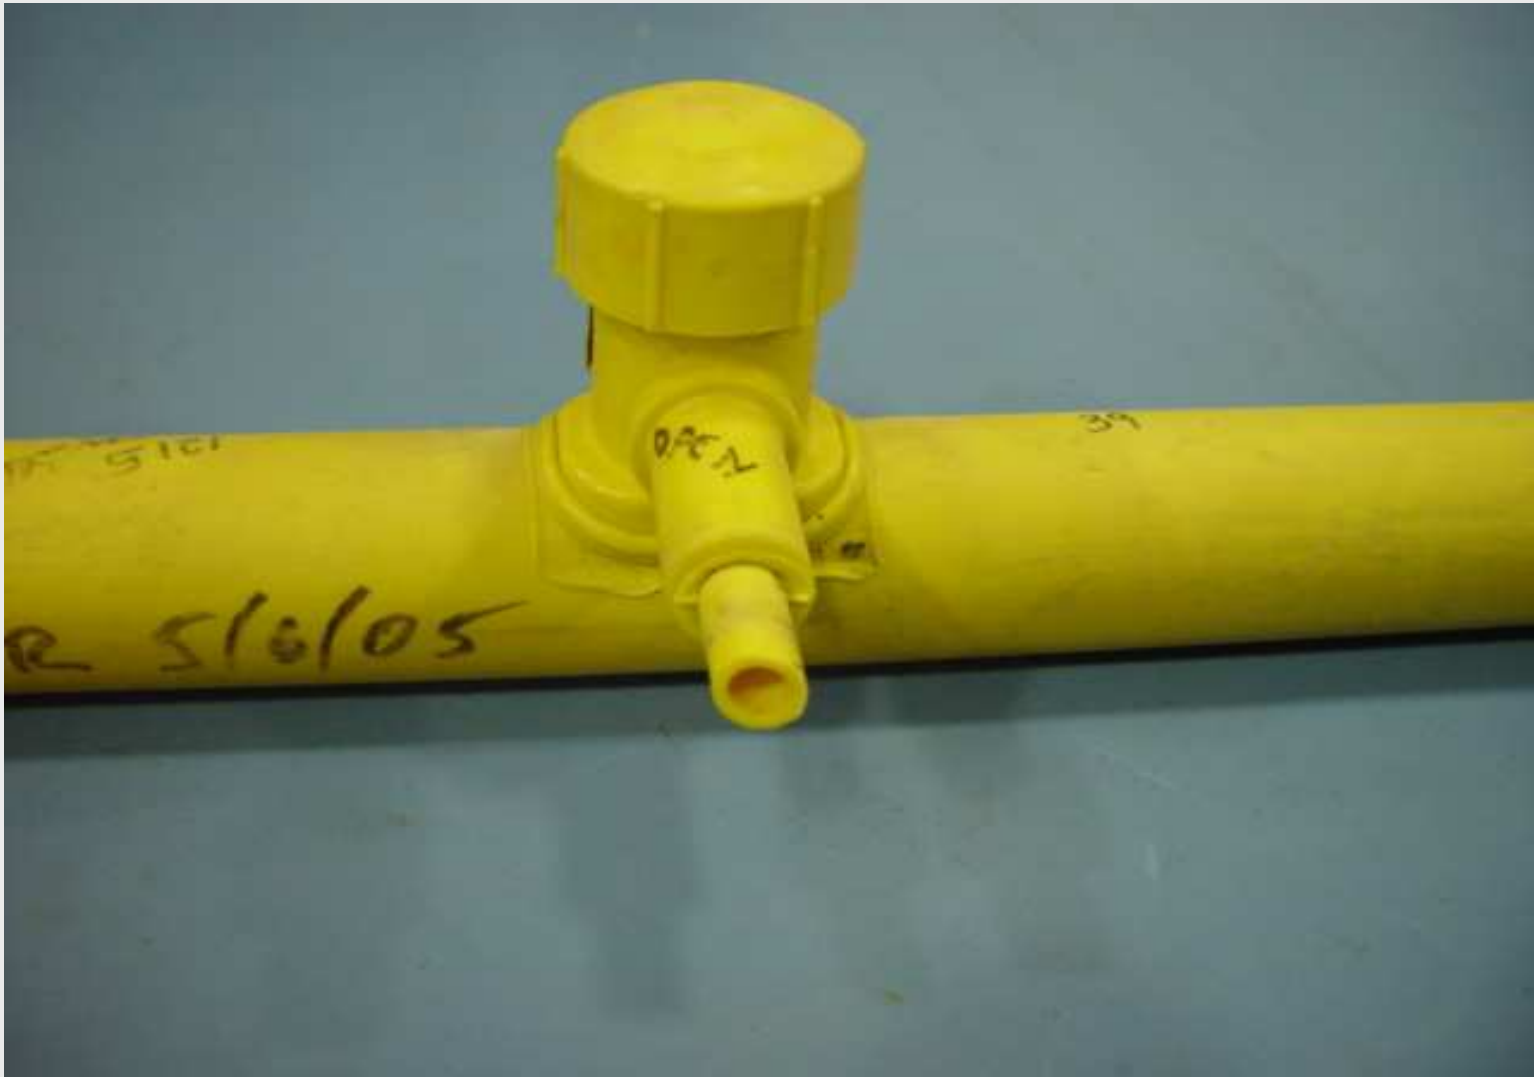
Heat Fused Lateral Joint Failure

Type of Failure	Probable Root Cause
Saddle/Lateral Fusion Joints	Inadequate fusion--lack of bond or penetration, Contaminants, Inclusions, Stress Concentrations
Socket Fusion Joints	Inadequate fusion--lack of bond or penetration, Contaminants, Extrusion lines,
Butt Fusion Joints	Inadequate fusion--lack of bond or penetration, Wall-to-wall mismatch, Contaminants, Inclusions,
Material: Quality Control (Pin Holes)	Defects, Inclusions, Cavities, Extrusion Lines, Non-Homogenous Melting (High % of Re-Grind)
Rock Impingement	High Localized Stress Concentration Combined with Defects, Inclusions,
Bending and Earth Settlement	High Bending Stresses
Squeeze-off	High Localized Stresses Due to High % Squeeze

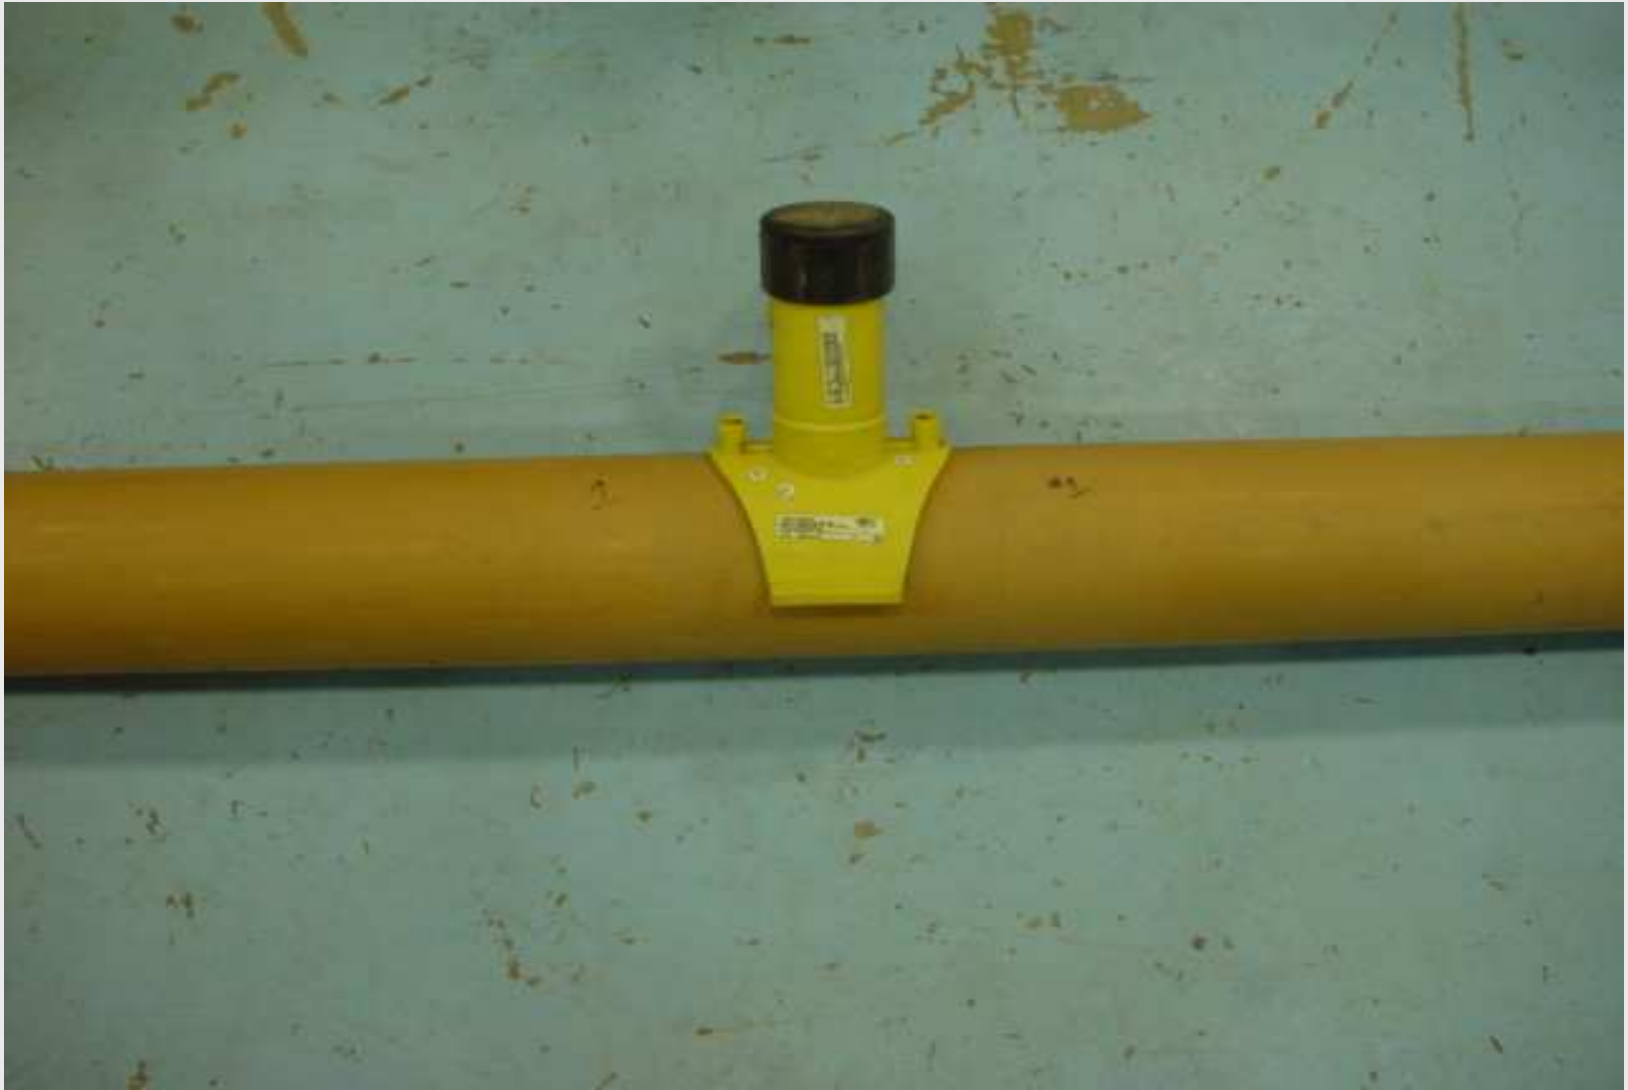
Electro-fusion Saddle Joint Failure

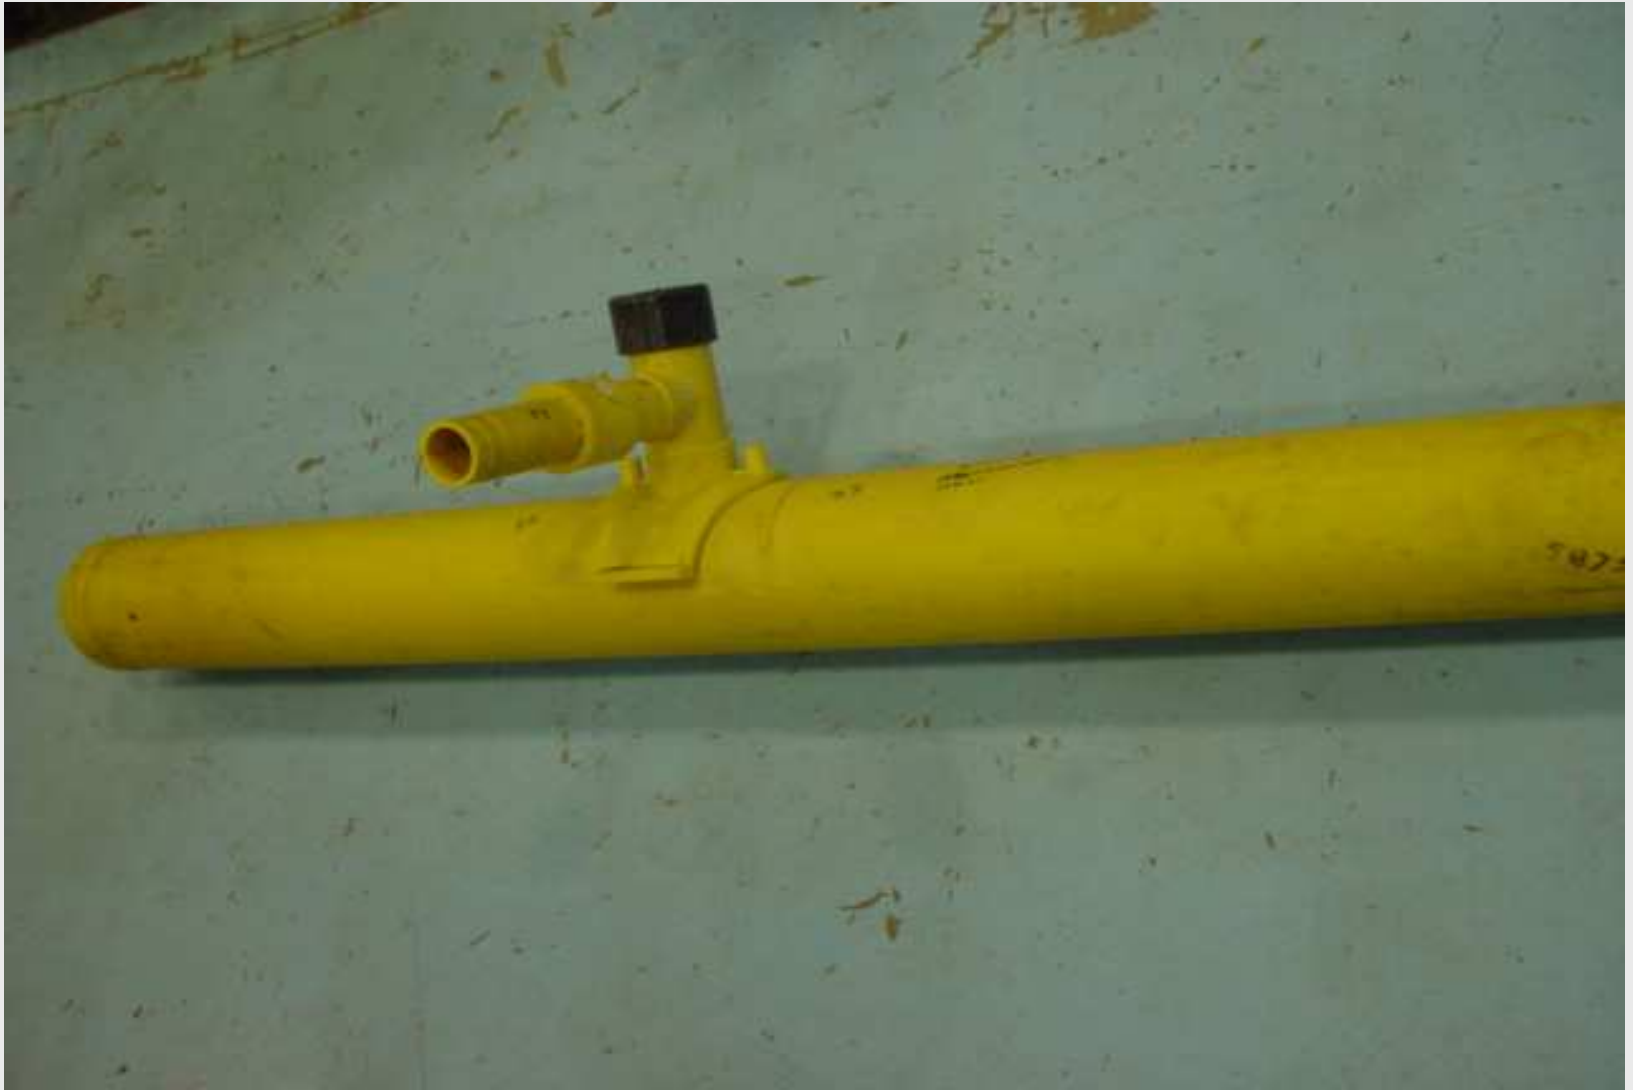
Electrofusion Lateral Joint Failure

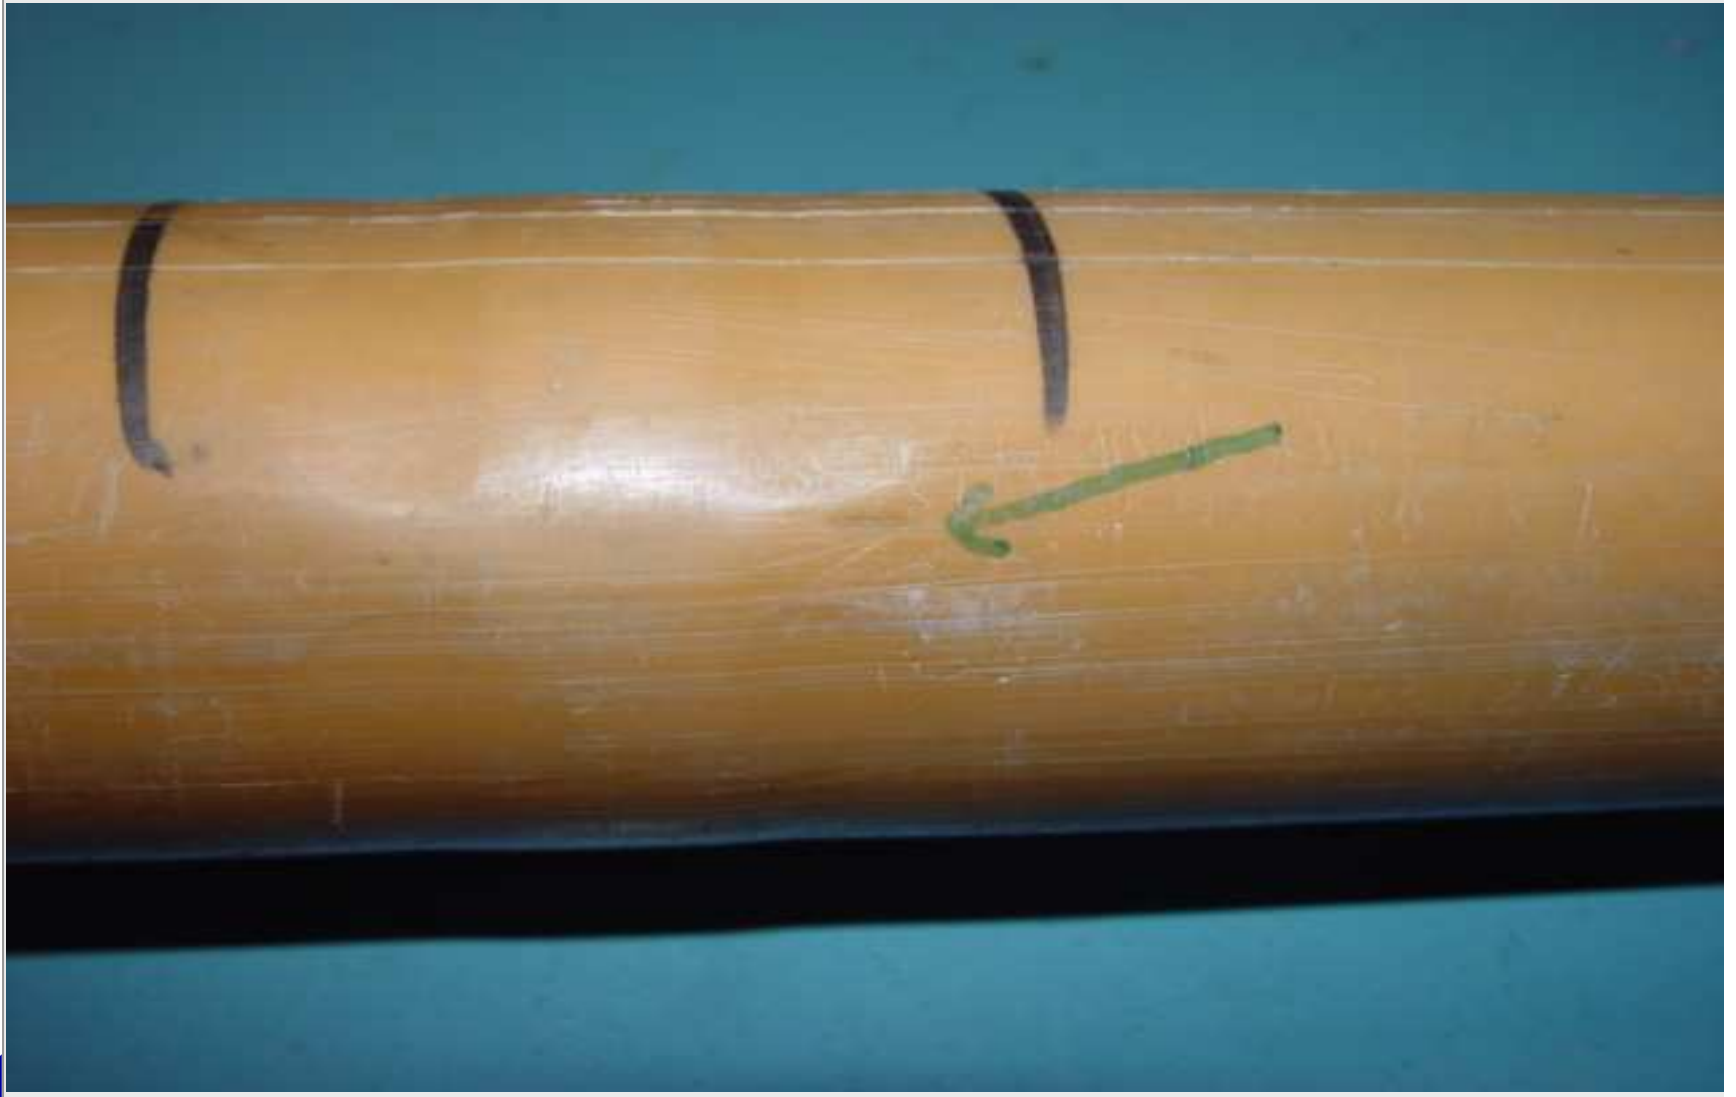
Squeeze-off Failure

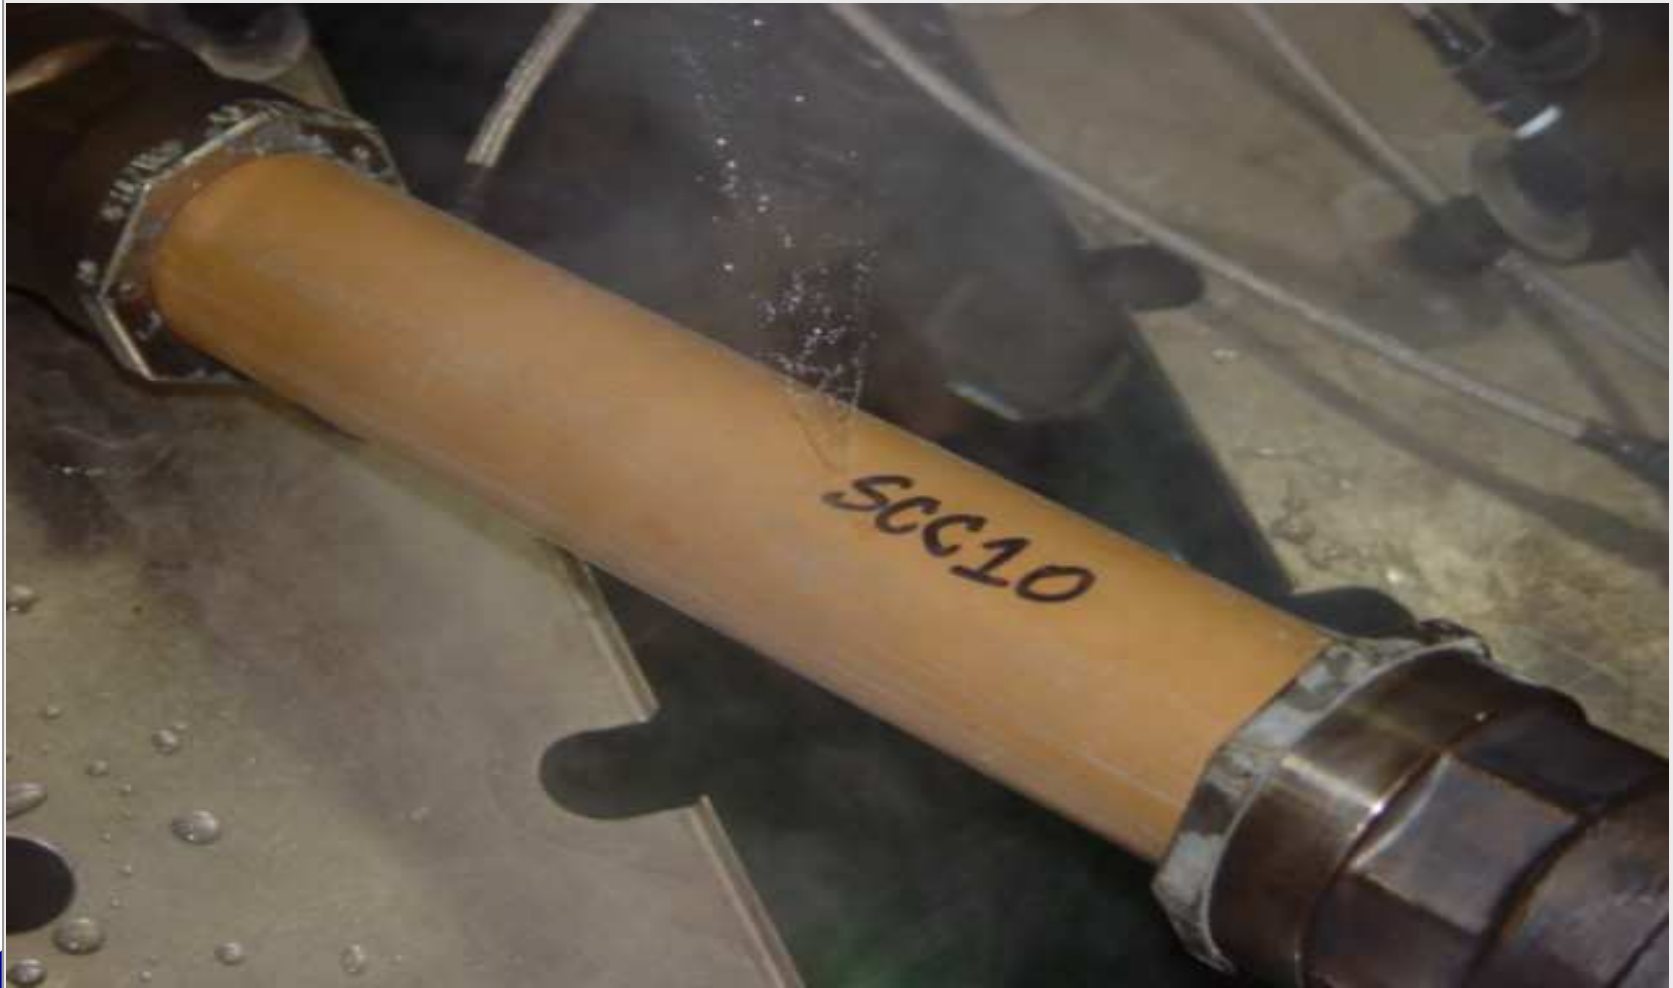
Slit failure In Pipe Due to an Inclusion

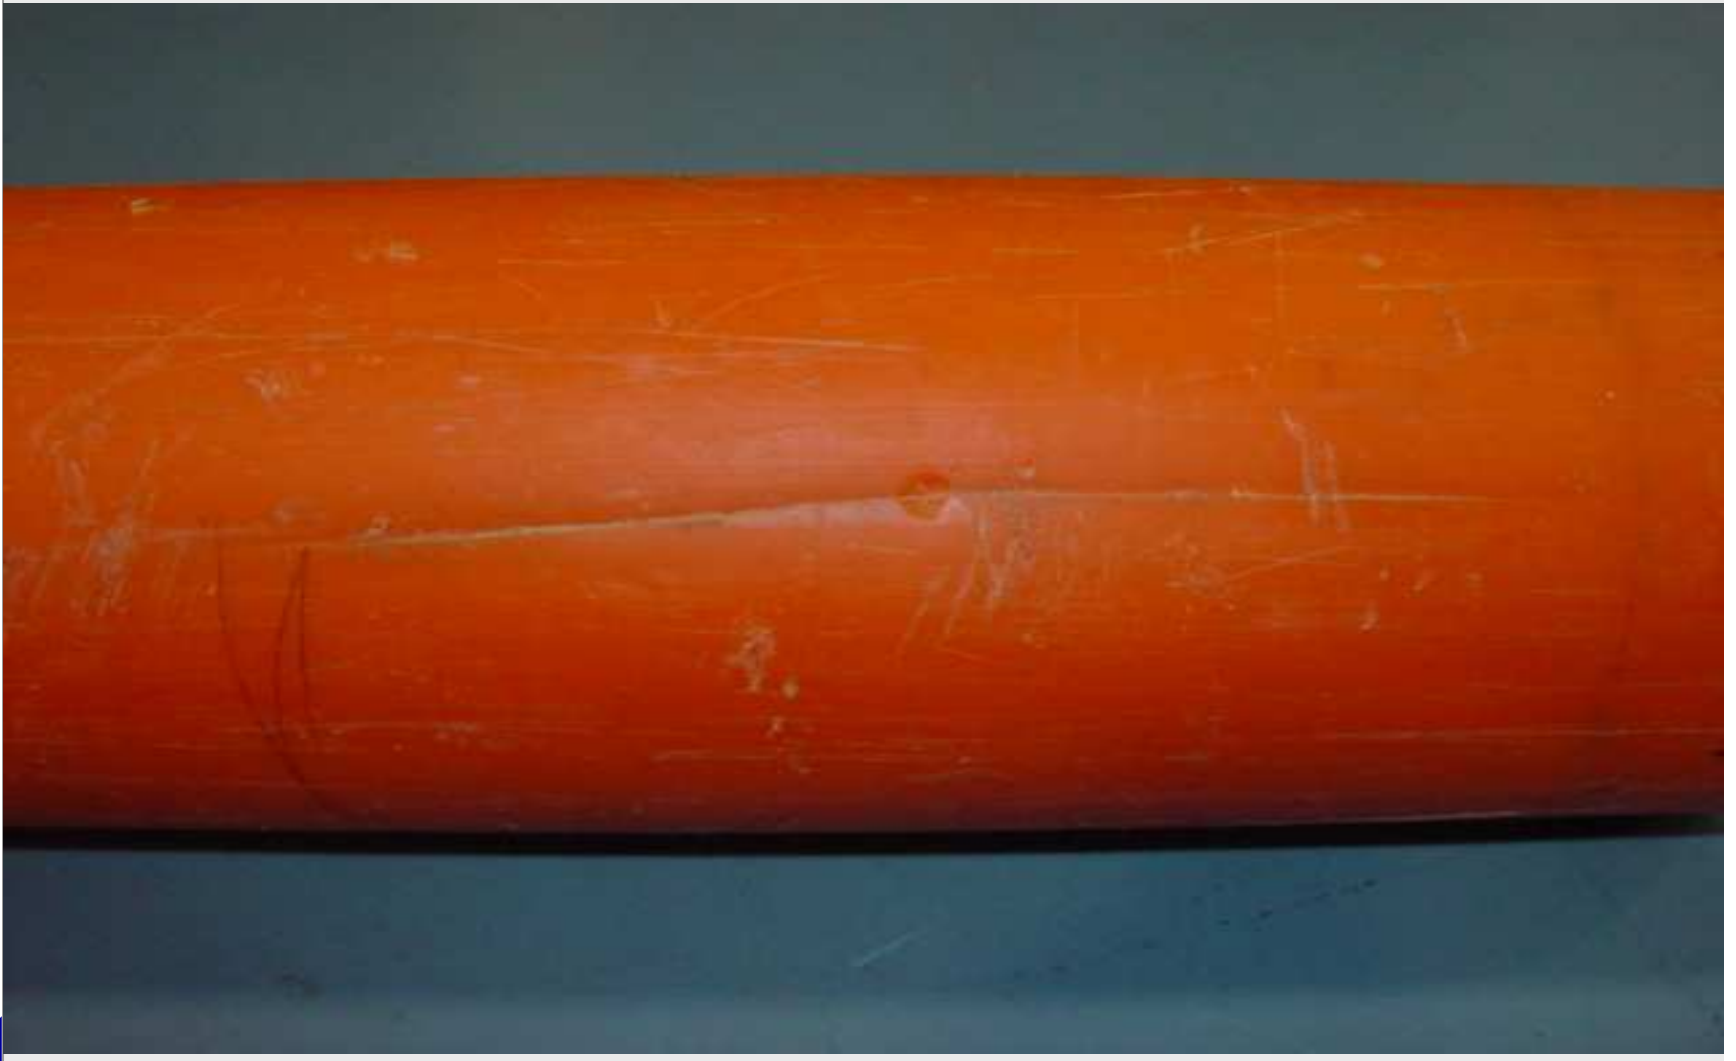
Rock Impingement Failure
