Regulatory Next Steps in Addressing Pipeline Seam Weld Challenges

Steve Nanney
U.S. DOT/PHMSA

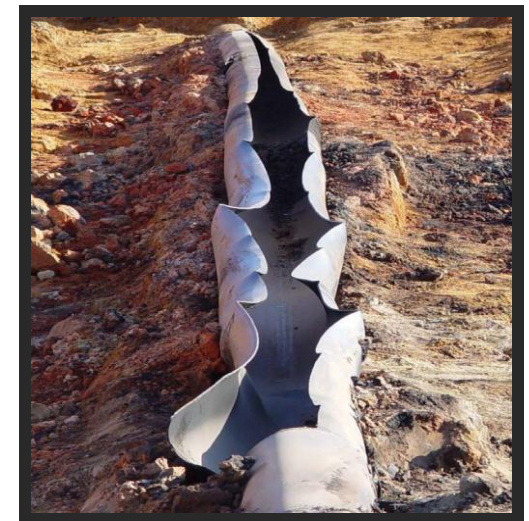
**Incident #1 -
Carmichael, MS**

- **Liquid Propane Pipeline Rupture – Carmichael, MS**
 - November 1, 2007
 - Fracture along LF-ERW seam
 - 2 fatalities and 7 injuries
