MECHANICAL PROPERTIES OF TANK CAR STEELS RETIRED FROM THE FLEET

FINAL REPORT

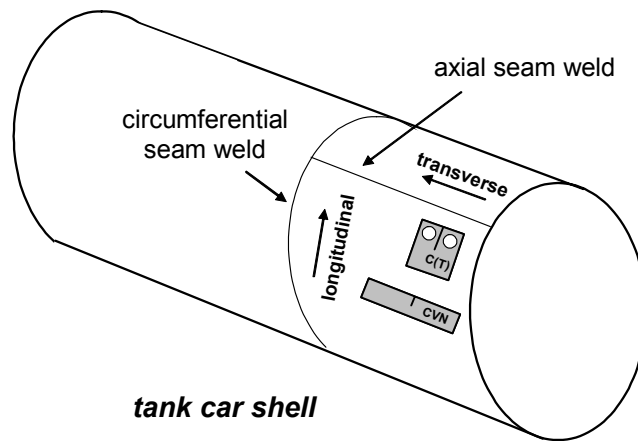
Figure 2-4. Definition of the orientation of fracture toughness samples in the shell.

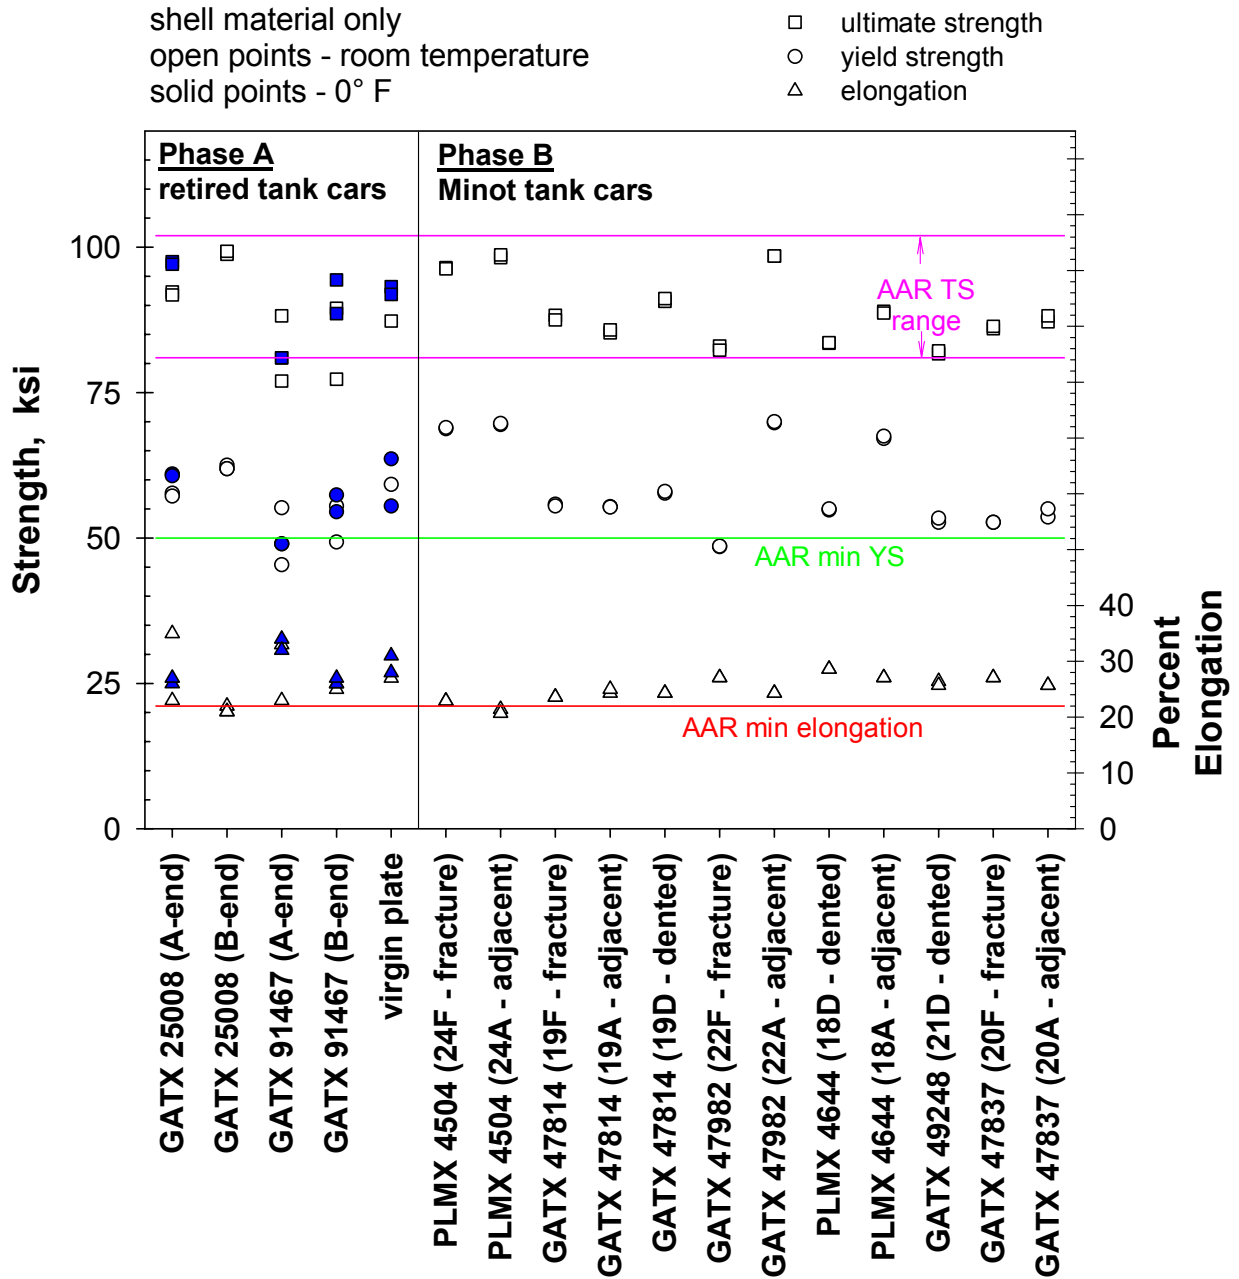
Figure 2-5. Tensile property variation with material examined. Note that the AAR specification applies for the longitudinal orientation whereas the samples tested were orthogonal to this orientation.

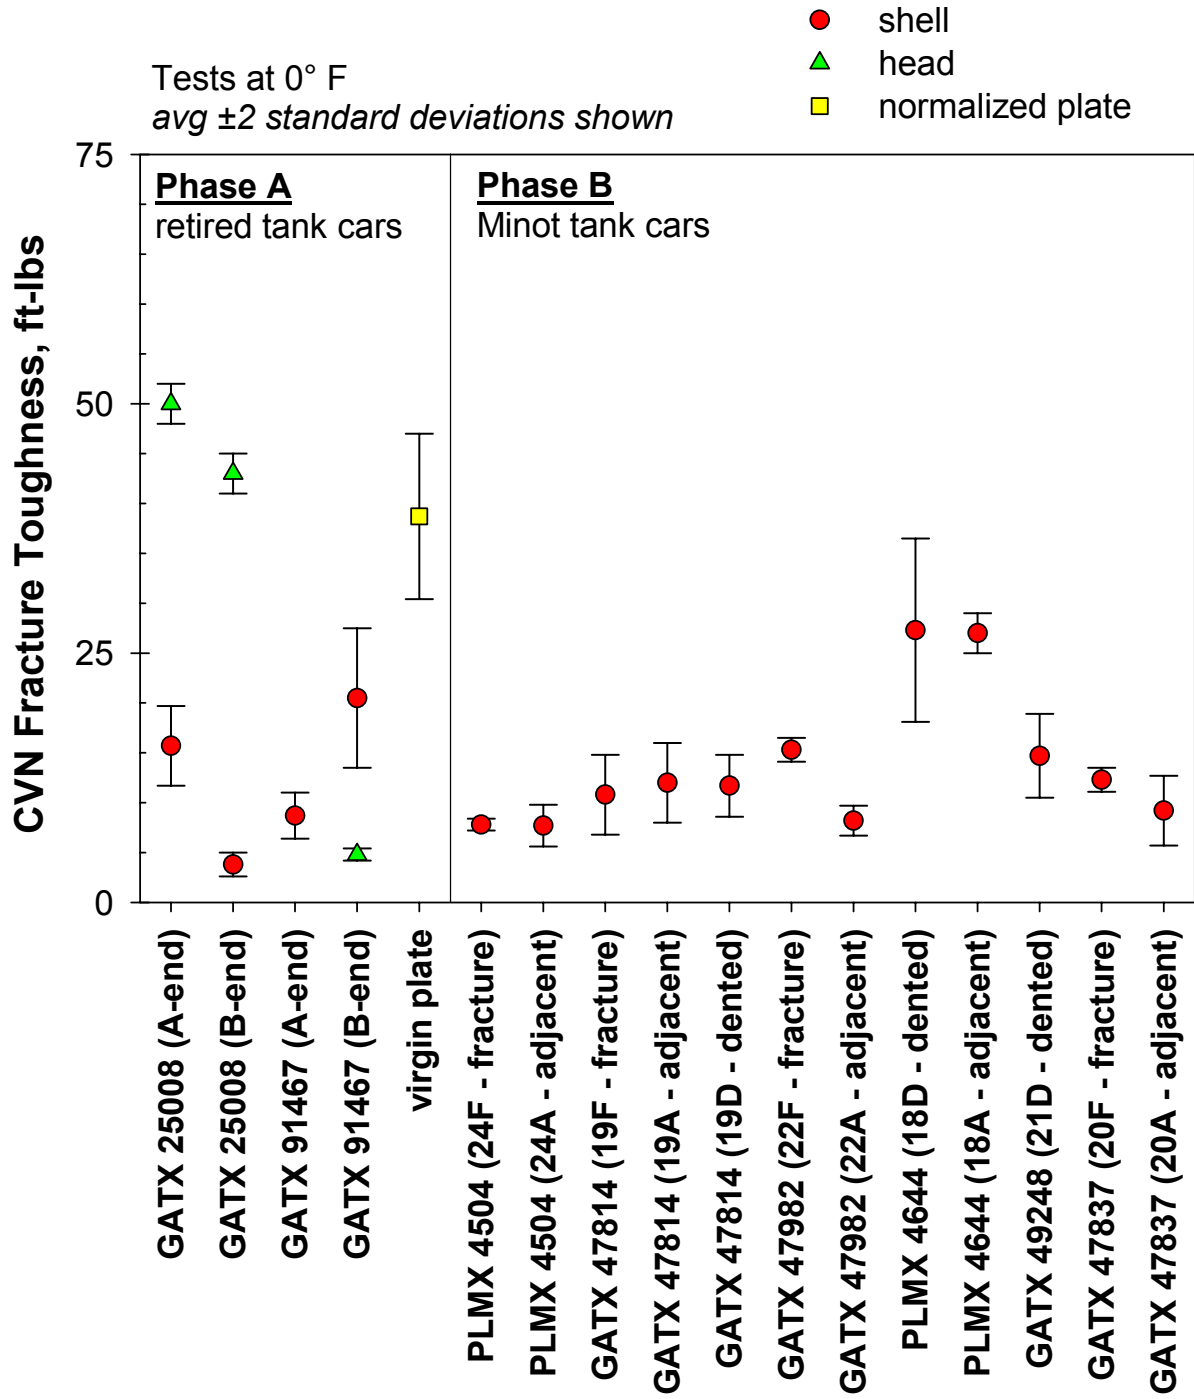
Figure 2-6. CVN fracture toughness variation with material examined.

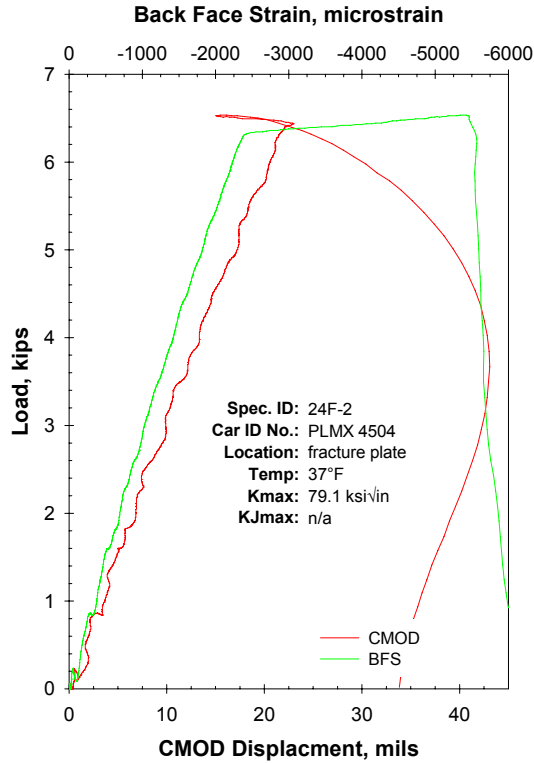
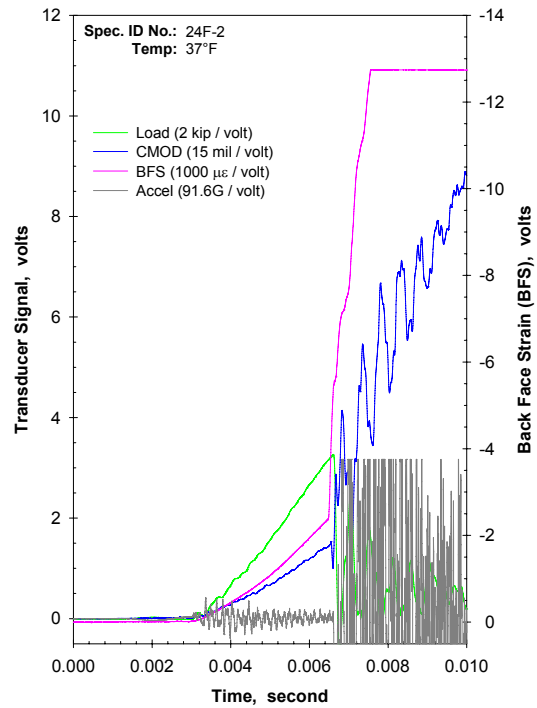
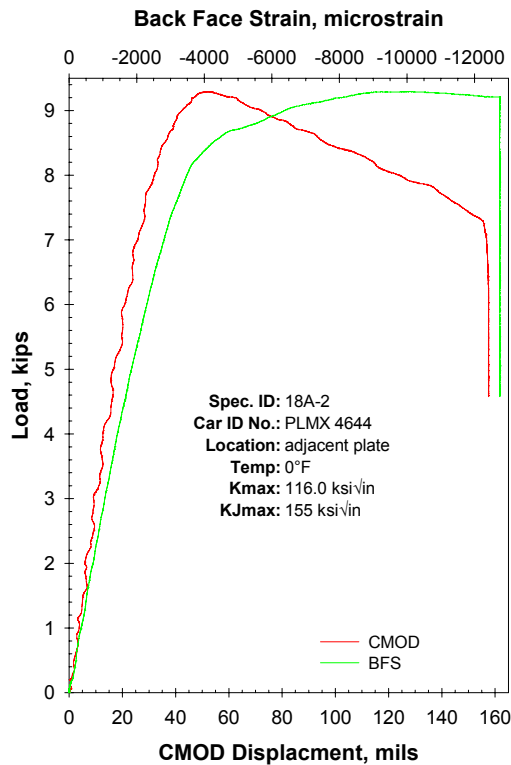
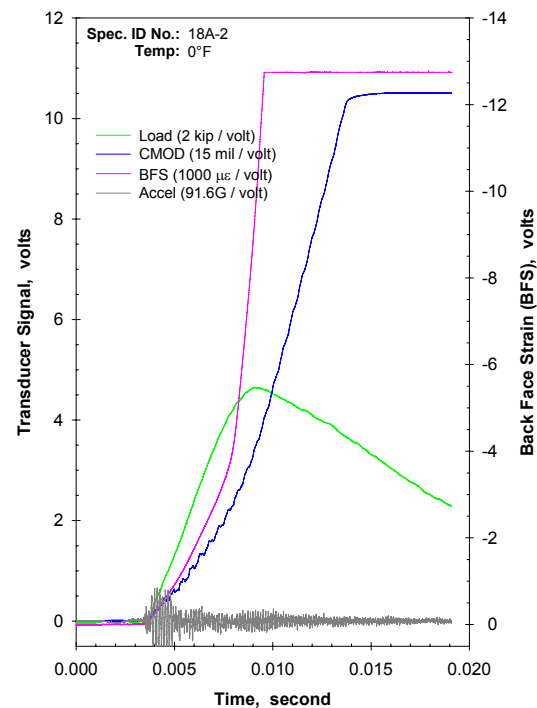
Figure 2-7. Typical recorded data for brittle (top) and ductile (bottom) examples of fracture toughness tests.

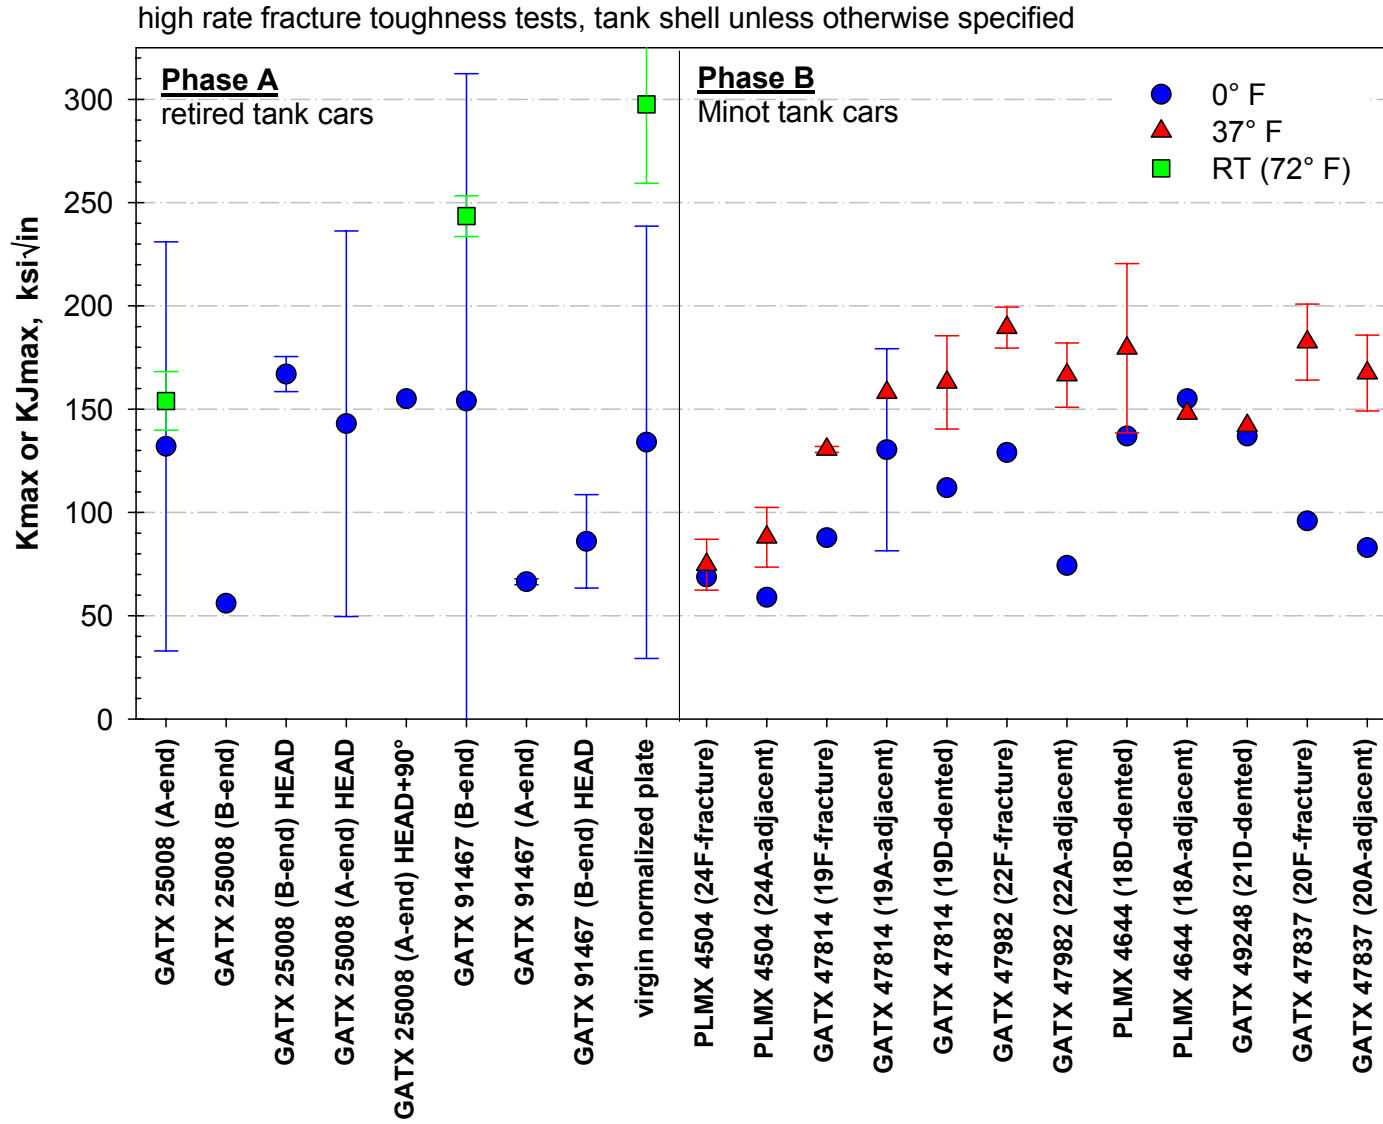
Figure 2-8. Variation in average high rate fracture toughness as a function of temperature and material (error bars ±2 std. devs.).

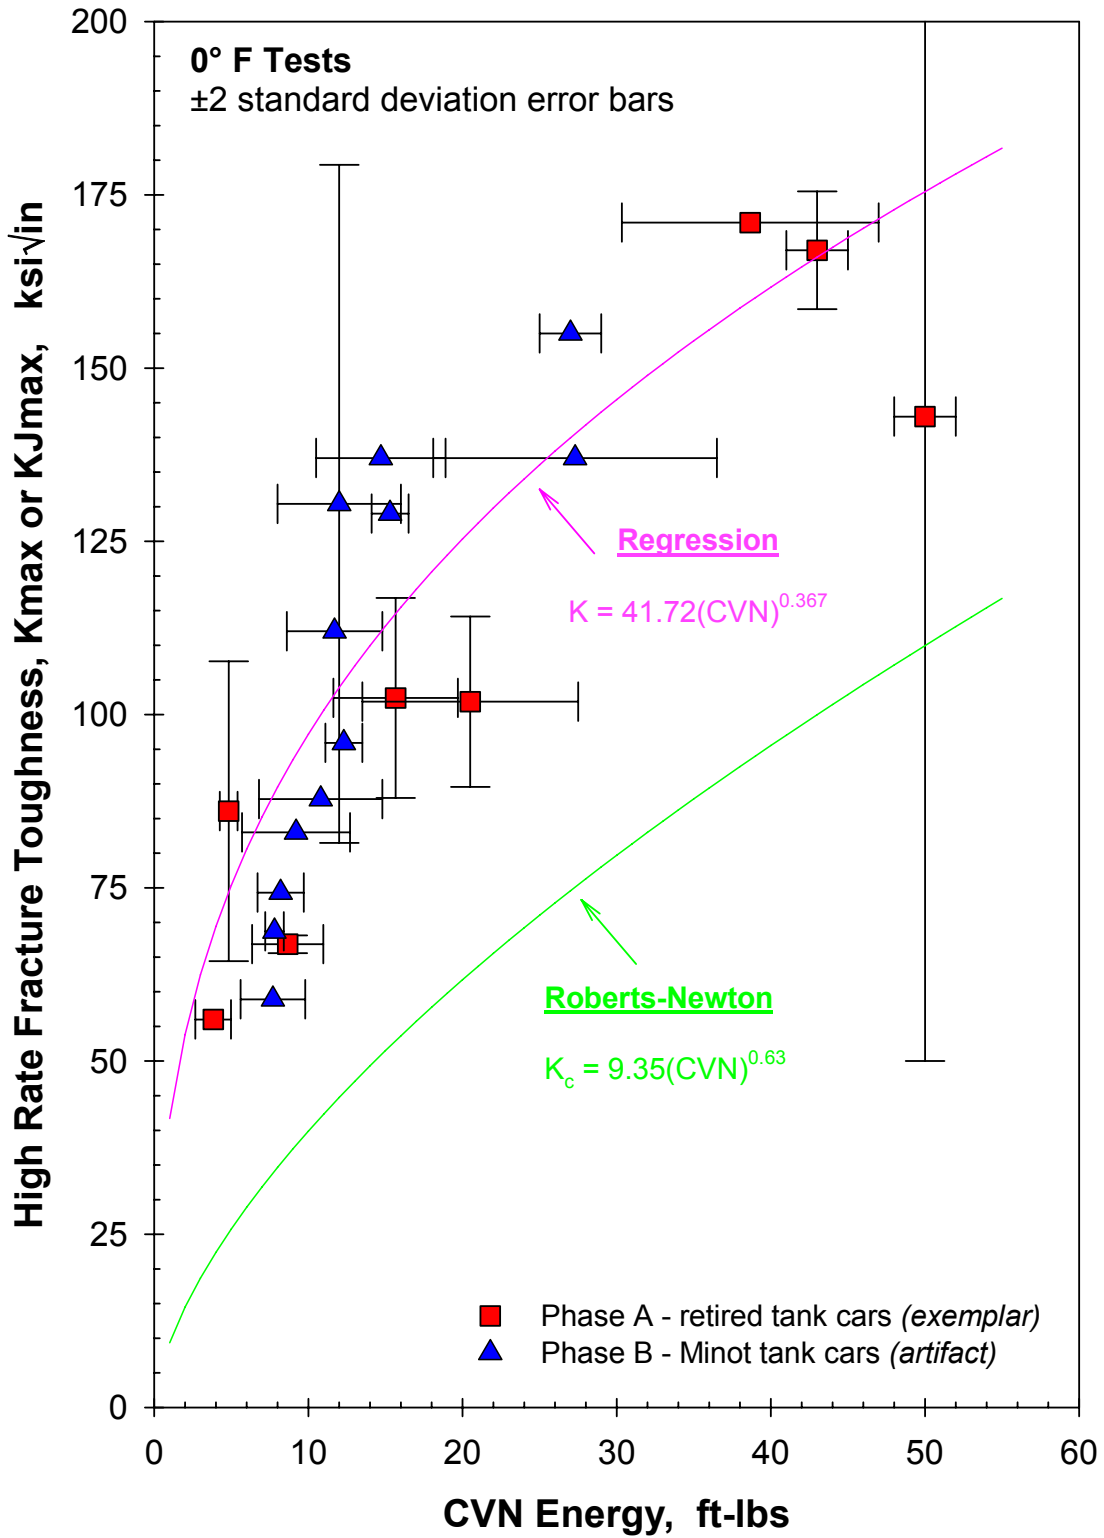
Figure 2-9. Correlation between fracture toughness and CVN energy for tests at 0°F.

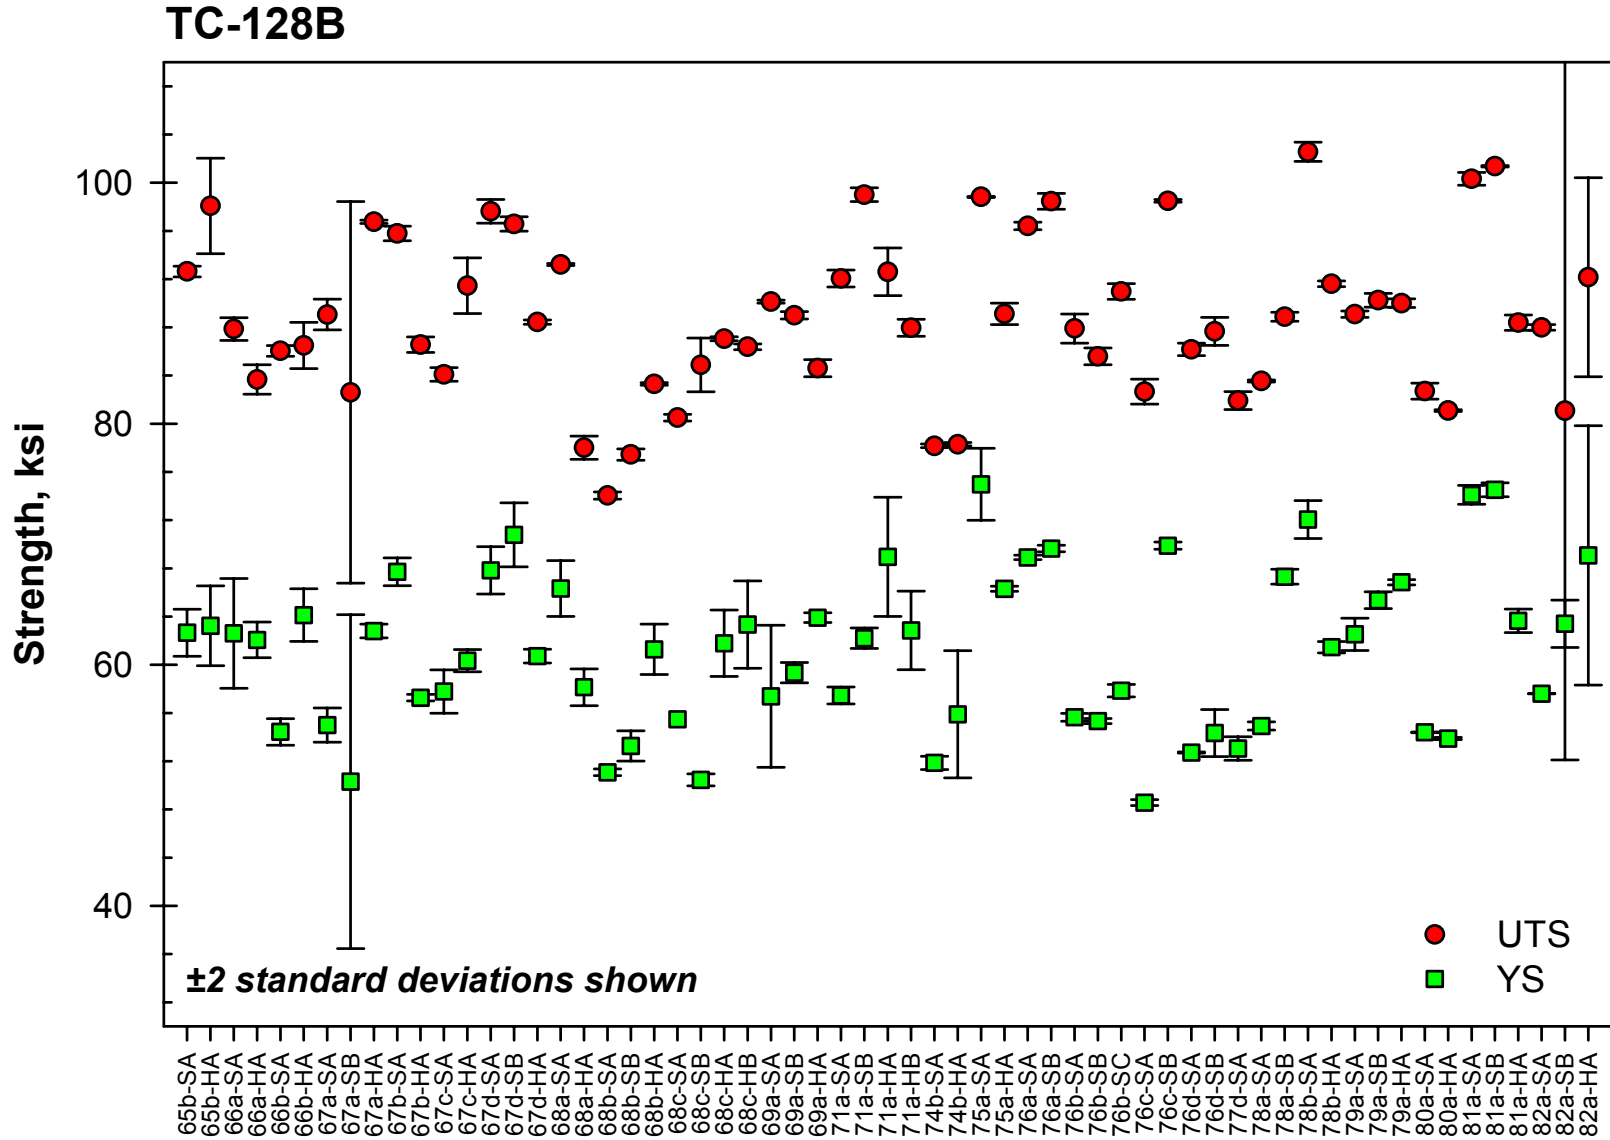
Figure 4-1. Room temperature tensile yield and ultimate strength for different vintage TC128-B conditions.

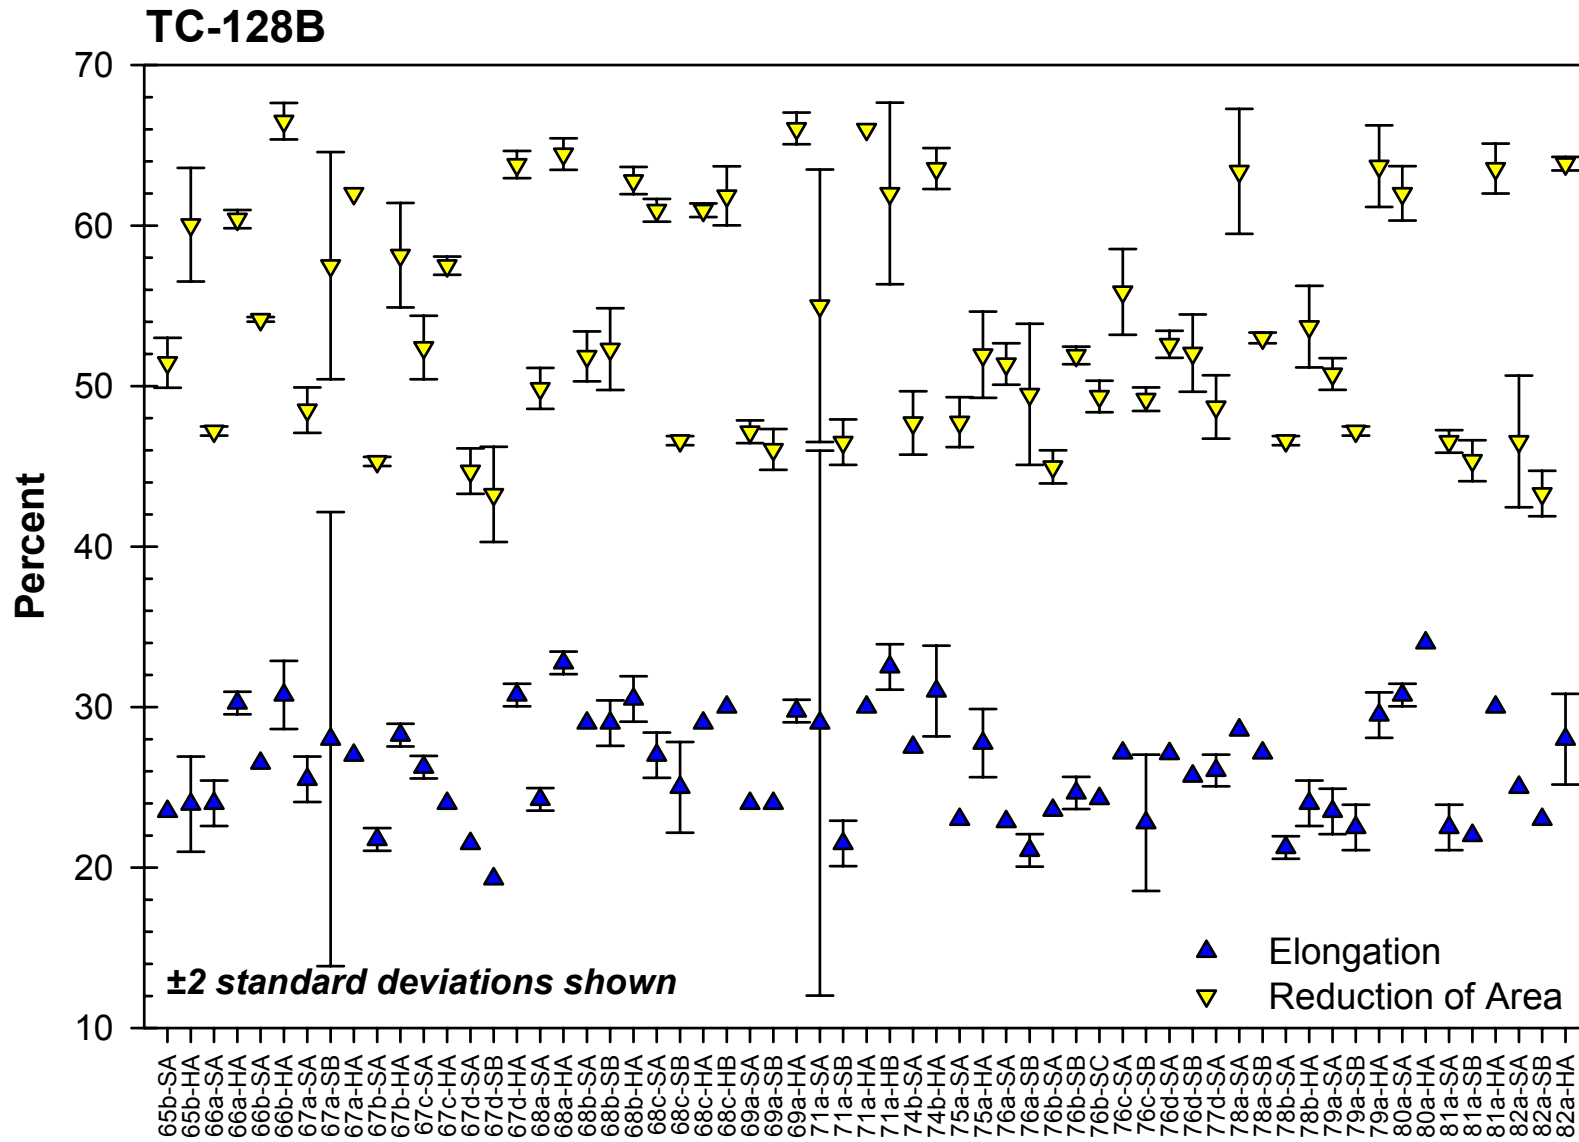
Figure 4-2. Room temperature tensile elongation and reduction of area for different vintage TC128-B conditions.

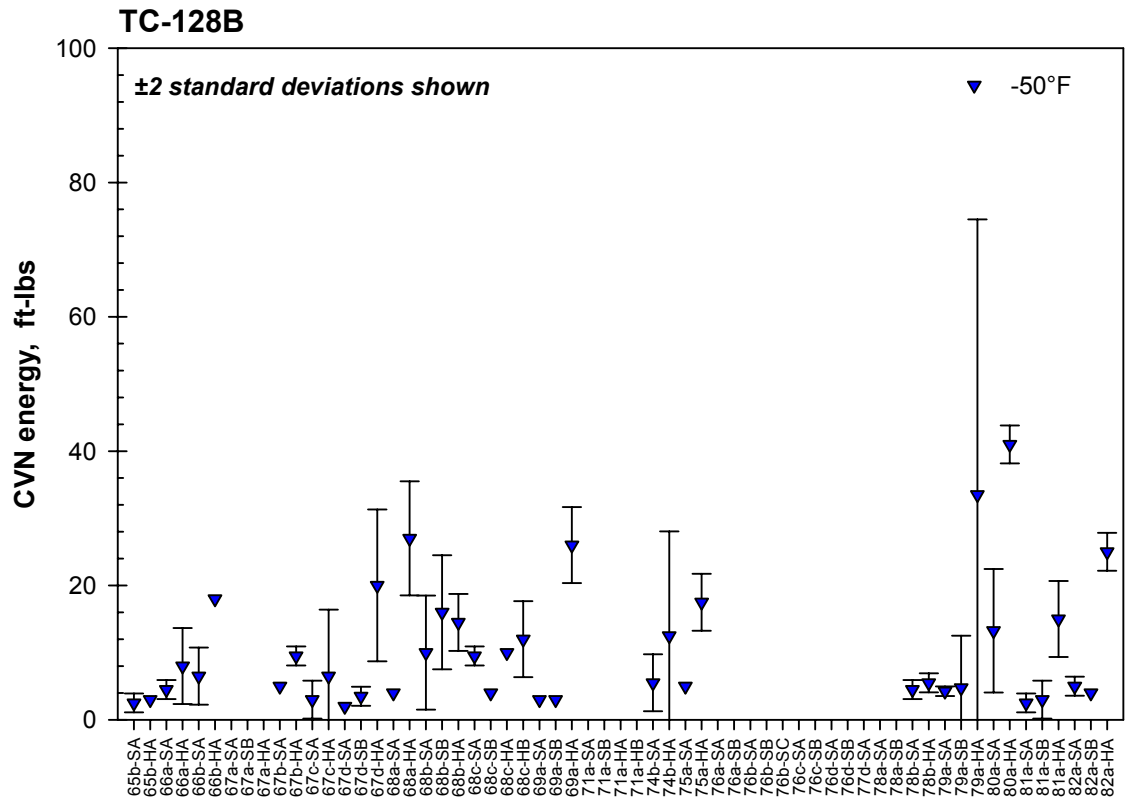
Figure 4-4. CVN toughness at 50°F for different vintage TC128-B conditions.

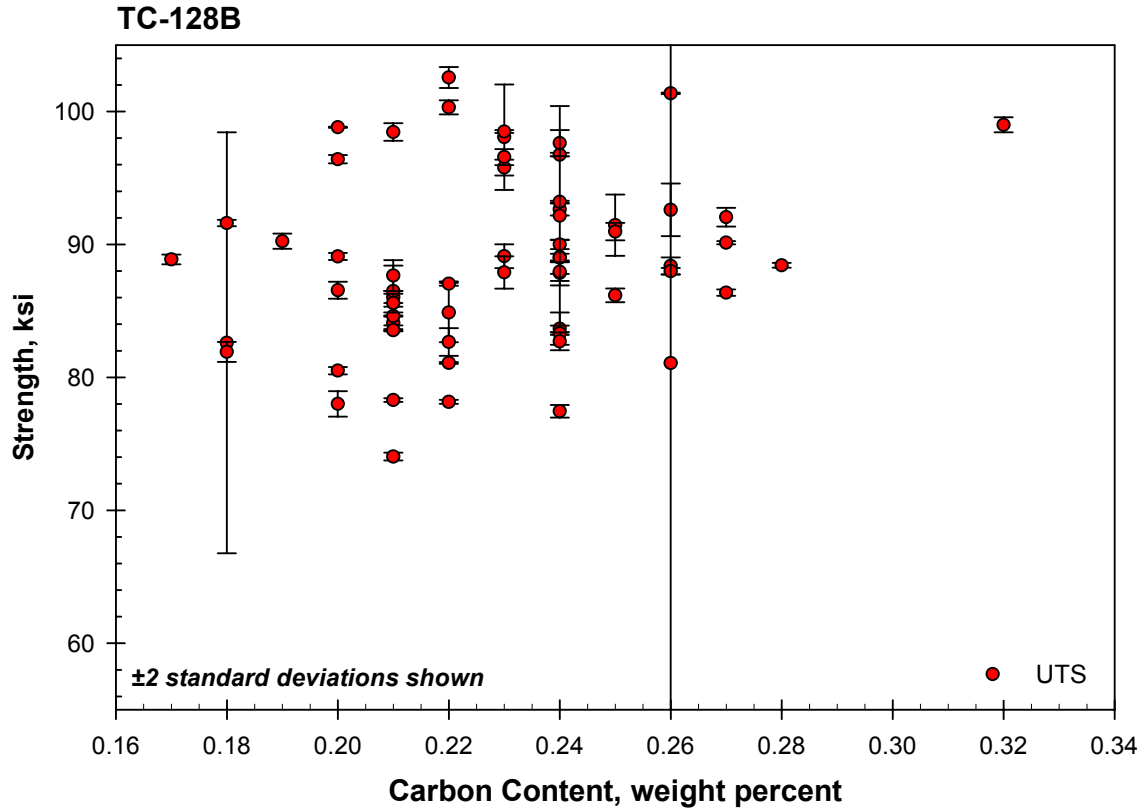
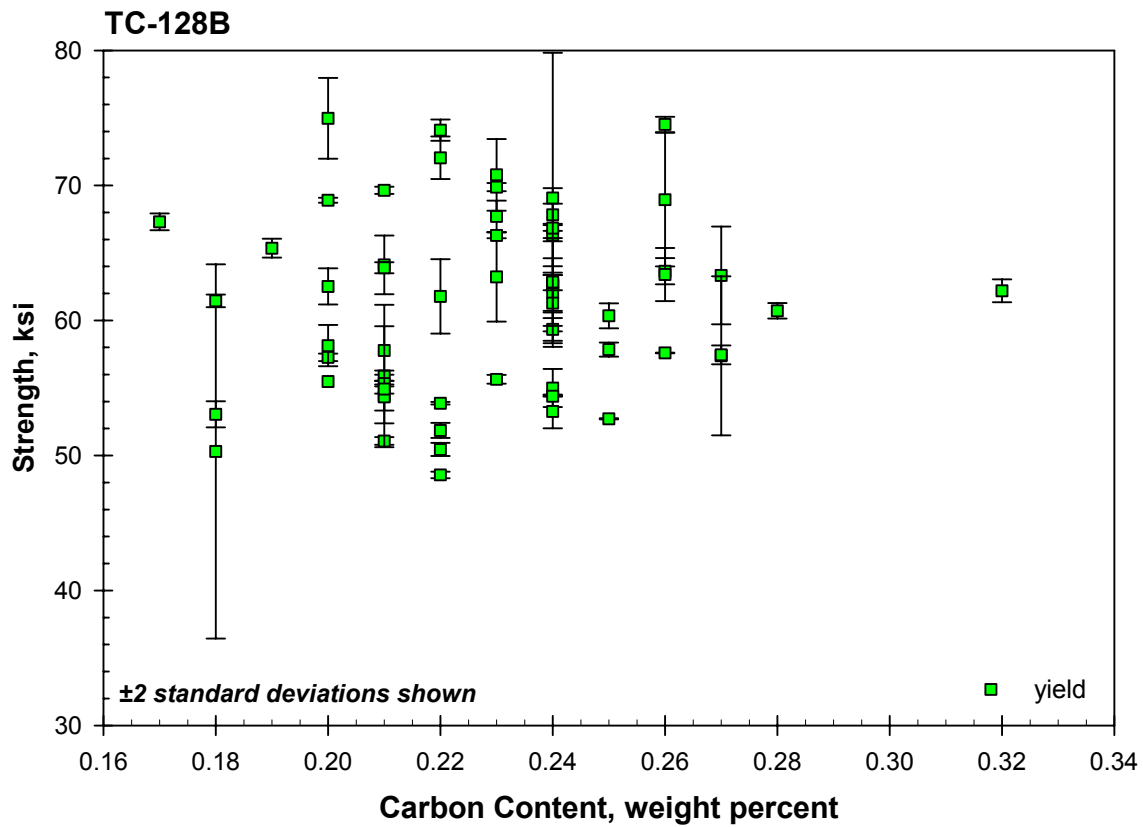
Figure 4-5. Influence of carbon content on room temperature strength for vintage TC128-B.

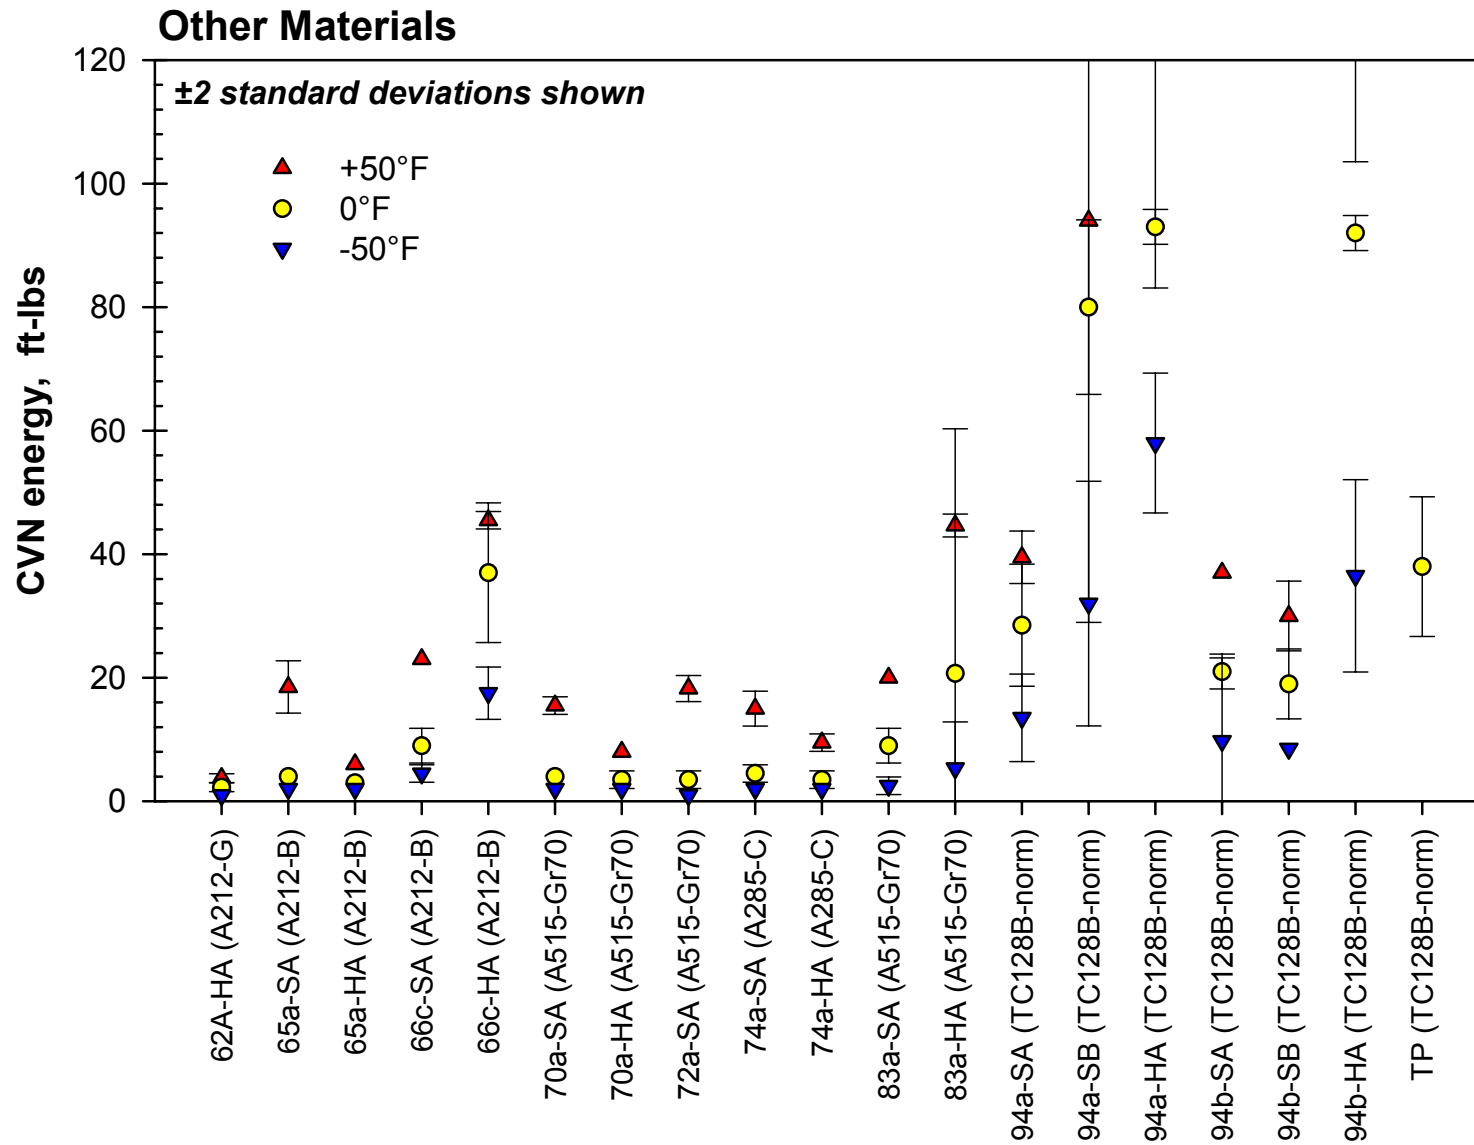
Figure 4-8. CVN toughness at -50°F, 0°F and 50°F for different materials and post-1989 TC128-B conditions.

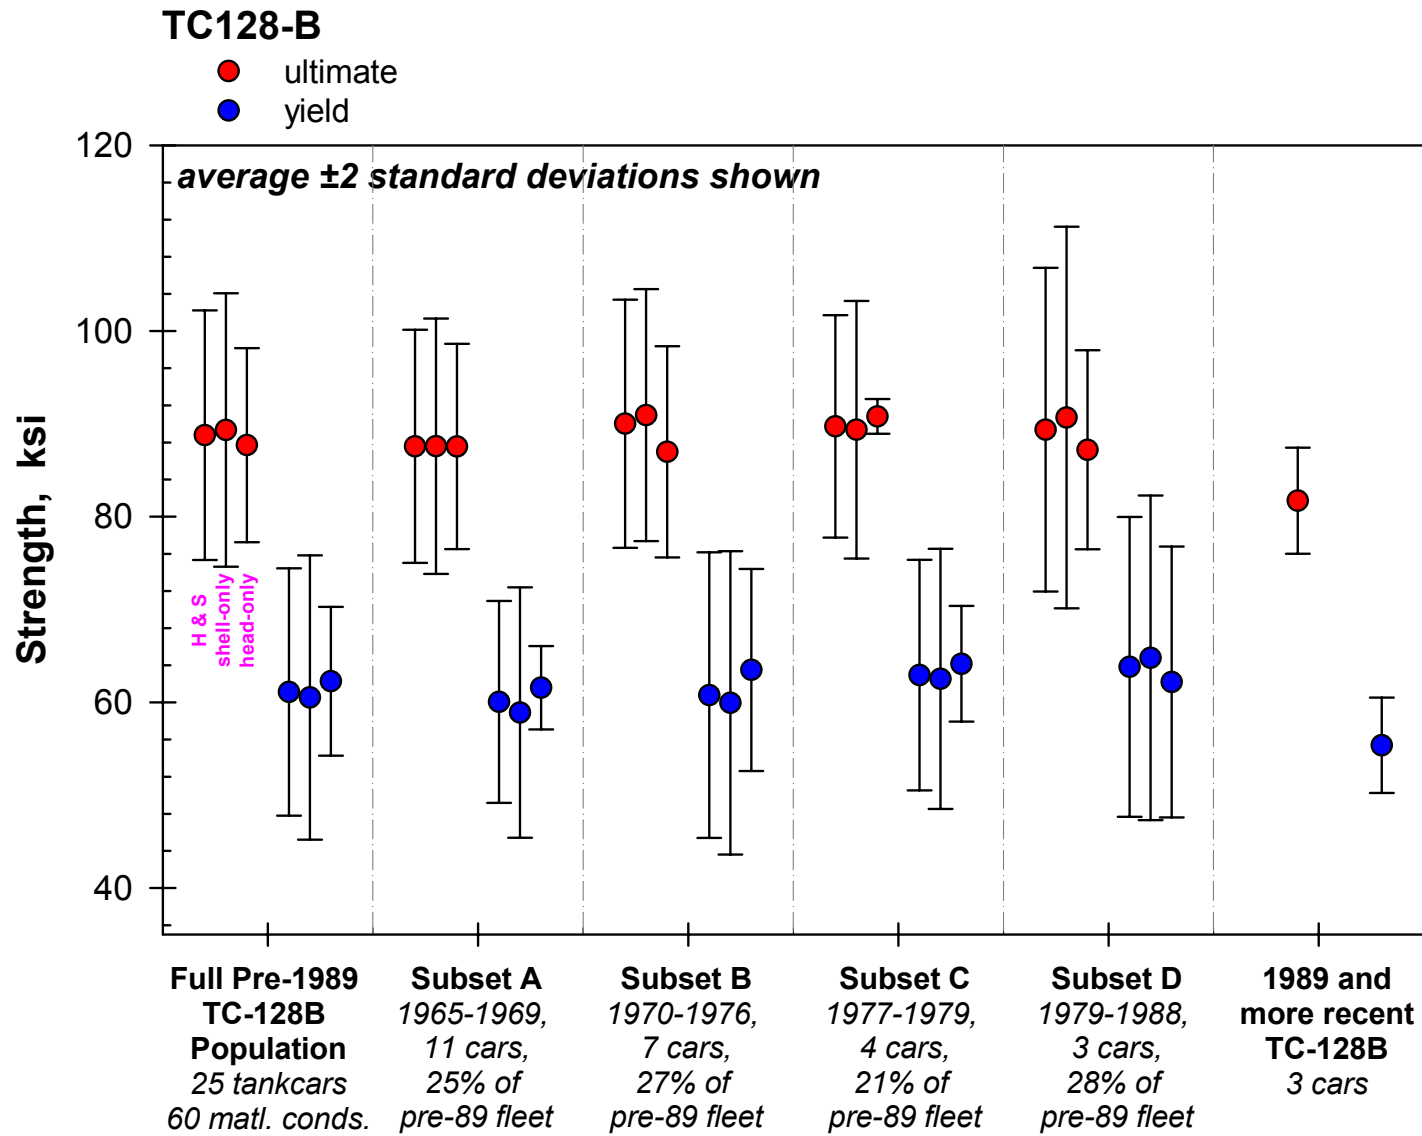
Figure 4-9. Strength properties of vintage TC128-B as a function of when manufactured.

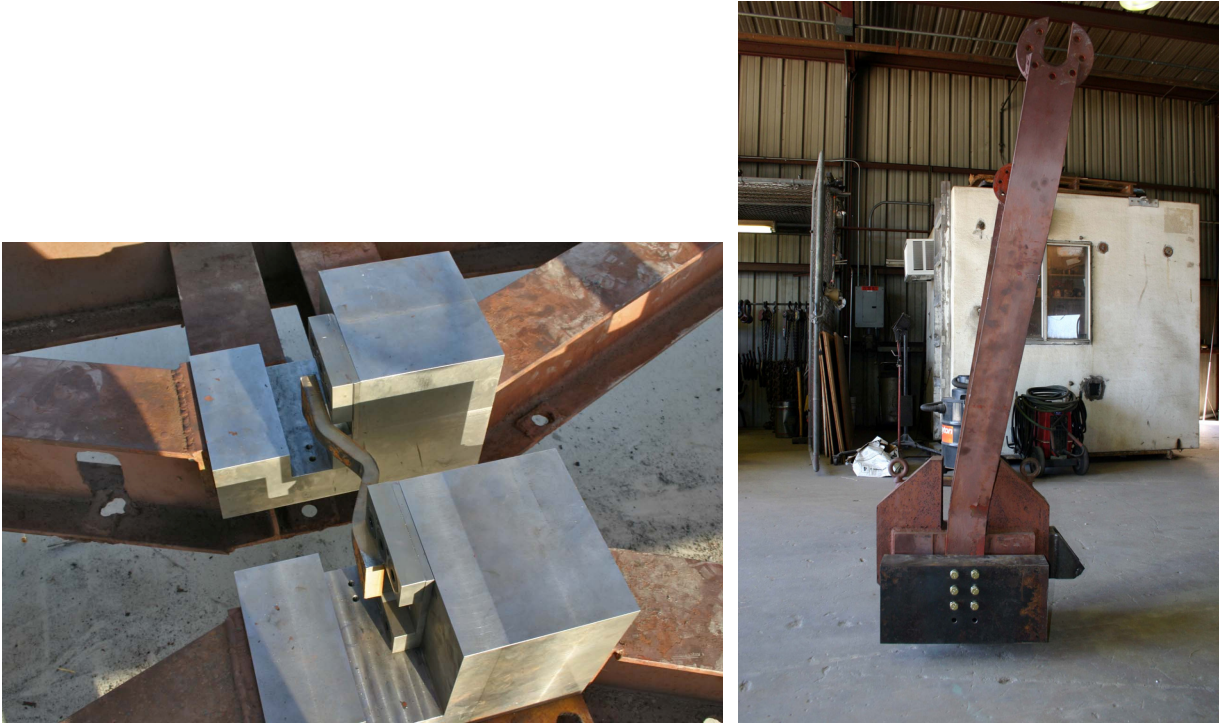
Figure 5-7. The original BFCM arm bent after attempting to fracture the first specimen.

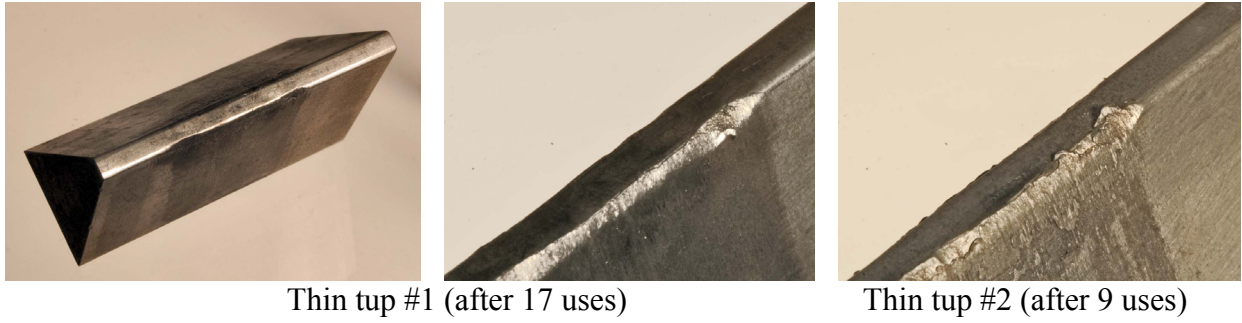
Figure 5-9. Worn tups after a number of different uses.

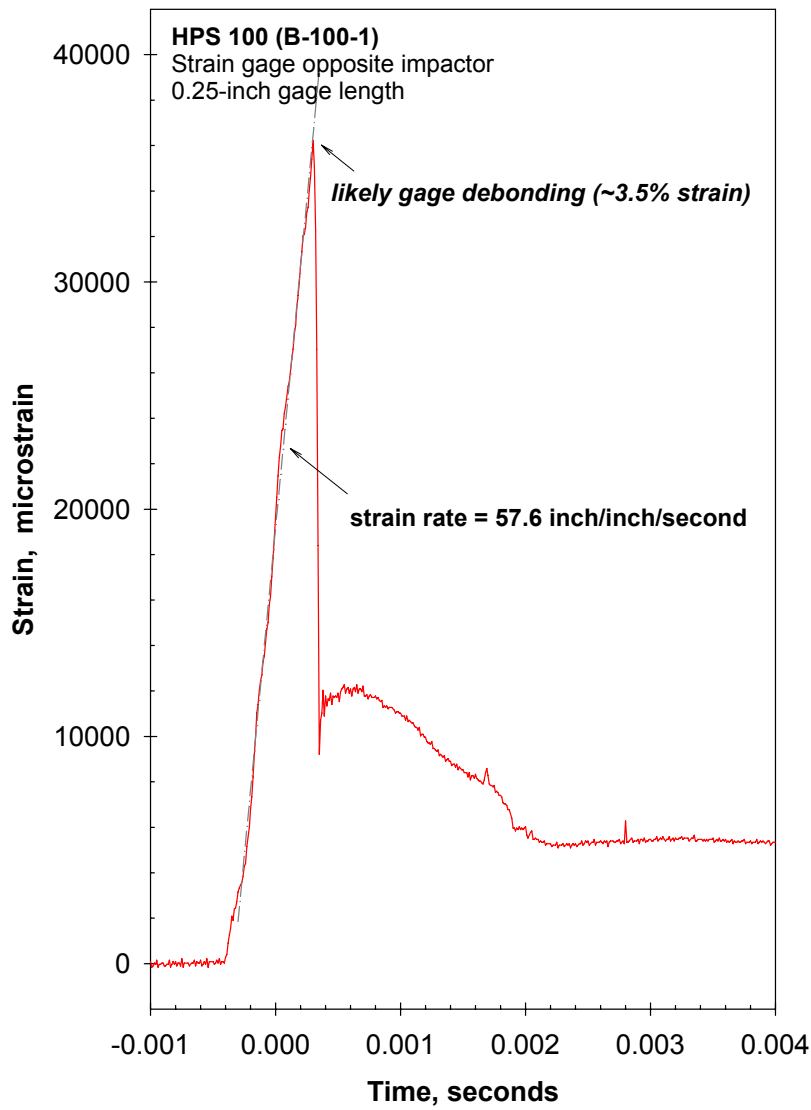
Figure 5-10. Measured strain response on the back of the specimen behind impactor.

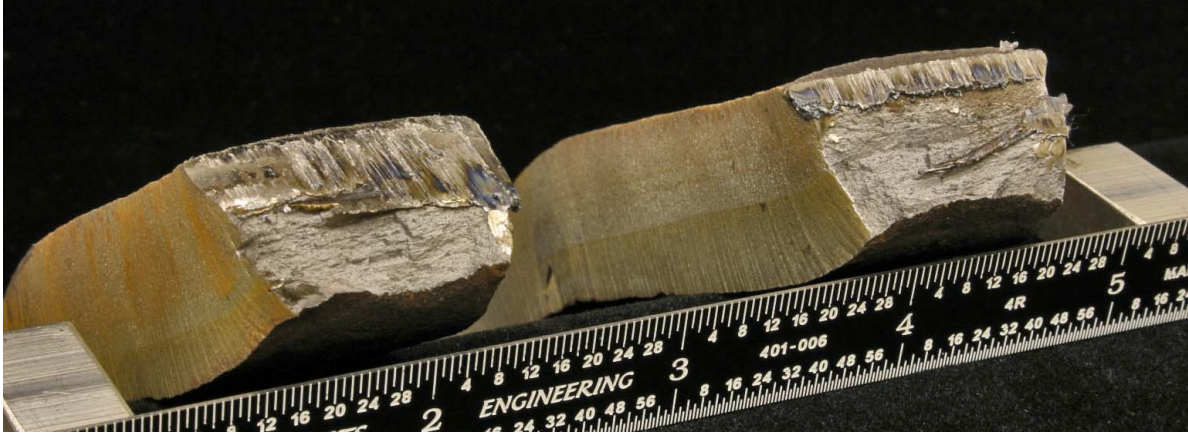
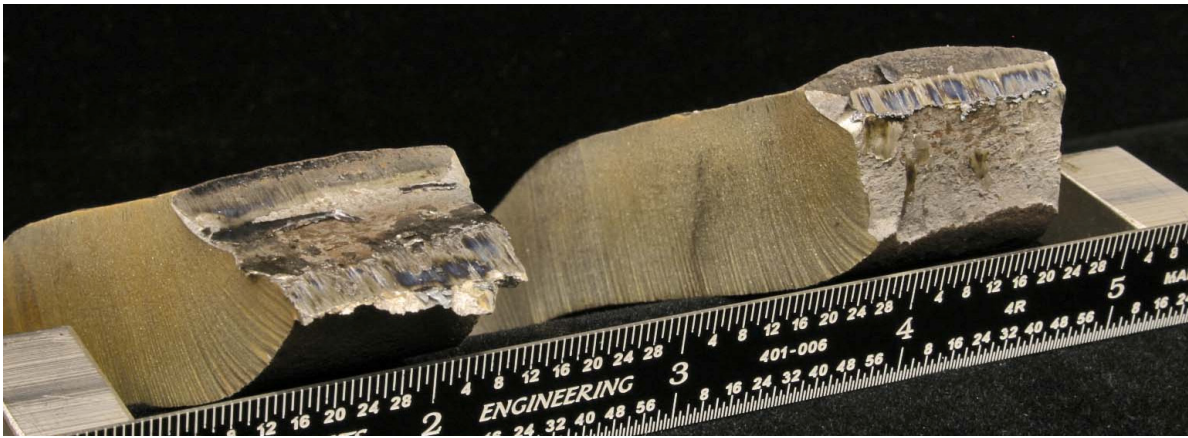
Figure 5-11. Typical BFCM fracture surfaces (sharpest top).

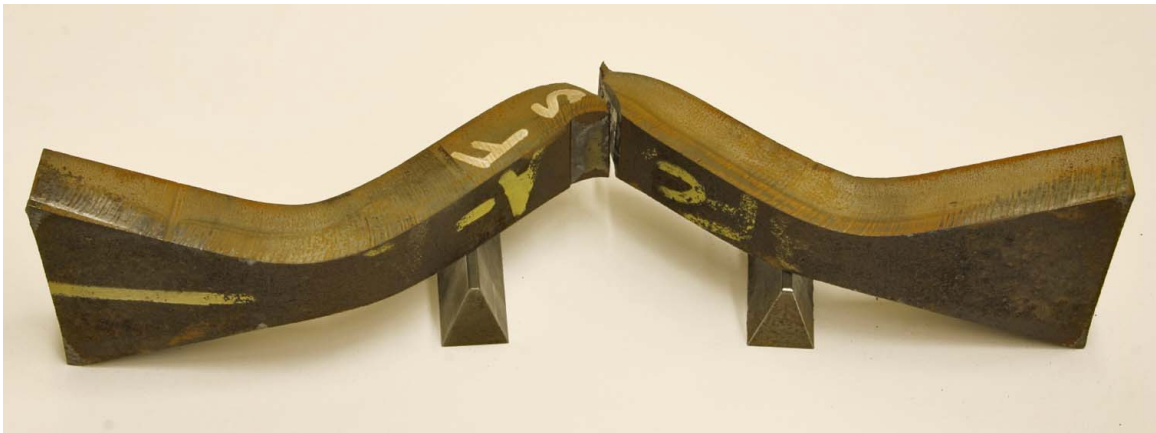
Figure 5-12. Deformation observed in a blunt impact specimen.
