MECHANICAL PROPERTIES OF TANK CAR STEELS RETIRED FROM THE FLEET

FINAL REPORT

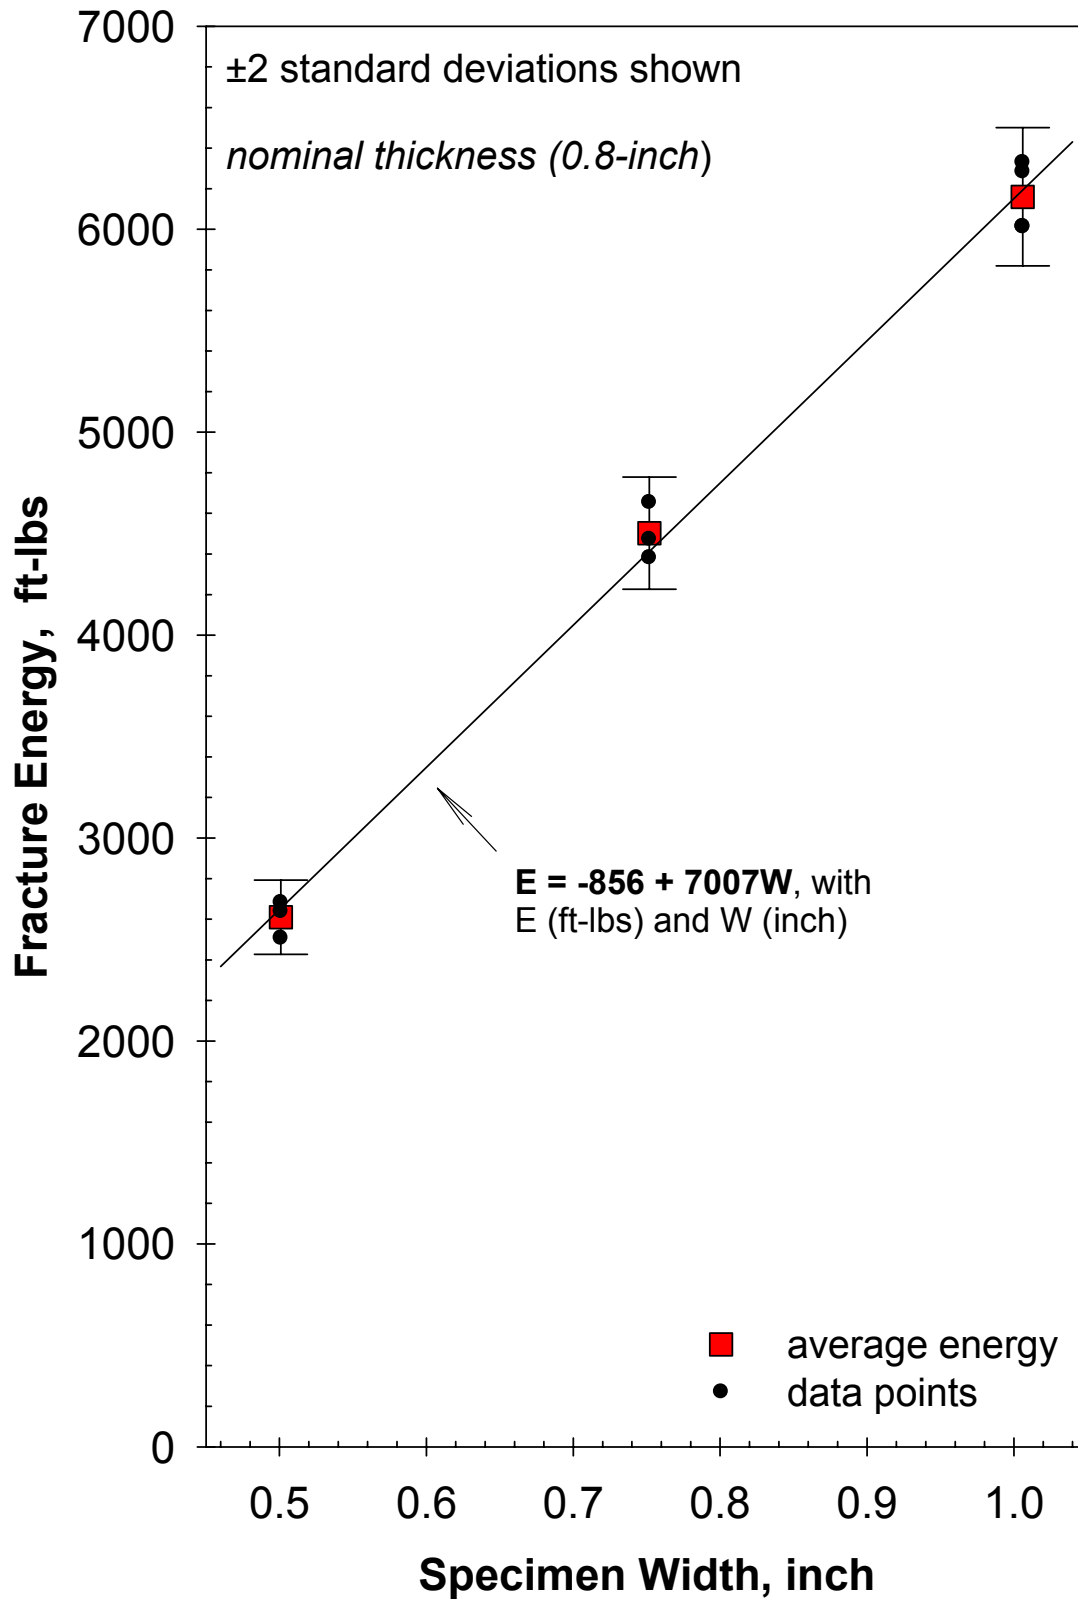
Figure 5-13. Effect of specimen width on the pendulum impact energy (sharpest tup).

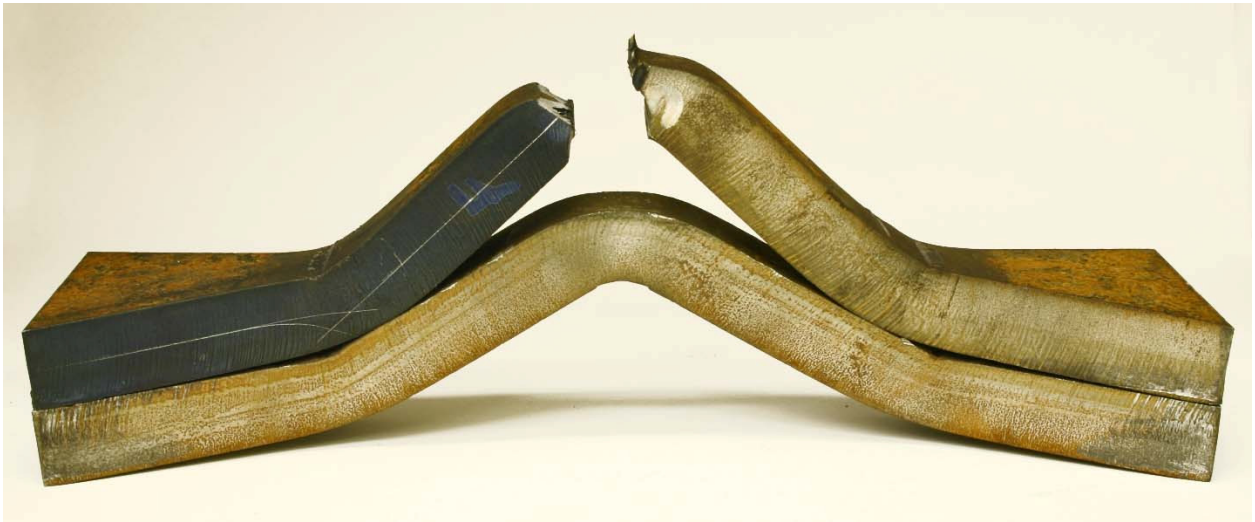
Figure 5-27. Comparison between the specimen that stalled the machine and a failed specimen.

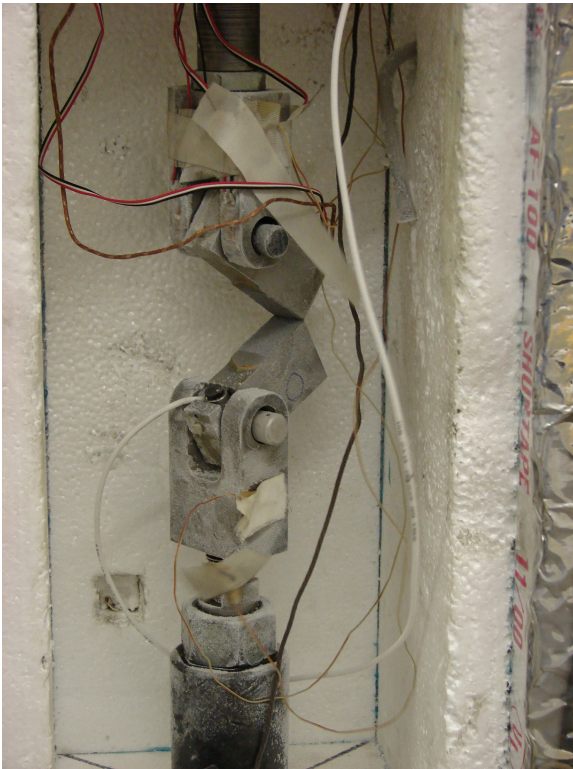
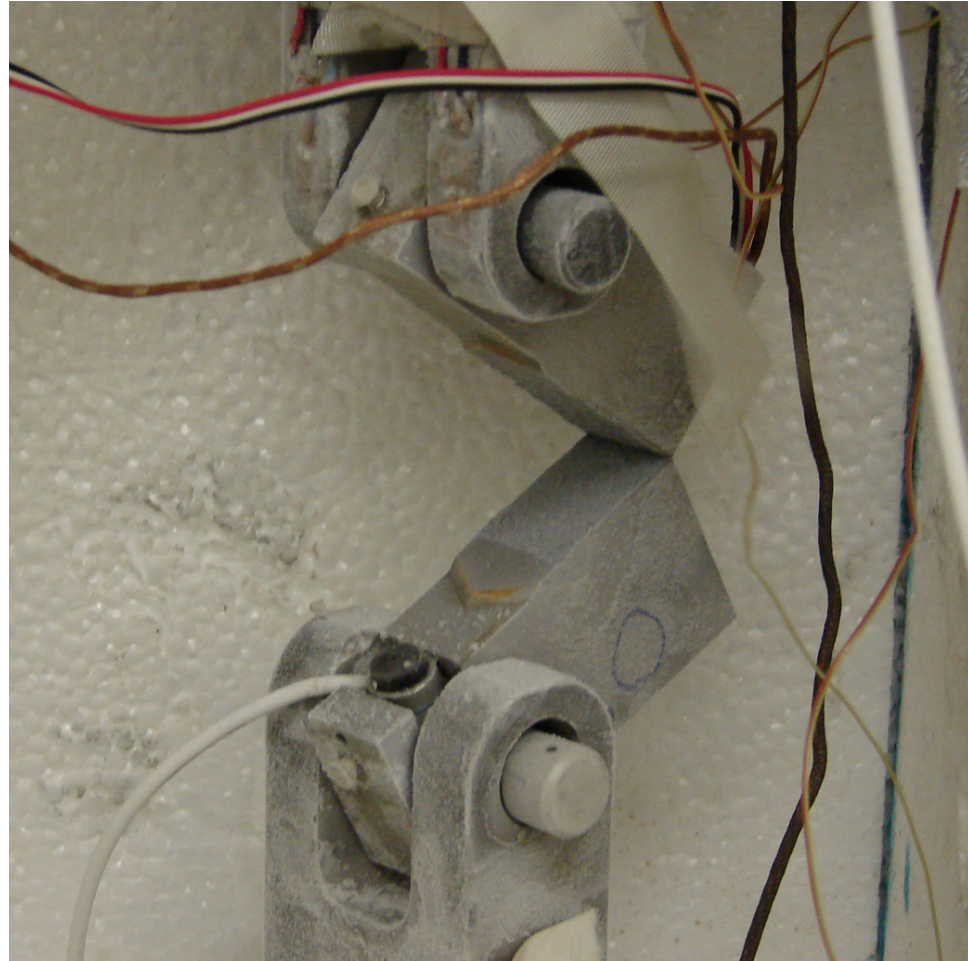
Figure 6-7. Immediately after a high rate, low temperature fracture test with frost formed on the fracture surface and the eddy current transducer exposed.

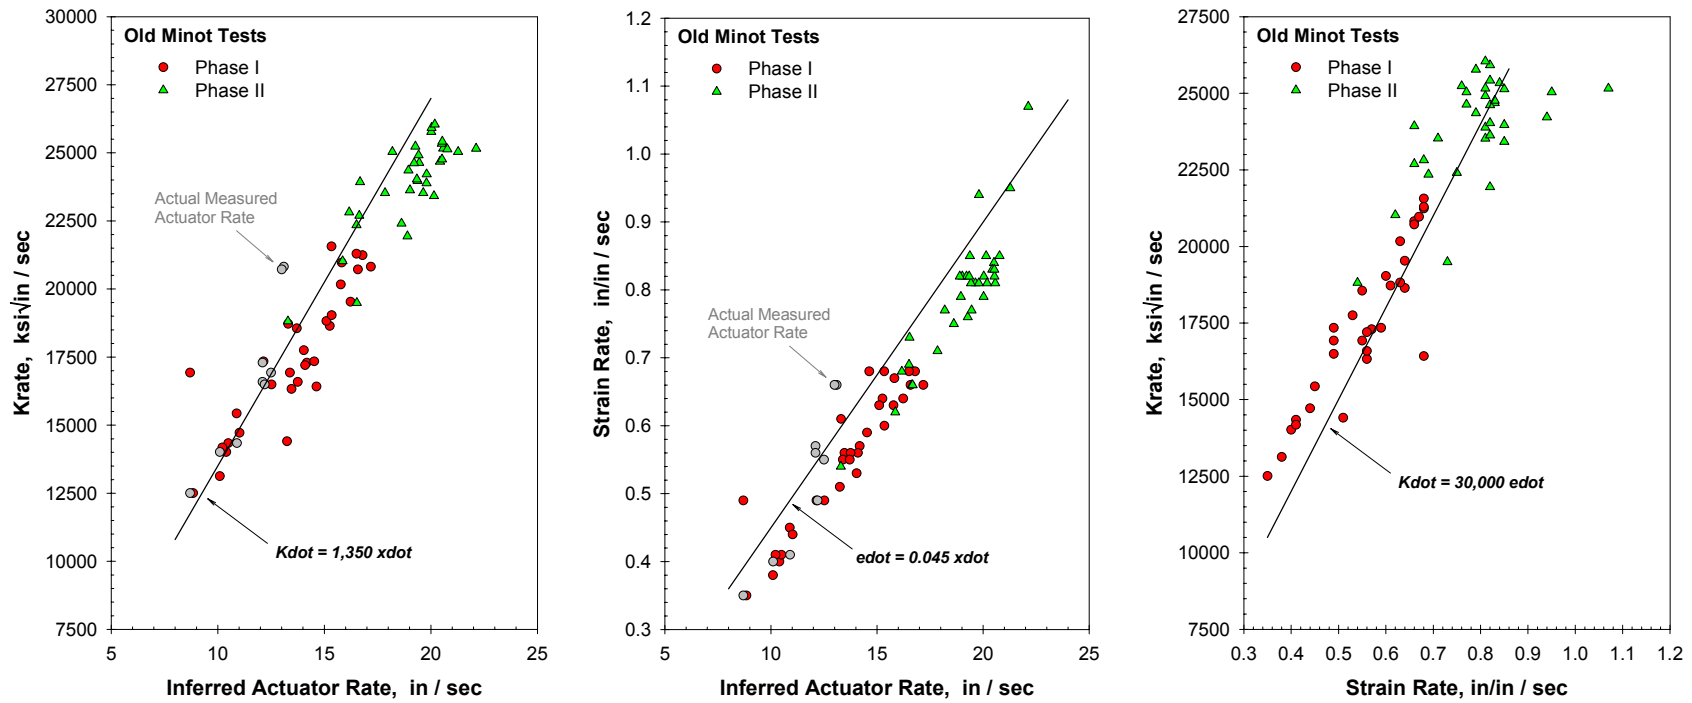
Figure 6-8. The data generated during the Minot testing was examined to establish the relationship between applied stress intensity factor rate (K-rate), actuator rate and strain rate.

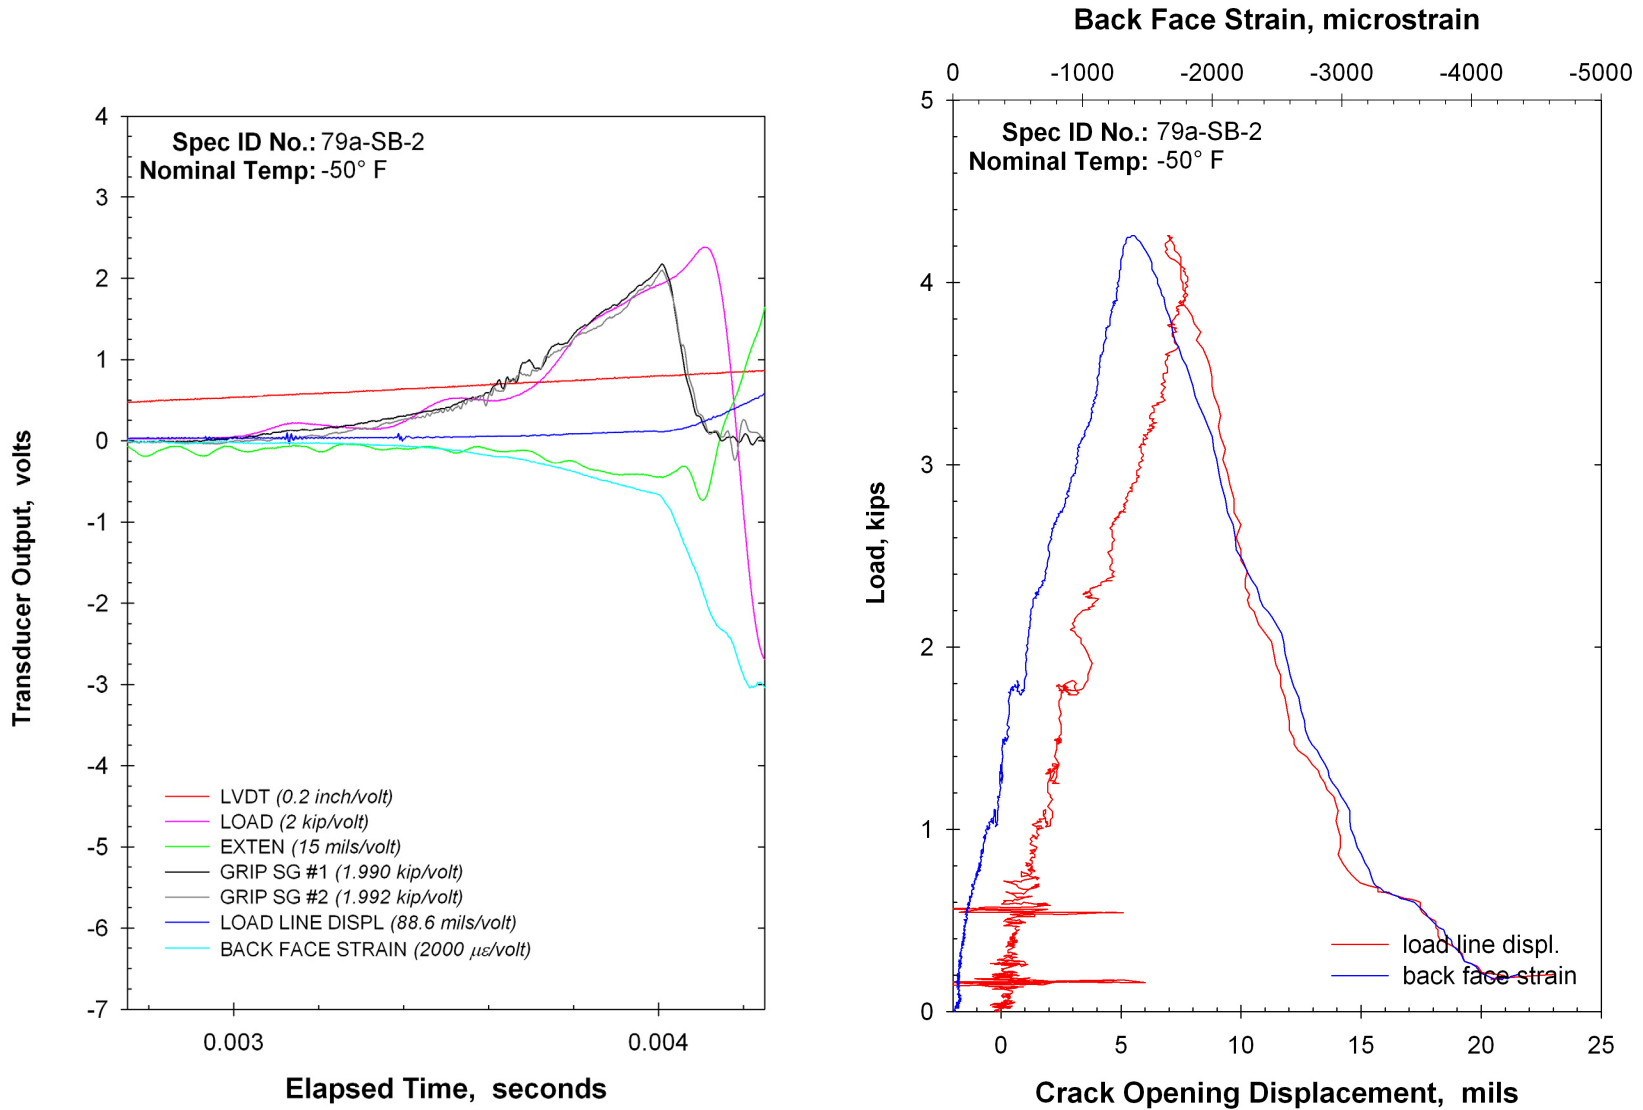
Figure 6-15. Example data from a “brittle” fracture toughness test.

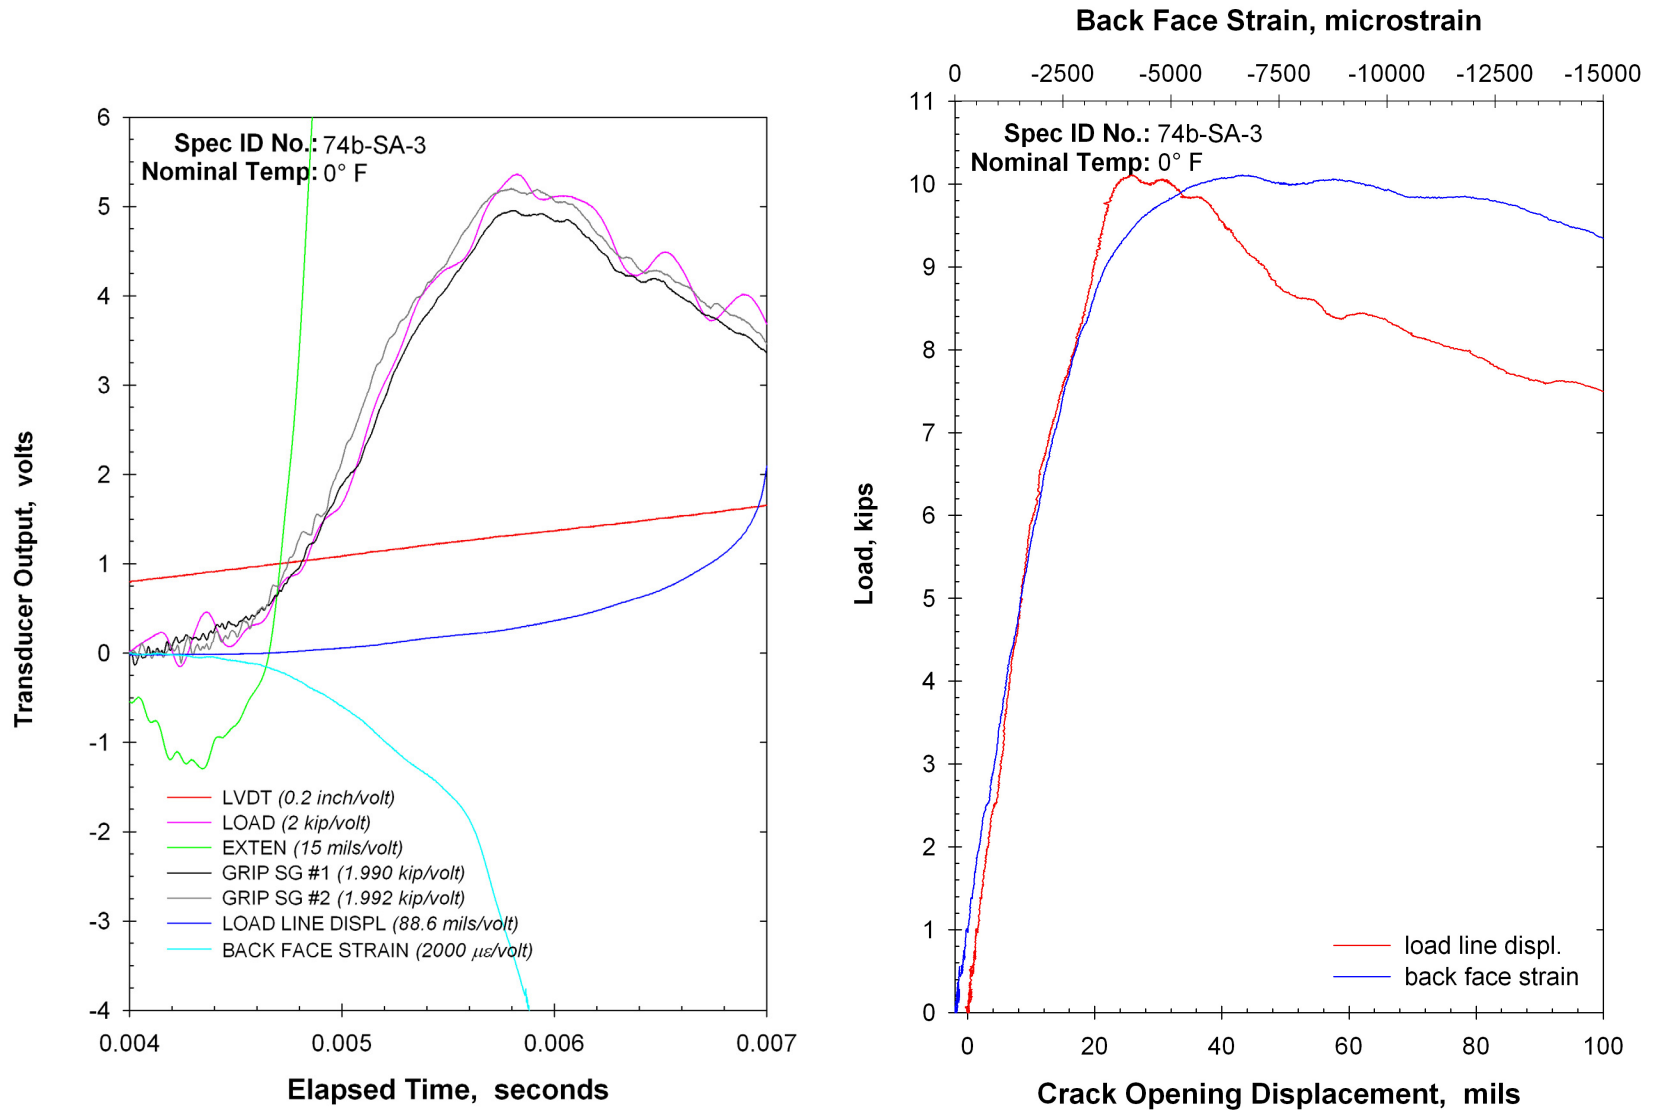
Figure 6-16. Example data from a “ductile” fracture toughness test.

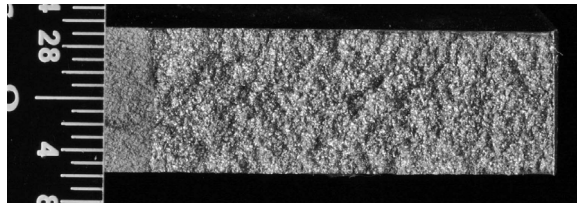
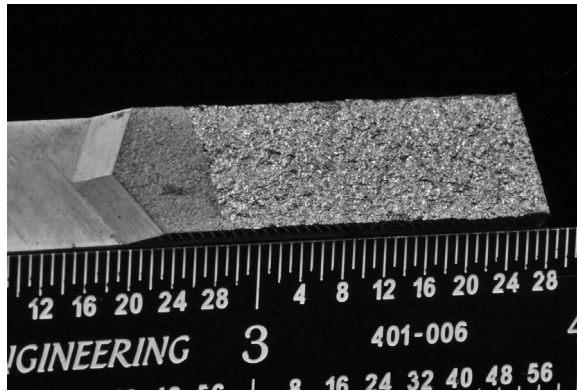
65a-HA-2 ($T=-50^{\circ}F$, $K_{Jmax} = 39.4 \text{ ksi } \sqrt{in}$)

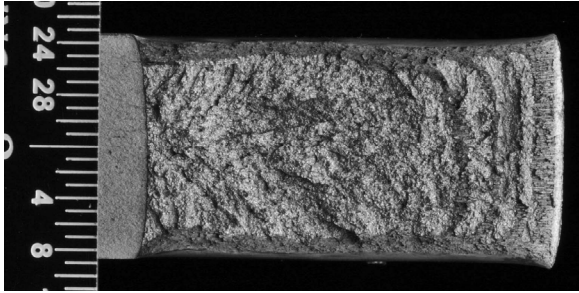
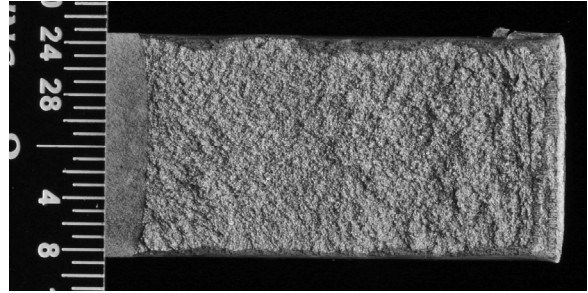
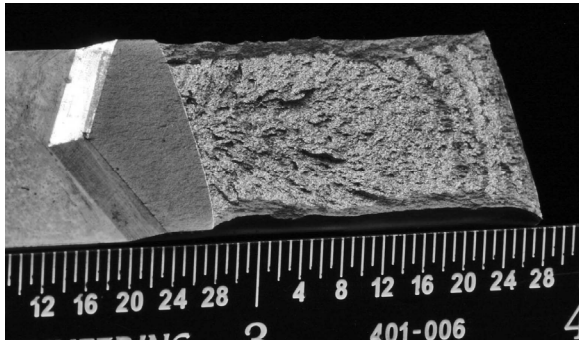
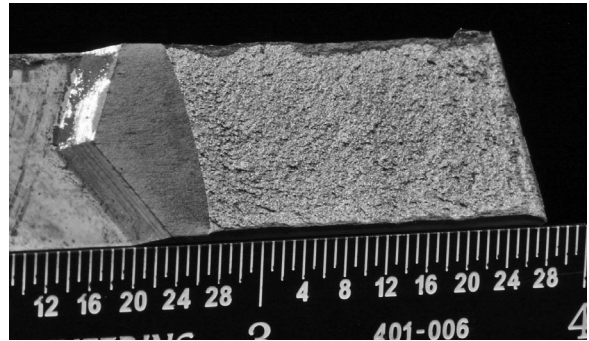
94a-SA-1 ($T=0^{\circ}\text{F}$, $K_{Jmax} = 103.8 \text{ ksi } \sqrt{\text{in}}$)

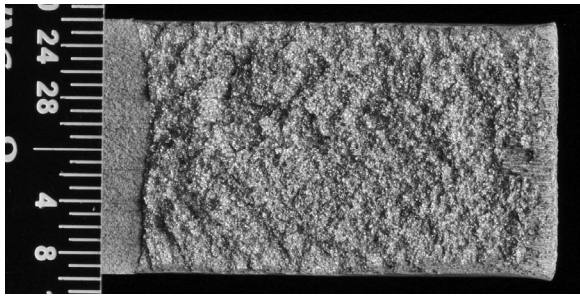
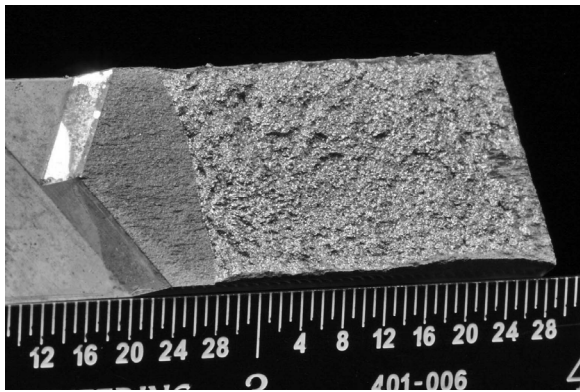
66b-SA-1 ($T=0^{\circ}\text{F}$, $K_{Jmax} = 79.7 \text{ ksi}\sqrt{\text{in}}$)

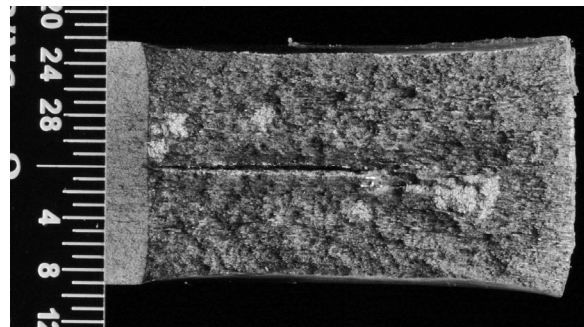
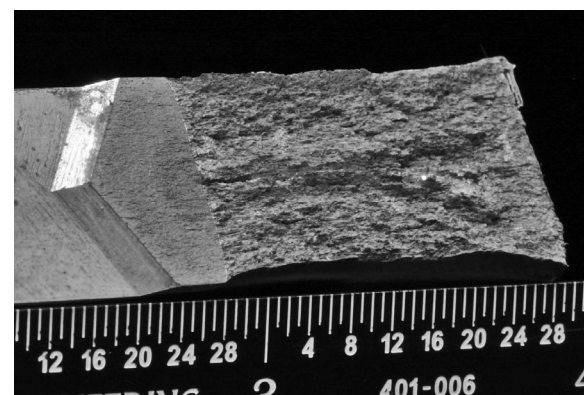
75a-HA-2 ($T=-50^{\circ}\text{F}$, $K_{Jmax} = 113.8 \text{ ksi}\sqrt{\text{in}}$)

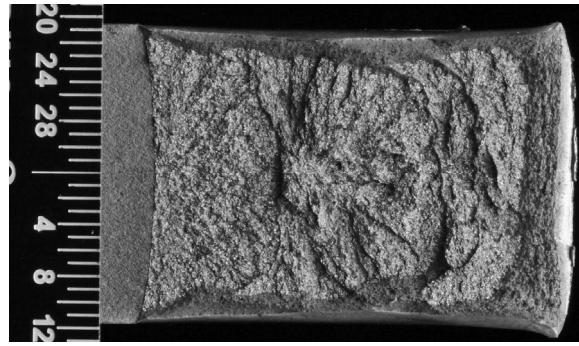
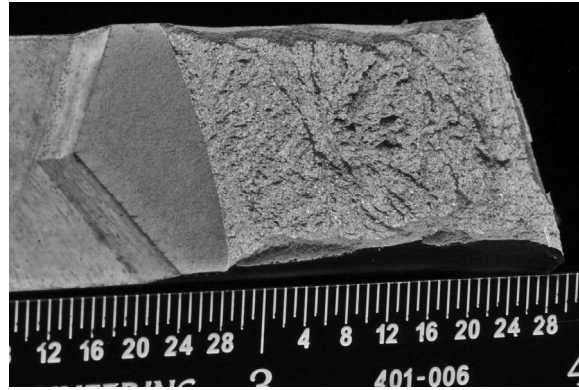
80a-HA-2 ($T=-50^{\circ}\text{F}$, $K_{Jmax} = 91.7 \text{ ksi } \sqrt{\text{in}}$)

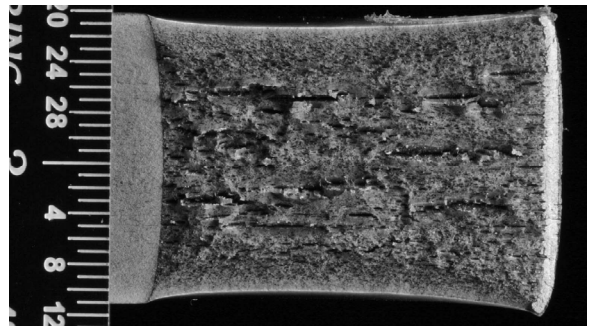
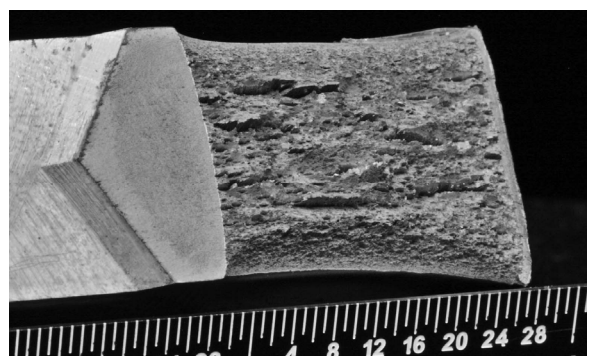
82a-HA-3 ($T=0^{\circ}\text{F}$, $K_{Jmax} = 130.2 \text{ ksi } \sqrt{\text{in}}$)

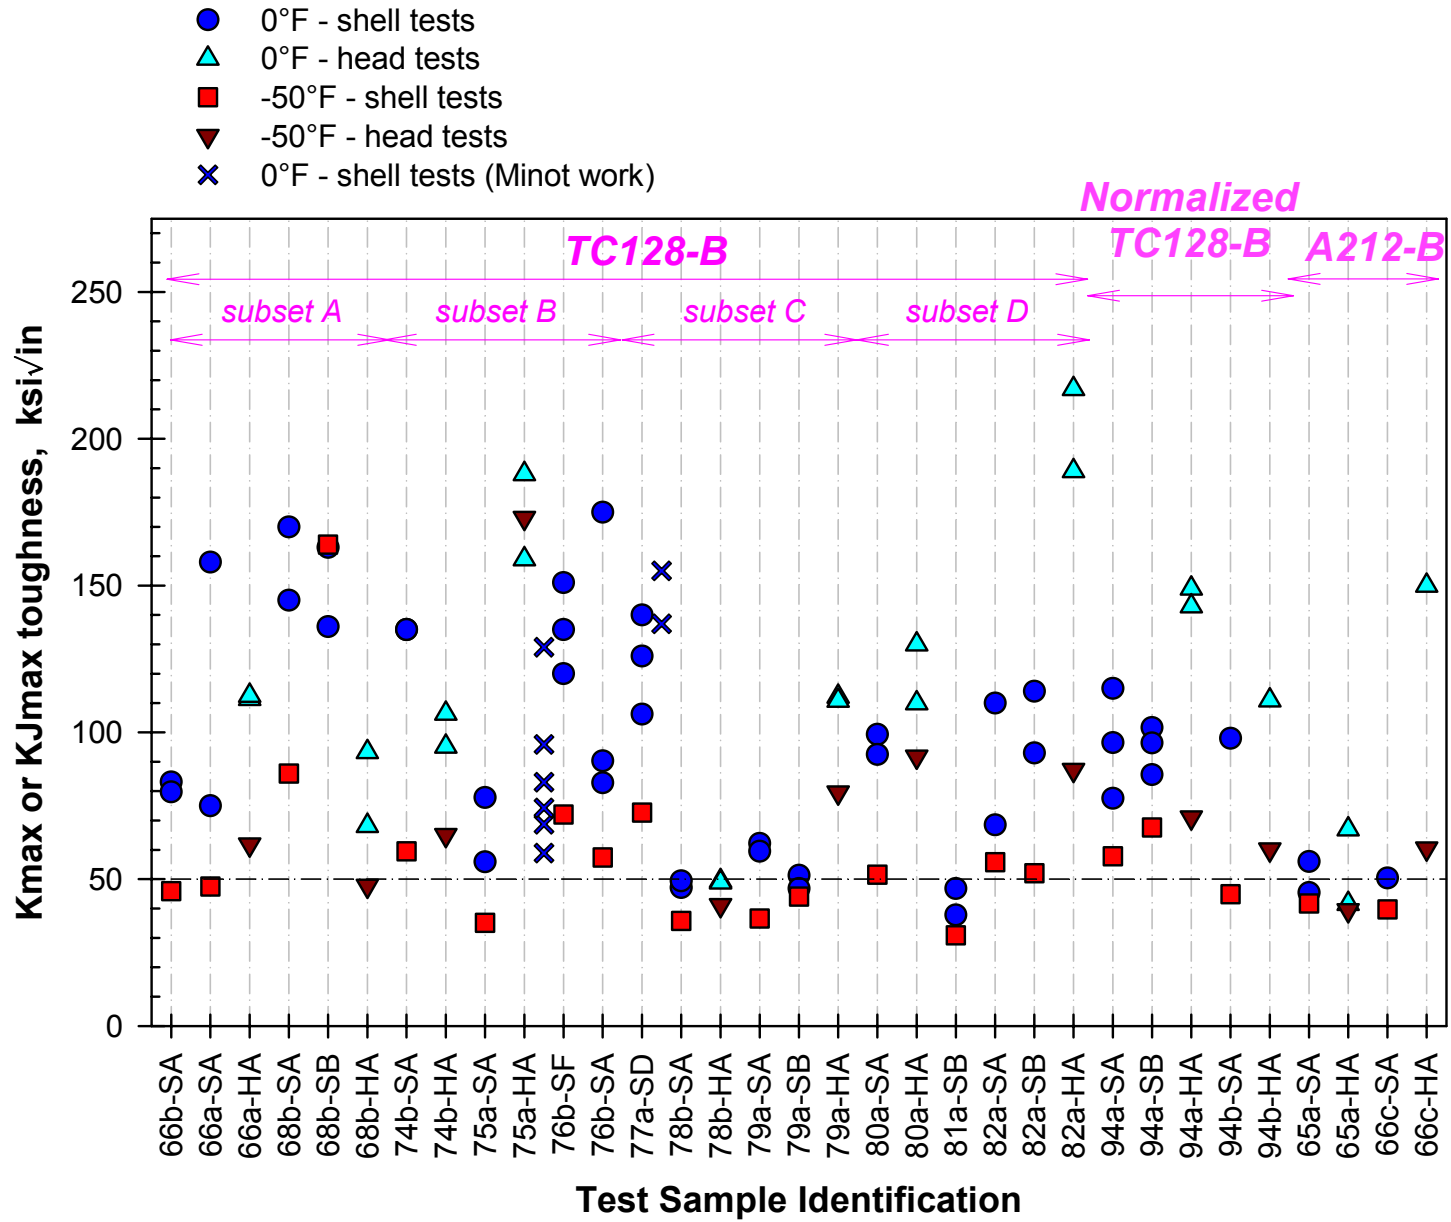
Figure 6-21. Fracture toughness plotted as a function of year for the different classifications of materials.

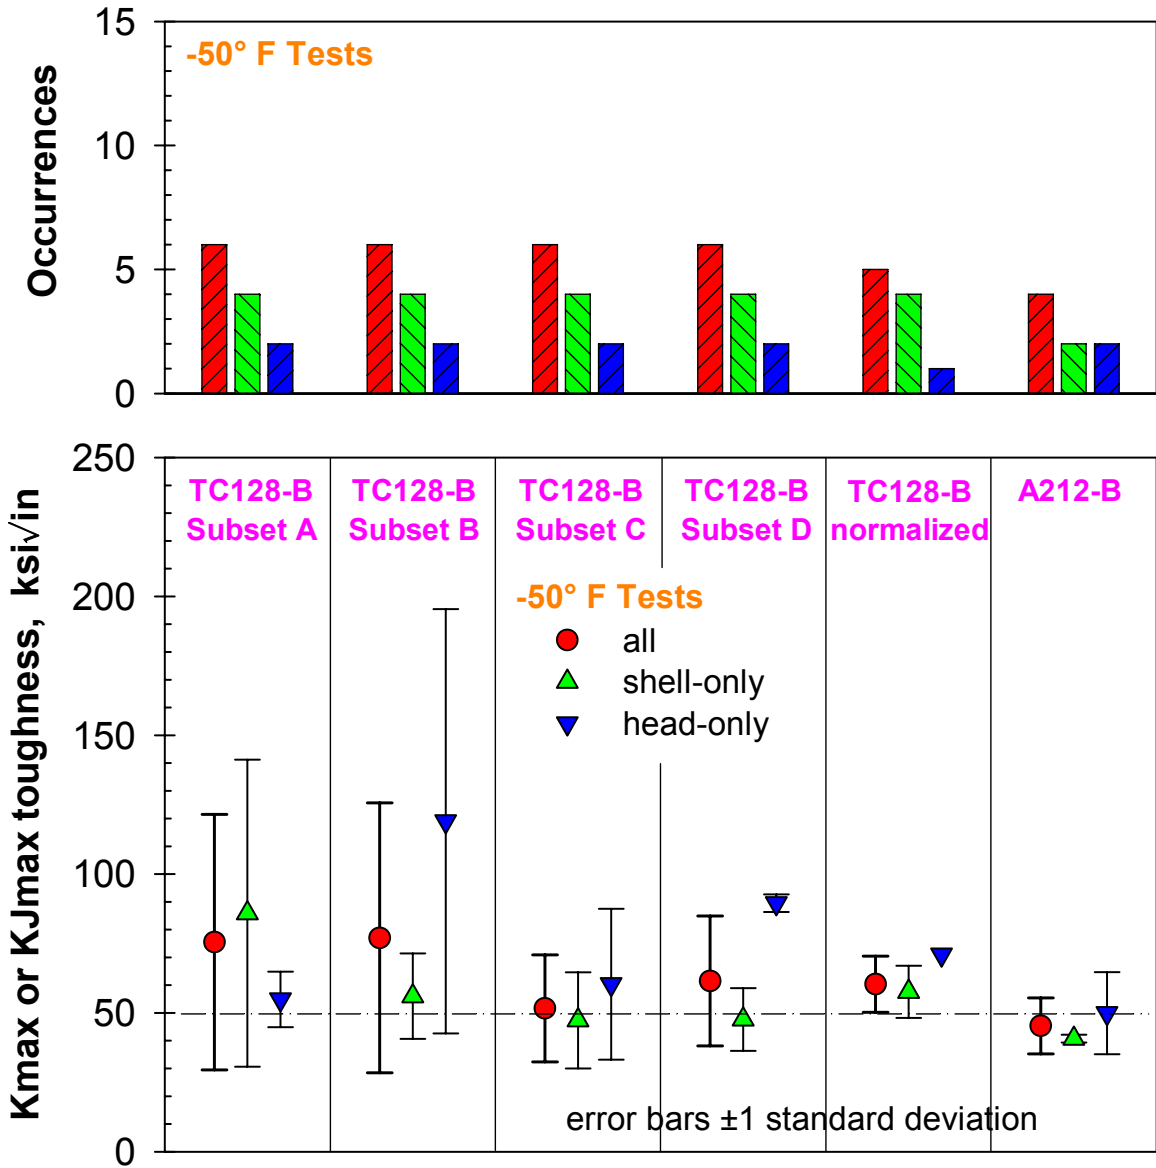
Figure 6-23. Fracture toughness average for the different ages/materials at -50°F.

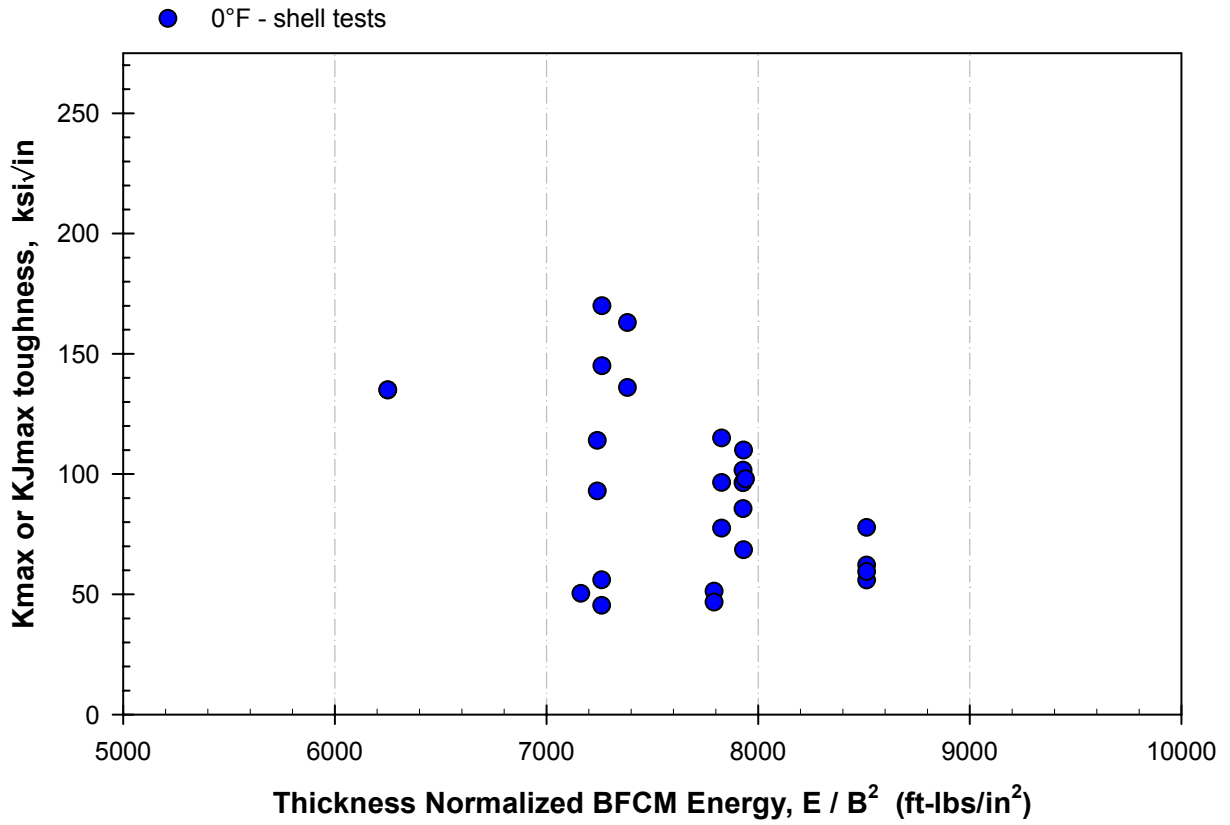
Figure 6-25. Fracture toughness variation with thickness normalized BFCM energy.

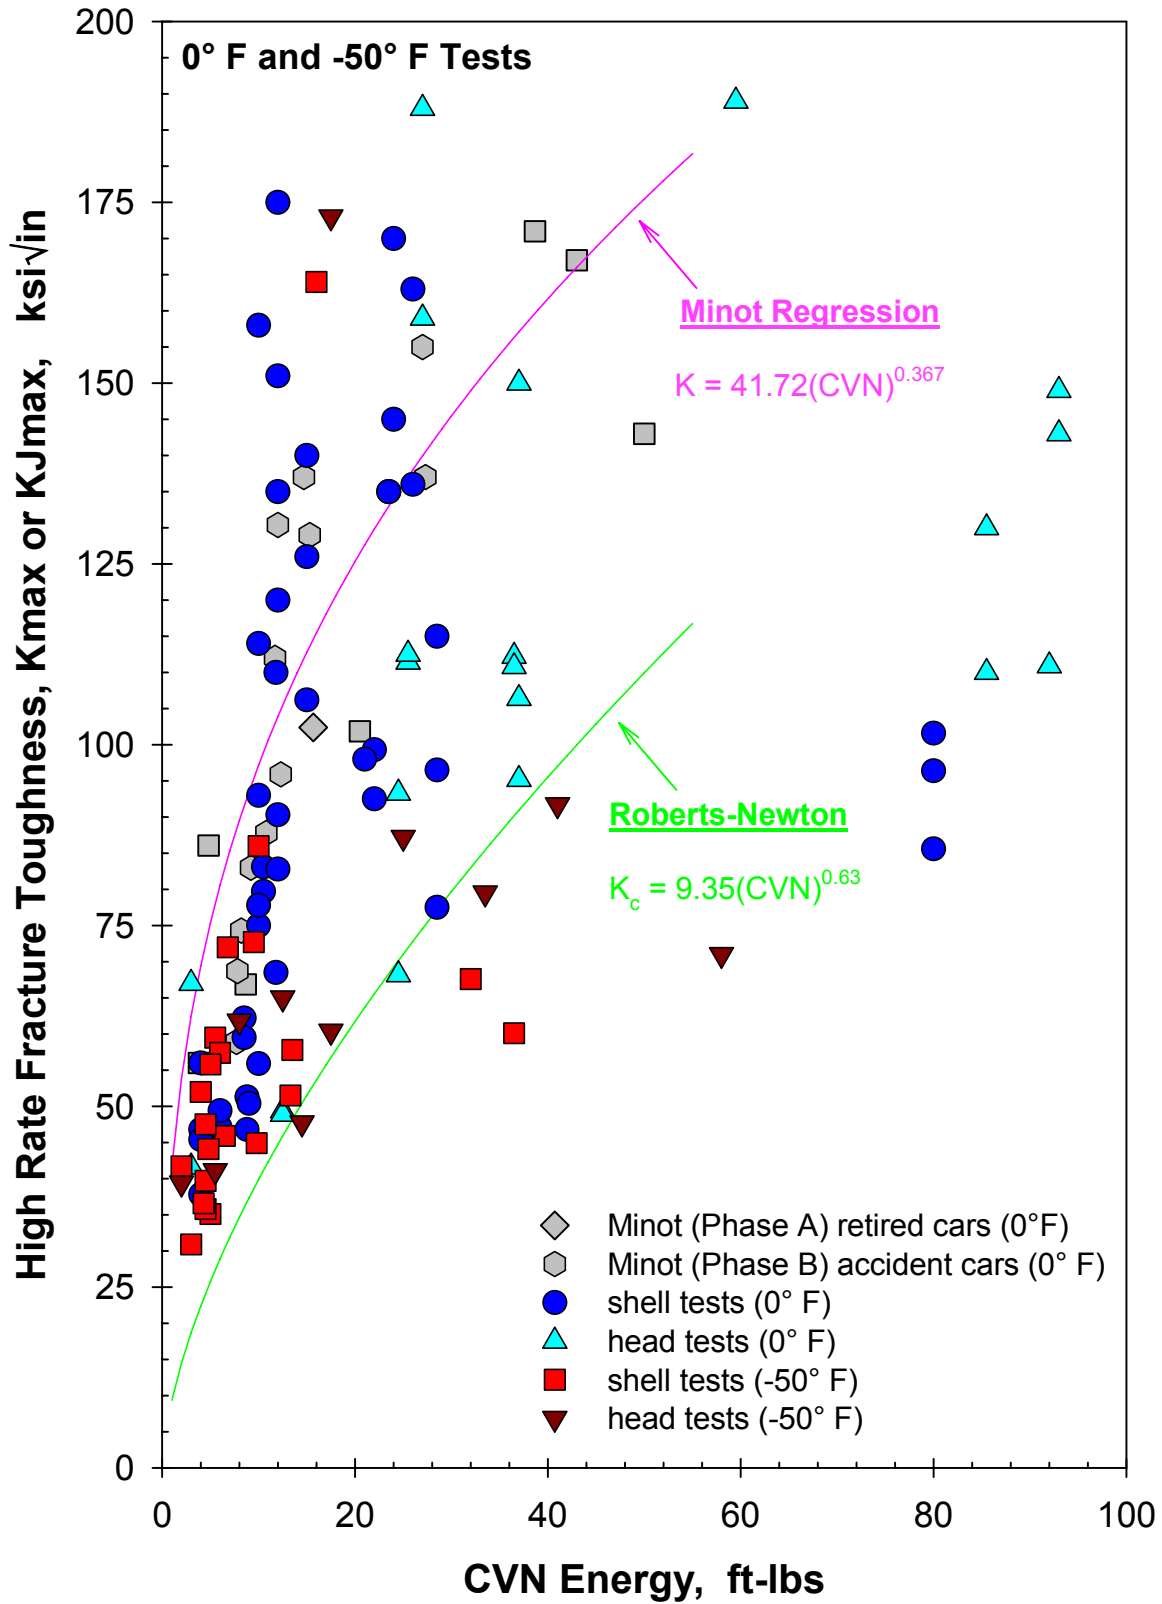
Figure 6-26. Fracture toughness as a function of CVN energy (at relevant temperature).

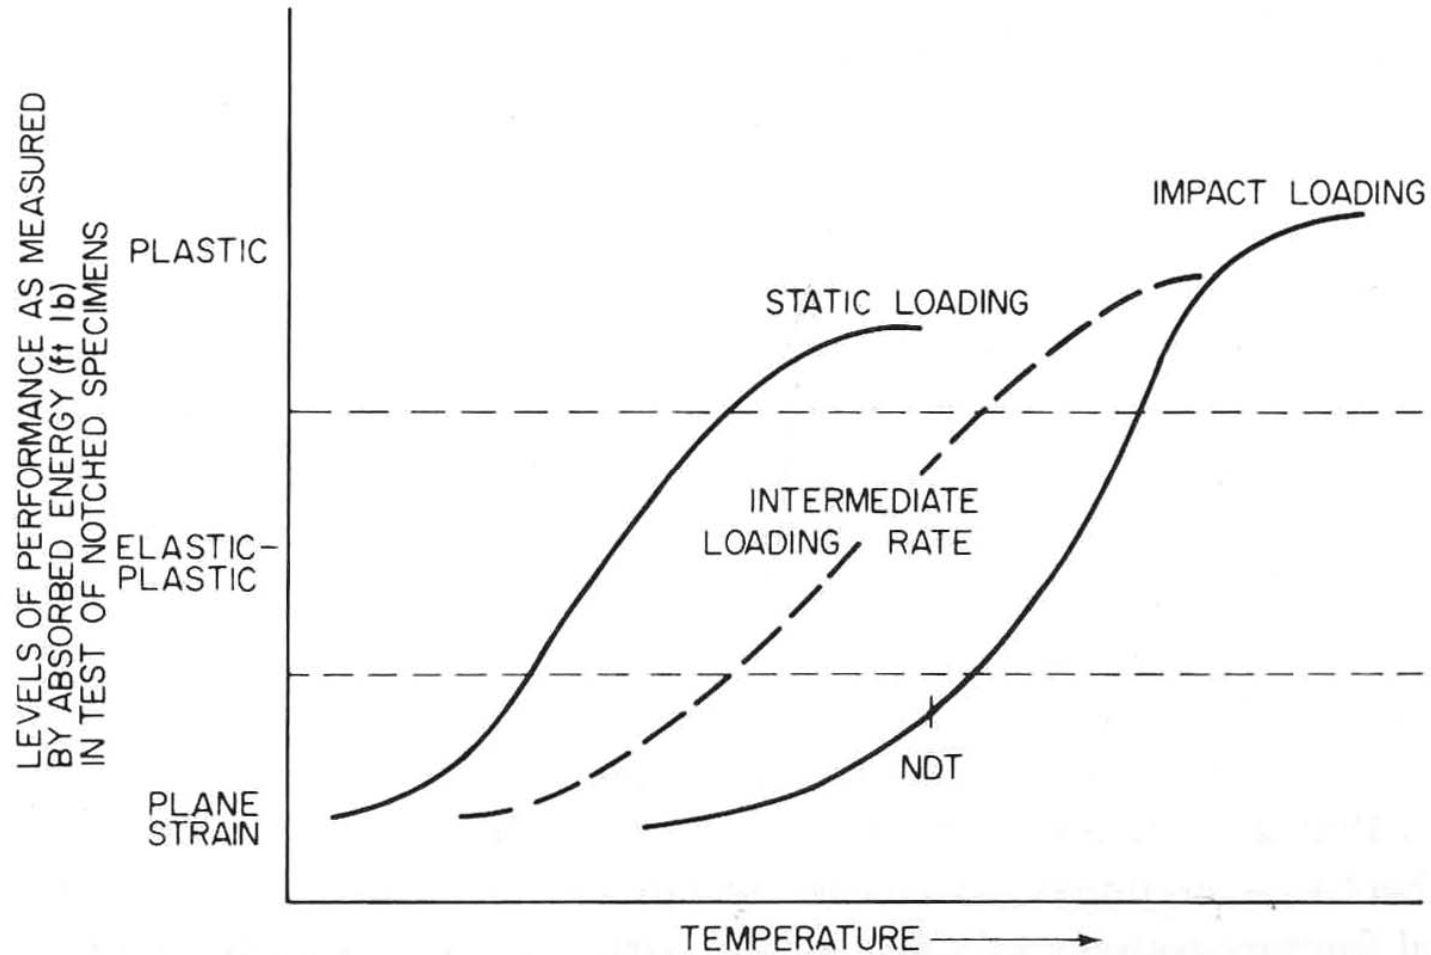
Figure 7-1. Variation in toughness as a function of temperature and loading rate (from reference [14]).

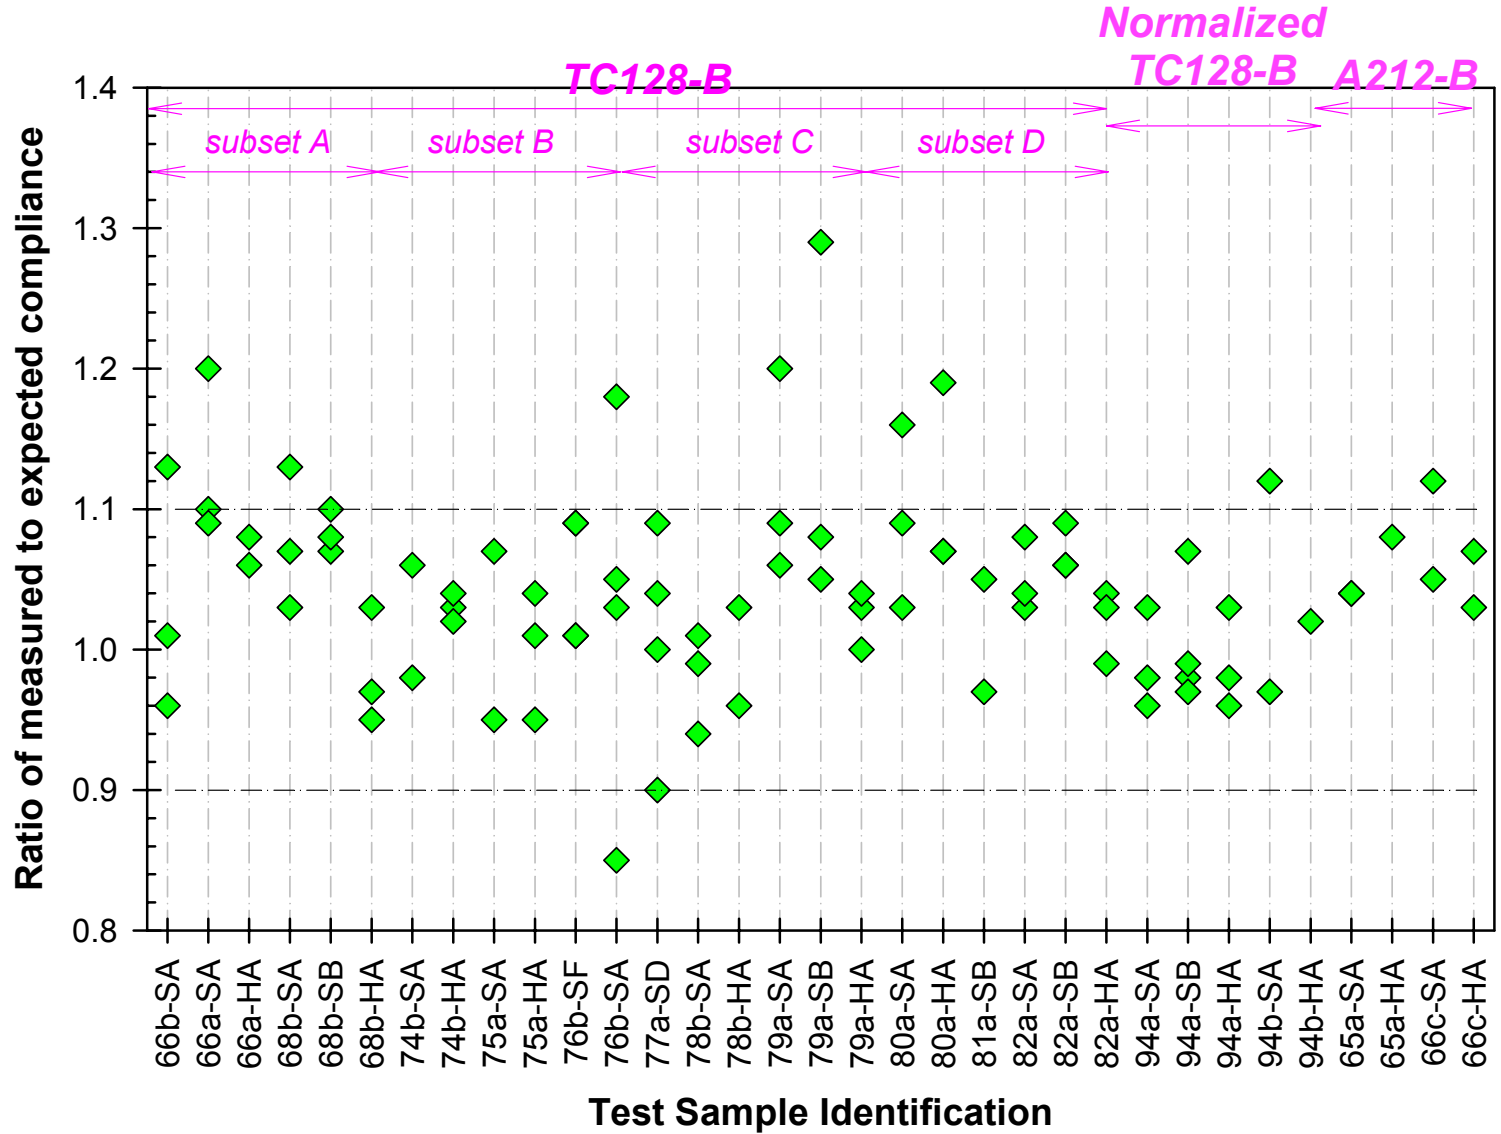
Figure 7-3. Comparison between expected compliance (based on crack length) to measured compliance.

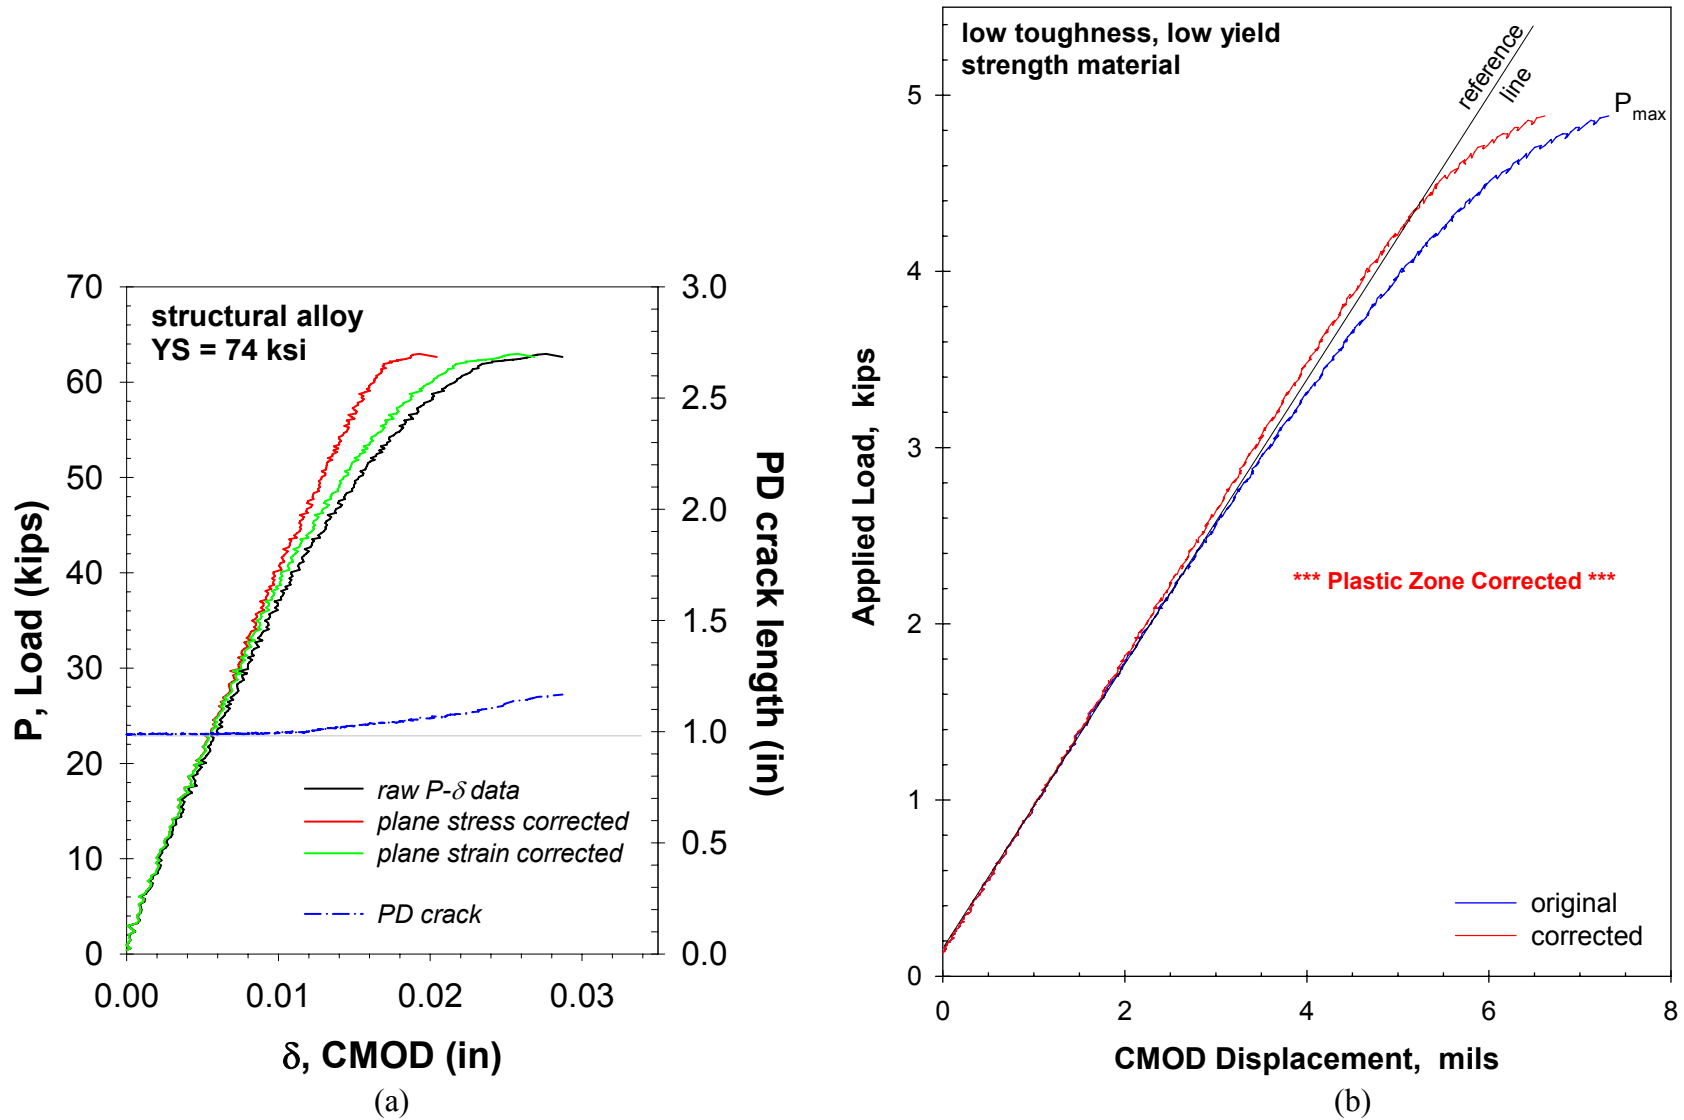
Figure 7-4. Sample nonlinear data where the majority of the nonlinearity is plastic zone growth for two different tests/materials.
