MECHANICAL PROPERTIES OF TANK CAR STEELS RETIRED FROM THE FLEET

FINAL REPORT

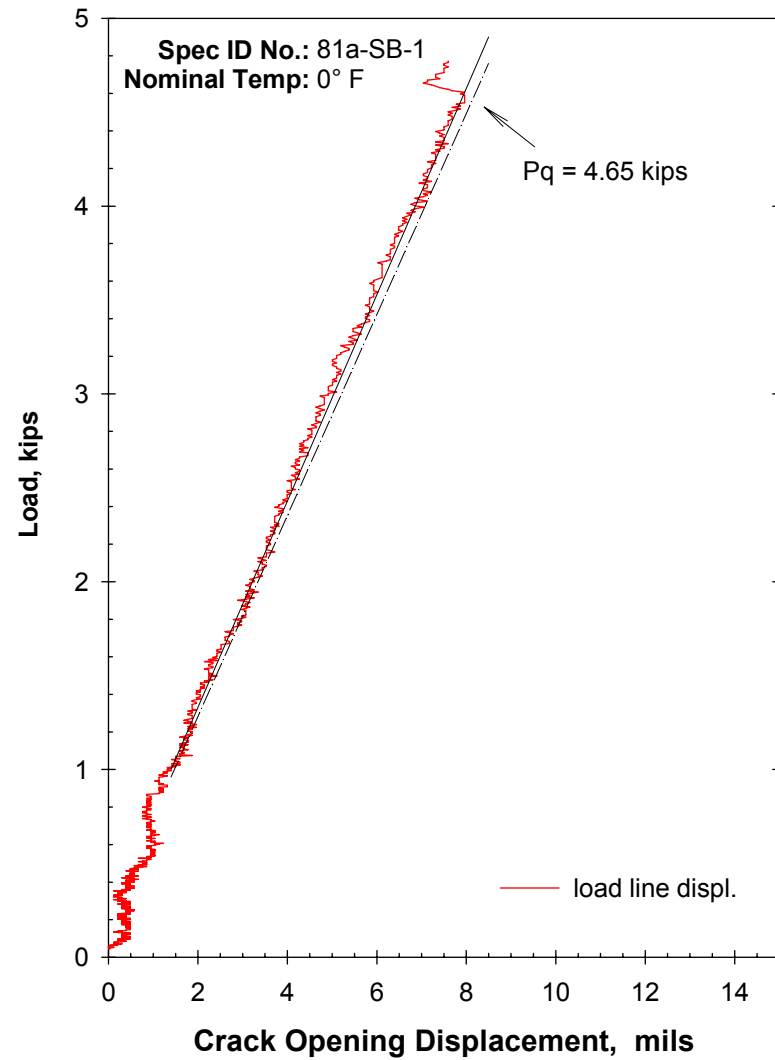
(b) after Fourier polynomial load smoothing

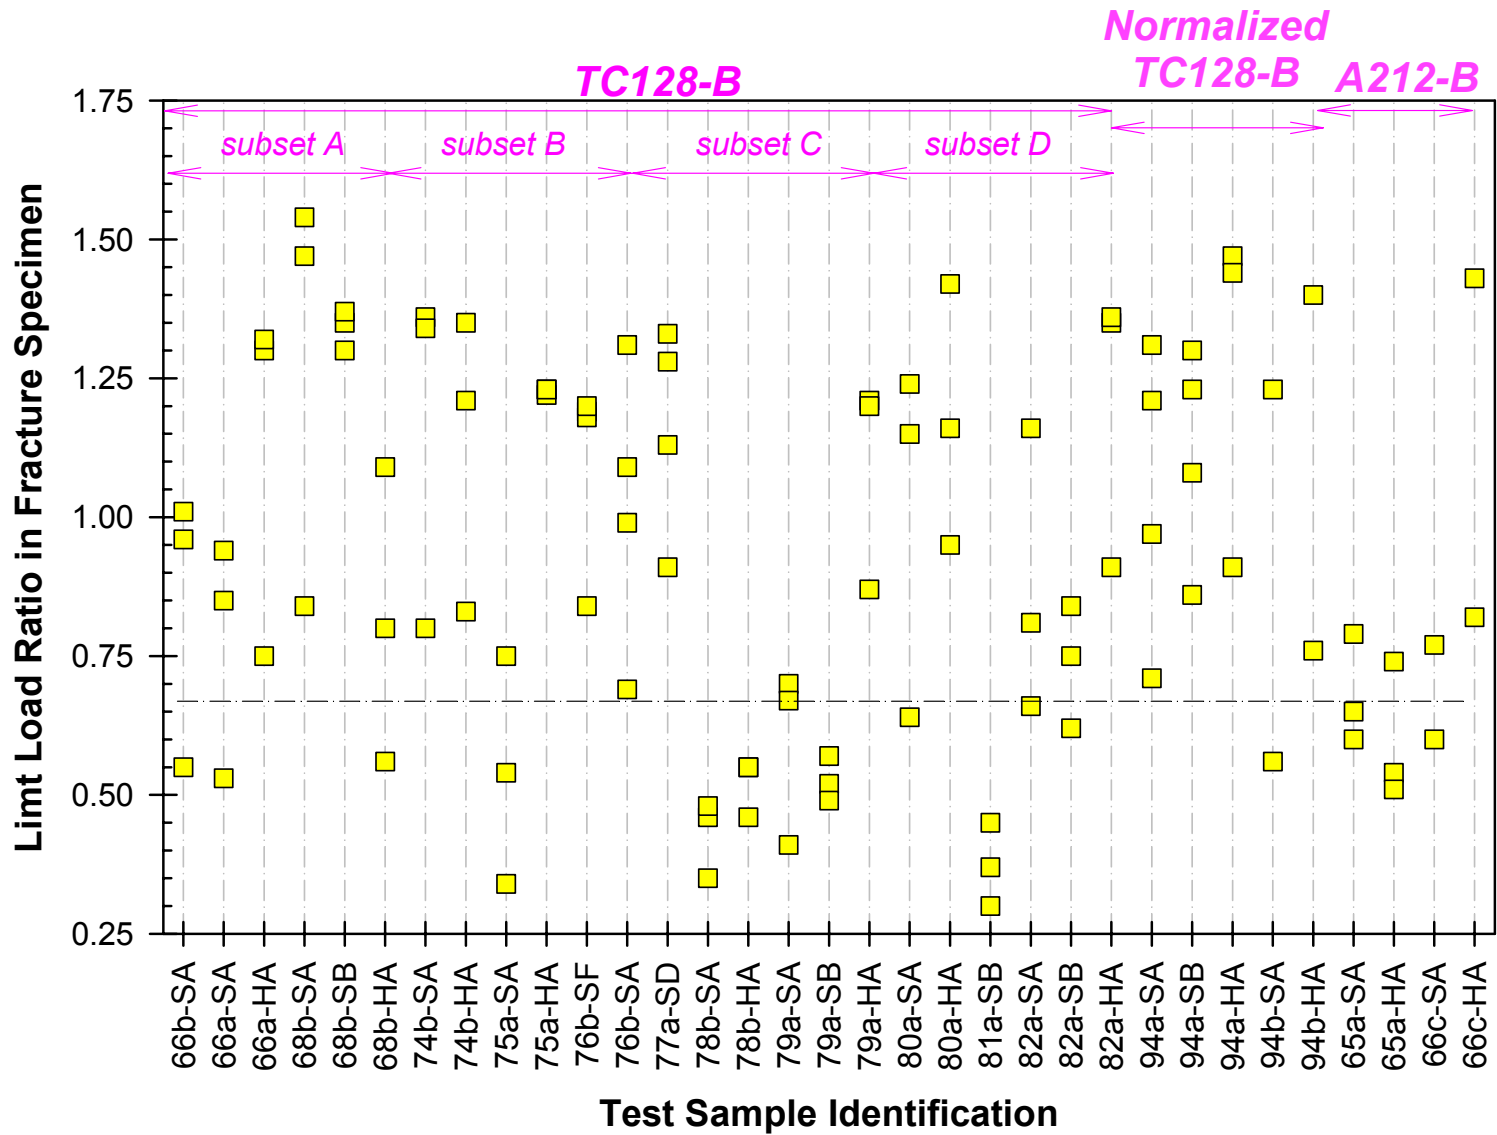
Figure 7-8. Variation of limit load ratio (ratio of max load to the limit load of the specimen) for all tests.

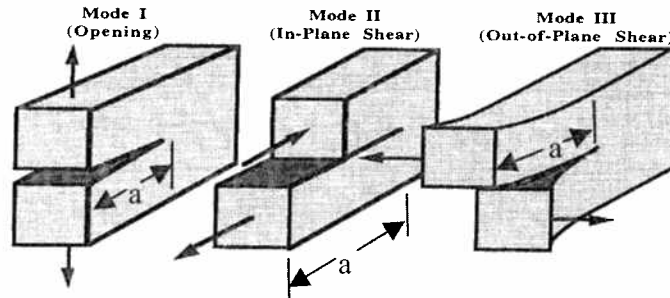
Figure 1. Deformation Mechanisms Associated with Three Fracture Modes

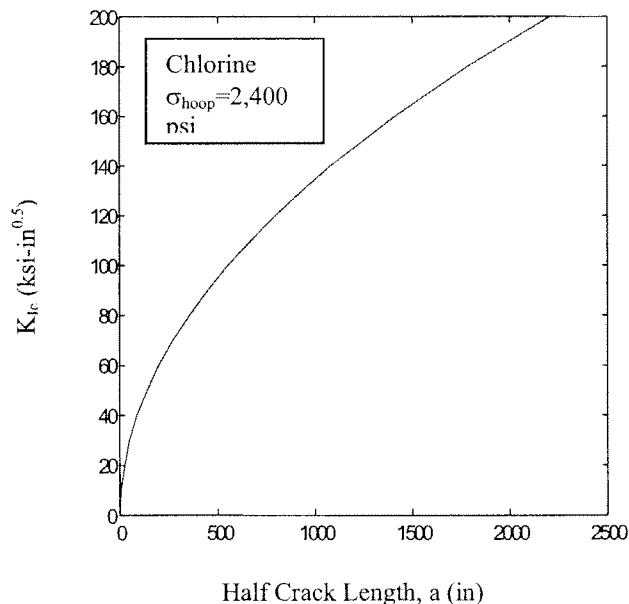
Figure 2. Relationship between Critical Fracture Toughness and Crack Size for Tank Car in Macdona, TX Accident

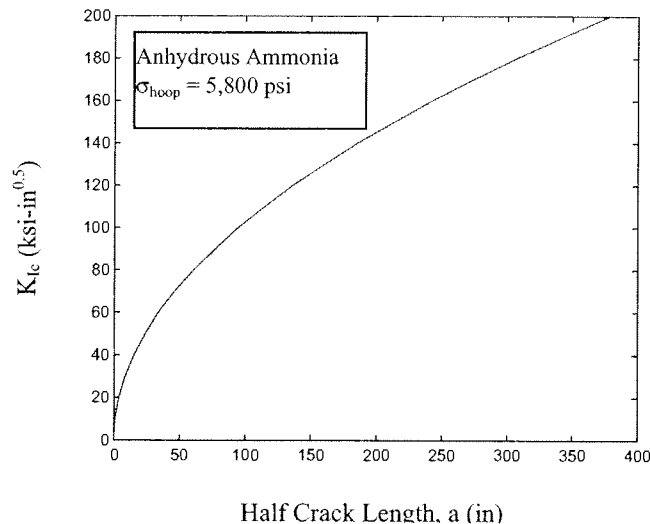
Figure 3. Relationship between Critical Fracture Toughness and Crack Size for Tank Car in Minot, ND Accident

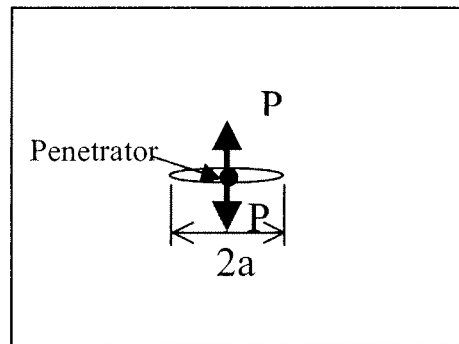
Figure 4. A Penetrator creates Opening forces on crack surfaces as it pushes open crack

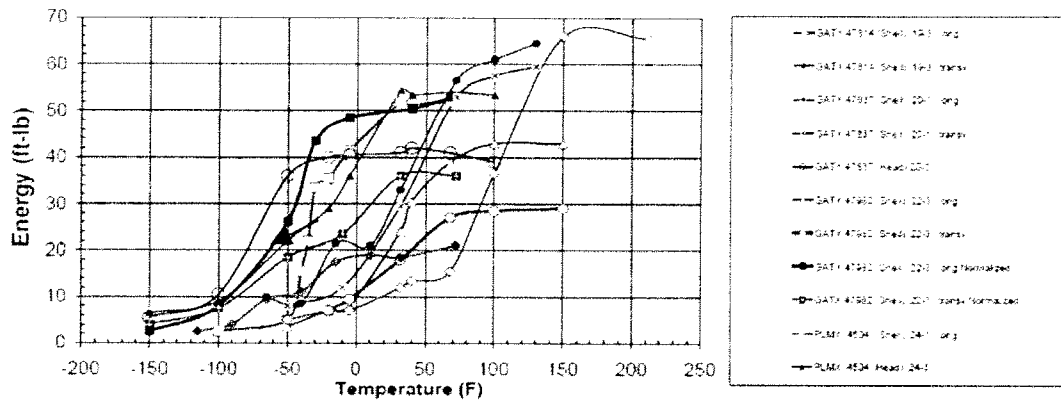
Figure 7. Ductile to Brittle Transition Temperature Curves Generated by Charpy V-notch Testing for Samples Taken from Tank Cars Involved in Minot Accident (Zakar, 2003)

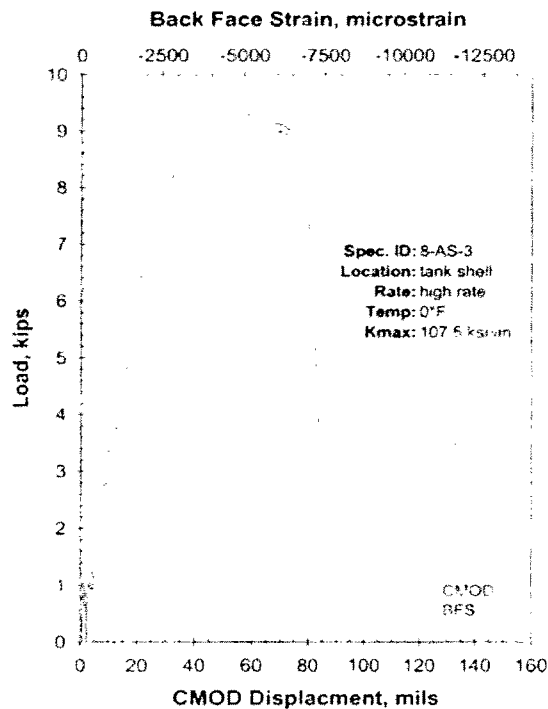
Figure 9. Resolved CMOD and BFS versus Load for Specimen from Retired Tank Car GATX 25008

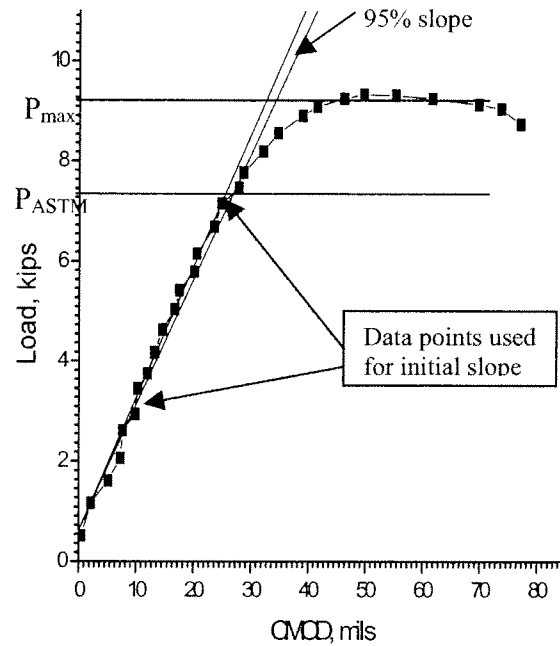
Figure 10. Computation of Load for Defining K_{Ic} from Data in Figure 9 According to ASTM Procedure

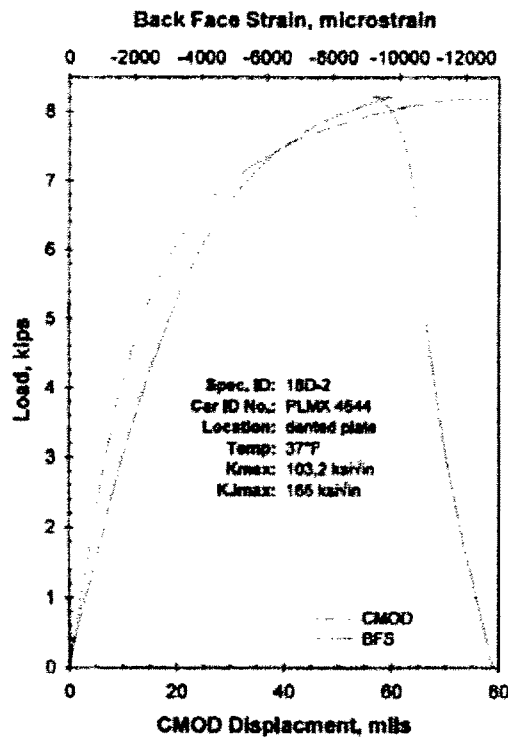
Figure 11. Resolved CMOD and BFS versus Load for Specimen from Tank Car PLMX 4644 Involved in Minot Accident

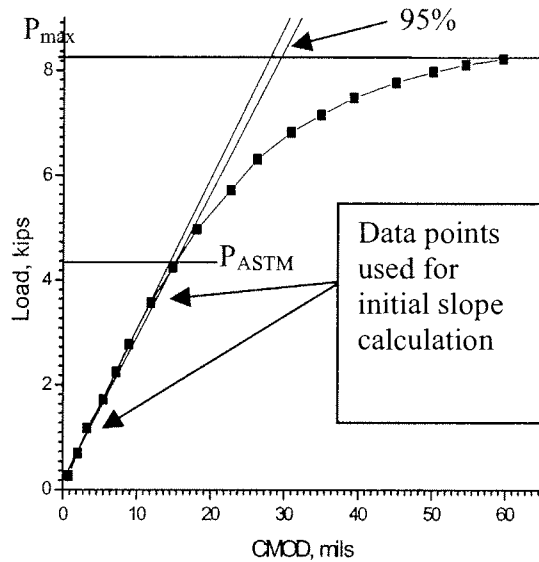
Figure 12. Computation of Load for Defining K_{Ic} from Data in Figure 11 According to ASTM Procedure

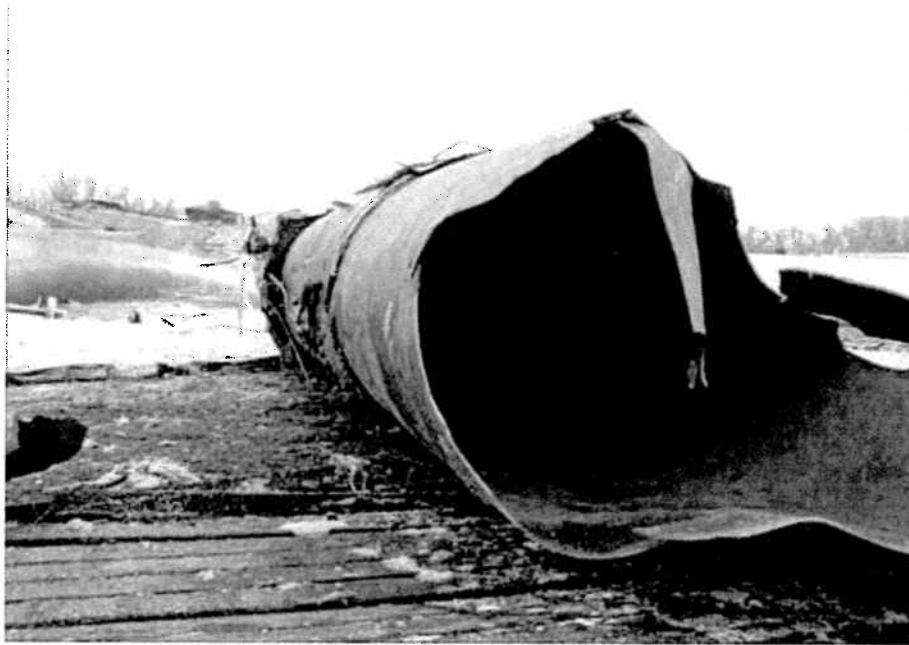
Figure 13. Photograph of B-end View of Tank Car PLMX 4504 at Minot Accident Site

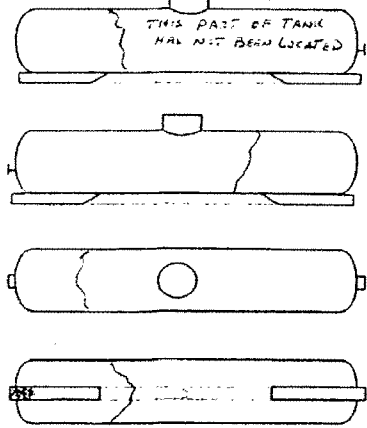
APX 2 1/2 RINGS OF TANK PROPEL APX 1000 FT

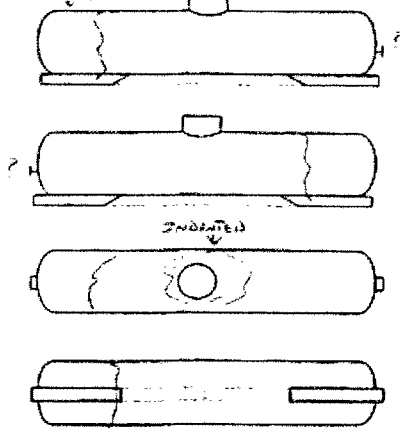
SECTION OF TANK MISSING

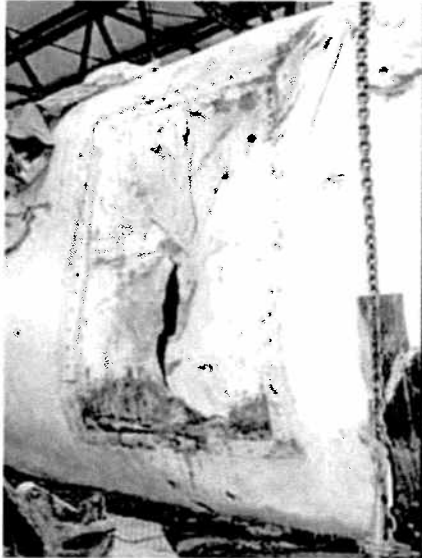
View of the right side of the tank car after the patch was disassembled.

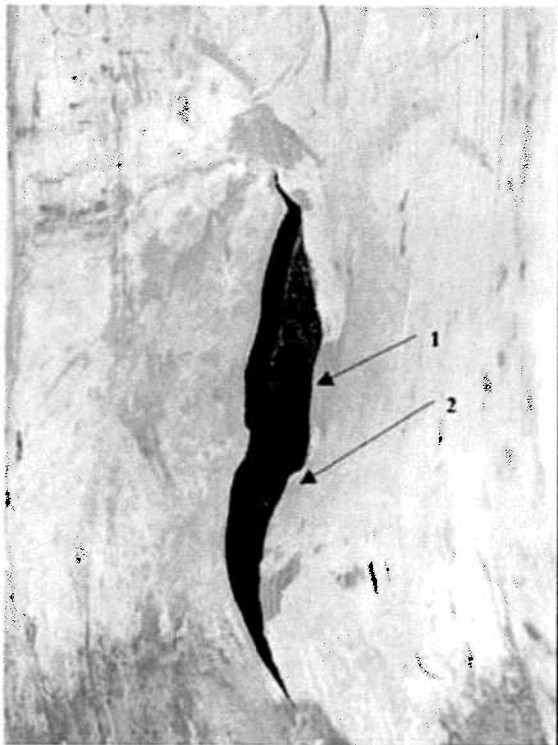
Close-up photograph of the fracture. Arrows "1" and "2" indicate the location of the two impression marks.
