Safety Edge_{SM}

Demonstration Project
Little Divine Road in
Johnston County,
North Carolina

Draft Field Report July 1, 2011

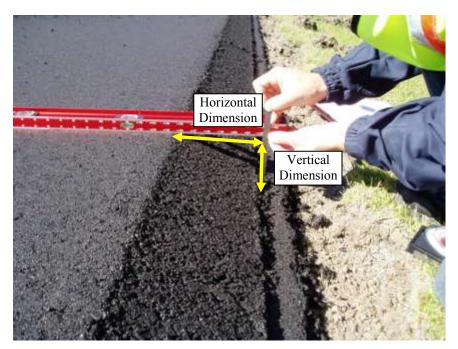
Figure 2. Slope measurement technique.

Slope measurements were recorded at 25-feet intervals using a straight-edge and ruler to measure the horizontal and vertical dimensions of the edge (see Figure 2). The Carlson device was set at a 25°angle and produced an average slope of 29° after compaction.

Table A-1 in Appendix A contains slope measurements recorded at each individual measurement location. Accurate edge thickness measurements were not possible due the slope of the Safety Edge_{SM} extending over the edge of the existing pavement, thereby exaggerating and confounding the edge thickness measurements.

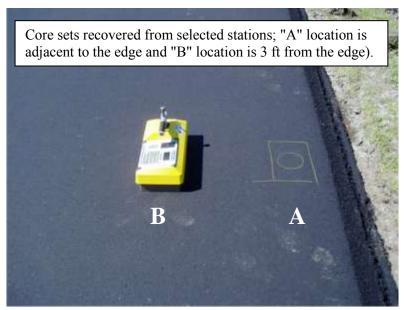
Several pairs of cores were cut from each test section. Each pair of cores had a core taken 3 feet from the edge of the mat (where the maximum number of roller passes were made) and a corresponding core taken adjacent to the edge (where fewer roller passes were made). Figure 3 shows the layout of a typical core set. Table A-2 in Appendix A lists the stations from where these cores were taken and the respective core thicknesses measured. Laboratory density was determined from the bulk specific gravity at saturated surface dry test condition, the results of which are presented in Table A-3 in Appendix A. Figure 4 compares the laboratory core density measurements for the test sections. The core densities from the Safety Edge_{SM} section show more variability than the control section.

Figure 3. Photo shows the layout of cores and nuclear density tests (nuclear density tests were taken and then the overlay was cored).

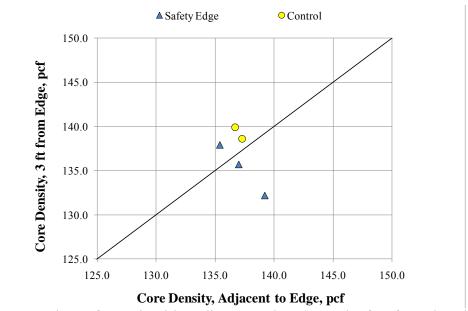
Figure 4. Comparison of core densities adjacent to the edge and 3 feet from the edge.

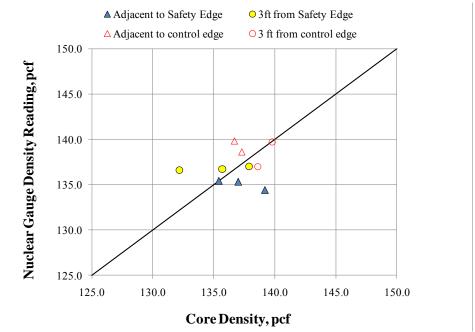
Before coring took place, nuclear density tests were conducted at each location on the pavement where the cores were to be cut for the purpose of calibrating the density readings of the nuclear gauge to the laboratory-determined densities from the cores. Table A-3 and Table A-4 in Appendix A present the results of the nuclear density testing and the laboratory-determined core density results. Figure 5 compares the nuclear density readings to the densities measured from the cores.

Figure 5. Comparison of the nuclear densities and core densities.

Adjustment factors used to calibrate the nuclear gauge density values were determined from correlating the nuclear density readings and the densities from the laboratory results. The two test sections had unique adjustment factors and are summarized as follows:

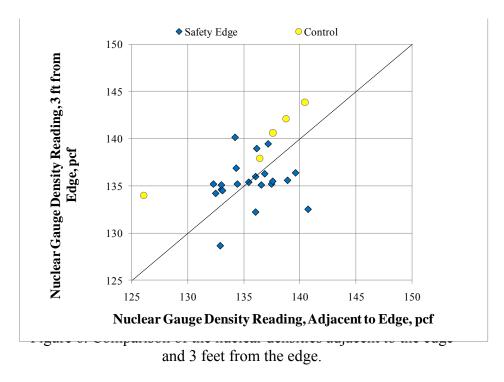
Figure 6 compares the density values taken adjacent to the edge and 3 feet from the edge. Generally, the Safety $Edge_{SM}$ section shows no distinct trend in the relationship between data adjacent to the edge and 3 feet from the edge whereas, the values for the control section tend to be higher 3 feet from the edge.

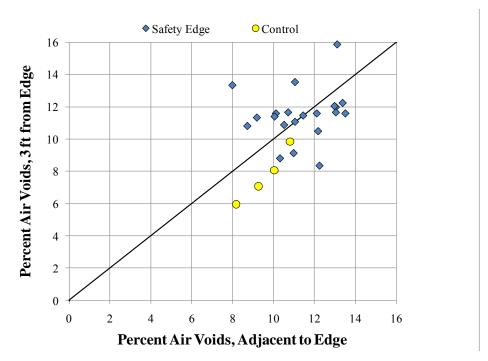
Figure 7 compares the percent air voids (as calculated from the density test results and the maximum theoretical mix density). The percent air voids shows no clear trend for the Safety Edge_{SM} section whereas, the values for the control section were higher adjacent to the edge.

Figure 7. Comparison of the air voids adjacent to the edge and 3 feet from the edge.

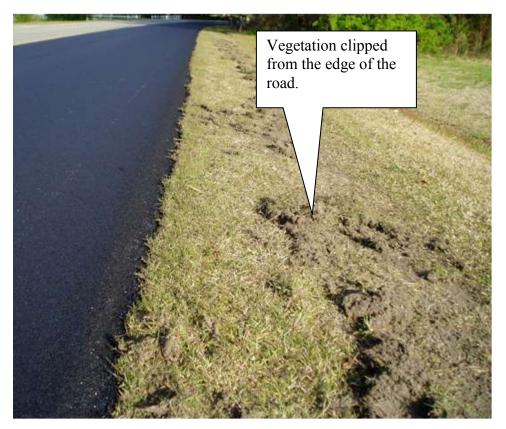
Isolated HMA patching and continuous brooming was conducted prior to paving. In limited locations the contractor used a small tractor equipped with a blade to clip soil/vegetation from the edge of the road, exposing the existing edge of pavement. Figure 8 shows some of the vegetation removed by the preparatory work. There were a few isolated areas where the soil/vegetation was slightly higher than the existing pavement and should have been clipped back farther to make room for the Safety Edge_{SM}. It is important to clip the shoulders far enough back so the soil/vegetation does not become mix with the asphalt during paving.

Figure 8. Vegetation removed by clipping the edge of the existing pavement.

• It is important to clip the shoulders far enough back so soil/vegetation does not become mixed with the edge of the asphalt during paving. Clipping should be extended farther into the existing shoulder than with conventional overlays to allow extra width for the Safety Edge_{SM}.

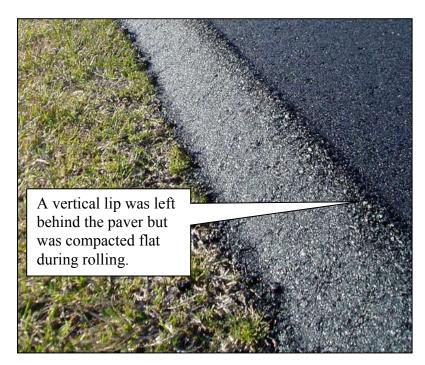
The Carlson device created a 0.25-inch vertical lip at the breakpoint of the edge as shown in Figure 9. The lip was compacted flat by the rolling operation. The texture of the finished slope face of the Safety $Edge_{SM}$ edge as shown in Figure 10 was nearly as smooth and sealed as the rest of the mat.

Figure 9. Vertical lip produced by the Carlson paver.

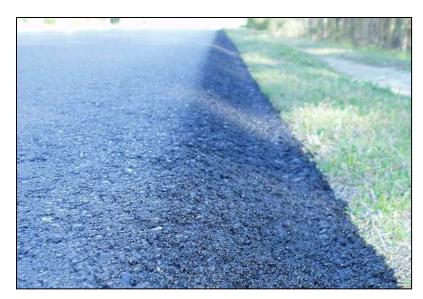
Figure 10. Texture of the Safety $Edge_{SM}$ slope face was nearly as smooth and sealed as the rest of the mat.

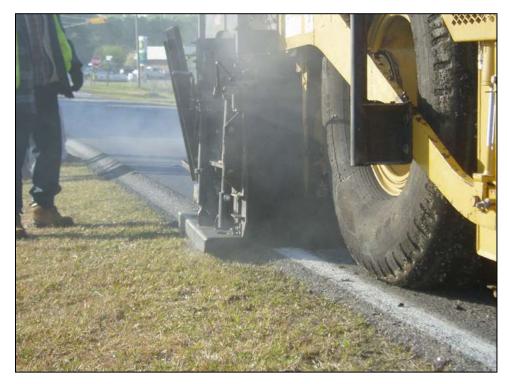
The Carlson device was set at a horizontal angle to the mat as shown in Figure 11 to add confining pressure to the edge as the paver moved forward. Figure 12 shows the Safety Edge_{SM} directly behind the Carlson device.

Figure 11. Angled approach of the Carlson device.

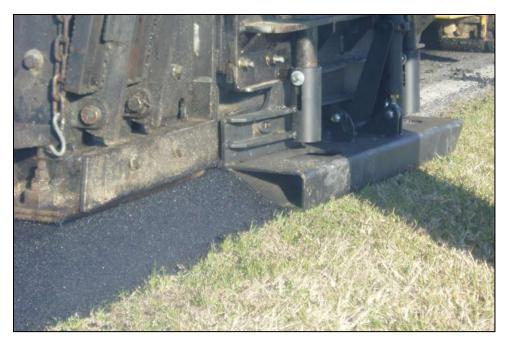
Figure 12. Safety Edge_{SM} directly behind the Carlson device.
