Pipeline & Hazardous Materials Safety Administration

Pipeline Inspection Technologies Demonstration Report

Pipeline Safety Research & Development Program

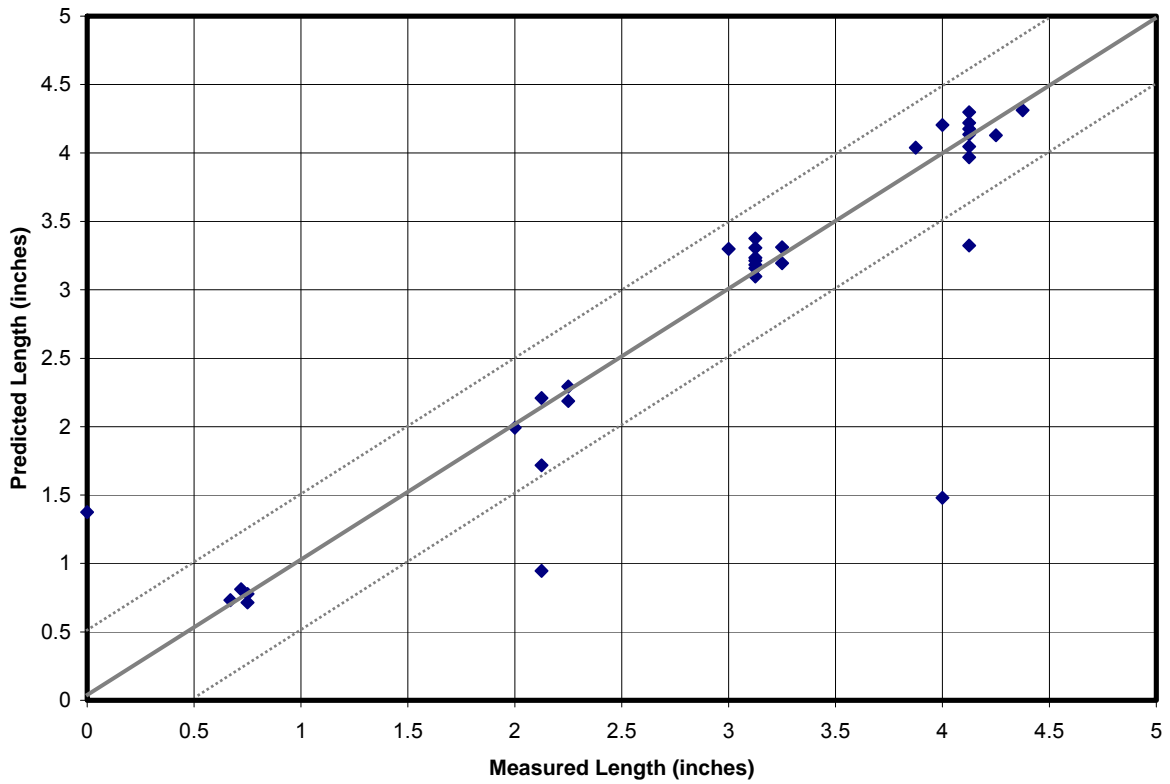
Figure 11. Measured Length vs. Predicted Length for the SwRI *RFEC*

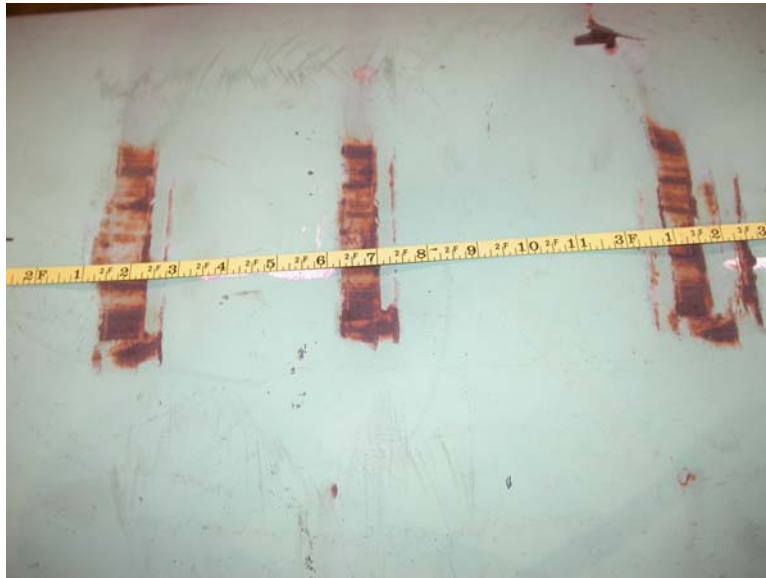
Figure 19. Example Mechanical Damage Defect from Pipe Sample 1

Only one technology, the PNNL *Ultrasonic Strain Measurement* technology, was tested for assessment of mechanical damage. Two 24-inch diameter pipes were inspected by PNNL for mechanical damage. The first pipe (Pipe Sample 1) consisted of two pipes welded together with mechanical damage defects along three rows separated by 120° and measured approximately 28-feet in length. The test line on Pipe Sample 1 consisted of mechanical damage created using a 50-ton track hoe. An example mechanical damage defect from Pipe Sample 1 is shown in Figure 19. The second pipe (Pipe Sample 2) measured approximately 40 feet in length with plain (or smooth) dent defects along one test line. An example mechanical damage defect from Pipe Sample 2 is shown in Figure 20.

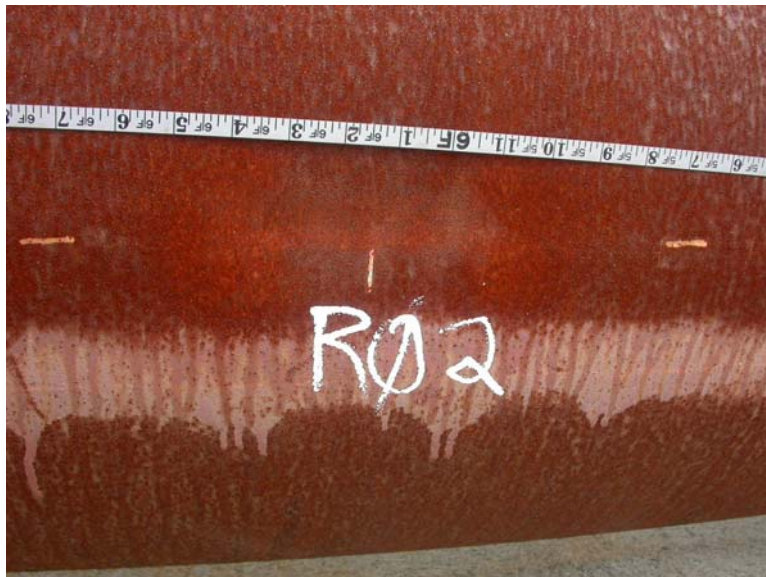
Figure 20. Example Mechanical Damage Defect from Pipe Sample 2

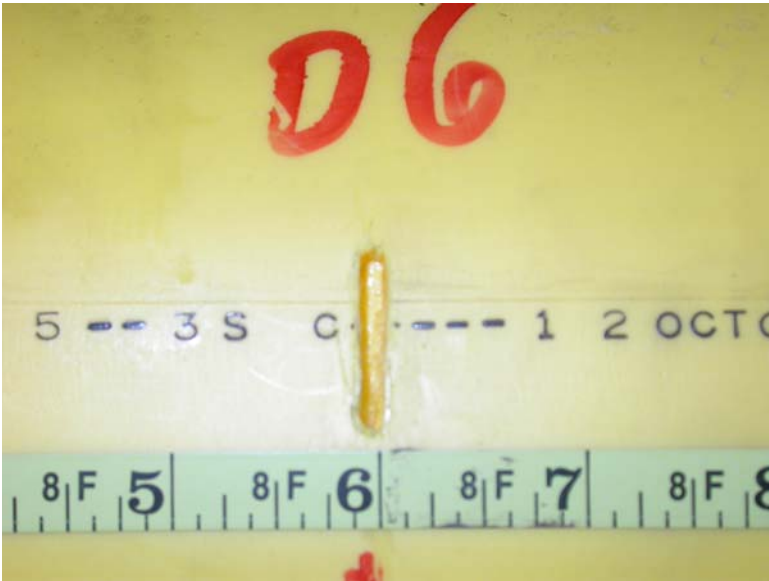
calibration defect. An example defect is shown in Figure 22. This defect was calculated to have a volume of 0.04 cubic inches which equals a significance of 1.43. As shown in Table 11, the technology ran one test line on a 6-inch diameter polyethylene pipe sample.

Figure 22. Example Plastic Pipe Defect

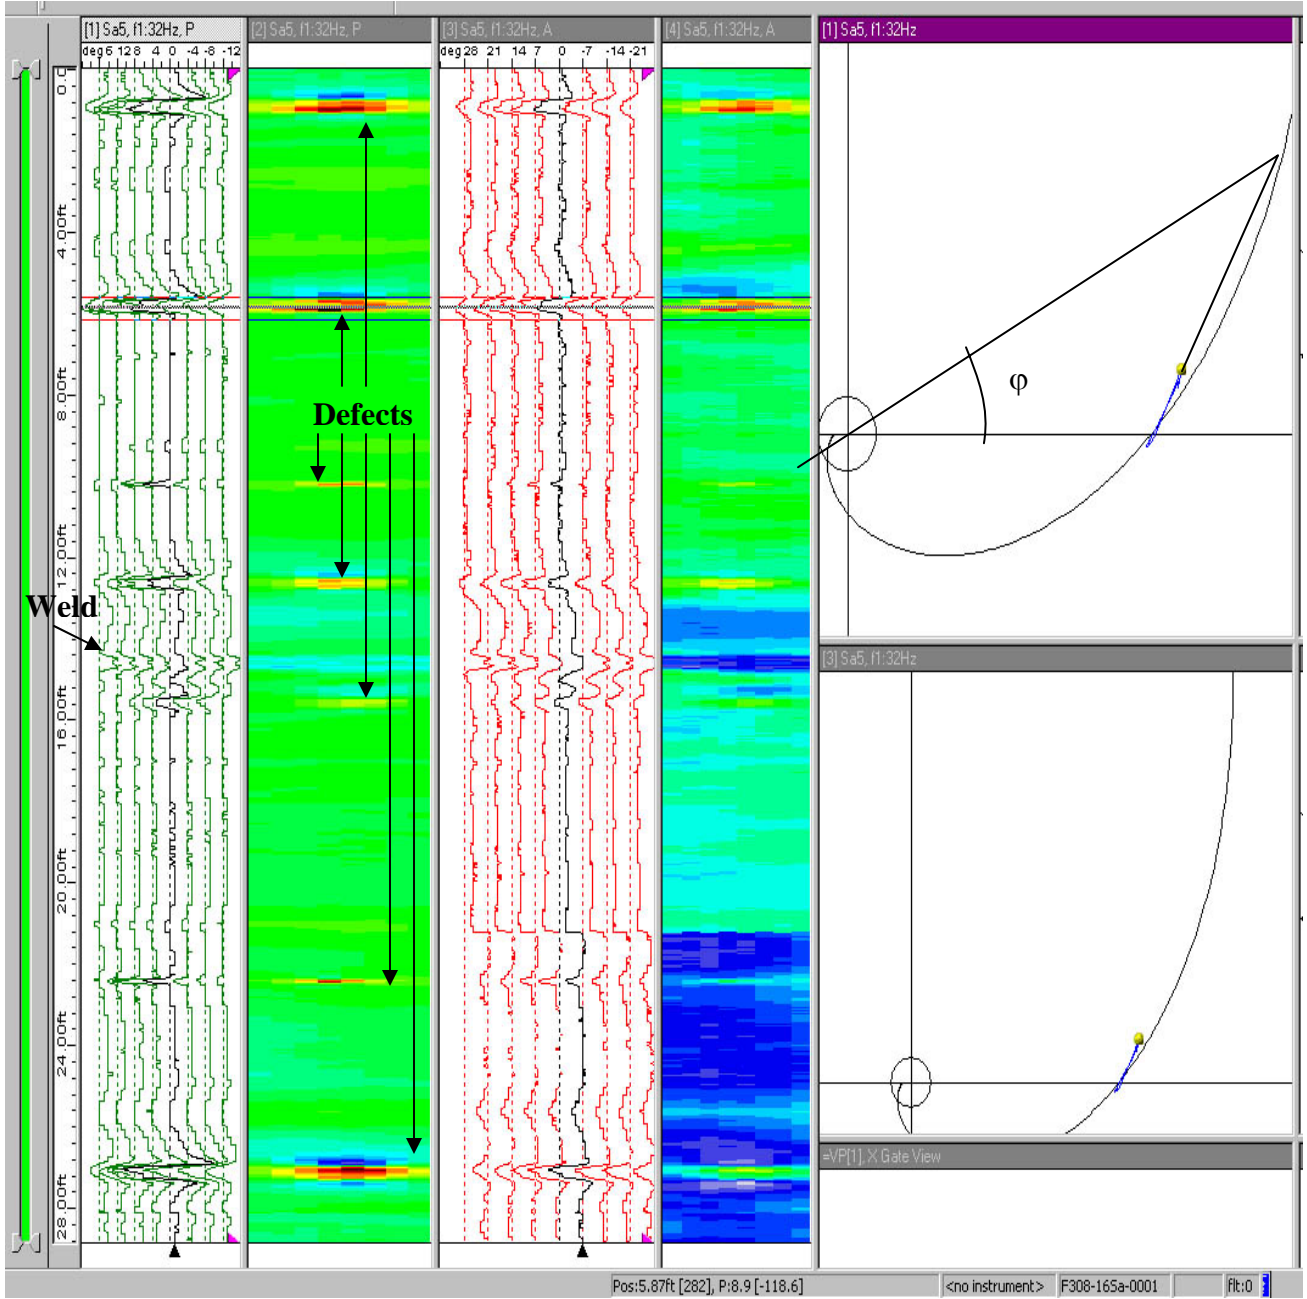
Analysis of defect depth on Pipe Sample 3 was primarily done using Russell NDE Systems Inc.'s Adept Pro program. This program is the result of decades of research and focuses on the Voltage Plane for analysis. The display produced by the program is shown for Defect Line1 in Figure 6.

Figure 6: Adept Pro display of Defect Line 1 from Pipe Sample 3.

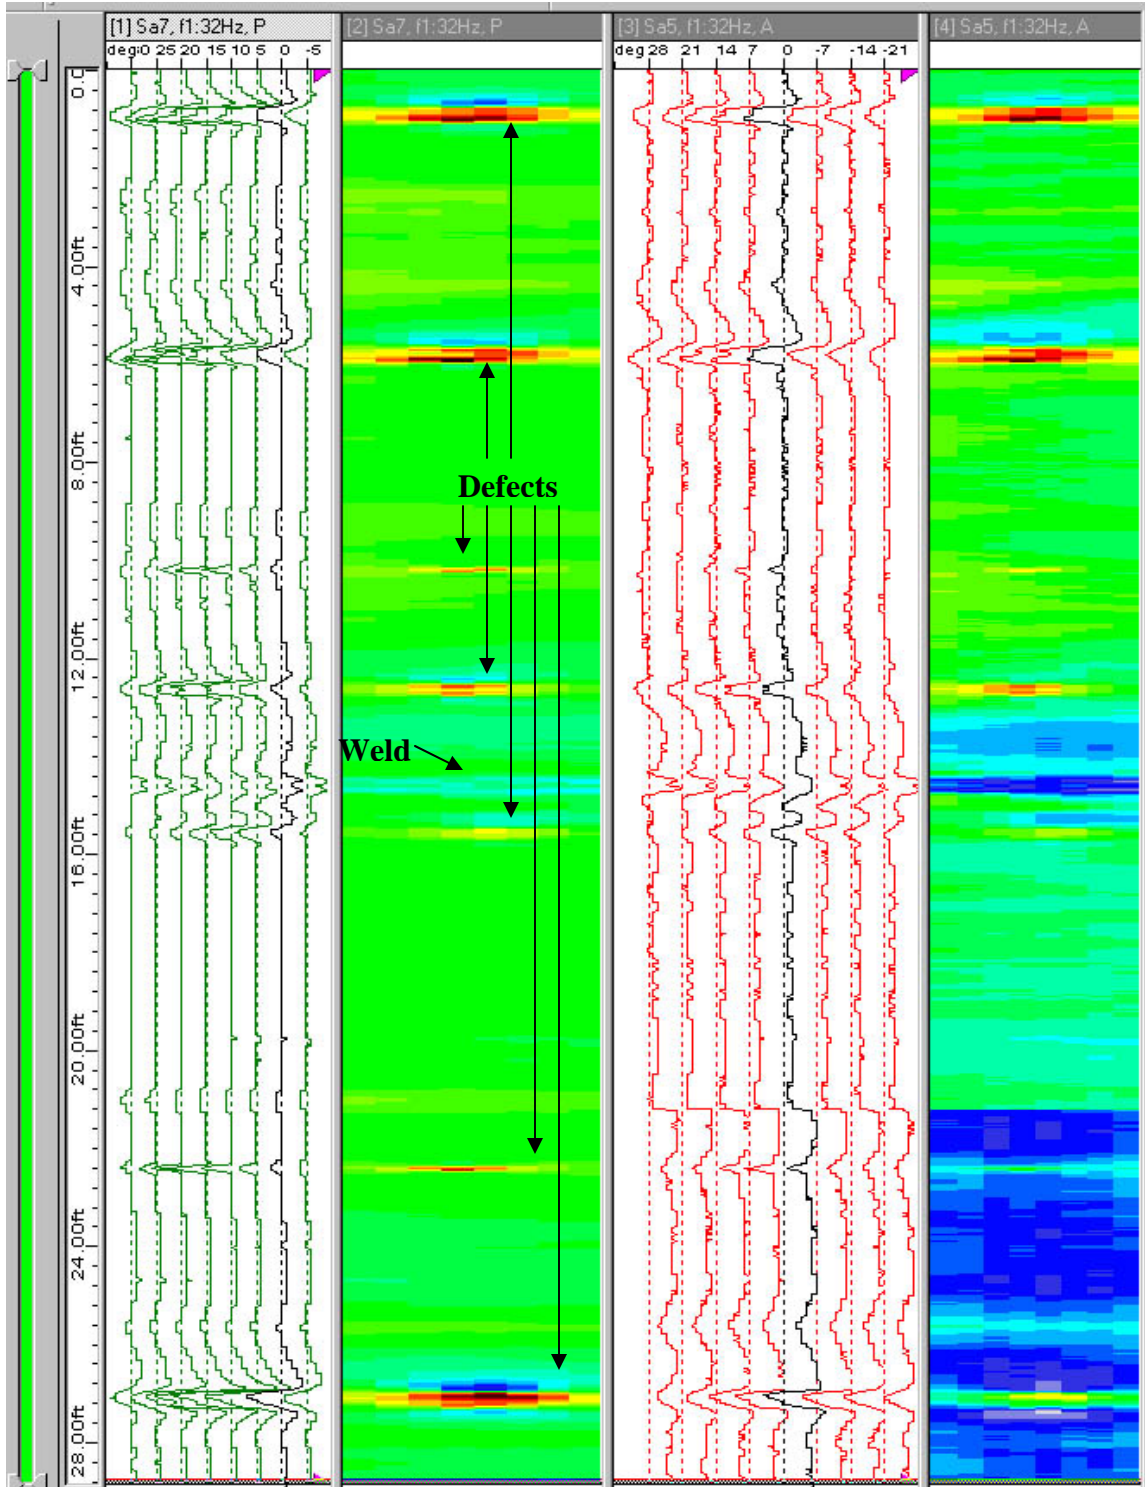
If the blue line is extended to intersect the wall-thinning spiral, the vector from the origin of the polar plot to the intersection point makes an angle ϕ with the x-axis. Angle ϕ is used to determine the depth of the defect. The length of the blue line is used to find the circumferential extent of the defect. As in Figure 6, Figure 7 shows the analysis of Line 2 of Pipe 3.

Figure 9: Adept Pro Display of Defect Line 2.

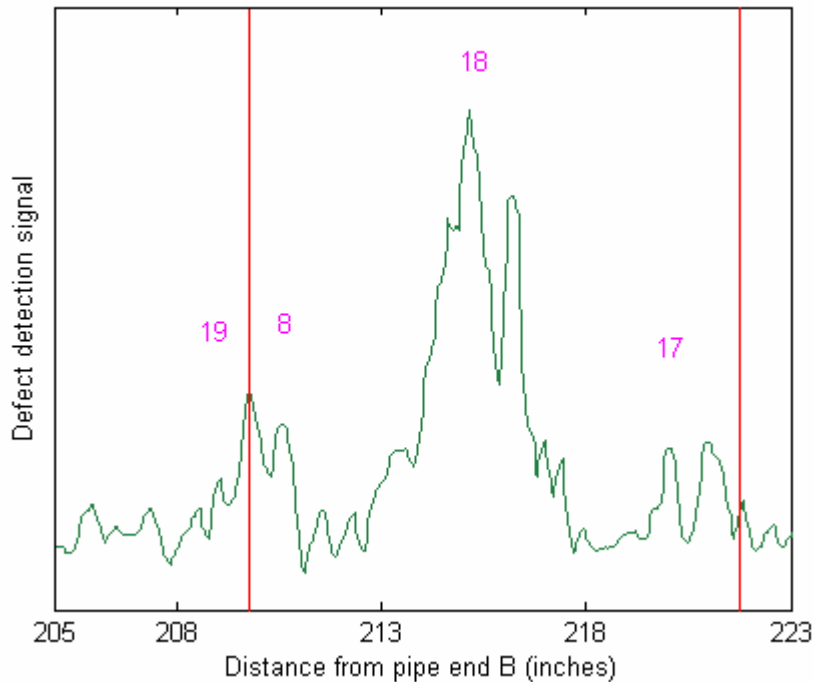
Figure 5. Defect response signal for SCC3 area.

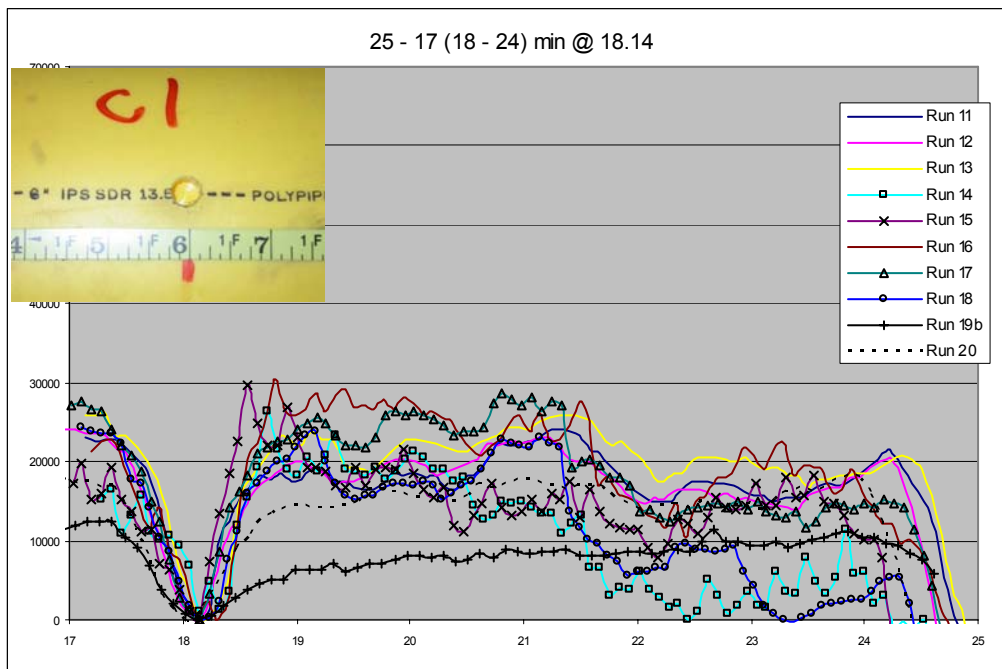
Figure 4 Calibration Hole and Probe Response (18'' position)

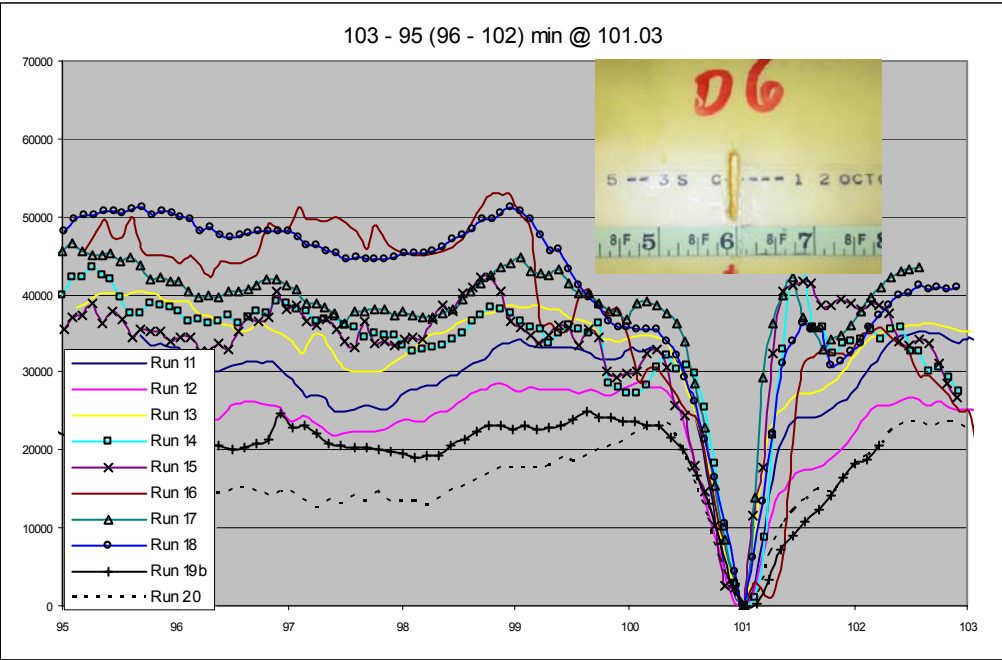
Figure 6 Saw Cut Defect and Probe Response (102'' position)

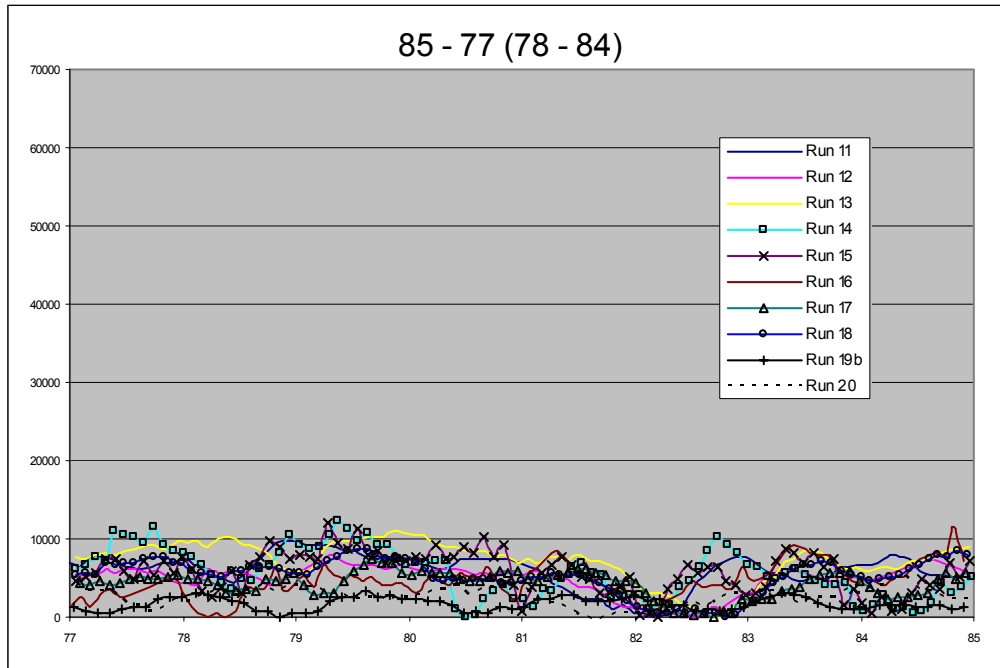
Figure 7 Probe Response with no Defect (102" position)
