**Field Demonstration Report
Enhancing Direct Assessment by Inspection through
Coatings and Buried Regions of Non-Piggable Pipelines**

23 August 2007

Contract DTPH56-06-T-0009

Prepared by:
EMAT Ultrasonics, Inc.
170 Granada Drive, Suite D
San Luis Obispo, CA 93401

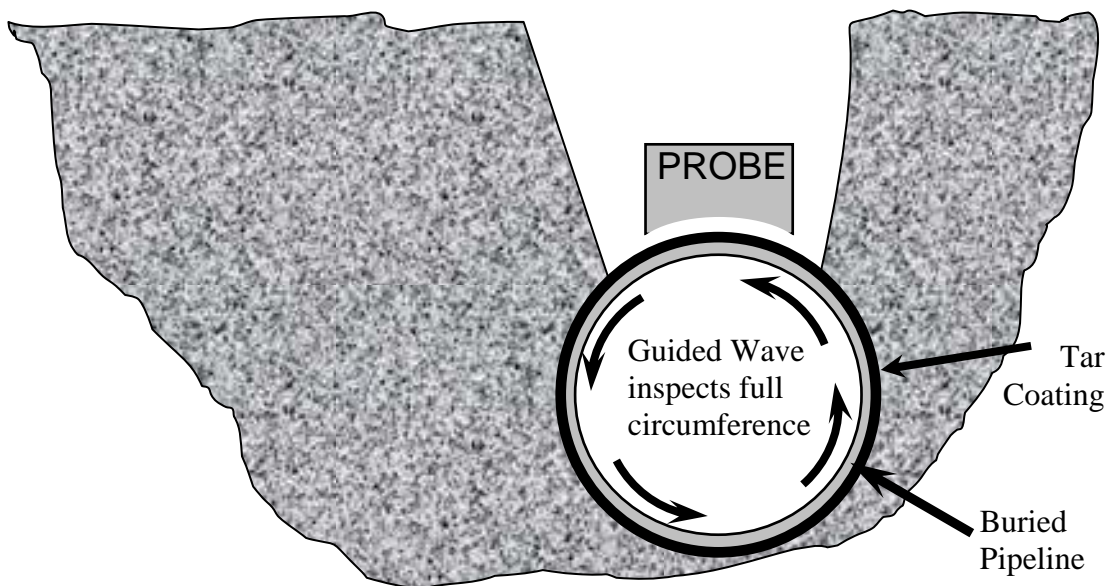
Figure 1: Full body inspection from the top surface of the pipe. There is no need to remove good coating or fully excavate the pipe to perform a complete inspection.
