# **Cooperative Intersection Collision Avoidance System Limited to Stop Sign and Traffic Signal Violations (CICAS-V)**

## **Phase I Final Report**

**September 30, 2008**

Crash Avoidance Metrics Partnership (CAMP) Produced  
In conjunction with Virginia Tech Transportation Institute for  
ITS Joint Program Office  
Research and Innovative Technology Administration  
U.S. Department of Transportation

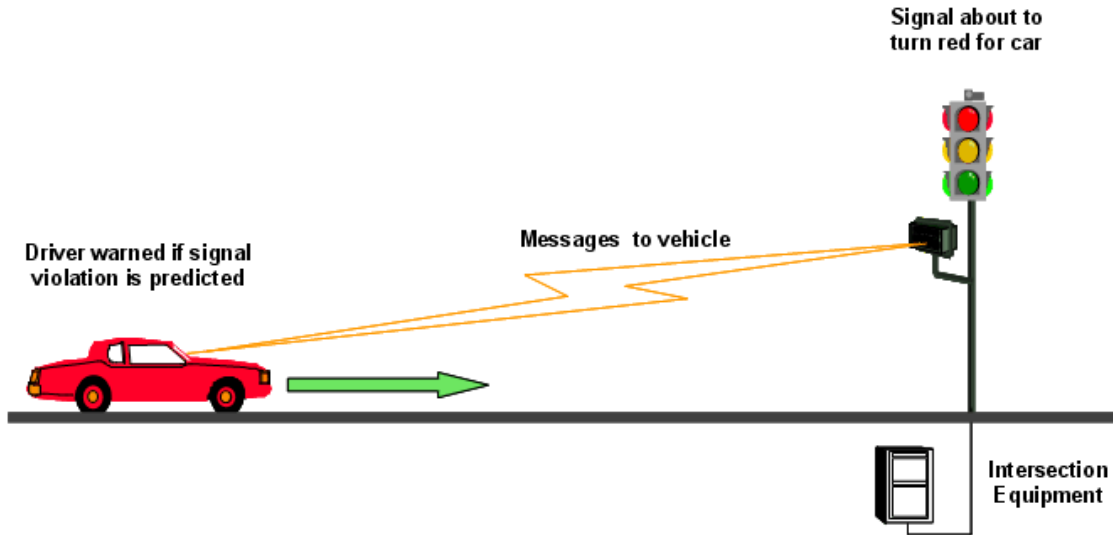
**Figure 1: Basic Concept of the CICAS-V System at a Signalized Intersection**

CICAS-V is intended to provide a cooperative vehicle and infrastructure system that assists drivers in avoiding crashes at intersections by warning the vehicle driver that a violation, at an intersection controlled by a stop sign or by traffic signal, is predicted to occur. The basic concept of CICAS-V is illustrated at a high level in Figure 1 for a signalized intersection. In the figure, a CICAS-V equipped vehicle approaching a CICAS-V equipped intersection receives messages about the intersection geometry, GPS differential corrections and status of the traffic signal. The driver is issued a warning if the equipment in the vehicle determines that, given current operating conditions, the driver is predicted to violate the signal in a manner which is likely to result in the vehicle entering the intersection. While the system may not prevent all crashes through such warnings, it is expected that, with an effective warning, the number of traffic control device violations will decrease and result in a decrease in the number and severity of crashes at controlled intersections.

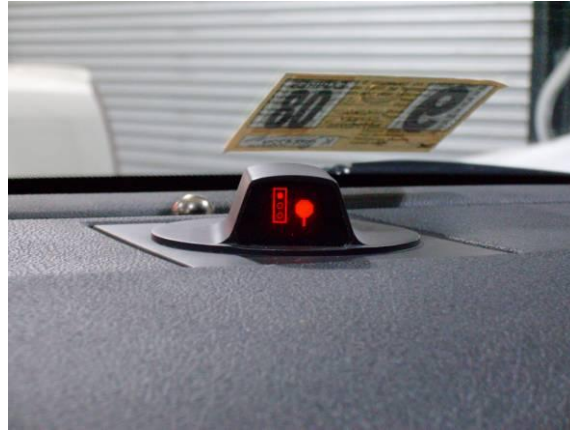
**Figure 3 The Visual Display is Located on the Dash of the Experimental Vehicle**

The auditory warning consisted of a female voice stating either “Stop Light” or “Stop Sign,” and was presented at 72.6 dBA via the front speakers as measured at the location of the driver’s head. The visual warning (Figure 3) displayed a traffic signal and stop-sign icon from a high “head down” display located on top, center of the dashboard near the windshield. Finally, the haptic brake pulse warning consisted of a single 600 millisecond brake pulse (or vehicle jerk) presented in conjunction with the visual icon and an auditory warning.

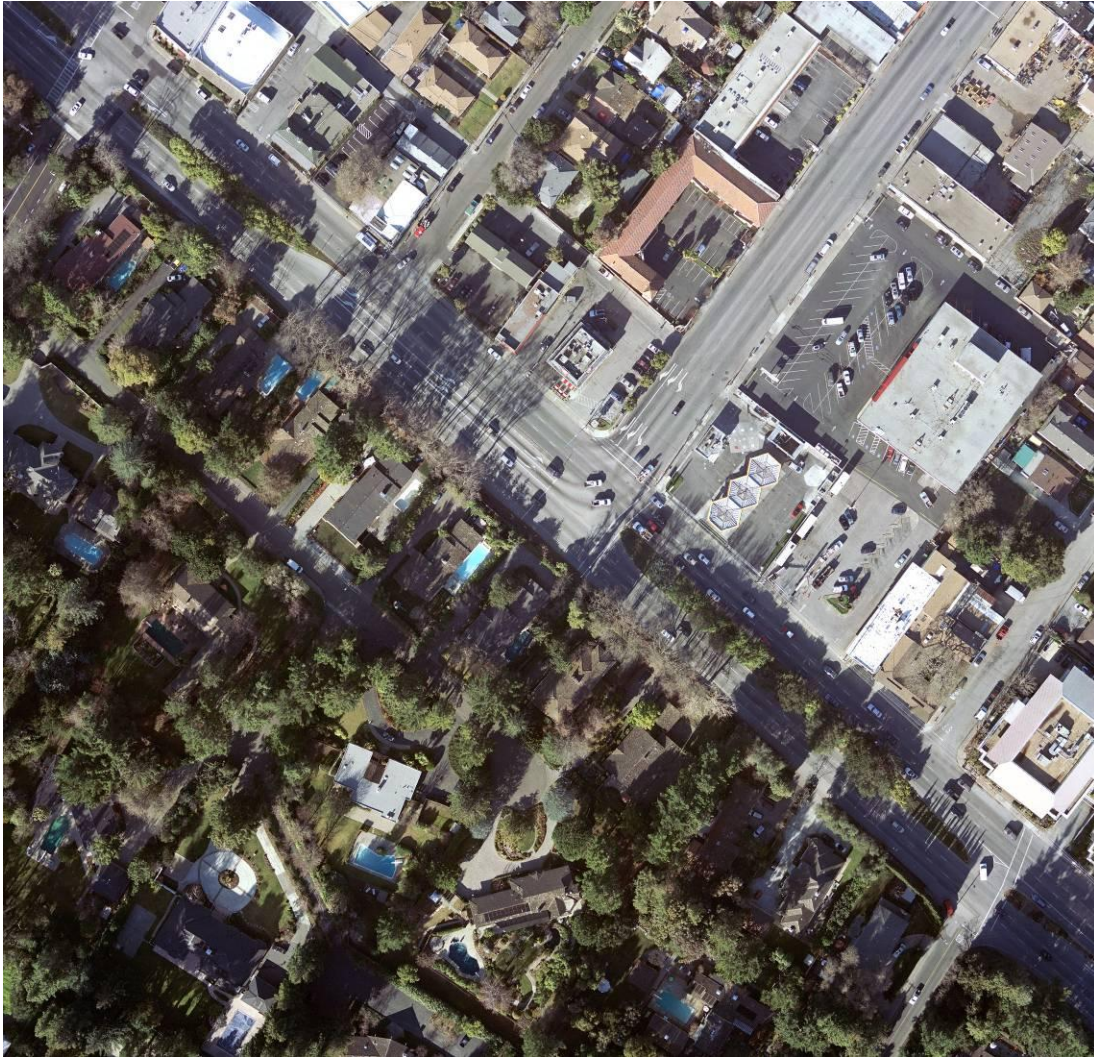
The intersection of El Camino Real and 5<sup>th</sup> Ave. in Redwood City/Atherton in California as shown in Figure 4 was the first CICAS-V instrumented intersection. This intersection

came online in February 2007 and has been working almost uninterruptedly since then. The intersection was instrumented in cooperation with UC Berkeley/PATH and Caltrans.

**Figure 4: Intersection at El Camino Real and 5th Avenue in Redwood City, CA**

The setup of this intersection was elaborate due to the constraints imposed by the environment, such as optimal antenna placement, controller cabinet location and the presence of high-voltage power lines that made the antenna placement challenging. The block diagram in Figure 5 shows the components and the connections for the intersections.

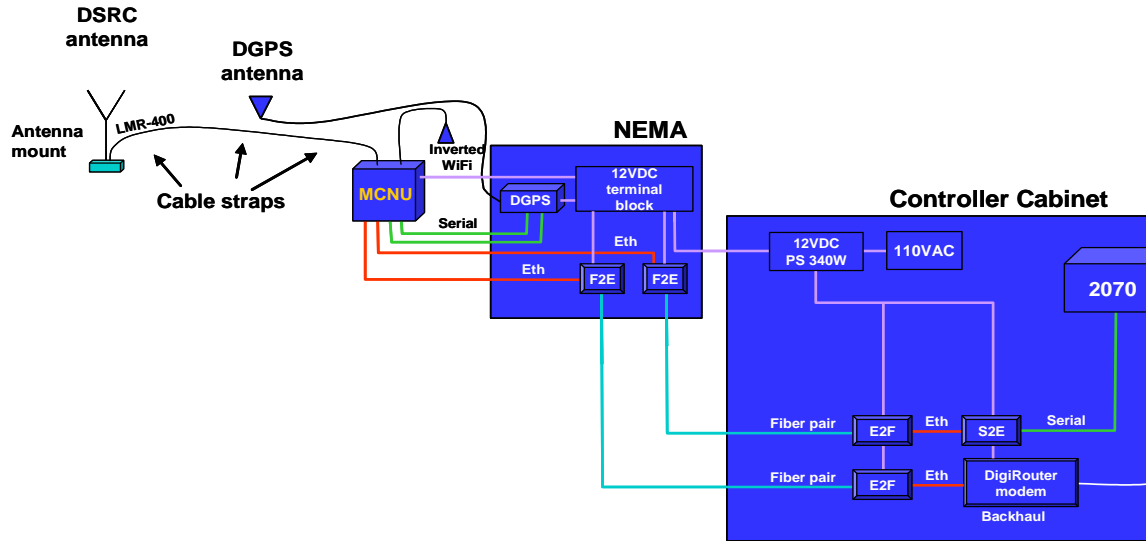
**Figure 5: Block Diagram of the Intersection Equipment and Connections**

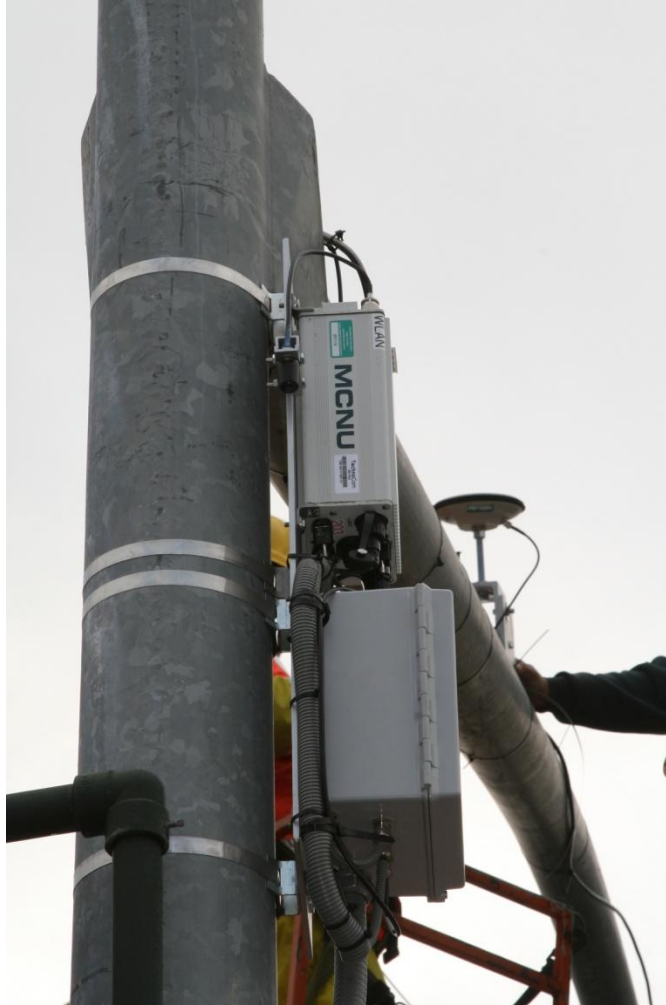
Figure 6 shows a picture of the installation of the equipment in the intersection. The MCNU can be seen on the top of the metal plate and the cabinet at the bottom holds the GPS receiver and the fiber optic to Ethernet converters.

**Figure 6: RSE Installation at the First California Intersection**

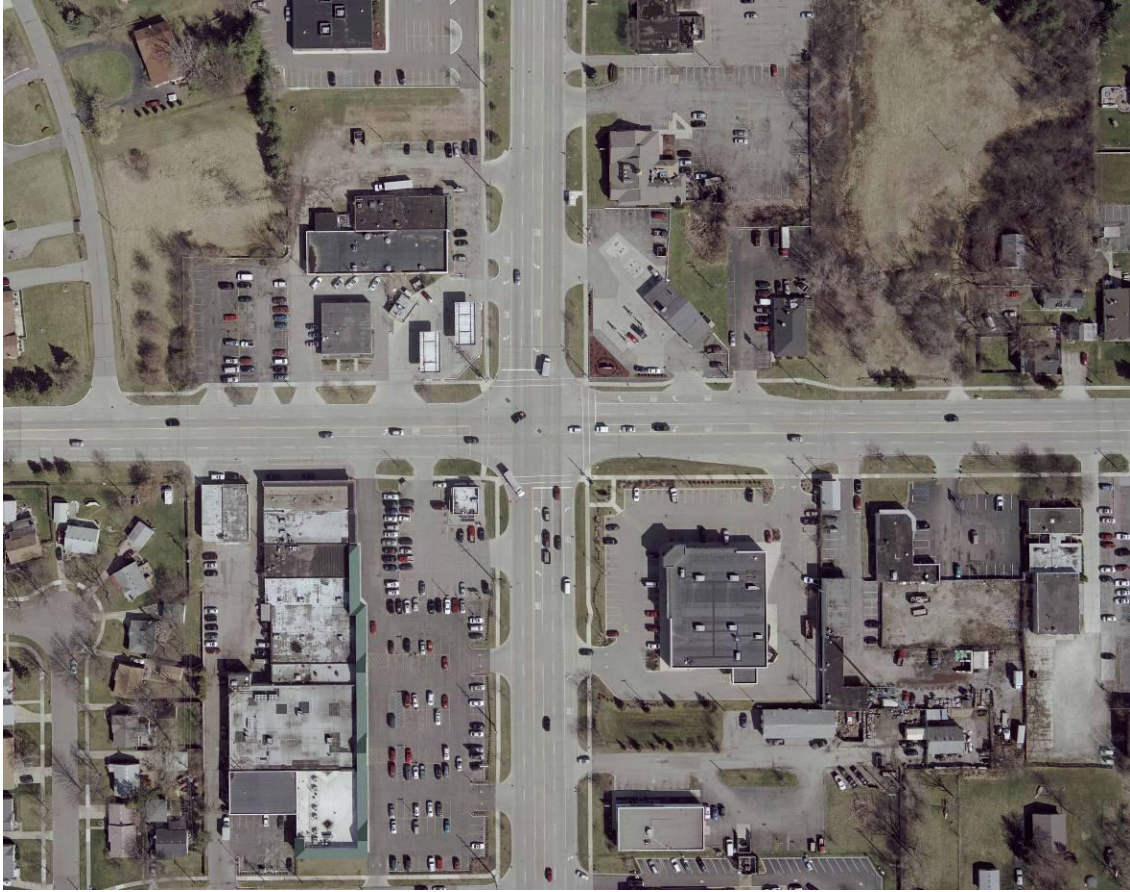
The first intersection in Michigan to come online was the intersection at West 10 Mile and Orchard Lake Roads (Figure 7).

**Figure 7: Intersection at West 10 Mile and Orchard Lake Roads in Michigan**

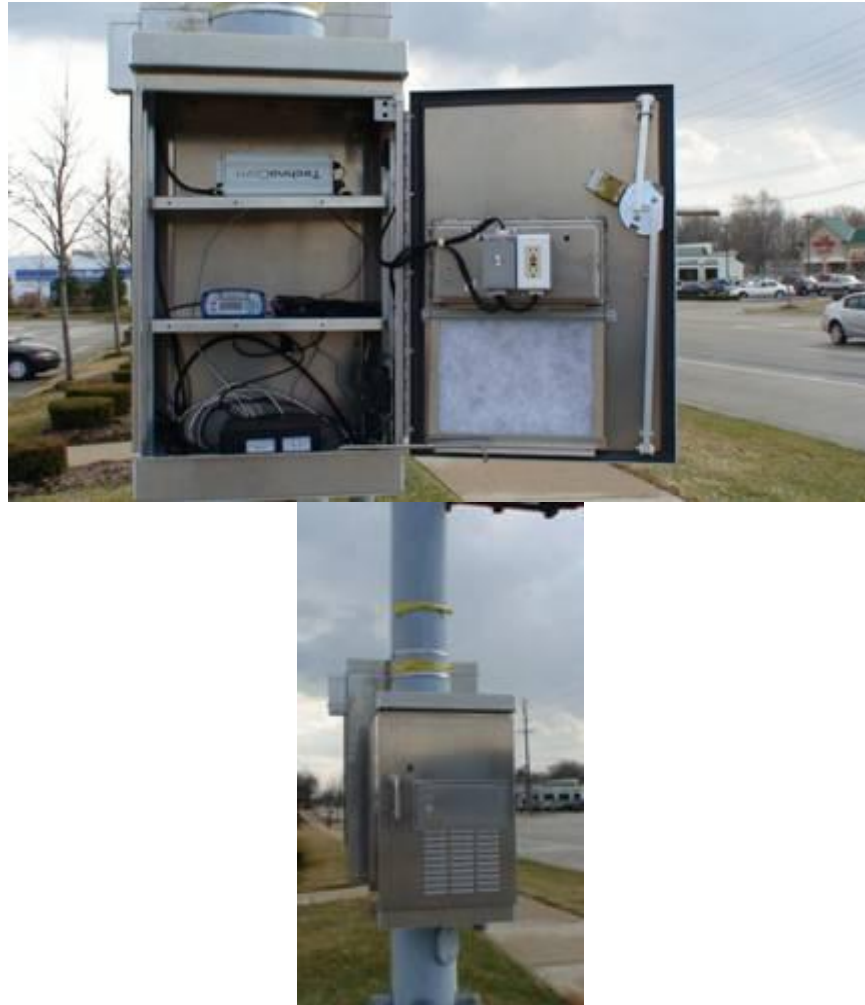
The CICAS-V intersection installation for West 10 Mile and Orchard Lake Roads is shown in Figure 8.

**Figure 8: CICAS-V Intersection Equipment**

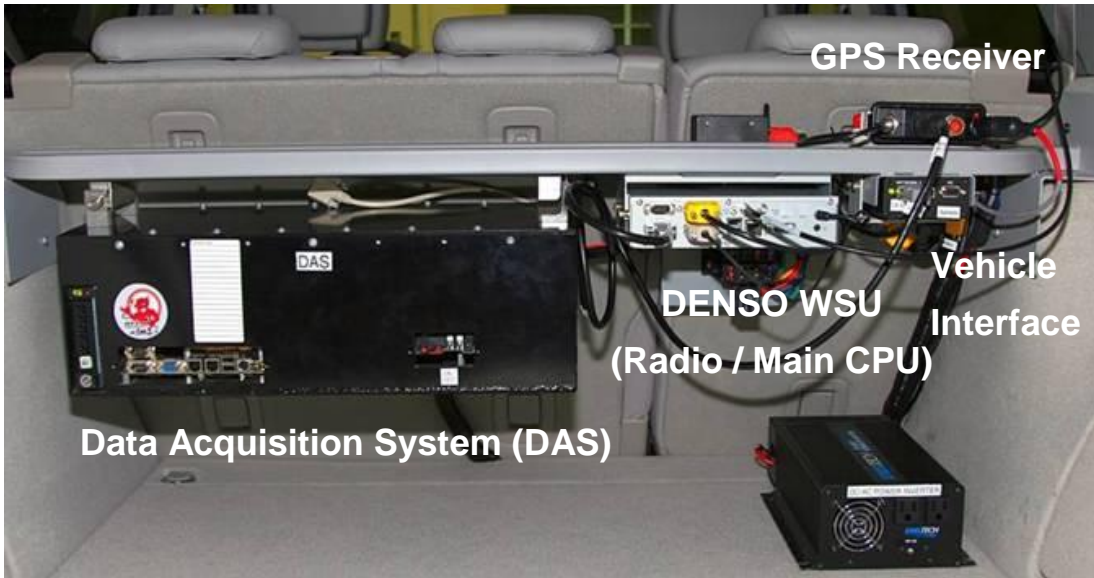
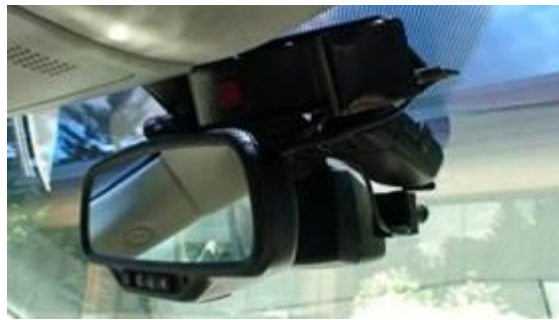
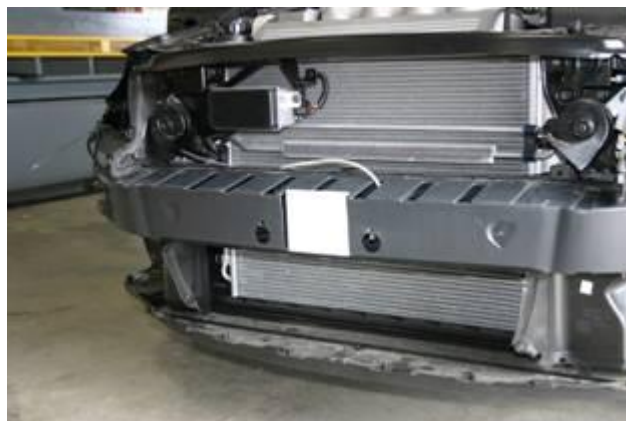
**Figure 10: CICAS-V Components in the Vehicle**

**Figure 11: Forward View and Driver View Cameras**

**Figure 12: Front Radar Installation**

Figure 10 to Figure 12 show the installation of the in-vehicle components of the CICAS-V system, the cameras and radar.

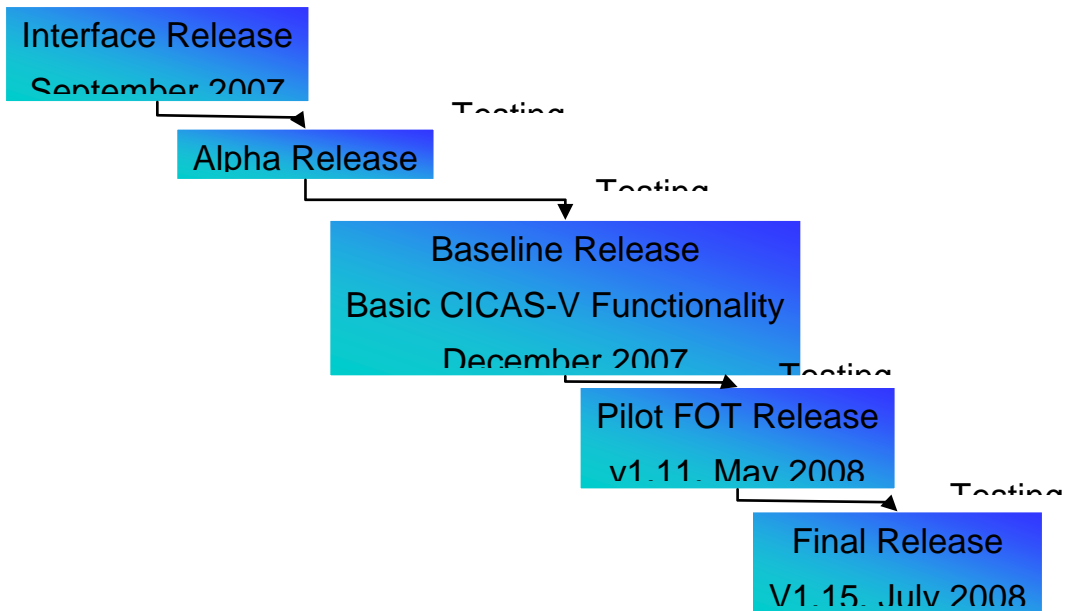
The vehicle component of the software development in Task 10 was accomplished in several stages where increased functionality was added and tested in a tight feedback loop with DENSO (Figure 13). The tests included system level tests (such as scenario testing at the intersection) and component tests at the subsystem level where individual components of the software were tested for correct functionality. The technical team developed the individual procedures and test plans to conduct the tests.

**Figure 13: Development Sequence**

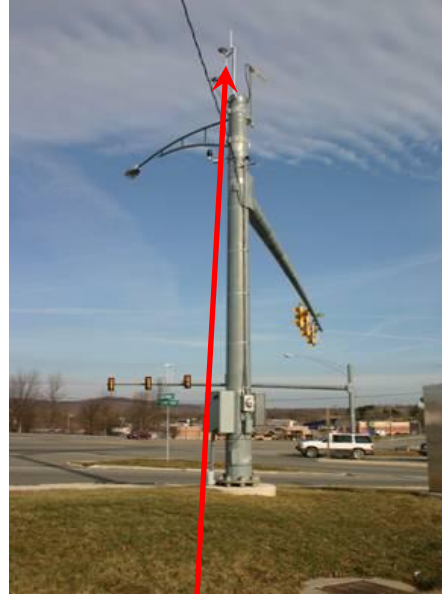
The intersection component of the CICAS-V used the DENSO WSU as the hardware for the Road-Side Equipment (RSE). The RSE was installed in cabinets on the mast with the signal heads at the intersection. The cabinets also included the GPS receiver and in the installation in Blacksburg, VA, the intersection Data Acquisition System (DAS). Figure 15 shows a picture of the intersection installation at Franklin and Peppers Ferry in Blacksburg.

CICAS-V Cabinet with GPS, RSE and Data Acquisition System

DSRC, GPS Antennas

### Figure 15: CICAS-V Intersection Installation in Blacksburg, VA

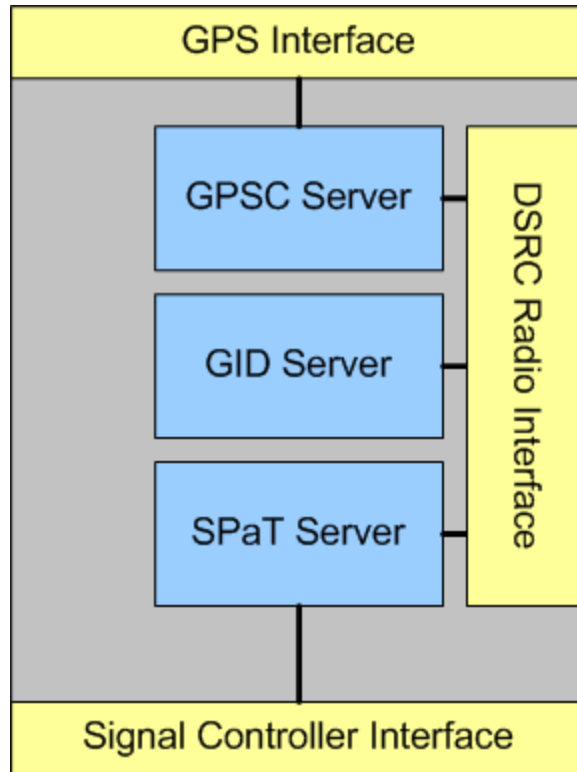
The software components for the intersection part of the CICAS-V were developed by the CICAS-V technical team and the components differed for the installations in California and Michigan just as in Task 8 due to different signal controllers and signal controller software. The Task 10 installation ported the developed software in Task 8 to the new RSE and added functionality that took advantage of the improved hardware, such as channel switching. This enabled the transmission of GID and GPSC messages on a service channel that could be different for intersections within communication range of each other and would in a deployment scenario improve channel utilization. Figure 16 shows a block diagram of the software components of the RSE.

**Figure 16: RSE Software Components**

The SPaT server received the signal phase and timing information from the signal controller, formatted it in the correct message set, and sent it to the vehicle through the DSRC radio 10 times a second. The GID server sent the GID that was stored on the RSE to the vehicle once a second. It also sent Area GIDs that contained the GIDs for several stop signs in the area around the RSE at a rate of once a second. The GPSC server took the differential correction information from the GPS receiver in the intersection and sent it to the vehicle once a second.

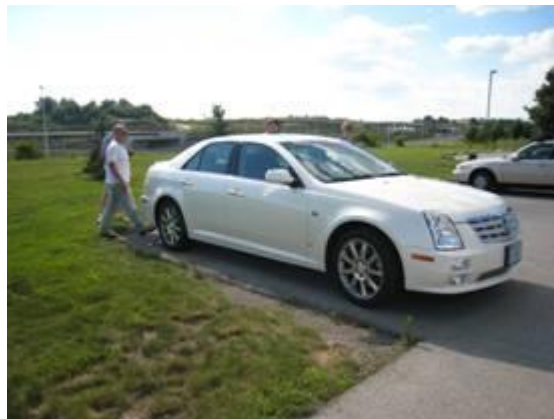
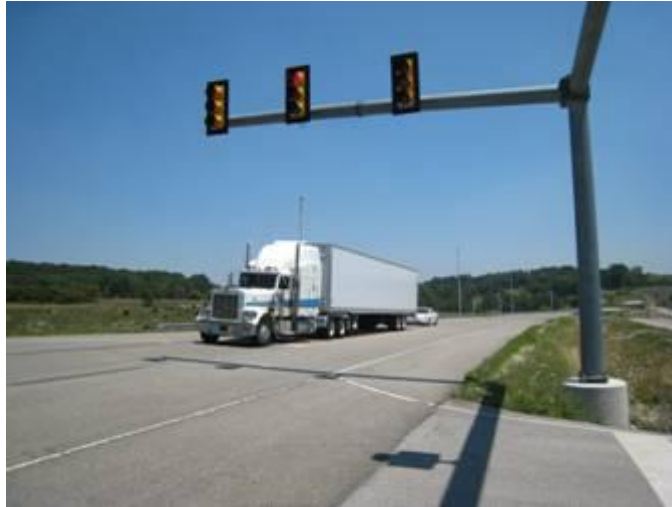
The vehicles used for conducting the objective tests were the VTTI Cadillac STS vehicles that were also used in Task 3.4 for the Pilot FOT (Figure 18) and a Tractor-Trailer as the leading vehicle in the SPaT Reflection and Reception test.

**Figure 18: Cadillac STS and Tractor-Trailer Used for the Objective Tests**

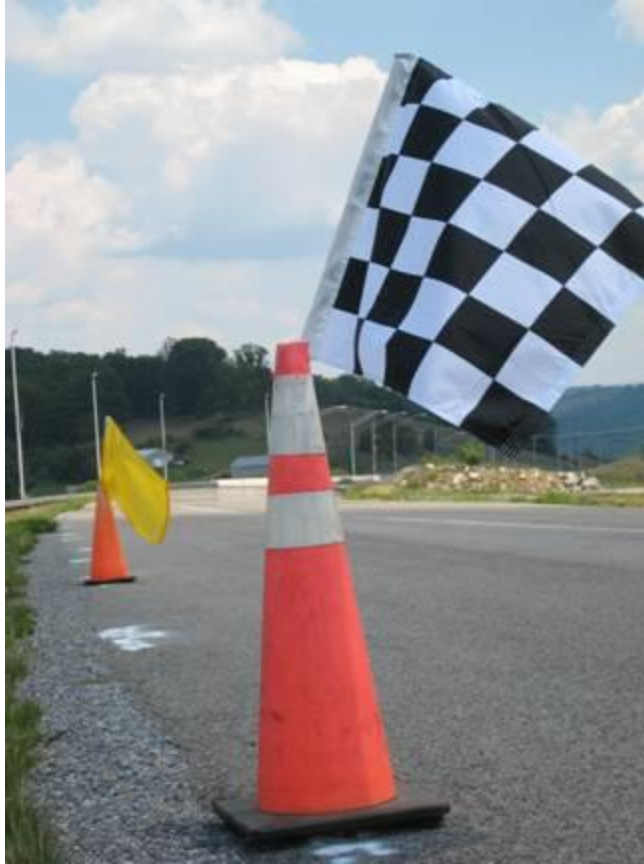
In addition to the data collection, the road was also set up to provide visual feedback to the experimenters. A set of cones was set up to demark the zone within which the warning would have to occur for the speed of the individual procedure. Figure 19 shows the cones for the warning zone.

**Figure 19: Cones with Flags Demarking the Warning Zone**

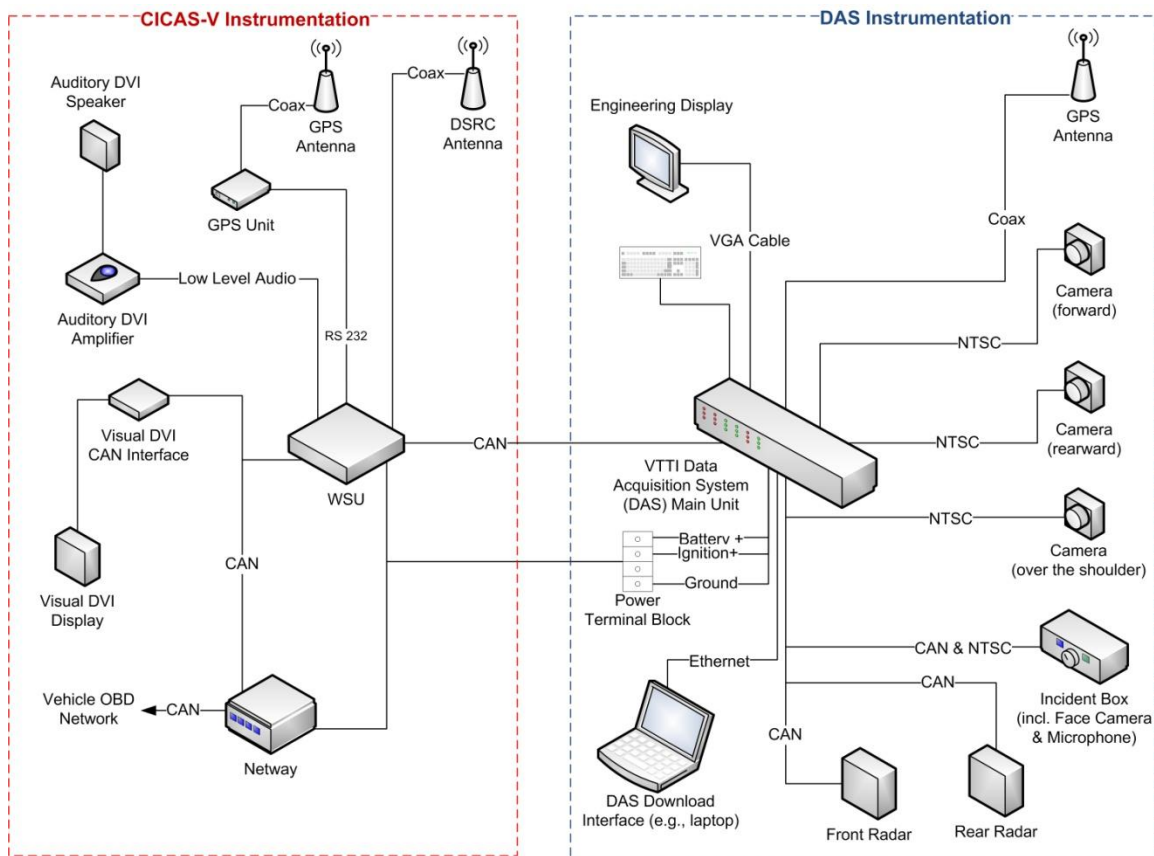
The vehicle DAS developed for the CICAS-V Project is based on the high-performance, adaptable data collection system developed by the Virginia Tech Transportation Institute (VTTI). It is ideal for collecting a wide range of variables in a manner that is unobtrusive to the driver and made possible by hardware, software, and data storage components. Each of the vehicle DAS components are depicted in Figure 20 with further elaboration provided in the Task 12 Final Report (Stone et al., In Print).

**Figure 20: Vehicle DAS System Schematic**

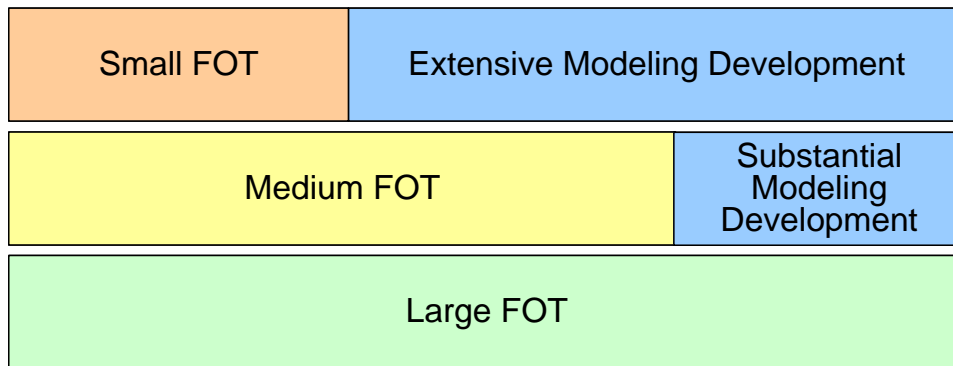
**Figure 23: Modeling Effort for Different FOT Sizes**

In order to keep the modeling effort and the uncertainties in the accuracy of the answers to the FOT questions low, a majority of the FOT drivers must experience CICAS-V alerts during their participation. The number of intersection crossings is a primary determinant of the number of alerts that will be triggered. This means that the number of intersection crossings per driver must be maximized so that alert opportunities are generated. Alerts would come from violations and near-violations at signalized and stop-controlled intersections.

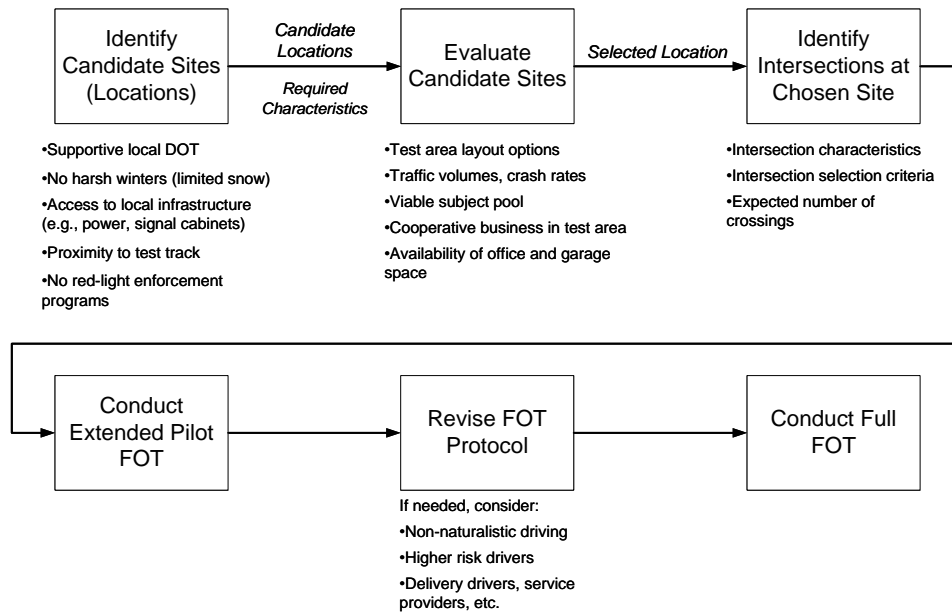
The process for selecting an FOT site is shown in Figure 24.

**Figure 24: FOT Site Selection Process**

An initial pool of candidate locations that satisfies the initial selection criteria such as a supportive local DOT, no harsh winters with limited snow, no red-light enforcement cameras, etc, will then be analyzed as to whether it supports a test area layout that would maximize daily intersection crossings and whether it would support the logistics requirements of the FOT. Also, the intersection characteristics and satisfying the intersection selection criteria are being taken into account for the final site selection. After this step is completed, the intersections will be instrumented and the extended Pilot FOT will be conducted. After the extended Pilot FOT the FOT protocol will be revised if necessary and the full FOT will be conducted.
