**National Highway  
Traffic Safety  
Administration**

DOT HS 810 634

September 2006

## **Experimental Evaluation of the Performance of Available Backover Prevention Technologies**

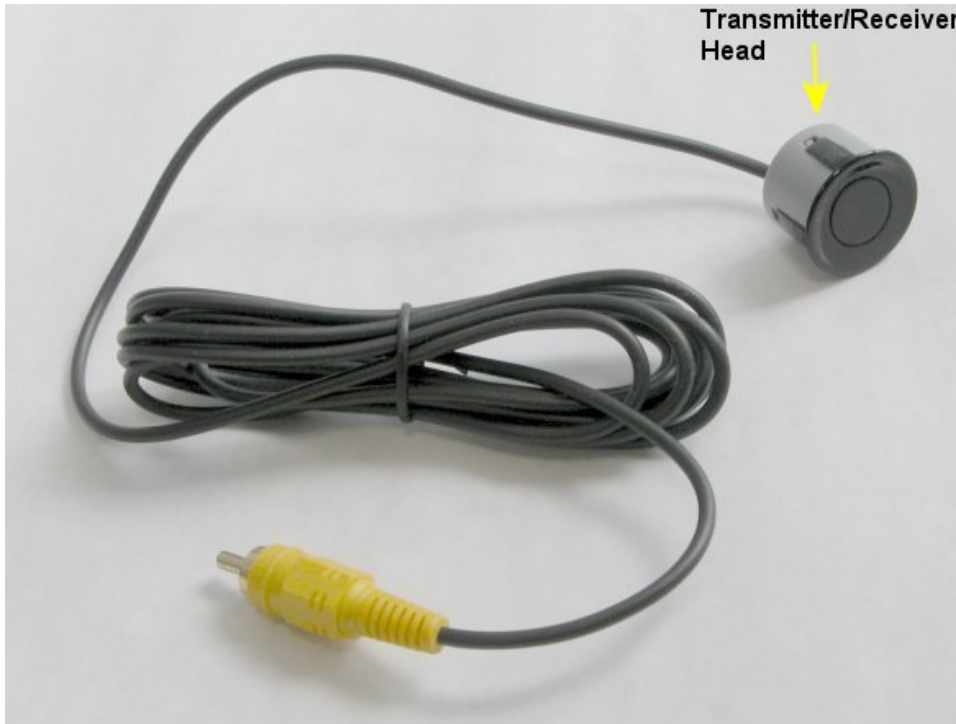
Figure 2. Example of an ultrasonic sensor

Figure 2 shows an ultrasonic sensor for rear object detection. This sensor is designed to be mounted in a hole in the rear bumper with the transmit/receive head of the sensor flush with the surface of the bumper.

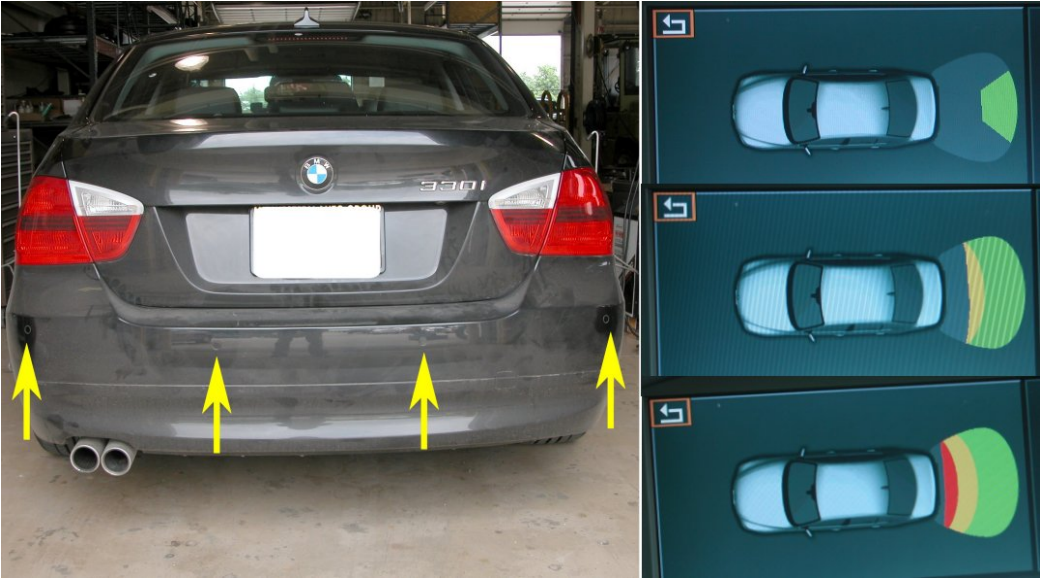
Figure 4. BMW 330i sensor locations and graphical display

The “Park Distance Control” system in BMW’s 2006 330i sedan used ultrasonic technology to detect objects and presented alerts via a graphical display showing an overhead view of the vehicle and colored areas to indicate objects to the rear. The system provides staged visual and auditory warnings to alert the driver of rear obstacles. The system was offered as optional equipment at a cost of \$300. The visual display for the system tested did not appear, regardless of shifting the vehicle into reverse gear, until the navigation system warning message was acknowledged by pressing the “accept” button. The rear sensor locations and stages of the visual display are picture in Figure 4.

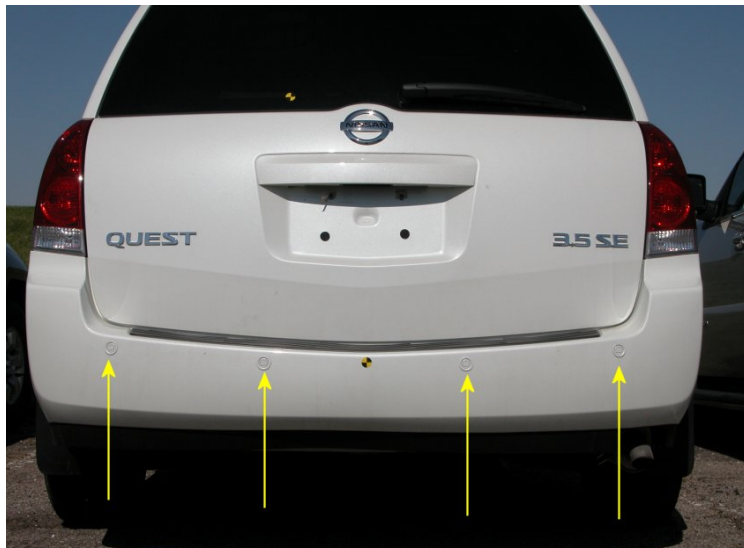
Figure 5. Nissan Quest sensor locations

The “Rear Sonar System” of the 2005 Nissan Quest also used ultrasonic sensor technology. According to a 2005 NHTSA report on advanced technologies [8], the system detects obstacles up to 6 feet from the vehicle’s rear bumper, and operates at speeds at or below 3 mph. That report [8] also stated that the system is not designed to prevent contact with small or moving objects, and may not detect small objects below or on the ground close to the bumper. The system used only auditory alerts to notify the driver of obstacles behind the vehicle. Figure 5 contains a photograph showing the sensor locations for this system.

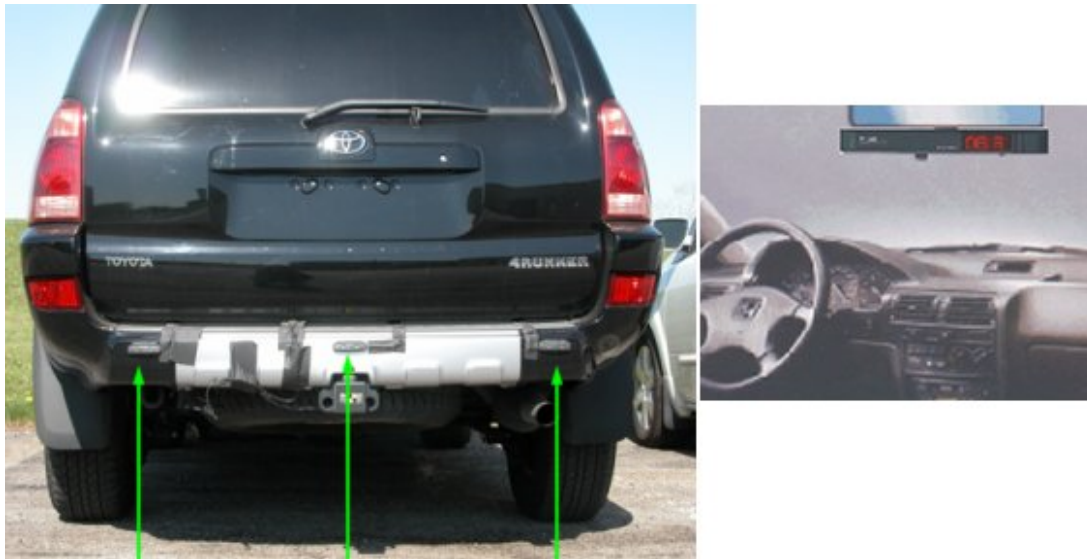
Figure 6. Poron sensors and LED distance visual display

Poron's "Mini3 LV Car Reversing Aid" is a commercially available system that was found for sale on the internet. This system is very similar to a system sold by the name of "Tail Gauge". The system used ultrasonic technology and indicated the presence of rearward obstacles using an auditory alert and an LED display showing the distance to the detected object. The maximum detecting distance for this system was stated to be 8.2 feet. Figure 6 shows the location of the Poron ultrasonic sensors and its visual display. This system ceased to work properly after a short time and thus could not be run through the complete set of sensor system performance tests.

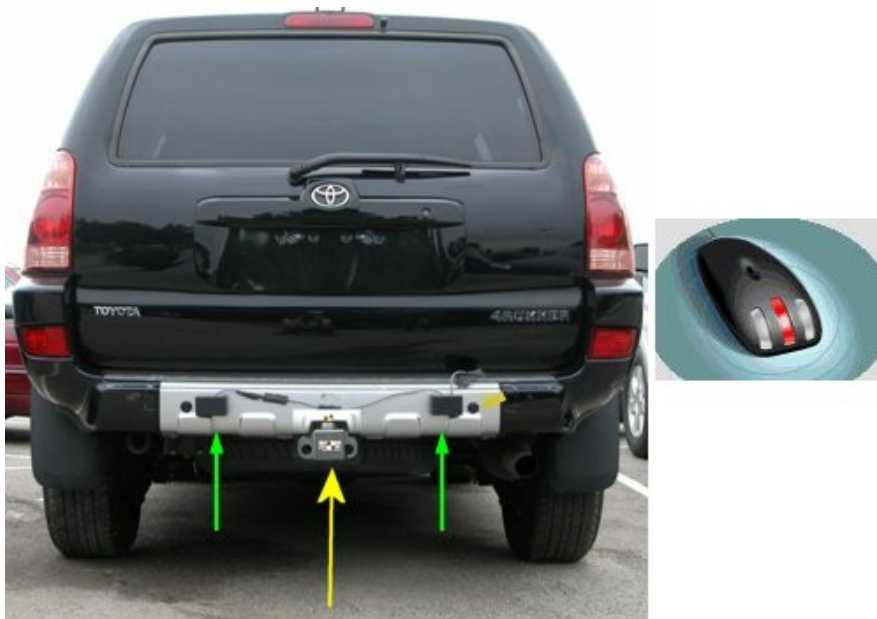
Figure 7. Guardian Alert sensors and visual display

Two versions of the Guardian Alert system by Sense Technologies were examined: an X-band Doppler radar system and a K-band Doppler effect radar sensors. The Guardian Alert system used auditory alerts and colored LEDs to indicate the presence of obstacles behind the vehicle. The Guardian Alert system price was \$200. The photograph in Figure 7 shows both the K-band and X-band Guardian Alert Sensors. This system is marketed as a companion product to the “ScopeOut” mirror system, which is described in Section 2.2.3. However, for the purposes of this test program, the sensor system and mirror system were examined separately.

Note: (X-band sensor in center, K-band sensors outboard)

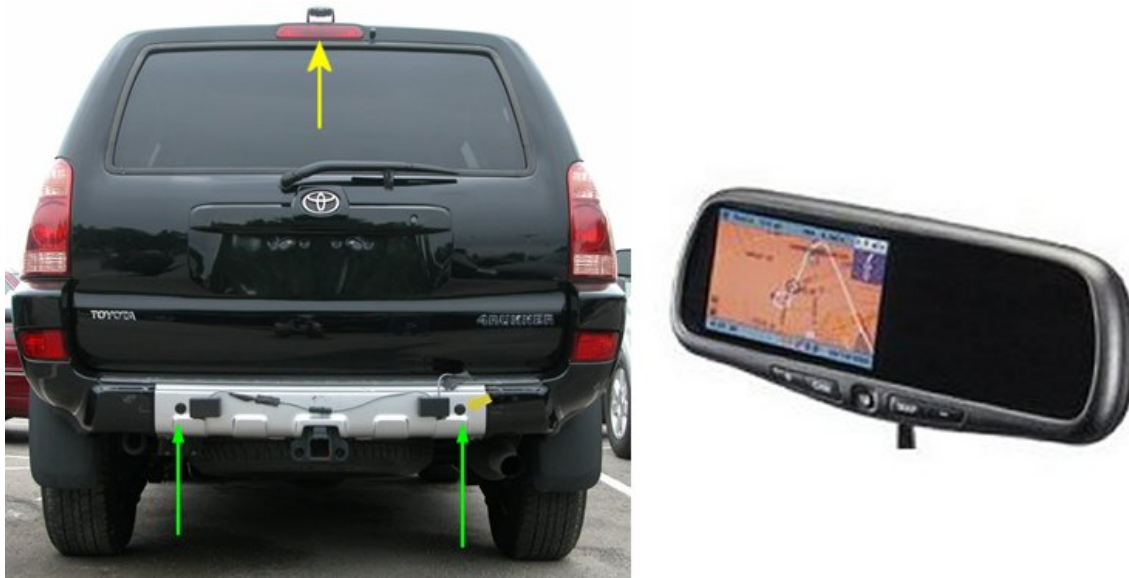
Figure 10. Audiovox system sensor and camera locations and rearview mirror video display

Audiovox offers both a “Reverse Sensing System” using ultrasonic sensors (\$101) and a “Rear Observation System” (\$525) which uses a video camera and video display embedded in a replacement rearview mirror. Both of these systems were installed and examined as a single system. However, time was not available to perform field-of-view measurements for the camera system. Figure 10 contains photographs of the Audiovox ultrasonic sensors and rearview mirror display tested here.

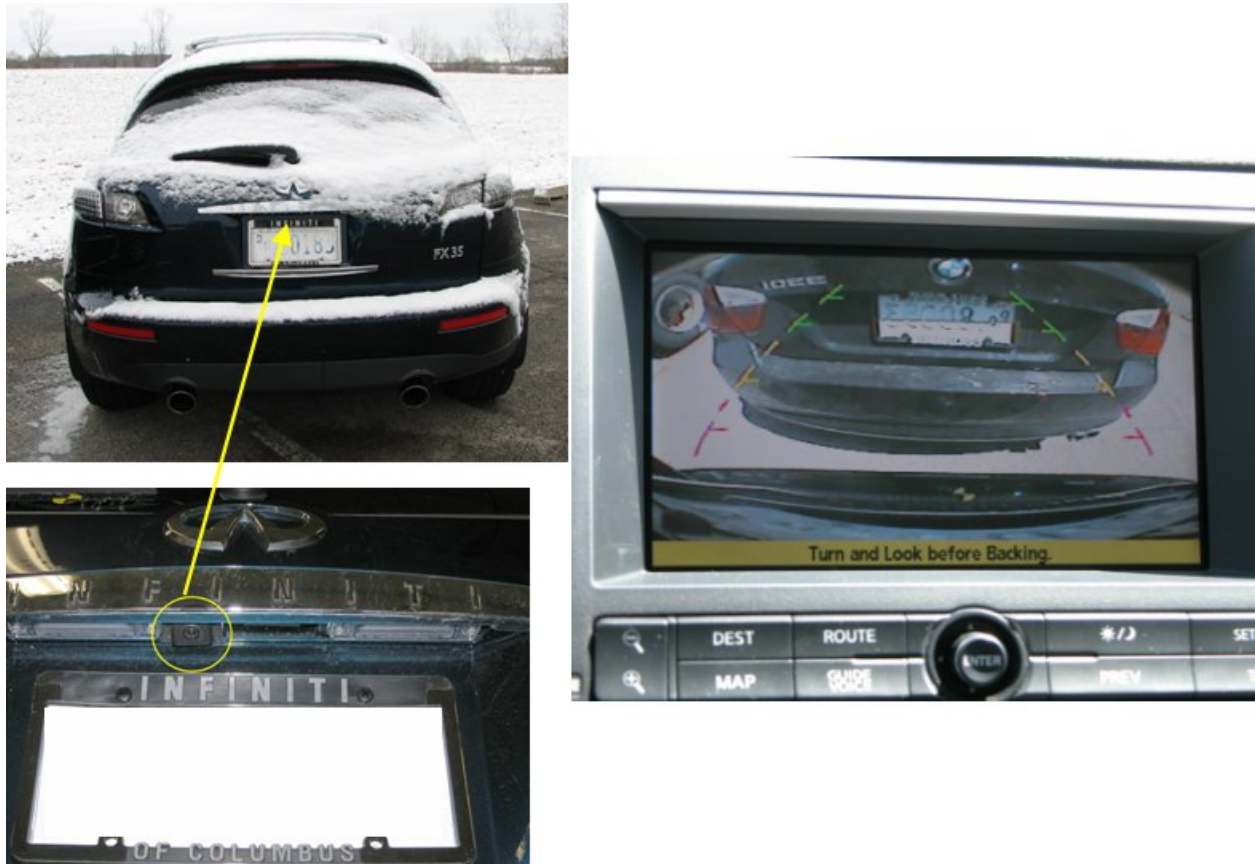
Figure 11. Infiniti FX35 camera location and video display

A single system that used only video as its “sensor” technology was examined, Infiniti’s “RearView Monitor”. The camera for this system was mounted above the license plate area on the rear of the vehicle. The system’s video display contained perspective lines to assist the driver in knowing which part of the view shown in the video was directly behind the vehicle. Figure 11 contains photographs of the Infiniti RearView Monitor system camera location and its visual display.

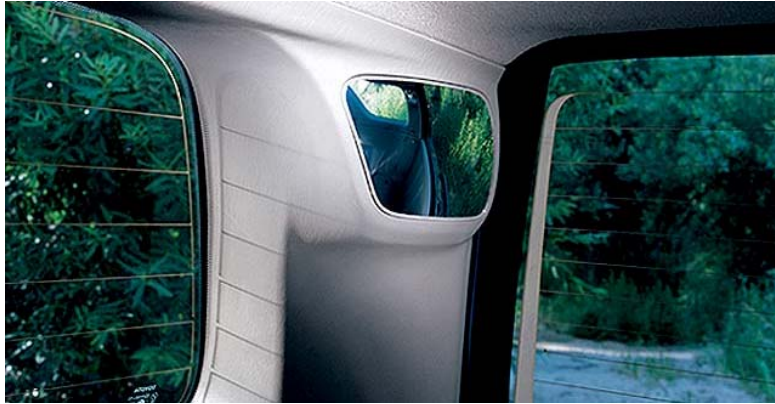
Figure 12. Rear pillar mirrors on Toyota 4Runner (photo from Toyota web site)

One mirror system tested as original equipment was a set of rear-pillar mounted mirrors available on the Toyota 4Runner. The Toyota mirrors are pictured in Figure 12.

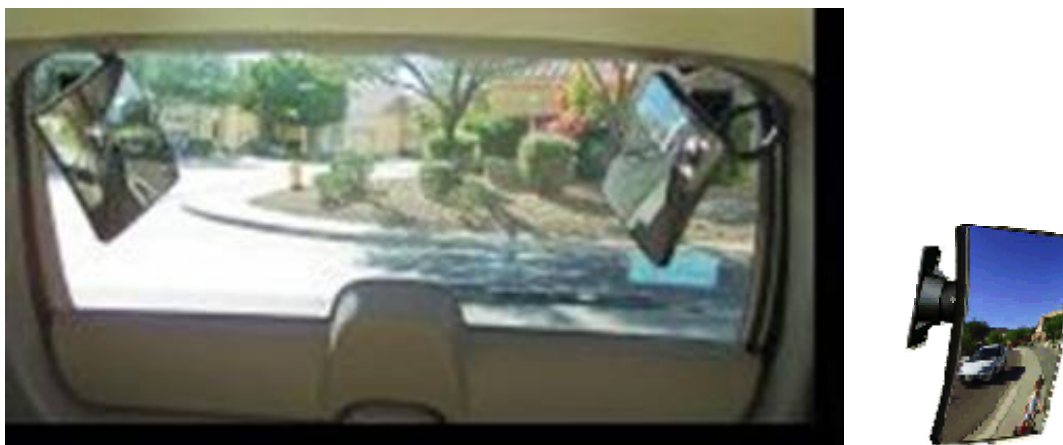
Figure 13. ScopeOut mirror system (SUV version)

ScopeOut mirror system is an aftermarket mirror system which consisted of a set of rectangular convex mirrors mounted on the inside of the rear SUV window or on the rear trunk lid of a sedan. The ScopeOut mirror system is sold as a companion system to the Guardian Alert radar system also examined as part of this work. The ScopeOut mirror system is intended to allow drivers to see objects approaching the area behind their vehicle from a perpendicular direction (e.g., such as when backing out of a parking space when a vehicle is driving down the same aisle). The cost of the system is less than \$100. While the primary focus of this work was to assess technologies that help the driver know what may be directly behind the vehicle, these mirrors were examined to determine whether any portion of the area to the rear of the vehicle was included in the area covered by the mirrors' fields-of-view. These mirrors are pictured in Figure 13.

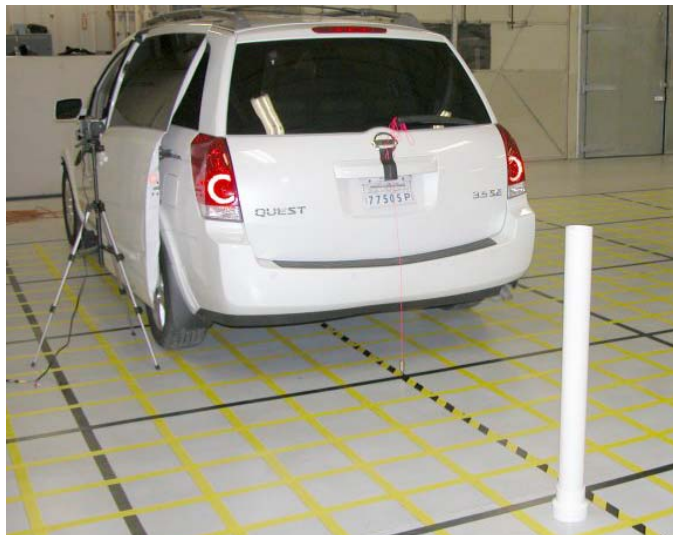
Figure 14. ISO Pole behind the Nissan Quest test vehicle.

Traffic cones and poles were chosen as test objects since their conical and cylindrical shapes, when positioned vertically upright, present the same appearance to the sensors despite any rotation about their vertical axis. This quality renders them likely to achieve a more repeatable response in objective testing. This is likely the reason that a PVC pole was recommended as a test object in the International Standard's Organization's (ISO) Standard 17386, "Transport information and control systems – Maneuvering Aids for Low Speed Operation (MALSO) – Performance requirements and test procedures" [1]. The 40-inch "ISO pole" (pictured in Figure 14) was included in this testing to assess the performance of systems in detecting this object.

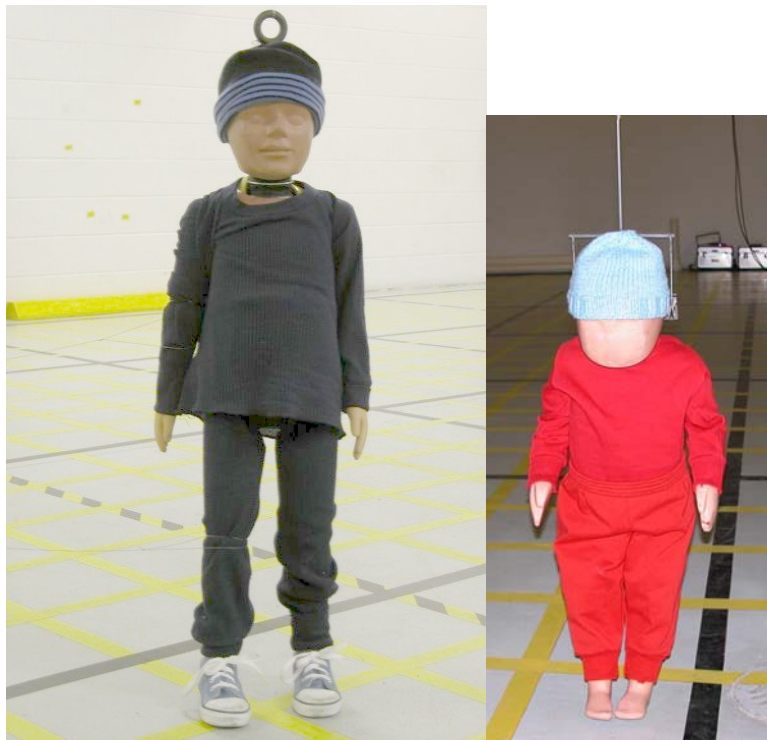
Figure 15. Photographs of ATDs used in testing

<b>CRABI 12-month-old ATD</b>	<b>Hybrid III 3-year-old ATD</b>
Weight (lbs)	22.0	34.2
Standing Height (inch)	29.4	37.2
Sitting Height (inch)	18.9	21.5

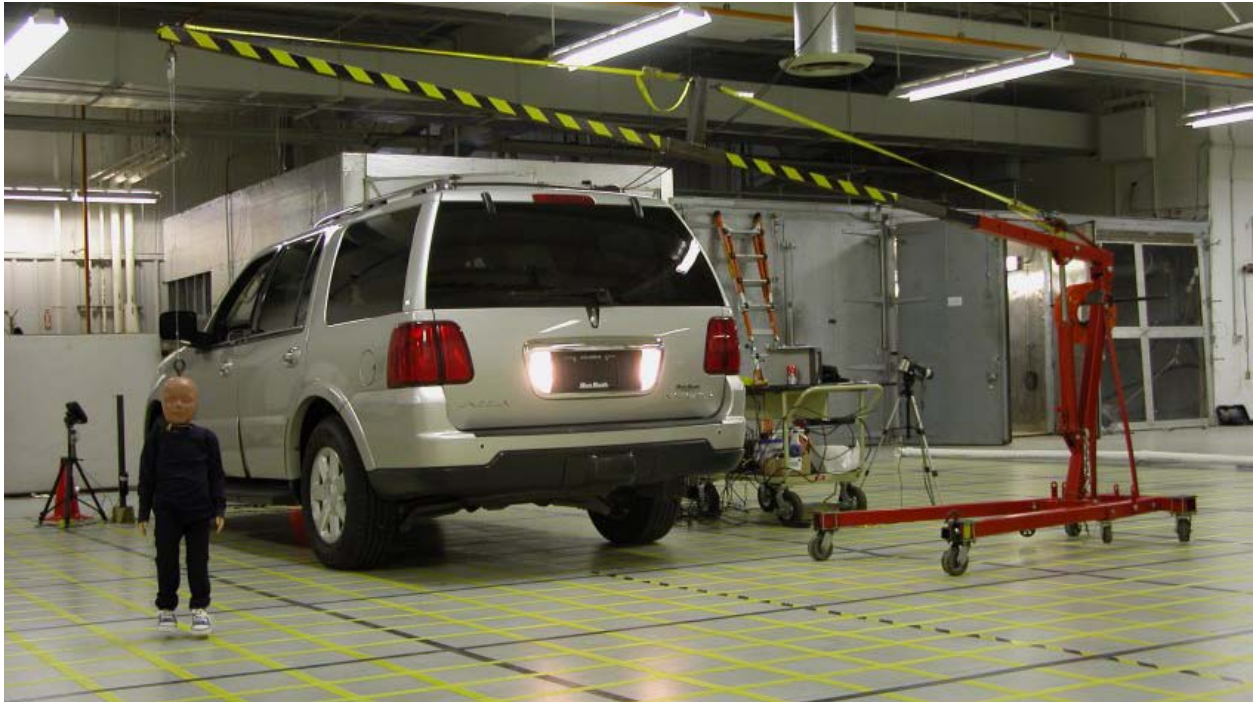
Figure 16. Hoist and boom apparatus with 3-year-old ATD on indoor test grid

Test objects that were too heavy to be moved repeatedly by hand or that were not self-supporting were suspended from above using a modified engine hoist and boom fixture. The hoist was also used to suspend and stabilize movement of the ISO pole during dynamic testing. Monofilament line of 75 pound test was used to suspend objects from the boom. Figure 16 shows a photograph of this fixture with the 3-year-old ATD suspended.

Dimensioned floor grids facilitated measurement of the horizontal area in which objects were detected by sensors systems. The grids were comprised of 1 foot squares. The indoor grid was created using colored vinyl tape and was 60 by 50 feet. The 20 by 25 foot outdoor grid was painted on level, asphalt pavement. Figure 16 shows a portion of the indoor test grid.

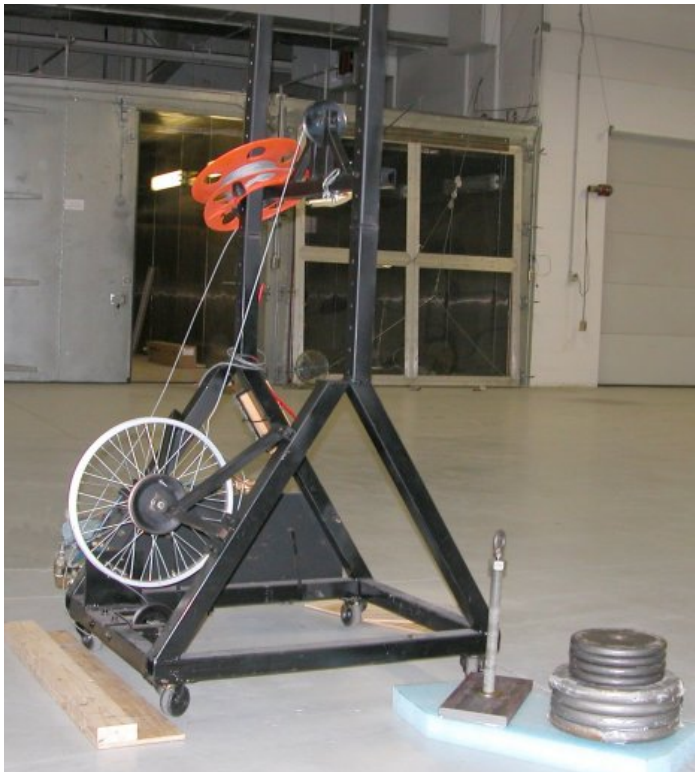
Figure 17. Pulley system used for controlled speed dynamic tests.

For controlled-speed dynamic sensor system object detection tests, a pulley system was used to tow the hoist and boom fixture (as described in Section 3.1) with suspended test object laterally behind the vehicle. The hoist was positioned such that it was outside the range of detection of the sensor system. A pulley system used weights, which were dropped by remote control, to cause a steel-braided cable to pull the hoist with attached test objects. Using this method, objects were moved at specific speeds across lines of the grid parallel to the vehicle's rear bumper. Figure 17 shows a photograph of the pulley system.

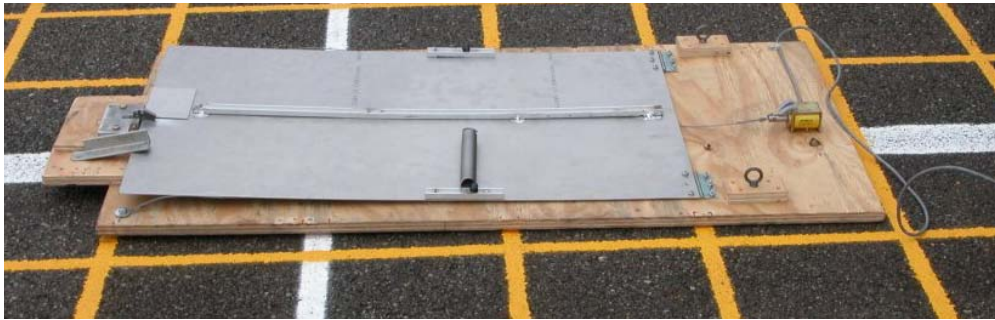
Figure 18. Response time fixture (down)

to release a cam type latch that held the plate down (with springs fully extended) prior to deployment. When the cam was released it pushed the bottom of the aluminum plate upward, initiating the movement. The springs provided the force to move the plate into its deployed vertical position. Braided stainless steel cables were attached from the plywood plate to the back side of the aluminum plate to limit its travel. The height of the fixture when deployed was 36.5 inches. Testing was conducted indoors on a flat, level, concrete surface.

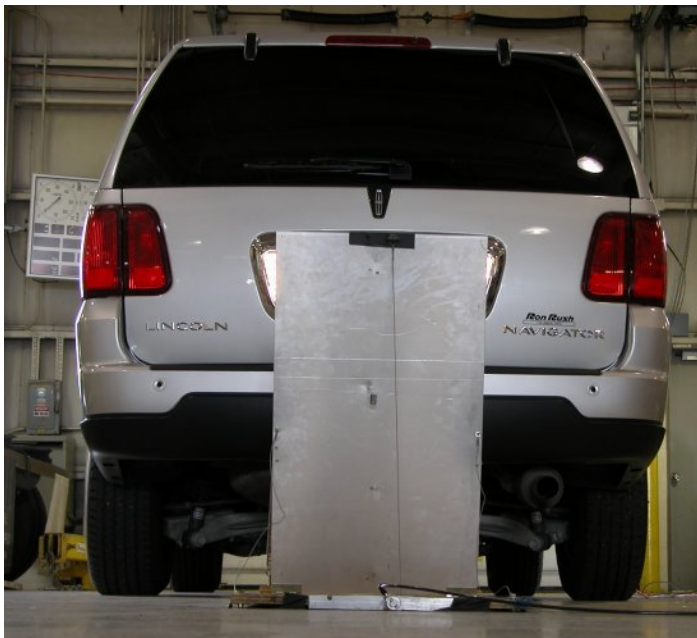
Figure 19. Response time fixture (deployed)

Sensor system detection response time was measured using a remote-controlled fixture containing an aluminum plate that would pop up from the ground. The dimensions of the plate were 20.25 by 35.5 inches. The plate was attached to a plywood board using hinge. The plywood board rested on the ground and provided weight to fix one end of the plate at ground level. The aluminum plate began in a horizontal position resting atop the plywood board, as shown in Figure 18. When released, the plate rotated about the hinge point to a vertical position at full deployment, as shown in Figure 19. Two springs were attached 14 inches up from the pivot point position one on each side of the aluminum plate and to the plywood 3 inches before the pivot point. A solenoid was triggered by wired remote control

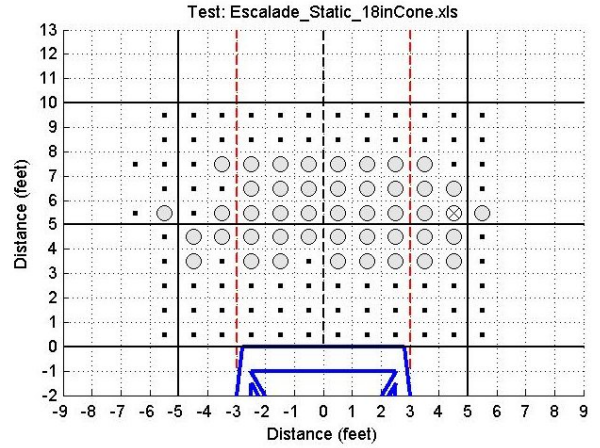
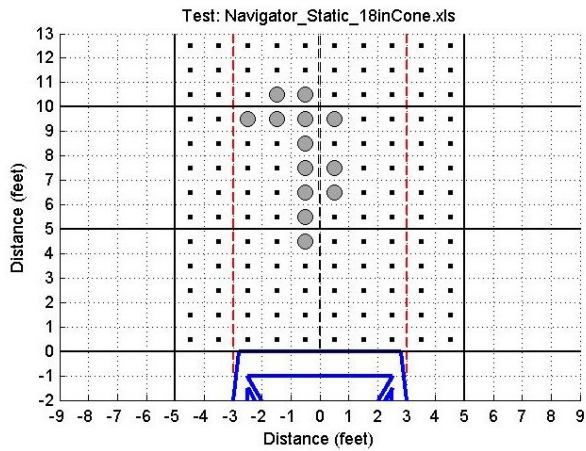
Figure 21. Sensor system object detection performance results: 18-inch traffic cone

The 18-inch cone was detected by the systems somewhat better than the 12-inch cone, supporting the assumption noted above that the 12-inch cone was simply not tall enough to reach the lower edge of the sensor beam and be detected. As shown in Figure 21, all systems detected the 18-inch cone in at least some locations. The broad detection area shown for the BMW 330i demonstrates that the 18-inch cone is a detectable object. These graphs suggest that the detection beam of the Escalade, Poron, and Navigator systems are probably aimed higher than those of the BMW 330i and Audiovox systems.

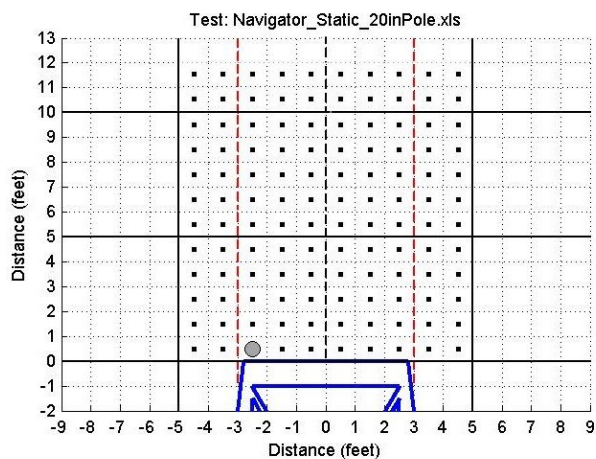
Figure 24. Sensor system object detection performance results: 20-inch PVC pole

The 20-inch PVC pole was included in the set of test objects to provide additional height and shape combination information. The subtleties of shape differences are highlighted when comparing the results for the 20-inch pole to the 18-inch cone. The 20-inch pole was nearly not detected at all by four of the systems, as shown in Figure 24. The BMW system detected the 20-inch pole only about half as well as the 18-inch cone, despite the similar height of the objects. It is possible that the shape of the cone with its sloped sides may have allowed more of the sensor's detection beam to be reflected back to the receiver. Given that the shape of the pole is not similar to that of a human, this object provides information related to detectability of objects a driver might encounter in a parking lot.

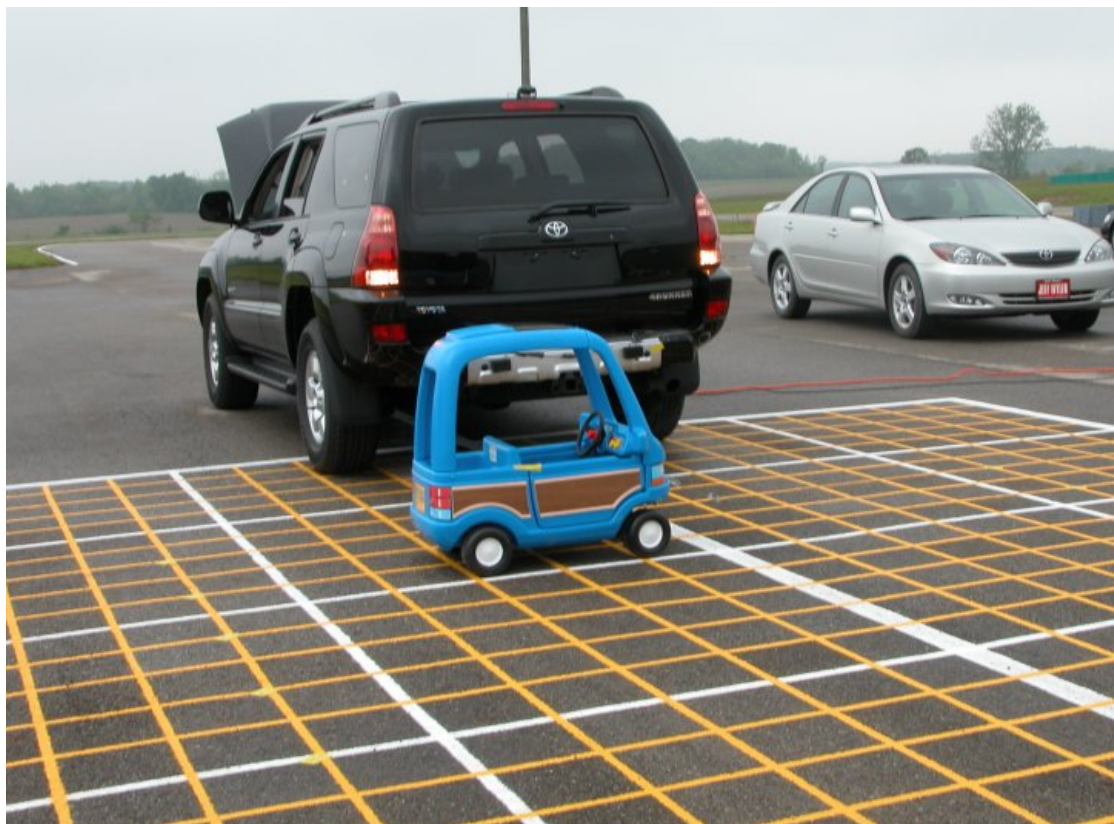
Figure 40. Photograph of toy car outdoor dynamic test trial

One outdoor, controlled-speed dynamic sensor system detection performance test scenario was performed involving a toy car, called a “Cozy Coupe®” (made by the Little Tikes Company). The toy car was moved across the lines of the outdoor test grid using the pulley system. Trials with this test object were conducted at 2 and 3 mph. Figure 40 shows a photograph of the toy car test scenario.

The toy car was well detected by all systems with detection ranges seen from 6 feet (Guardian Alert, X-band) to 11 feet (Lincoln Navigator). As shown in Table 9, detection ranges were identical across the two test speeds for all systems except the Guardian Alert, K-band system, which detected the toy car 1 foot further out at 2 mph than it did at 3 mph.

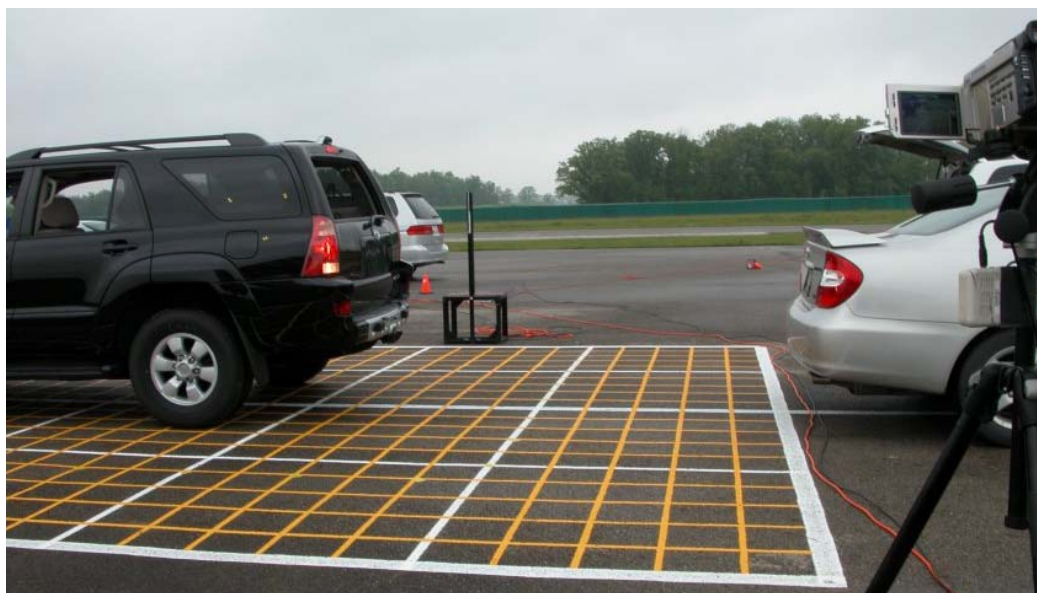
Figure 41. Photograph of car backing to a car scenario

Tests were conducted in which each system-equipped vehicle was backed up to another vehicle (a Toyota Camry, as pictured in Figure 41) and a 36-inch-tall traffic cone. All systems detected the vehicle, except the Poron system for which this test could not be performed due to prior malfunction.

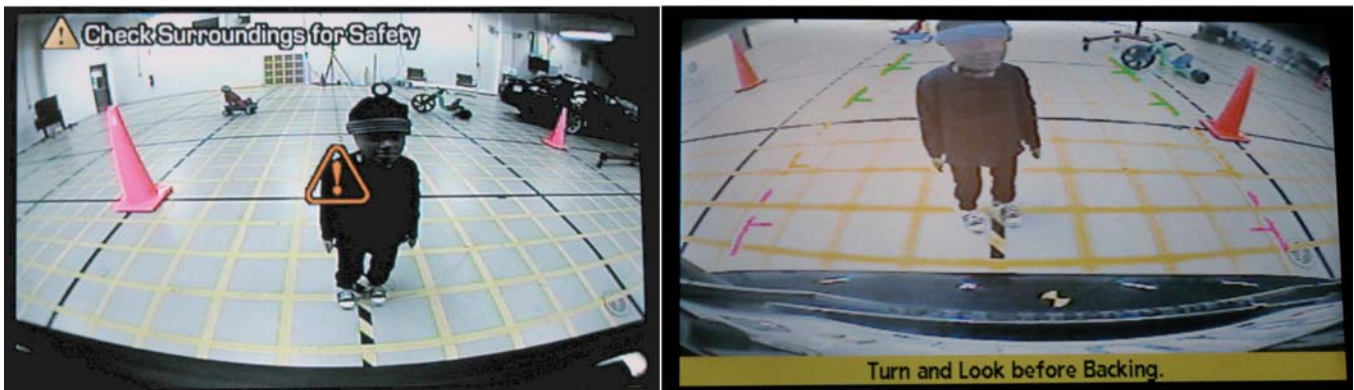
Figure 44. 3-year-old ATD at 2 feet from rear bumper as displayed by Cadillac Escalade (left) and Infiniti FX35 (right) rear video systems.

The height of the viewable area for the Infiniti system was significantly less than that of the Cadillac. The Infiniti camera along the centerline of the vehicle reached 0 feet in height at a longitudinal distance of approximately 23.5 feet from the rear bumper. In addition to limiting the field of view, as seen in Figures 44 and 45, the downward angled camera also seemed to complicate the judgment of the distance to rear objects. In addition, since the vertical upper limit of the view for this rear camera system seems to correspond to the camera height (approximately 41 inches above the ground) and slopes downward noticeably (e.g., at 2 feet from the rear bumper the view height is approximately 36 inches, as evidenced by the top of the 3-year-old ATDs head not being visible at 2 feet, as shown in Figure 44), it is possible that objects above that height (e.g., tree branch) might be missed by the driver and struck while backing. Figures 44 and 45 below illustrate the field of view height difference by showing the 3-year-old ATD pictured in both displays standing 2 feet and 10 feet, respectively, from the rear bumper.

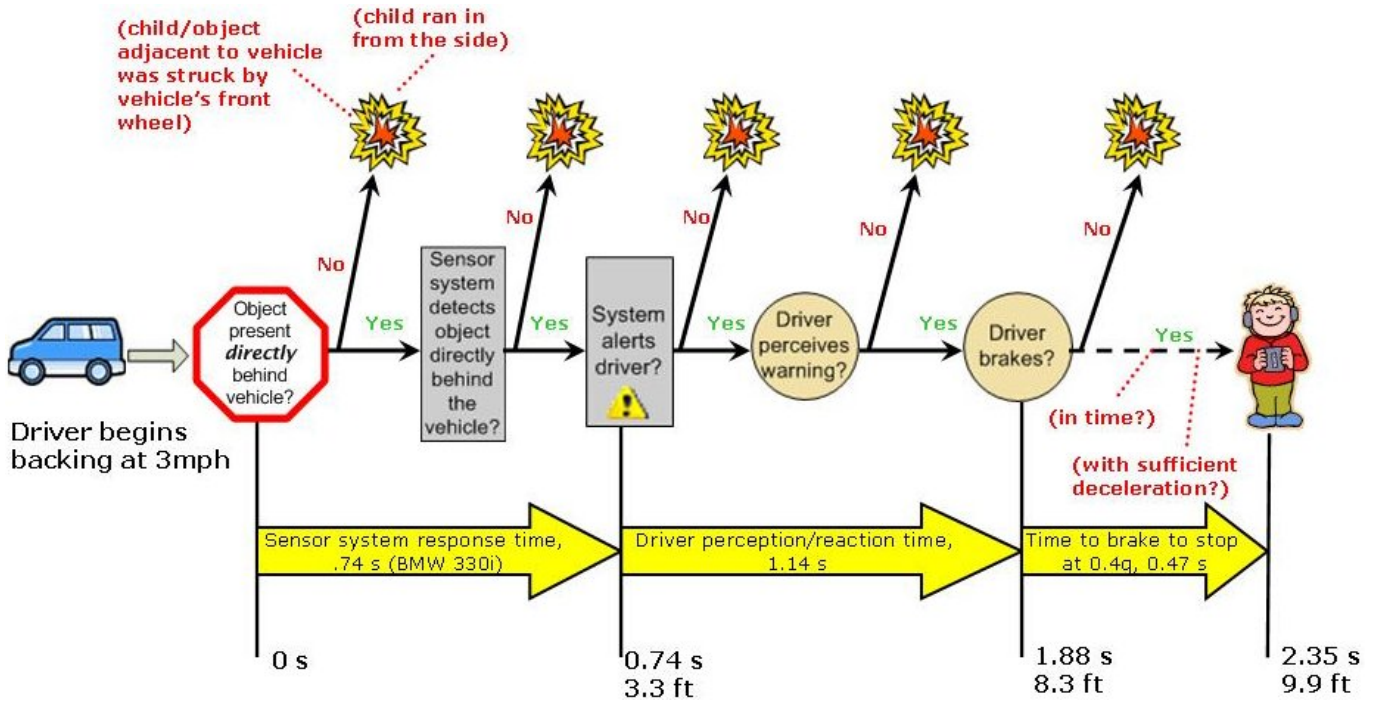
Figure 49. Crash Avoidance Scenario Steps Timeline for Sensor-Based Systems

The three main variables in these steps include the system, the driver, and the physics of the situation. Figures 49 and 50 illustrate these steps for sensor-based and video-based systems, respectively, and note some additional factors that can impact the outcome of a backing situation. This section outlines aspects of each variable that can impact the outcome of a crash avoidance situation.

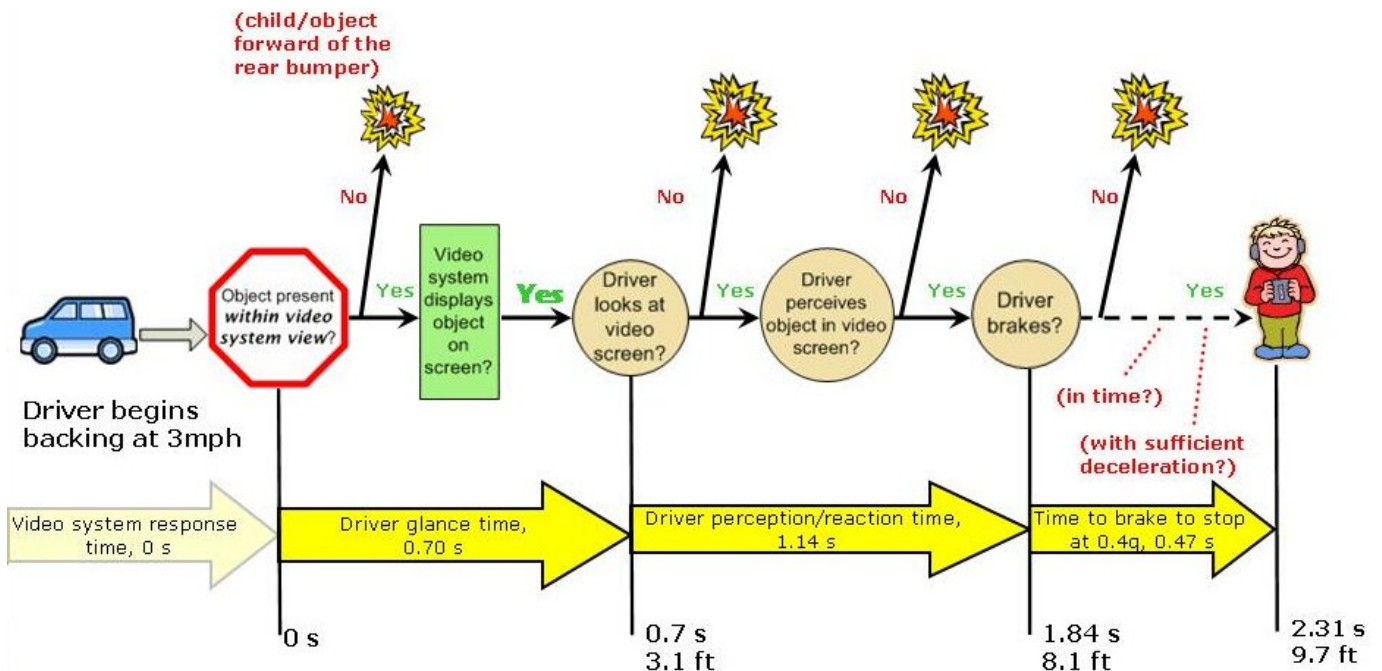
Figure 50. Crash Avoidance Scenario Steps Timeline for Video-Based Systems
