DOT HS 810 865

November 2007

## **Experimental Evaluation of the Performance of Available Backover Prevention Technologies for Medium Straight Trucks**

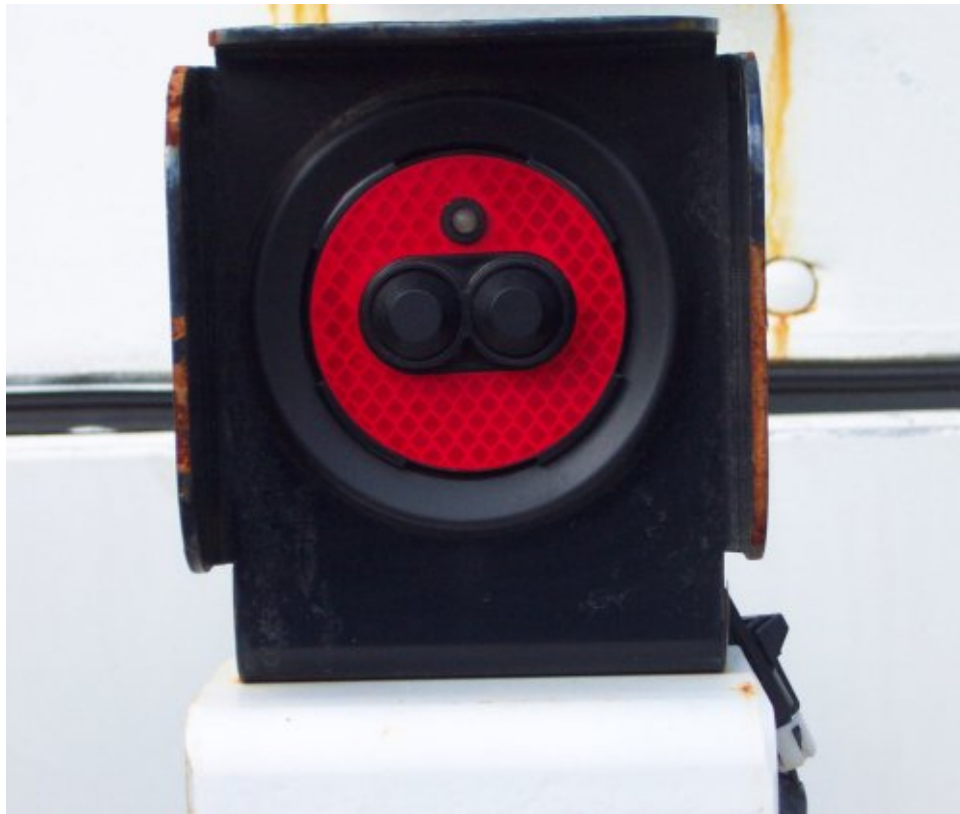
Figure 1. Eagle Eye Ultrasonic Sensor

1. The Eagle Eye Electronic Obstacle Detection System from Transportation Safety Technologies. This system was composed of two sensors and an audio-visual display. The two ultrasonic sensors, which are shown in Figure 1, are mounted fairly low down on the rear of a truck. The audio-visual display, shown in Figure 2, is mounted on top of the vehicle's dashboard where it can clearly be seen by the driver. This display warns the driver, both audibly and visually, of the presence of an obstacle behind the vehicle and conveys distance information. The Eagle Eye system was purchased as an aftermarket add-on. It was mounted onto the 2002 Mack MV222L test vehicle by representatives of Transportation Safety Technologies. NHTSA personnel mounted this system onto the 1996 Grumman-Olson step van test vehicle.

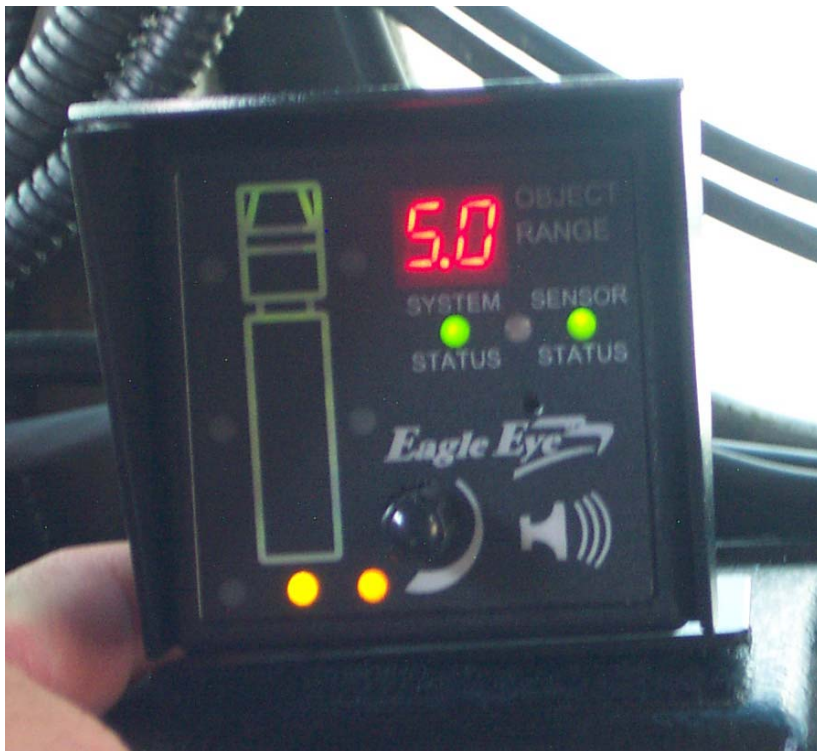
Figure 2. Eagle Eye Audio-visual Display

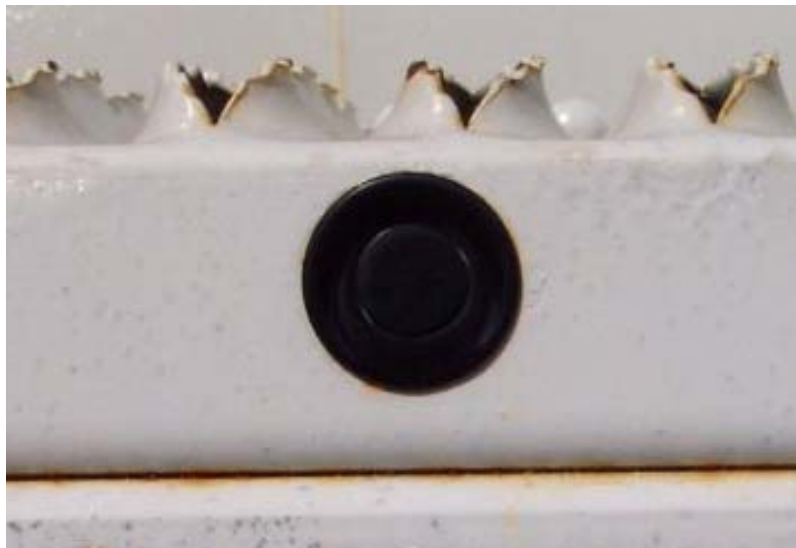
Figure 3. HaoDi Ultrasonic Sensor

2. The HaoDi PAS-405 from HaoDi USA. This system was also composed of four sensors and an LCD screen (with sound) display. The four ultrasonic sensors, which are shown in Figure 3, are mounted across the back bumper of a truck. The 2.75 inch diagonal LCD screen display, shown in Figure 4, is mounted on top of the vehicle's dashboard where it can clearly be seen by the driver. This display warns the driver, both audibly and visually, of the presence of an obstacle behind the vehicle and conveys distance information. The HaoDi PAS-405 system was purchased as an aftermarket add-on and mounted on the test vehicles by NHTSA personnel.

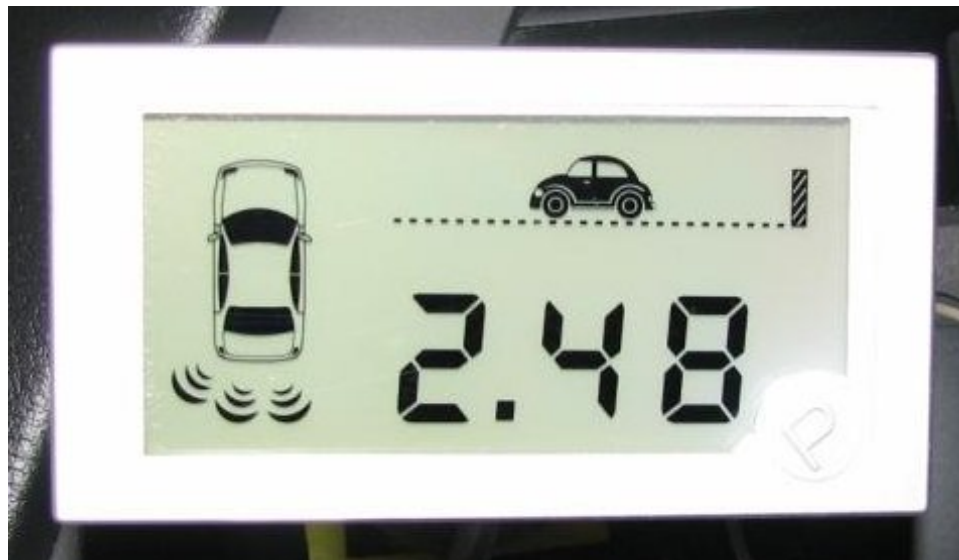
Figure 4. HaoDi LCD Screen Audio-visual Display

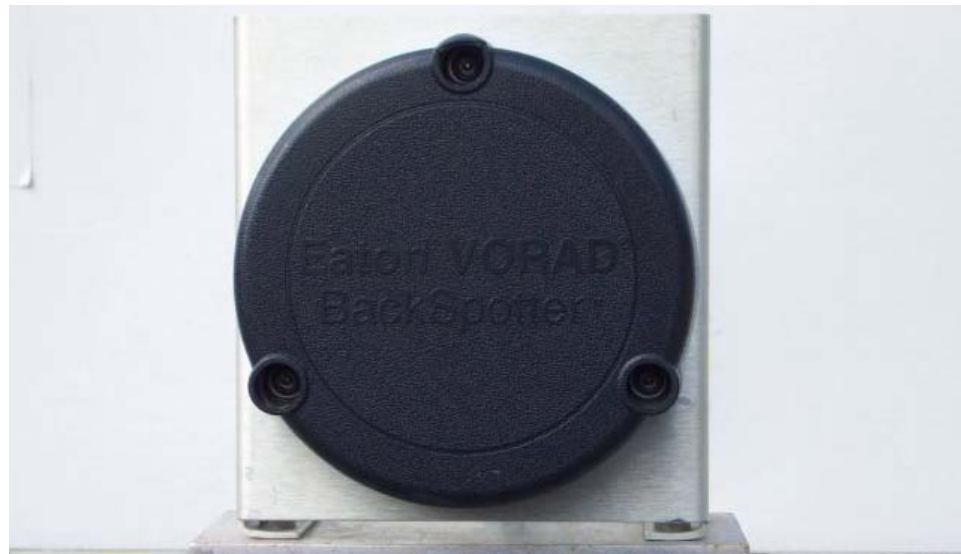
Figure 5. Vorad Backspotter Radar Sensor

3. The VORAD Backspotter Rear Object Detection System from Eaton-VORAD. This system was composed of one frequency modulated continuous wave sensor and an audio-visual display. The radar sensor, which is shown in Figure 5, is mounted low down on the rear of a truck. The audio-visual display, shown in Figure 6, is mounted on top of the vehicle's dashboard where it can clearly be seen by the driver. This display warns the driver, both audibly and visually, of the presence of an obstacle behind the vehicle and conveys distance information. The VORAD Backspotter system was purchased as an aftermarket add-on and mounted on the test vehicles by NHTSA personnel.

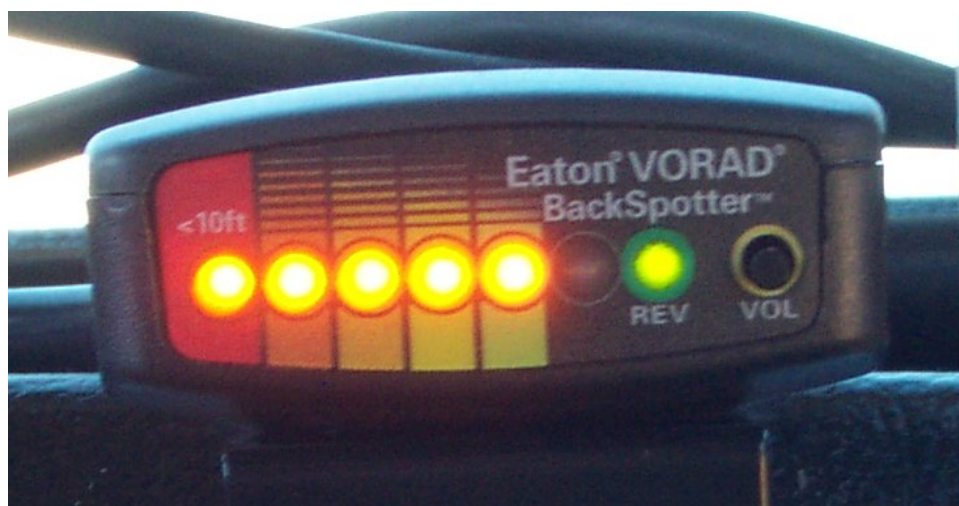
Figure 6. Vorad Backspotter Audio-visual Display

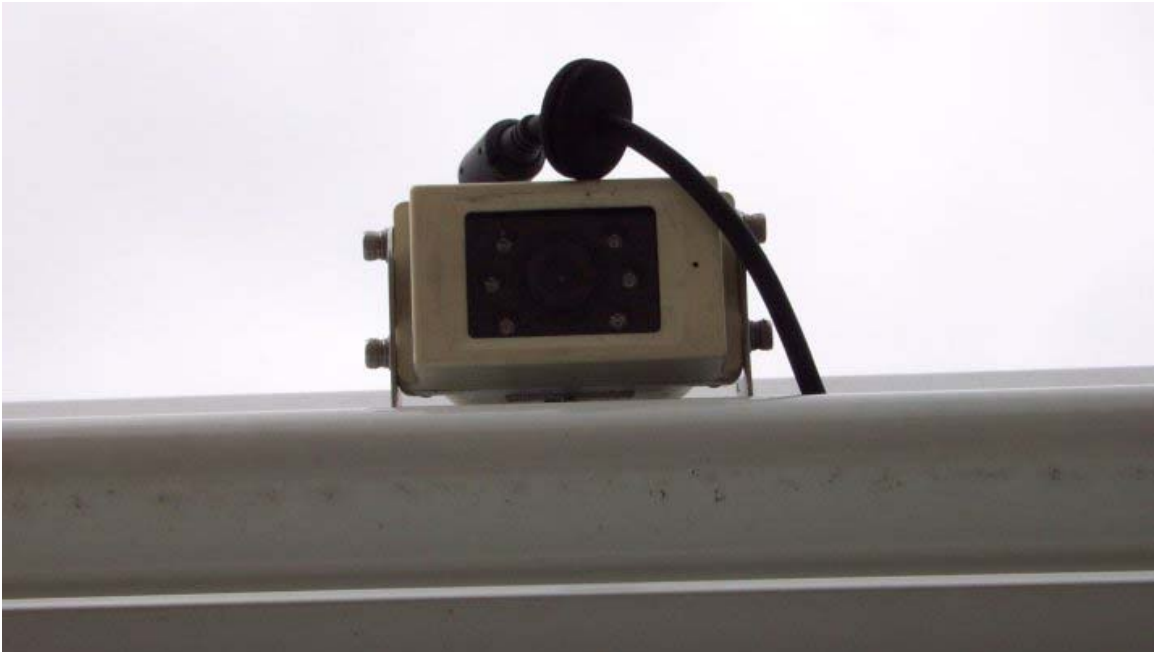
Figure 8. Hindsight 20/20 Video Camera

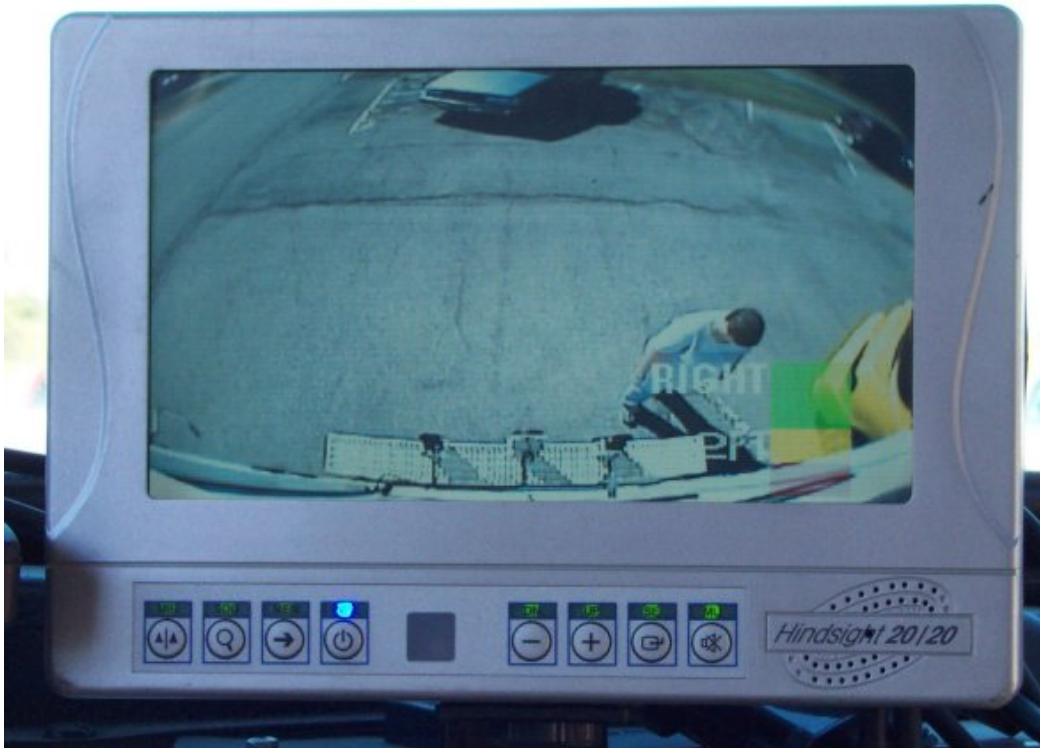
Figure 9. Hindsight 20/20 Audio-visual Display

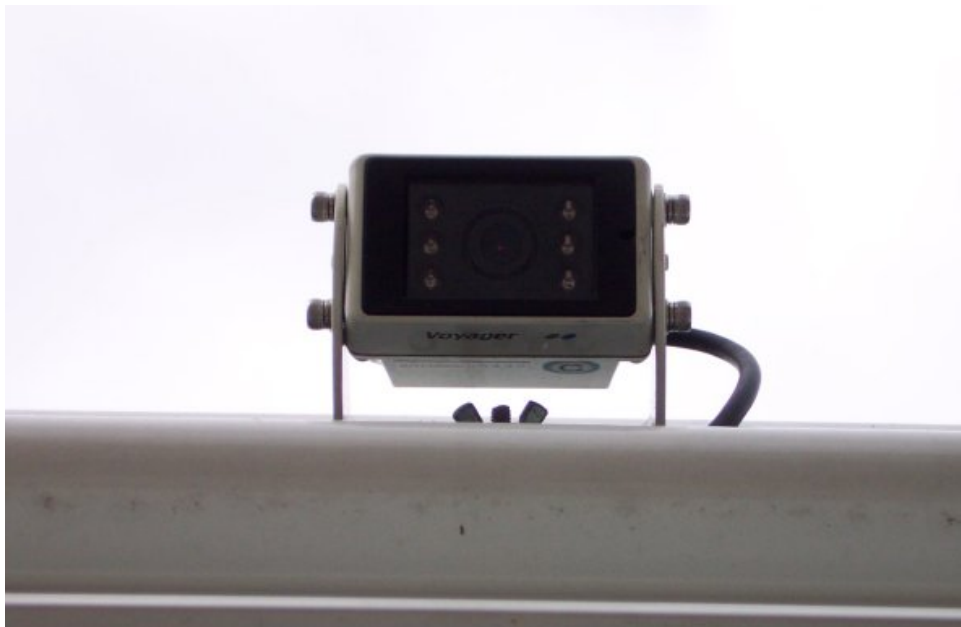
Figure 10. Audiovox Video Camera

One rearview video (only) system was examined. This was the Audiovox System from Audiovox. This system was composed of a rear pointing video camera and a LCD screen display (no sound). The video camera, which is shown in Figure 10, is mounted high up above the rear door of the truck. The 7 inch diagonal LCD screen display (actually 6.8125 inches diagonally), shown in Figure 11, is mounted on top of the vehicle's dashboard where it can clearly be seen by the driver. This LCD screen displays an image of area behind the vehicle to the driver. The Audiovox system was purchased as an aftermarket add-on and mounted on the test vehicle's by NHTSA personnel.

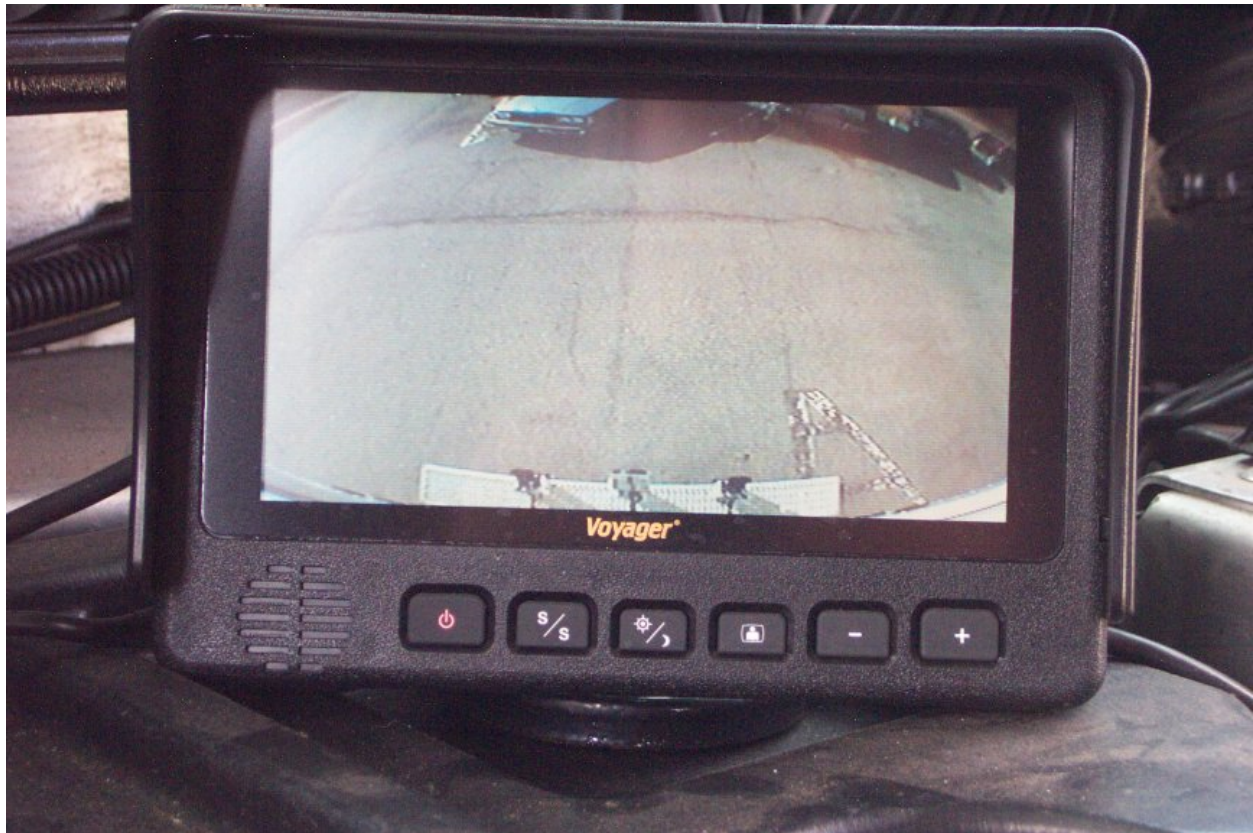
Figure 11. Audiovox LCD Screen Display

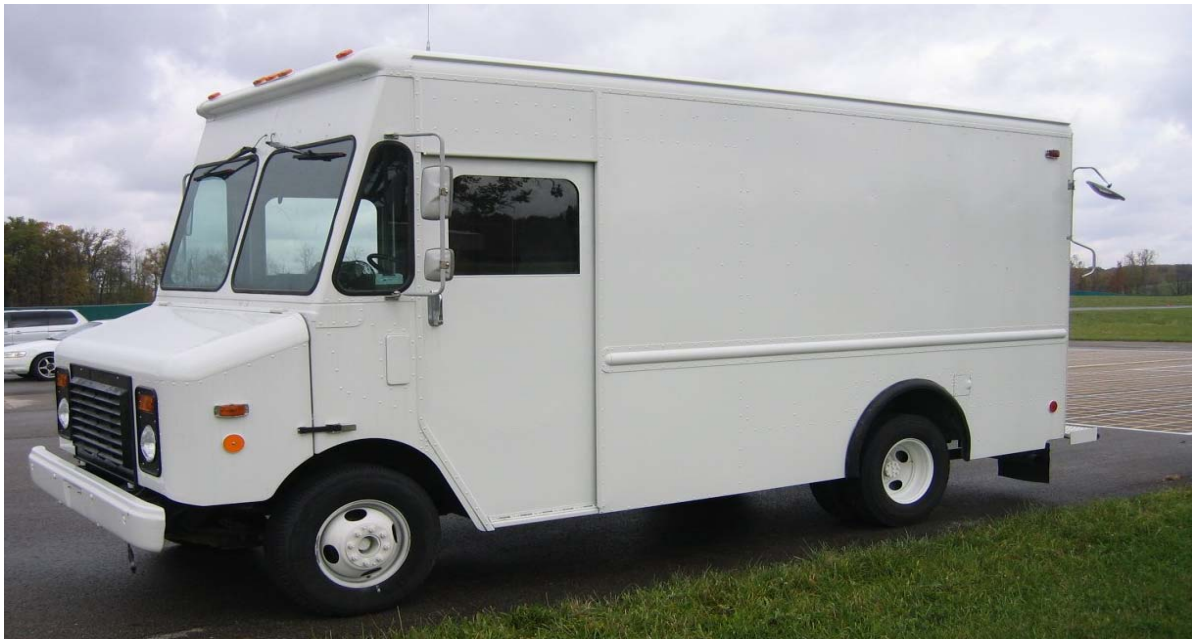
Figure 13. 1996 Grumman-Olson 4x2 Step Van Showing Flat Left Side-view Mirror and Rear Cross-view Mirror

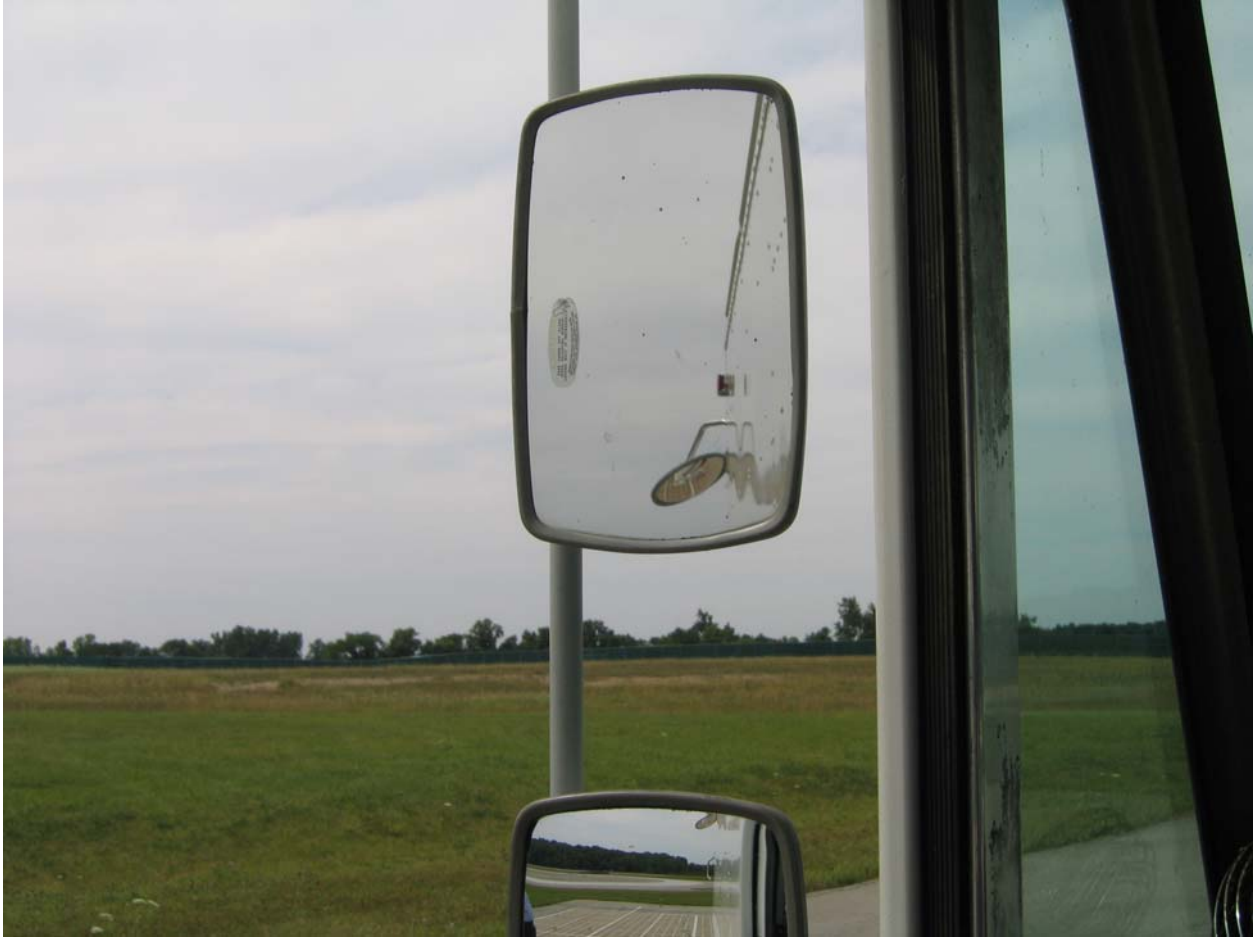
Figure 14. Driver's View of the Rear Cross-view Mirror as Seen in the Planar Side-view Mirror on the 1996 Grumman-Olson 4x2 Step Van

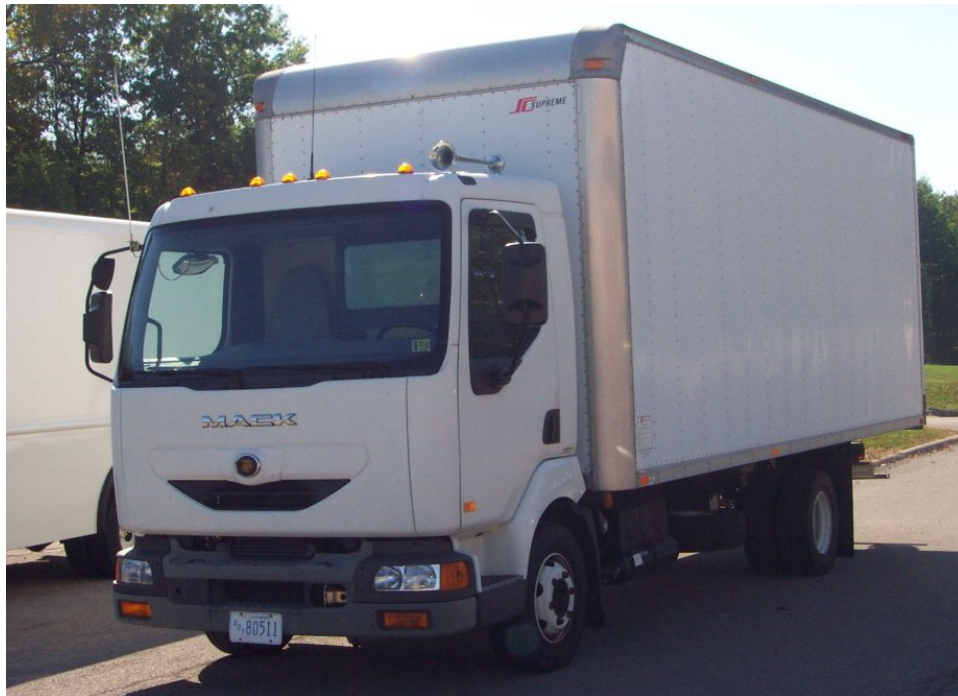
Figure 15. 2002 Mack MV22L Medium Straight Truck

All outdoor sensor and video camera testing for this program was conducted using the 2002 Mack MV222L truck.

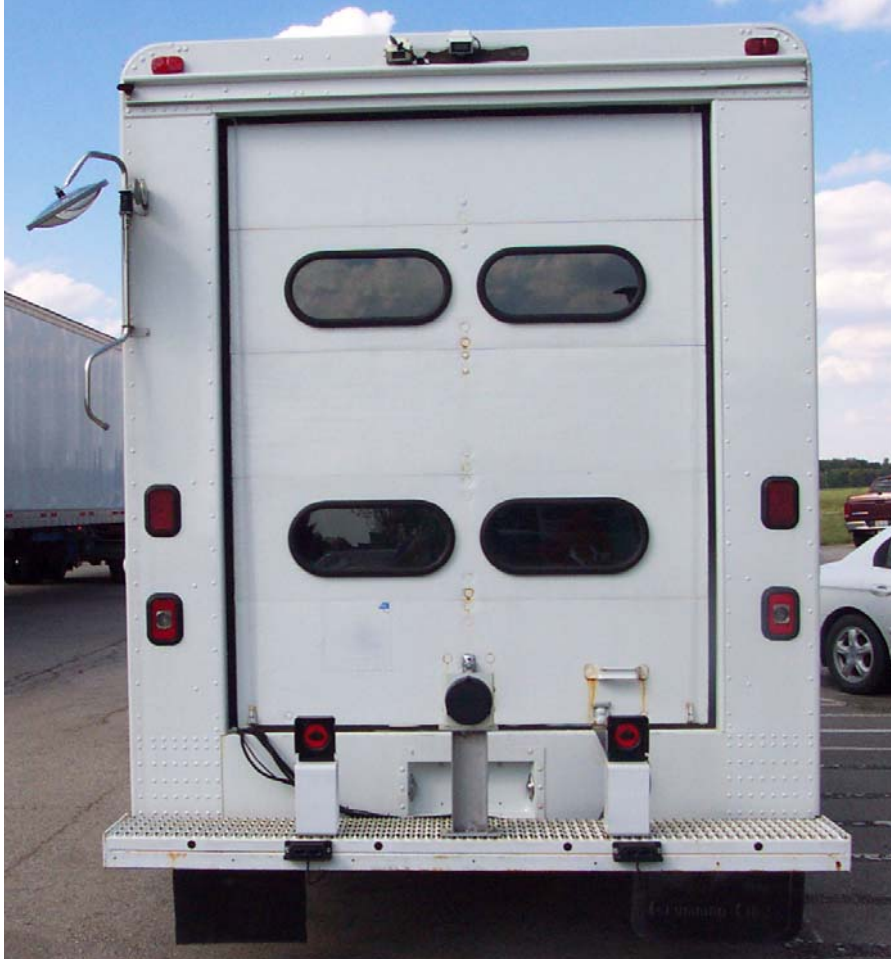
Figure 17. Rear of the 1996 Grumman-Olson 4x2 Step Van Showing Sensor Showing Installed Sensor, Camera, and Mirror Locations

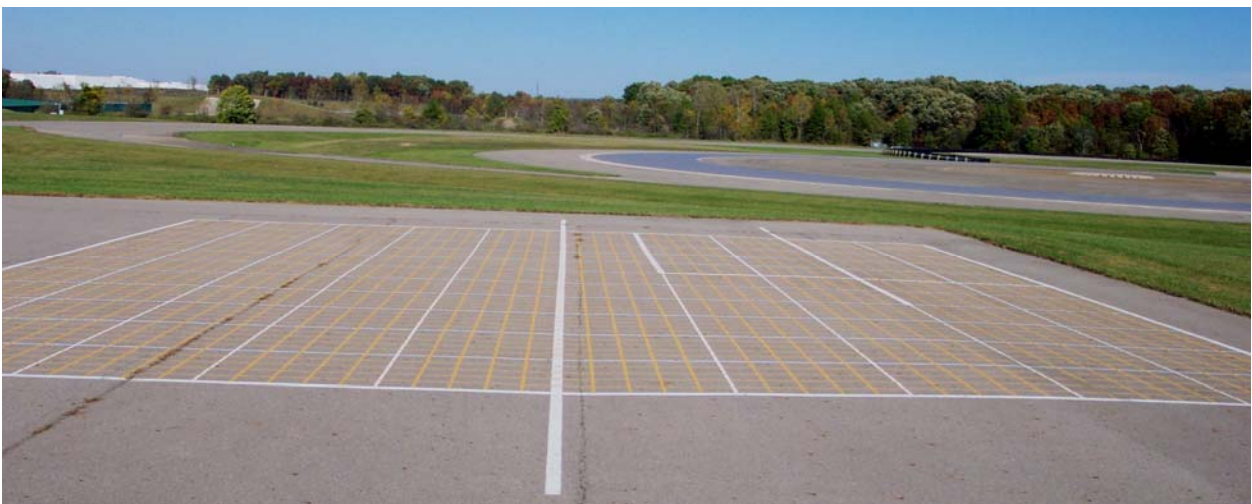
Figure 19. Outdoor Field of View Measurement Grid

Dimensioned grids were used to facilitate measurement of the horizontal area in which objects were detected by sensors, video, and cross view mirrors. One grid was set up indoors and a second outdoors. The grids were comprised of 1 foot squares. The 50 by 50 foot indoor grid is shown in Figure 18, was constructed on a flat, painted concrete floor. The 50 by 55 foot outdoor grid, shown in Figure 19, was painted on level asphalt pavement.

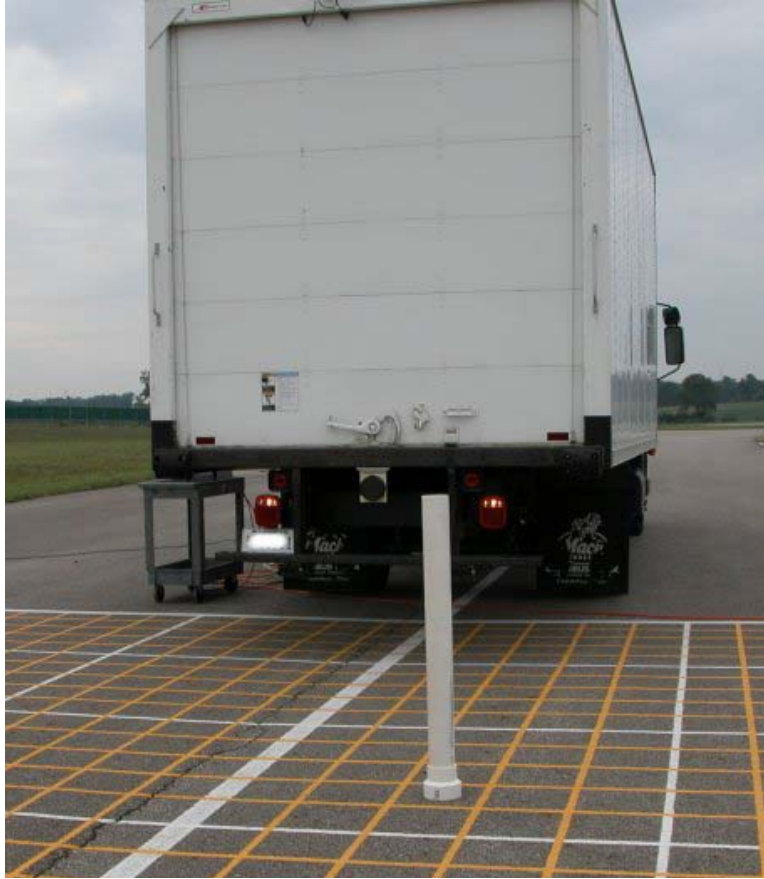
Figure 20. ISO 40-inch pole Set Up on Indoor Field of View Measurement Grid Behind a Light Vehicle

Traffic cones and poles were chosen as test objects since their conical and cylindrical shapes, when positioned vertically upright, present the same appearance to the sensors despite any rotation about their vertical axis. This quality renders them likely to achieve a more repeatable response in objective testing. This is likely the reason that a PVC pole was recommended as a test object in the International Standard’s Organization’s (ISO) Standard 17386, “Transport information and control systems – Manoeuvring Aids for Low Speed Operation (MALSO) – Performance requirements and test procedures” [9]. The 40-inch “ISO pole” (pictured in Figure 20) was included in this testing to assess the performance of systems in detecting this object.

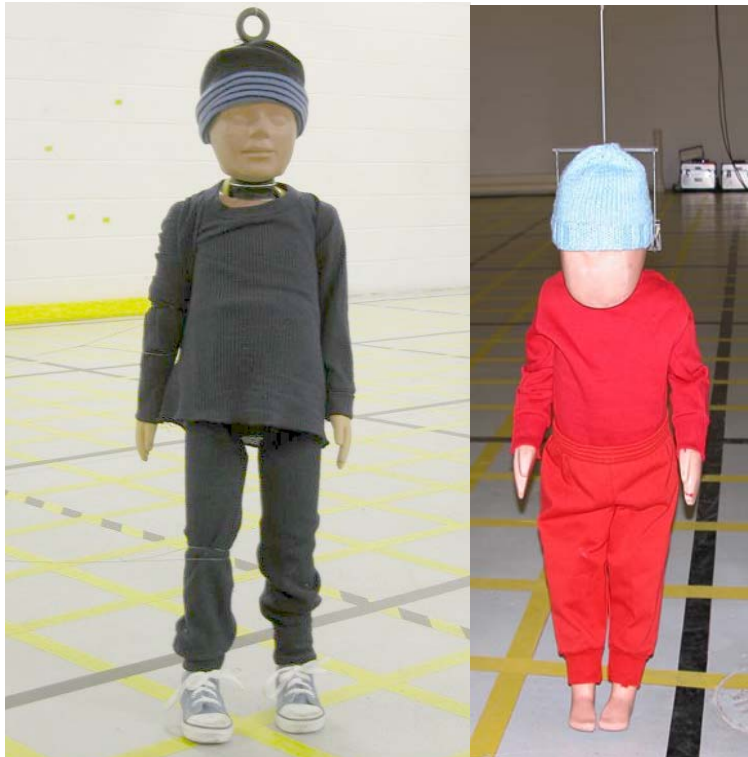
Property	1-year-old ATD	3-year-old ATD
Weight (lbs)	22.0	34.2
Standing Height (inches)	29.4	37.2
Sitting Height (inches)	18.9	21.5

Figure 21. Photographs of ATDs Used in Testing

The particular ATDs used in this testing included the Hybrid III 3-year-old ATD (H-III3C) and the Child Restraint/Air Bag Interaction (CRABI) 1-year-old ATD. The crash dummies are constructed from steel and rubber with fiberglass heads surrounded by polyurethane skins. Table 3 contains some basic data about these devices. For testing, the crash dummies were dressed in long-sleeved knit shirts and long knit pants typically worn for crash testing. Crash dummies were also fitted with knit hats to

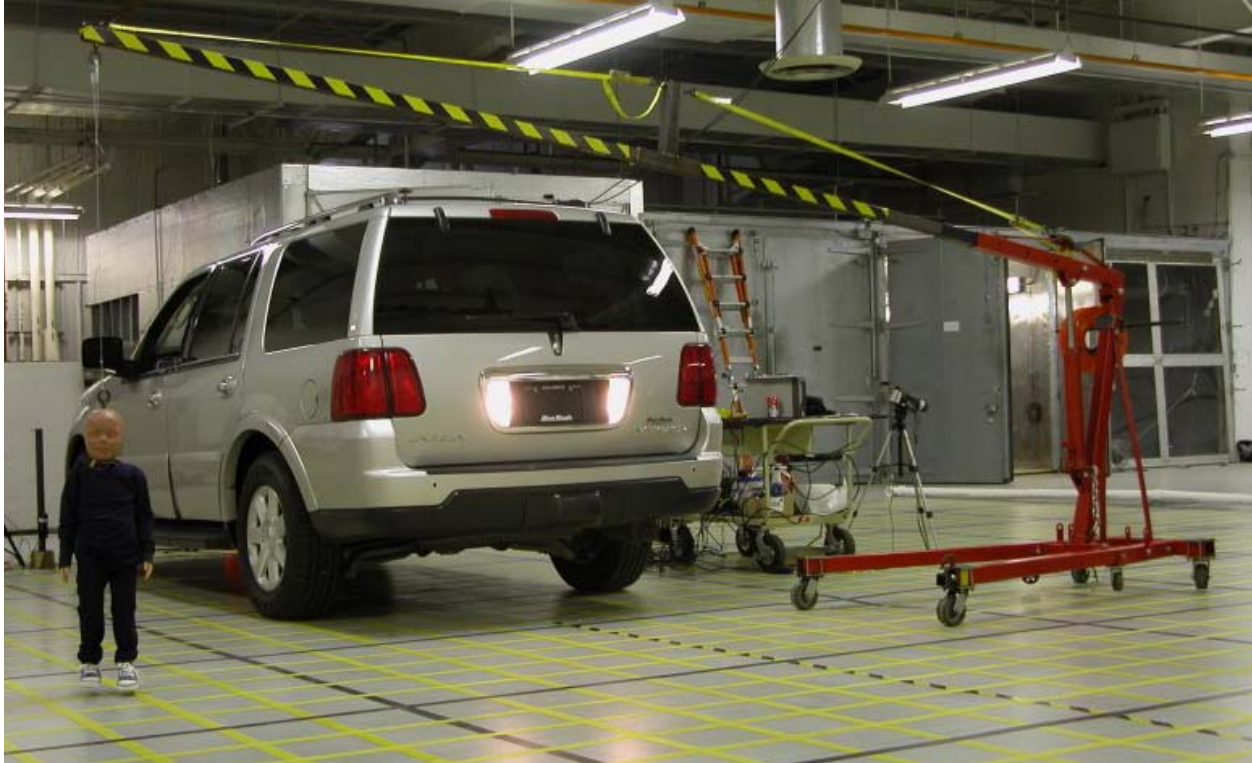
Figure 22. Hoist and Boom Apparatus with 3-year-old ATD on Indoor Field of View Measurement Grid

Test objects that were too heavy to be moved repeatedly by hand or that were not self-supporting were suspended from above using a modified engine hoist and boom fixture. The hoist was also used to suspend and stabilize movement of the ISO pole during dynamic testing. Monofilament line of 75 pound test was used to suspend objects from the boom. Figure 22 shows a photograph of this fixture with the 3-year-old ATD suspended from it.

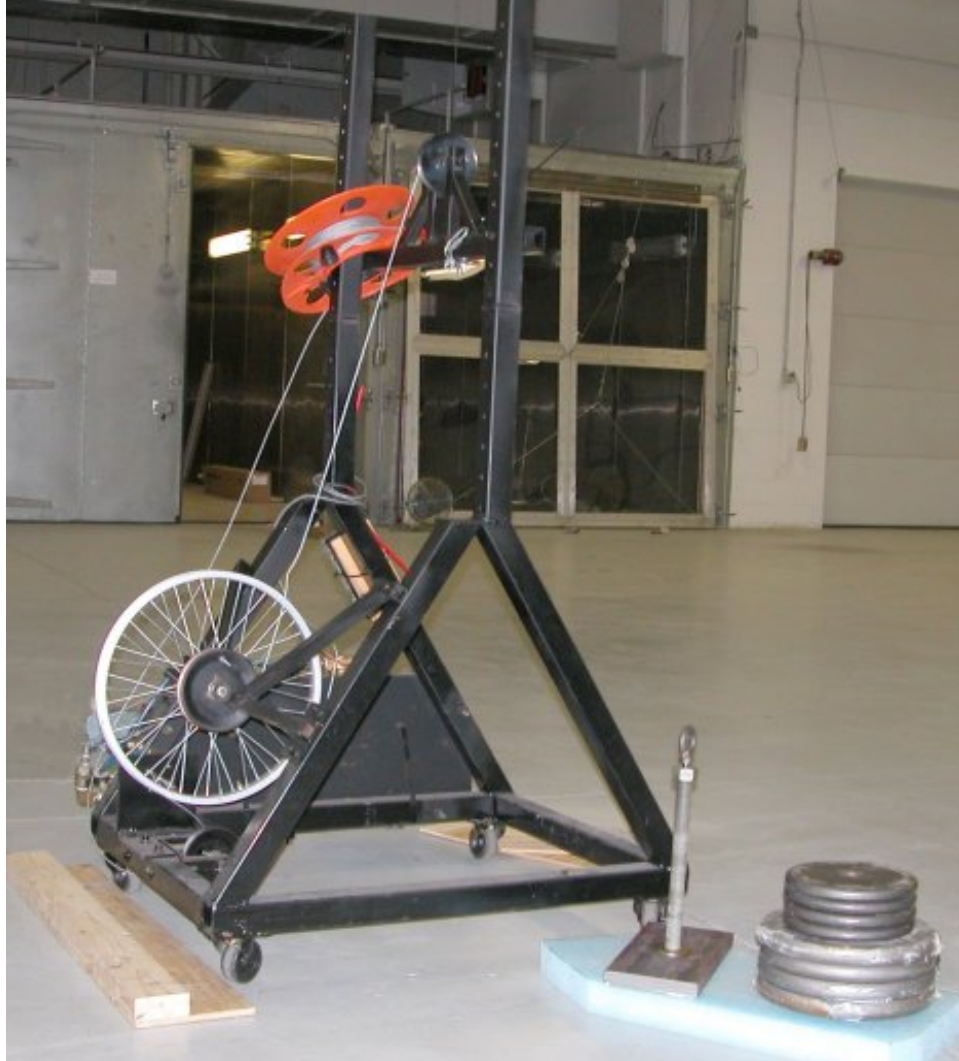
Figure 23. Pulley System Used for Controlled Speed Dynamic Tests

For controlled-speed dynamic sensor system object detection tests, a pulley system was used to tow the hoist and boom fixture (as described at the end of Section 3.4) with suspended test object laterally behind the vehicle. The hoist was positioned such that it was outside the range of detection of the sensor system. A pulley system used weights, which were dropped by remote control, to cause a steel-braided cable to pull the hoist with attached test objects. Using this method, objects were moved at specific speeds across lines of the grid parallel to the vehicle's rear bumper. Figure 23 shows a photograph of the pulley system.

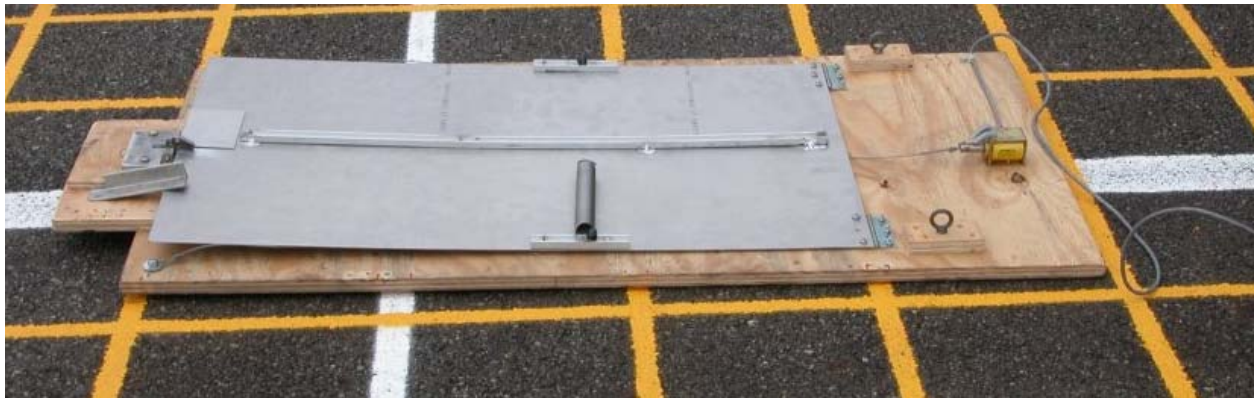
Figure 24. Response Time Fixture (Down Position)

latch that held the plate down (with springs fully extended) prior to deployment. When the cam was released it pushed the bottom of the aluminum plate upward, initiating the movement. The springs provided the force to move the plate into its deployed vertical position. Braided stainless steel cables were attached from the plywood plate to the back side of the aluminum plate to limit its travel. The height of the fixture when deployed was 36.5 inches. The fixture was situated such that, when deployed, the plate was 3 feet from the vehicle's rear bumper.

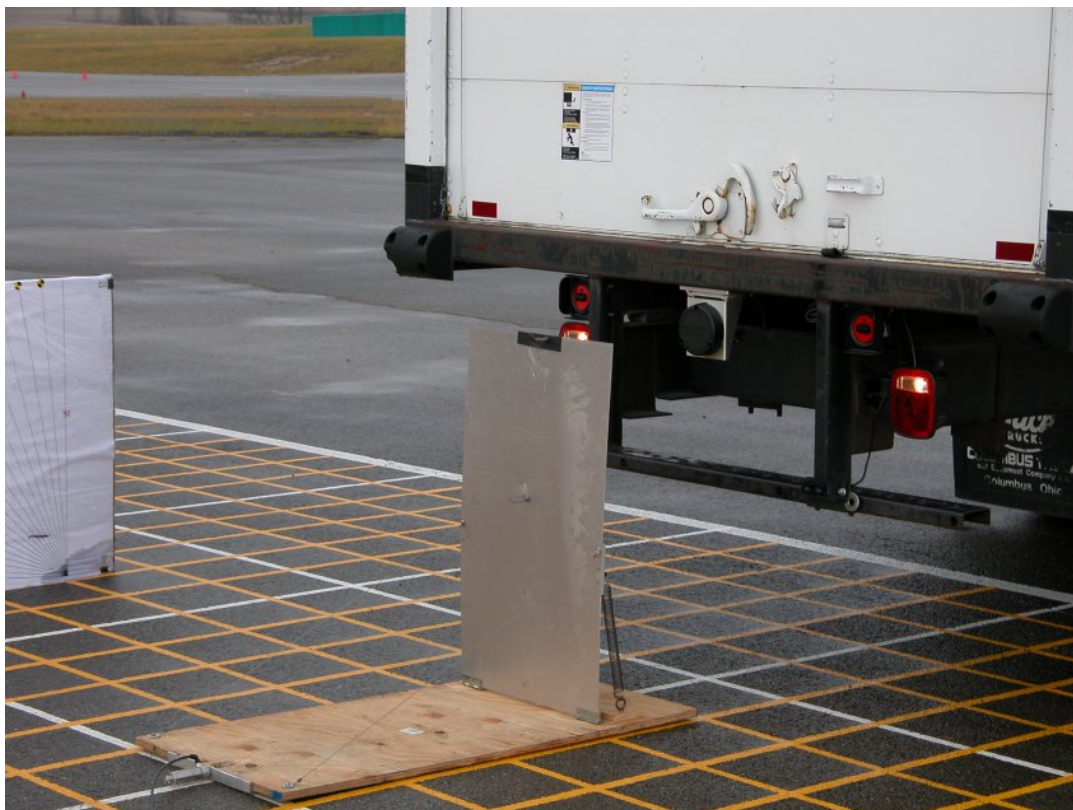
Figure 25. Response Time Fixture (Deployed Position)

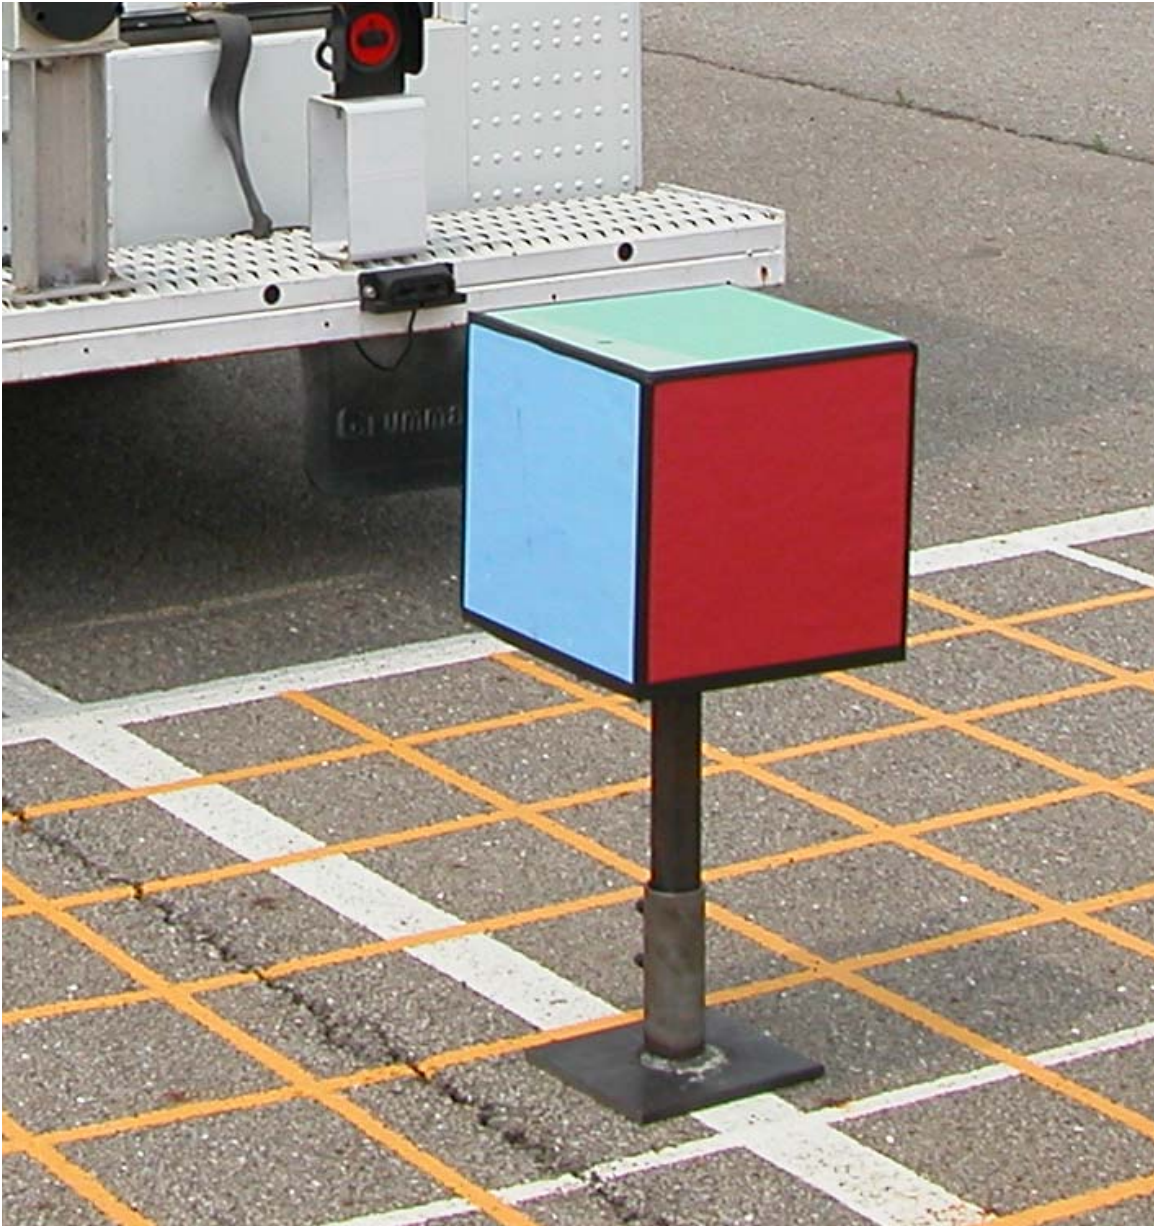
Figure 26. Cube Used for Image Distortion Determination

For image distortion determination, a cube mounted on a metal stand was constructed. This cube is shown in Figure 26. Each face of the cube was 1-foot square in size. The top face of the cube, which was colored green, was parallel to, and 29.6 inches above (the average height of a 1-year-old child), the ground. The cube's front and rear faces, which were colored red, were parallel to the rear bumper of the test vehicle. The left and right faces of the cube were colored blue.

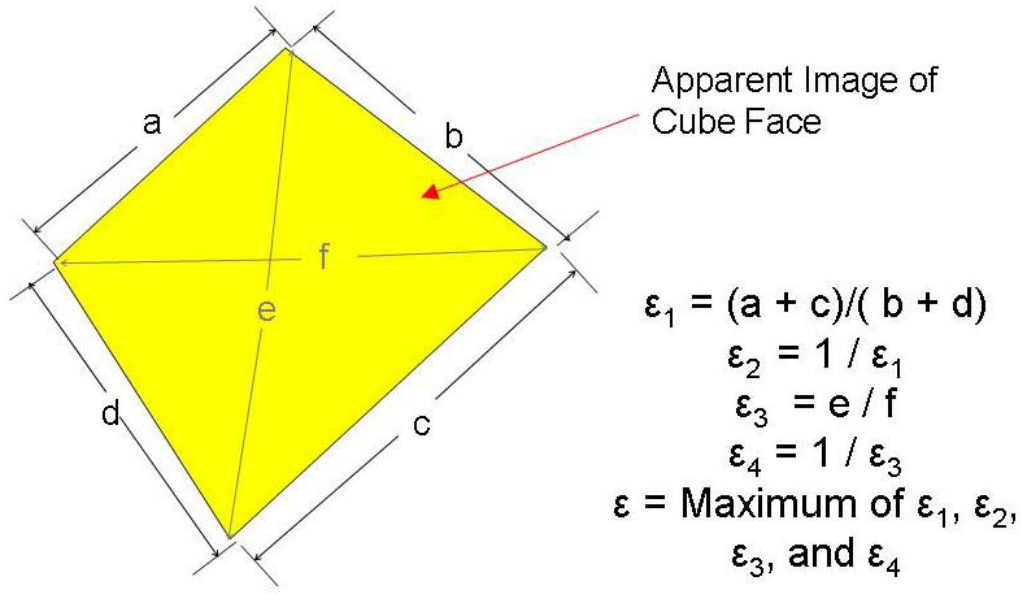
Figure 29. Measurements Made and Formulas Used for Determining Image Distortion

From the six measurements that were made for each distorted image of a cube face quadrilaterals, a four epsilons (called  $\epsilon_1$  through  $\epsilon_4$ ) were computed using the equations shown in Figure 29. The largest of  $\epsilon_1$  through  $\epsilon_4$  was then chosen as the overall epsilon for each distorted image of each cube face.

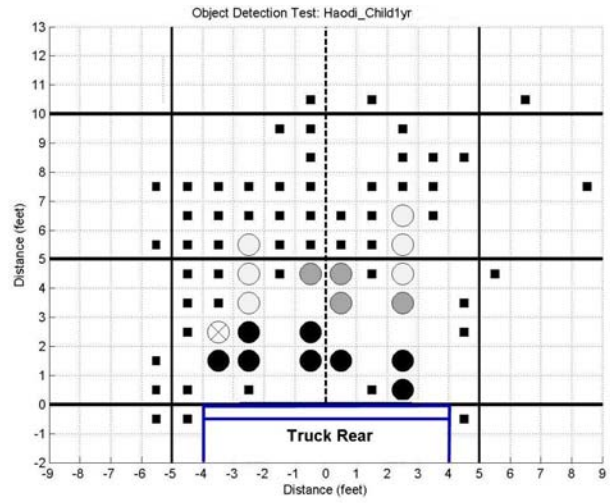
Figure 36. Detection Results for the 1-Year-Old Child

A complete field of data points was difficult to obtain with a 1-year-old child, as indicated by the numerous empty cell locations in Figure 36. The 1-year-old child subject was detected by all four systems in some locations, but with no clear pattern.

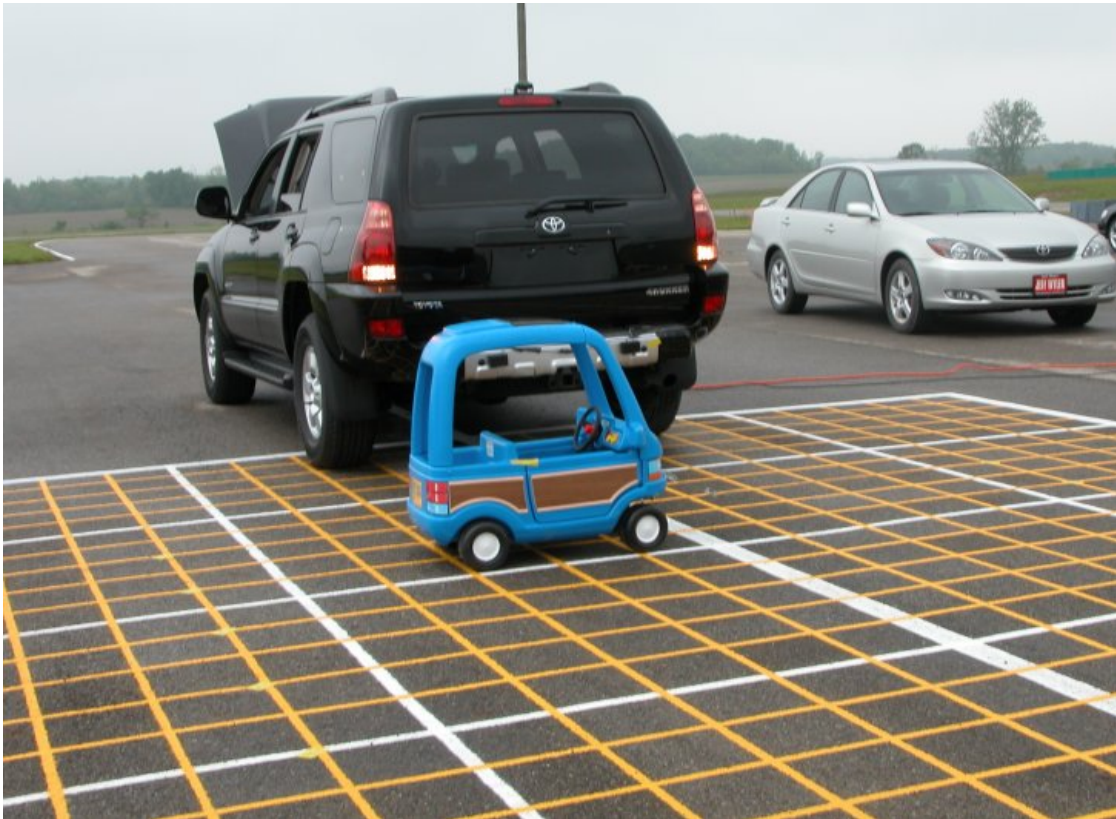
Figure 45. Photograph of Toy Car Outdoor Dynamic Test Trial

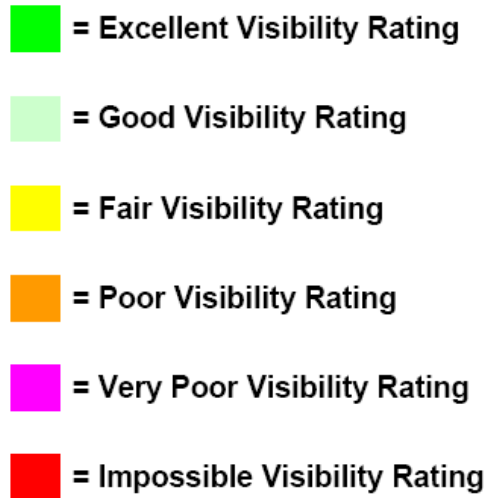
Figure 53. Key for Scheme Used to Display Rear Cross-view Mirror Image Quality Ratings

The coding scheme shown in Figure 53 is used in Figures 54 through 56 to show the image quality ratings at each measurement grid point (see Figure 27 for the measurement grid points used).

Figure 54 shows the rear-cross view mirror image distortion ratings at each of the image quality measurement points. As can be seen, the distortion ratings range from Excellent (minimal distortion) to Impossible (extreme distortion). As might be expected, the least distortion ratings occurred near the step van's bumper. Image distortion becomes worse as the test object is moved back from the bumper and from the right to the left side of the vehicle. (Note that Figures 54 through 56 are drawn from the vehicle bumper looking backwards. Therefore, somewhat confusingly, the left side of the vehicle is on the right side of these figures.) The highest distortion ratings occurred on the left side of the vehicle well back from the bumper. Generally acceptable image distortion ratings (ratings of Fair or better) were measured for distances up to 5.0 feet behind the bumper except for one Poor rating on the extreme left edge of the measurement grid.

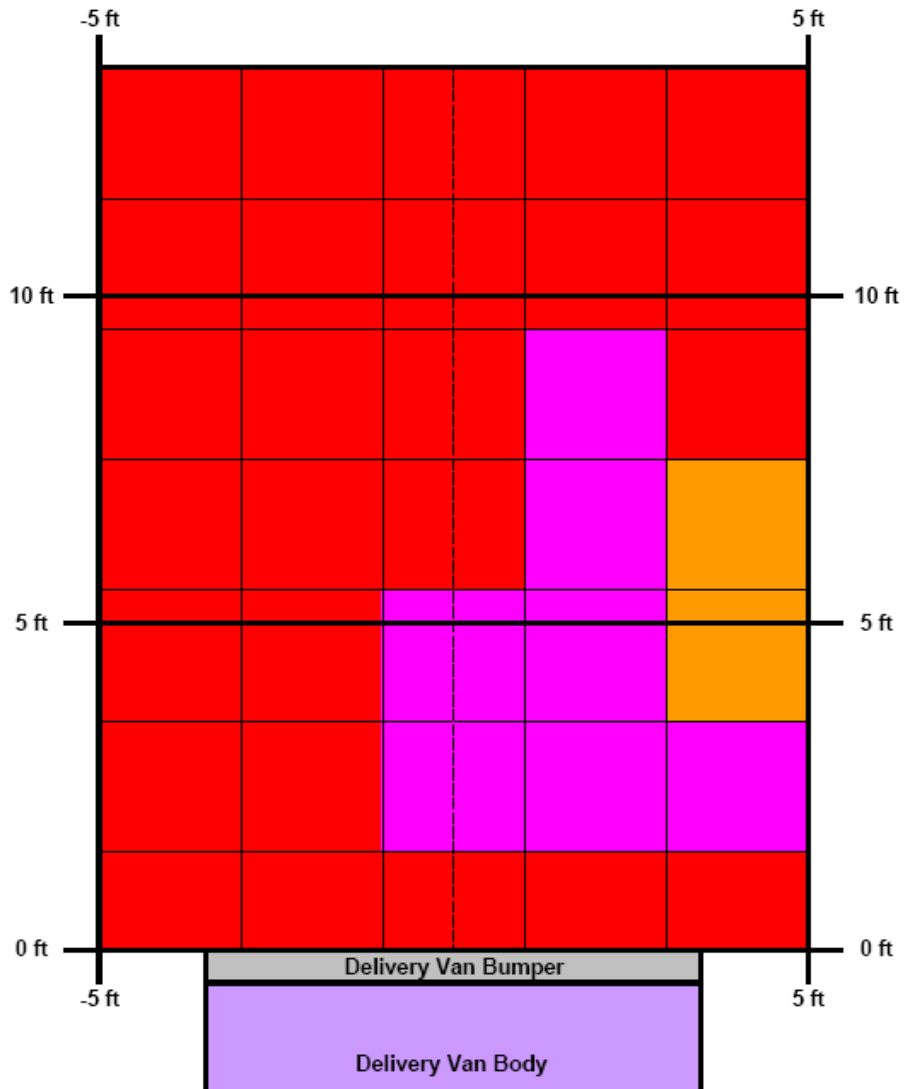
Figure 56. Minification Ratings of Images by Location for the 1-Year-Old ATD Seen in the Rear Cross-view Mirror
