DOT HS 810 865

November 2007

## **Experimental Evaluation of the Performance of Available Backover Prevention Technologies for Medium Straight Trucks**

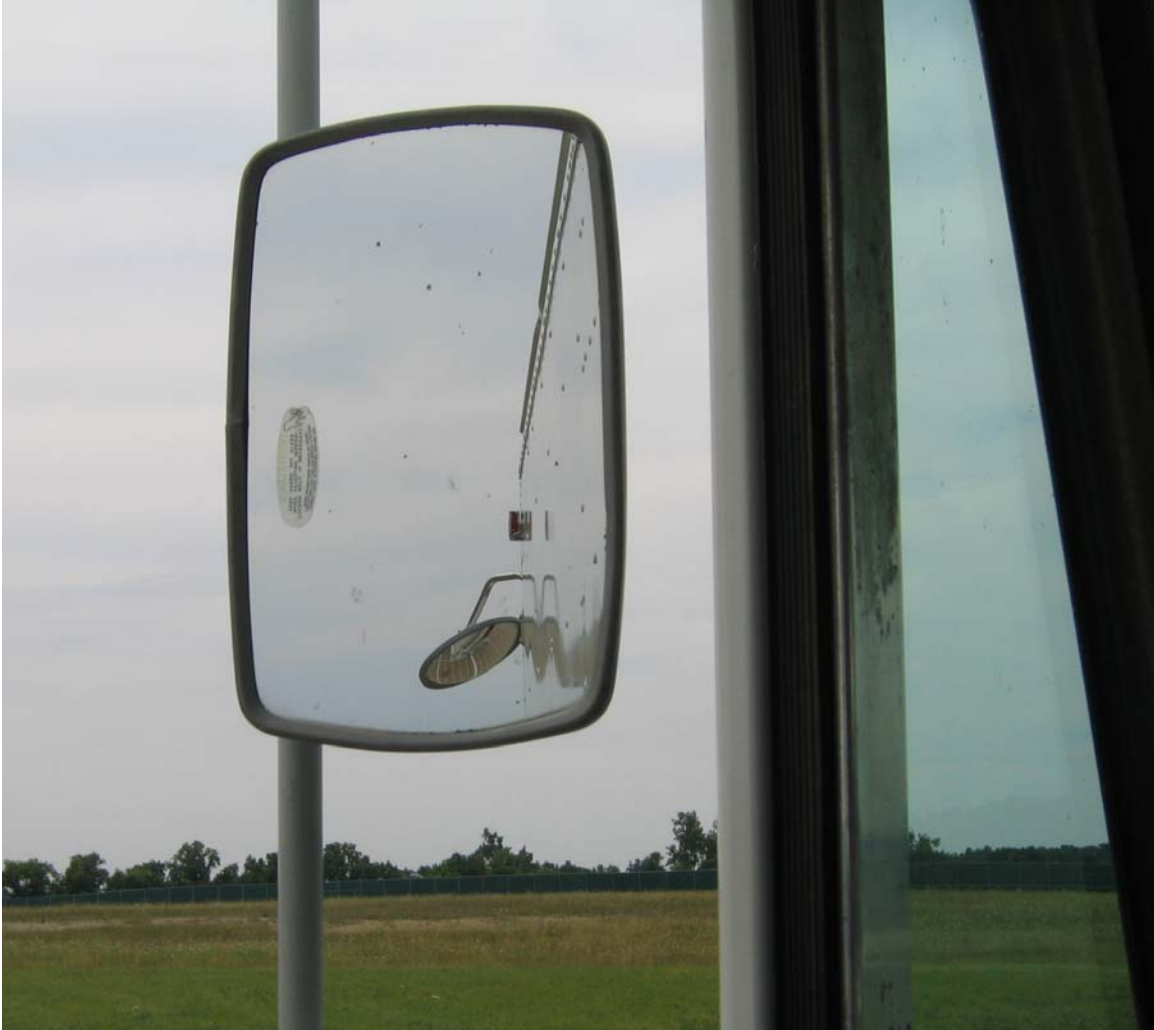
Figure 60. Picture of 1-Year-Old ATD as Seen in the Rear Cross-view Mirror and the Left Side-view Mirror of the Step Van

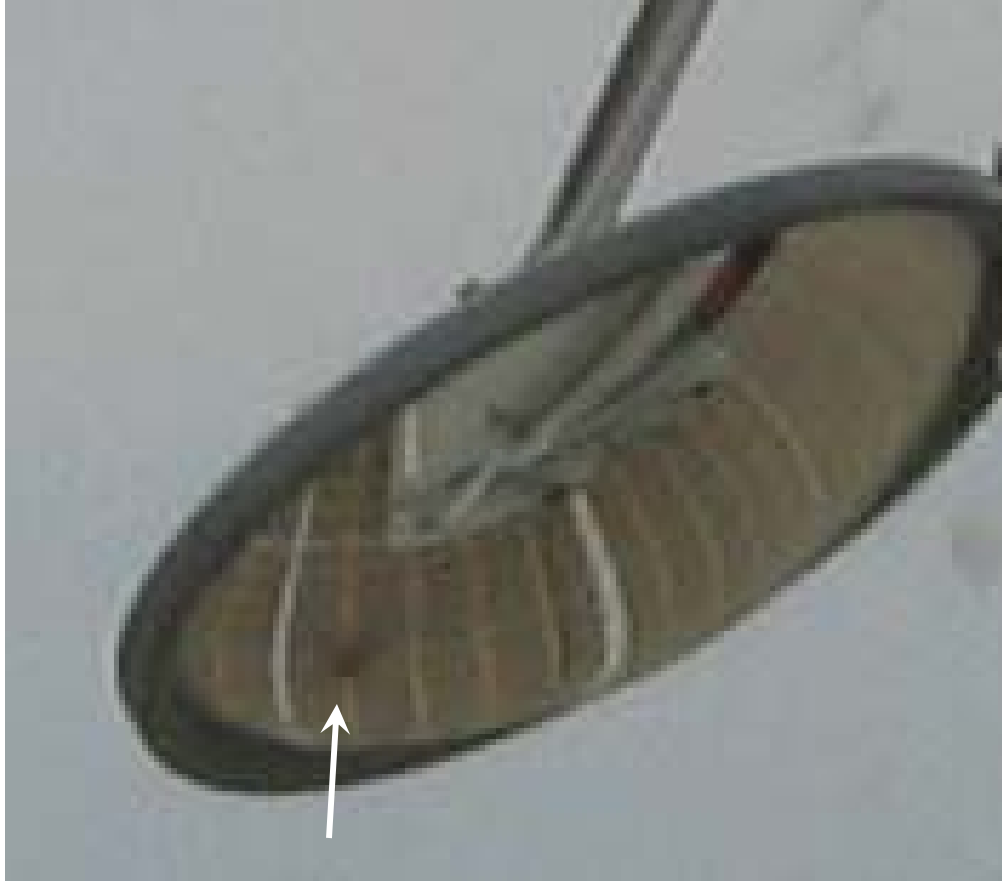
Figure 61. Magnified Picture of 1-Year-Old ATD as Seen in the Rear Cross-view Mirror and the Left Side-view Mirror of the Step Van

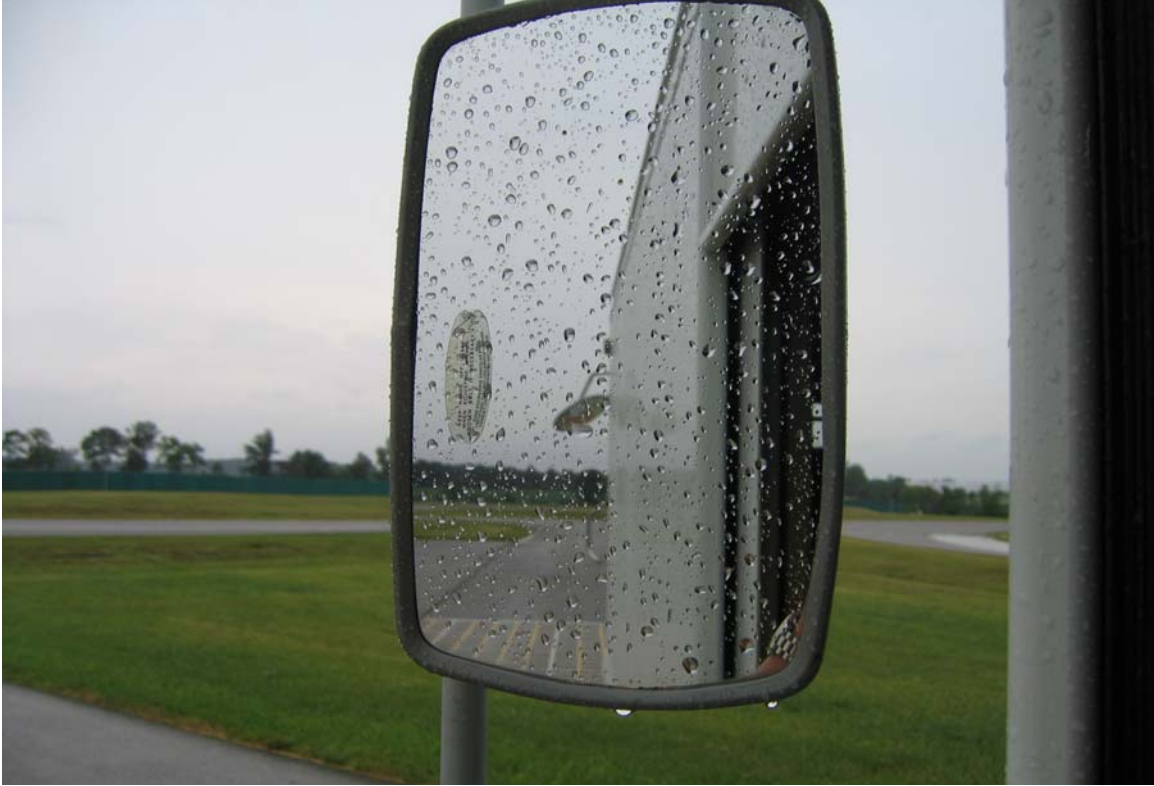
This testing found that the image quality of the rear cross-view mirror is greatly degraded by rain. One day during mirror image quality testing a light rain began to fall. Figure 62 shows the driver's view of the rear cross-view mirror in the side-view mirror when light rain is falling. As can be seen, it is no longer possible to see anything in the rear cross-view mirror in this weather condition.

Figure 62. Driver's View of the Rear Cross-view Mirror in the Side-view Mirror During Light Rainfall
