U.S. Department  
of Transportation  
**Federal Highway  
Administration**

In Reply Refer To:  
HSA-10/B137C

July 12, 2006

In your June 22, 2006, letter, you requested the Federal Highway Administration's (FHWA's) concurrence that your TL-4 cable barrier system would be acceptable as a National Cooperative Highway Research Program (NCHRP) Report 350 test level 3 (TL-3) traffic barrier when placed as described below on a side slope as steep as 1V: 4H. At that time, you also provided staff members with preliminary test results. On July 11, Mr. Powers received a test report prepared by KARCO Engineering, LLC, entitled "Crash Test Report for Gibraltar TL-4 Cable Barrier System Installed on a 4:1 Sloped Median" and dated June 12, 2006.

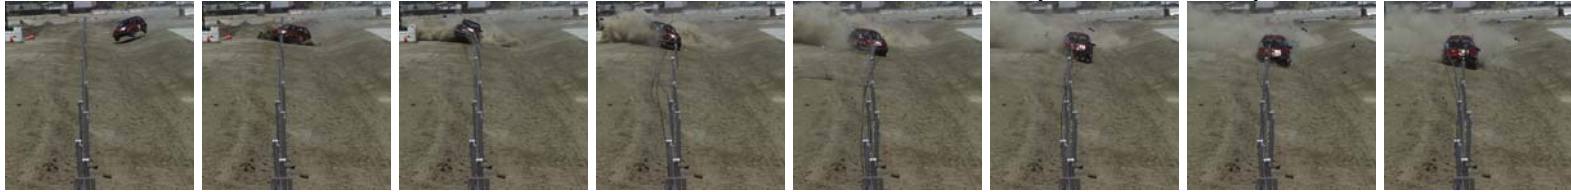
**DATA SHEET NO. 2**  
**SUMMARY OF RESULTS FOR TEST NO. P26133-01 (MODIFIED 3-10)**

GENERAL INFORMATION		OCCUPANT RISK VALUES	
TEST AGENCY	KARCO ENGINEERING	FLAIL SPACE VELOCITY (m/sec)	
TEST NO.	Modified 3-10	X-DIRECTION	5.2
DATE	06/12/06	Y-DIRECTION	0.8
TEST ARTICLE		THIV (optional)	
TYPE	Gibraltar Cable Barrier System	RIDEDOWN ACCELERATION (g's)	
INSTALLATION LENGTH (m)	91.44 m (300 ft.)	X-DIRECTION	-7.4
SIZE AND/OR DIMENSION OF KEY ELEMENTS	¾ in 3 X 7 cable on 30 ft. post spacings	Y-DIRECTION	-4.3
SOIL TYPE AND CONDITION	4:1 slope (upslope 25°)	PHD (optional)	
TEST VEHICLE	820C	ASI (optional)	0.84
TYPE	Production	TEST ARTICLE DEFLECTIONS (m)	
DESIGNATION	3-10	DYNAMIC	1.50 m (4.92 FT.)
MODEL	Geo Metro	PERMANENT	N/A
MASS (CURB)	799 kg (1762 lbs)	VEHICLE DAMAGE	
MASS (TEST INERTIAL)	812 kg (1790 lbs)	EXTERIOR	
DUMMY(S) MASS	75 kg (165 lbs)	VDS	1-FR-4
GROSS STATIC WEIGHT	874 kg (1926 lbs)	CDC	01RDMN6
IMPACT CONDITIONS		INTERIOR	
SPEED (km/h)	104.7 km/h (65.08 mph) 97.51 km/h (60.60 mph) at impact	OCDI	FR0000000

ANGLE (Deg.)	25		
IMPACT SEVERITY (kJ)	34.8	POST-IMPACT VEHICULAR BEHAVIOR	
EXIT CONDITIONS		MAXIMUM ROLL ANGLE (Deg.)	22.7
SPEED (km/h)	N/A*	MAXIMUM YAW ANGLE (Deg.)	-41.0
ANGLE (Deg.)	N/A*	MAXIMUM PITCH ANGLE (Deg.)	6.7

\* Vehicle remained in contact with the cable barrier for the duration of the event.

The first test was a modified 3-10 test in which a Geo Metro weighing 874 kg (1926 lb) was directed into the median at a 25° angle and 104.7 km/hr (65.1 mph), went down the slope, across the ditch bottom [located 3.7 m (12 ft) from edge of pavement] and 2.7 m (9 feet) up the far side of the ditch where it then impacted the backside of the cable [located 8.5 m (21 ft) from edge of pavement] at 97.5 km/hr (60.6 mph). The vehicle deflected the barrier 1.5 m (4.9 ft) laterally and was safely contained and redirected by the Gibraltar cable.

Enclosure 1 is the summary sheet for this test.

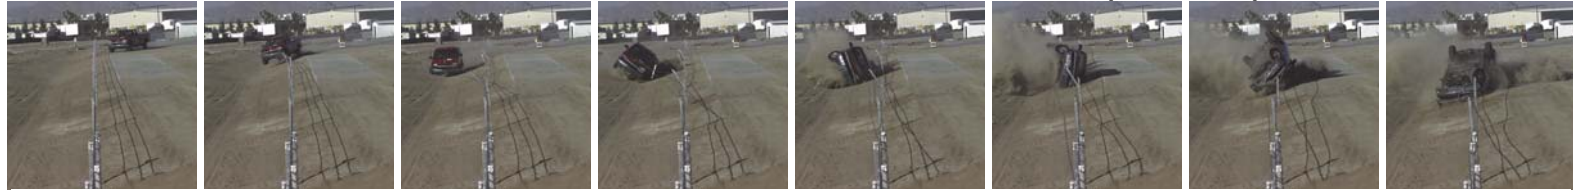
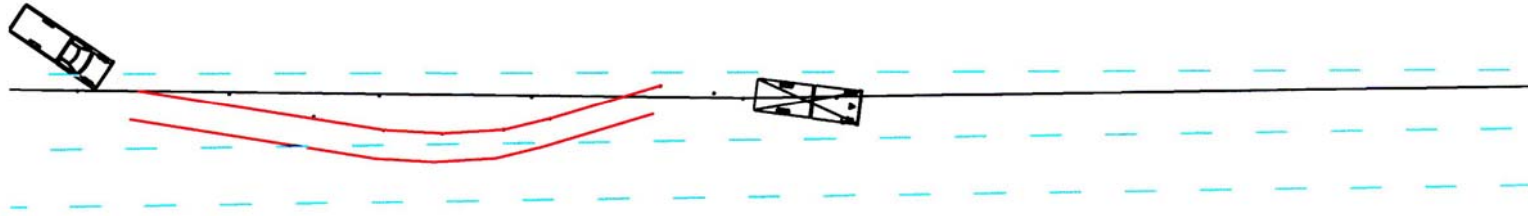
**DATA SHEET NO. 6**  
**SUMMARY OF RESULTS FOR TEST NO. P26133-02 (Test 3-11)**

GENERAL INFORMATION		OCCUPANT RISK VALUES	
TEST AGENCY	KARCO ENGINEERING	FLAIL SPACE VELOCITY (m/sec)	
TEST NO.	3-11	X-DIRECTION	3.3
DATE	06/12/06	Y-DIRECTION	5.4
TEST ARTICLE		THIV (optional)	
TYPE	Gibraltar Cable Barrier System	RIDEDOWN ACCELERATION (g's)	
INSTALLATION LENGTH (m)	91.44 m(300 ft.)	X-DIRECTION	-15.1
SIZE AND/OR DIMENSION OF KEY ELEMENTS	¾ in 3 X 7 cable on 30 ft. post spacings	Y-DIRECTION	10.4
SOIL TYPE AND CONDITION	4:1 slope	PHD (optional)	
TEST VEHICLE	2000P	ASI (optional)	0.49
TYPE	PRODUCTION	TEST ARTICLE DEFLECTIONS (m)	
DESIGNATION	3-11	DYNAMIC	
MODEL	2500	PERMANENT	N/A
MASS (CURB)	2210 kg (4872 lbs)	VEHICLE DAMAGE	
MASS (TEST INERTIAL)	2038 kg (4494 lbs)	EXTERIOR	
DUMMY(S) MASS	N/A	VDS	1-L&T-6
GROSS STATIC WEIGHT	N/A	CDC	01RDGN2
IMPACT CONDITIONS		INTERIOR	
SPEED (km/h)	98.65 km/h (61.31 mph)	OCDI	FS0100000
ANGLE (Deg.)	25		
IMPACT SEVERITY (kJ)	89.5	POST-IMPACT VEHICULAR BEHAVIOR	
EXIT CONDITIONS		MAXIMUM ROLL ANGLE (Deg.)	258.7

SPEED (km/h)	N/A*	MAXIMUM YAW ANGLE (Deg.)	-49.3
ANGLE (Deg.)	N/A*	MAXIMUM PITCH ANGLE (Deg.)	35.5

\* Vehicle rolled over on the cable barrier.

The second test was a standard NCHRP Report 350 3-11 test, with the Gibraltar cable, again with a 30-foot post spacing, located 1.2 m (4 ft) down the 1V: 4H slope from the edge of pavement. A Chevrolet C2500 3/4-ton pickup truck weighing 2,038 kg (4,494 lb) impacted the barrier at a 25-degree angle at 98.7 km/hr (61.3 mph). The maximum dynamic deflection of the barrier was not reported. Although the barrier contained the vehicle, cable deflection allowed the pickup truck to impact the backslope of the ditch and it subsequently overturned as it was being redirected by the cable. This test clearly demonstrated that adverse terrain behind a barrier can cause significant instability when barrier deflection allows an impacting vehicle to reach it, even when the barrier itself prevents penetration. Enclosure 2 is the test summary sheet for this test.

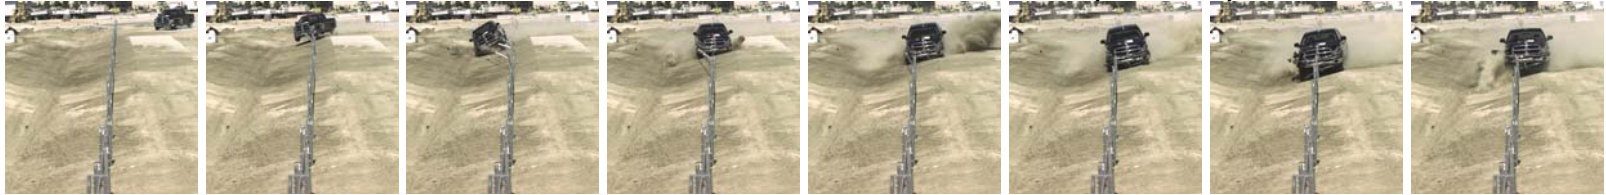
**DATA SHEET NO. 10**  
**SUMMARY OF RESULTS FOR TEST NO. P26133-03 (Test 3-11)**

GENERAL INFORMATION		OCCUPANT RISK VALUES	
TEST AGENCY	KARCO ENGINEERING	FLAIL SPACE VELOCITY (m/sec)	
TEST NO.	3-11	X-DIRECTION	2.7
DATE	06/14/06	Y-DIRECTION	8.3
TEST ARTICLE		THIV (optional)	
TYPE	Gibraltar Cable Barrier System	RIDEDOWN ACCELERATION (g's)	
INSTALLATION LENGTH (m)	92.9 m(305 ft.)	X-DIRECTION	-3.6
SIZE AND/OR DIMENSION OF KEY ELEMENTS	¾ in 3 X 7 cable on 20 ft. post spacings	Y-DIRECTION	-3.9
SOIL TYPE AND CONDITION	4:1 slope(down slope 25°)	PHD (optional)	
TEST VEHICLE	2270P	ASI (optional)	0.35
TYPE	Production	TEST ARTICLE DEFLECTIONS (m)	
DESIGNATION	3-11	DYNAMIC	2.61 m (8.58 ft.)
MODEL	RAM 1500	PERMANENT	N/A
MASS (CURB)	2194 kg (4836 lbs)	VEHICLE DAMAGE	
MASS (TEST INERTIAL)	2222 kg (4898 lbs)	EXTERIOR	
DUMMY(s) MASS	N/A	VDS	1-FR-2
GROSS STATIC WEIGHT	N/A	CDC	01RDEN2
IMPACT CONDITIONS		INTERIOR	
SPEED (km/h)	97.05 km/h (60.32 mph)	OCDI	FS0000000
ANGLE (Deg.)	25		
IMPACT SEVERITY (kJ)	144.7	POST-IMPACT VEHICULAR BEHAVIOR

EXIT CONDITIONS		MAXIMUM ROLL ANGLE (Deg.)	23.8
SPEED (km/h)	N/A*	MAXIMUM YAW ANGLE (Deg.)	-44.3
ANGLE (Deg.)	N/A*	MAXIMUM PITCH ANGLE (Deg.)	-17.9

\* Vehicle remained in contact with the cable barrier for the duration of the event.

The third test was a repeat of the failed test, but the post spacing was reduced to 20 feet, and a heavier test vehicle was used, specifically a Dodge Ram 1500 weighing 2222 kg (4898 lbs). This is the new vehicle currently proposed for use in the draft Report 350 update. Impact conditions were 25 degrees and 97 km/h (60.3 mph). In this test, the pickup truck was contained and redirected upright with a maximum cable deflection of 2.6 m (8.6 ft). Test results are shown in Enclosure 3.

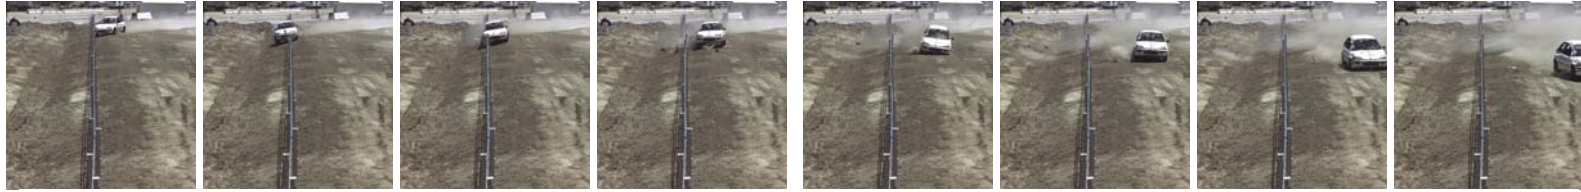
**DATA SHEET NO. 14**  
**SUMMARY OF RESULTS FOR TEST NO. P26133-04 (Test 3-10)**

GENERAL INFORMATION		OCCUPANT RISK VALUES	
TEST AGENCY	KARCO ENGINEERING	FLAIL SPACE VELOCITY (m/sec)	
TEST NO.	3-10	X-DIRECTION	2.8
DATE	06/16/06	Y-DIRECTION	4.9
TEST ARTICLE		THIV (optional)	
TYPE	Gibraltar Cable Barrier System	RIDEDOWN ACCELERATION (g's)	
INSTALLATION LENGTH (m)	91.44 m (300 ft.)	X-DIRECTION	-4.8
SIZE AND/OR DIMENSION OF KEY ELEMENTS	¾ in 3 X 7 cable on 30 ft. post	Y-DIRECTION	-5.6
SOIL TYPE AND CONDITION	4:1 slope (upslope 25°)	PHD (optional)	
TEST VEHICLE	820C	ASI (optional)	0.63
TYPE	PRODUCTION	TEST ARTICLE DEFLECTIONS (m)	
DESIGNATION	3-10	DYNAMIC	1.43 m ( 4.70 FT.)
MODEL	Geo Metro	PERMANENT	N/A
MASS (CURB)	858 kg (1892 lbs)	VEHICLE DAMAGE	
MASS (TEST INERTIAL)	845 kg (1862 lbs)	EXTERIOR	
DUMMY(S) MASS	75 kg (165 lbs)	VDS	1-FR-2
GROSS STATIC WEIGHT	919 kg (2026 lbs)	CDC	01RRGN8
IMPACT CONDITIONS		INTERIOR	
SPEED (km/h)	101.63 km/h (63.16 mph)	OCDI	FS0000000
ANGLE (Deg.)	20		
IMPACT SEVERITY (kJ)	39.3	POST-IMPACT VEHICULAR BEHAVIOR

EXIT CONDITIONS		MAXIMUM ROLL ANGLE (Deg.)	37.6
SPEED (km/h)	N/A*	MAXIMUM YAW ANGLE (Deg.)	-34.3
ANGLE (Deg.)	N/A*	MAXIMUM PITCH ANGLE (Deg.)	4.4

\*Test vehicle exit conditions occurred beyond the view of the overhead cameras.

The final test was a standard NCHRP Report 350 3-10 test with the Gibraltar cable again located 1.2 m (4 ft) down the 1V: 4H slope from the edge of pavement. A Geo Metro weighing 919 kg (2,026 lb) impacted the barrier at a 20-degree angle at 101.6 km/hr (63.2 mph). The maximum dynamic deflection of the barrier was 1.4 m (4.7 ft), and the vehicle was safely contained and redirected by the cable. Enclosure 4 is the test summary sheet for this test.
