Photographic Data Extraction Feasibility and Pilot Study in Support of Roadside Safety and Roadway Departure Research

PUBLICATION NO. FHWA-HRT-13-088

MAY 2014

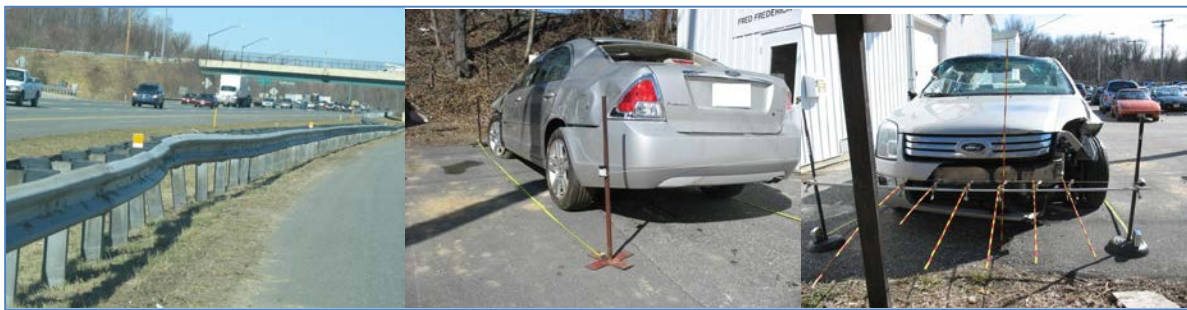
Figure 3 provides a summary of data relevant to the roadside element study extracted from NASS CDS Case 2007-09-013.⁽⁶⁾ The left image provides the roadside element, the deformed metal guardrail. The vehicle damage can be discerned from the center and right images. In this case, the front of the vehicle made contact with the barrier, followed by a subsequent impact with the barrier, culminating in a one-quarter turn driver-side rollover. The rollover was identified as a climb-over probably associated with the guardrail damage shown in the left image. In this case, the vehicle scaled the barrier, causing the vehicle to roll to the opposite side of the barrier.

Figure 3. Illustration. NASS CDS data acquisition example showing damaged roadside elements (left, W-beam strong post) and vehicle damage (center, back/left oblique and right, front with measurement rods).⁽⁶⁾

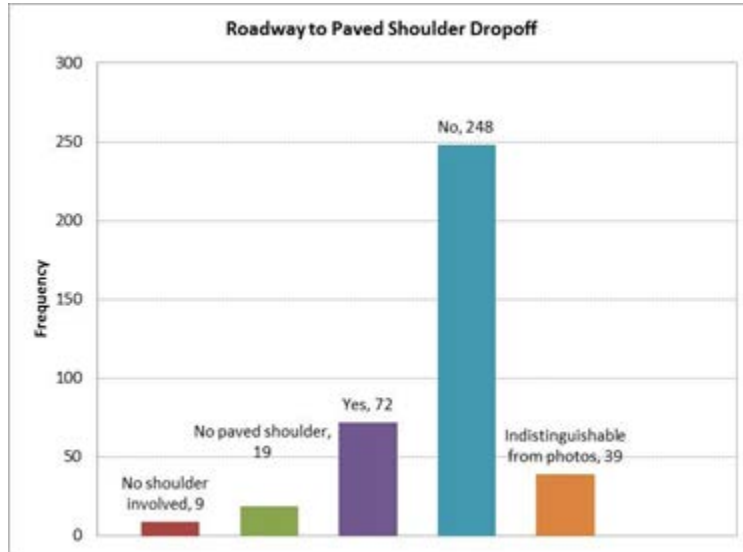
Figure 4. Graph. Attributes observed in the roadway to paved shoulder drop-off variable.

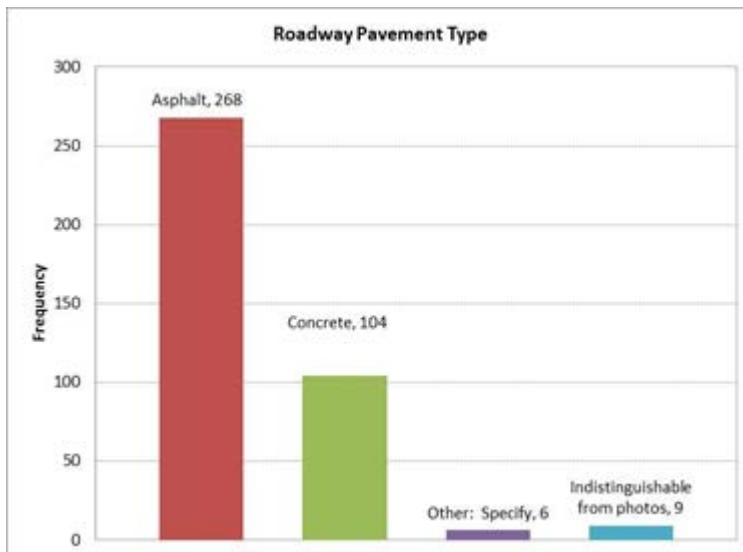
Figure 5. Graph. Attributes observed in the roadway pavement type variable.

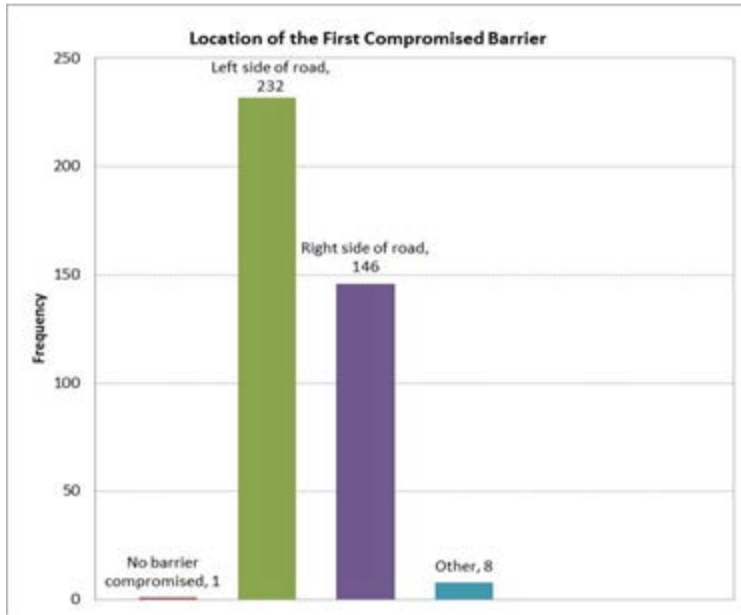
Figure 6. Graph. Attributes observed in the location of the first compromised barrier variable.

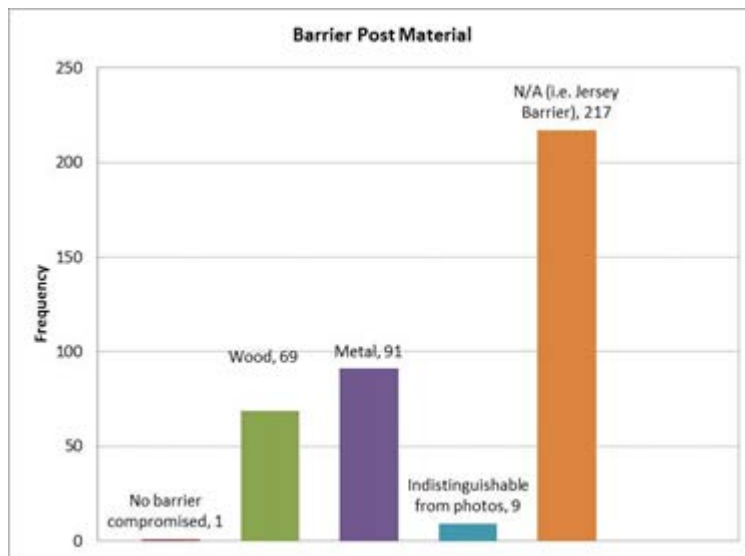
Figure 7. Graph. Attributes observed in the barrier post material variable.

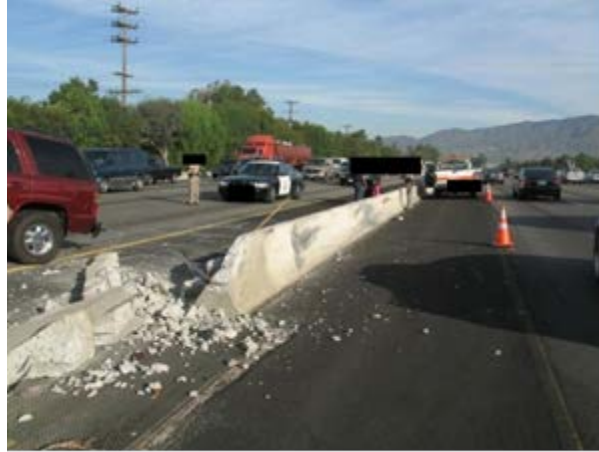
Figure 8. Photo. First view of Case No. 2005079486822 showing the point of impact.

Variables 2 and 3 require the judgment of the analyst to indicate a length range for the shoulder. Figure 8 shows a pickup parked on the shoulder. Since a standard lane has a length of 12 ft, is assumed that the shoulder is longer than 8 ft. Variables 4 and 5 have a “yes” value if the shoulder varies considerably from the point where the vehicle hits the barrier to upstream. Because the photographs in figure 8 and figure 9 do not provide a good perspective for an answer to variable 4, the analyst needs to look at other photographs of the case, such as the photograph in figure 10 to confirm the “no” value. From figure 8 through figure 10, the analyst can confirm that the shoulder has no rumble strips (variable 6). They also allow the analyst to confirm that there is no drop-off between the roadway and the shoulder.

The photographs in figure 8 and figure 9 from the NMVCCS database indicate the following values to the variables corresponding to the shoulder:⁽⁴⁾

- Representative paved shoulder width: More than 8 ft (2).
- Representative unpaved shoulder width: No unpaved shoulder (3).
- Major variations in paved shoulder width: No (4).
- Major variations in unpaved shoulder width: No unpaved shoulder (5).
- Roadway to paved shoulder drop-off: No (6).
- Presence of rumble strips: No (7).

Regarding characteristics on the roadway, figure 8 through figure 10 indicate the following values for the listed variables:

- Barrier type: Jersey barrier (16).
- Barrier end treatment type: Outside the road segment of analysis (17).
- Barrier post material: Not applicable (i.e., Jersey barrier) (18).
- Barrier block-out material: Not applicable (i.e., Jersey barrier) (19).
- Barrier conditions: Breakage of barrier face (30).

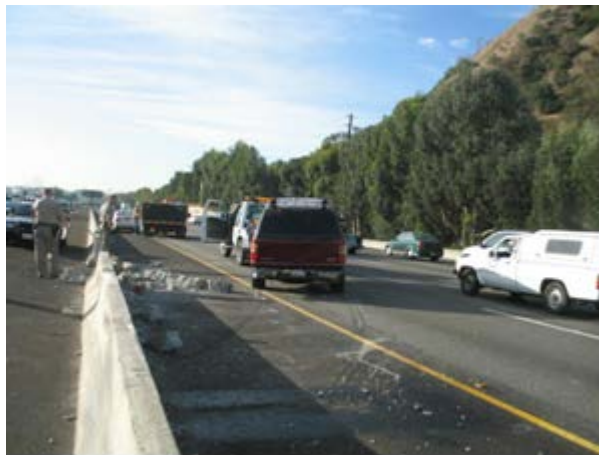
Figure 9. Photo. Second view of Case No. 2005079486822 showing the point of impact.

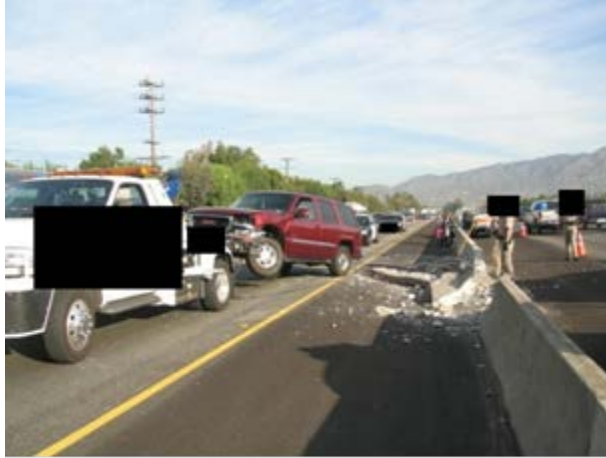
Figure 10. Photo. Case No. 2005079486822 look back from point of impact.

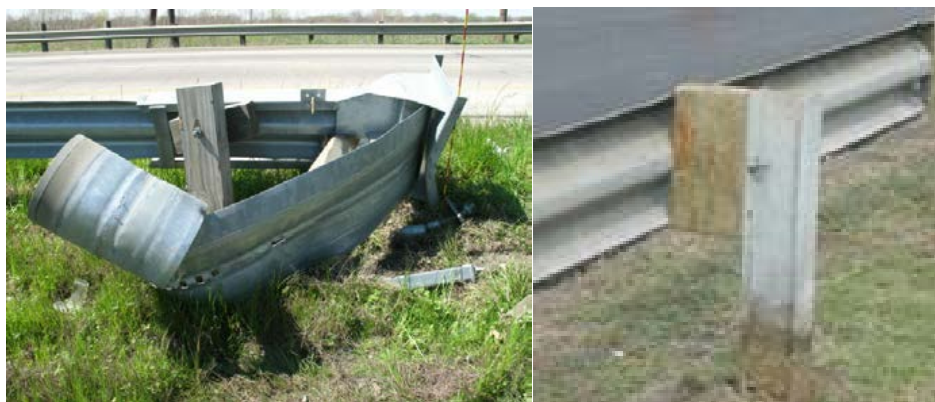
Figure 11. Photo. Case No. 2005049602183 post-crash W-beam strong post (left) contrasted with comparative catalog image (right).^(4,14)

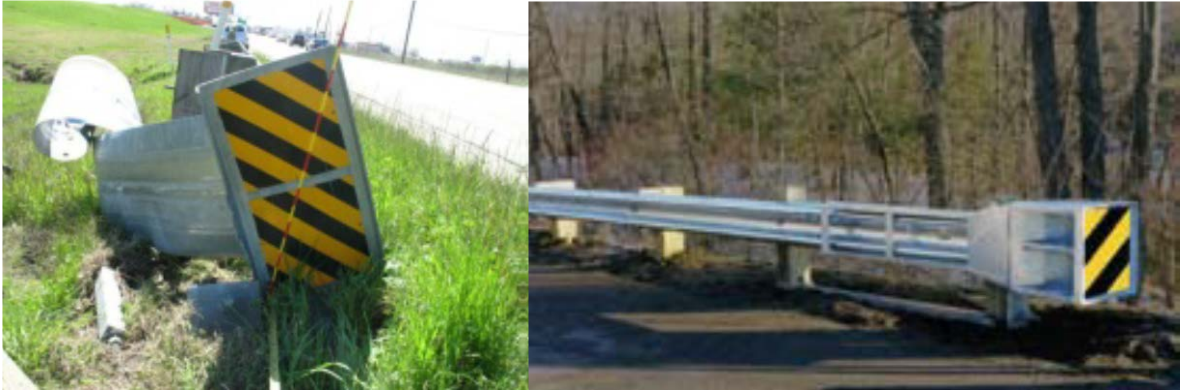
Figure 12. Photo. Case No. 2005049602183 post-crash W-beam strong post highlighting energy absorbing end treatment.^(4,14)

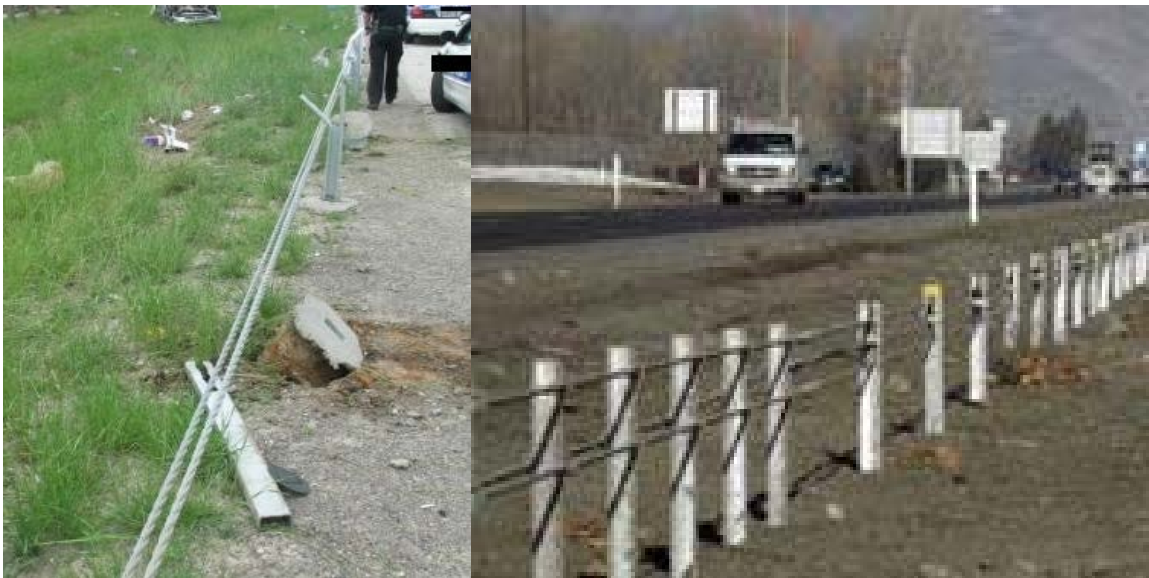
Figure 13. Photo. Case No. 2005049602403 post-crash high-tension cable guardrail systems (left) contrasted with comparative catalog image (right).^(4,15)

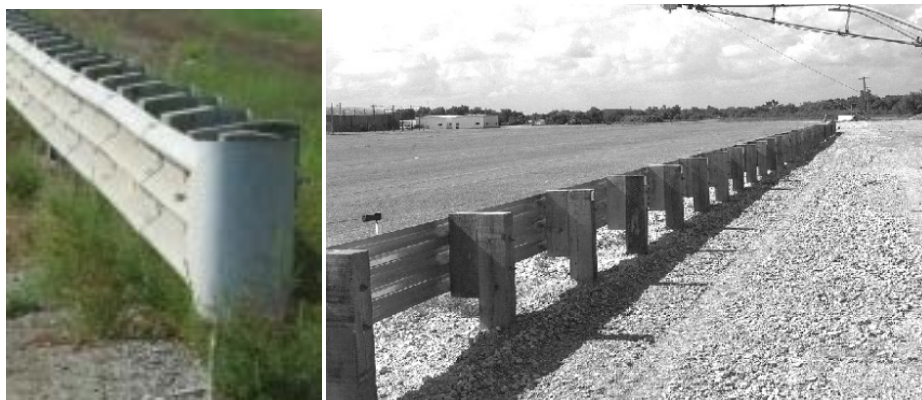
Figure 14. Photo. Case No. 2005012696122 post-crash Thrie beam strong post (left) contrasted with comparative catalog image (right).^(4,16)

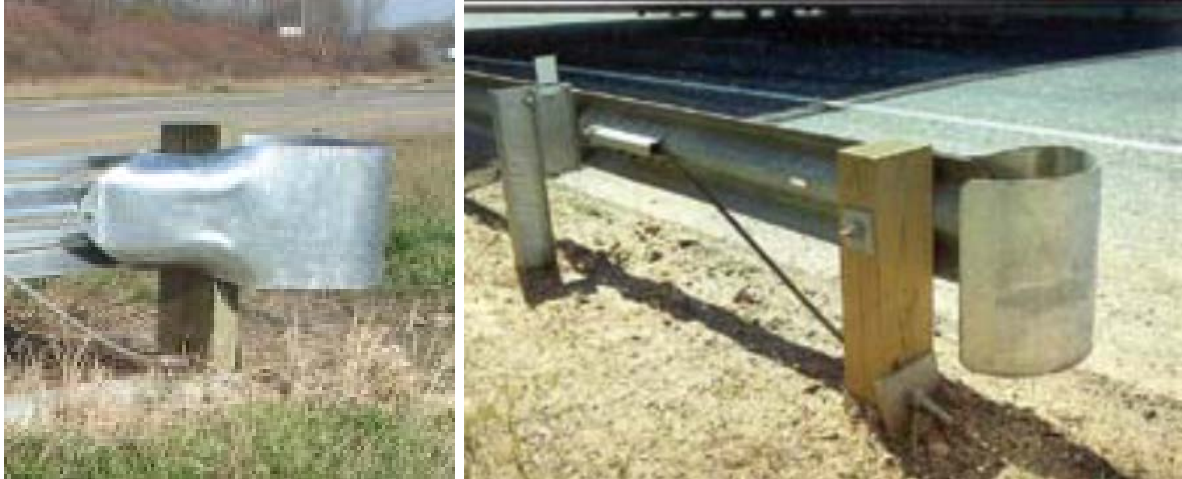
Figure 15. Photo. Case No. 2005012696122 post-crash Thrie beam strong post (left) highlighting non-energy absorbing slotted rail terminal contrasted with comparative catalog image (right).^(4,14)

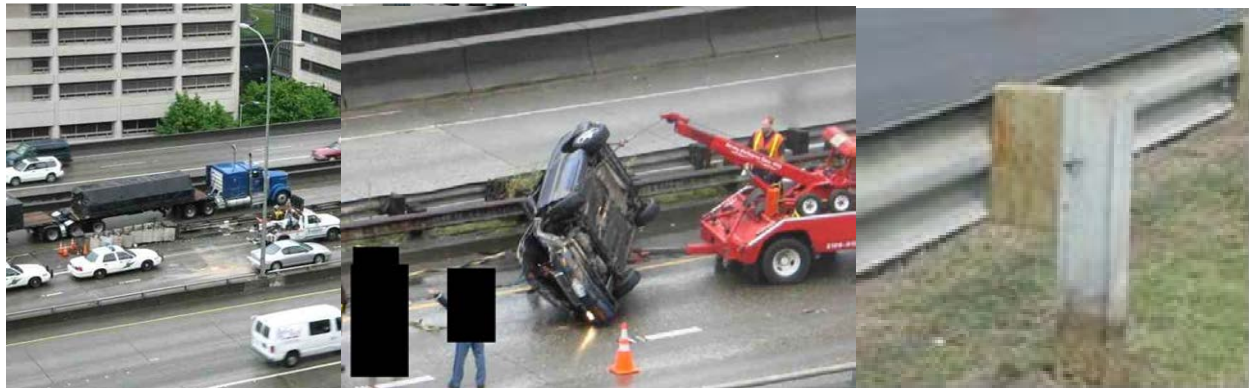
Figure 16. Photo. Case No. 2005082626081 post-crash impact attenuator (left) in advance of W-beam strong post (center) contrasted with comparative catalog image (right).^(4,14)

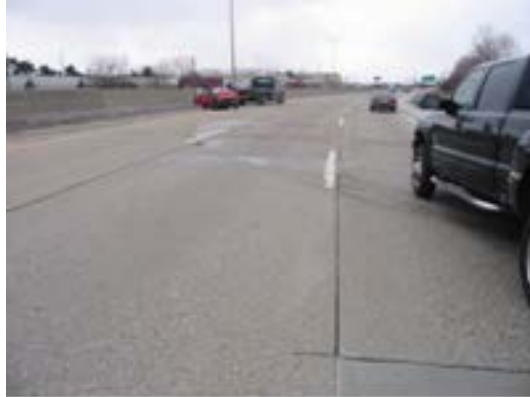
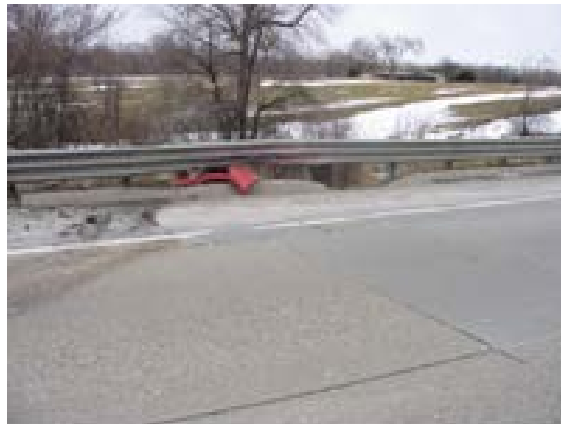
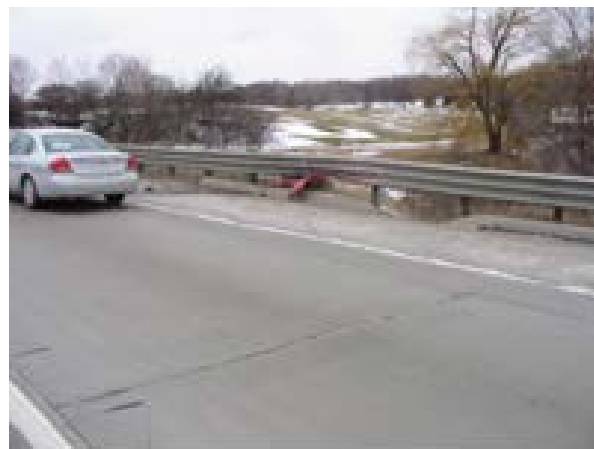
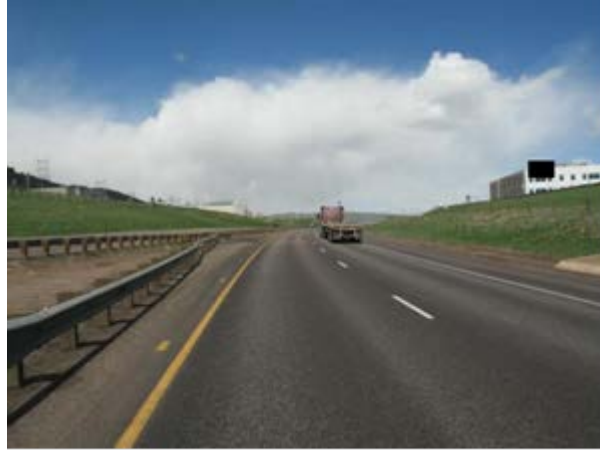
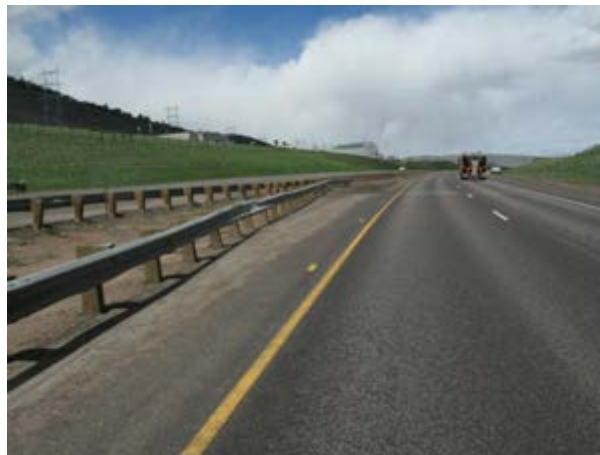
In response to colleagues studying pavement performance issues, this study was extended to identify variables related to pavement properties and contamination (see table 6). A pavement pilot study was initiated within the photographic data extraction pilot study. One of these variables was the macrotexture (11) of the pavement. The objective of this variable was to identify whether the road surface was in optimal condition (case in which the variable would have a “no” value) or whether it had features on the surface that highlighted some type of macrotexture. Figure 17 through figure 21 present photographs used to identify this variable. Experts in the field determined that these pictures are not of high enough quality to establish with assurance if the road surfaces present an identifiable macrotexture. For this reason, this variable was dropped and does not appear in the statistics of this study.

Figure 17. Photo. Photograph 1 used for identifying macrotexture in Case No. 2005012695244.

Figure 18. Photo. Photograph 2 used for identifying macrotexture in Case No. 2005012695244.

Figure 19. Photo. Photograph 3 used for identifying macrotexture in Case No. 2005012695244.

Figure 20. Photo. Photograph 1 used for identifying macrotexture in Case No. 2007075702347.

Figure 21. Photo. Photograph 2 used for identifying macrotexture in Case No. 2007075702347.

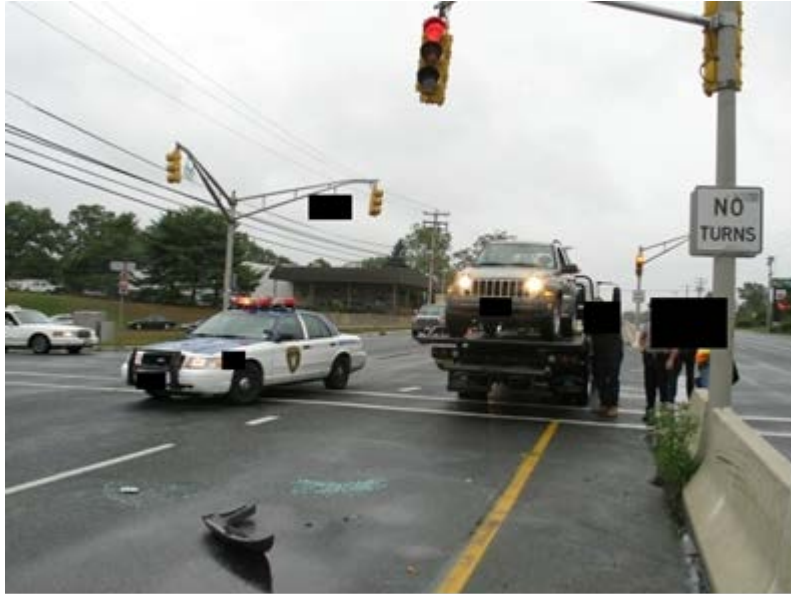
Another variable that was included at the beginning of the study was rutting (variable 12). Figure 22 shows a probable case of rutting. After submitting this photograph to experts in the field, it was determined that it could not be used to determine rutting. As a result, this variable was dropped from the study. Due to similar reasons, the following other variables were dropped: paved shoulder contamination (8), pavement contamination (13), and gross pavement irregularities (14).

Figure 22. Photo. Photograph used for identifying rutting in Case No. 2007075702347.

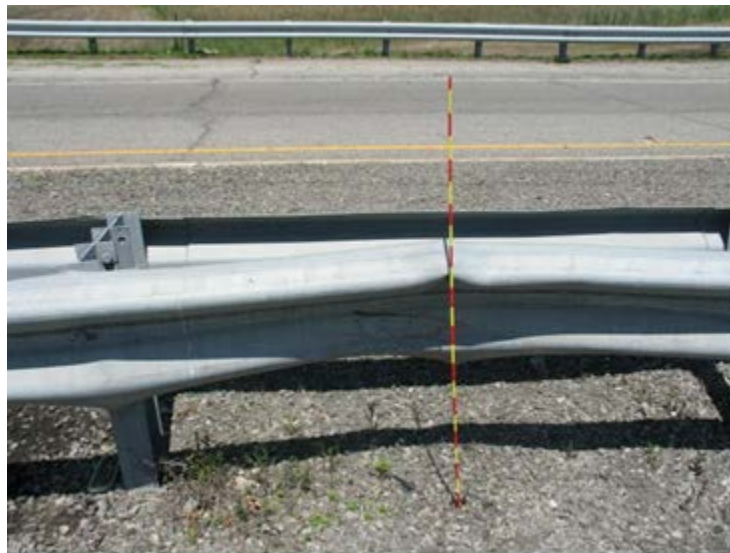
Finally, obtaining values for the following variables was challenging: ground to barrier face, measurement rods; vertical barrier face, measurement rods; horizontal damage barrier face, measurement rods; and damage height from ground, measurement rods. In very few cases, such as the one shown in figure 23, these measurements were possible to obtain.

Figure 23. Photo. Photograph from Case No. 2005073438121 in which measurements were obtained using rods.

The pilot study yielded unexpected results. Several roadside elements were highlighted by measurement rods that were originally used to take vehicle damage measurements for NASS CDS cases. NMVCCS photography protocols did not contemplate the roadside environment, as did LBSS in the early 1980s, with only known NASS classification of variables using a limited number of attributes. In the model of the NCHRP studies, all photographic data were considered.⁽⁸⁻¹⁰⁾ The measurement rods, when available, provided insight into the height of the barrier from the ground, the height from where the measurement rods were placed in the photograph to damaged barrier location, and, occasionally, the width of the damage. It was found that most roadside element photographs were absent of measurement rods, leaving very small cell sizes from which to draw conclusions. With added sample size, the benefit would involve assessing variations in barrier height owing to maintenance and vehicle compatibility with barriers.
