Failure Assessment Of Guardrail Extruder Terminals

January 11, 2012

This presentation is the sole opinion of SPIG Industries based on an empirical analysis of guardrail terminal impacts throughout a number of states.

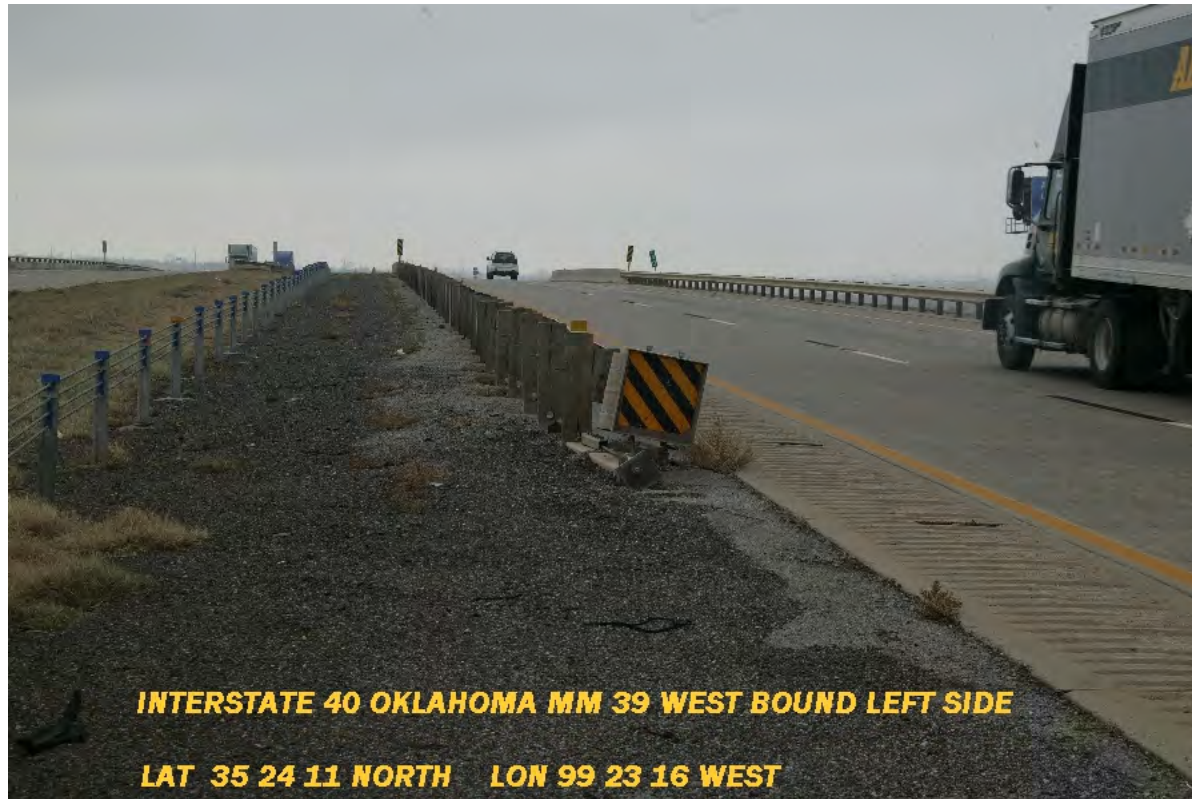
The ET-2000 is the first extruding type guardrail end terminal and was accepted by FHWA in August 1995.

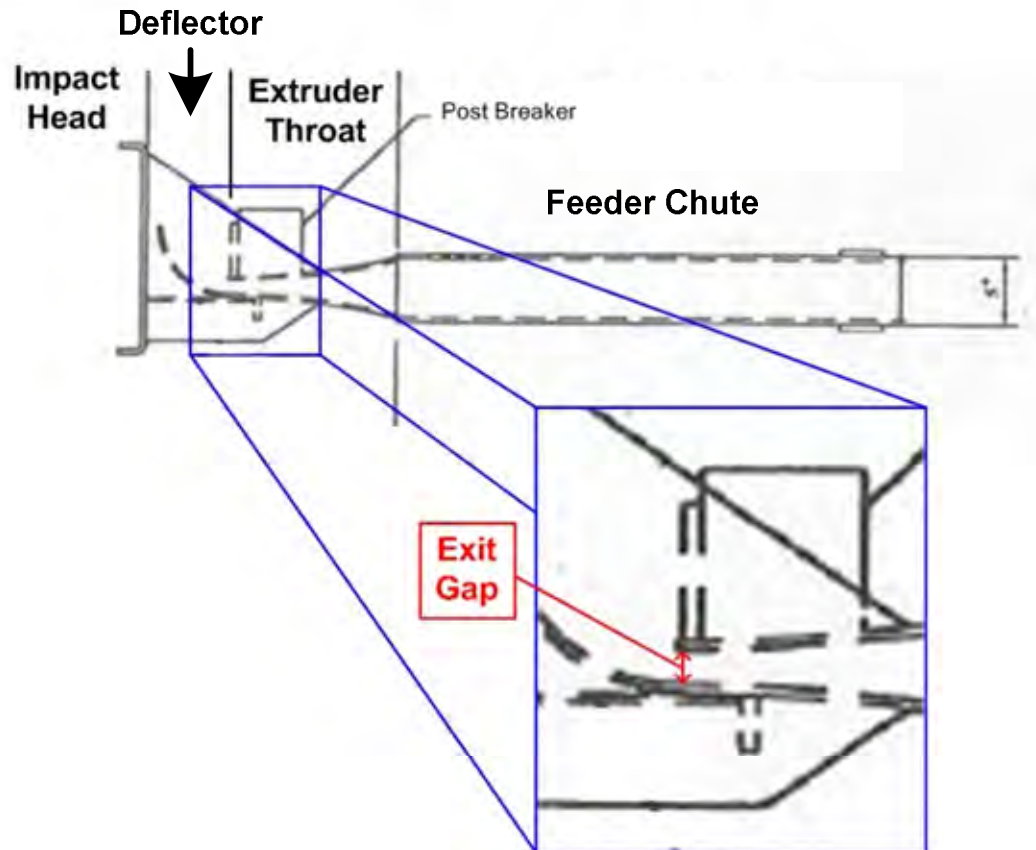
The end of the extruder throat has an exit gap.

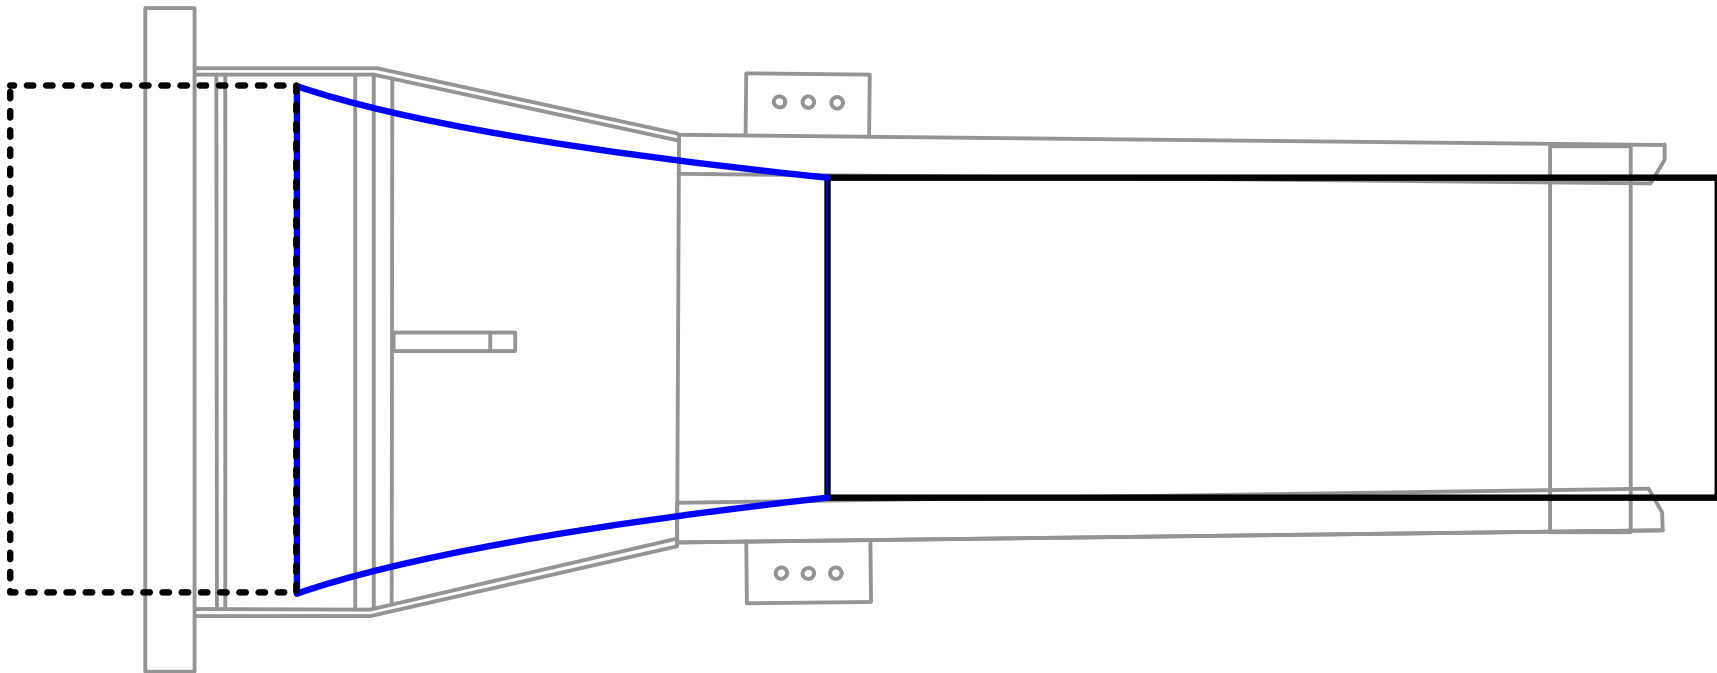
The extruding type guardrail terminal creates a **dynamic compression plume** as the terminal moves down the guardrail.

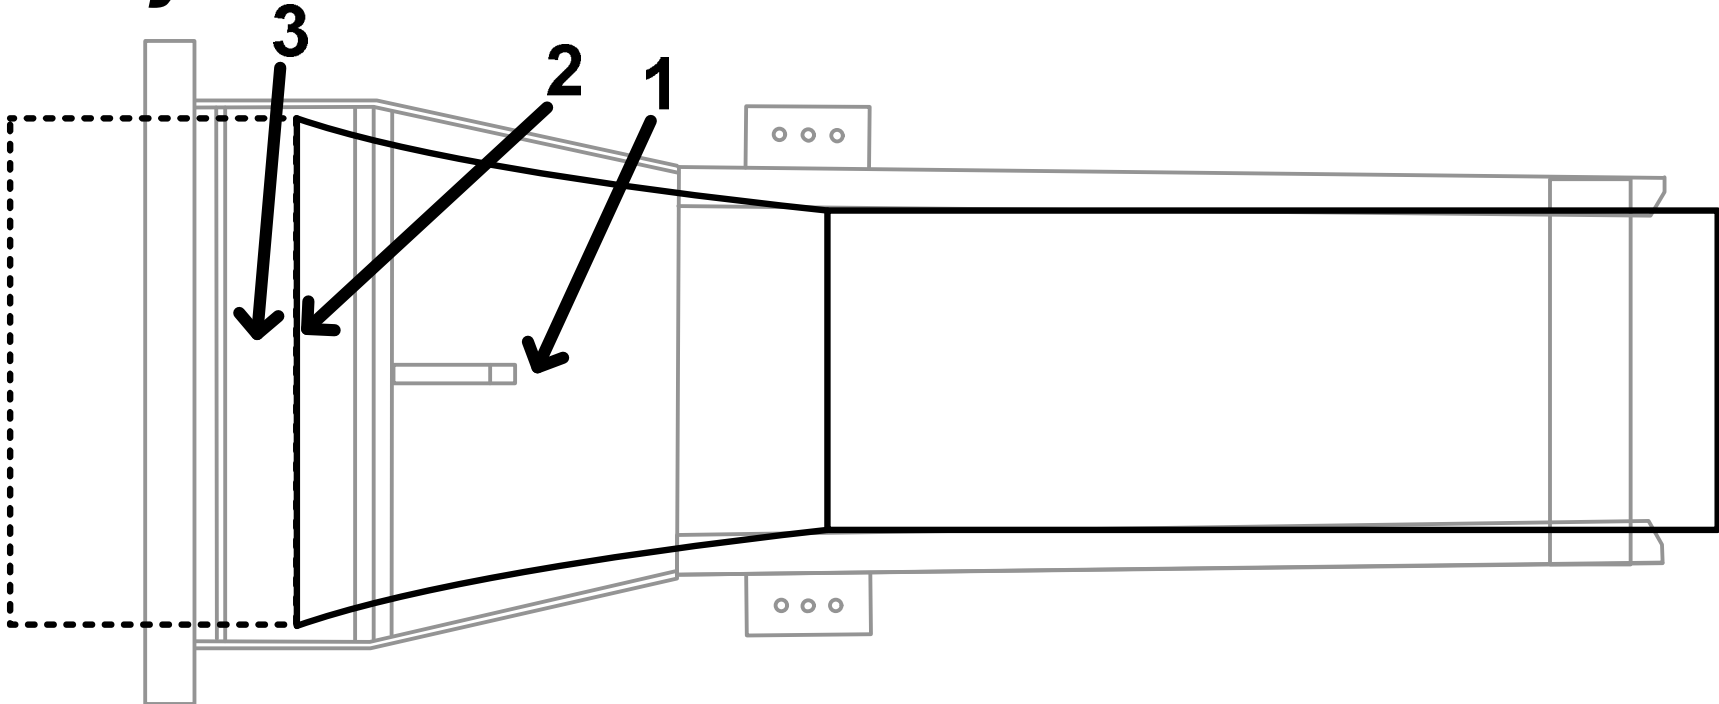
The extruding type guardrail terminal 1) plumes the guardrail, 2) flattens the guardrail, and then 3) deflects the flattened guardrail.

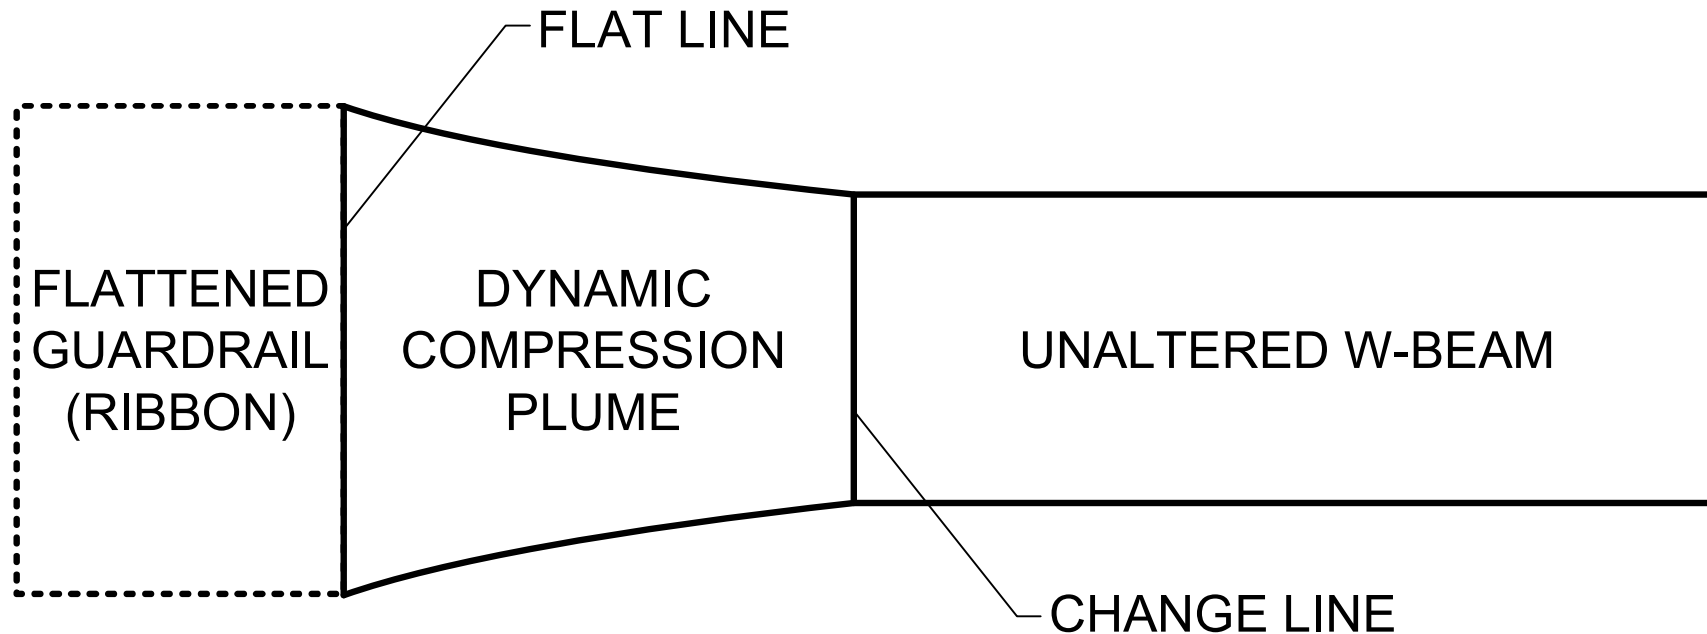
The dynamic compression plume is located between the change line and the flat line as the terminal moves along the guardrail during an impact.

As shown above, a smaller exit gap creates a larger or longer dynamic compression plume.

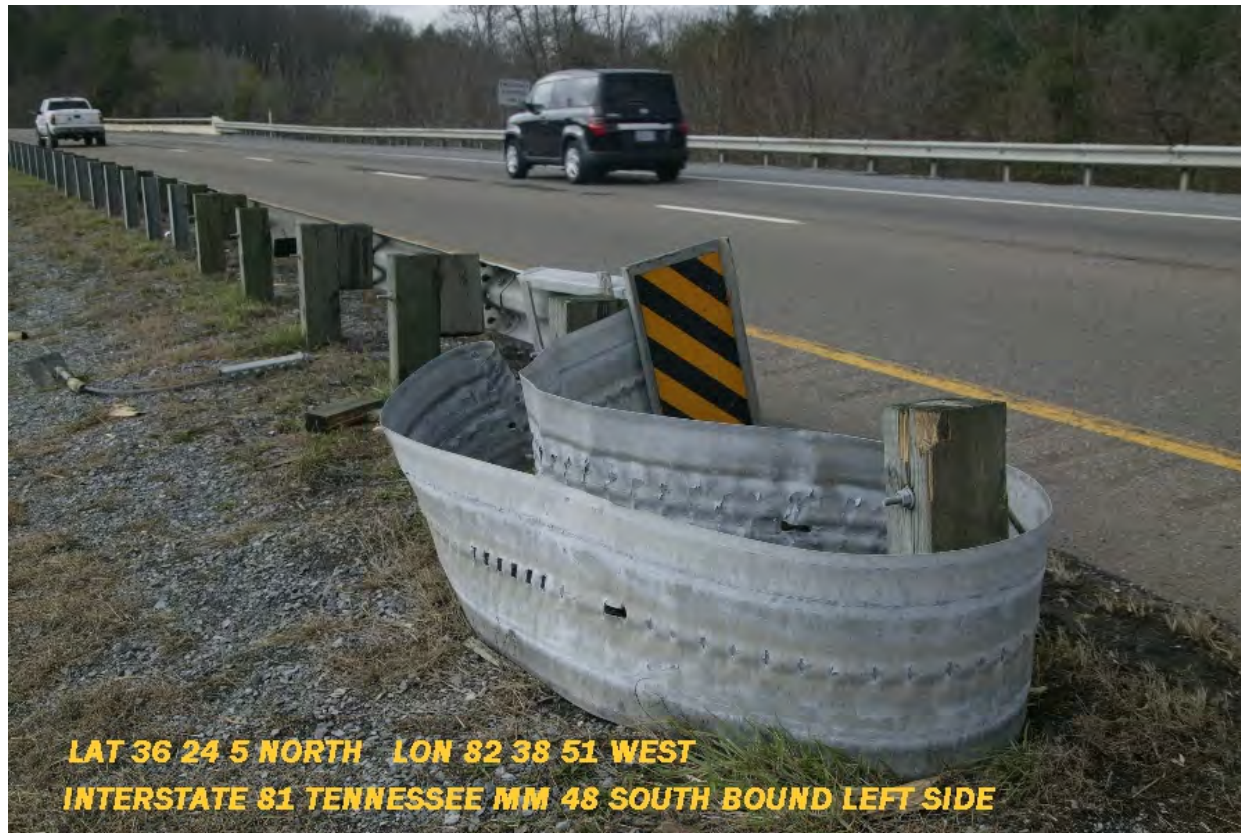
The early production ET-Plus work.*

* Those with exit gaps less than 1.35 inches may fail at a guardrail splice since guardrail bolts have an overall length of 1.5 inches.

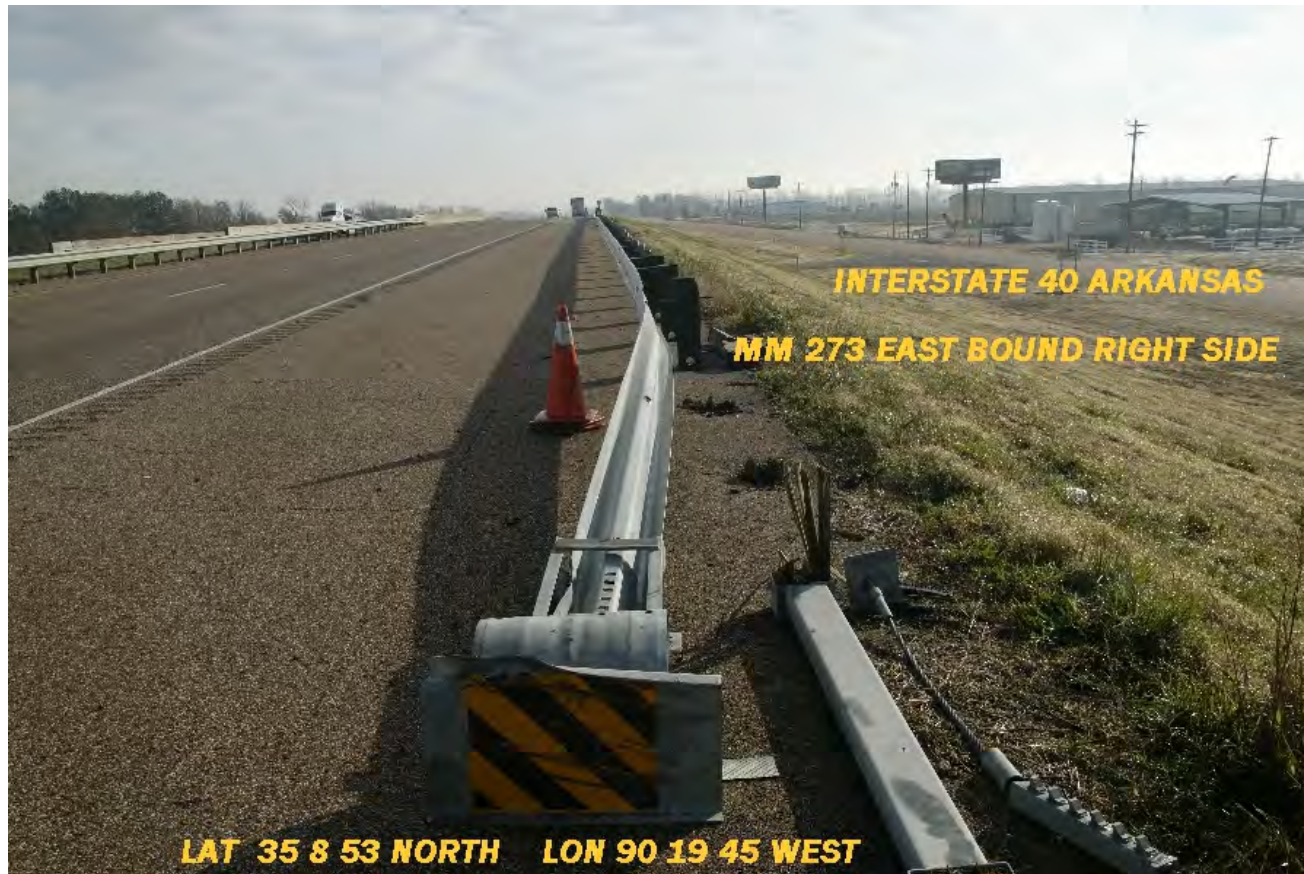
A glancing blow on an early production ET-Plus and it worked.

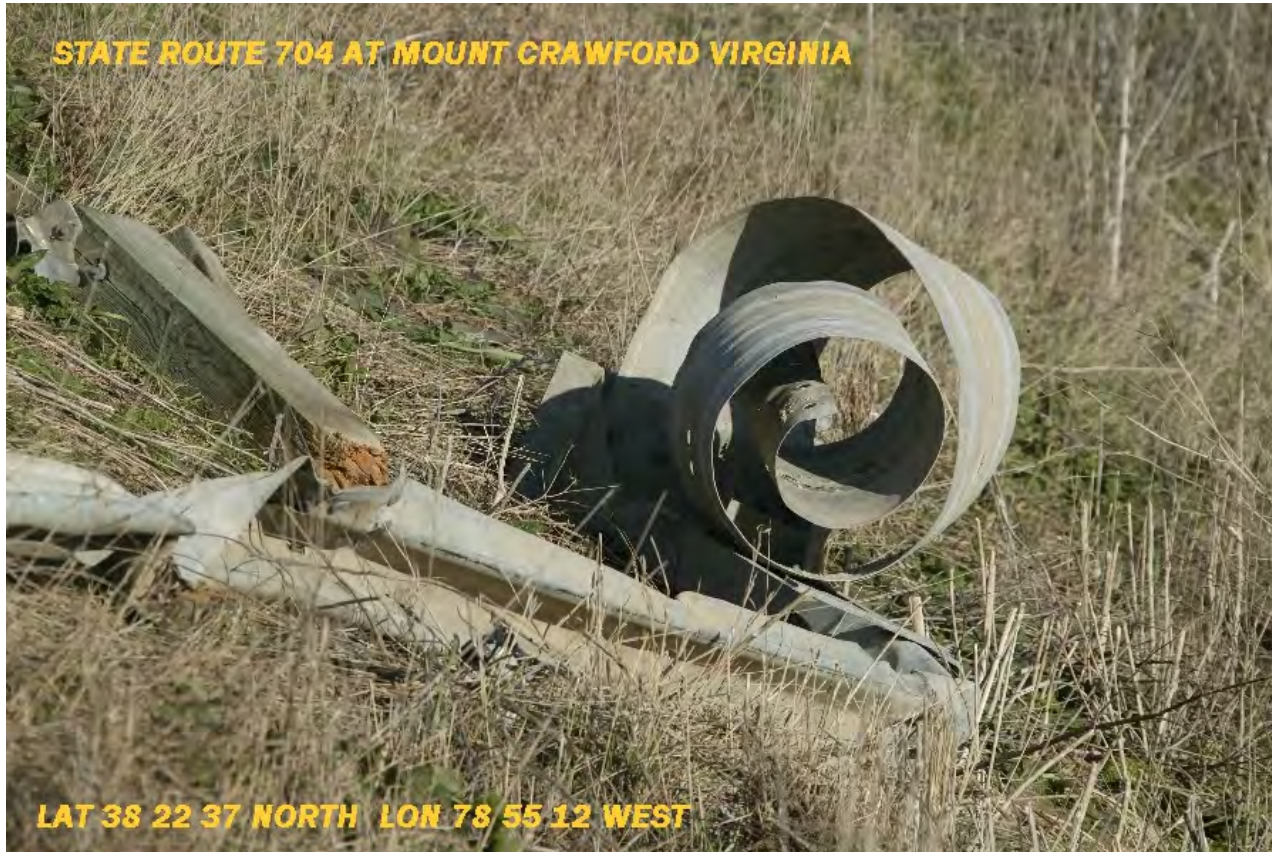
An early production ET-Plus that worked until the guardrail splice.

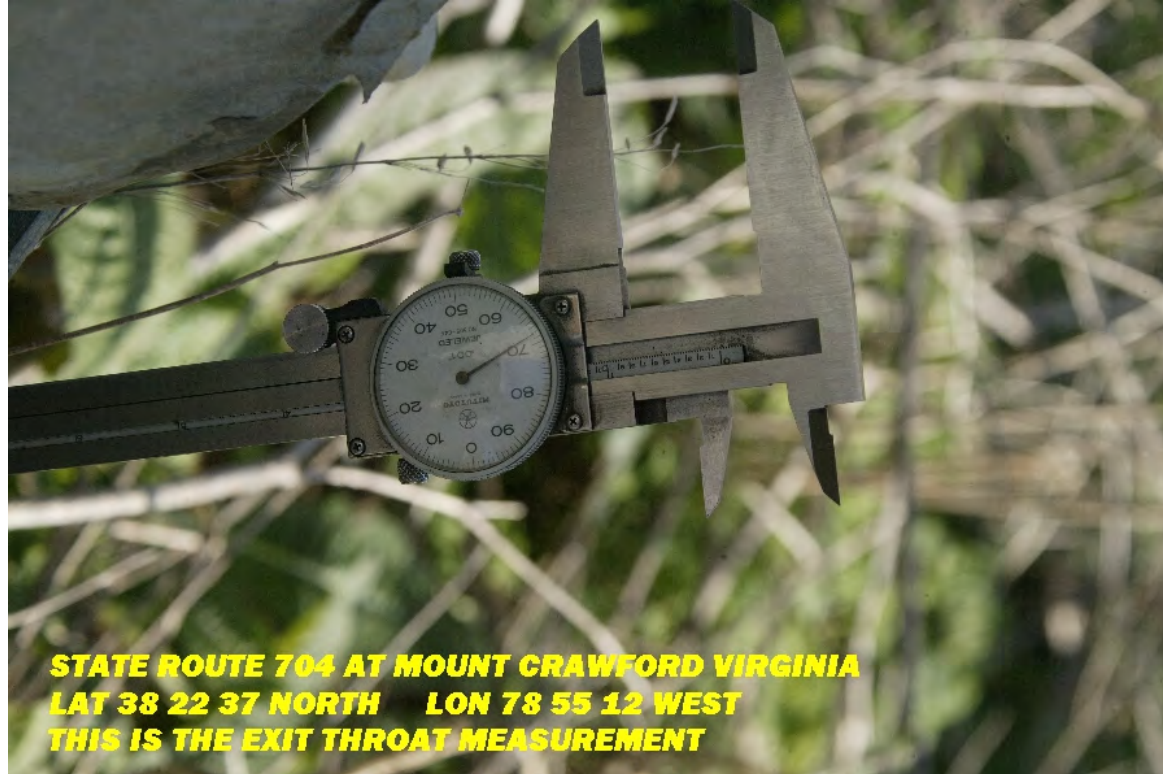
The exit gap for the extruder throat was 1.17 inches. If the exit gap had been 1.35 the splice could have gone through.

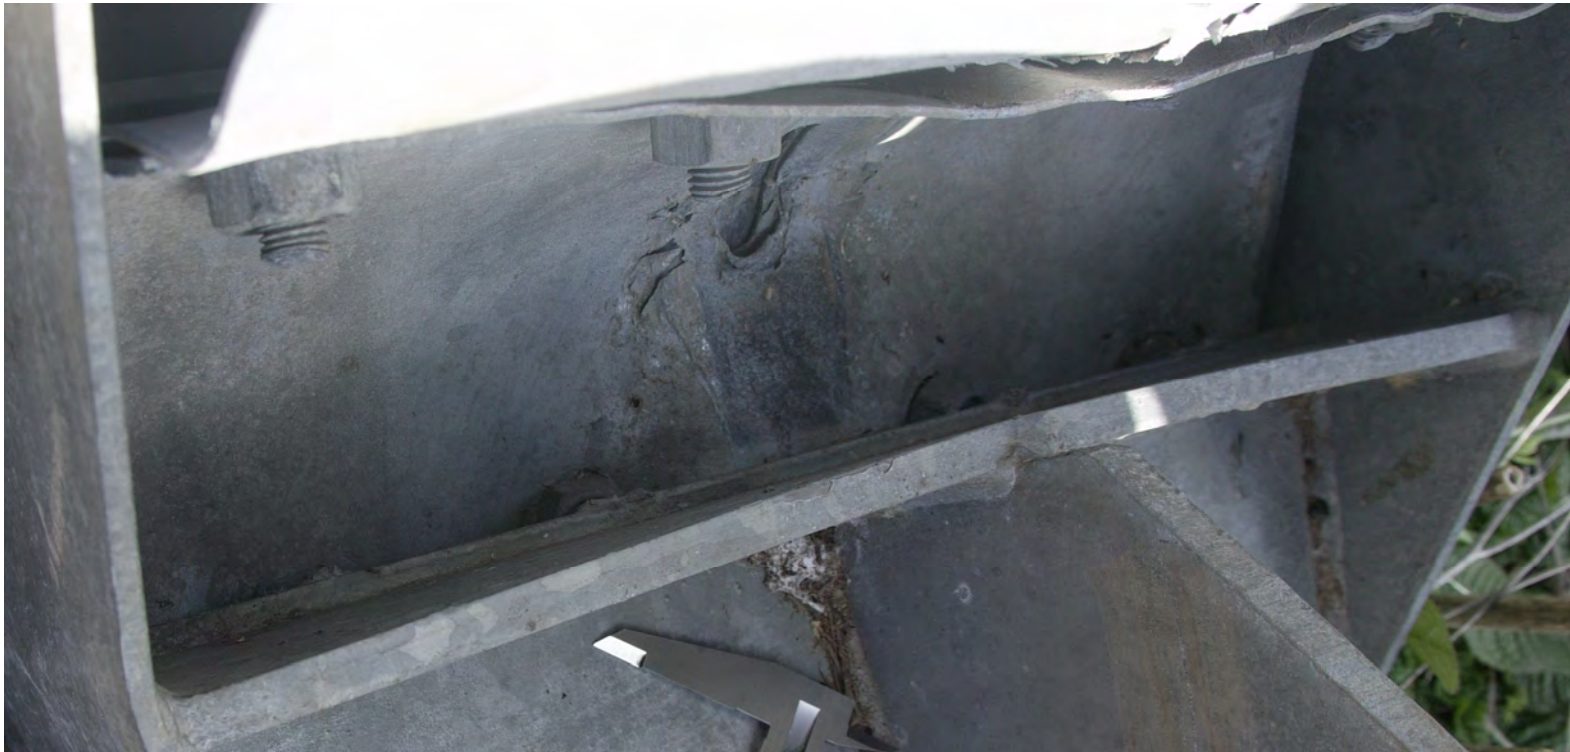
A 1.5 inch bolt has hard time getting through a 1.17 inch gap and bending the 4 inch wide $\frac{1}{2}$ inch thick steel back vertical brace of the ET-Plus.

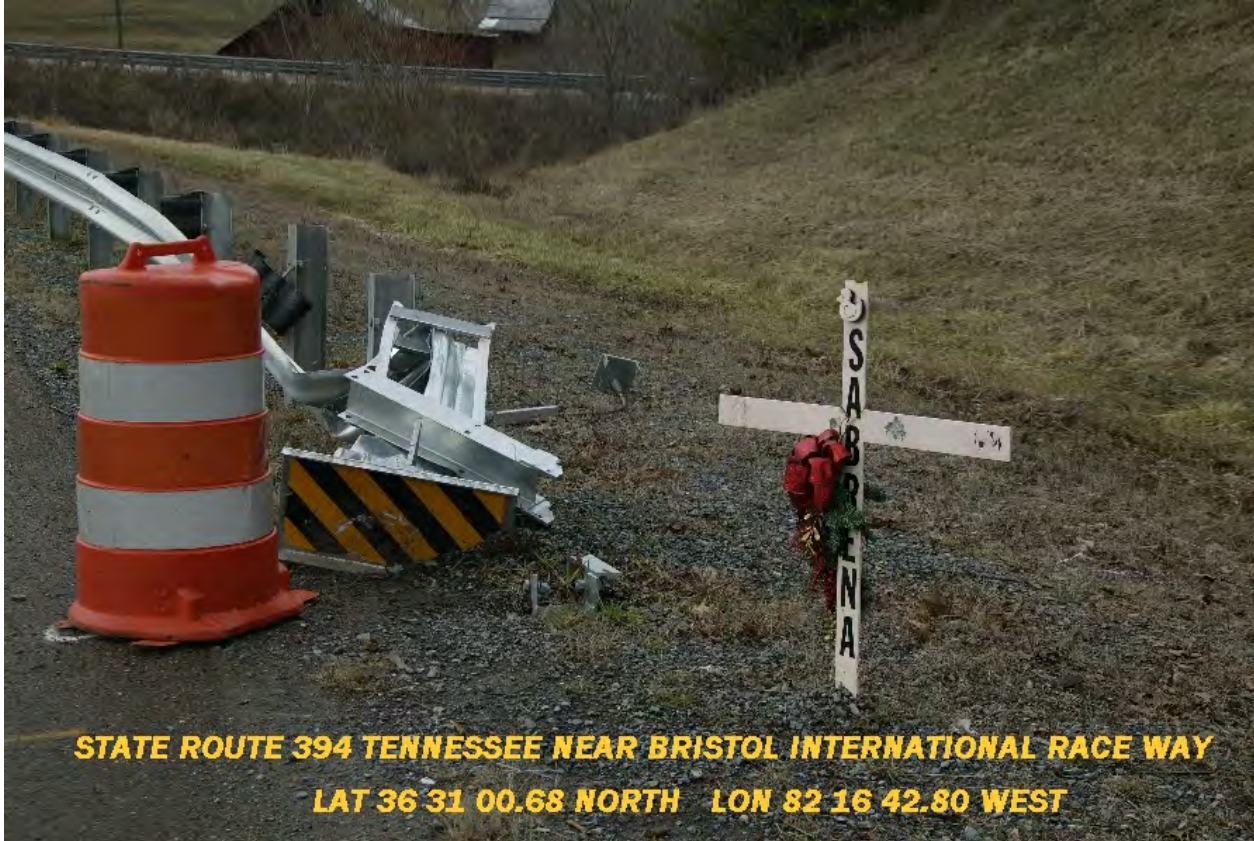
The current production ET-Plus with a feeder chute having 4 inch wide rails started to appear in 2005.

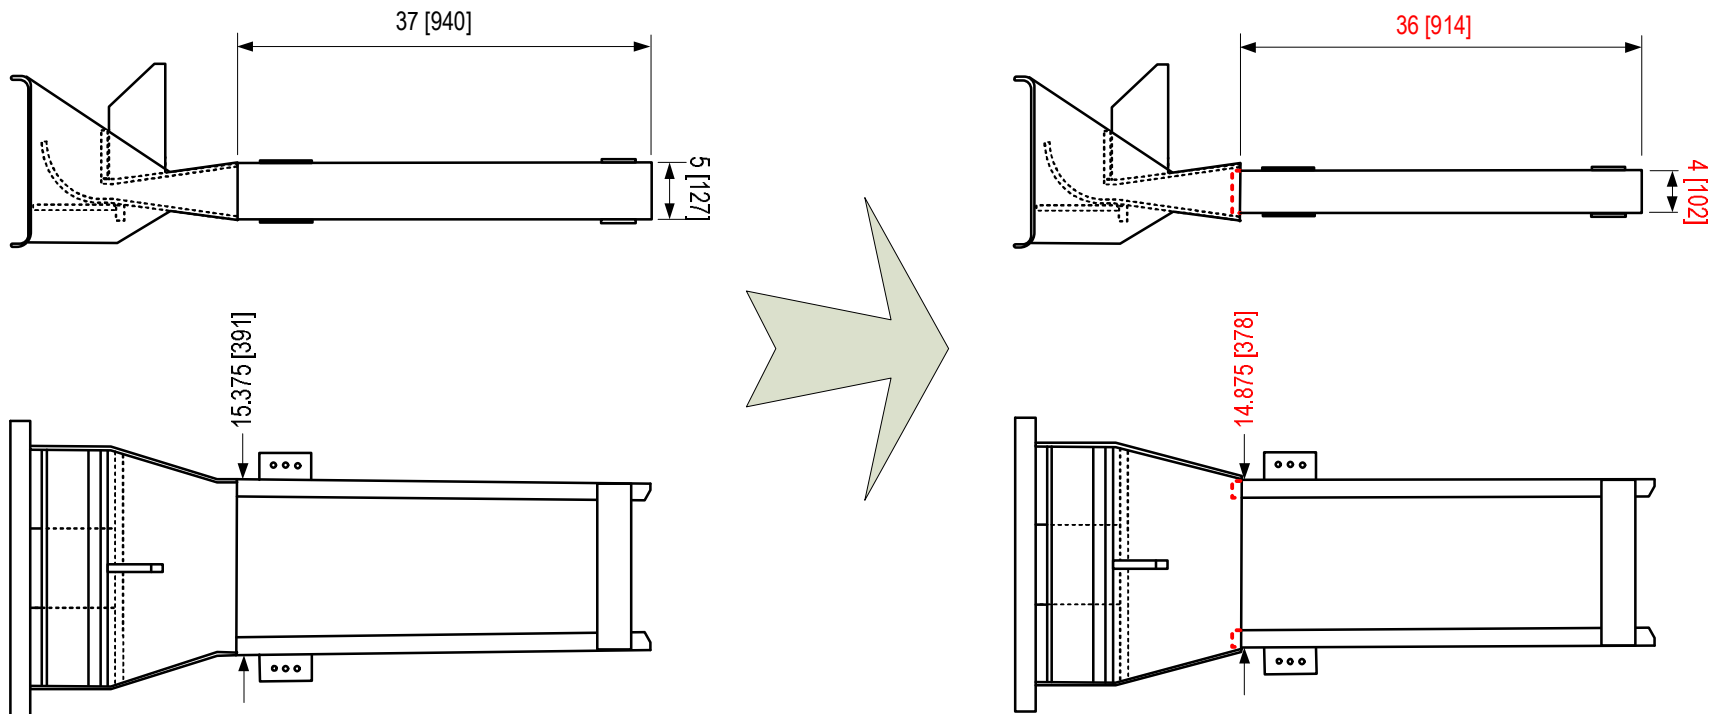
The following explains how a 2005 redesign changed an early production ET-Plus into a current production ET-Plus.

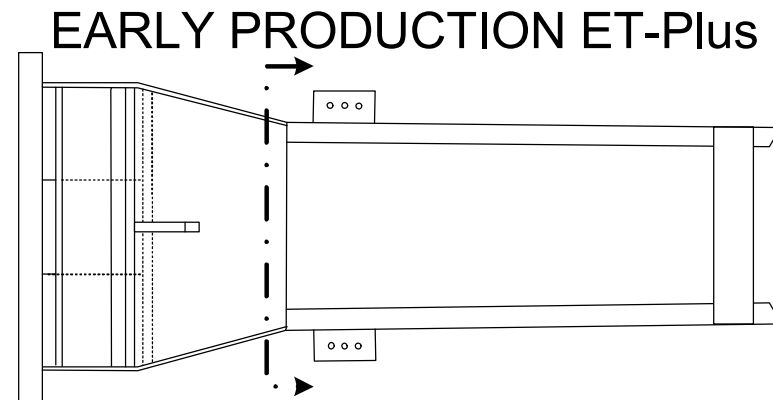
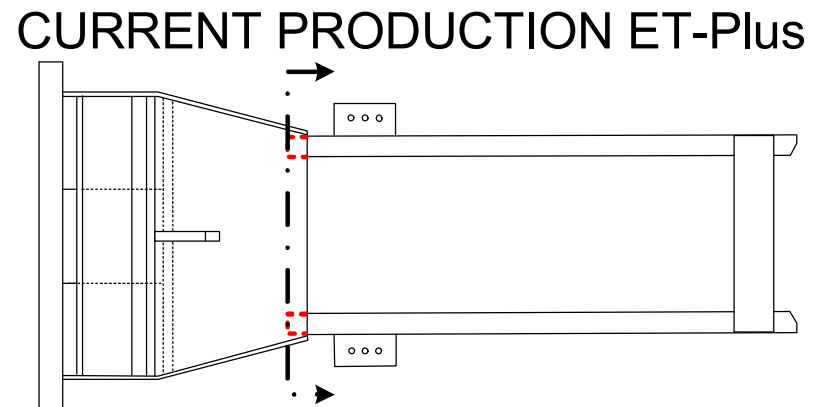
The insertion of the feeder chute into the extruder throat has caused changes to critical dimensions within the extruder throat that adversely effect performance.

Note positions for following cross-sections at .75 inches into the extruder throat from feeder chute for both.

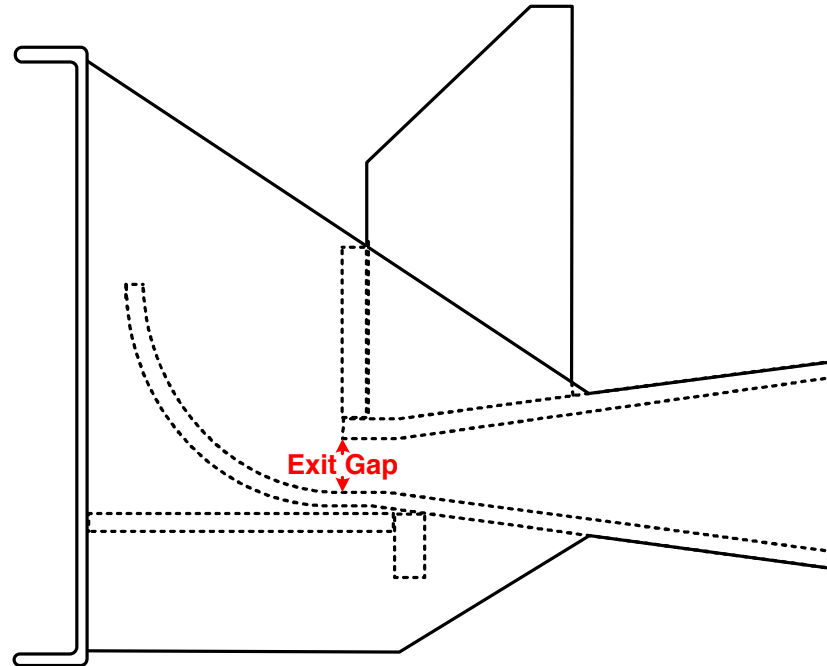
The exit gap of current production ET-PLUS now has manufacturing variances between 1 to 1.2 inches.

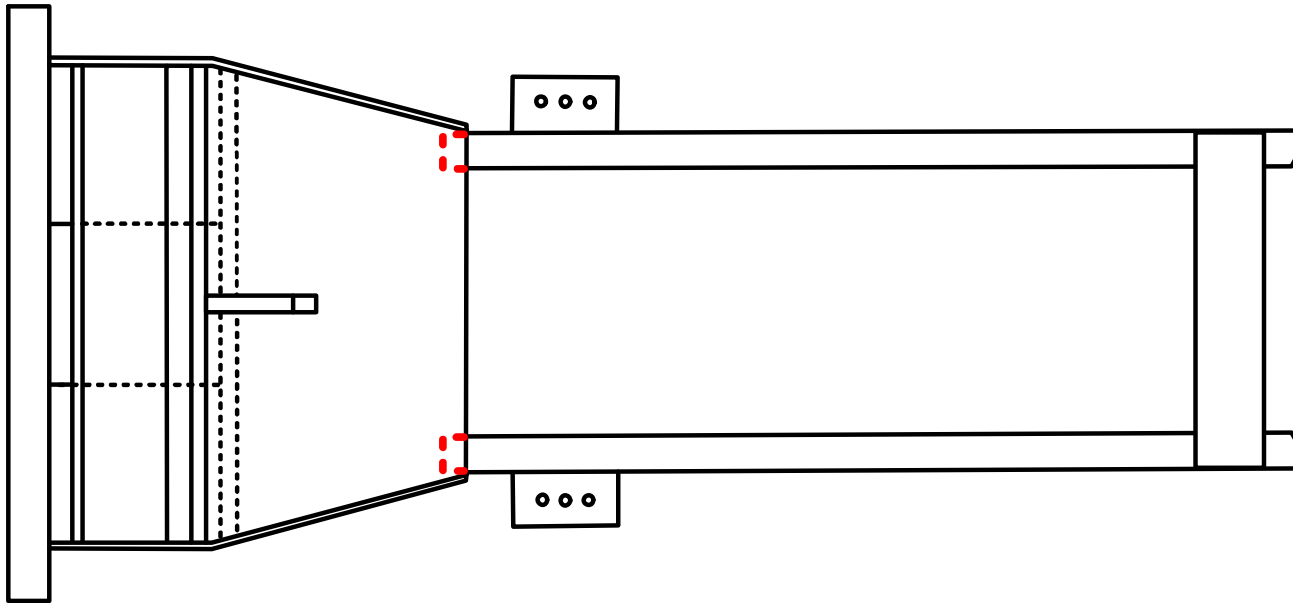
The height reduction of at least 1.2 inches at .75 inches within the extruder throat coupled with reduction in the exit gap of the extruder throat to below 1.3 inches cause the guardrail to “Throat Lock” in the extruder throat during an impact.

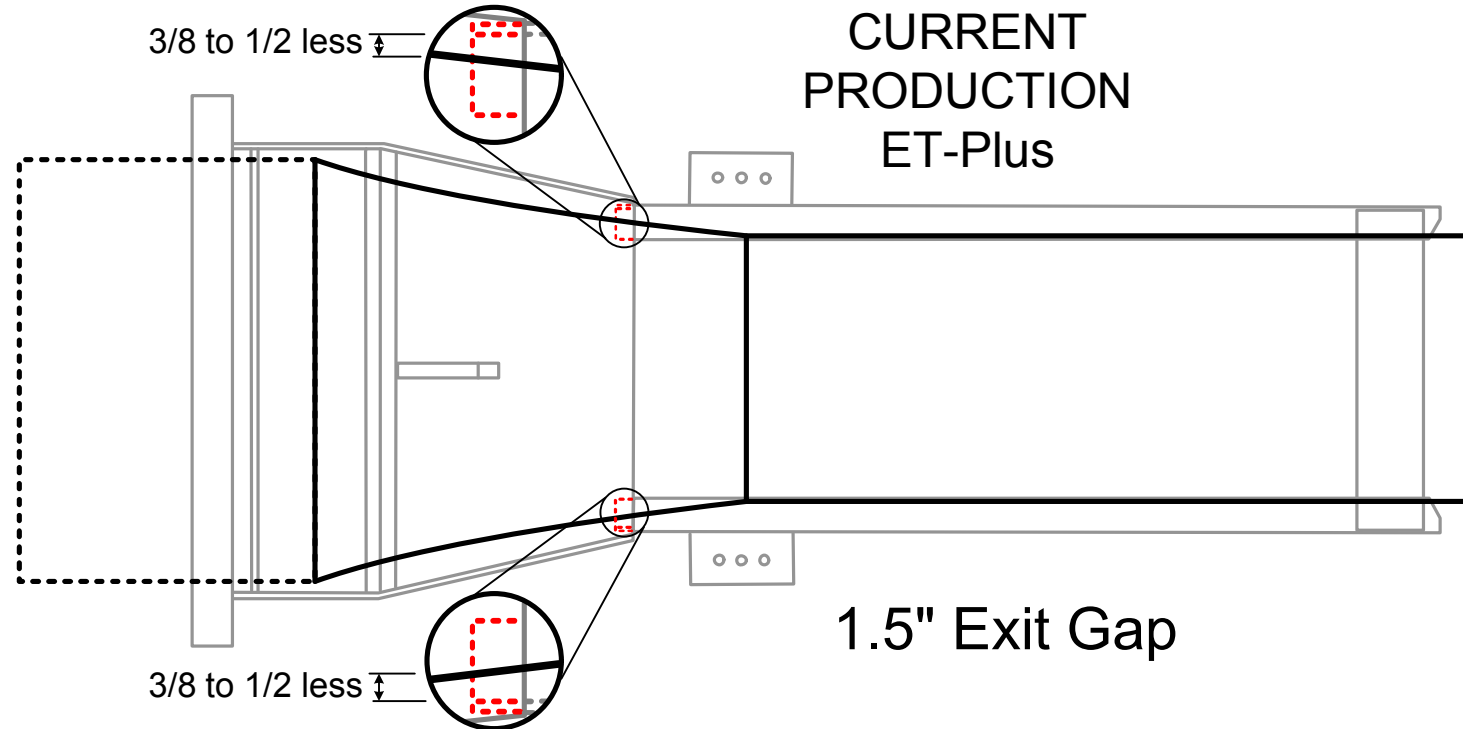
When the exit gap of the extruder throat is 1.5 inches, the resultant dynamic compression plume is well within the top and bottom feed rails within the extruder throat.

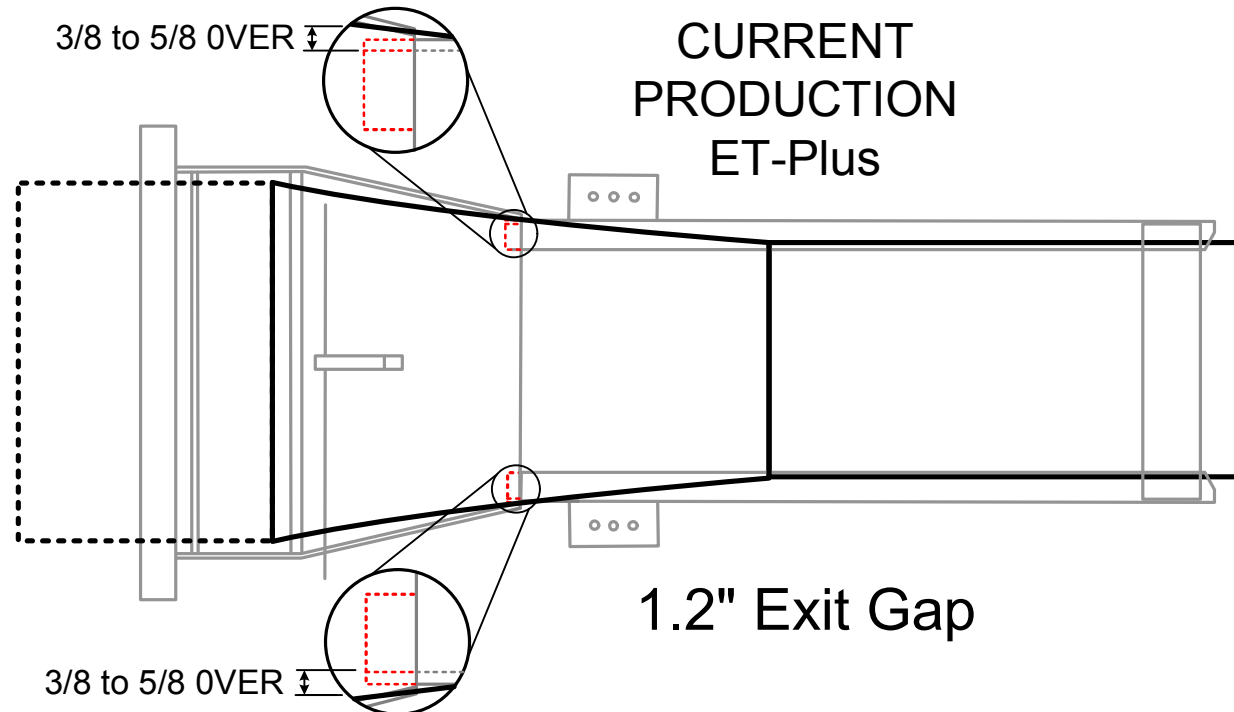
When the exit gap of the extruder throat is 1.2 inches, the resultant dynamic compression plume is beyond the top and bottom feed rails within the extruder throat by $\frac{3}{4}$ to 1.25 inches.

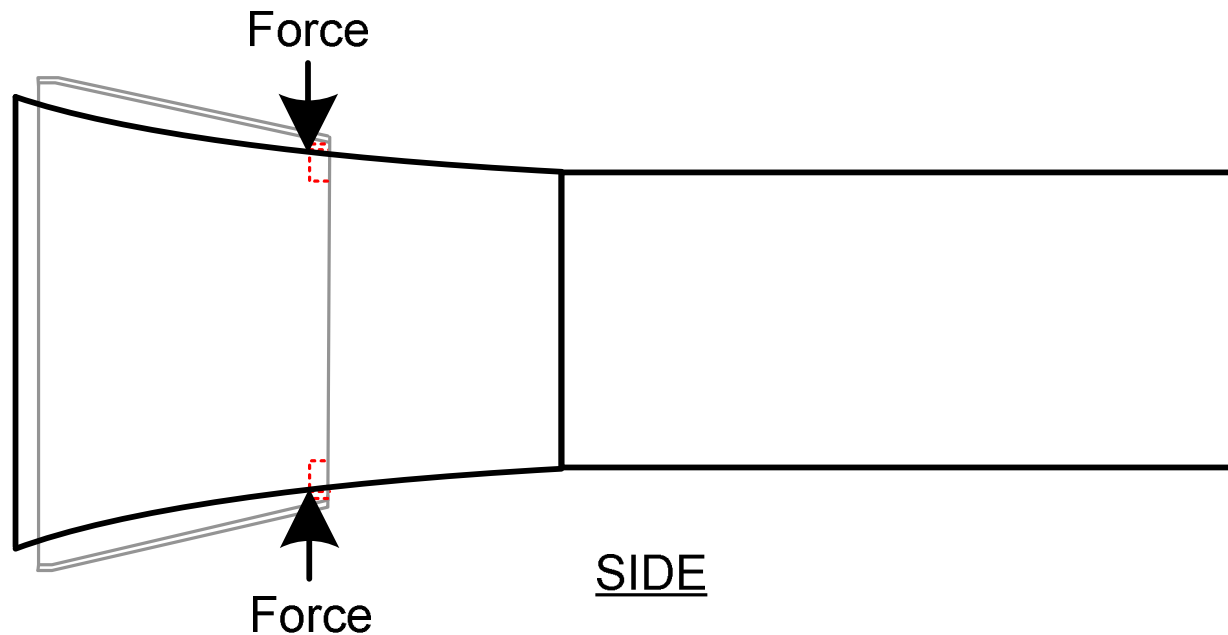
...there are also vertical constraining forces on the dynamic compression plume due to the ends of the feeder rails intruding into the extruder throat by $\frac{3}{4}$ inches.

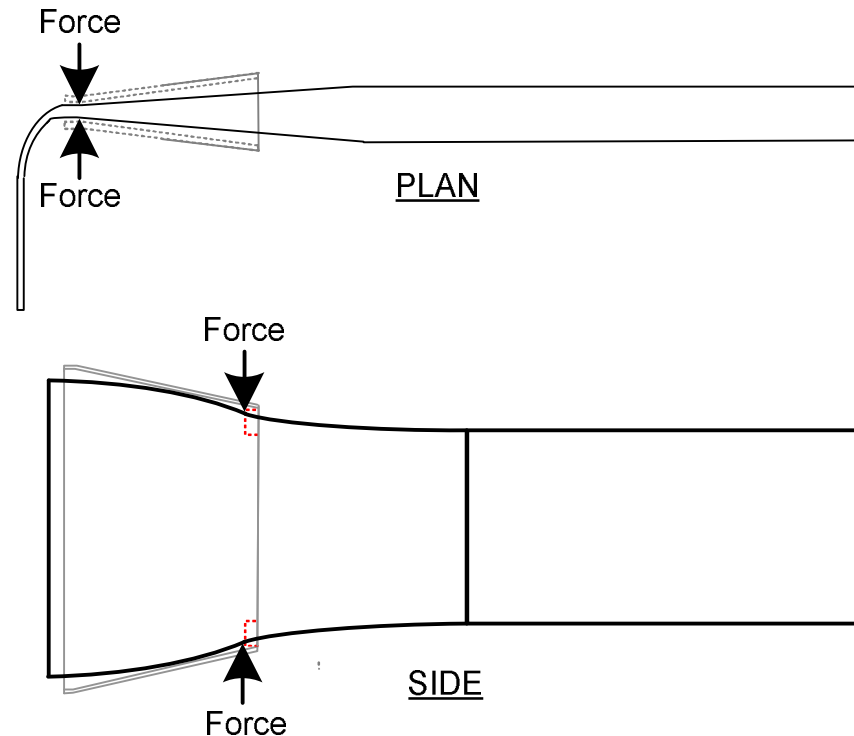
The vertical constraining forces from the ends of the feeder rails deforms the natural shape of the dynamic compression plume resulting from the horizontal compressing forces.

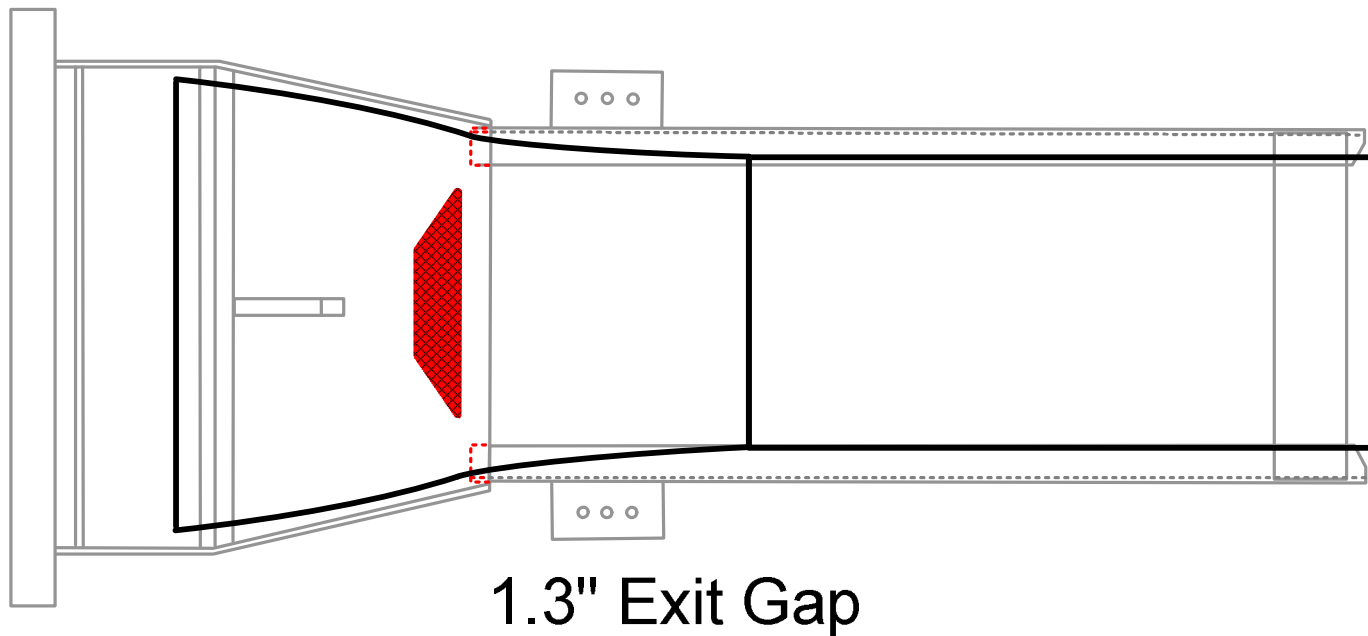
The deformation of the natural dynamic compression plume creates a contortion zone in the guardrail within the extruder throat.

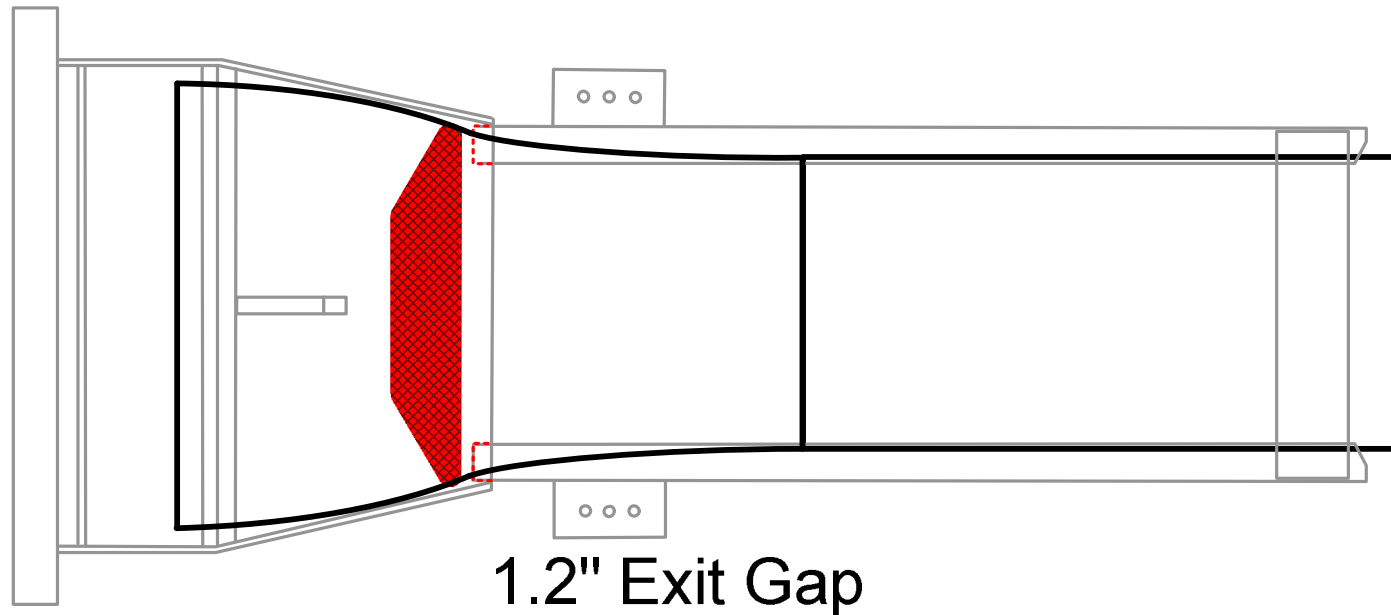
The contortion zone of a current production ET-Plus with 1.2 inch exit gap will span across the distance between ends of the feeder rails in the extruder throat so as to cause the guardrail to lock up in the extruder throat during an impact.

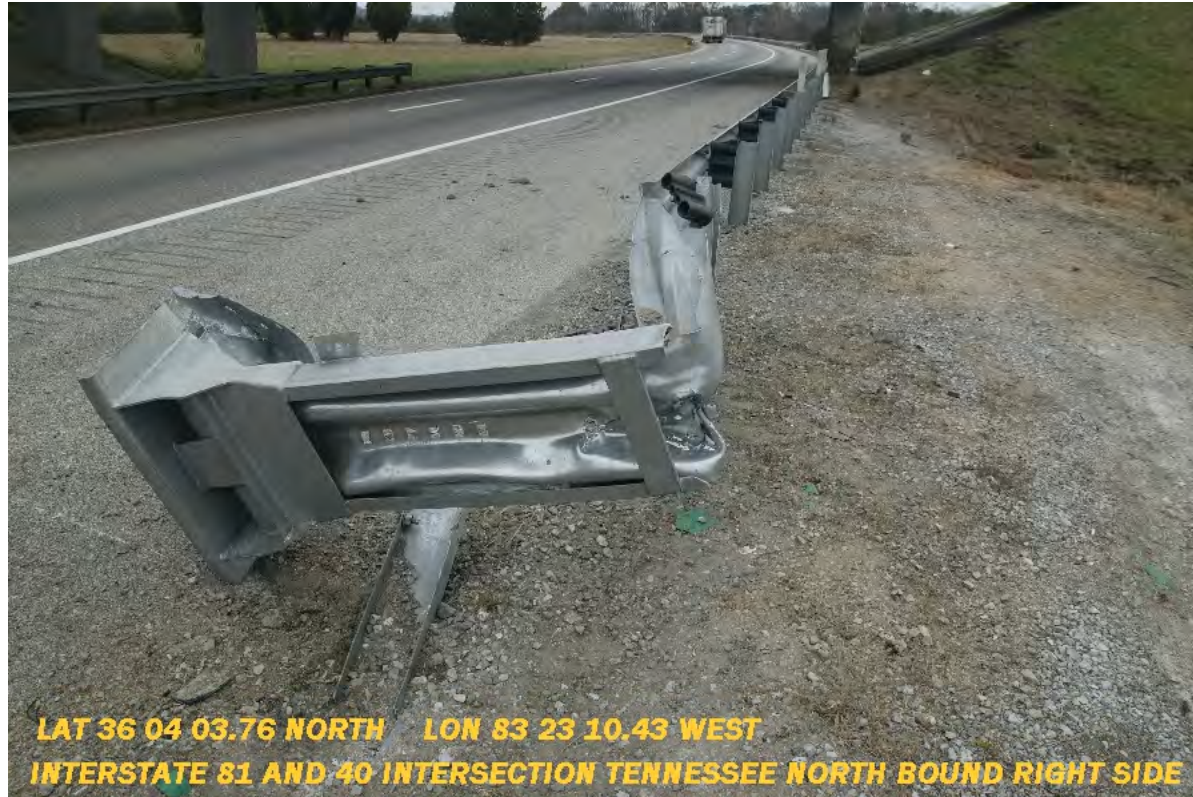
This is an example of throat lock that occurred in a current production ET-Plus with 1.2 inch exit gap during an impact.

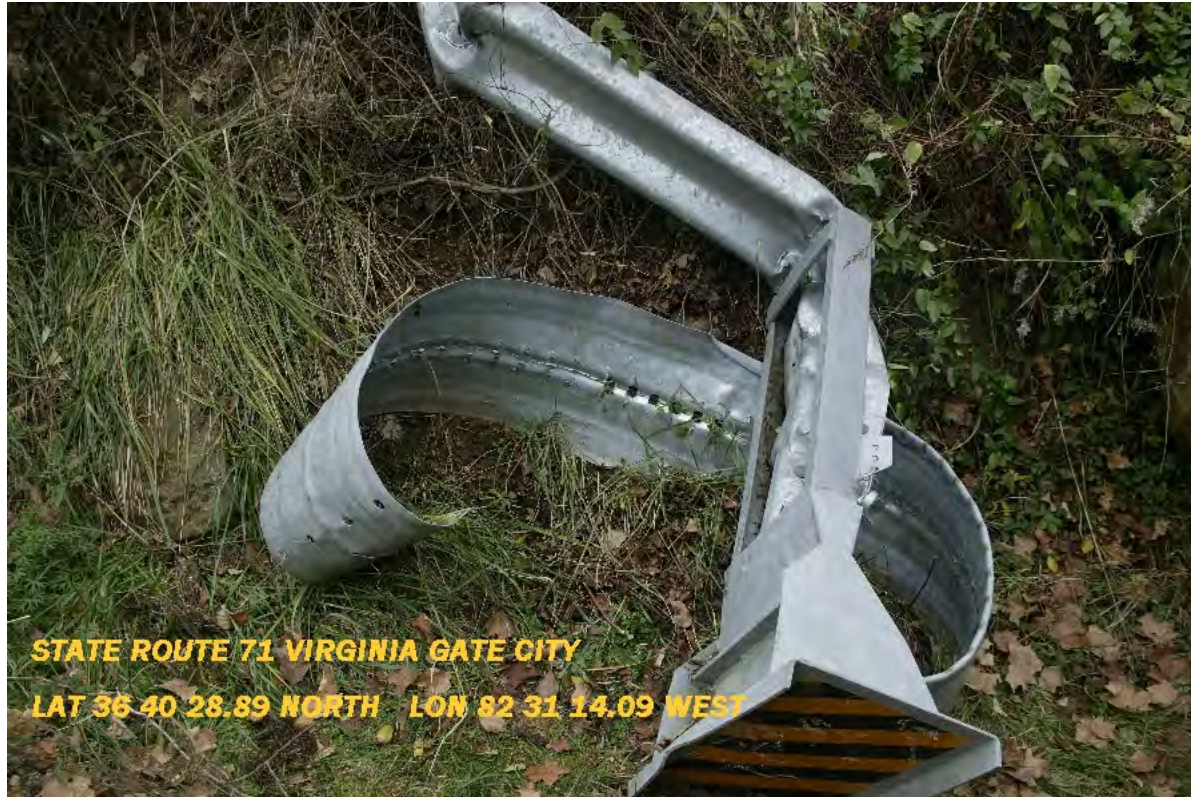
This is an example of a current production ET-Plus with 1.2 inch exit gap that did not throat lock because...
