Failure Assessment Of Guardrail Extruder Terminals

January 11, 2012

This presentation is the sole opinion of SPIG Industries based on an empirical analysis of guardrail terminal impacts throughout a number of states.

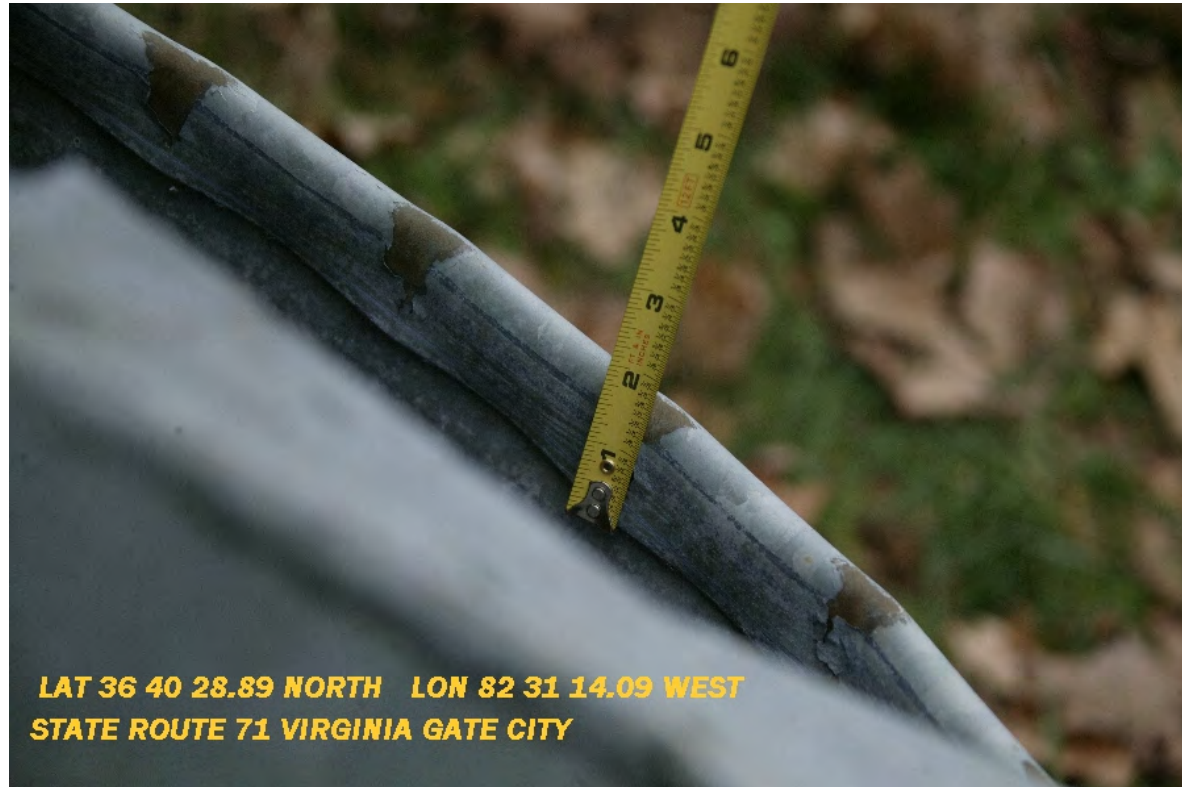
...the rail bent over at the top of the guardrail.

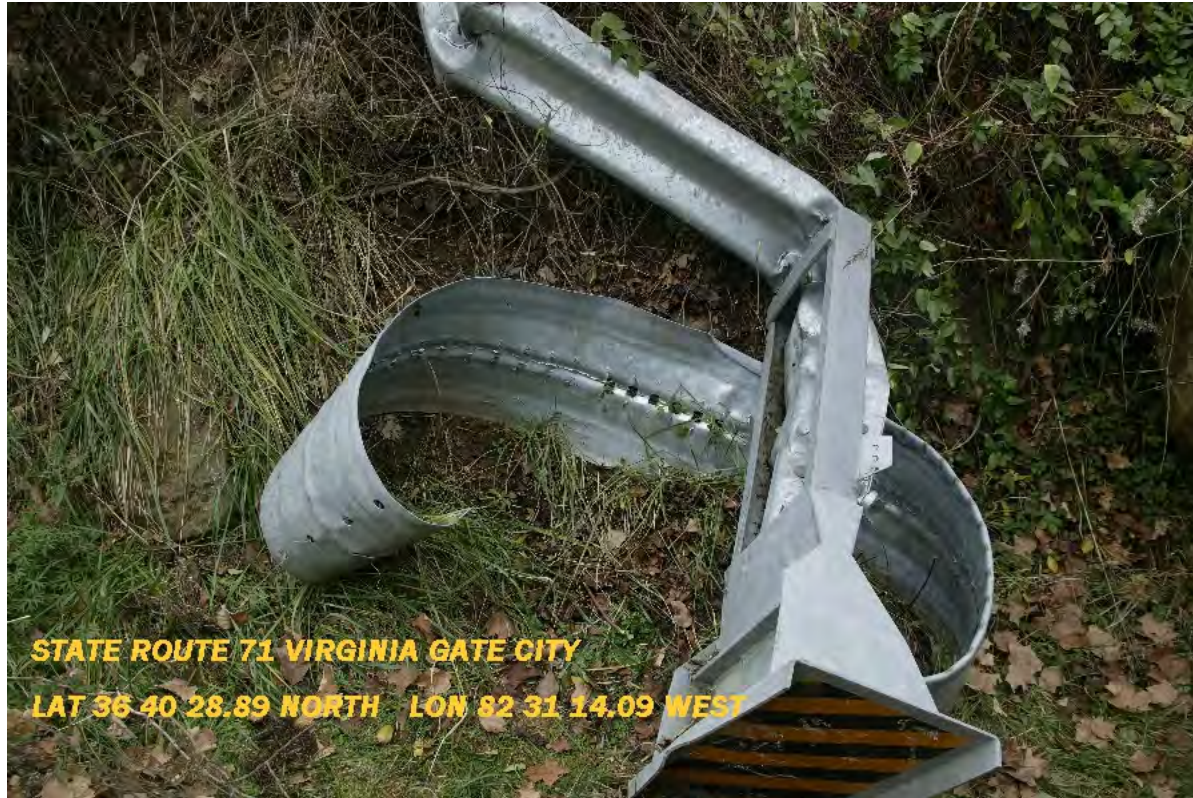
Then, this current production ET-Plus failed at the guardrail splice.

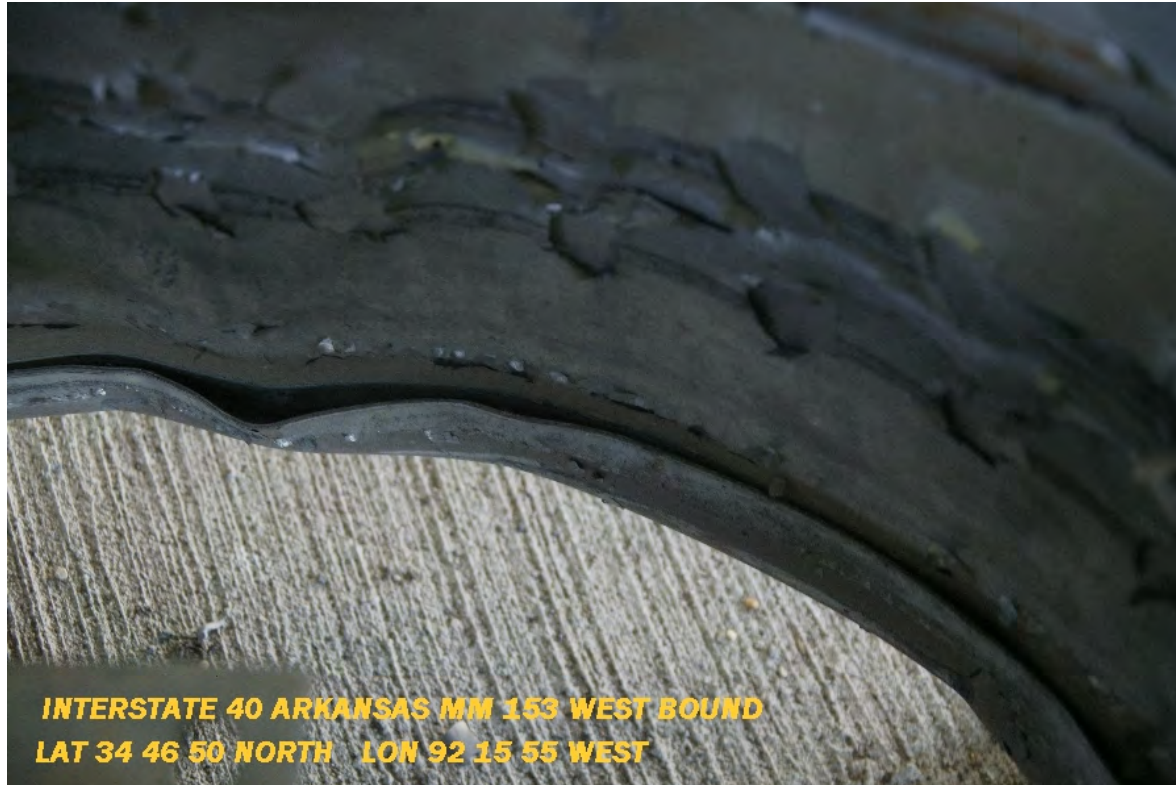
This guardrail bent over at the bottom, fed through the extruder throat some distance, and then throat locked.

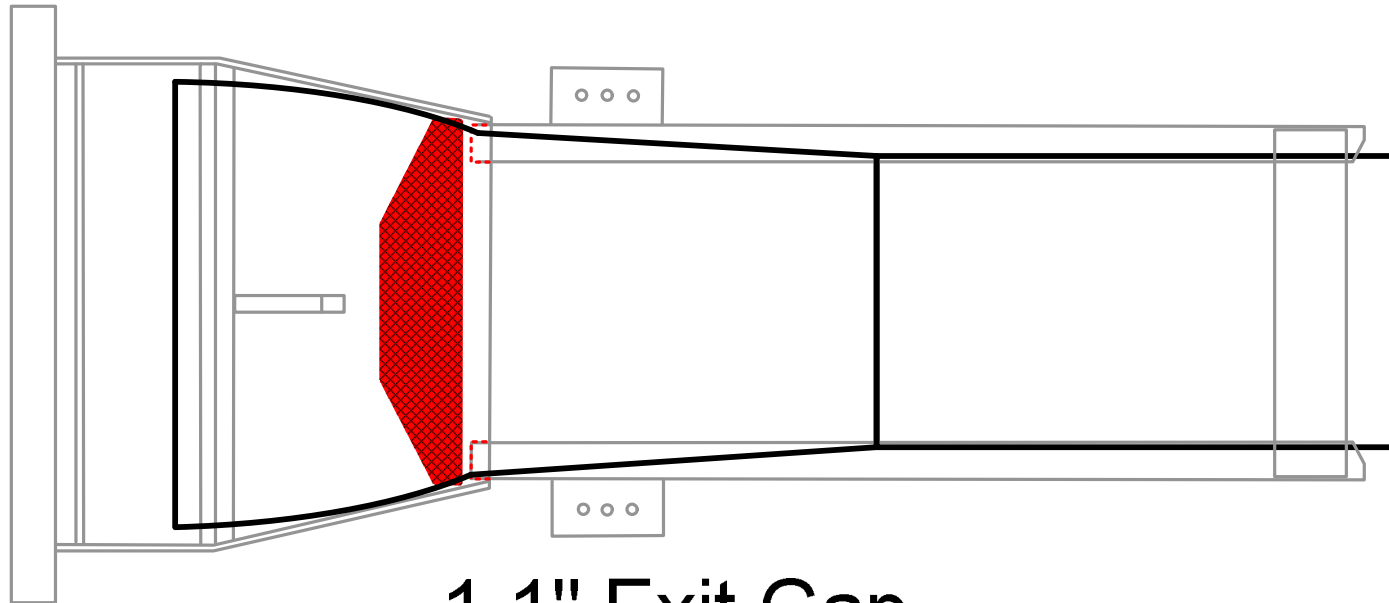
1.1" Exit Gap

The contortion zone of a current production ET-Plus with 1.1 inch exit gap is even larger and thus is more likely to throat lock quicker during an impact.

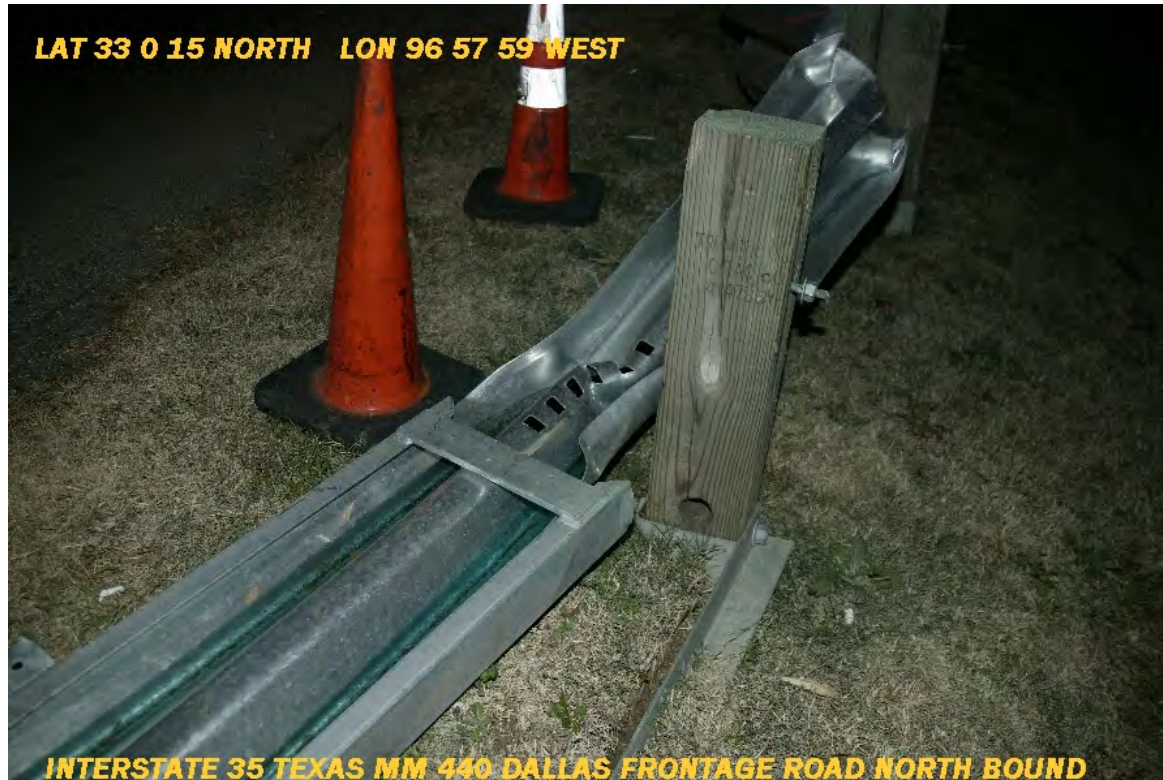
This is an example of throat lock that occurred in a current production ET-Plus with 1.1 inch exit gap during an impact.

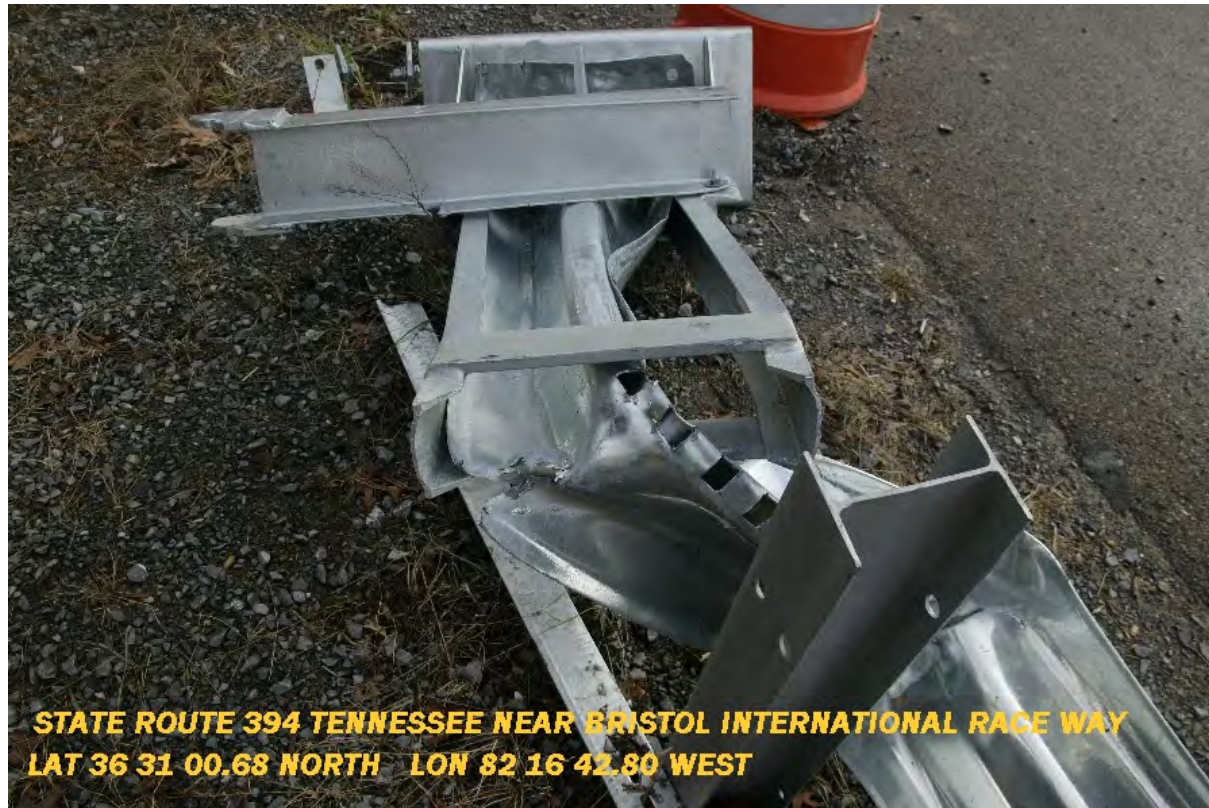
This is an example of throat lock that occurred in a current production ET-Plus with 1.1 inch exit gap during an impact.

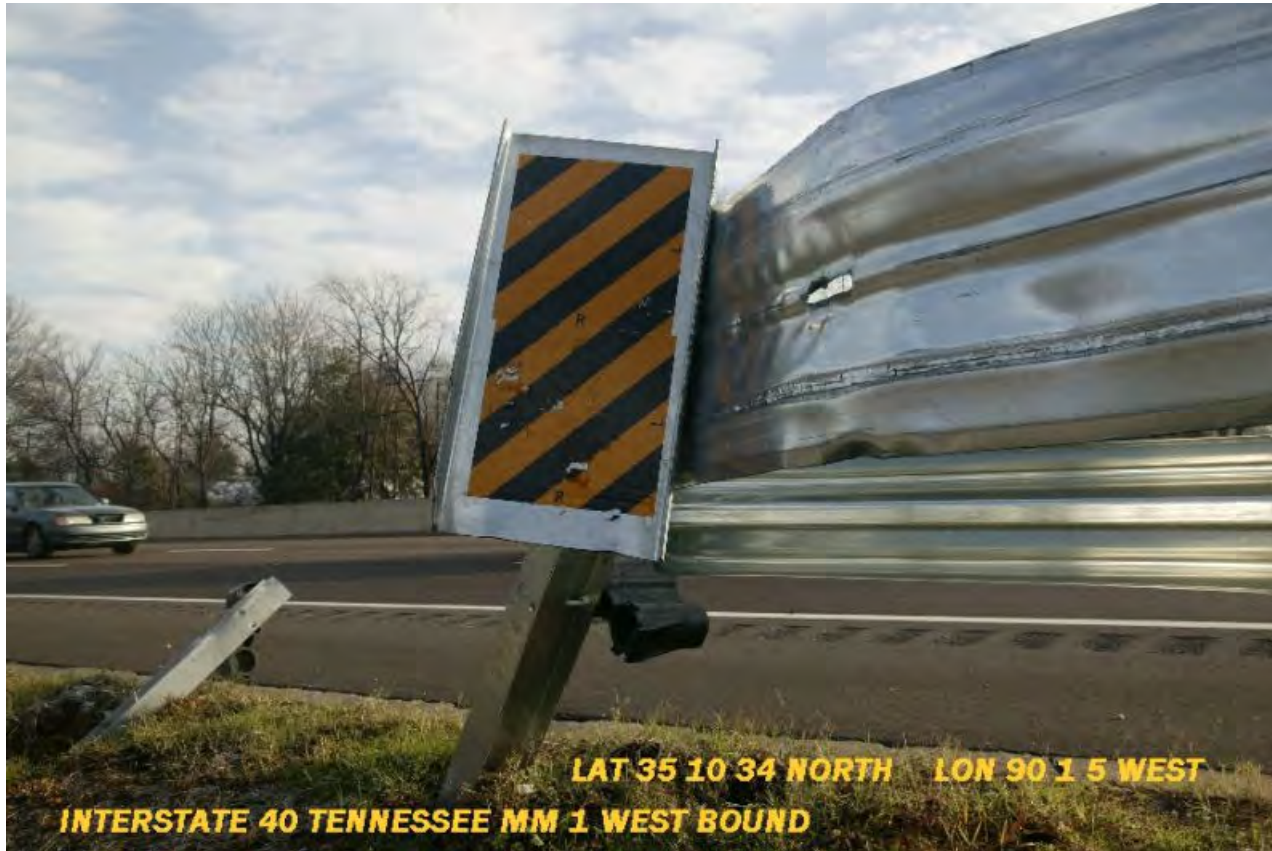
Note edge stress on guardrail ribbon of this throat locked current production ET-Plus with 1.1 inch exit gap.

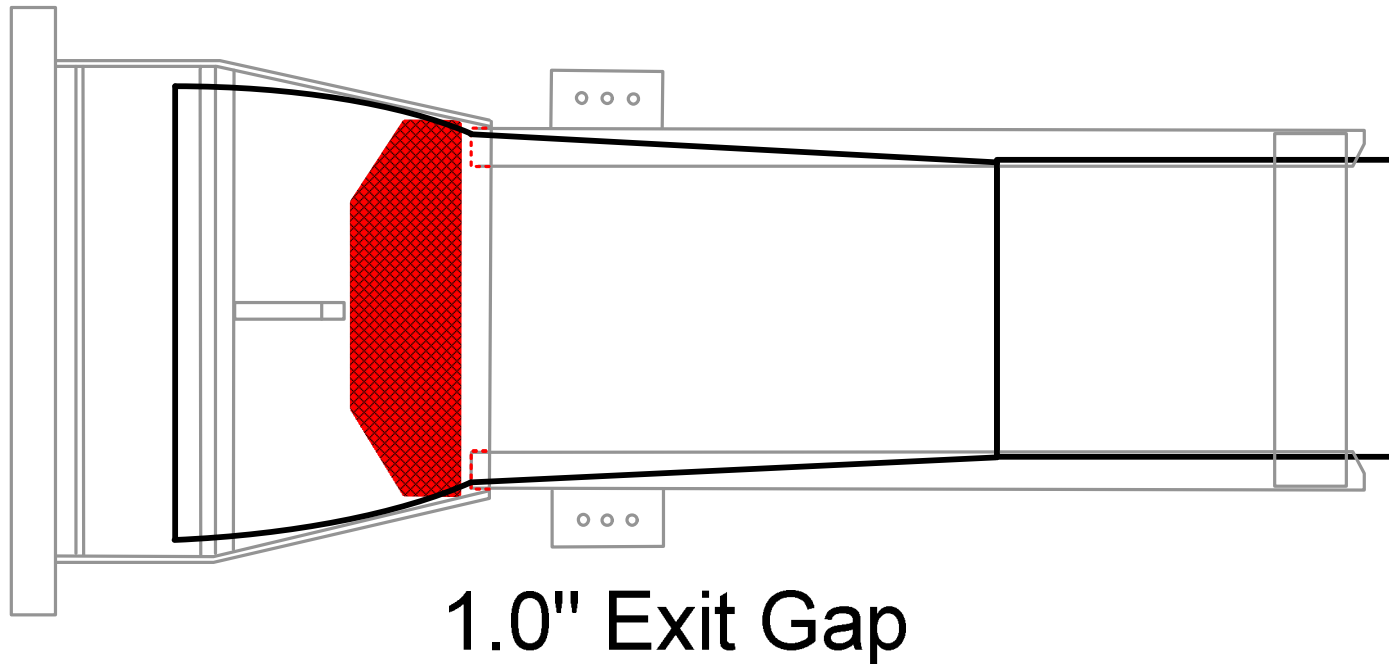
The contortion zone of a current production ET-Plus with 1.0 inch exit gap is the largest.

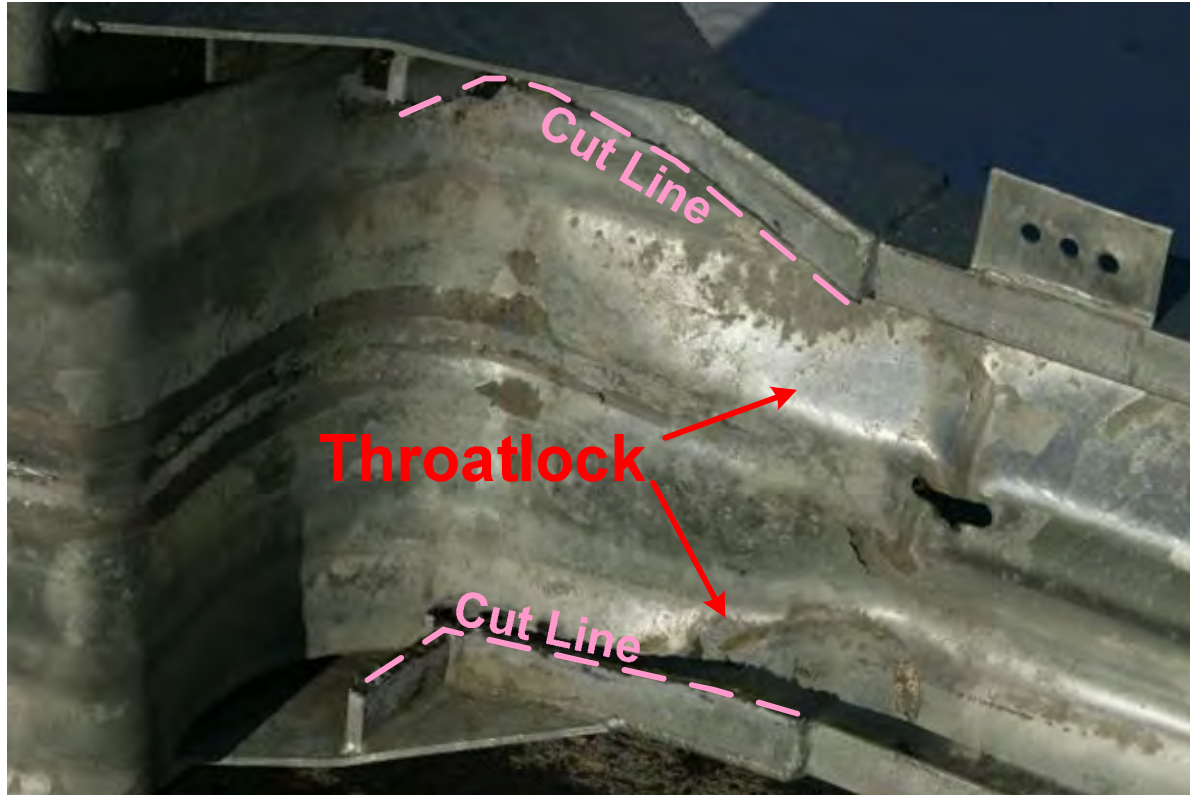
This is a current production ET-Plus that has been cut apart to show throat locked guardrail in the extruder throat.

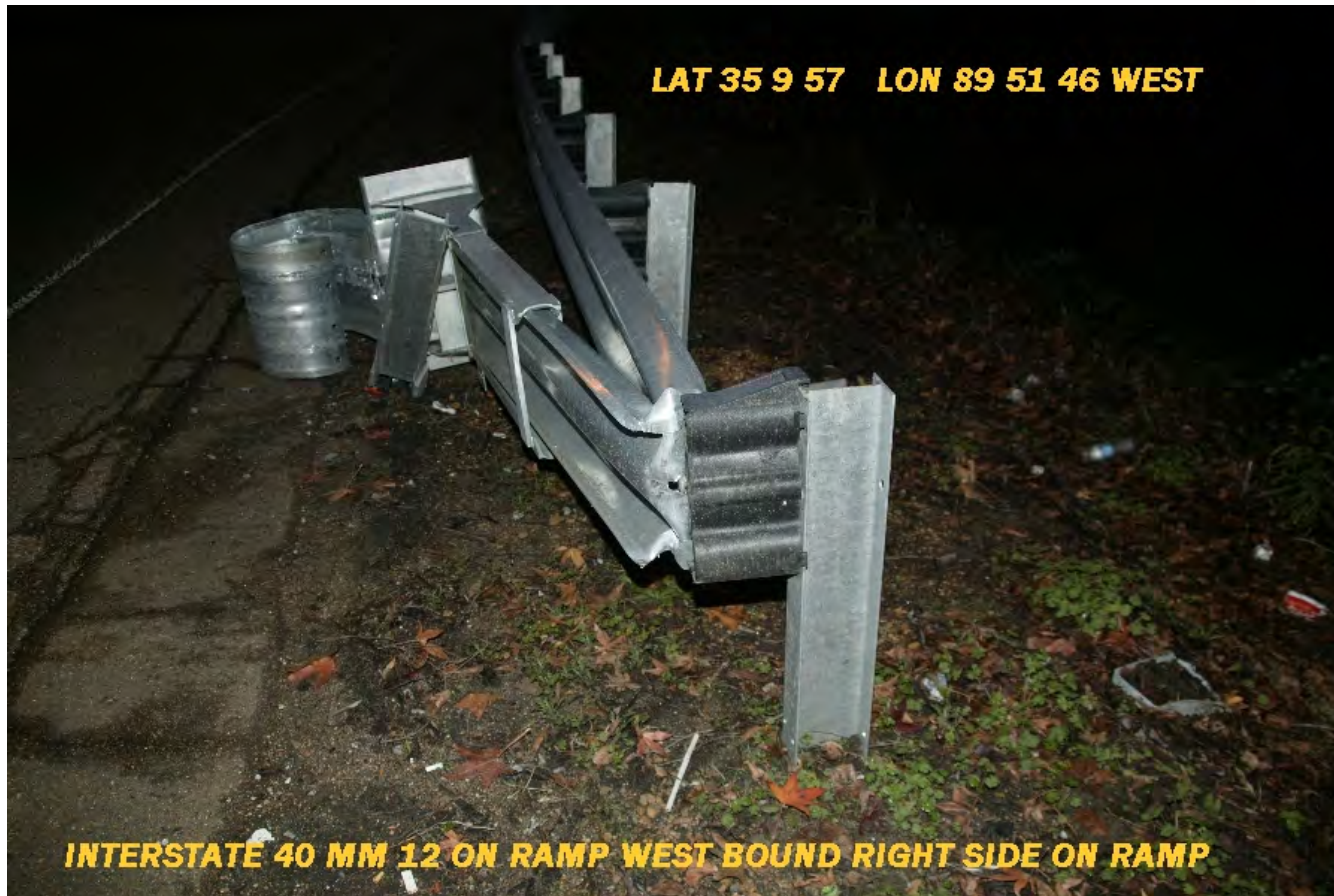
The blockout's lack of resilience may further contribute to throat lock in that the guardrail is allowed to flex.

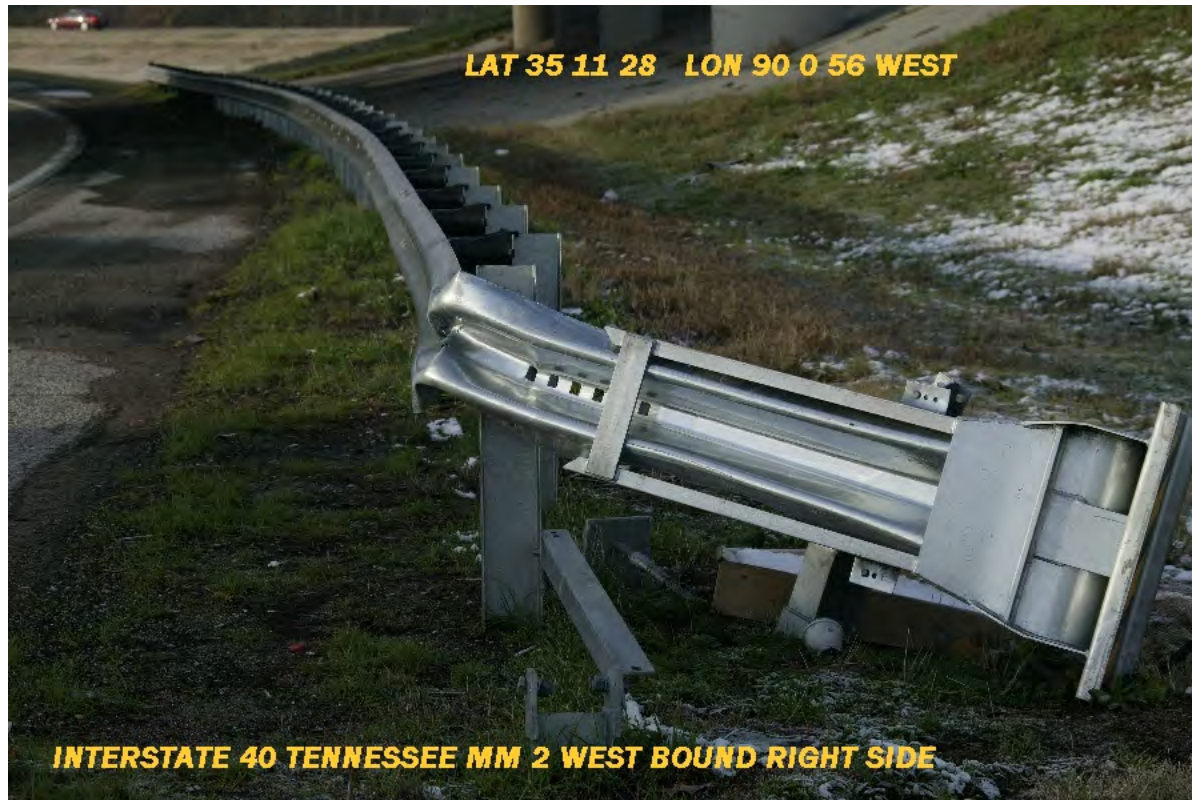
The early release of the tension cable by the hinged breakaway post may also contribute to throat lock by not holding the guardrail tight at initial compression/deflection.

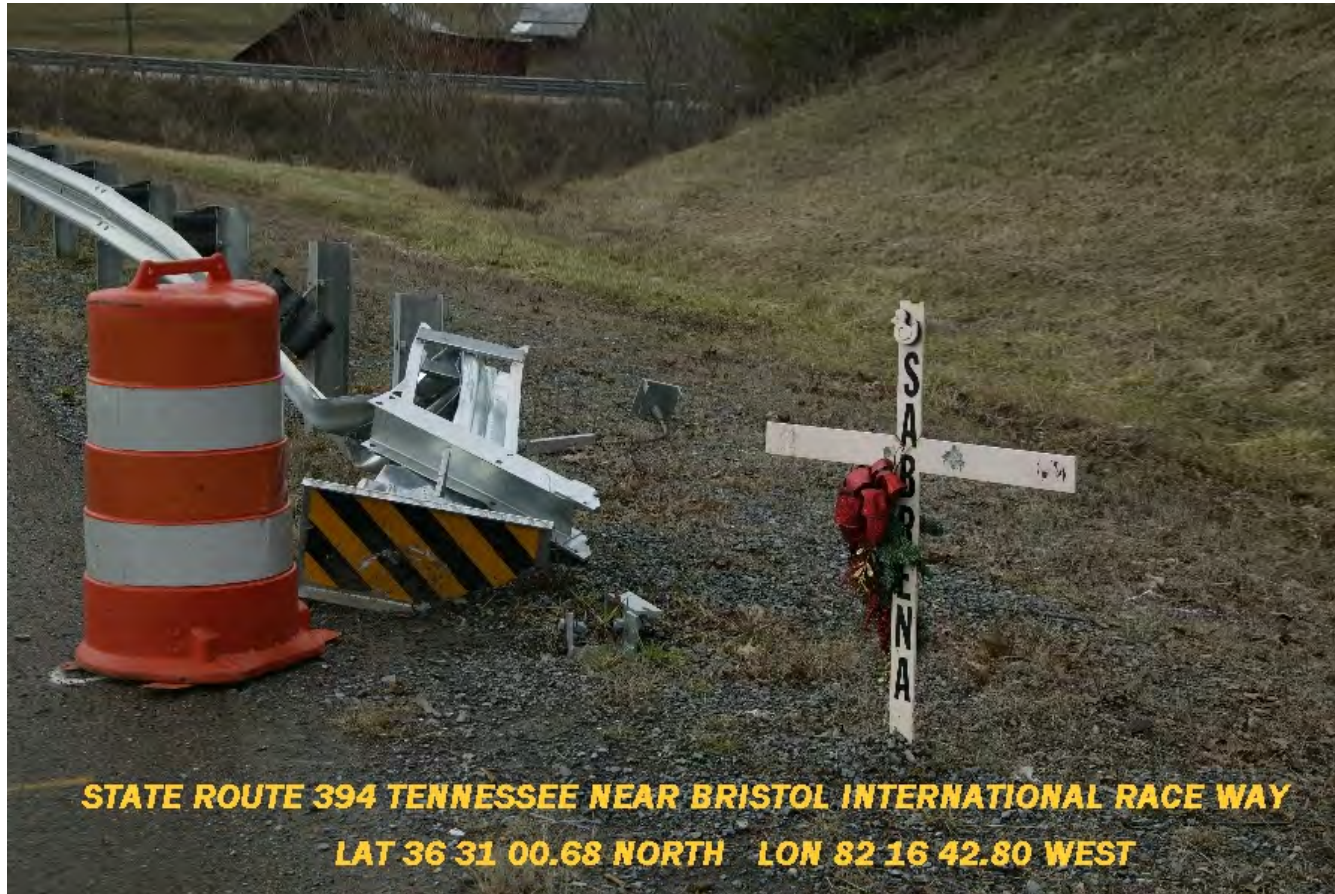
In this December 2011 picture of a throat locked current production ET-Plus with a 1.0 exit gap, the memorial is for...

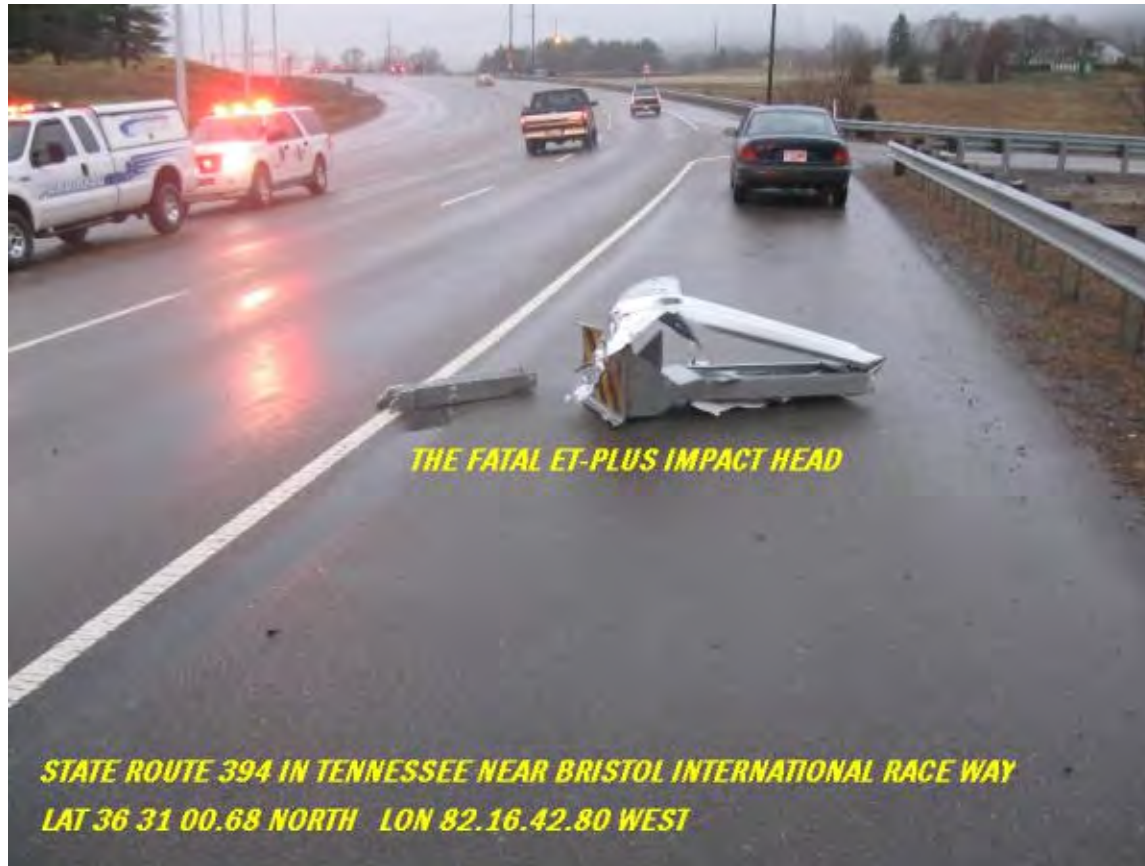
This current production ET-Plus has an exit gap of 1.0 inch and the guardrail is throat locked in the extruder throat.

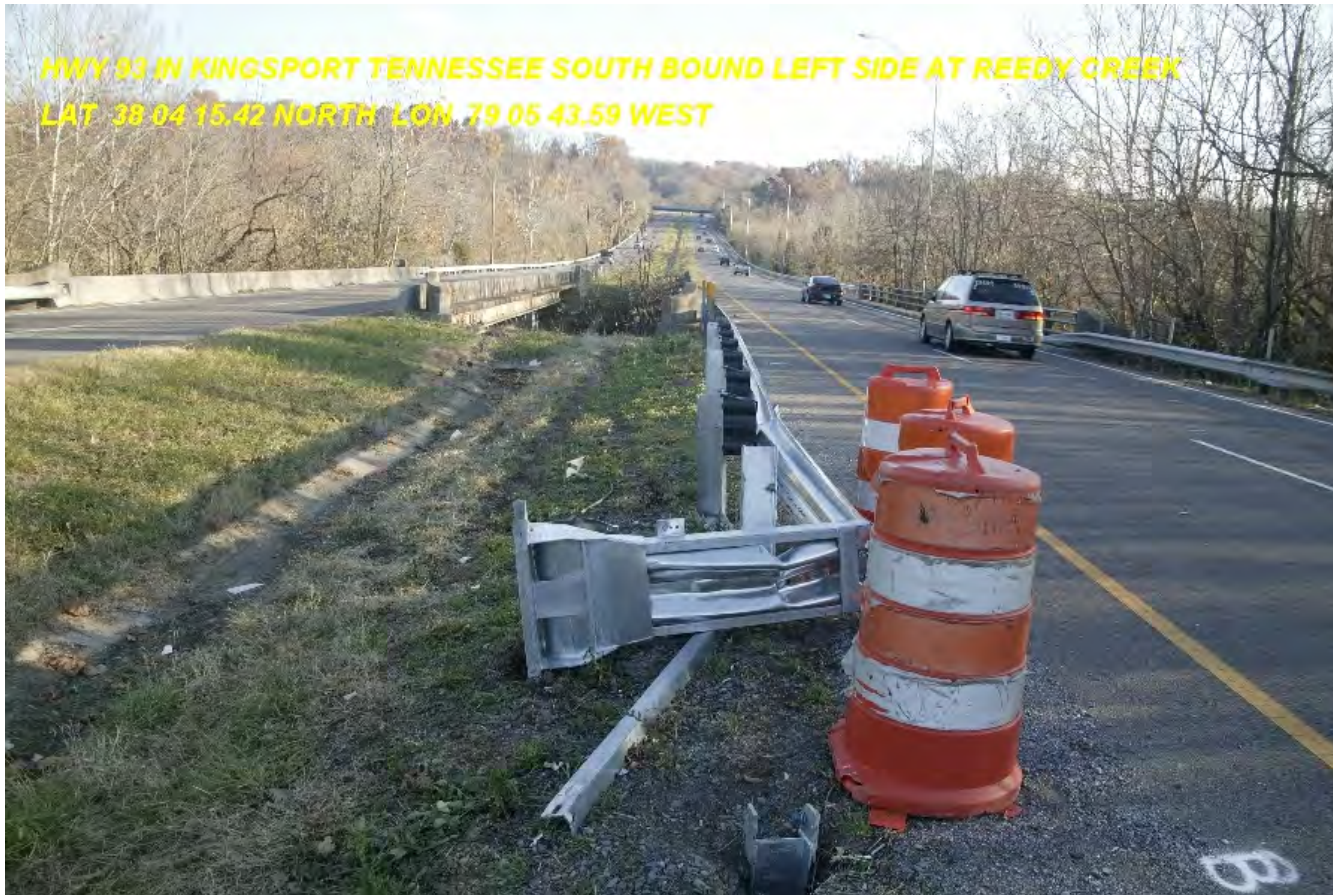
Guardrail compression in feeder chute of throat locked head.

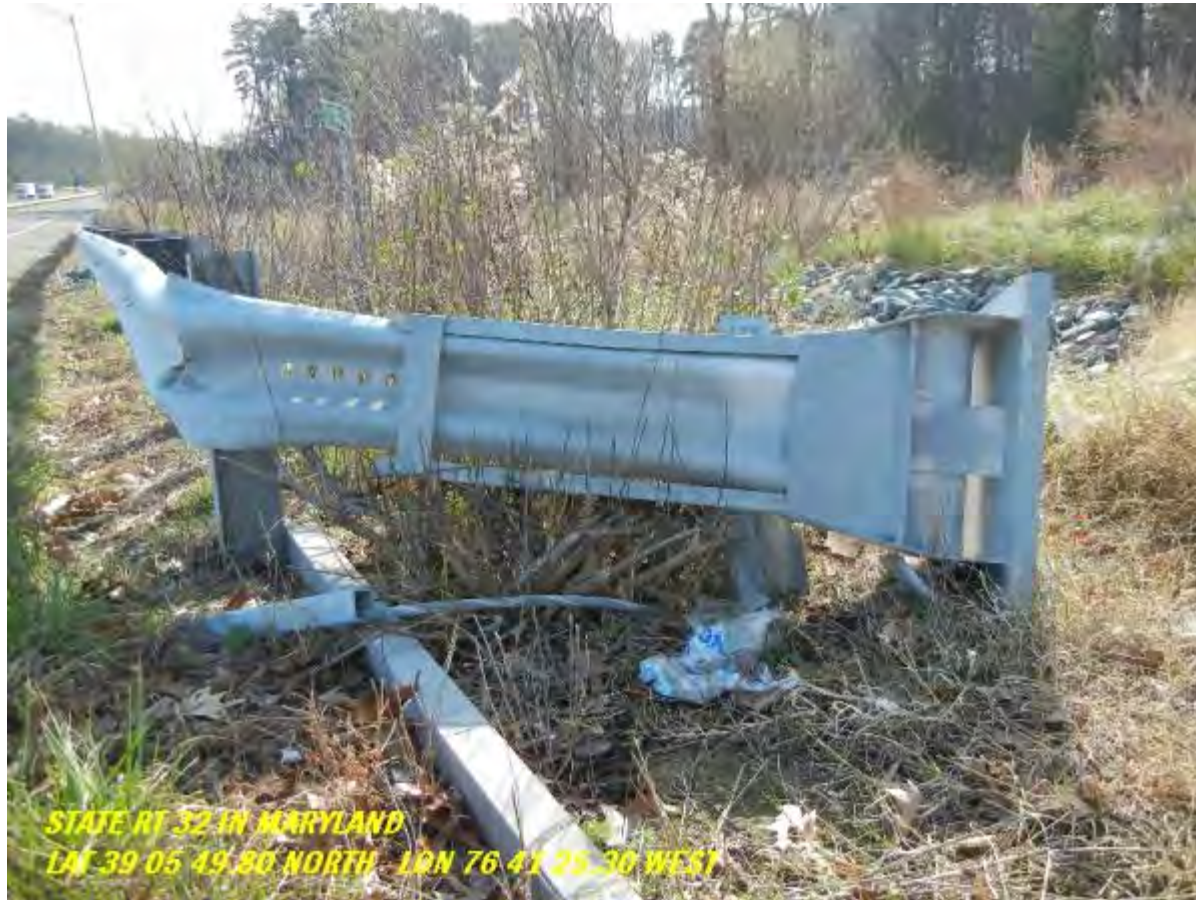
Guardrail bulge in feeder chute of throat locked head.

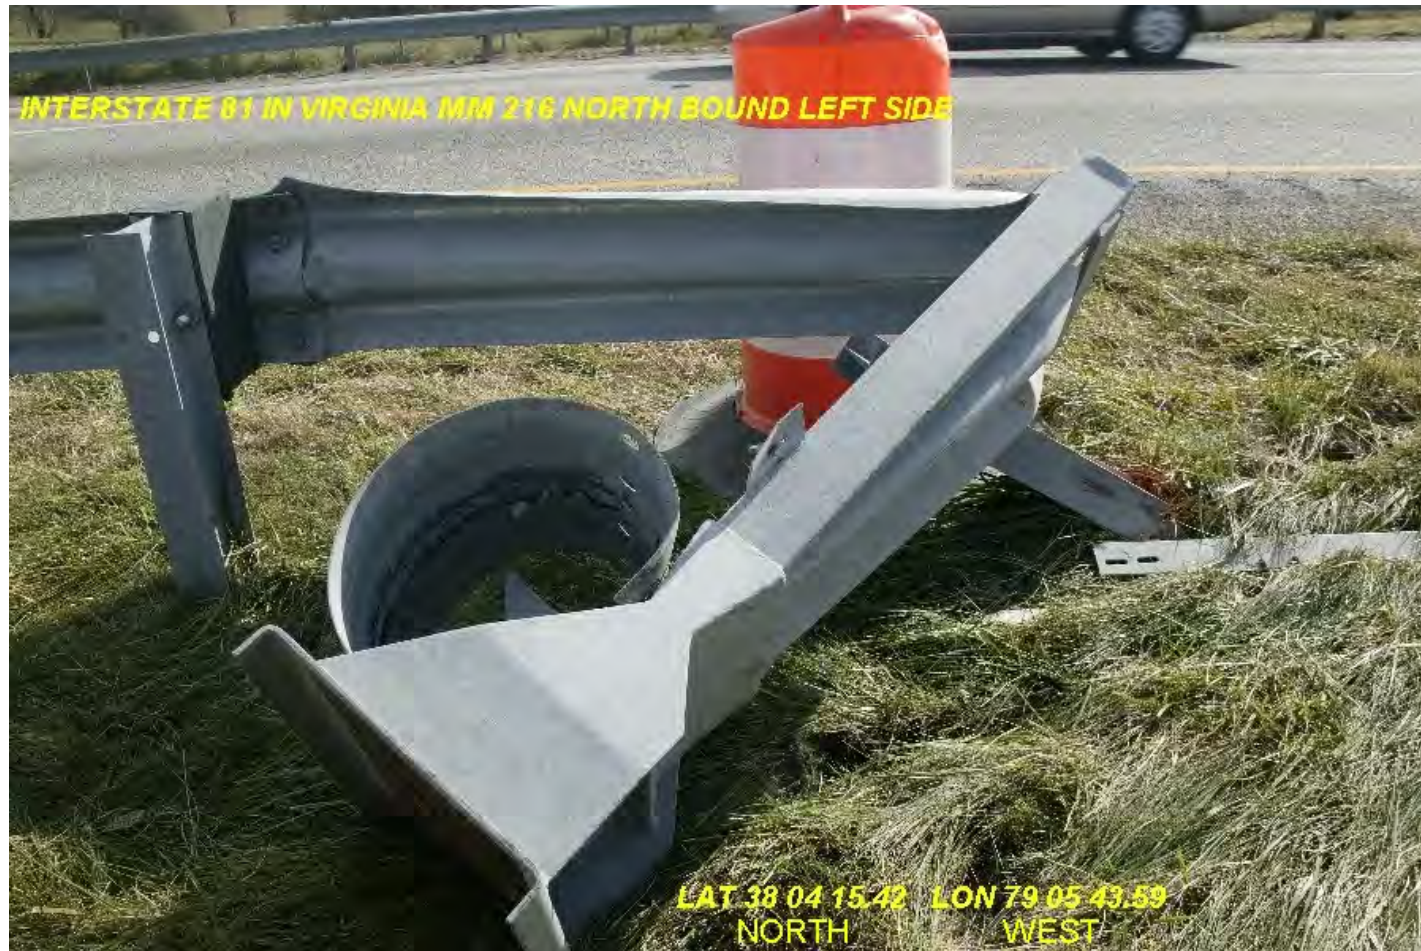
Kinking guardrail at splice because of throat locked head.

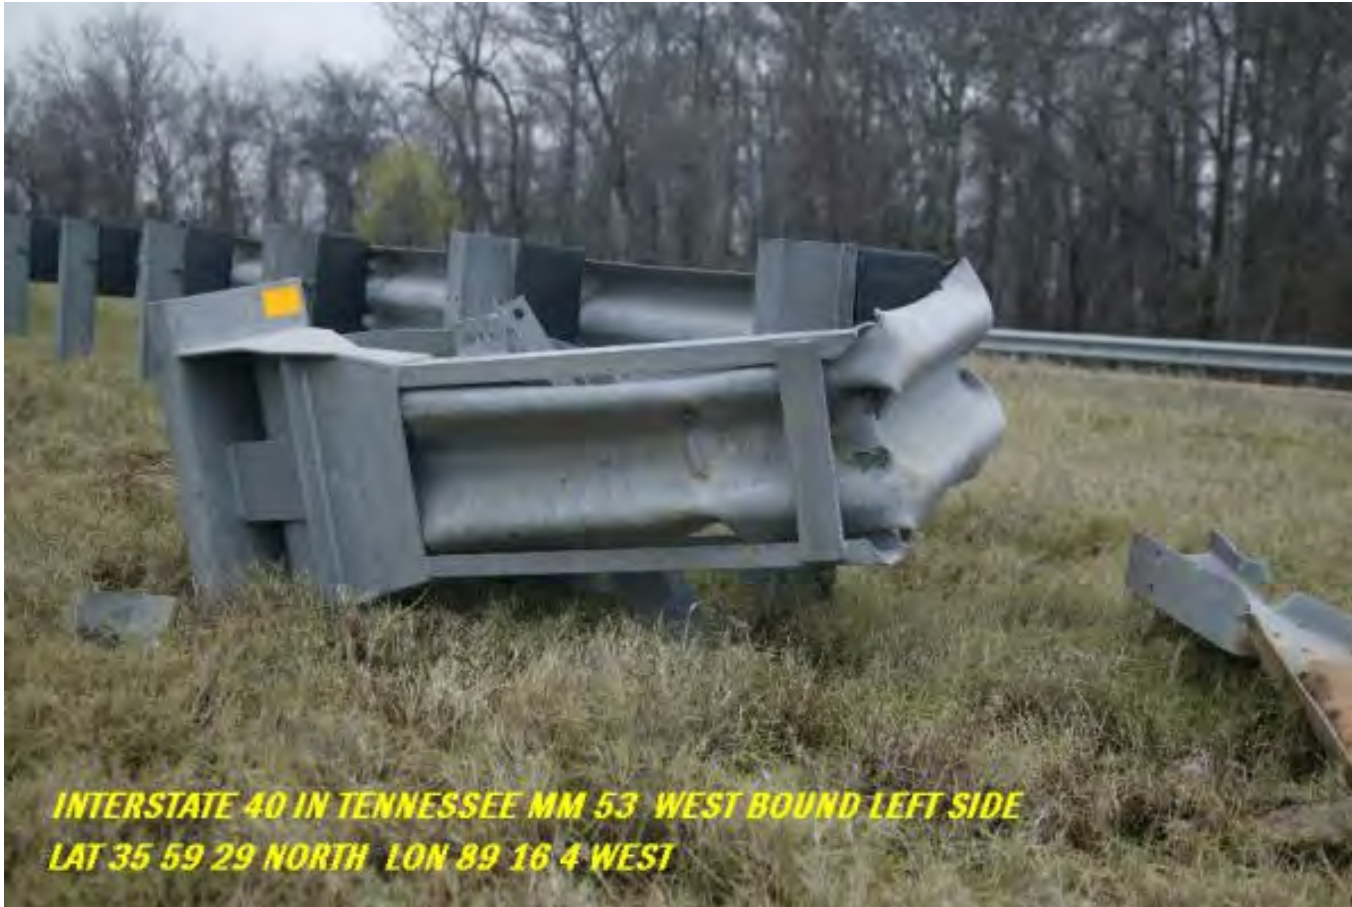
Guardrail compression in feeder chute of throat locked head.

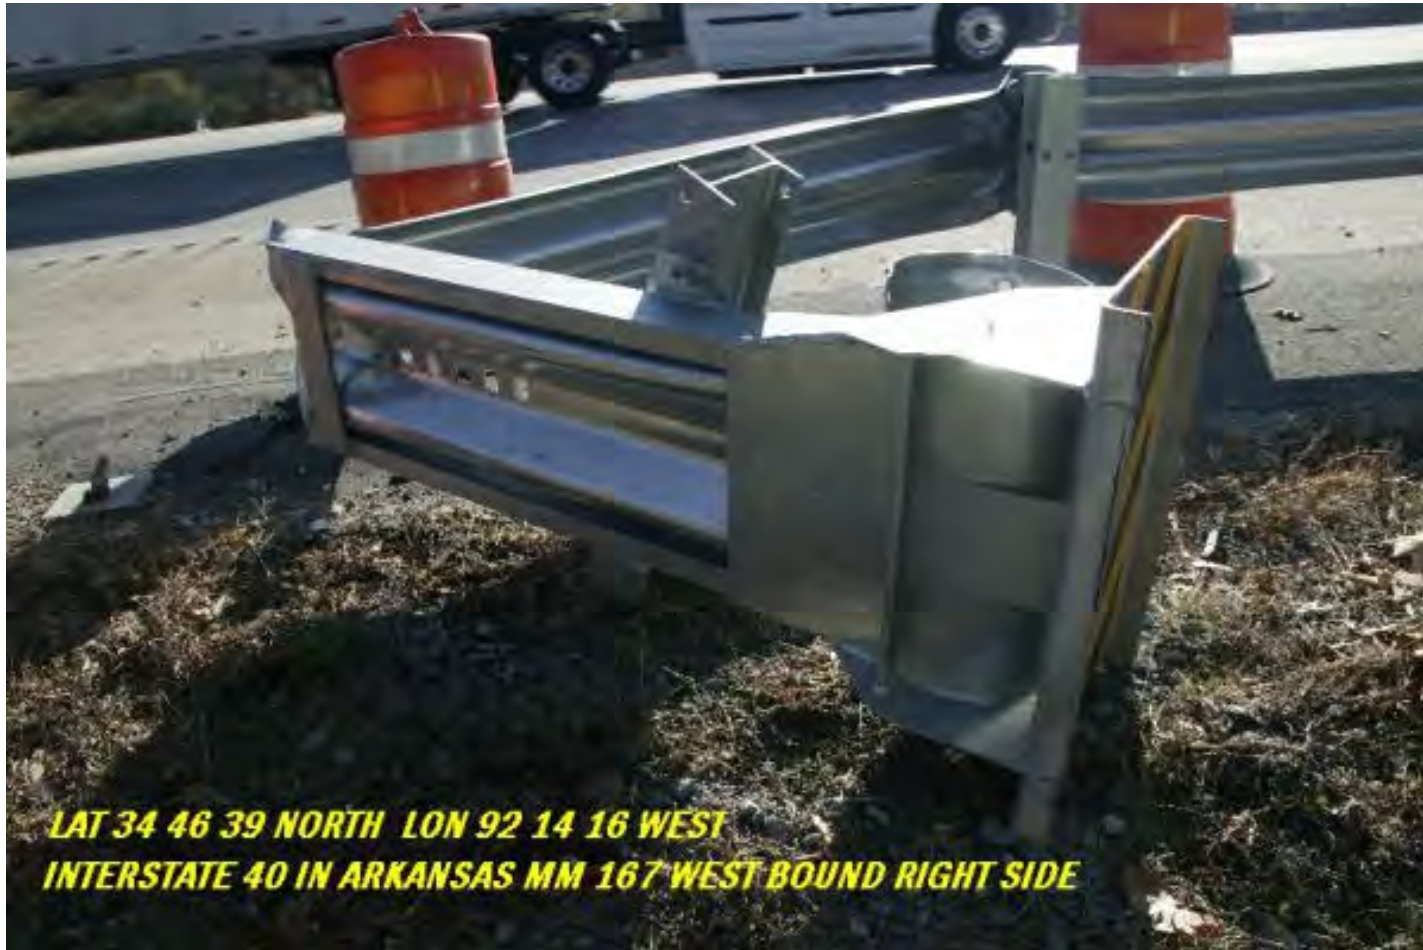
Remnants of plume outside in the feeder chute.

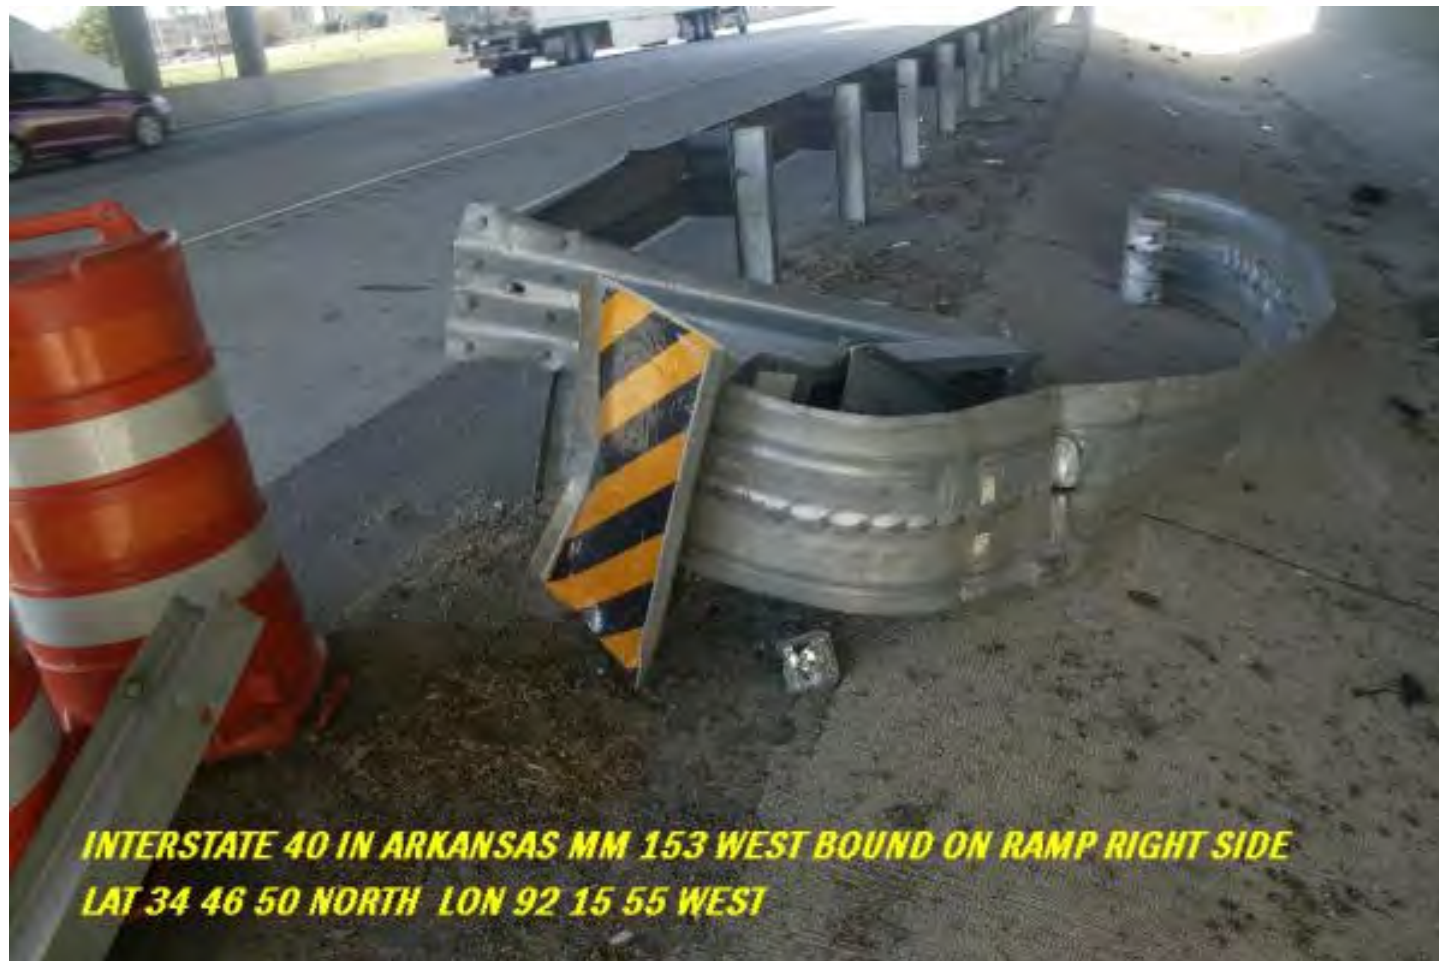
Ran a good bit but...

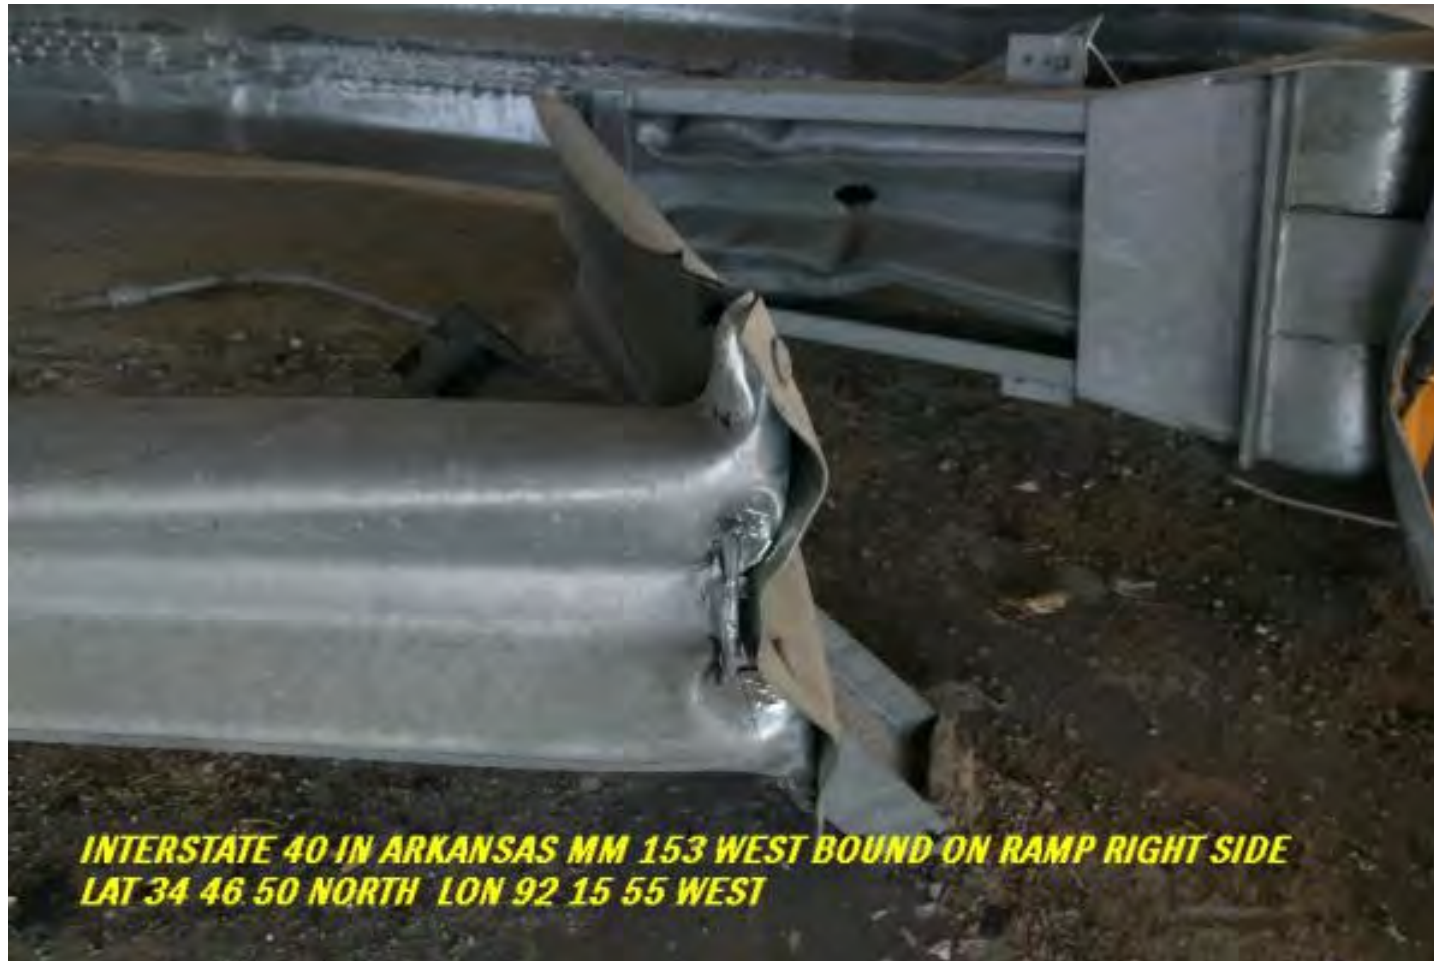
...guardrail still throat locked in the extruder throat.
