## Connecticut Department of Transportation

### Climate Change and Extreme Weather Vulnerability Pilot Project

Final Report December 2014

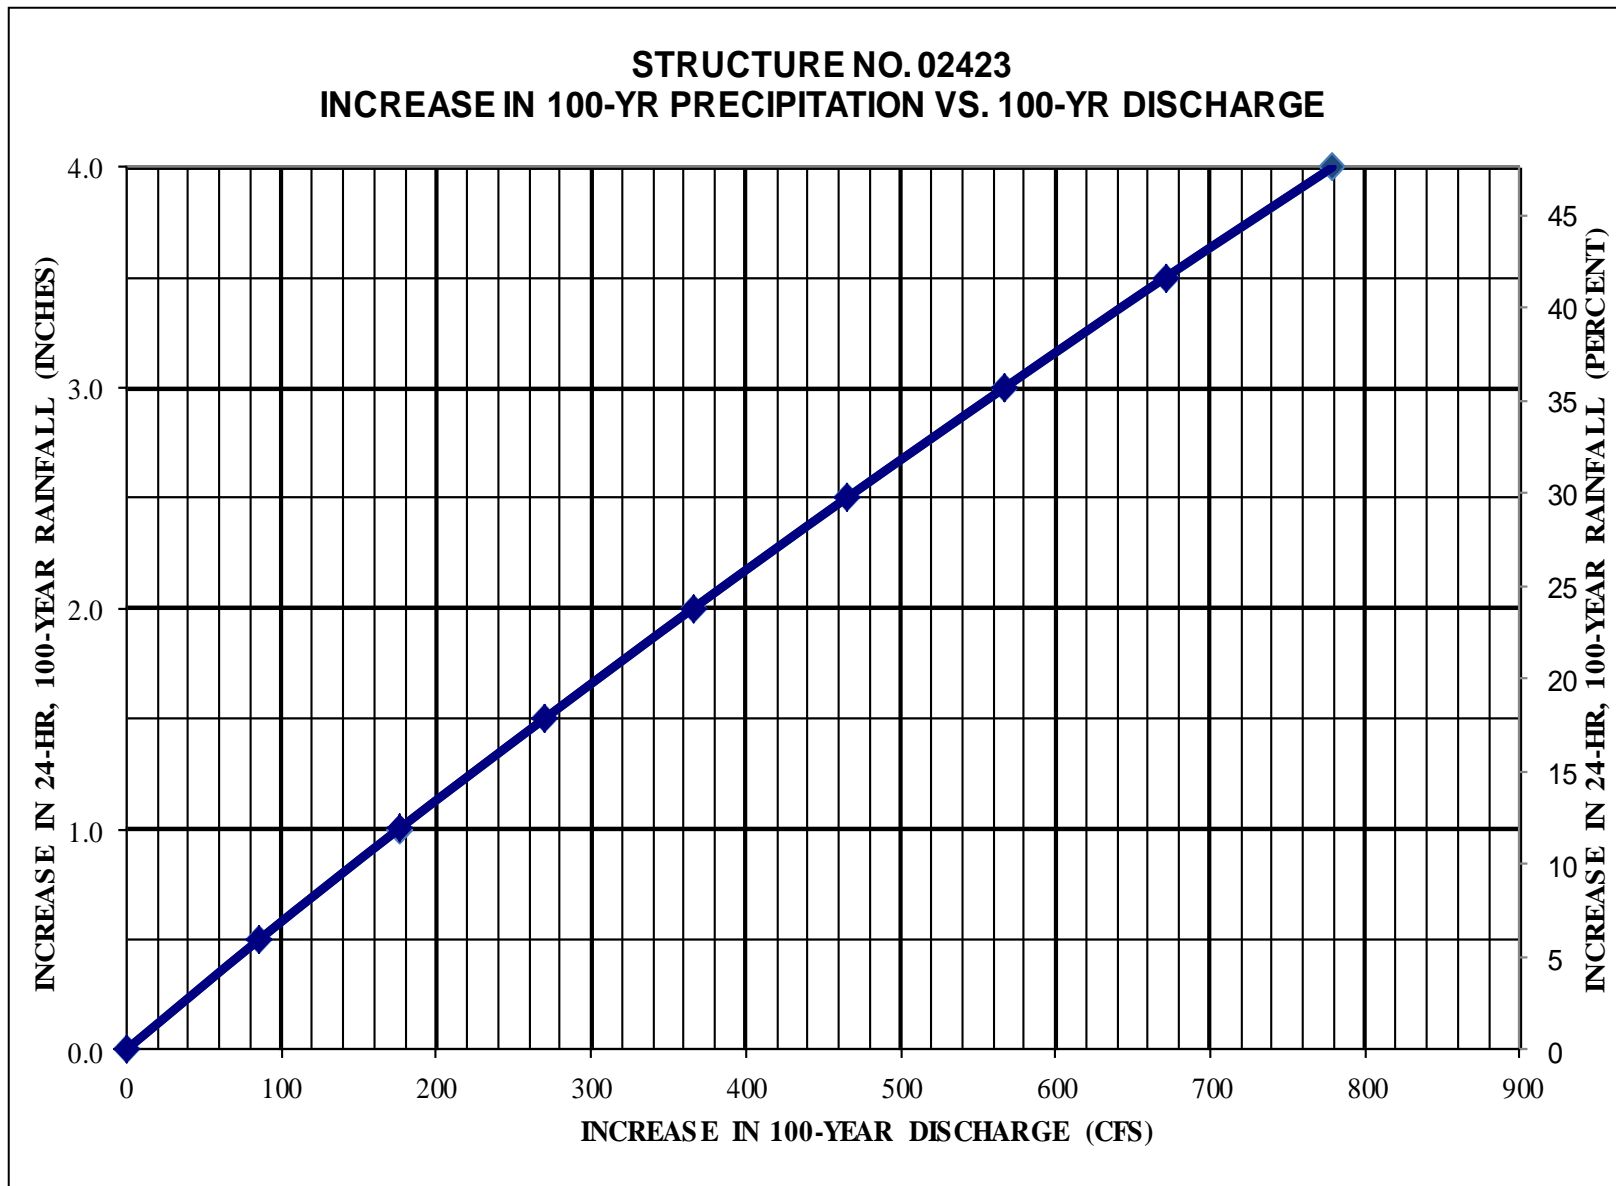
Figure 4 - Increase in 100-Yr (Design) Discharge vs. Increase in 100-Yr Precipitation for Structure No. 02423

The sensitivity of the design discharge estimates was examined based on changes in the precipitation parameter. For each structure, a graph was prepared showing how the design discharge would increase based on varying increases in the precipitation parameter. An example of one of these graphs is shown in **Figure 4**, which is a plot of the increase in the 100-year precipitation versus the increase in the 100-year discharge for Structure No. 02423.

The peak discharge estimates for Structure No. 02423 were determined using StreamStats. Structure No. 02423 is classified as an Intermediate Structure; therefore, the design discharge for the structure is the 100-year discharge, which was estimated as 881 cubic feet per second (cfs), based on a 24-hour, 100-year precipitation of 8.4 inches. To illustrate the use of the graph, **Figure 4a** has been annotated showing a 2-inch or approximately 24 percent increase in 100-year precipitation. This increase in precipitation would increase the discharge estimate by 366-cfs from 881cfs to 1,247-cfs, a 41.5 percent increase in peak discharge.

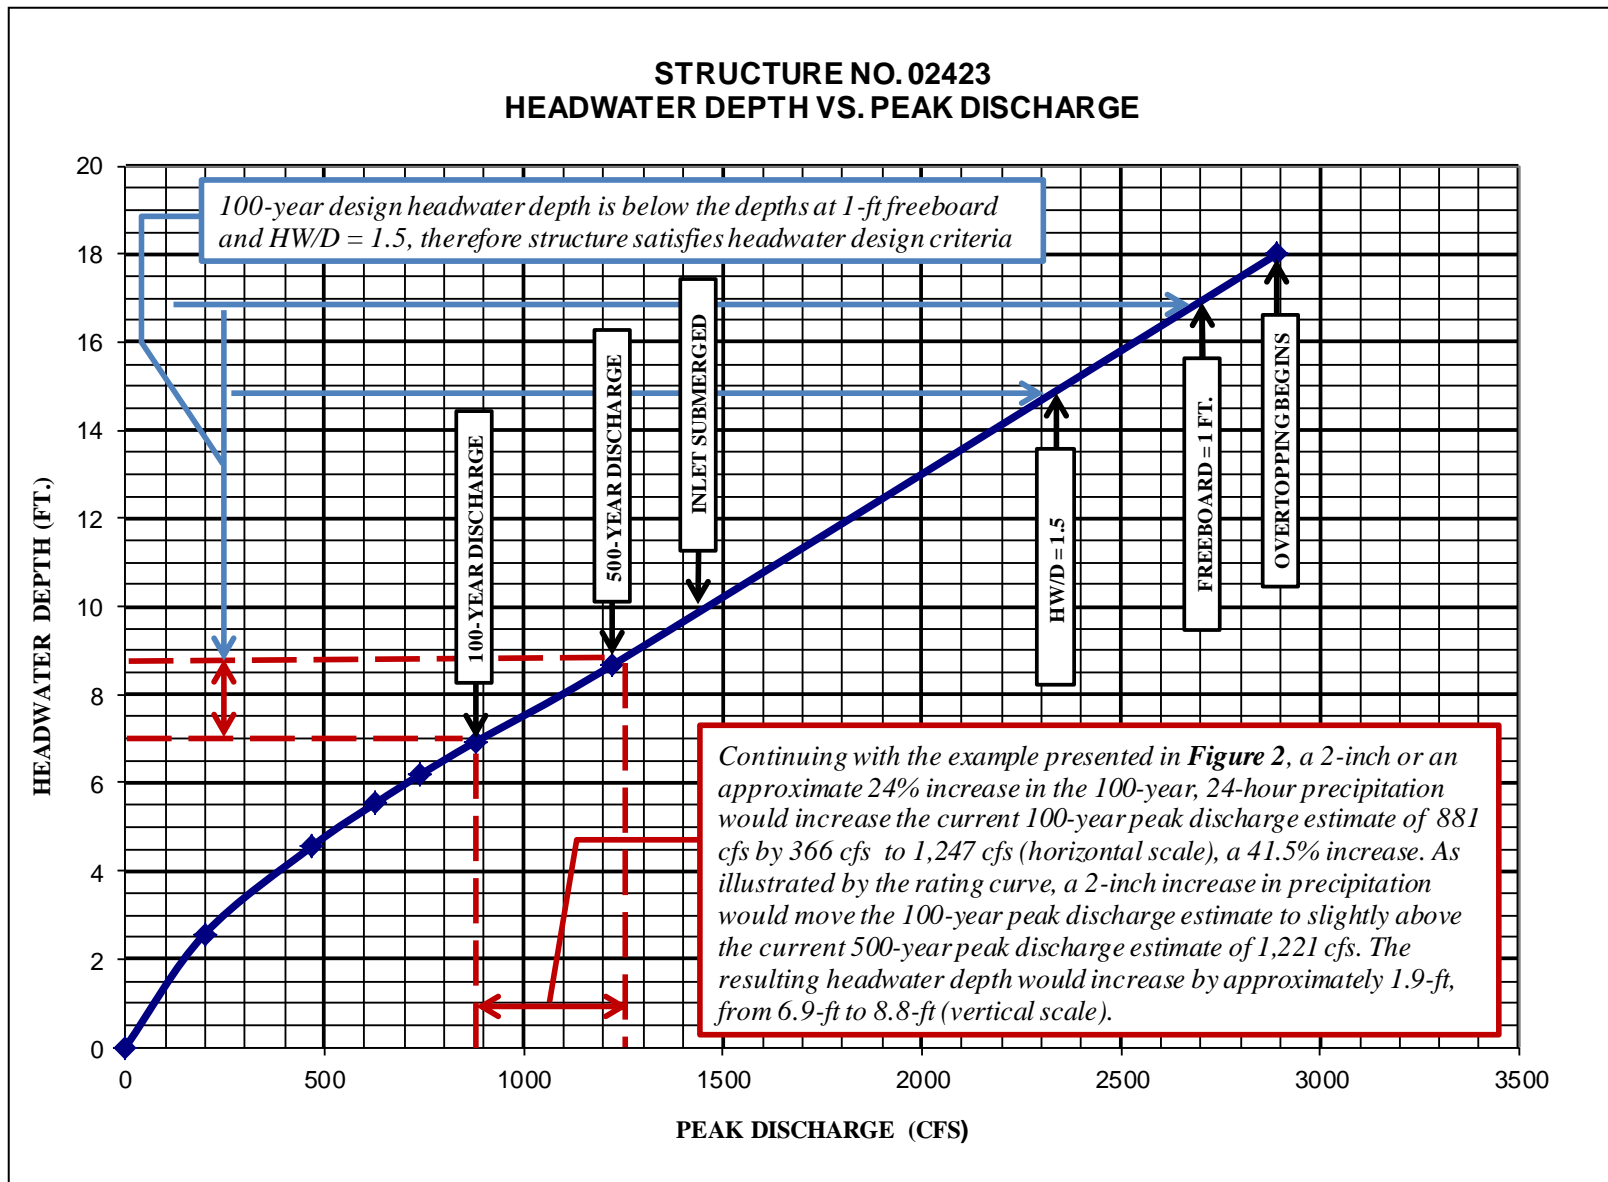
Figure 5a - Headwater Depth vs. Peak Discharge for Structure No. 02423

**Figure 5a** is an annotated plot of the Headwater Depth versus Peak Discharge for Structure No. 02423. Continuing with the example presented in **Figure 4a**, a 2-inch or an approximate 24% increase in the 100-year, 24-hour precipitation would increase the current 100-year peak discharge estimate of 881-cfs by 366-cfs to 1,247-cfs (horizontal scale), a 41.5% increase in peak discharge. As illustrated by the rating curve, a 2-inch increase in precipitation would move the 100-year peak discharge estimate slightly above the current 500-year peak discharge estimate of 1,221-cfs. The resulting headwater depth would increase by approximately 1.9 feet, from 6.9 feet to 8.8 feet (vertical scale).

**Figure 6a** is an annotated plot of the Outlet Velocity versus Peak Discharge for Structure No. 02423. Continuing with the example presented in **Figures 4a** and **5a**, a 2-inch increase in the 100-year, 24-hour precipitation would increase the current 100-year peak discharge estimate as noted above. Using the rating curve, the resulting outlet velocity would increase by approximately 1.4-fps, from 18.8-fps at 881-cfs to 20.2-fps at 1,247-cfs, a 13% increase in velocity.

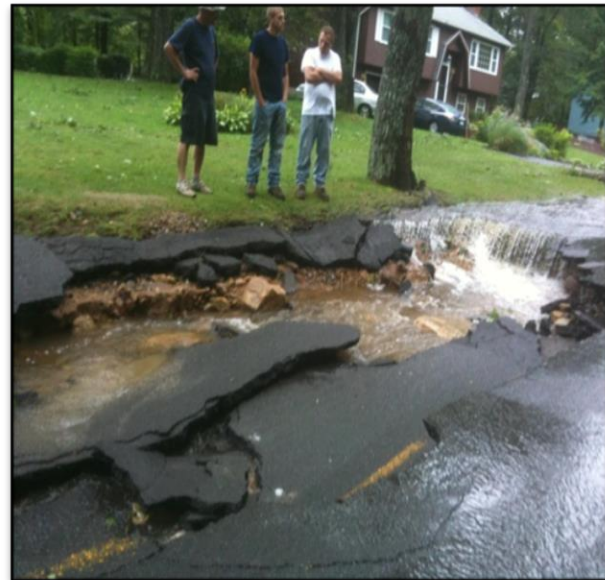
Figure 7 - Damage from Hurricane Irene, Bemis Street, Plymouth  
Copyright: Foothills Media Group

The Litchfield Hills region of Connecticut has been hit by intense storms in the past few years that have cost the state and municipalities millions of dollars in emergency repair and replacement costs. In late August of 2011, Tropical Storm Irene highlighted the vulnerability of transportation system assets to the effects of heavy rains and high winds. In Connecticut, bridges were closed, roads failed, and Metro North service was halted for nearly a week. Debris cluttered roads throughout the state, rendering many roads, including the Merritt and Wilbur Cross parkways, impassable for significant periods. Similar damage to the transportation infrastructure in New York

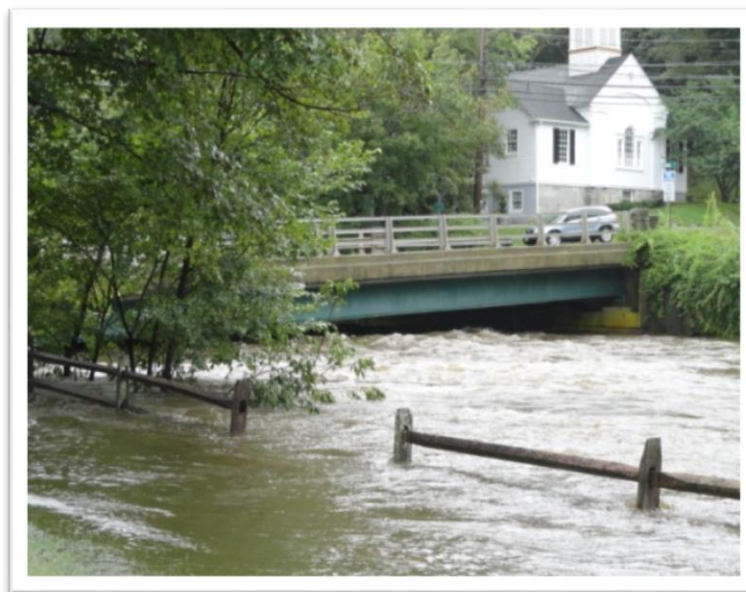
Figure 11 – Flood waters rush under a bridge in Washington, CT  
Copyright: Washington Ambulance

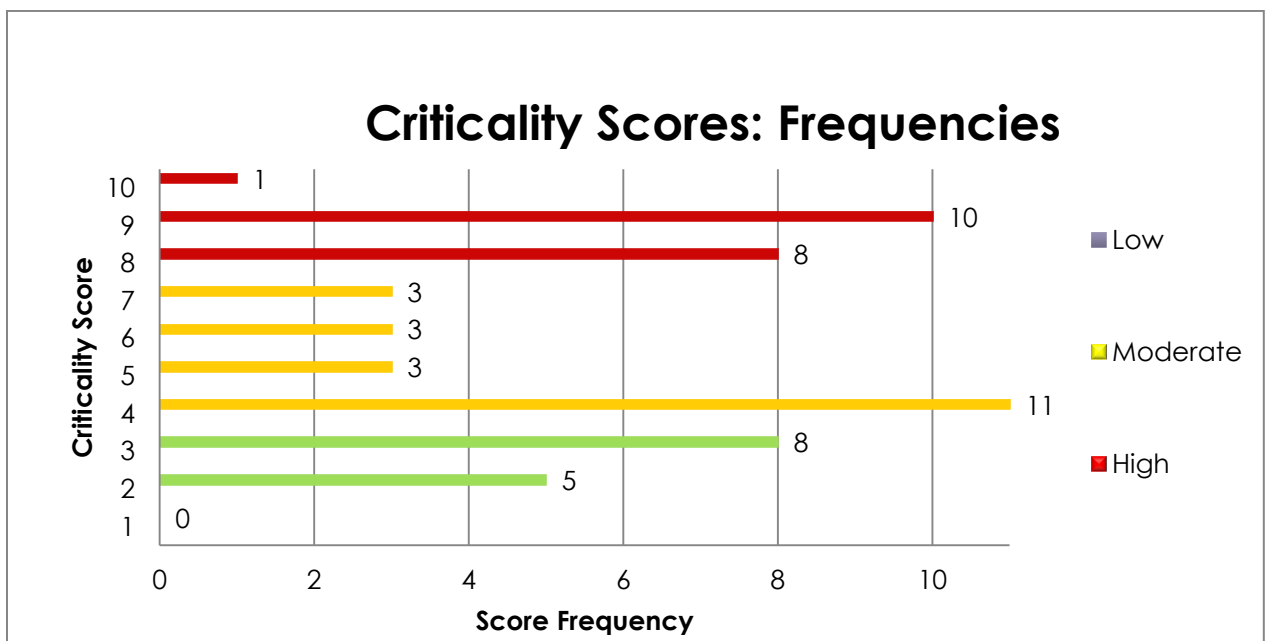
Figure 11- Frequency of Criticality Scores

Compiling and visualizing each piece of the criticality analysis was an organizational necessity. Each structure and the data points for the matrix factors were inputted into an Excel spreadsheet, and color coded based on their relative values. This made it easier to see how each structure compares to all the others. It also assisted in keeping track of study changes, such as structure deletions or additions. The bulk of the structures, 20, were rated moderately critical, while 19 structures were rated Critical or Very Critical- see **Figure 11**. The recommendations and findings, particularly as they relate to Critical structures, are discussed in the next chapter.
