### RE: NOTICE OF PROBABLE VIOLATION AND PROPOSED CIVIL PENALTY CPF No. 1-2013-5018

### PHMSA allegation #1

## Kinder Morgan's response to allegation #1

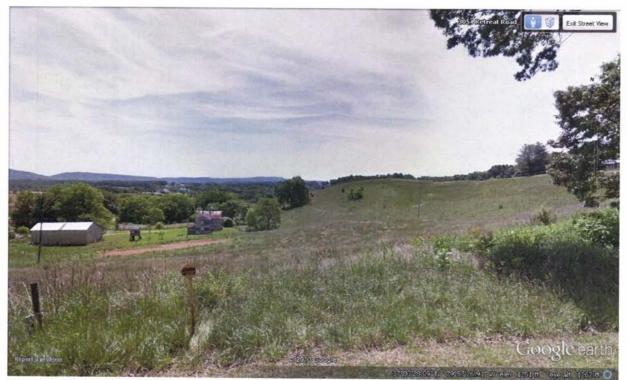
Figure No.1

8RK pipeline crossing at Retreat Road-Google Earth Street View Imagery (dated May 2012), demonstrating pipeline marker at road crossing as required by 49 CFR Part 195.410 Mr. Byron Coy, PE P a g e | **4** September 17, 2013

PHMSA alleges "PPL's Roanoke pipeline did not have a sufficient number of line markers to accurately know the buried pipeline location <u>near public road crossings</u>" (emphasis added). However, both the pipeline road crossing at Retreat Road and Crooked Oak Road had pipeline markers located "<u>at each public road crossing</u>" (emphasis added) as required by regulation 49 CFR Part 195.410. See Figures No. 1 and No.2 as visual evidence of pipeline markers "<u>at each</u> <u>public road crossing</u>" (emphasis added) as required by regulation 49 CFR Part 195.410. Although a photograph of the road crossing at Retreat Road was not taken on the day of the inspection, Figure No. 1 is satellite imagery from Google Earth showing what one of the two road crossing markers looked like on the day of the inspection. The imagery date for the Google Earth Street View is May of 2012 (4 months prior to inspection). Figure No. 2 is a photograph taken the day of the inspection at Crooked Oak Road and shows markers at the road crossing and at the nearby valve site.

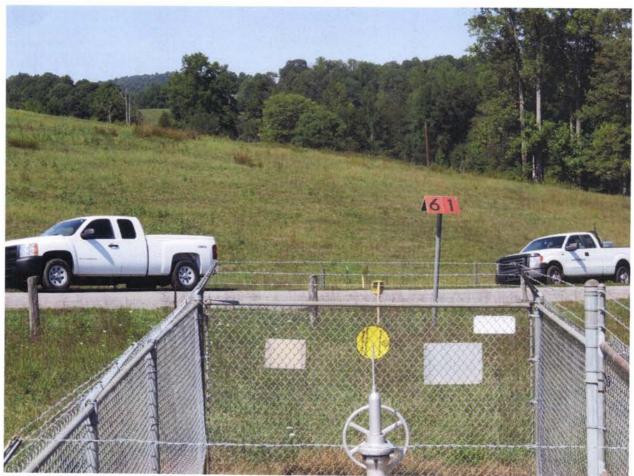
Figure No. 2

8RK pipeline crossing at Crooked Oak Road-Photo taken the day of inspection, demonstrating pipeline markers at road crossing as required by 49 CFR Part 195.410

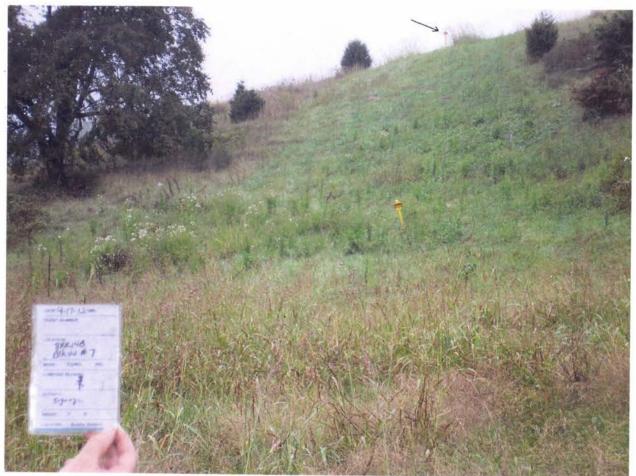
8RK pipeline at Retreat Road-Showing pipeline marker in place (300 ft downstream) and observed the day of the inspection and the pipeline marker which was re-installed (arrow)

Additionally, even though it was not mentioned in your Notice to Kinder Morgan, the crest on the pasture hill at Retreat Road which the VA SCC inspector had a concern, did have another pipeline marker visually present approximately 300 feet downstream of the crest (between the road and the crest of the hill). The marker seen during the inspection and the marker installed at the crest of the hill are shown in Figure No. 3. The arrow in Figure No. 3 shows the marker that was not seen during the inspection and subsequently installed. It should be noted that the marker with the arrow in Figure No. 3 replaced a marker, which had been knocked down in the brush next to it from farming activities conducted in the pasture. The downed line marker was Mr. Byron Coy, PE P a g e | **3** September 17, 2013

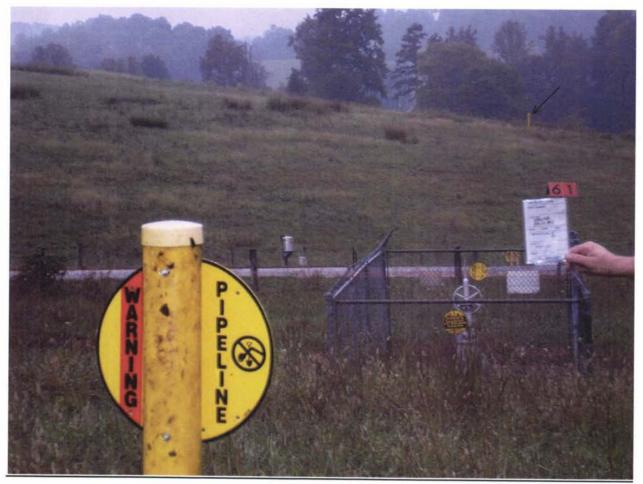
Figure No. 4 8RK pipeline at Crooked Oak Road shows numerous pipeline markers present on day of inspection and the pipeline marker added (arrow)

discovered in the brush by the Kinder Morgan employee immediately after he installed the new line marker. Figure No. 4 illustrates the added pipeline marker with the arrow and the numerous pipeline markers that were already in place at the Crooked Oak Road location.

The addition of the pipeline marker at Crooked Oak Road was a "good faith" effort by PPL to demonstrate its commitment to addressing concerns raised by inspectors during an inspection and not an admission to non-compliance in this matter. Based on the photographic evidence demonstrating a sufficient number of pipeline markers and additional clarifying statements presented, Kinder Morgan requests that PHMSA withdraw the NOPV for 49 CFR Part §195.410 concerning the pipeline locations at Retreat Road and Crooked Oak Road.

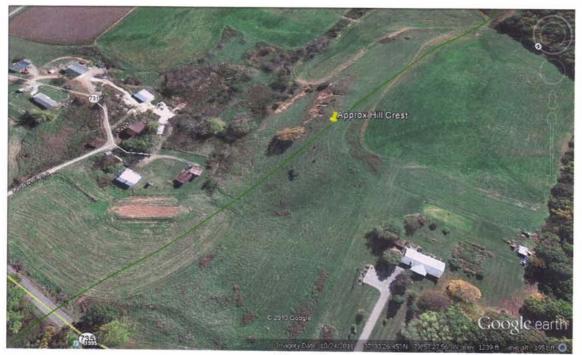
Figure No. 5 8RK pipeline crossing mowed pasture at Retreat Road

PHMSA states in its Notice that the pastures were "uncultivated". However, this does not mean that the pastures were "unused" or not maintained as demonstrated in Google Earth Imagery (see Figure Nos. 5 and 6); these pastures appear to be mowed with heavy equipment. The Google Earth imagery date for these figures is 10/24/2011. Both pipeline marker locations are in the path of heavy mowing/farming equipment. As you can deduce from these figures, it is extremely difficult to maintain pipeline markers when subject to heavy mowing equipment as on these two pastures. As mentioned previously, the pipeline marker in question at the Retreat Road location had been knocked down by the mowing conducted at the pasture.

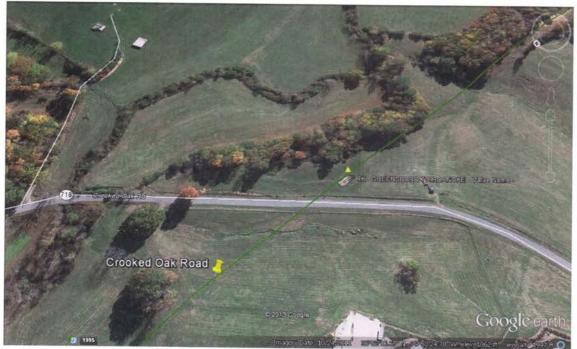
Figure No. 6 8RK pipeline crossing mowed pasture at Crooked Oak Road

Additionally, PPL has encountered problems with pipeline markers at the pasture at Crooked Oak Road due to cows chewing the plastic pipeline markers. Mr. Byron Coy, PE P a g e | **7** September 17, 2013
