Vehicle Assist and Automation (VAA) Demonstration Evaluation Report

FTA Report No. 0093
Federal Transit Administration

Rob Gregg and
Brian Pessaro, AICP
National Bus
Rapid Transit Institute

13. ABSTRACT This report summarizes an evaluation of a vehicle assist and automation (VAA) system used by Lane Transit District in Eugene, Oregon, for its Emerald Express (EmX) Bus Rapid Transit (BRT). The 1.5-mile demonstration involved the use of magnetic sensors for precision docking at three stations and lane guidance between the stations. The VAA system was evaluated in six broad areas: bus driver satisfaction, customer satisfaction, efficiency/productivity, technical performance, maintenance, and safety. Data were collected from a variety of sources, including customer surveys, driver surveys and focus groups, accident reports, maintenance reports, and lane position data from the VAA on-board computer system. Key findings indicated that the VAA system kept the bus better centered in the busway while it was in motion, and it consistently docked the bus closer to the station platform. The VAA was widely praised by the bus operators and passengers for its precision docking at the station p

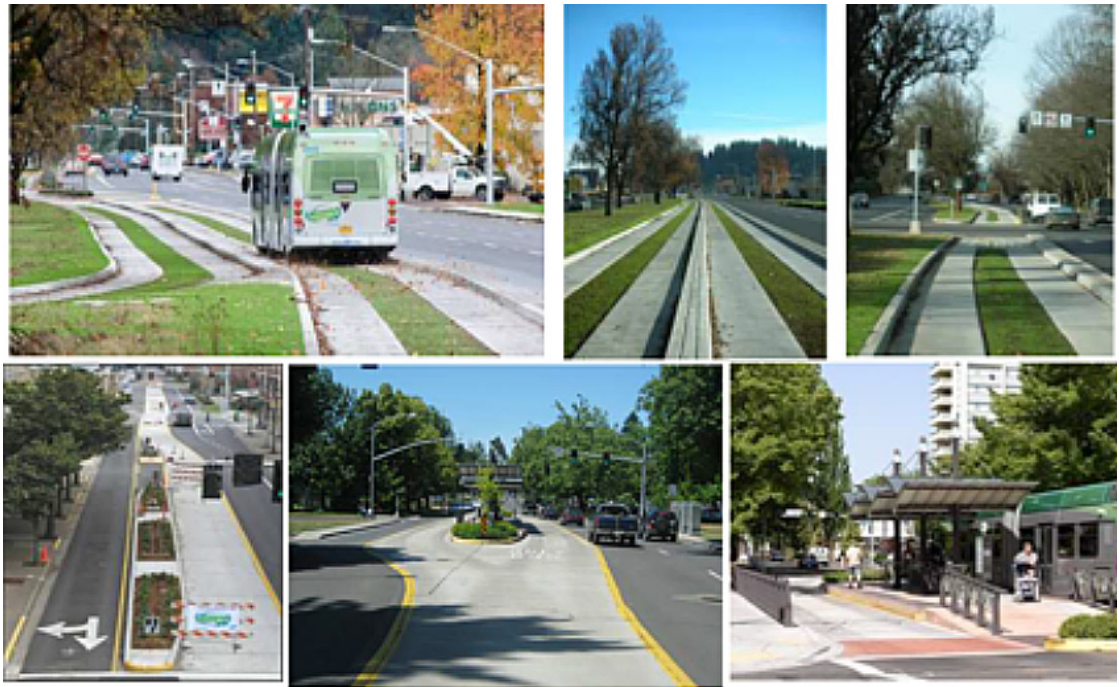
Figure 1-1
EmX route configurations

The EmX is an 11.8-mile BRT system that began service in 2007 as a 4-mile east-west route between downtown Eugene and downtown Springfield. In 2011, the 7.8-mile Gateway Extension opened, which runs north-south on Pioneer Parkway from the Springfield Station and provides service to the Gateway Mall and Sacred Heart Medical Center (see EmX route map in Appendix A.) The EmX was an ideal choice for the VAA demonstration from both technical and operational standpoints because it uses 60-foot articulated buses and the route has multiple lane types/alignments and curves, as illustrated in Figure I-1.

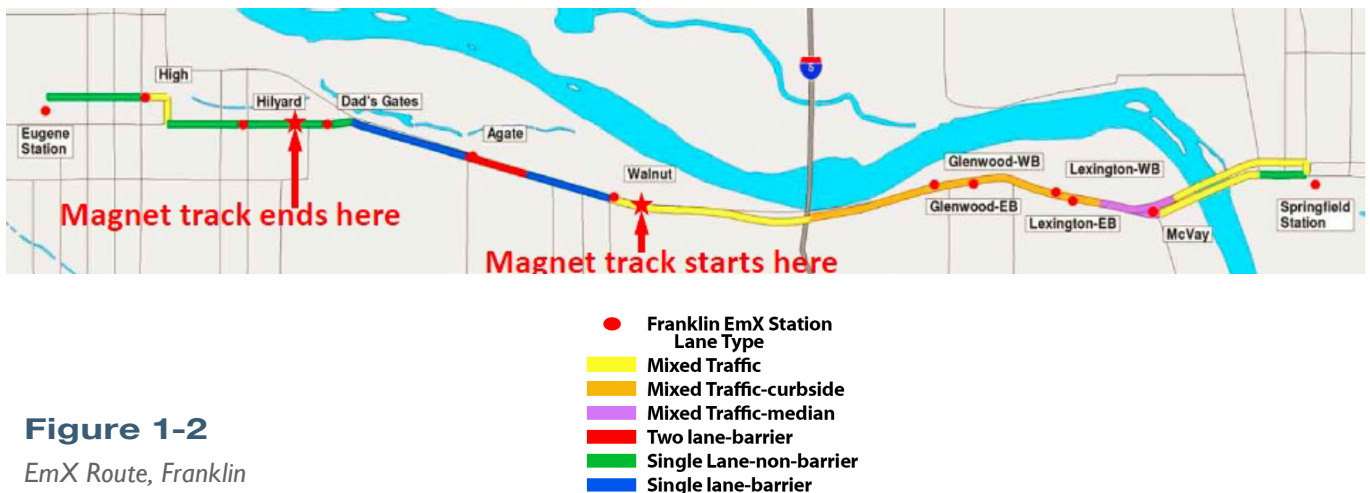
Figure 1-2
EmX Route, Franklin

The original plan was to demonstrate the VAA on the 4-mile length between downtown Eugene and downtown Springfield, which included 10 stations. Because costs were greater than originally projected, the project limits were reduced to a 1.5-mile test segment and 3 stations. Figure 1-2 shows a map of the original EmX route with the various lane types/alignments, and Figure 1-3 is a map of the test segment and the three stations (Dad's Gate, Agate, and Walnut).

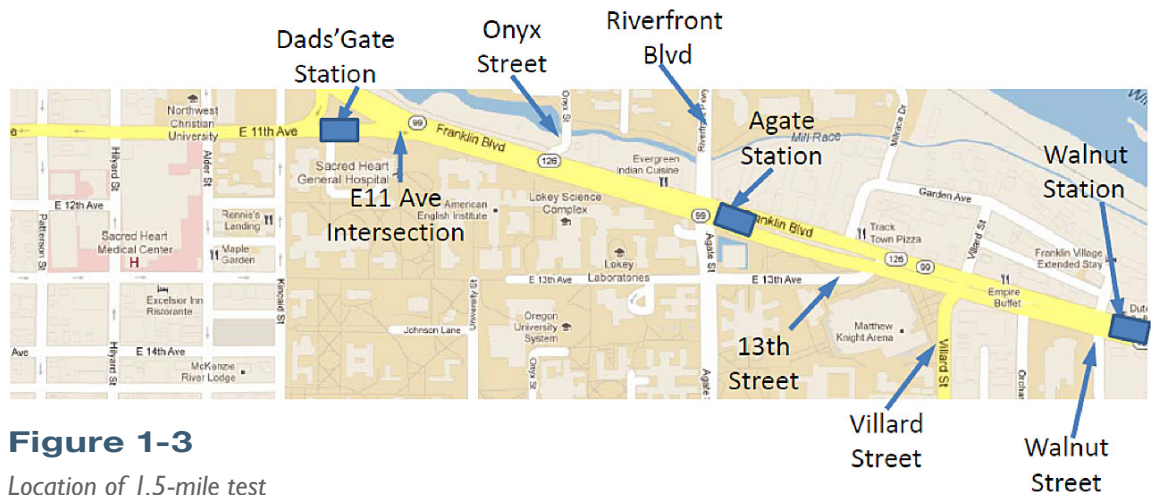
Figure 1-3

Location of 1.5-mile test

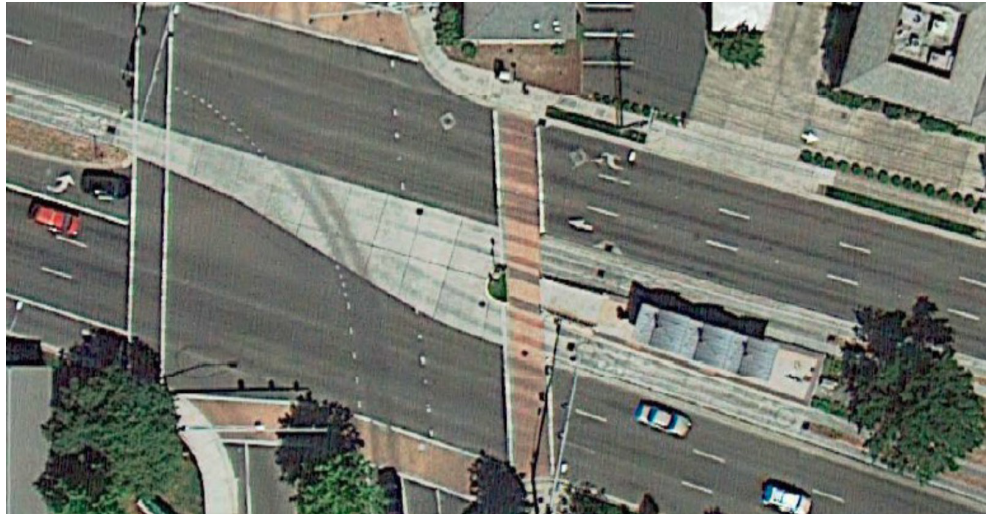
Figure 1-4

Dad's Gate

As noted, the EmX corridor in general is very curvy; the test segment includes 36 curves (19 in the westbound direction and 17 in the eastbound direction). Of those 36 curves, 8 have a radius of less than 100 meters. The eastbound approaches to Agate Station and Walnut Station require multiple lane changes within short distances. Aerial photos of the three stations are shown in Figures 1-4, 1-5, and 1-6.

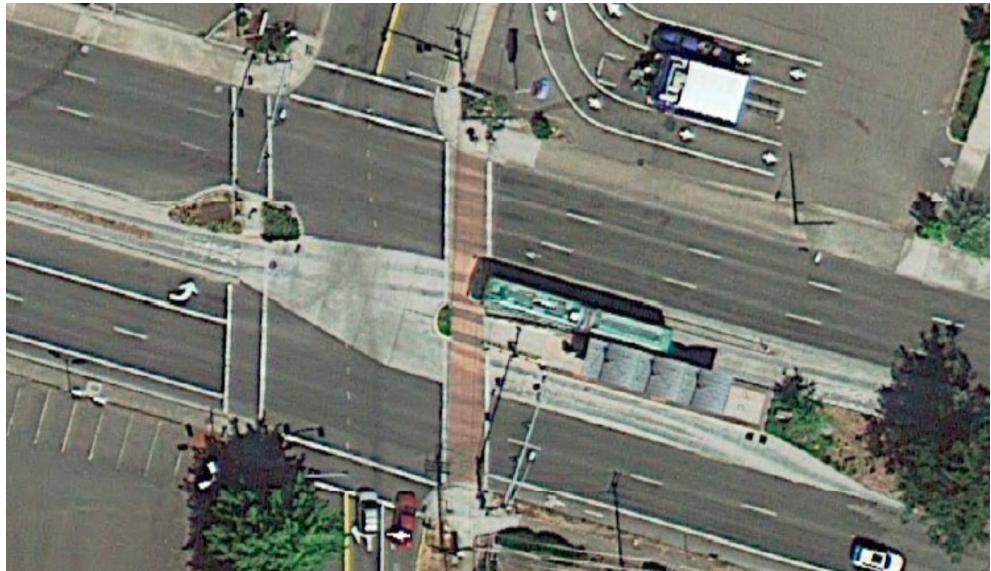
Figure 1-5

Agate Station

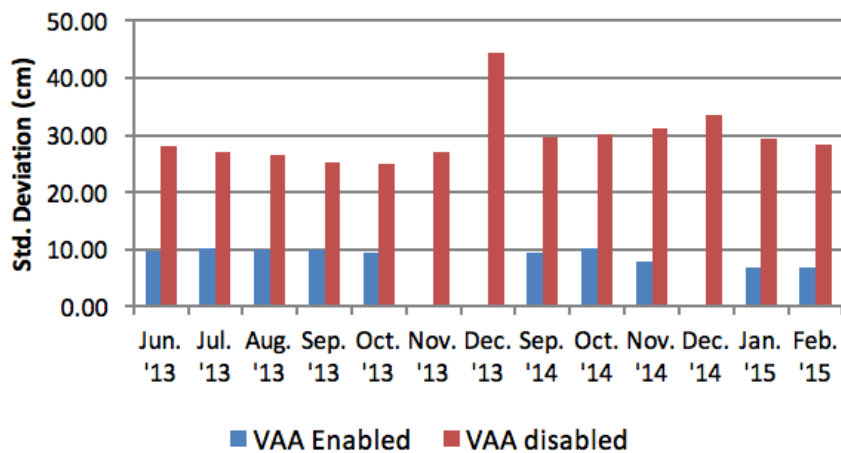
Figure 8-2

Lateral deviation from center line (eastbound)

Note: No VAA-enabled data were collected in November or December 2013 or December 2014.

The VAA performed exceptionally well at keeping the bus centered on the eastbound approach to Agate Station. This segment is identified in Figure 8 2 as (EB) Riverfront Blvd. to Agate Station. Here, the bus had to make more than 2 lane changes within 223 feet. (An aerial photo of Agate Station is shown in Figure 1 5.) Without the VAA, the bus deviated from lane center by as much as 33.08 cm. With the VAA enabled, the maximum deviation was 8.33 cm. Another segment in which the VAA performed exceptionally well at keeping the bus centered was 11th Avenue to Onyx Street in the eastbound direction. This segment includes a sharp turn to the right as the bus leaves 11th Avenue and returns to Franklin Blvd. Without the VAA enabled, the bus deviated from the center line by as much as 23.63 cm. With the VAA enabled, the maximum deviation was 8.94 cm.

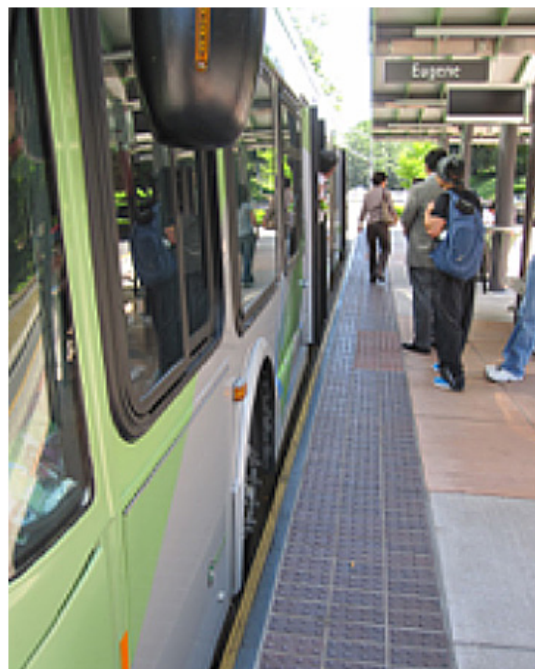
Figure 8-3

A sample photo of the EmX precision docking is shown in Figure 8-3. EmX stations include a yellow polyethylene guide strip along the side of the platform to prevent damage to bus tires. For precision docking, the magnetic track was laid to achieve a target horizontal gap of 4 cm between the vehicle floor and the guide strip. The results for the precision docking at Walnut Station, Agate Station, and Dad's Gate Station are shown in Figures 8-4, 8-5, and 8-6, respectively. These figures show the standard deviation in centimeters from the point in the pavement that the bus needed to be to achieve a 4 cm gap as measured from the front magnetometer. A standard deviation of zero means that the edge of vehicle is exactly 4 cm from the guide strip.

Precision docking

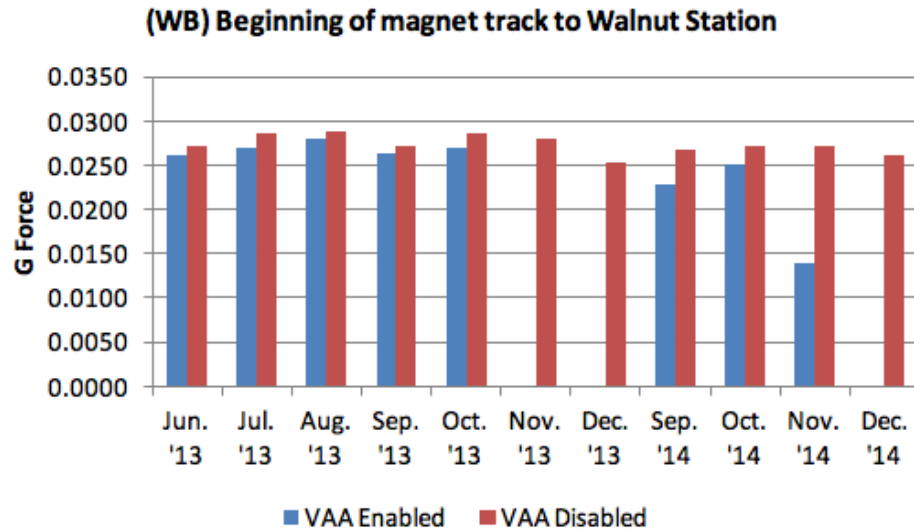
Figure 8-7 (cont.)

*Lateral acceleration
(westbound segments)*

Note: No VAA-enabled data were collected in November or December 2013 or December 2014.
