NIST Technical Note 1785

**Thermal Performance of Self-
Contained Breathing Apparatus
Facepiece Lenses Exposed to Radiant
Heat Flux**

Anthony Putorti Jr
Amy Mensch
Nelson Bryner
Fire Research Division
Engineering Laboratory
National Institute of Standards and Technology
Gaithersburg, MD 20899

February 2013

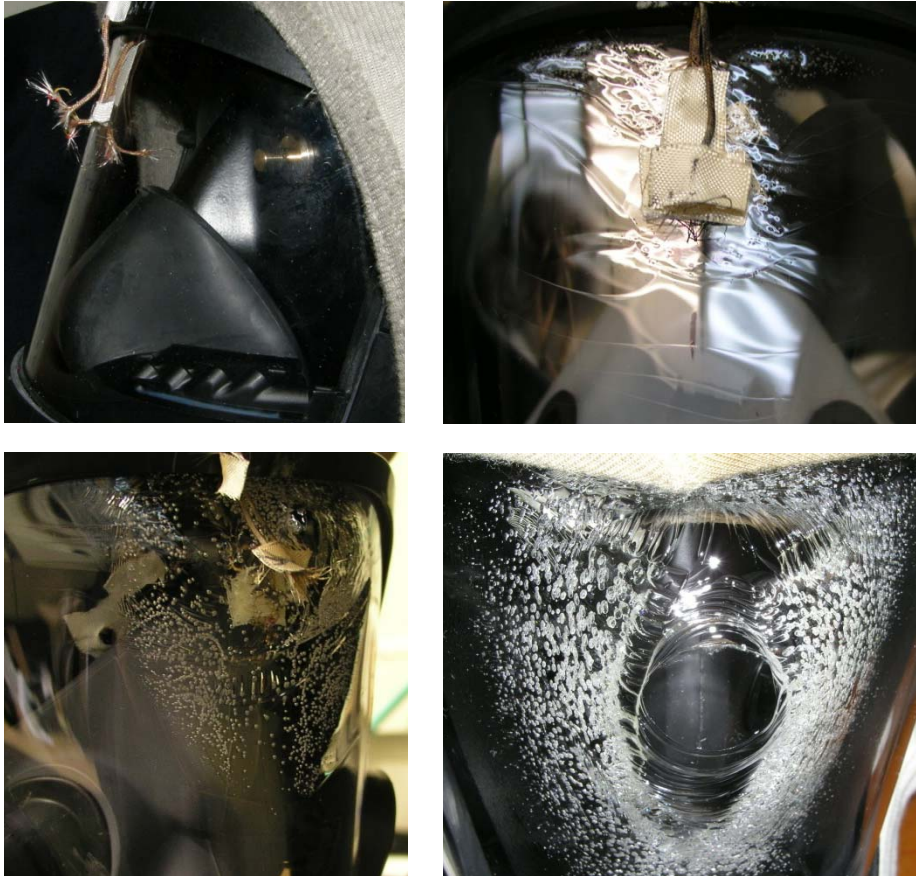
Figure 1 – Photos of example facepiece lenses; pre-exposure with the thermocouples placed on the lens (top left), post-exposure with cracks/crazing (top right), post-exposure with bubbling (bottom left), and post-exposure with deformation causing a hole and bubbling (bottom right).

The experimental data was analyzed to obtain the intensity and duration of exposure associated with cracking/crazing, bubbling, and deformation which compromise facepiece lens integrity. Examples of visibly discernible degrees of thermal degradation are shown in Figure 1. Holes and gaps created by thermal exposure present a threat to the wearer's respiratory protection through a possible drop in facepiece pressure and reduced air cylinder service time. Respiratory protection is compromised if the SCBA cannot maintain a higher facepiece pressure (inside the mask) than the ambient pressure (positive pressure) in the presence of a hole [34] or other deformation. If positive pressure is maintained after hole formation or other deformation induced leakage, the outward leakage causes an additional loss of cylinder air at a rate depending on factors such as facepiece pressure differential and leakage area.

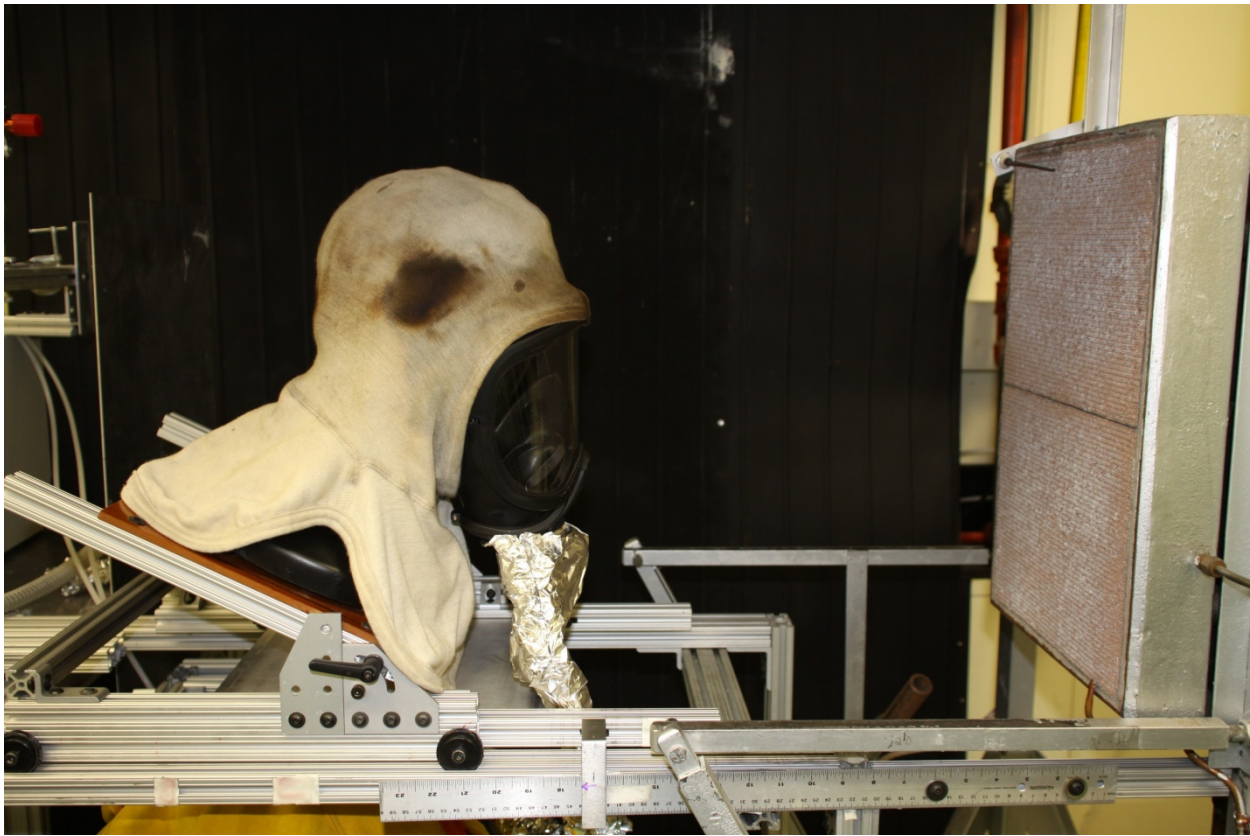
Figure 2. Radiant panel apparatus with SCBA facepiece and hood installed on adjustable headform frame.

The radiant panel apparatus consists of a vertically oriented refractory panel, heated by a premixed natural gas flame sheet on the surface of the panel. The panel has an approximate width of 31 cm (12 in) and an approximate height of 46 cm (18 in). The radiant panel source is described in detail in *ASTM E162 Standard Test method for Surface Flammability of Materials Using a Radiant Heat Energy Source* [36]. The air flow rate to the panel was approximately 434 L/min (920 SCFH), and the natural gas flow rate was approximately 30 L/min (63 SCFH). The hot combustion gases from the flame were pulled upward into a canopy hood above the apparatus with an exhaust flow rate of approximately 42 m³/min (1500 SCFM). As hot gases were directed upward into the hood, and the facepieces were located outside of the hot convective flow from the radiant panel, the heat transfer mechanism to the facepiece specimen was primarily radiative. Extraneous air flow in the room was controlled by closing doors and blocking sources of drafts to stabilize the flame during testing.

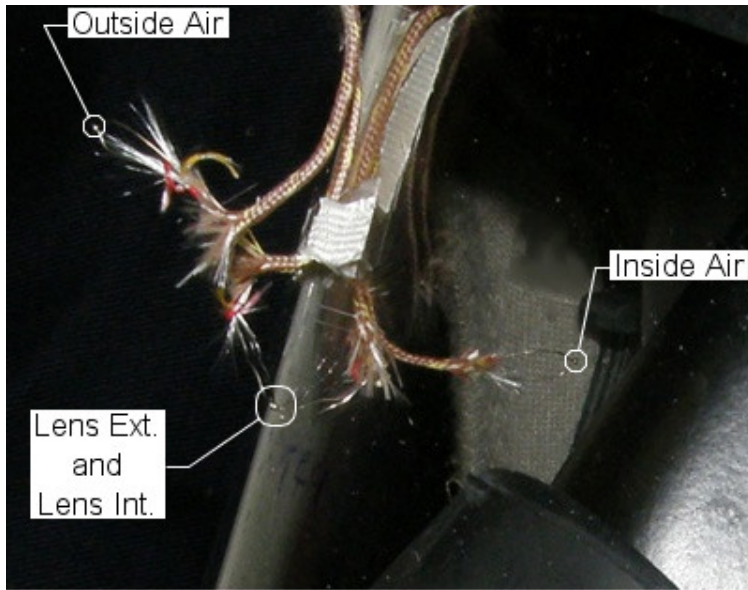
Figure 3. Facepiece lens thermocouples.

The thermocouples were secured to the lens and the headform with high temperature fiberglass tape placed over the wire. The thermocouple wire was formed and shaped in order for the bead to touch the appropriate surface or air space. A mark was made along the vertical centerline of the lens, 4.5 cm (1.8 in) $\pm 0.2 \text{ cm}$ (0.08 in) below the top edge of the exposed portion of the lens. This location was used for lens surface thermocouple placement for all facepieces. The air thermocouples were located 1.0 cm (0.4 in) $\pm 0.5 \text{ cm}$ (0.2 in) away from the lens surface. The thermocouples installed near the facepiece lens are shown in Figure 1 and Figure 3. The location of the thermocouple installed on the headform surface is shown in Figure 4.

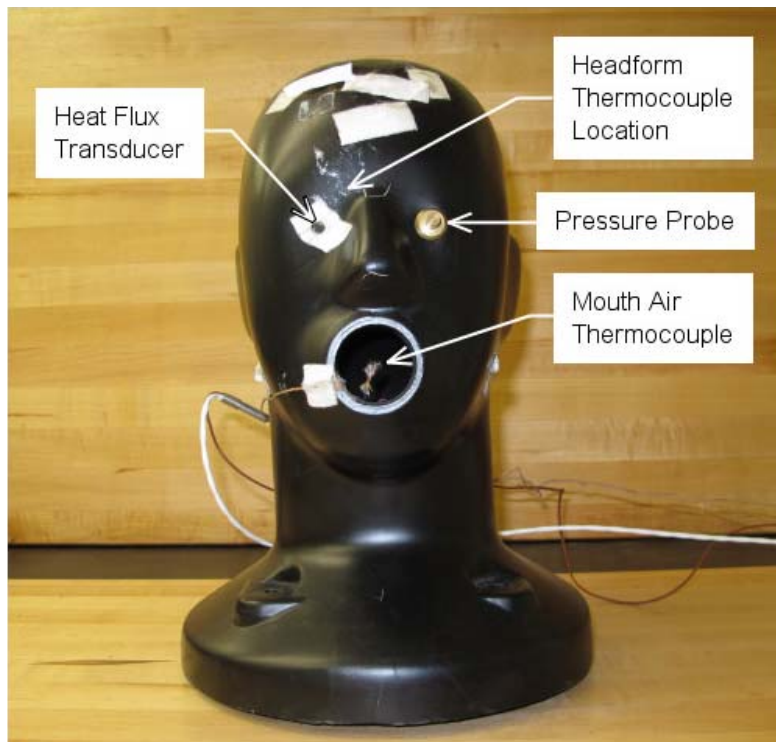
Figure 4. Headform with instrumentation locations.

The level of heat flux was measured inside the facepiece at the right eye location of the headform during some of the experiments. Heat flux was measured using a 0.64 cm (0.25 in) nominal diameter, Schmidt-Boelter type, water cooled, total heat flux transducer, with the measuring surface of the transducer installed approximately 1 mm (0.04 in) above the surface of the headform. The nominal operating range of the transducer was 0 kW/m² to 50 kW/m². The manufacturer reports a $\pm 3\%$ calibration expanded uncertainty for these devices [37]. Results from an international study on total heat flux gauge calibration and response demonstrated that the expanded uncertainty of a Schmidt-Boelter gauge is typically $\pm 8\%$ [38]. The location of the heat flux transducer in the headform is shown in Figure 4.

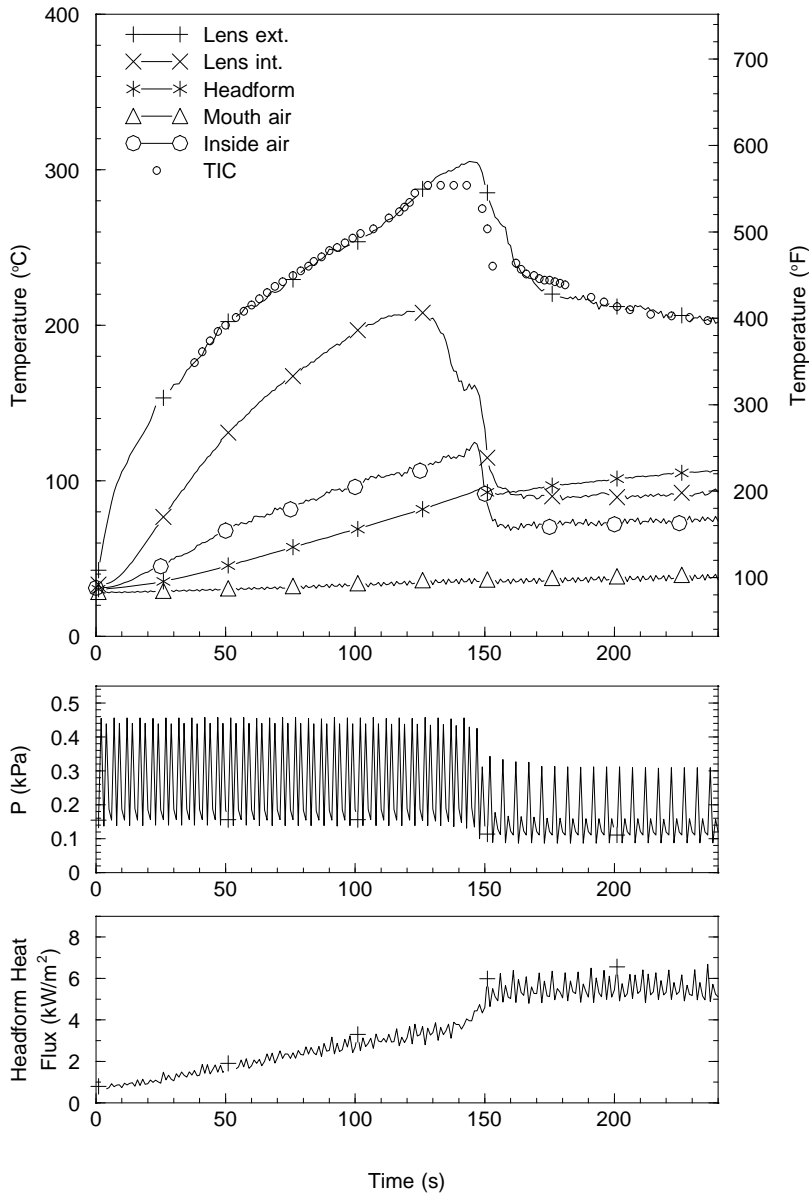
Figure 5 – Facepiece D thermocouple temperatures during a radiant panel exposure of 15 kW/m². A hole forms in the facepiece lens at approximately 148 s into the experiment.

Temperatures of the six thermocouples on and around the facepiece are plotted as a function of time in Figure 5 for an exposure of 15 kW/m^2 incident on facepiece model **D**. The lines represent data every 1 s, but the symbols are shown every 25 s for clarity. The lens exterior temperature was the hottest surface temperature, followed by the lens interior temperature. At approximately 60 s into the test, the lens softened and began moving in and out with the inhalation and exhalation of the breathing cycle. Approximately 120 s into the test, the lens interior thermocouple temperature began to decrease, likely due to separation from the surface of the outwardly deforming lens. Shortly thereafter, at approximately 148 s, a hole formed in the lens, and the exterior lens surface thermocouple temperature decreased. When the hole formed, air was forced out of the hole due to the positive pressure within the SCBA facepiece. The lens temperatures decreased due to the increased airflow through the facepiece as the SCBA regulator provided more air to maintain positive pressure within the mask. Due to the leak through the hole(s) in the lens, the SCBA air cylinder began to decrease pressure at a faster rate due to the increased flow of air to the mask. Increased airflow and cooling of the lens were observed in each facepiece that formed a hole. While the lens interior surface thermocouple appeared to detach from the surface, the exterior lens thermocouple appeared to stay in contact, as can be seen from the thermal imaging camera (TIC) temperature data (assuming an emissivity of 1.0) in Figure 5. The measured temperatures appear to plateau at approximately 125 s during the experiment, due to the TIC maximum temperature range setting of $290 \text{ }^\circ\text{C}$ ($550 \text{ }^\circ\text{F}$).

Figure 5 shows the profiles of the headform temperature, air temperature in the mouth, and air temperature inside the facepiece. Although the headform temperature exceeded 100 °C (212 °F) in the experiment, this does not translate directly into skin temperature as the headform surface and skin do not have the same thermal properties. The skin temperature of a wearer is expected to be lower due to the ability of the human body to dissipate heat through perspiration and circulation, a characteristic the headform does not possess. The mouth air temperature, which also follows the nominal breathing frequency of 0.4 Hz (24 breaths/min), remained cooler than the inside air temperature due to the flow of relatively cool breathing air supplied from the cylinder, which was largely isolated from the facepiece inside air by the nose cup. These trends are typical of the experiments in this study.

The changes in the thermal conditions at the headform are also evident in Figure 5. At the time of hole formation, there is an increase in the heat flux measured at the headform inside the facepiece. In addition, the temperature of the headform surface thermocouple continued to increase after hole formation, although at a lesser rate. Analysis of the data did not uncover a trend in the behavior of headform heat flux or temperature after hole formation. This may be due to the variability in the location and characteristics of the holes and their spatial relationship to the single heat flux transducer and thermocouple installed on the headform. After a hole forms, the headform temperature and heat flux may increase, as shown in Figure 5 and Figure 8, or may decrease, as shown in Figure 7. Note that there is also periodicity in the heat flux data, due to the breathing air, with a nominal frequency of 0.4 Hz (24 breaths/min). The periodicity was due to the use of a total heat flux transducer, which was affected by convection from the movement of air within the facepiece.

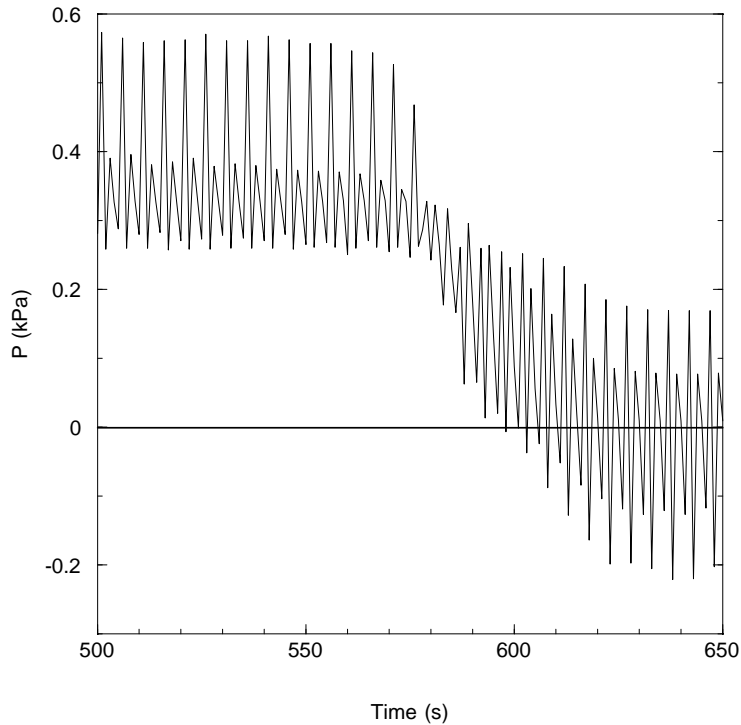
Figure 6. Pressure inside facepiece A during an experiment with radiant panel exposure of 15 kW/m². A hole forms in the facepiece lens at approximately 205 s into the experiment, and the pressure inside becomes negative during inhalation at approximately 600 s.

Due to the connection between hole formation in the lens and increased airflow, recorded pressure data reveals the time of hole formation. The normal pressure profile without a hole can be seen in Figure 5, with a minimum value associated with inhalation and a maximum value associated with exhalation, with a nominal frequency of 0.4 Hz (24 breaths/min). When a hole formed at approximately 148 s, there was a shift in the local minimum and maximum of the pressure wave profile. The size of the shift depended on the SCBA design and the geometry of the hole. Video observation confirmed a hole formed in the mask at this time. Identifying the time when a hole formed from the pressure data was more reliable than watching the video,

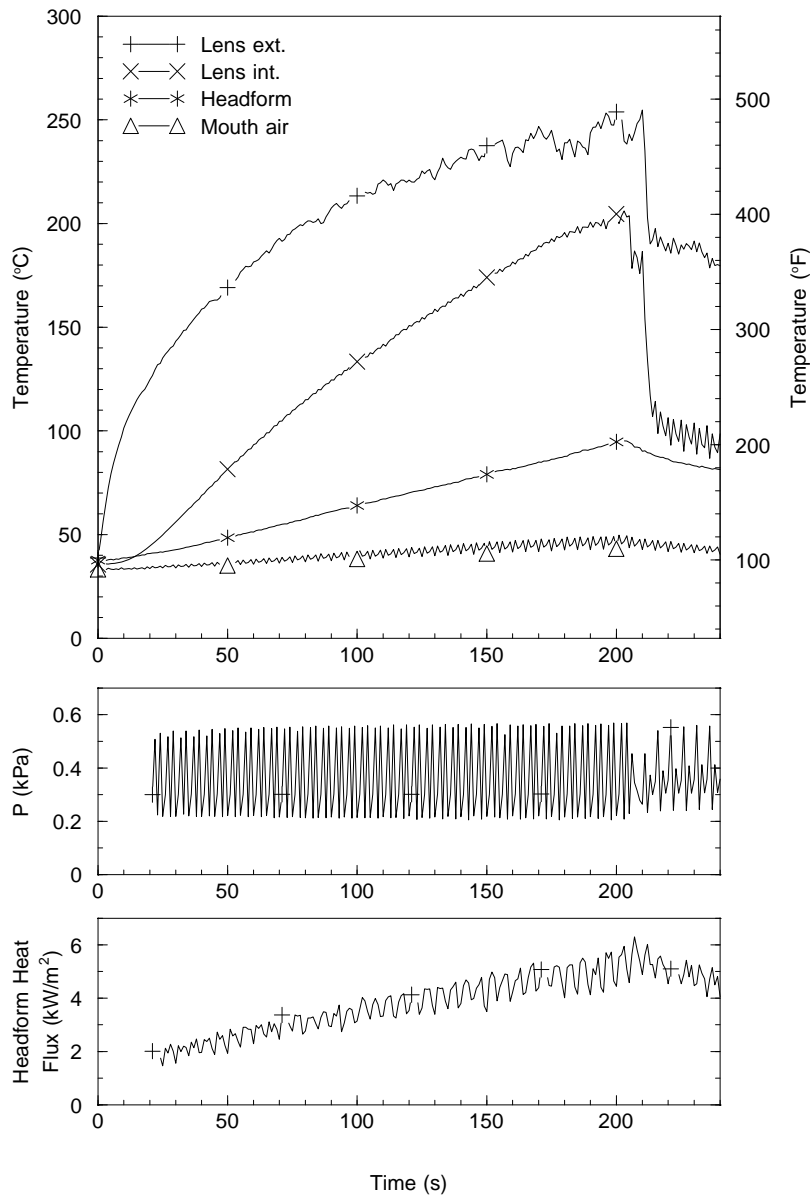
Figure 7. Facepiece A thermocouple temperatures during a radiant panel exposure of 15 kW/m². A hole forms in the facepiece lens at approximately 205 s into the experiment.

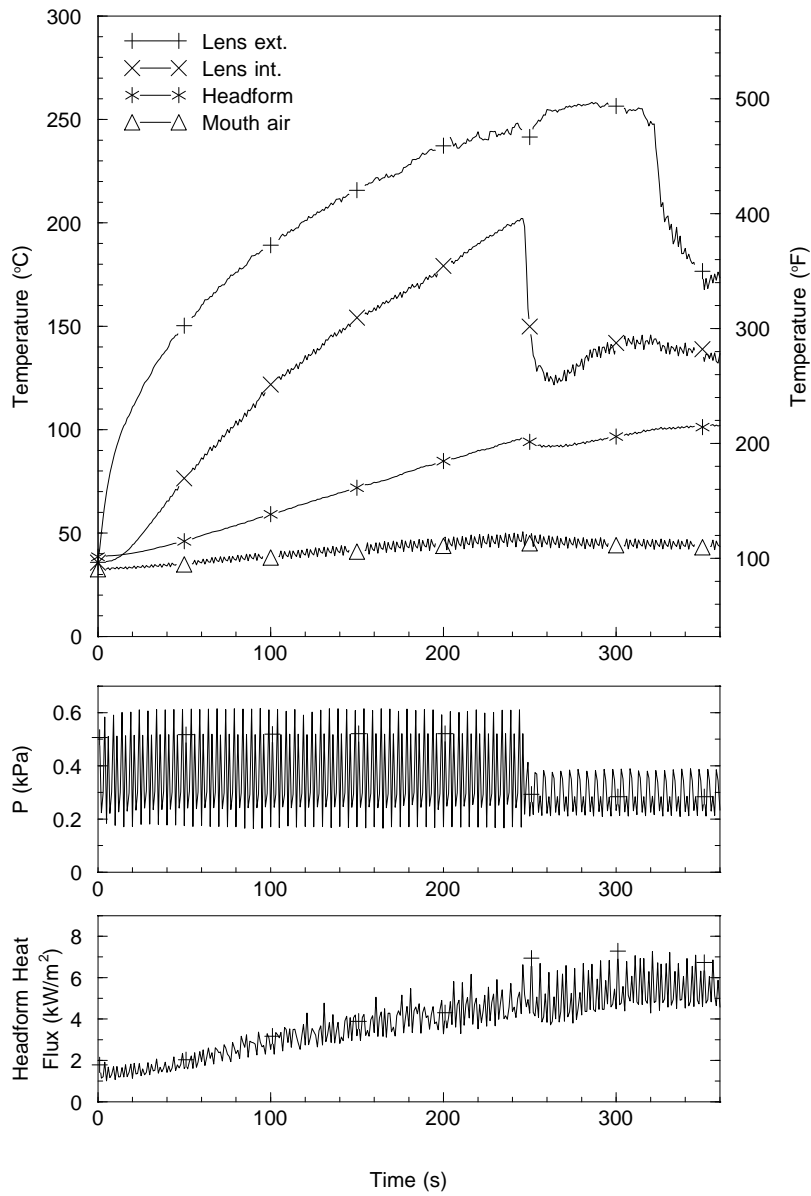
Figure 8. Facepiece A thermocouple temperatures during a radiant panel exposure of 12 kW/m². A hole forms in the facepiece lens at approximately 247 s into the experiment.

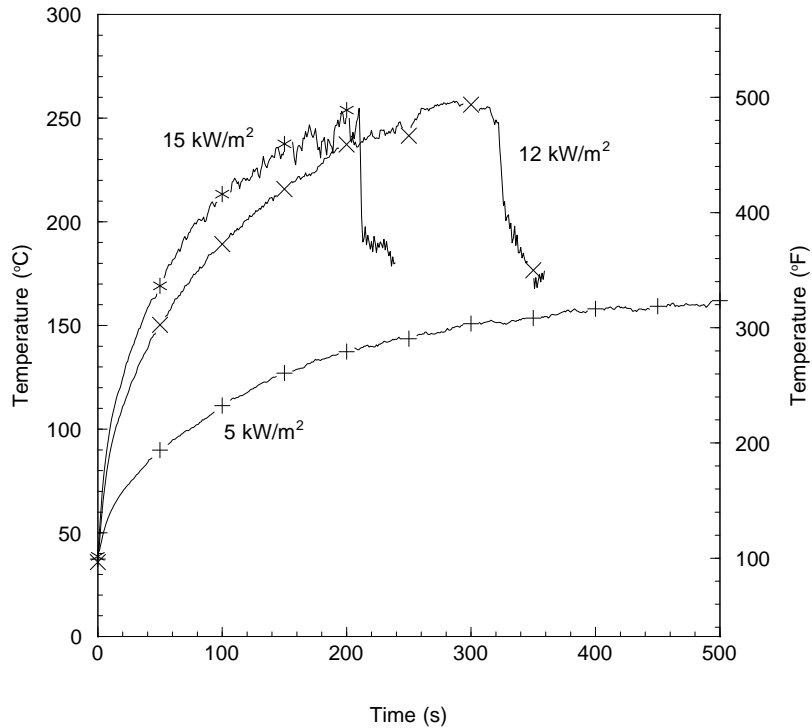
Figure 9 – Facepiece A lens exterior surface temperatures (via thermocouple) during radiant panel exposures of 5 kW/m², 12 kW/m², and 15 kW/m².

For all levels of heat flux, the lens exterior thermocouple experienced the highest temperature, which increased for increasing levels of flux. In Figure 9, the lens exterior temperature rise of facepiece model A is shown for different levels of heat flux. As expected, the exterior facepiece lens temperatures increase more rapidly at higher imposed heat flux exposures. In addition, holes form more rapidly at higher heat fluxes. Holes were formed in approximately 206 s and 247 s for 15 kW/m² and 12 kW/m² fluxes, respectively, while no holes were formed at 5 kW/m² for the duration of a 1200 s exposure. The temperature plots for 15 kW/m² and 12 kW/m² stop when the facepiece exposures end at approximately 240 s and 313 s, respectively. The thermocouples appear to have remained on the surface for the experiments plotted in Figure 9 until shortly after hole formation, with the 15 kW/m² thermocouple detaching from the surface at approximately 210 s and the 12 kW/m² thermocouple detaching at approximately 313 s. For

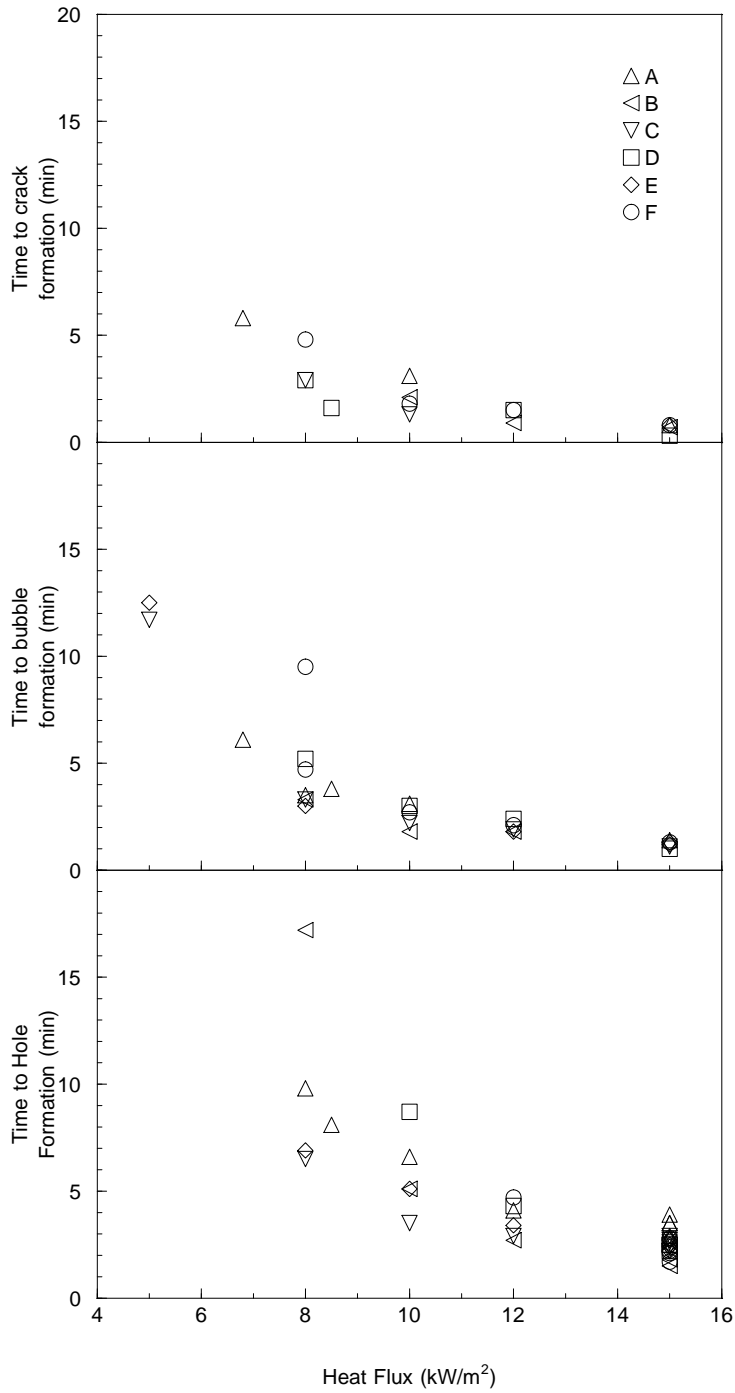
Figure 10 – Times for cracks, bubbles, and holes to develop plotted as a function of the exposure heat flux for six different facepiece models.

Regardless of facepiece model, the length of time to each stage of degradation decreased as the heat flux was increased. For a specific level of heat flux, the cracks and crazing appeared first, followed by bubbling, and then holes. At 5 kW/m^2 for 20 min, a few facepieces exhibited cracking and bubbling. Holes were not observed for any of the facepieces after 20 min of exposure at heat fluxes below 8 kW/m^2 . For exposures of 8 kW/m^2 and above, all facepieces showed some thermal degradation in 20 min. At the highest heat flux tested, 15 kW/m^2 , holes formed between approximately 1.5 min and 3.9 min.

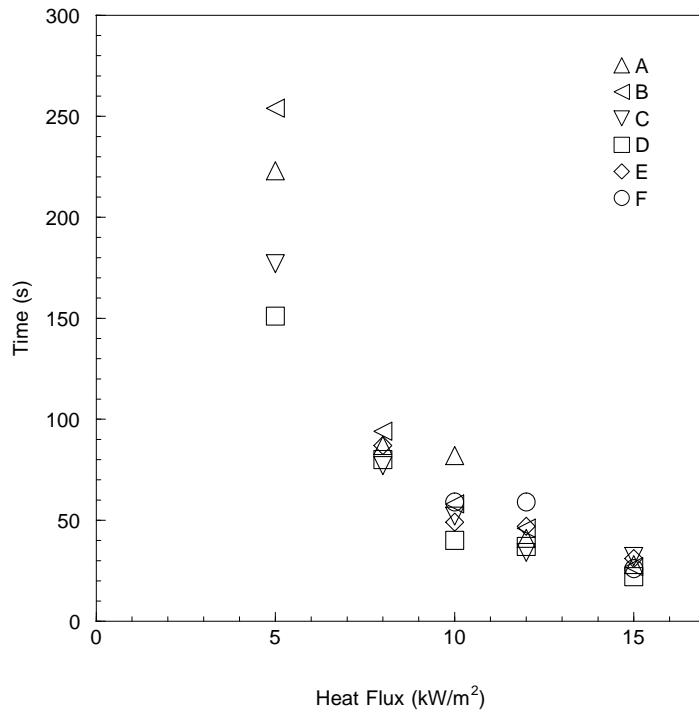
Figure 12. Time for facepiece lens exterior to reach 140 °C (284 °F).

The times for the exteriors of the facepieces lenses to reach 140 °C (284 °F), which approaches the glass transition temperature of polycarbonate, are shown in Figure 12 and Figure 13. As the heat flux increases, the time to reach 140 °C (284 °F) decreases, with the same trend for all facepieces. The times for all facepieces across all fluxes are similar, with the mean and uncertainty quantified in Figure 13. The uncertainty bars denote Type A uncertainty with a coverage factor of two, representative of a confidence level of approximately 95 %. The uncertainty in the mean time for the facepiece exterior to reach 140 °C (284 °F) shows a general decreasing trend as the incident heat flux increases, with the smallest absolute uncertainty at an incident heat flux of 15 kW/m². The results show the similarity of results for all facepieces tested, regardless of design or manufacturer.

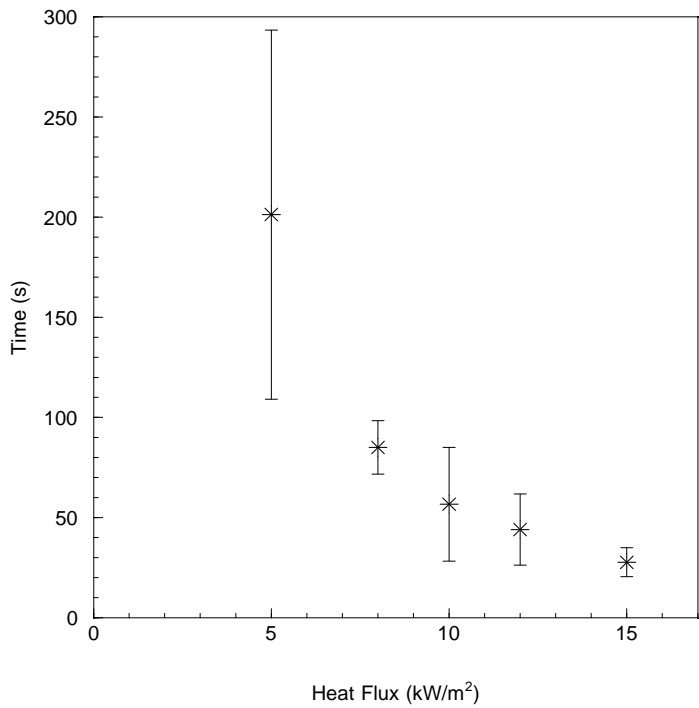
Figure 13. Mean time (for the data in Figure 12) for facepiece lens exterior to reach 140 °C (284 °F).

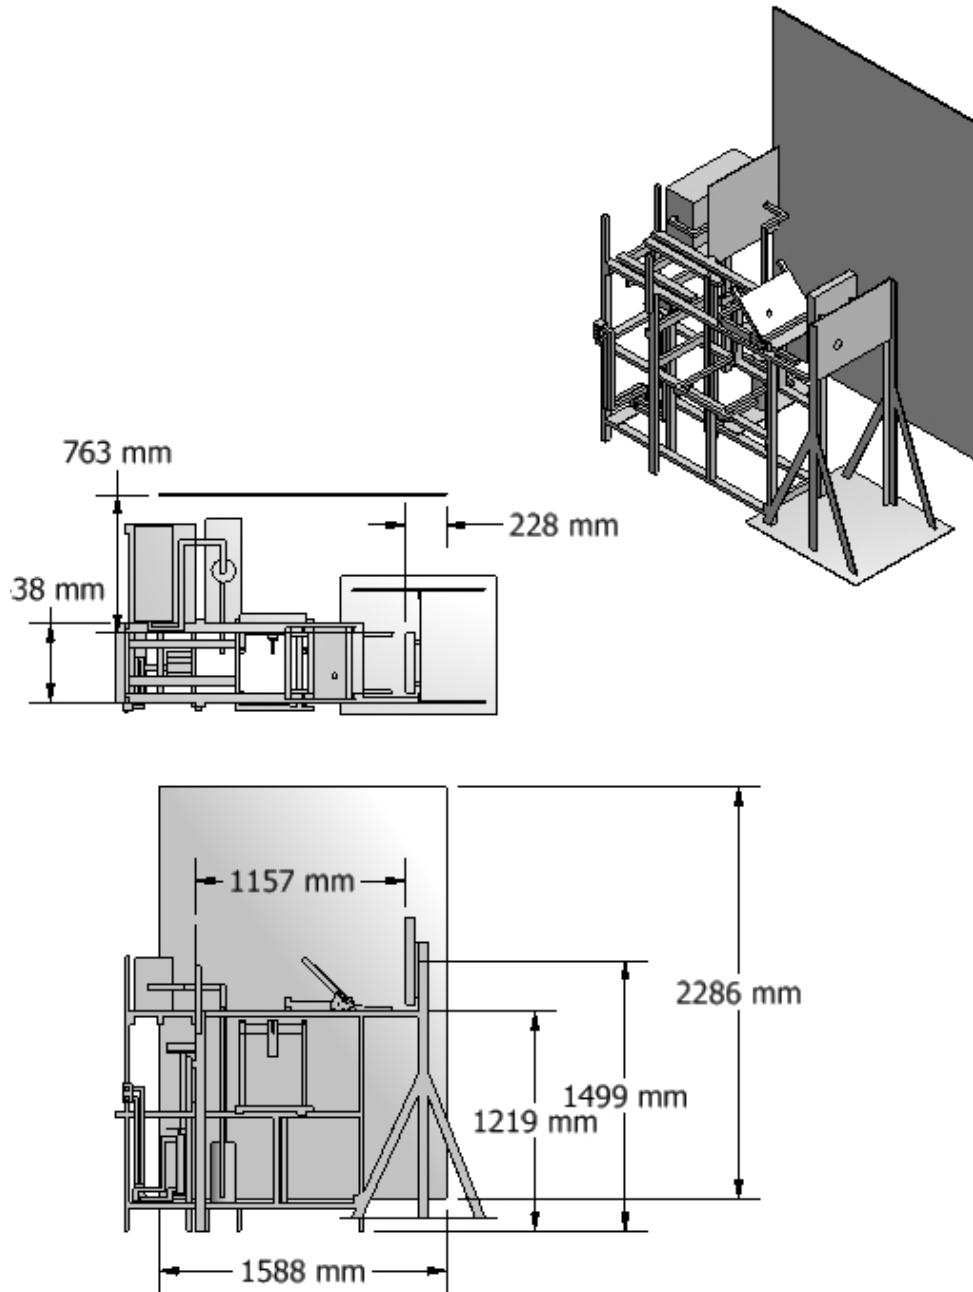
Figure 14. Radiant panel apparatus with headform cart installed. Isometric view (top), plan view (middle), and elevation view (bottom).

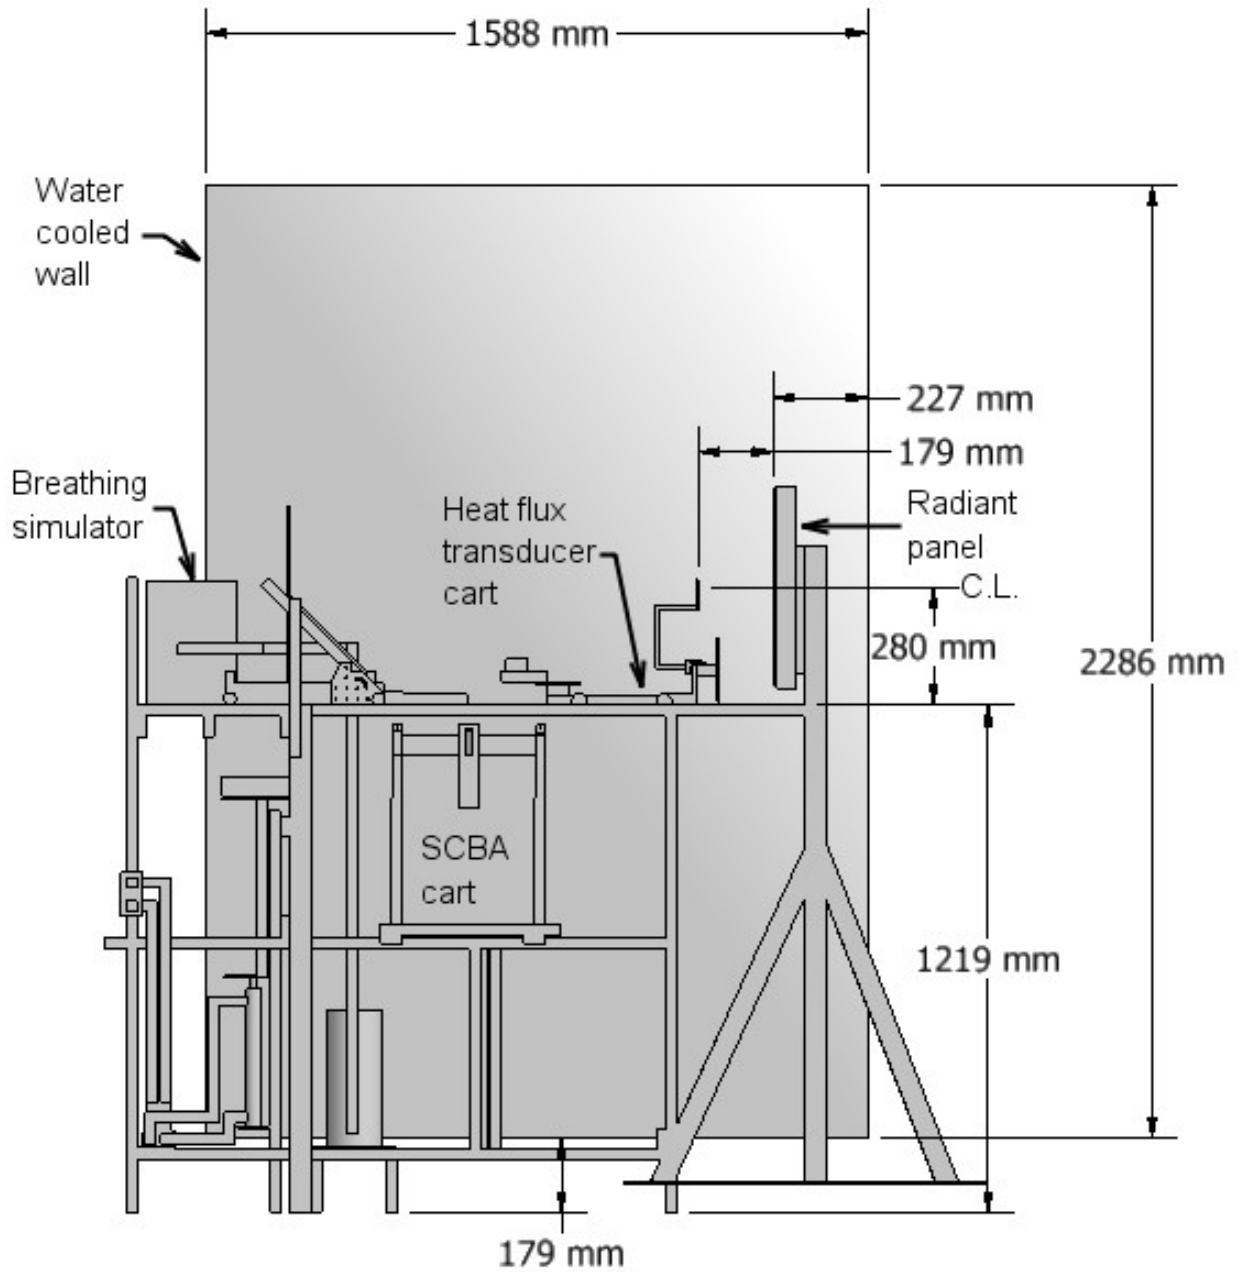
Figure 15. Radiant panel apparatus, elevation view. Heat flux transducer centerline (C.L.) aligned with centerline of gas fired radiant panel. Exhaust hood installed over entire apparatus, not shown.

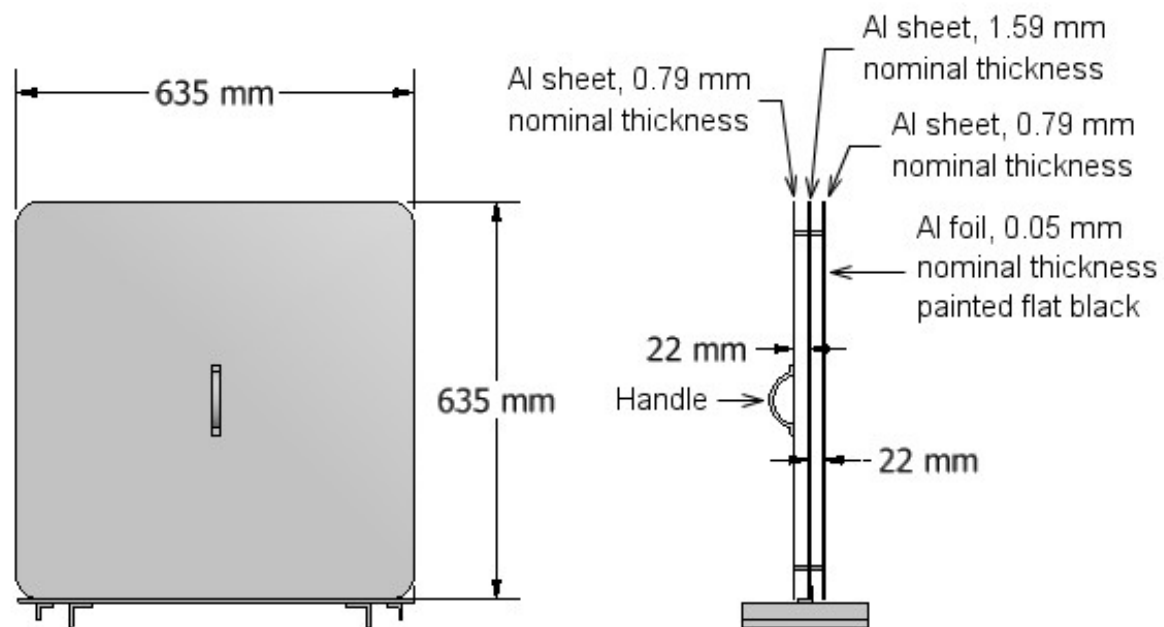
Figure 16. Radiant heat shield.

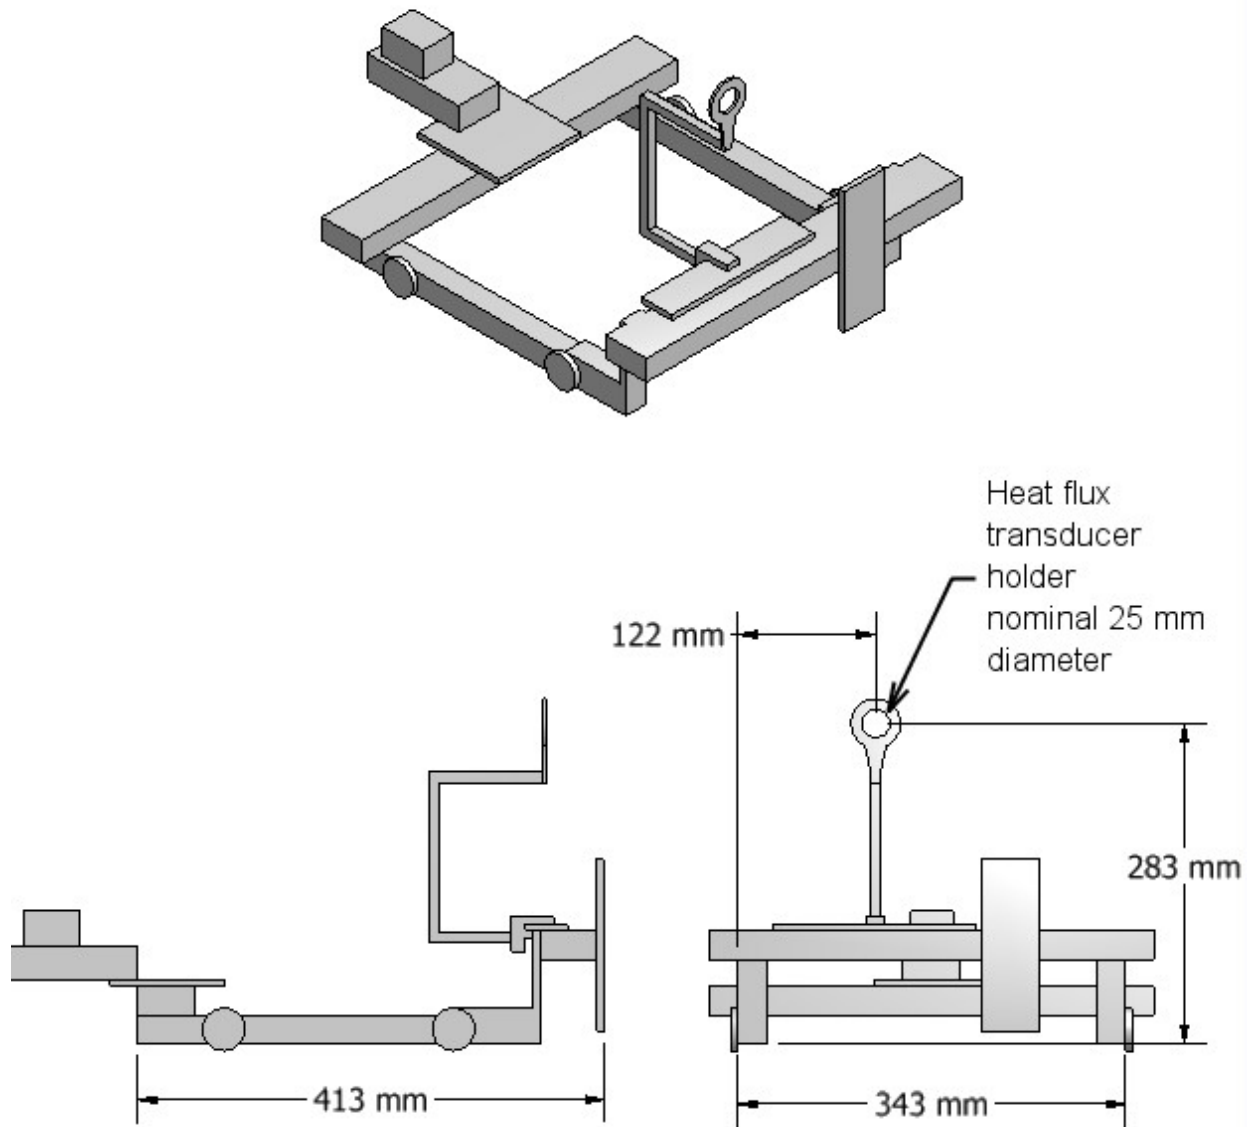
Figure 17. Heat flux transducer cart. Centerline of heat flux transducer passes through horizontal and vertical center of the face of the radiant panel. Transducer not shown.

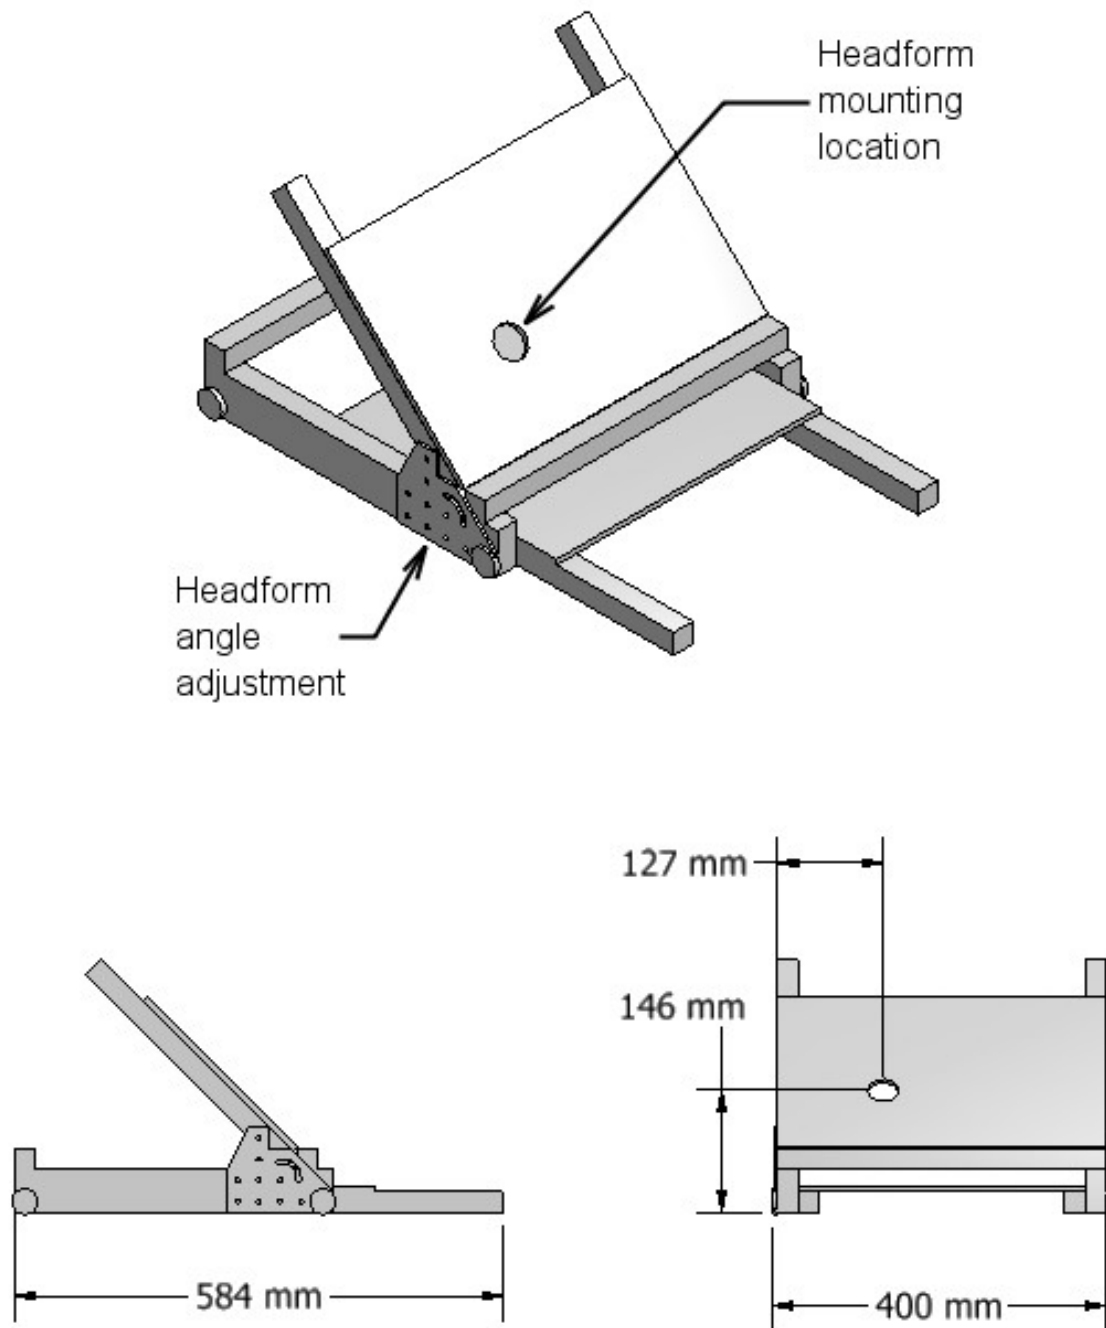
Figure 18. Headform and facepiece cart.

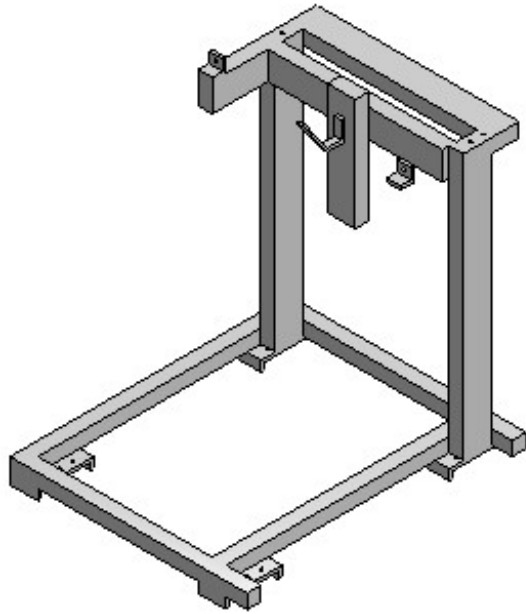
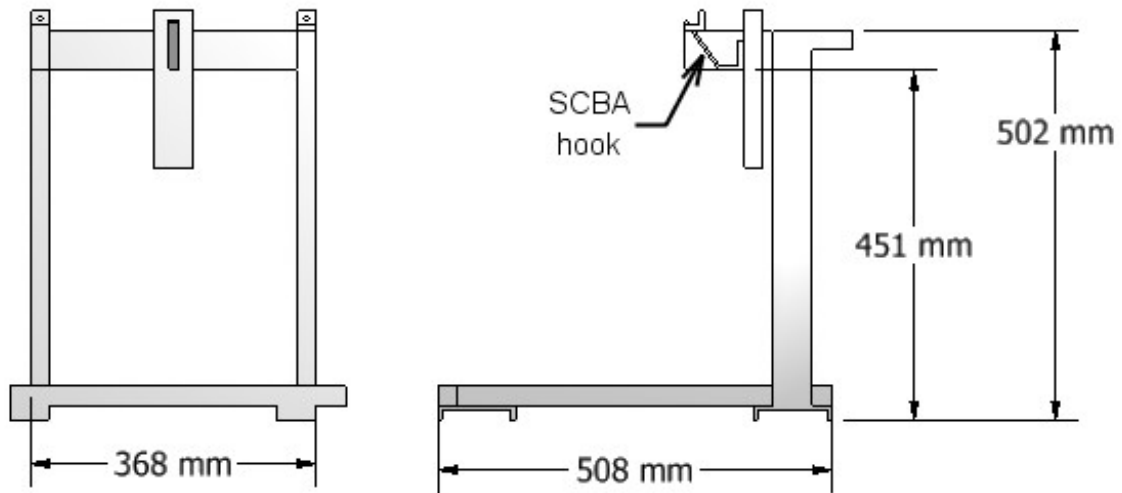
Figure 19. SCBA cart. SCBA pack with air cylinder attached to the hook during experiments.

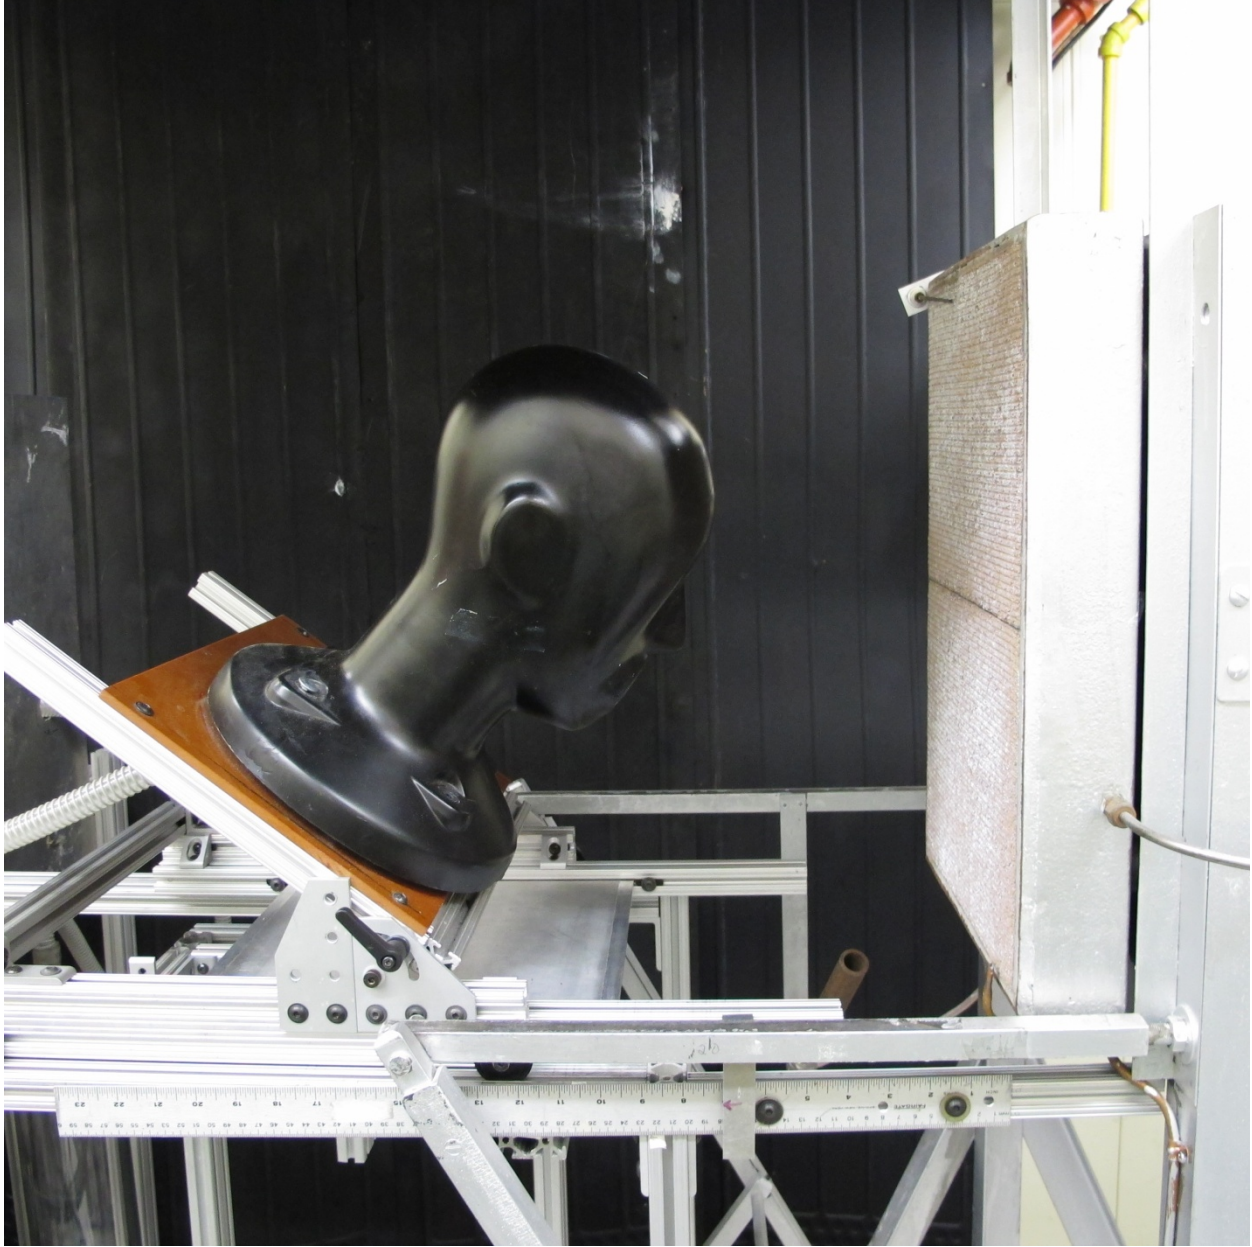
Figure 20. Headform mounted on cart and positioned in front of radiant panel.
