NIST Technical Note 1785

**Thermal Performance of Self-
Contained Breathing Apparatus
Facepiece Lenses Exposed to Radiant
Heat Flux**

Anthony Putorti Jr
Amy Mensch
Nelson Bryner
Fire Research Division
Engineering Laboratory
National Institute of Standards and Technology
Gaithersburg, MD 20899

February 2013

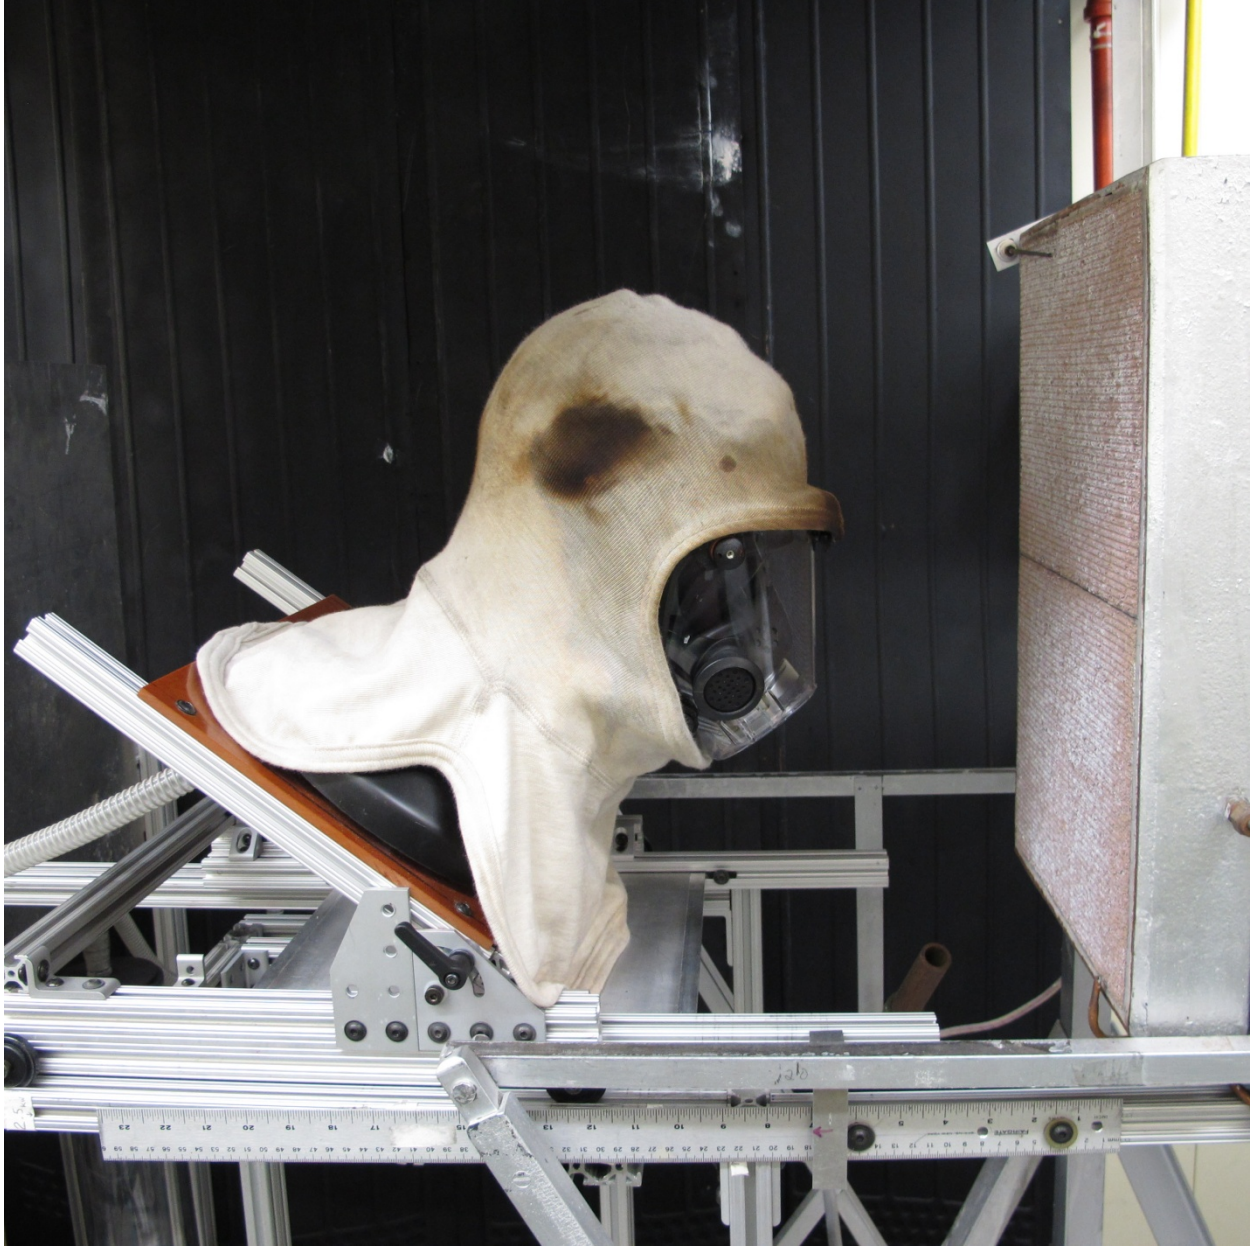
Figure 21. Headform and facepiece mounted on cart and positioned in front of radiant panel. Facepiece lens is parallel with radiant panel, and located approximately 178 mm (7.0 in) from panel surface.
