COMPREHENSIVE MONITORING STUDY OF A BENEFICIAL REUSE PROJECT AT EGMONT KEY, FL

US Army Corps of Engineers (USACE)

Engineer Research and Development Center

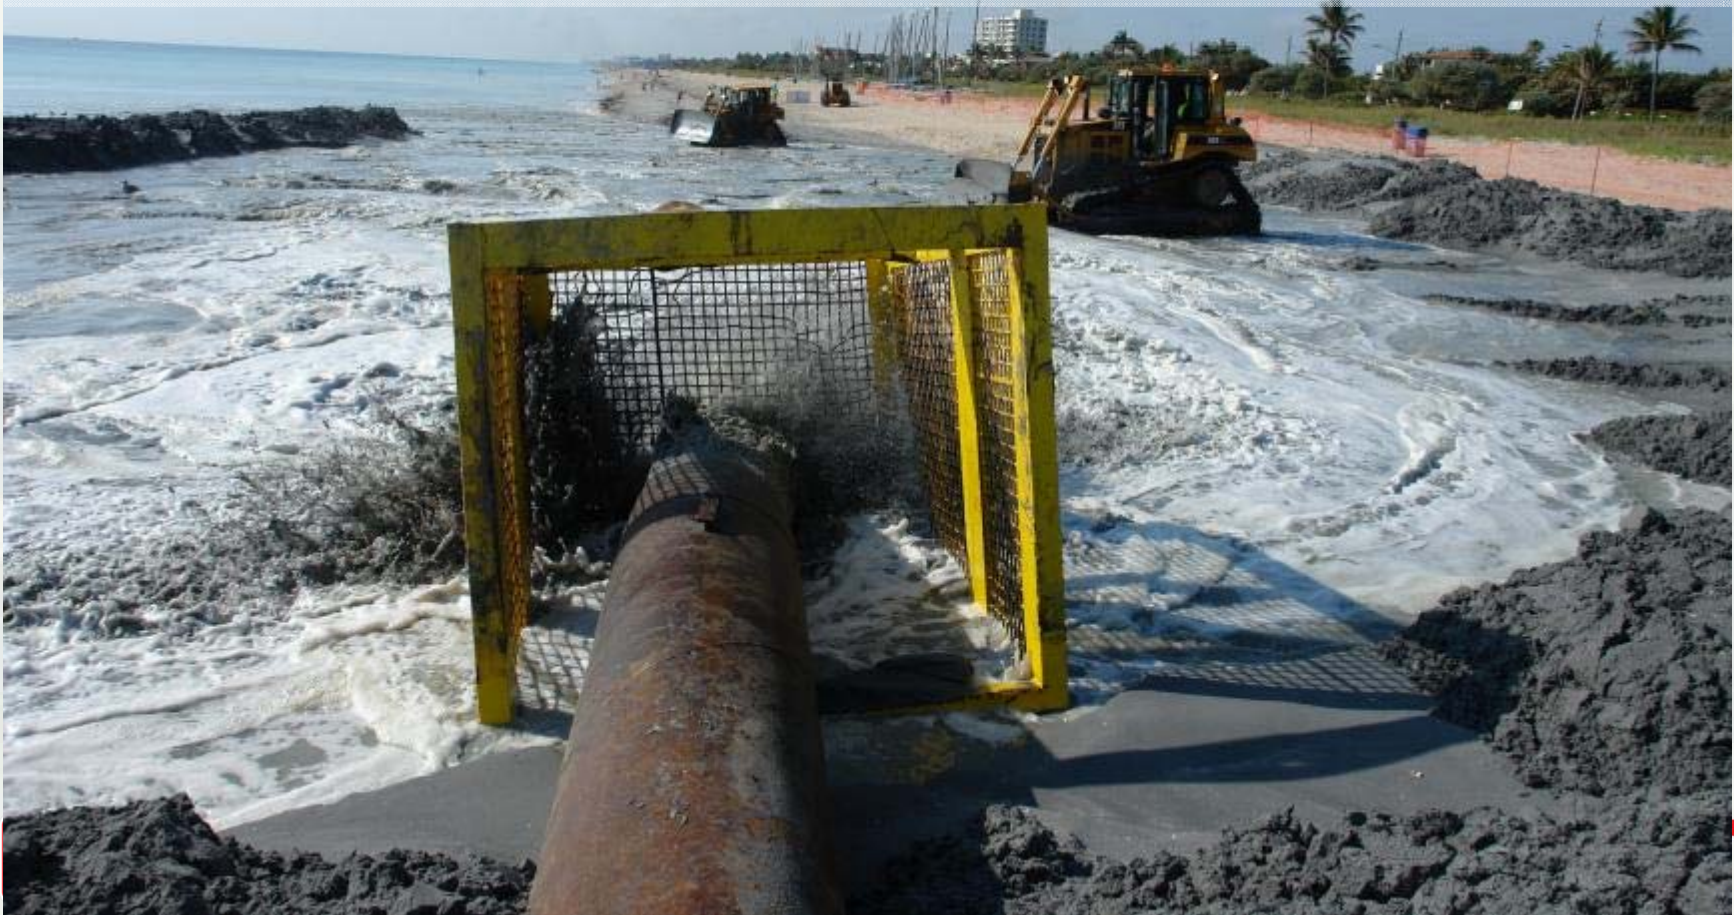
Definitions

- **Traditional Placement** – placement of material to “build a beach” using longitudinal dikes to increase settlement. This projects purpose is to create a wide flat dry beach berm.

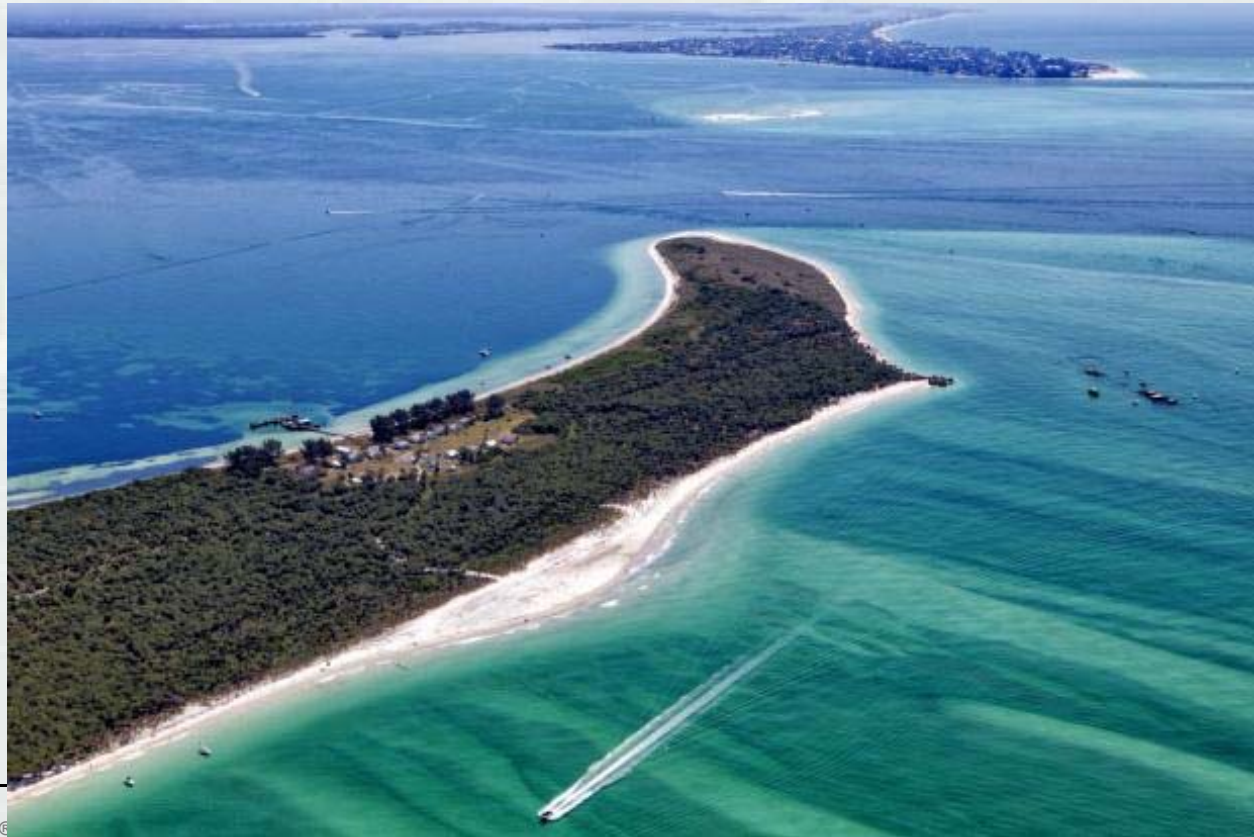
Definitions

- **Cross Shore Swash Zone Placement (CSSZ)** – placement of dredged material by discharging material directly into the swash zone until a delta builds and then extending outfall shore perpendicular thus building a “point” (salient) feature.

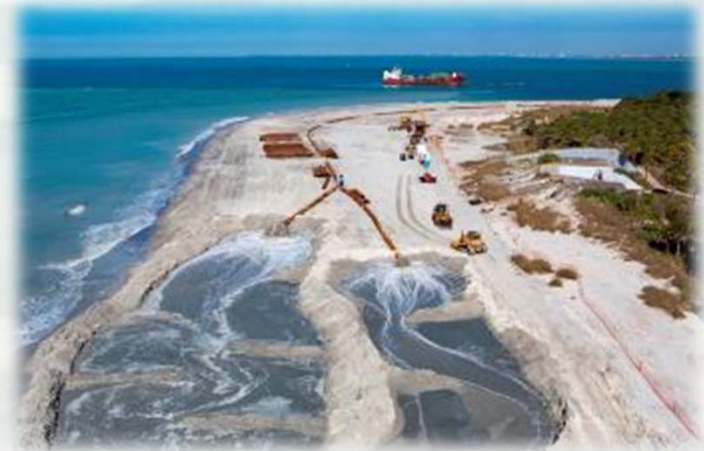
Fines Content and Density

Tampa Harbor MD - Egmont Key 2014		
	# of Samples	Avg. % by wt. passing 230 sieve
In-situ	80	20.7
pre-Beach	6	0.03
post-Dredged	21	0.51
Traditional	14	0.52*
CSSZ	7	0.49*

* Sampling occurred within 72 hours of placement completion

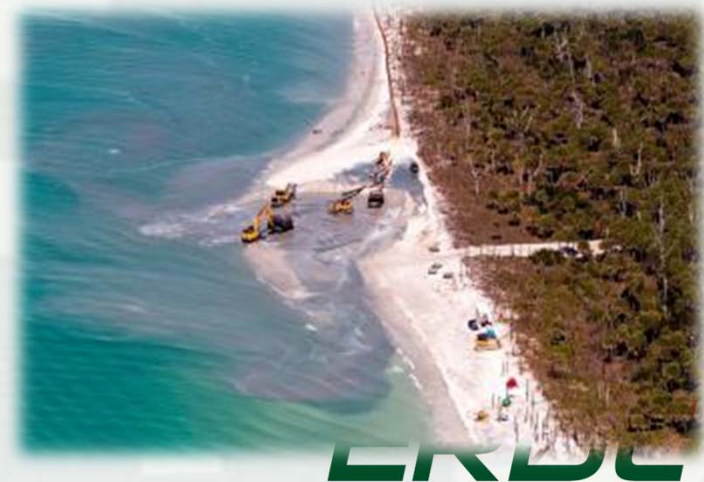
Tampa Harbor MD - Egmont Key 2014			
	# of Samples	Value avg. (kg/m3)	% Greater
Density			
pre-Beach	7	1405.1	0.0%
post-Dredged	17	1471.6	4.7%
Traditional	11	1476.0	5.0%
CSSZ	6	1463.5	4.2%

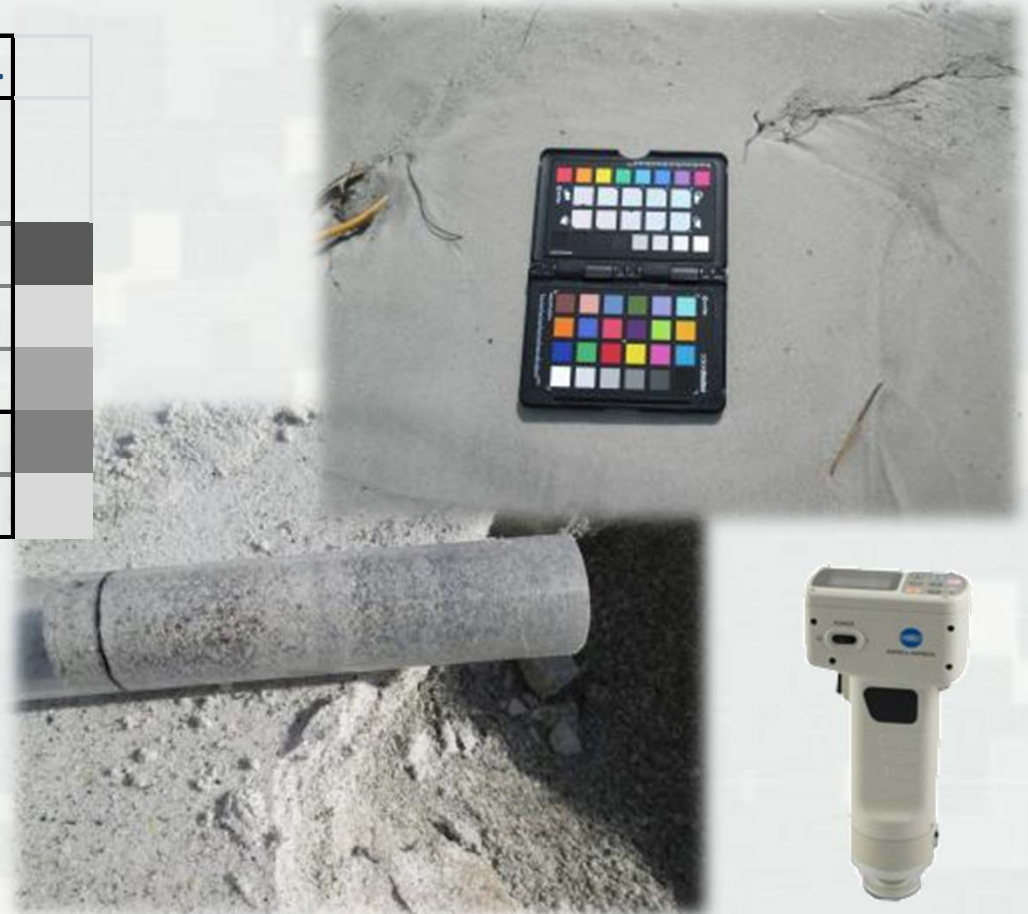
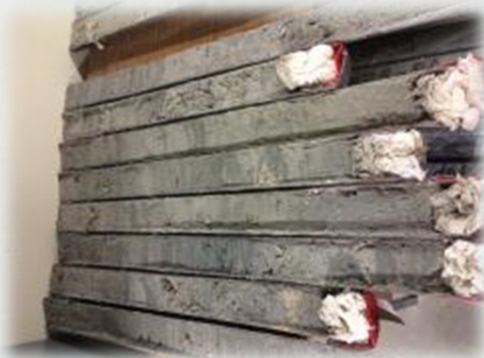
Munsell Color

# of Samples	Value avg.
In-situ	80	4.36*
pre-Beach	13	5.9
post-Dredged	24	5.3
Traditional	16	5.0
CSSZ	8	5.9

*Munsell color value < 5 unacceptable for beach placement in Florida

NOTES: Triplicate measurements of hue, value, and chroma were collected from three areas on each moist sand sample using a digital colorimeter (CR-400, Konica Minolta, Osaka, Japan).

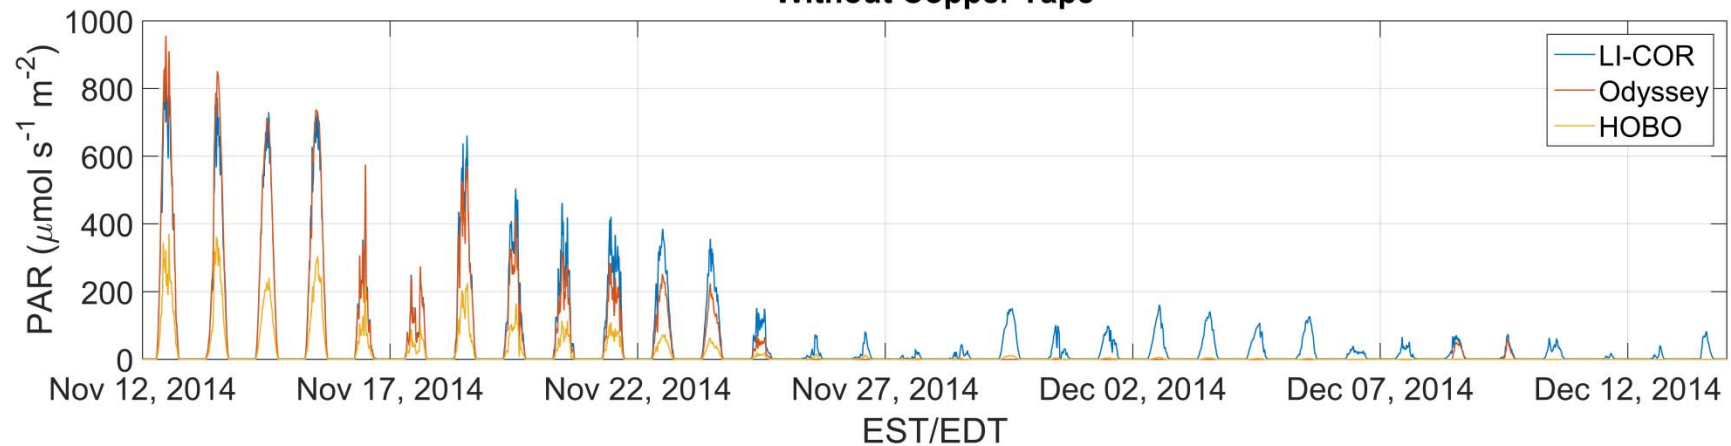
Without Copper Tape

Preventing Data Quality Degradation Due to Biofouling through the Use of Copper Tape

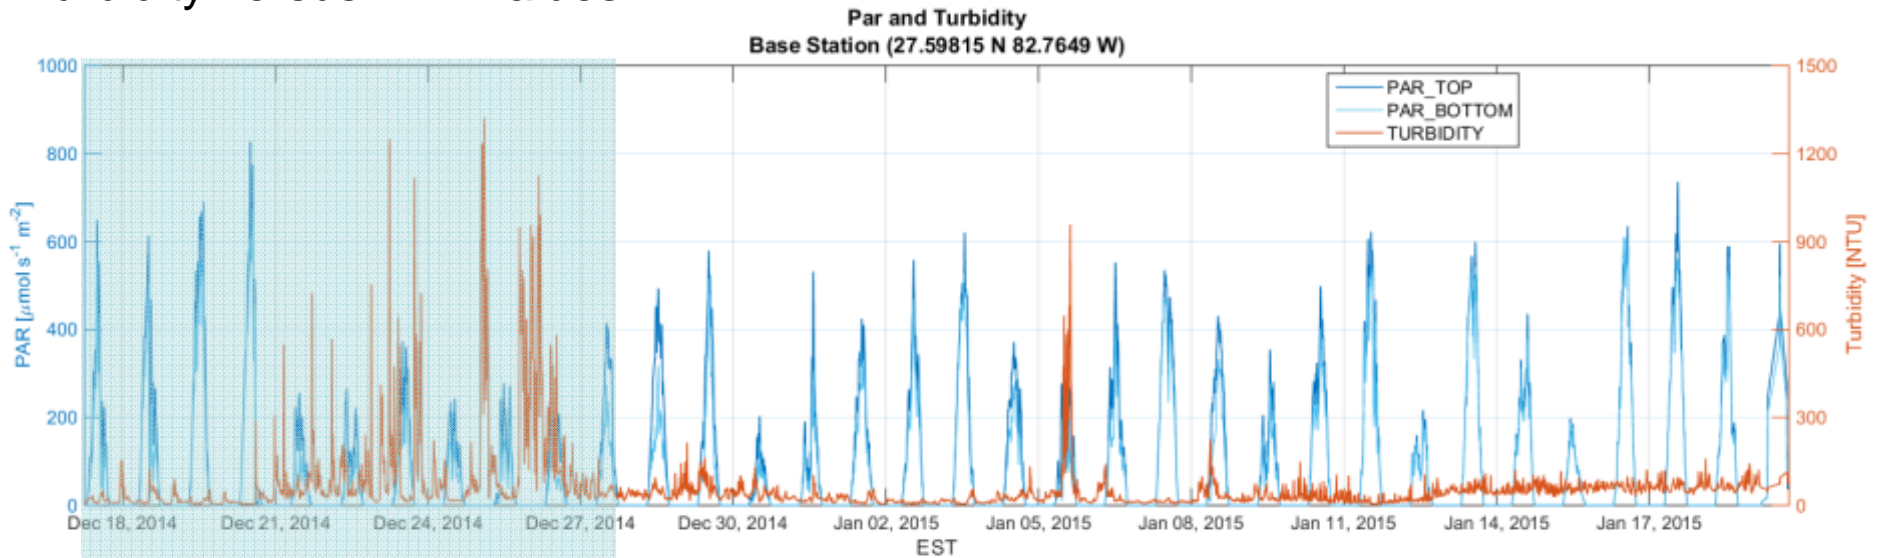
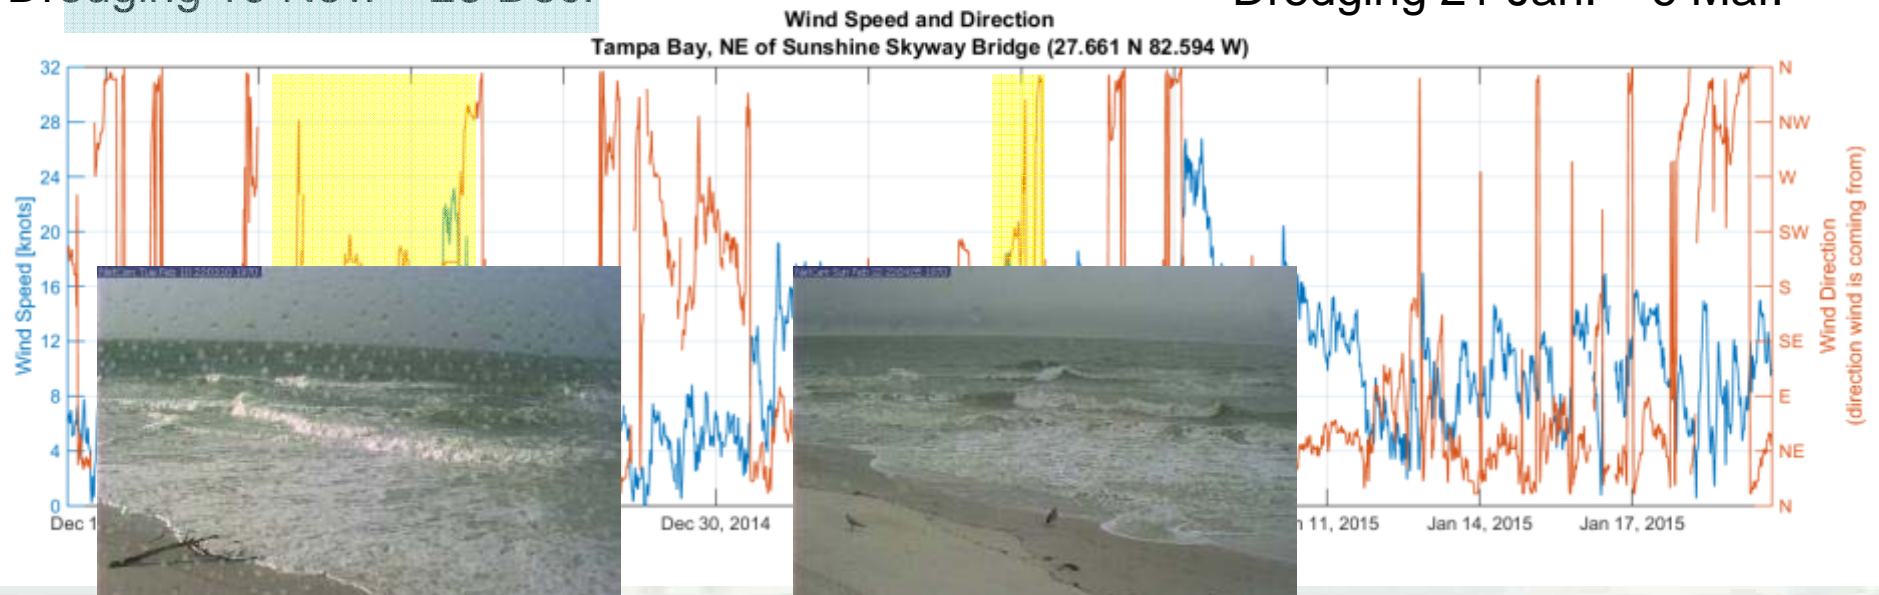
Turbidity versus PAR values

Dredging 19 Nov. – 28 Dec.

Dredging 21 Jan. – 6 Mar.

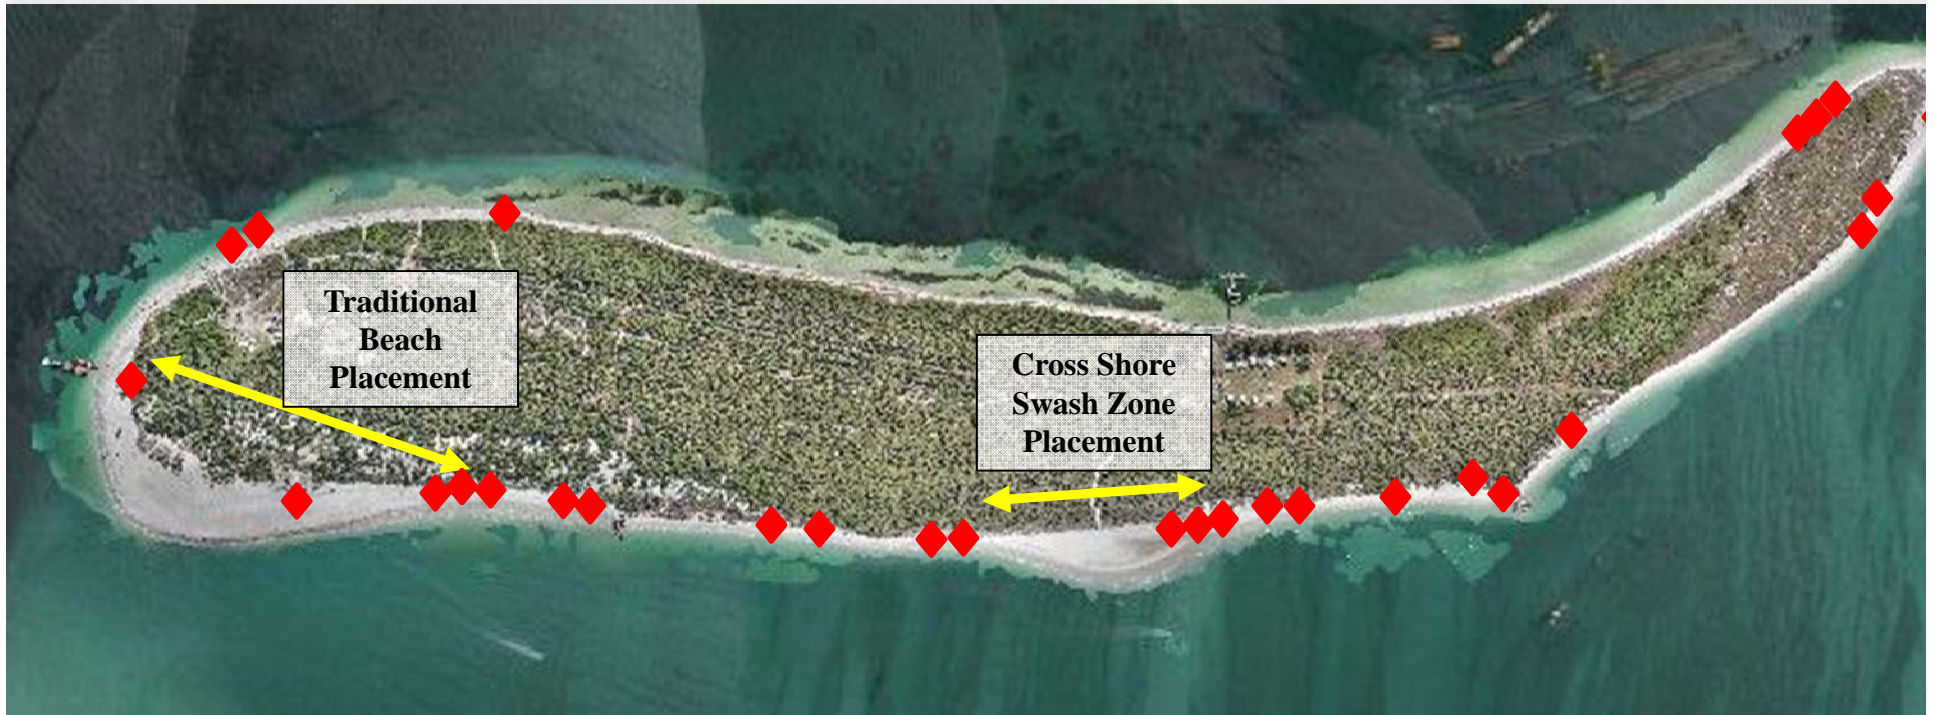
Sea Turtle Nesting 2015

Nesting as of 16 August 2015
