Methods for Evaluating and Treating ASR-Affected Structures: Results of Field Application and Demonstration Projects

Volume I: Summary of Findings and Recommendations

Final Report

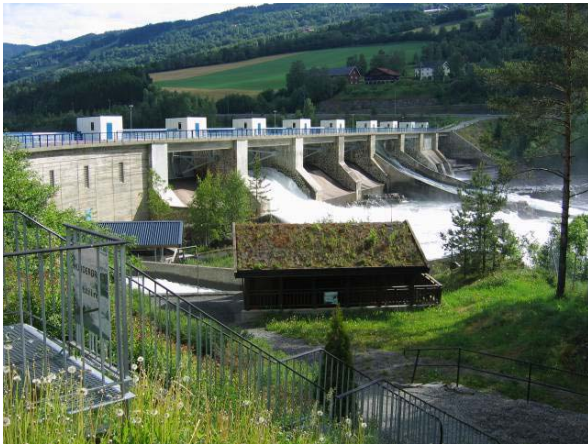
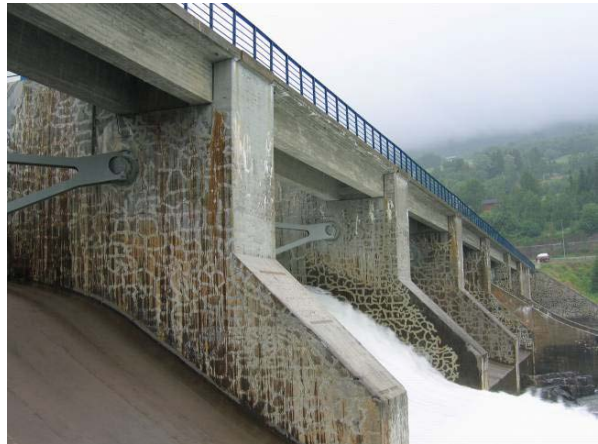
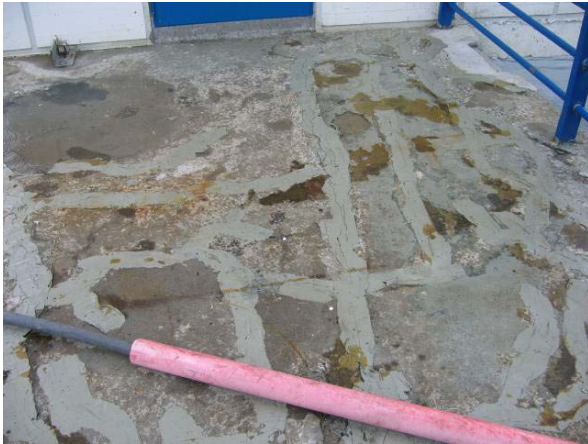
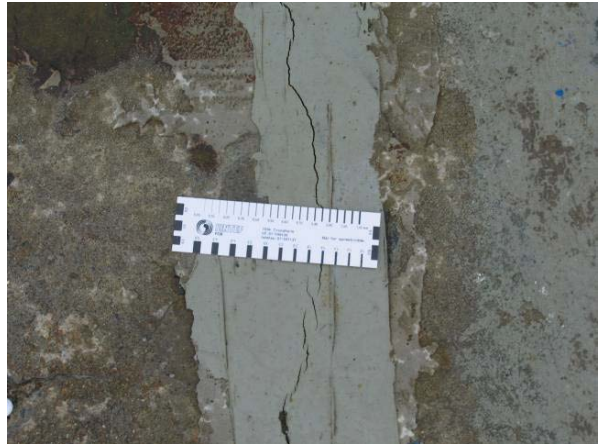
Figure 1. Large hydraulic dam affected by ASR in Norway.
A: General view of the dam. **B&C:** View of the epoxy-injected pillars. **D:** Cracking reappearing in the injected cracks.

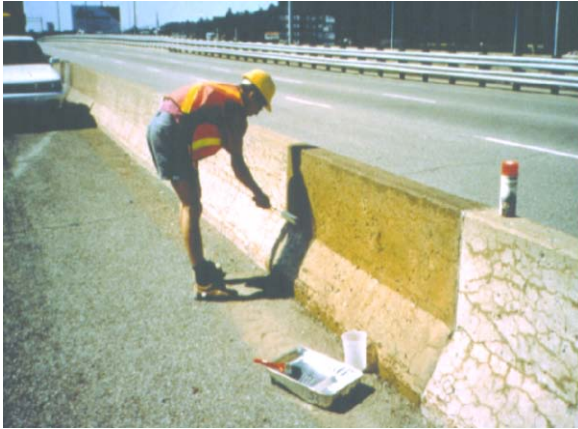
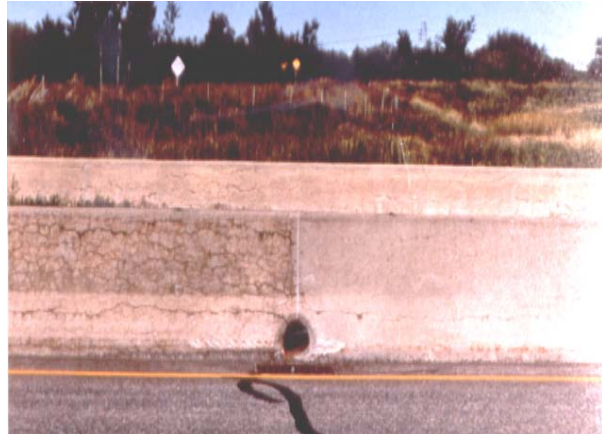
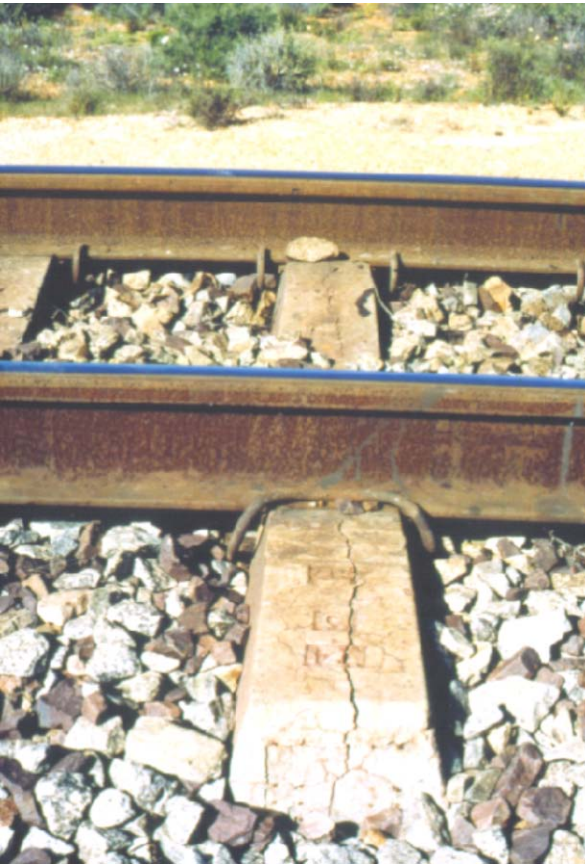
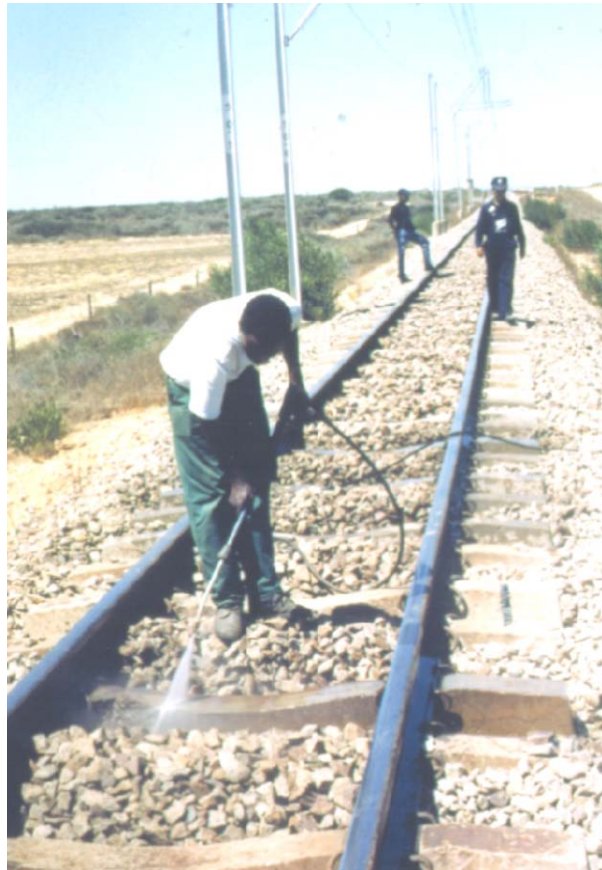
Figure 2. Median barriers and concrete sleepers.

A: Application of sealers on highway median barriers affected by ASR. B: Unsealed/control (left) and sealed (right) of a highway median barrier treated with silane (photos taken three years after treatment). C: Condition of concrete sleepers affected by ASR in the Sishen-Saldanha railway line in South Africa. D: As part of the management program, a number of cracked concrete sleepers were treated with silane. (Pictures C and D: courtesy of R.E. Oberholster, PPC Technical Services, Cleveland, South Africa.)

The effectiveness of surface treatments against ASR is influenced by the actual effectiveness of the specific product to control moisture exchange between the concrete and the atmosphere; coatings that permit the escape of water vapor are preferable to allow progressive drying of the concrete. Some silane and siloxane sealers have shown beneficial effect in controlling moisture content in concrete and the extent of deleterious expansion due to AAR (Bérubé et al. 2002a). Bérubé et al. (2002b) described the application of various types of sealers on highway median barriers affected by ASR (see Figure 2A). In some cases (e.g., some silanes), the treatment had a

dramatic beneficial impact not only on the cosmetic appearance of the affected concrete member (see Figure 2B) but also contributed in progressively reducing internal humidity content and expansion of the concrete (Bérubé et al. 2002b). Grabe and Oberholster (2000) reported that a silane treatment on ASR-affected concrete railway sleepers has been effective in reducing the rate of deterioration due to ASR, thus extending their service life (see Figure 2C and Figure 2D).

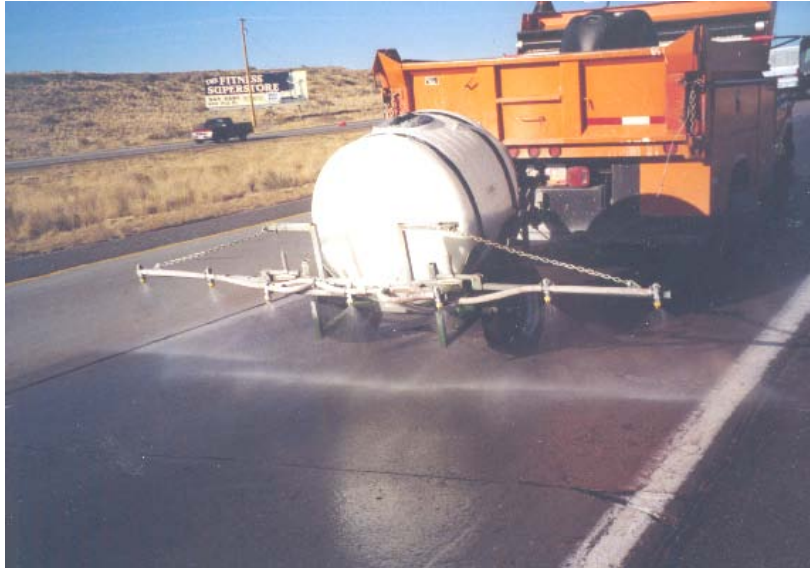
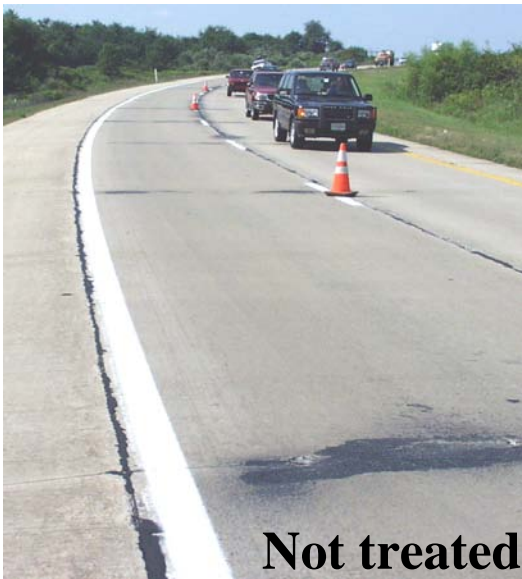
Figure 3. Concrete pavement affected by ASR.

A: Topical application of lithium-based solutions at the surface of a pavement section affected by ASR.
B: Condition of not-treated (control) and treated sections (after six topical treatments with lithium nitrate solution) of concrete pavement affected by ASR in Delaware. Spalling of concrete at joints in more frequently observed in the untreated sections.

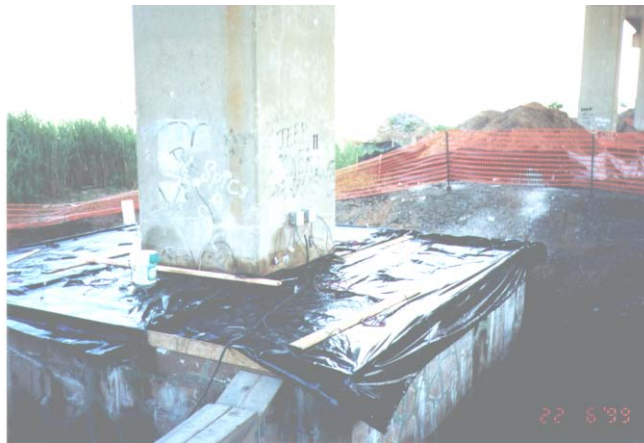
Figure 4. Repair of pier footings of a highway structure suffering from severe cracking and spalling due to ASR using an electrochemical system for lithium impregnation.

Electrochemical techniques have been developed to remove chloride ions from reinforced concrete. This involves the application of low voltage DC electric potential to cause the migration of negatively-charged chloride anions away from steel and towards a surface-mounted anode. By making a few modifications to this system, it can be used to deliver positively-charged lithium cations into a structure (Whitmore and Abbott 2000). Various lithium compounds have been used to date as the electrolyte including lithium nitrate, lithium hydroxide, and lithium borate. Limited testing of bridge decks treated electrochemically have indicated that a significant quantity of lithium is absorbed from the electrolyte during treatment and that depths of penetration of at least 30 mm (1.2 in.) are possible (greater depths were not tested). Whitmore and Abbott (2000) described the treatment of five concrete pier footings of a bridge in New Jersey using an electrochemical system. The treatment involved installation of titanium mesh on the top surface of each footing, and the addition of several anode “reservoirs” and auxiliary cathodes (see Figure 4A) to accelerate migration of the lithium solution. The system ran for four weeks, with an average consumption of 7.9 L of lithium solution per m³ of concrete (1.6 gal per yd³) (Vector 2001) (see Figure 4B).

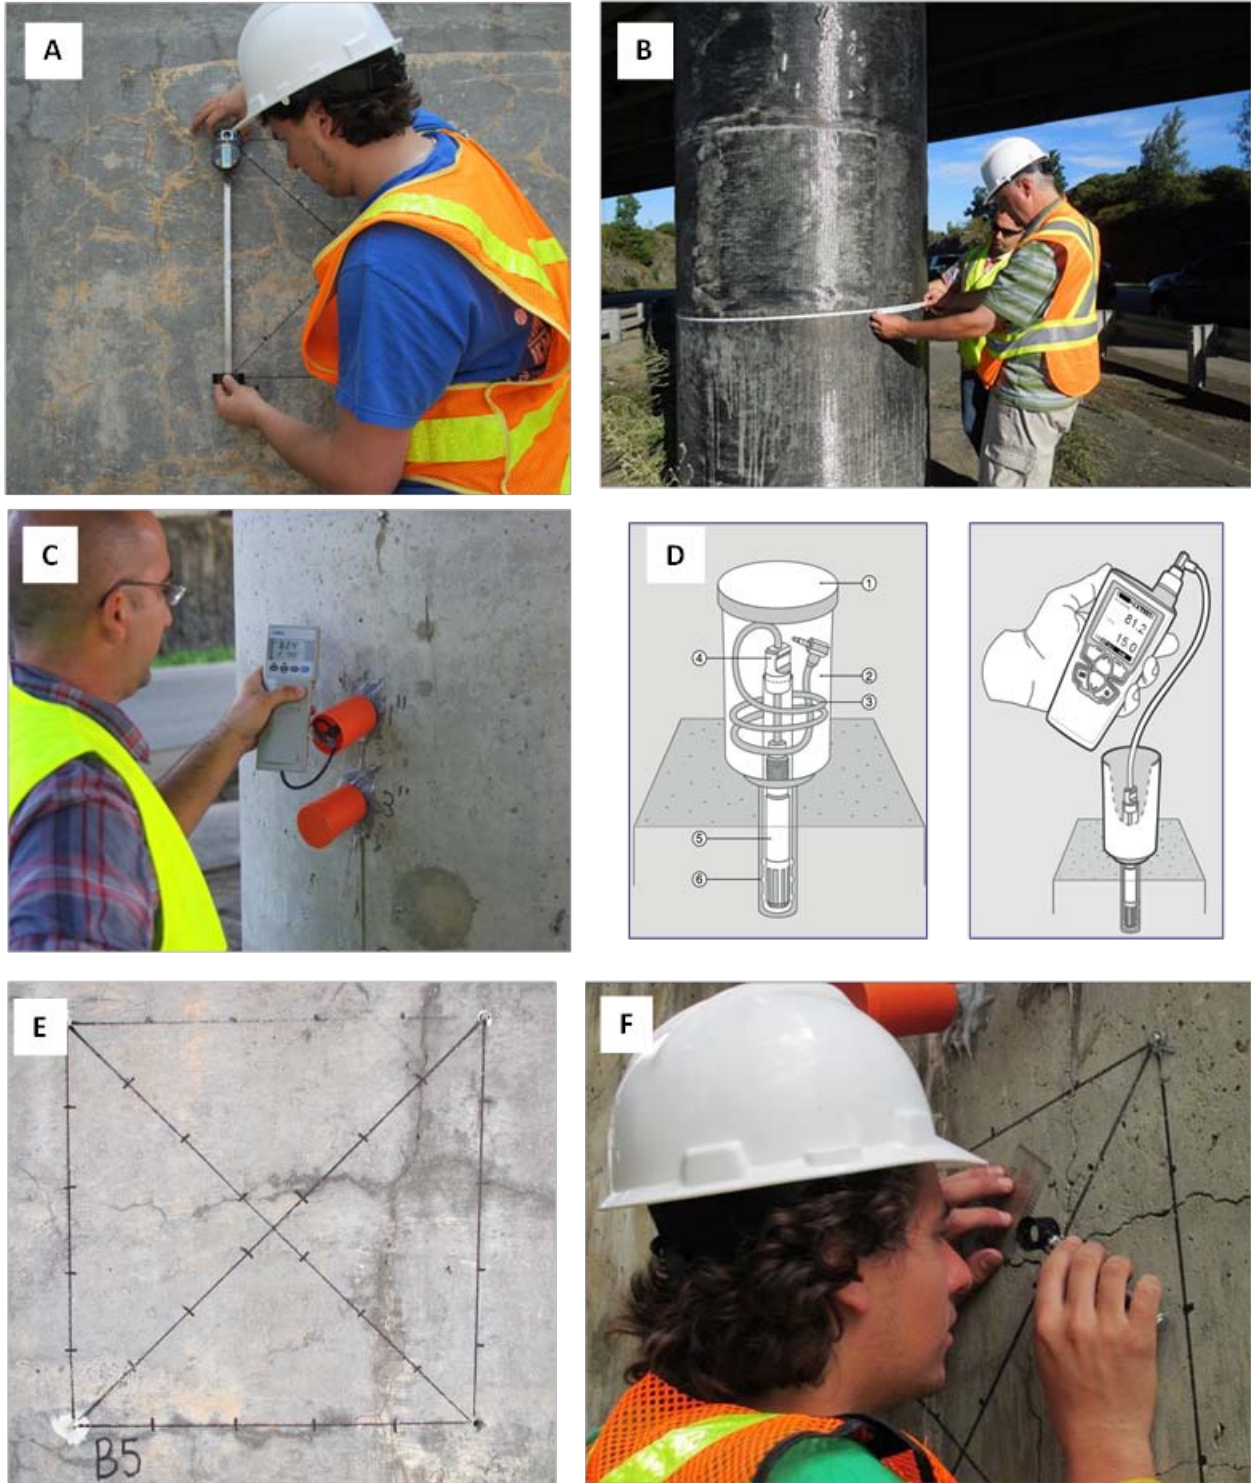
Figure 5. Expansion, RH, temperature, and CI measurements.

- A: Length-change measurements using DEMEC gauge. B: Circumferential measurements using a PI-tape.
 C: RH and temperature measurements. D: Vaisala RH probes (photo courtesy www.vaisala.com).
 E: Grid pattern used for CI. F: Performing Cracking Index.

The Cracking Index (CI) was measured by recording and summing the crack widths measured along a set of lines drawn on the surface of the selected sections (see Figure 5E and Figure 5F). When possible, 1000-mm (39.4-inch) squares are drawn on the surface of the structures, and the cracks that cross the vertical, horizontal, and diagonal lines (6 total) of the square are counted and measured (width estimated using a magnifying glass and a crack-indicator card). A Cracking Index is then calculated, and an average crack opening per unit length of structure can be determined. Note that a 500-mm (20-in.) square was used when the space for drawing the grid was limited.

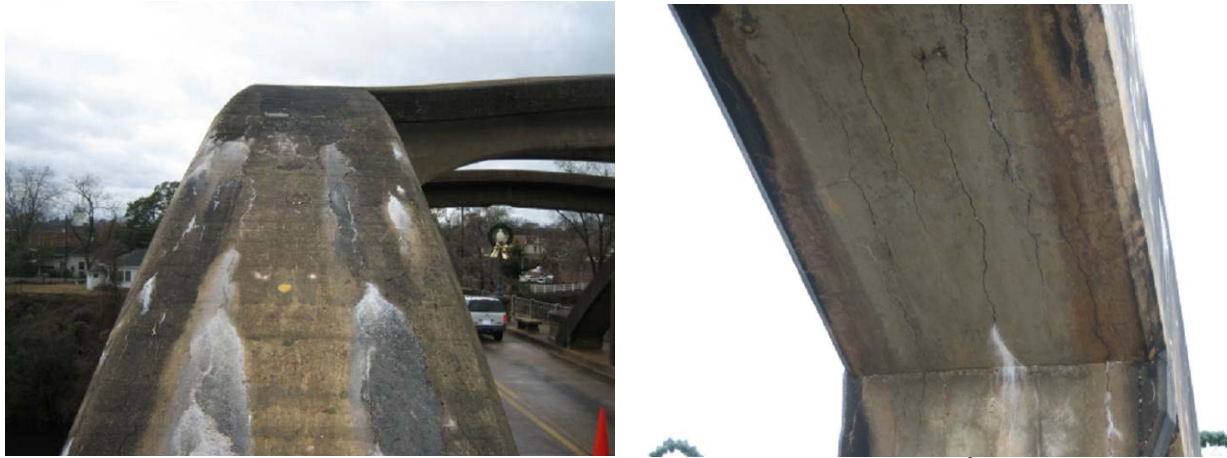
Figure 7. Cracking on top and underside of archway supporting 5th span.

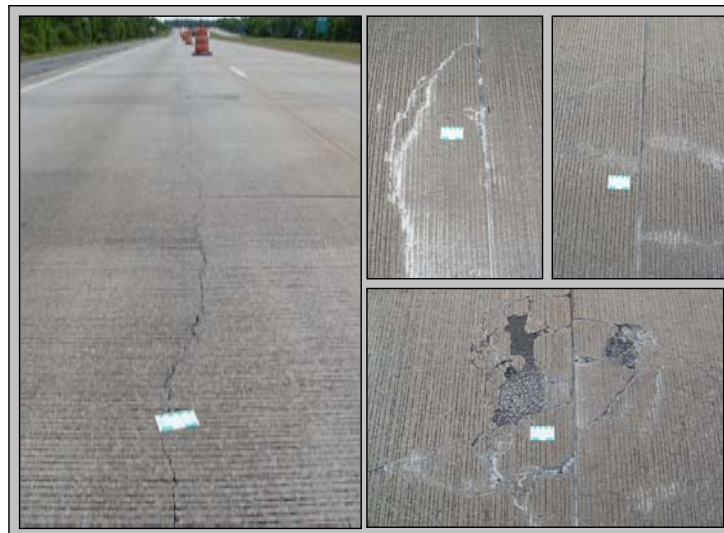
Figure 8. Typical distress observed in concrete pavement near Pine Bluff, AR.

In November 2011, a 19.3 km (12-mi) stretch of jointed plain concrete pavement (JPCP) on Interstate 530 near Pine Bluff, AR was visually inspected for symptoms of ASR. Distress in the form of map-cracking, joint cracking and distress, and efflorescence/gel staining was quite common, with the extent ranging from minimal to moderate to severe (Figure 8).

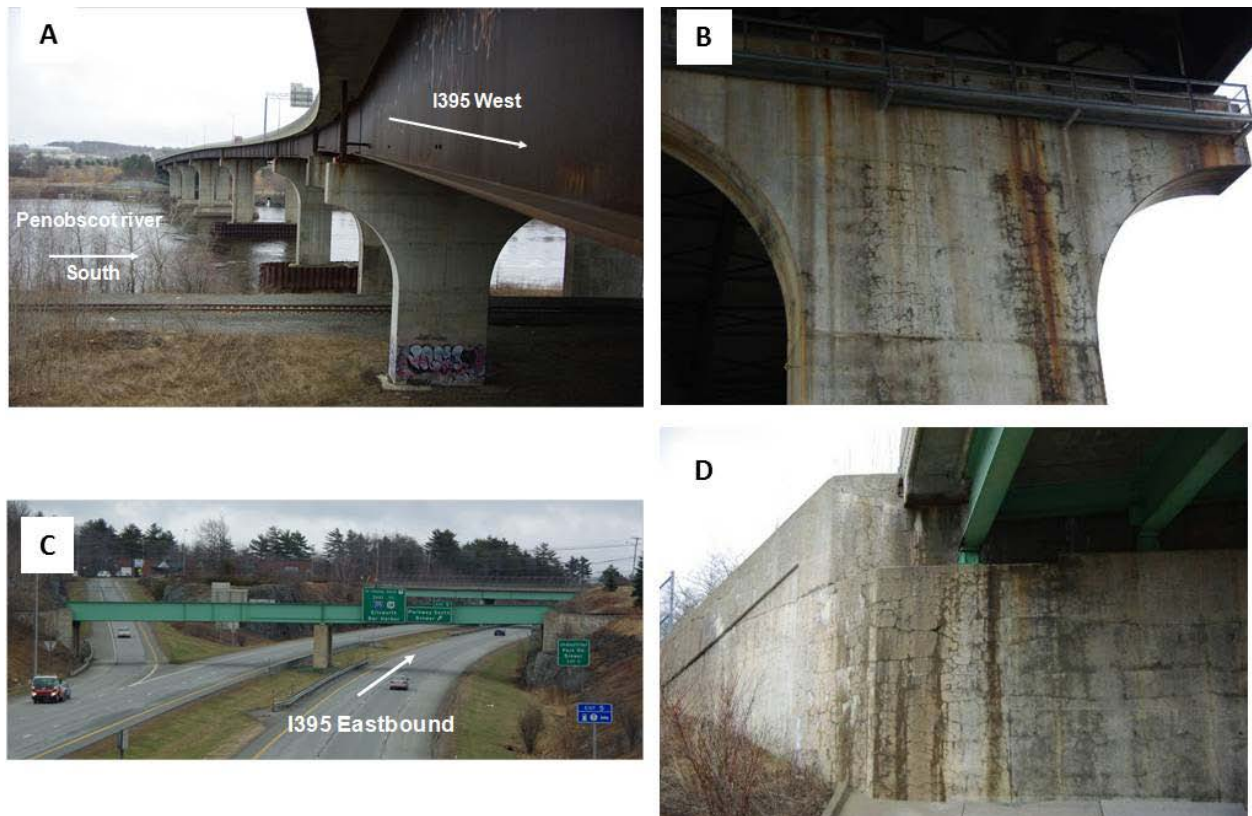
Figure 9. I-395 and 5th Parkway bridges.

A: Bridge carrying I-395 over the Penobscot River showing (B) increased cracking on exposed part of pier.
C: Bridge carrying 5th Parkway over I-395 showing (D) increased cracking on wing wall and the exposed part of the abutment.

In April 2009, a number of bridge structures along Interstate 395 near Bangor, ME were inspected for symptoms of ASR-related distress. The symptoms consisted of map cracking in abutments, wing walls, and columns; some preferred alignment (vertical) of cracks was observed in columns. The extent of damage ranged from mild to severe within a given structure depending on the nature of the exposure. Concrete that was directly exposed to rainfall exhibited very severe cracking in some cases, whereas the damage observed on parts of the same structure that were protected from rainfall by the bridge deck showed considerably less damage (see Figure 9).

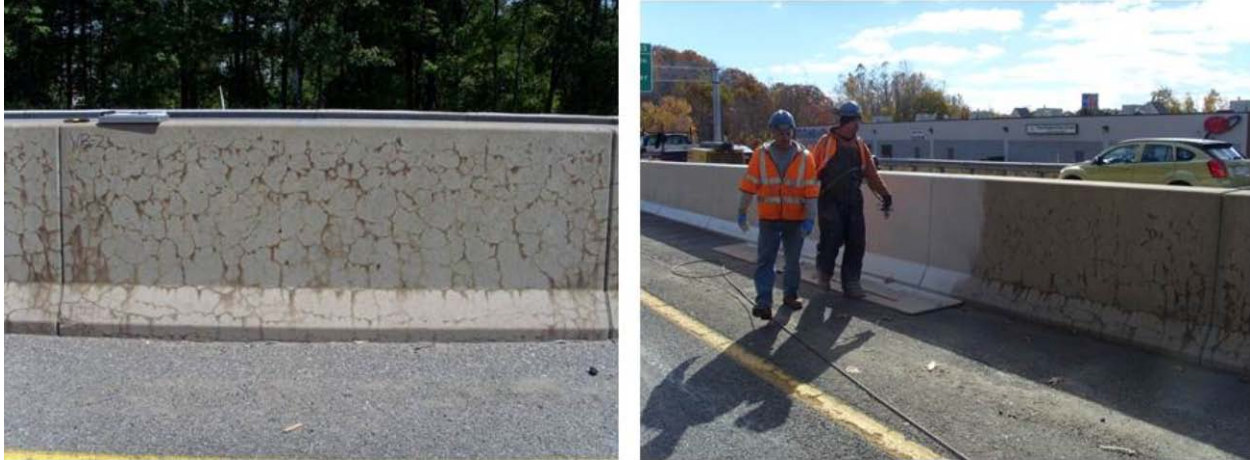
Figure 11. Typical ASR damage on barrier walls (left) and barriers treated with elastomeric coating.

- In July 2005, approximately 40 sections of barrier wall were treated with a range of products including different silanes and lithium nitrate as described below; this is referred to as the “original test section.”
- Later in 2005, MassDOT treated additional barriers, beyond this original test section, with silane (40 percent silane, water-based); this is referred to as the “extended test section.” A selected number of these barriers were also monitored.
- In 2010, most of the barriers in the “extended test section” treated by MassDOT were subsequently treated under the FHWA Development and Deployment Program with an elastomeric paint that aimed to serve as a breathable, flexible coating that may provide additional resistance to freezing and thawing damage observed on the bottom sloping face of the barriers (see Figure 11).

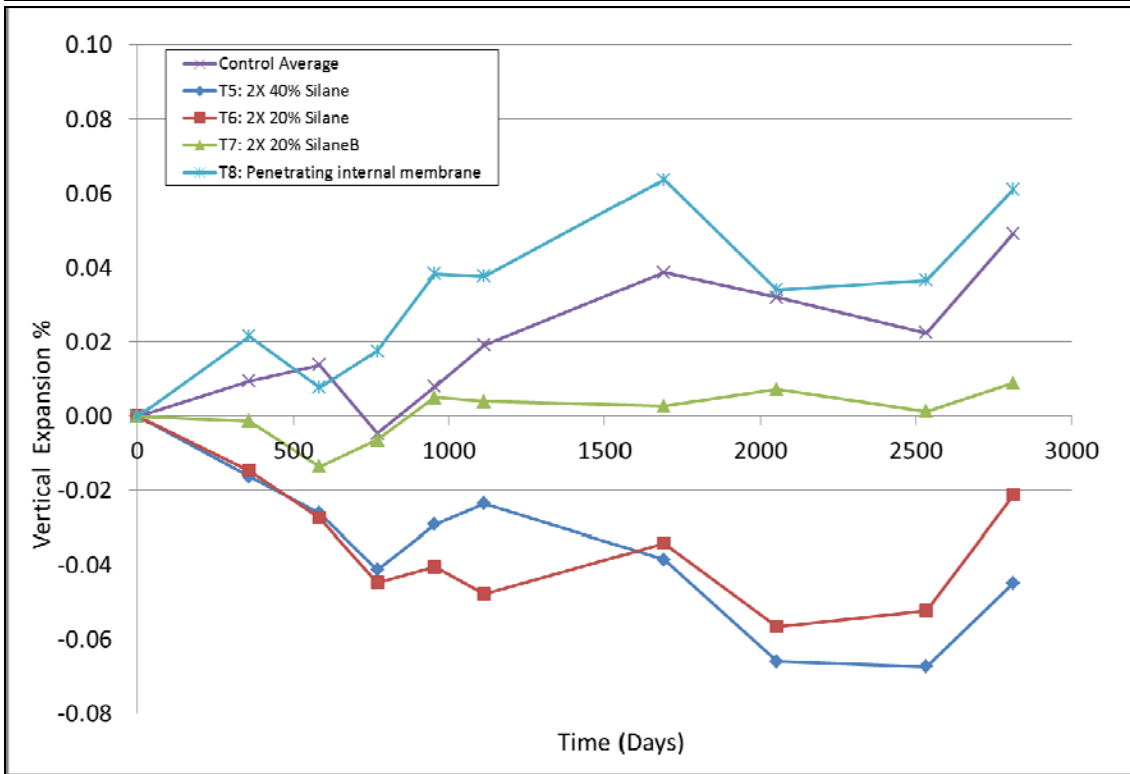
Figure 12. Average vertical expansion of treated and control barrier walls.

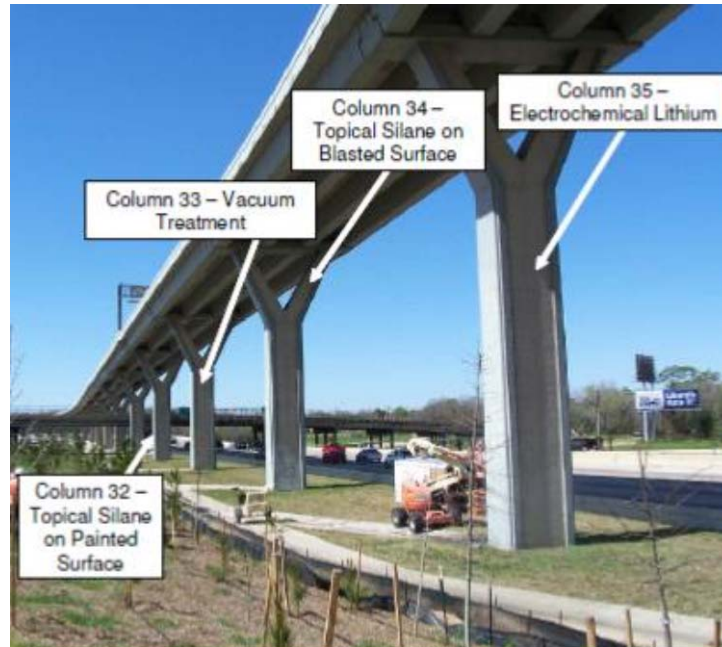
Figure 14. Columns 32-35 in Houston, TX.

Based on these preliminary visual inspection and laboratory data, it was decided to select a total of 12 columns for treatment and monitoring; one set of six columns (Columns 31, 32, 33, 34, 35, and 36) was selected to represent moderate-to-severe visual damage, and a second set of six columns (Columns 41, 42, 43, 44, 45, and 46) was selected to represent slight-to-moderate visual damage. The types of treatment applied are summarized in Table 2.

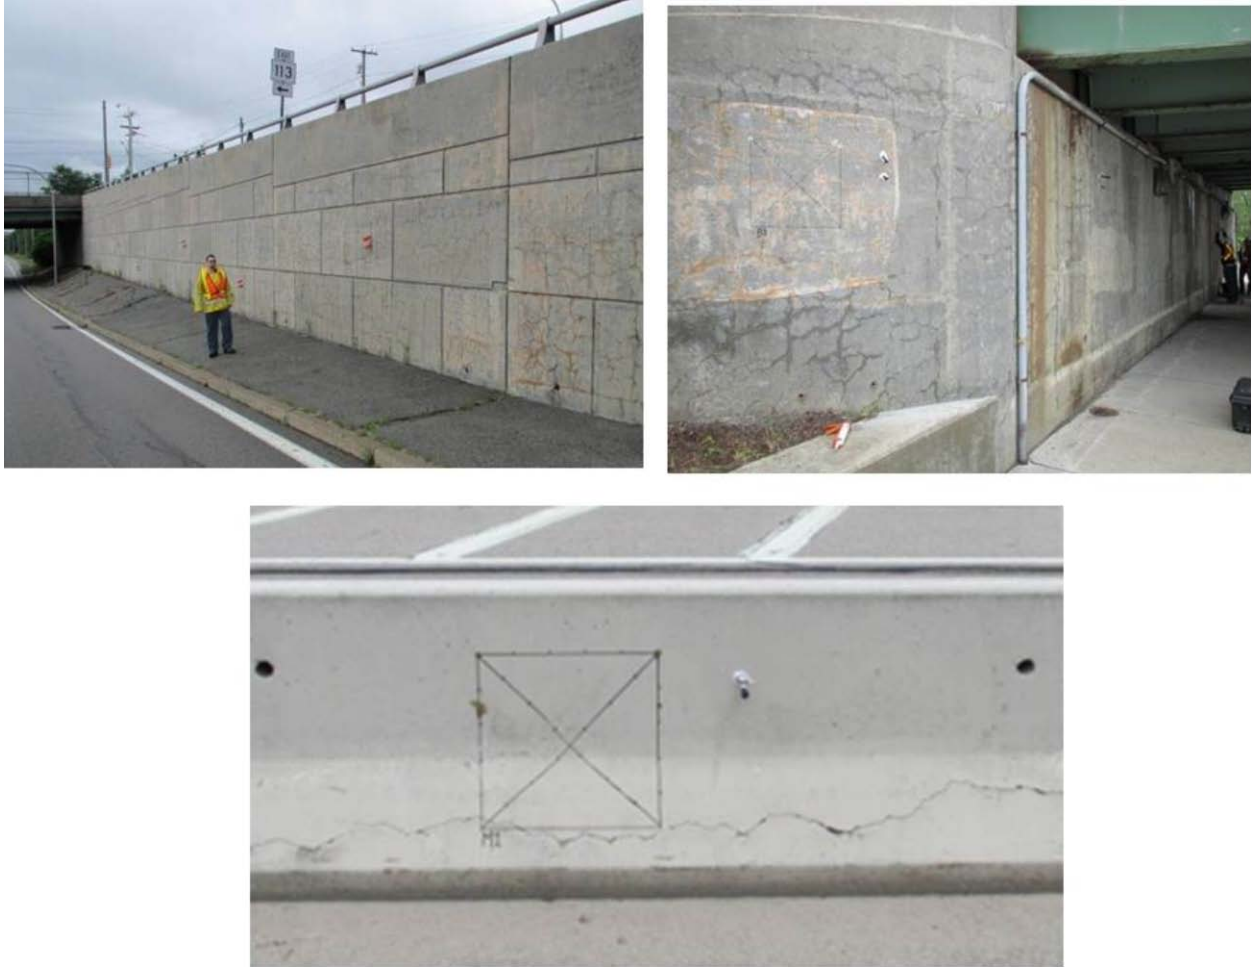
Figure 15. Cracking in retaining wall (top left), wing wall and bridge abutment (top right), and median barrier wall (bottom).

In May 2011, a field visit to a series of concrete structures in Rhode Island was conducted. A number of structures (bridge abutment, retaining wall, and median barrier walls) along Post Road and Post Road Extension, in Warwick, RI, were identified as potentially suffering from ASR-induced cracking (Figure 15). Petrographic examination of cores confirmed ASR as a cause of deterioration, with the extent of the reaction ranging from low to moderate for the abutments, wing walls, and retaining walls, and moderate to high for the barrier wall. Aggregate particles in the cores show a wide variety of petrographic compositions (quartzite, granitic gneiss, sandstone).

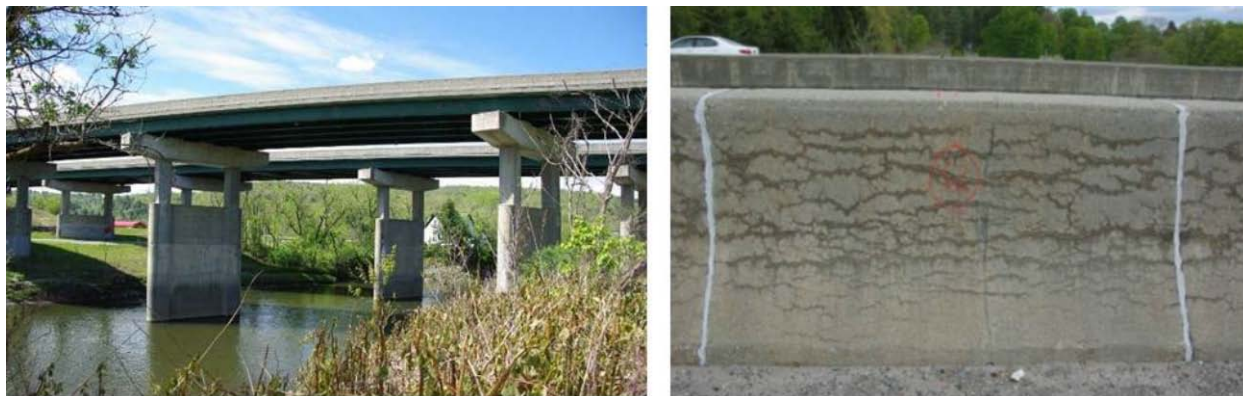
Figure 16. Bridges (left) carrying I-89 over U.S. 2/State St. and the Dog River near Montpelier, VT, and cracking on barrier walls (right).

(longitudinal) cracking with severity ratings ranging from mild to severe. Concrete cores for petrographic examination were taken from locations showing either a moderate-to-severe or mild degree of damage. The presence of ASR was confirmed with reactive components (e.g., schist, microquartzite, sandstone, argillite, and other undifferentiated magmatic rocks) being found in the sand. DRI values ranged from low (53 to 202) to high (647 and 568), indicating that the extent of ASR varied from low to moderate to severe; the DRI values for cores were generally consistent with the extent of visible damage on the structure in the location where the cores were taken.

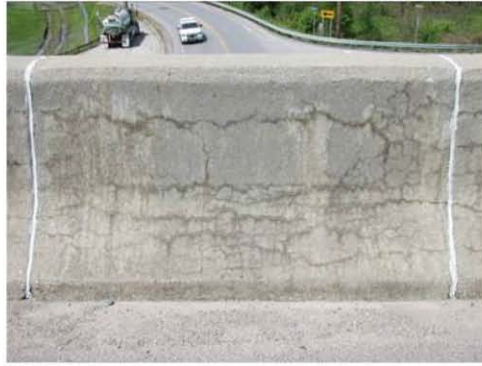
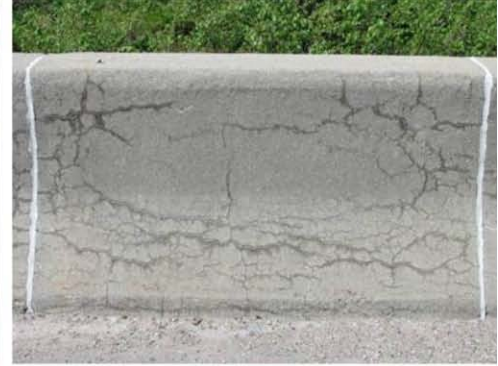
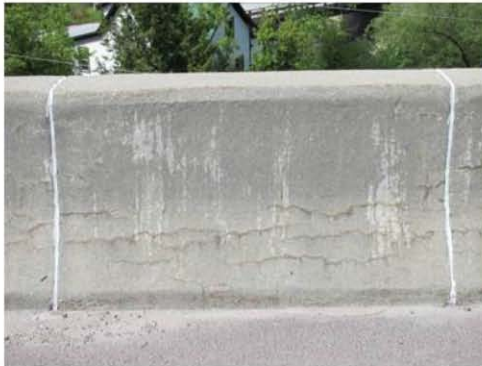
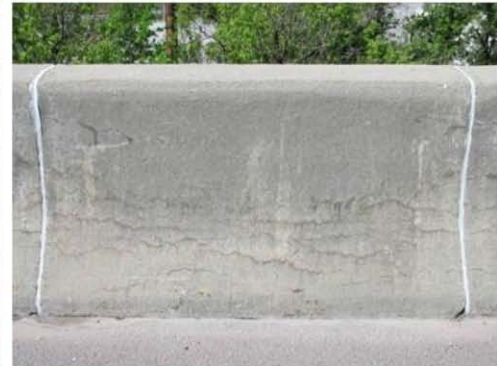
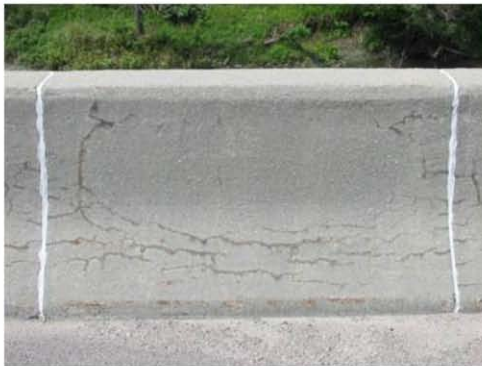
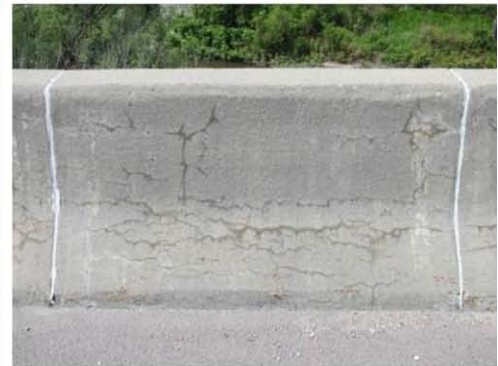
Figure 17. Barriers in 2013 (approximately two years after treatment).

treatment. The elastomeric coating has covered up any sign of visible cracking, and a longer evaluation period is required to determine if this is a permanent improvement. The extent of visible cracking is much less on the barrier walls treated with silanes compared to the control (untreated) sections, and this is largely the result of reducing moisture and exudation activity in the vicinity of the cracks after treatment with a hydrophobic sealer (silane). Again, a longer study period is required to fully evaluate the long-term impact of the treatments on the service life of the barriers.

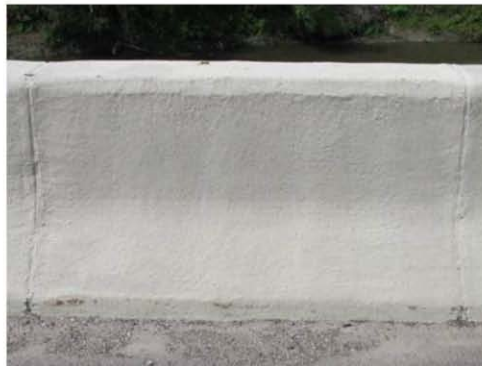
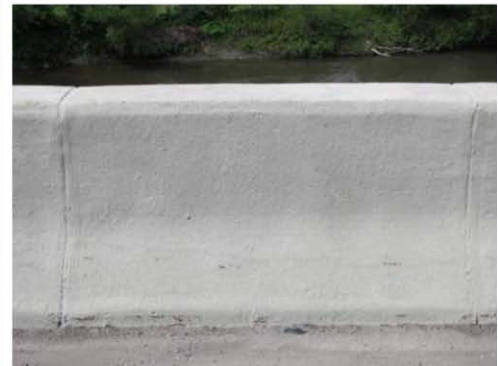
Elastomeric
coating

With only two years of monitoring data accumulated, it is currently too early to conclude on the efficacy of the above treatments at reducing the deleterious effects of ASR on the barrier walls treated. However, interesting trends have been identified, for instance possible reductions in the relative humidity values in the surficial portions of the barrier walls treated with penetrating sealers and elastomeric coating, and in general a better visual appearance of the treated barrier walls compared to the control sections. Long-term monitoring is expected to provide data on the effect of various types of surface treatments on the progress of ASR-related damage in the above elements. Figure 17 illustrates the barriers initially and in 2013, approximately two years after

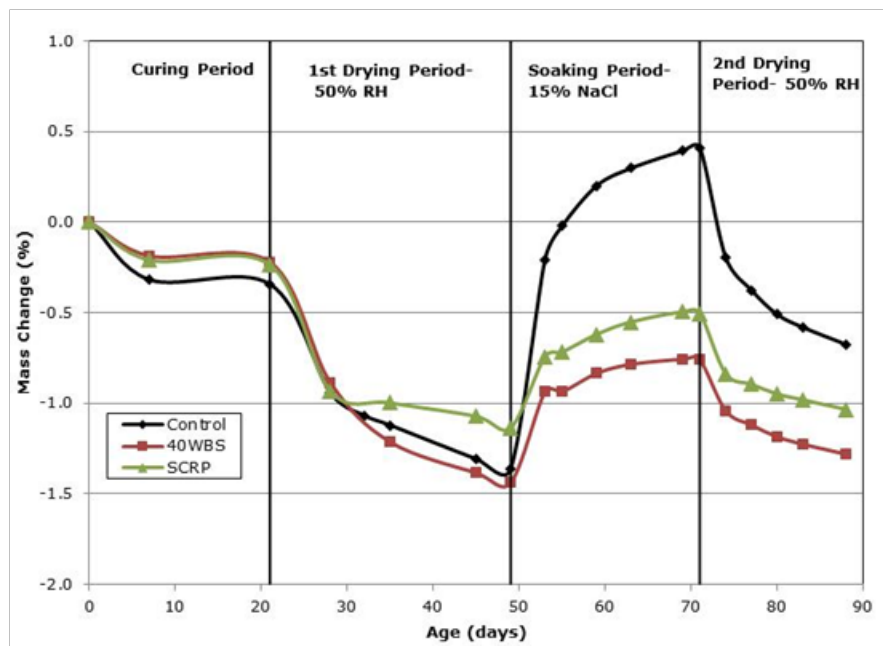
Figure 18. Mass change of specimens during NCHRP Series II testing. (After Wehrle et al. 2010.)
