High Performance Concrete Pavements

Project Summary

Publication No. FHWA-IF-06-031
February 2006

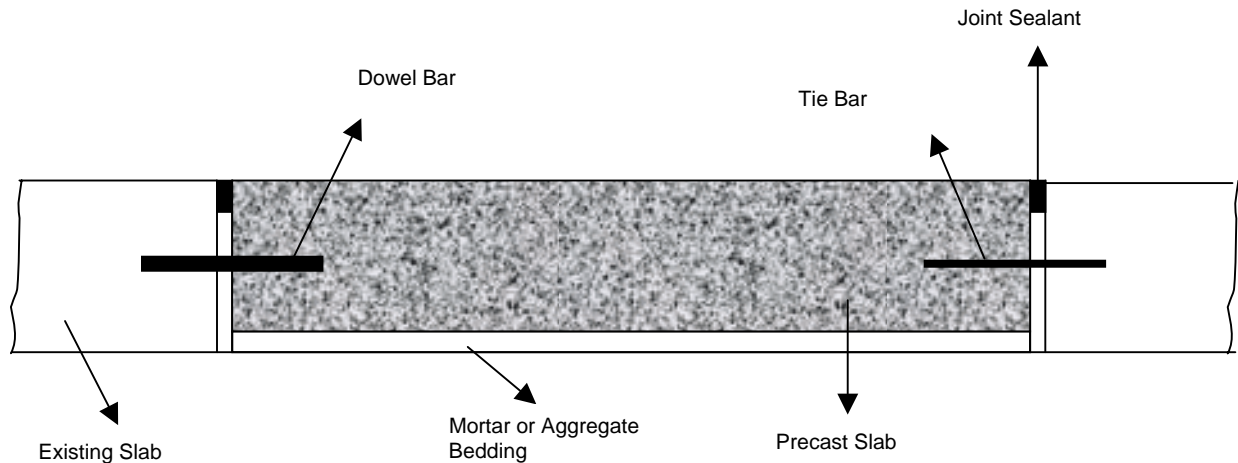
Figure 3. Precast panel design for Michigan.

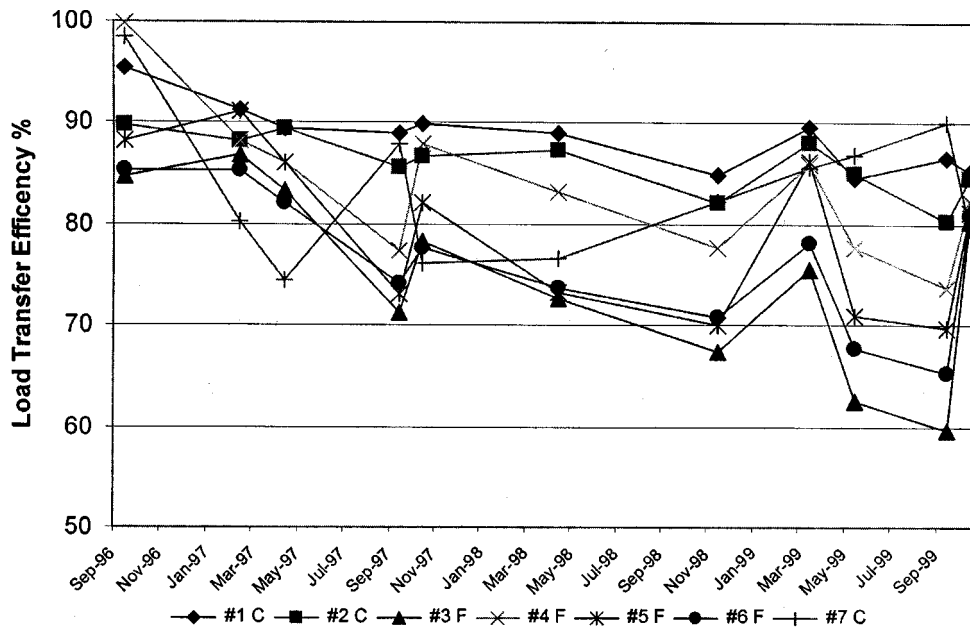
A gradual decrease in overall load transfer efficiency is observed in Figure 8, with the conventional steel dowel bars consistently showing higher levels of load transfer than the fiber composite bars. But, as seen in Figure 9, the largest deflection is consistently shown by one of the conventional doweled joints, although the other two conventional doweled joints show consistently low deflections. LTE values less than 70 percent provide very low stress load transfer, and the results of the LTE testing suggest that many of the joints are exhibiting an unacceptable LTE level after only 7.5 years.

Figure 8. Load transfer efficiency on IL 1 (Gawedzinski 2000).

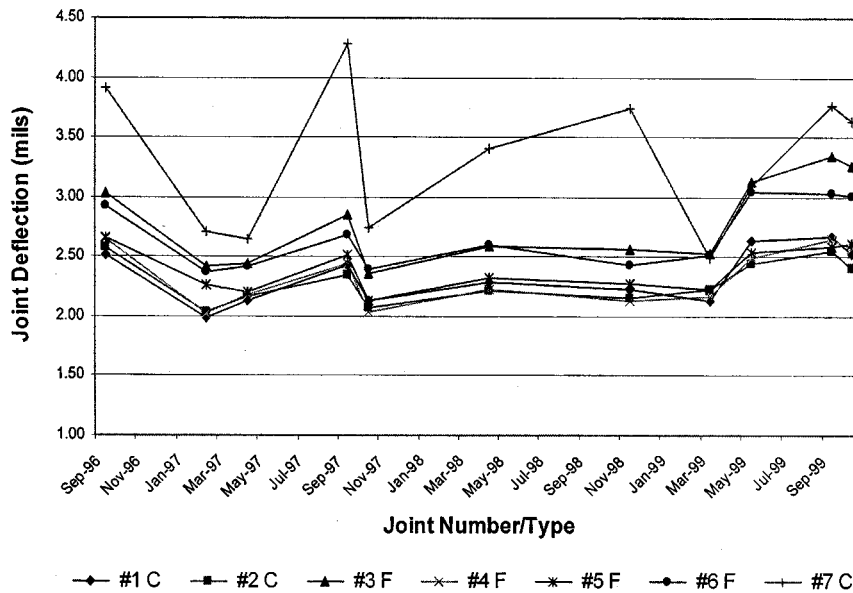
Figure 9. Maximum joint deflections on IL 1 (Gawedzinski 2000).

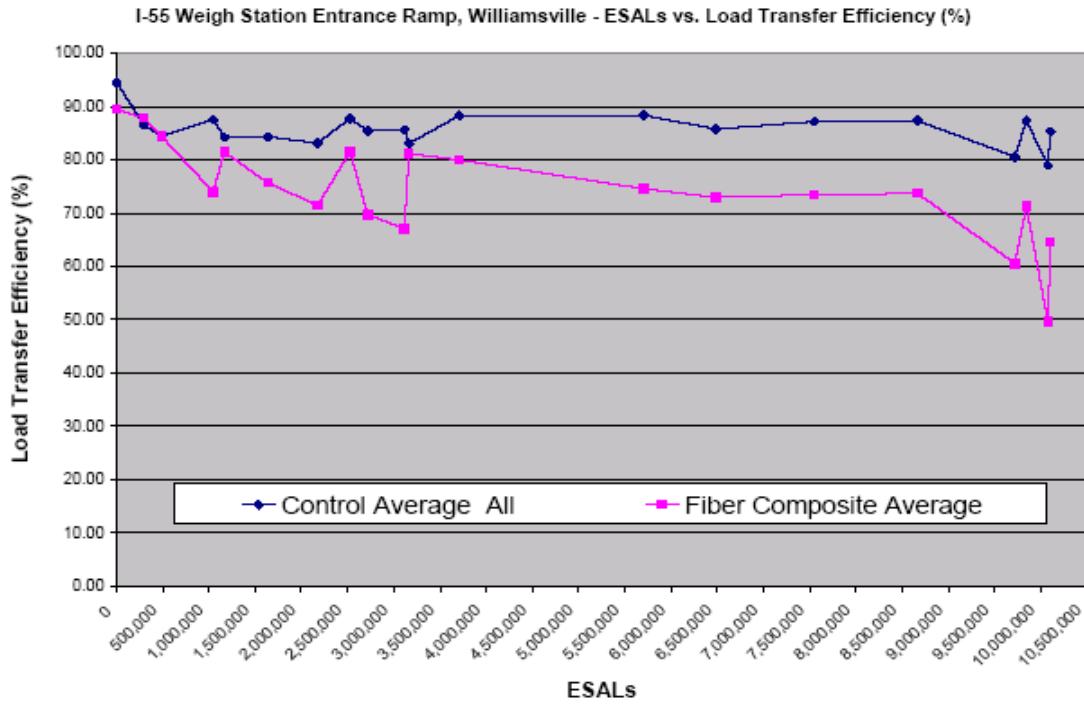
Figure 10. Load transfer efficiency vs. ESALs (Gawedzinski 2004).

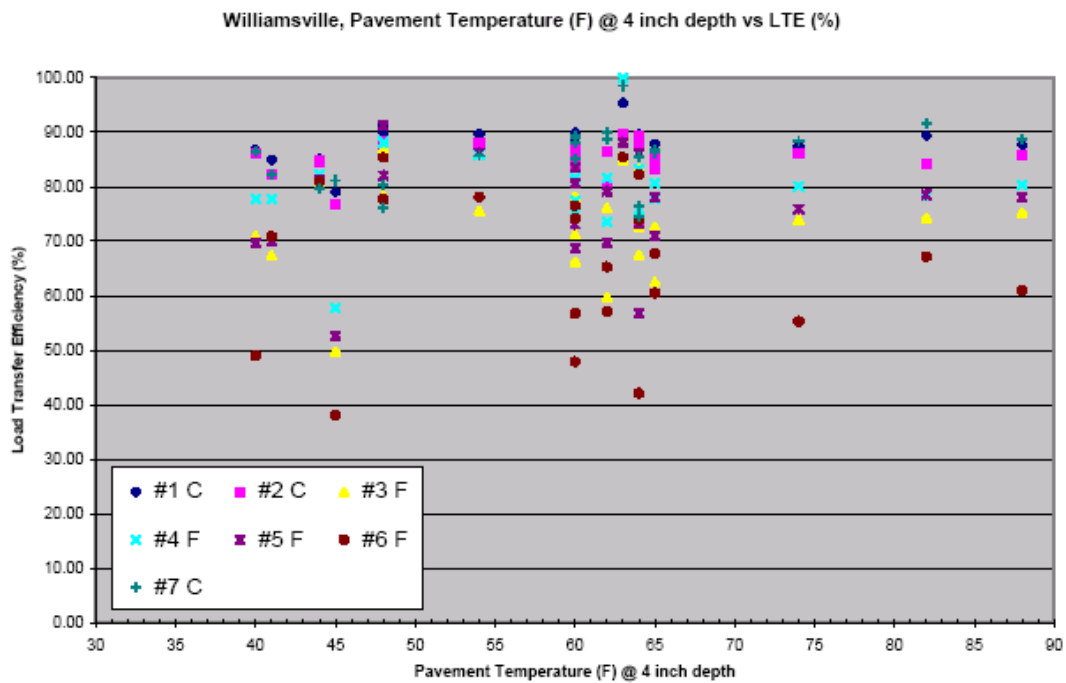
Figure 11. Load transfer efficiency vs. pavement temperature (Gawedzinski 2004).

More frequent FWD testing is planned for the Williamsville site in order to evaluate what causes this response for the bars. Data show LTE and joint deflection do not appear to be affected by changes in pavement temperature. It is unknown what the moisture content is at the dowel bar/joint interface and how much the moisture content effects LTE and joint deflections.

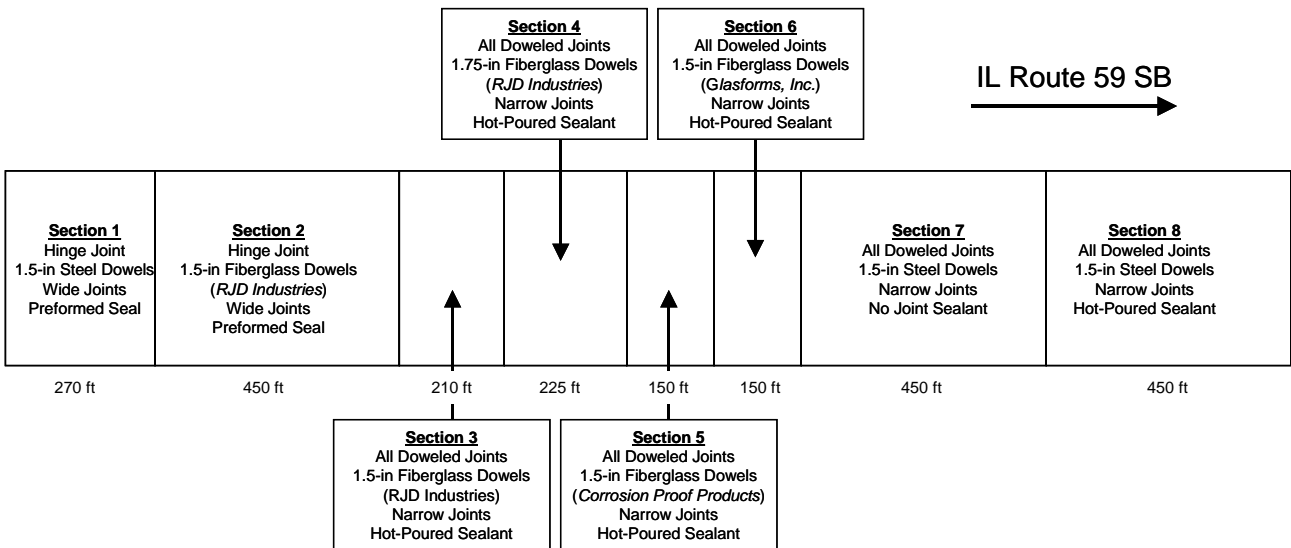
The layout of the sections is presented in Figure 13. This figure summarizes the main features included in each of the sections. The experimental design matrix for this project is shown in Table 7.

Figure 13. Layout of IL 2 project.

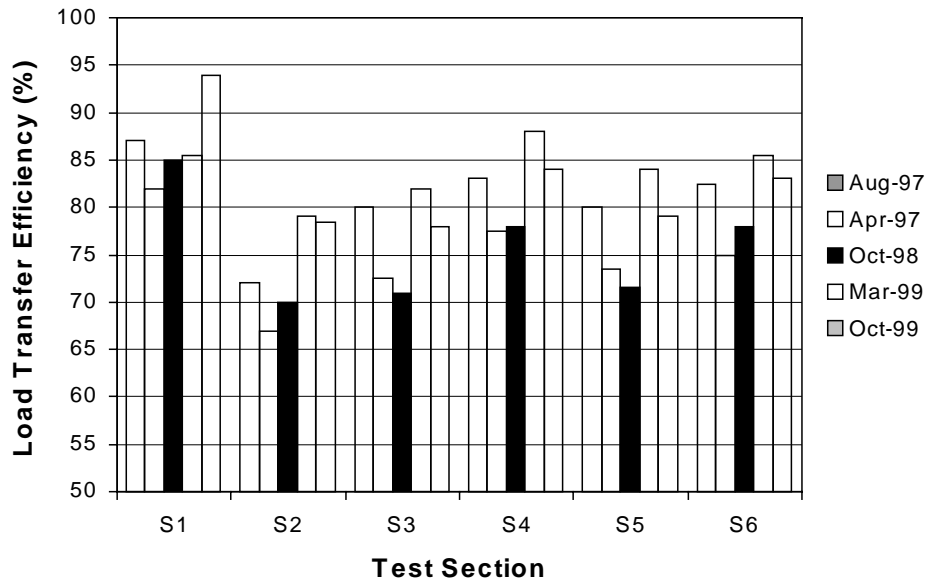
Figure 14. Load transfer efficiency on IL 2 (Gawedzinski 2000).

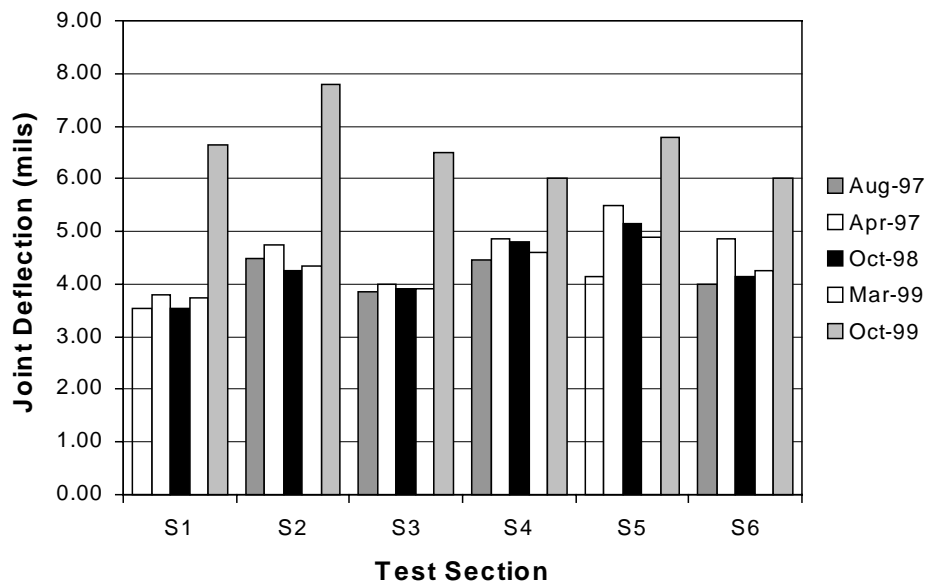
Figure 15. Maximum joint deflections on IL 2 (Gawedzinski 2000).

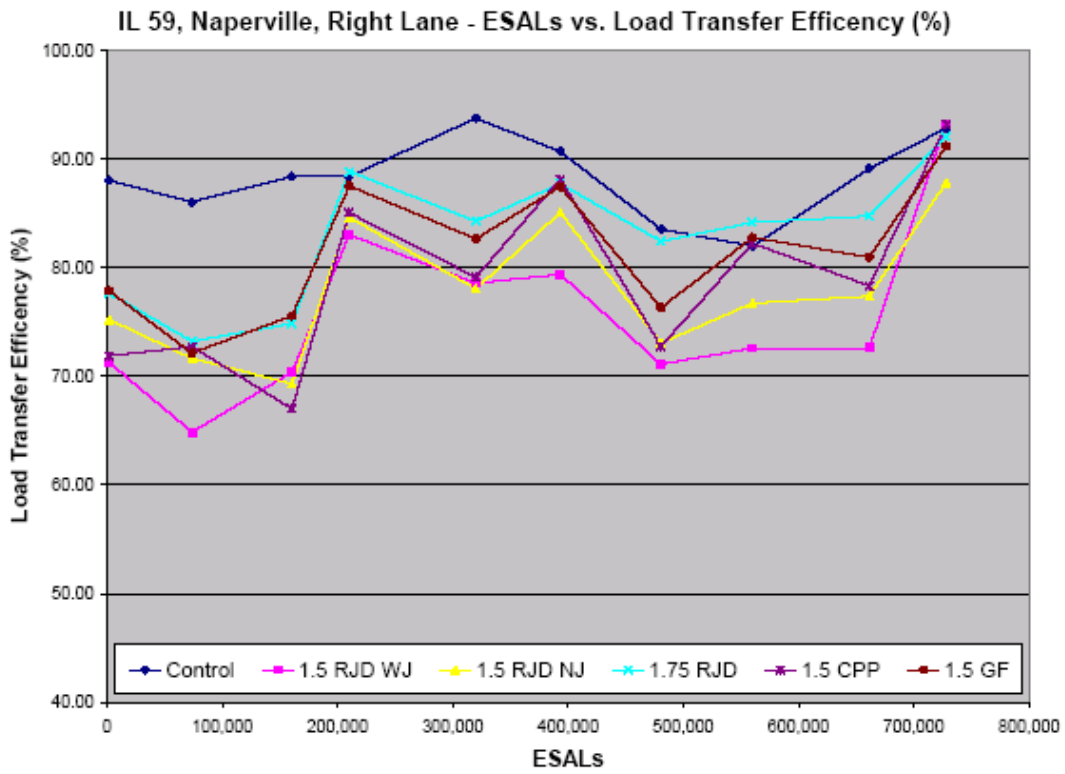
Figure 16. Load transfer efficiency vs. ESALs for the right lane (Gawedzinski 2004).

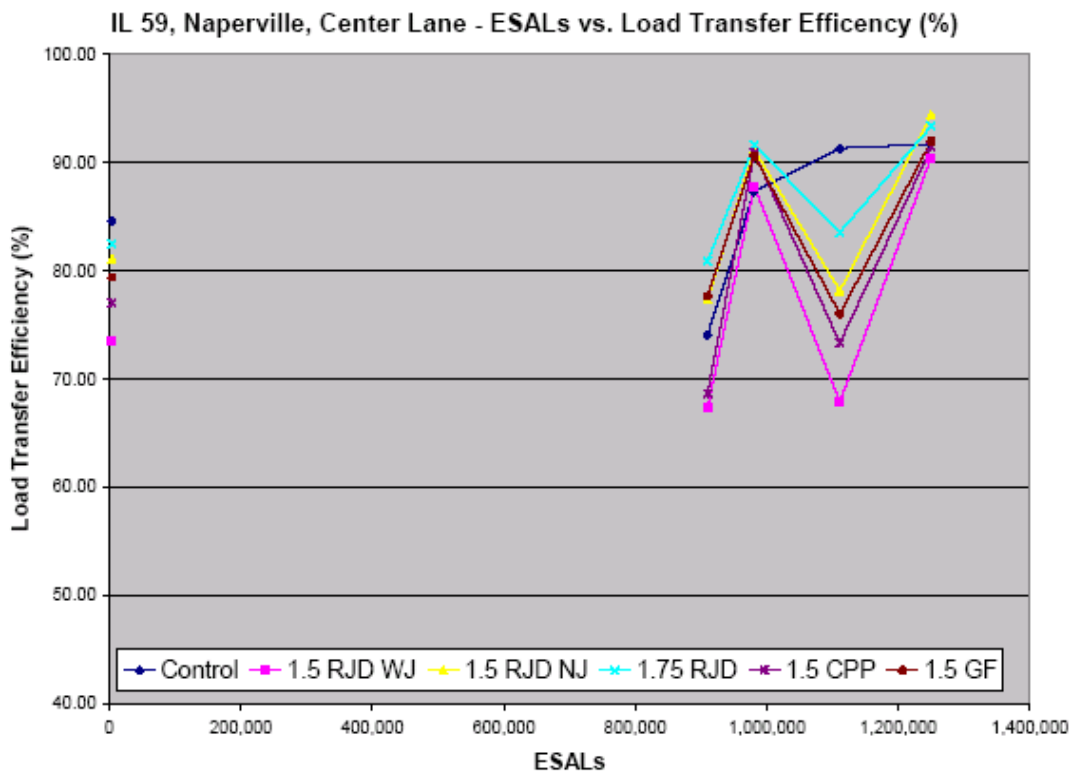
Figure 17. Load transfer efficiency vs. ESALs for the center lane (Gawedzinski 2004).

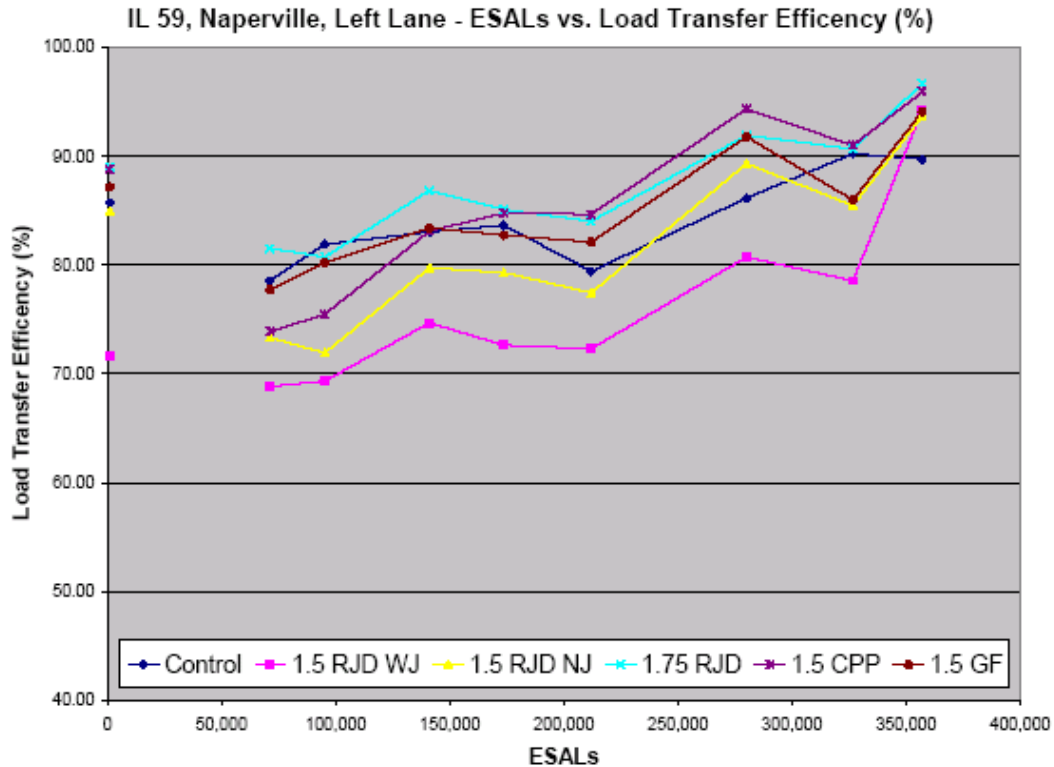
Figure 18. Load transfer efficiency vs. ESALs for the left lane (Gawedzinski 2004).

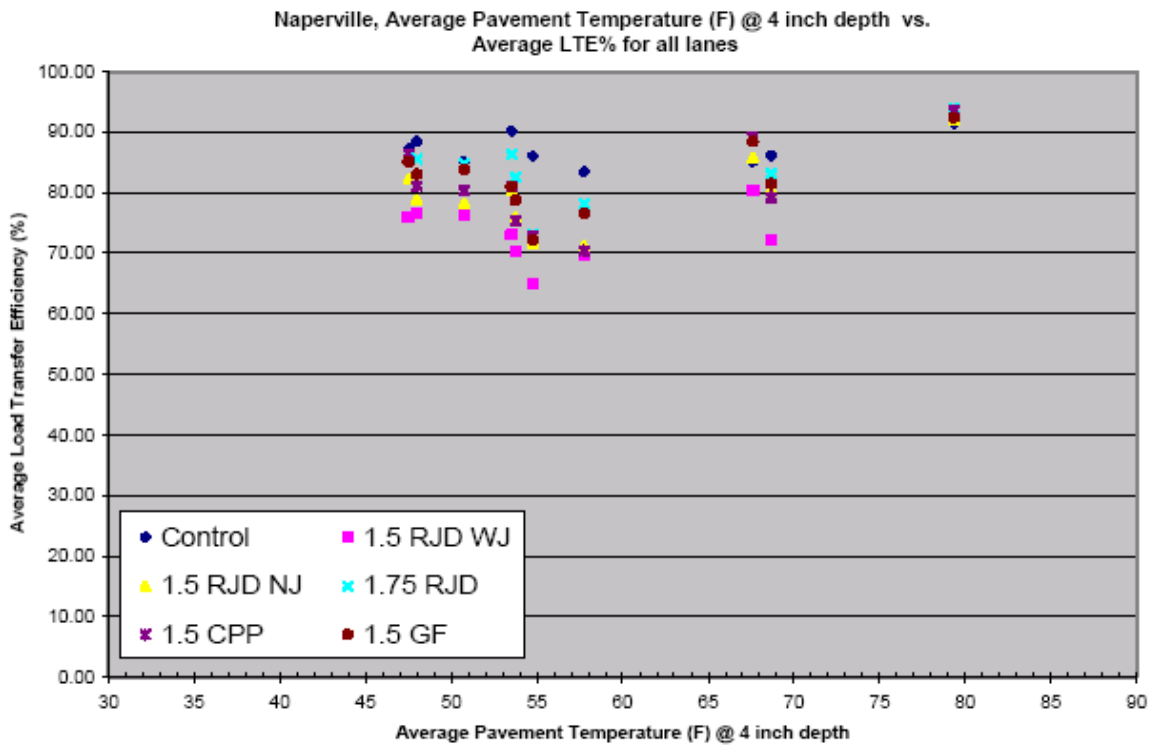
mils. The LTE graphs show behavior consistent with a decrease in joint deflection. Figure 19 shows the same type of behavior displayed at the Williamsville test site (IL 1). Plots of average values show no relationship between LTE or joint deflection and average pavement temperature. The control bars (38.1-mm [1.5-in.] diameter epoxy-coated carbon steel) have a higher LTE and lower joint deflection than any of the fiber composites, but the overall performance of the fiber composite bars appears to be very close to the behavior of the epoxy-coated steel control set. Nevertheless, LTE values on the order of 70 to 80 percent after only a few years of service may suggest that the FRP bars are not suitable for long-term performance.

Figure 19. Average load transfer efficiency vs. pavement temperature for all lanes (Gawedzinski 2004).

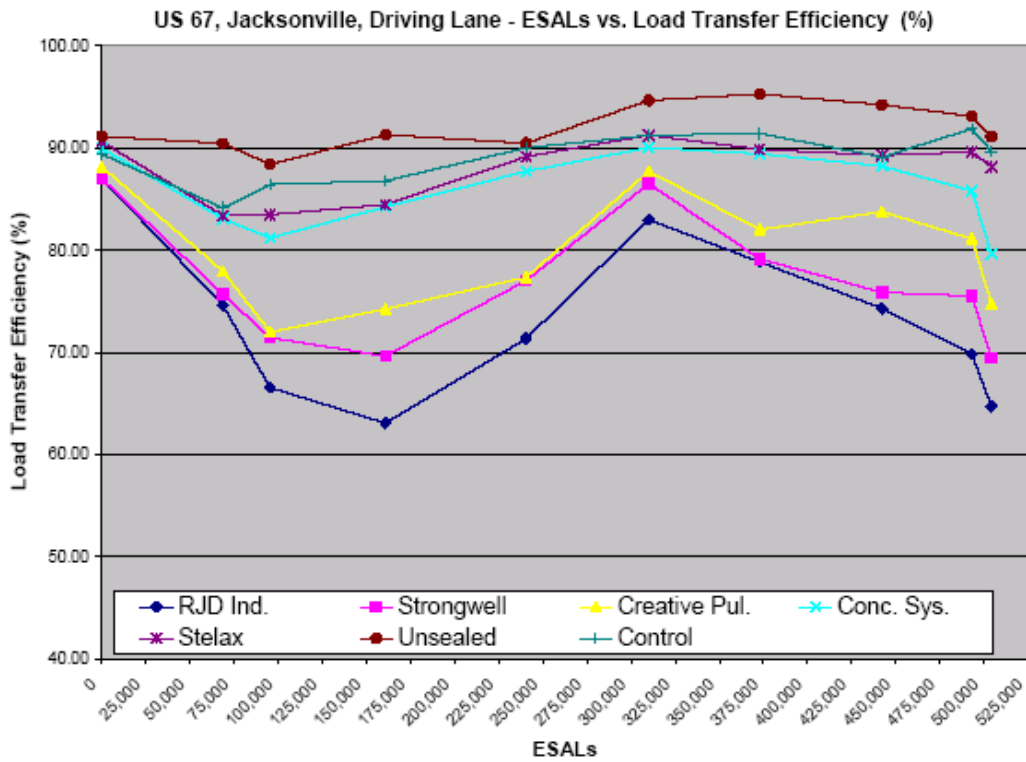
Figure 24. Driving lane load transfer efficiency vs. ESALs (Gawedzinski 2004).

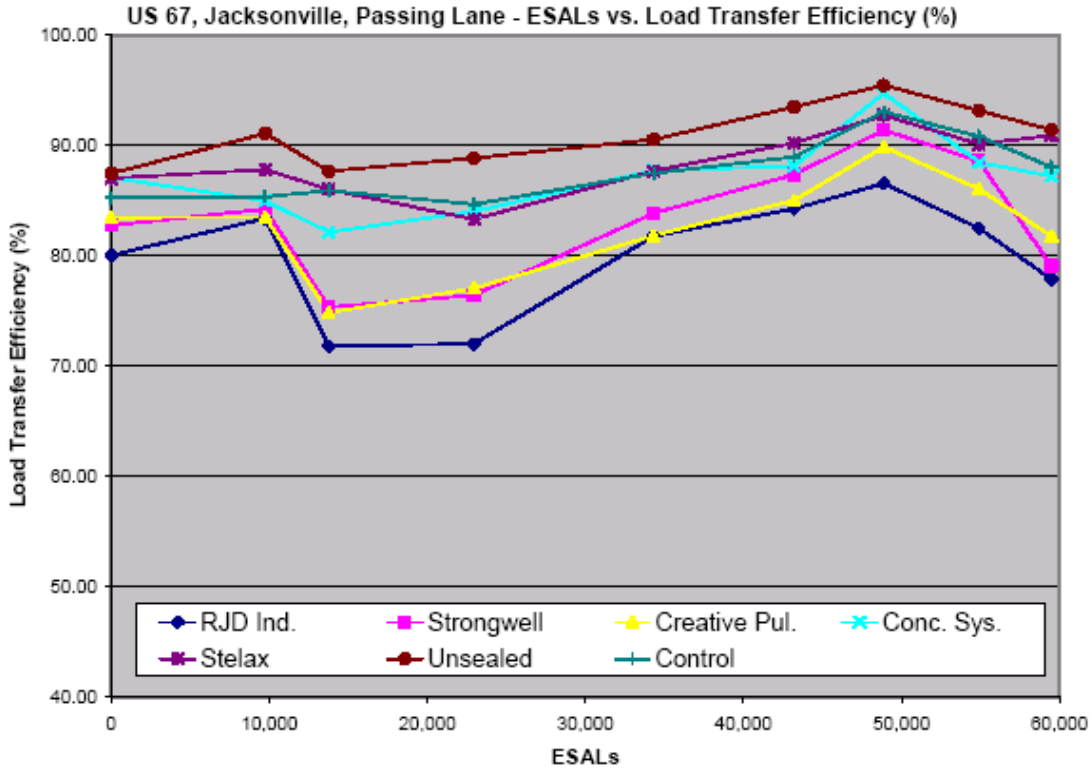
Figure 25. Passing lane load transfer efficiency vs. ESALs (Gawedzinski 2004).

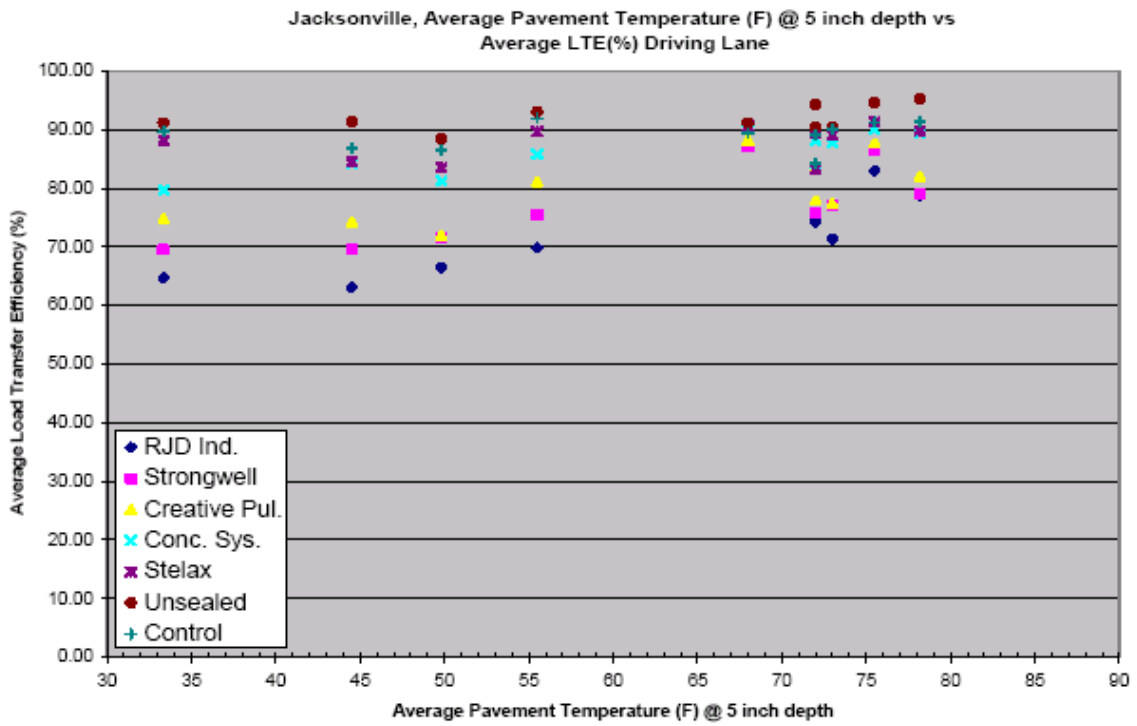
Figure 26. Average load transfer efficiency vs. average pavement temperature (Gawedzinski 2004).

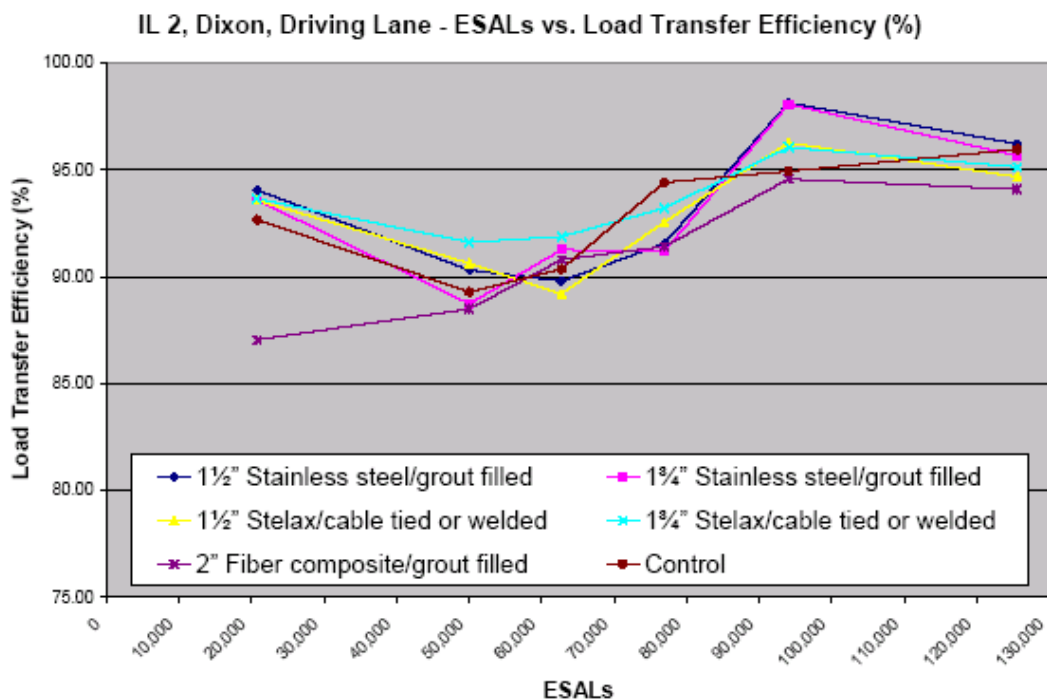
Figure 28. Driving lane load transfer efficiency vs. ESALs (Gawedzinski 2004).

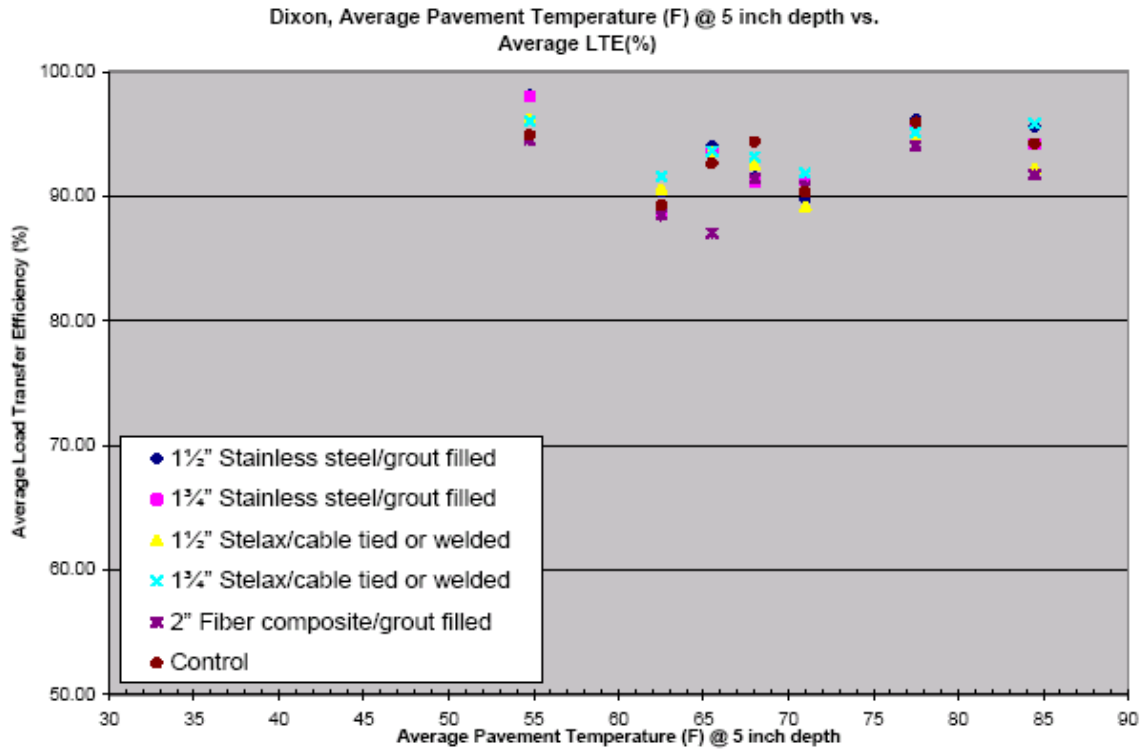
Figure 29. Average load transfer efficiency vs. average pavement temperature (Gawdzinski 2004).

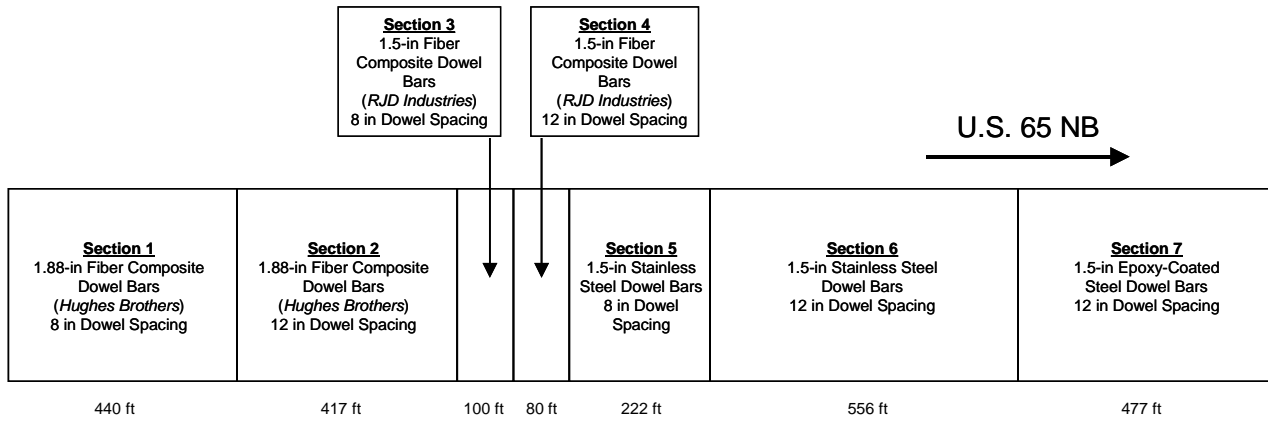
305-MM (12-IN.) JPCP, 6.1-M (20-FT) JOINT SPACING (SKEWED)				
	203-mm (8-in.) Dowel Spacing		305-mm (12-in.) Dowel Spacing	
	38-mm (1.5-in.) Diameter Dowel	48-mm (1.88-in.) Diameter Dowel	38-mm (1.5-in.) Diameter Dowel	48-mm (1.88-in.) Diameter Dowel
Fiber composite dowel bars (Hughes Brothers)		Section 1 (440 ft)		Section 2 (417 ft)
Fiber composite dowel bars (RJD Industries)	Section 3 (100 ft)		Section 4 (80 ft)	
Stainless steel dowel bars	Section 5 (222 ft)		Section 6 (556 ft)	
Epoxy-coated steel dowel bars			Section 8 (477 ft)

Figure 33. Layout of IA 2 project.

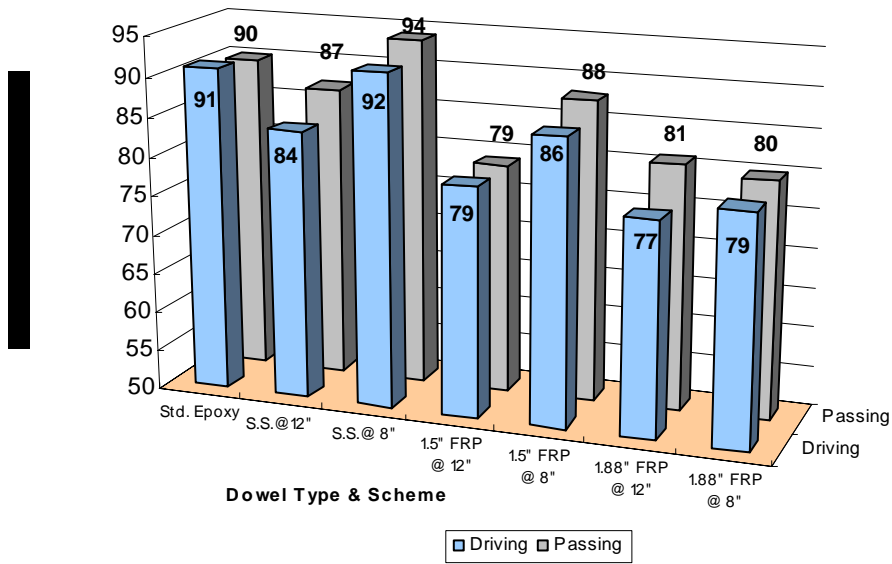
The results of the load transfer analysis are illustrated in Figure 35 (Cable and Porter 2003). In Figure 35, the dowel bars are labeled according to their material and spacing: standard epoxy (std. epoxy), stainless steel (S.S.), and fiber composite (FRP). Figure 36 displays the overall average faulting over the period of research (Cable and Porter 2003). Figure 37 illustrates the changes in joint openings over the research period (Cable and Porter 2003). Visual surveys of this project resulted in only minor corner cracking being noted immediately after construction. There are no visible signs of pavement distress that can be associated with joint reinforcement or typical highway loading over the 5-year monitoring period (Cable and Porter 2003).

Figure 35. Average load transfer efficiency for IA 2 project.

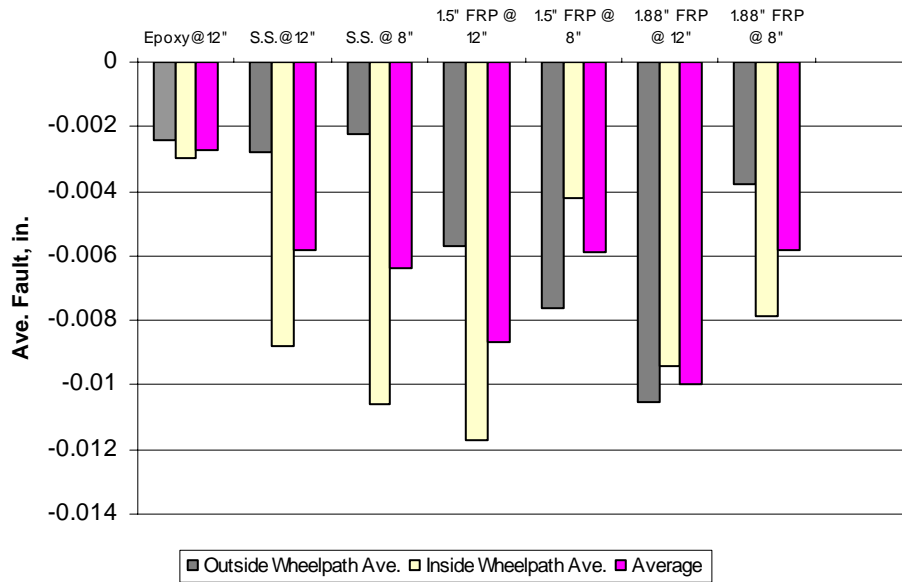
Figure 36. Average faulting on IA 2 project.

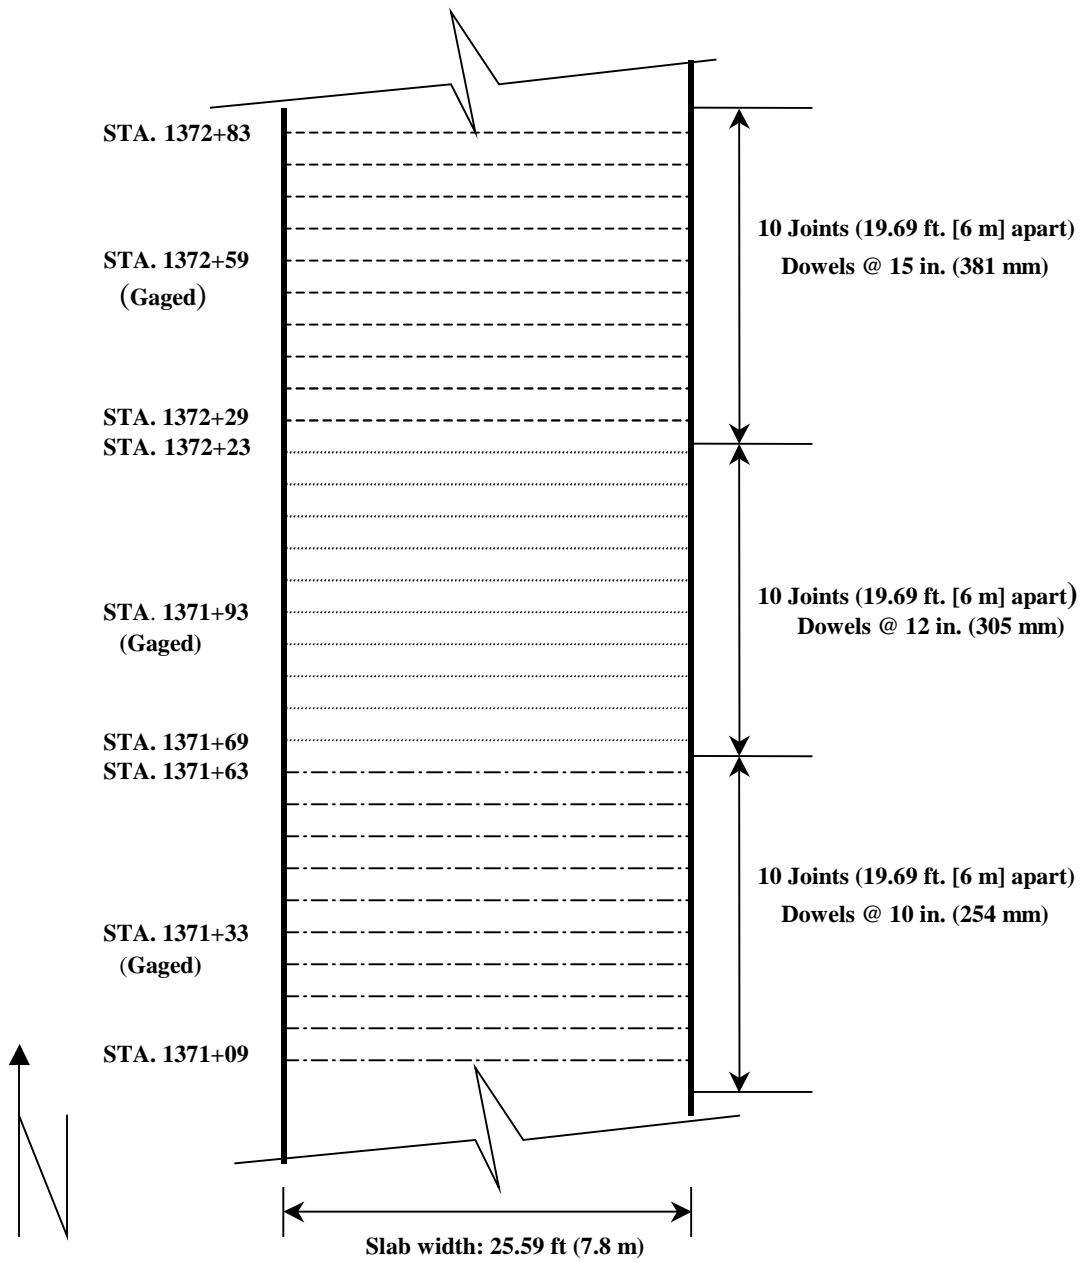
Figure 41. Layout of dowel bars on IA 5 project.

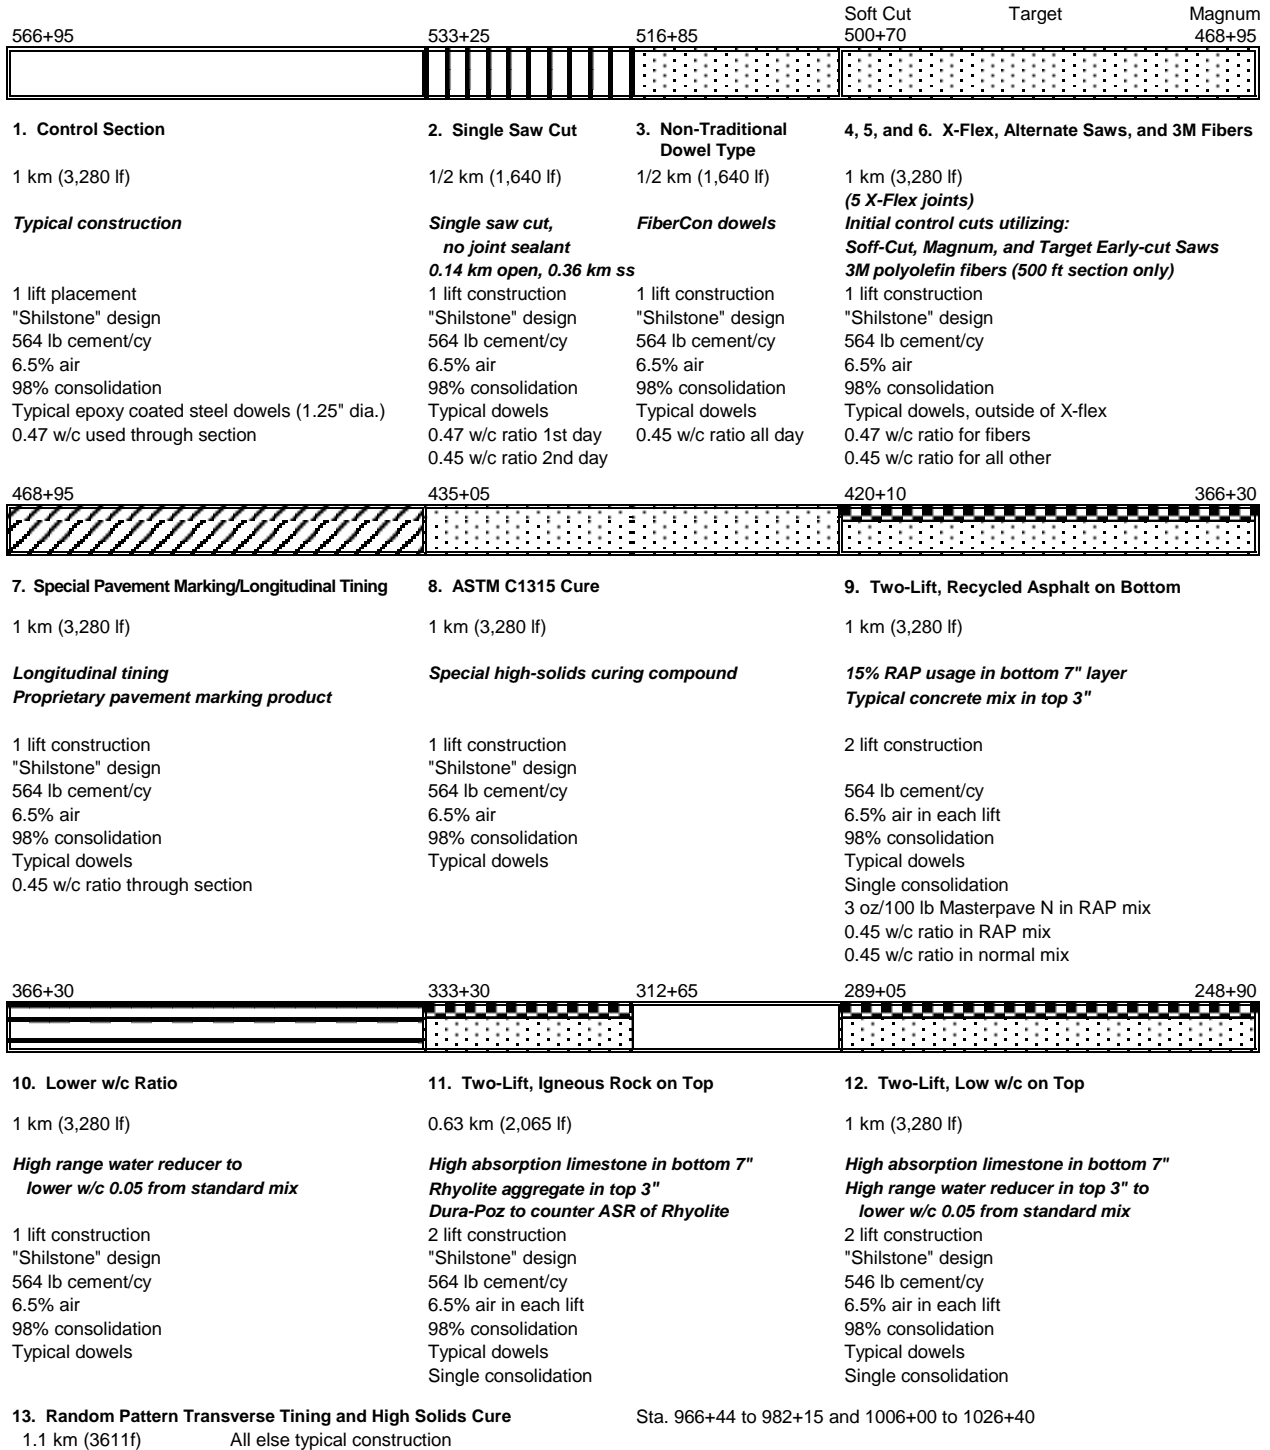
Figure 45. Layout of KS 1 project (Wojakowski 1998).

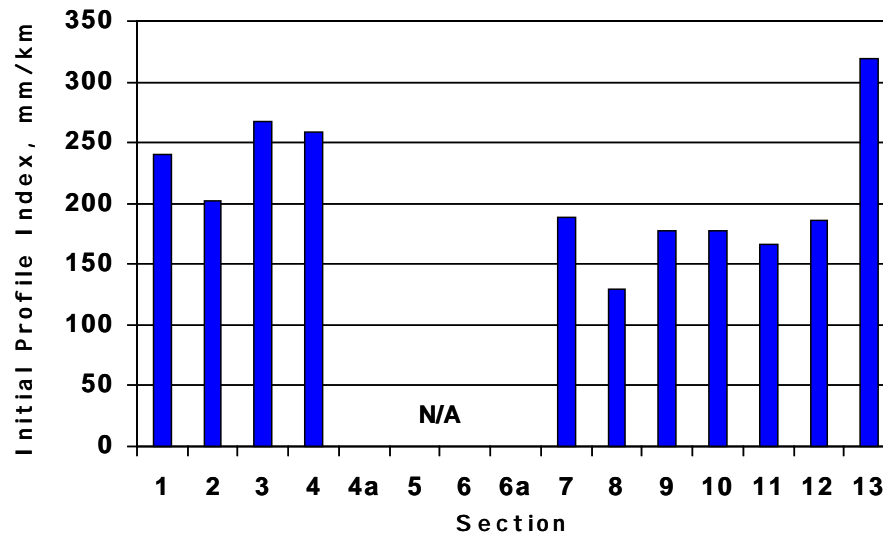
Figure 47. Comparison of Initial Profile Index of KS 1 test sections (Zero-Blanking Band).

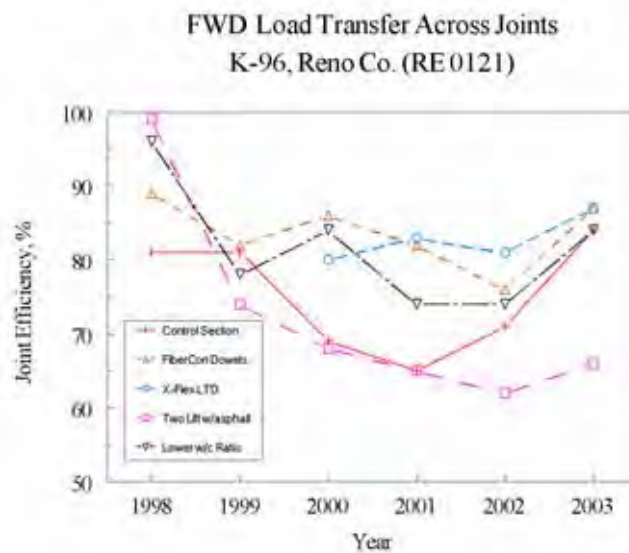
Figure 48. Joint load transfer efficiency on KS 1.

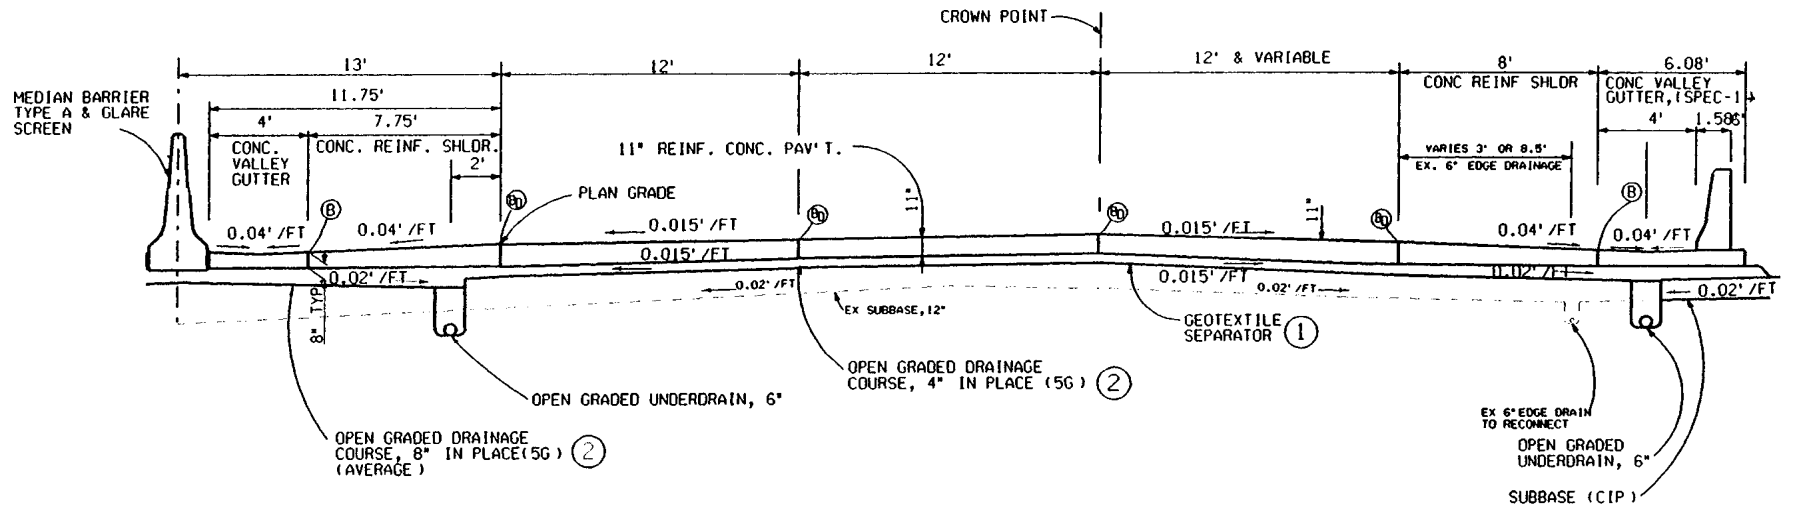
MICHIGAN CONVENTIONAL SECTION NB I-75

Figure 52. Cross section for Michigan standard pavement (Smiley 1995).

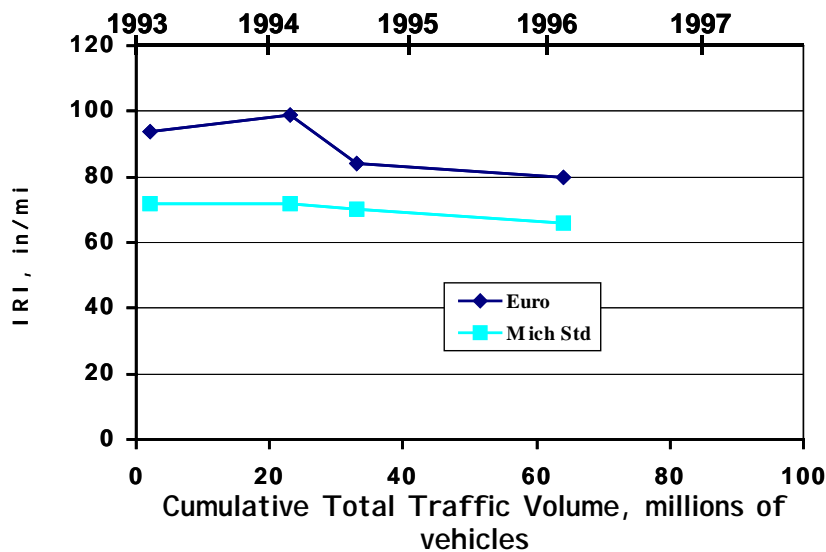
MDOT has monitored the roughness of these pavement sections using an inertial profiler. International Roughness Index (IRI) values computed from the measured profiles are shown in Figure 56 as a function of total traffic (Buch, Lyles, and Becker 2000). The European pavement is noted to be slightly rougher than the Michigan standard pavement, but overall the smoothness levels have remained fairly constant. It should be noted that IRI values less than 1.3 m/km (80 in./mi) are considered to be smooth (Buch, Lyles, and Becker 2000).

Figure 56. Computed IRI values for MI 1 test sections (Buch, Lyles, and Becker 2000).

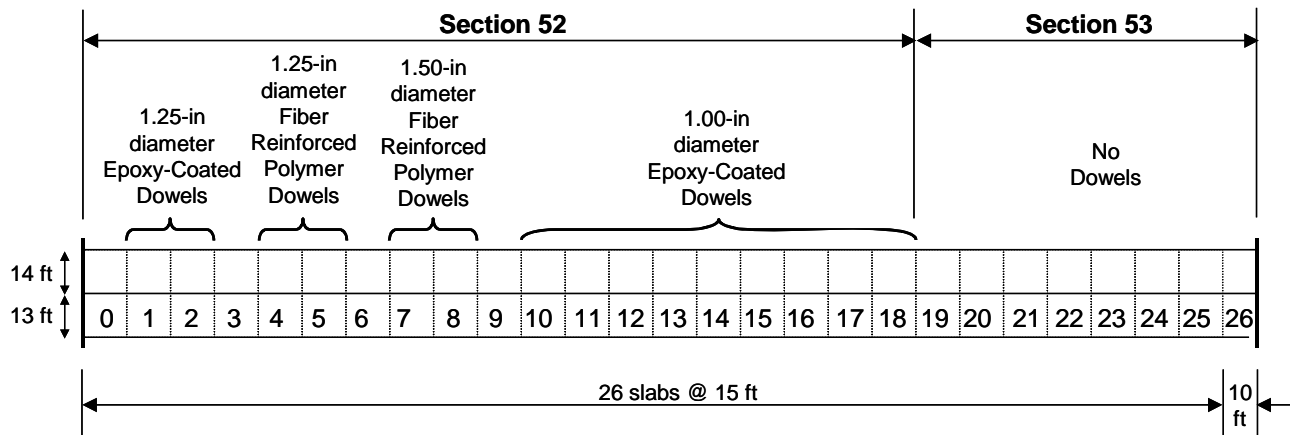
Figure 61. Layout of test sections 52 and 53 for MN 2 project.

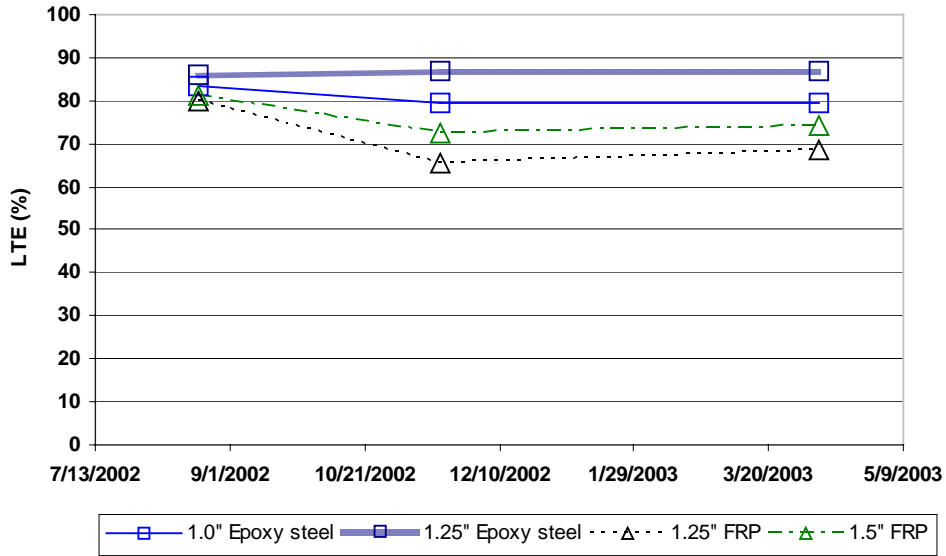
Figure 62. Load transfer efficiency of joints with different types of dowel bars for MN 2 project.

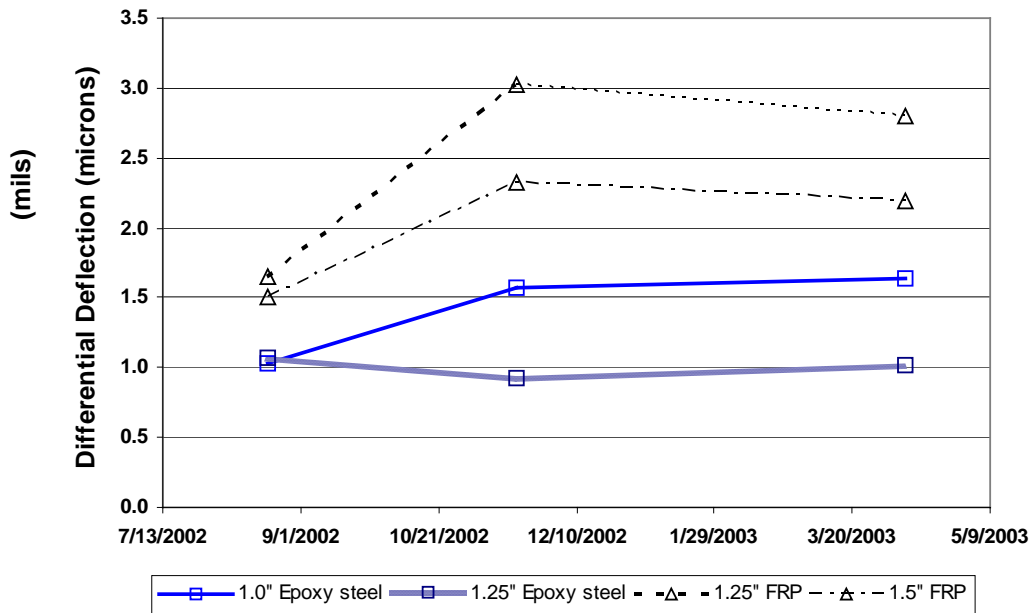
Figure 63. Differential deflections across joints with different types of dowel bars for MN 2 project.
