High Performance Concrete Pavements

Project Summary

Publication No. FHWA-IF-06-031
February 2006

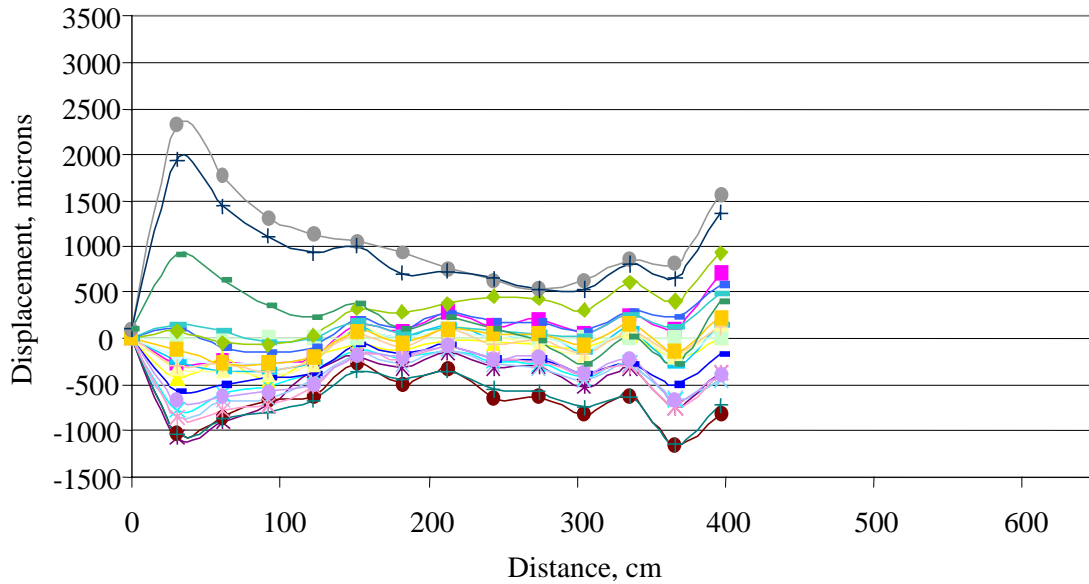
Figure 64. Transverse profile of unrestrained slab in Cell 53 for MN 2 project (Vandenbossche 2003).

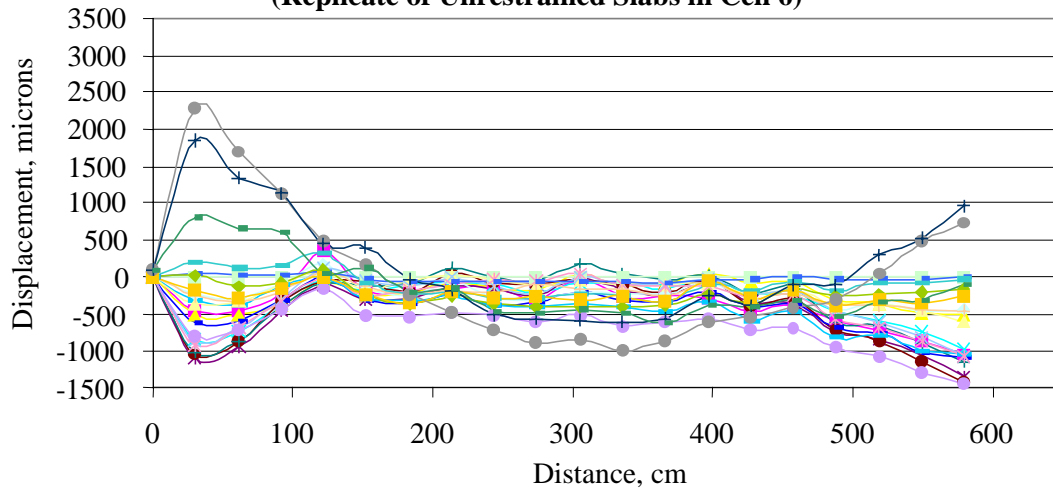
Figure 65. Diagonal profile of unrestrained slab in Cell 53 for MN 2 project (Vandenbossche 2003).

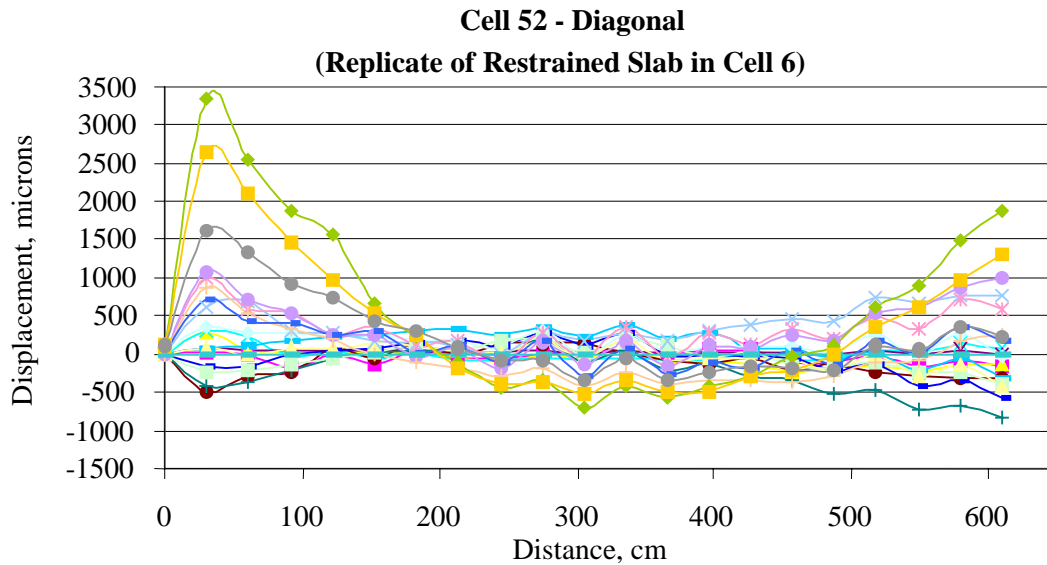
Figure 66. Diagonal profile of restrained slab in Cell 52 for MN 2 project (Vandenbossche 2003).

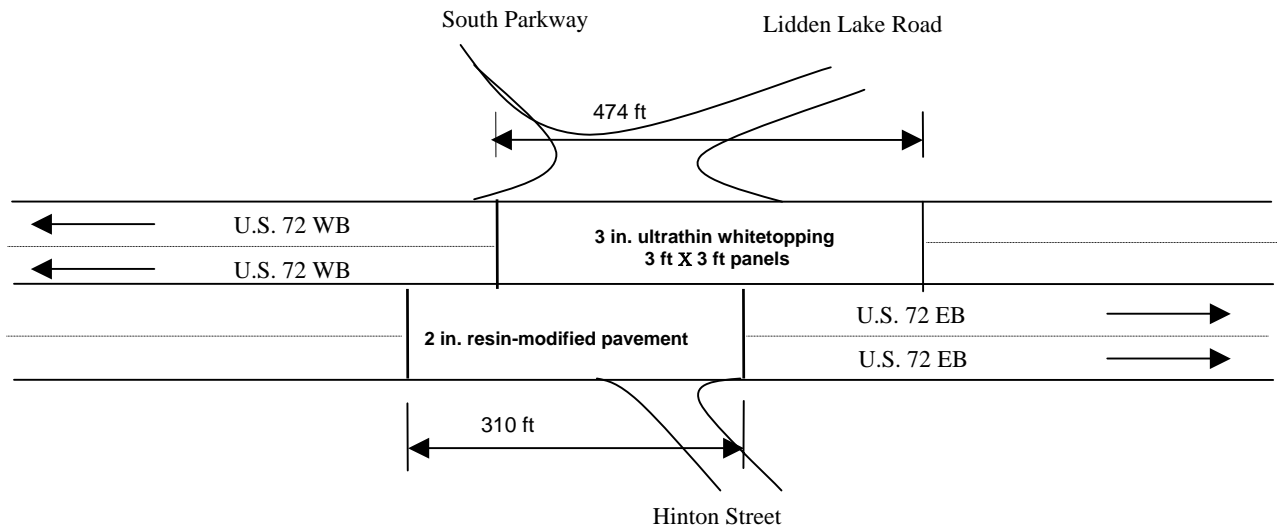
Figure 69. Layout of test sections at the intersection of US 72 and Hinton Street, South Parkway, and Lidden Lake Road.

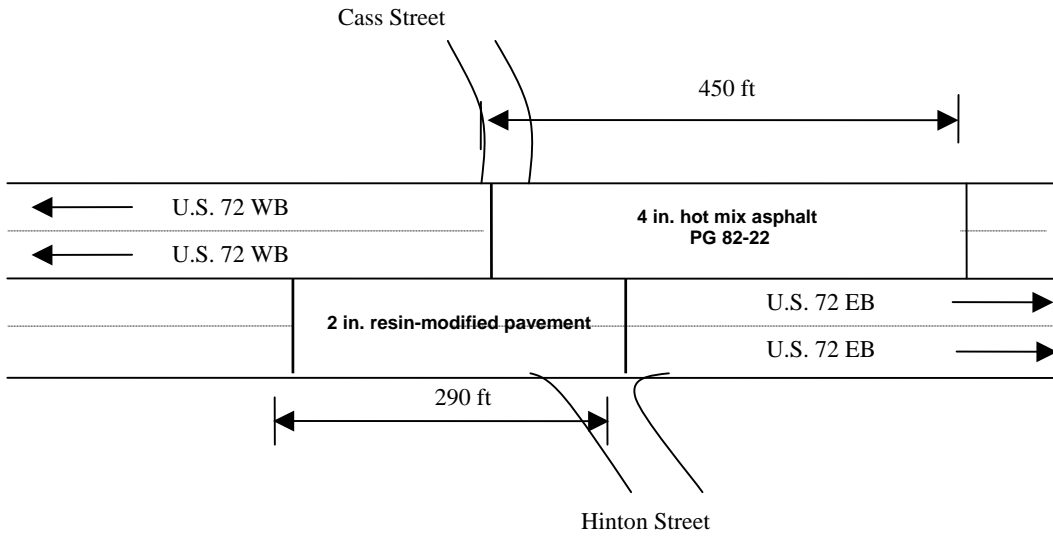
Figure 70. Layout of test sections at the intersection of US 72 and Cass Street.

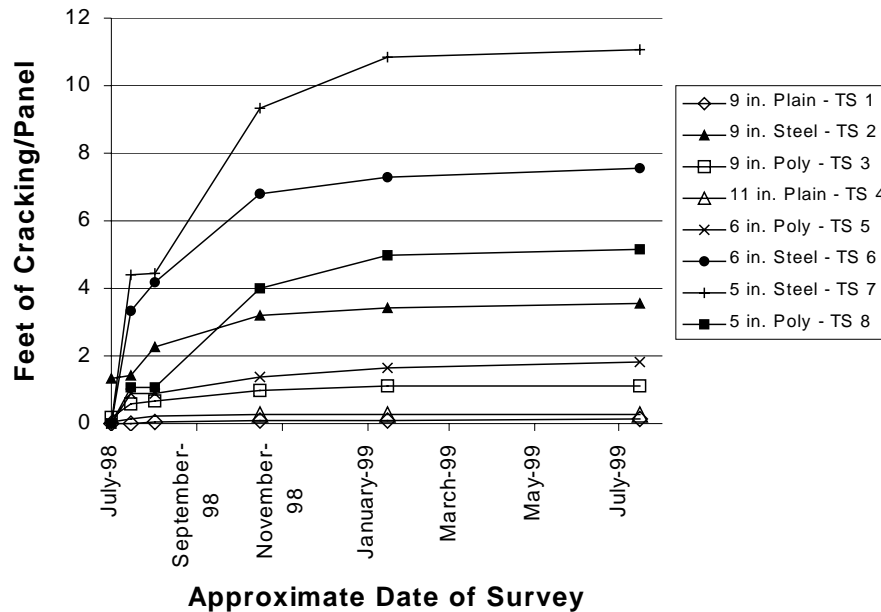
Figure 75. Transverse cracking on MO 1 test sections (MoDOT 2000).

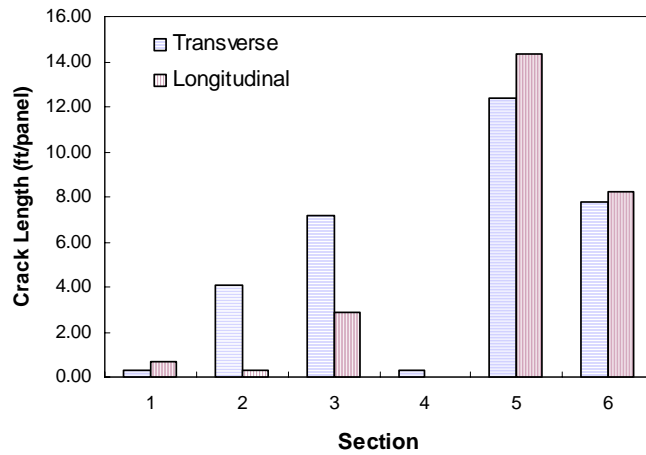
Figure 76. Transverse and longitudinal cracking on MO 1 test sections (Chojnacki 2004).

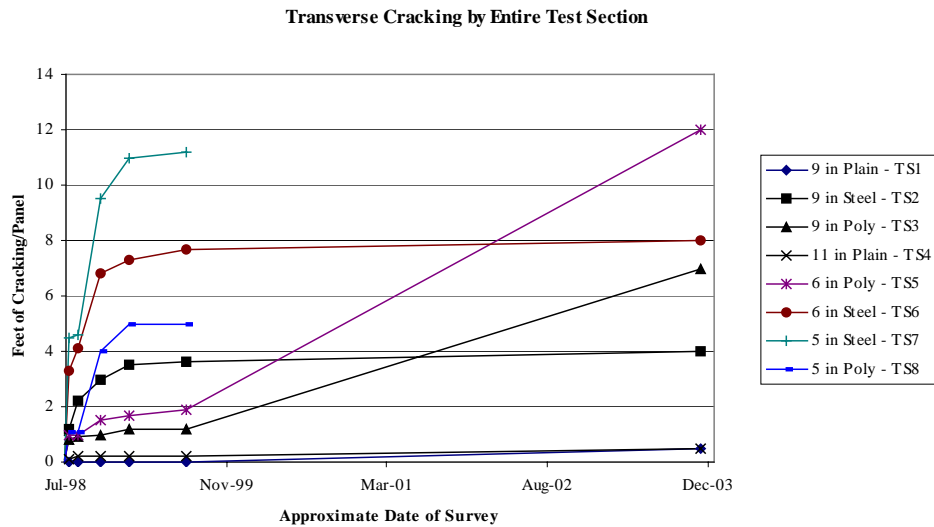
Figure 77. Transverse cracking on MO 1 test sections.

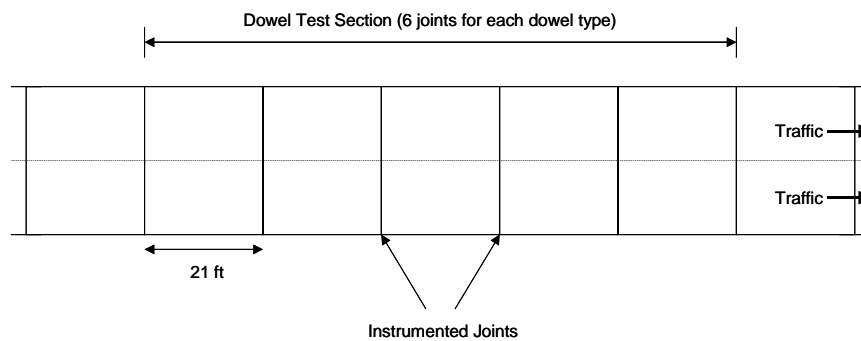
Figure 80. Layout of dowel test sections on Ohio US 50 project.

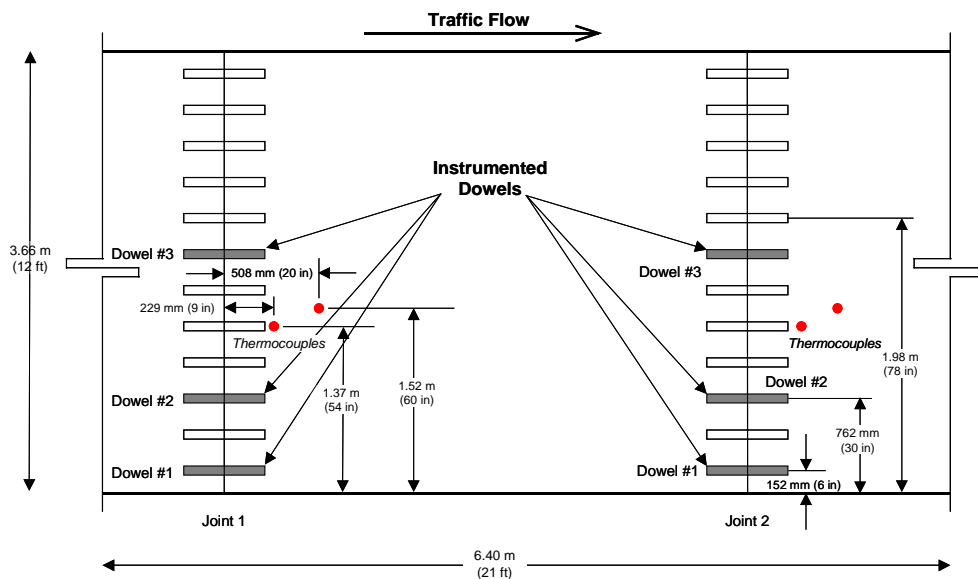
Figure 81. Dowel instrumentation layout for Ohio US 50 project (Sargand 2000).

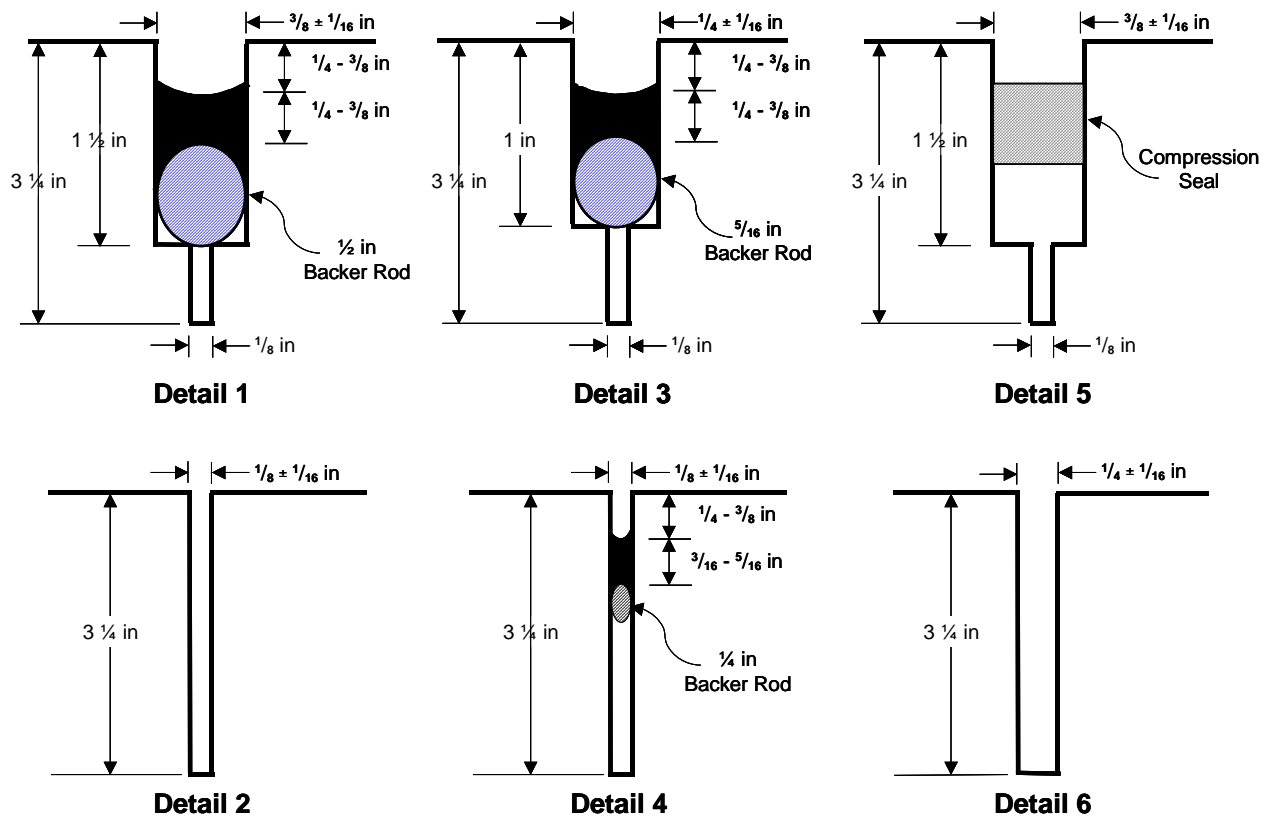
Figure 82. Joint channel configurations used in sealant study on Ohio US 50 project (Hawkins, Ioannides, and Minkarah 2000).

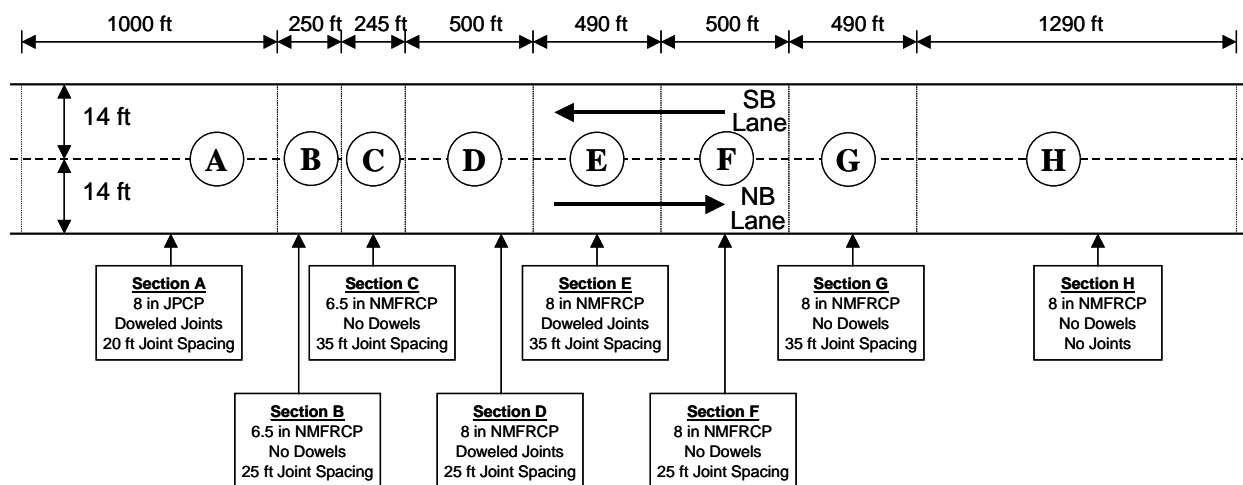
Figure 86. Layout of SD 1 test sections (Ramakrishnan and Tolmare 1998).

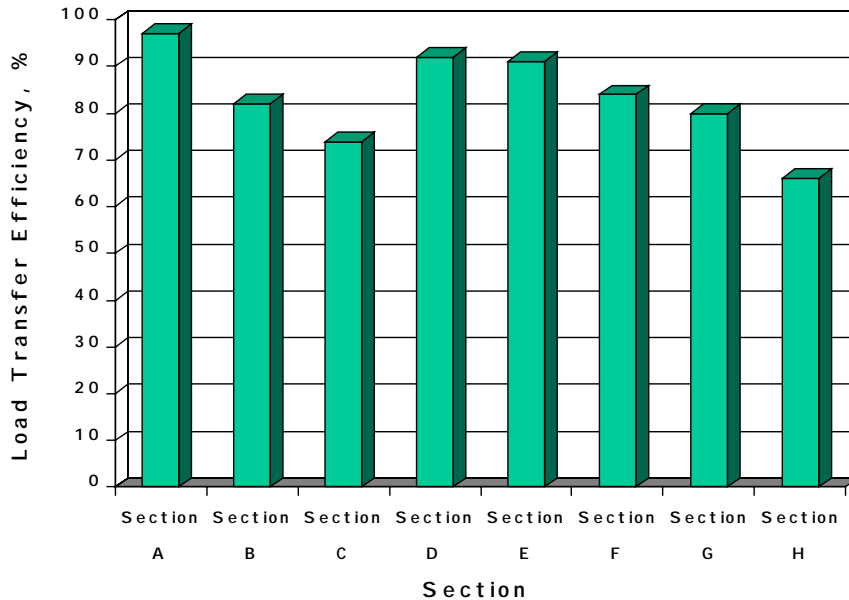
Figure 88. Load transfer efficiencies for SD 1 sections.

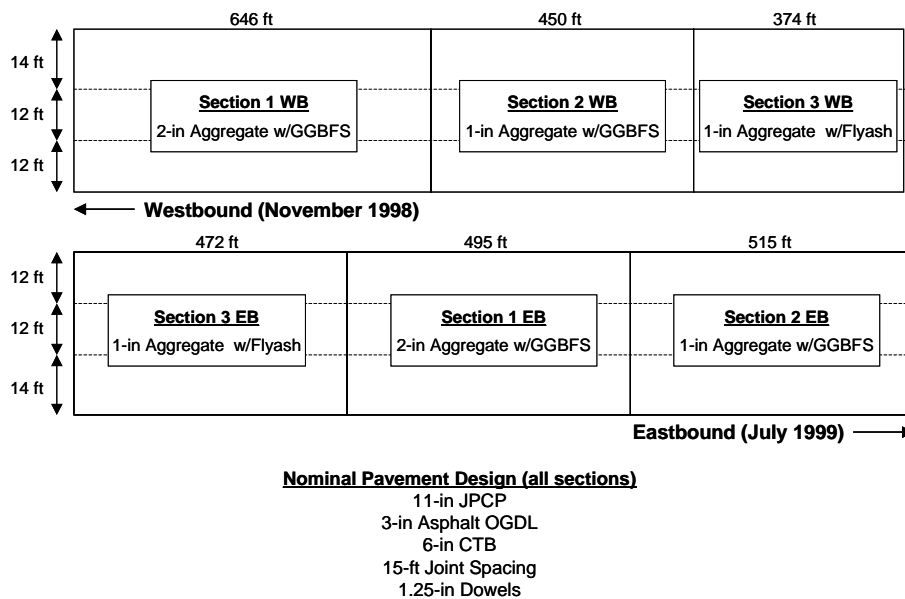
Figure 90. Layout of VA 1 test sections (Ozyildirim 2000).

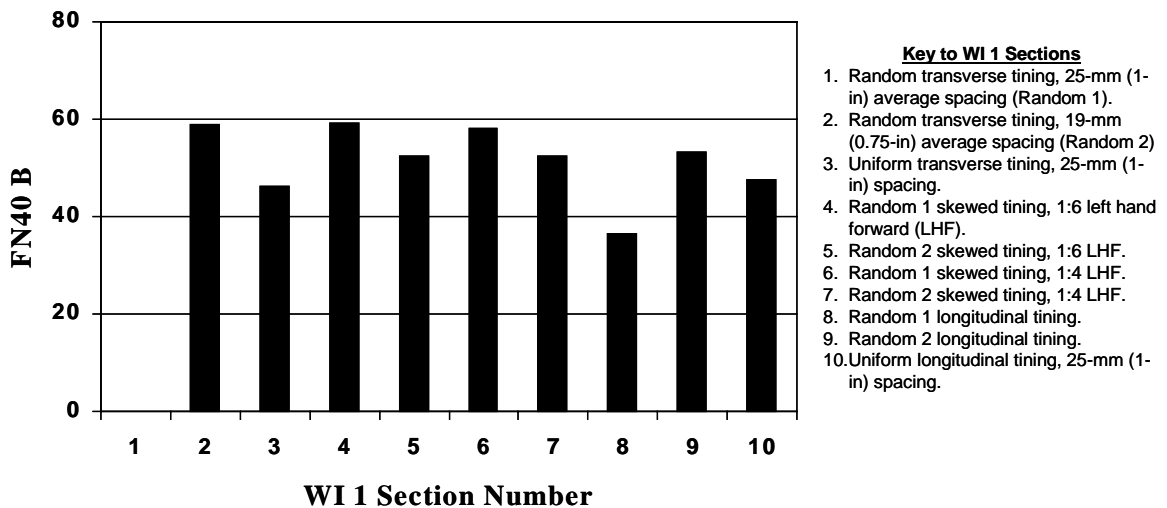
Figure 97. Surface friction of WI 1 test sections (Kuemmel et al. 2000).

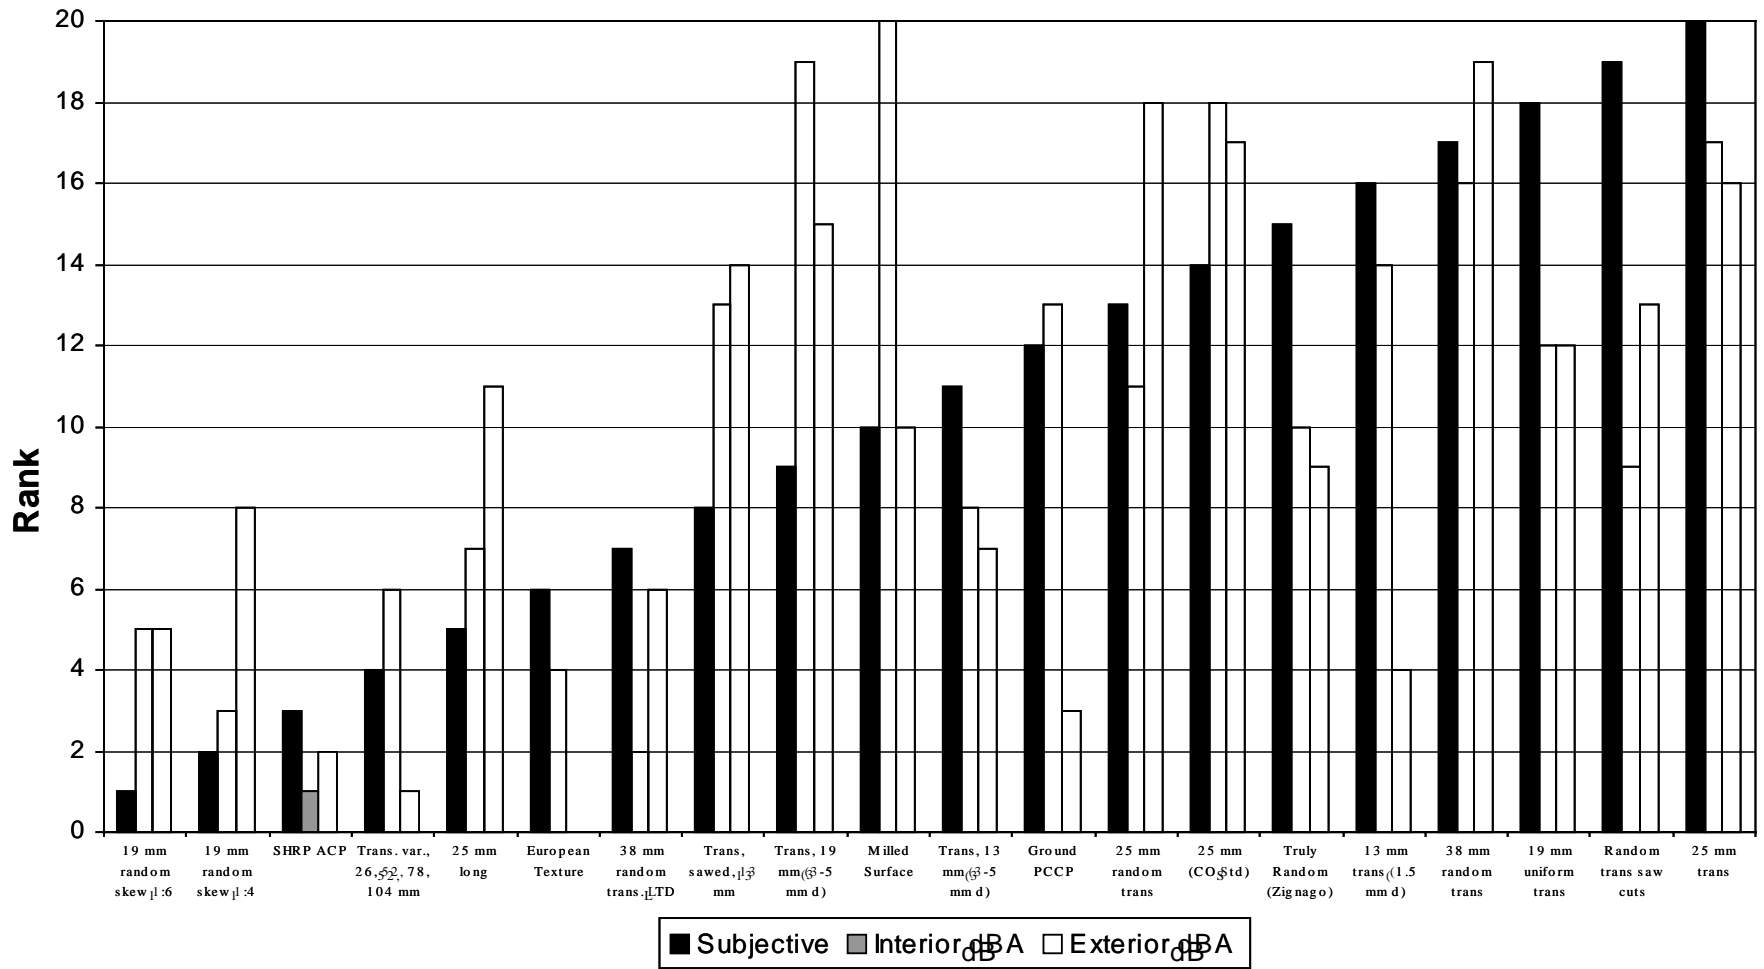
Figure 98. Relative noise rankings of pavement surface texturings (Kuemmel et al. 2000).

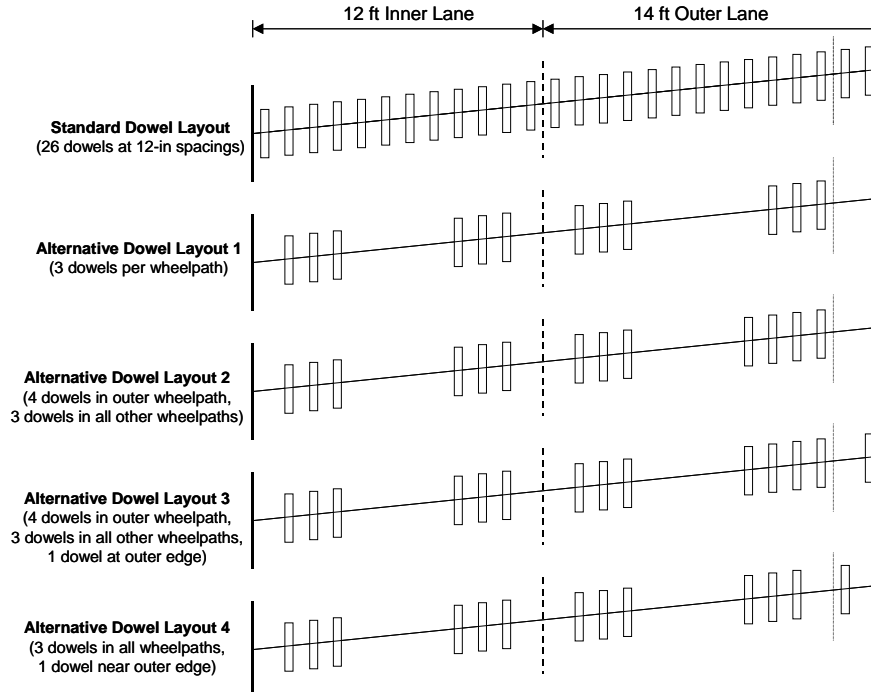
Figure 100. Alternative dowel bar layouts used on WI 2.

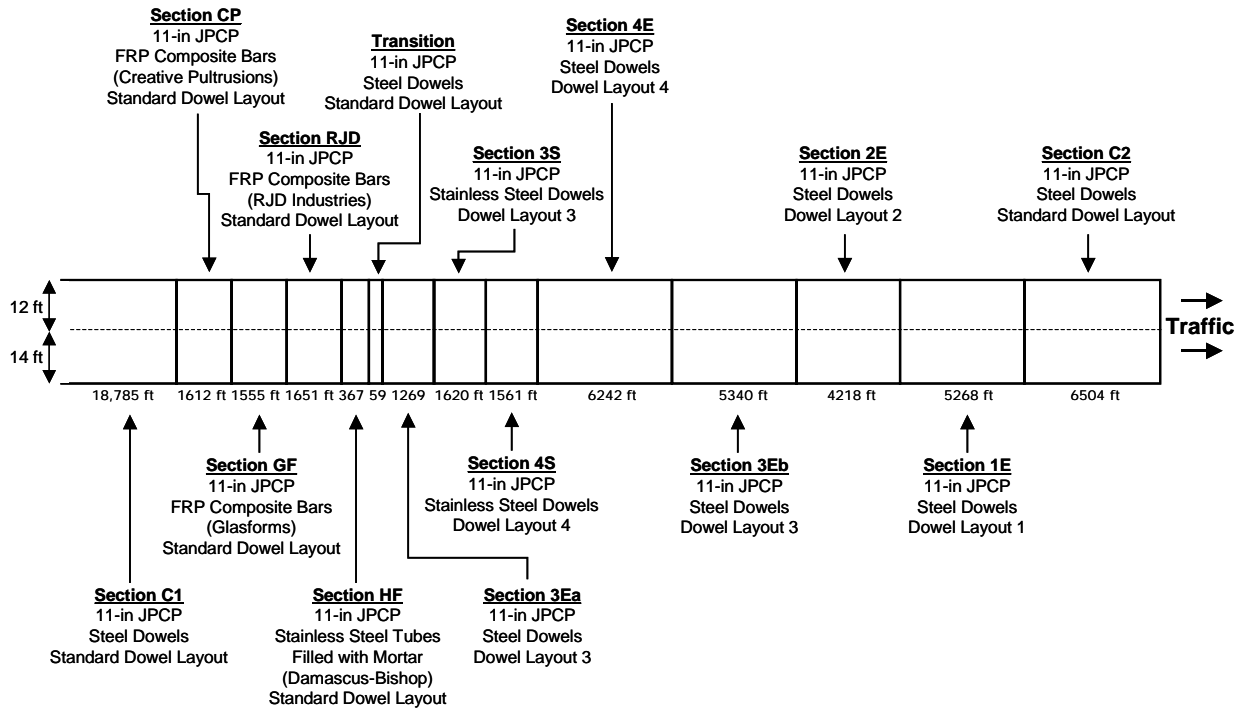
Figure 101. Approximate layout of WI 2 test sections.

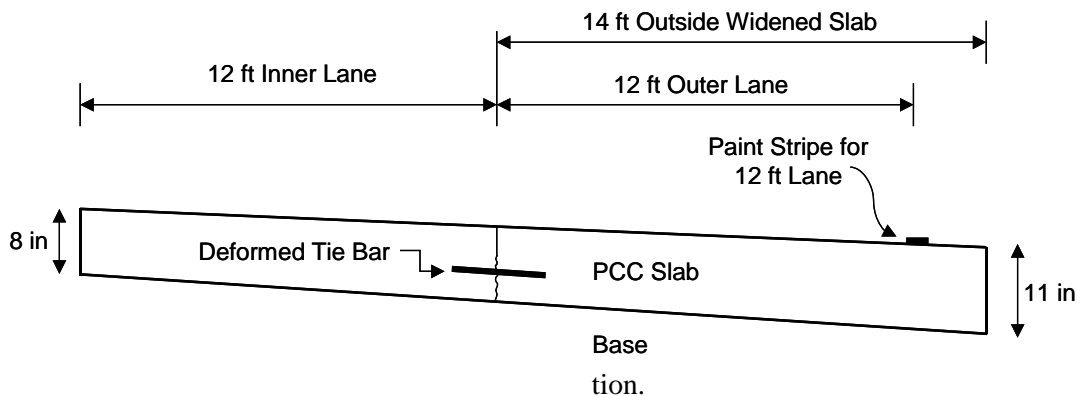
Figure 102. Variable cross section used on WI 3.

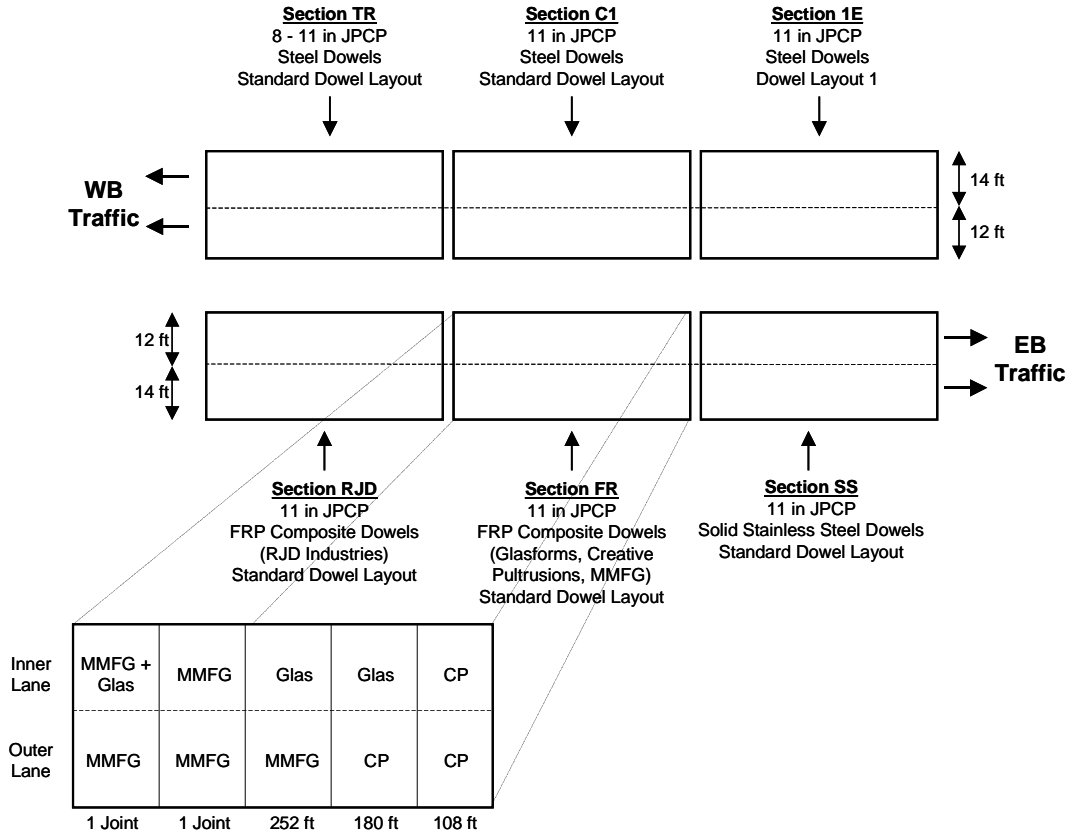
Figure 103. Approximate layout of WI 3 monitoring sections.

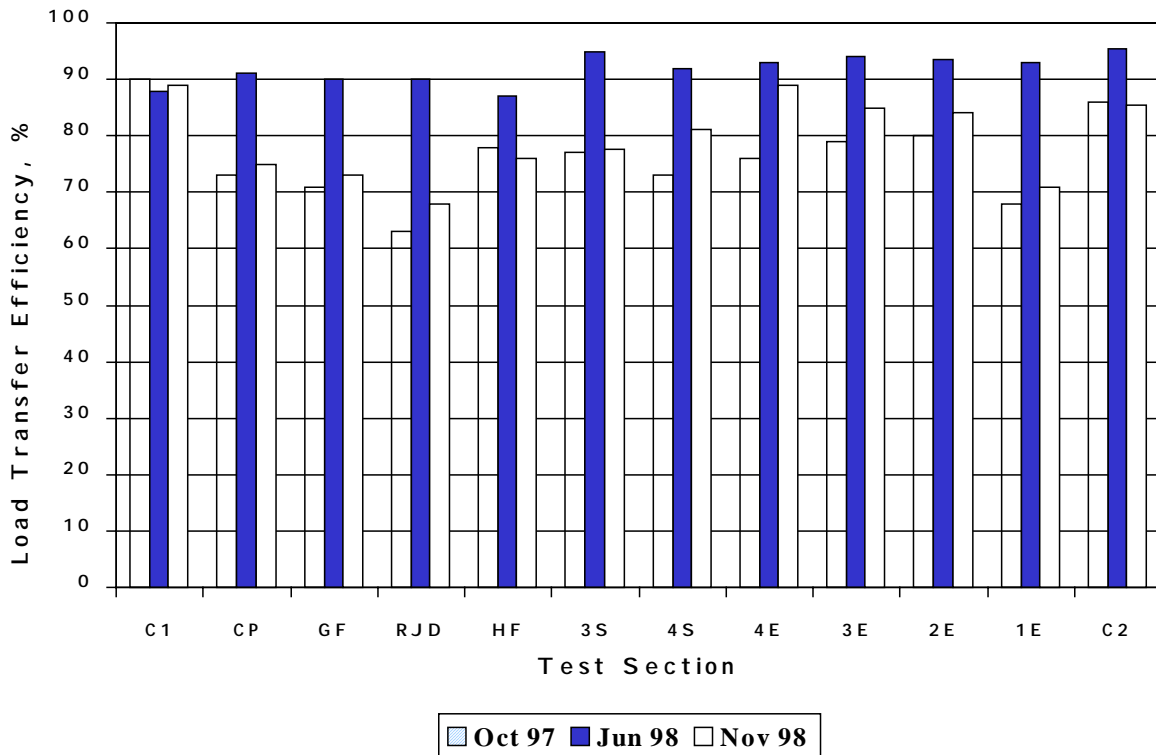
Figure 104. Transverse joint load transfer for outermost wheelpath on WI 2 (Crovetto 1999).

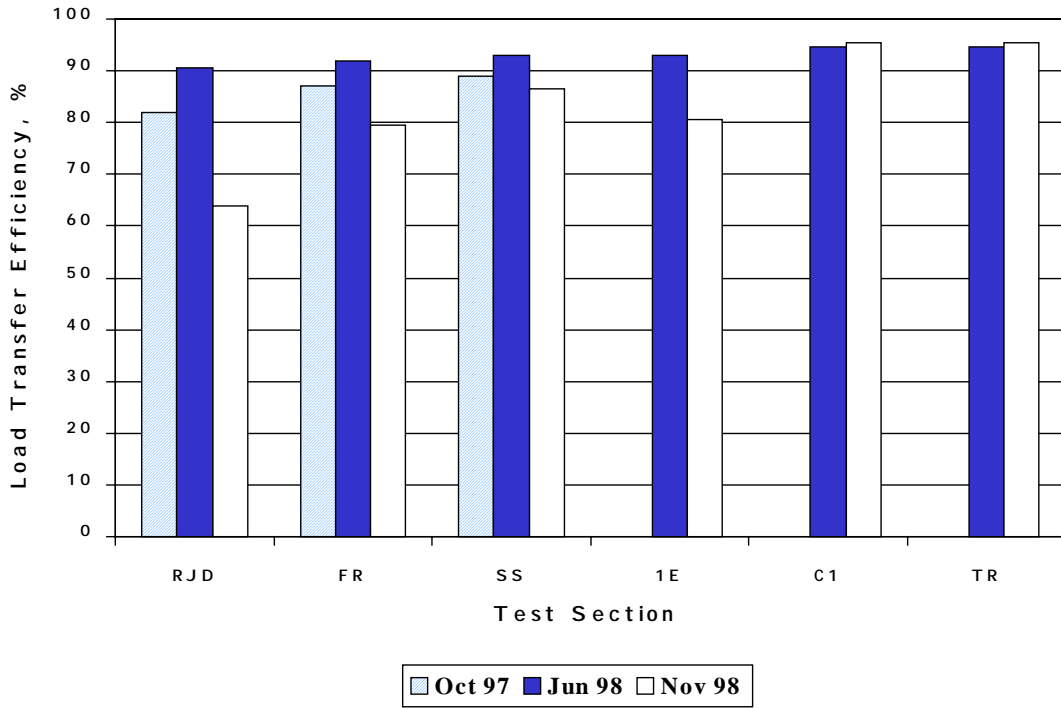
Figure 105. Transverse joint load transfer for outermost wheelpath on WI 3 (Crovetti 1999).

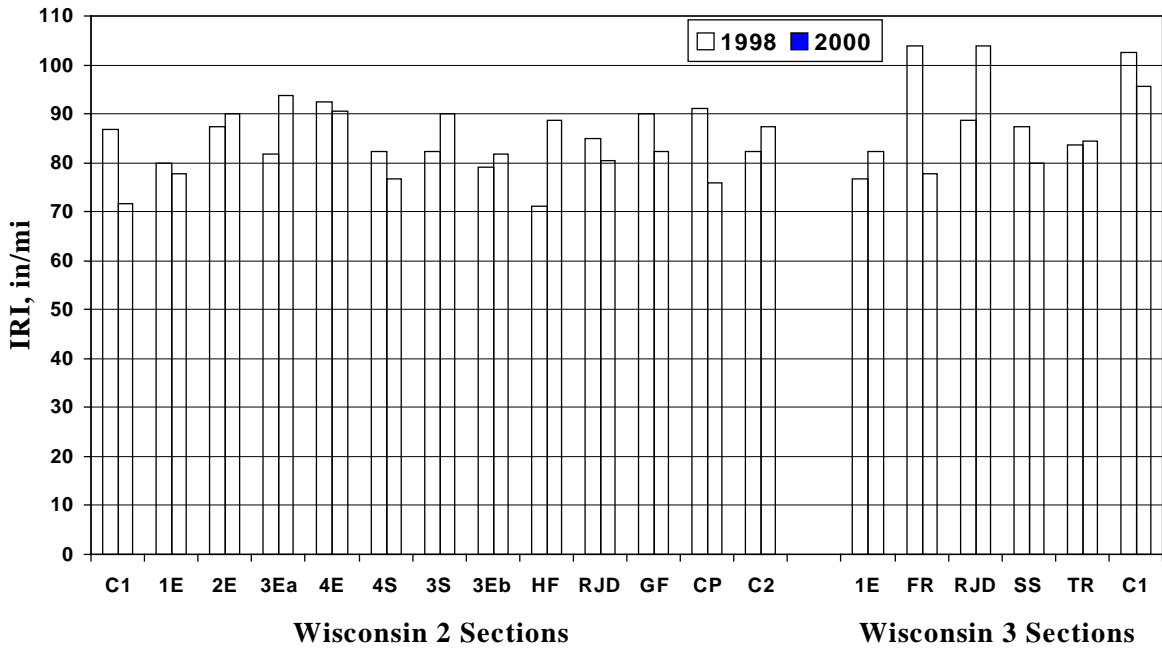
Figure 106. Average IRI values in the outer traffic lanes of WI 2 and WI 3 pavement sections (Crovetti and Bischoff 2001).

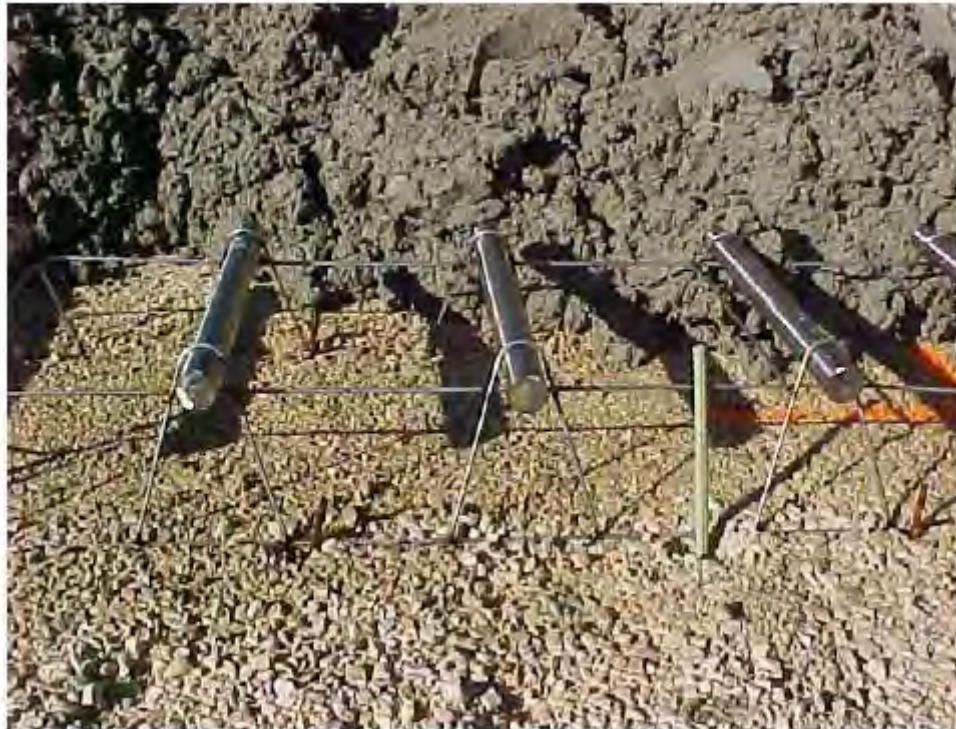
Figure 108. Stainless steel dowels and basket on WI 4 (Kemp 2004).

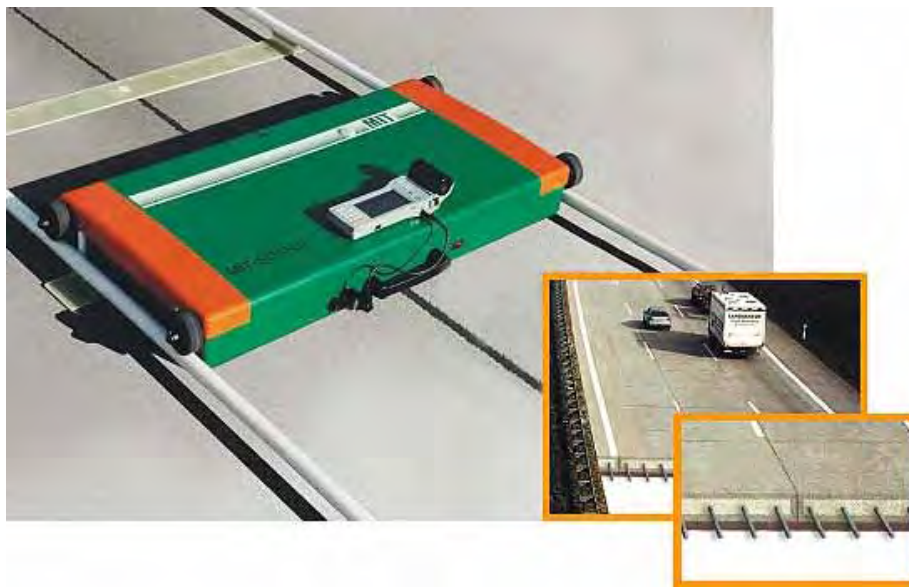
Figure 110. Close-up view of MIT Scan-2.
