# The Effects of Higher Strength and Associated Concrete Properties on Pavement Performance

PUBLICATION NO. FHWA-RD-00-161

JUNE 2001

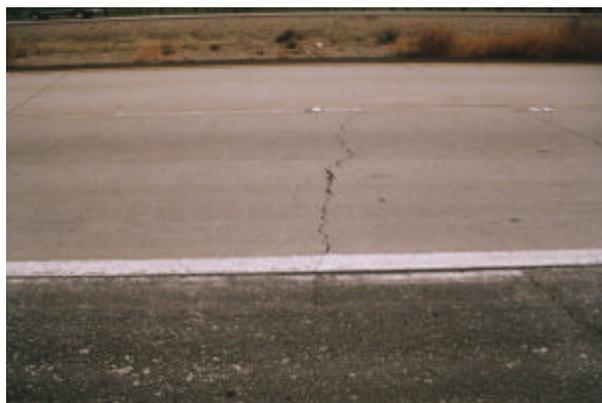
***Figure 3.1.10*** Medium severity transverse crack at 06-CS1, Tracy Test Road (control section).

The test section was in fair condition. On the longer slabs, low and medium severity corner breaks and transverse cracks were observed. The shorter slabs were found in very good condition. The test section had only a minor amount of faulting, on the order of 0 to 5 mm. Residue left from pumping of fines at the pavement edge adjacent to many transverse joints was observed. The pumping evidence was also observed at some transverse cracks. The concrete surface showed map cracking, but it did not appear to have affected the concrete durability or the concrete surface condition.

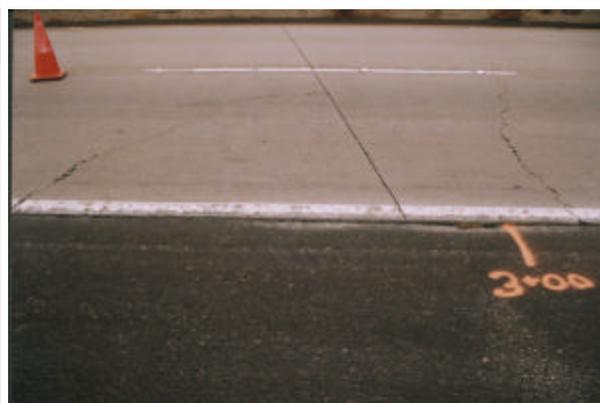
***Figure 3.1.11*** Corner break near approach joint at 06-CS1, Tracy Test Road (control section).

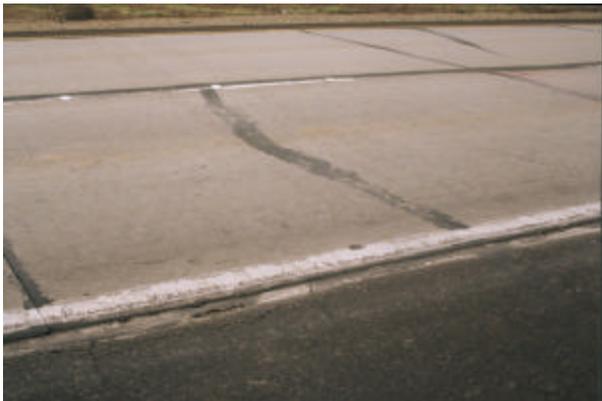
***Figure 3.1.12*** Crack only in truck lane at 06-CS3, Tracy Test Road (control section).

The test section was in fair condition. Low to medium severity transverse cracks were observed on 2/3 of the slabs, with only the 3.65-m (12-ft) slabs unaffected. There were two locations with low severity corner breaks. The test section had only a minor amount of faulting, on the order of 0 to 6 mm, with an average of 2 to 3 mm. Residue left from pumping of fines at the pavement edge adjacent to many transverse joints was observed. The concrete surface, the wheel path in particular, showed map cracking, but it did not appear to have affected the concrete durability or the concrete surface condition. This test section, 06-CS3, exhibited twice the number of transverse cracks as compared to the control section, 06-CS1, and also the amount of faulting was higher for this section. However, the spalling of this section was only half of that observed at the control section.

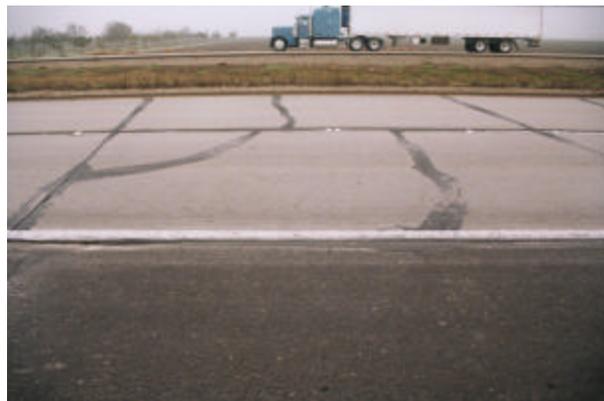
***Figure 3.1.13*** Corner break in truck lane at 06-CS3, Tracy Test Road (control section).

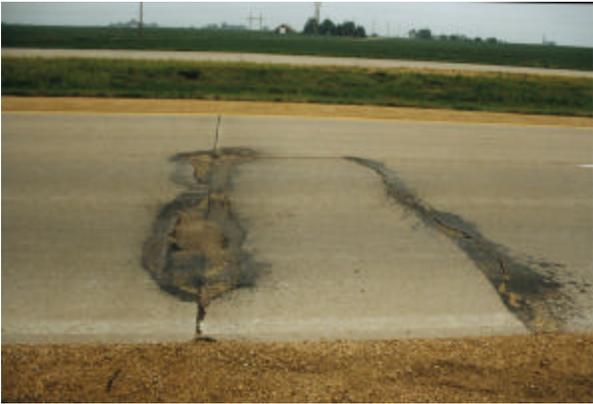
*Figure 3.1.18 Typical transverse joint distress at 19-3006.*

The test section was in very poor condition with all joints exhibiting some degree of spalling. High and low severity spalling with loss of material was noted at 22 of the 26 joints. Transverse joint faulting ranged from about 0.2 to 8.5 mm, with an average of about 3 mm. Previous survey records indicate that this section has been deteriorating rapidly since 1994.

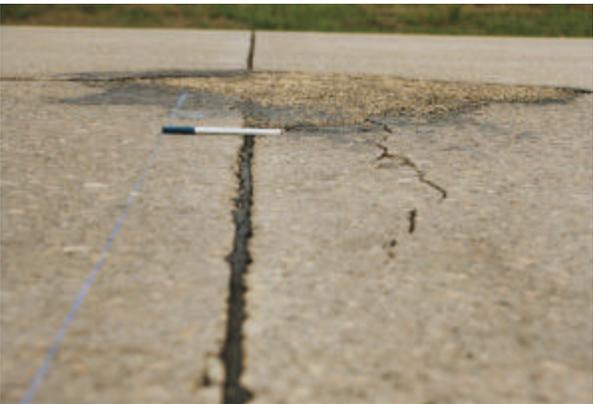
*Figure 3.1.19 Close-up on transverse joint spalling at 19-3006.*

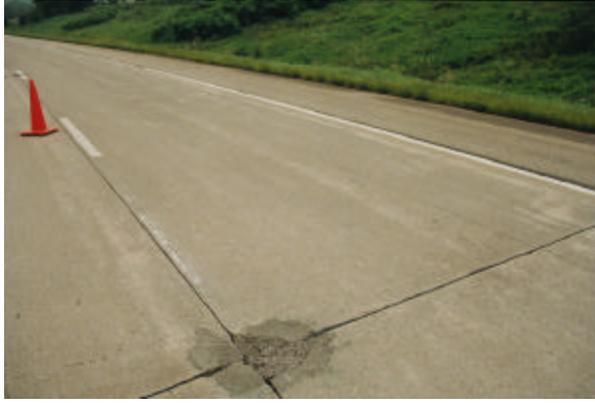
*Figure 3.1.23 Corner break and repair at 27-4054.*

The test section was in a relatively good condition except for the faulting, which ranged from 0.8 to 7.5 mm, two small high severity corner breaks, and low severity transverse joint spalling due in part to snow plowing.

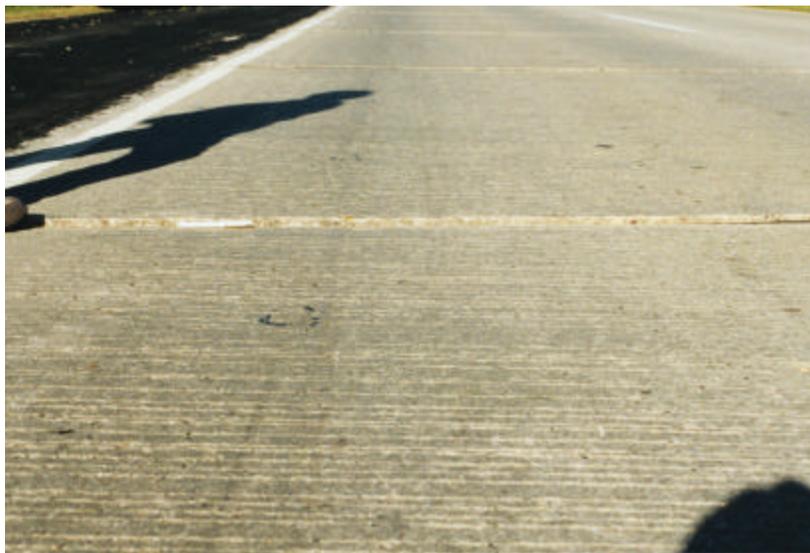
*Figure 4.2.1 Faulted transverse joint in test section 55-3008.*

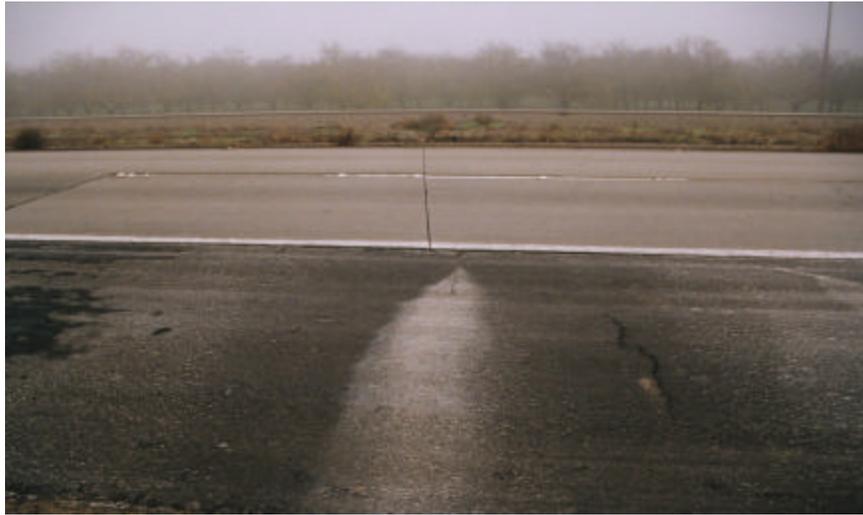
*Figure 4.2.3* Surface staining on the shoulder close to joints from Tracy Test Road (06-CS1).

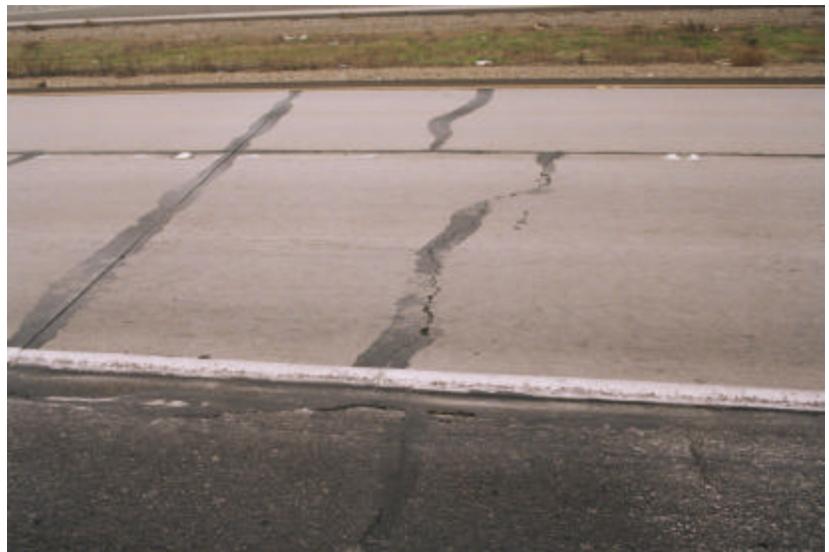
**Figure 4.2.5** Depressed shoulder in test section 06-CS3 from pumping of fines. Transverse cracking in outer and inner lane.

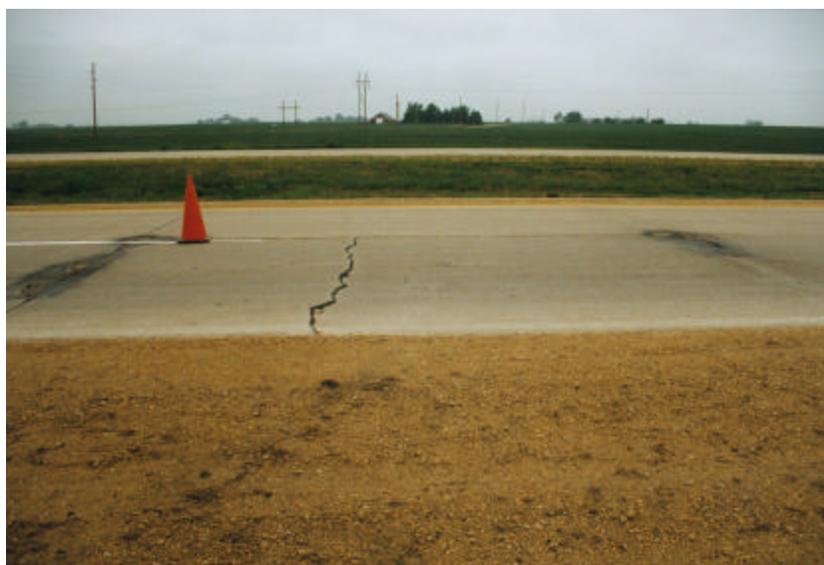
**Figure 4.3.5** Transverse cracking closer to the leave joint for the Iowa section 19-3006.

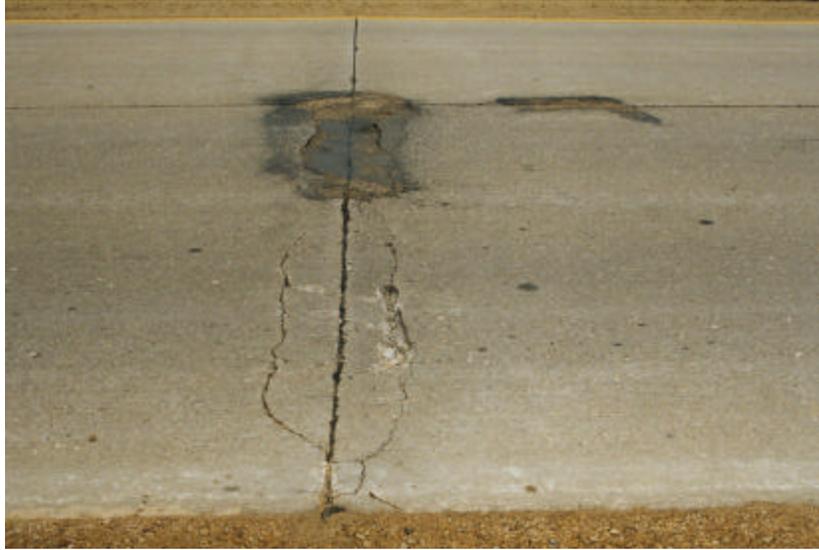
*Figure 4.4.2 Spalling crack running parallel with the joint in a distance of about 0.3 m.*

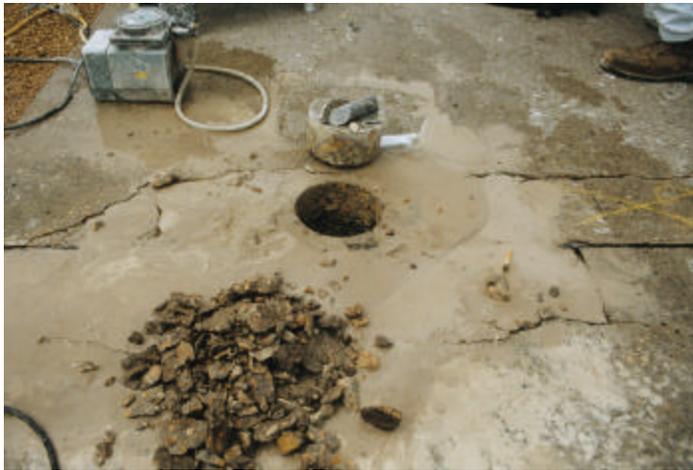
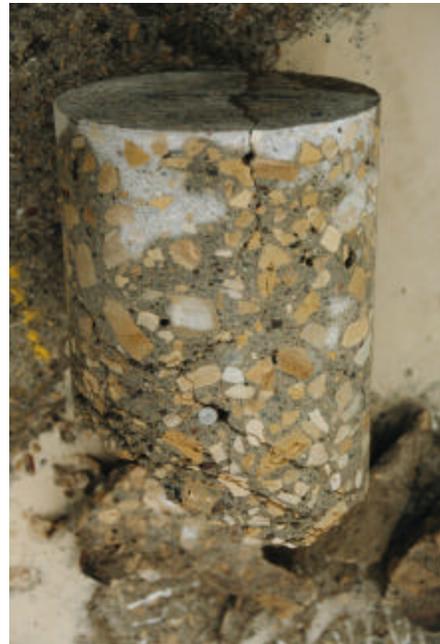
*Figures 4.4.3 Close-up photos of joint deterioration from test section 19-3006.*

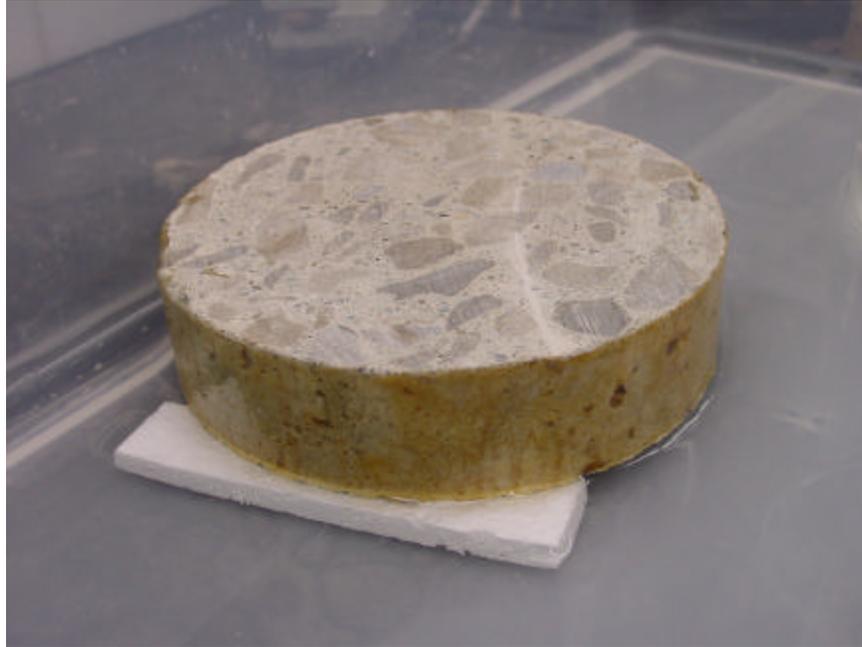
**Figure 5.6.6** *Close-up of water absorptivity test.*

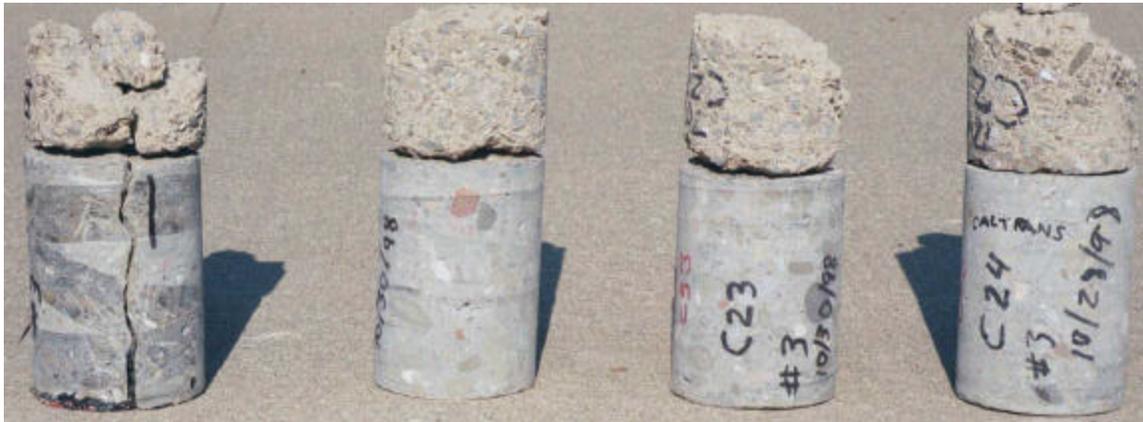
**Figure 7.1.2** Eroded CTB at joint. Decreasing erosion moving away from joint (left to right). Experimental test road at Tracy, California, with higher cement content.
