Manual for Repair and Retrofit of Fatigue Cracks in Steel Bridges

March 2013

FHWA Publication No. FHWA-IF-13-020

U.S. Department of Transportation
Federal Highway Administration

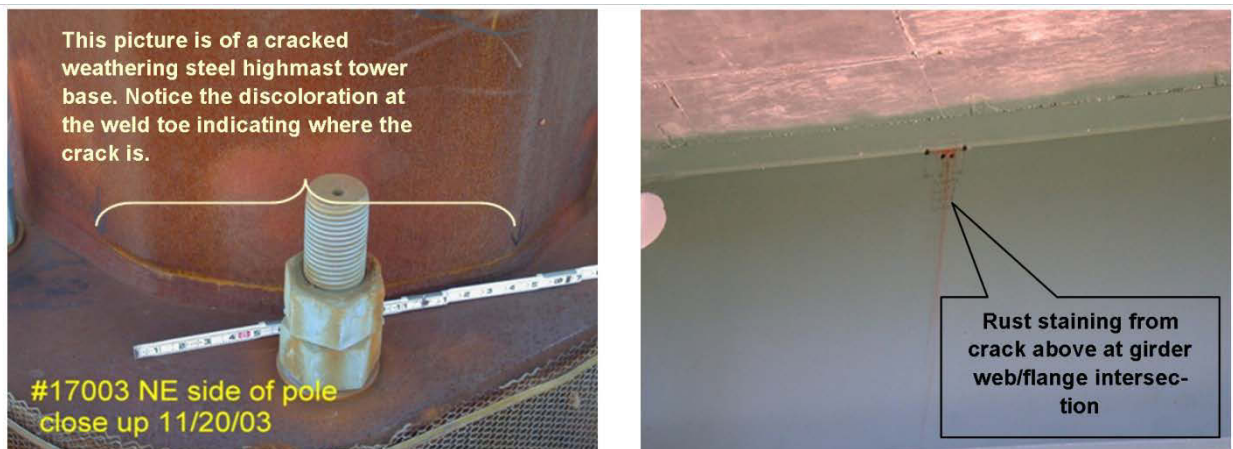
Figure 7. Photo. These two pictures show how cracks can sometimes be found from discoloration or rust staining. Photo courtesy of the Iowa Department of Transportation.

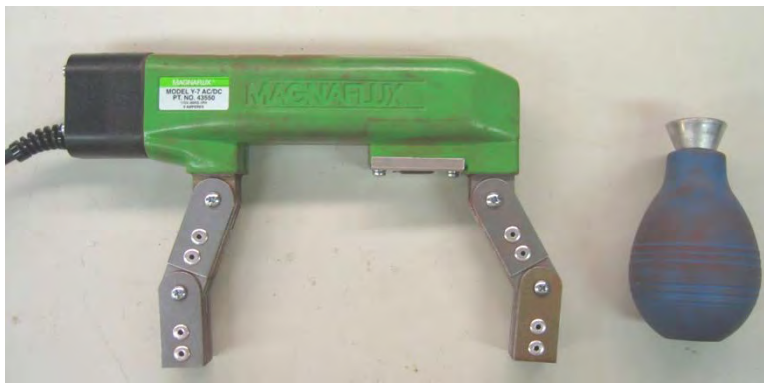
Figure 9. Photo. Mag particle yoke (left). Powder bulb for sprinkling iron powder (right).

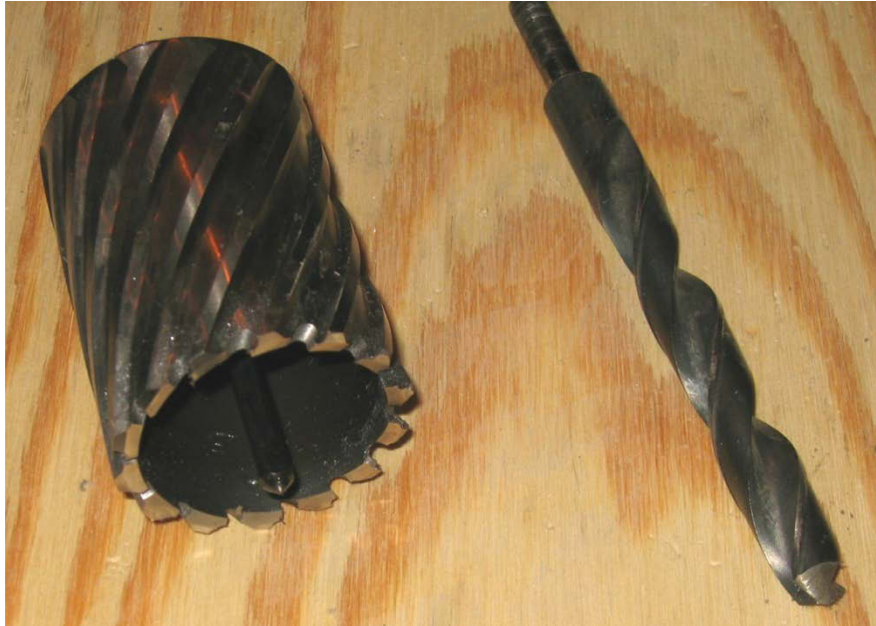
Figure 22. Photo. Annular cutter (left). Twist bit (right).

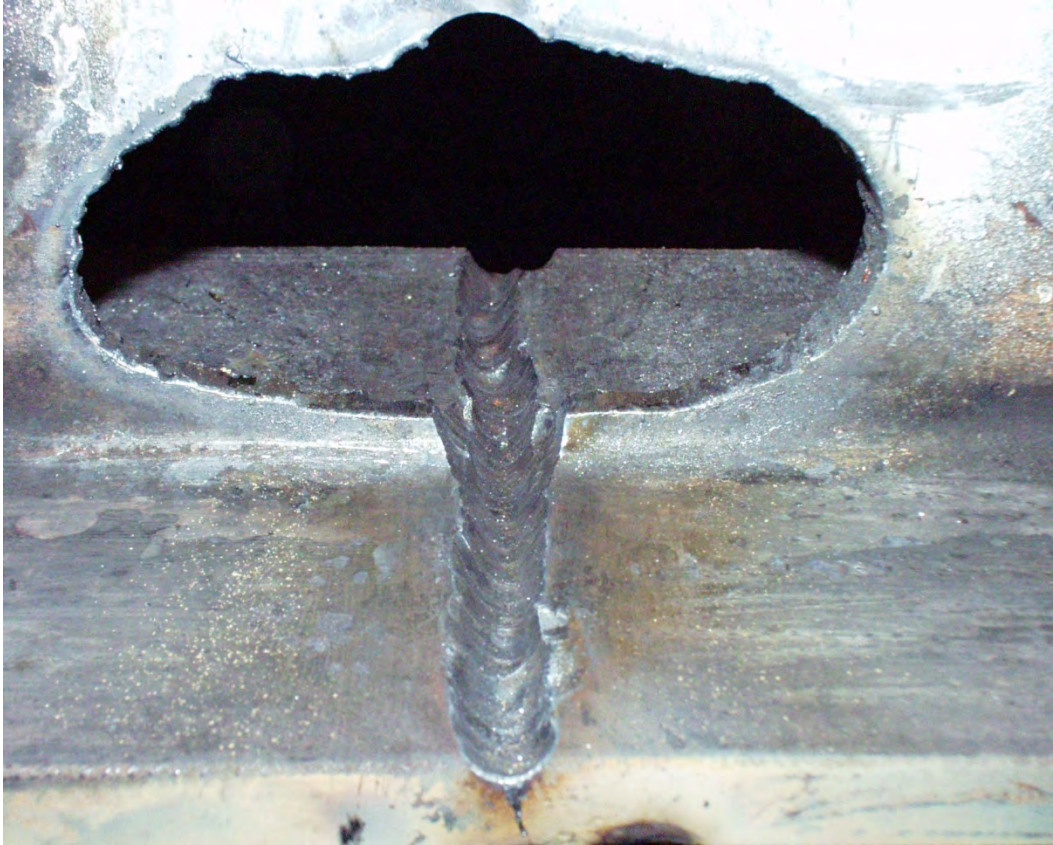
Figure 24. Photo. Air arc gouged flange of a beam for Vee and Weld Repair, which was completely cracked. The hole had to be placed in the web to allow for complete gouging of the flange. The access hole has not been ground smooth as recommended in this manual.

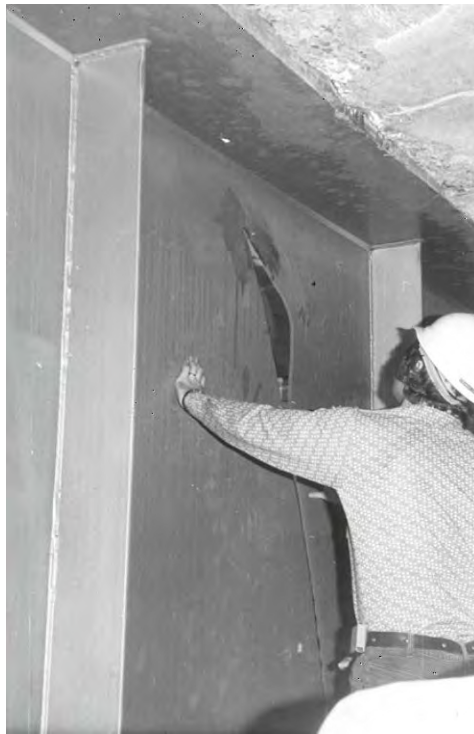
Figure 25. Photo. Full girder depth fatigue crack of Lafayette Street Bridge in St. Paul, MN. Photo courtesy of the Minnesota Department of Transportation.

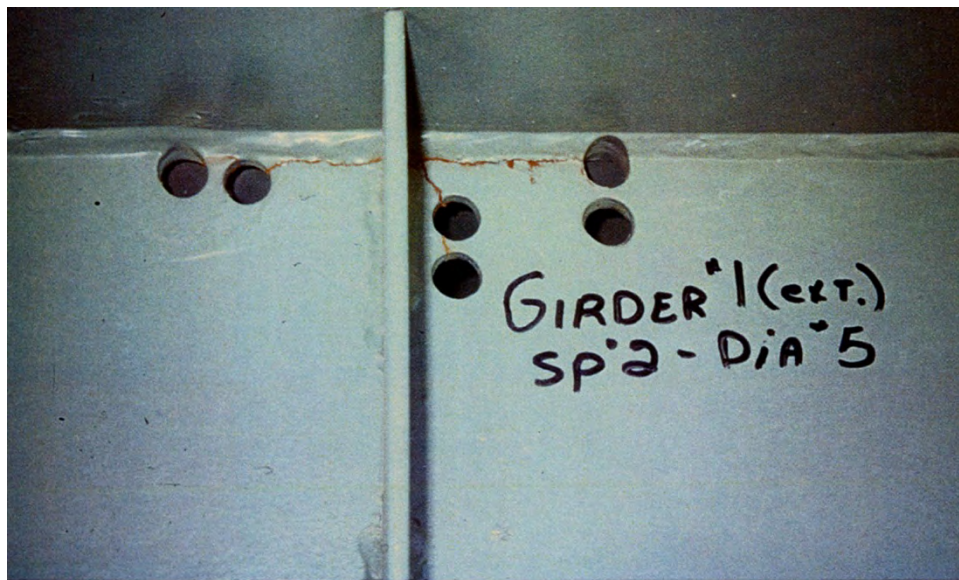
Figure 29. Photo. Picture of multiple drilled holes in the vicinity of the web gap due to crack reinitiation from holes. Photo courtesy of Iowa Department of Transportation.

Many web-gap cracks have been blindly repaired/retrofitted with the hole drilling method, which will only work under special circumstances as described above. Some bridges have been retrofitted numerous times using this method, but the holes being drilled are just too small or the crack driving force is too high for the hole to work by itself. Therefore, cracks keep reinitiating from the previously drilled holes, leading to a “swiss-cheese” effect drilled in the vicinity of the web gap as shown in Figure 29.

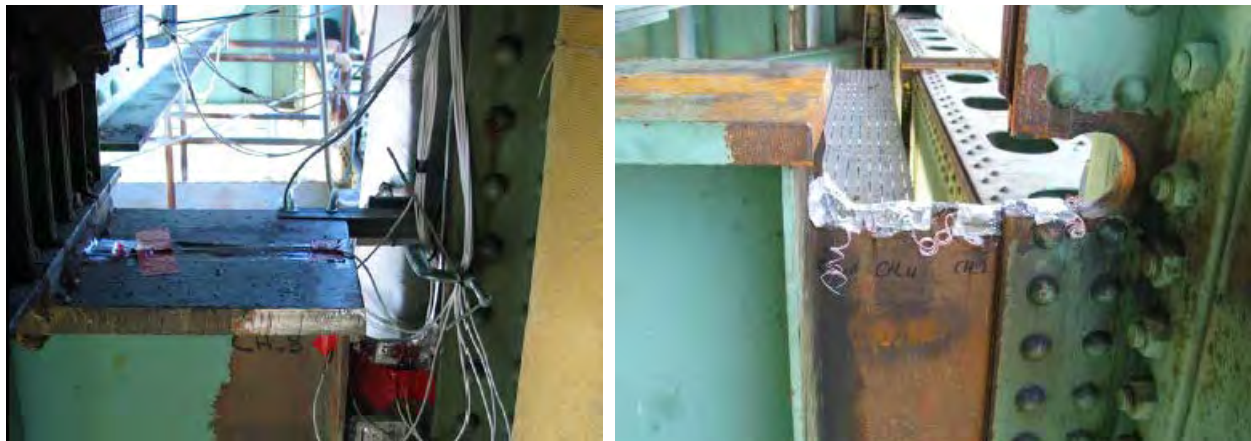
Figure 53. Photo. First retrofit performed on Girard Point Bridge in Philadelphia, Pennsylvania (left) and modified retrofit (right). Taken from Mahmoud and Connor.⁽⁸⁸⁾

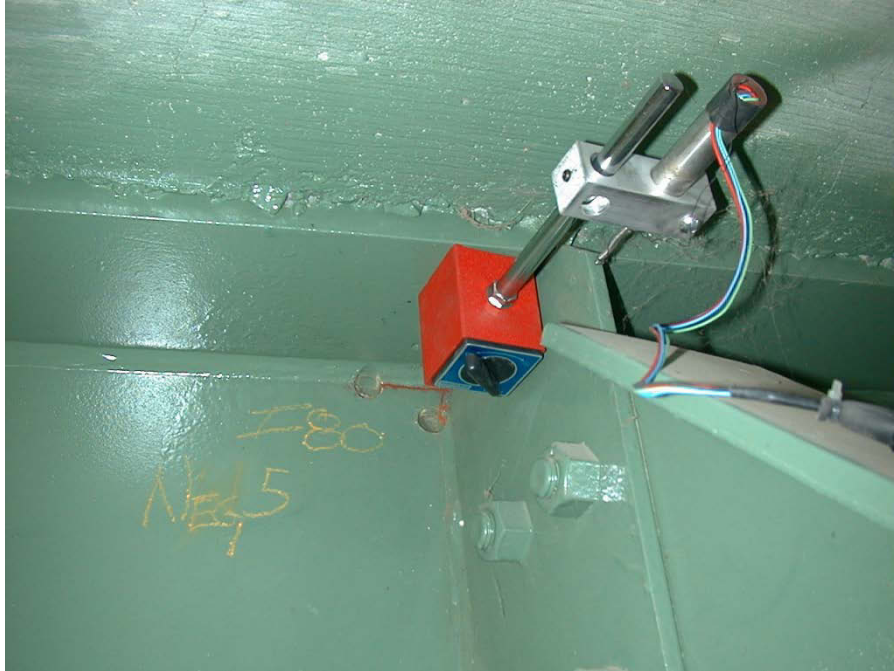
Figure 61. Photo. Magnetic base and LVDT to measure the relative displacement between the girder and connection plate. Photo courtesy of Iowa Department of Transportation.

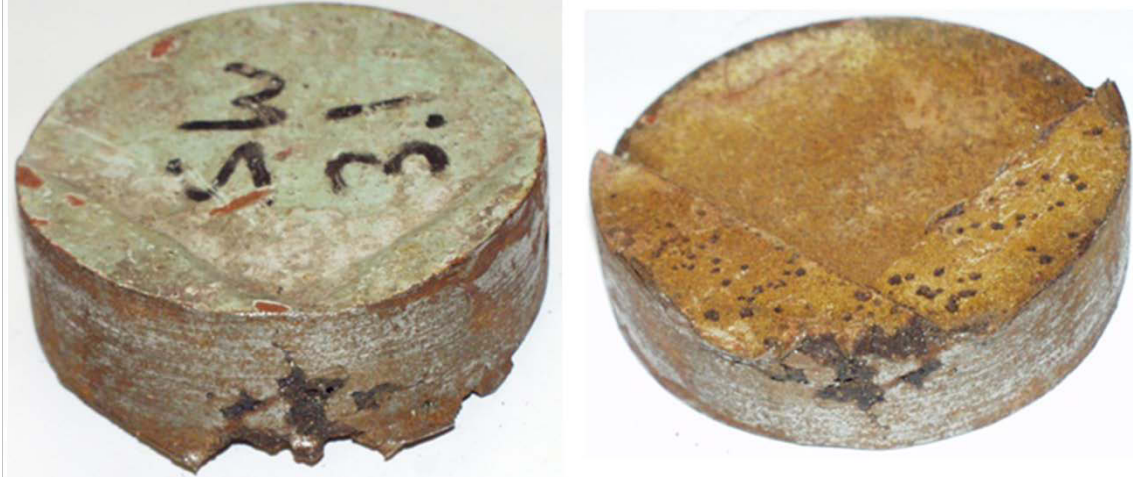
Figure 72. Photo. Core taken from intersecting welds between gusset plate, girder web, and connection plate. View of top of the gusset (left) and bottom of the gusset (right). Cores courtesy of Wiss, Janney, Elstner Associates.

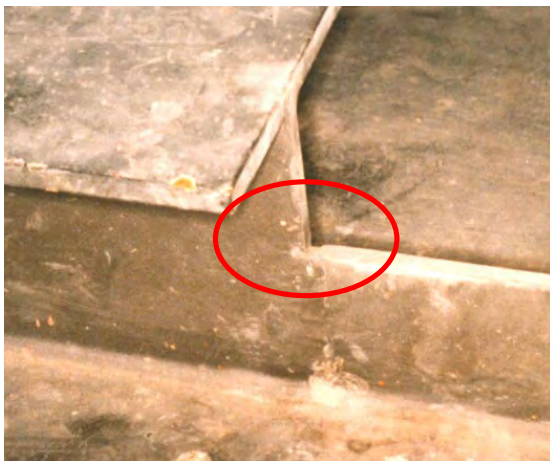
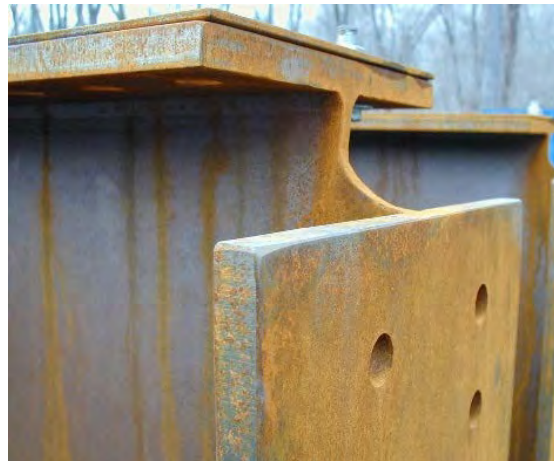
Figure 85. Photo. Bad coped beam detail with a sharp corner (left) and better coped detail with a smooth ground transition radius (right).
