Novel Alternative Cementitious Materials for Development of the Next Generation of Sustainable Transportation Infrastructure

TECHBRIEF

1. Report No. FHWA-HRT-16-017	2. Government Accession No.	3. Recipient's Catalog No.	
4. Title and Subtitle Novel Alternative Cementitious Materials for Development of the Next Generation of Sustainable Transportation Infrastructure		5. Report Date October 2015

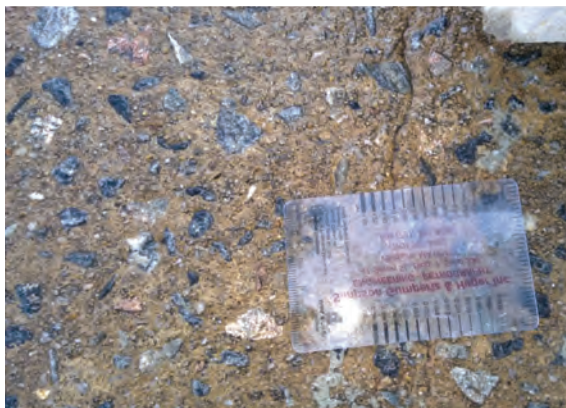
Figure 2. The wearing surface of the I-16 slab section in Dublin, GA, and one of the few cracks present. (It is not known if the crack was present before slab removal.)

The research team examined full-depth chemically-activated binder concrete slabs, originally placed on U.S. Interstate 16 in Dublin, GA. Images from the site are shown below in figures 2 and 3. These slabs were originally placed in early 2008 and remained in service until 2013, when a full highway section replacement was completed. Since then, the slabs have been stored at a Georgia DOT storage yard.

The research team observed that the slabs appeared to be in excellent condition, with only

very minimal cracking. This cracking was likely caused by removing the slab from the roadway and transporting it via a front-end loader from the original site to a Georgia DOT storage area. The slab surface showed exposed aggregates; however, this was assumed to be a result of the paving process, and perhaps grinding of the surface to smooth it and improve rideability, rather than a durability issue, as no evidence indicated salt scaling or delamination.

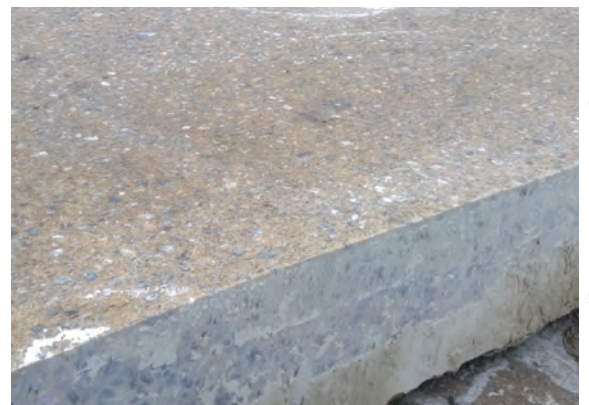
Figure 3. Cast surface of the slab section in Dublin, GA.

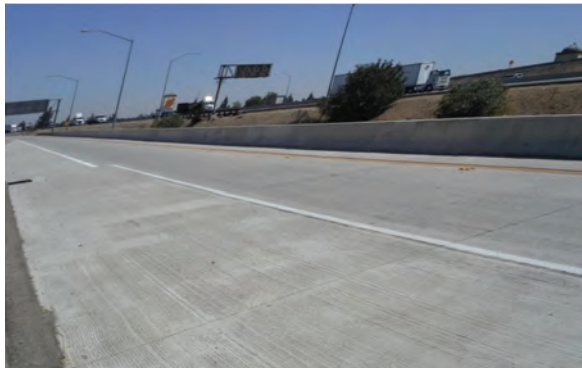
Figure 4. The Route 60W/71S interchange in the Los Angeles, CA, area shows good performance after 17 years of continual heavy traffic loads.

The California State Route 60W to State Route 71S interchange near Pomona, CA, was constructed in 1997 with a commercially available ACM, which Caltrans has described as an 85-percent CSA and 15-percent portland-cement binder. Figures 4-7 show the condition of the pavement. After the pavement had been exposed for 17 years, the research team observed that the pavement was still in very good condition with only occasional spalls noted at the joints, although the research team noted some evidence of surface abrasion.

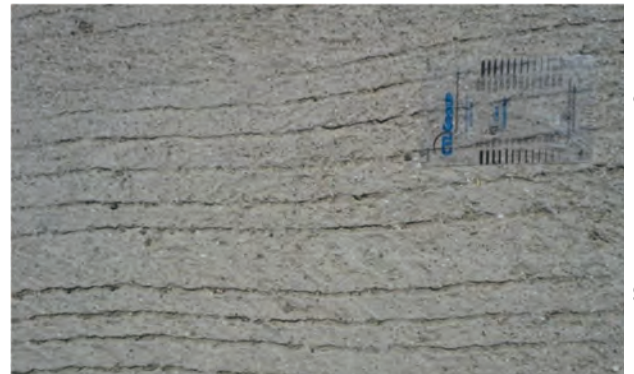
Figure 5. A close-up view of the Route 60W/71S interchange in the Los Angeles, CA, area.

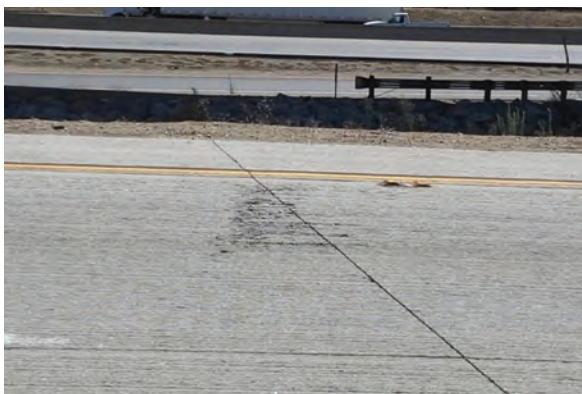
Figure 6. The Route 60W/71S interchange in the Los Angeles, CA, area. (A defect, perhaps caused by a placing or finishing issue, is apparent in the passing lane.)

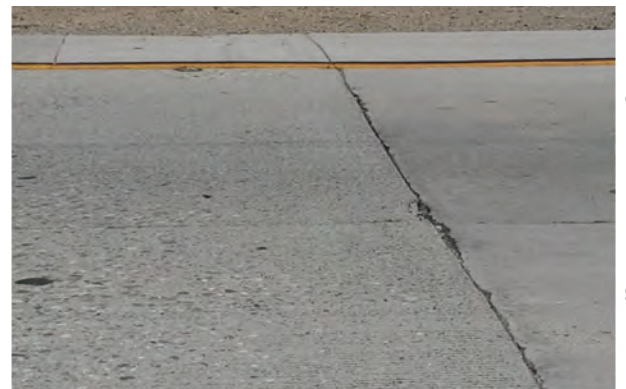
Figure 7. Surface wear and minor joint spalling on the Route 60W/71S interchange in the Los Angeles, CA, area.

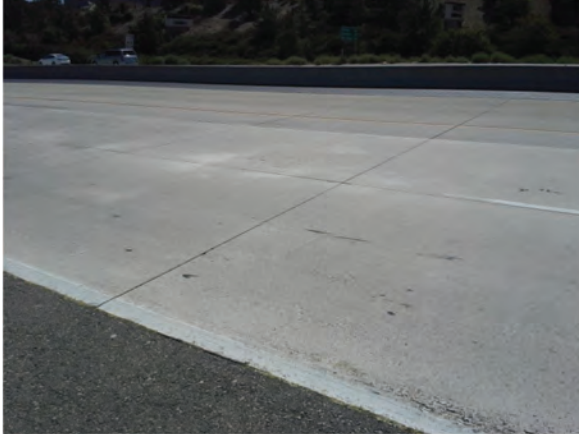
Figure 8. The Route 60E/71N interchange in the Los Angeles, CA, area shows good performance after 17 years of continual heavy traffic loads.

The California State Route 60E to State Route 71N interchange near Pomona, CA, was constructed in 1997 with a 100-percent CSA binder. The pavement required grinding

after placement, possibly caused by poor compactability or a set time that was too rapid for proper finishing. Despite this grinding, the research team noted that this pavement was in good condition, as shown in figures 8 and 9.

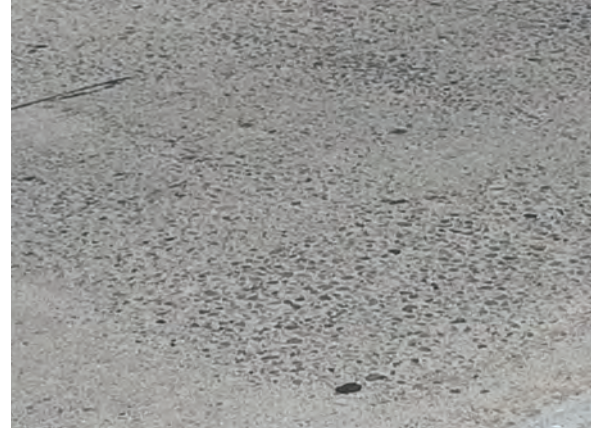
Figure 9. A close-up view of the Route 60E/71N interchange in the Los Angeles, CA, area shows good performance after 17 years of continual heavy traffic loads. (Surface wear and perhaps early grinding for rideability is apparent.)

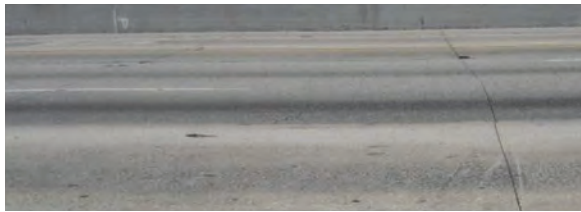
Figure 10. A close-up view of pavement slabs on I-10E near Los Angeles, CA, shows deterioration after 15 years.

Forty-five km (28 mi) of U.S. Interstate 10 (I-10) near Los Angeles, CA, also called the San Bernardino Freeway, were placed in 1999 using a 100-percent CSA binder. The research team observed that pavement slabs in both the eastbound and westbound directions at this site showed significantly more damage than did the previous sites. The condition of pavement on I-10E is shown in figures 10 and 11. The slabs showed evidence of damage, including joint deficiencies and spalls. In

addition, the research team noticed mid-panel cracking and corner cracking in many of the slabs in these sections, including both ACM and portland cement concrete, leading the team to conclude that the ACMs did not contribute to the damage. Caltrans attributed the damage to the combination of subgrade deficiencies and underdesign and a slab thickness that is too low for today's traffic loads. The flow of water down an adjacent hillside also contributes to the poor subgrade conditions.

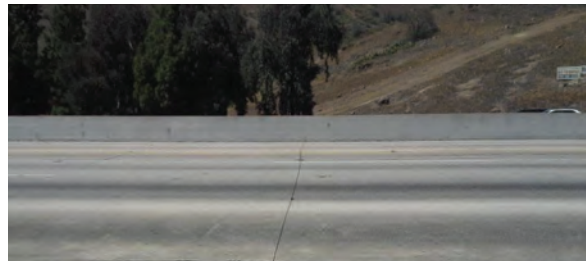
Figure 11. Pavement slabs on I-10E near Los Angeles, CA, shows deterioration after 15 years.

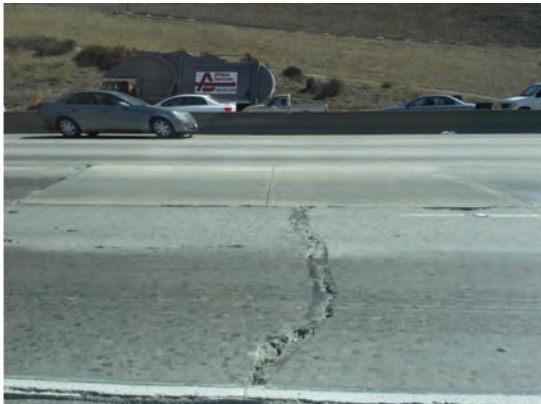
Figure 12. Pavement slabs on Route 60W in Los Angeles, CA, show some cracking and spalling at joints after 1 year of use.

Sixty-four km (40 mi) of the Pomona Highway (California SR 60) between California State Route 57 and California Interstate 605 (I-605) were constructed in 2012 using a 100-percent CSA binder. Figures 12 and 13 show the condition of the pavement. Pavement was placed in both the eastbound and westbound directions over new base material, with the pavement designed for higher traffic loads constructed with an increased slab thickness

and doweled joints. Similar to what was seen with the Route 60E to 71N interchange, the surface of this pavement was intentionally ground after placement because of pavement irregularities observed during placement. Despite its short time in service and improved design, the research team observed some spalling at joints, extensive longitudinal cracking, and corner cracking. Patches were required in several areas.

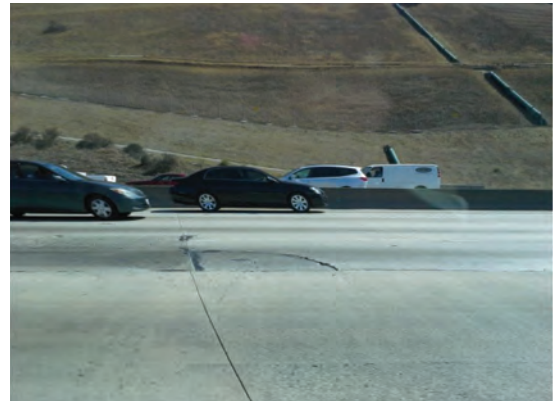
Figure 13. An example of pavement slabs cracking and spalling at joints after 1 year of use on Route 60W near Los Angeles, CA.

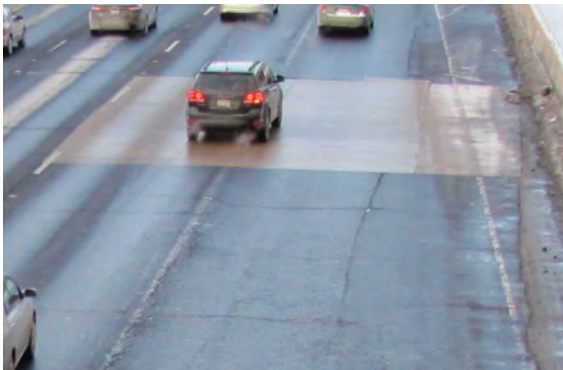
Figure 15. Repaired pavement on northbound I-90 in Chicago, IL, shows good performance of the CAC concrete after 5 years.

In 2009, the Illinois DOT replaced a significant section of interstate highway pavement in downtown Chicago with CAC concrete after what they described as a “catastrophic blowup of a section of pavement” resulting from nearby tunnel construction. Figures 15 and 16 show the repaired section of pavement. The Illinois DOT chose CAC as the replacement material for the damage to three northbound lanes of I-90/94 between Jackson and Adams

Streets because of its capacity for high early strength. The Illinois DOT placed the CAC using mobile volumetric mixers and poured 58.3 m³ (76.25 yd³) of concrete and reopened the road within 5 hours after the start of the construction repairs. The engineer of record noted that the material seems to be holding up well, but that “experienced and well-organized contractors with top notch placement equipment” are required to obtain good results.

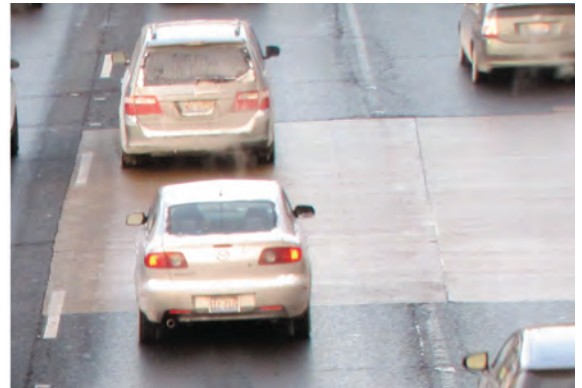
Figure 16. Vehicles travel over the repaired pavement on northbound I-90 in Chicago, IL, which shows good performance of the CAC concrete after 5 years.

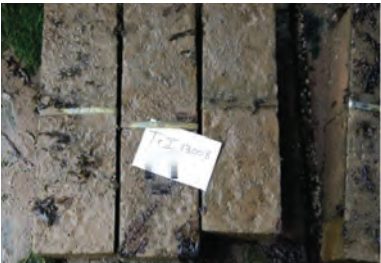
Figure 17. Fly ash geopolymer beams after 1 year of exposure at Treat Island.

The research team examined beams, produced from a fly ash-based geopolymer, a slag-based geopolymer, and a CSA cement, for signs of deterioration. These signs included scaling, cracking, and expansion. No signs of expansion or cracking were apparent in any of the ACM samples after 1 year of exposure. Research is ongoing to determine the chloride diffusion coefficient of the beams, which will be useful in assessing the potential resistance to corrosion for reinforced members.

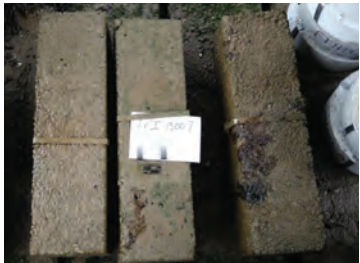
Figure 19. Slag geopolymer beams after 1 year of exposure at Treat Island.
