Federal Highway Administration
Every Day Counts
Innovation Initiative

Safety Edge_{SM}
Demonstration Project
Turner, Maine

Field Report
June 15, 2011

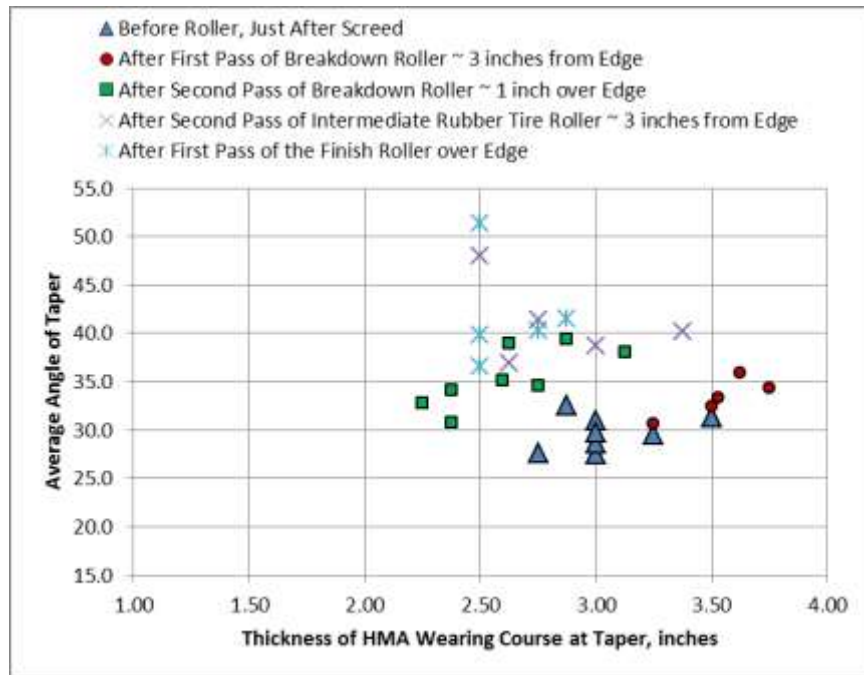
The change in the slopes of the Safety Edge_{SM} and thickness at the Safety Edge_{SM} was also evaluated as a function of the passes of the individual rollers for the section pavement using the TransTech Shoulder Wedge Maker (Refer to Figure 9).

Immediately behind the screed, and prior to the rolling of the HMA mat, the average slope was 30°. After the first pass of the breakdown roller, the average slope increased to 33°. There was a corresponding increase in average thickness (by about 0.5 inches) at the edge since the first pass of the breakdown roller was approximately 3 inches from the edge, resulting in some HMA wearing course material being shoved up near the edges. Following the second pass of the breakdown roller the average slope increased to 35°. The HMA thickness near the Safety Edge_{SM} was now reduced to an average value of 2.6 inches (from 3.5 inches) due to the fact that the second pass of the breakdown roller was 1 to 2 inches over the edge.

After two passes of the intermediate rubber tire roller (which did not go over the edge in either of the two passes but was approximately 3 inches from the edge), the average slope of the Safety Edge_{SM} increase to 41°. There was a slight increase in thickness of the HMA mat near the Safety Edge_{SM} from 2.6 inches to 2.9 inches. Following the first pass of the finish roller (over the edge) the HMA mat thickness was reduced to an average value of 2.6 inches. The average slope of the Safety Edge_{SM} was 42°.

Figure 9. Effect of rolling on the angle of taper and the thickness of HMA wearing course at the taper.

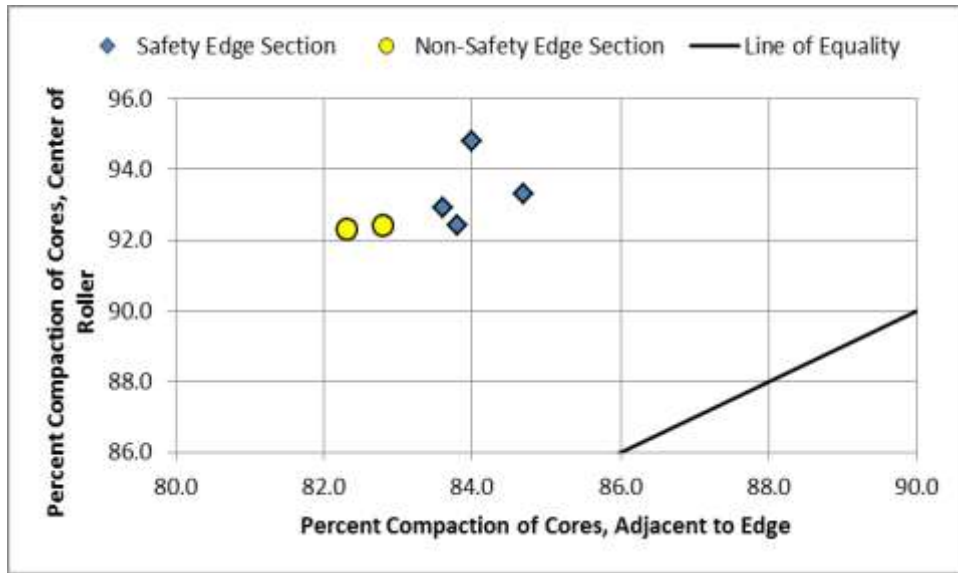
Table A-2 in Appendix A includes a summary of these test results and bulk specific gravities (saturated surface dry) converted to percent compactions. Figure 10 compares the core percent compactions taken along the edge and near the center of the steel drum roller for the Safety Edge_{SM} and non-Safety Edge_{SM} sections. As expected the compactions (and densities) near the center of roller are significantly higher than along the edge of the mat (unconfined edge). More importantly, the core percent compactions (and densities) taken along the pavement’s edge are consistently higher for the Safety Edge_{SM} section than for the non-Safety Edge_{SM}. These results suggest that the Safety Edge_{SM} is providing better confinement for rolling an unconfined edge of the mat.

Figure 10. Comparison of core percent compactions (densities) adjacent to the edge of pavement and the near center of the roller.

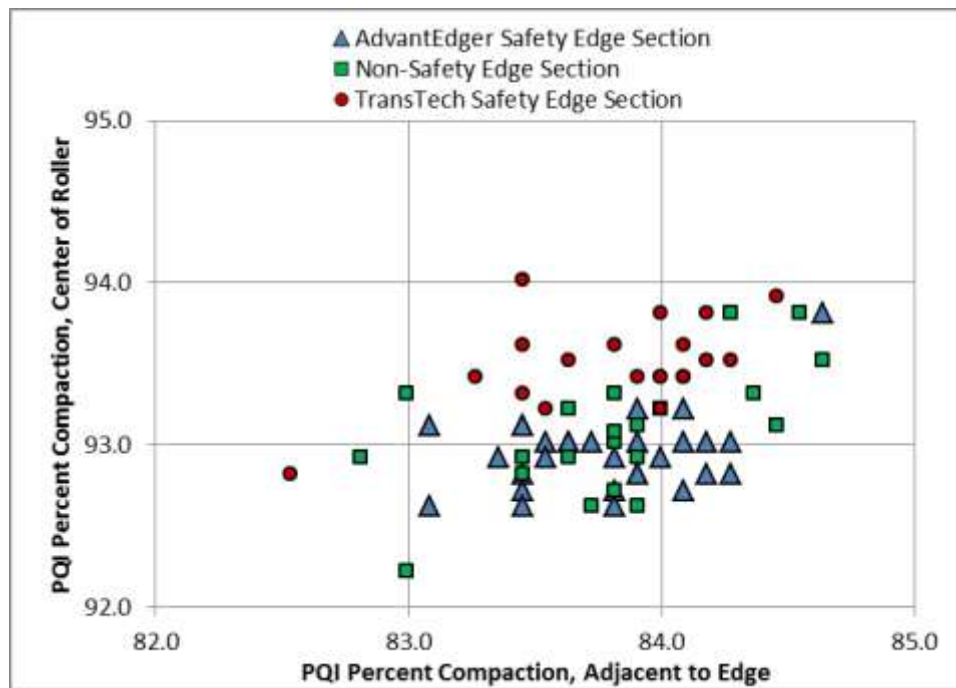
Figure 12 shows a comparison of the adjusted PQI gauge readings taken adjacent to the Safety Edge_{SM} and in the center of the vibratory steel wheel roller. As shown in the figure, the percent compaction near the edge (unconfined edge) for both the Safety Edge_{SM} sections and the control section is substantially lower than the percent compaction at the center of the roller (confined edge).

Figure 12. Comparison of the adjusted PQI percent compaction readings between the areas adjacent to the edge and center of the steel drum roller.

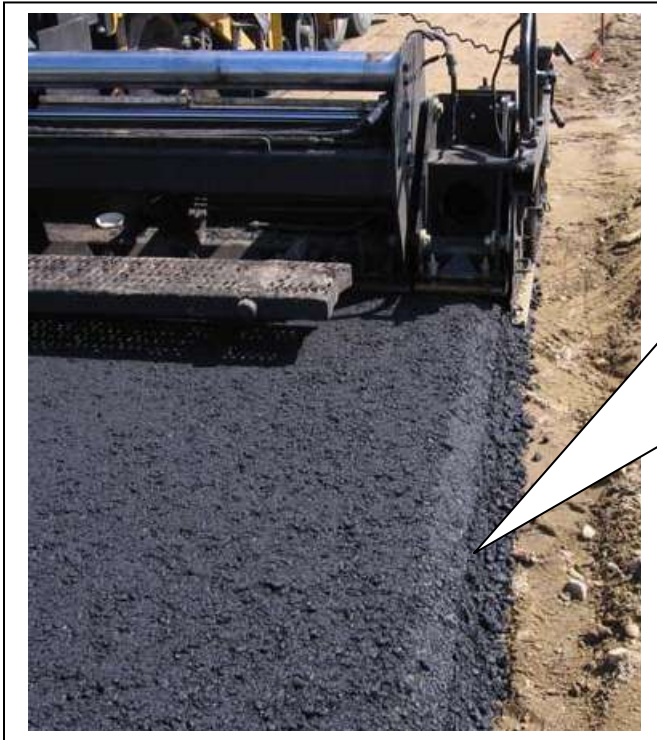
While paving the 3 inch HMA base course a line in the middle of the angled edge was made by the Advant-Edger. The material to the right of this line is loose. It would seem that the 3 inch mat thickness was too much for the Safety Edges_{SM} device. A slight adjustment to the angle was made by spot welding a shim to the back of the Advant-Edger.

Figure 13. Paving the lower 3 inch HMA 19 mm base course with the Advant-Edger on the compacted Type D aggregate subbase.

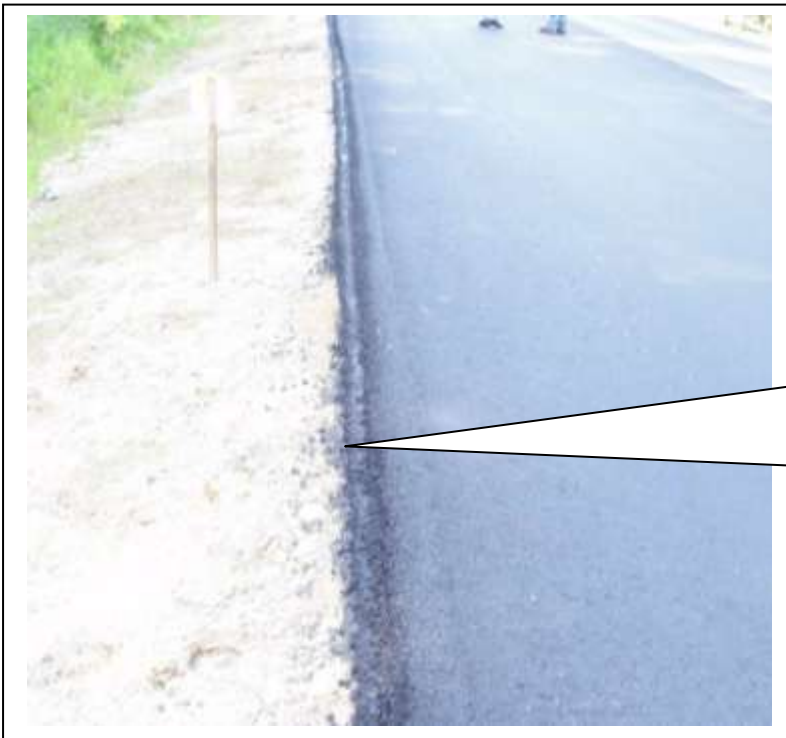
Both the 3 inch HMA 19 mm base course and the 2 inch HMA 12.5 mm wearing course were paved using a Safety Edges_{SM}. However, the Safety Edges_{SM} for the lower lift at many locations did not appear to have a distinct slope.

Figure 14. Both HMA lifts were paved using a Safety Edges_{SM} device.

The Advant-Edger was used to pave the first 3 inch HMA 19 mm base course on the compacted variable thickness (nominal thickness of 18 inches for grade improvement) Type D aggregate subbase. Figure 13 shows the HMA placed on top of the Type D aggregate subbase. Both the Advant-Edger and the TransTech Safety Edge_{SM} devices were used to pave the second 2 inch HMA 12.5 mm wearing course. Each side of the road had to be widened by about 8 inches to accommodate the Safety Edge_{SM} without reducing pavement width. Figure 14 shows the edge of both lifts.

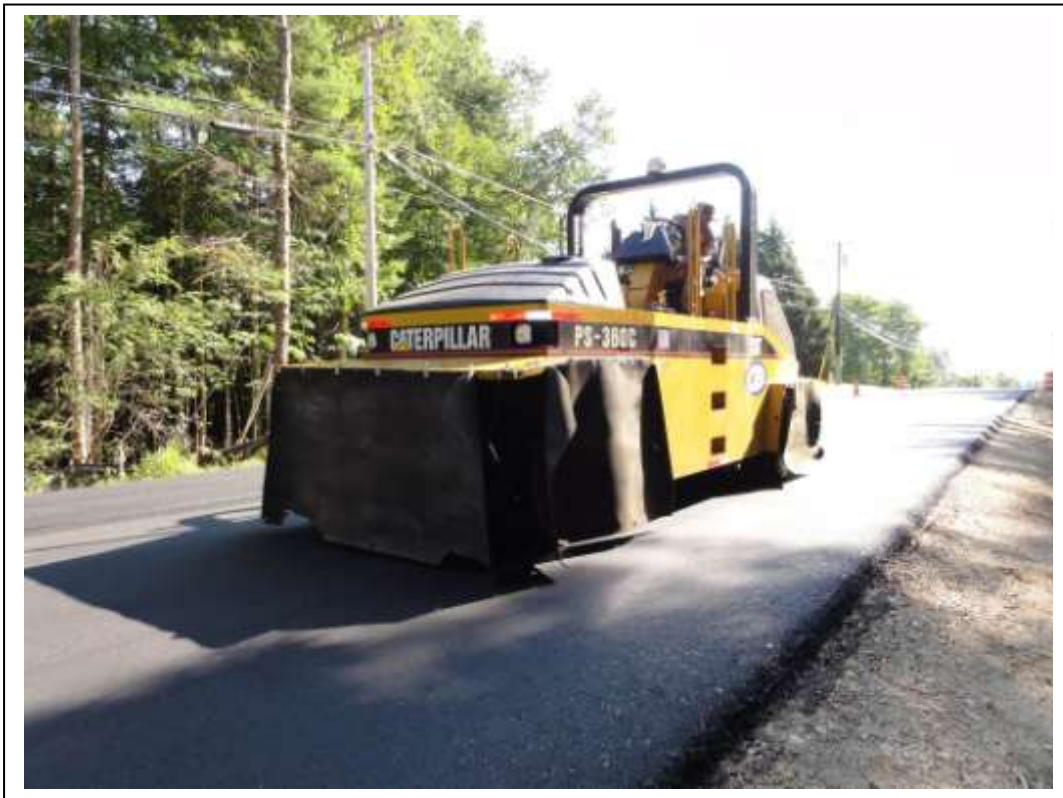
The Caterpillar intermediate rubber tire pneumatic roller shown in Figure 21 was operated right behind the breakdown roller along most of the areas. The roller had 4 tires (15 inch footprint with 9.5 inch gap between tires) in front and 3 tires (15 inch footprint with 9.5 inch gap between tires) in back to cover the gaps between the front tires. The roller was operated without water ballast; the operator indicated that the tire pressure was about 85 psi (pressure set to give good compaction and still allow the finish roller to remove the intermediate roller tire marks).

- Caterpillar intermediate rubber tire pneumatic roller:
 - First pass is on the centerline hanging over about 2 inches.
 - 6 passes to traverse across the pavement such that with each pass the roller moves over about 12 inches.
 - Another 6 passes to traverse back across the pavement.
 - Roller does not get any closer to outside edge than 6 inches (so pneumatic roller does not roll the outside edge where the Safety Edges_{SM} is located).

Figure 21. Rubber tire pneumatic roller used in the intermediate position.
