4 NONSTRUCTURAL EXAMPLES: EARTHQUAKE DAMAGE AND UPGRADE DETAILS

NONSTRUCTURAL EXAMPLES

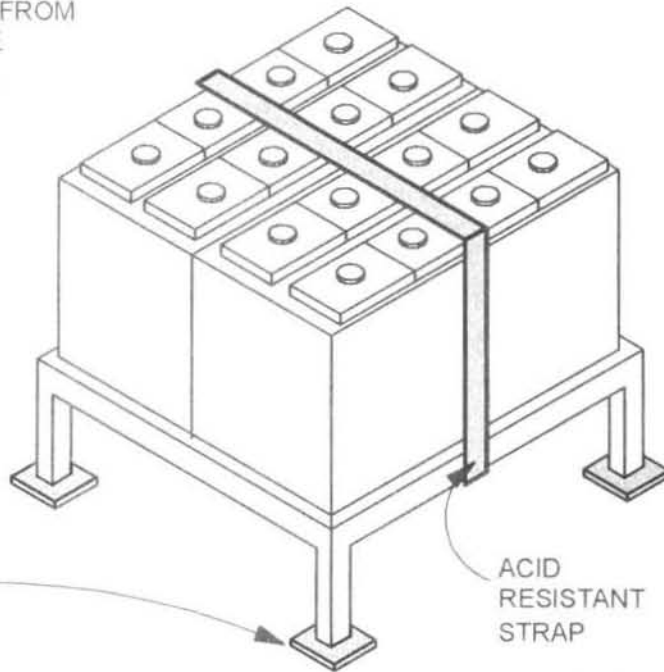
Schematic Upgrade Detail U2
Approximate Cost: \$200

SEISMIC RESISTANT BATTERY RACKS ARE AVAILABLE FROM VENDORS THAT MAY BE BOLTED TO THE FLOOR AND/OR WALL.

BOLTED TO FLOOR.
BRACING OF LEGS
MAY BE REQUIRED.

ACID
RESISTANT
STRAP

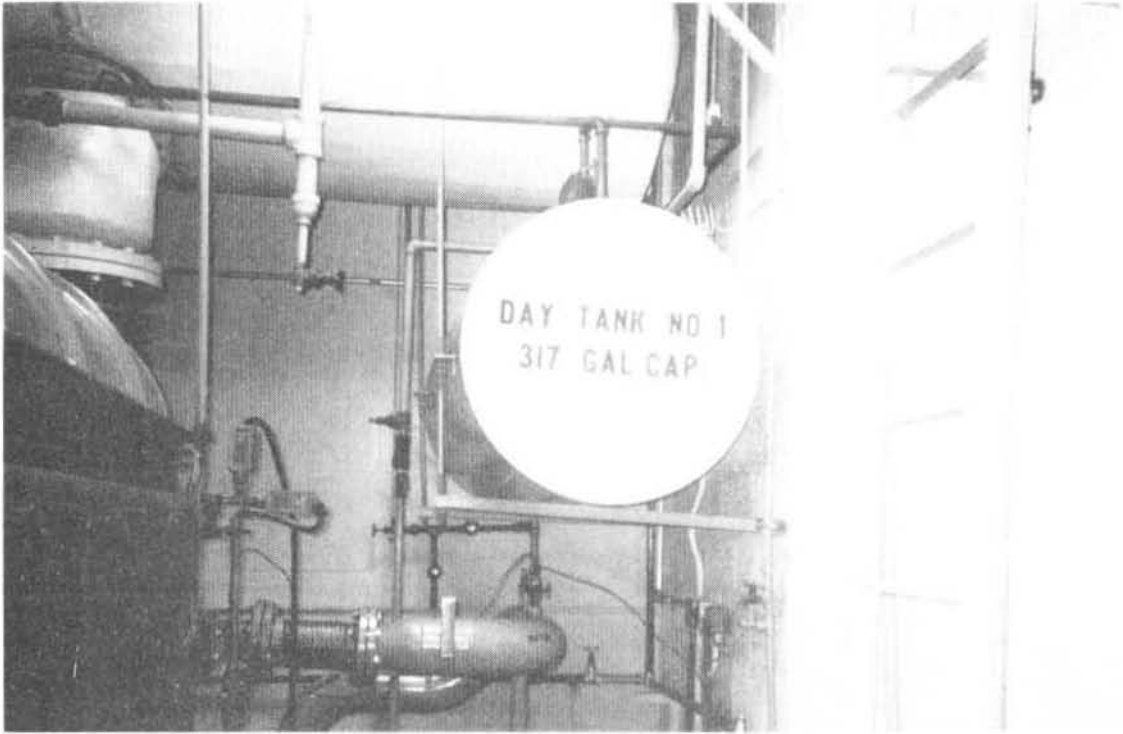
Unbraced Day Tank, Hospital, Puerto Rico
Photo Credit: Wiss, Janney, Elstner Associates, Inc.

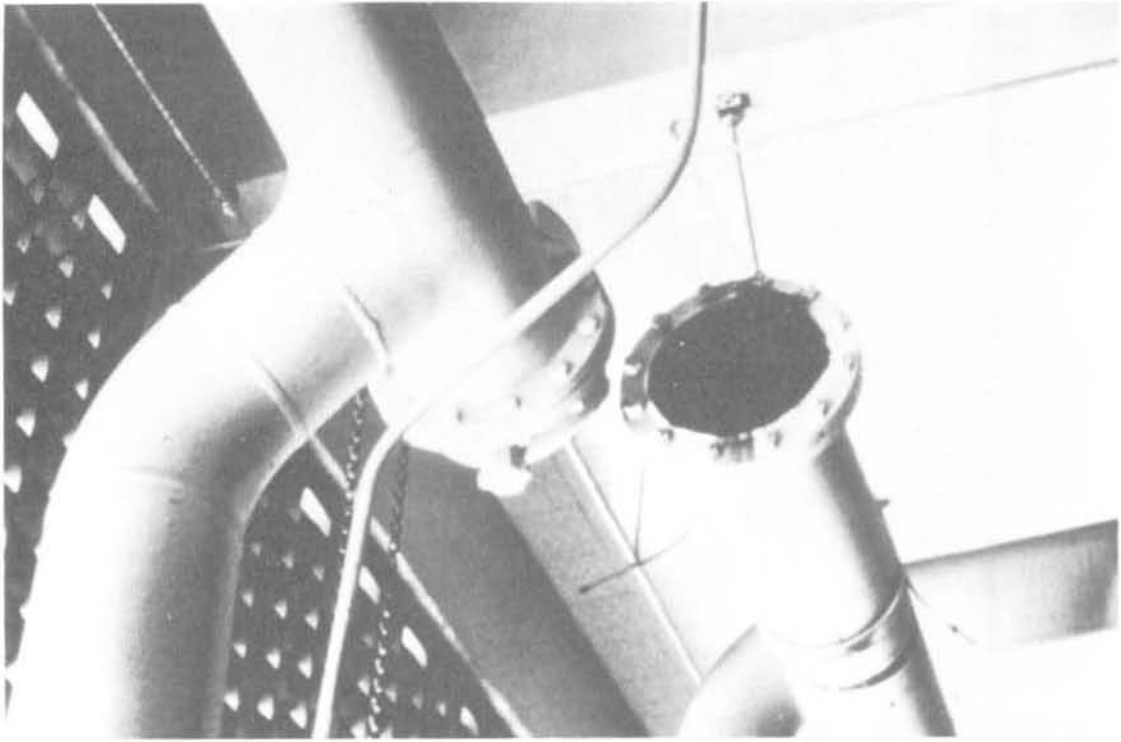
Earthquake Damage: 1971, San Fernando, California
Photo Credit: John F. Meehan

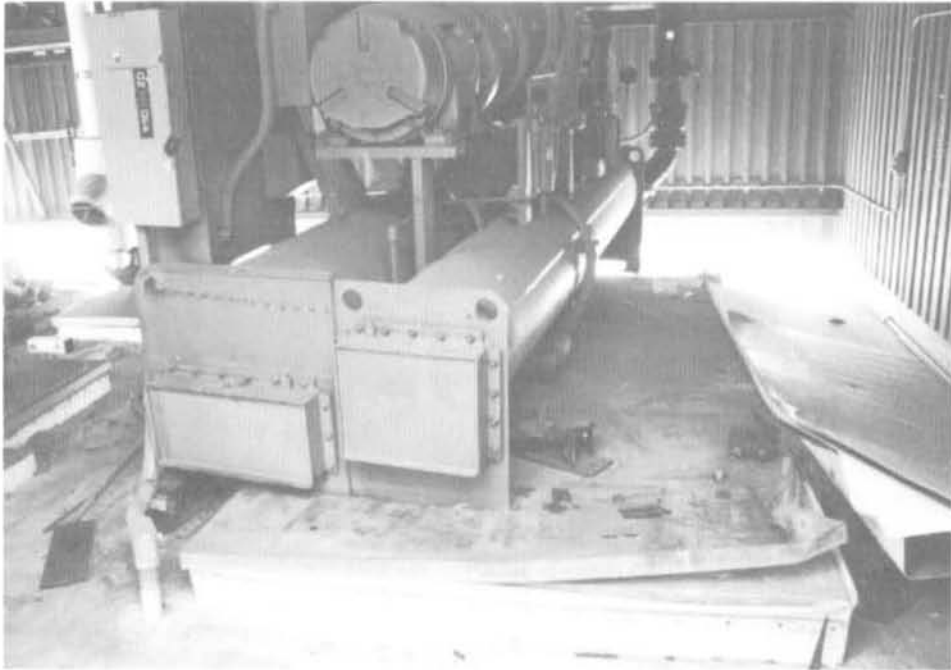
Failed chiller mounts due to insufficient uplift resistance.
Earthquake Damage: 1994, Northridge, California
Photo Credit: Wiss, Janney, Elstner Associates, Inc.

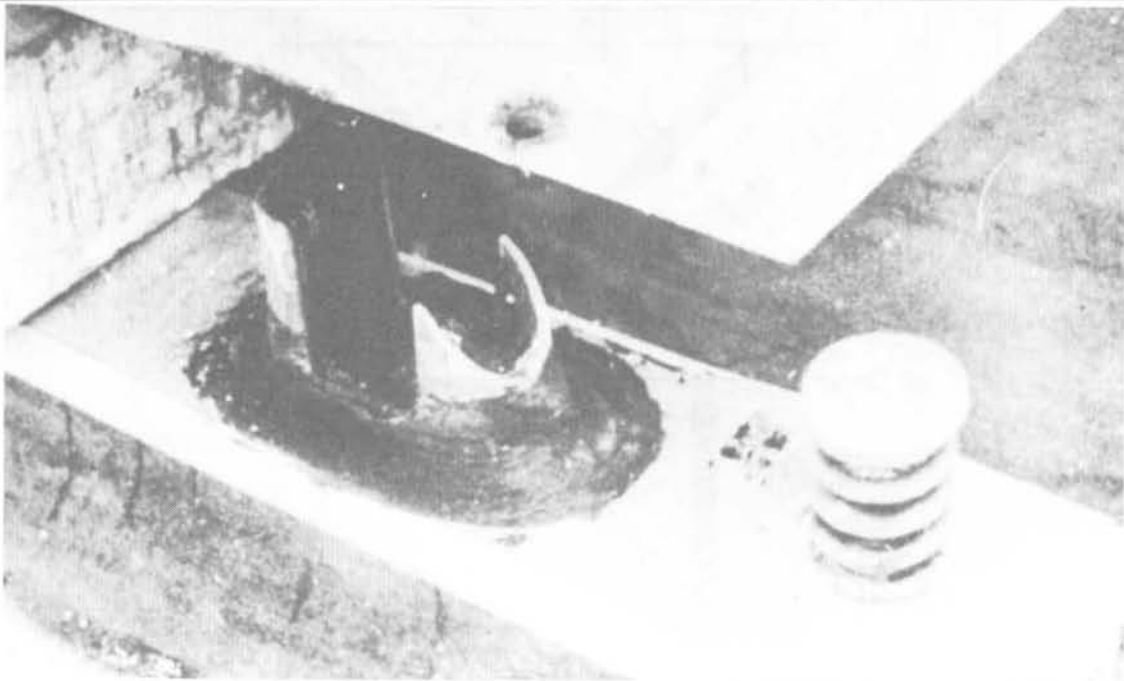
Failed chiller due mount due to insufficient shear resistance.
Earthquake Damage: 1980, Livermore, California
Photo Credit: William T. Holmes

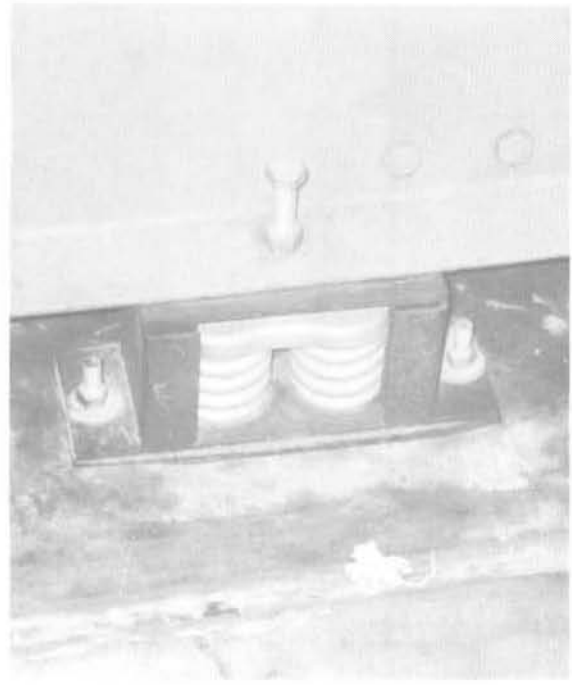
U29b

Chiller mount with no uplift resistance and insufficient or no shear resistance.
Photo Credit: Wiss, Janney, Elstner Associates, Inc.
Schematic Upgrade Detail: See Detail U32, Air Compressor

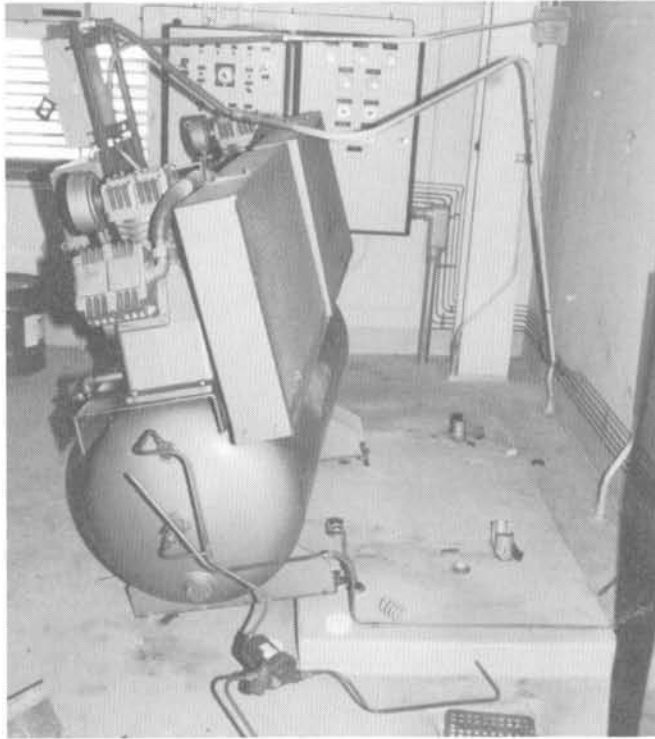
Earthquake Damage: 1994, Northridge, California
Photo Credit: Wiss, Janney, Elstner Associates, Inc.

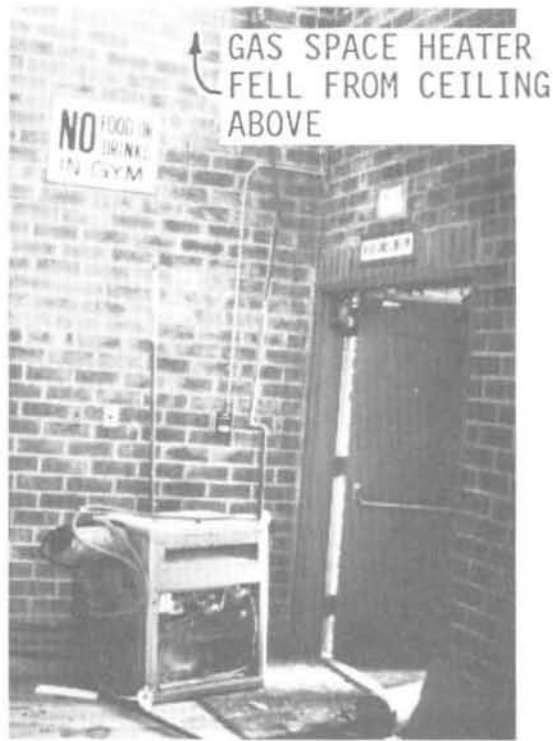
Earthquake Damage: 1971, San Fernando, California
Photo Credit: C. Wilton, Scientific Service, Inc.

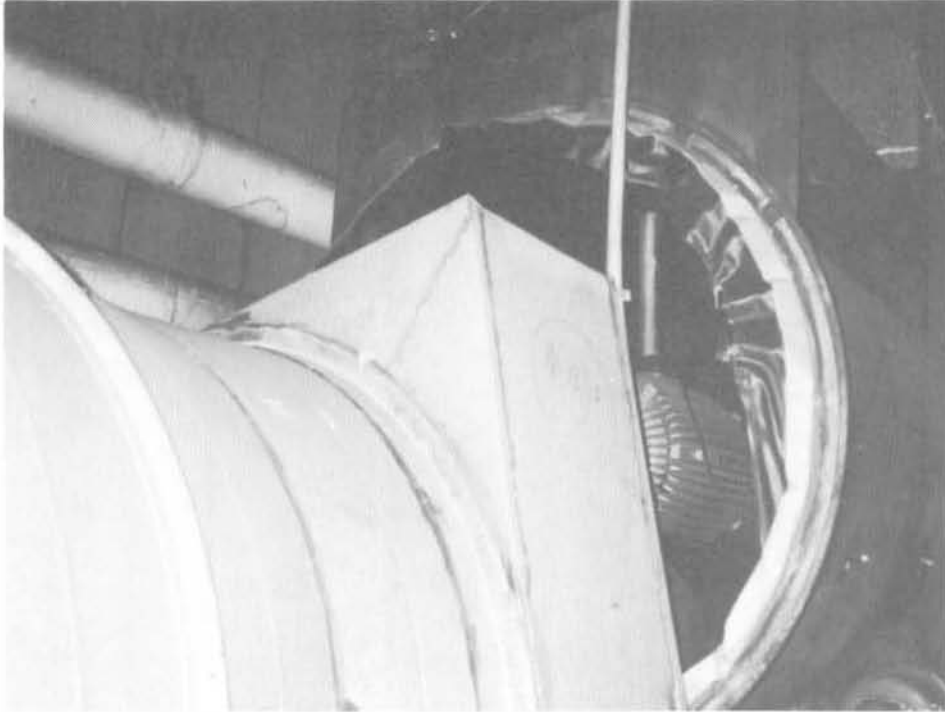
Sheet metal duct separated from fan unit.
Earthquake Damage: 1994, Northridge, California
Photo Credit: Wiss, Janney, Elstner Associates, Inc.

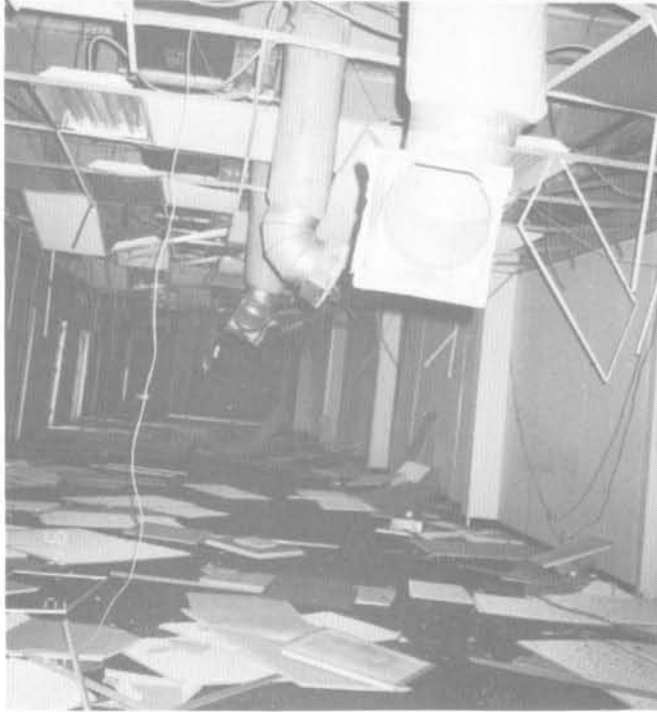
Air diffusers fell to the floor.
Earthquake Damage: 1994, Northridge, California
Photo Credit: Wiss, Janney, Elstner Associates, Inc

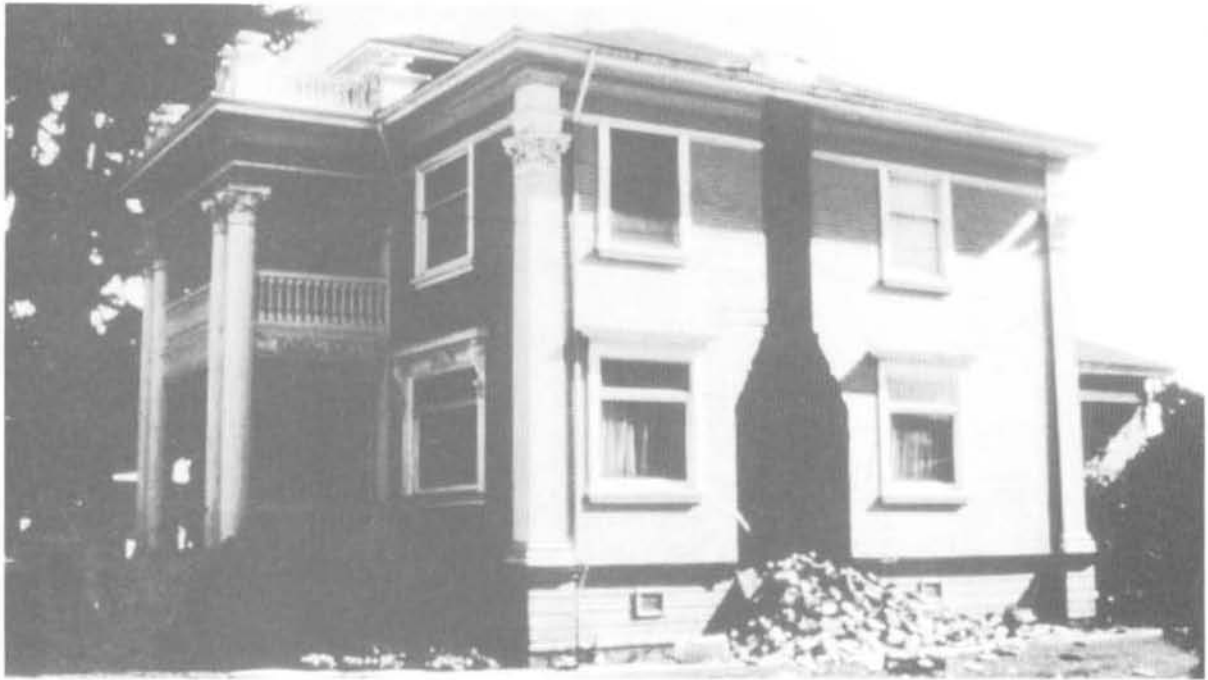
Earthquake Damage: 1989, Loma Prieta, California

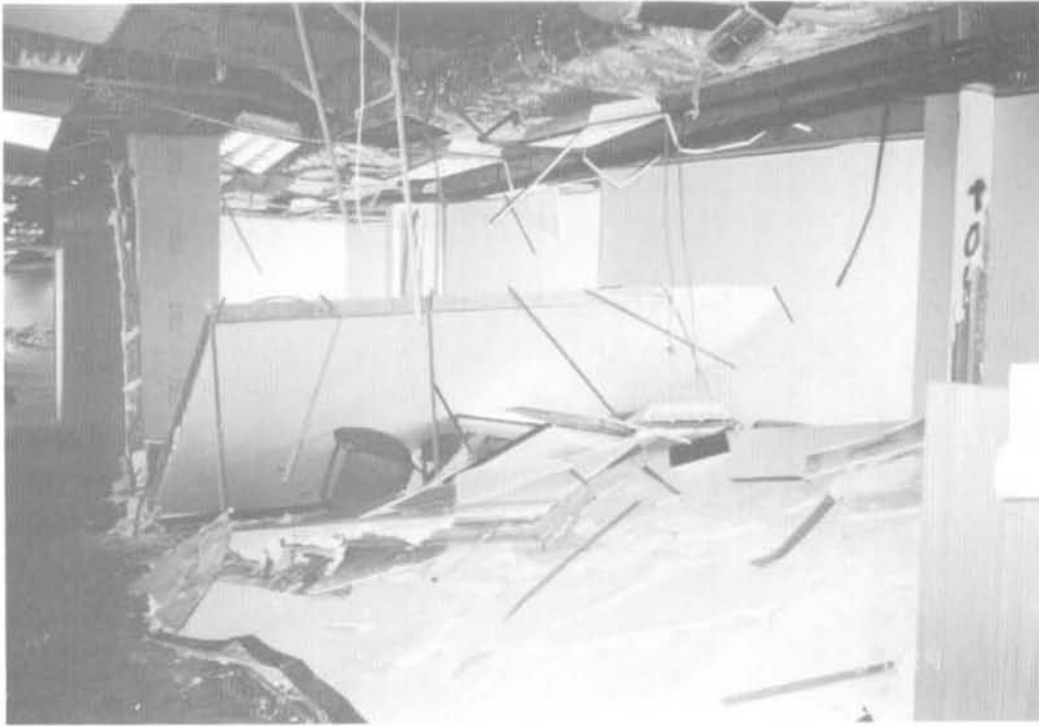
BUILT-IN PARTIAL-HEIGHT PARTITIONS

Earthquake Damage: 1994, Northridge, California
Photo Credit: Wiss, Janney, Elstner Associates, Inc.

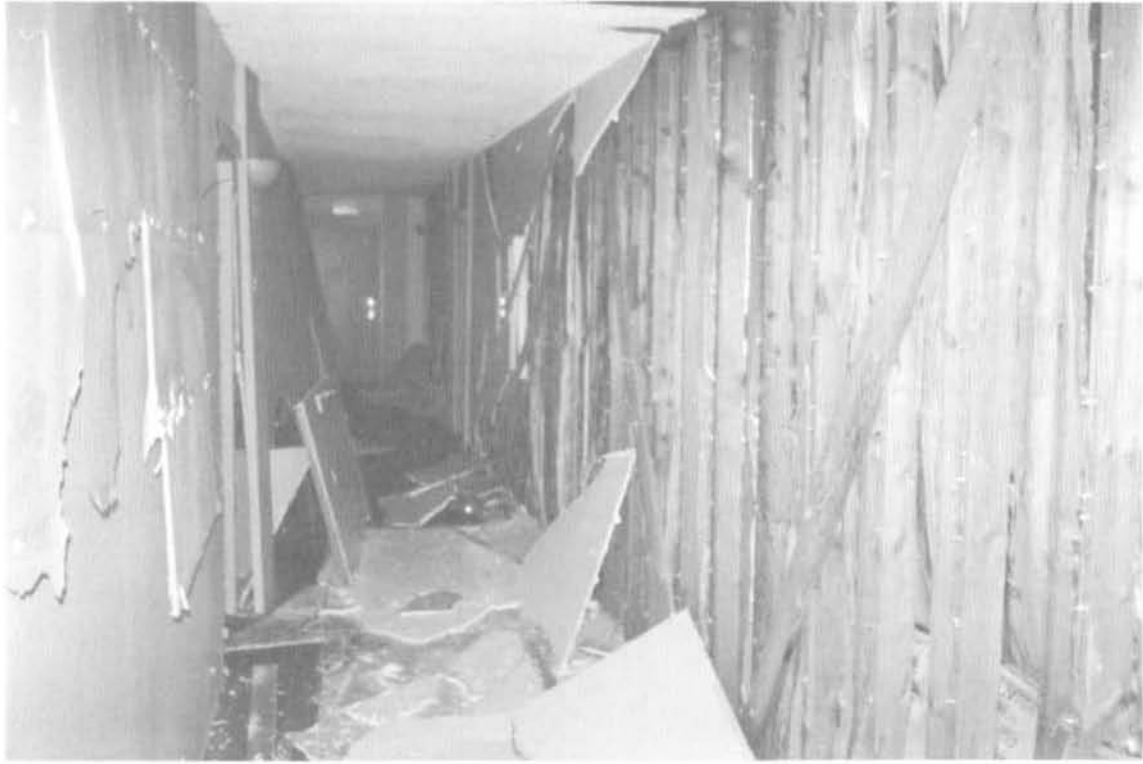
BUILT-IN FULL-HEIGHT PARTITIONS

Earthquake Damage: 1994, Northridge, California
Photo Credit: Wiss, Janney, Elstner Associates, Inc.

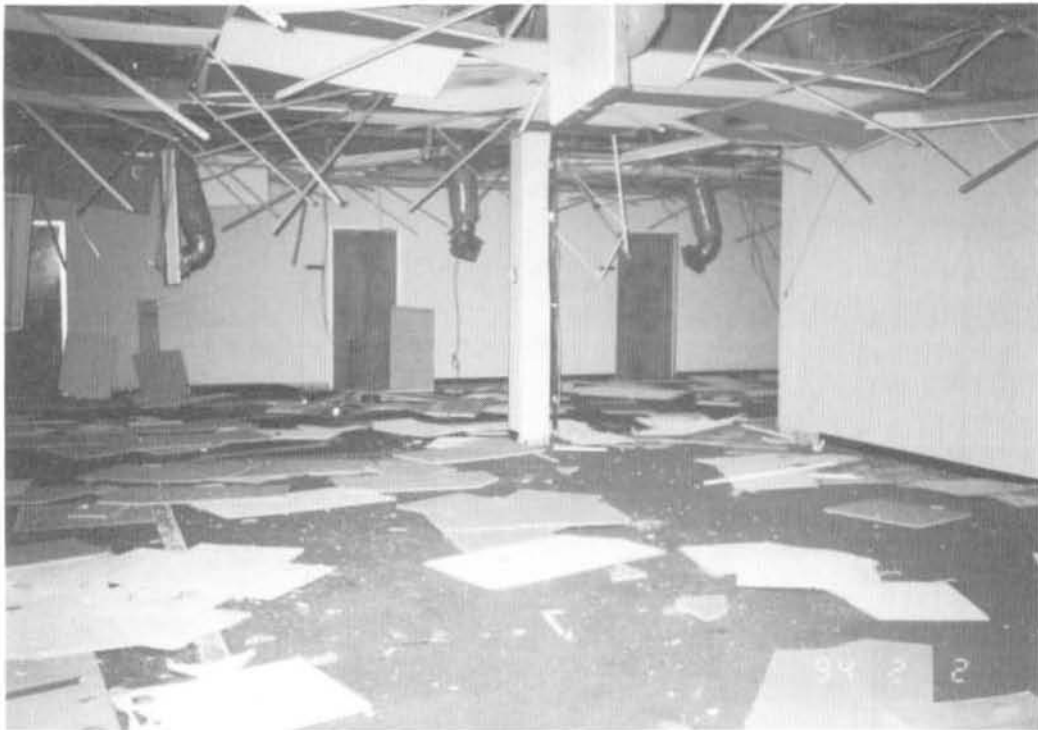
SUSPENDED T-BAR CEILINGS

Earthquake Damage: 1994, Northridge, California
Photo Credit: Wiss, Janney, Elstner Associates, Inc.

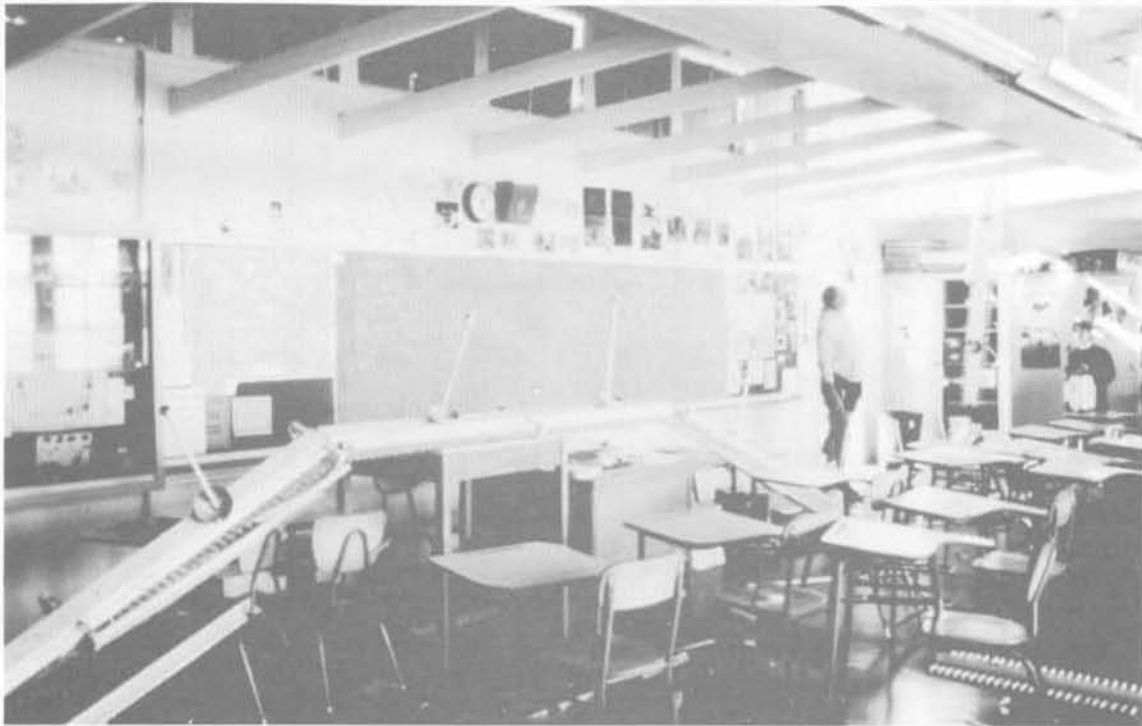
Failure of light fixtures at Northridge Junior High School
Earthquake Damage: 1994, Northridge, California
Photo Credit: Earthquake Engineering Research Institute, Gary L. McGavin

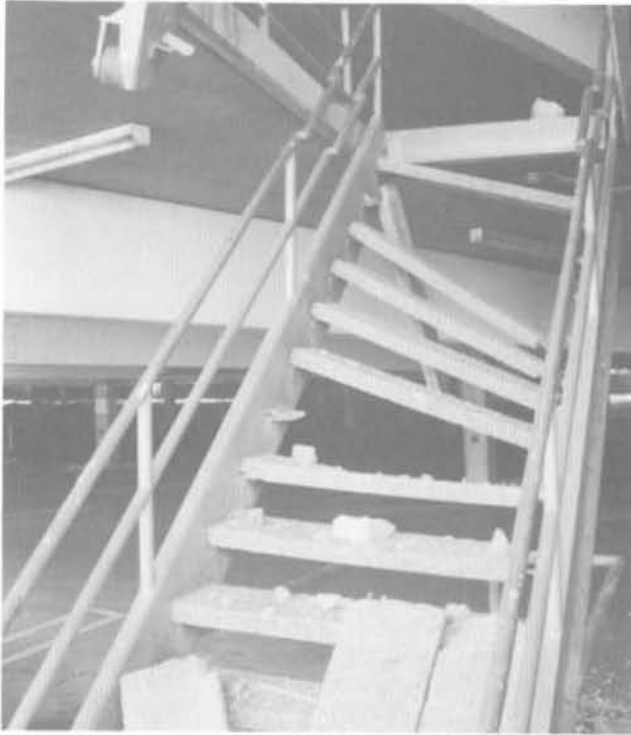
Earthquake Damage: 1994, Northridge, California
Photo Credit: Wiss, Janney, Elstner Associates, Inc.

- TO PREVENT DAMAGE TO STAIRS THEY SHOULD BE MODIFIED TO ALLOW THEM TO SLIDE AT LANDINGS WITH "GANG PLANK" DETAILS; THIS IS DESIRABLE FOR FLEXIBLE FRAME BUILDINGS.
- IF STAIR ENCLOSURES ARE CONSTRUCTED USING BRITTLE MATERIALS, SUCH AS, HOLLOW CLAY TILE, GLASS BLOCK PARTITIONS, OR SKYLIGHTS, IT IS RECOMMENDED THAT THEY BE ENCAPSULATED OR REPLACED TO PREVENT FALLING HAZARDS AND DEBRIS IN THE STAIRWELL.
- PROVIDE ANCHORAGE FOR PIPES, LIGHTING OR DUCTS IN STAIRWELLS TO PREVENT FALLING HAZARDS AND DEBRIS.

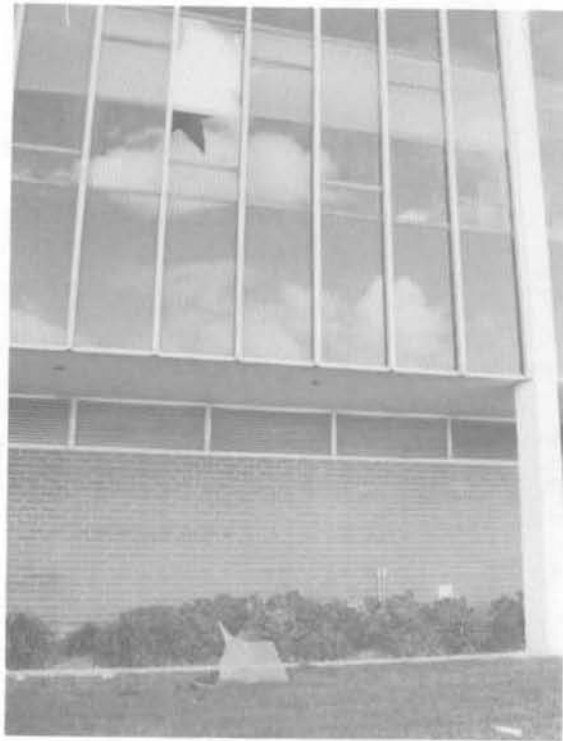
Earthquake Damage: 1994, Northridge, California
Photo Credit: Wiss, Janney, Elstner Associates, Inc.

- USE OF TEMPERED GLASS WILL GREATLY REDUCE THE SEISMIC HAZARD. TEMPERED GLASS MAY STILL BREAK, BUT WILL BREAK INTO SMALL DULL FRAGMENTS INSTEAD OF LARGE DANGEROUS SHARDS.
- POLYESTER SHATTER RESISTANT FILMS ARE AVAILABLE THAT HELP HOLD TOGETHER FRAGMENTS OF ANY PANES THAT CRACK IN AN EARTHQUAKE. (TYPICAL SOLAR FILM MAY NOT BE ADEQUATE FOR THIS PURPOSE).
- USE OF LAMINATED GLASS FOR STOREFRONTS REDUCES SEISMIC RISK AND ALSO INCREASES PROTECTION FROM BURGLARY OR VANDALISM.
- SMALLER, OPERABLE, AND WOODEN FRAMED WINDOWS TOLERATE MORE LATERAL DRIFT.
- FOR NEW CONSTRUCTION, STIFFER BUILDINGS AND GLAZING WITH MORE THAN THE STANDARD EDGE CLEARANCES MAY BE DESIRABLE. CHECK WHETHER OR NOT THE BUILDING'S CALCULATED SEISMIC DRIFT HAS BEEN CONSIDERED IN THE DESIGN OF THE GLAZING.

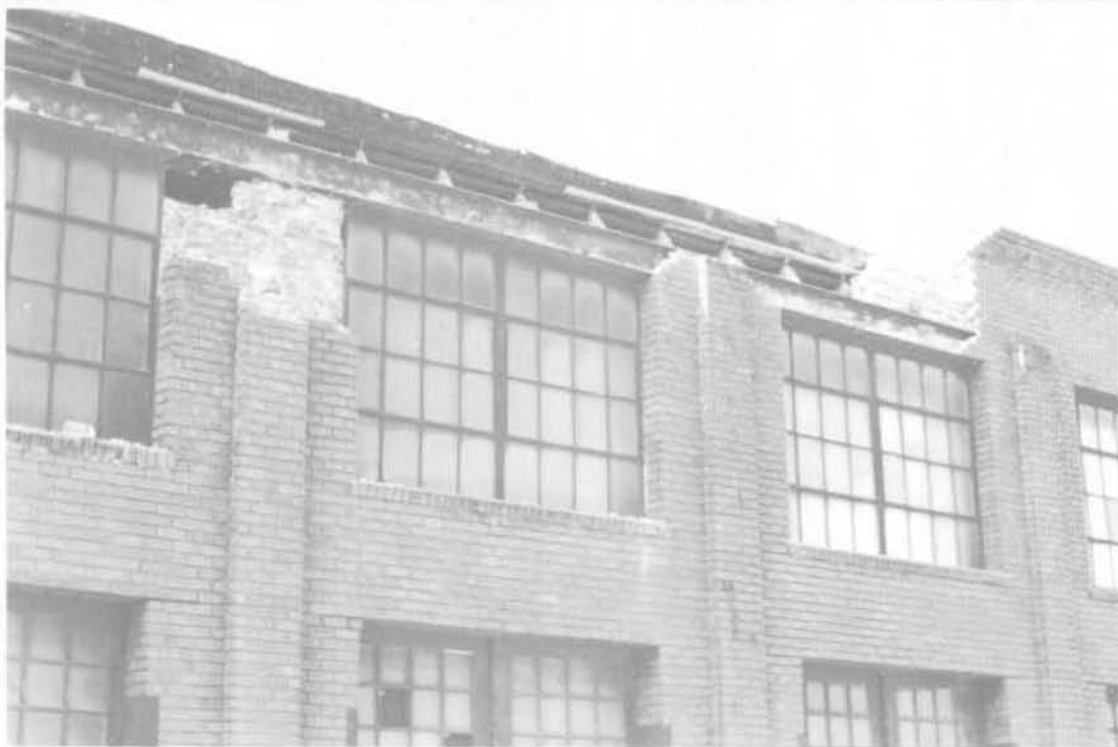
UNREINFORCED BRICK PARAPETS

Earthquake Damage: 1989, Loma Prieta, California
Photo Credit: Wiss, Janney, Elstner Associates, Inc.

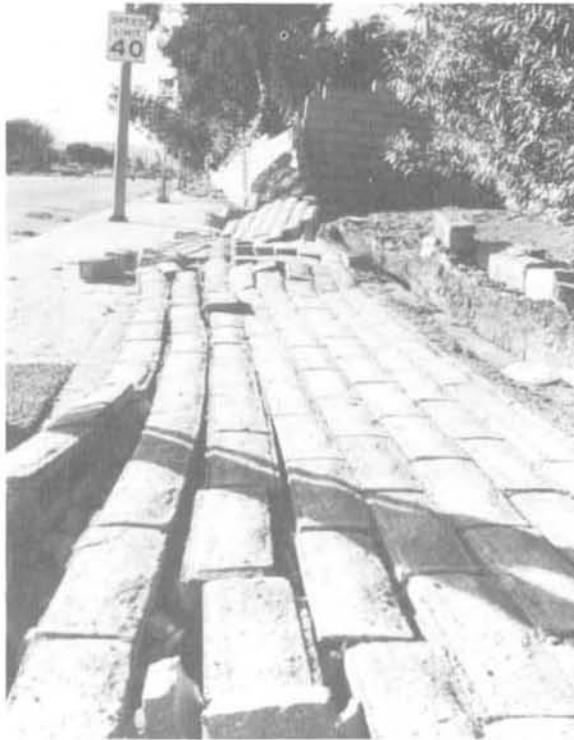
Earthquake Damage: 1994, Northridge, California
Photo Credit: Robert Reitherman

- MANY MILES OF POORLY CONSTRUCTED CONCRETE MASONRY UNIT (CMU) FENCES WERE DAMAGED DURING THE 1994 NORTHRIDGE EARTHQUAKE. COLLAPSE OF WALLS WITH INADEQUATE OR ABSENT REINFORCING AND/OR FOUNDATIONS WAS COMMON IN NORTHRIDGE AND SYLMAR. IN MANY CASES, MOST OF THE SIDEWALK WAS COVERED WITH DEBRIS, AS SHOWN ABOVE.
- FREESTANDING WALLS OR FENCES BUILT OF CMU, BRICK, OR STONE NEED TO BE ENGINEERED AND CONSTRUCTED WITH APPROPRIATE FOUNDATIONS, ADEQUATE REINFORCEMENT, AND GOOD QUALITY MORTAR.
- STANDARD DETAILS FOR LOW FENCES OR SHORT RETAINING WALLS MAY BE AVAILABLE FROM THE LOCAL BUILDING DEPARTMENT.

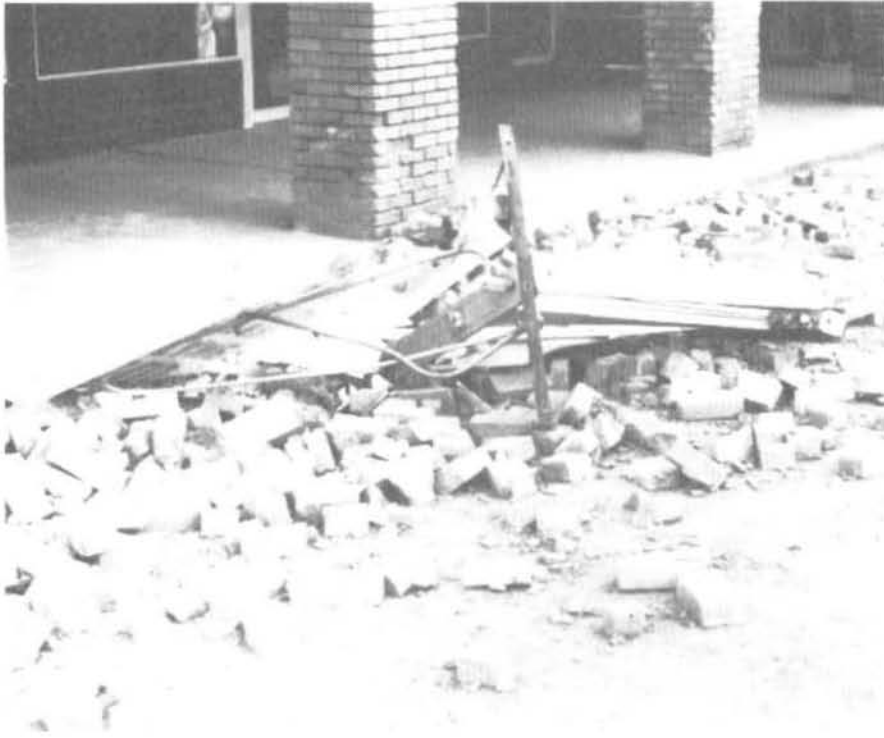
EXTERIOR SIGNS

Earthquake Damage: 1979, Imperial Valley, California
Photo Credit: Robert Reitherman/BSD, Inc.

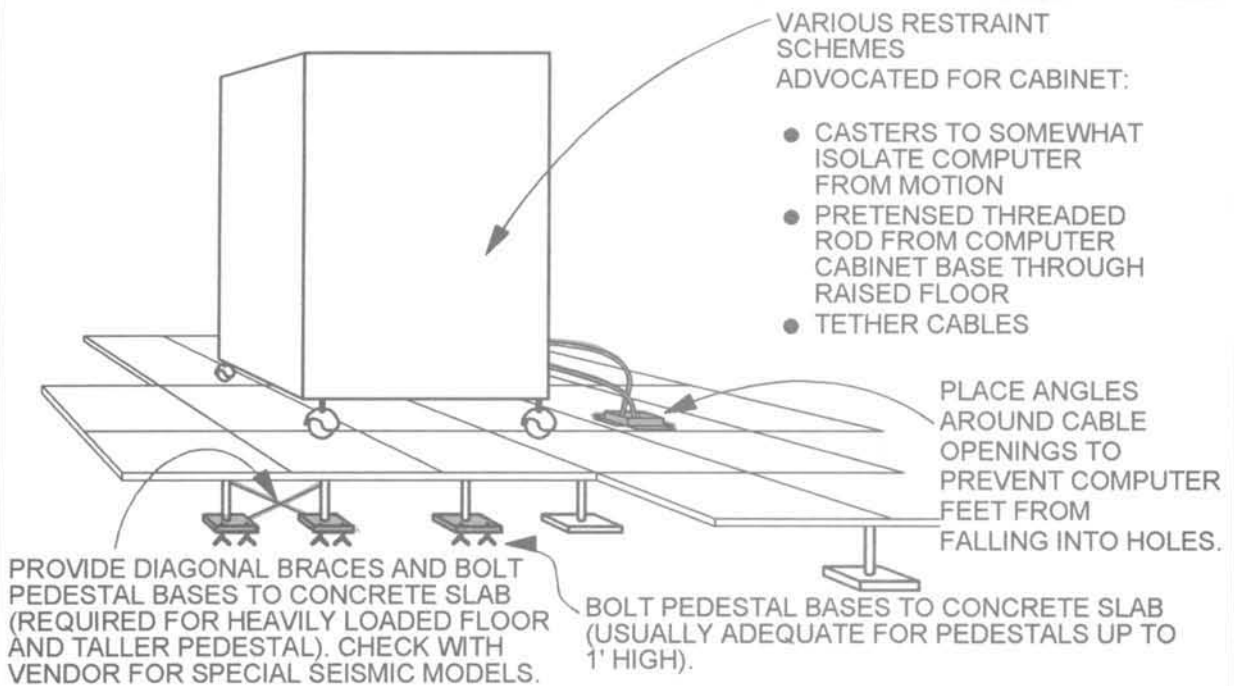
Schematic Upgrade Detail C8

Approximate Cost: Access floor alone -- \$3 - \$7 per square foot
Cabinet restraint -- \$300 - \$500 per cabinet

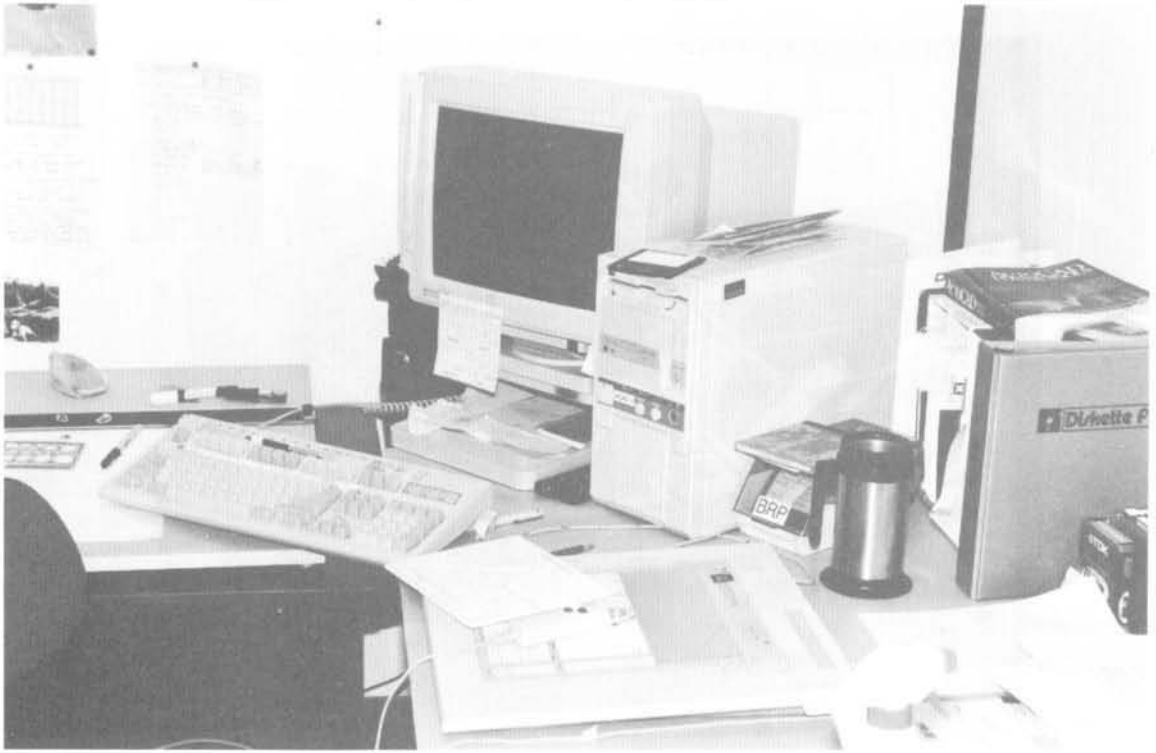
DESKTOP COMPUTERS AND OFFICE EQUIPMENT

Unsecured computers may fall and suffer damage
Photo Credit: Wiss, Janney, Elstner Associates, Inc.

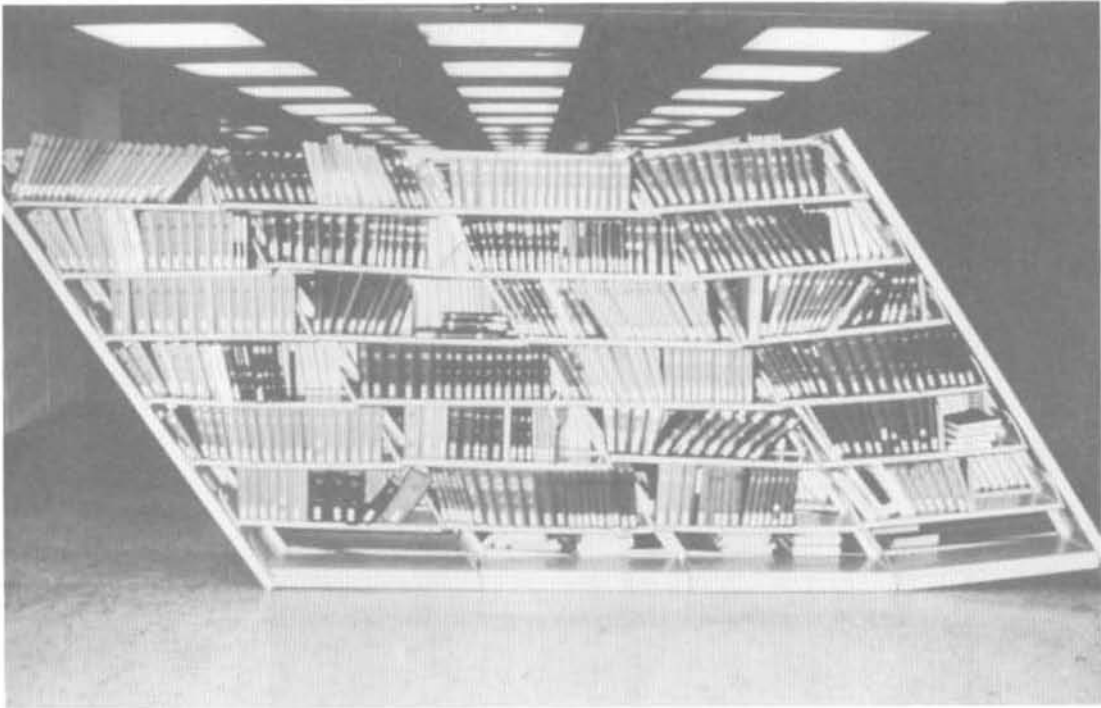
Failure of library shelving
Earthquake Damage: 1987, Whittier Narrows, California
Photo Credit: Earthquake Engineering Research Institute, Larry Parsons

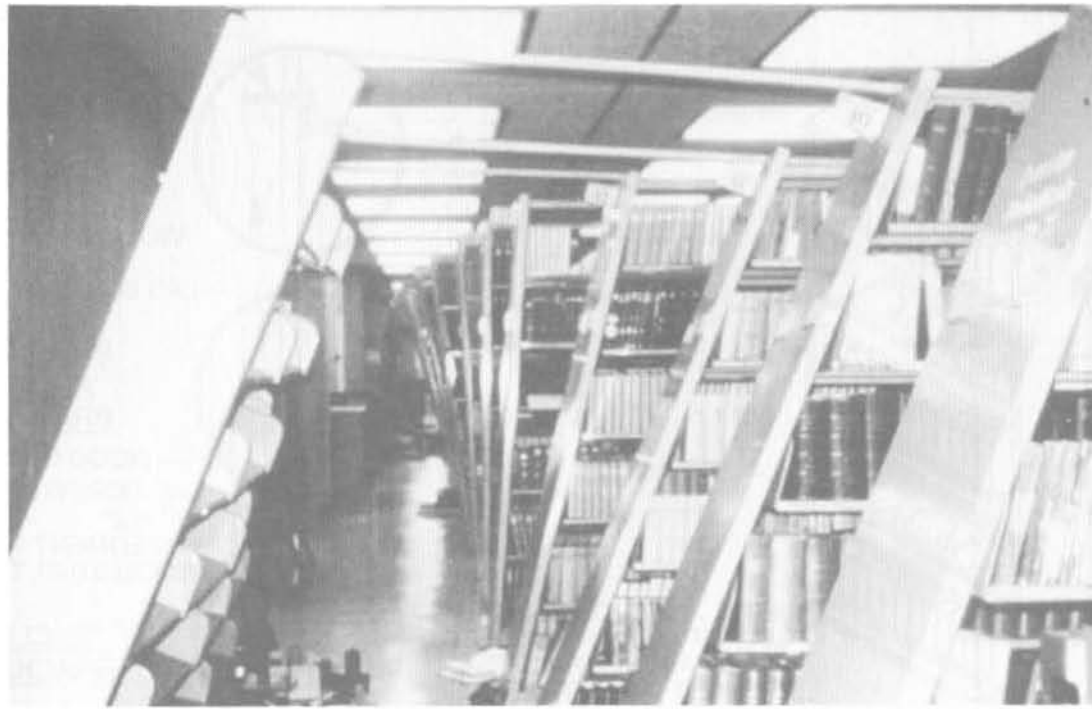
Failure of inadequately upgraded library shelving
Earthquake Damage: 1987, Whittier Narrows, California
Photo Credit: Earthquake Engineering Research Institute, Marshall Lew & Greg Brandow **C12b**

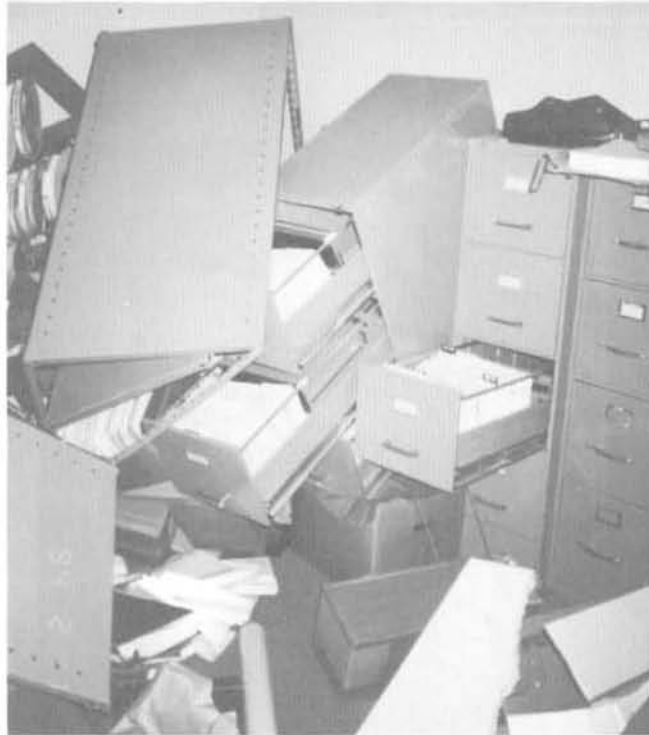
TALL FILE CABINETS

Earthquake Damage: 1994, Northridge, California
Photo Credit: Wiss, Janney, Elstner Associates, Inc.

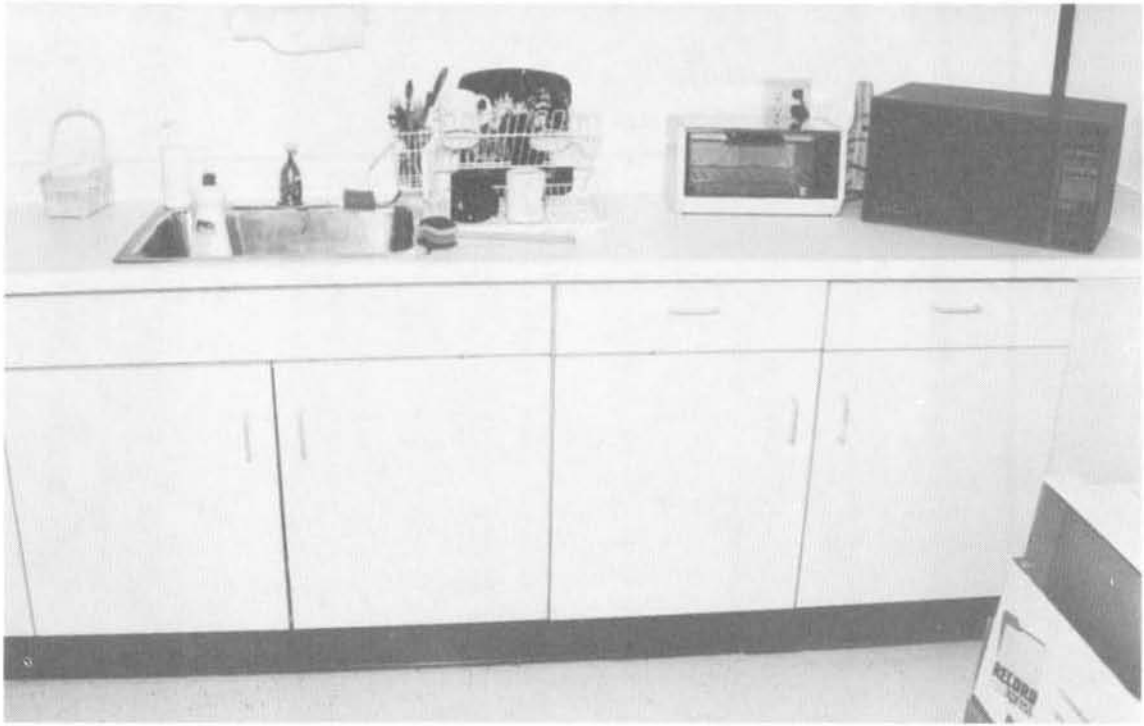
DRAWER AND CABINET LATCHES

Unrestrained drawers and cabinets

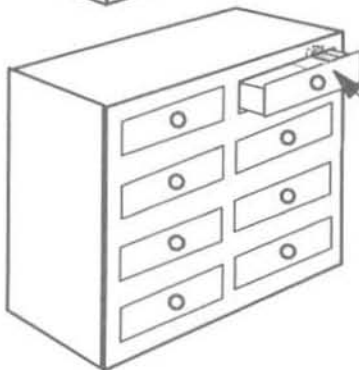
Upgrade Detail C19

INSTALL STRONG MECHANICAL CABINET CATCHES (SAFETY HASP, SLIDE BOLT, TOUCH-DOOR CABINET CATCH, CLIP-ROLLER OR SNAP-ACTION CABINET CATCH, ETC.)

ALTERNATIVE: PROVIDE BABY-PROOF CLOSURE

INSTALL MECHANICAL DRAWER CLOSURE (BABY-PROOF LATCHES, DRAWER LOCKS, OR OTHER SPECIALTY LATCHES)

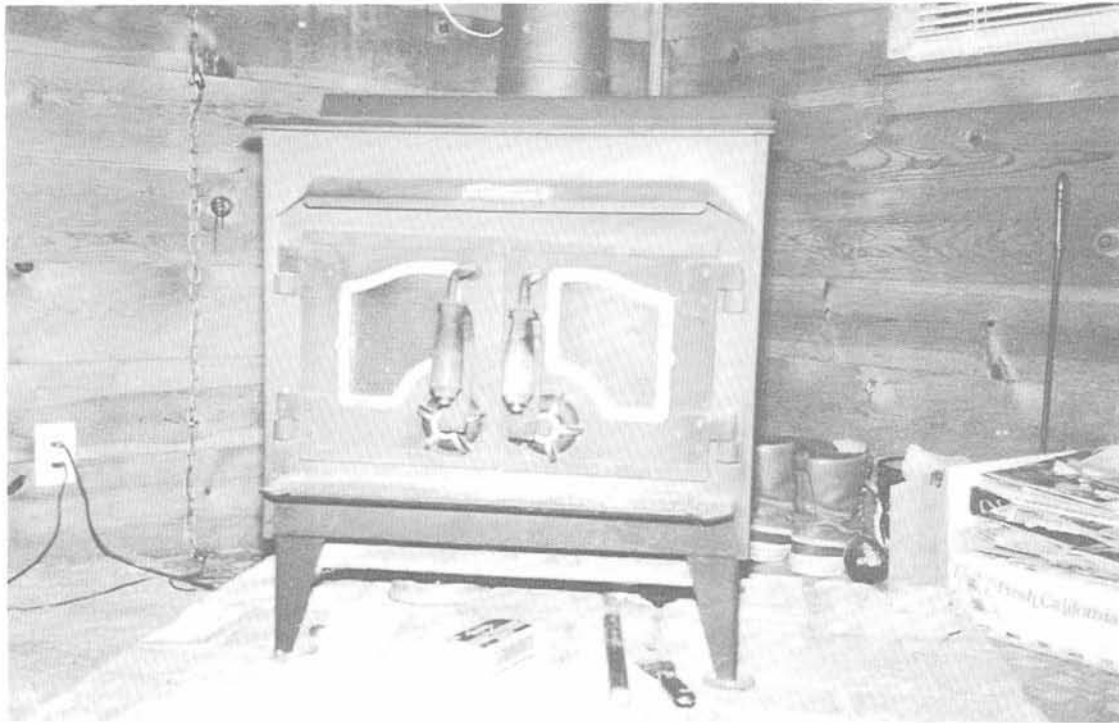
FREESTANDING WOOD STOVE

Unrestrained wood burning stove
Photo Credit: Wiss, Janney, Elstner Associates, Inc.

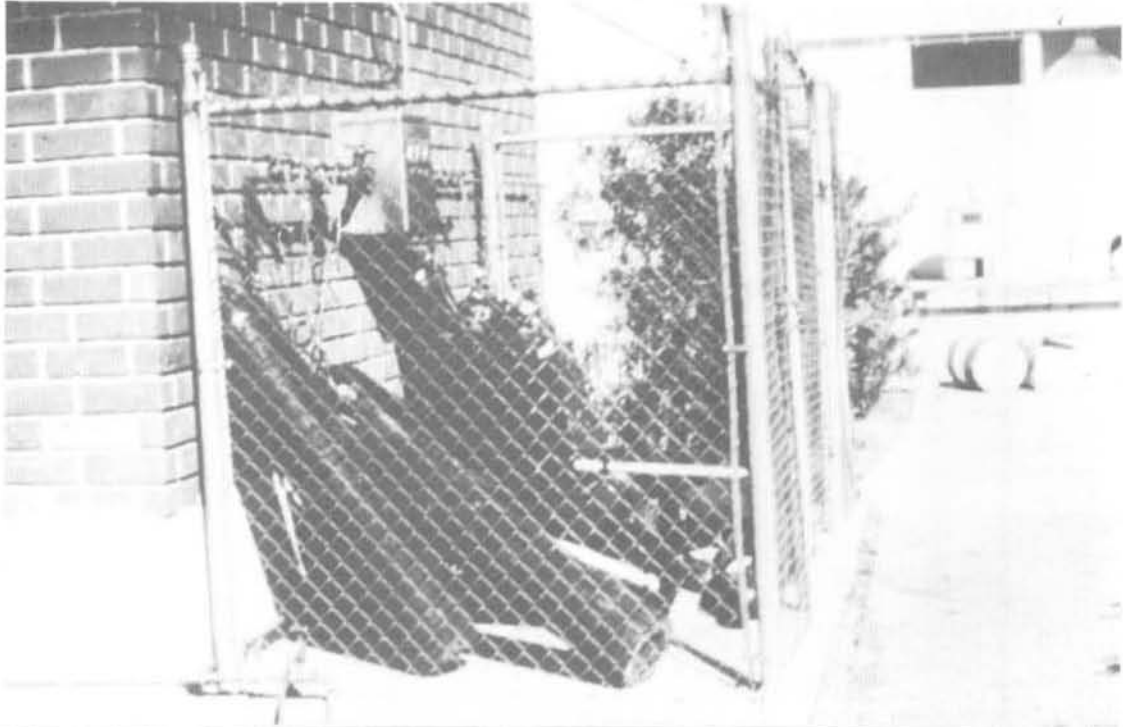
COMPRESSED-GAS CYLINDERS

Earthquake Damage: 1971, San Fernando, California
Photo Credit: Scientific Service, Inc.

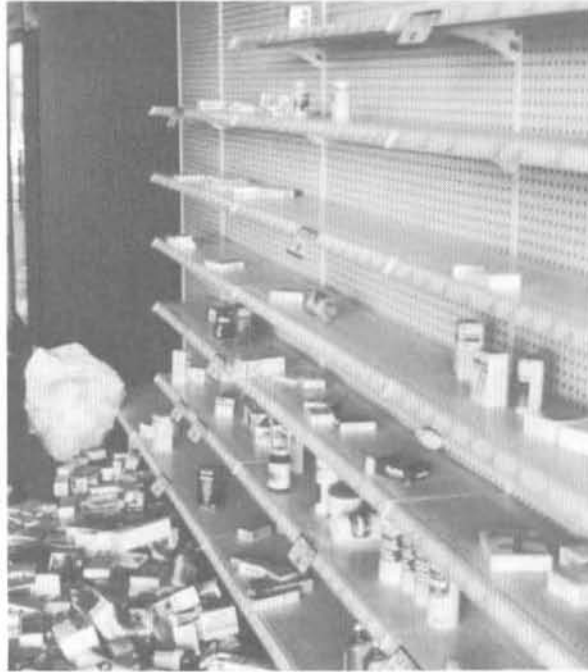
Spilled pharmaceutical and medical supplies.
Earthquake Damage: 1994, Northridge, California
Photo Credit: Robert Reitherman

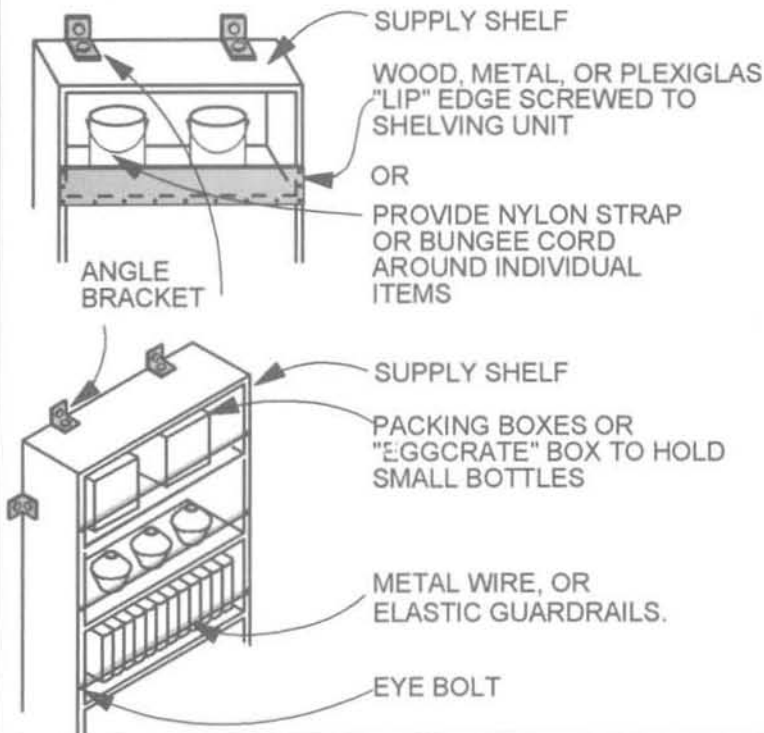
Schematic Upgrade Detail C22

- ANCHOR STORAGE SHELVES
- PROVIDE SAFETY LIP OR SHELF EDGE
- PROVIDE MECHANICAL LATCHES FOR CABINETS AND DRAWERS
- STORE SMALL OR BREAKABLE ITEMS IN ORIGINAL PACKING OR EGGCRATE BOXES, NOT LOOSE ON SHELF OR IN DRAWER
- STORE INCOMPATIBLE MATERIALS AT A SAFE DISTANCE TO AVOID MIXING IF THE CONTAINERS FALL
- ORDER HAZARDOUS LAB CHEMICALS IN UNBREAKABLE PLASTIC BOTTLES OR IN GLASS BOTTLES WITH AN EXTERIOR PLASTIC SAFETY COATING

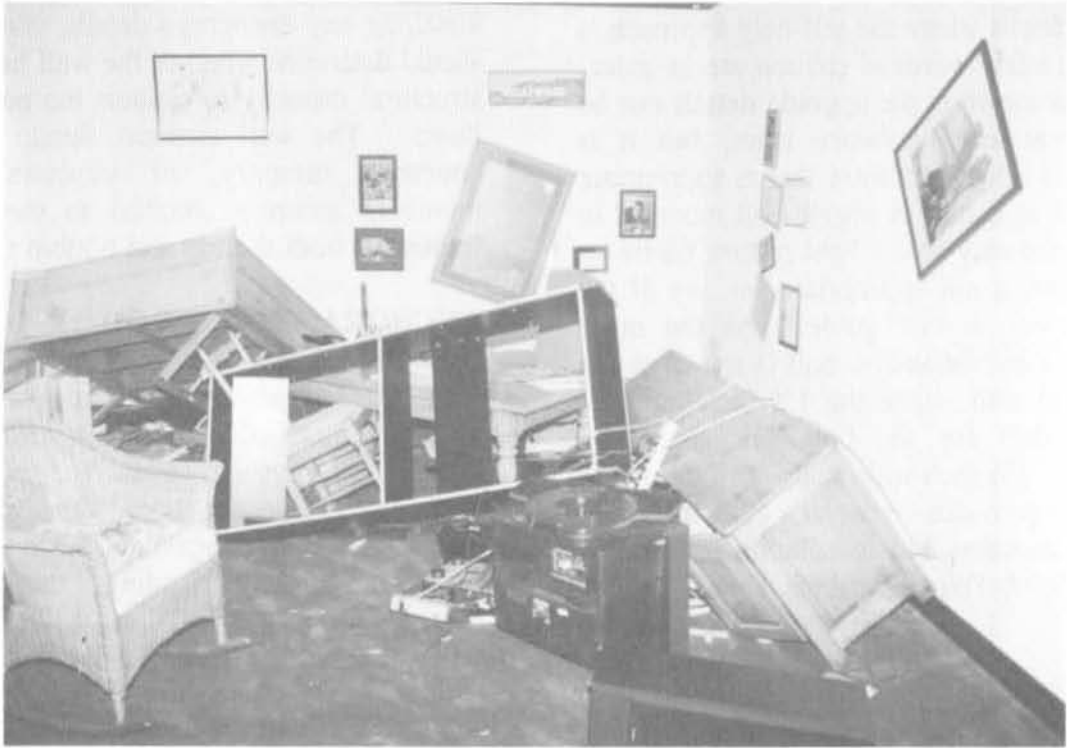
MISCELLANEOUS FURNITURE

Earthquake Damage: 1994, Northridge, California
Photo Credit: Wiss, Janney, Elstner Associates, Inc.
