# 2 Historical Perspective

## 2.1 Introduction

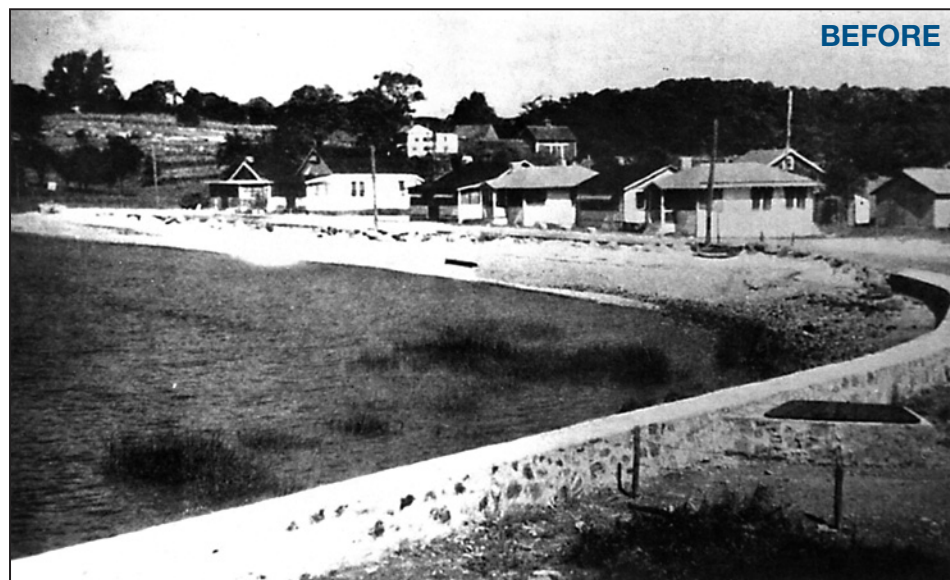
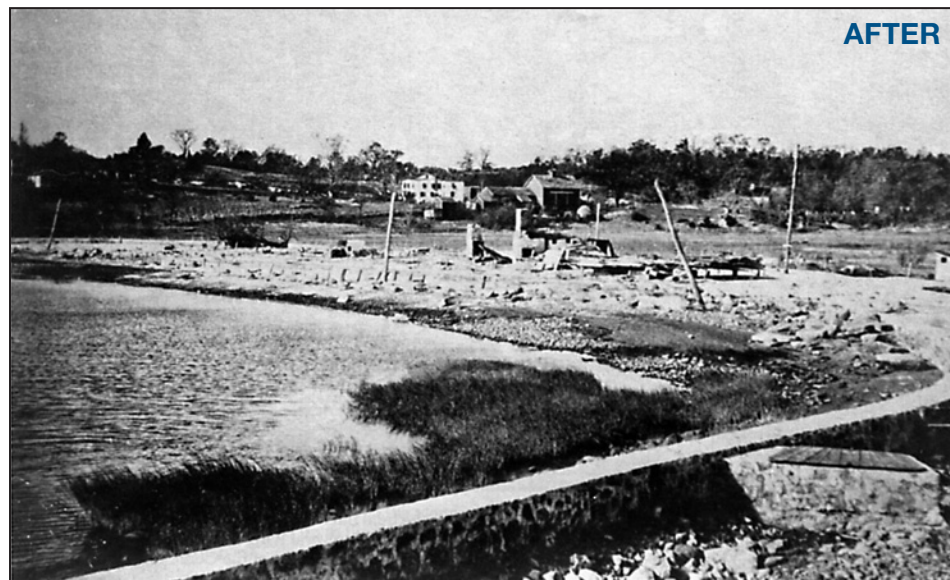
Figure 2-2.  
Schell Beach before and  
after the Long Island  
Express Hurricane in  
1938; houses near the  
shoreline were destroyed  
and more distant houses  
were damaged  
(Guilford, CT)

In 1938, the “*Long Island Express*” hurricane moved rapidly up the east coast from New York through New England. The storm caused widespread surge and wind damage to buildings, and is still used as a benchmark for predicting worst-case scenario damage in the region (Figure 2-2). Although not shown in the photograph, this hurricane also destroyed many elevated homes along this stretch of coastline.

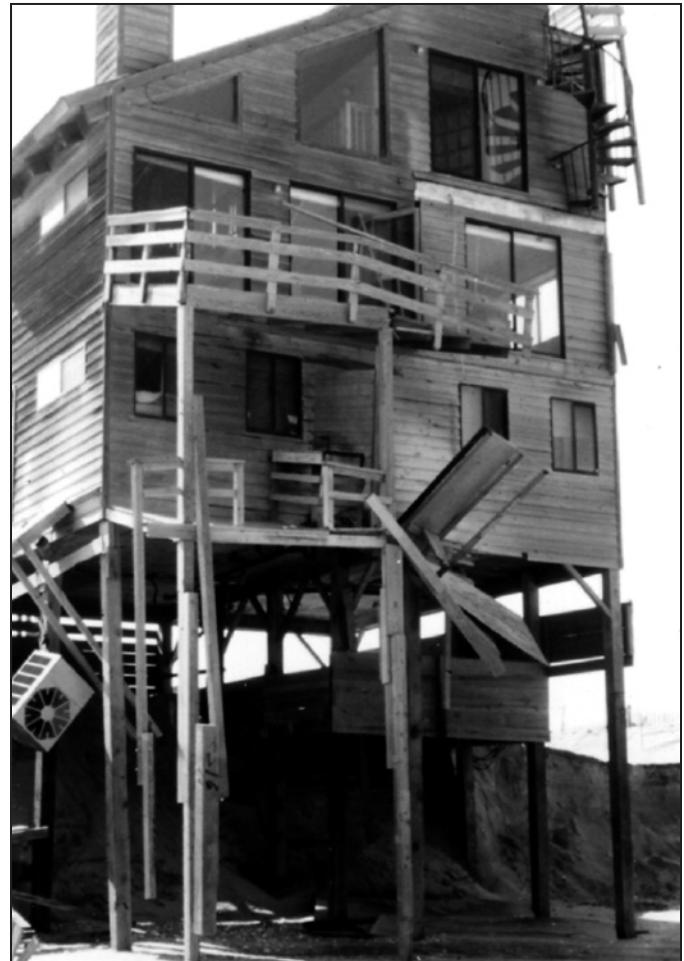
**Figure 2-3.** Although this house seems to have lost only several decks and a porch during the March 1989 nor'easter, the loss of supporting soil due to long-term erosion left its structural integrity in question following successive storms

An *April 1988 nor'easter* caused foundation damage to elevated homes in Virginia and North Carolina. Long-term shoreline erosion, coupled with the effects of three previous coastal storms, had left the area vulnerable. Inspections following the 1988 nor'easter revealed that repairs to previous foundation damage were only partially effective. In some cases, ineffective repairs implemented after storms resulted in subsequent storm damage that may not have occurred if the original repair had been properly made (URS 1989). A *March 1989 nor'easter* in the same area caused even further foundation damage. The damage from the 1988 and 1989 storms showed that long-term erosion makes buildings increasingly vulnerable (Figure 2-3) to the effects of even minor storms (URS 1990).

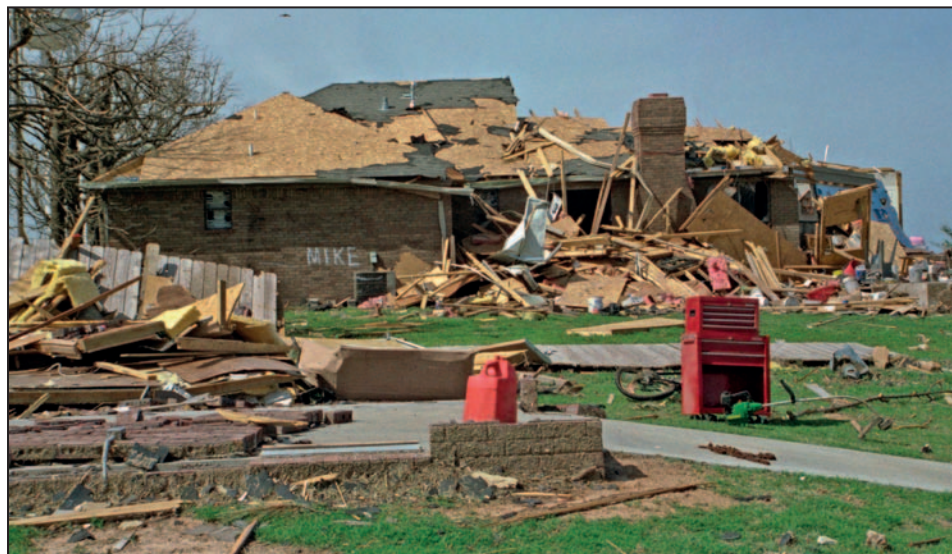
**Figure 2-4.**  
Roof structure failure due to inadequate bracing and inadequate fastening of the roof deck, Hurricane Andrew (Dade County, FL, 1992)

In August 1992, *Hurricane Andrew* struck the southeast Atlantic coast. This hurricane remains one of the most memorable hurricanes to hit this region and one of the costliest to date. The majority of the damage from this hurricane was due to wind; many of the failures were traced to inadequate connections between building elements (Figure 2-4). As such, buildings could not resist wind forces because of the lack

of continuous load transfer paths from the roofs to the foundations (FEMA 1993). Hurricane Andrew was a major catalyst for building code changes involving wind design that improved wind pressure calculation procedures and emphasized the need for a continuous load transfer path in buildings for uplift and lateral loads, not just for the traditional downward-acting gravity loads. Hurricane Andrew destroyed 97 percent of the manufactured homes in its path, leading the Department of Housing and Urban Development (HUD) to adopt more stringent wind design criteria for manufactured homes (FEMA 2009a).

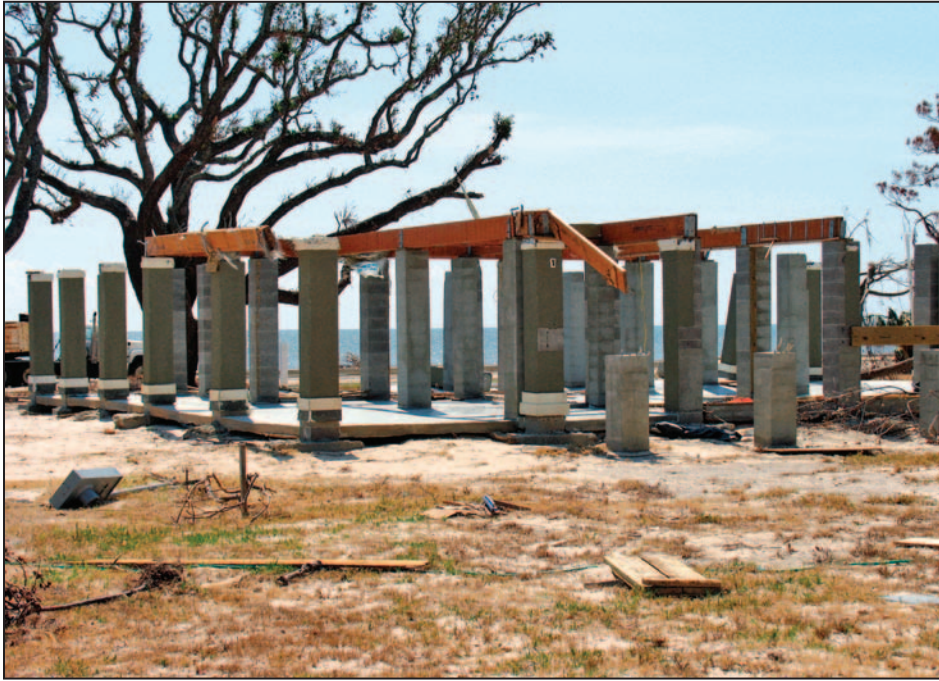
Figure 2-5. This elevated house atop a masonry pier foundation was lost, probably due to waves and storm surge reaching above the top of the foundation, Hurricane Katrina (Long Beach, MS, 2005)

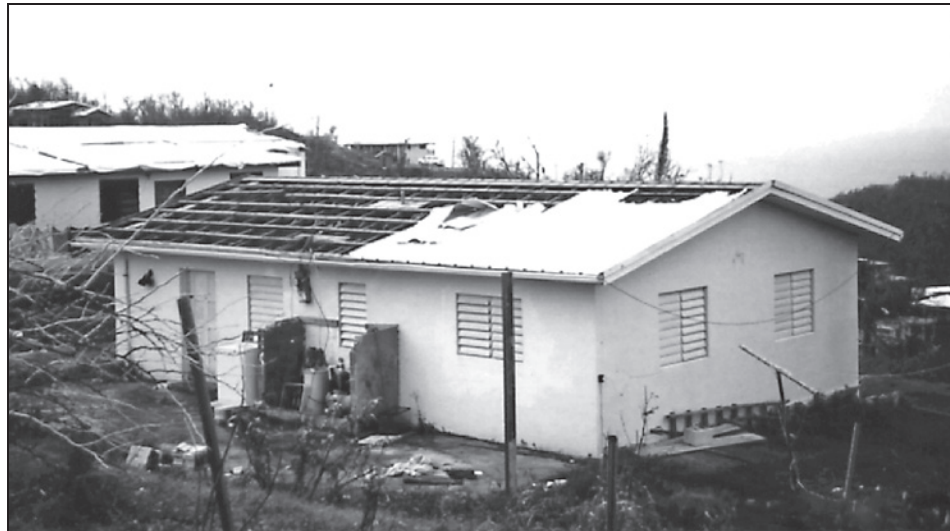
Figure 2-6.  
This house lost most of  
its metal roof covering  
due to high winds during  
Hurricane Marilyn in 1995  
(location unknown)  
SOURCE: NRCA 1996

In 1989, *Hurricane Hugo* destroyed many buildings in the U.S. Virgin Islands and Puerto Rico (York 1989). In 1995, the U.S. Virgin Islands and Puerto Rico were again struck by a hurricane. High winds from *Hurricane Marilyn* damaged roofs (Figure 2-6), allowing water to penetrate and damage building interiors (National Roofing Contractors Association [NRCA] 1996). This storm highlighted the need for more stringent building codes, and the U.S. Virgin Islands adopted the 1994 UBC.

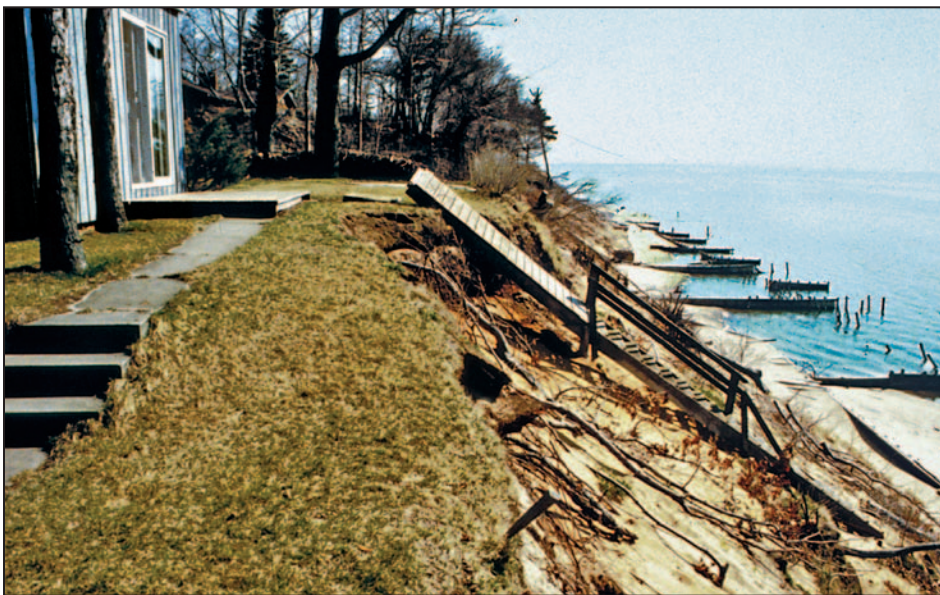
**Figure 2-7.**  
Erosion along the Lake Michigan shoreline at Holland, MI, resulting from high lake levels and storm activity (August 1988)

A **February 1987 storm** hit Chicago, IL, during a period of record high lake levels on Lake Michigan (Figure 2-7 shows damage from a similar storm). High waves destroyed a seawall and caused severe erosion to Chicago's lakeshore. Waves slammed high-rise condominiums, smashing first floor windows, and flooding basements.

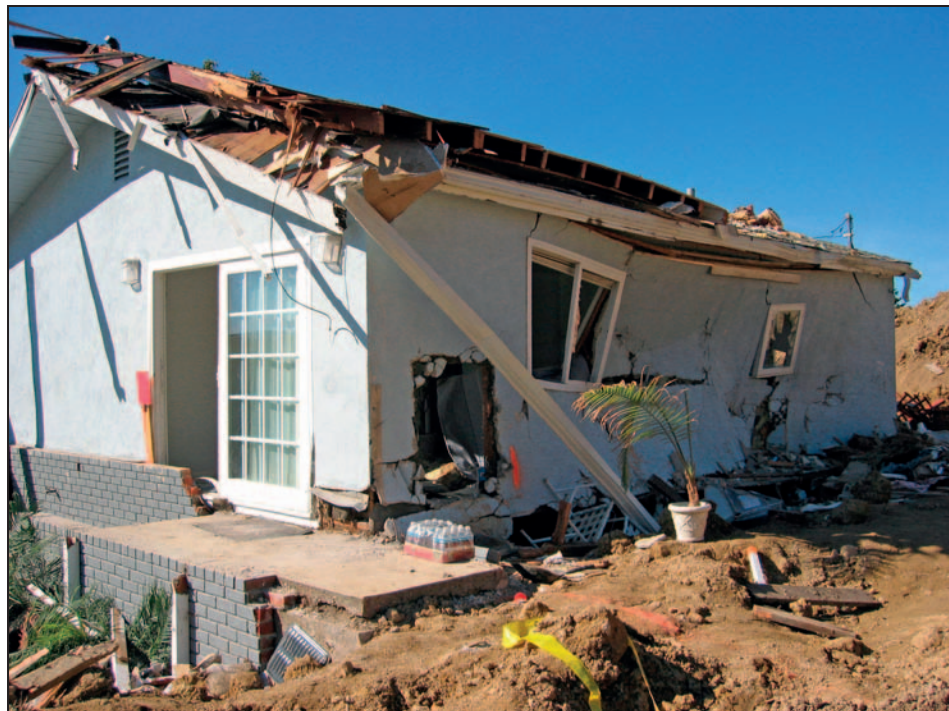
**Figure 2-8.**  
This building experienced structural damage due to a landslide in La Conchita, CA, after a January 2005 storm event

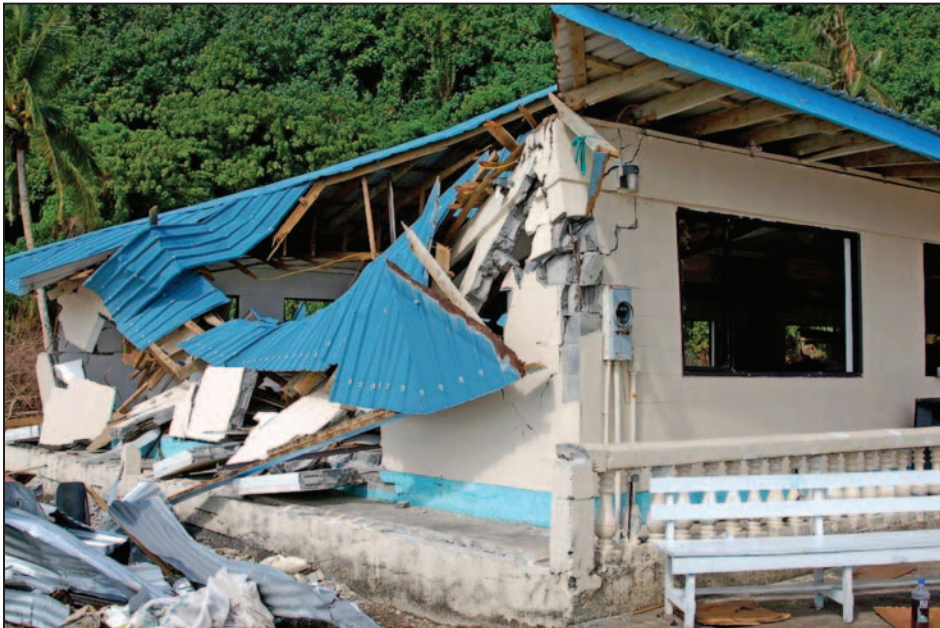
**Figure 2-9.**  
**Tsunami damage at**  
**Poloa, American Samoa**  
SOURCE: ASCE, USED WITH  
PERMISSION

In September 2009, an 8.0 magnitude earthquake occurred approximately 160 miles southwest of American Samoa. Within 20 minutes, a series of *tsunami* waves struck the island. Due to high waves and runup, at least 275 residences were destroyed and several hundred others were damaged (Figure 2-9). Damage to commercial buildings, churches, schools and other buildings was also widespread. Elevated buildings and buildings farther inland generally performed better because they were able to avoid dynamic flood loads.

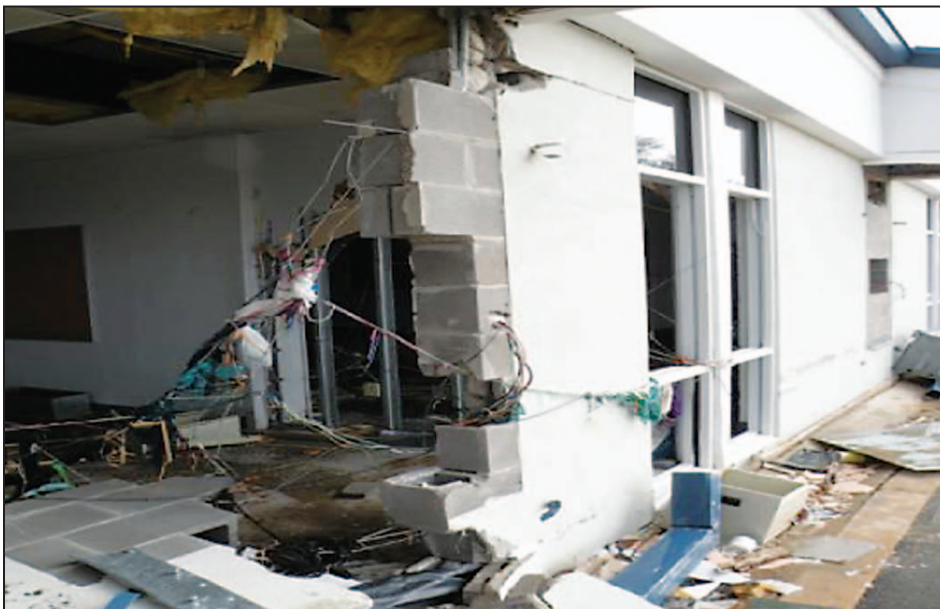
Figure 2-10. School located approximately 1.3 miles from the Gulf shoreline damaged by storm surge and small waves, Hurricane Ike (Cameron Parish, LA, 2008)

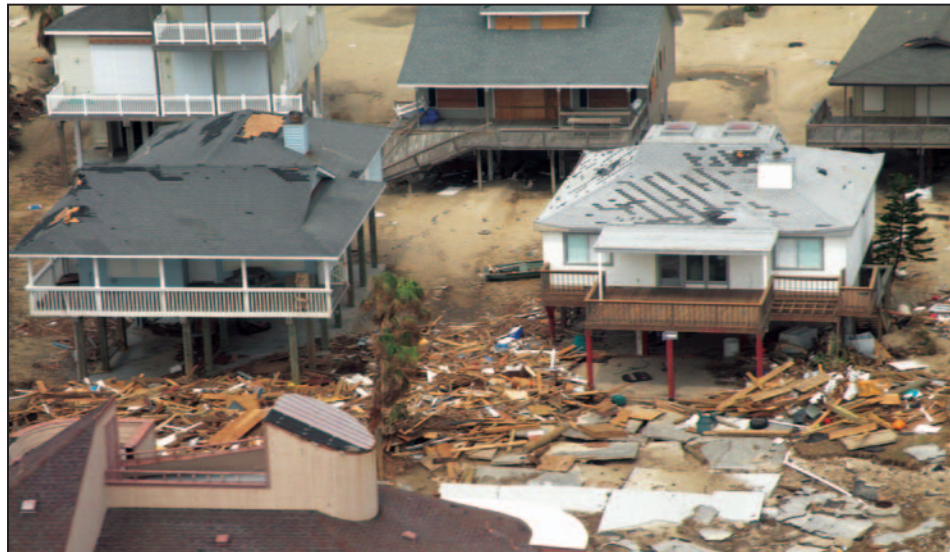
Figure 2-11.  
Galveston Island beach house with wind damage to roof in high pressure zones at roof edge and roof corners, Hurricane Ike, 2008

may be exposed to wind pressures higher than in areas of flat terrain, especially at high pressure zones of the roof. The house in Figure 2-11 sustained damage at the roof edge and roof corners, even though the hurricane was below the design event and wind damage should not have occurred. Recent studies have influenced wind design standards to increase design wind pressures on these exposed structures. Failure to consider the *effects of topography* (and changes in topography such as bluff erosion) on wind speeds can lead to an underestimation of design wind speeds. *Siting buildings on bluffs* or near high-relief topography requires special attention by the designer.

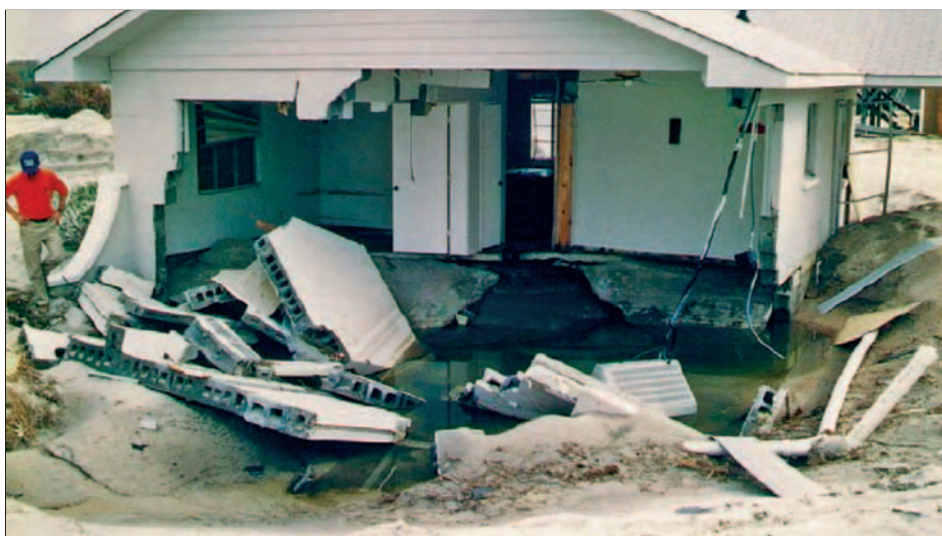
Figure 2-13. Extreme case of localized scour undermining a Zone A continuous perimeter wall foundation located several hundred feet from the shoreline, Hurricane Fran (Topsail Island, NC, 1996)

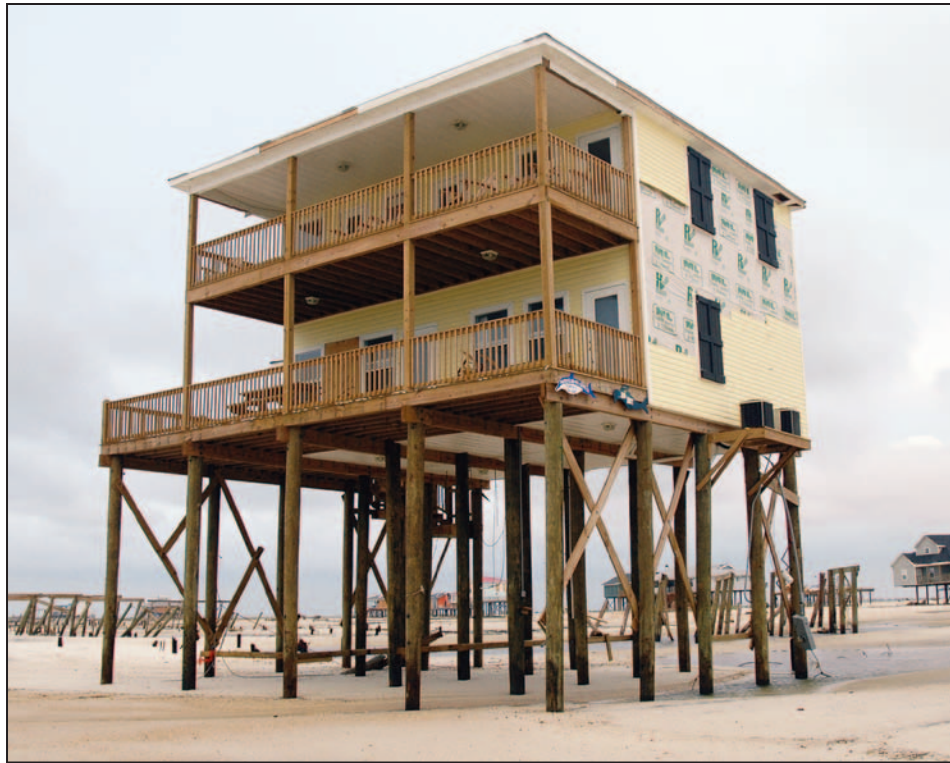
Figure 2-14. Successful example of well-elevated and embedded pile foundation tested by Hurricane Katrina. Note adjacent building failures (Dauphin Island, AL, 2005)

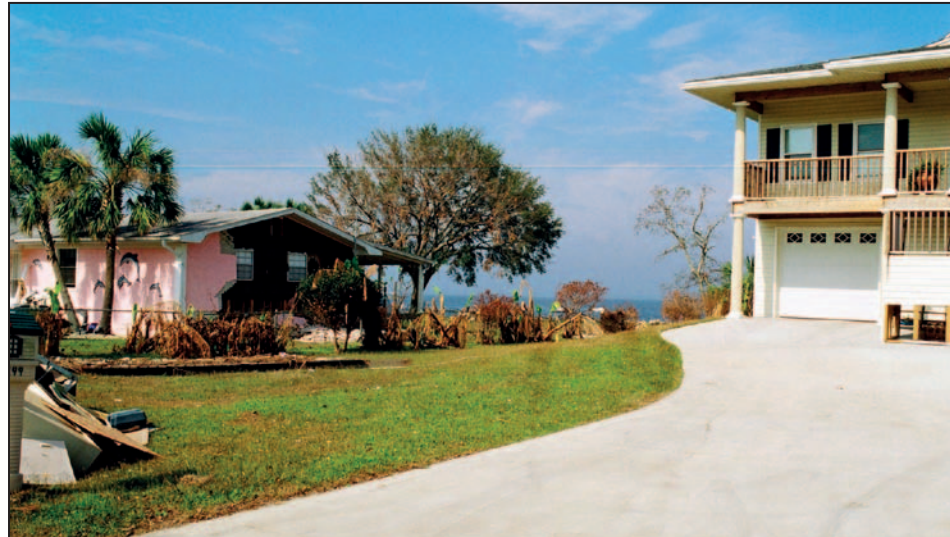
Figure 2-15. The pre-FIRM house (left) experienced damage due to surge and waves while the newer, elevated, post-FIRM house (right) experienced minimal damage, Hurricane Ivan (Santa Marina, Pensacola, FL, 2005)

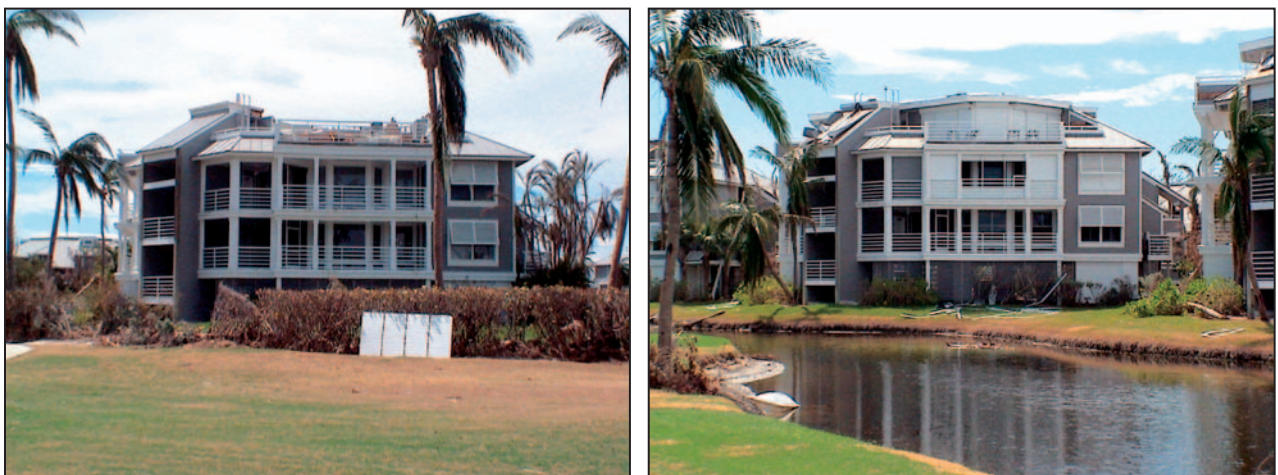
Figure 2-16.

The unprotected building sustained roof damage due to pressurization (left) while the other sustained only minor damage because it was protected by shutters (right), Hurricane Charley (Captive Island, FL, 2004)

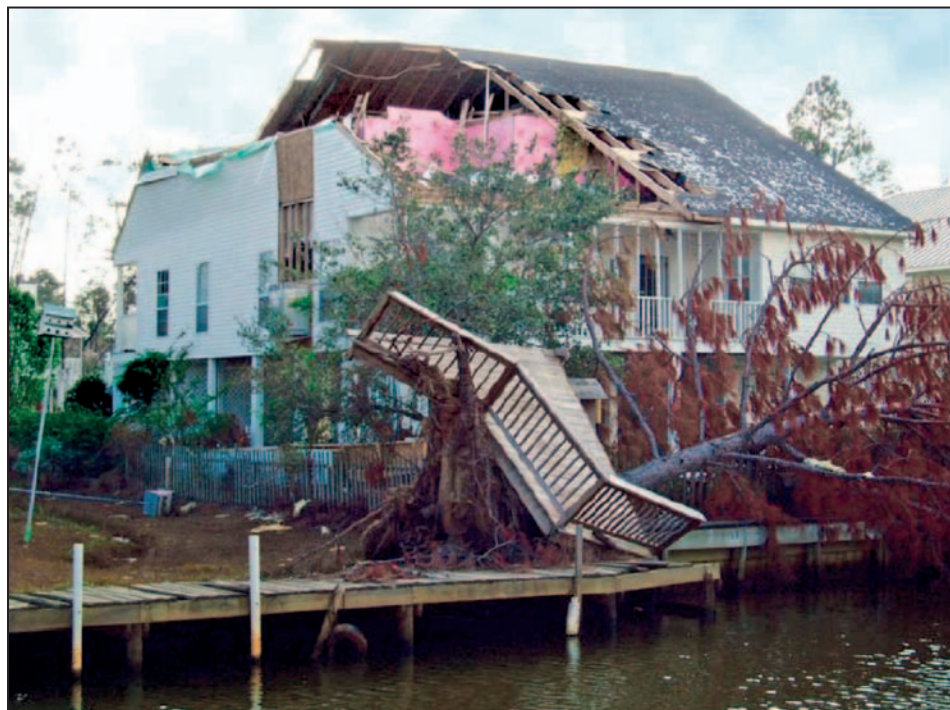
**Figure 2-17.**  
Wind damage to roof structure and gable end wall, Hurricane Katrina (Pass Christian, MS, 2005)

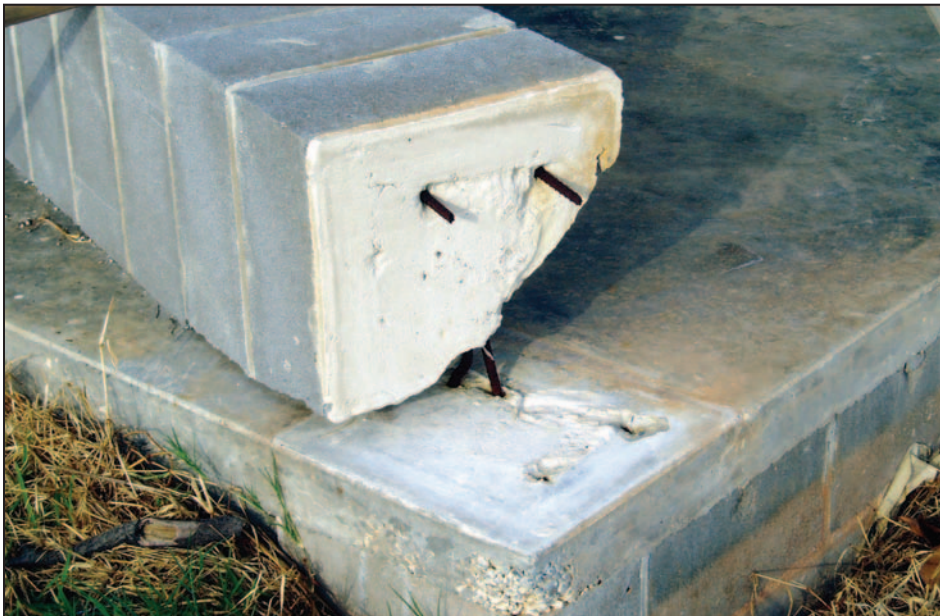
Figure 2-18.  
Failed masonry column  
connection, Hurricane  
Katrina (Jackson County,  
MS, 2005)

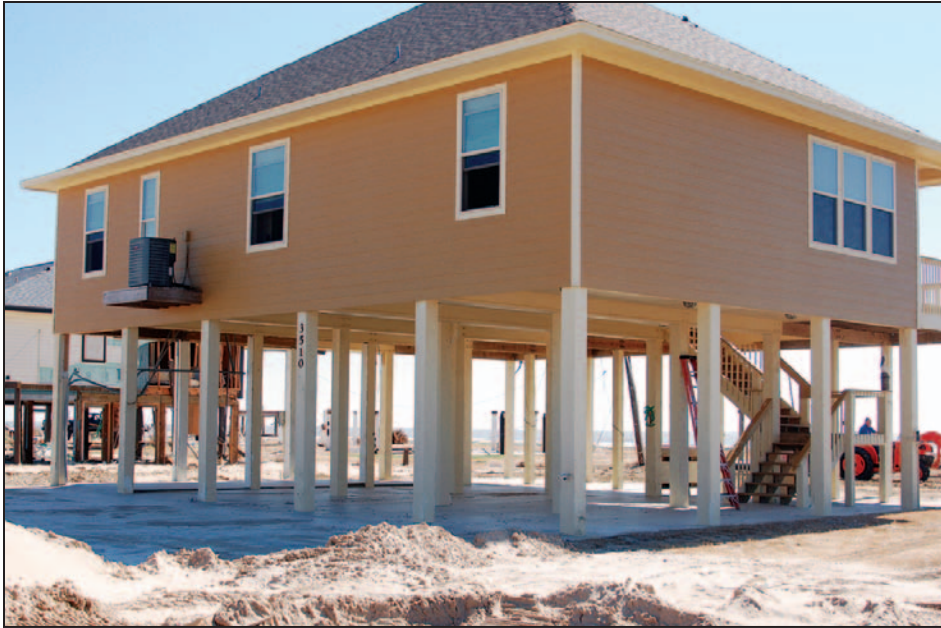
Figure 2-19.  
Breakaway walls below the first floor of this house broke as intended under the flood forces of Hurricane Ike (Bolivar Peninsula, TX, 2008)

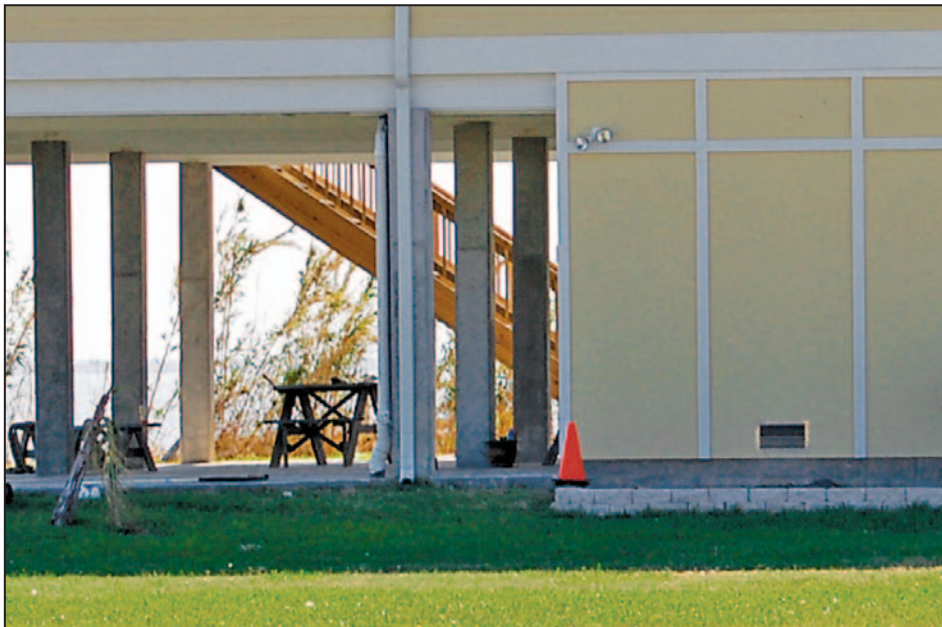
Figure 2-20.  
Flood opening in an enclosure with breakaway walls, Hurricane Ike (Galveston Bay shoreline, San Leon, TX)

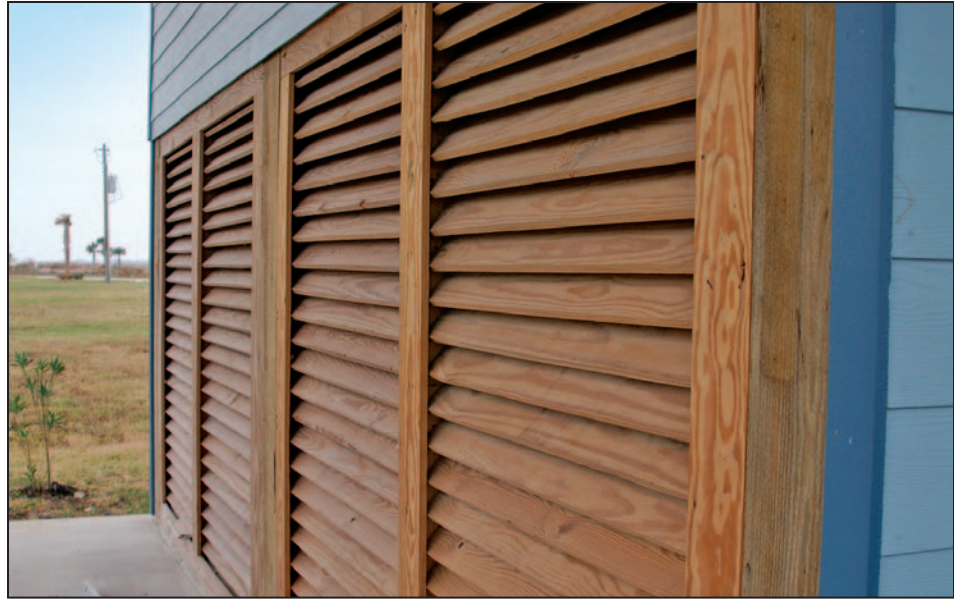
**Figure 2-21.**  
Louvers installed beneath  
an elevated house are  
a good alternative to  
breakaway walls

Taller breakaway walls appear to produce larger pieces of flood-borne debris. Post-disaster investigations have observed some breakaway walls in excess of 11 feet high (FEMA 2009b). These investigations have also observed that louvered panels (Figure 2-21) remained intact longer than solid breakaway walls under the same flood conditions. As a result, houses with louvered panels had less flood-related damage (and repair cost) and generated less flood-borne debris. The use of louver panels can also result in lower flood insurance

premiums. Flood insurance premiums for a building located in Zone V are much less when a below-BFE enclosure is formed by louvers than by breakaway walls. A building with an enclosure formed by louvers is classified the same as if it had insect screening or open lattice (Figure 2-22), i.e., as “free of obstructions,” while a solid breakaway wall enclosure results in a “with obstruction” rating for the building.

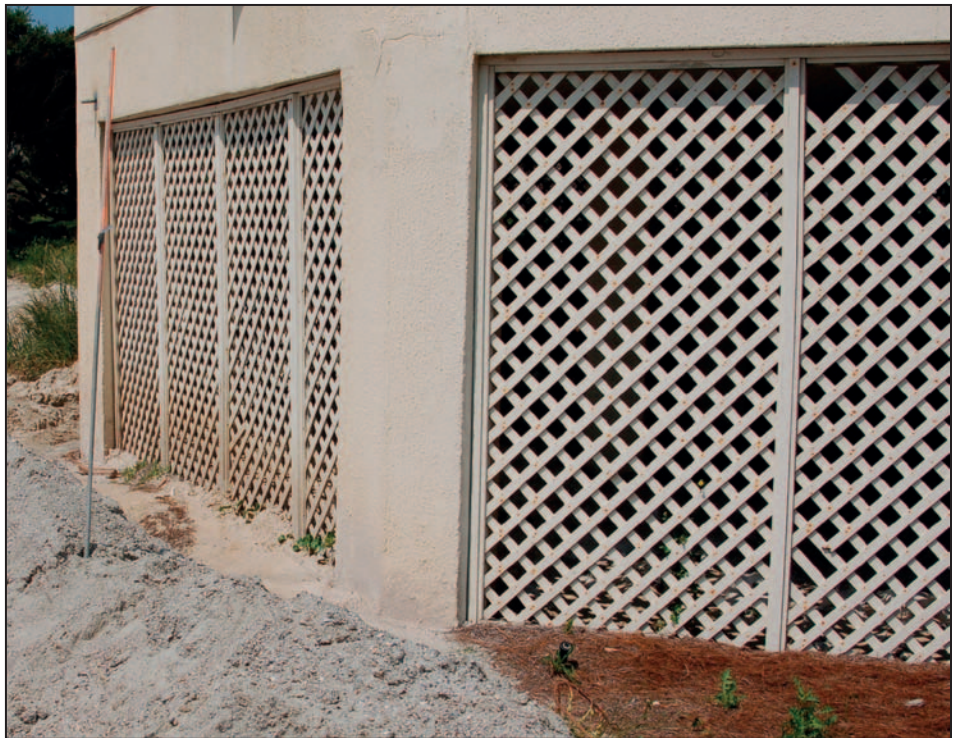
**Figure 2-22.**  
An enclosure formed  
by open lattice (Isle of  
Palms, SC)

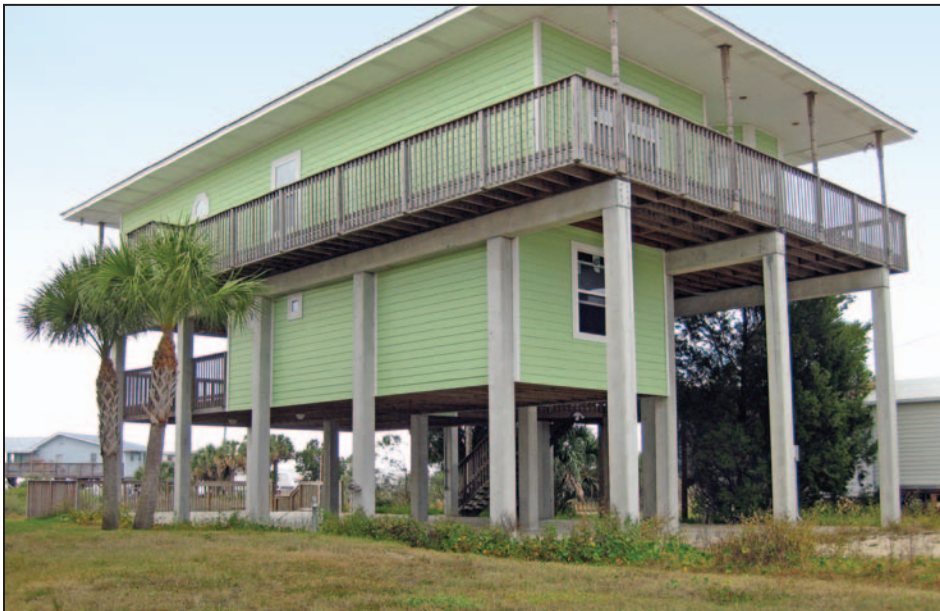
Figure 2-23.  
Above-grade enclosure  
(Perry, FL)

- **Enclosures that do not extend all the way to the ground (sometimes called “above-grade,” “hanging,” or “elevated” enclosures).** These enclosures have a floor system that is not in contact with the ground, but that may be connected to the building foundation or supported on the primary pile system or short posts (Figure 2-23). Having the floor of the enclosure above grade means frequent flooding passes underneath, which may reduce the frequency and severity of damage. These enclosures were not contemplated when flood insurance premium rate tables were prepared, and thus can result in significantly higher flood insurance premiums. As of early 2011, the NFIP was working to address this type of construction, but until such time as it is resolved, owners will pay a substantial premium penalty for this type of enclosure.

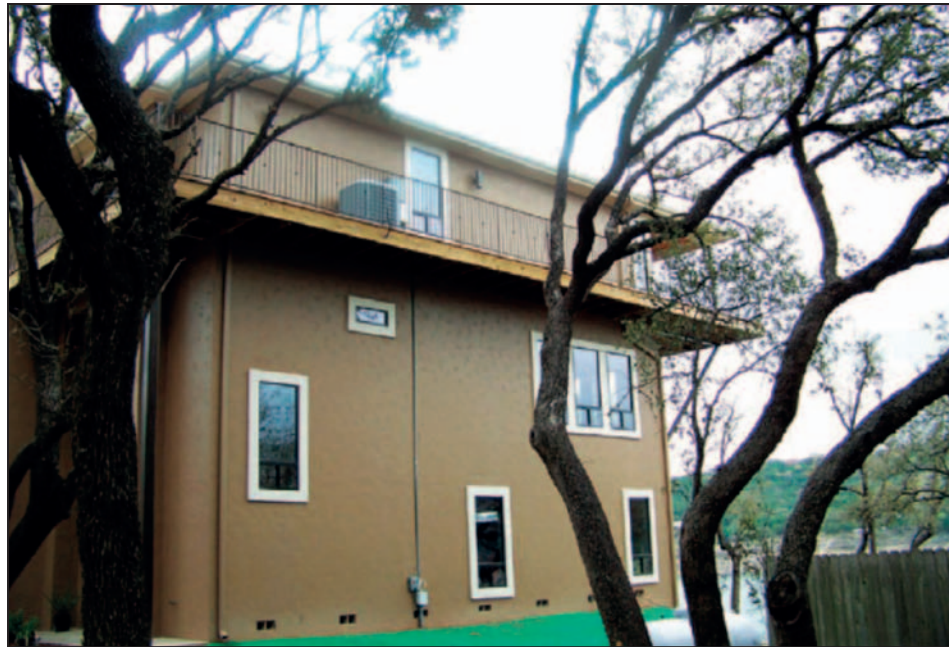
Figure 2-24.  
Two-story enclosure  
SOURCE: FEMA P-499 2010

- **Two-story enclosures.** In flood hazard areas with very high BFEs, some owners have constructed two-story, solid walls to enclose areas below elevated buildings, typically with a floor system approximately midway between the ground and the elevated building (Figure 2-24). These enclosures present unique problems. In Zone A, the walls at both levels of the enclosure must have flood openings; there must be some means to relieve water pressure against the floor system between the upper and lower enclosures; and special ingress and egress code requirements may apply. These enclosures may also result in substantially higher flood insurance premiums.
