Coastal Flood and Wind Event Summaries

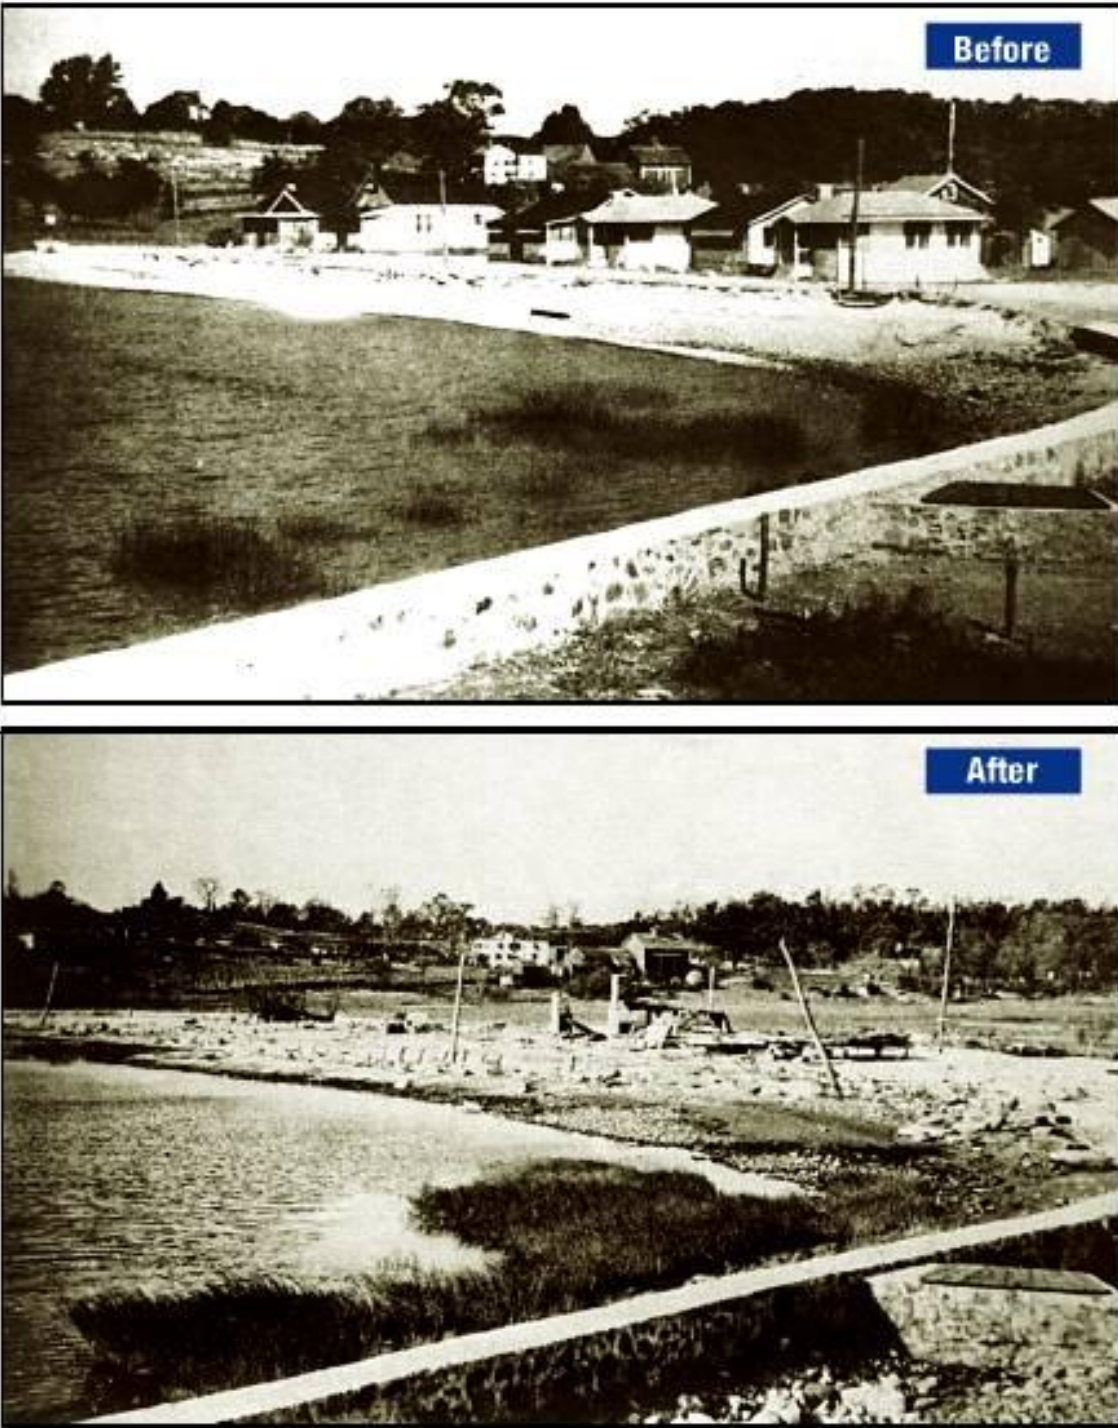
Figure 1. “Long Island Express” Hurricane. Schell Beach, Guilford, CT, before and after the storm. Non-elevated houses at the shoreline were destroyed.

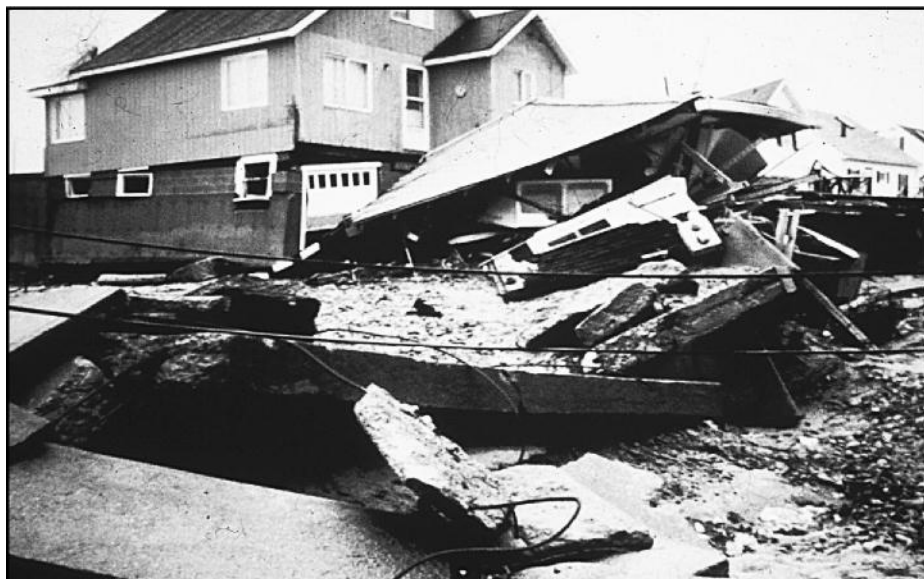
Buildings on continuous masonry block foundations (such as those permitted in Zone A) were commonly damaged or destroyed when exposed to flooding, wave action, erosion, and/or localized scour (see Figure 3).

Figure 3. October 1991 nor'easter damage to homes at Scituate, MA.

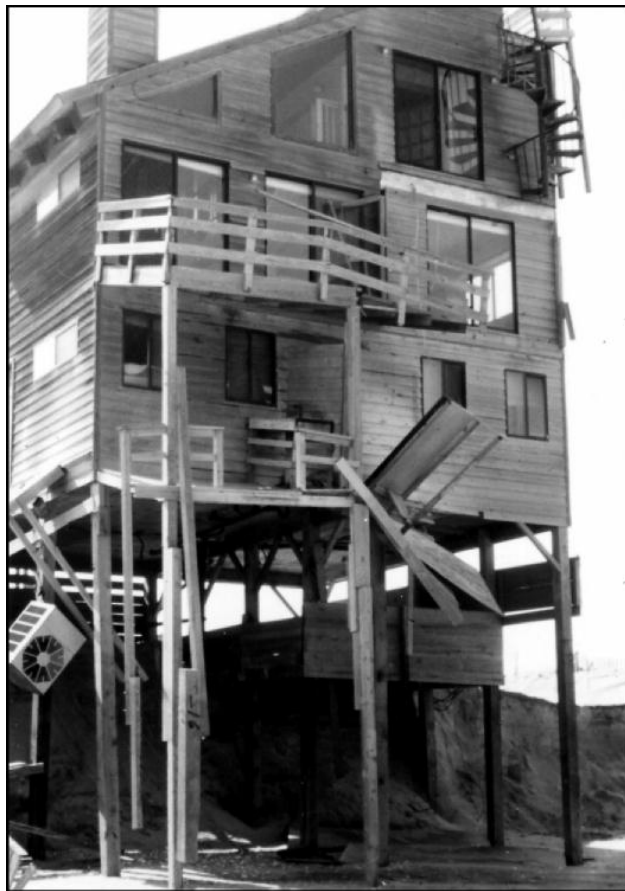
Figure 6. March 1989 nor'easter. Although this house seems only to have lost decks and a porch, the loss of supporting soil compromises its structural integrity.

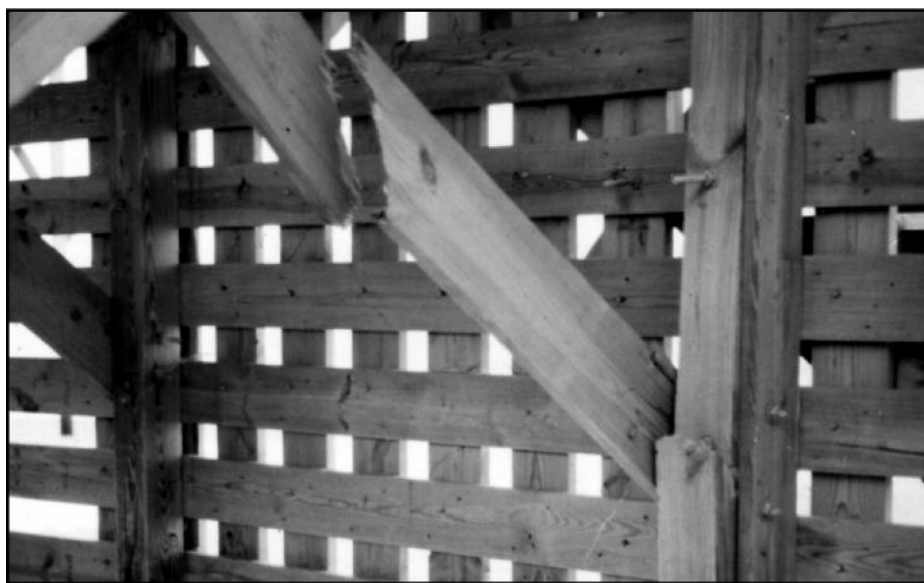
- Cracks in piles and deck posts, or failed connections to them, were in some cases attributed to cross-bracing oriented parallel to the shore or the attachment of closely spaced horizontal planks.
- Construction in areas subject to high rates of long-term erosion is problematic. Buildings become increasingly vulnerable to the effects of even minor storms (see Figure 6). This process eventually necessitates their removal or results in their destruction.
- Many of the buildings affected during the April 1988 storm were further damaged during the March 1989 storm, either because of additional erosion and undermining or debris damage to cross-bracing and foundation piles (see Figure 7 and Figure 8).

Figure 7. March 1989 nor'easter. Failure of cross-bracing.

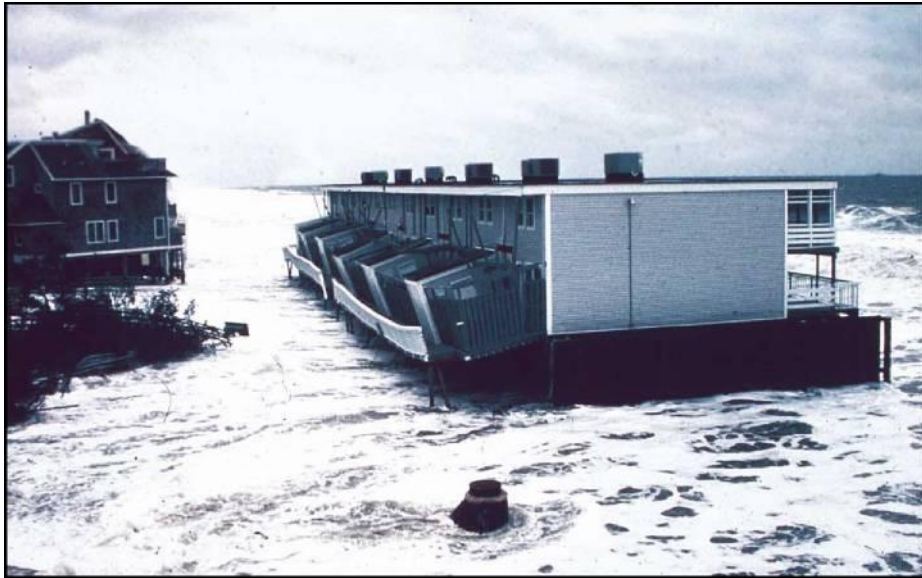
Figure 9. 1992 storm impacts at Dewey Beach, DE. Note collapse of deck on landward side of building.

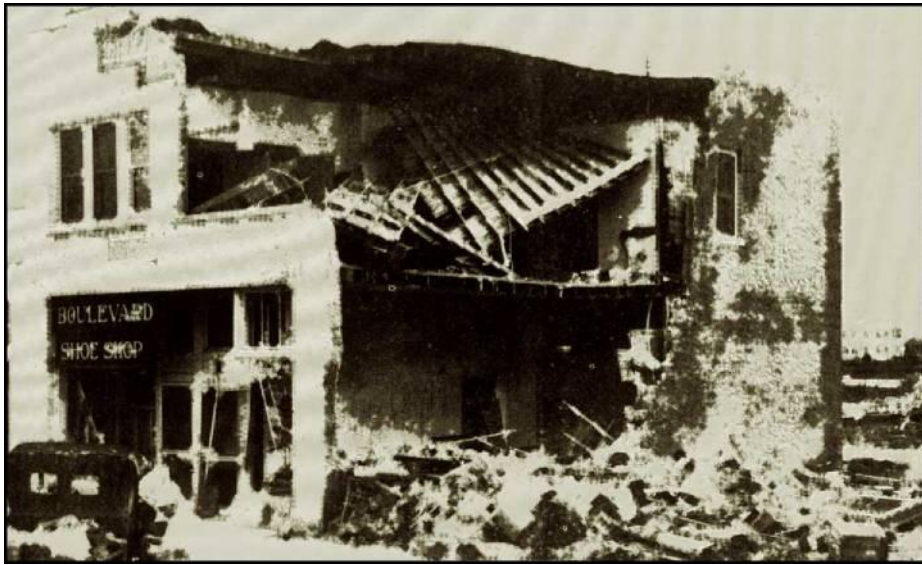
Figure 10. Building damage from 1926 hurricane, Miami, FL.

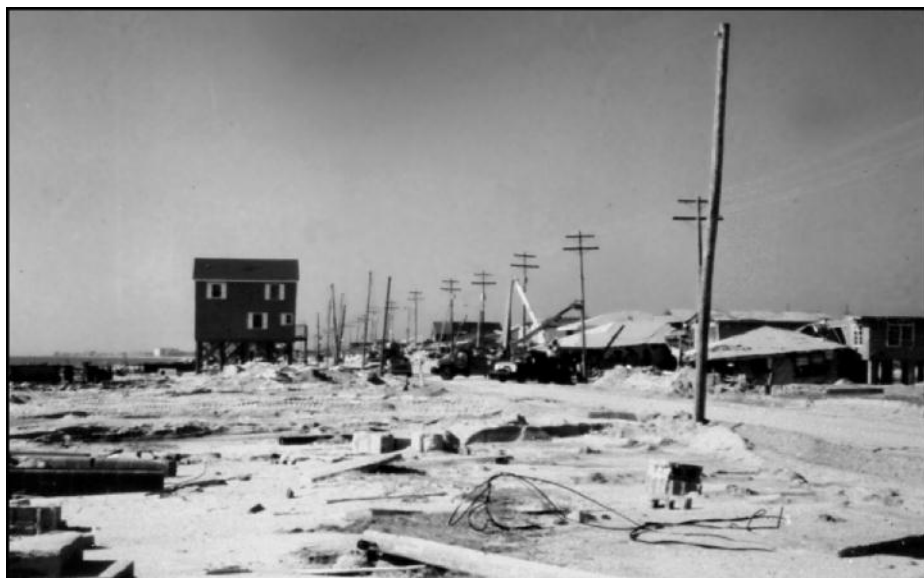
- Post-FIRM buildings that were both properly constructed and elevated survived the storm (see Figure 11). These buildings stood in sharp contrast to pre-FIRM buildings and to post-FIRM buildings that were poorly designed or constructed.

Figure 11. Hurricane Hugo (1989), Garden City Beach, SC. House on pilings survived while others did not.

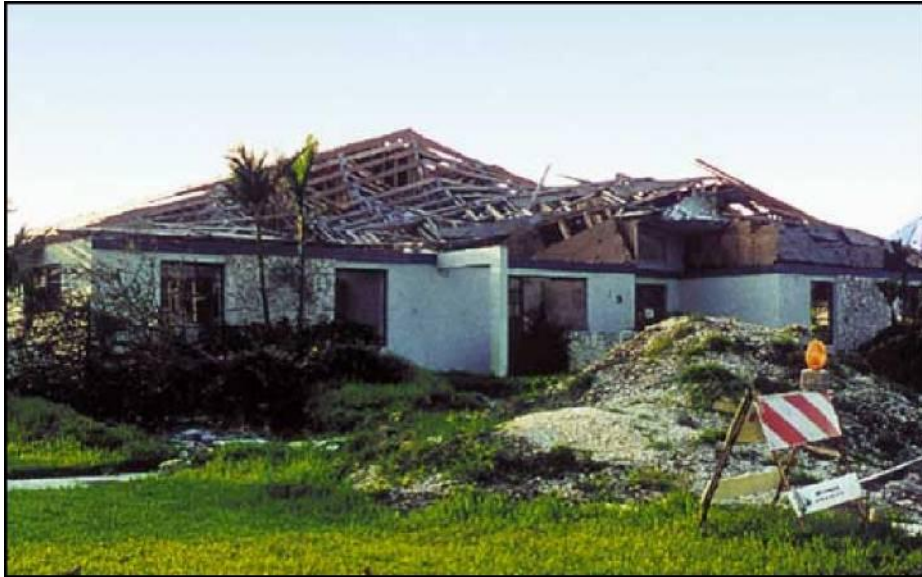
Figure 13. Hurricane Andrew (1992). Roof failure due to inadequate bracing.

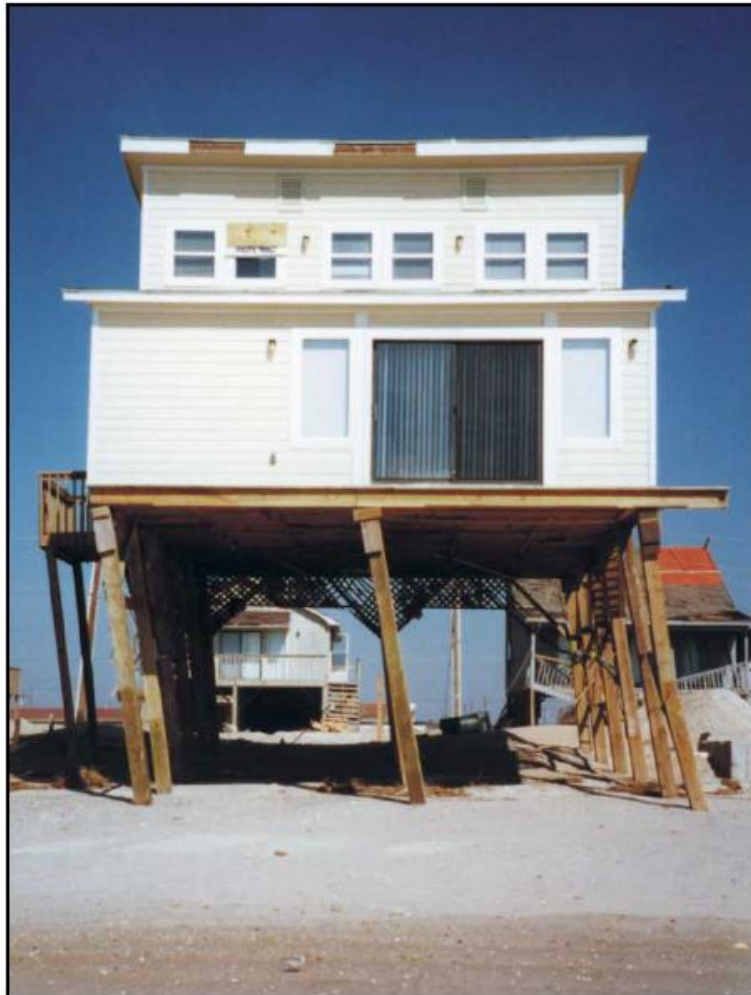
- Hundreds of oceanfront houses were destroyed by the storm, mostly as a result of insufficient pile embedment (see Figure 14) and wave effects. Most of the destroyed buildings had been constructed under an older building code provision that required that piling foundations extend only 8 feet below the original ground elevation. Erosion around the destroyed oceanfront foundations was typically 5–8 feet. In contrast, foundation failures were rare in similar, piling-supported buildings located farther from the ocean and not subject to erosion.

Figure 14: Hurricane Fran (1996). Many oceanfront houses built before the enactment of the 1986 North Carolina State Code were found to be leaning or destroyed.

- A significant reduction in building losses was observed in similarly sized oceanfront buildings constructed after the North Carolina Building Code was amended in 1986 to require a minimum embedment to –5.0 feet National Geodetic Vertical Datum (NGVD) or 16 feet below the original ground elevation, whichever is shallower, for pilings near the ocean. A study of Topsail Island found that 98 percent of post-1986 oceanfront houses (200 of 205) remained after the hurricane. Ninety-two percent of the total displayed no significant damage to the integrity of the piling foundation. However, 5 percent (11) were found to have leaning foundations (see Figure 16). A non-destructive test used to measure piling length in a partial sample of the leaning buildings revealed that none of the leaning pilings tested met the required piling embedment standard. Many were much shorter. However, given the uncertainty of predicting future erosion, the BPAT recommended that consideration be given to a piling embedment standard of –10.0 feet NGVD.

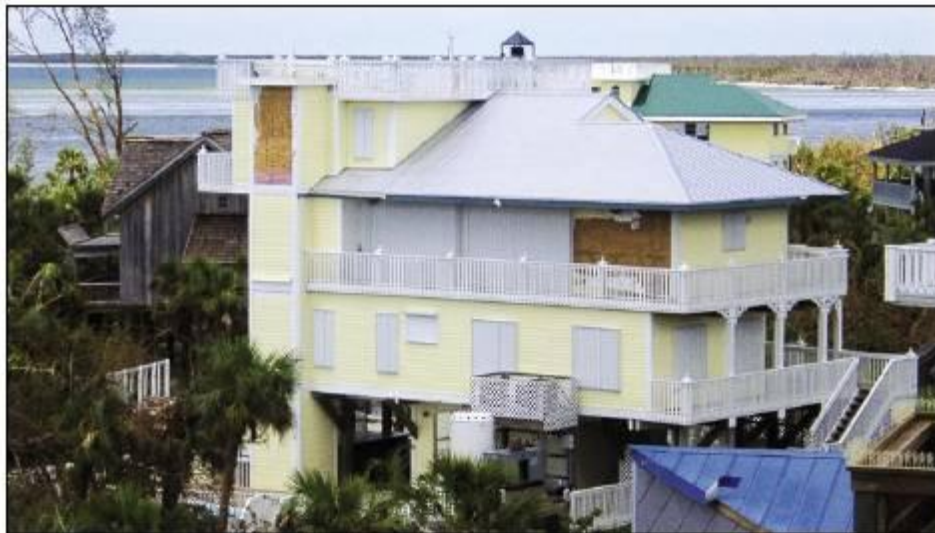
Figure 15. No structural damage was observed to homes built to the 2001 FBC (North Captiva Island, FL, 2004).

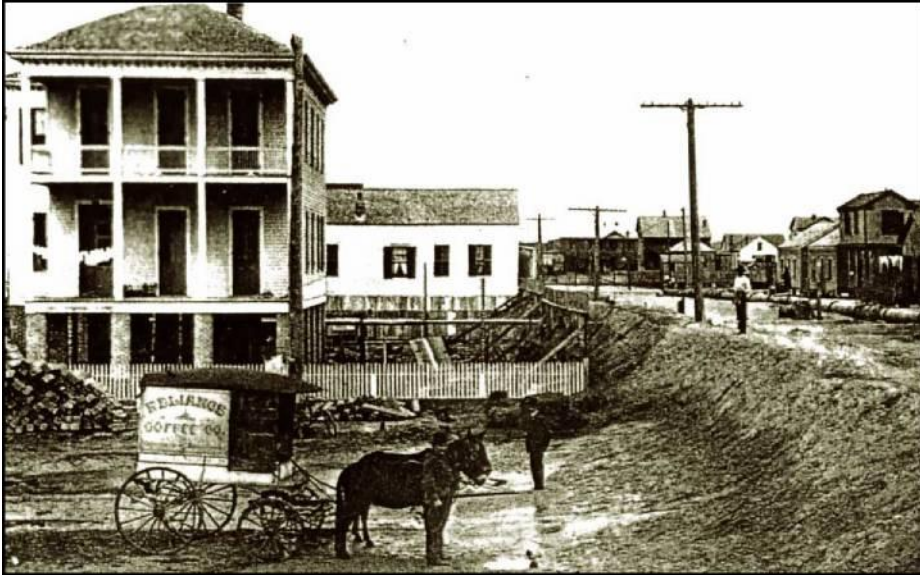
Figure 16. Galveston on two levels—the area at the right has already been raised; on the left, houses have been lifted, but the land is still low.

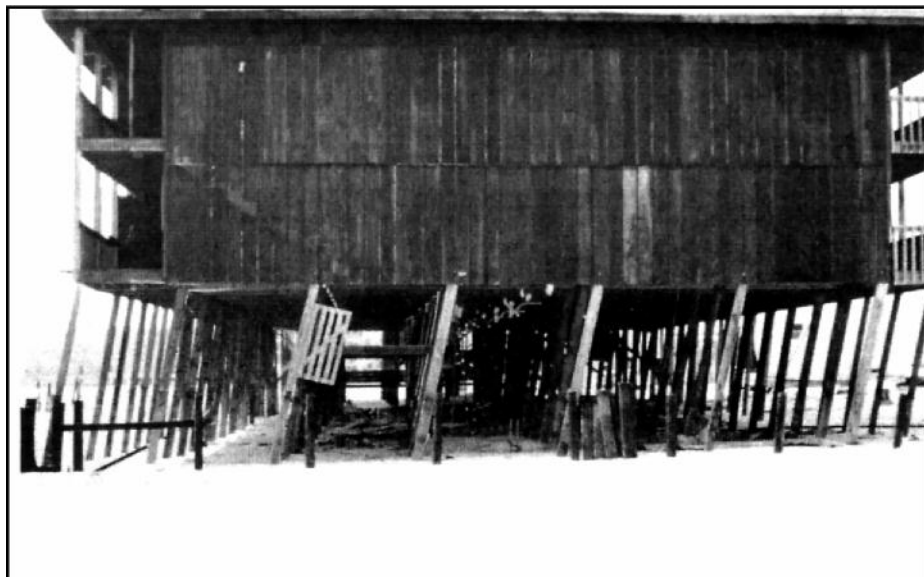
Figure 17. Hurricane Frederic (1979). Effects of wind and water forces on unbraced pile foundation.

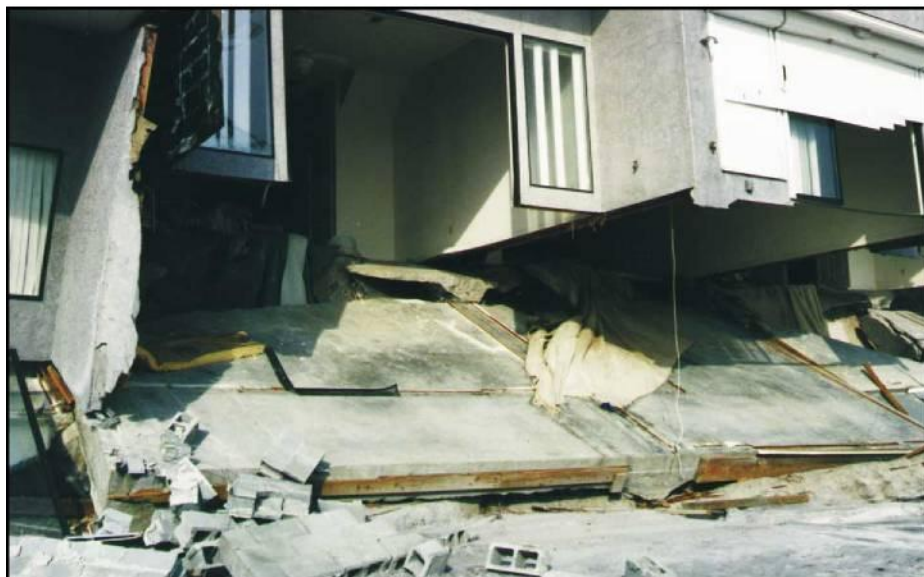
Figure 18. Hurricane Opal (1995), Bay County, Florida. Building damage from erosion and undermining.

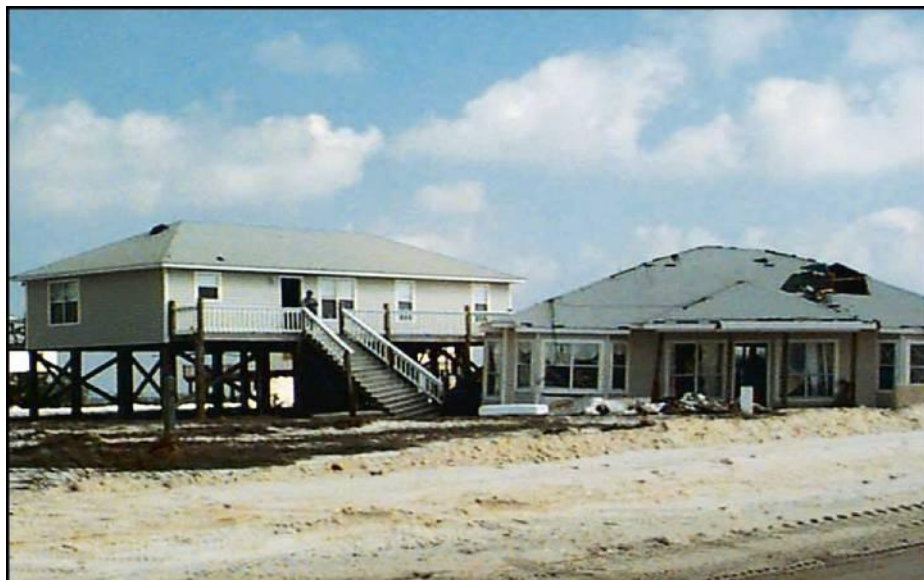
Figure 19. Hurricane Georges (1998), Dauphin Island, AL. As a result of erosion, scour, and inadequate pile embedment, the house on the right was washed off its foundation and into the house on the left.

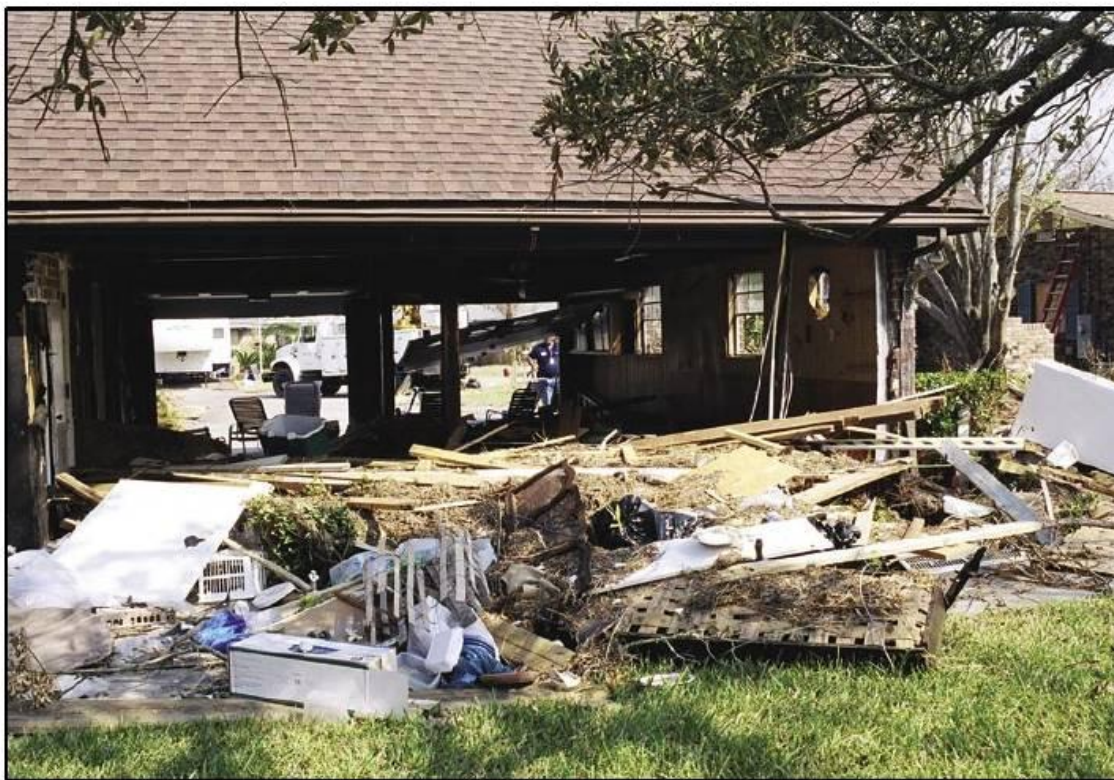
Figure 20. This house, located in Zone AE, experienced Zone V surge and wave conditions (Santa Rosa Sound, FL, 2004).

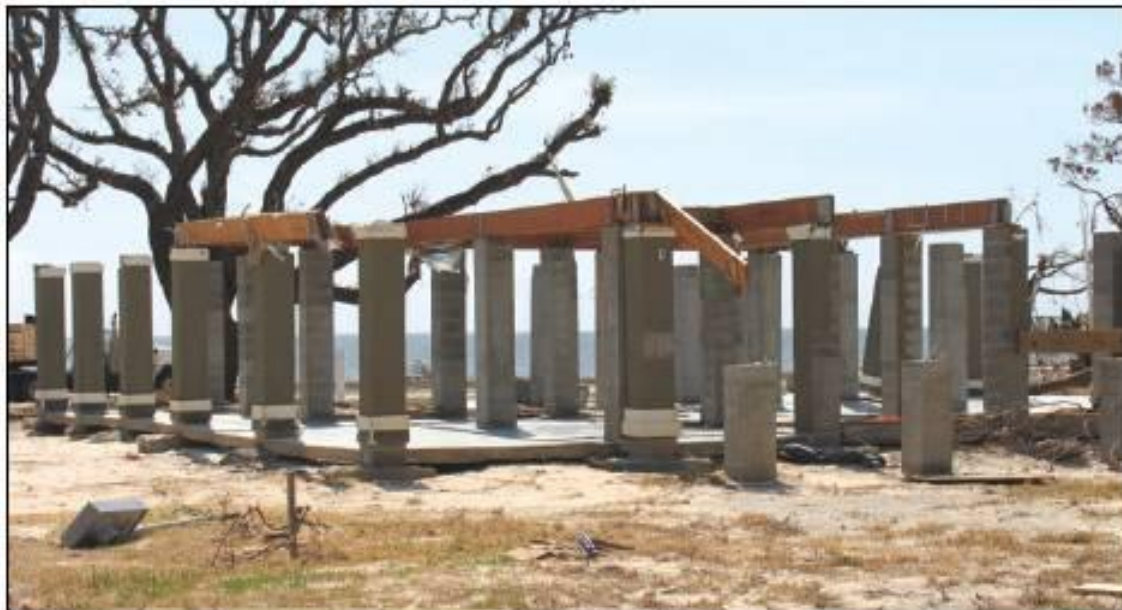
Figure 21. This elevated house on a masonry pier foundation was lost, probably due to waves and storm surge overtopping the foundation (Long Beach, MS, 2005).

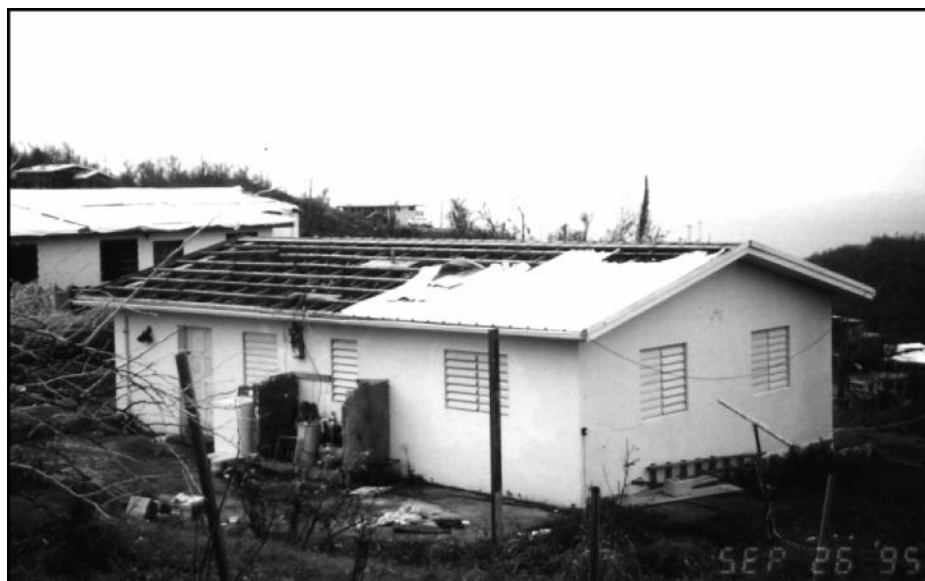
Figure 22. Hurricane Marilyn (1995). This house lost most of the metal roof covering.

Neighbors stated that the house also lost its roof covering during Hurricane Hugo, in 1989.

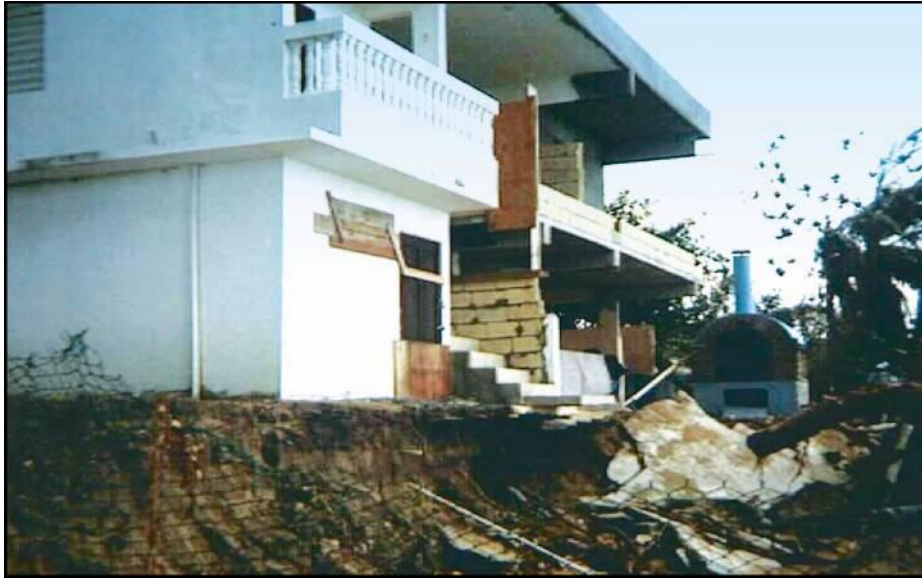
Figure 24. Hurricane Georges (1998). Coastal building in Puerto Rico damaged by storm surge and waves.

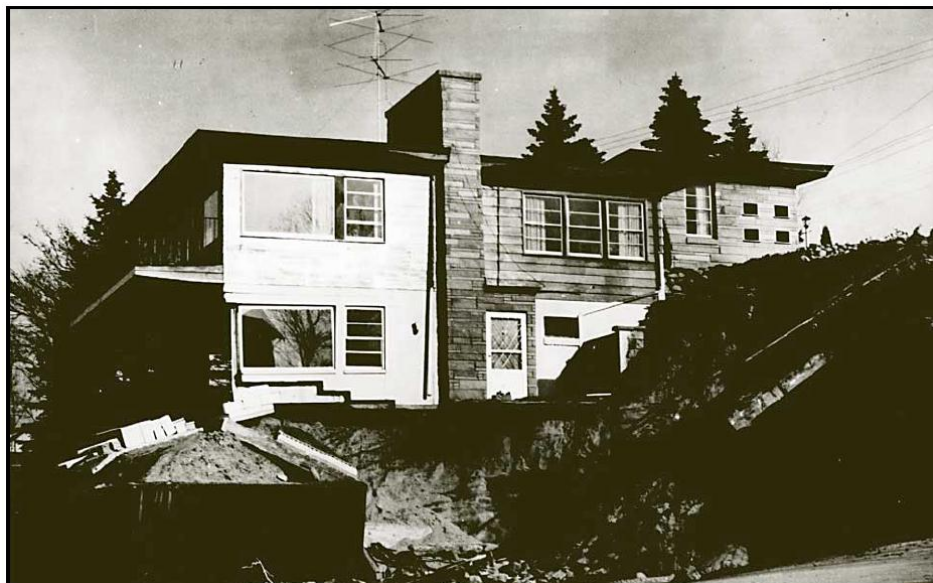
Figure 25. House on southeastern shoreline of Lake Michigan undermined by erosion during storm of November 1951..... 31

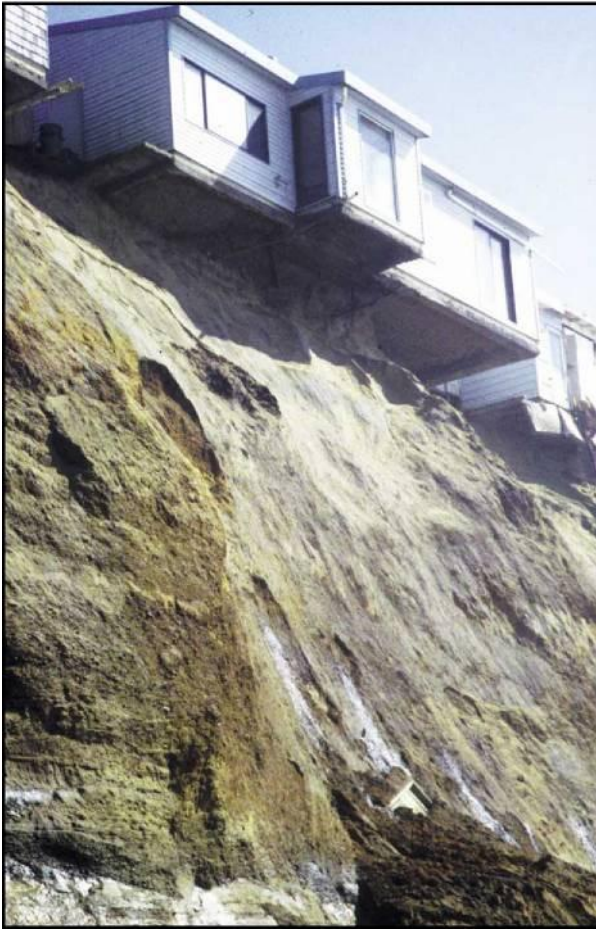
Figure 27. Winter coastal storms, California and Oregon (1997– 1998). House in Pacifica, CA, undermined by bluff erosion. 34

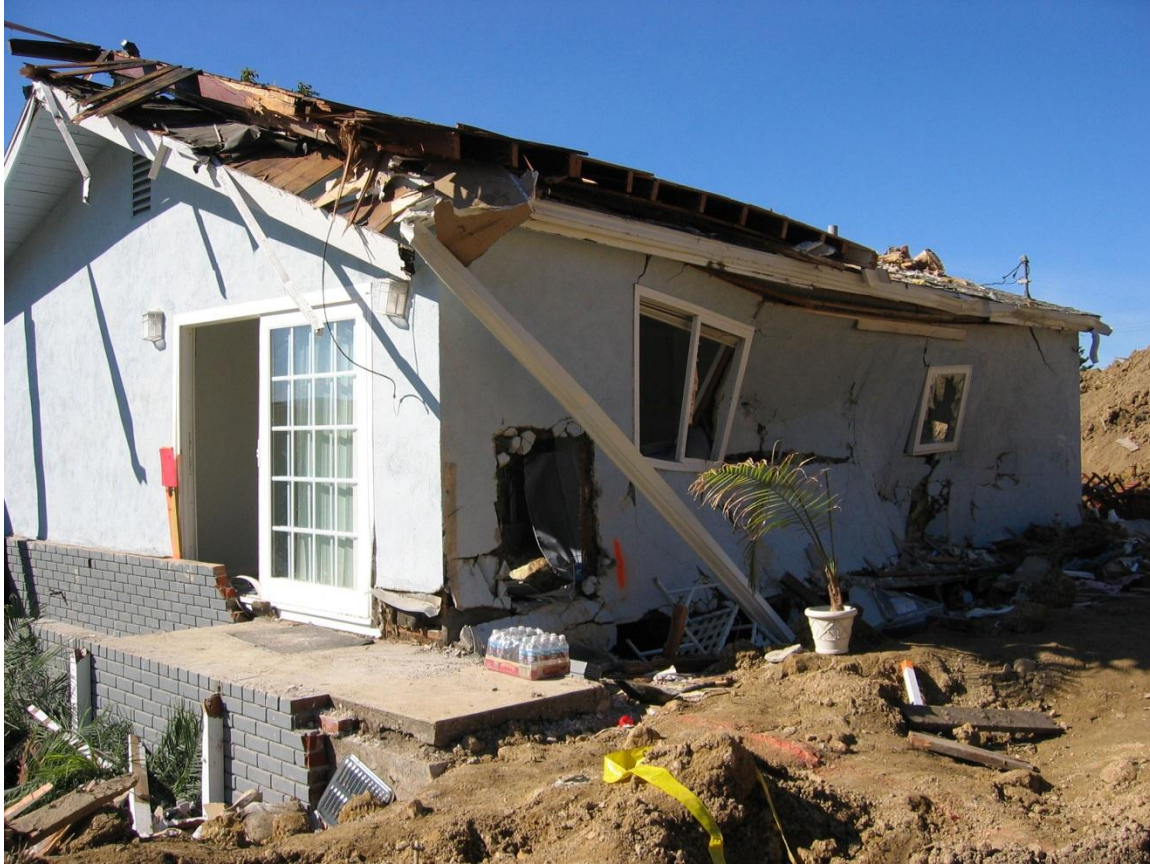
Figure 28. Damaged building braced for structural support in La Conchita, CA, after January 2005 storm event.

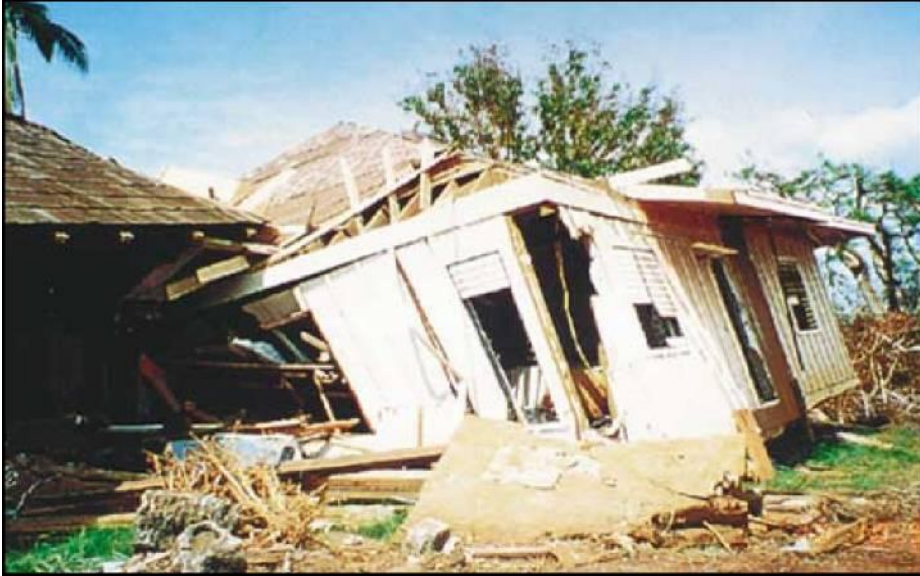
Figure 29. Hurricane Iniki (1992). Non-elevated house at Poipu Beach that floated off its foundation and was pinned against another house and destroyed by waves.

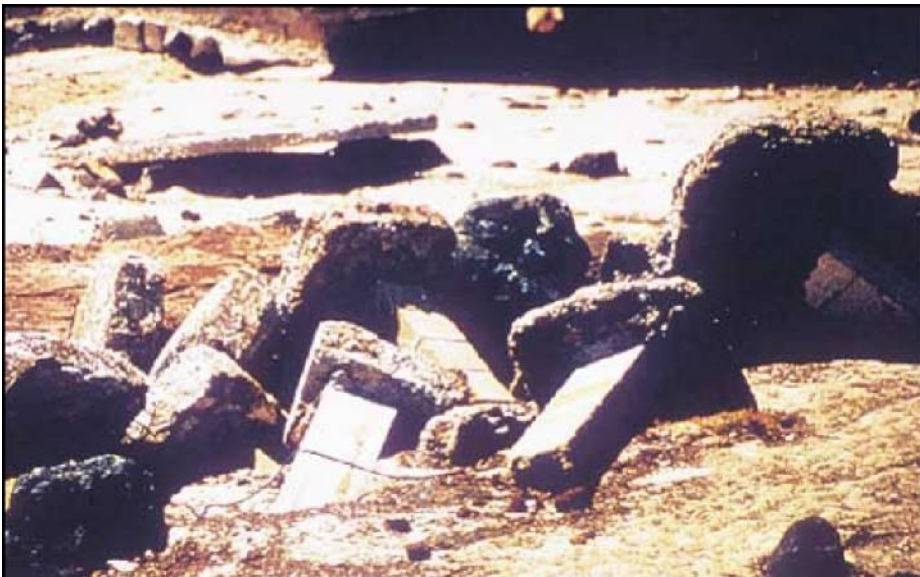
Figure 30. Hurricane Iniki (1992). Undermining of shallow footings supporting columns at Poipu Beach due to lack of sufficient embedment below erosion level.

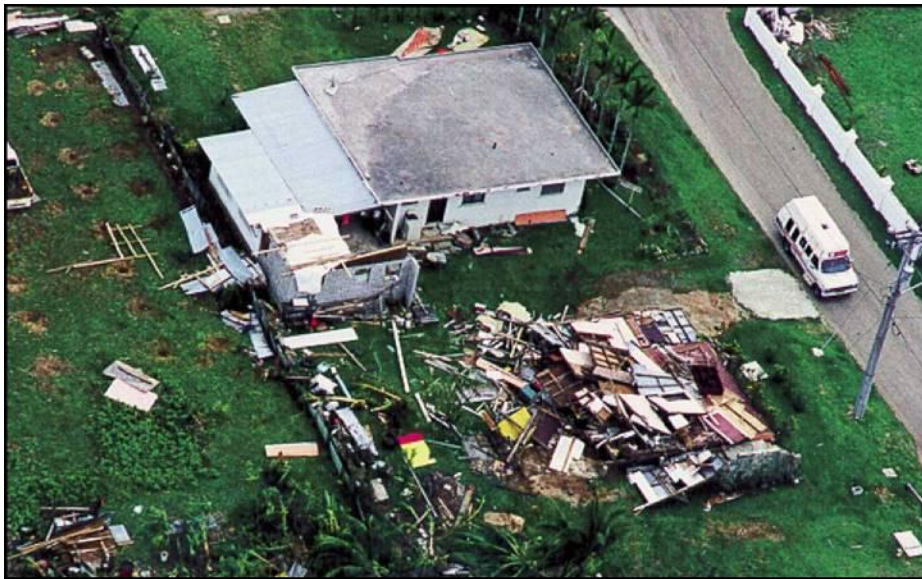
Figure 31. Typhoon Paka (1997). Although damaged by the storm, the concrete house in the upper part of the photograph survived, while the wood-frame house next to it was destroyed.

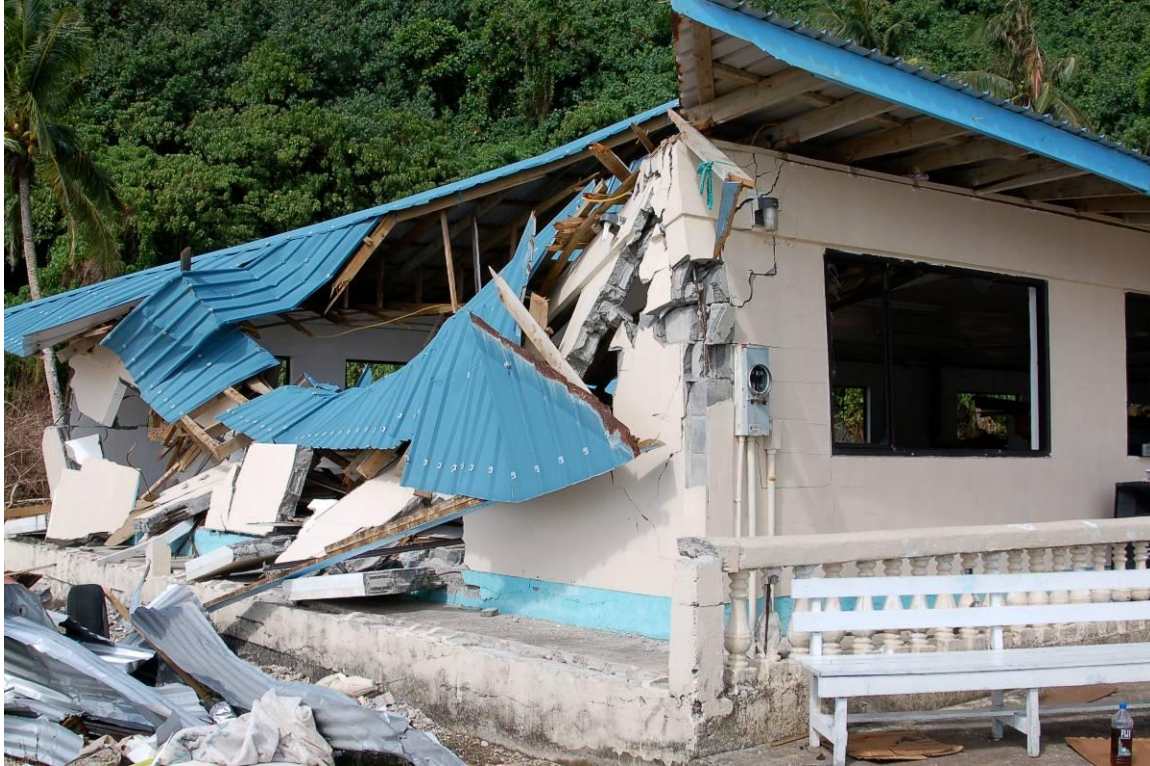
Figure 32. Tsunami damage at Poloa, American Samoa. 38

15 to 40 feet above sea level. At least 275 residences were destroyed by the tsunami and several hundred others were damaged (Figure 31). Damage to commercial buildings, churches, schools and other buildings was also widespread. Elevated buildings and buildings farther inland generally performed better. Thirty four people were killed by the tsunami.
