# Rapid Visual Screening of Buildings for Potential Seismic Hazards

A Handbook

FEMA 154, Edition 2 / March 2002

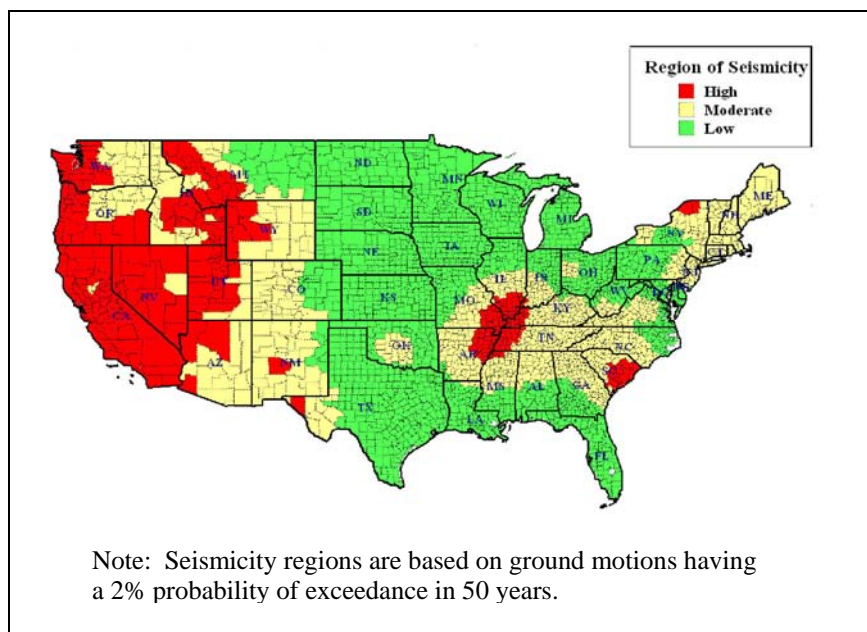
Figure 1-1 High, moderate, and low seismicity regions of the conterminous United States. A different RVS Data Collection Form has been developed for each of these regions. Enlarged maps are available in Appendix A.

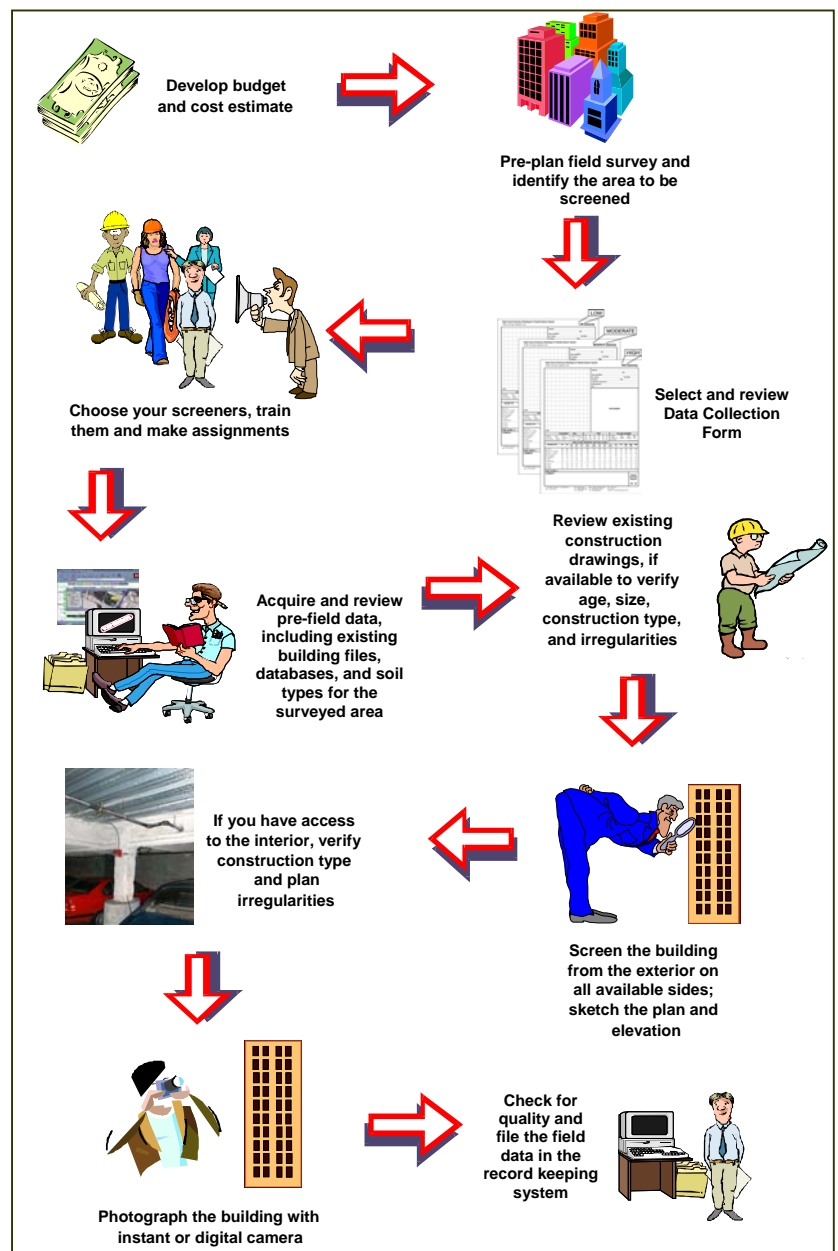
Figure 2-1 Rapid visual screening implementation sequence.

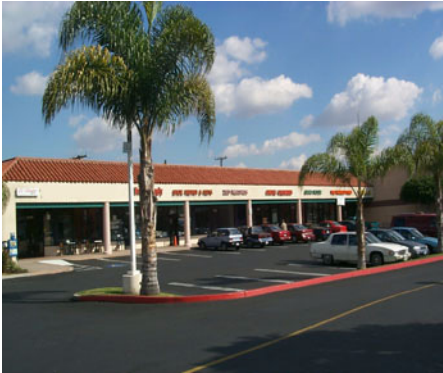
<p><b>W2</b> Light wood frame buildings greater than 5,000 square feet</p>

<p>H = 3.8 M = 4.8 L = 6.0</p>	<ul style="list-style-type: none"> <li>● These are large apartment buildings, commercial buildings or industrial structures usually of one to three stories, and, rarely, as tall as six stories.</li> </ul>

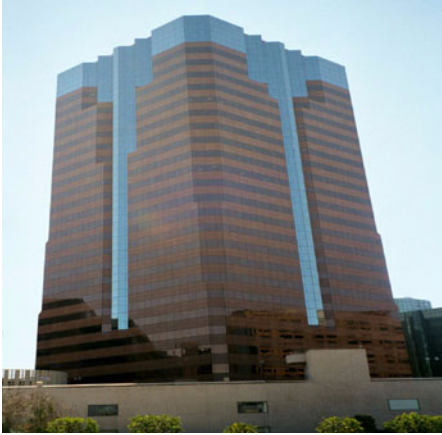
<i>Building Identifier</i>	<i>Photograph</i>	<i>Basic Structural Hazard Score</i>	<i>Characteristics and Performance</i>
<p><b>S1</b> Steel moment-resisting frame</p>

<p>H = 2.8 M = 3.6 L = 4.6</p>	<ul style="list-style-type: none"> <li>• Typical steel moment-resisting frame structures usually have similar bay widths in both the transverse and longitudinal directions, around 20-30 ft.</li> <li>• The floor diaphragms are usually concrete, sometimes over steel decking. This structural type is used for commercial, institutional and public buildings.</li> <li>• The 1994 Northridge and 1995 Kobe earthquakes showed that the welds in steel moment-frame buildings were vulnerable to severe damage. The damage took the form of broken connections between the beams and columns.</li> </ul>
<p><b>S2</b> Braced steel frame</p>

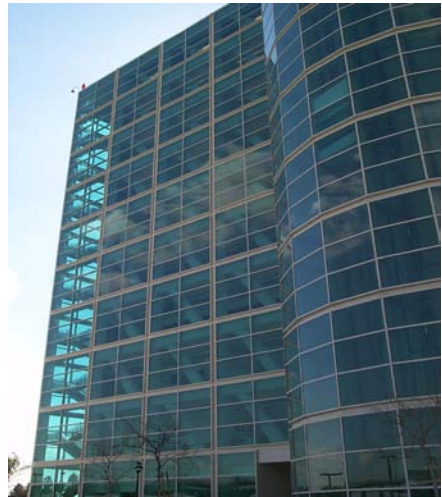
<p>Zoom-in of upper photo</p>	<p>H = 3.0 M = 3.6 L = 4.8</p>	<ul style="list-style-type: none"> <li>• These buildings are braced with diagonal members, which usually cannot be detected from the building exterior.</li> <li>• Braced frames are sometimes used for long and narrow buildings because of their stiffness.</li> <li>• From the building exterior, it is difficult to tell the difference between steel moment frames, steel braced frames, and steel frames with interior concrete shear walls.</li> <li>• In recent earthquakes, braced frames were found to have damage to brace connections, especially at the lower levels.</li> </ul>

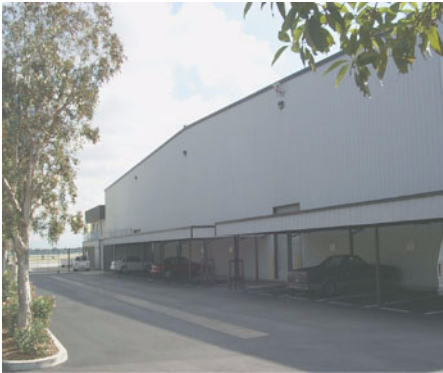
<i>Building Identifier</i>	<i>Photograph</i>	<i>Basic Structural Hazard Score</i>	<i>Characteristics and Performance</i>
<p><b>S3</b> Light metal building</p>

<p>H = 3.2 M = 3.8 L = 4.6</p>	<ul style="list-style-type: none"> <li>● The structural system usually consists of moment frames in the transverse direction and braced frames in the longitudinal direction, with corrugated sheet-metal siding. In some regions, light metal buildings may have partial-height masonry walls.</li> <li>● The interiors of most of these buildings do not have interior finishes and their structural skeleton can be seen easily.</li> <li>● Insufficient capacity of tension braces can lead to their elongation and consequent building damage during earthquakes.</li> <li>● Inadequate connection to a slab foundation can allow the building columns to slide on the slab.</li> <li>● Loss of the cladding can occur.</li> </ul>

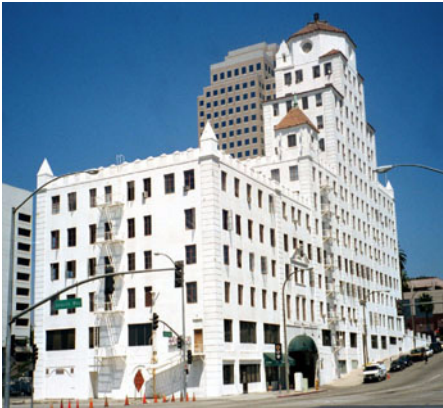
<p><b>S4</b> Steel frames with cast-in-place concrete shear walls</p>

<p>H = 2.8 M = 3.6 L = 4.8</p>	<ul style="list-style-type: none"> <li>● Lateral loads are resisted by shear walls, which usually surround elevator cores and stairwells, and are covered by finish materials.</li> <li>● An interior investigation will permit a wall thickness check. More than six inches in thickness usually indicates a concrete wall.</li> <li>● Shear cracking and distress can occur around openings in concrete shear walls during earthquakes.</li> <li>● Wall construction joints can be weak planes, resulting in wall shear failure below expected capacity.</li> </ul>

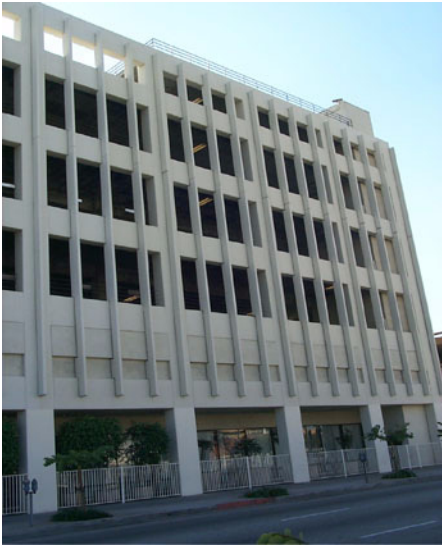
<p>H = 2.5 M = 3.0 L = 4.4</p>	<ul style="list-style-type: none"> <li>● All exposed concrete frames are reinforced concrete (not steel frames encased in concrete).</li> <li>● A fundamental factor governing the performance of concrete moment-resisting frames is the level of ductile detailing.</li> <li>● Large spacing of ties in columns can lead to a lack of concrete confinement and shear failure.</li> <li>● Lack of continuous beam reinforcement can result in hinge formation during load reversal.</li> <li>● The relatively low stiffness of the frame can lead to substantial nonstructural damage.</li> <li>● Column damage due to pounding with adjacent buildings can occur.</li> </ul>

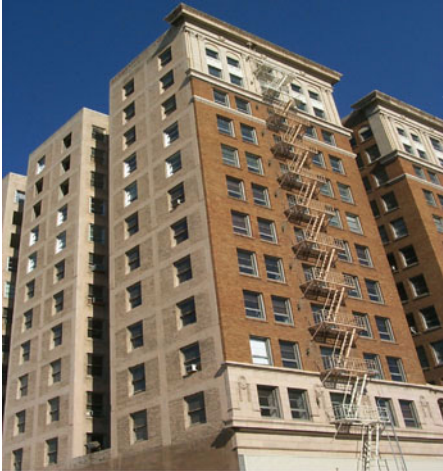
<p>H = 1.6 M = 3.2 L = 4.4</p>	<ul style="list-style-type: none"> <li>● Concrete columns and beams may be full wall thickness and may be exposed for viewing on the sides and rear of the building.</li> <li>● Usually masonry is exposed on the exterior with narrow piers (less than 4 ft wide) between windows.</li> <li>● Portions of solid walls will align vertically.</li> <li>● This type of construction was generally built before 1940 in high-seismicity regions but continues to be built in other regions.</li> <li>● Infill walls tend to buckle and fall out-of-plane when subjected to strong lateral out-of-plane forces.</li> <li>● Veneer masonry around columns or beams is usually poorly anchored and detaches easily.</li> </ul>

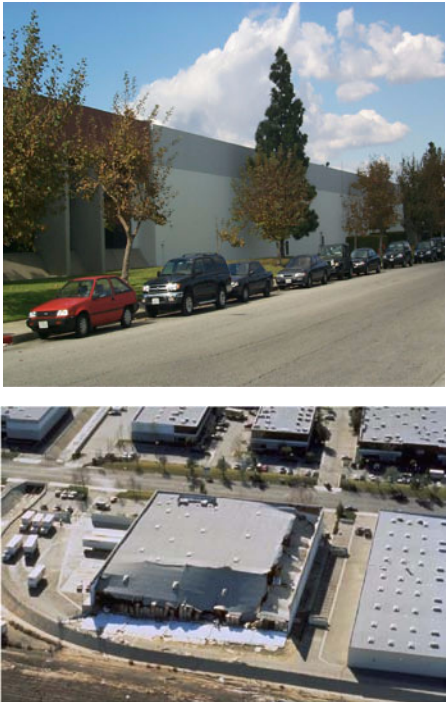
<i>Building Identifier</i>	<i>Photograph</i>	<i>Basic Structural Hazard Score</i>	<i>Characteristics and Performance</i>
<p><b>PC1</b> Tilt-up buildings</p>

<p>Partial roof collapse due to failed diaphragm-to-wall connection</p>	<p>H = 2.6 M = 3.2 L = 4.4</p>	<ul style="list-style-type: none"> <li>● Tilt-ups are typically one or two stories high and are basically rectangular in plan.</li> <li>● Exterior walls were traditionally formed and cast on the ground adjacent to their final position, and then “tilted-up” and attached to the floor slab.</li> <li>● The roof can be a plywood diaphragm carried on wood purlins and glulam beams or a light steel deck and joist system, supported in the interior of the building on steel pipe columns.</li> <li>● Weak diaphragm-to-wall anchorage results in the wall panels falling and the collapse of the supported diaphragm (or roof).</li> </ul>

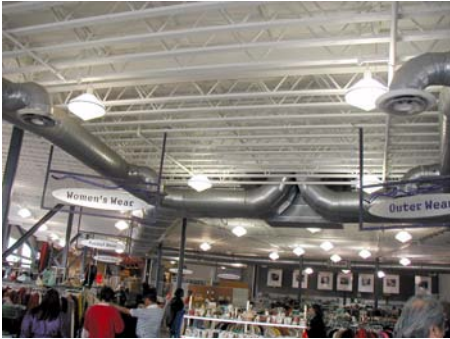
<p>Truss-joists support plywood and light-weight concrete slab</p>

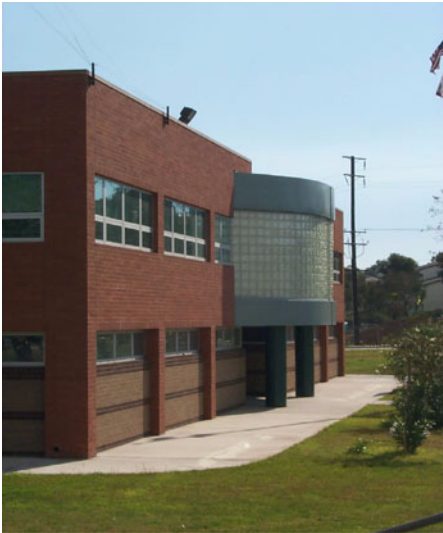
<i>Building Identifier</i>	<i>Photograph</i>	<i>Basic Structural Hazard Score</i>	<i>Characteristics and Performance</i>
<p><b>RM2</b> Reinforced masonry buildings with rigid diaphragms</p>

<p>H = 2.8 M = 3.4 L = 4.6</p>	<ul style="list-style-type: none"> <li>● Walls are either brick or concrete block.</li> <li>● Wall thickness is usually 8 inches to 12 inches.</li> <li>● Interior inspection is required to determine if diaphragms are flexible or rigid.</li> <li>● The most common floor and roof systems are wood, light steel, or precast concrete.</li> <li>● These buildings can perform well in moderate earthquakes if they are adequately reinforced and grouted, with sufficient diaphragm anchorage.</li> <li>● Poor construction practice can result in ungrouted and unreinforced walls, which will fail easily.</li> </ul>
<p><b>URM</b> Unreinforced masonry buildings</p>

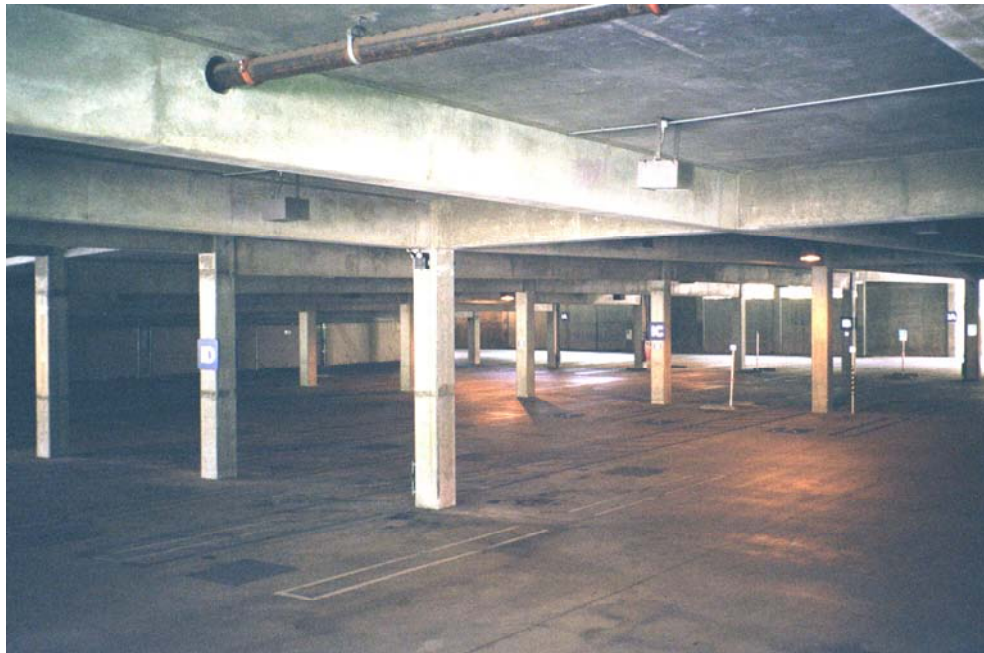
Figure 3-12 Interior view showing concrete columns and girders, which indicate a concrete moment frame (C1).

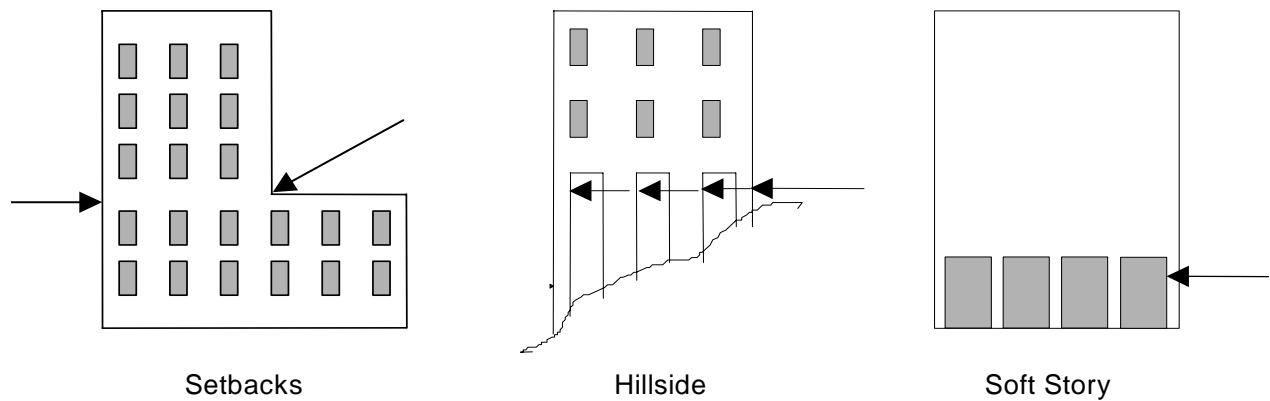
Figure 3-14 Elevation views showing vertical irregularities, with arrows indicating locations of particular concern.

If the building is on a steep hill so that over the up-slope dimension of the building the hill rises at least one story height, a problem may exist because the horizontal stiffness along the lower side may be different from the uphill side. In addition, in the up-slope direction, the stiff short columns attract the seismic shear forces and may fail. In this case the performance modifier is applicable. See Figure 3-14 for an example.

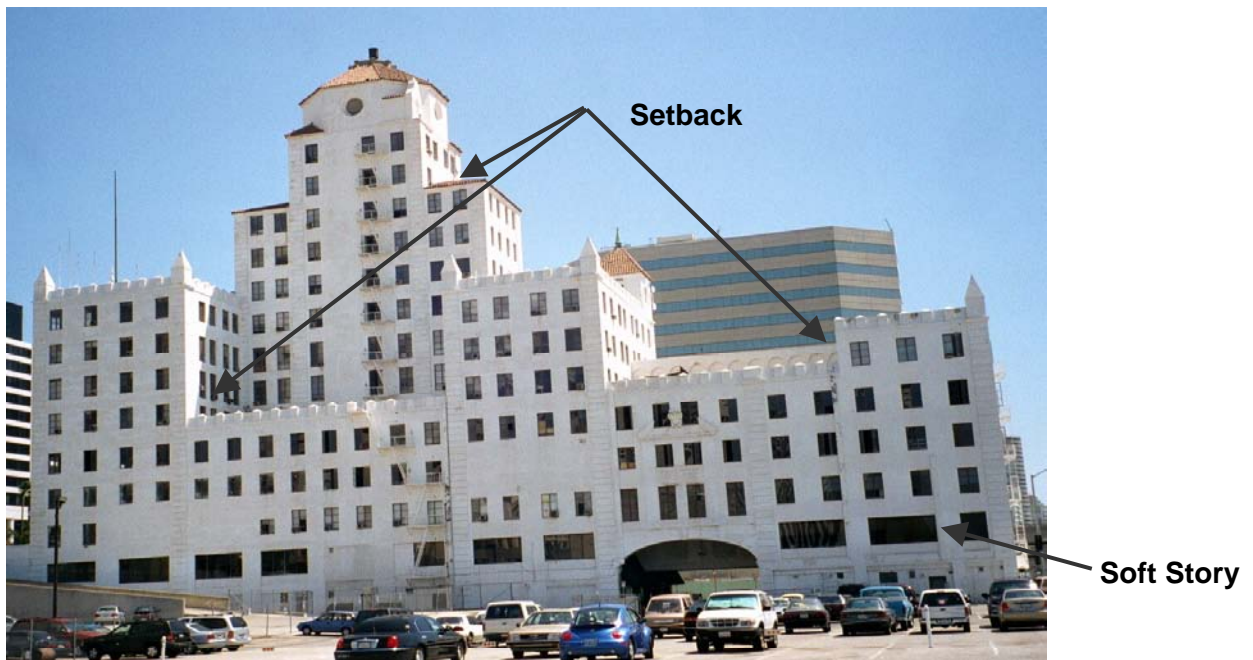
Figure 3-15 Example of setbacks (see Figure 3-14) and a soft first story.

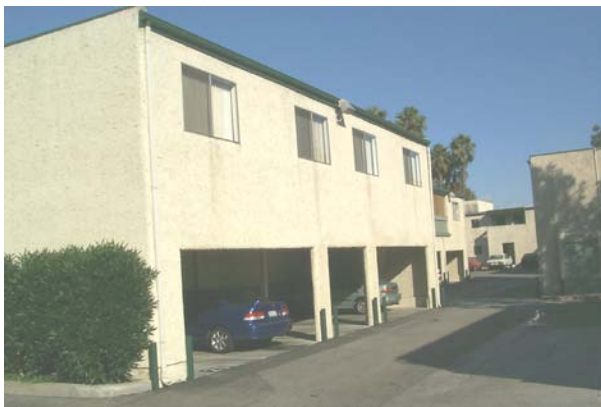
Figure 3-16 Example of soft story conditions, where parking requirements result in large weak openings.

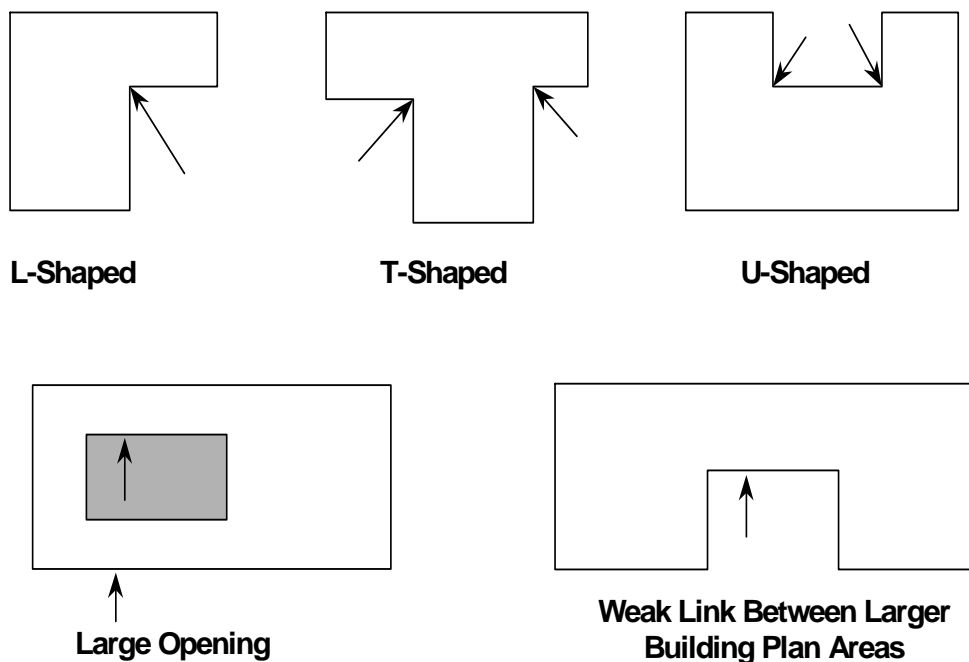
Figure 3-17 Plan views of various building configurations showing plan irregularities; arrows indicate possible areas of damage.

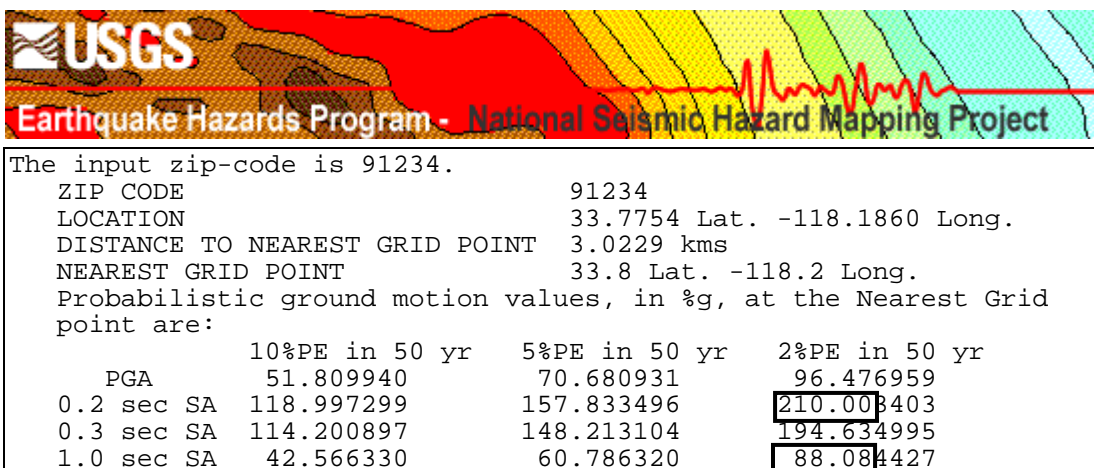
Figure 5-1 Screen capture of USGS web page showing SA values for 0.2 sec and 1.0 sec for ground motions having 2% probability of being exceeded in 50 years (values shown in boxes).

To choose the correct Data Collection Form, the RVS authority elected to establish the seismicity for Anyplace USA by using Method 2 (see Section 2.4.1), rather than by selecting the seismicity region from the maps in Appendix A. Method 2, using the zip-code option, provides more precision than the Appendix A maps which use county boundaries. Method 2 was executed by accessing the USGS seismic hazard web site (<http://geohazards.cr.usgs.gov/eq/>), selecting Hazard by Zip Code, entering the zip code, 91234, and obtaining spectral acceleration (SA) values for 0.2 second and 1.0 second for ground motions having a 2% probability of being exceeded in 50 years (see Figure 5-1). The values of 2.10 g and 0.88 g for 0.2 second and 1.0 second, respectively, were multiplied by 2/3 to obtain the reduced values of 1.40 g and 0.59 g, respectively, for 0.2

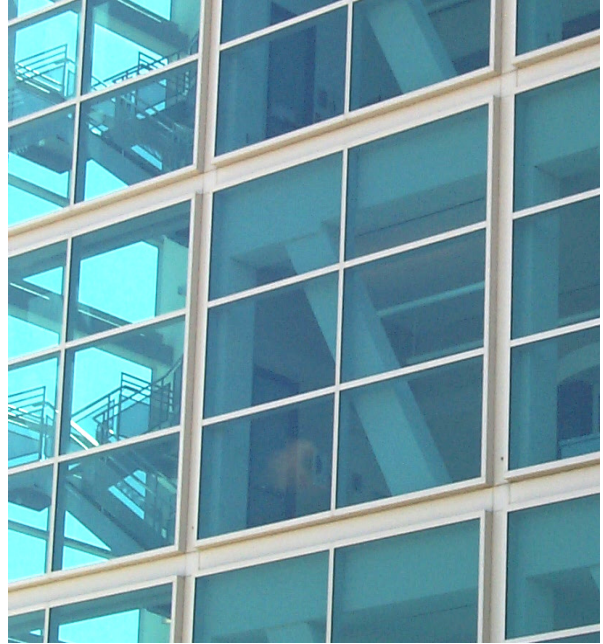
Figure 5-6 Close-up view of 3703 Roxbury Street exterior showing perimeter braced steel framing.

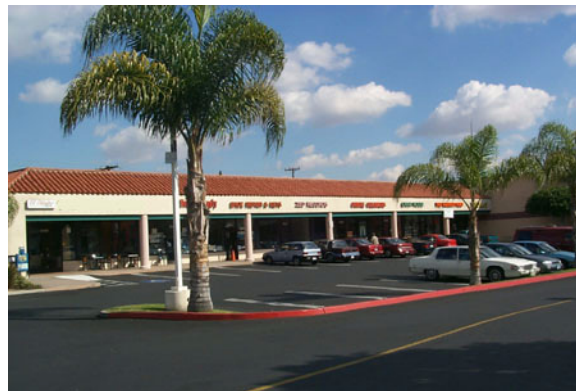
Figure E-2 Larger wood-framed structure, typically with room-width spans (W2, light, wood-frame buildings greater than 5000 square feet).

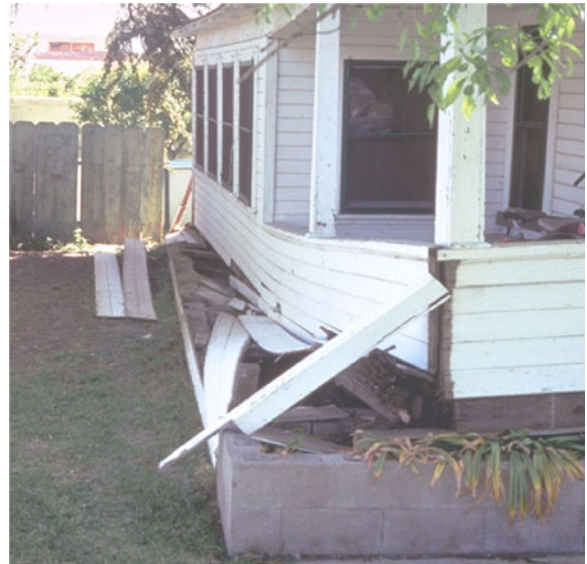
Figure E-7 House off its foundation, 1983 Coalinga earthquake.

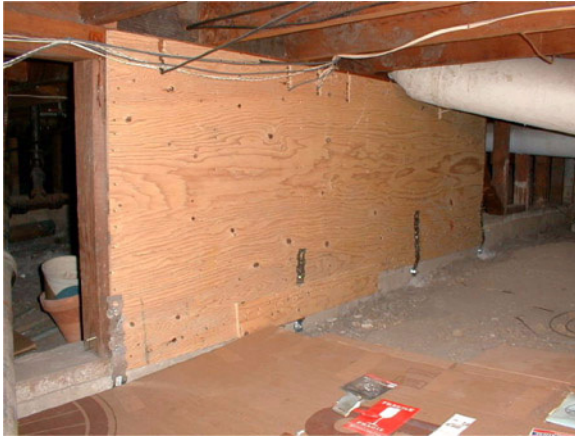
Figure E-10 Seismic strengthening of a cripple wall, with plywood sheathing.

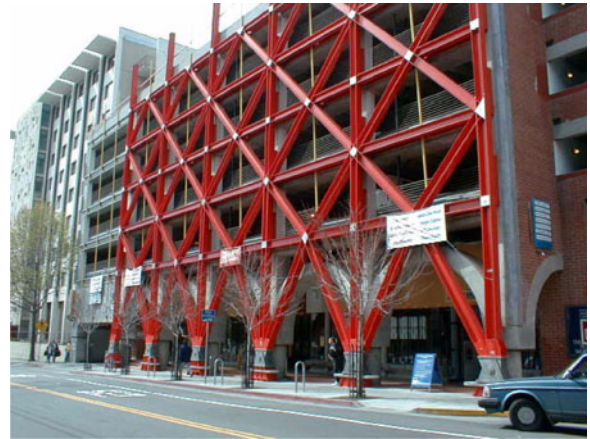
Figure E-15 Rehabilitation of a concrete parking structure using exterior X-braced steel frames.

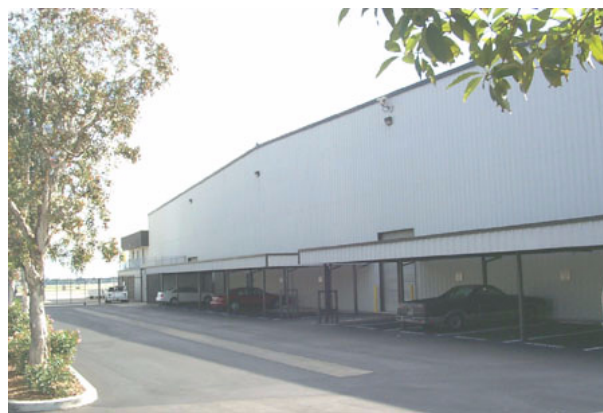
Figure E-19 Prefabricated metal building (S3, light metal building).

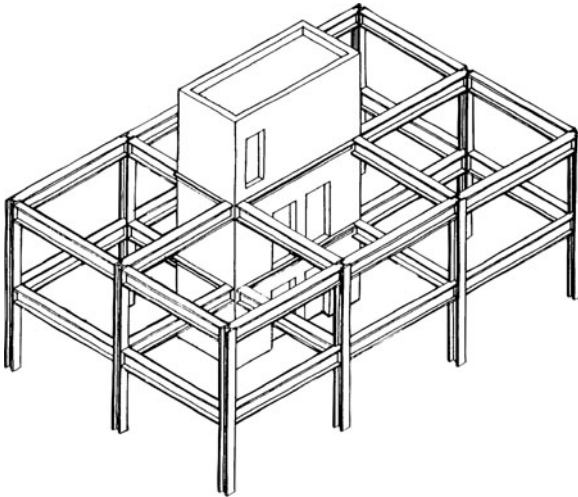
Figure E-20 Drawing of steel frame with interior concrete shear-walls.

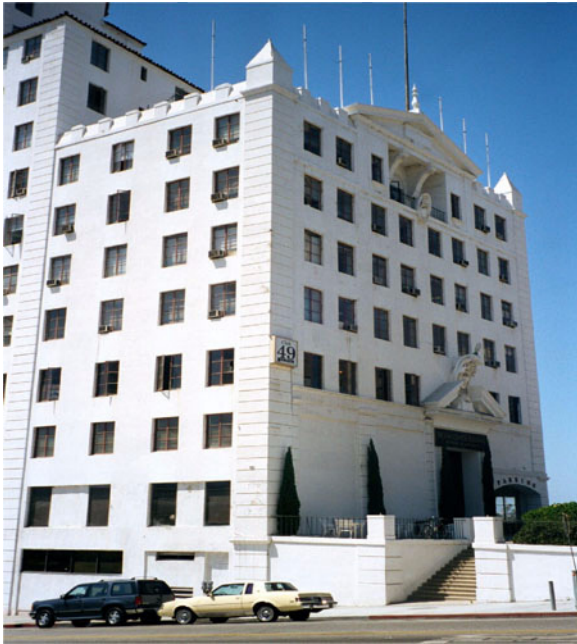
Figure E-21 Concrete shear wall on building exterior.

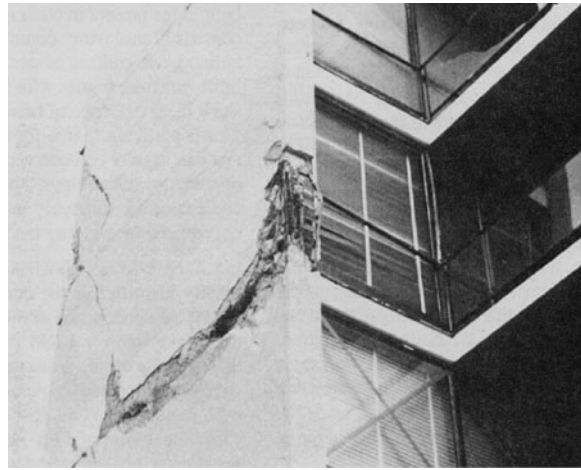
Figure E-22 Close-up of exterior shear wall damage during a major earthquake.

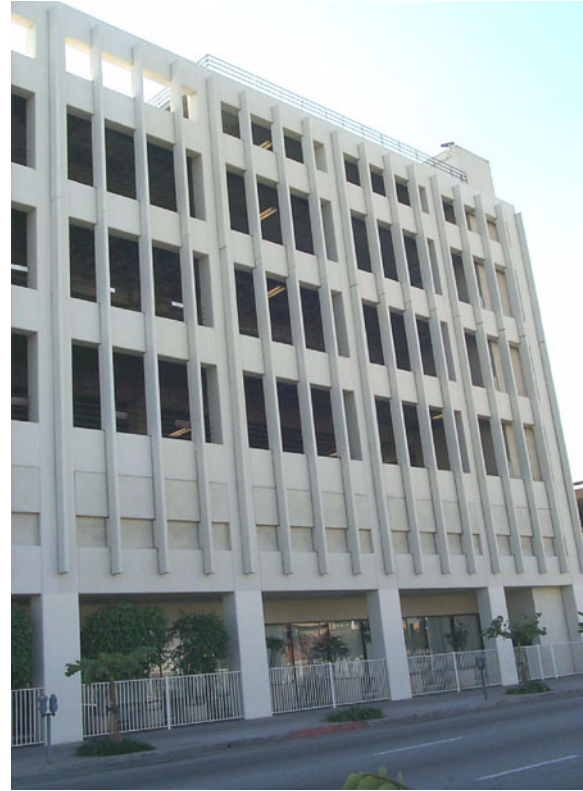
Figure E-28 Concrete moment-resisting frame building (C1) with exposed concrete, deep beams, wide columns (and with architectural window framing).

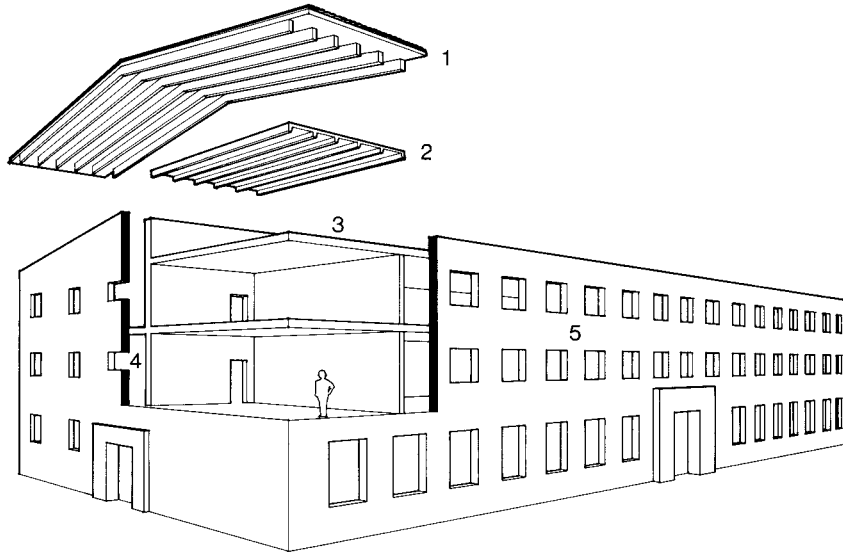
Figure E-30 Drawing of concrete shear-wall building.

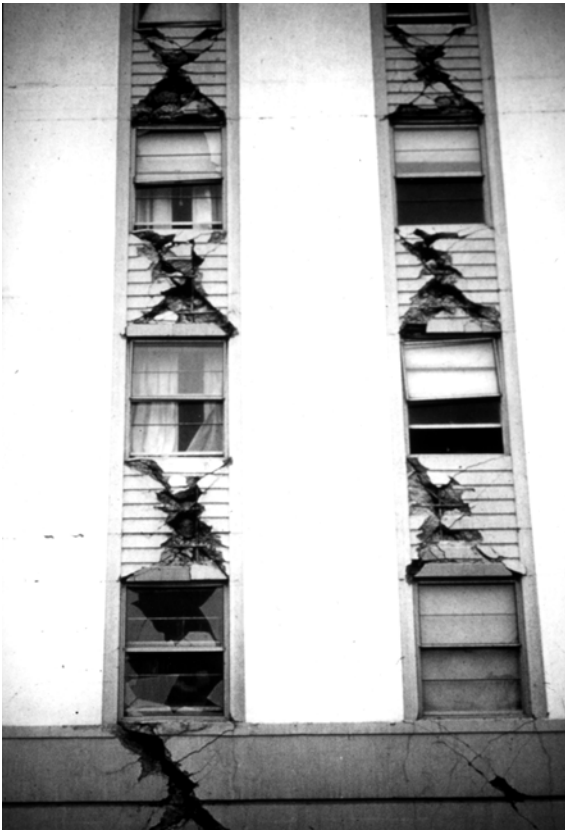
Figure E-31 Tall concrete shear-wall building: walls connected by damaged spandrel beams.

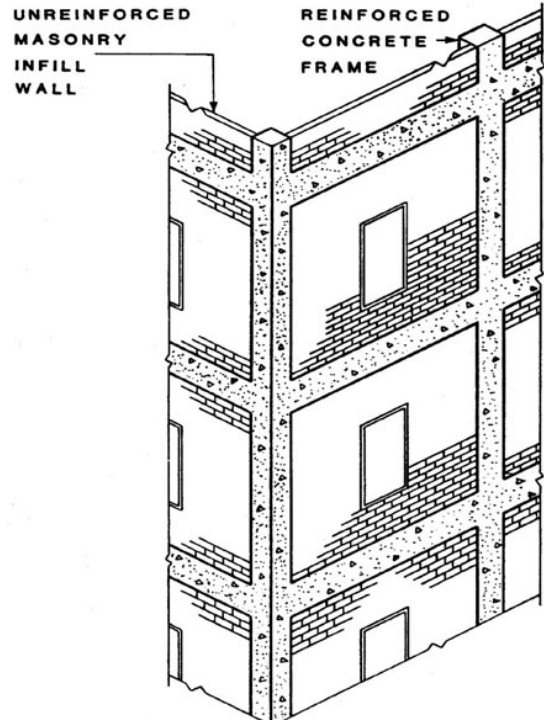
Figure E-33 Concrete frame with URM infill.

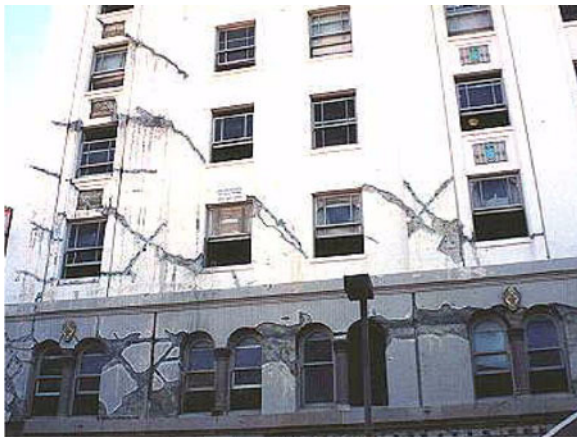
Figure E-32 Shear-wall damage, 1989 Loma Prieta earthquake.

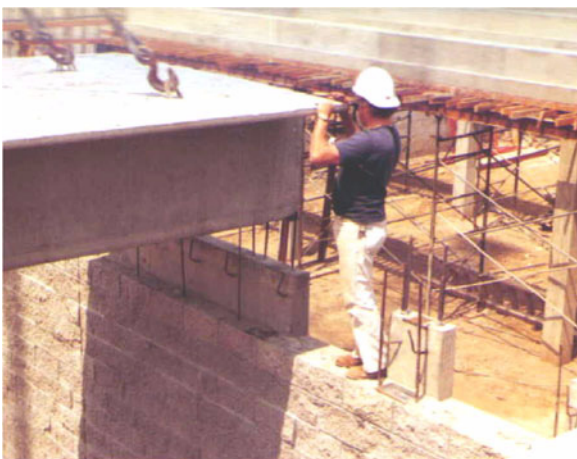
Figure E-44 Example of precast double-T section during installation.

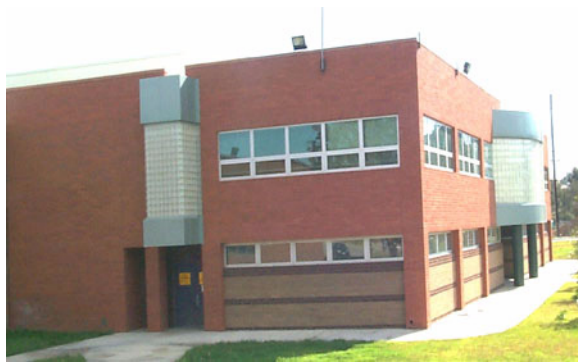
Figure E-46 Modern reinforced brick masonry.

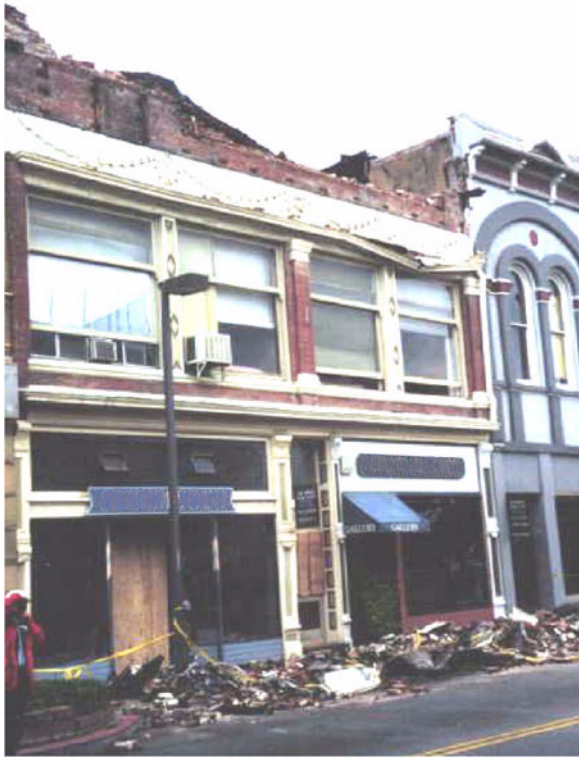
Figure E-53 Parapet failure leaving an uneven roof line, due to inadequate anchorage, 1989 Loma Prieta earthquake.

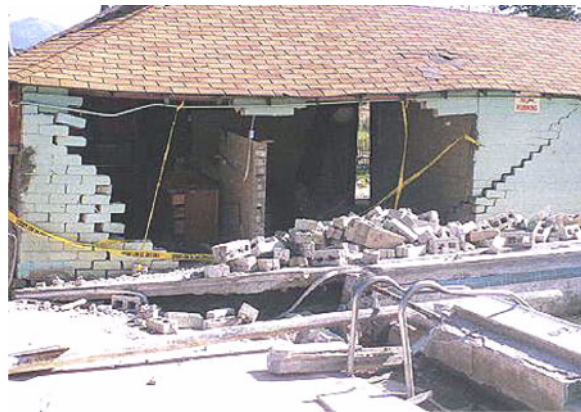
Figure E-54 Damaged URM building, 1992 Big Bear earthquake.

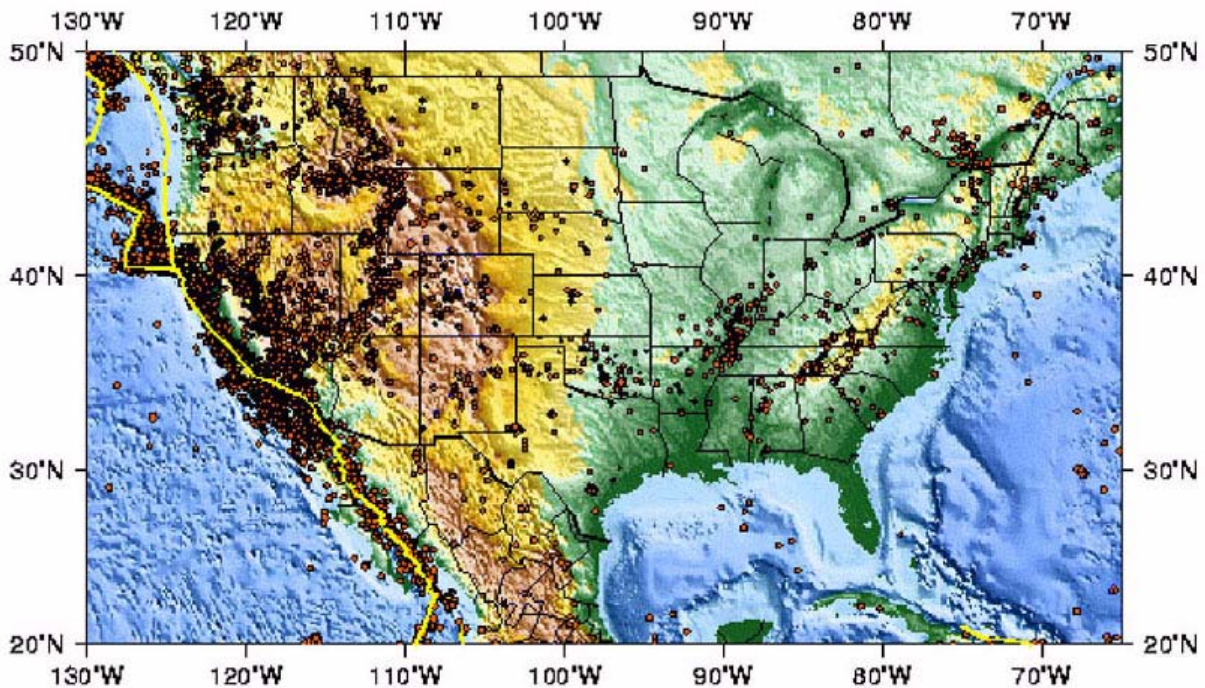
Figure F-2 Seismicity of the conterminous United States 1977 – 1997 (from the website at <http://neic.usgs.gov/neis/general/seismicity/us.html>). This reproduction shows earthquake locations without regard to magnitude or depth. The San Andreas fault and other plate boundaries are indicated with white lines.

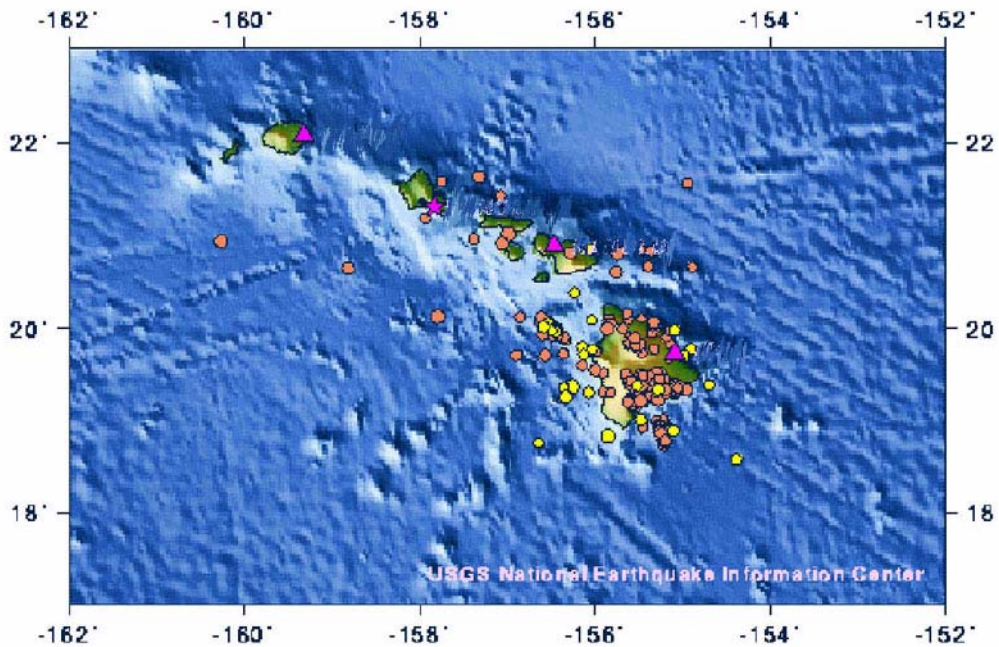
Figure F-4 Seismicity of Hawaii 1977 – 1997. See Figure F-2 caption.

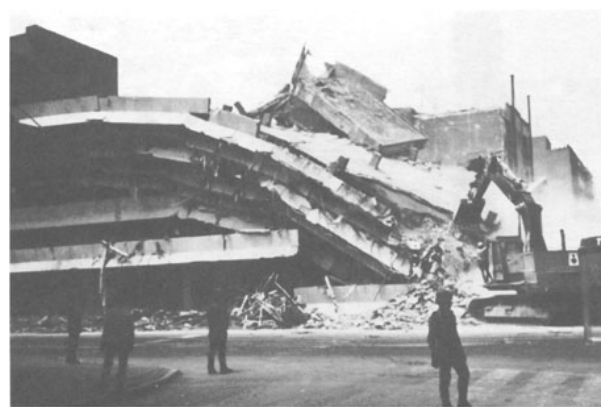
Figure F-5 Mid-rise building collapse, 1985 Mexico City earthquake.

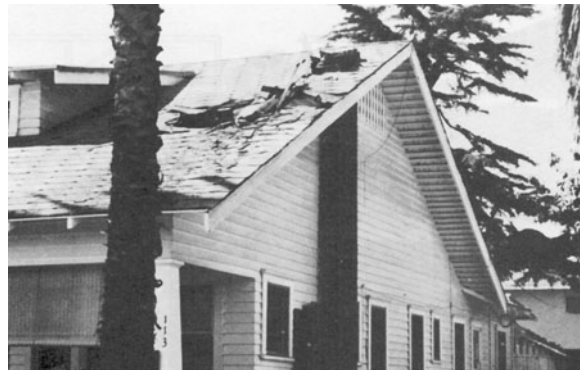
Figure F-7 Collapsed chimney with damaged roof, 1987 Whittier Narrows earthquake.

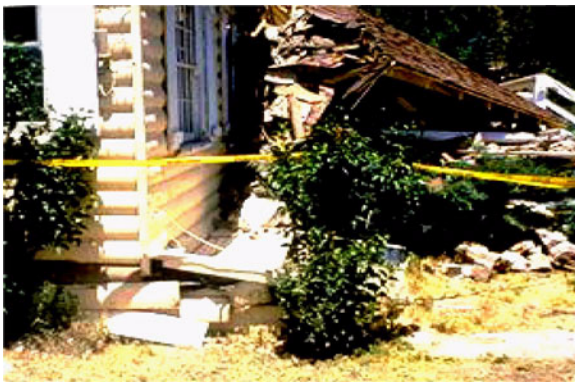
Figure F-9 Collapsed cripple stud walls dropped this house to the ground, 1992 Landers and Big Bear earthquakes.

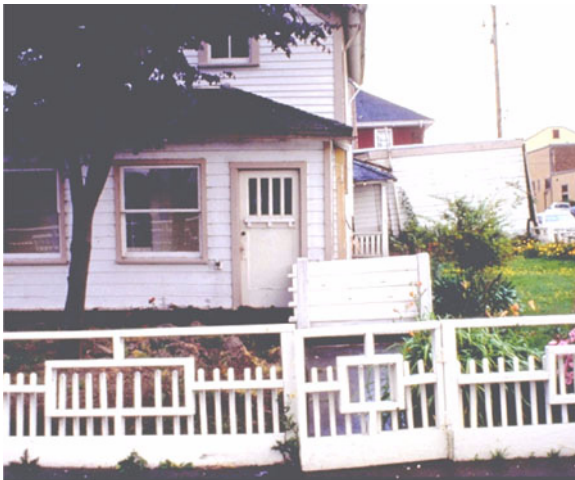
Figure F-10 This house has settled to the ground due to collapse of its post and pier foundation.

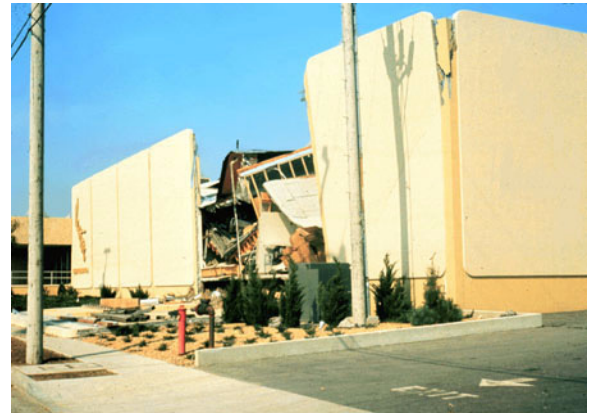
Figure F-12 Collapse of a tilt-up bearing wall.
