Techniques for the Seismic Rehabilitation of Existing Buildings

FEMA 547/2006 Edition

FEMA 547 – October 2006

Rutherford & Chekene (R & C) Consulting Engineers (Subconsultant) under contract with National Institute of Standards and Technology (NIST).

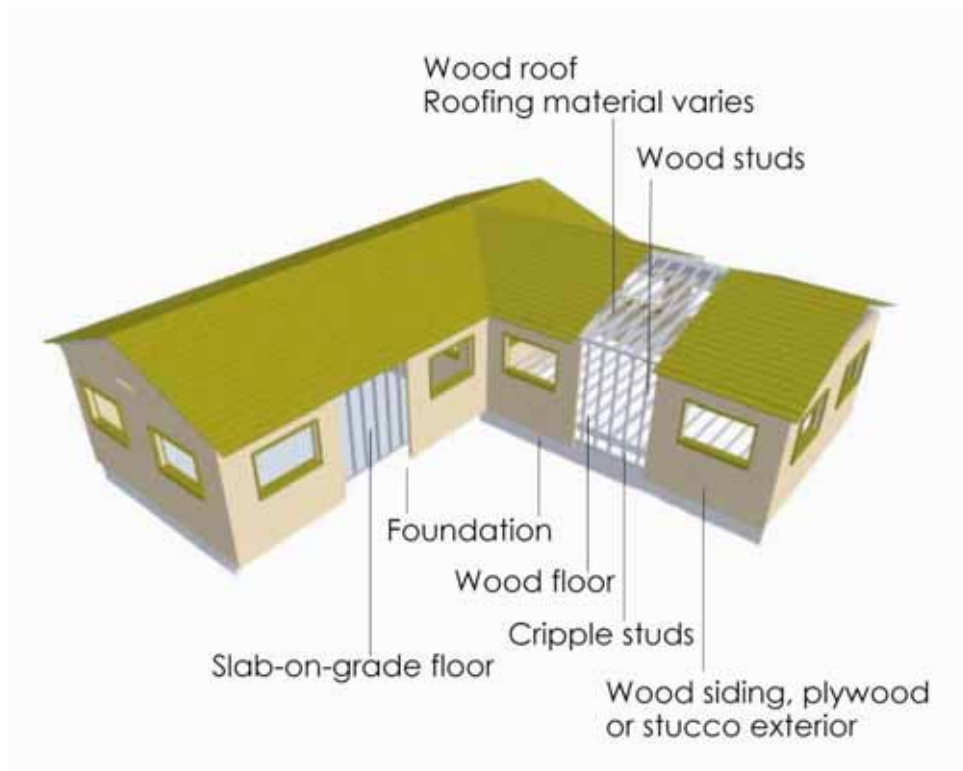
**Figure 5.1-1: Building Type W1: Wood Light Frames
One- and Two-Family Detached Dwelling**

Building Type **W1** consists of one- and two-family detached dwellings of one or more stories. Floor and roof framing are most commonly wood joists and rafters supported on wood stud walls (called woodframe or wood light-frame). The first floor may be slab-on-grade or a raised framed floor. Lateral forces in **W1** buildings are resisted by woodframe diaphragms and shear walls. Chimneys, where present, consist of solid brick masonry, masonry veneer, or woodframe with internal metal flues. Although materials for detached one- and two-family dwellings vary beyond woodframe, this chapter will focus on this most common type of construction. Figure 5.1-1 provides one illustration of this building type.

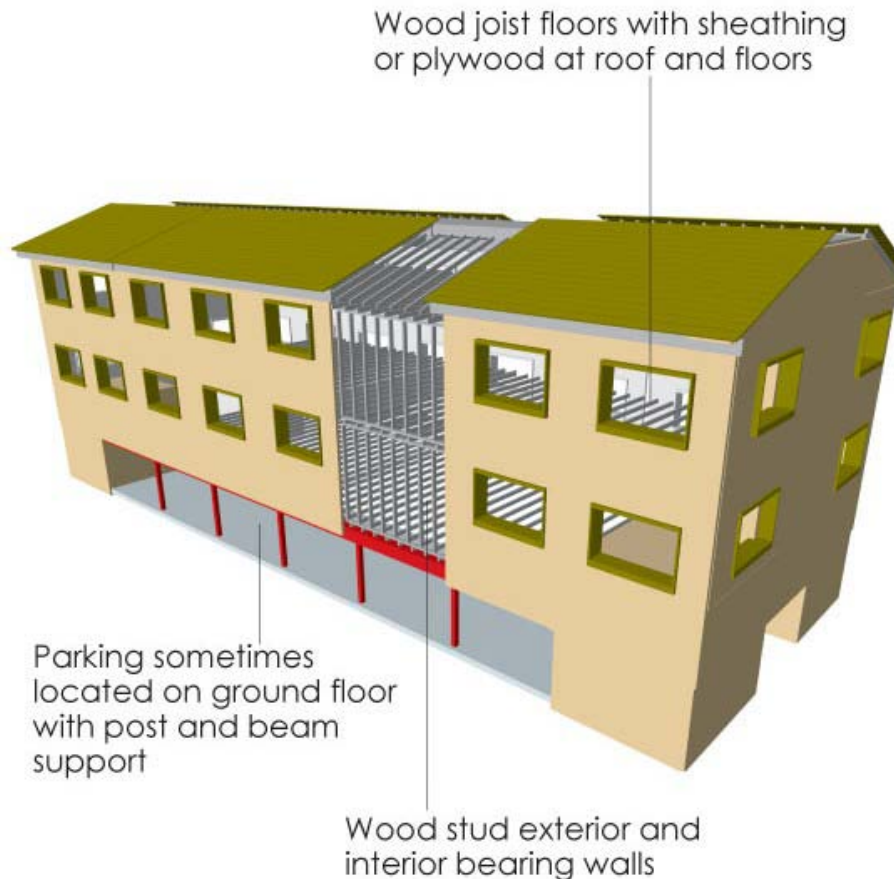
Figure 6.1-1: Building Type W1A: Multistory Multi-Unit Residential Woodframes

Building Type **W1A** is similar to Building Type **W1** in use of woodframe wall, floor and roof construction, but includes large multi-family, multistory buildings. In **W1A** buildings, second and higher stories are almost exclusively residential use, while the first story can include any combination of parking, common areas, storage, and residential units. Post and beam framing often replaces bearing walls in non-residential areas. Multi-family residential buildings with commercial space at the first story are included in building Type **W1A** due to similar building characteristics. Lateral forces in **W1A** buildings are primarily resisted by wood diaphragms and shear walls. Figure 6.1-1 provides an illustration of this building type.

This chapter addresses **W1A** buildings where the first story walls are of woodframe construction. This includes both multistory woodframe buildings supported at grade and the multistory woodframe portion of buildings with concrete or masonry walls at one or more lower stories. The stories with concrete or masonry walls represent building types other than **W1A**, and they are addressed by other chapters in this document.
