Unreinforced Masonry Buildings and Earthquakes

Developing Successful Risk Reduction Programs

FEMA P-774 / October 2009

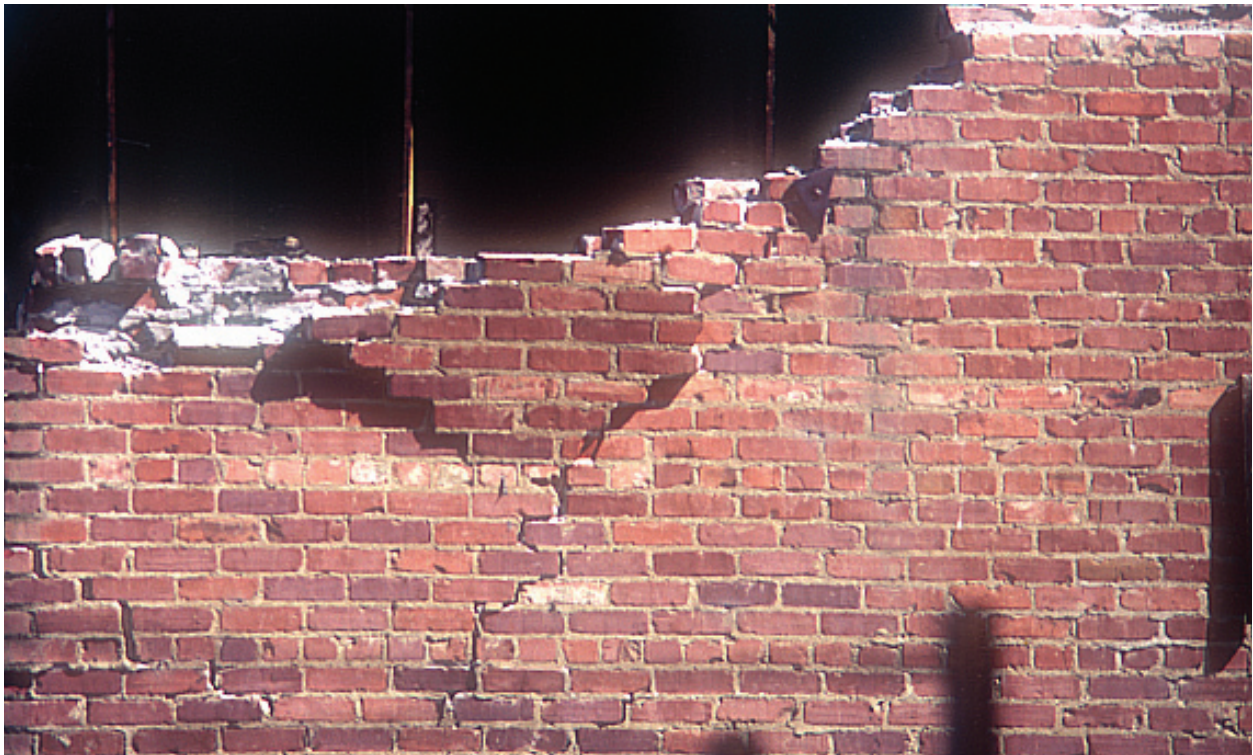
■ **Figure 6. Damaged URM wall in a red-tagged building, fated to be torn down or to undergo a multi-year closure for repairs and upgrading.**

Pre-earthquake retrofitting usually looks quite modest, compared to the comprehensive upgrading that building codes will require to repair a damaged, non-code-conforming building after an earthquake. —*Robert Reitherman*

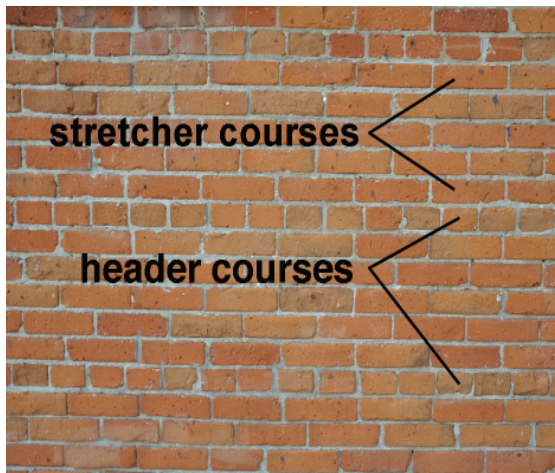
■ Figure 8. "Header" versus "stretcher" courses. The presence of header courses is usually the easiest way to tell if a brick wall is unreinforced.

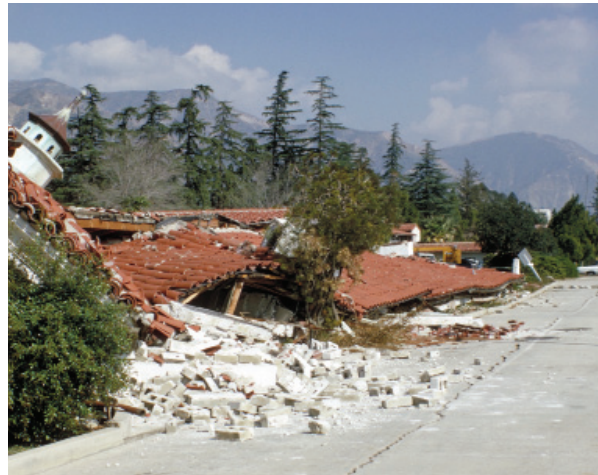
■ Figure 9. Complete collapse of an unreinforced concrete block building, 1971 San Fernando earthquake. —Karl Steinbrugge, NISEE, U.C. Berkeley

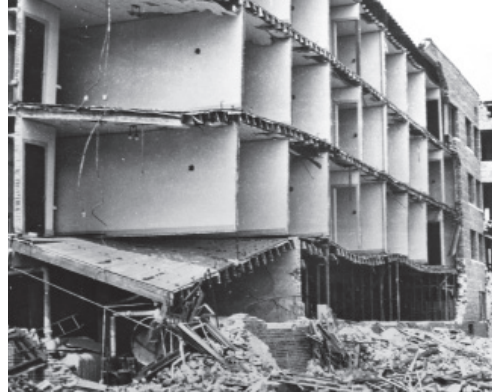
■ Figure 14. Heavily damaged Hotel Californian, 1925 Santa Barbara, California earthquake. —NISEE, U.C. Berkeley

1925 Santa Barbara Earthquake, Southern California, M 6.2: The most severe damage from this earthquake occurred among unreinforced brick commercial and residential construction and was a primary motivation for engineers in California to adapt seismic design ideas from Japan into the *Uniform Building Code*. Forty percent of the unreinforced masonry buildings were severely damaged or collapsed.⁶ See Figure 14, the Hotel Californian, in which extensive wood-frame and plaster partitions barely managed to hold the building up, after exterior brick walls failed.

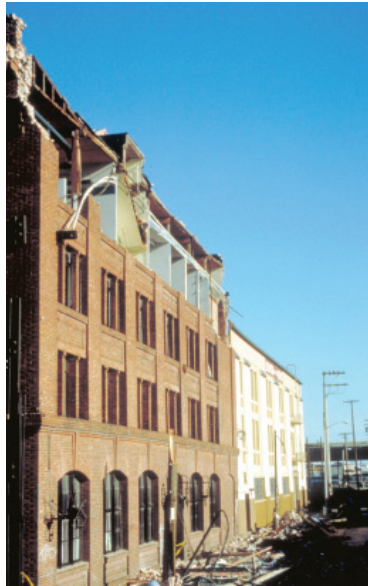
■ **Figure 18. Upper story wall collapse, with resulting fatalities.**

1989 Loma Prieta Earthquake, Northern California, M 7.1: In this earthquake, 374 (16%) of the 2,400 unreinforced masonry buildings in the region experienced damage severe enough to require that they be vacated.⁹ The earthquake was centered 60 miles south of the San Francisco Bay Area, and the majority of these buildings were subjected to only light to moderate shaking. Figure 18 illustrates an upper-story failure of brickwork, which fell onto the sidewalk and cars below, killing five people.

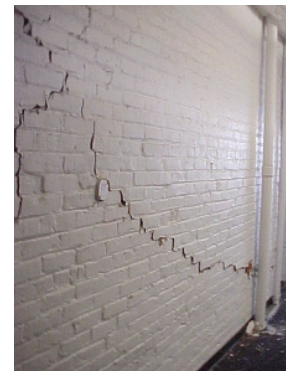
■ **Figure 19. URM building damage, 2001 Nisqually, Washington earthquake.**

At left, hollow clay tile debris from a collapsed wall; at right, diagonal “stair-step” cracking of a brick wall (the crack following mortar horizontal bed joint and vertical head joint lines), a sign of the wall’s inability to resist shear stress from in-plane forces. —André Filiatraut

2001 Nisqually Earthquake, Puget Sound Region, Washington, M 6.8: “URM buildings built before 1950 exhibited the poorest behavior. The most common damage included shedding of brick from parapets and chimneys. Other URM buildings exhibited diagonal ‘stair-step’ cracking in walls and piers, damage to walls in the upper stories, vertical cracking in walls, damage to masonry arches, and damage to walls as a result of pounding. In many cases, fallen brick resulted in damage to objects, such as cars and canopies, outside the building.”¹⁰ See Figure 19.
