## 7 Results

### Mecklenburg County, NC (16 feet pixel)

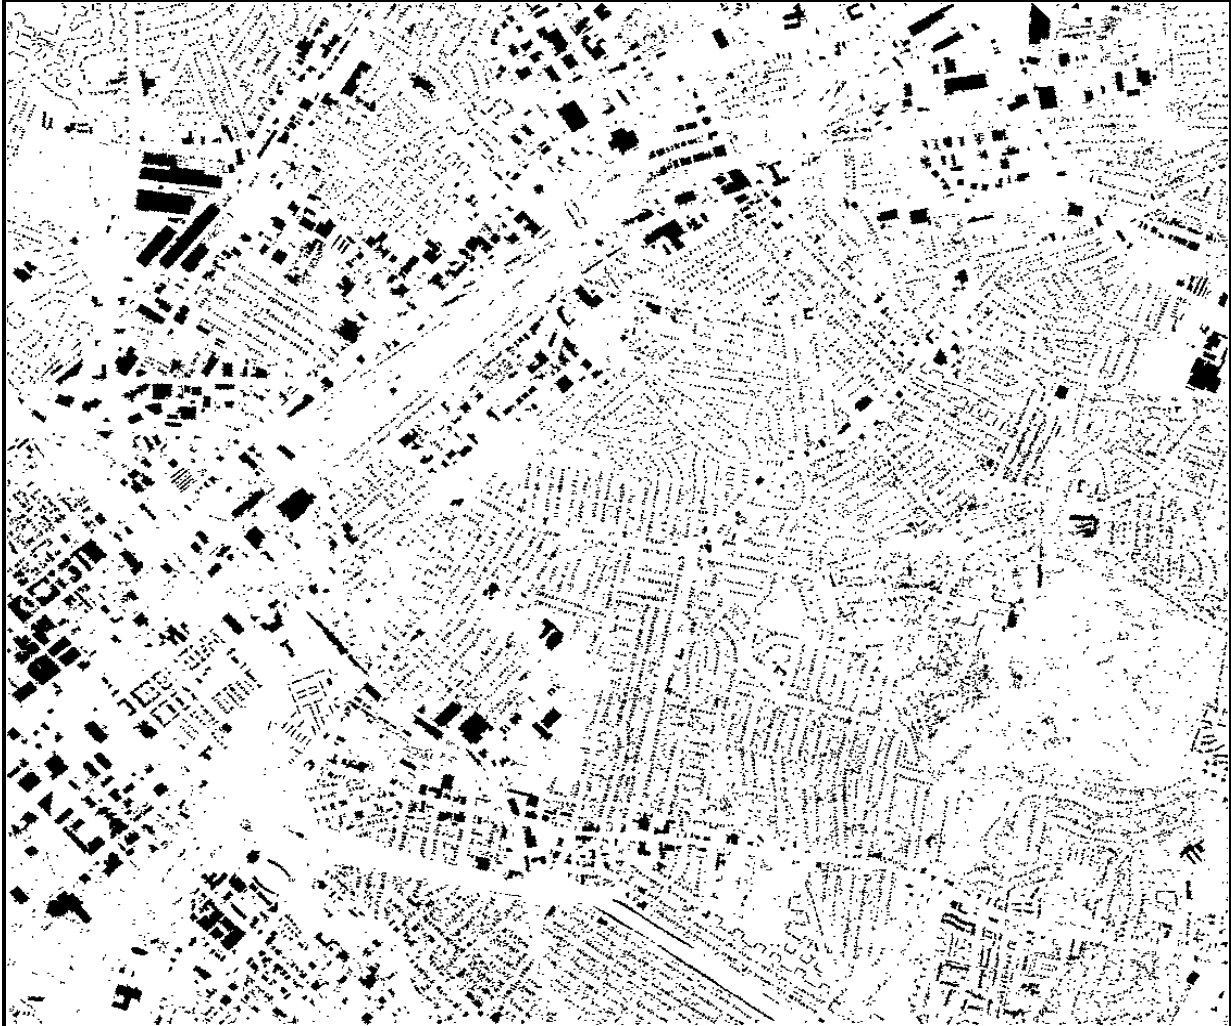
**Figure 27 — Footprints of 13,076 Structures Extracted Automatically for Highly Populated Tile E08 Mecklenburg County, NC.**

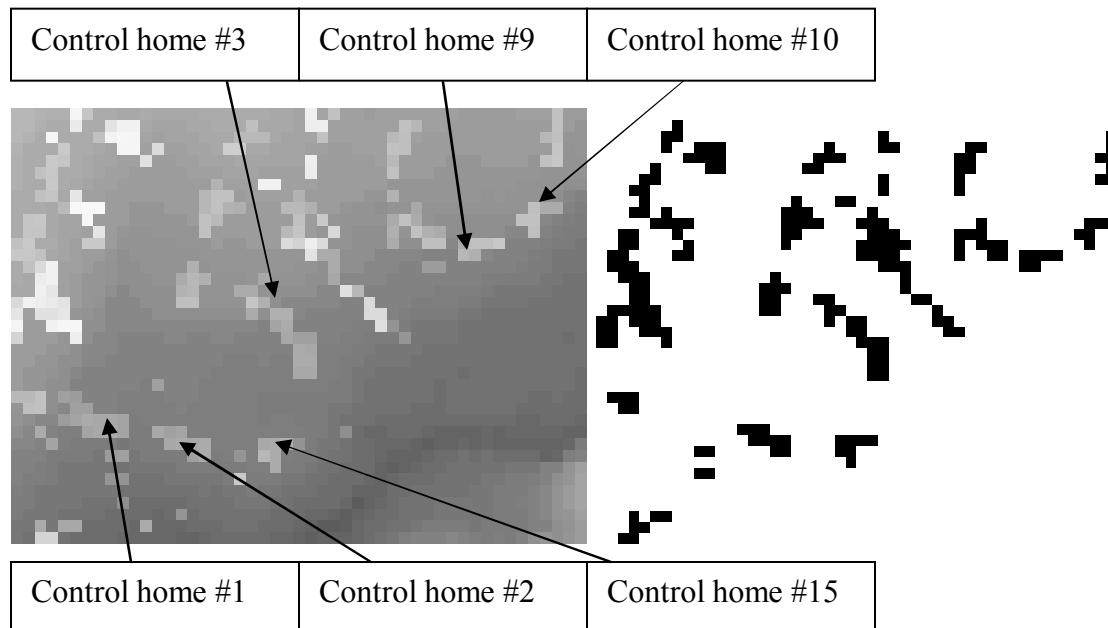
**Figure 32 — Control homes #1, 2, 3, 9, 10 and 15 from Dewberry's list. Left: Z\_minimal from last returns; Right: extracted footprints. Footprint of home N1 missed.**

- \* Building N1 was not extracted due to small gradient on the edge.
- \*\* CCS can not find a reason for such a large LAG error (the home was extracted properly and LAG has good agreement with last returns of LIDAR data around home). Two sources for the error are possible: 1) error in control data (elevation certificate); 2) large slope of ground surface near home (4-5 feet per 16 feet pixel; no signature because of large natural gradient around home, but large artificial gradient in boundary pixels is possible).

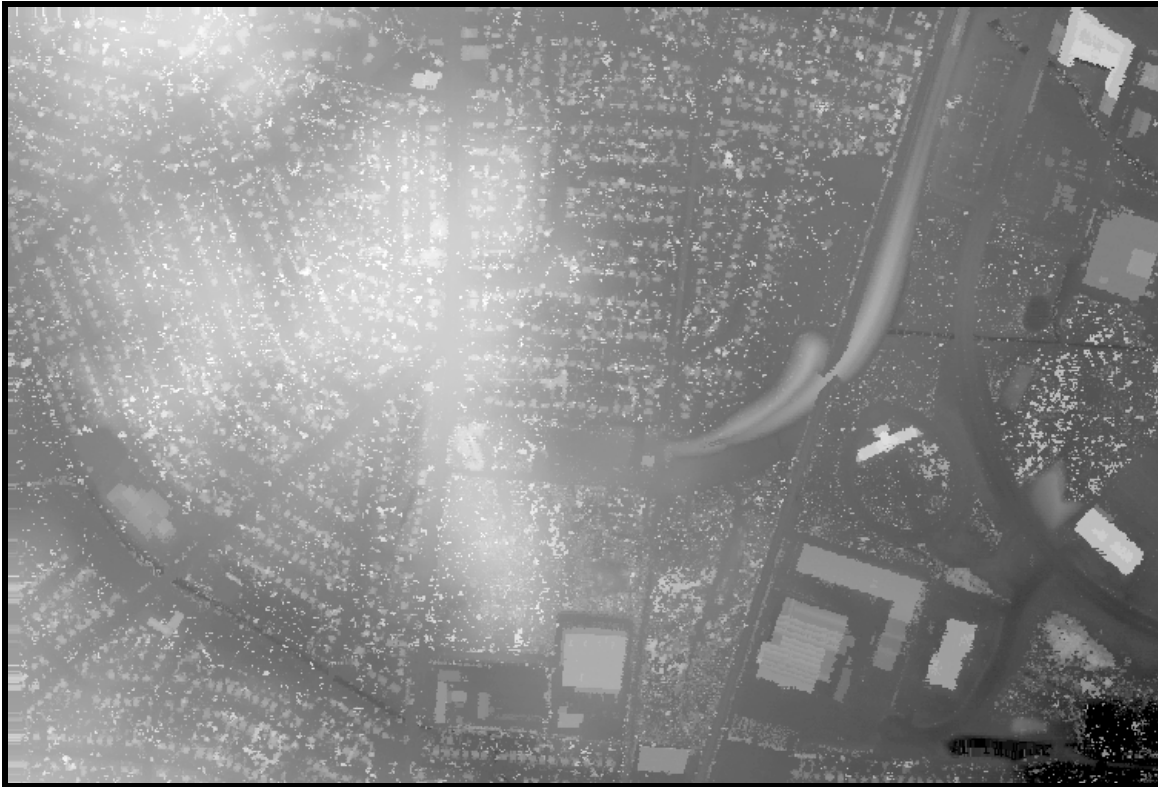
**Figure 34 — Z\_minimal from last returns for tile 208NE04, Prince George's County, MD.**

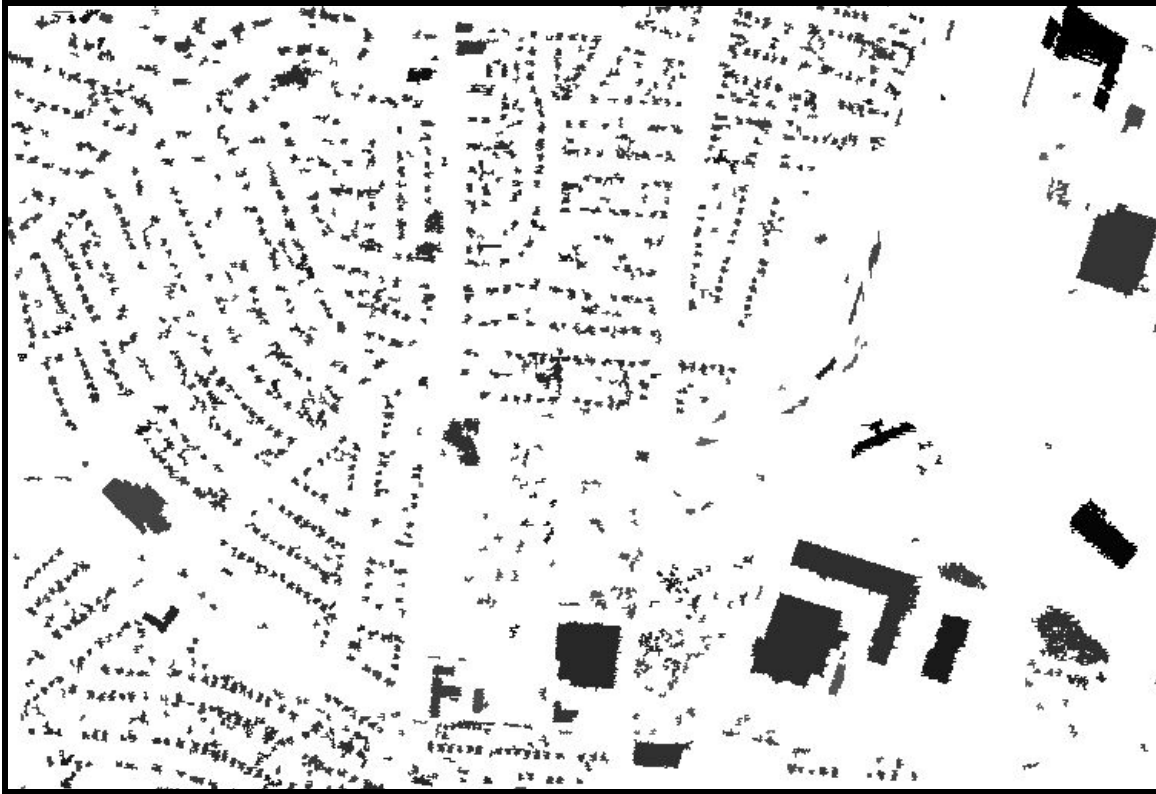
**Figure 35 — Footprints of 1,220 Objects and Structures Automatically Extracted for Tile 208NE04 of Highly Populated Prince George's County, MD.**

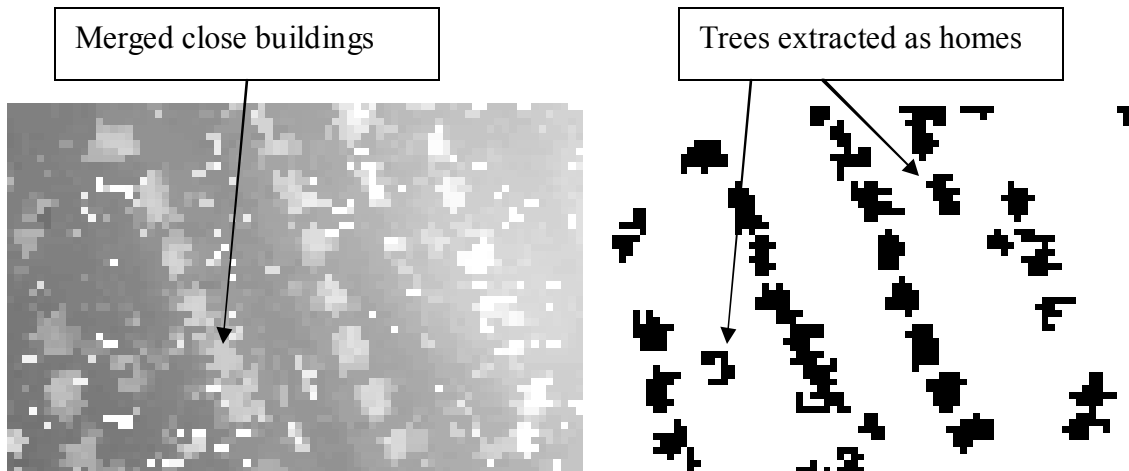
**Figure 36 — Small Area of tile 208NE04.**  
**Left: Z\_minimal from Last Returns**  
**Right: Footprints of Extracted Objects (two typical problems: merging closest homes and false alarms from large trees)**

About 80-90% of the homes were extracted correctly in Prince Georges County, MD; 10-20% of the structures were merged with another or with trees or not extracted properly due to low laser light reflection. Nearly 20% of extracted objects were false alarms.

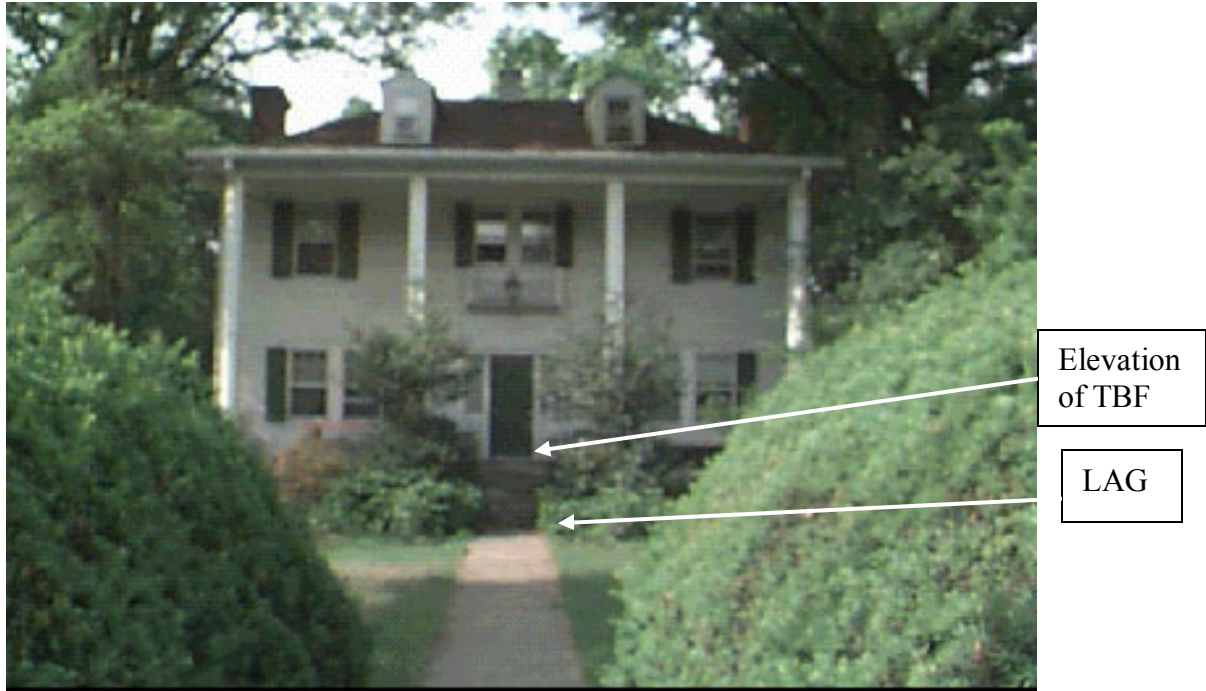
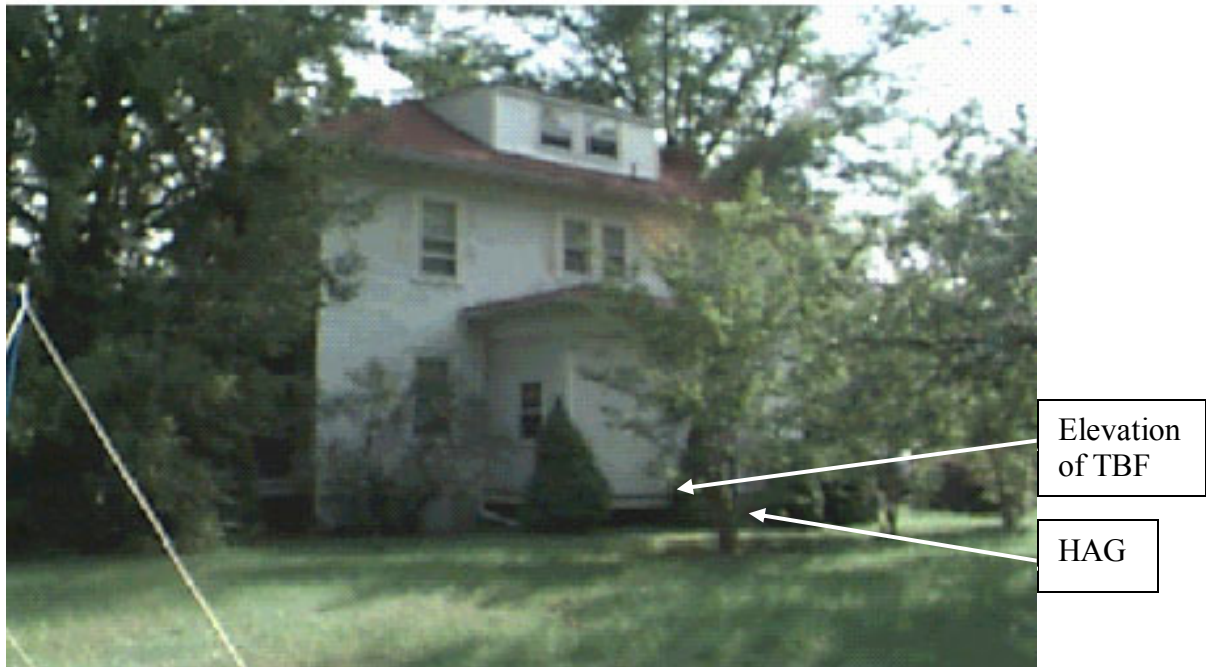
**Figure 37 — Front (top) and rear (bottom) images of the home #1 (24), 25.pdf.  
From imagery, CCS can estimate that HAG is close to the TBF and much higher than LAG. Imagery supports the LIDAR-based estimation and confirms a probable blunder in the EC.**

\* See Figure 37 and comments

<b>Control</b>	<b>Extracted</b>	<b>Error</b>
LAG:	58.05 ft	57.76 ft	-0.29 ft or -8.7 cm
HAG:	58.75 ft	60.95 ft	2.2 ft or 66.0 cm
TBF:	61.45 ft	61.76 ft	0.31 ft or 9.3 cm

According to the elevation certificate, the control HAG is higher than the LAG by 21 cm and the TBF is higher than the HAG by 81 cm. According to the extracted data, the LIDAR-based HAG is higher than the LAG by 96 cm, and the TBF is higher than the HAG by 24 cm. Imagery of the home in Figure 37 shows that the HAG is closer to the TBF, not the LAG. These results indicate that the LIDAR-based determination of LAG, HAG and TBF can be used to check for blunders in existing ECs.

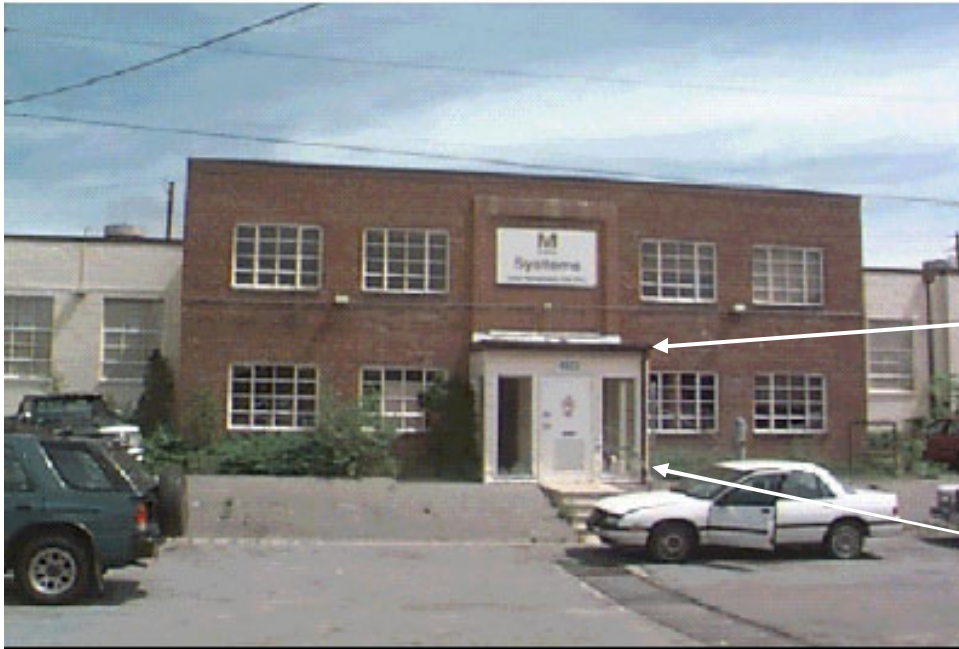
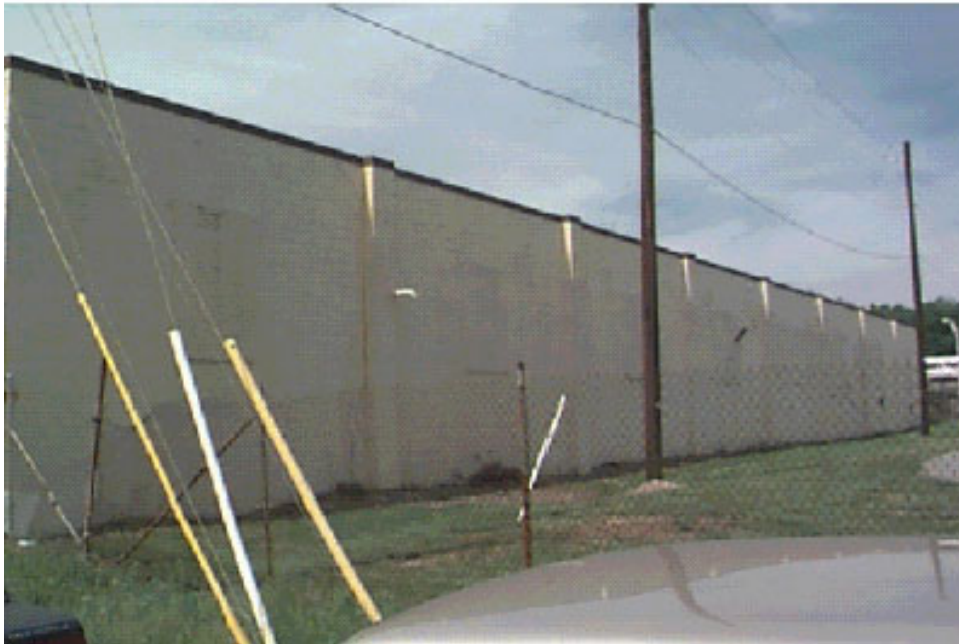
TBF according to Elevation Certificate (56.18 ft or 9.73 ft higher than LAG)

LAG according to Elevation Certificate (46.45 ft)

**Figure 38 — Front (top) and rear (bottom) images of the home #17 (111), 37.pdf. From imagery CCS can estimate that the TBF must be very close to the LAG, but the elevation certificate shows that the TBF is much higher than the LAG. This, too, appears to be a blunder in the EC.**

\*\* See Figure 38 and comments

<b>Control</b>	<b>Extracted</b>	<b>Error</b>
LAG:	46.45 ft	46.70 ft	+7.5 cm
HAG:	48.10 ft	51.05 ft	+88.5 cm
TBF:	56.18 ft	51.05 ft	-153.9 cm

According to the elevation certificate, the control TBF is higher than the LAG by 9.73 ft or 292 cm. From the imagery, CCS cannot find a reason for such differences, but prior experience indicates errors in the control data. Another lesson from this imagery is that LIDAR-based determination of LAG, HAG and TBF considers any long building (cluster of townhomes, shopping mall) as a single structure with one set of LAG, HAG and TBF. CCS can not extract separate LAG, HAG and TBF for each townhome or building with individual postal address but physically merged with other buildings. This is the source for large errors in LAG, HAG and TBF. Human intervention cannot help in this situation (at least not in all cases).

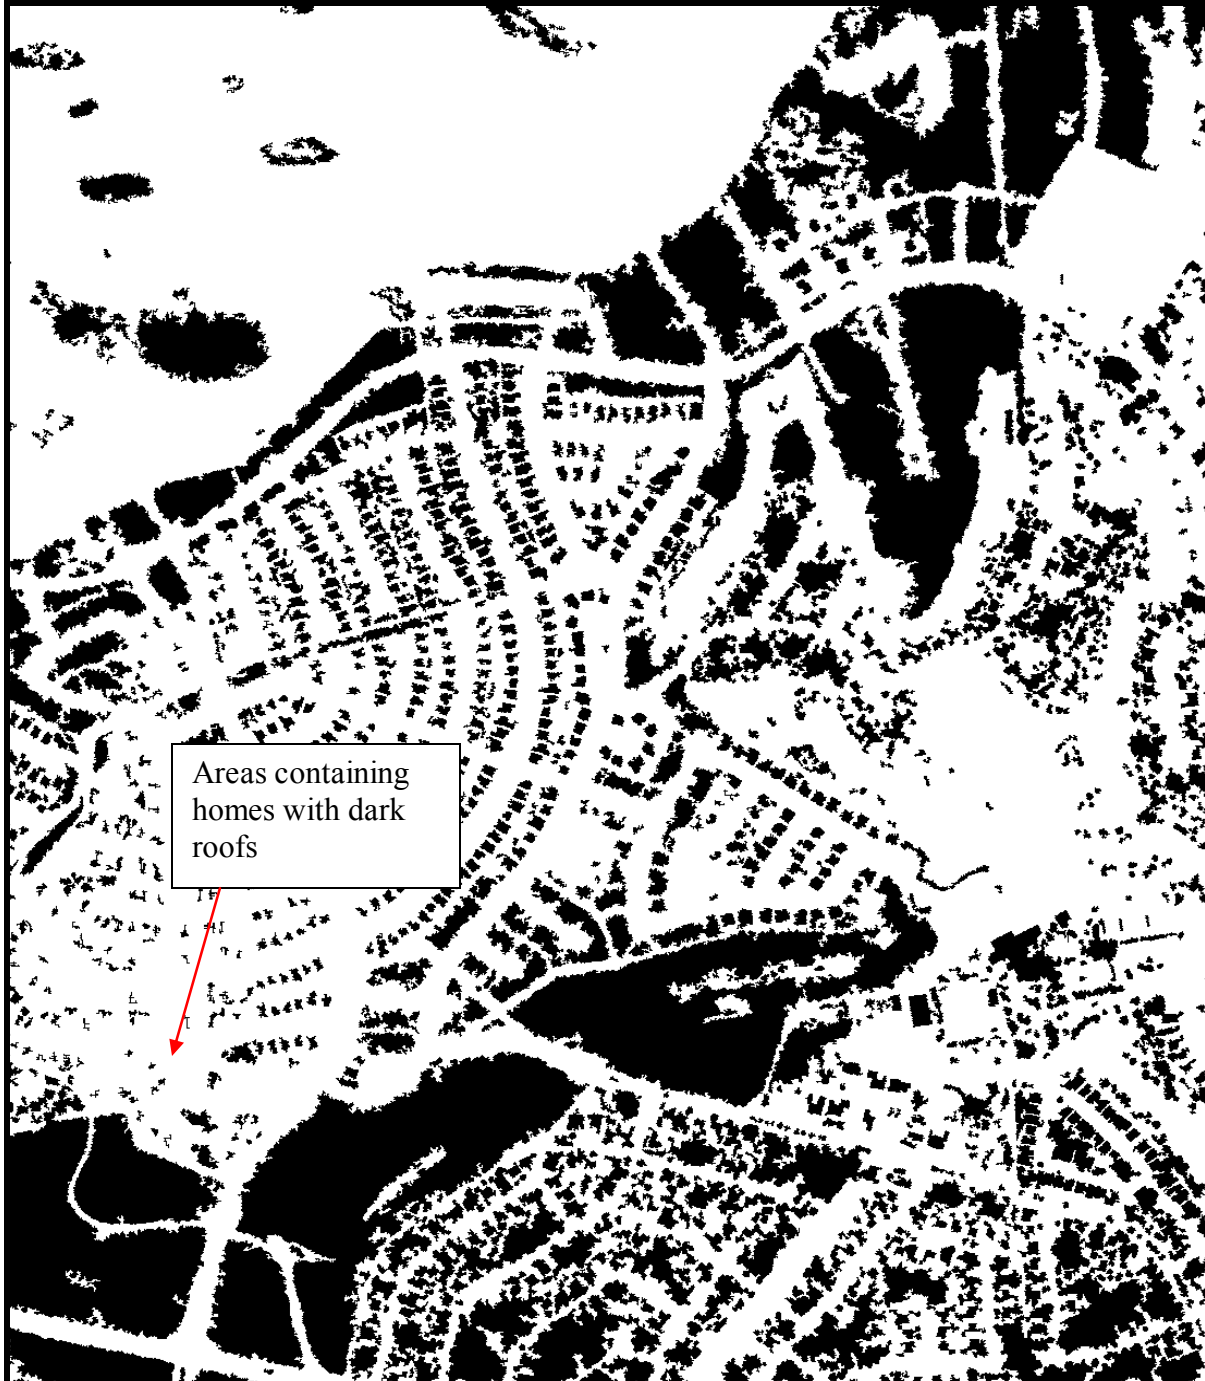
**Figure 41 — Footprints of structures extracted in tile q30095a24. As result, there is poor penetration of laser beams in foliage, most buildings in forested area are merged. Forested areas look like huge clusters versus individual stands of tree.**

Automatic determination of LAG, HAG and elevation of TBF was performed for 19 tiles in Harris County, TX (each tile 11.34 km<sup>2</sup>, total area 215 km<sup>2</sup>). The main problem with this data was the low sensitivity of the LIDAR receiver. As a result, buildings with dark roofs were not captured in the data (see Figures 39-43). The low sensitivity of the LIDAR equipment resulted in single returns and very poor penetration of foliage (see Figures 39 and 40). As a result, there is systematic merging of buildings and large tree clusters. The CCS software that had good results in Mecklenburg and Prince George's Counties could extract only large clusters in forested areas (see Figure 41).

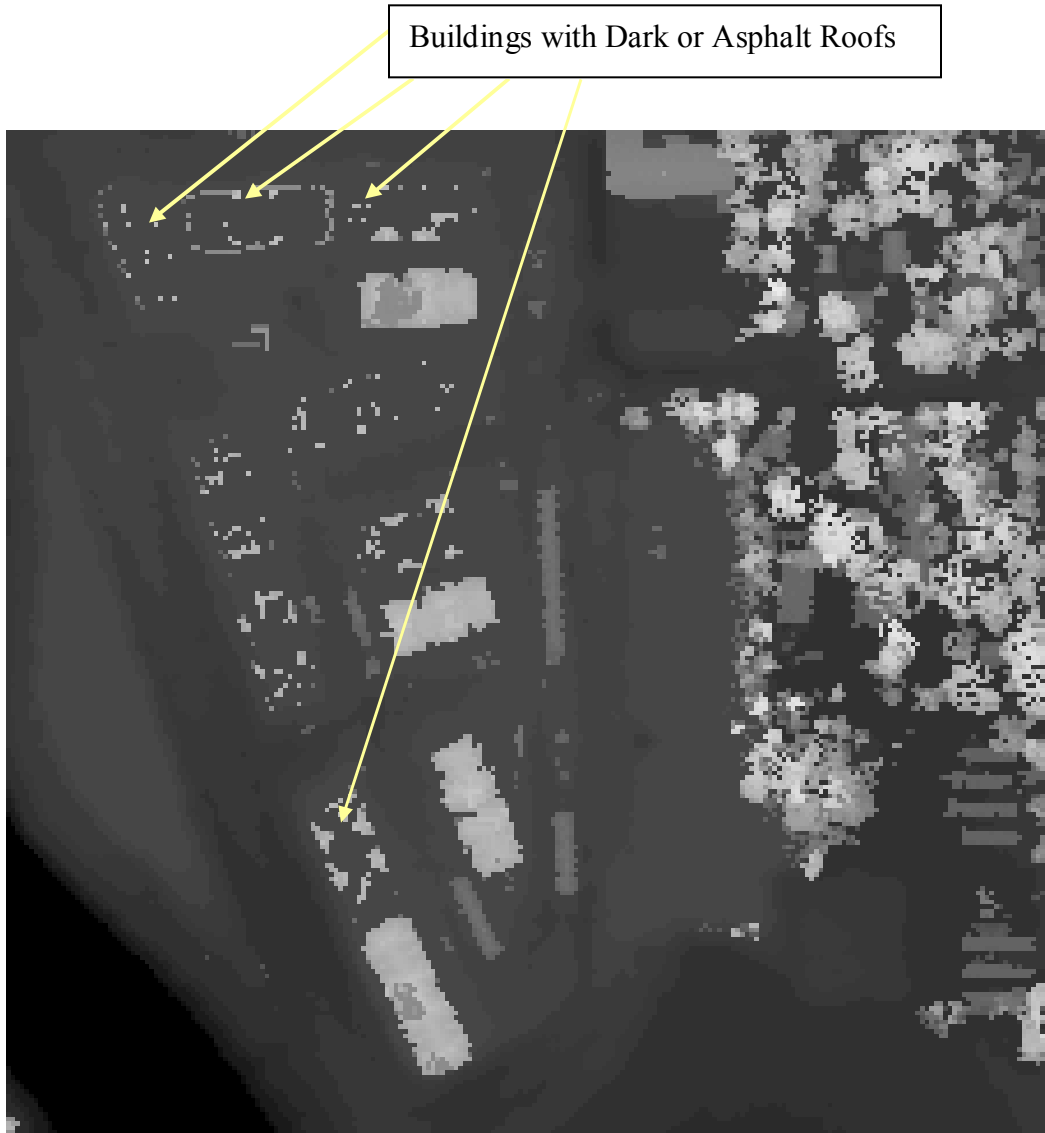
**Figure 42 — No LIDAR data collected for certain buildings with dark roofs (i.e., tar or asphalt). Tile q29095g44.**

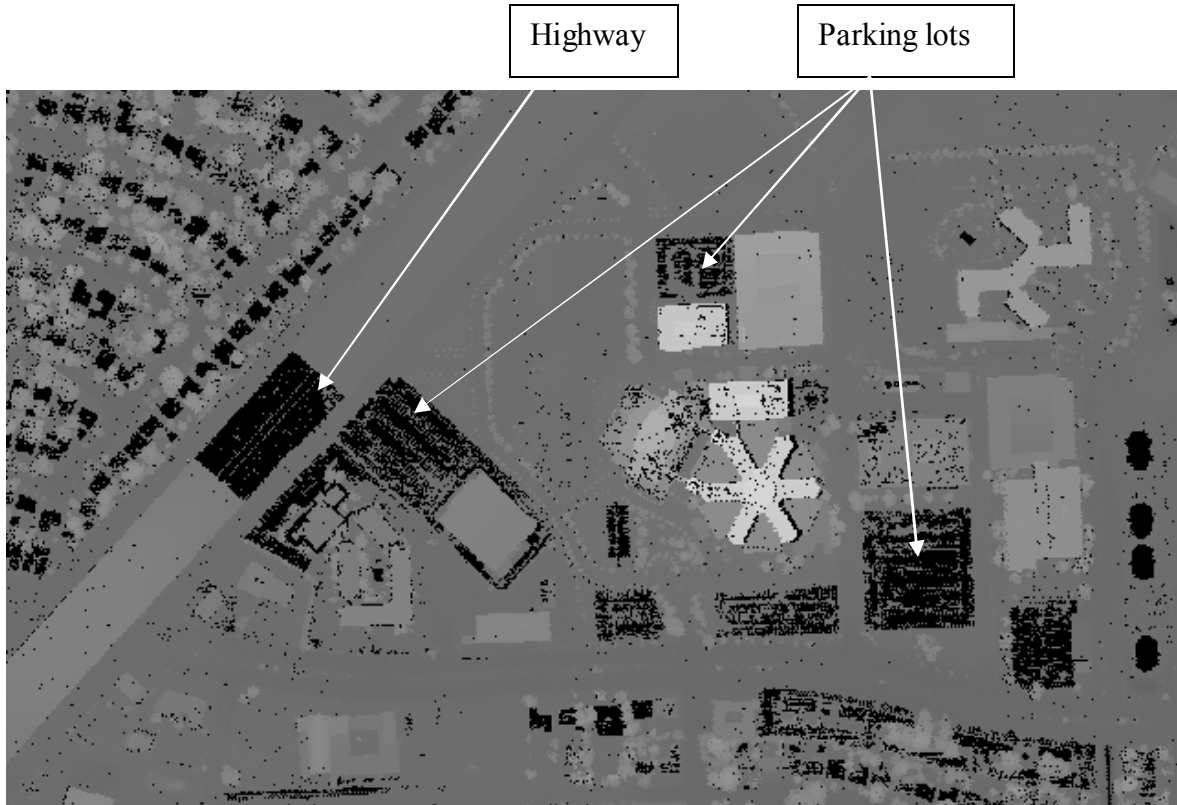
**Figure 43 — Z\_minimal for part of tile q29095f52 (center of bottom part), Harris County, TX before filling holes. All dark areas are areas without LIDAR data. These dark areas include the part of highway, parking lots and homes in this tile.**

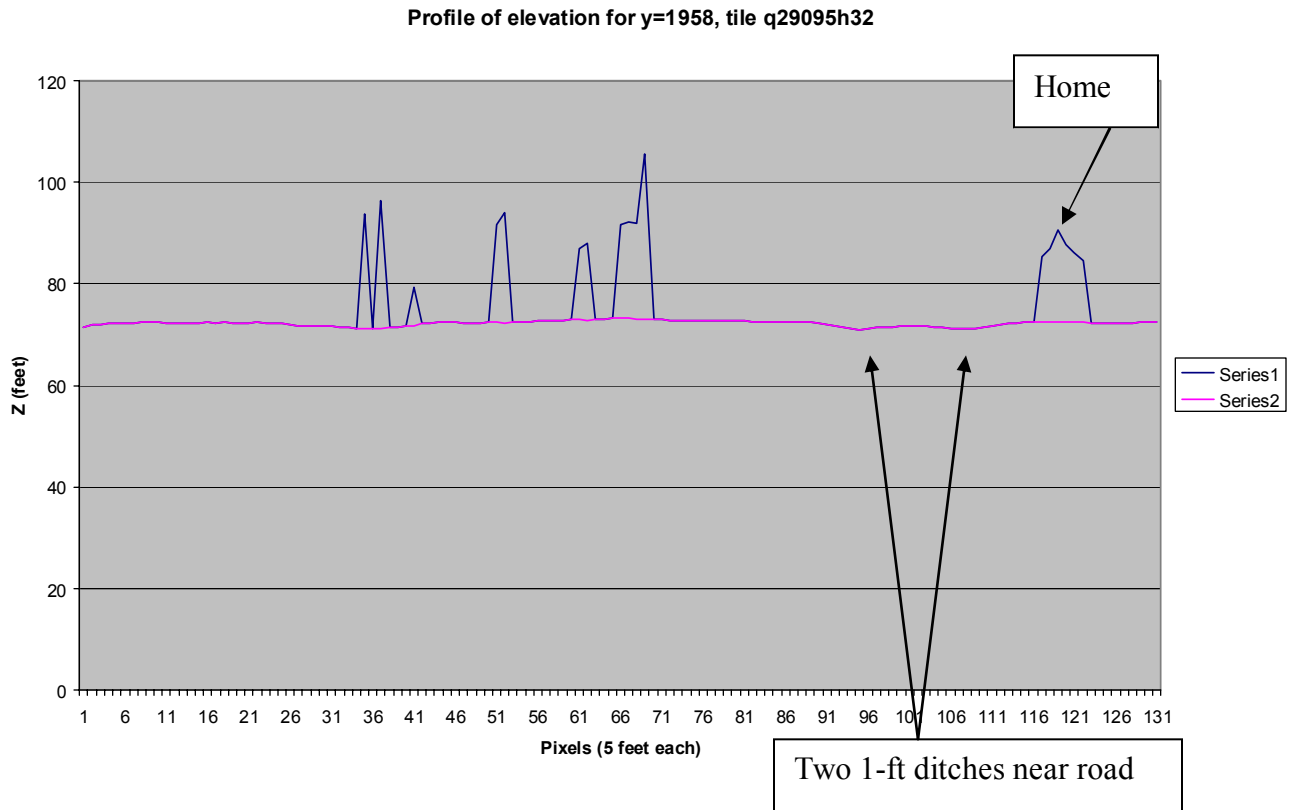
**Figure 47 — Profile of elevation between two control points shows flat area (72 - 73 ft) with variation near 1 ft.**

The top profile of elevations in Figure 47 shows the elevation near control points on Morningsdale St and Marwood Dr. The profile shows an elevation for all areas near 72 ft. Compared with the control LAG and HAG for these points, the control points are much higher (2 - 6 ft) than the LIDAR profile. The reason for such a difference is not clear. Bad calibration of LIDAR data can be responsible for the systematic shift of elevation LIDAR profile, but this hypothesis does not explain why control homes in the flat area have LAG and HAG variance up to 6 ft. An example of this is the control point on Marwood Dr. which is lower than the control point on Morningdale St. by 4.07 ft, but the LIDAR profile (Figure 47) shows that these two points must be very close to each

other (within 1 ft). CCS sees the same situations with all control points: they are higher than LIDAR data and have suspicious variability in the LAG and HAG.

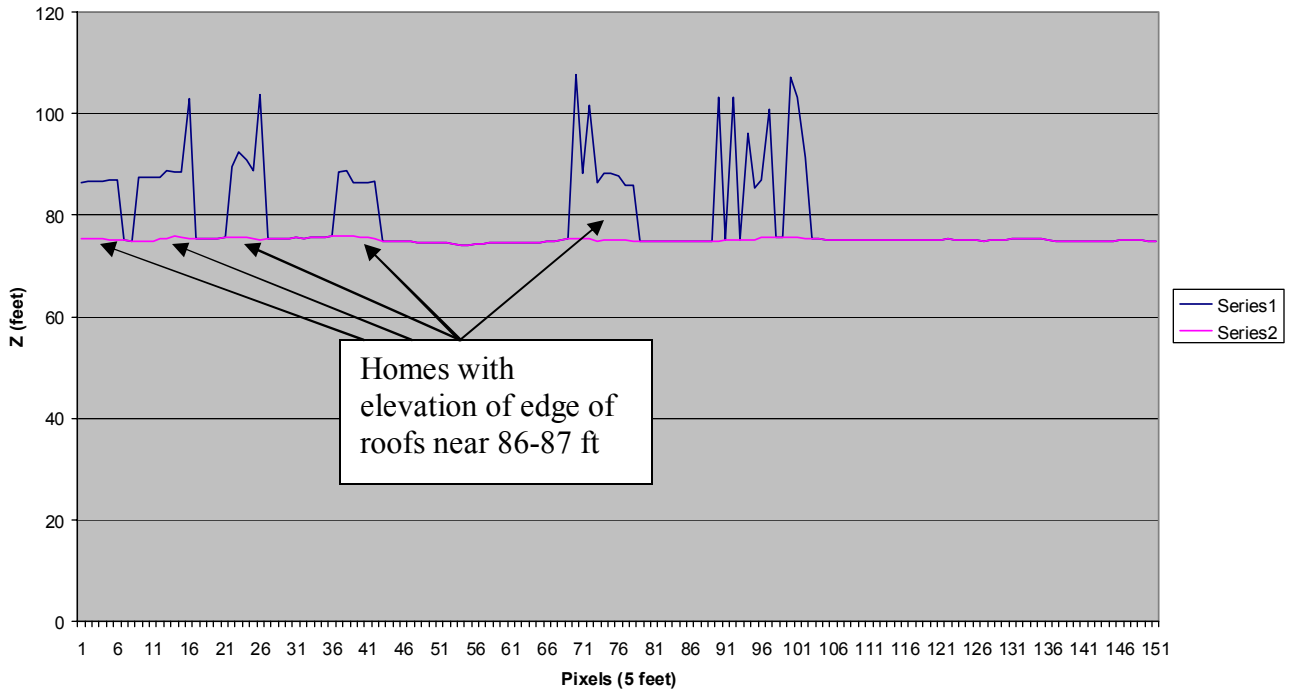
Profile of elevation for Y=1762, tile q29095h32

**Figure 48 — Profile of elevations near Glee Lee Dr shows five homes with elevation of roof edges near 86 - 87 ft and flat ground (74 - 75 ft) with variation near 1 ft. The control LAG and HAG for this area is more than 80 ft, which cannot be correct.**

The second profile of elevation (Figure 48) shows heights near the control point on Glen Lee Dr. The elevation varies between 74 - 75 ft and the control LAG and HAG is greater than 80 ft, which is not realistic from the LIDAR data. The LIDAR data shows that the control points on Glen Lee Dr. and Woodview Dr. must be within 1 ft of each other, but the control LAG for Woodview Dr. is less than Glen Lee Dr. point by 4 ft. CCS cannot exclude bad calibration of the LIDAR as a possible cause, but more likely is that the control data for the LAG and HAG has serious errors (up to 6 ft in elevation). In this situation, it does not make sense to compare the control data with data extracted from LIDAR. In addition, there are large horizontal shifts in the control points that cannot provide robust identification between control points and specific homes.

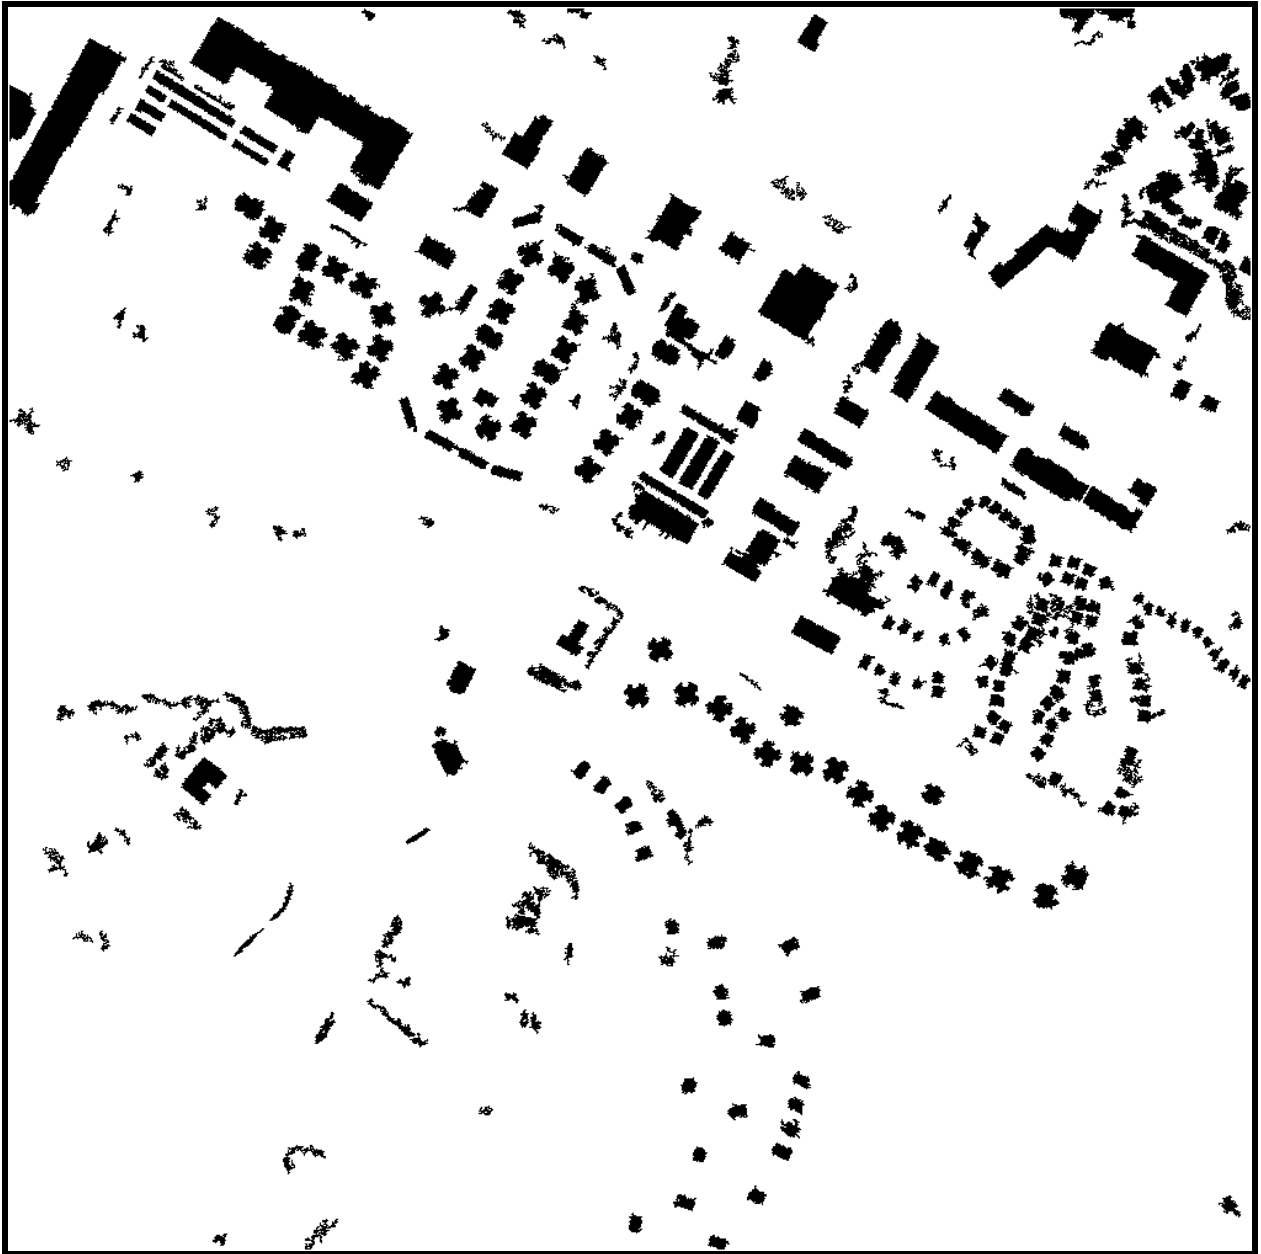
Figure 52 — Footprints of extracted buildings in Beaufort County, SC (Tile 2056\_144).

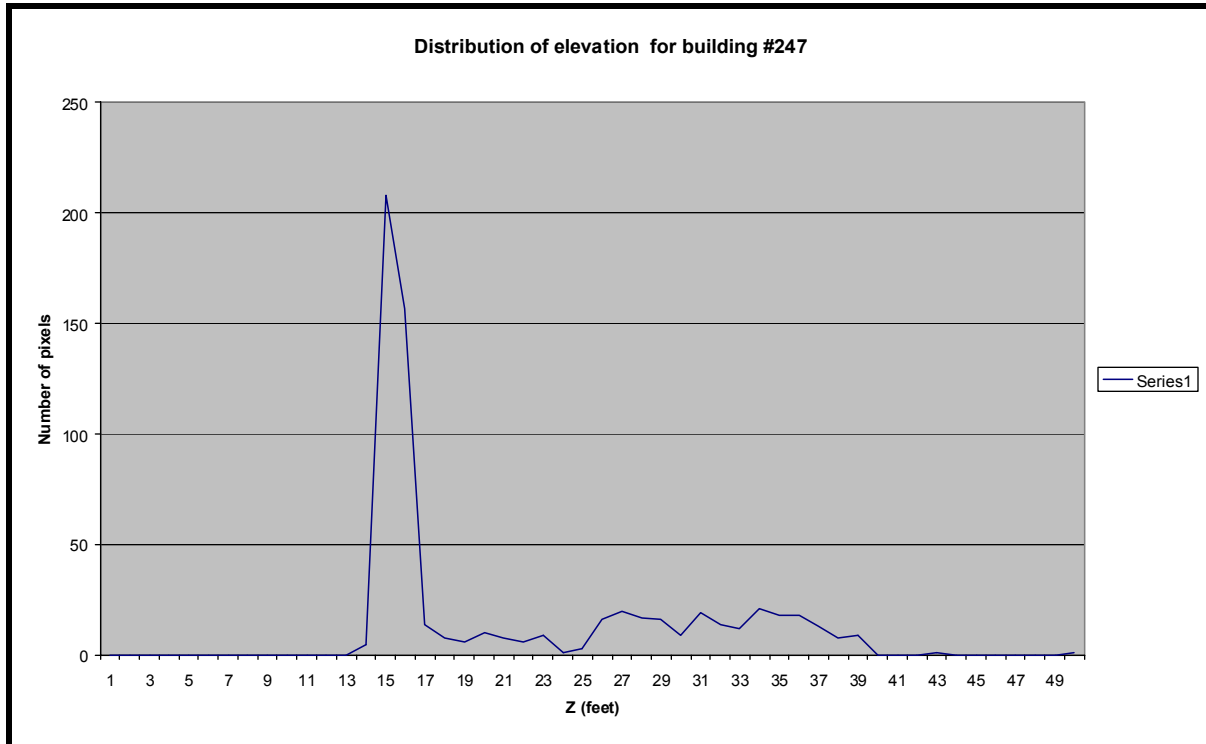
**Figure 62 — Distribution of heights of LIDAR shots shows that ground around home #247 have level near 15-16 feet. Control LAG (10.98) must be 4 feet lower than the ground.**

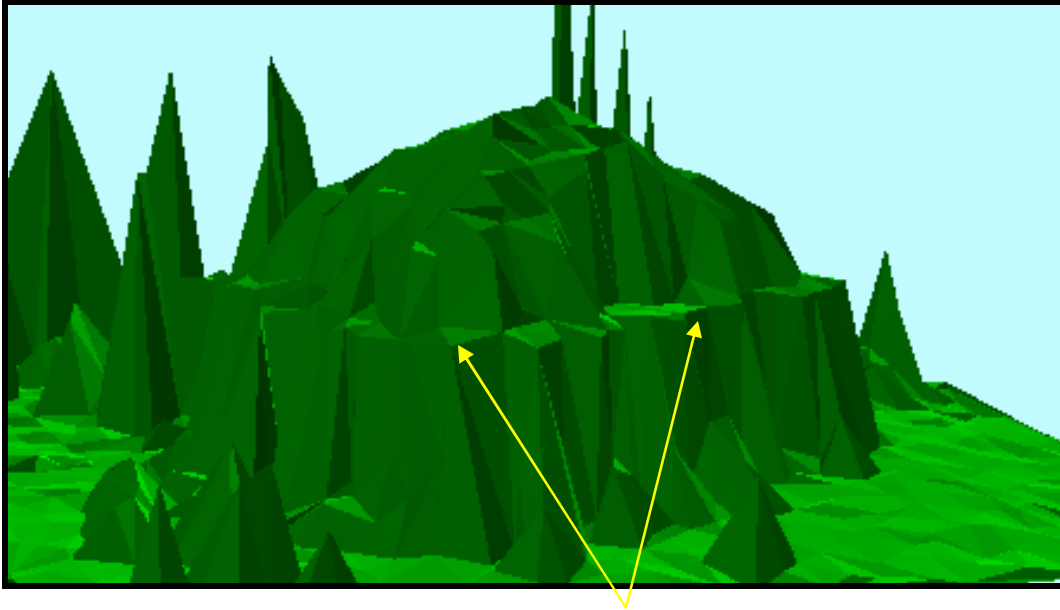
Figure 68 — Building #44 from 2048\_108. Level of second floor is visible.

Figures 68 and 69 show samples of buildings with decks and second floor levels. Such details can help determine the TBF more accurately.
