Mitigation Assessment Team Report on

Hurricane Ike

National Hurricane Conference

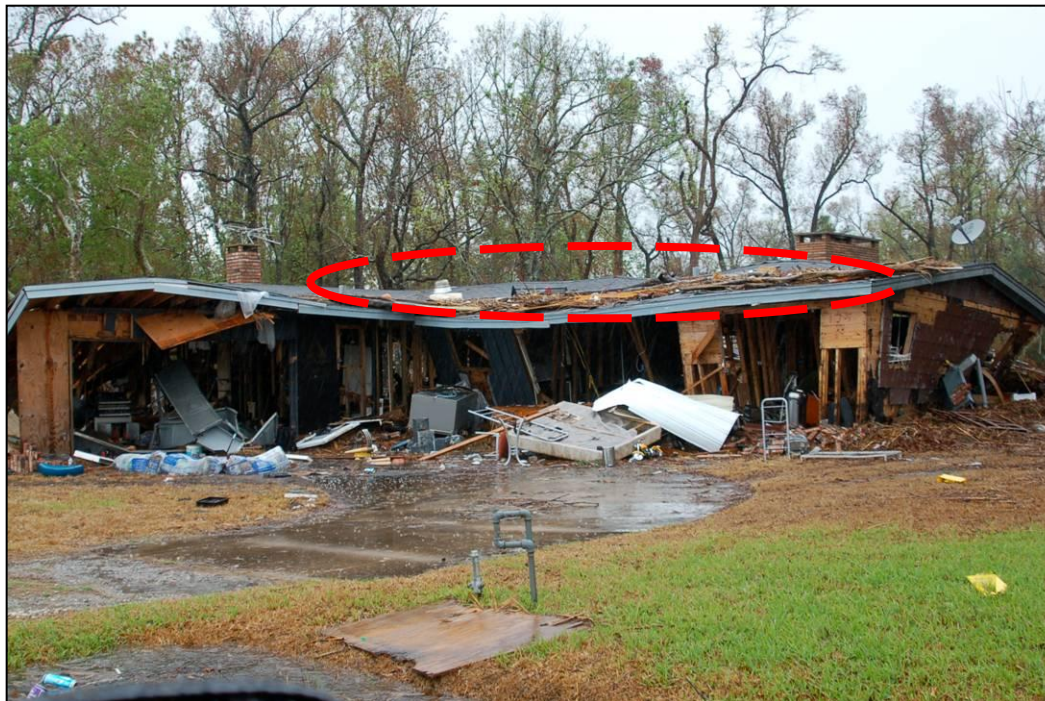
- **Observation: Ike Flood Levels reached 2-5 ft above the BFE across much of the study area**
- **Pre-FIRM and low didn't have a chance**

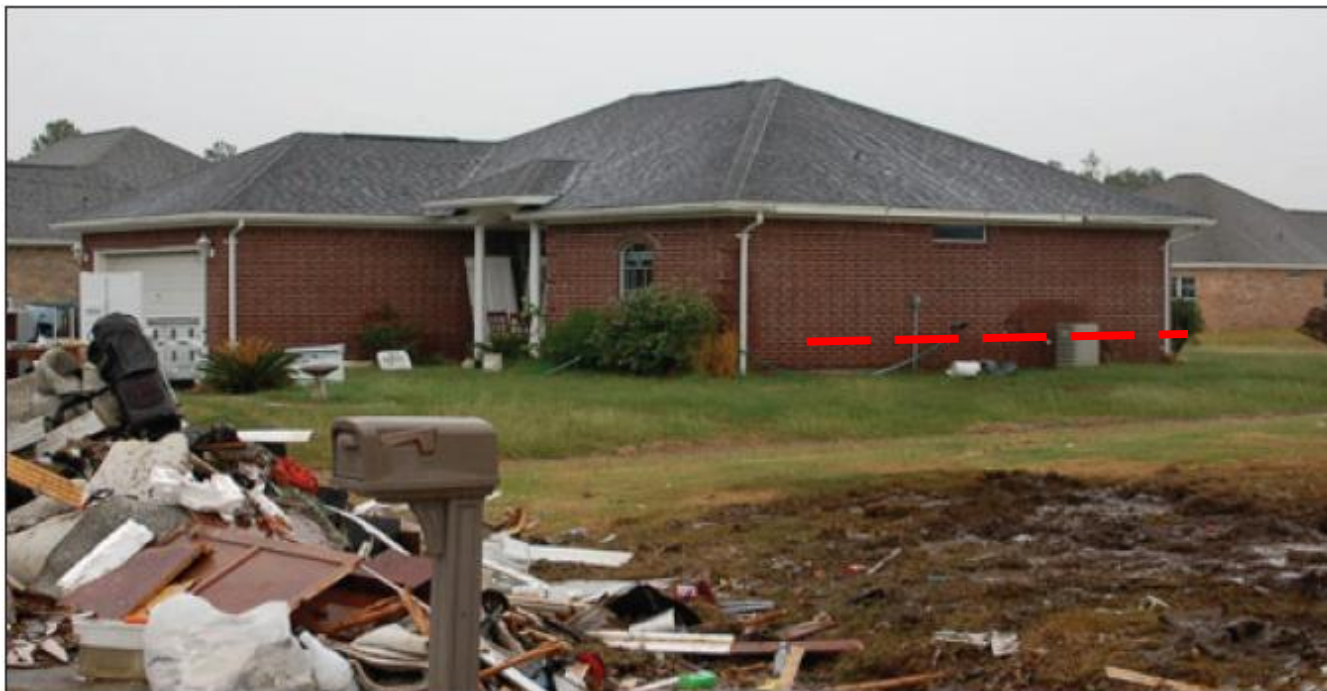
- **Observation: Ike Flood Levels reached 2-5 ft above the BFE across much of the study area**
- **Many Zone X homes were flooded**

**Zone X,
nearest BFE
= 4 ft below
flood level**

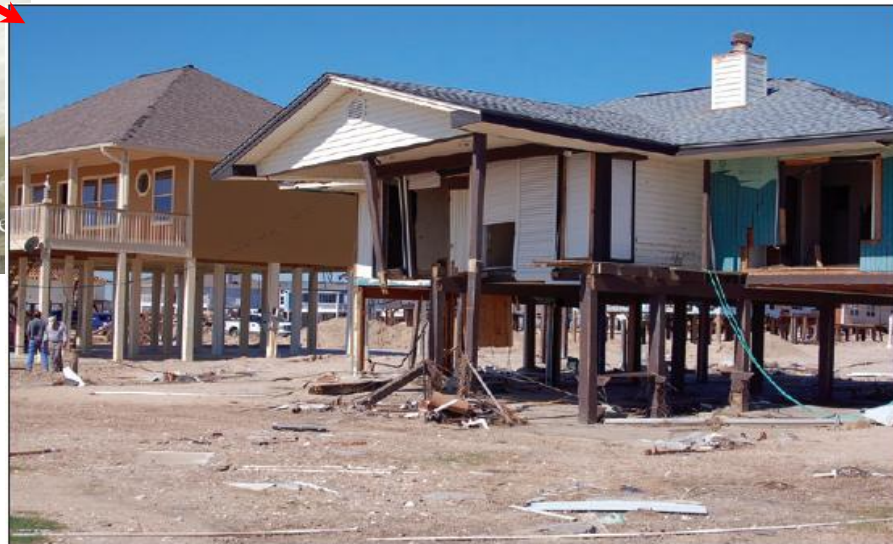
Ike Lesson 1: Elevate Residential Structures

- **Observation: Ike Flood Levels reached 2-5 ft above the BFE across much of the study area**
- **Homes elevated several ft above BFE survived**

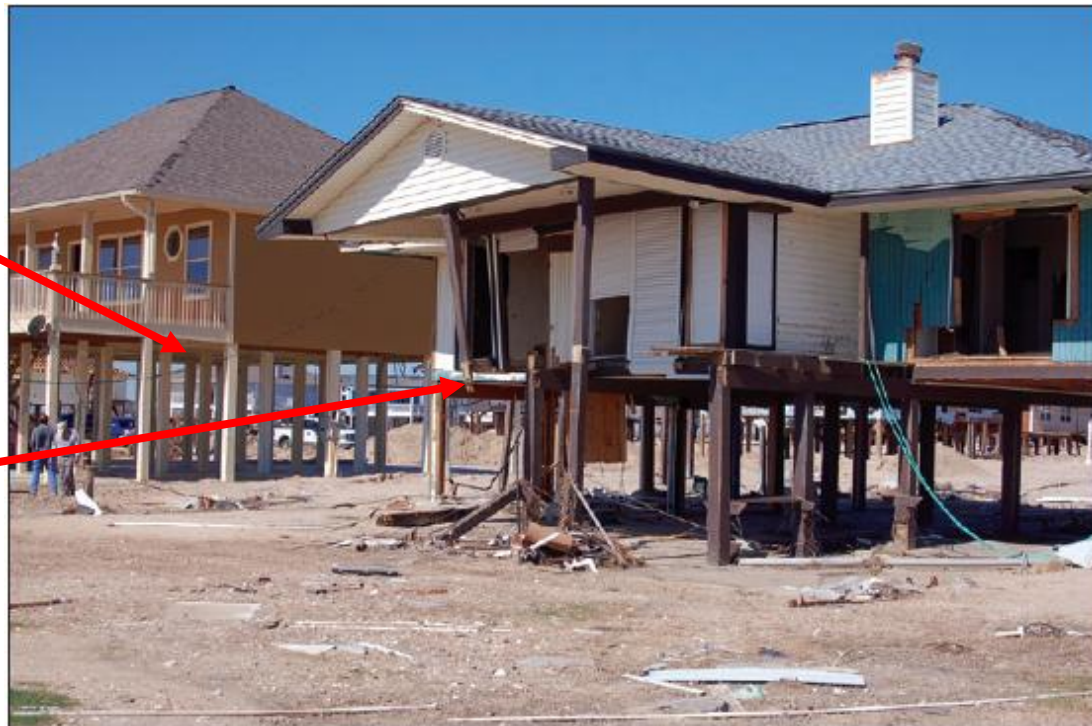
**BFE = 16 ft NGVD,
Floor at 21.5 ft**

Floor at +/- BFE

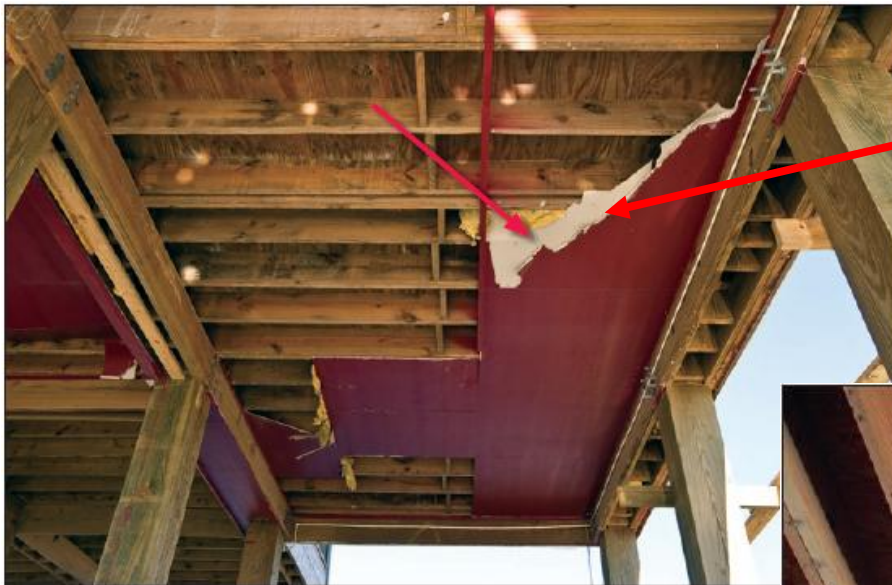
Incipient Wave Damage

Sheathing on underside removed

Joists pushed landward

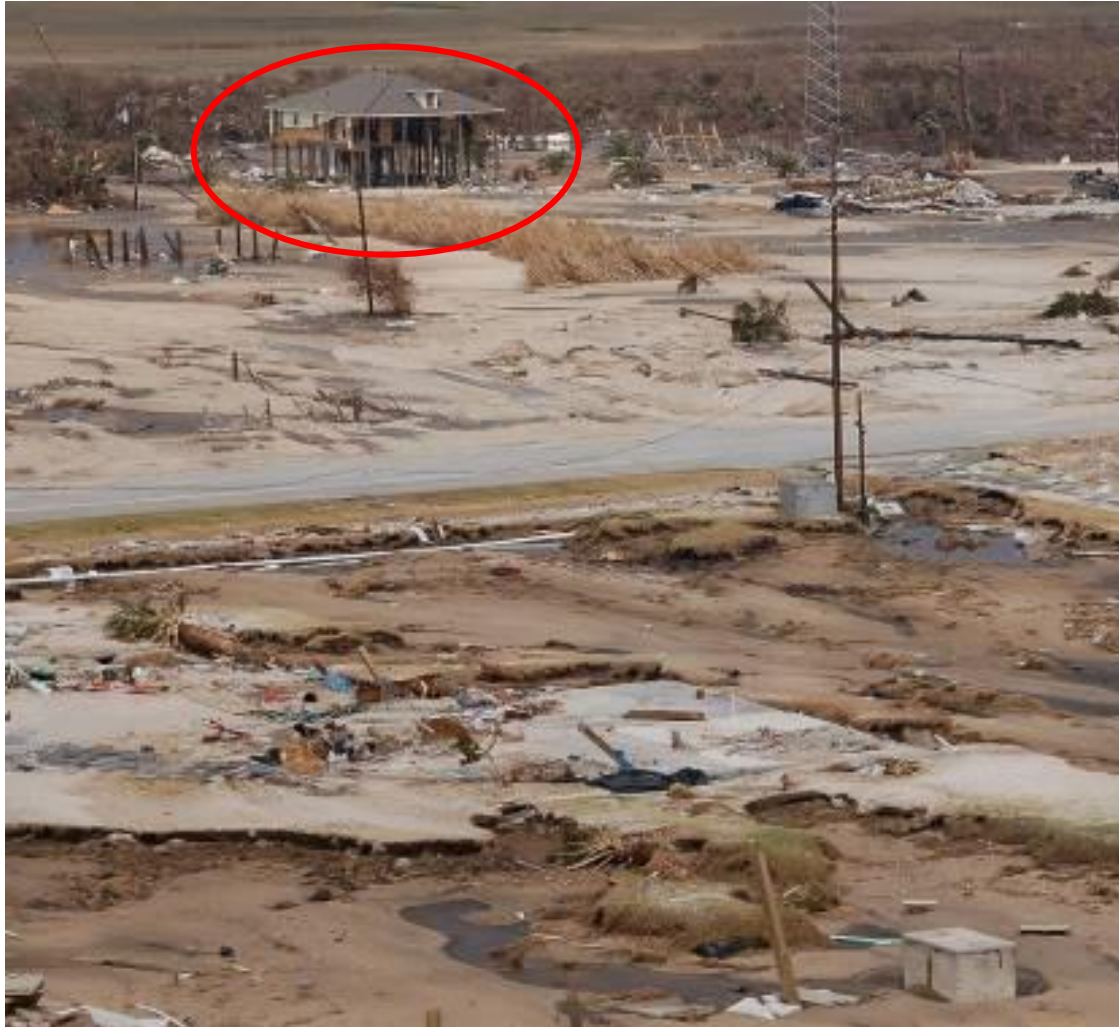
Wave Crest Above Floor

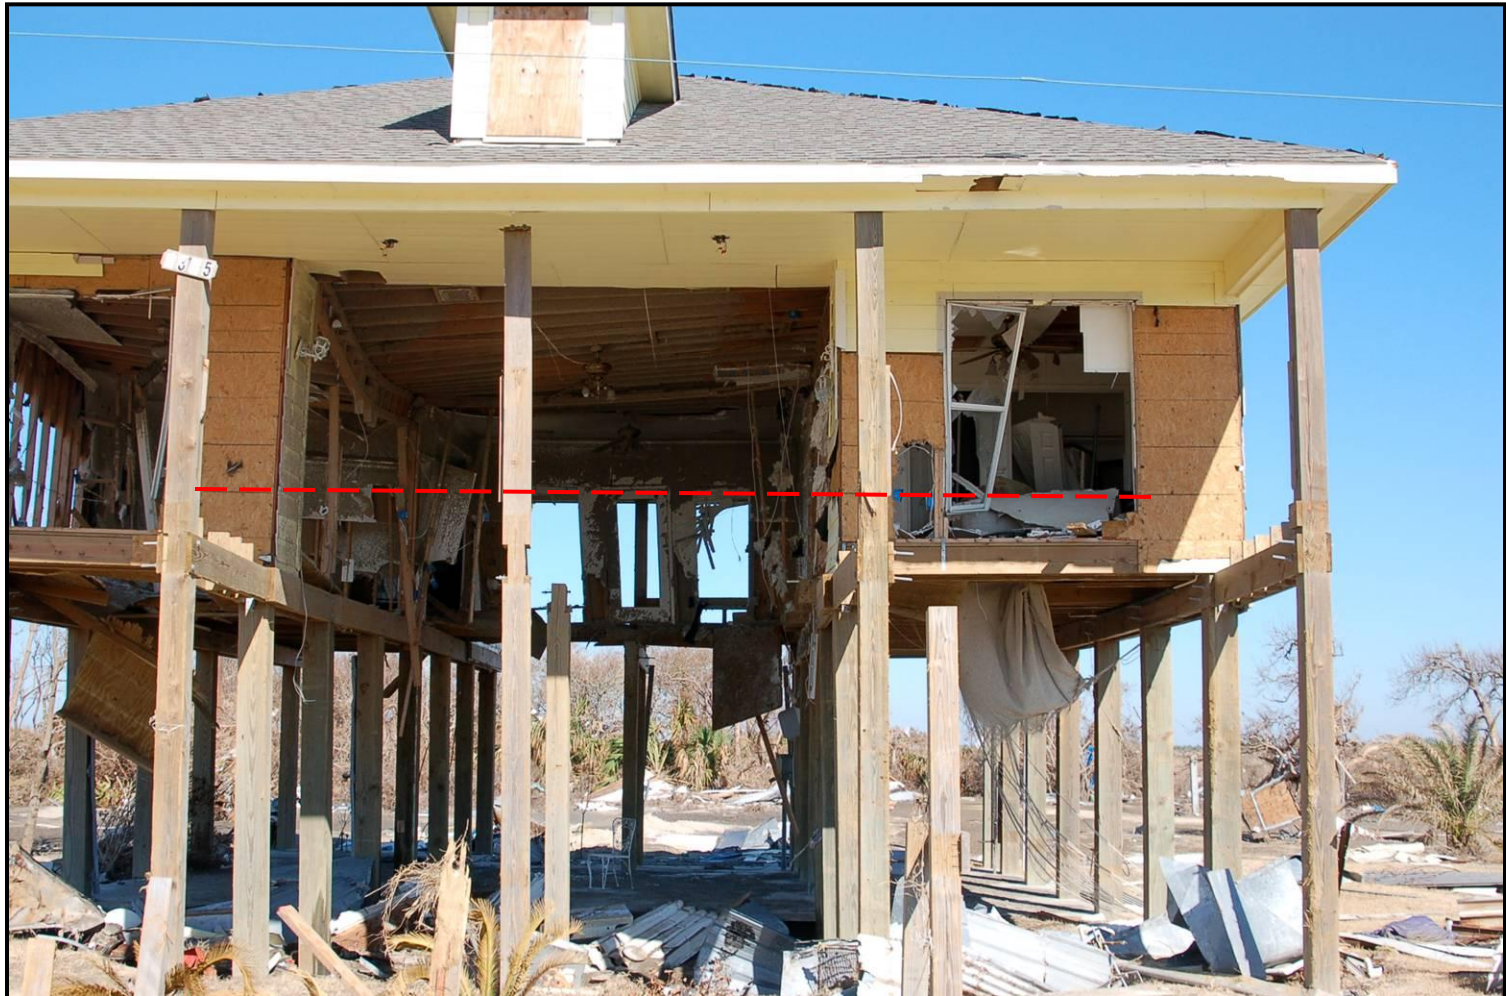
Wave Crest Above Floor

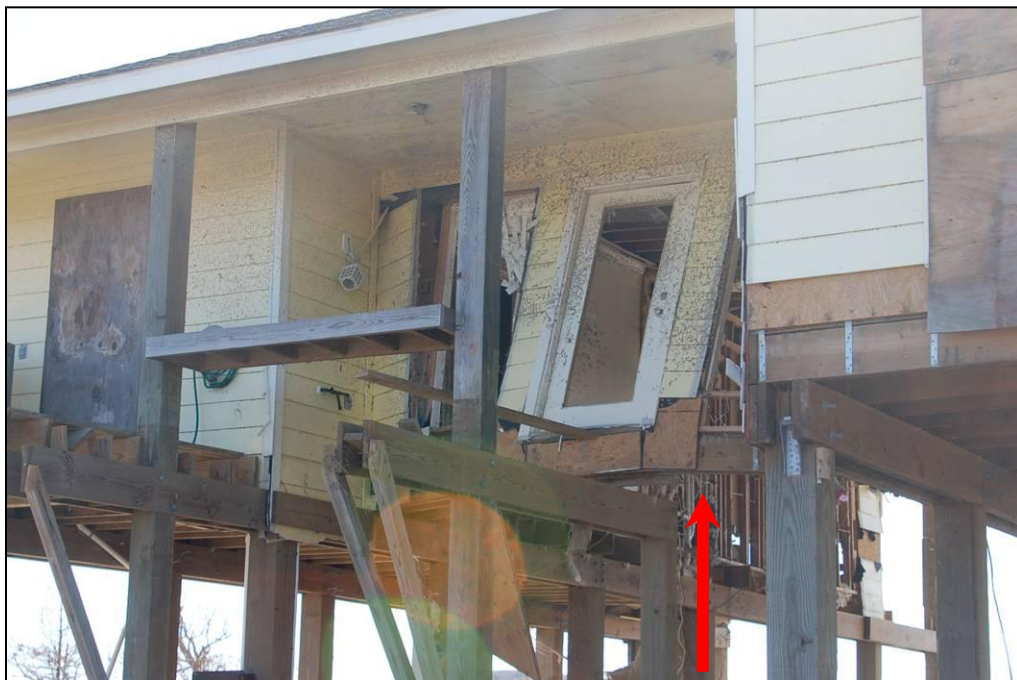
Wave Crest Above Floor

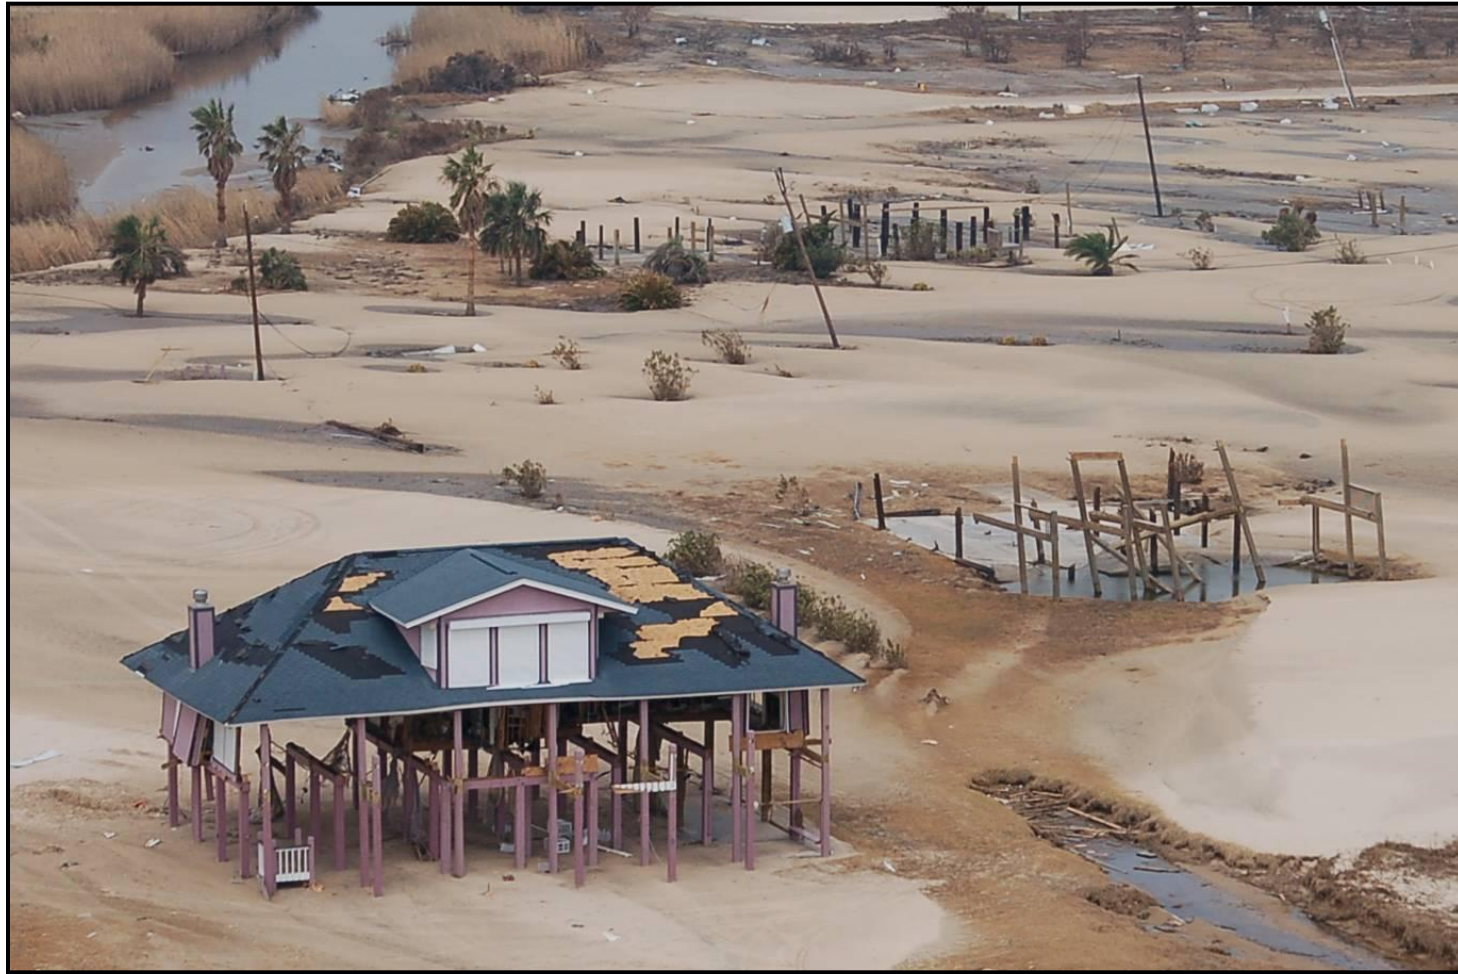
Wave Crest Above Floor

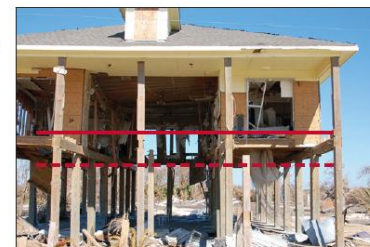
Figure 2. Bolivar Peninsula, TX, Vzone house constructed with the lowest floor (bottom of floor beam) at the BFE (dashed line). The estimated wave crest level during Ike (solid line) was 3 to 4' above the BFE at this location.

- Flood damage increases rapidly once the elevation of the flood extends above the lowest floor of a building, especially in areas subject to coastal waves. In a V zone, a coastal flood with a wave crest 3 to 4' above the bottom of the floor beam (approximately 1 to 2 feet above the walking surface of the floor) will be sufficient to substantially damage or destroy most light-framed residential and commercial construction (see Figure 2).

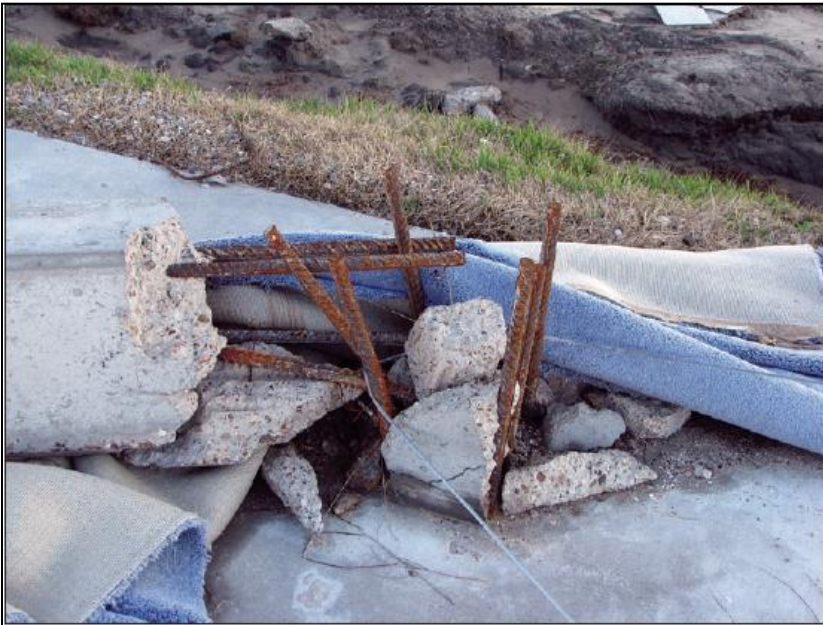
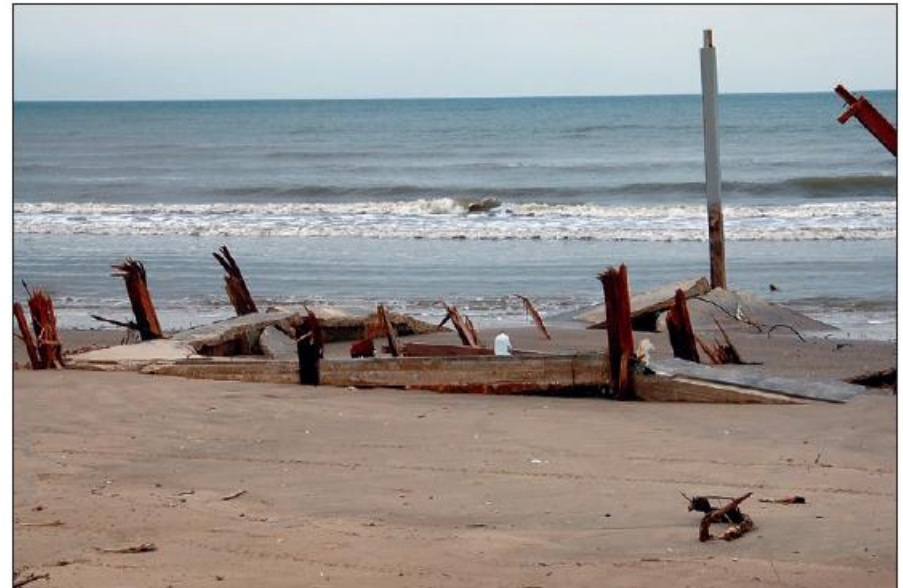
- **Observation: Many foundations failed when lateral loads exceeded column/pile capacity**

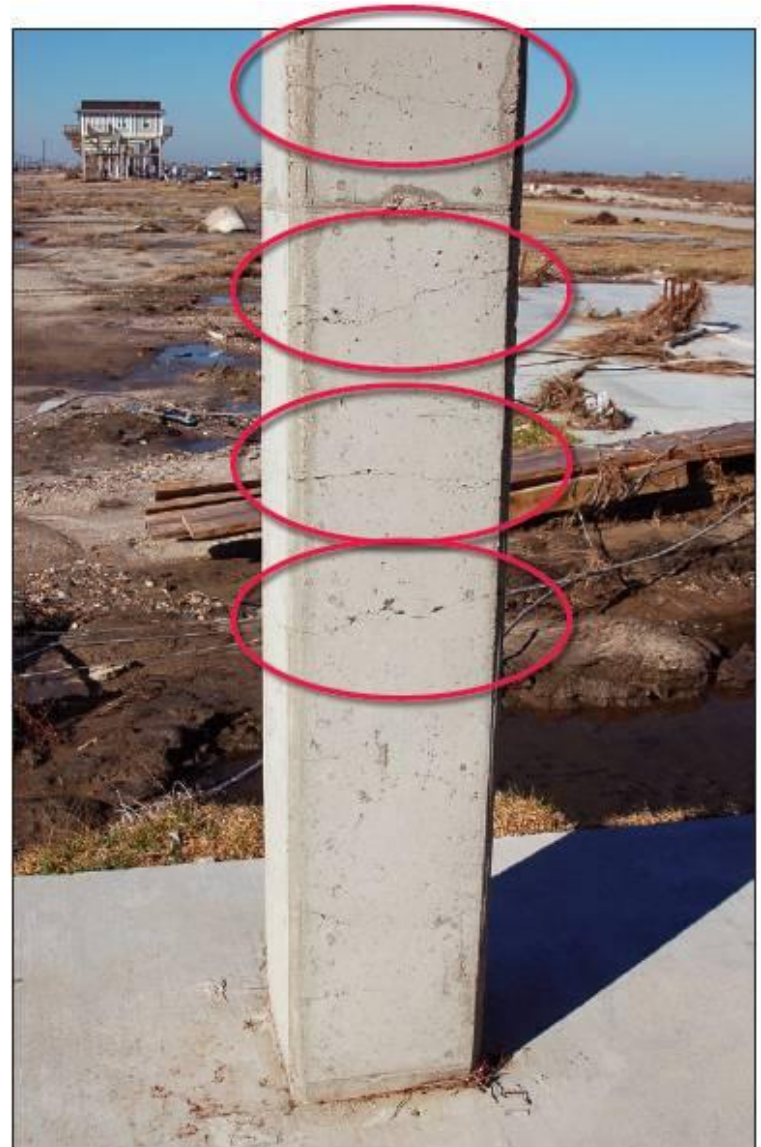
- **Observation:** columns of surviving homes showed numerous horizontal cracks -- a result of lateral flood loads on the foundation and wind loads on the elevated building

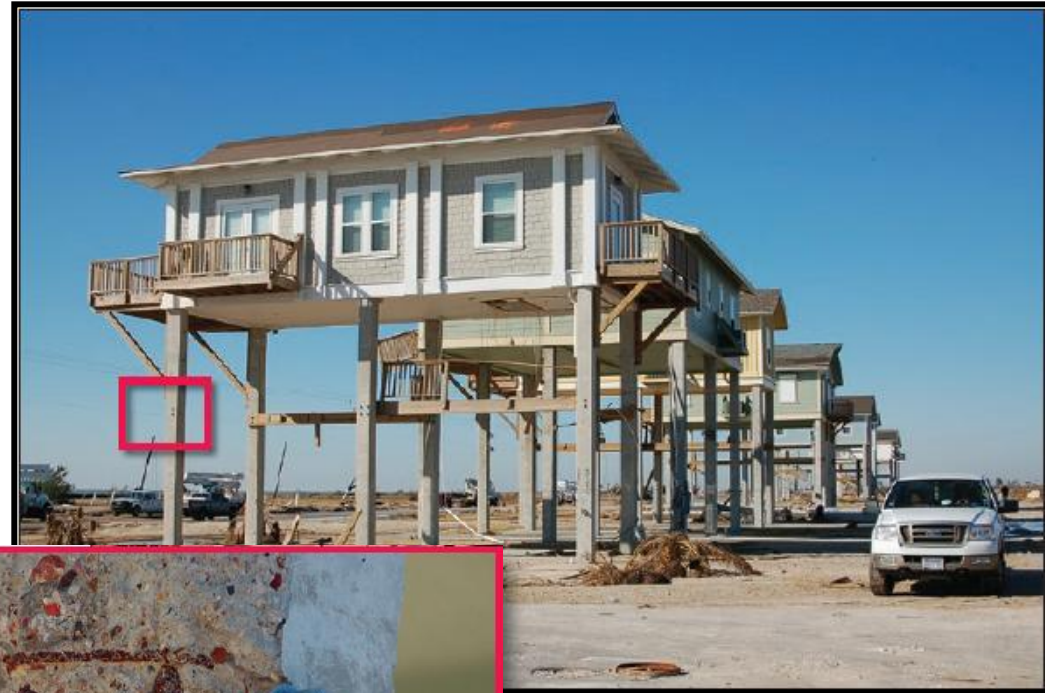
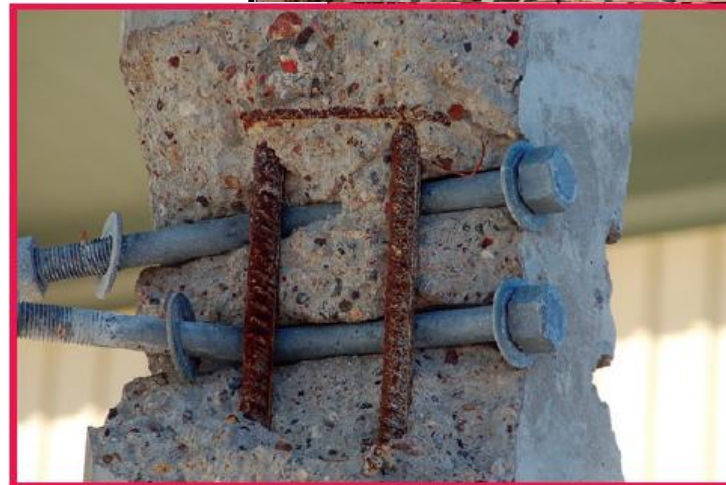
- **Observation: non-breakaway decks caused damage to columns when decks failed**

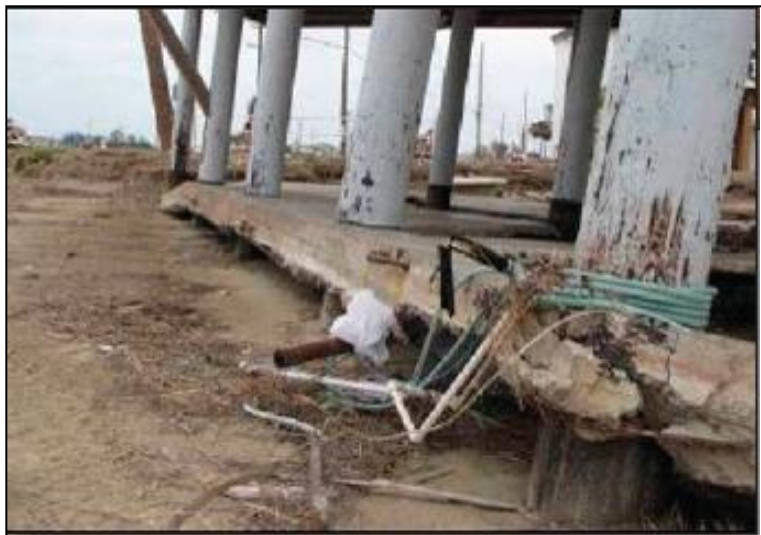
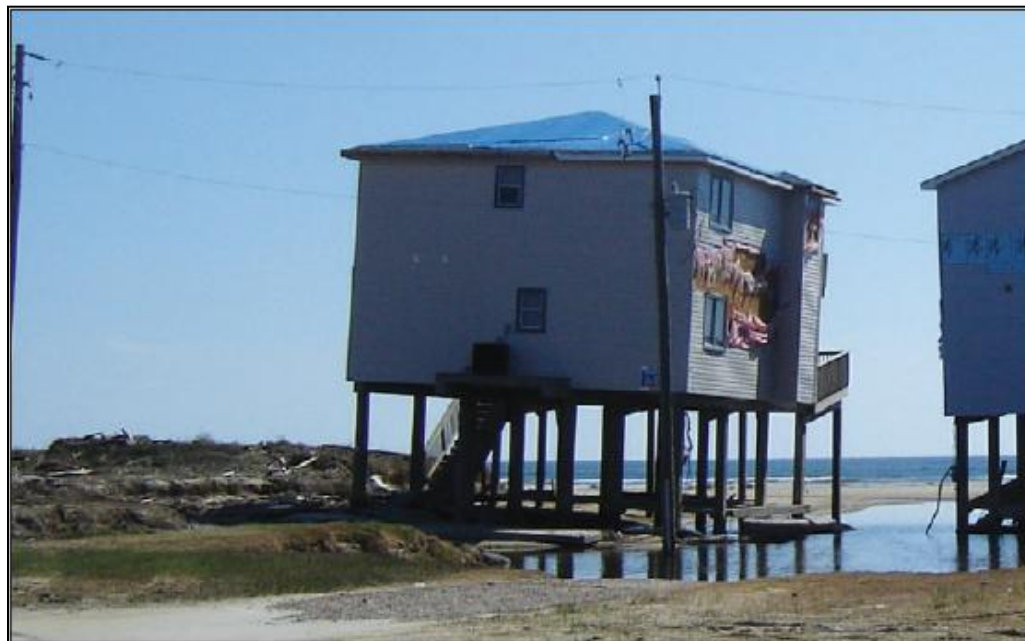
- **Observation: Many foundations failed due to lack of embedment and/or scour/erosion**

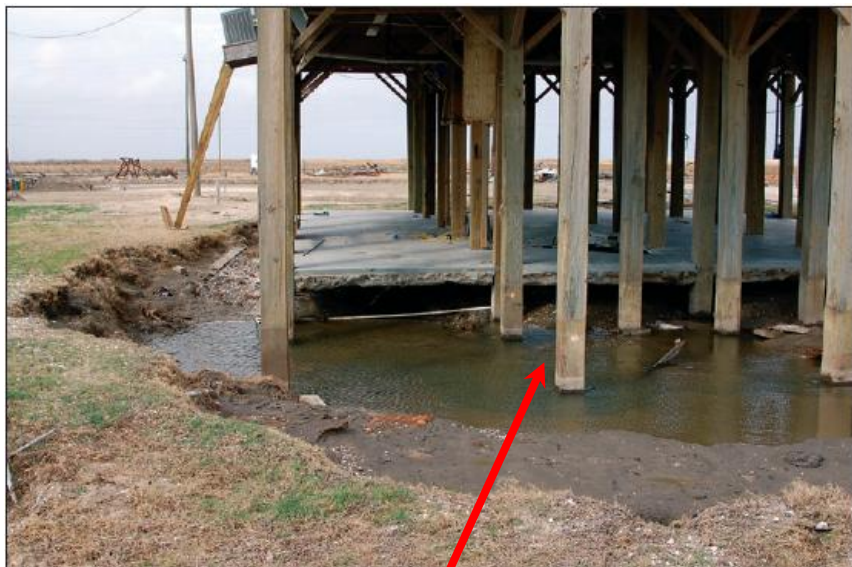
- **Observation: scour and erosion far exceeded design guidance**

Design guidance estimates scour around pile = 2 x pile diameter

Scour hole was reported to be 10 ft deep

- **FEMA should assist engineers and codes/standards organizations to develop new scour guidance based on Ike knowledge**
- **FEMA should study foundation scour in detail following future events**
- **Potential linear scour should be incorporated into design and land development guidance/practices**

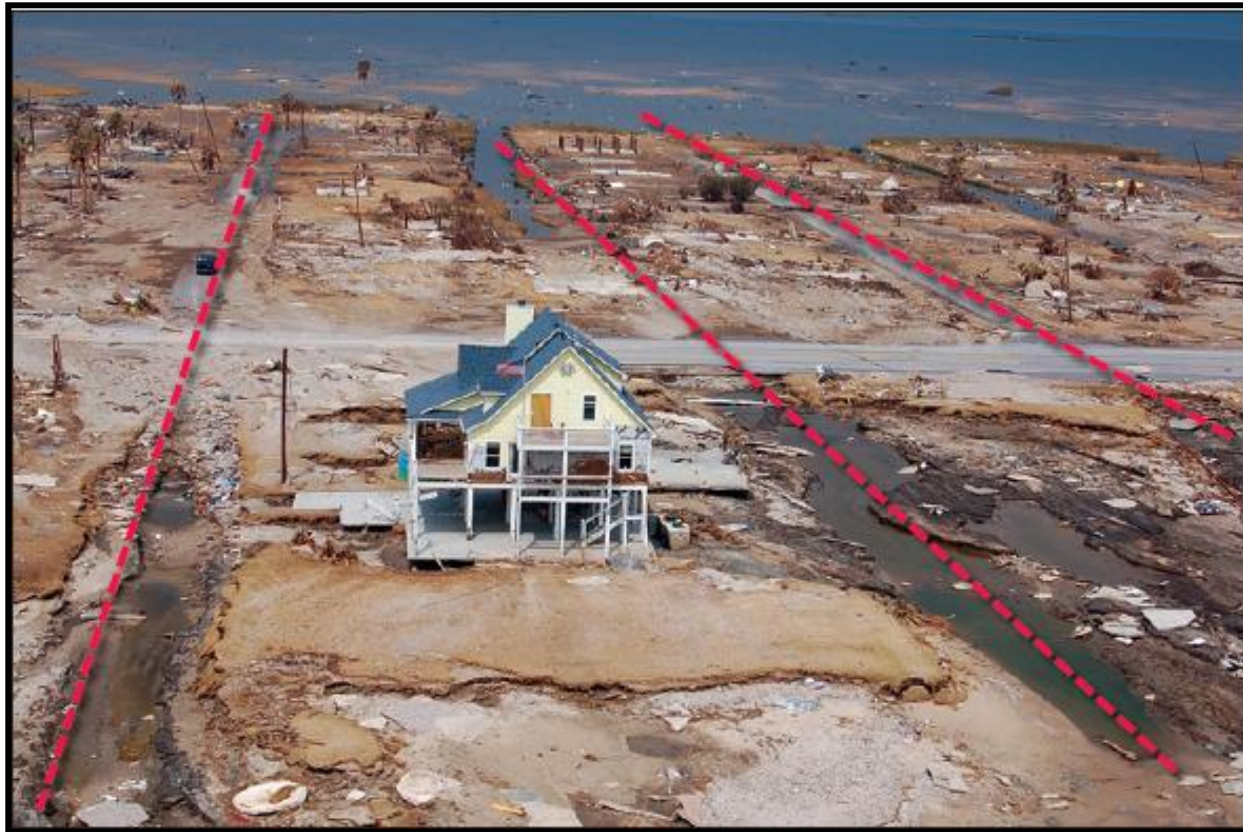
- **Observation: linear scour features follow roads, canals**

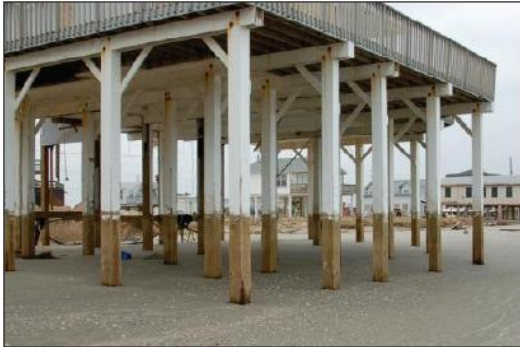
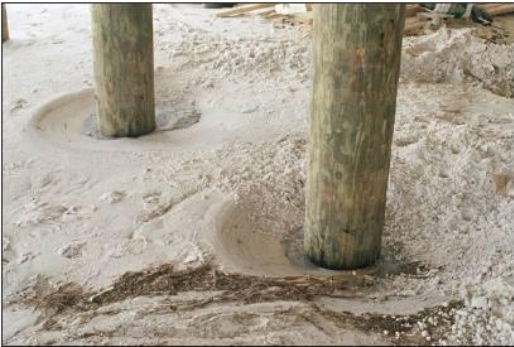
Figure 1. Distinguishing between coastal erosion and scour. A building may be subject to either or both, depending on the building location, soil characteristics, and flood conditions.

Affect Flood Loads?	Affect Embedment?
<p>Erosion</p>

<p>Yes</p>	<p>Yes</p>
<p>Scour</p>

<p>No</p>	<p>Yes</p>

Erosion is defined by the International Building Code® (ICC, 2006) as the “wearing away of the ground surface as a result of the movement of wind, water or ice.” Section 7.5 of FEMA’s *Coastal Construction Manual* describes erosion as “the wearing or washing away of coastal lands.” Since the exact configuration of the soil loss is important for foundation design purposes, a more specific definition is used in this Recovery Advisory (see text box and Figure 1).

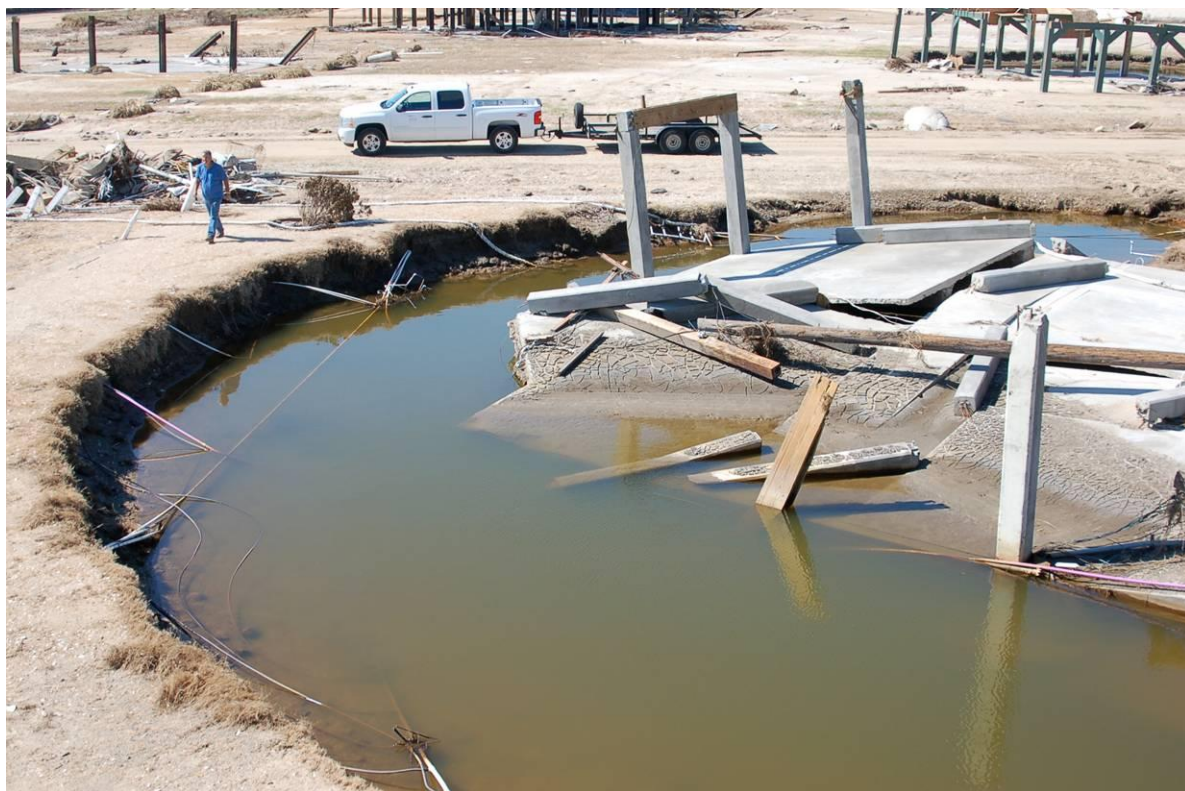
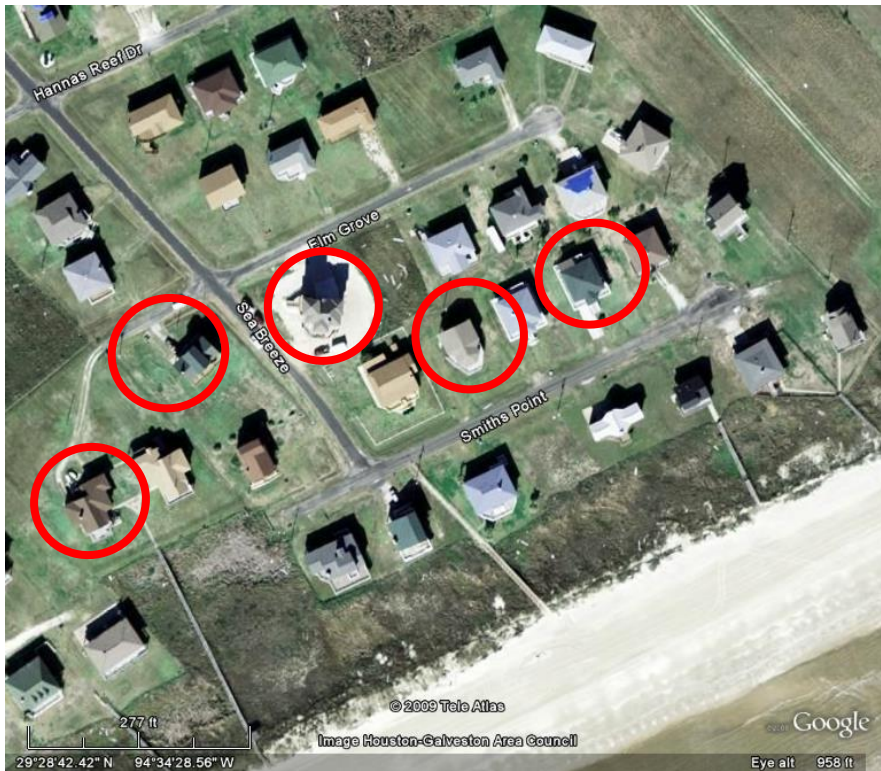
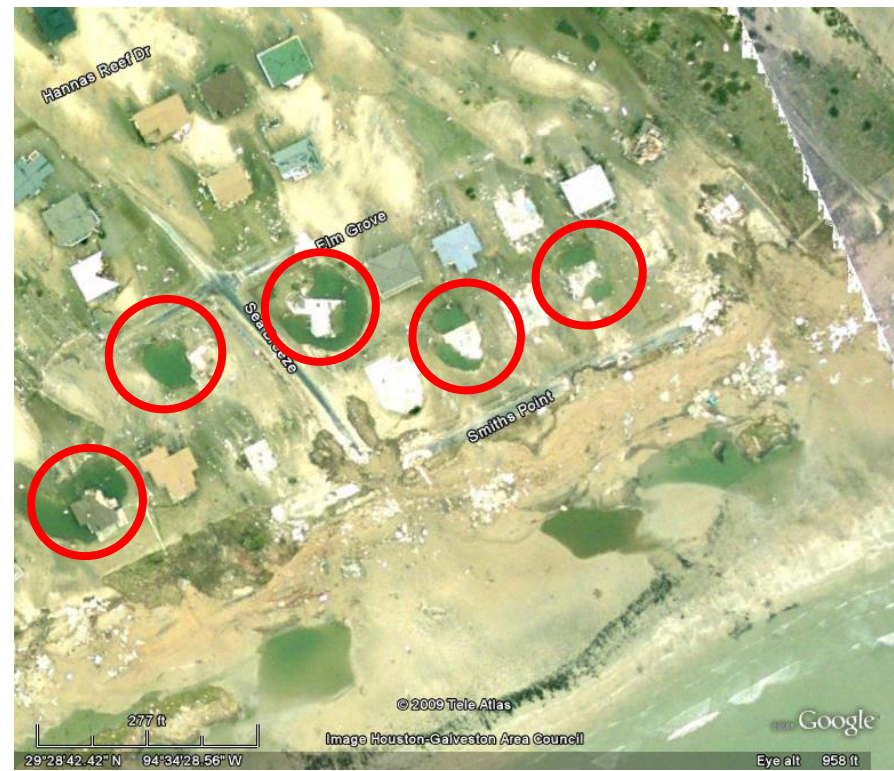
- Does method of foundation design/construction, or soil disturbance contribute to scour?

Maybe, but there are other (unknown) factors at work . . .

It is unlikely all 5 buildings circled above had the same foundation design or level of soil disturbance . . .

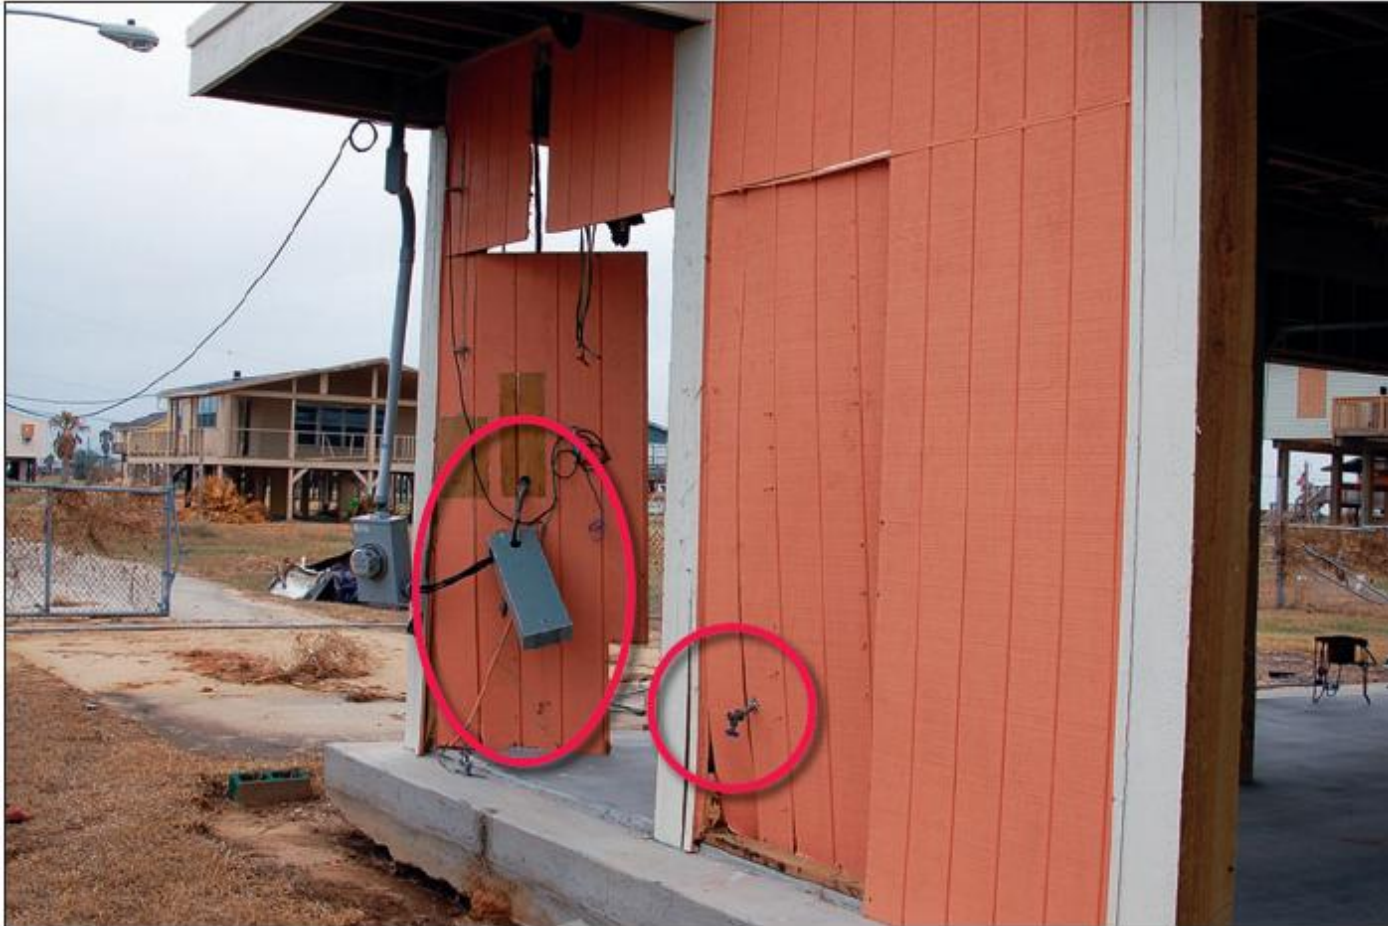
Ike Lesson 3: Breakaway Wall Performance Can be Improved

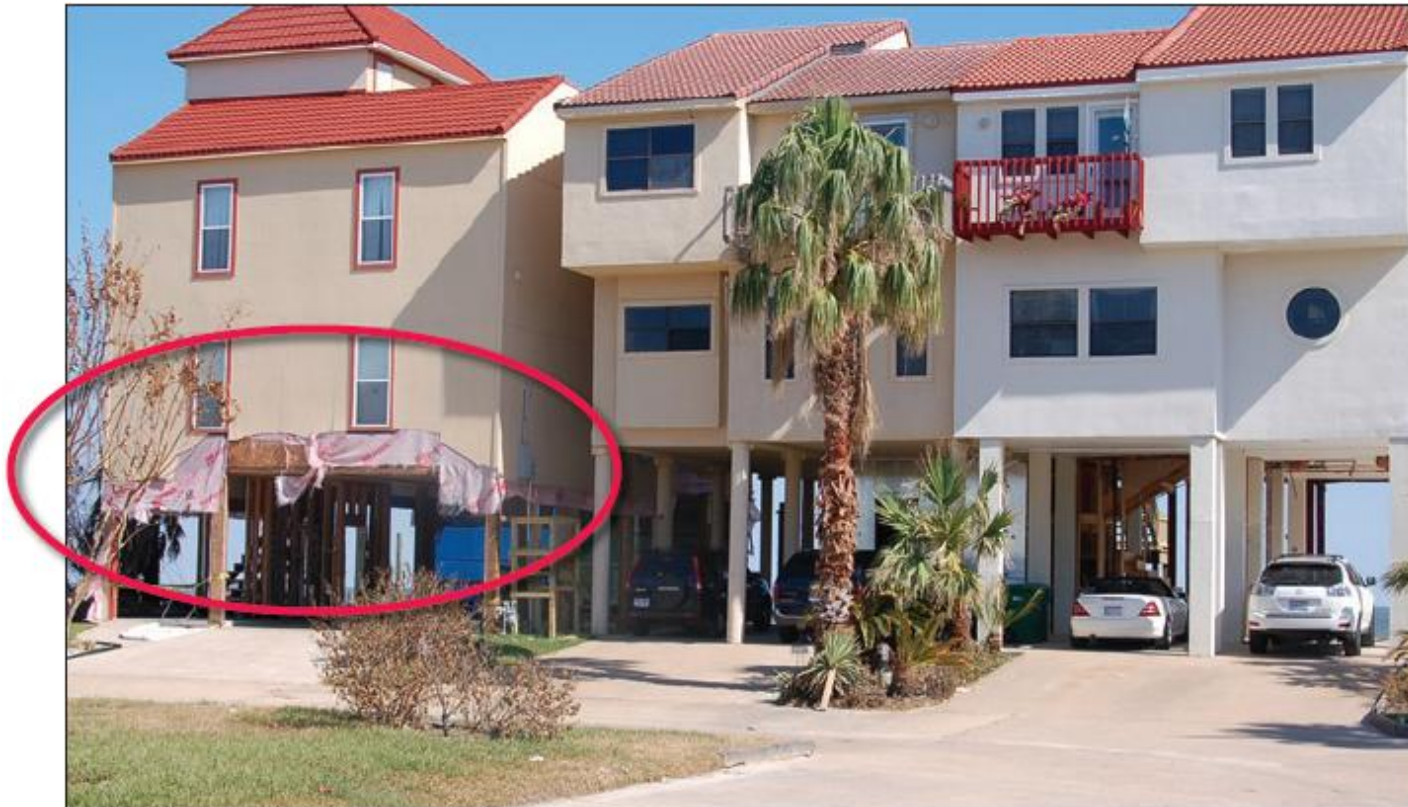
Louvers Performed Better Than Solid Walls

- Promote use of lattice/louvers
- Promote use of flood vents

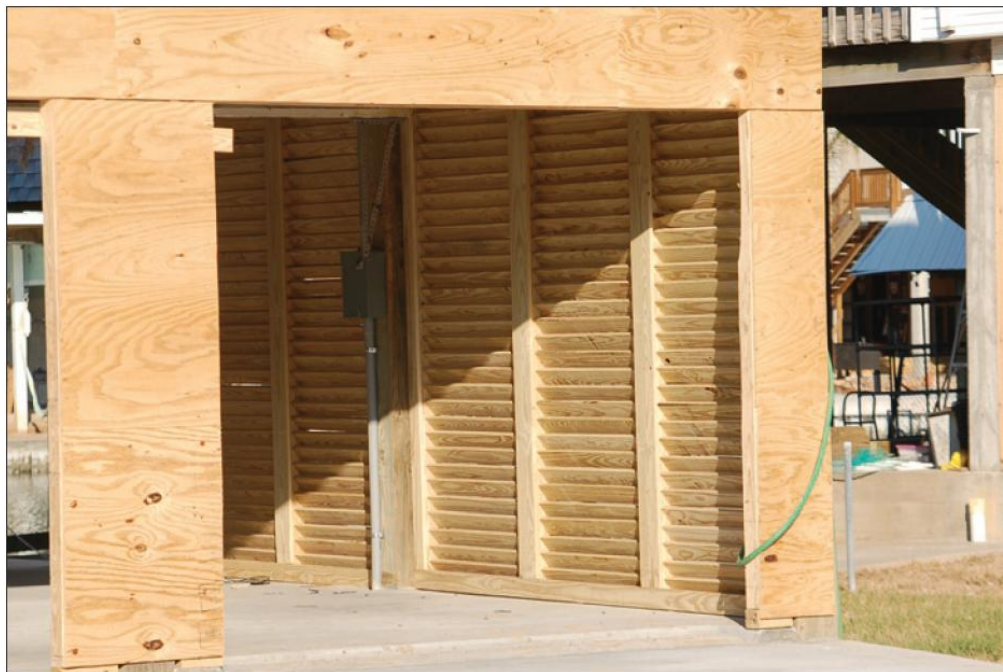
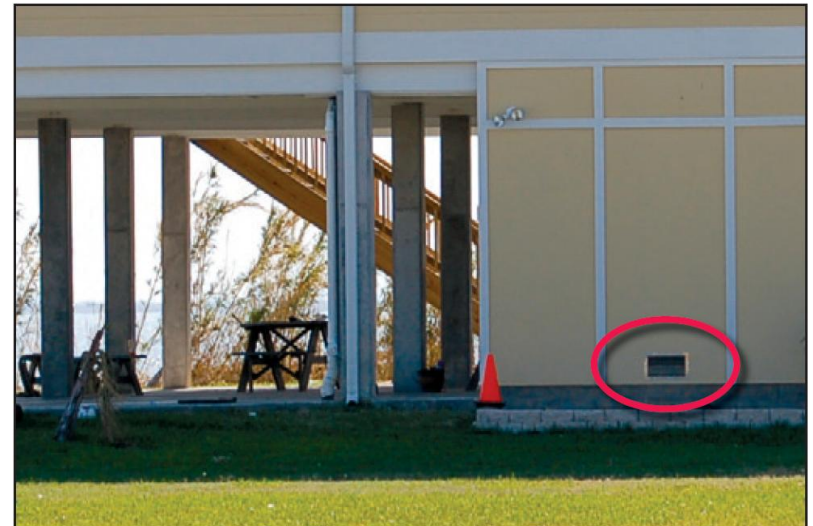
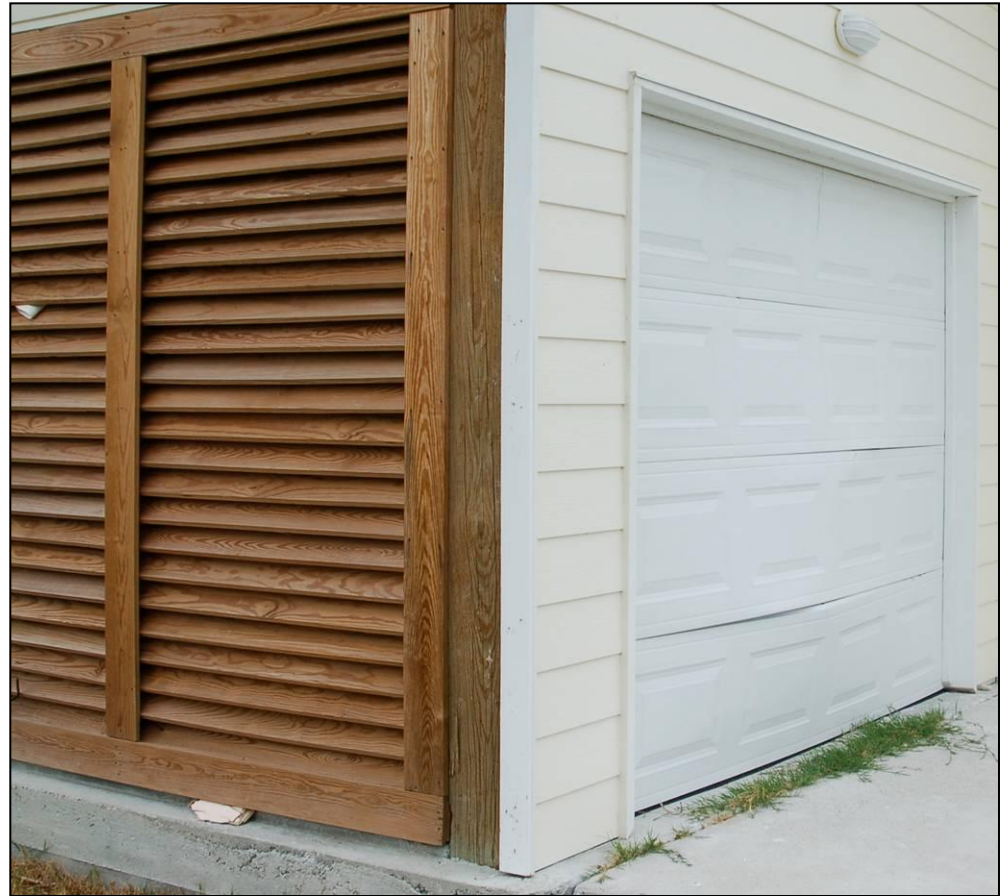
A change to the May 2009 FIM will rate V zone enclosures as “free of obstructions” if they are constructed with louvers/lattice on all walls except one (for garage door or solid breakaway wall).

Current rating practice calls this “with obstruction”.

V zone Flood insurance premiums will drop significantly with this change (new construction and re-rating of existing homes).

- For V zones, breakaway wall enclosures below an elevated building will result in higher flood insurance premiums; however, surrounding below-BFE space with insect screening, open lattice, slats, or shutters (louvers) can result in much lower flood insurance premiums (Figure 1). Use of these materials will allow floodwaters to pass into and out of the enclosed space and minimize damage to the enclosure "walls." Although not required by the NFIP, installation of flood openings in breakaway walls may also reduce damage to the walls.

Figure 1. Wood louvers installed beneath an elevated home in a V zone are a good alternative to solid breakaway walls.

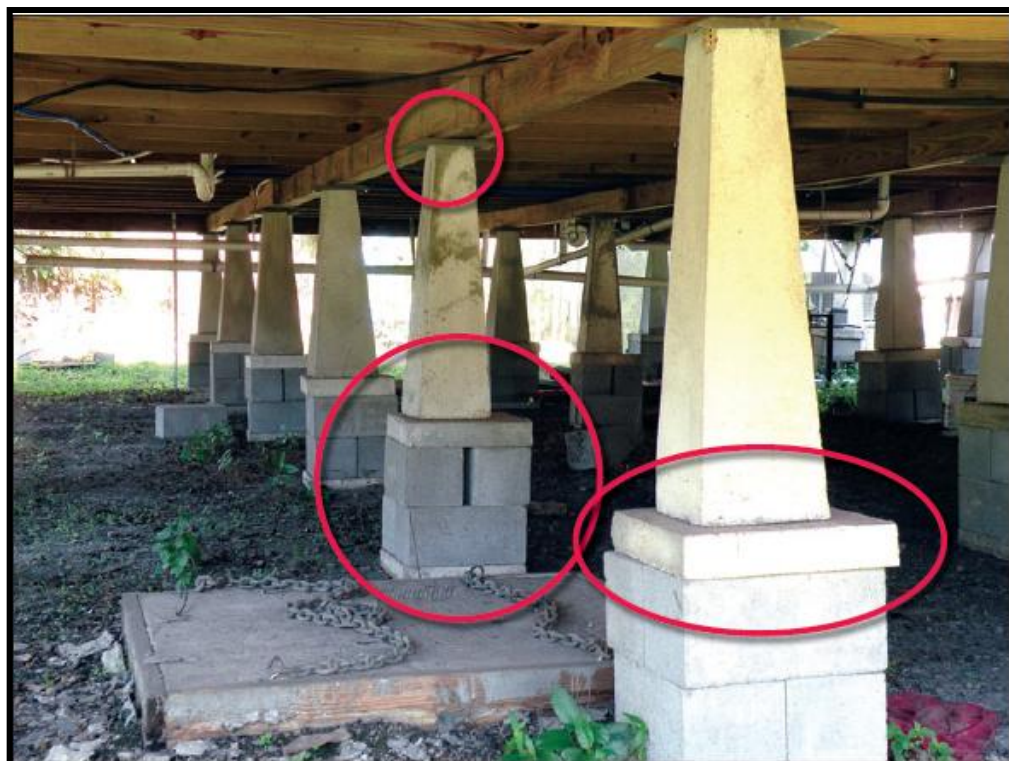
- MAT viewed 31 homes that had been elevated using HMGP or ICC funds
- **Good News:** none sustained flood damage during Ike
- **Bad News:** many of the homes lacked continuous load paths from elevated home to foundation to ground; other problems
