Mitigation Assessment Team Report on

Hurricane Ike

National Hurricane Conference

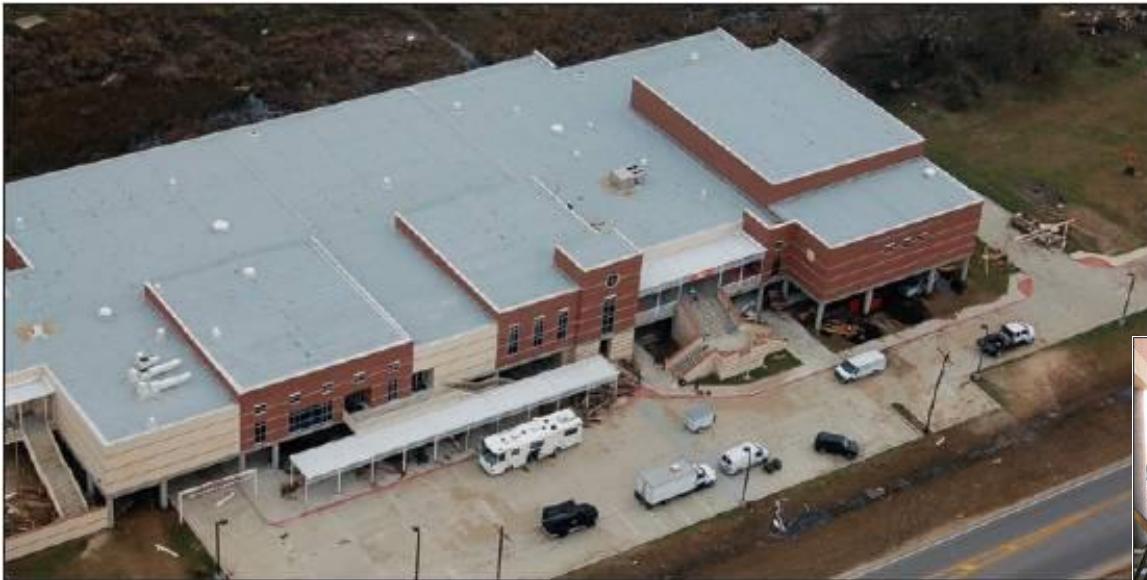
**Crenshaw Elementary
and Middle School,
Bolivar Peninsula**

- **Observation: Critical Facilities elevated above Ike surge and waves on strong foundations survived**

**Elevated 10 ft above
grade, Ike surge reached
5 ft above grade**

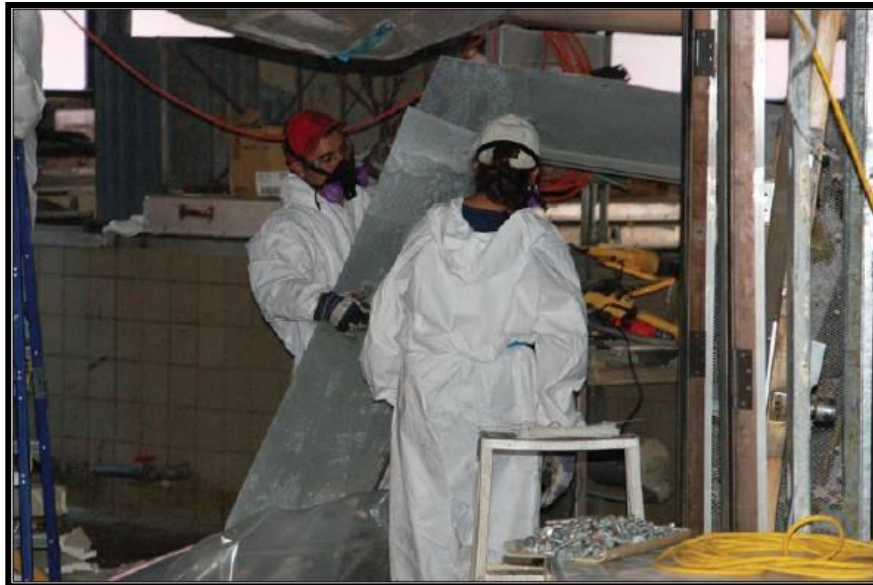
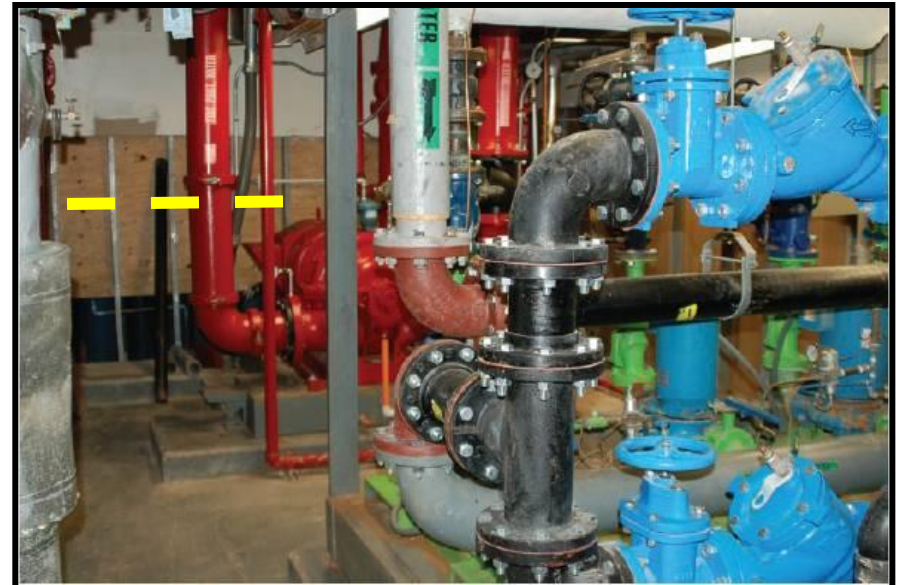
Many existing critical facilities are vulnerable

Approximately 2/3 of the UTMB buildings had first floors below Ike's 12.5 ft NGVD flood level; virtually all had equipment and utilities below ground.

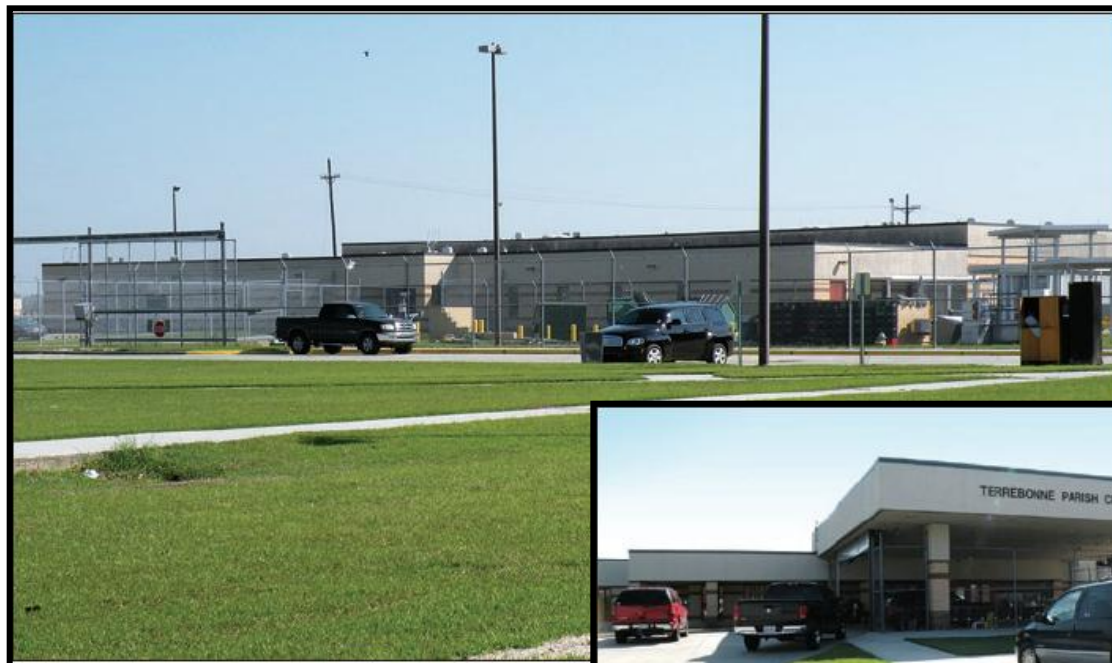
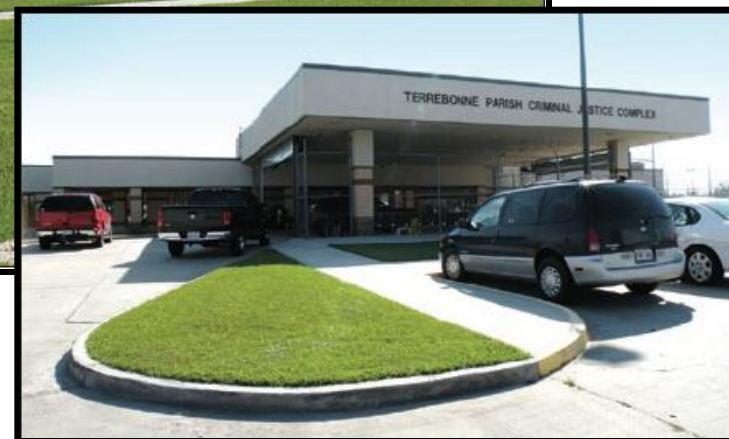
- Criminal Justice Complex Ike flood at 6 ft (18-24" depth)
- Similar flooding during Rita (2005)
- All utilities for security and communications systems run under the slab, and were damaged
- Prisoners had to be transferred.

- 1985 FIRM classified as Zone C
- Post-Rita map shows ABFE = 6 ft

- **New/replacement critical facilities should be located outside the 500-yr floodplain, where possible.**
- **Where not possible, elevate at least to 500-yr flood level or to ASCE 24-05 freeboard, whichever is higher**
- **Executive Order 11988; other guidance**
- **For existing facilities, evaluate vulnerability; raise or floodproof critical components; relocate or replace facility if necessary**
- **Audit facilities for flood, wind and other hazards**

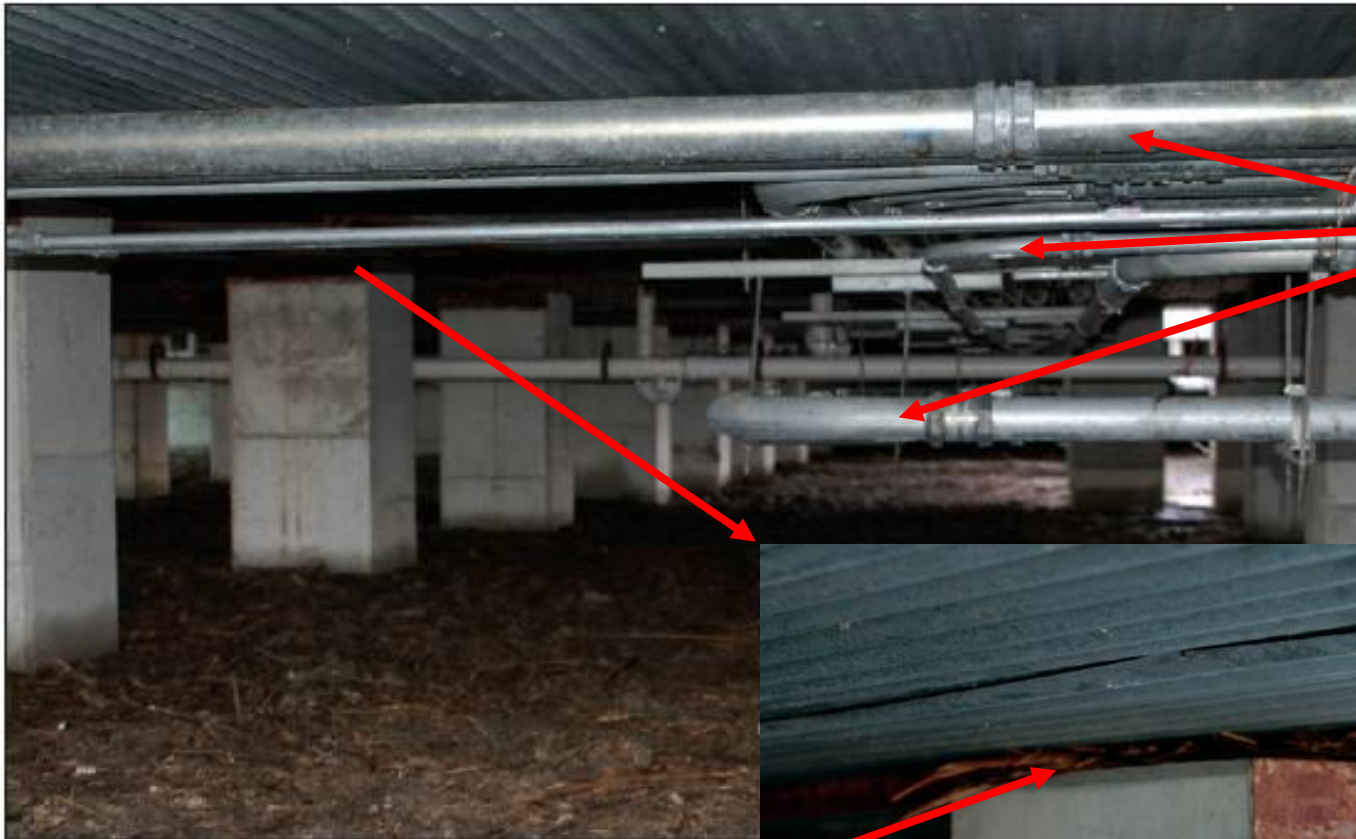
Ike Damaged Below-Floor Utilities

Piping and
Conduits
Replaced
Post-Ike

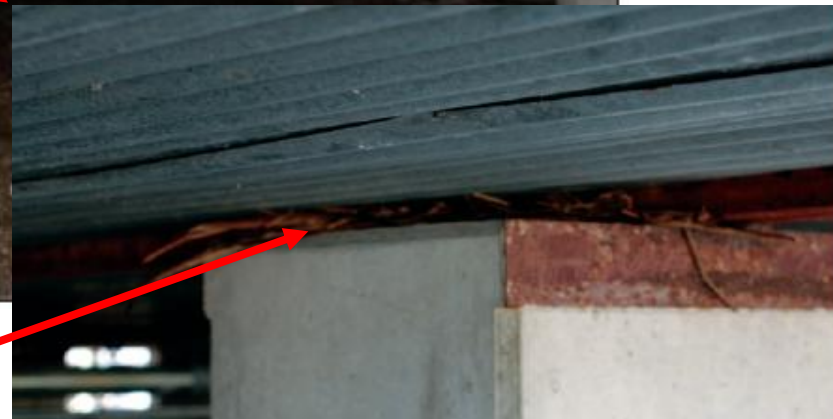
Marsh Grass Trapped at Top of
Columns During Ike
