Platform Debris Fields Associated with the Blue Dolphin (Buccaneer) Gas and Oil Field Artificial Reef Sites Offshore Freeport, Texas: Extent, Composition, and Biological Utilization

December 2008

Prepared under MMS Contract
0199CA30951-72406
by
LGL Ecological Research Associates, Inc.
1410 Cavitt Street
Bryan, TX 77801
and
Coastal Fisheries Institute
School of the Coast and Environment
Louisiana State University
Baton Rouge, Louisiana 70803

U.S. Department of the Interior
Minerals Management Service
Gulf of Mexico OCS Region

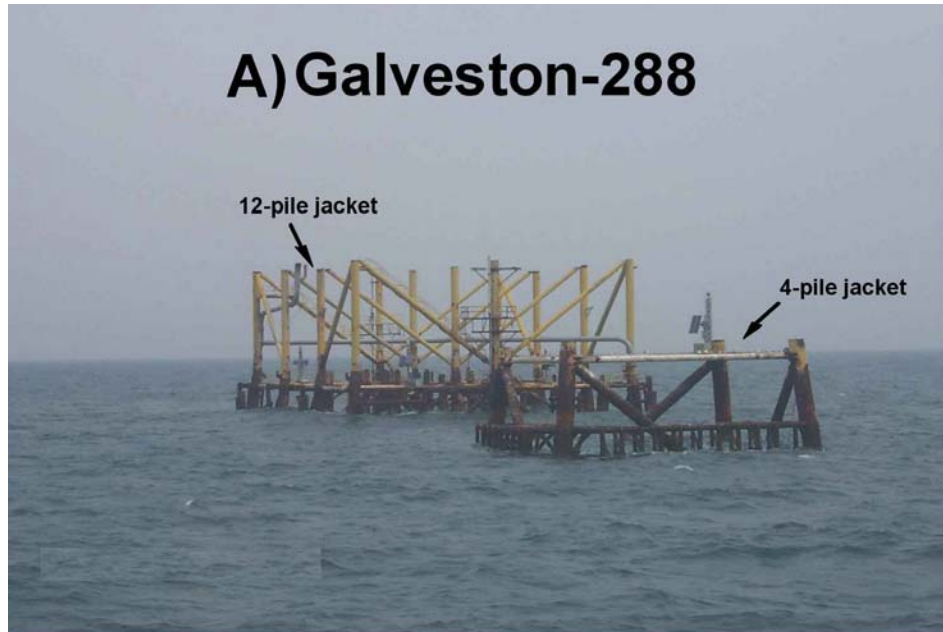
Figure 3. Decommissioning of Shell Oil's 12-pile production and 4-pile quarters platforms GA-288 (A) and GA-296 (B) in progress prior to the in-place reefing at these structures in summer of 2003. Photographs courtesy of John Embesi, Texas Parks and Wildlife Department.

The study platforms were dismantled and dropped to the seafloor in August of 2003. The first step in the process was to remove and salvage the platform decks and other materials of re-useable value (Figure 3). Each structure was then cut to about the 15.2-m (50 ft) depth. The top portions of the structures were cut into smaller pieces and placed on and around the base sections left in place. The standing base left in place was to have a planned profile of about 6.1 m (20 ft). Each reef was then marked with a lighted buoy maintained by the TPWD.

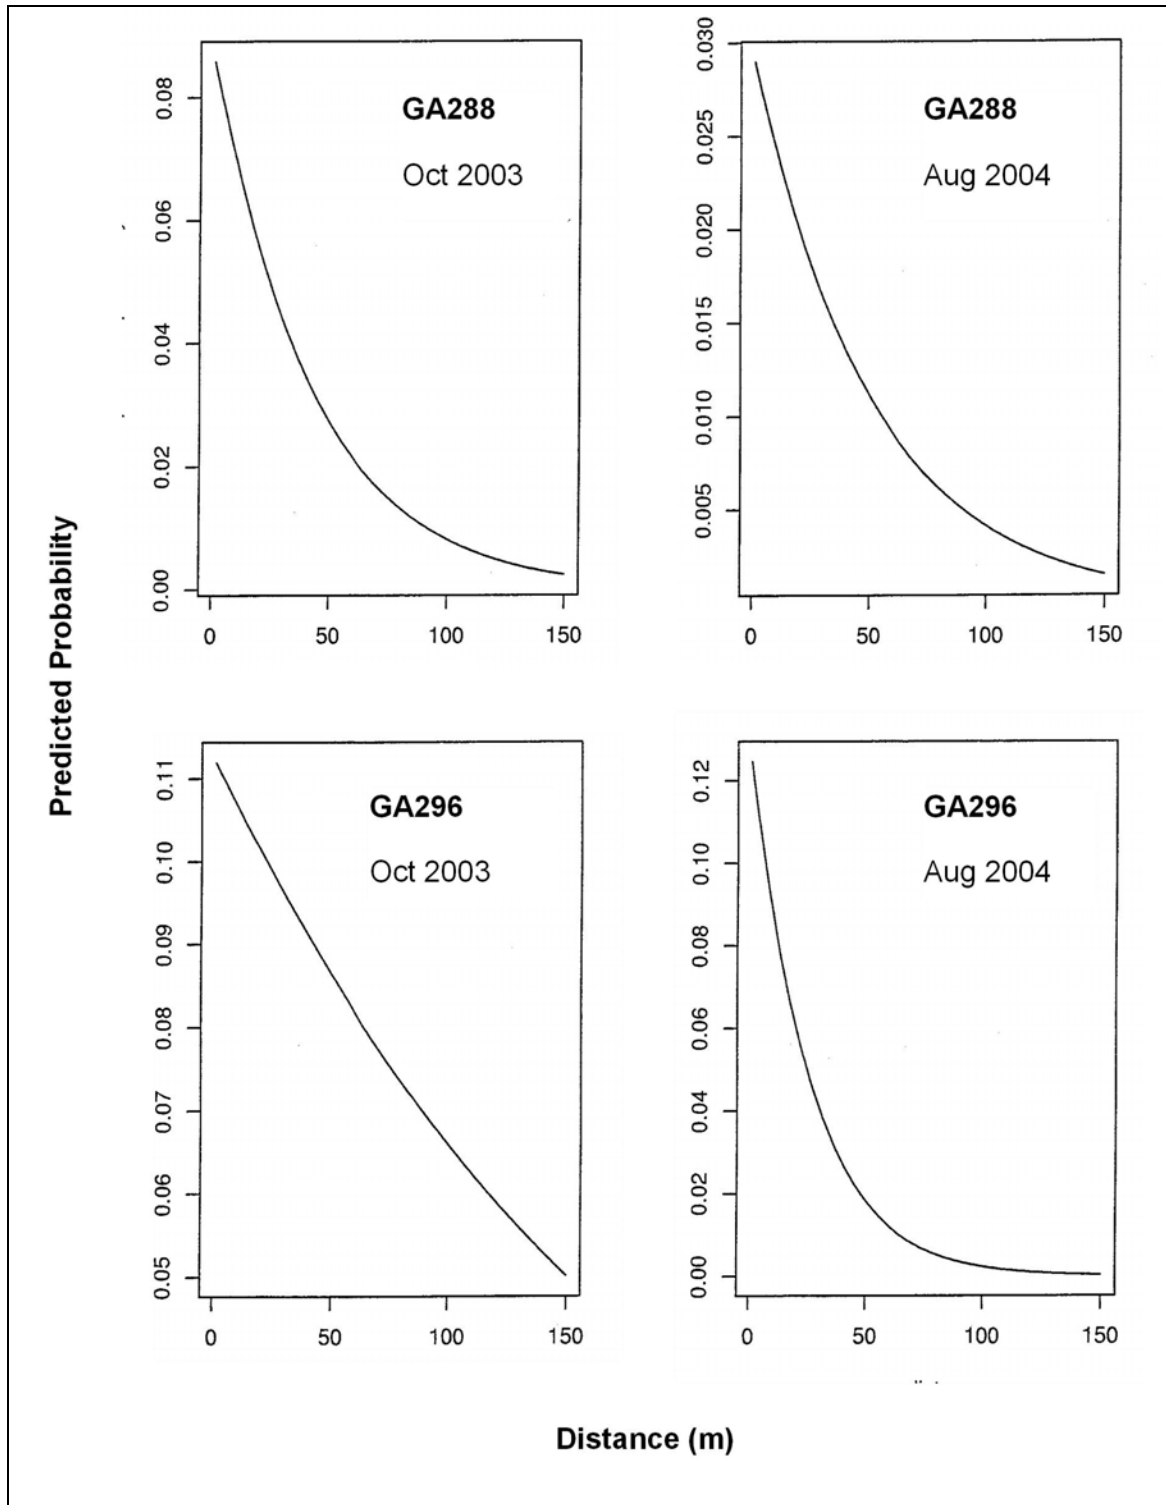
Figure 5. Predicted probability of a fish encounter with distance from the Texas Parks and Wildlife Department's Buccaneer Artificial Reefs GA-288 and GA-296, October 2003 and August 2004.

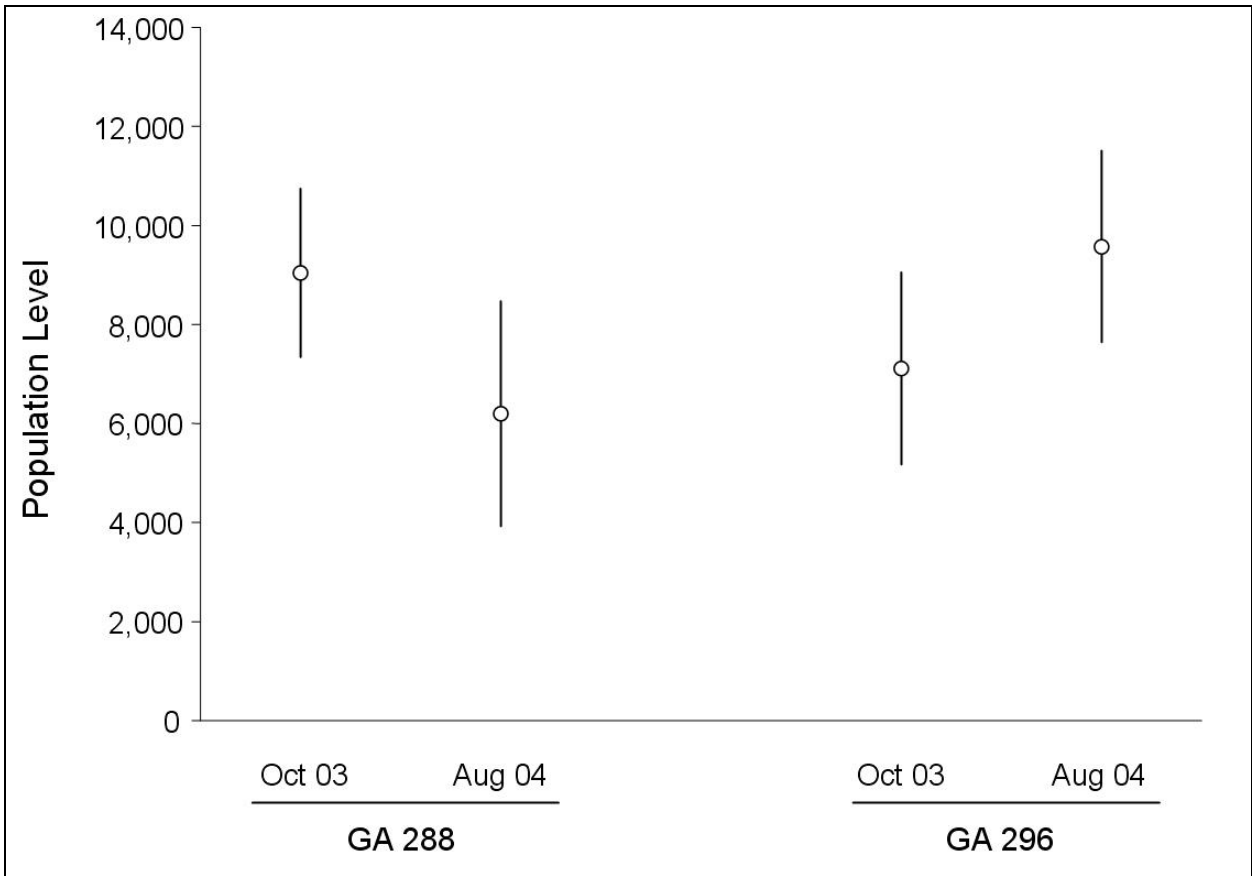
Figure 7. Population estimates (open circles) and 95% CIs (vertical lines) of fish at Texas Parks and Wildlife Department's Buccaneer Artificial Reefs GA-288 and GA-296, October 2003 and August 2004.

On the order of 9,000 fish (95% CI = 7,340 to 10,740) were present at GA-288 in October 2003 as compared to about 6,200 (95% CI = 3,925 to 8,472) which were present at this site in August of 2004 (Figure 7). In contrast, about 7,000 fish (5,178 to 9,046) were present at GA-296 in October 2003 with the total number increasing to 9,573 (7,640 to 11,507) in August of 2004 (Figure 7). The decrease in population size observed at GA-288 between October 2003 and August 2004 was mainly attributed to a decline of fish abundance within the 5- to 10-m depth range (Figure 8).

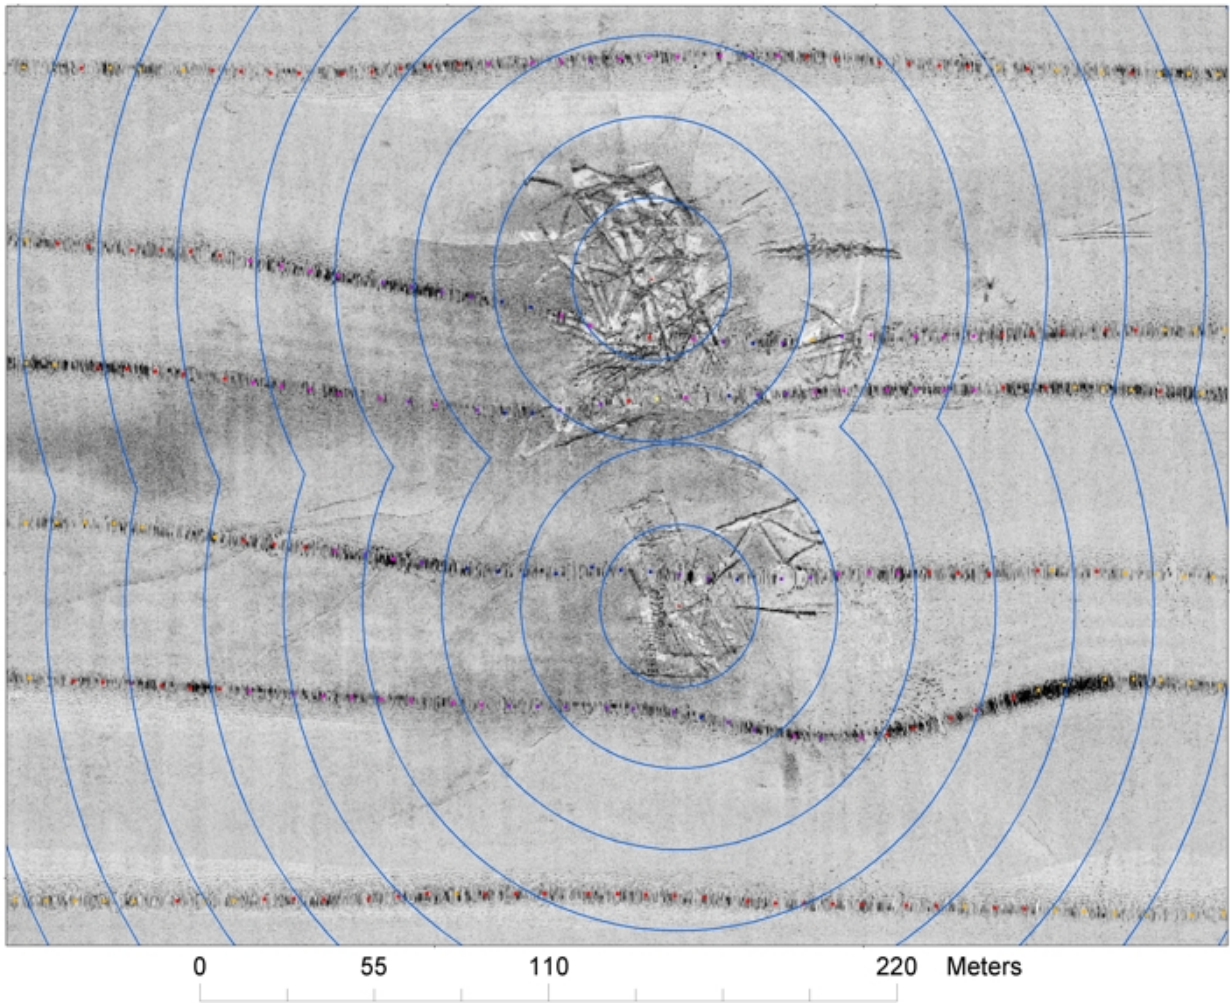
Figure A.4. Side-scan detail for GA-296, 13 October 2003.

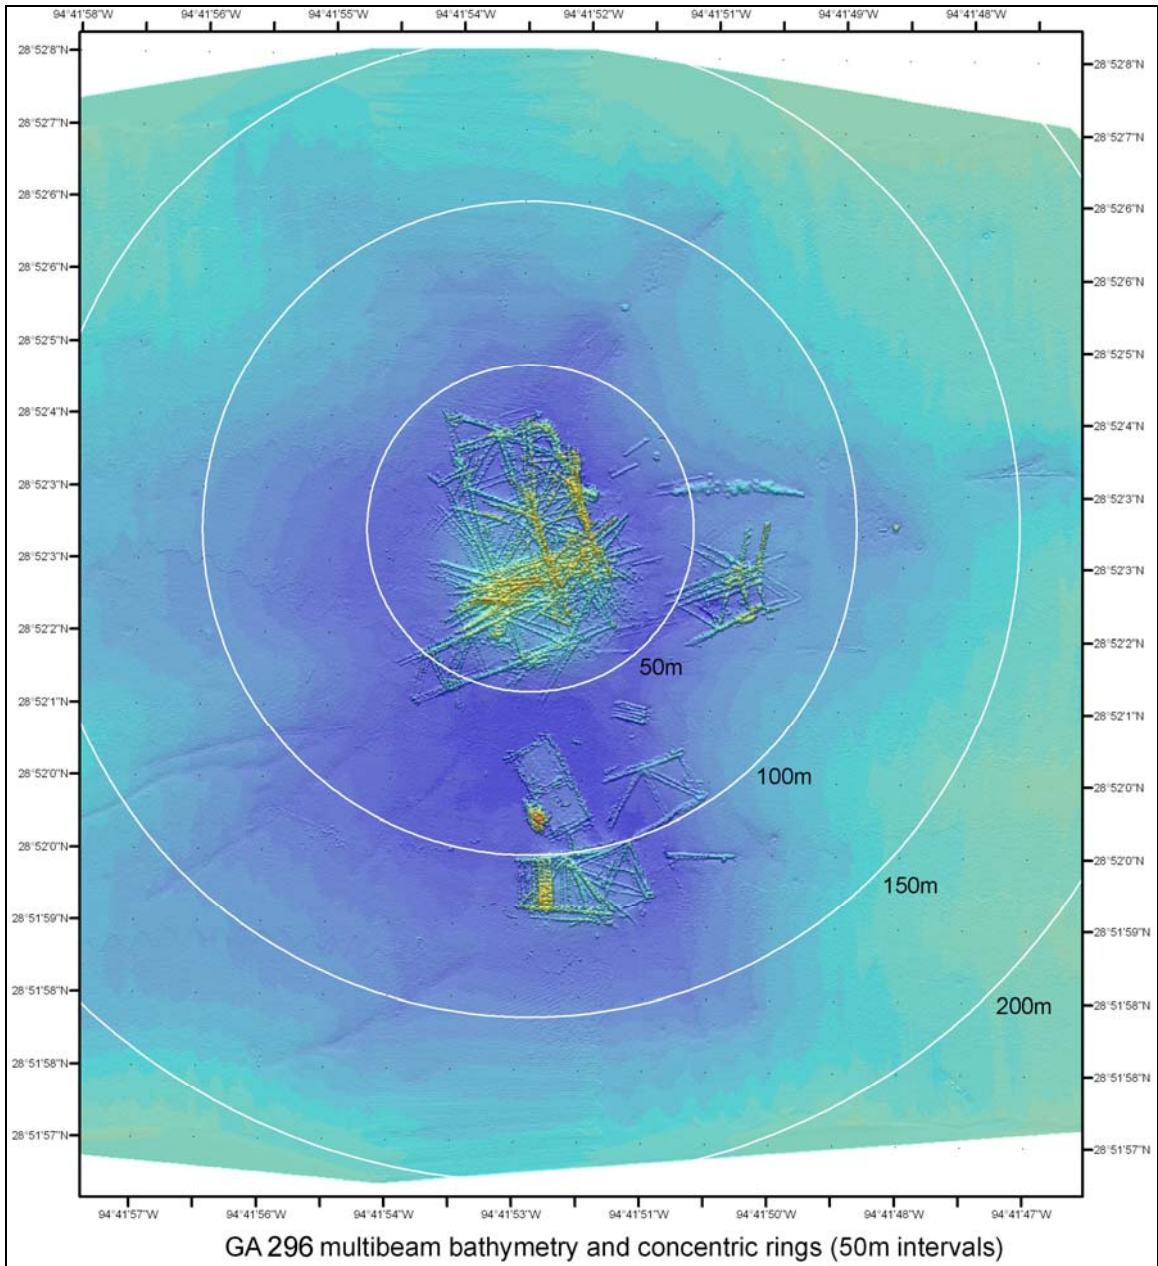
Figure A.10. GA-296 debris-pile distribution, MBES survey, June 2005.

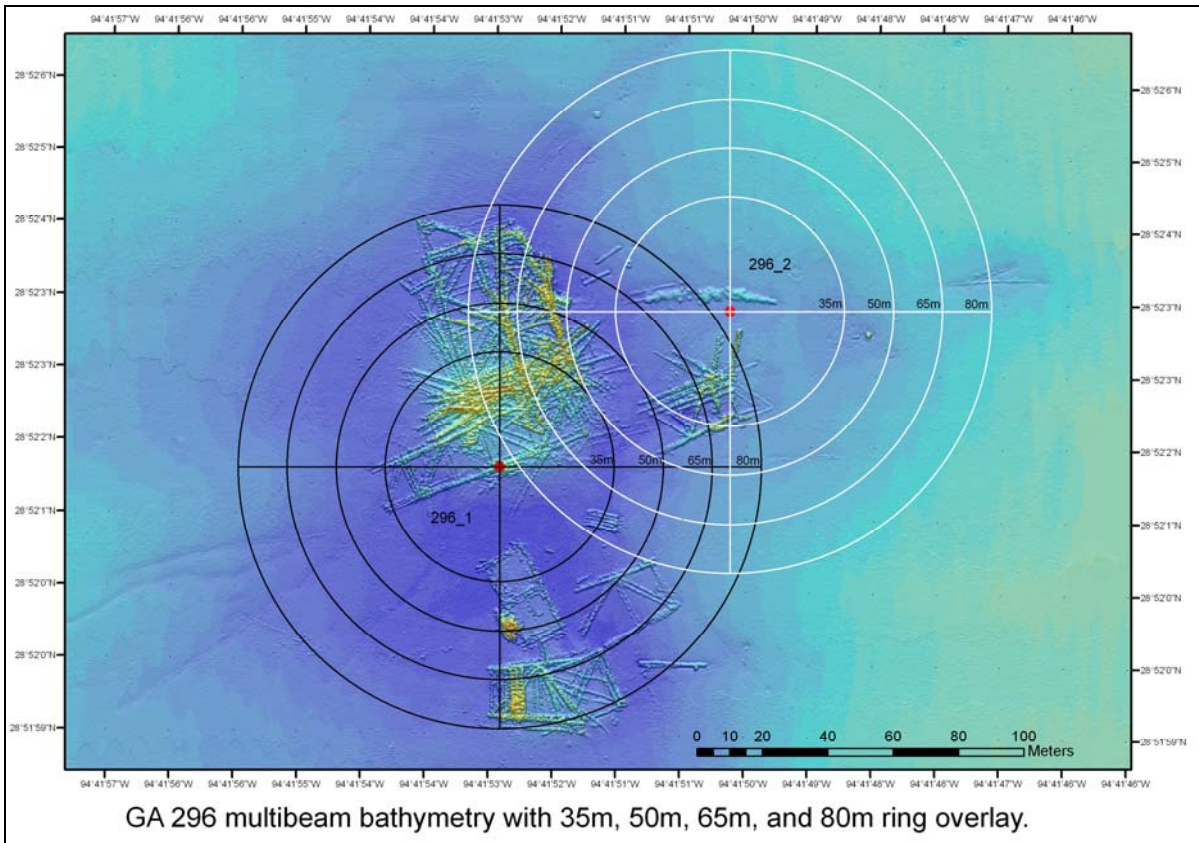
Figure A.12. GA-296 ROV sites relative to debris piles, MBES surveys, June 2005.

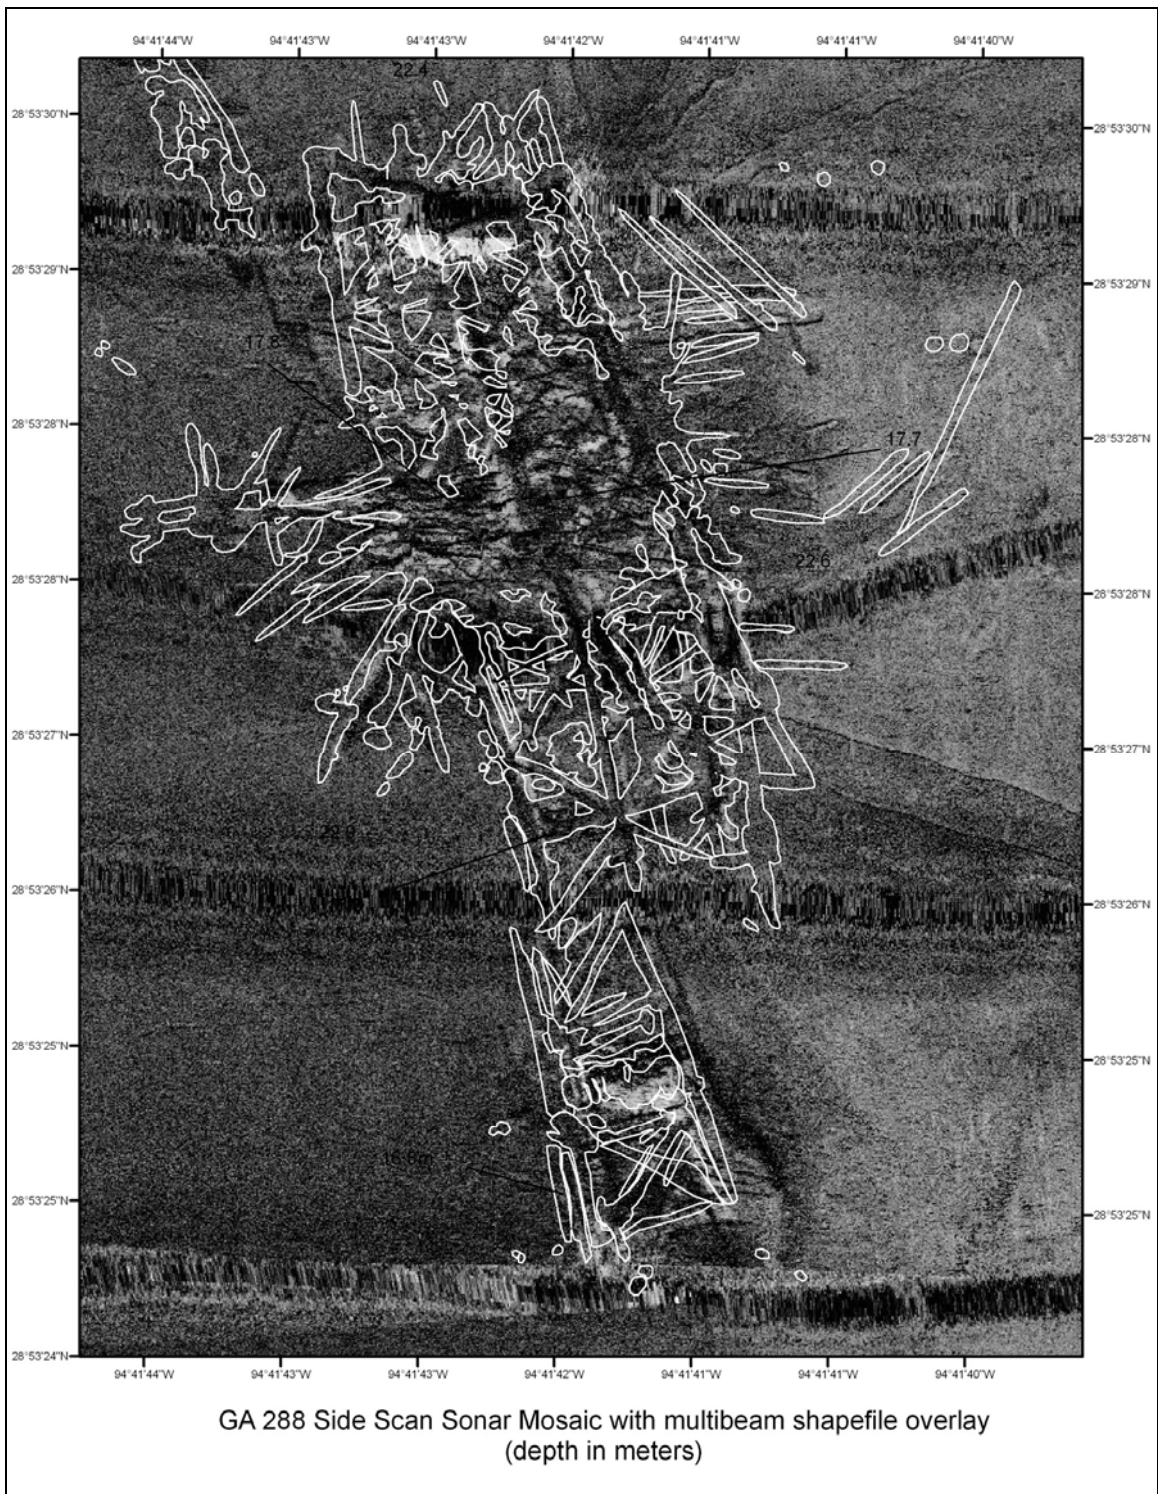
Figure A.13. GA-288 side-scan and MBES survey overlay; i.e., 2003 vs. 2005.

We found no evidence that debris had been dispersed more than 100- to 150-m away from the main platform debris fields. Based upon our observations, the distribution of the debris fields comprising the artificial reefs was stable based upon the lack of change observed between 2003 and 2005.

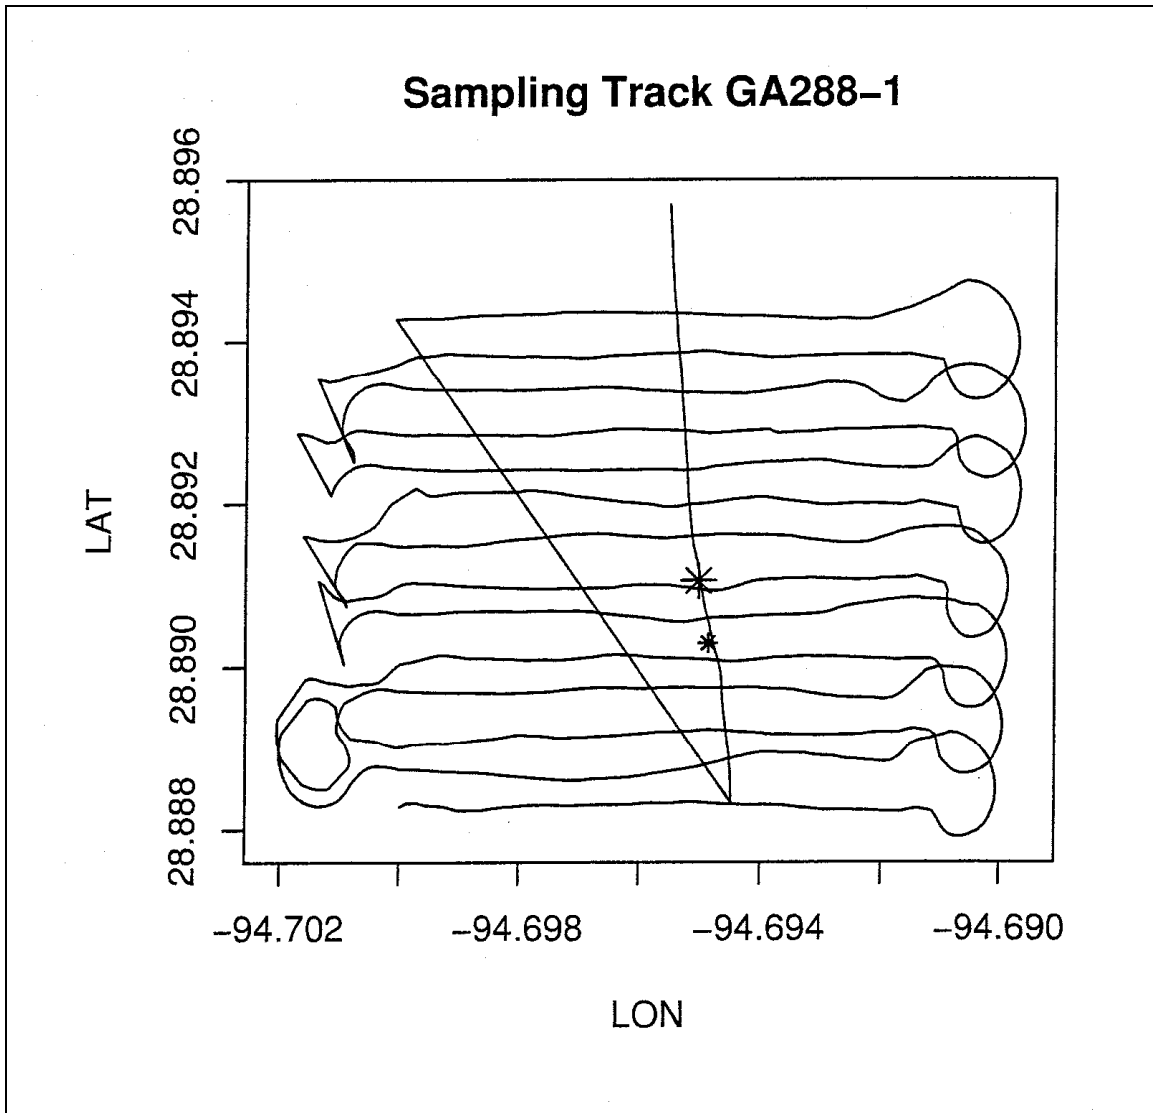
Figure B.1. Dual-beam hydroacoustic survey track, GA-288, October 2003. Large asterisk shows the center of the GA-288 production platform debris pile, small asterisk shows the center of the GA-288 quarters platform debris pile.

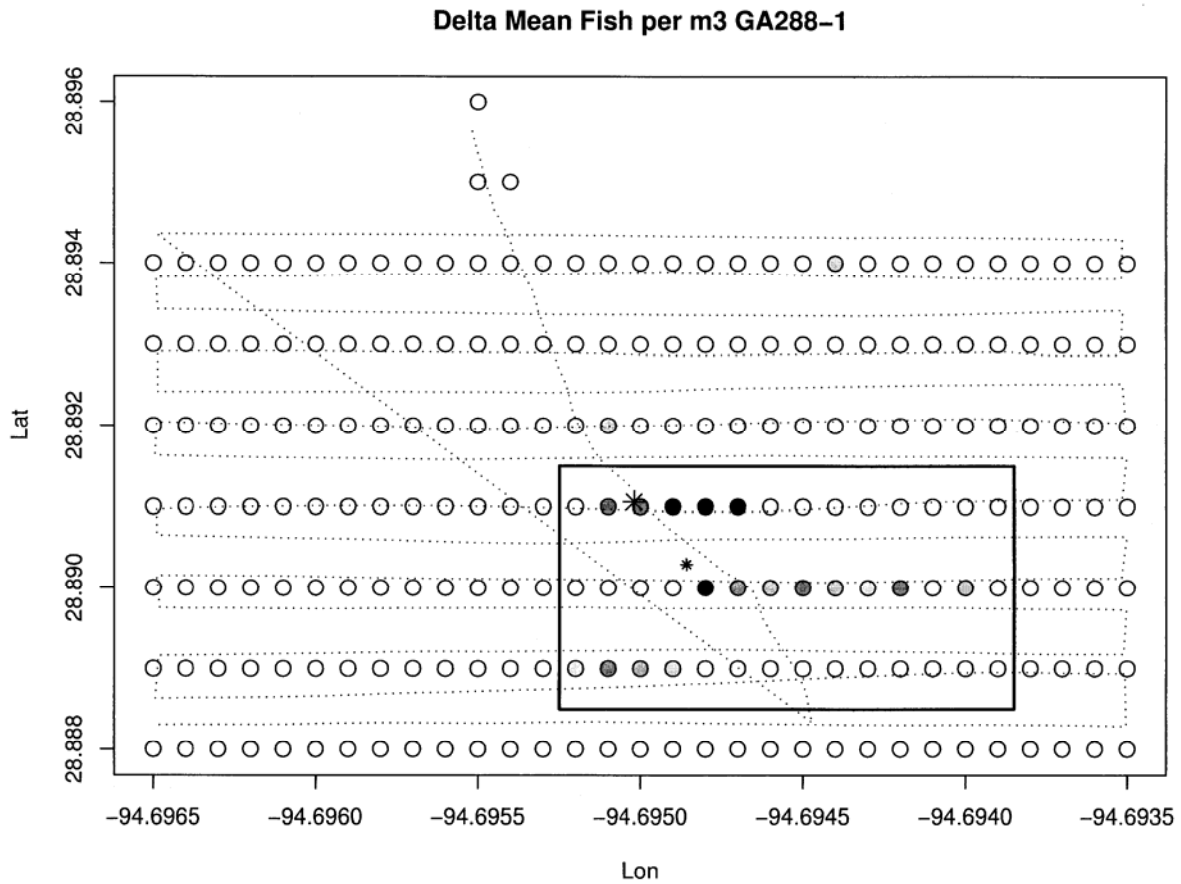
Figure B.5. Relative fish density along dual-beam hydroacoustic survey transect, GA-288, October 2003. Dotted lines show the actual transect track, large and small asterisks show locations of the GA-288 debris piles.

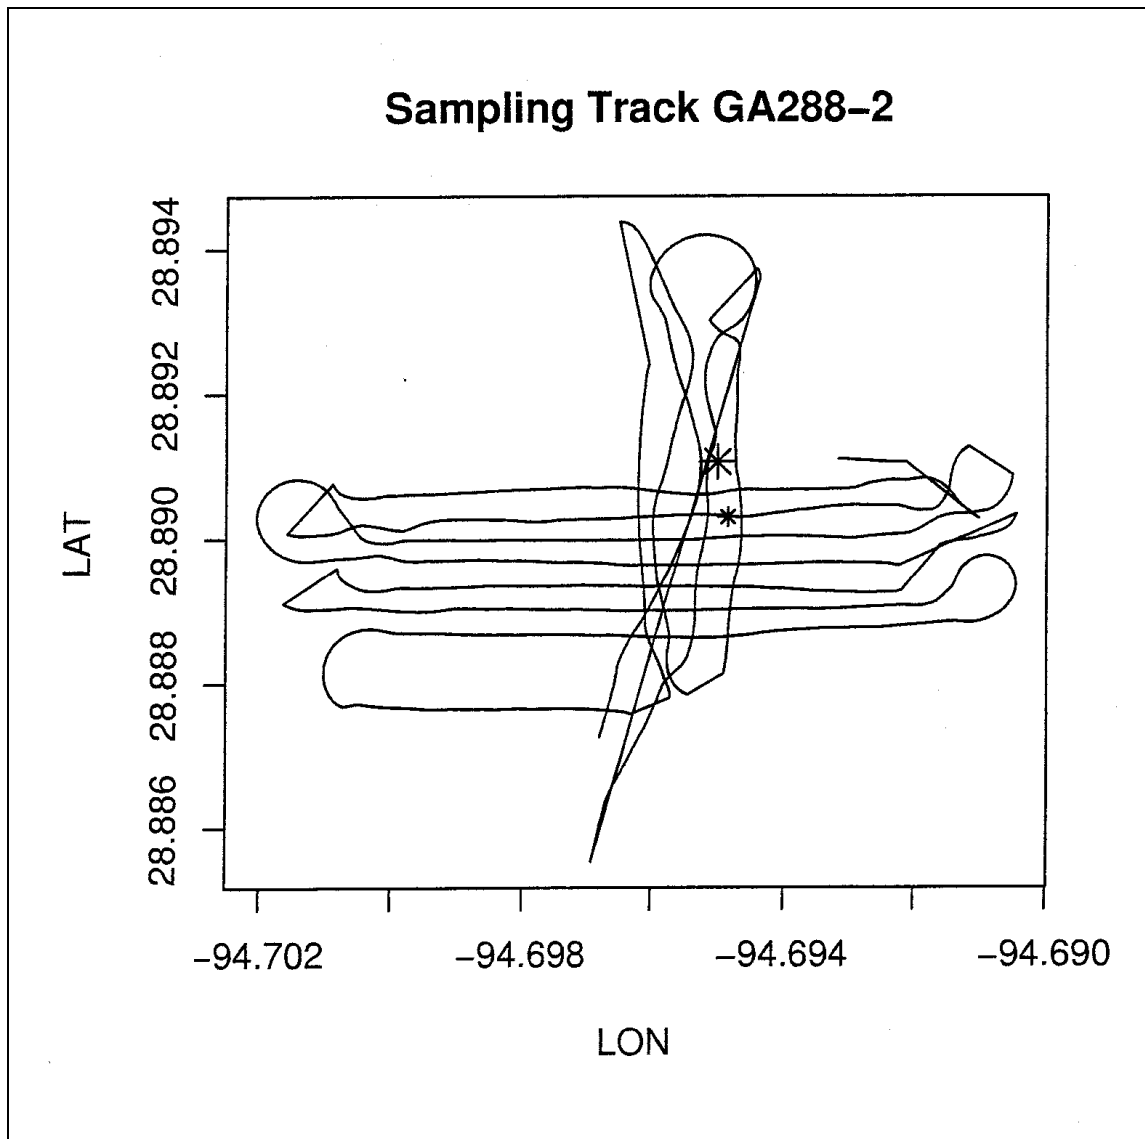
Figure B.7. Dual-beam hydroacoustic survey track, GA-288, August 2004. Large asterisk shows the center of the GA-288 production platform debris pile, small asterisk shows the center of the GA-288 quarters platform debris pile.

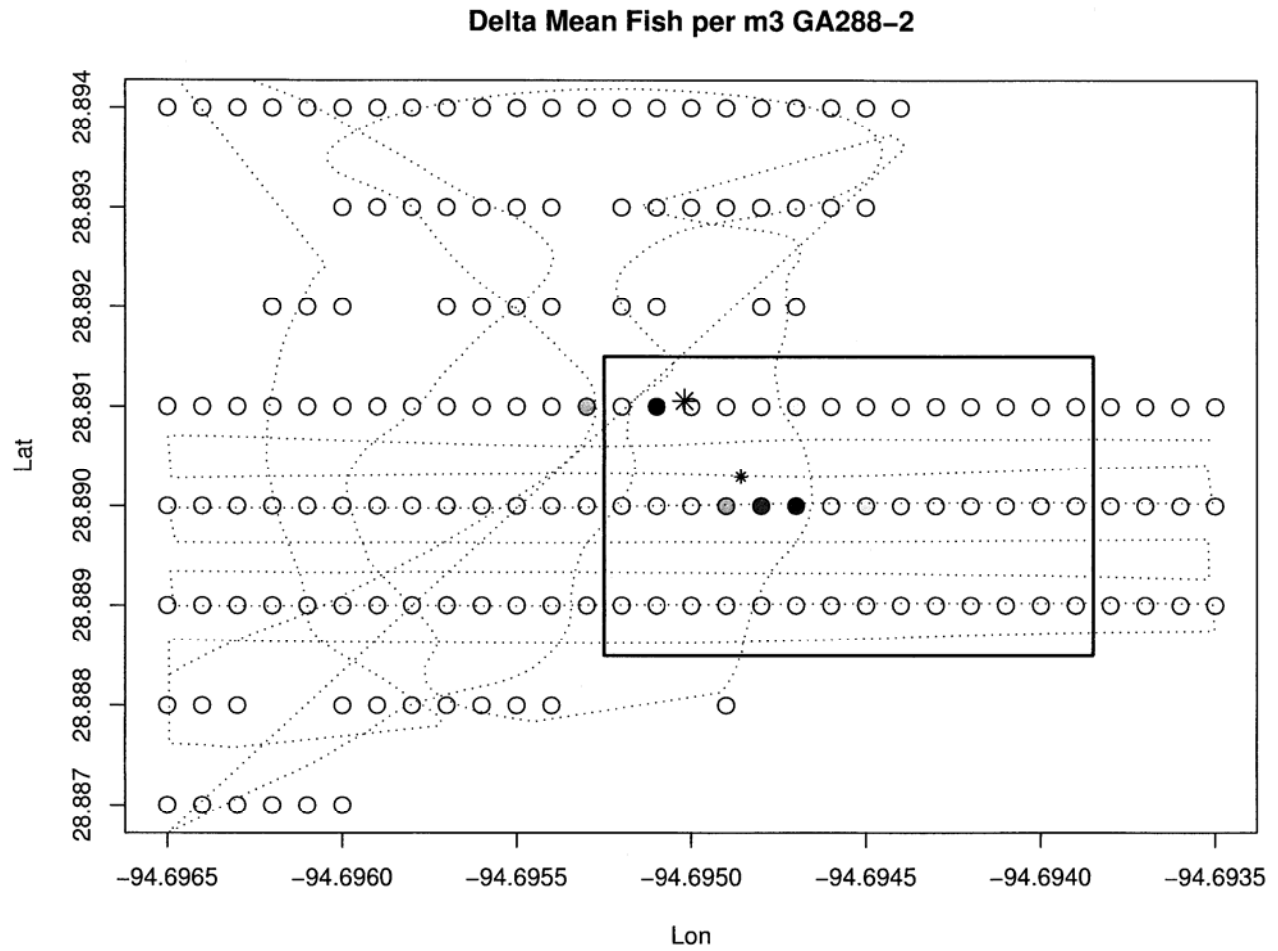
Figure B.11. Relative fish density along dual-beam hydroacoustic survey transect, GA-288, August 2004. Dotted lines show the actual transect track, large and small asterisks show locations of the GA-288 debris piles.

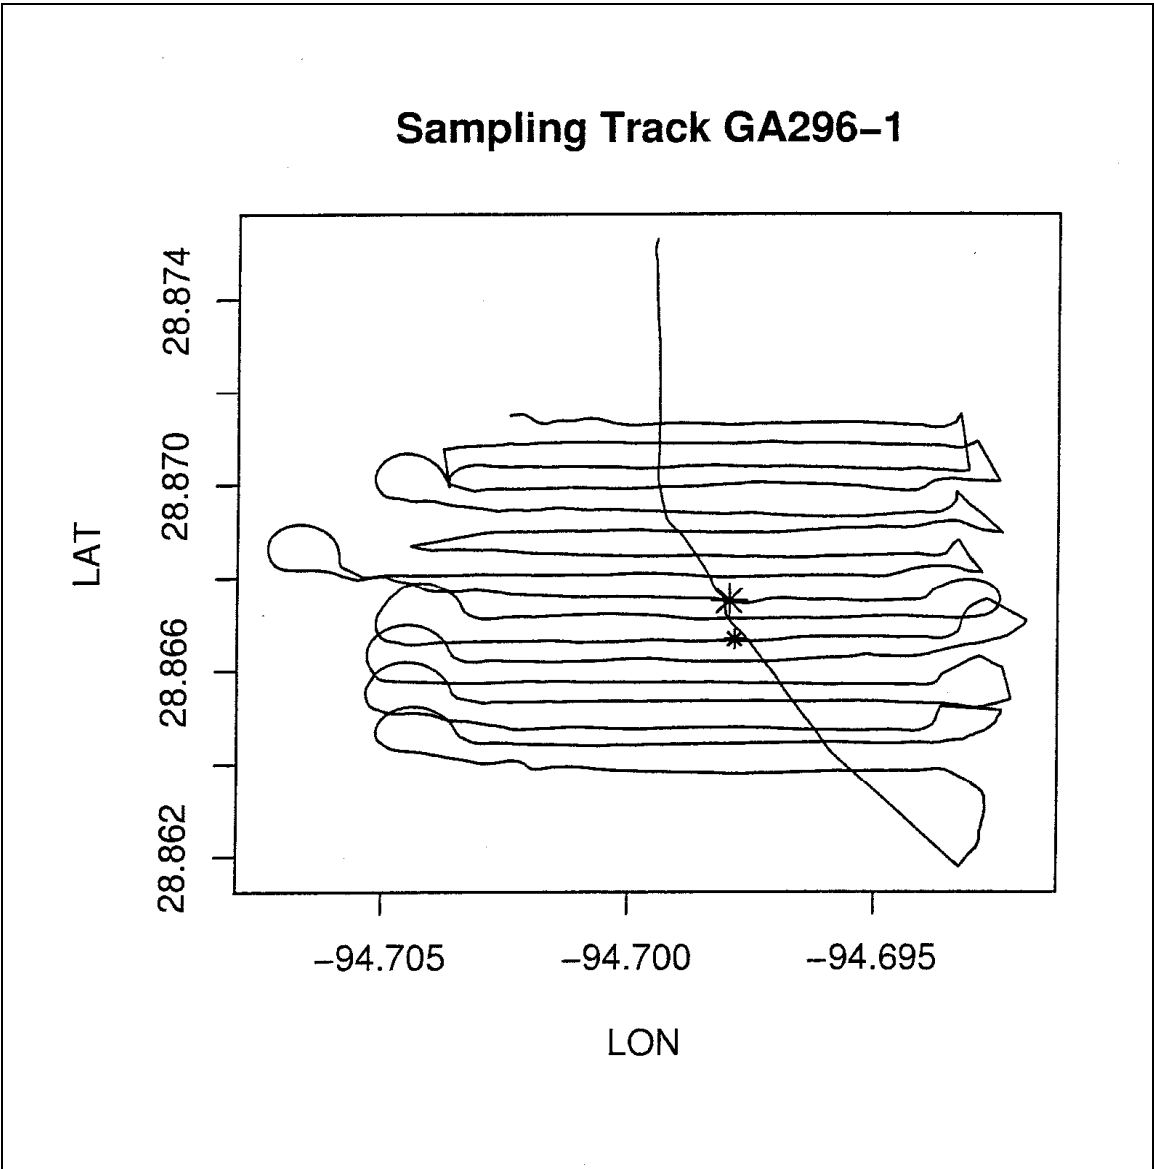
Figure B.13. Dual-beam hydroacoustic survey track, GA-296, October 2003. Large asterisk shows the center of the GA-296 production platform debris pile, small asterisk shows the center of the GA-296 quarters platform debris pile.

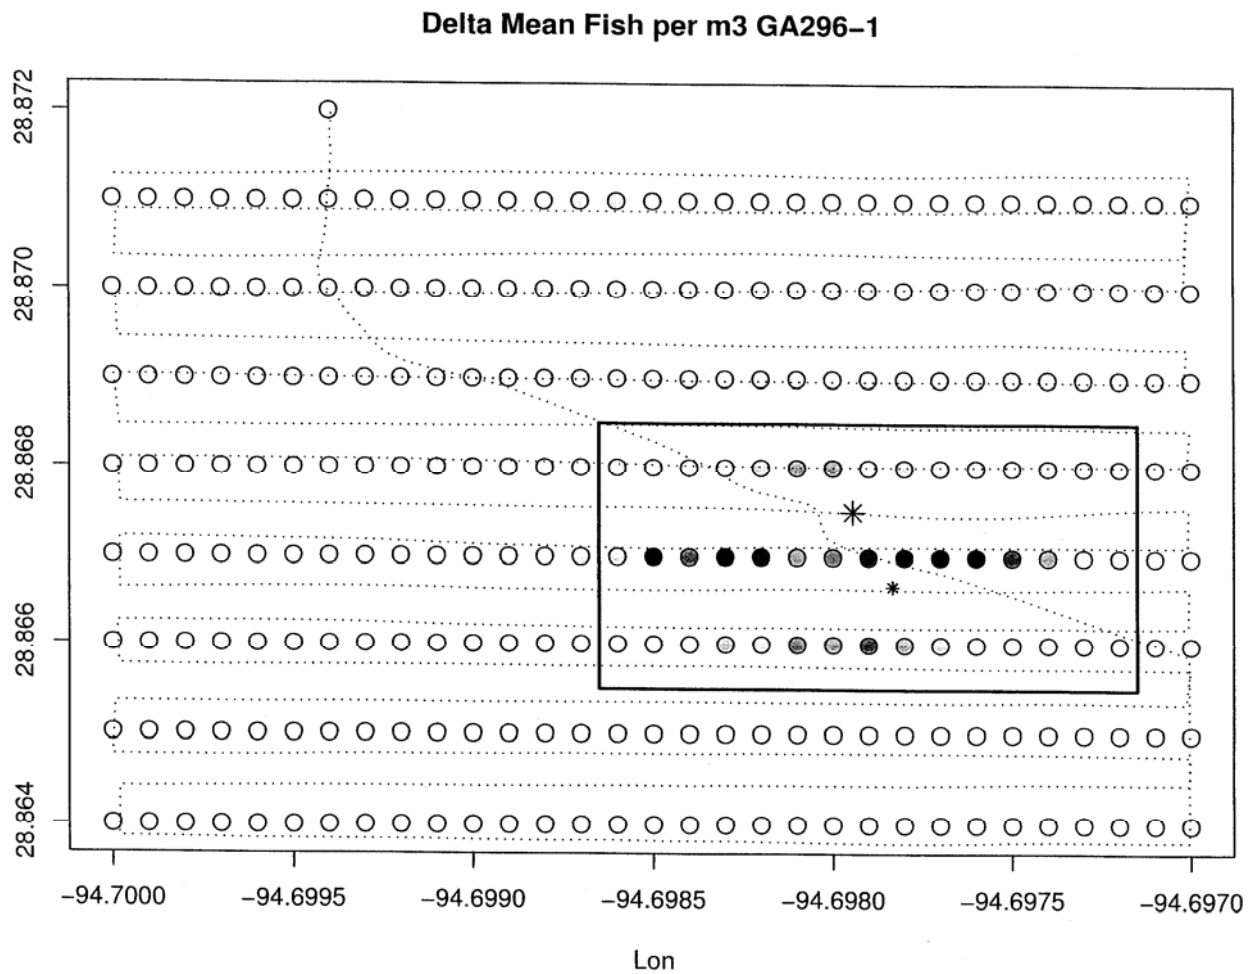
Figure B.17. Relative fish density along dual-beam hydroacoustic survey transect, GA-296, October 2003. Dotted lines show the actual transect track, large and small asterisks show locations of the GA-296 debris piles.

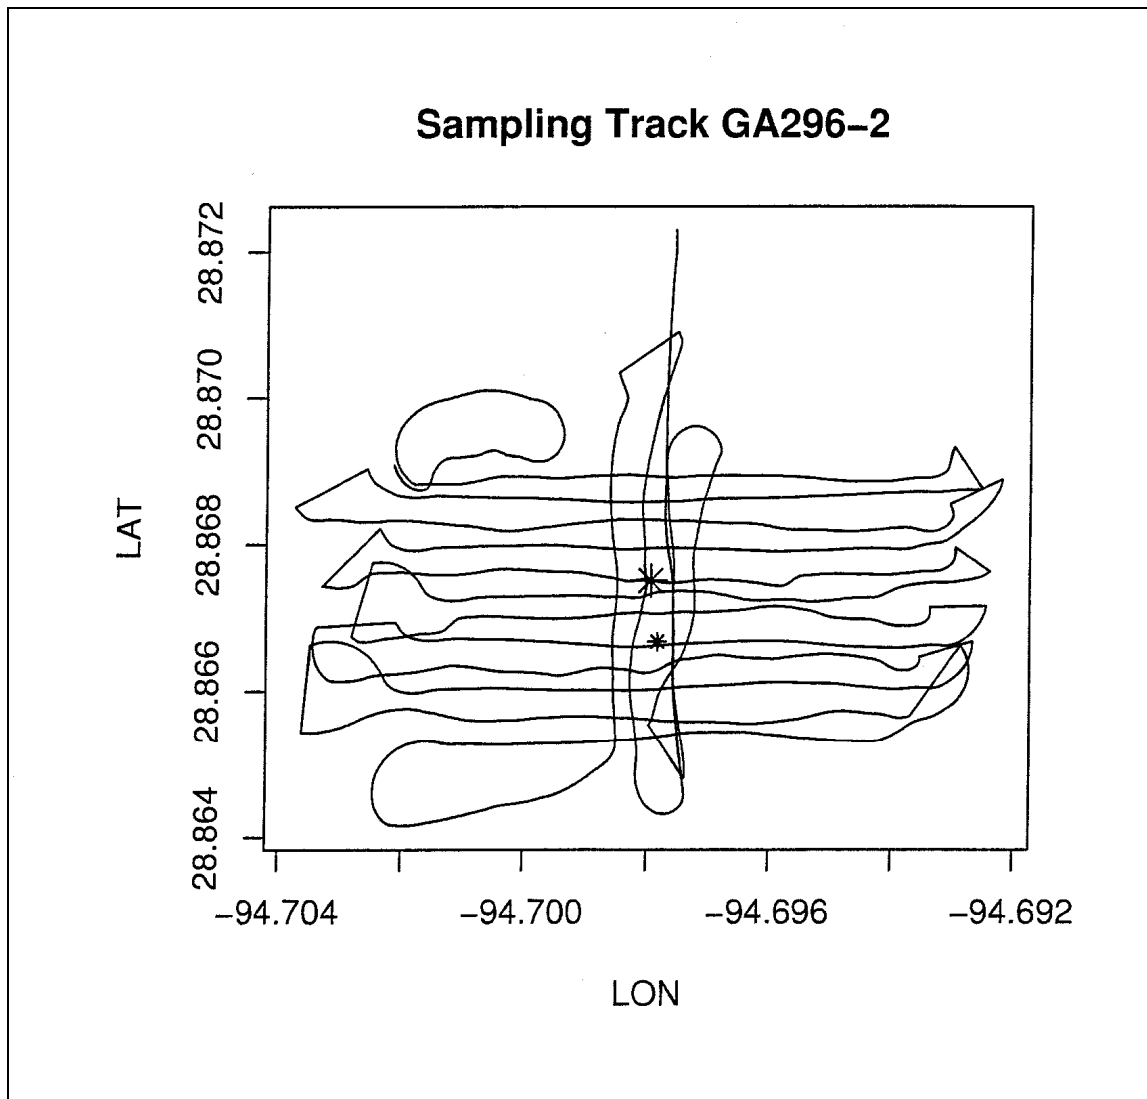
Figure B.19. Dual-beam hydroacoustic survey track, GA-296, August 2004. Large asterisk shows the center of the GA-296 production platform debris pile, small asterisk shows the center of the GA-296 quarters platform debris pile.

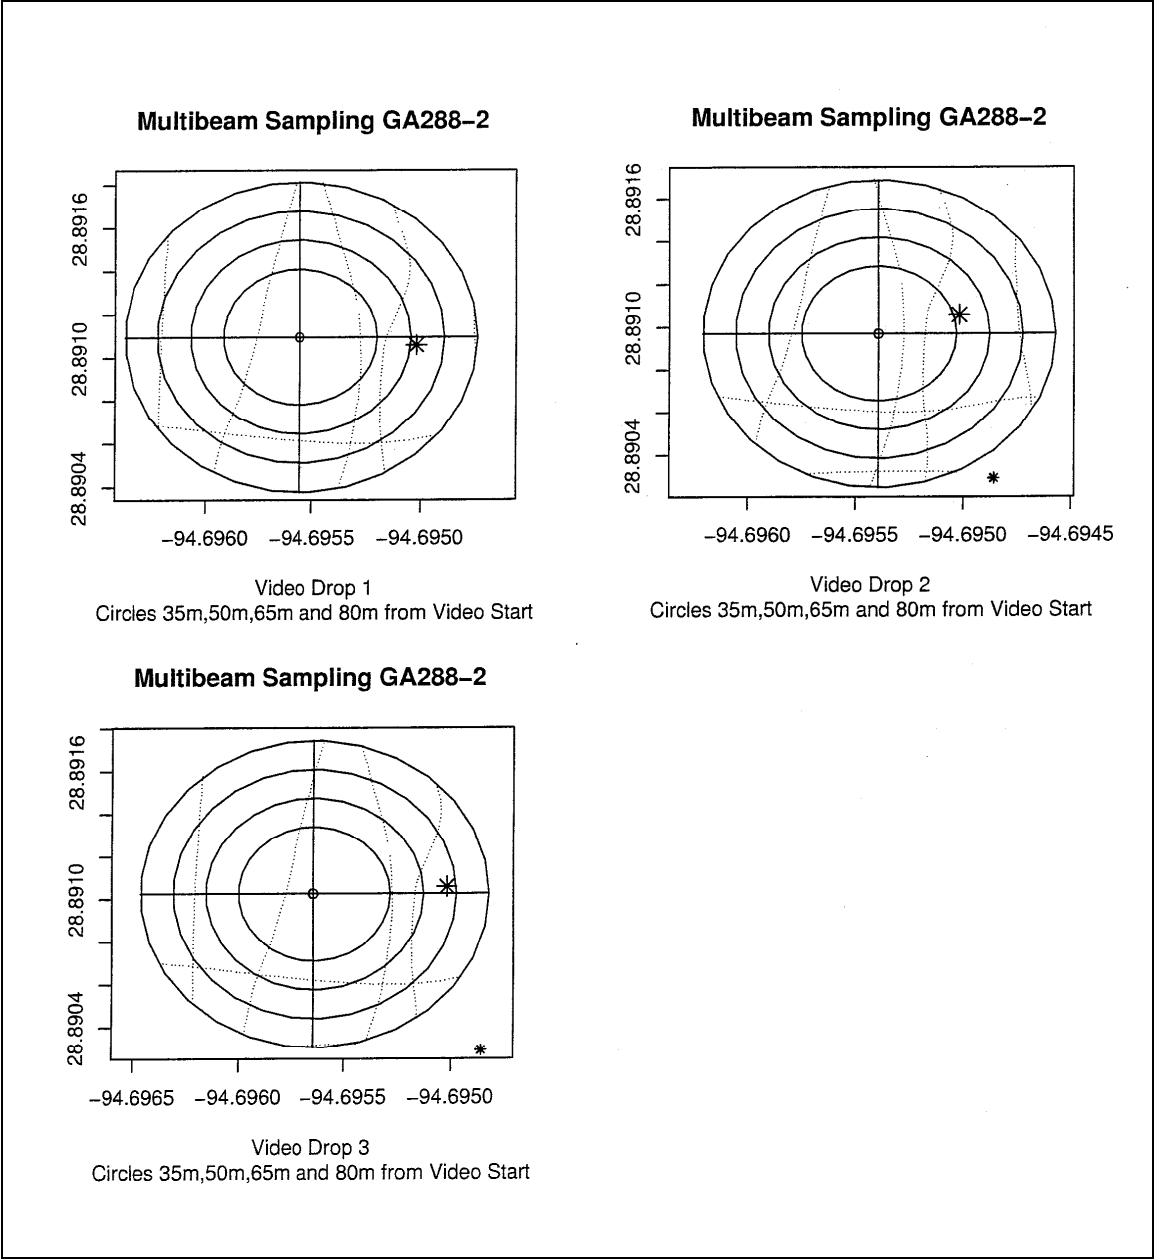
Figure B.25. Location of the ROV video drops (center of circle), at GA-288, August 2004. Large asterisk shows the location of the center of the production platform debris pile; the small asterisk shows the location of the quarters platform pile.
